US010240513B2

(10) **Patent No.:** **US 10,240,513 B2**
(45) **Date of Patent:** **Mar. 26, 2019**

(54) **METHOD OF REPAIRING AN ENGINE COOLING SYSTEM AND A REPAIRED ENGINE**

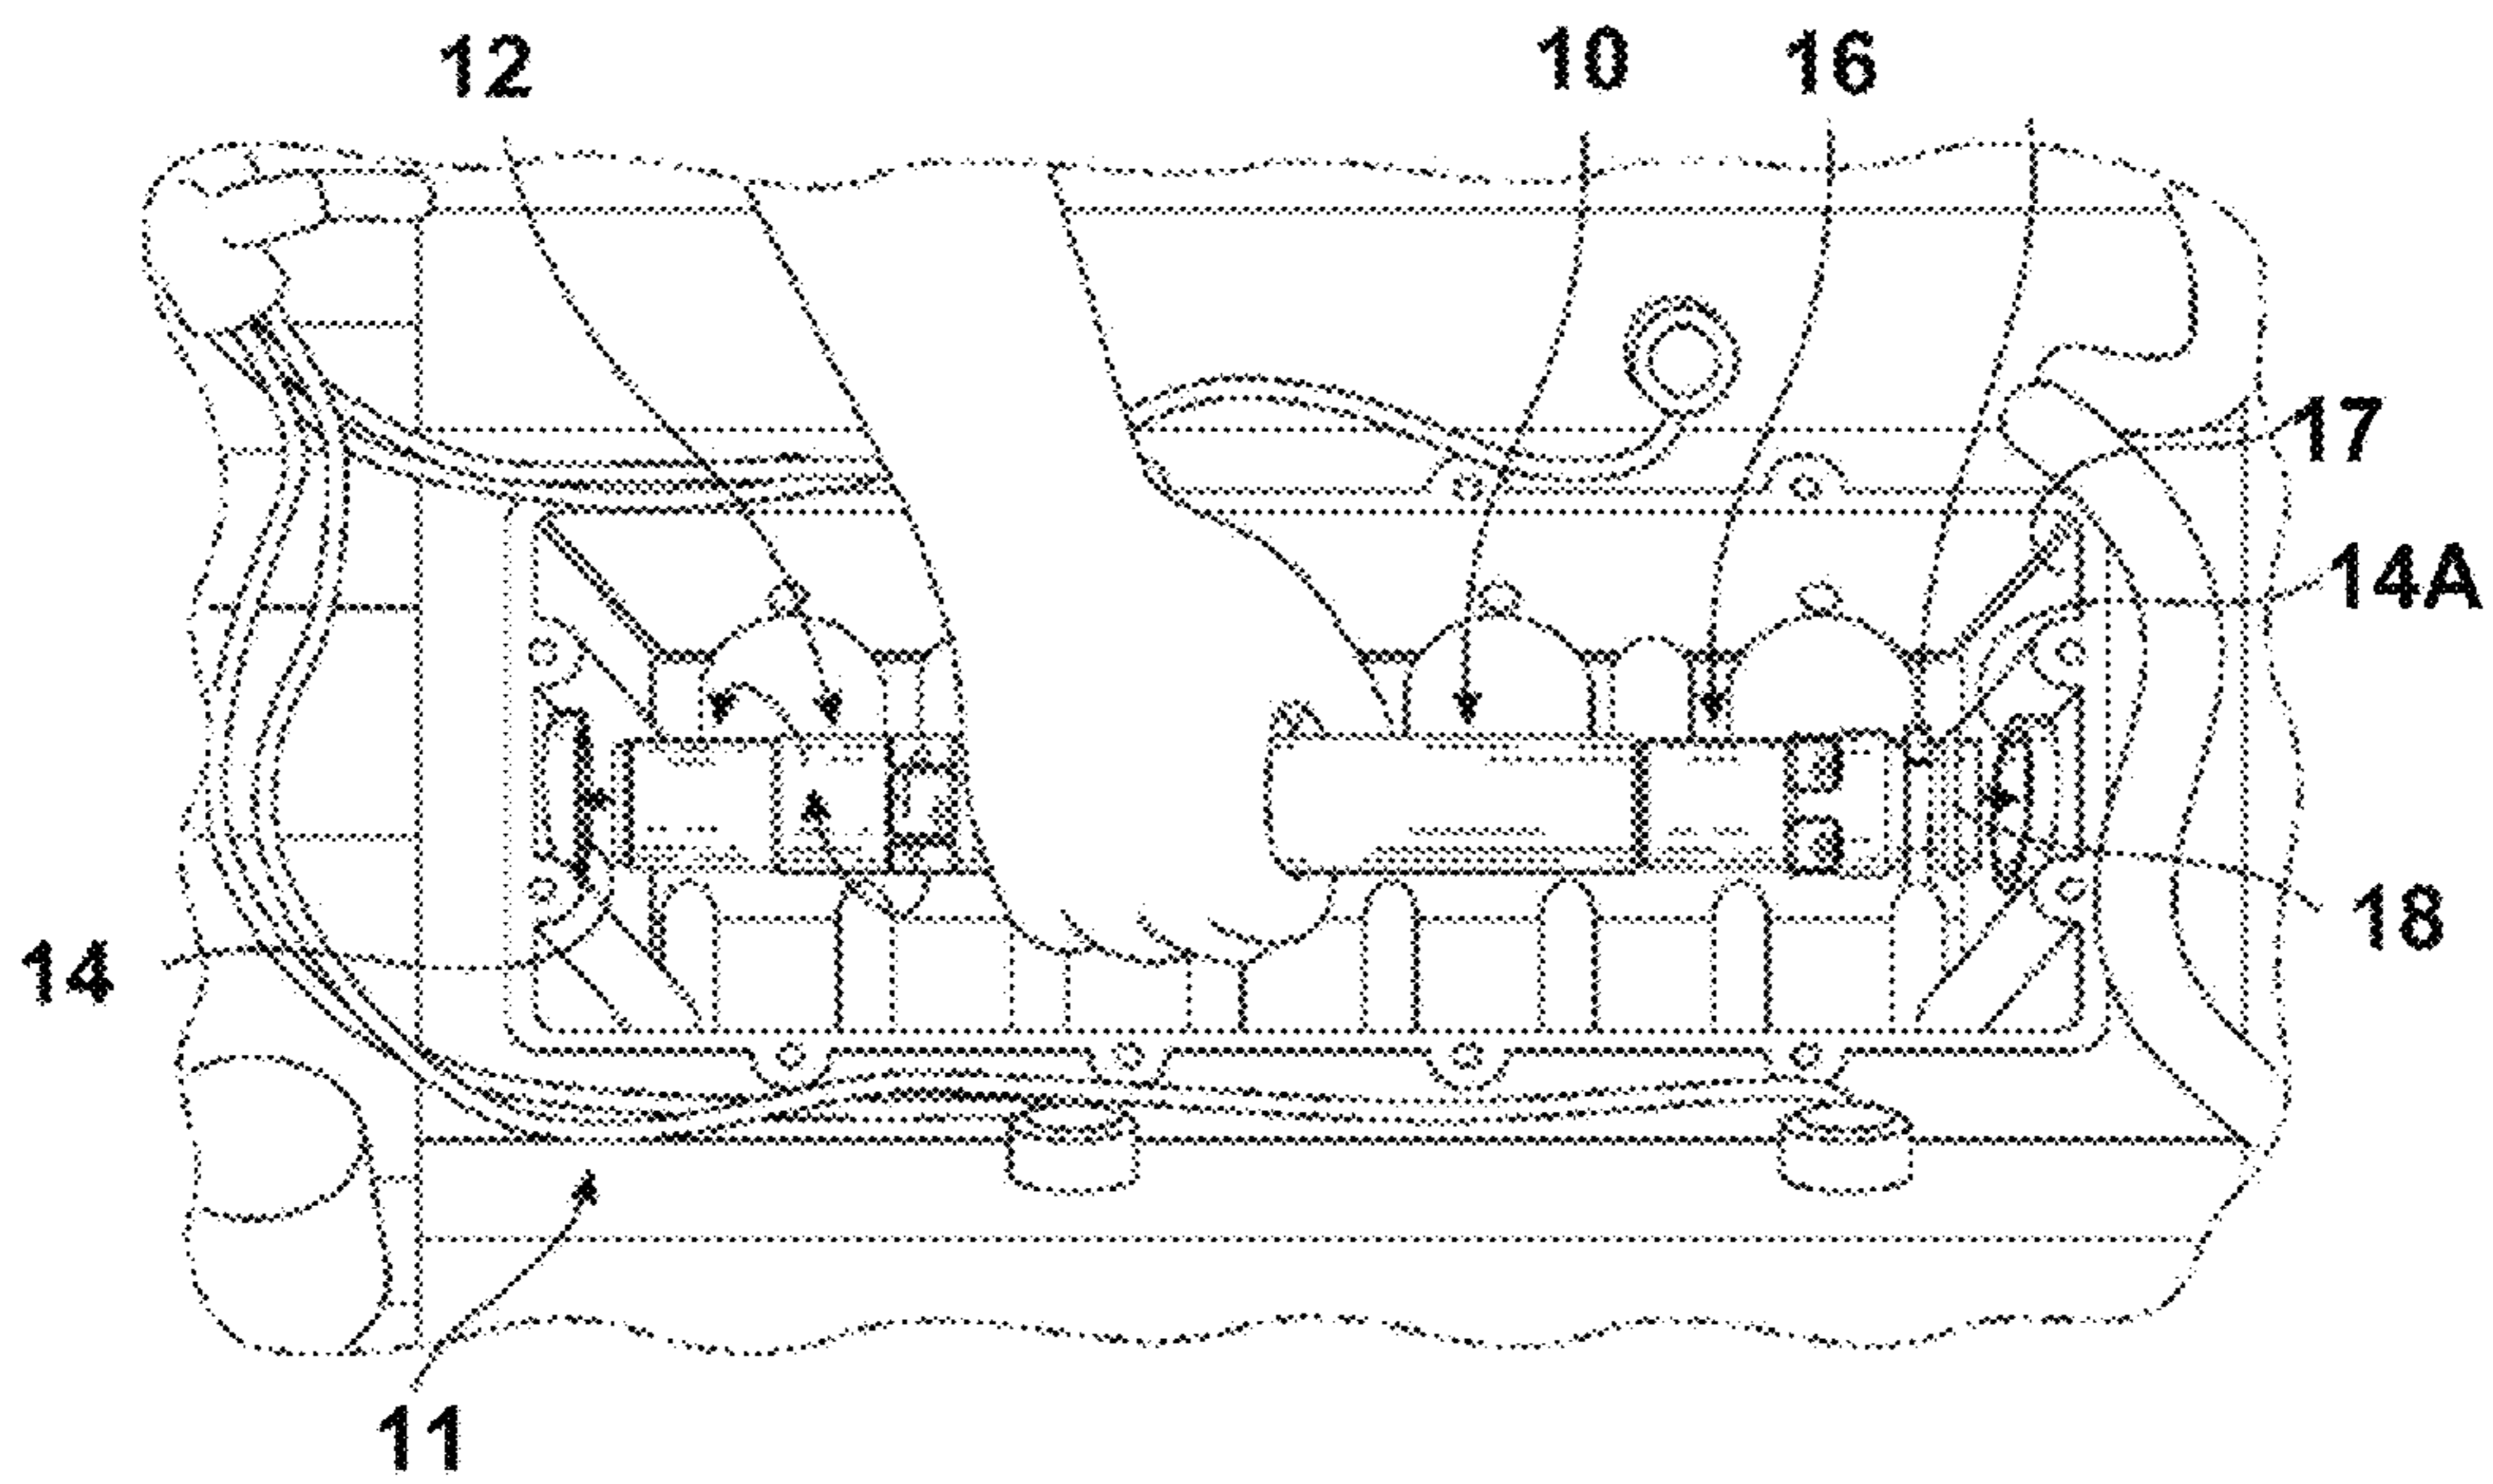
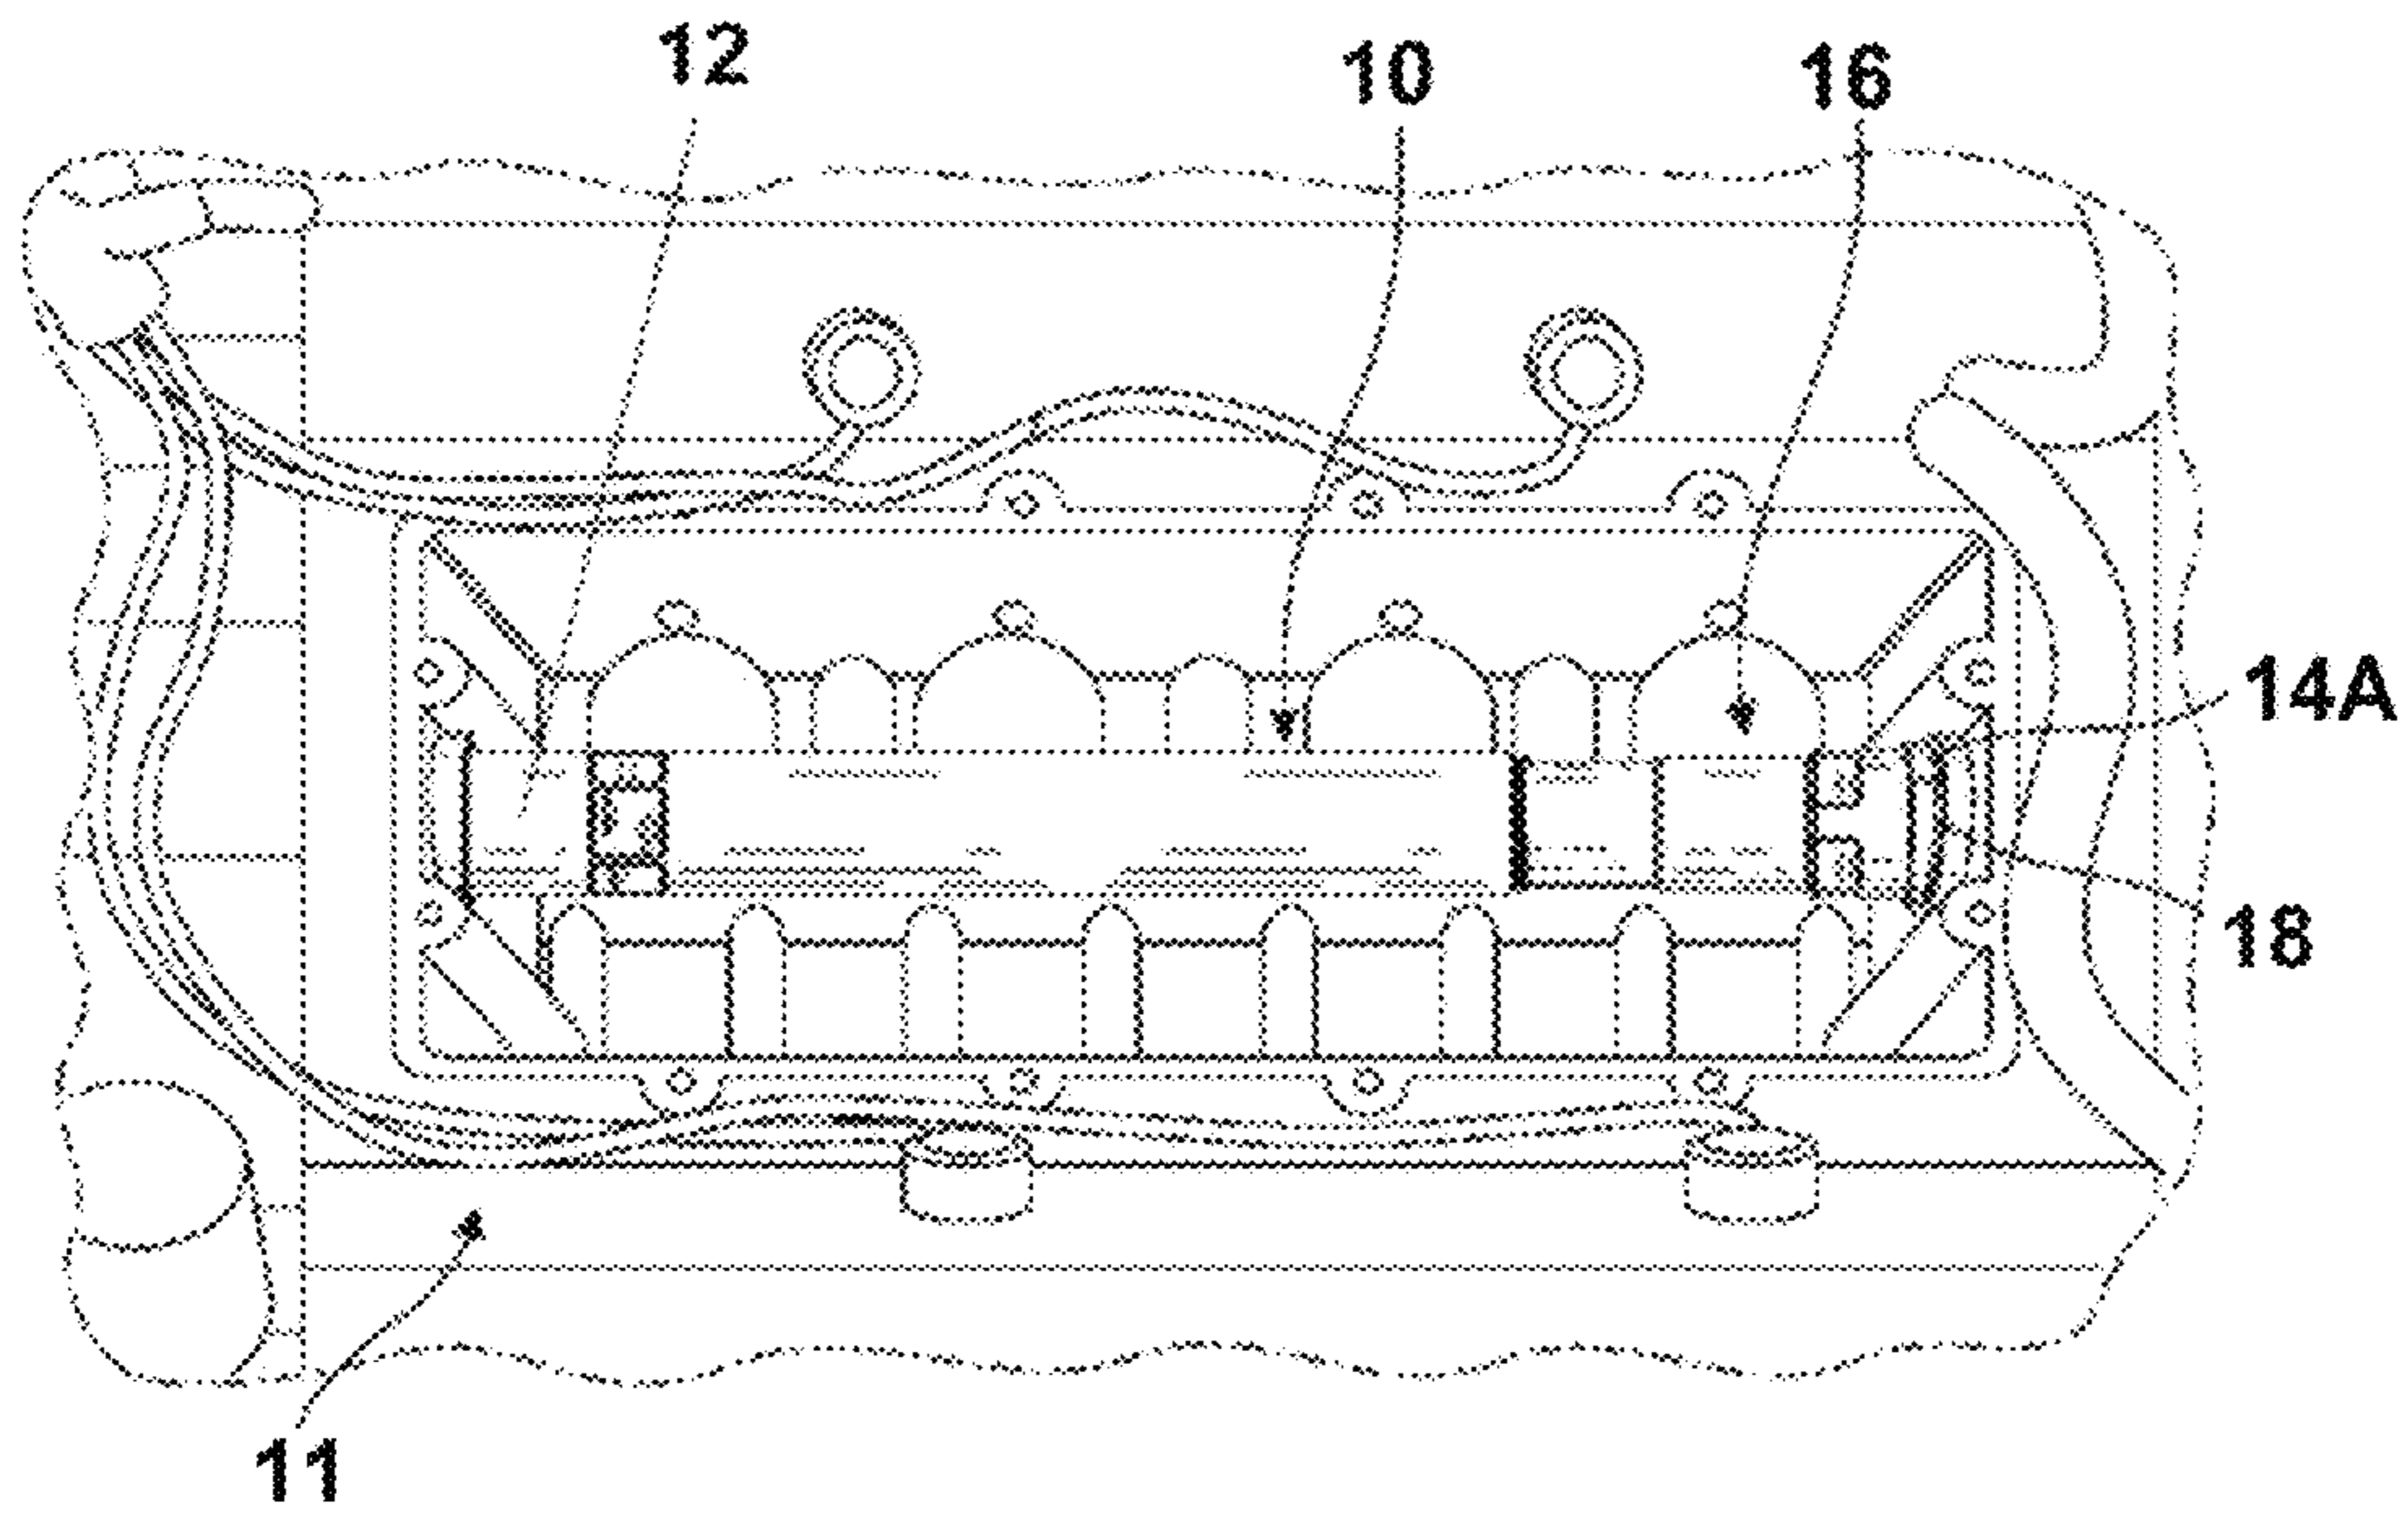
Fig. 1
(Prior Art)

FIGS. 1 and 2 show a replacement coolant transfer pipe **10** that is marketed by All German Auto as “the expanding cooling pipe,” in accordance with the disclosure in U.S. Pat. No. 8,464,424. The expanding cooling pipe is shown as being installed in an engine block **17** of a BMW automobile having an N62 engine **11**. Installation of the replacement coolant transfer pipe **10** is similar to that of the installation method for the collapsible BMW coolant transfer pipe, described above. Installation of the replacement coolant transfer pipe **10** also requires the removal of the intake manifold, and then requires cutting out the old coolant transfer pipe inside the engine block before the replacement coolant transfer pipe **10** can be installed.

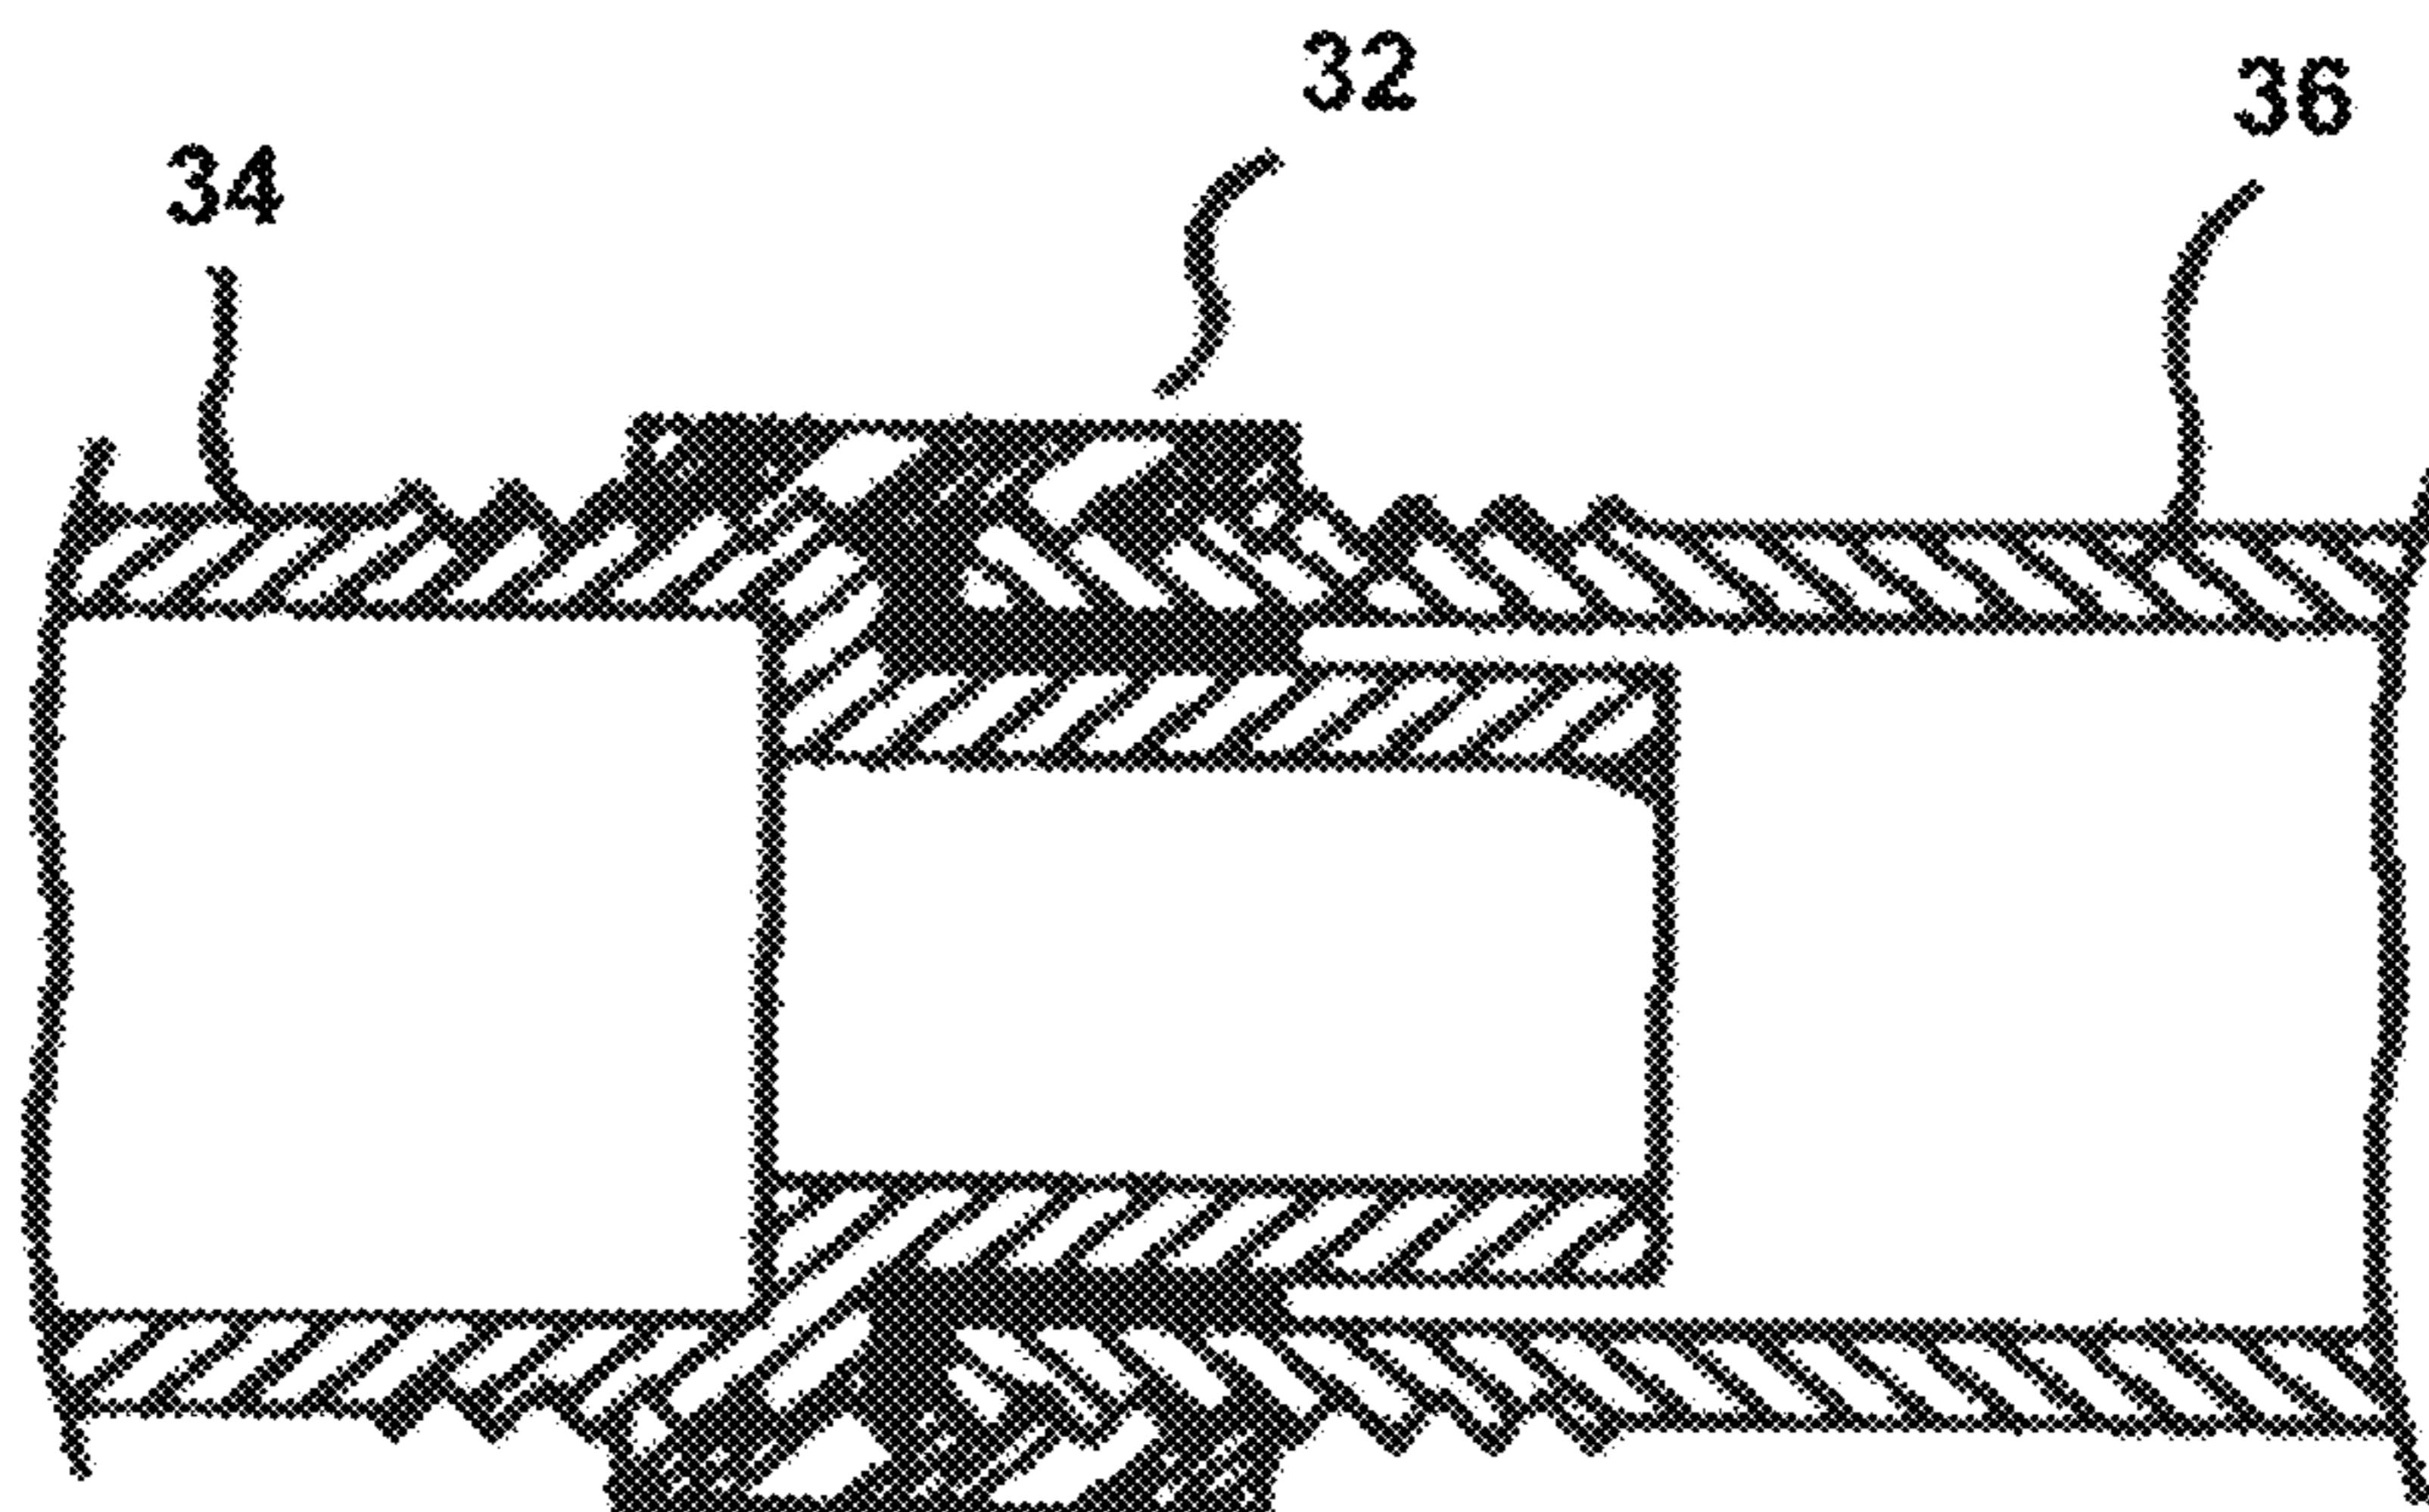
Fig. 4
(Prior Art)

Korean Patent publication KR 100143619 of Daewoo Motor Co. LTD., illustrated in FIG. **4**, discloses a pipe fitting **32** wherein a projecting part of a first pipe **34** can be inserted into a second pipe **36**. The joined portion is coupled with the fitting **32** to prevent a coolant from leaking through the gap between the first pipe **34** and the second pipe **36**. However, this arrangement involves a plurality of parts and is only as good as the integrity of the coupling. Compression and expansion can affect the integrity of the coupling. Also, such an arrangement cannot prevent coolant leakage at the front seal.

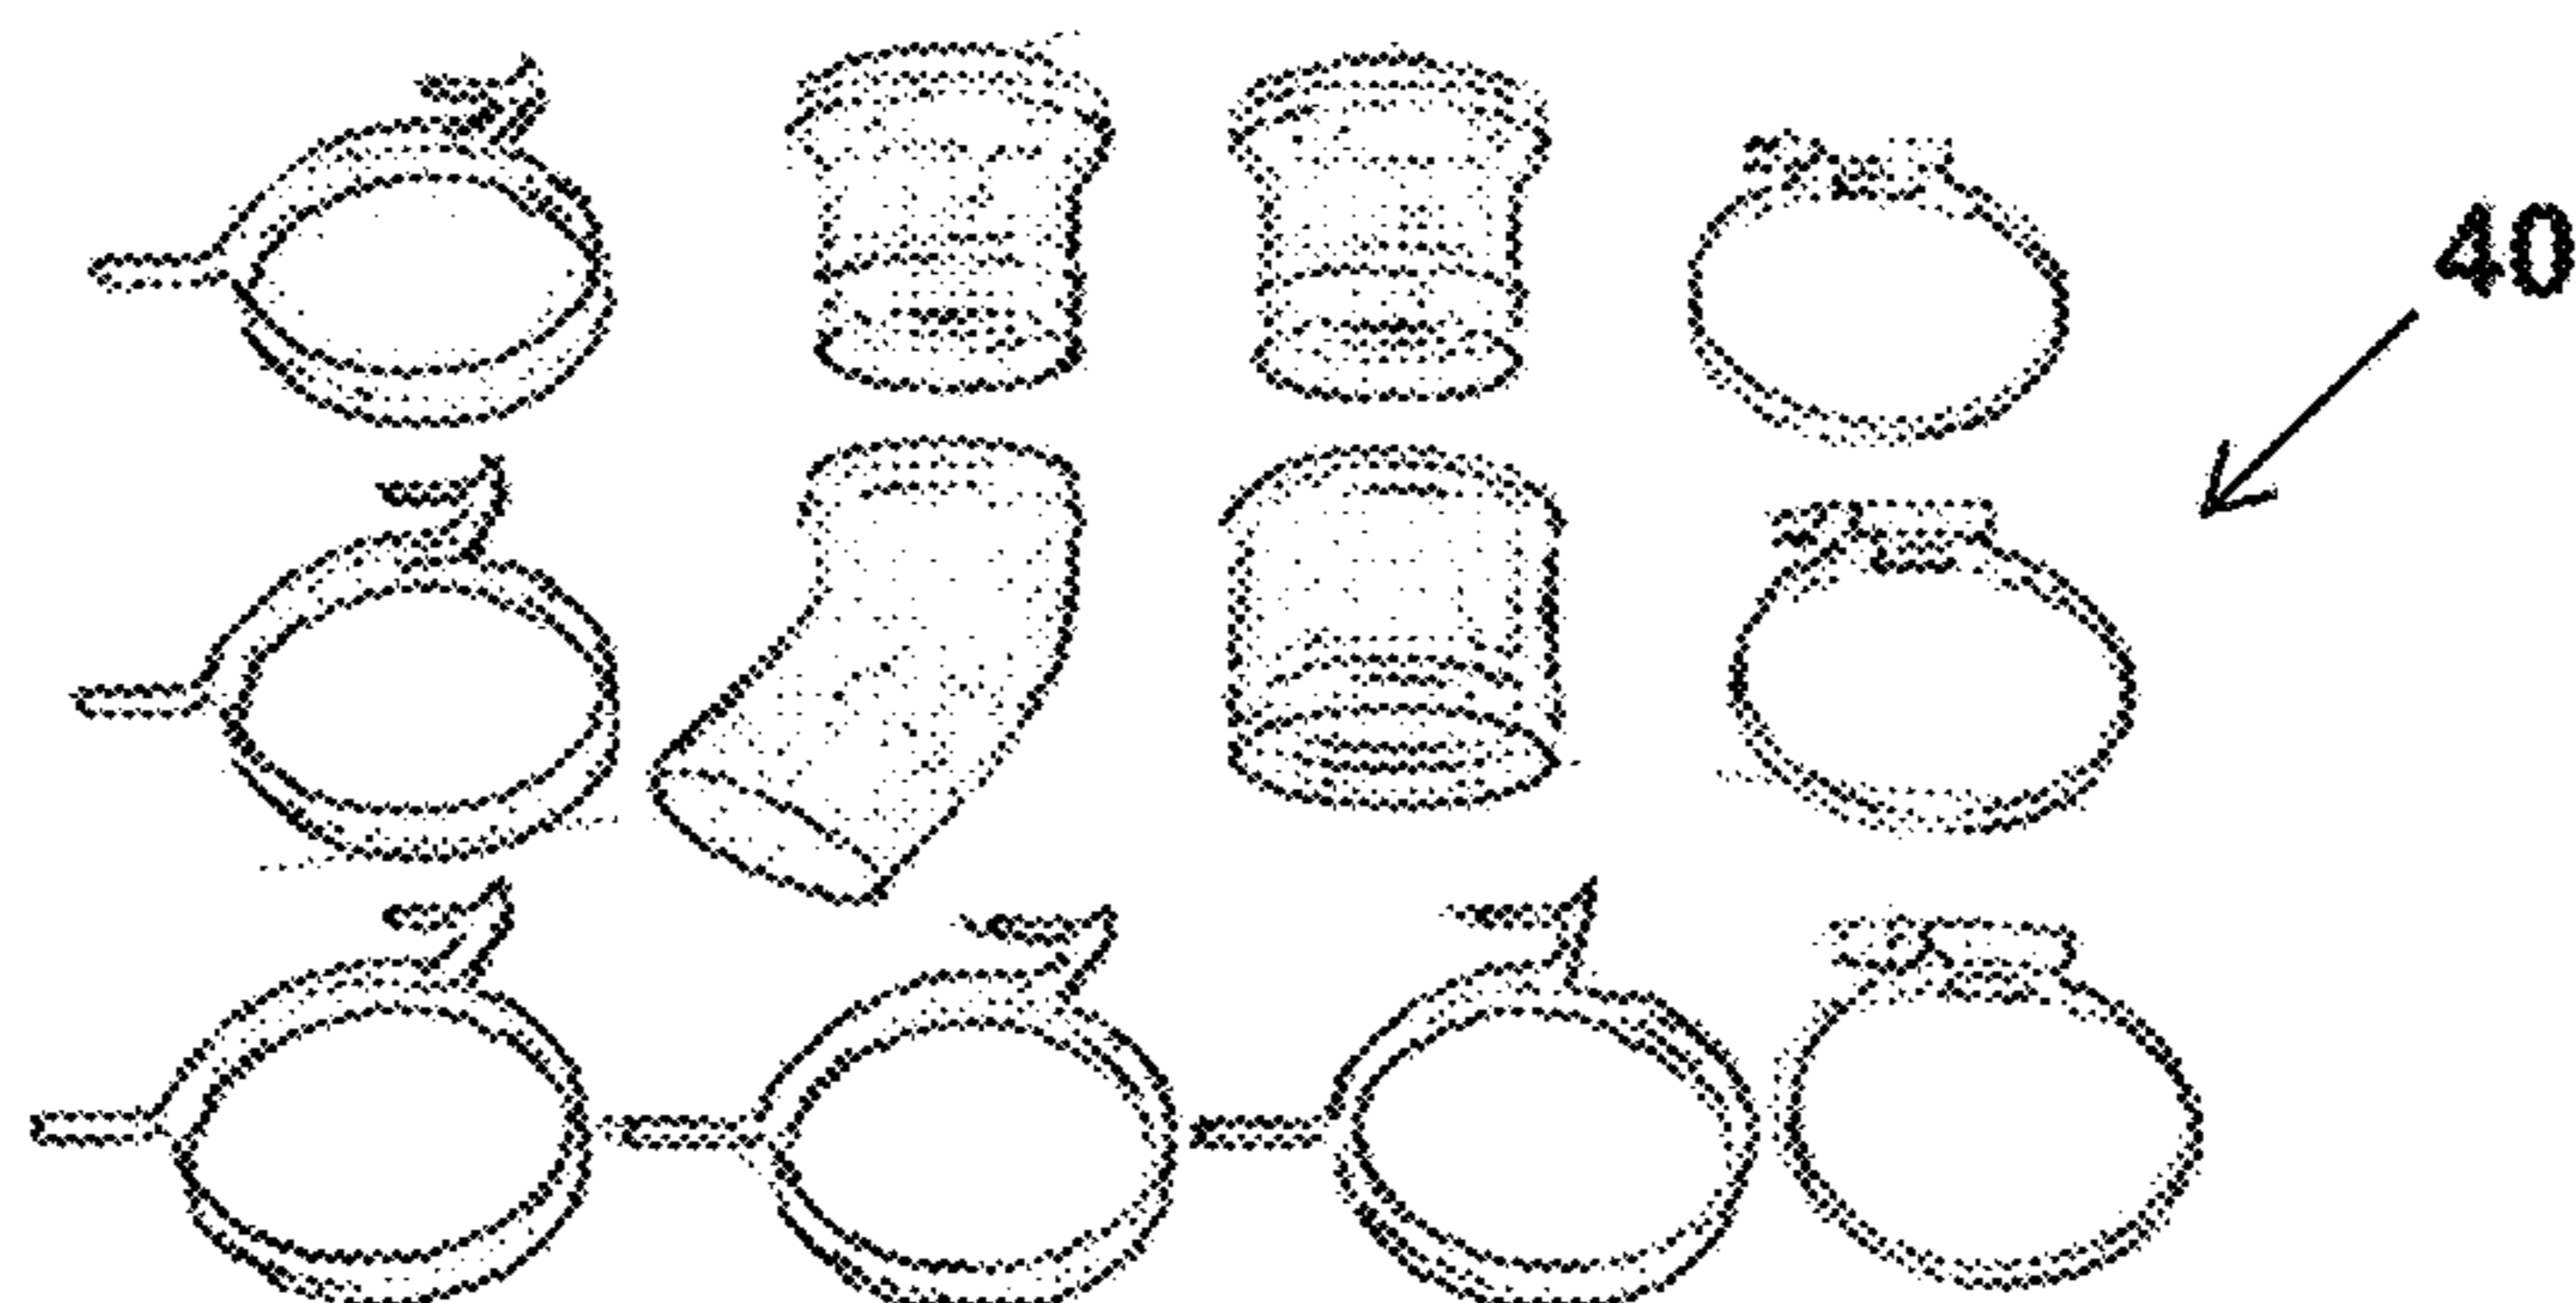
Fig. 5
(Prior Art)

A GoWesty coolant pipe repair kit, illustrated in FIG. **5**, provides a collection **40** of Brass fittings, screw clamps and spring clamps. However, these are suited only for repairing radiator coolant pipes located outside the engine block in Vanagons.

FIG. **5** is an illustration of components of a coolant pipe repair kit available from GoWesty, in accordance with the prior art;

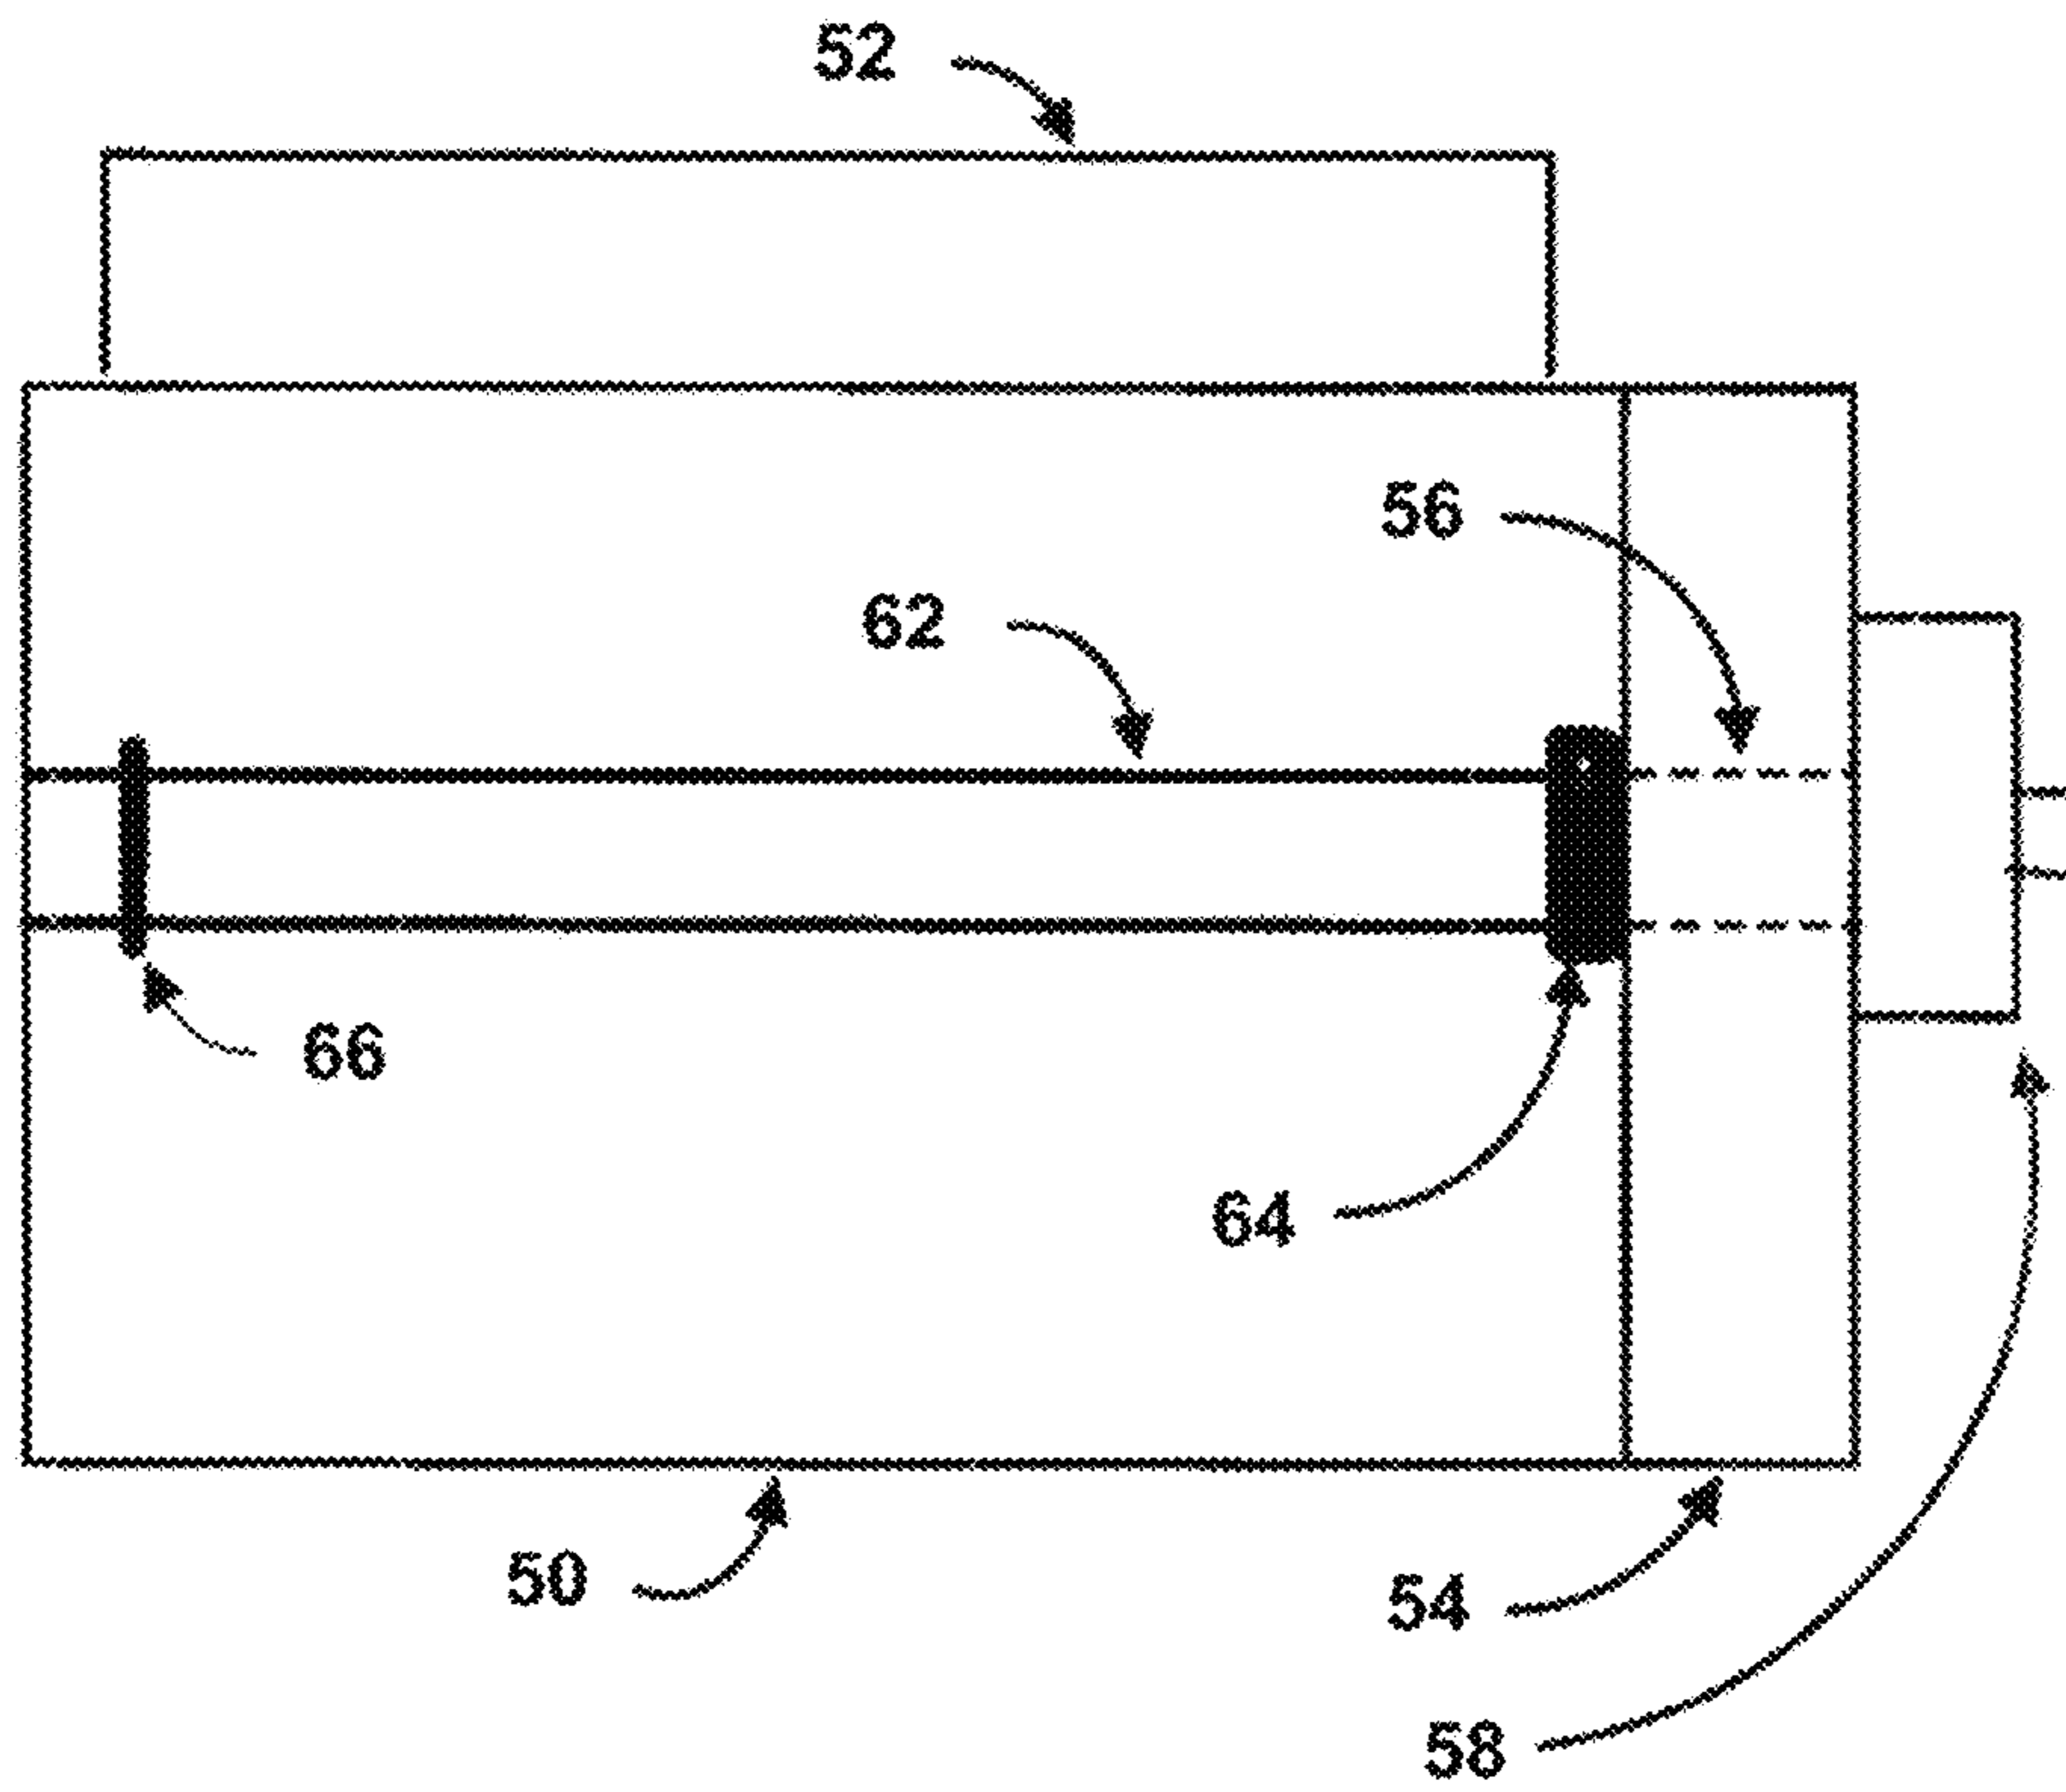
Fig. 6
(Prior Art)

FIG. 6 shows the side view of a crosscut section of a typical engine block 50. This drawing illustrates a typical configuration for a BMW "N62" engine, but other engine configurations will still be within the teachings of this apparatus and method disclosure herein. During normal engine operation, the water pump 58 pumps coolant through the engine block 50, first from the water pump 58, through a timing cover coolant passage 56 in the timing cover 54, then past the front seal 64, and into the coolant transfer pipe 62. In some cases, there can also be some leaking from a rear O-ring Seal 66.

When a front seal 64 fails, coolant will escape between the front seal 64 and the coolant transfer pipe 62, causing the engine to become overheated and risk potential costly damage to the engine, and the potential for passengers of the vehicle to become stranded on the side of the road. In order to replace the coolant transfer pipe 62 and front seal 64, a mechanic would need to remove the intake manifold 52 and/or the timing cover 54, in order to remove the defective parts.

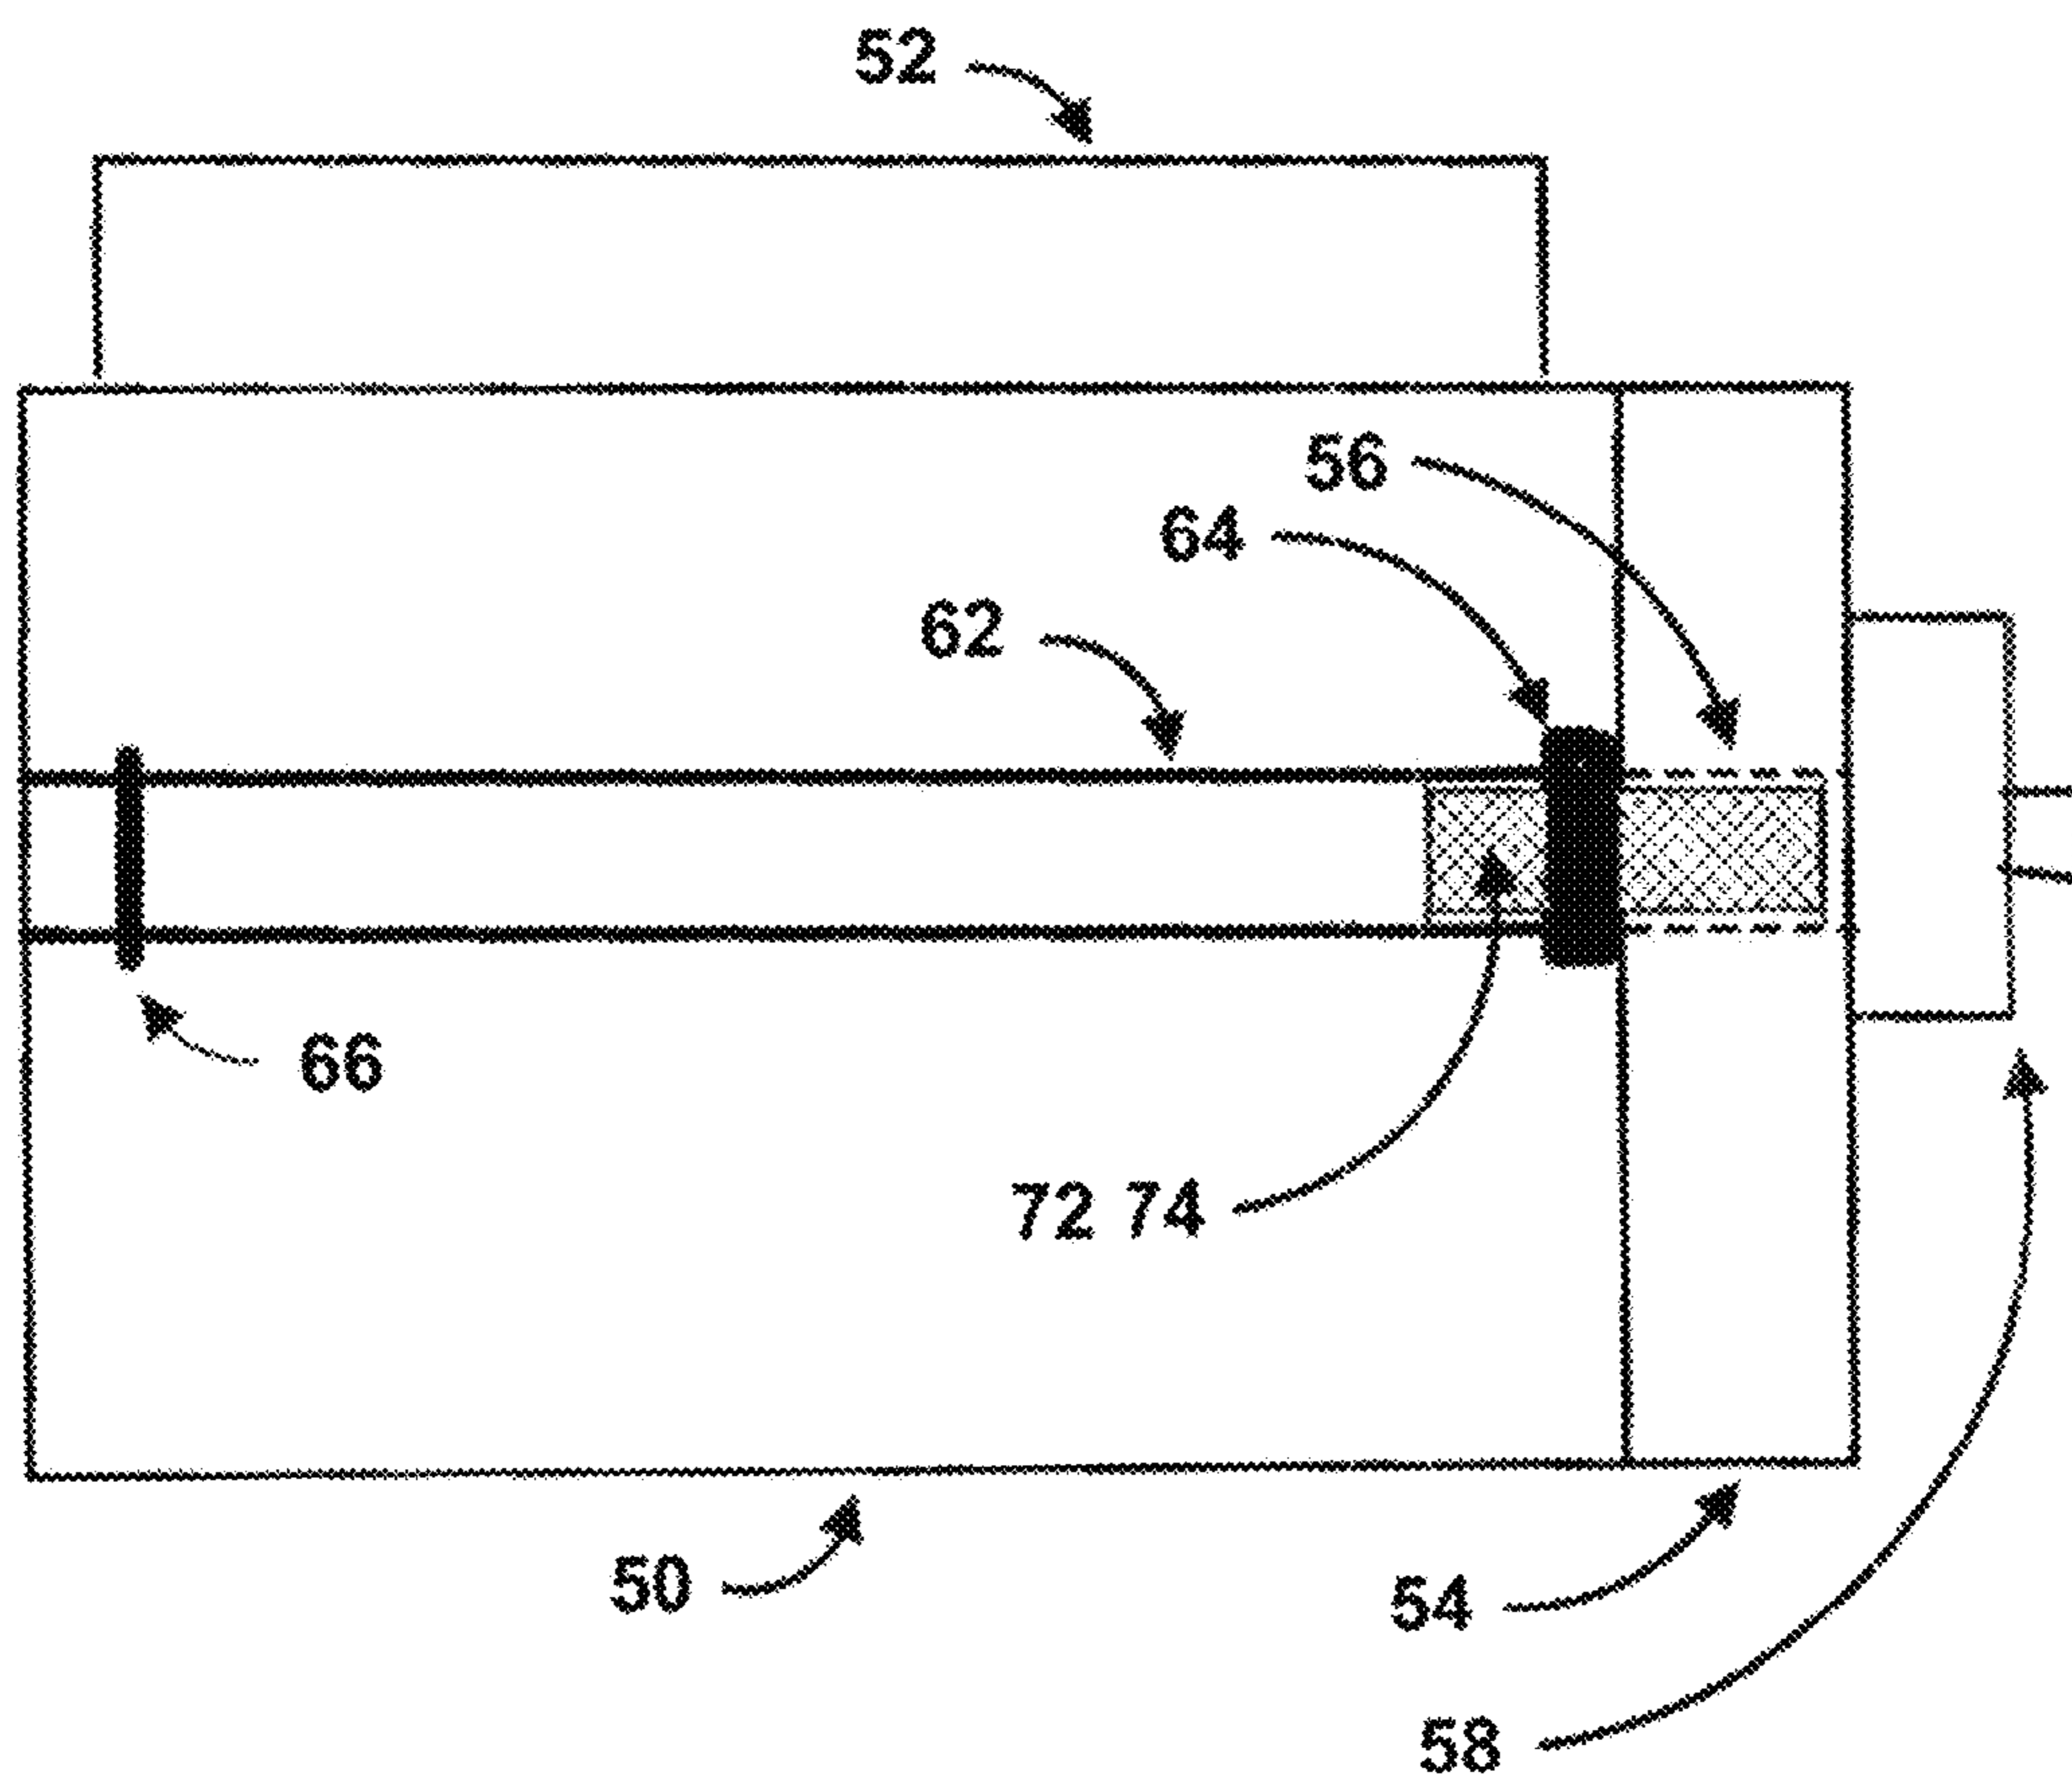
Fig. 7

FIG. **7** is a view of the conventional engine block of FIG. **6** illustrating an apparatus and method for repairing a leaking front seal and coolant transfer pipe, in accordance with the present invention;

FIG. 7 shows a unique apparatus and method for repairing the leaking front seal 64 and coolant transfer pipe 62, without the need to remove the intake manifold 52 or the timing cover 54, thereby saving many hours of expensive labor and costly parts and materials. After removing the water pump 58, a repair tube insert 72 may be coated with sealant 74 and inserted through the timing cover coolant passage 56 directly into the coolant transfer pipe 62.

The repair tube insert 72 when coated with sealant 74 creates a bond and seal between the timing cover coolant passage 56, the coolant transfer pipe 62 and the front seal 64, in order to stop coolant from leaking into the engine block 50. The original front seal 64 and the coolant transfer pipe 62 do not need to be removed from the engine block 50, and remain in place.
