US010240513B2

(10) **Patent No.:** **US 10,240,513 B2**
(45) **Date of Patent:** **Mar. 26, 2019**

(54) **METHOD OF REPAIRING AN ENGINE COOLING SYSTEM AND A REPAIRED ENGINE**

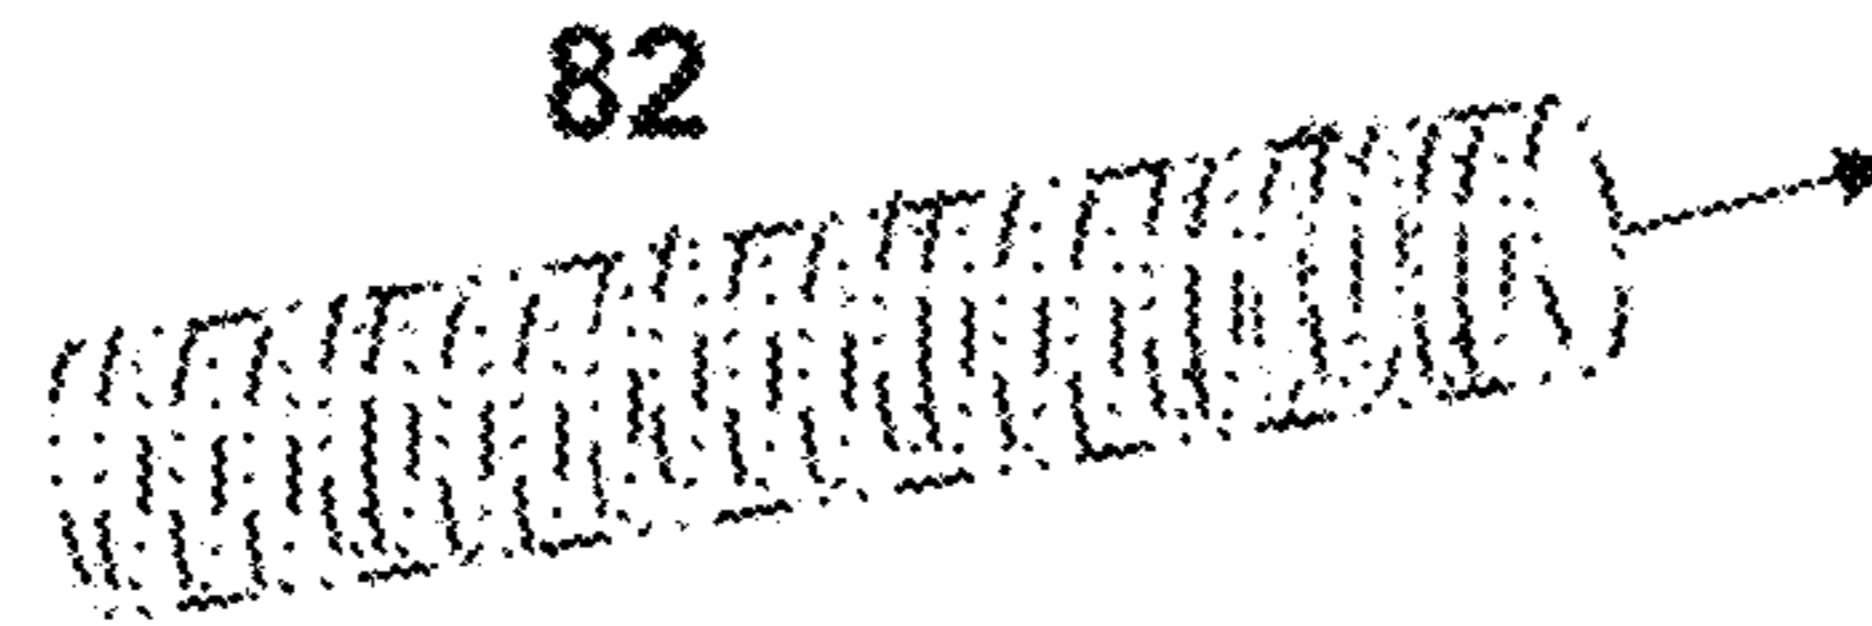
Fig. 10A

Sanding Rod

FIGS. **10A-10C** illustrate repair kit components, including a sanding rod, a cleaning rod and an sponge applicator brush, in accordance with the present invention; and

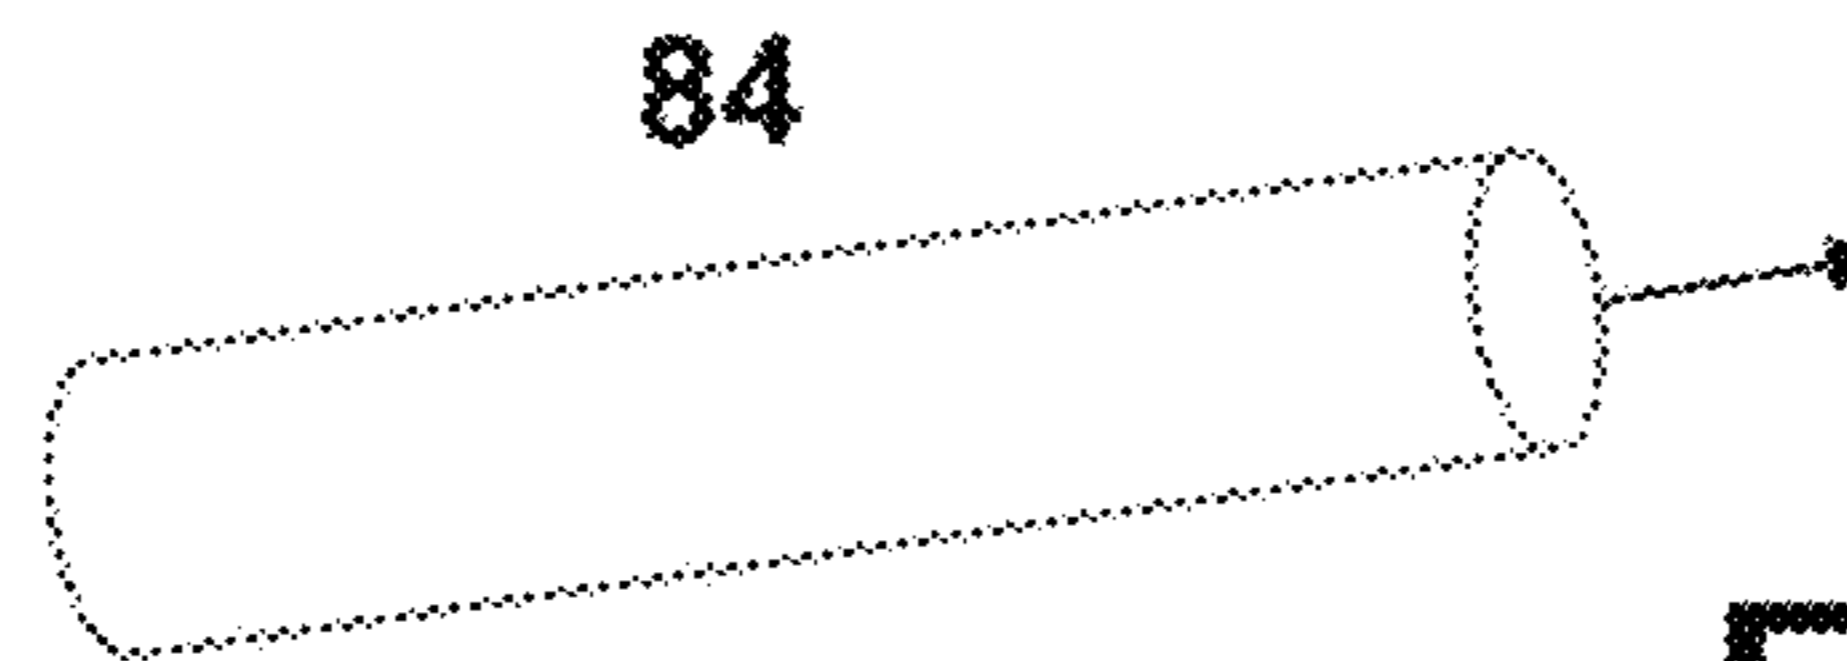
Fig. 10B

Cleaning Rod

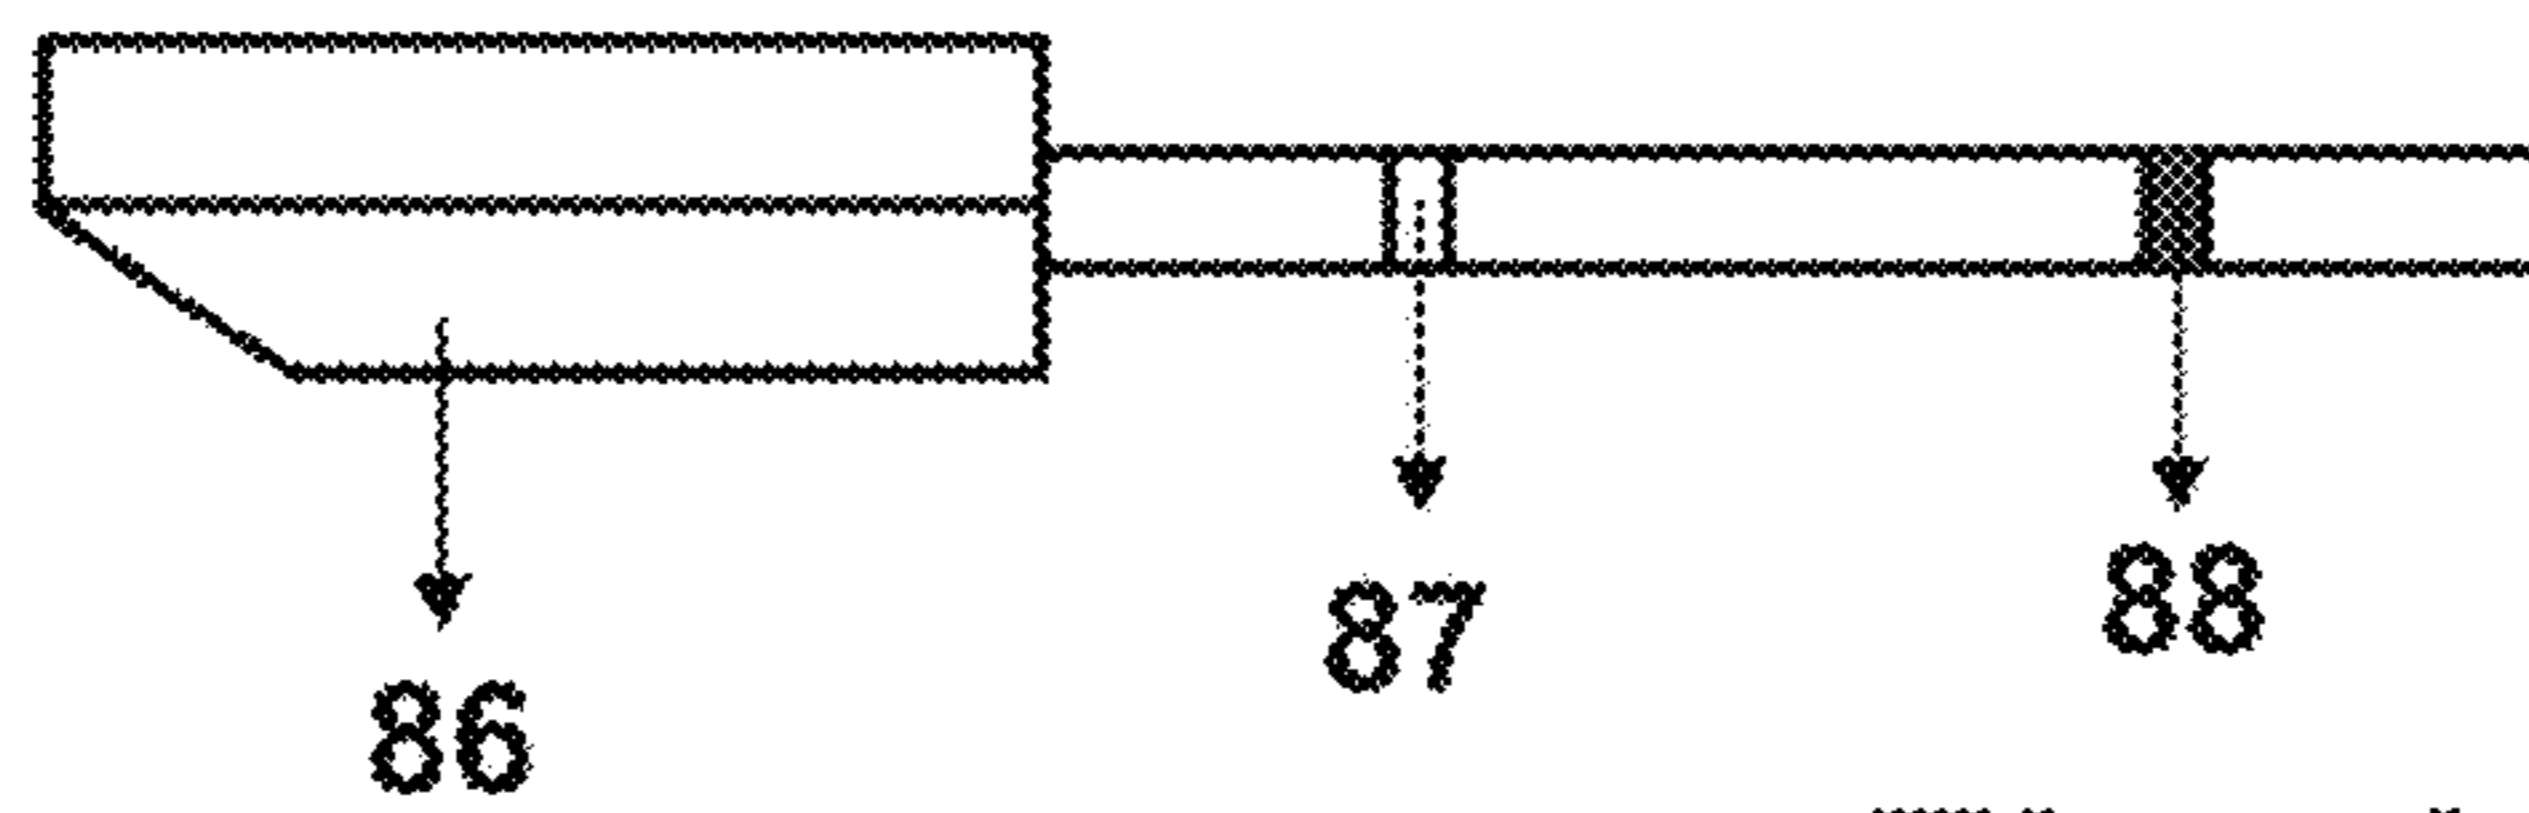
Fig. 10C

Sponge Applicator Brush

26. Applying the coolant pipe repair sealant to a sponge applicator brush **86**. Coating the inside passage of the timing chain cover and coolant transfer pipe with the coolant pipe repair sealant, ensuring that the sponge brush is not inserted past the "RED" mark **87** on the handle;

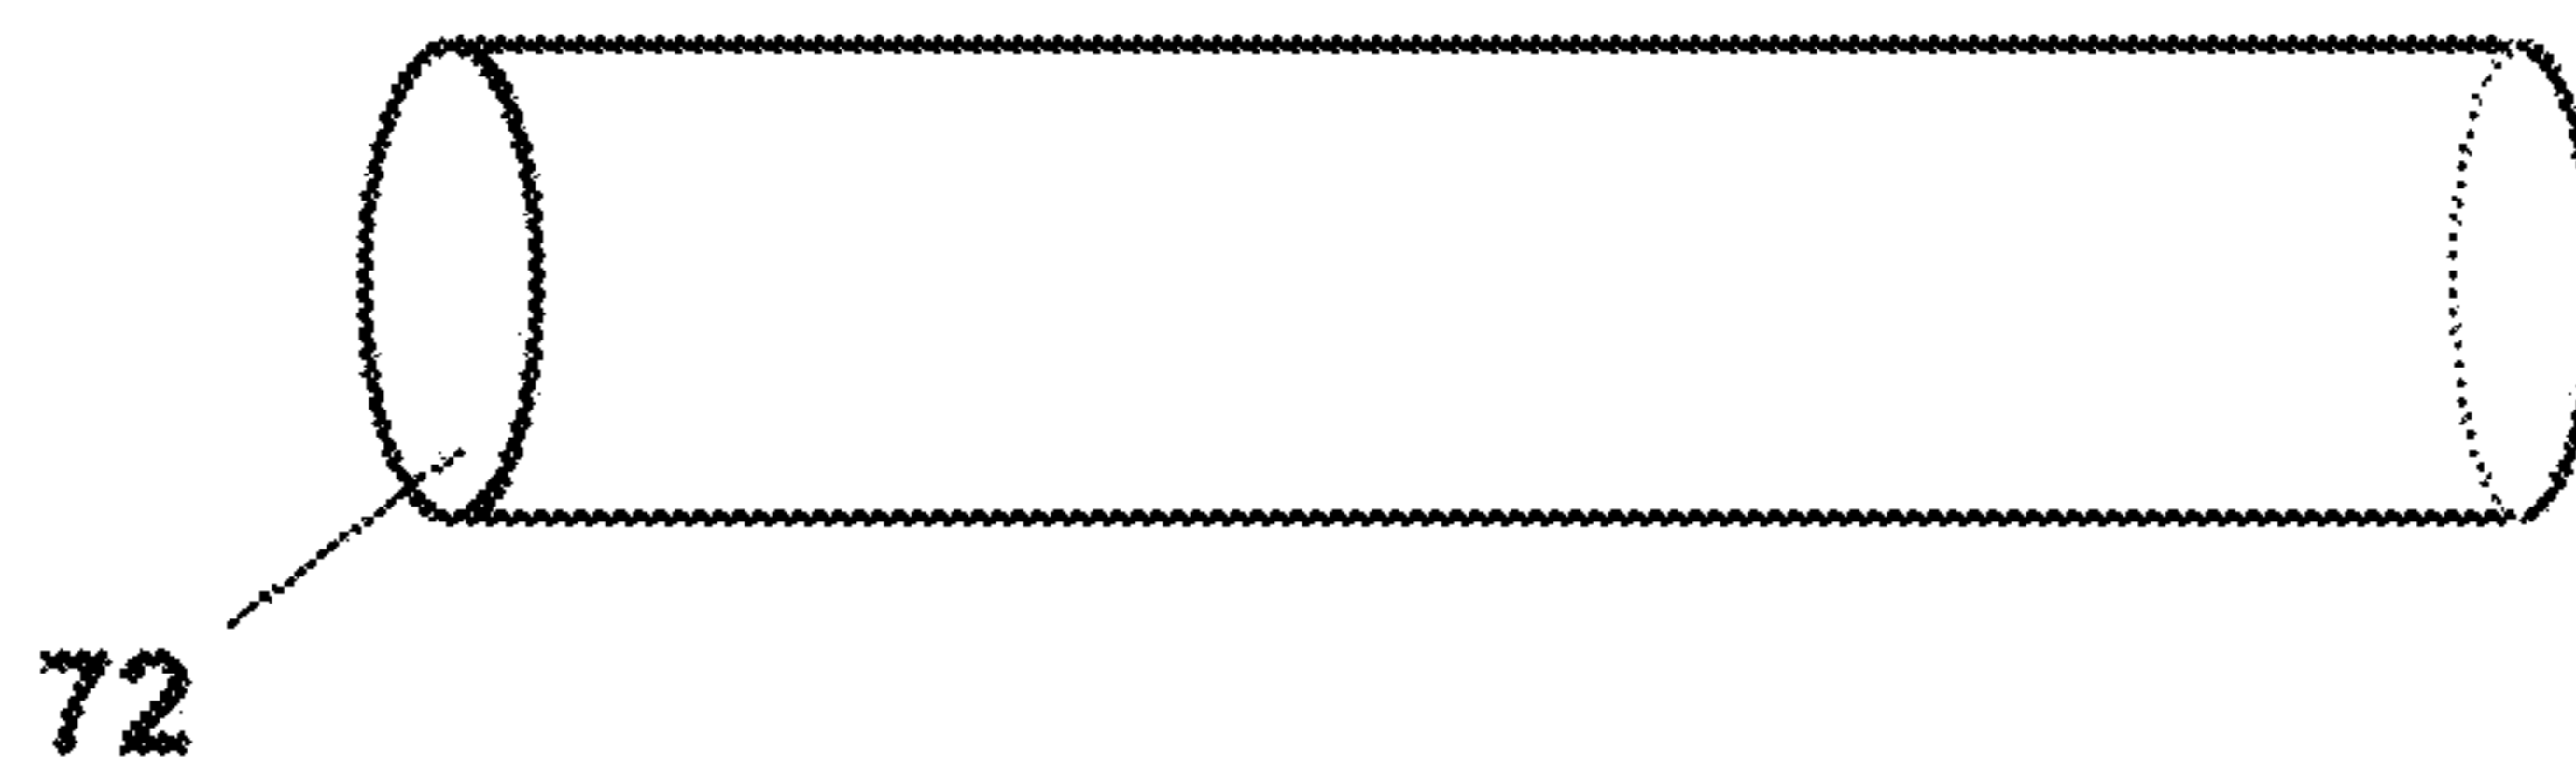
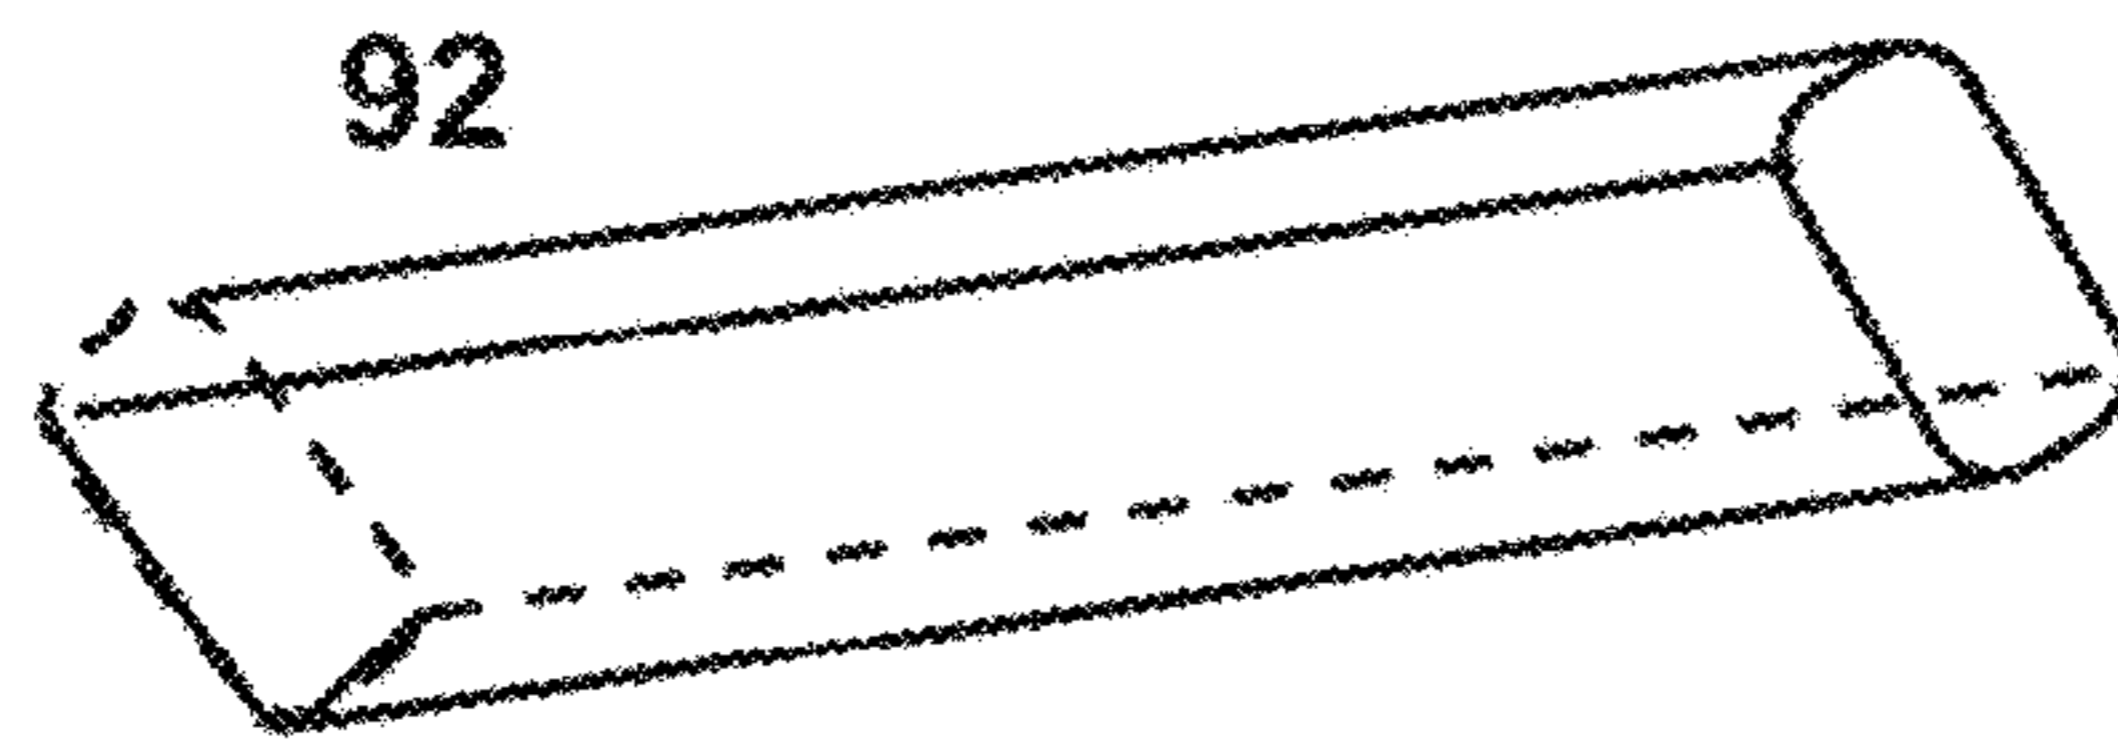
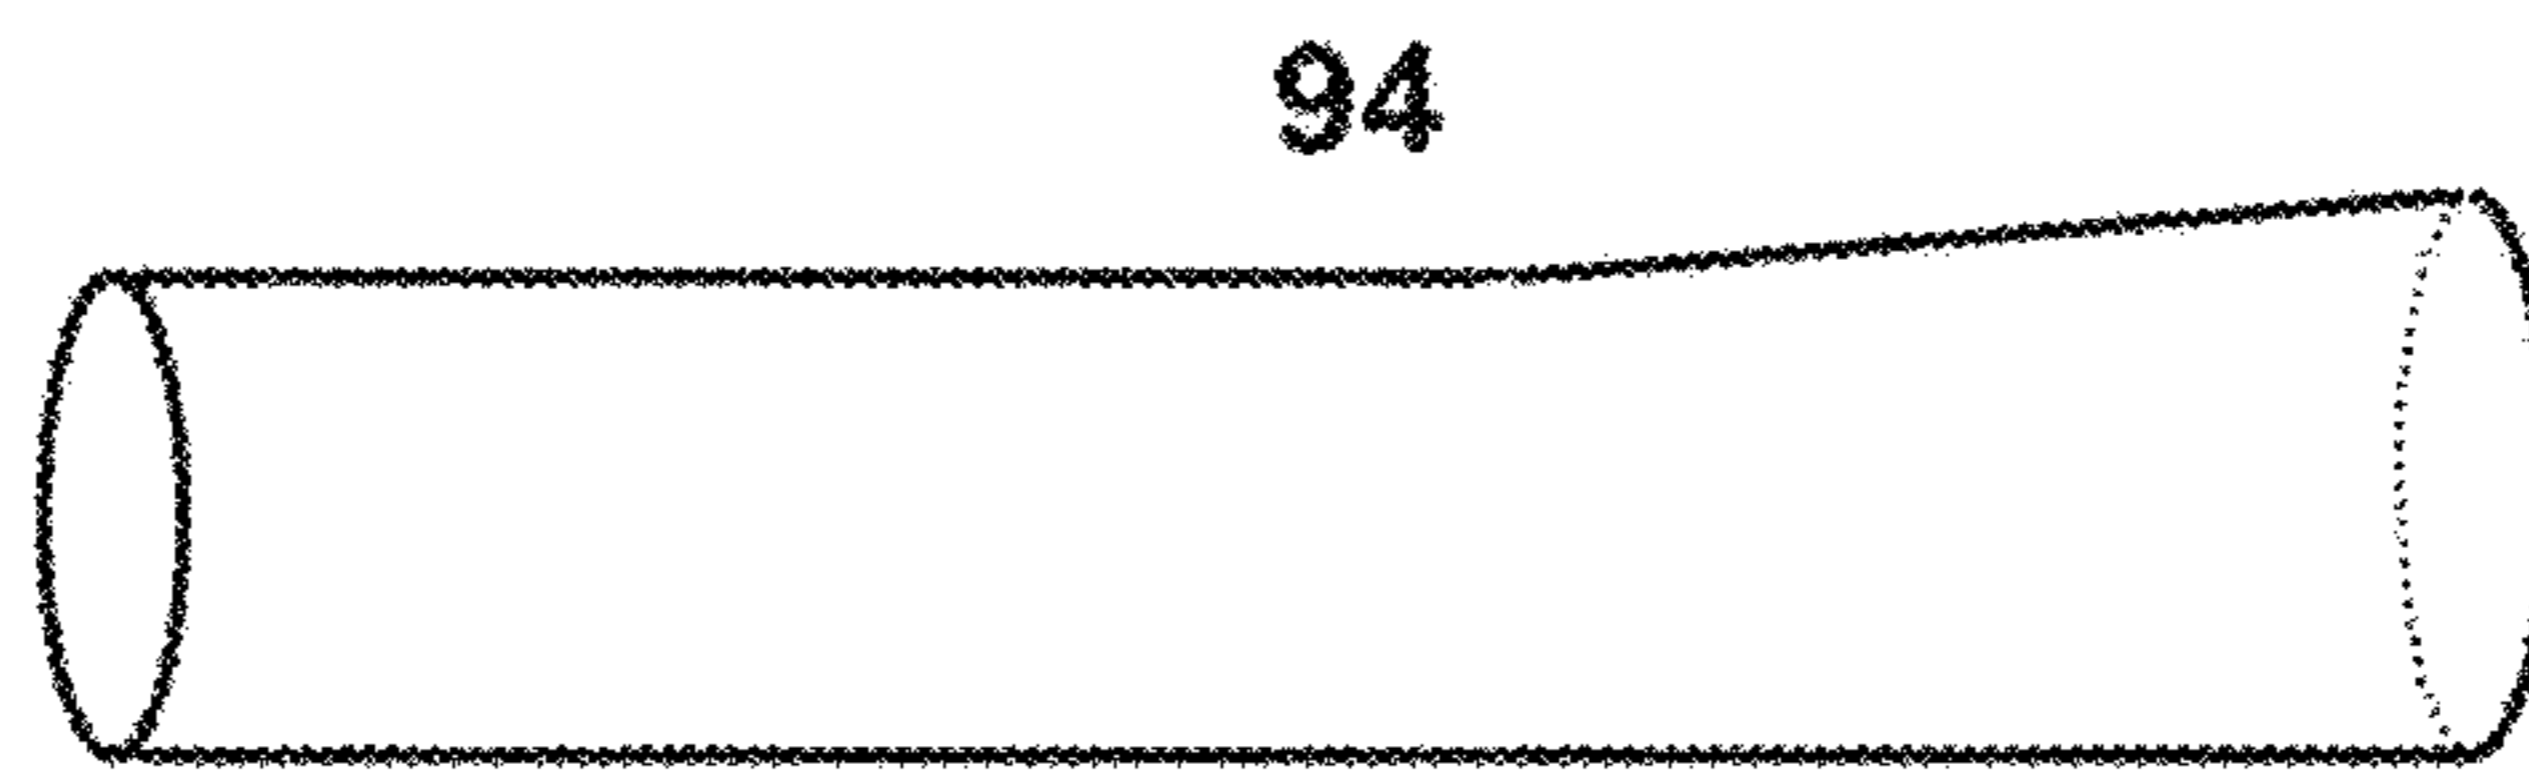
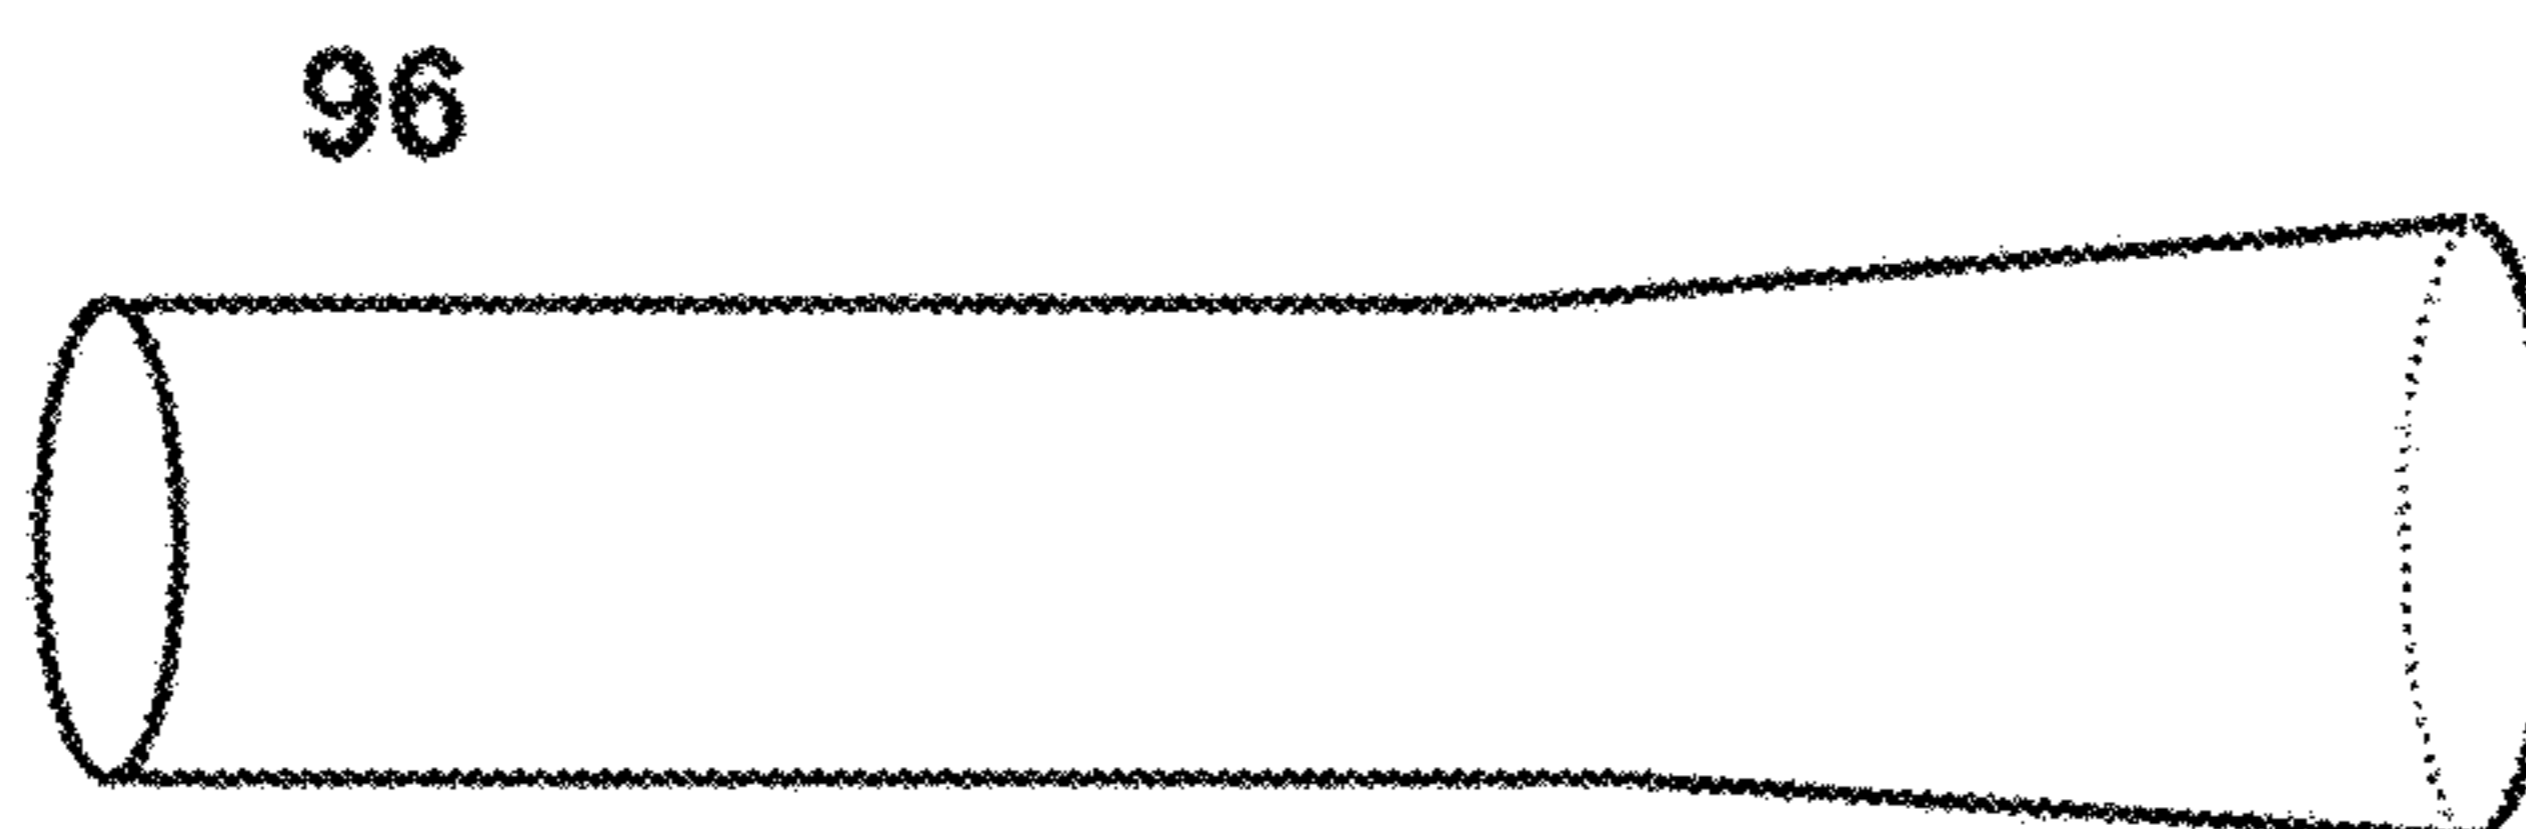
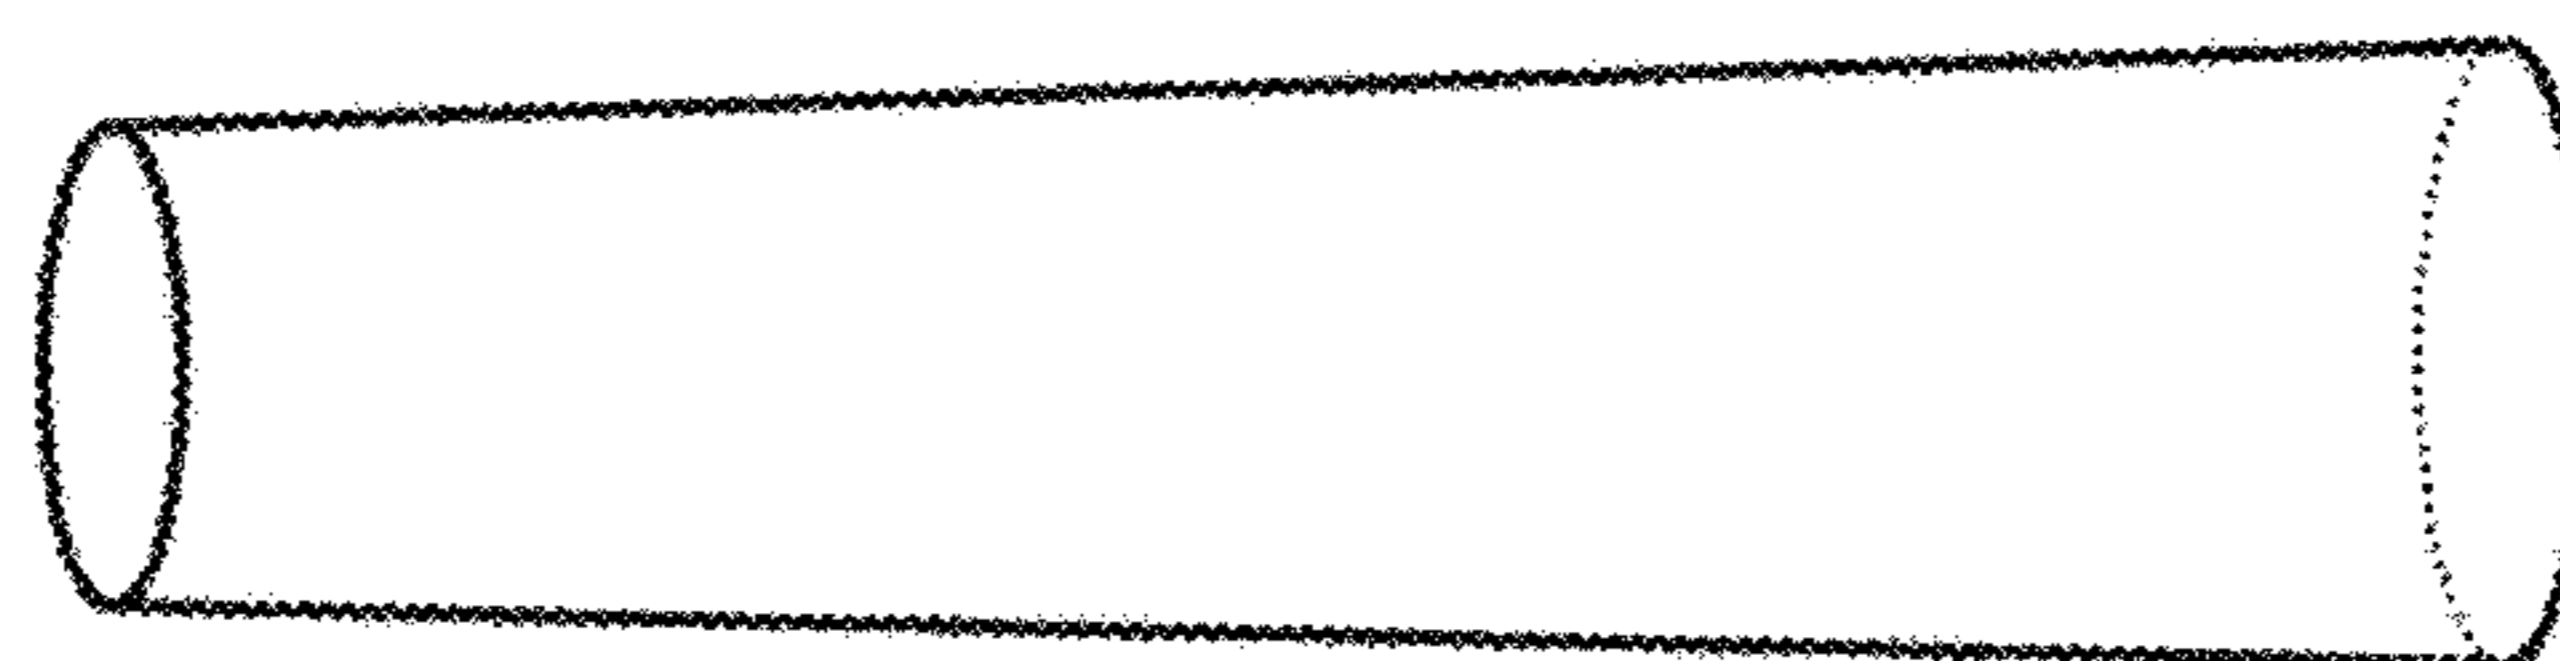
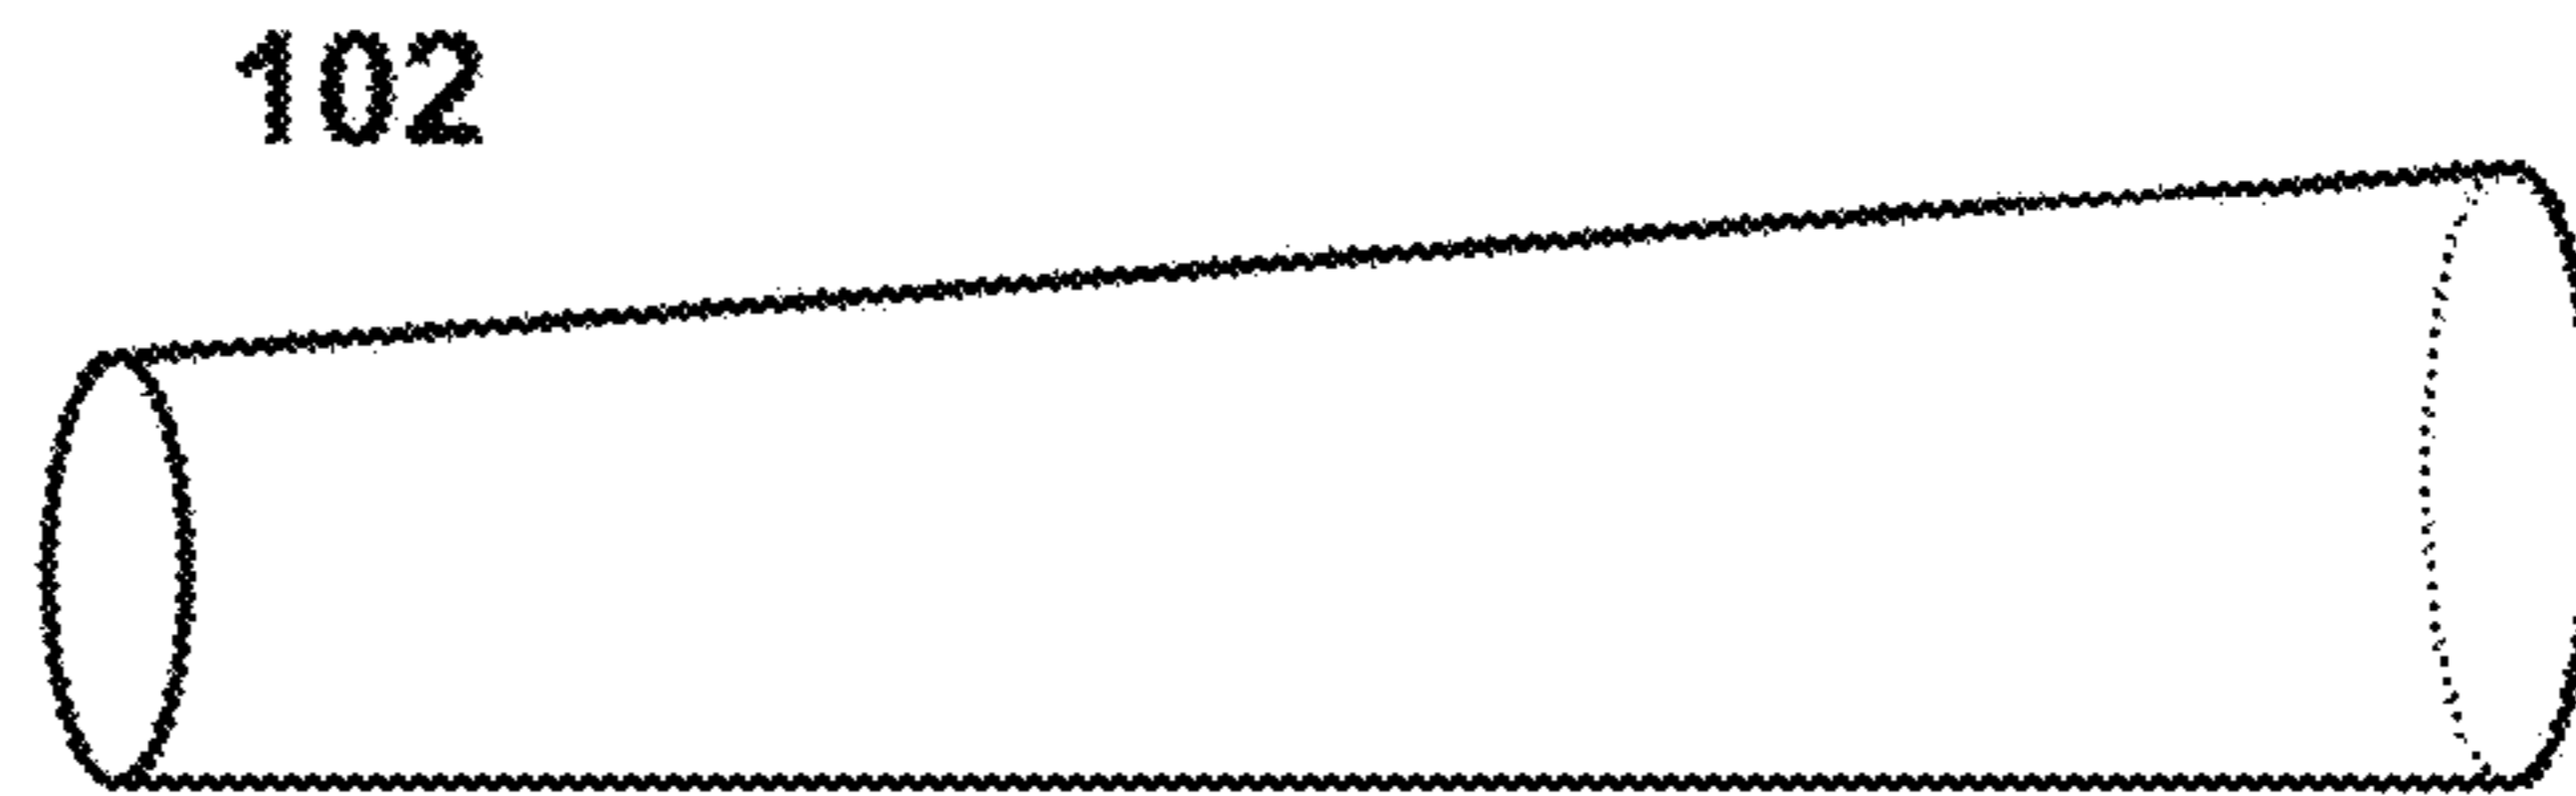
Fig. 11A

Repair Tube Insert (The Stent)

FIGS. **11A-11H** and **11J** illustrate various embodiments of repair tube inserts, in accordance with the present invention.

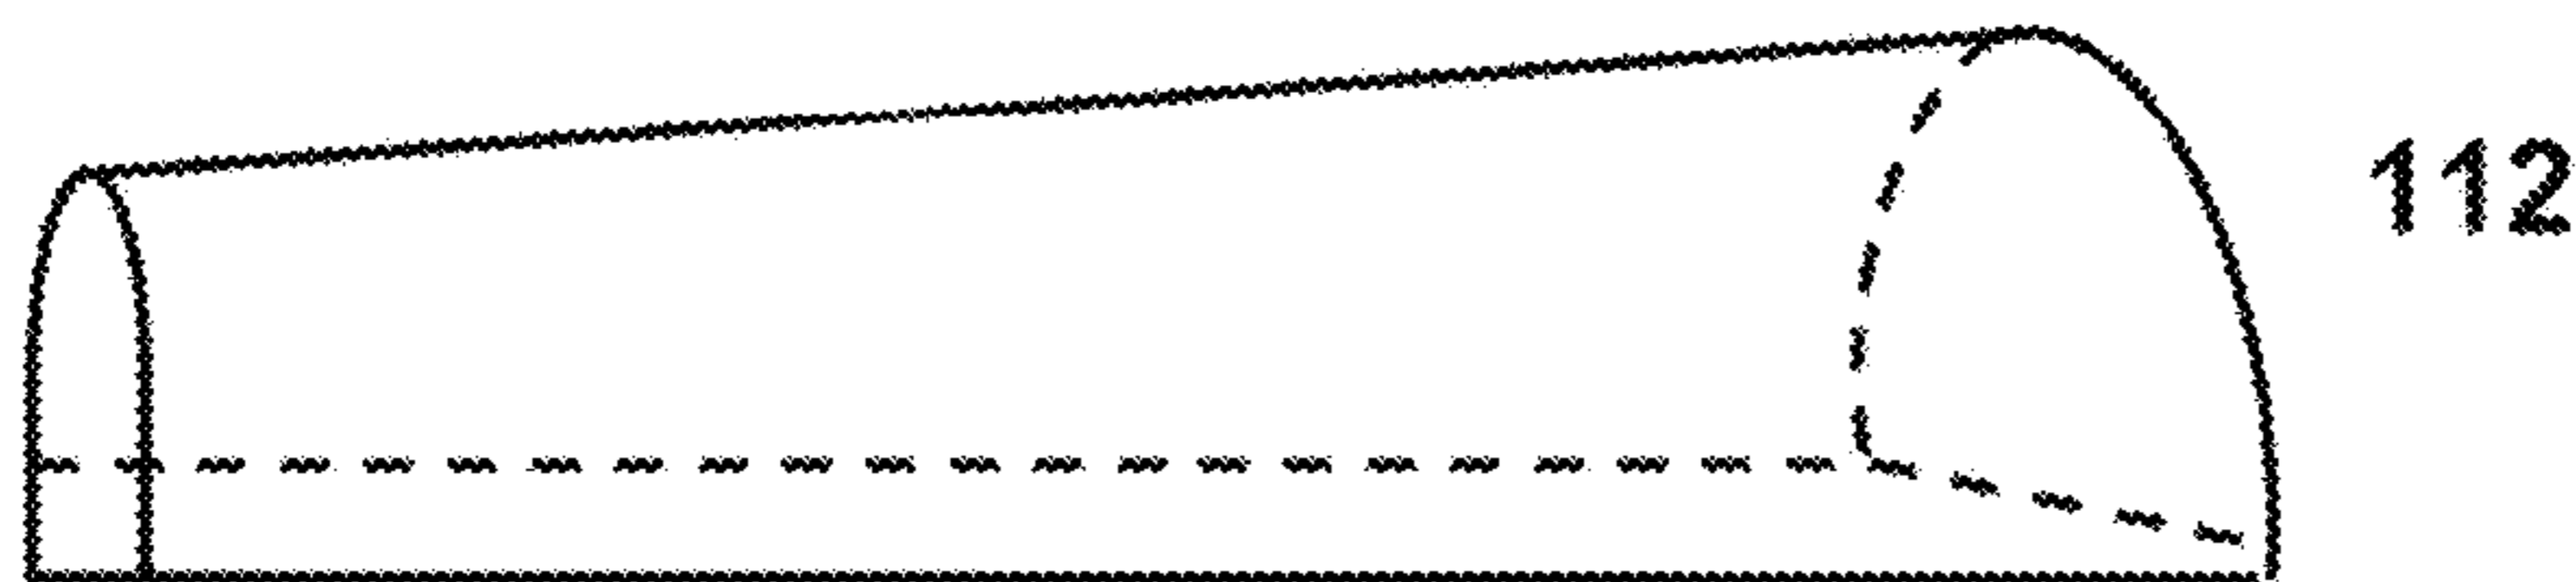
Fig. 11J

FIG. 11J illustrates the structure of a stent 112, which is a hollow semi-cylindrical or semi-oval tube having semi-circular or semi-oval ends, as the case may be; has a flat flared bottom side and a tapering top side. There could be several other variations in the shape and geometry of the repair tube insert and all such embodiments would still be deemed to be within the scope and teachings of the present invention.
