US010240513B2

(10) **Patent No.:** **US 10,240,513 B2**
(45) **Date of Patent:** **Mar. 26, 2019**

(54) **METHOD OF REPAIRING AN ENGINE COOLING SYSTEM AND A REPAIRED ENGINE**

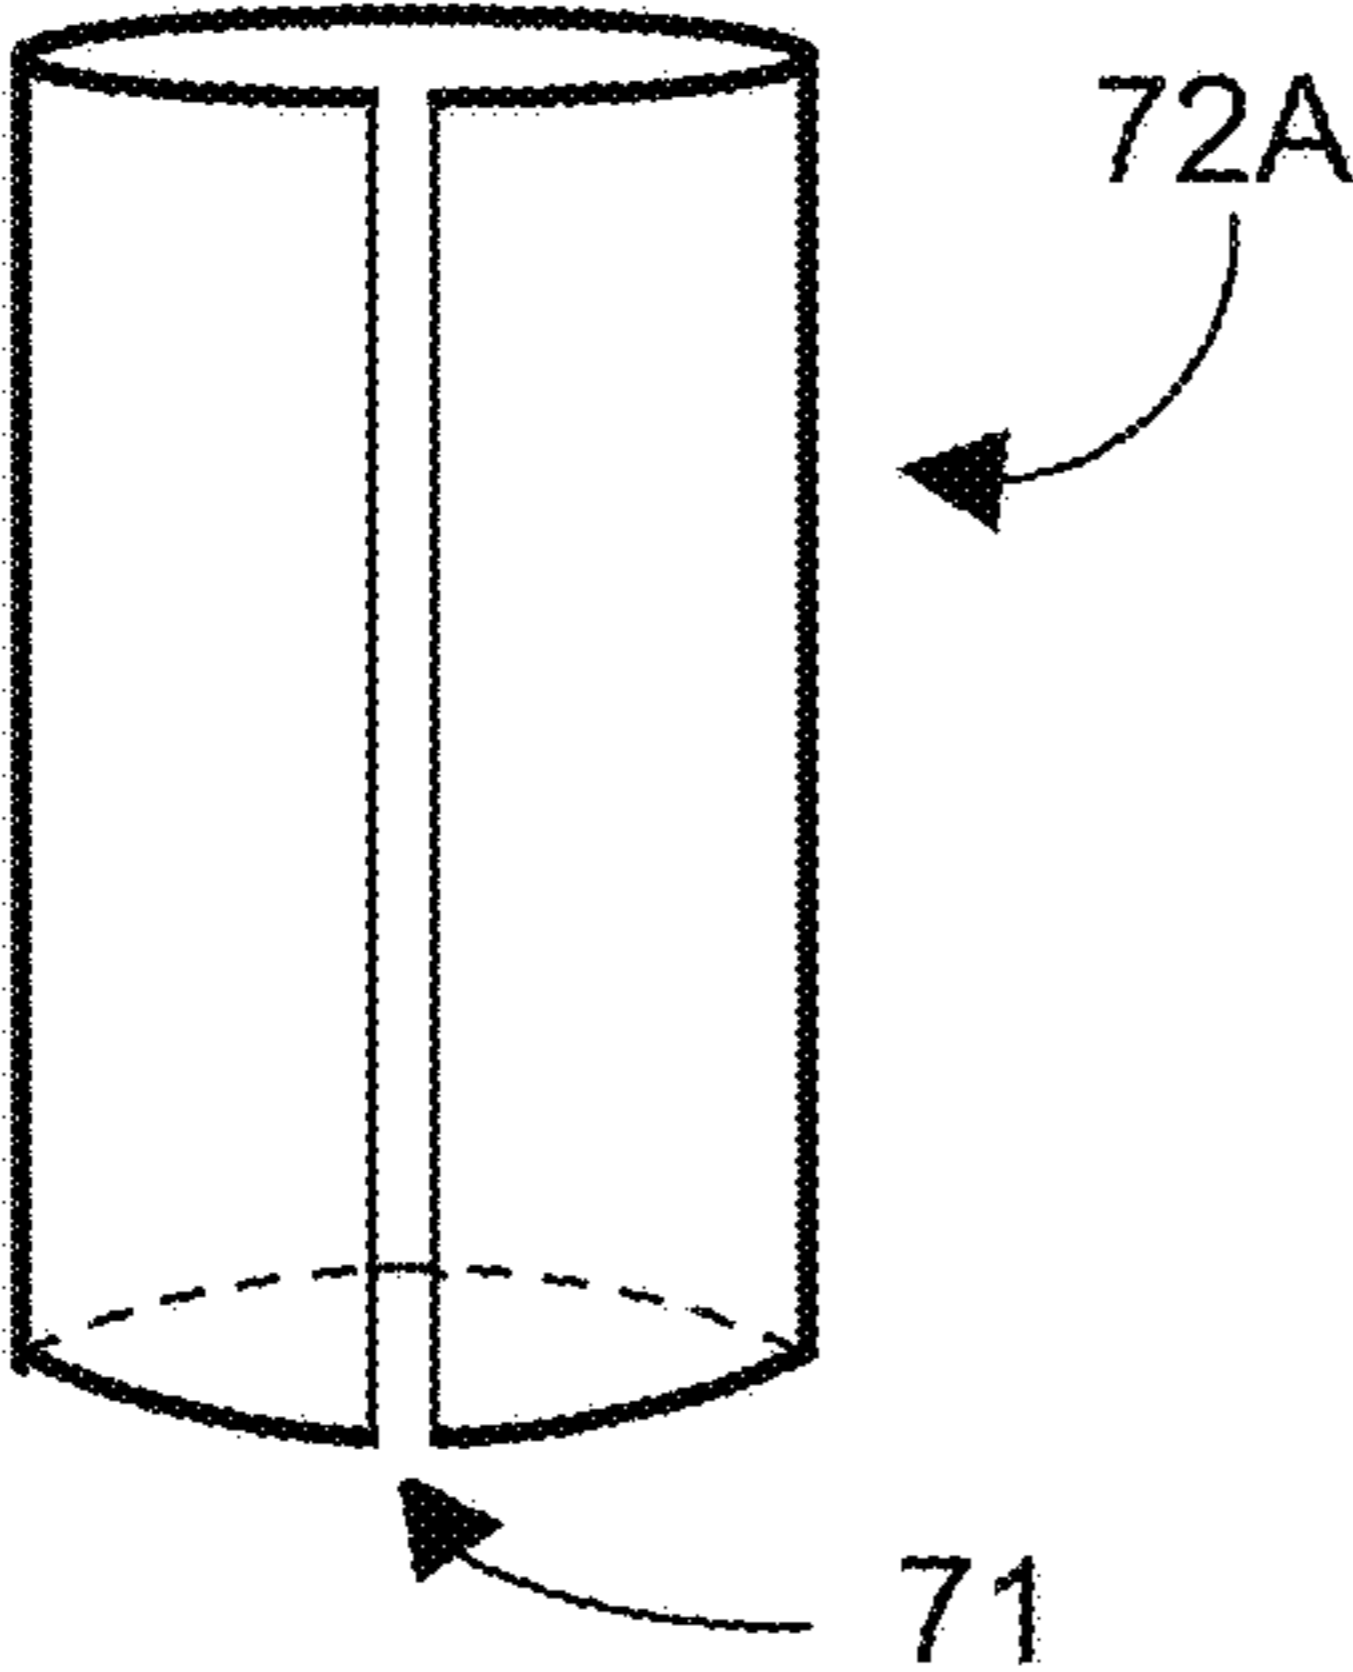
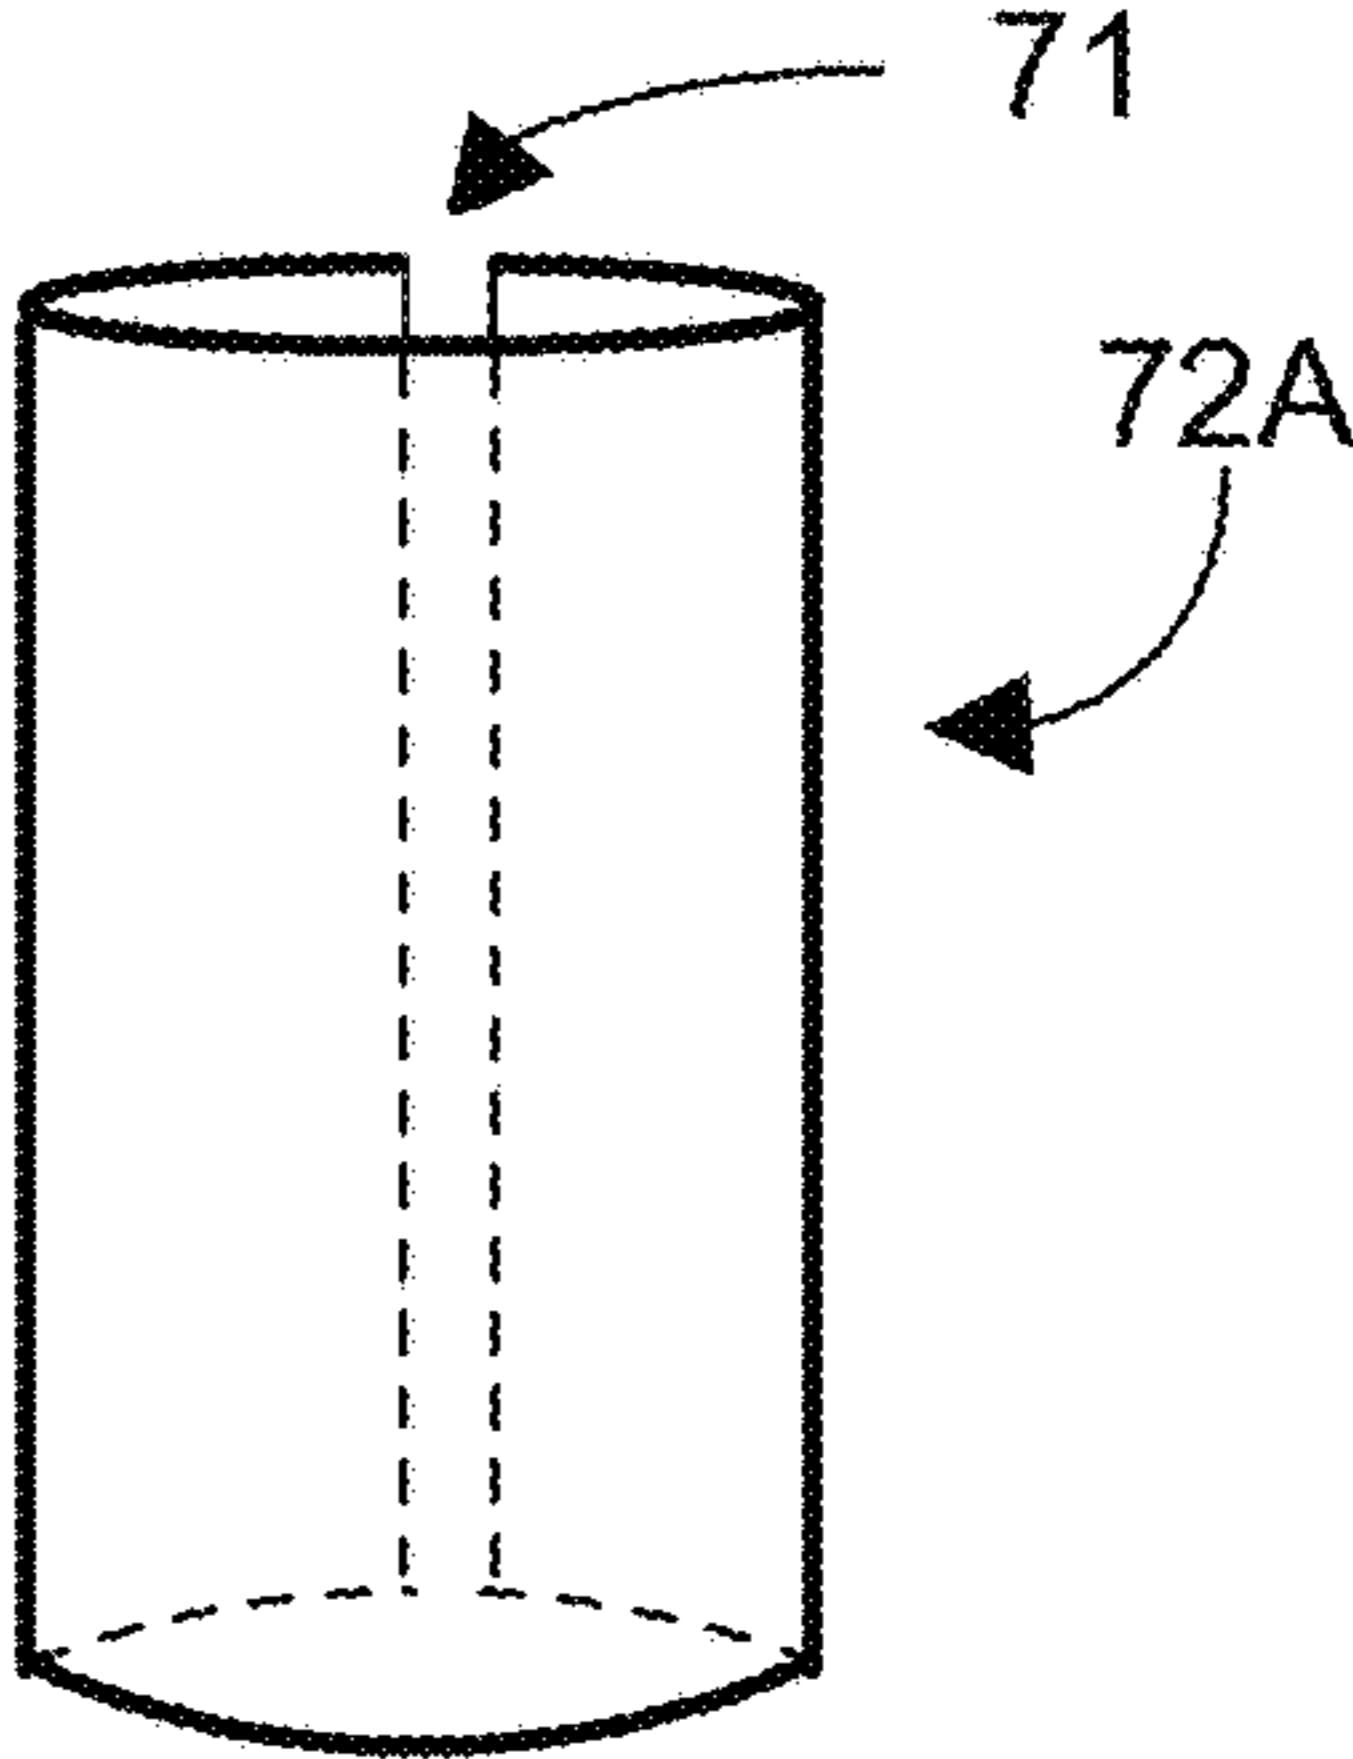
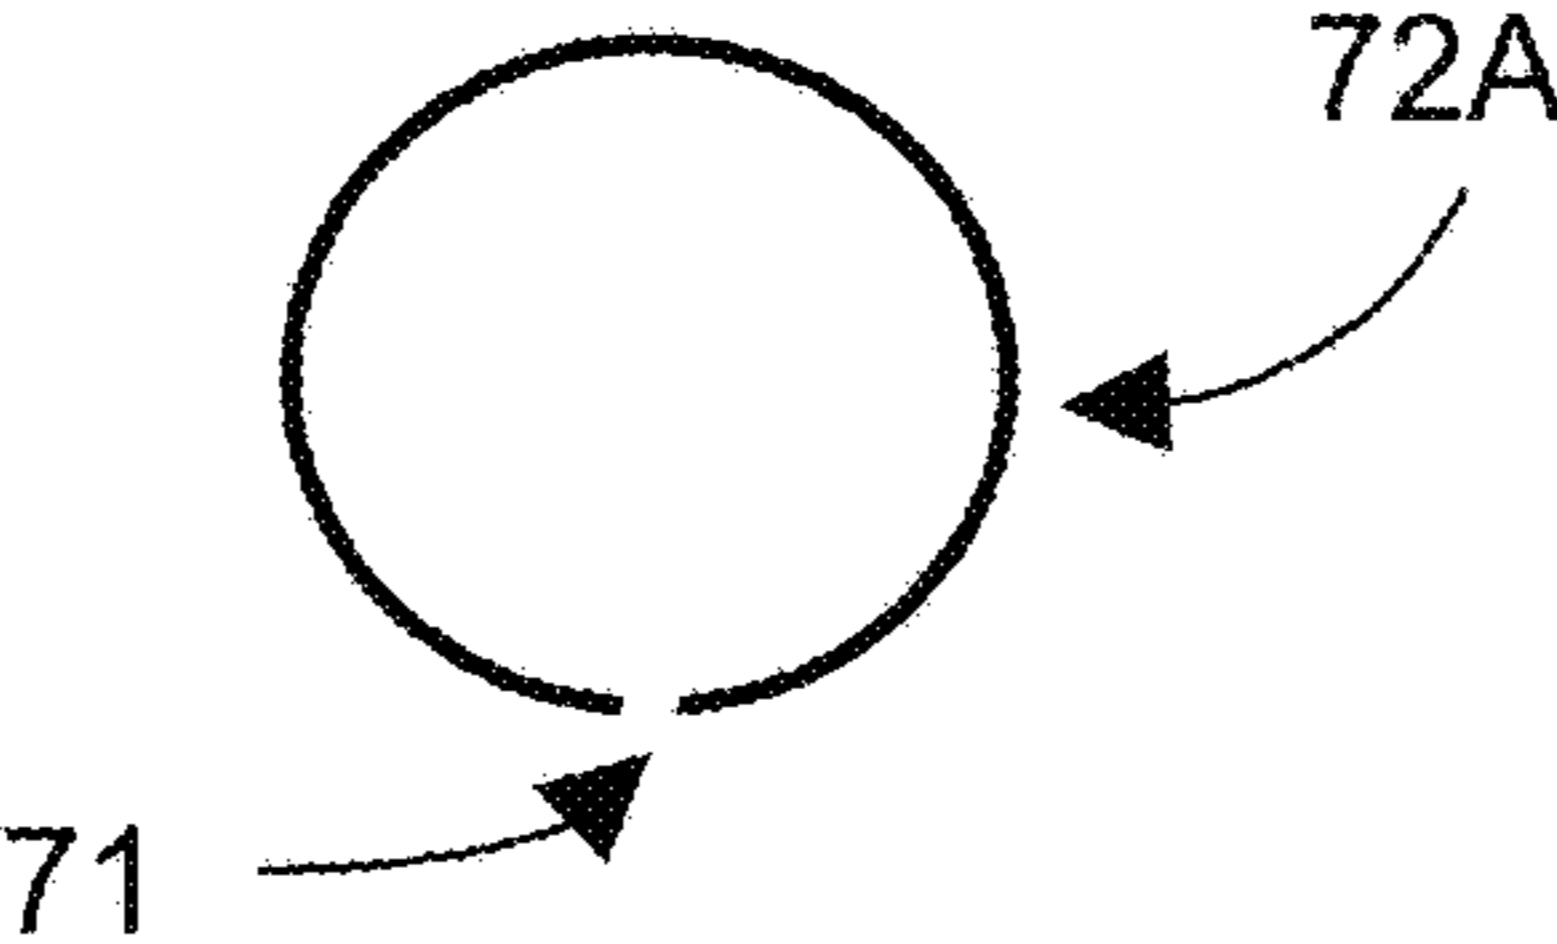
FIG. 12A

FIGS. **12A-12C** are a front perspective view, a back perspective view and an end view, respectively, of a repair tube insert in accordance with another embodiment of the present invention.

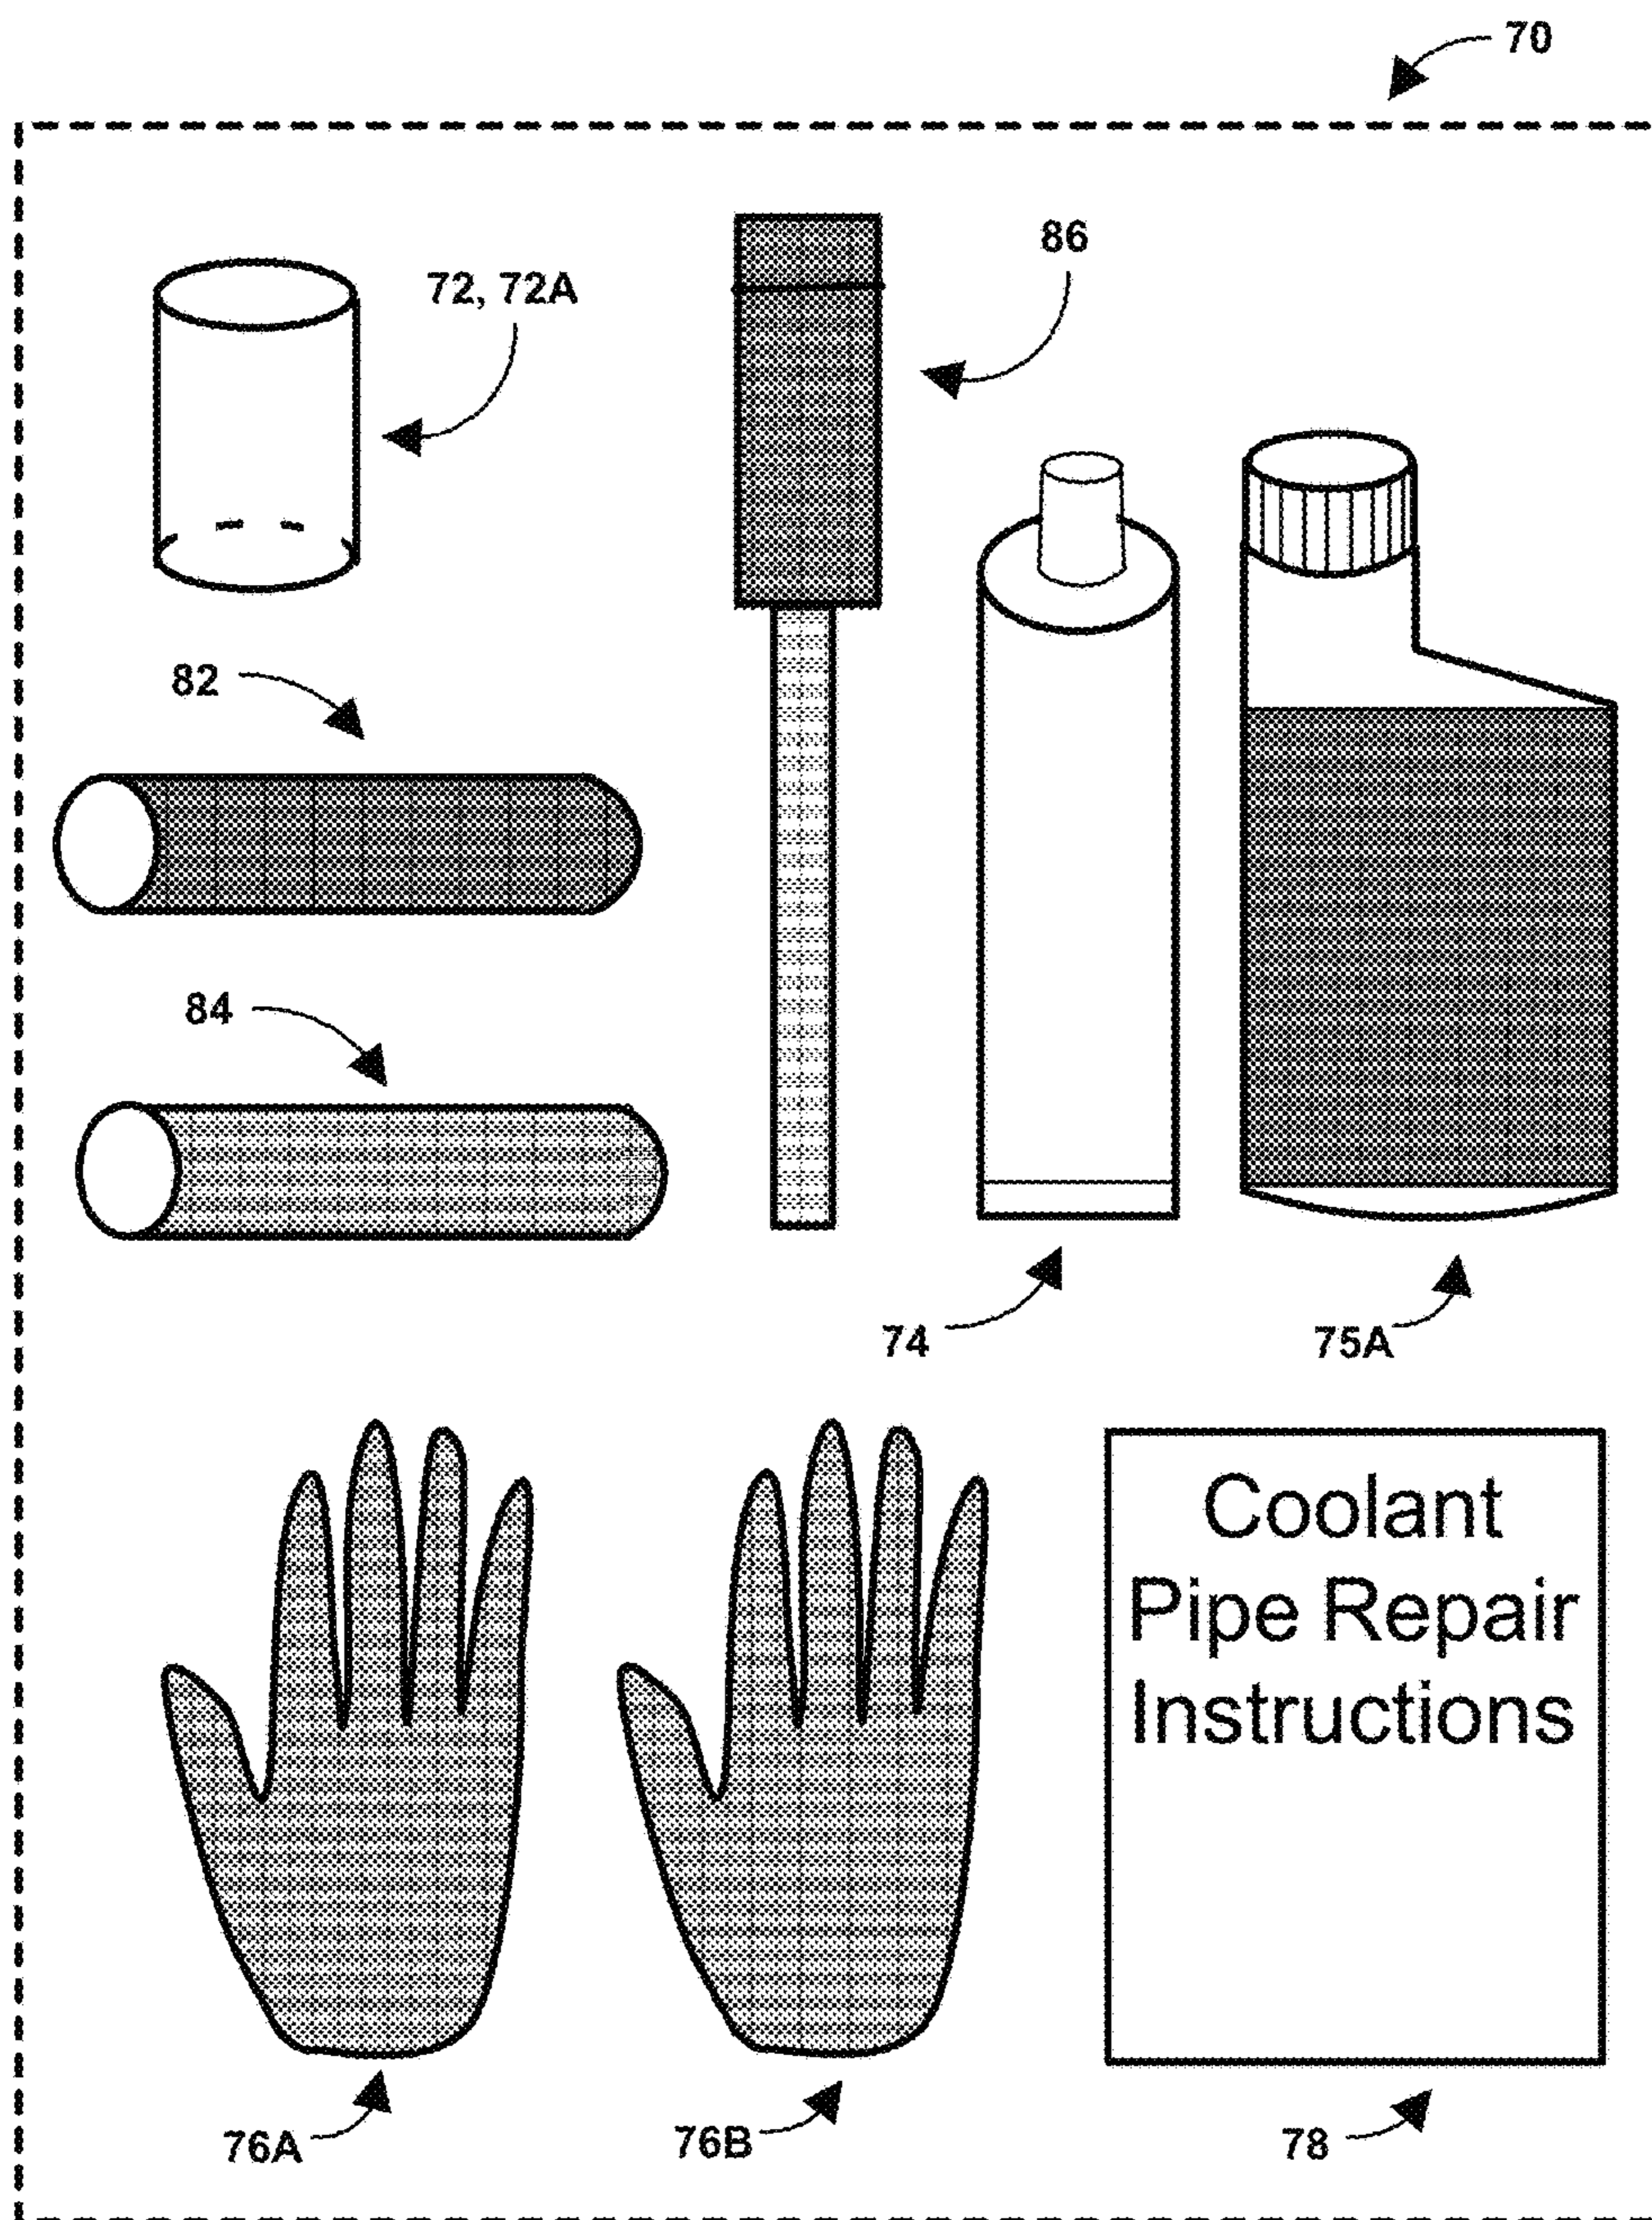
FIG. **13** illustrates a repair kit in accordance with yet another embodiment of the present invention.

The repair kit or apparatus disclosed herein is illustrated in FIG. 13 and comprises at least one open ended, hollow repair tube insert or stent 72 (or 72A as described in further detail below), at least one cleaning rod 84, at least one sanding rod 82, one or more sponge applicator brushes 86, at least one pair of rubber work gloves 76A, pairs of disposable rubber gloves 76B, at least one tube or pack of coolant pipe repair sealant 74A, at least one bottle or jar of cooling system sealer/coolant pipe O-ring conditioner conditioner 75, and detailed written instructions 78 with illustrations. The cooling system sealer/coolant pipe O-ring conditioner 75 are optional, as it is not necessarily required to achieve the objective of the present invention. The cooling system sealer and conditioner 75 is not required to stop the “weep hole” leak from the front seal on the coolant transfer pipe. The front seal leak is repaired by the stent 72. However, cooling system sealer/coolant pipe O-ring conditioner 75, is designed to condition the seals of the coolant transfer pipe, valley pan and gasket, as well as the gaskets of the rear coolant passage cover.

1. One repair tube insert or stent 72 (repairs front coolant pipe seal leak);
2. One tube of coolant pipe repair sealant 74;
3. One bottle of cooling system sealer and conditioner;
4. One round sanding rod 82;
5. One round cleaning rod 84;
6. Six sponge applicator brushes 86;
7. One pair of rubber work gloves;
8. Four pairs of disposable rubber gloves; and
9. Detailed written instructions with systematic procedure illustrated with color photographs.
