# (10) Patent No.: US 10,344,434 B2

#### (54) DETECTABLE WARNINGS

# DETECTABLE WARNINGS

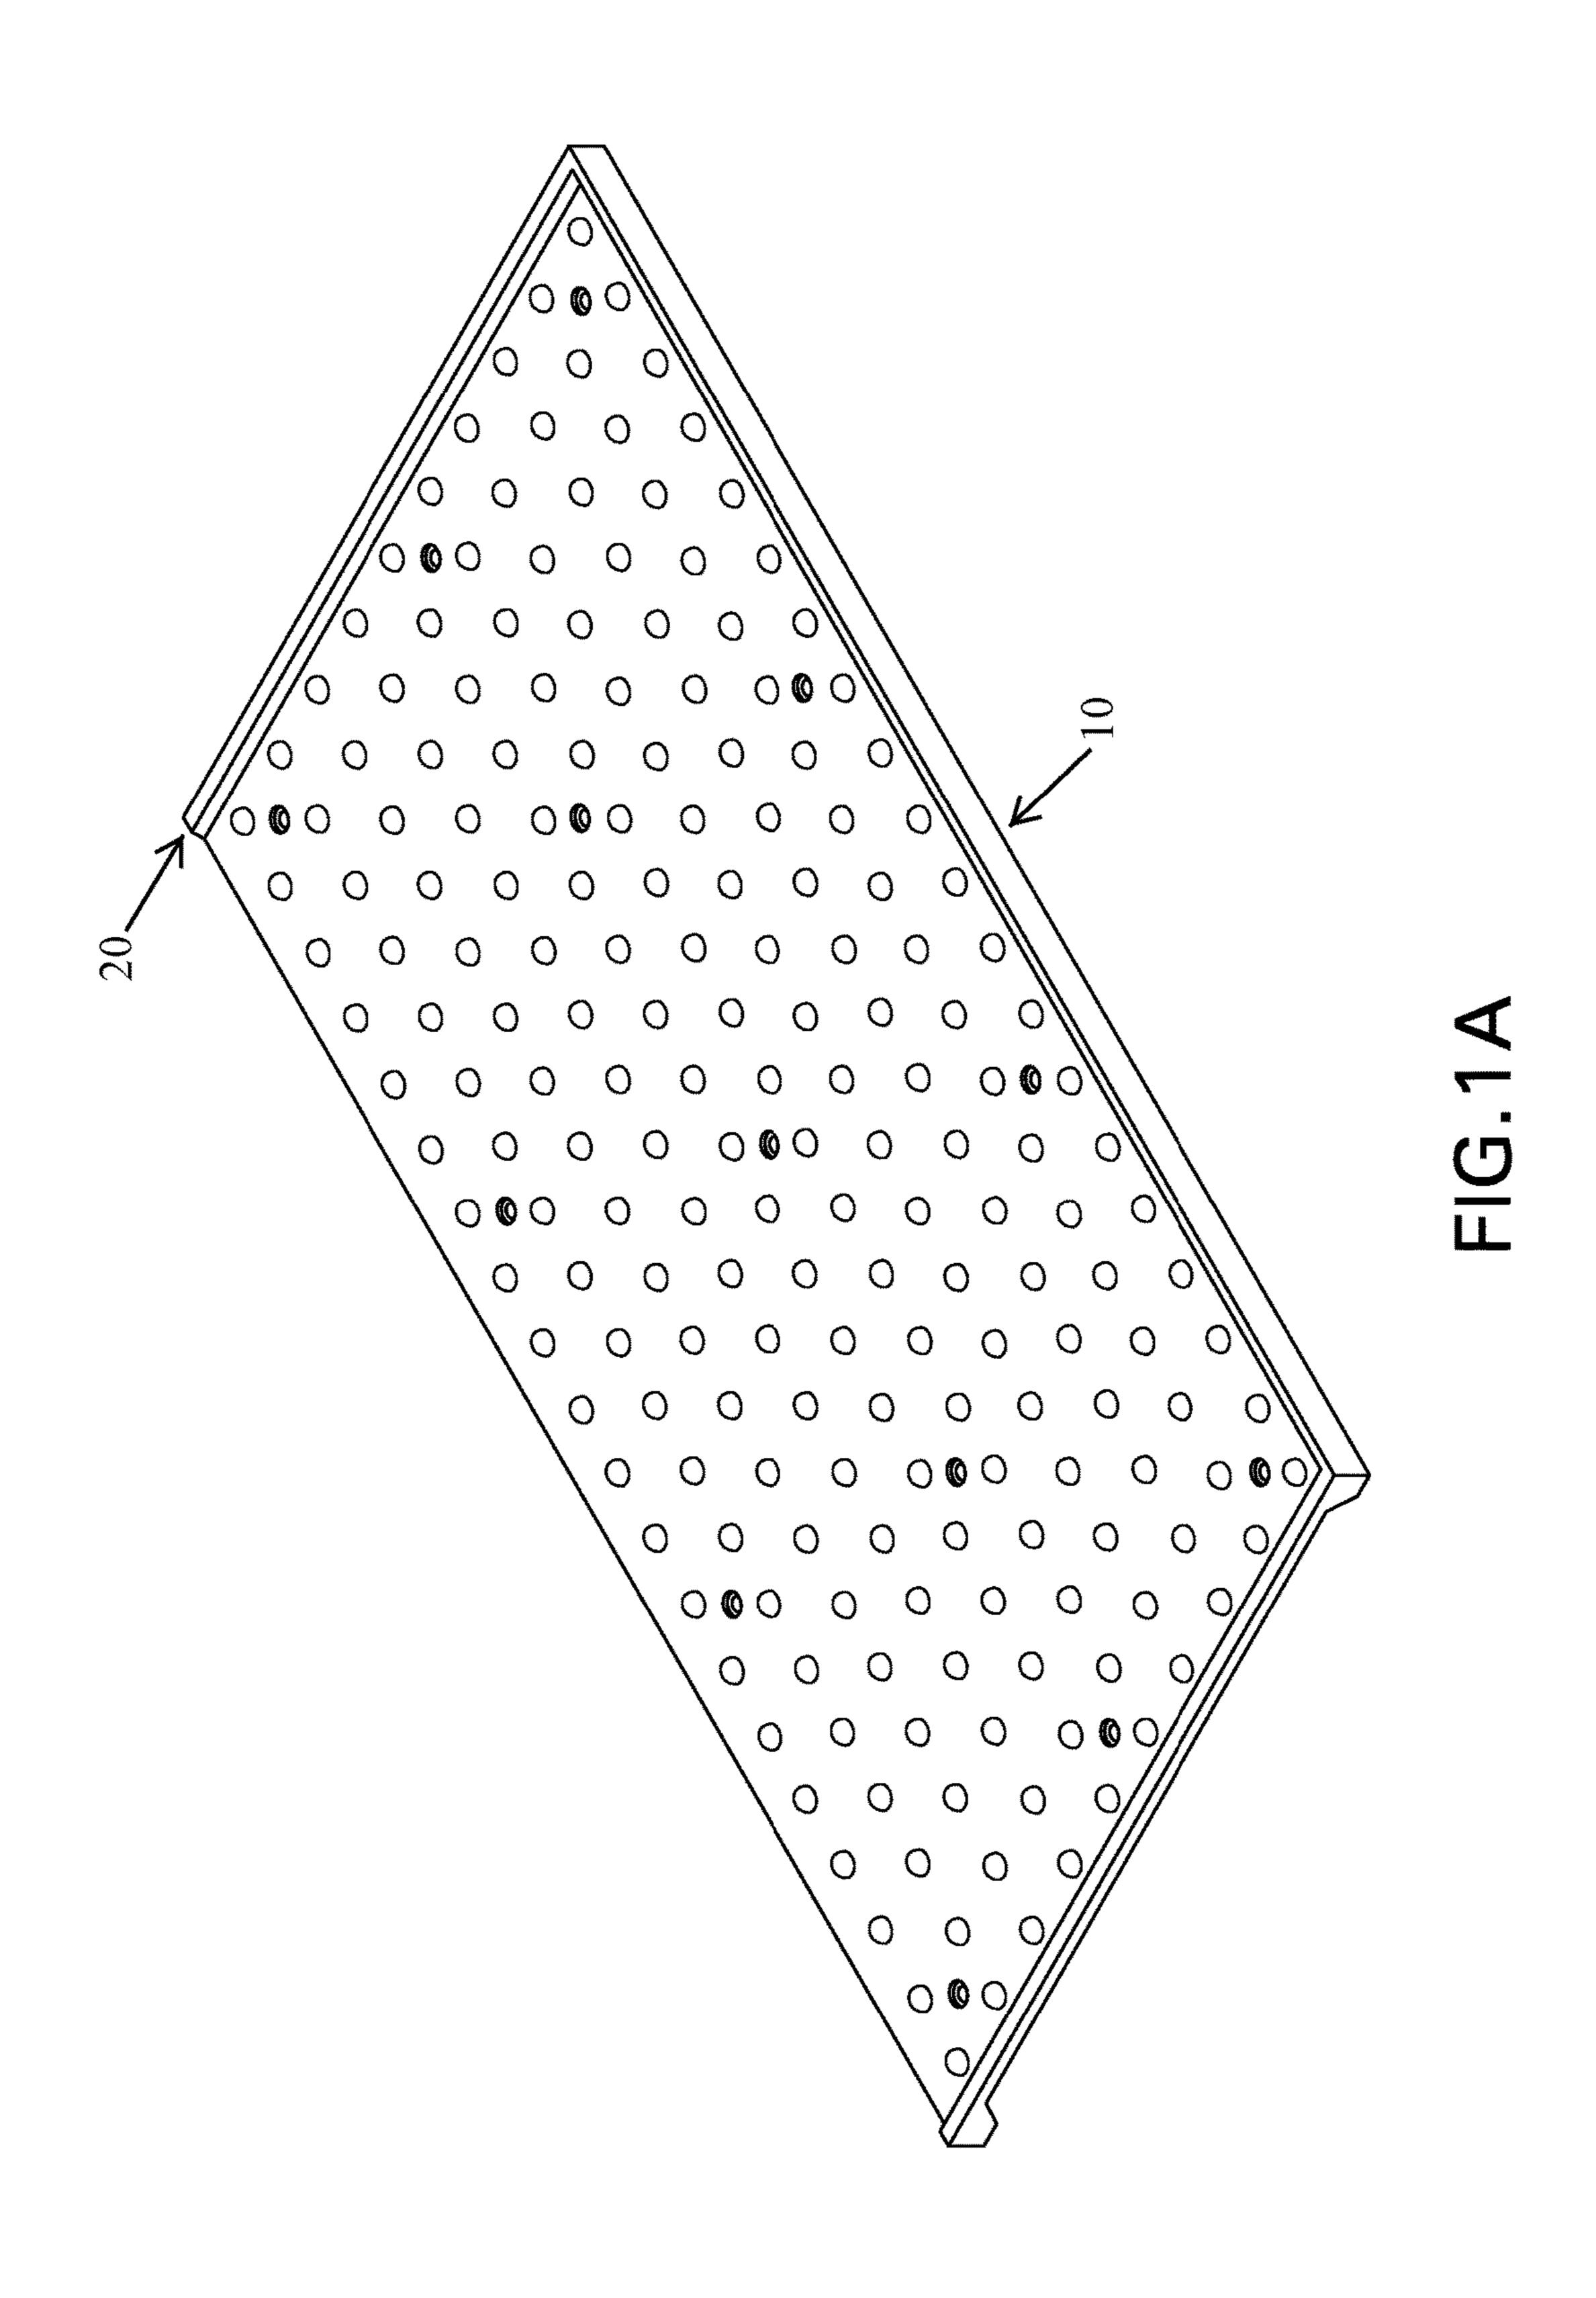
FIG. 1A is a schematic picture of a replaceable detectable 20 warning tile with a protective upper lip and lower flanges on two opposing edges but not on the other two edges.

FIG. 1A shows schematically a tile with underside flanges on only two opposing sides, with the other two opposing sides left without any flange. Some wet-set, replaceable, detectable warning tiles have underside flanges on all (typically four) sides of the tile. By leaving some sides of the tile with no underside flange, buckling may be reduced. In

particular, FIG. 1A shows a tile with a long direction, presumably perpendicular to the direction in which pedestrian will walk over the tile, and a short direction, parallel to the direction of pedestrian traffic. In FIG. 1A, the tile has underside flanges on the long sides, running perpendicular to 5 the direction pedestrian traffic, and no flanges on the short sides parallel to pedestrian traffic. As shown in detail in FIG. 1B, the underside flanges are separated by the shorter horizontal dimension of the tile. Longer flanges separated by the shorter direction of the tile may cause less buckling than 10 shorter flanges separated by the longer direction of the tile. But in either case, leaving one or more sides with no flange, may reduce buckling. More generally, a tile may reduce buckling where at least one, in some cases both, of two opposing sides has no flange.

A second problem with some detectable warning tiles is damage to the truncated domes when a snow plow or shovel is scraped across the top of the tile. Where detectable warnings protrude above the level of the surrounding walking surface, a plow or shovel that travels along the walking surface may shear off or otherwise damage a truncated dome. FIG. 1A shows a detectable warning tile with an upward facing lip to address this problem. The upper surface of the tile is generally flat, punctuated by truncated domes. The lip protrudes upward from the tile to a greater height than the truncated domes. In this way, the blade of a snow plow or shovel may ride along the upper lip without ever contacting the truncated domes. Thus the lip protects the truncated domes from damage. Where tiles are intended to be installed adjacent to one another, the upper lip may extend only along some sides of the tile. In that way, an upper lip can be formed around a collection of tiles with no upper lip along the internal seams between tiles. FIG. 1A shows a tile with an upper lip along only three of its four sides.

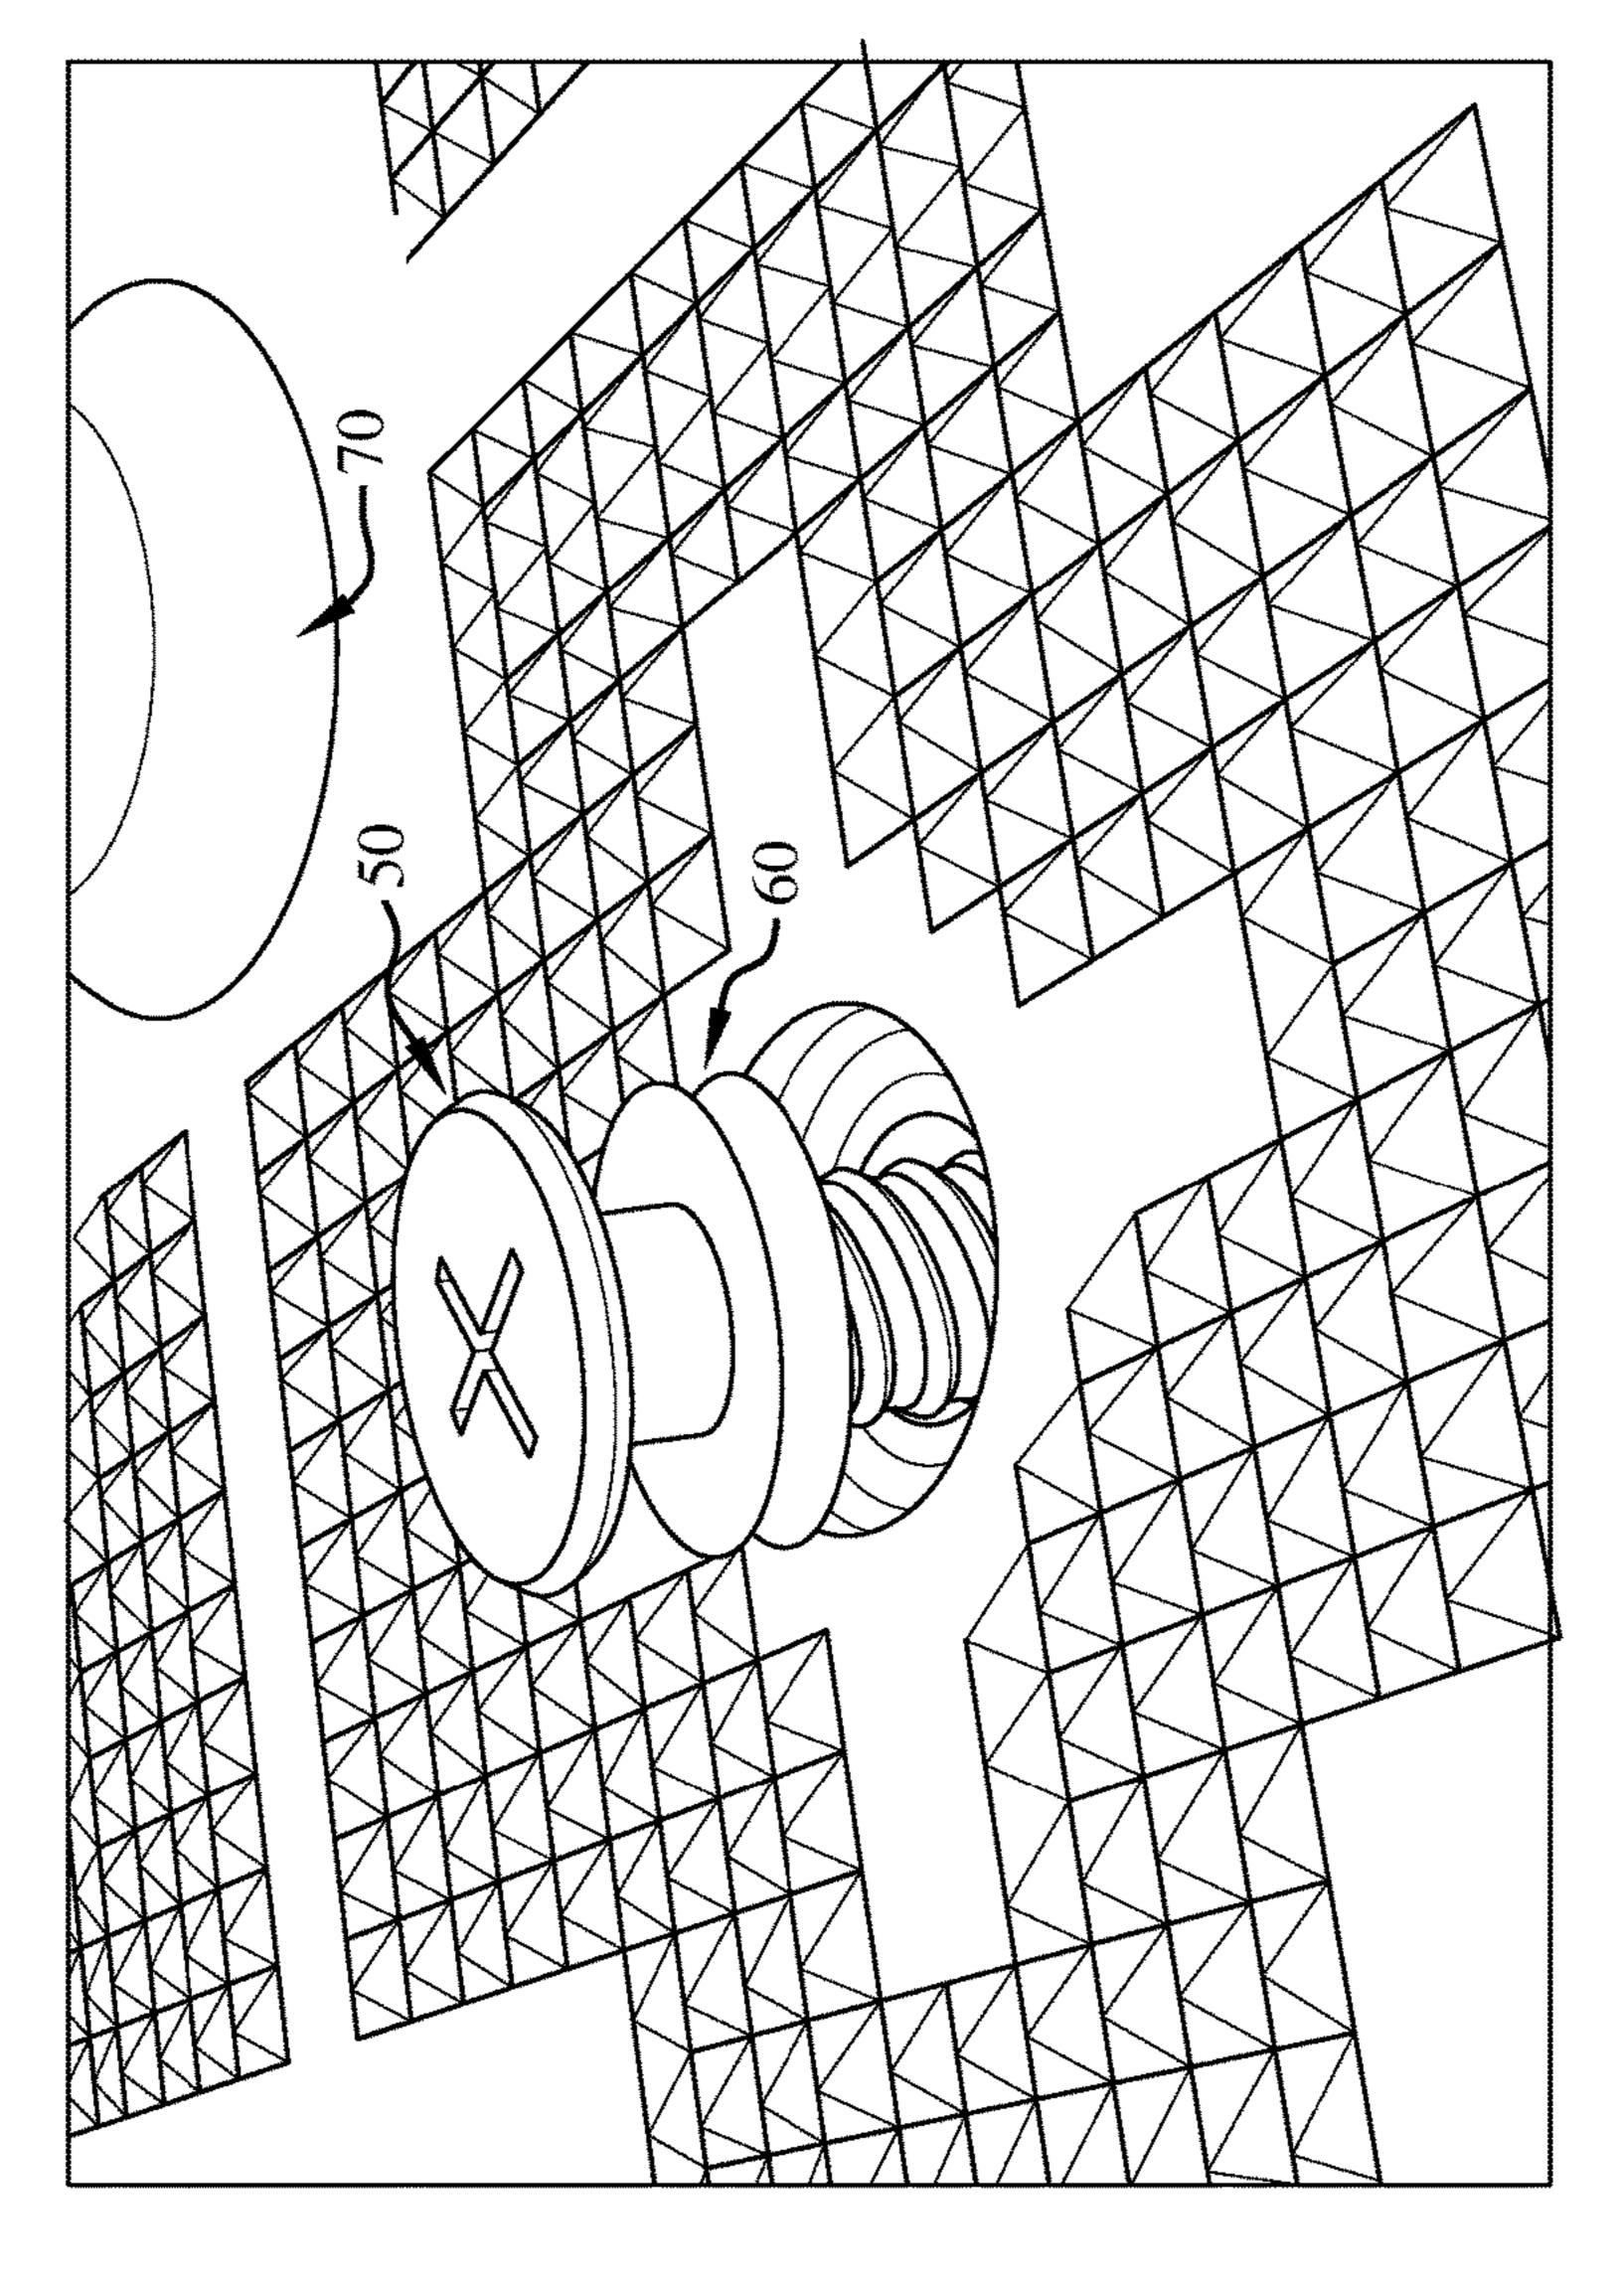
FIG. 2 is a photograph of an example of a tile including a flexible grommet surrounding a fastener.

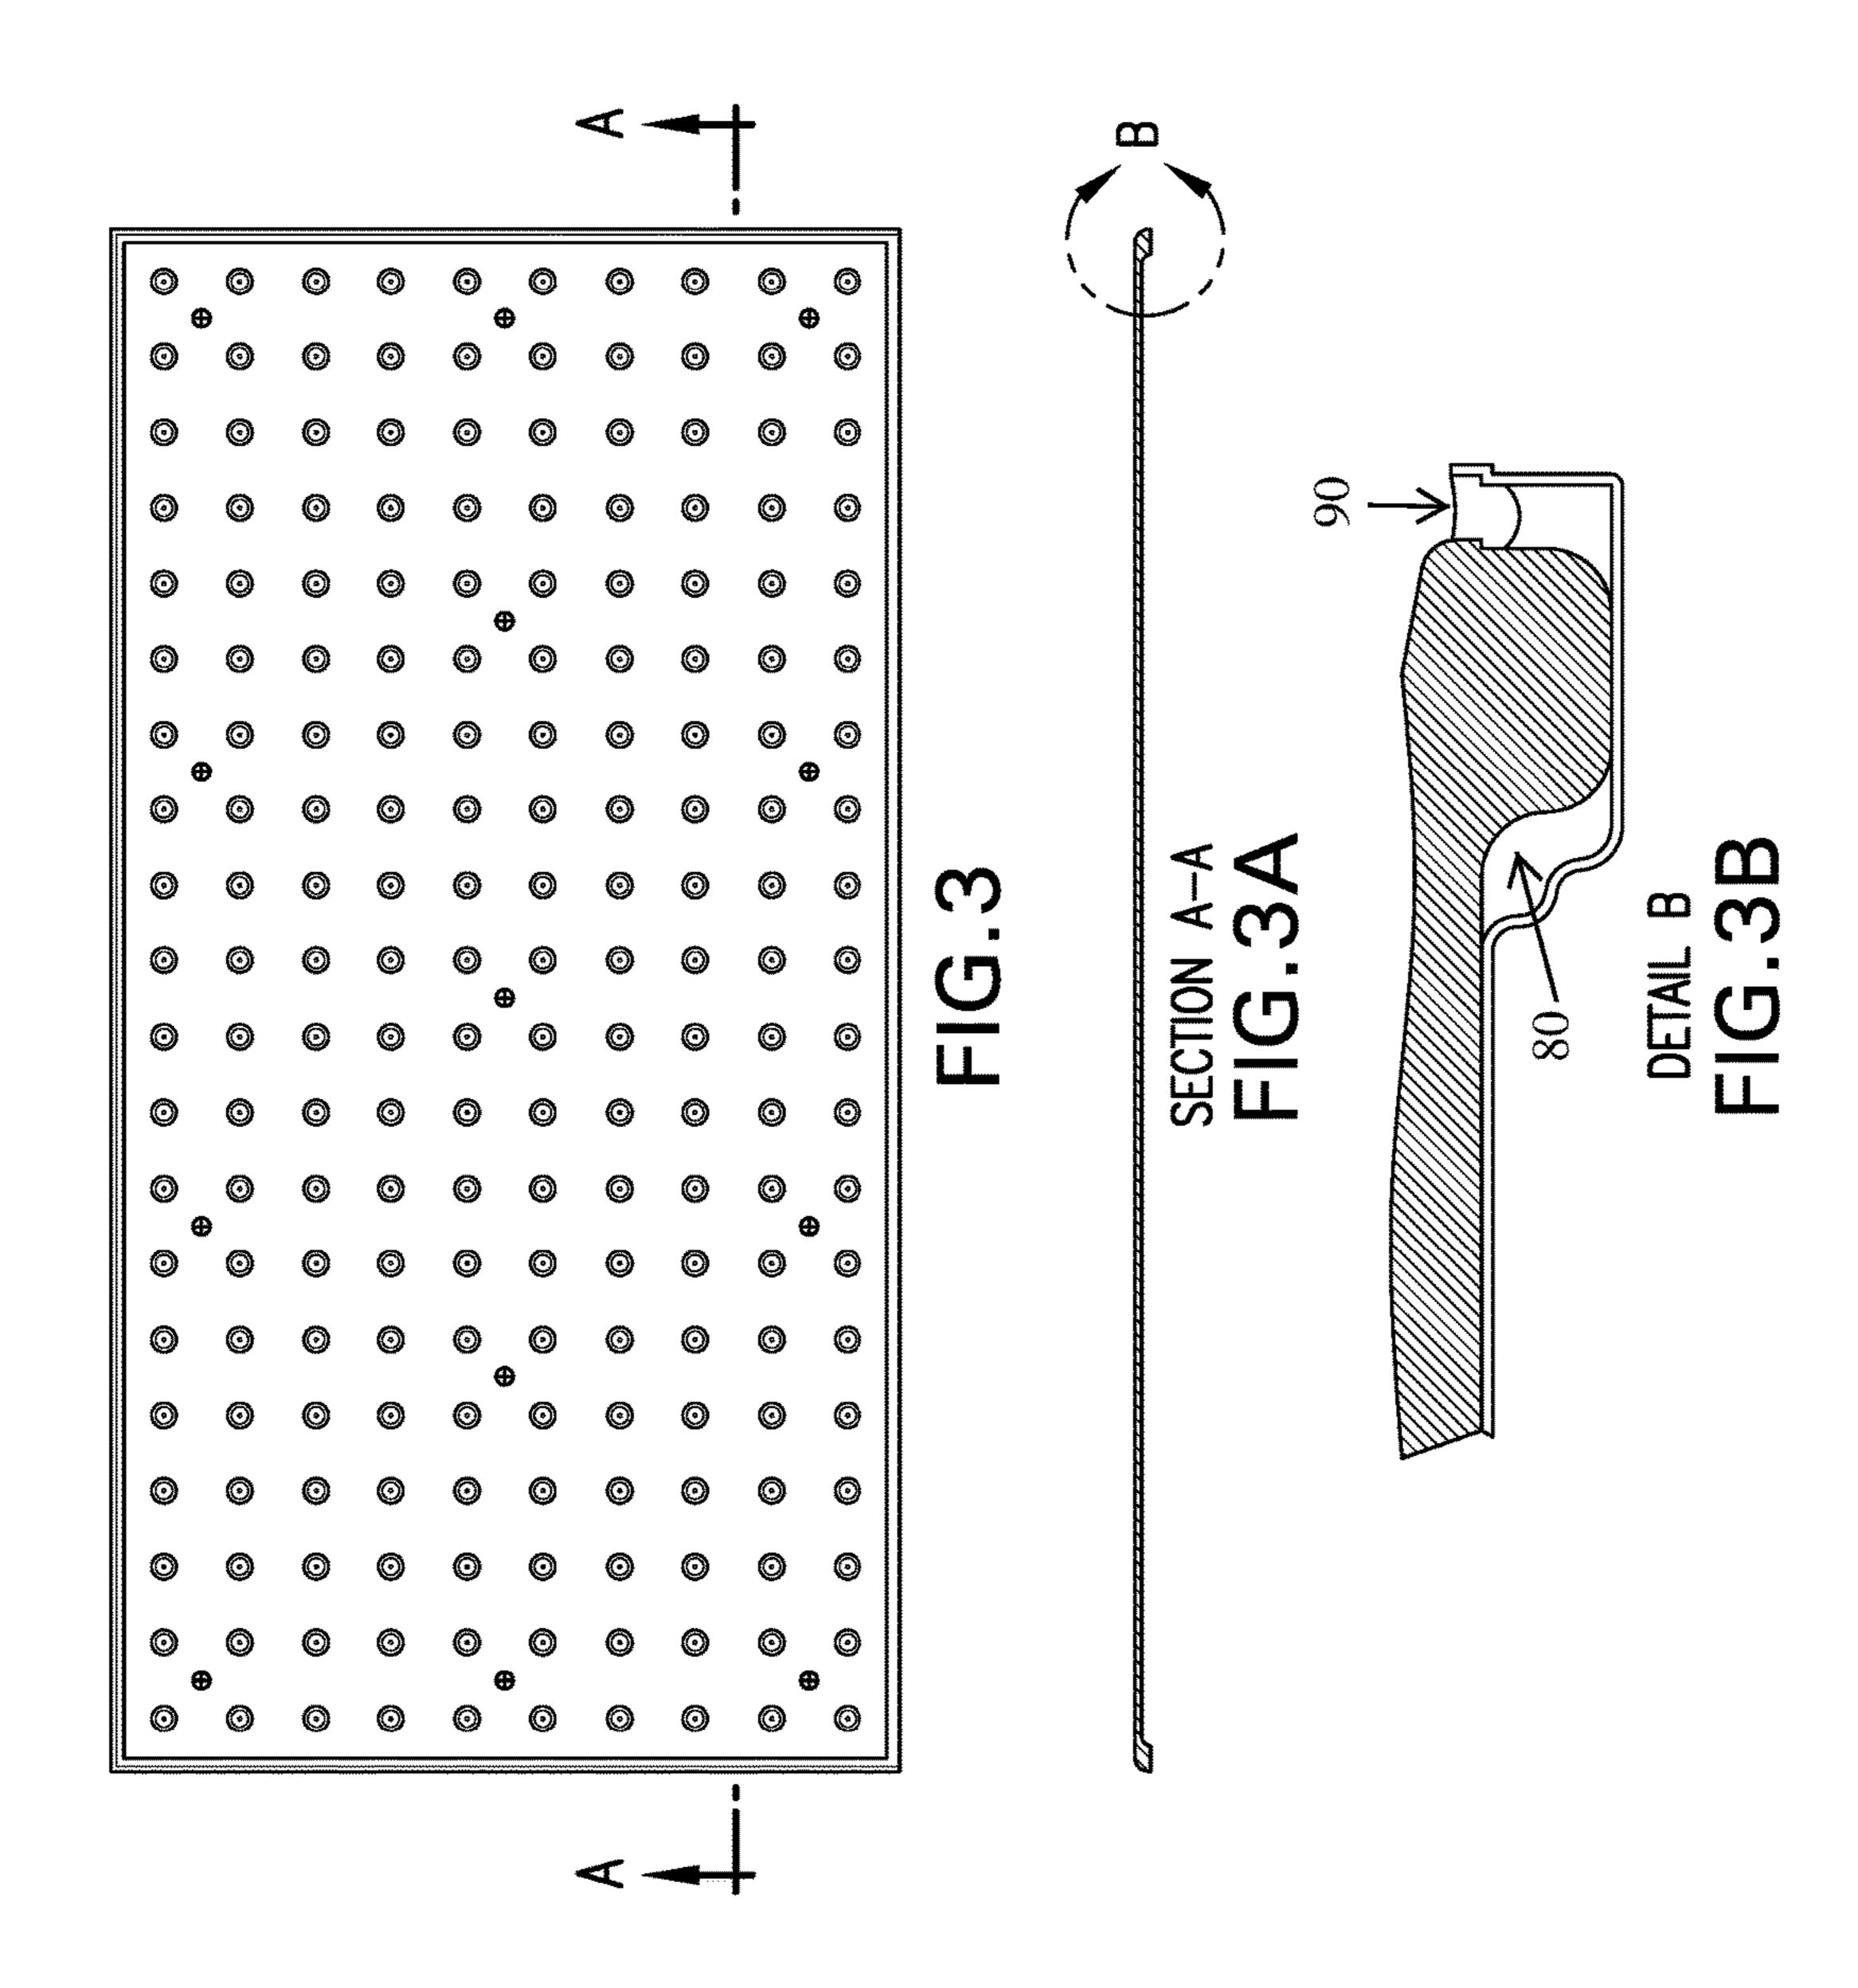
FIG. 3 is a series of schematic drawings of a tile assembly including an isolation tray.

FIG. 3 shows yet another way of addressing the problem of buckling, by installing the tile in an isolation tray. In this embodiment, a tray is affixed to the tile. The fasteners pass 55 through the tile, through the tray and then into the anchors. The isolation tray is larger than the tile, leaving room for the tile to expand and contract horizontally inside the tray. An exposed gap between the tray and the tile can be sealed, for example with a flexible caulking that allows for expansion 60 and contraction of the tile while preventing debris from falling into the tray. The presence of the tray leaves a horizontal gap between the tile and the surrounding concrete, allowing the tile to expand and contract relative to the concrete without buckling. The is also beneficial when used 65 with a replaceable tile in that the tray keeps the tile from coming directly in contact with the concrete, making the tile

easier to remove. Moreover, because the tile is not embedded directly in the concrete, underside protrusions can be any shape, including wider at their lowest point, without compromising replaceability. The isolation tray may be made from a variety of materials, and in particular, could be made from a material whose thermal expansion characteristics mimic those of concrete.

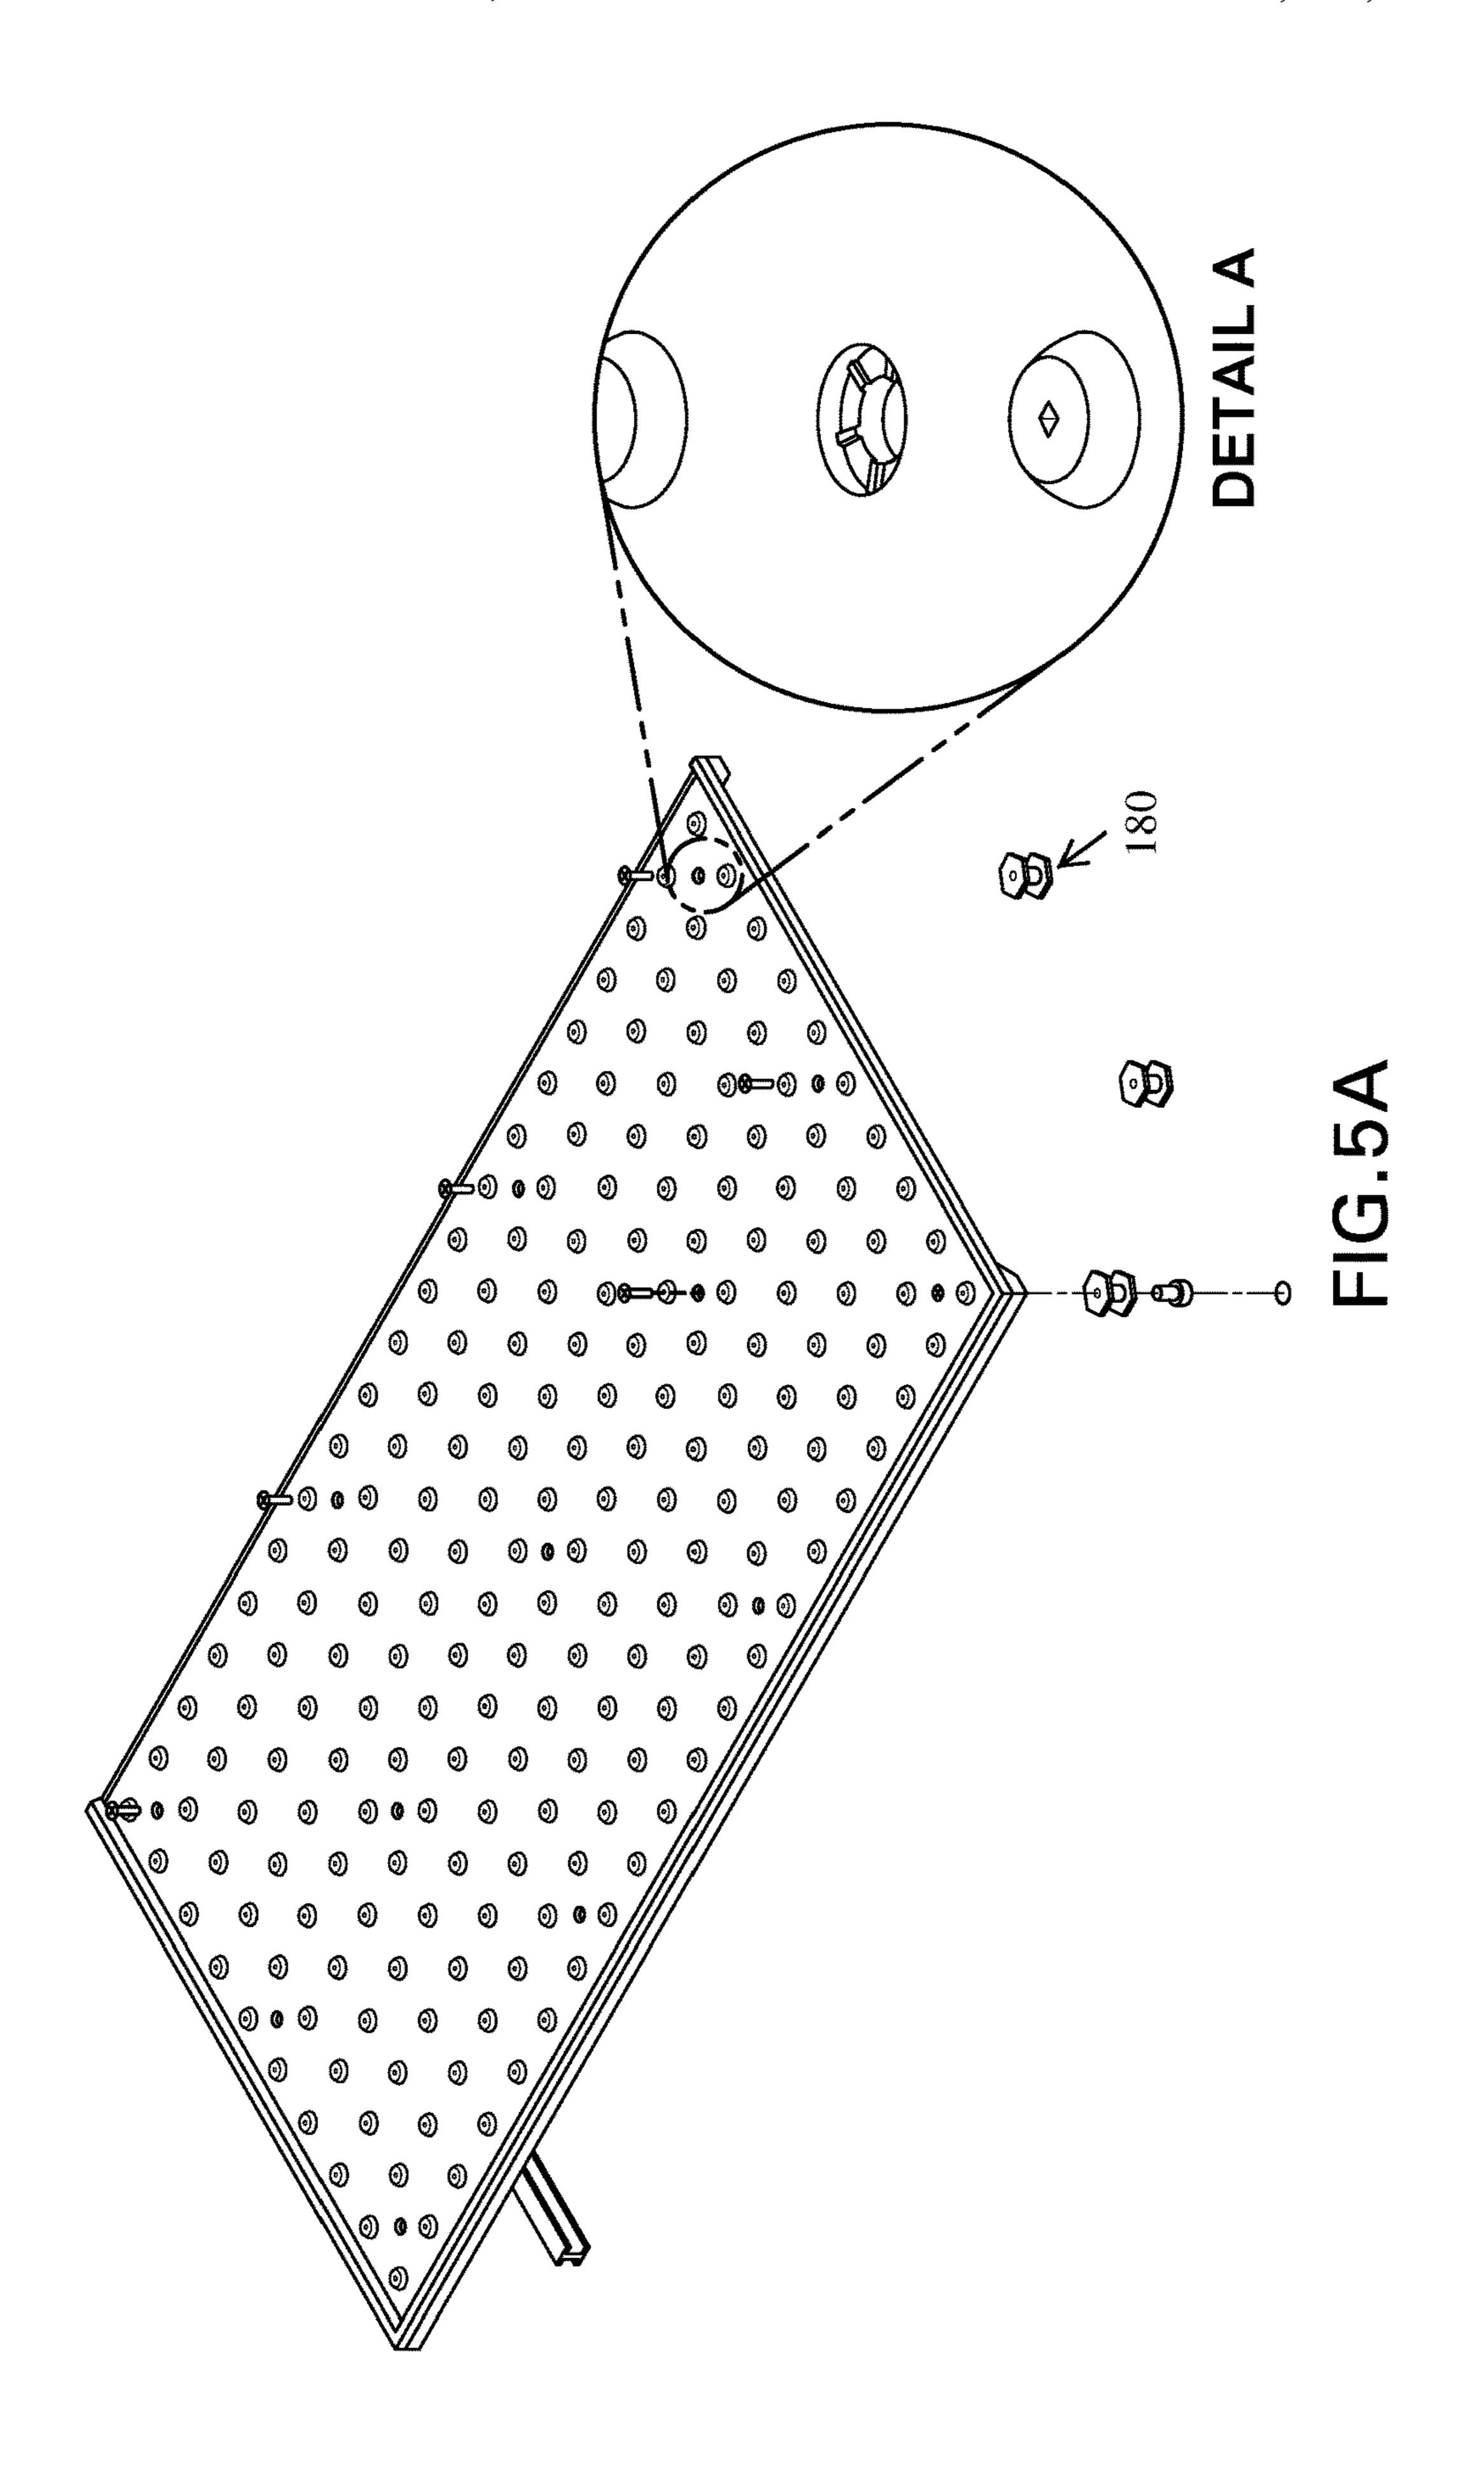
FIG.5B

Venting can also be achieved by leaving room for air to flow around the fasteners. FIG. 5A shows two ways of allowing venting around the fasteners. Detail A of FIG. 5A shows a hole through the tile. The fastener passes through the hole and attaches to the anchor. As the fastener is 5 tightened in the anchor, the anchor becomes held to the tile. But the hole shown in Detail A is not merely a countersink to allow the screw head to be recessed. The horizontal and vertical surfaces of the hole include channels that allow air to flow from below the tile to above the tile, even when a screw is seated in the countersink. When the screw is tightened down, it seats against the horizontal surface of the countersink, leaving channels underneath the screw that continue to the underside of the tile. This is shown in more detail in FIG. 5B.

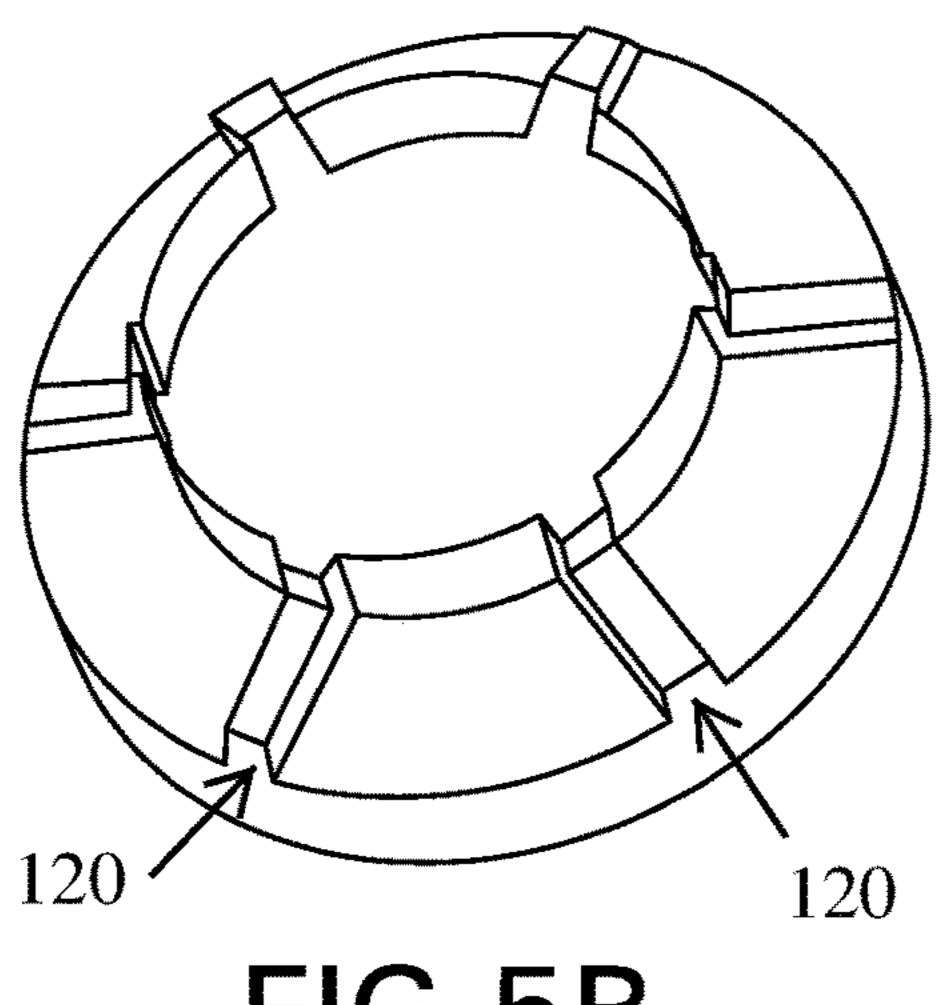
FIG. **5**B is a close up schematic picture of the tile depicted in FIG. **5**A.

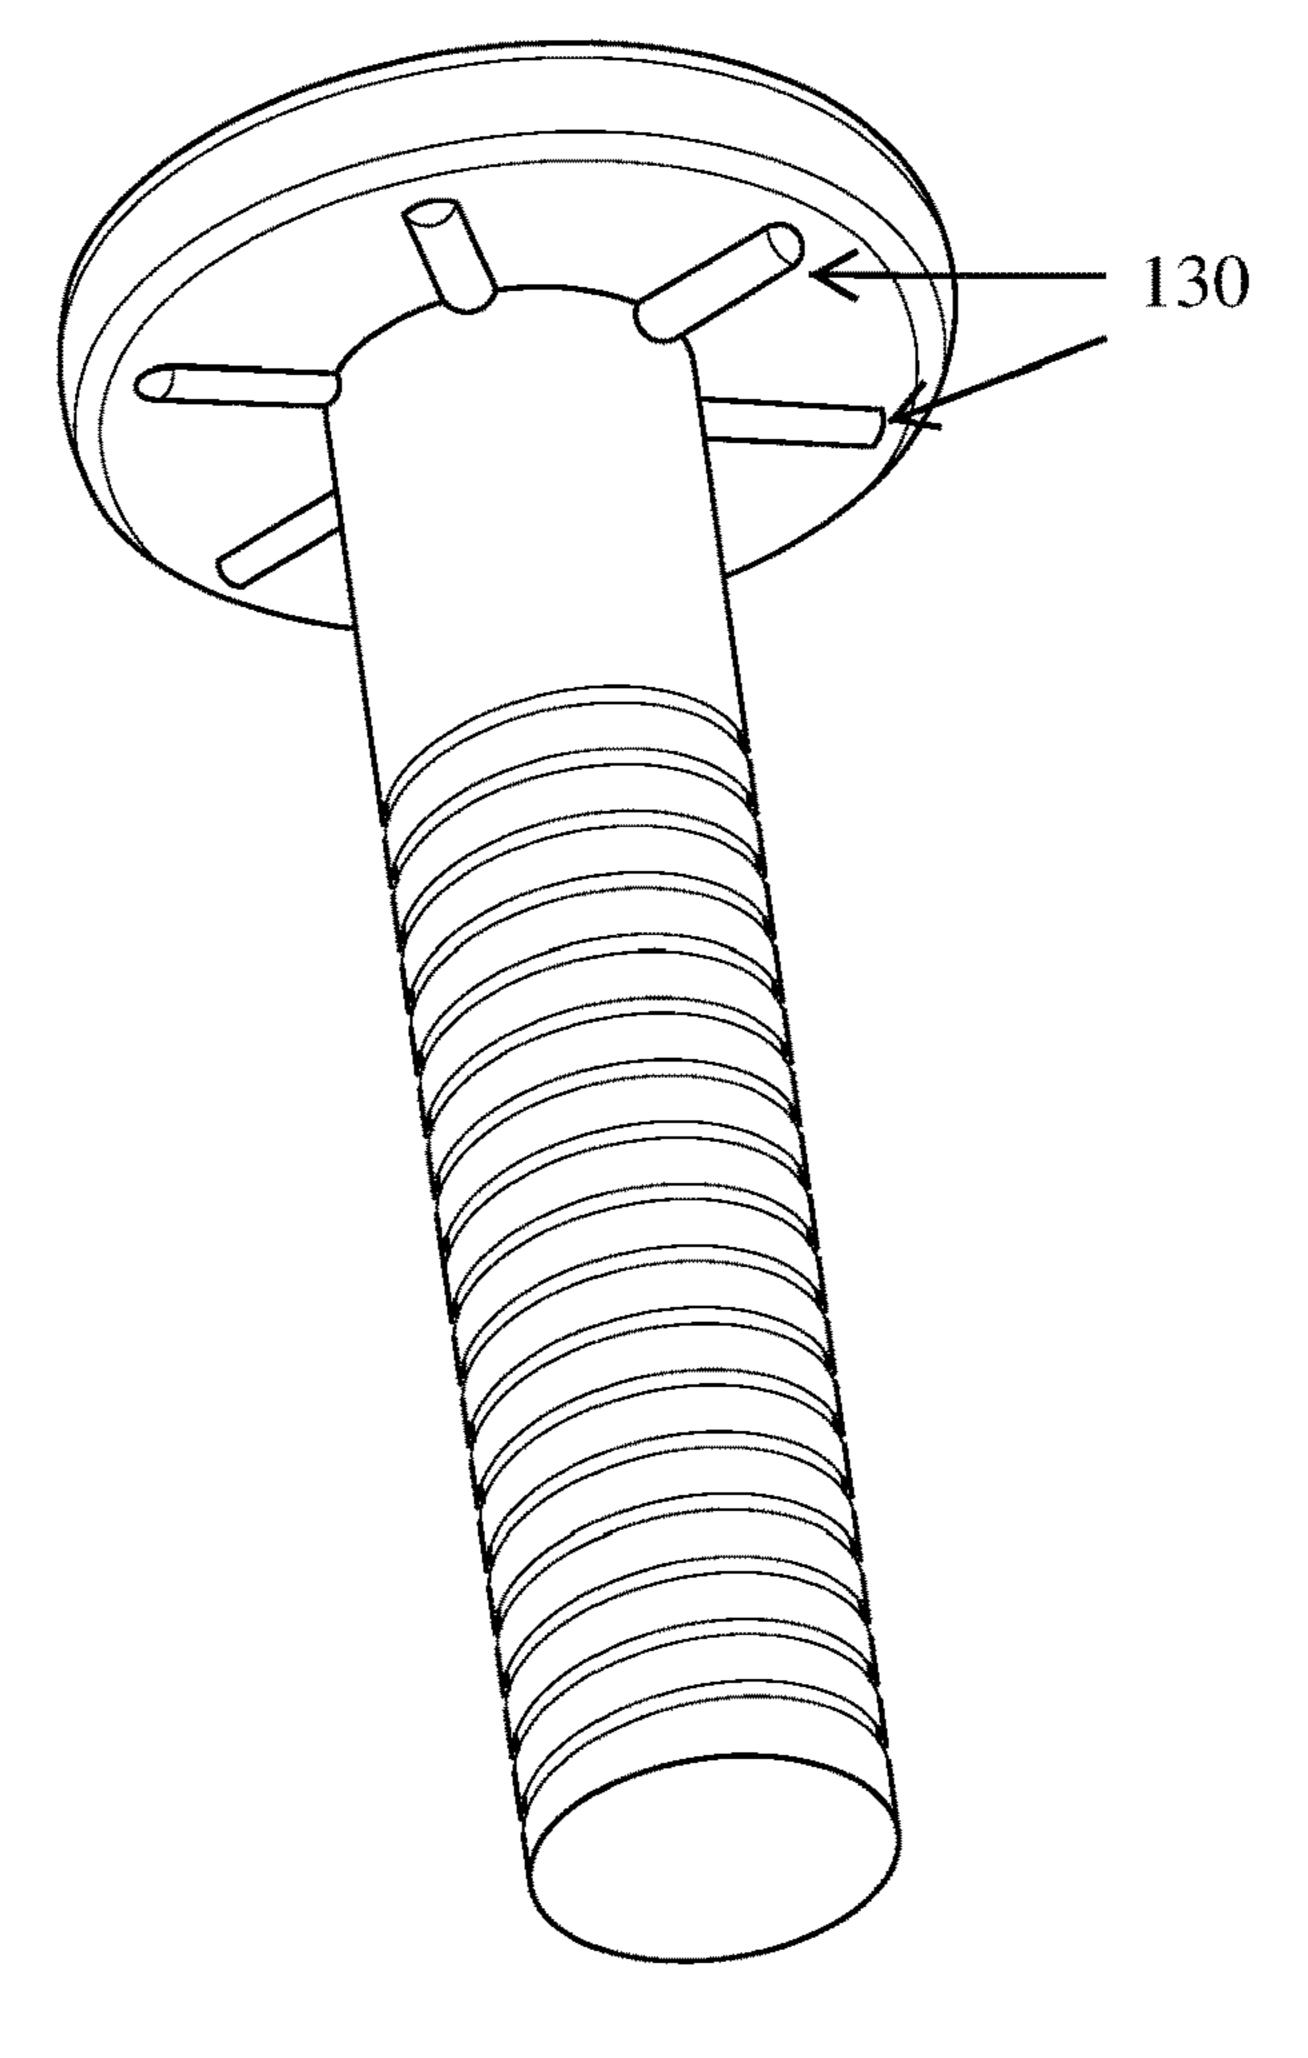
FIG.5C

FIG. 5C is a schematic of a screw with ribs on the underside of the screw head.

FIG. 5C shows a screw with protruding ribs on the underside of the screw head. This screw similarly serves to allow venting around the screw from below to above the tile. When the screw is tightened down against the tile, the ribs contact the horizontal surface of the countersink, leaving the rest of the screw head removed from the tile. As long as the screw does not completely fill the through hole and the head does not completely fill the countersink, the ribbed screw will thus leave openings for air to flow from below the tile to above the tile.
