# (10) Patent No.: US 10,344,434 B2

#### (54) DETECTABLE WARNINGS

# DETECTABLE WARNINGS

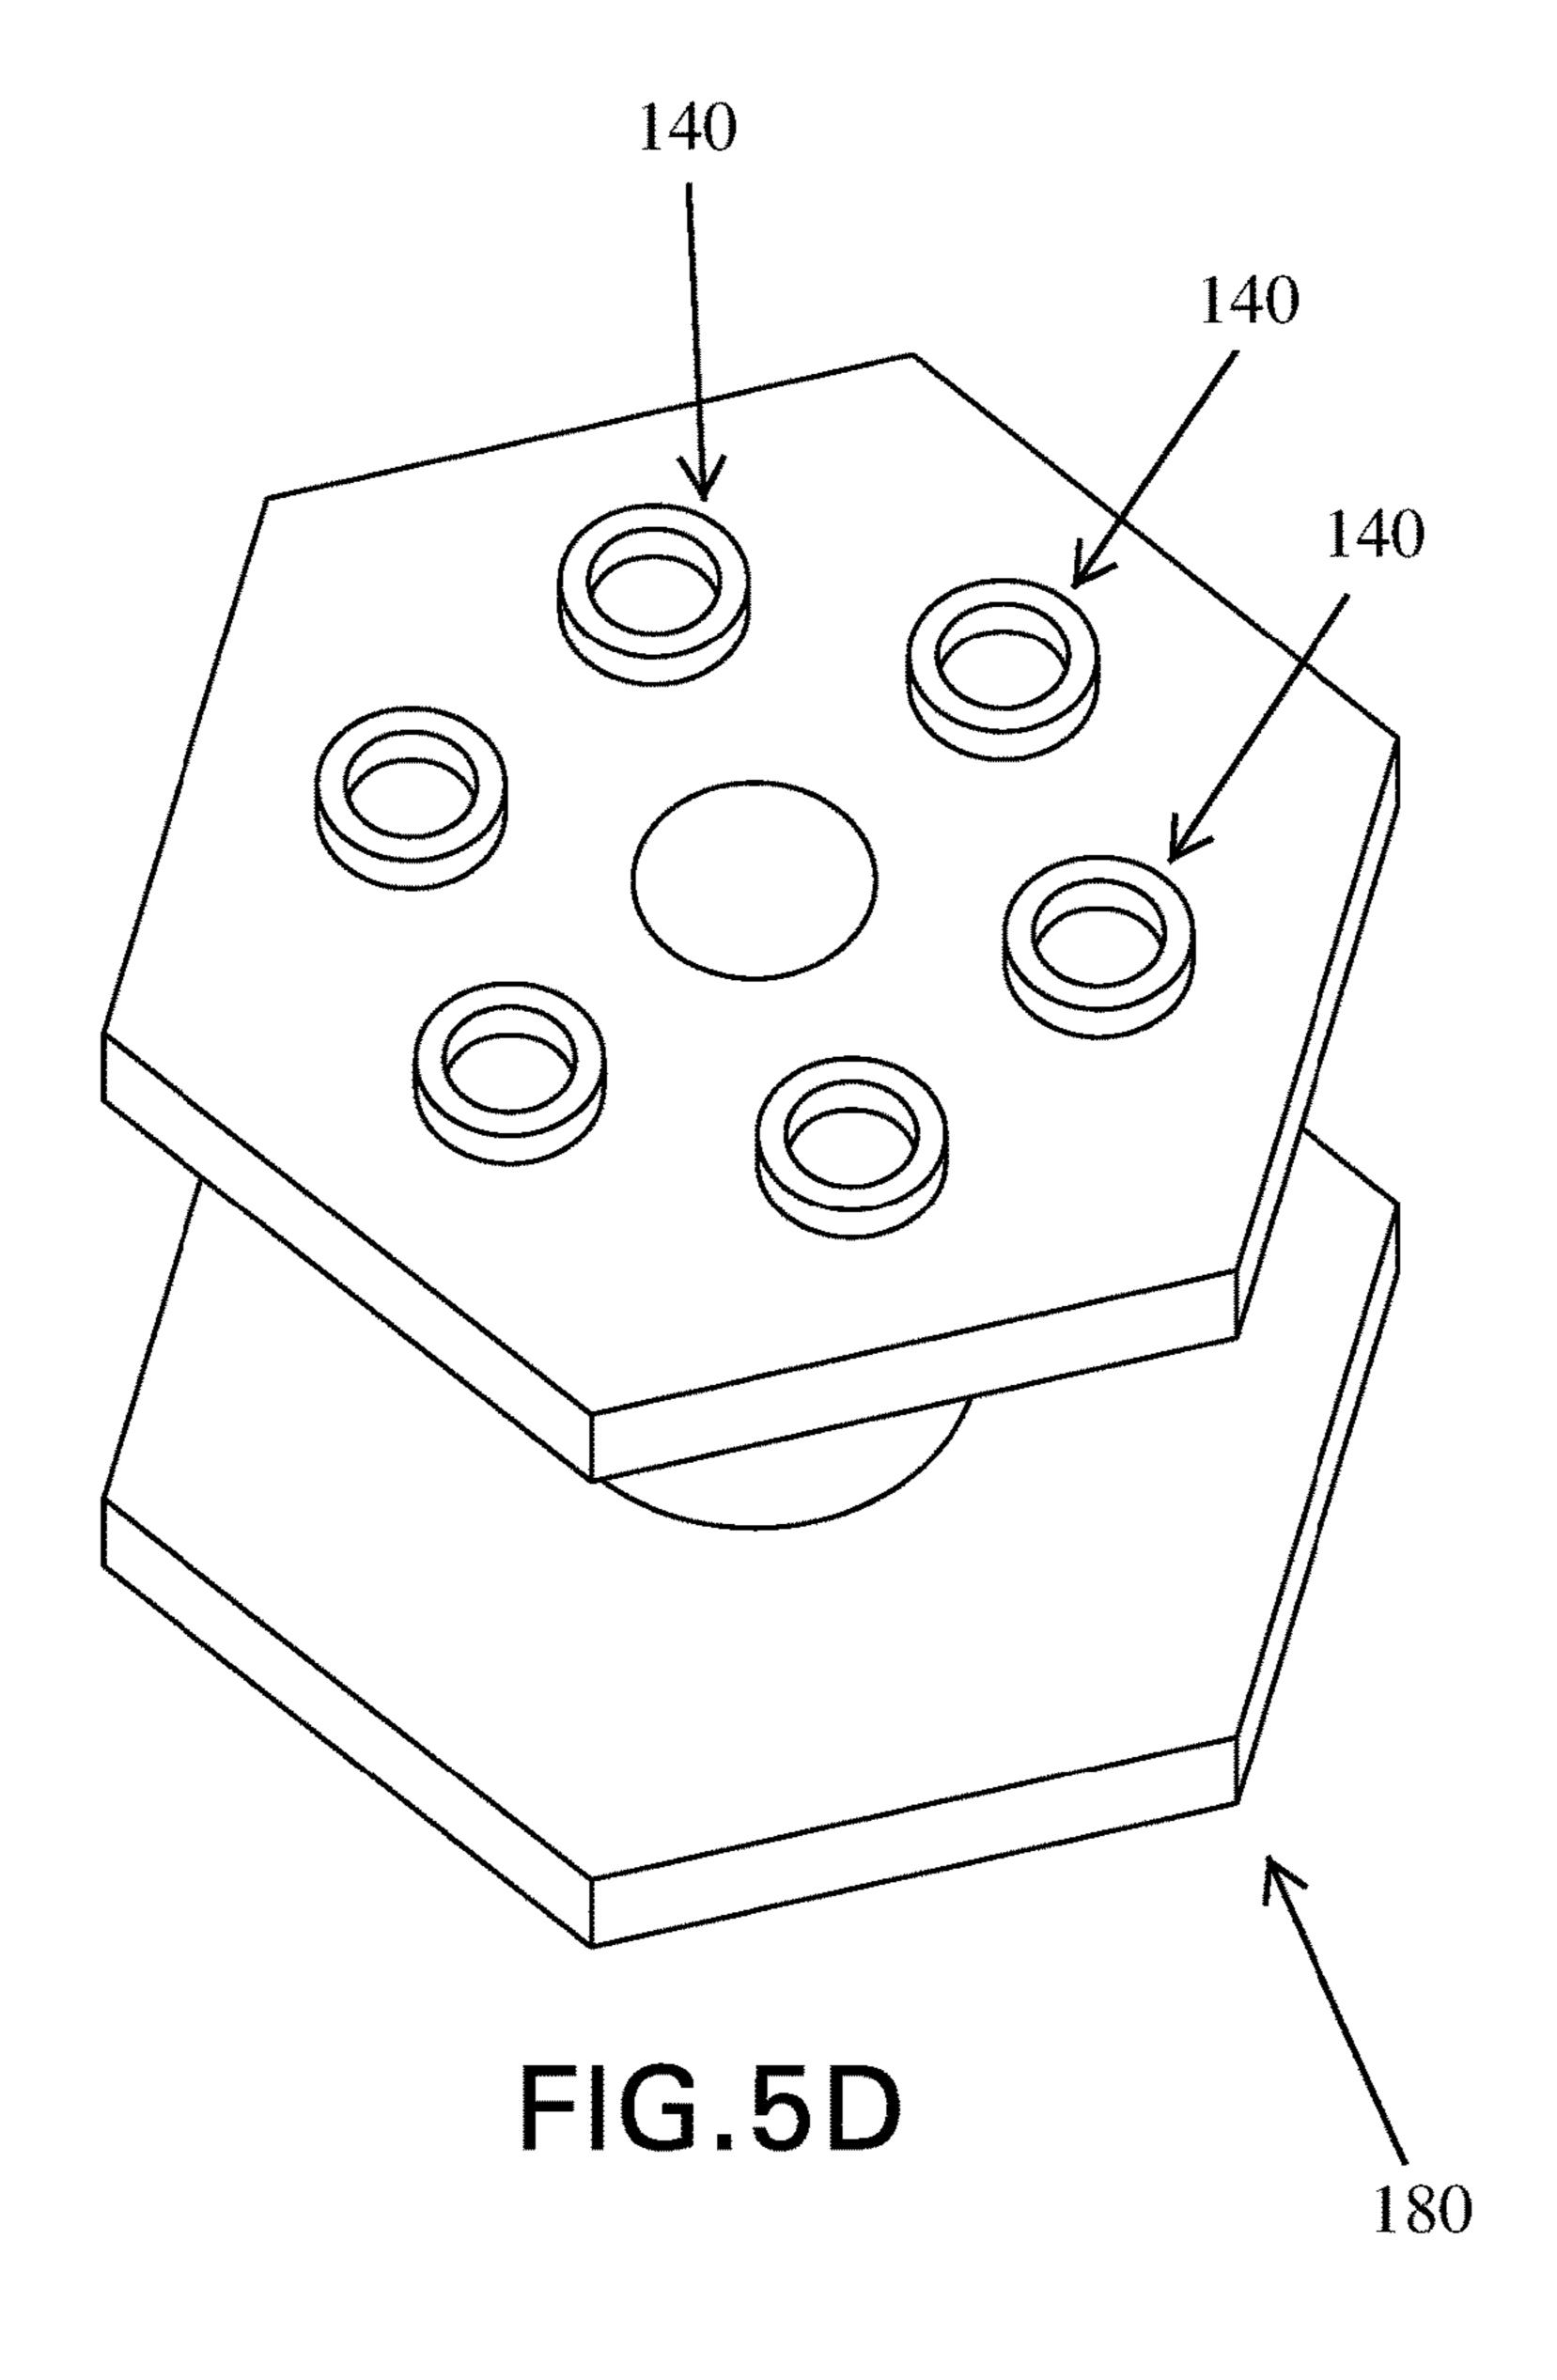
FIG. 5D is a schematic of an anchor that allows venting.

The fasteners attach to anchors that seat tightly against the underside of the tile. In order for air to flow around the 30 fastener, the anchor cannot be allowed to completely block the hole. FIG. **5**D shows an anchor with six circular bosses that allow the anchor to stand off from the underside of the tile even when firmly attached to the tile. An anchor like the one in FIG. **5**D can be used with any combination of 35 fasteners and holes that allows for venting.
