(12) **United States Patent**
Zhan et al.

(54) **METHOD OF ASSESSING RELIABILITY OF ELECTRONICS ASSEMBLIES UNDER DRILLING VIBRATION CONDITIONS**

The present disclosure relates to electronic devices for drilling operations, particularly relates to methods and apparatus for assessing reliability of the printed circuit board assembly (PCBA) under drilling vibration conditions.

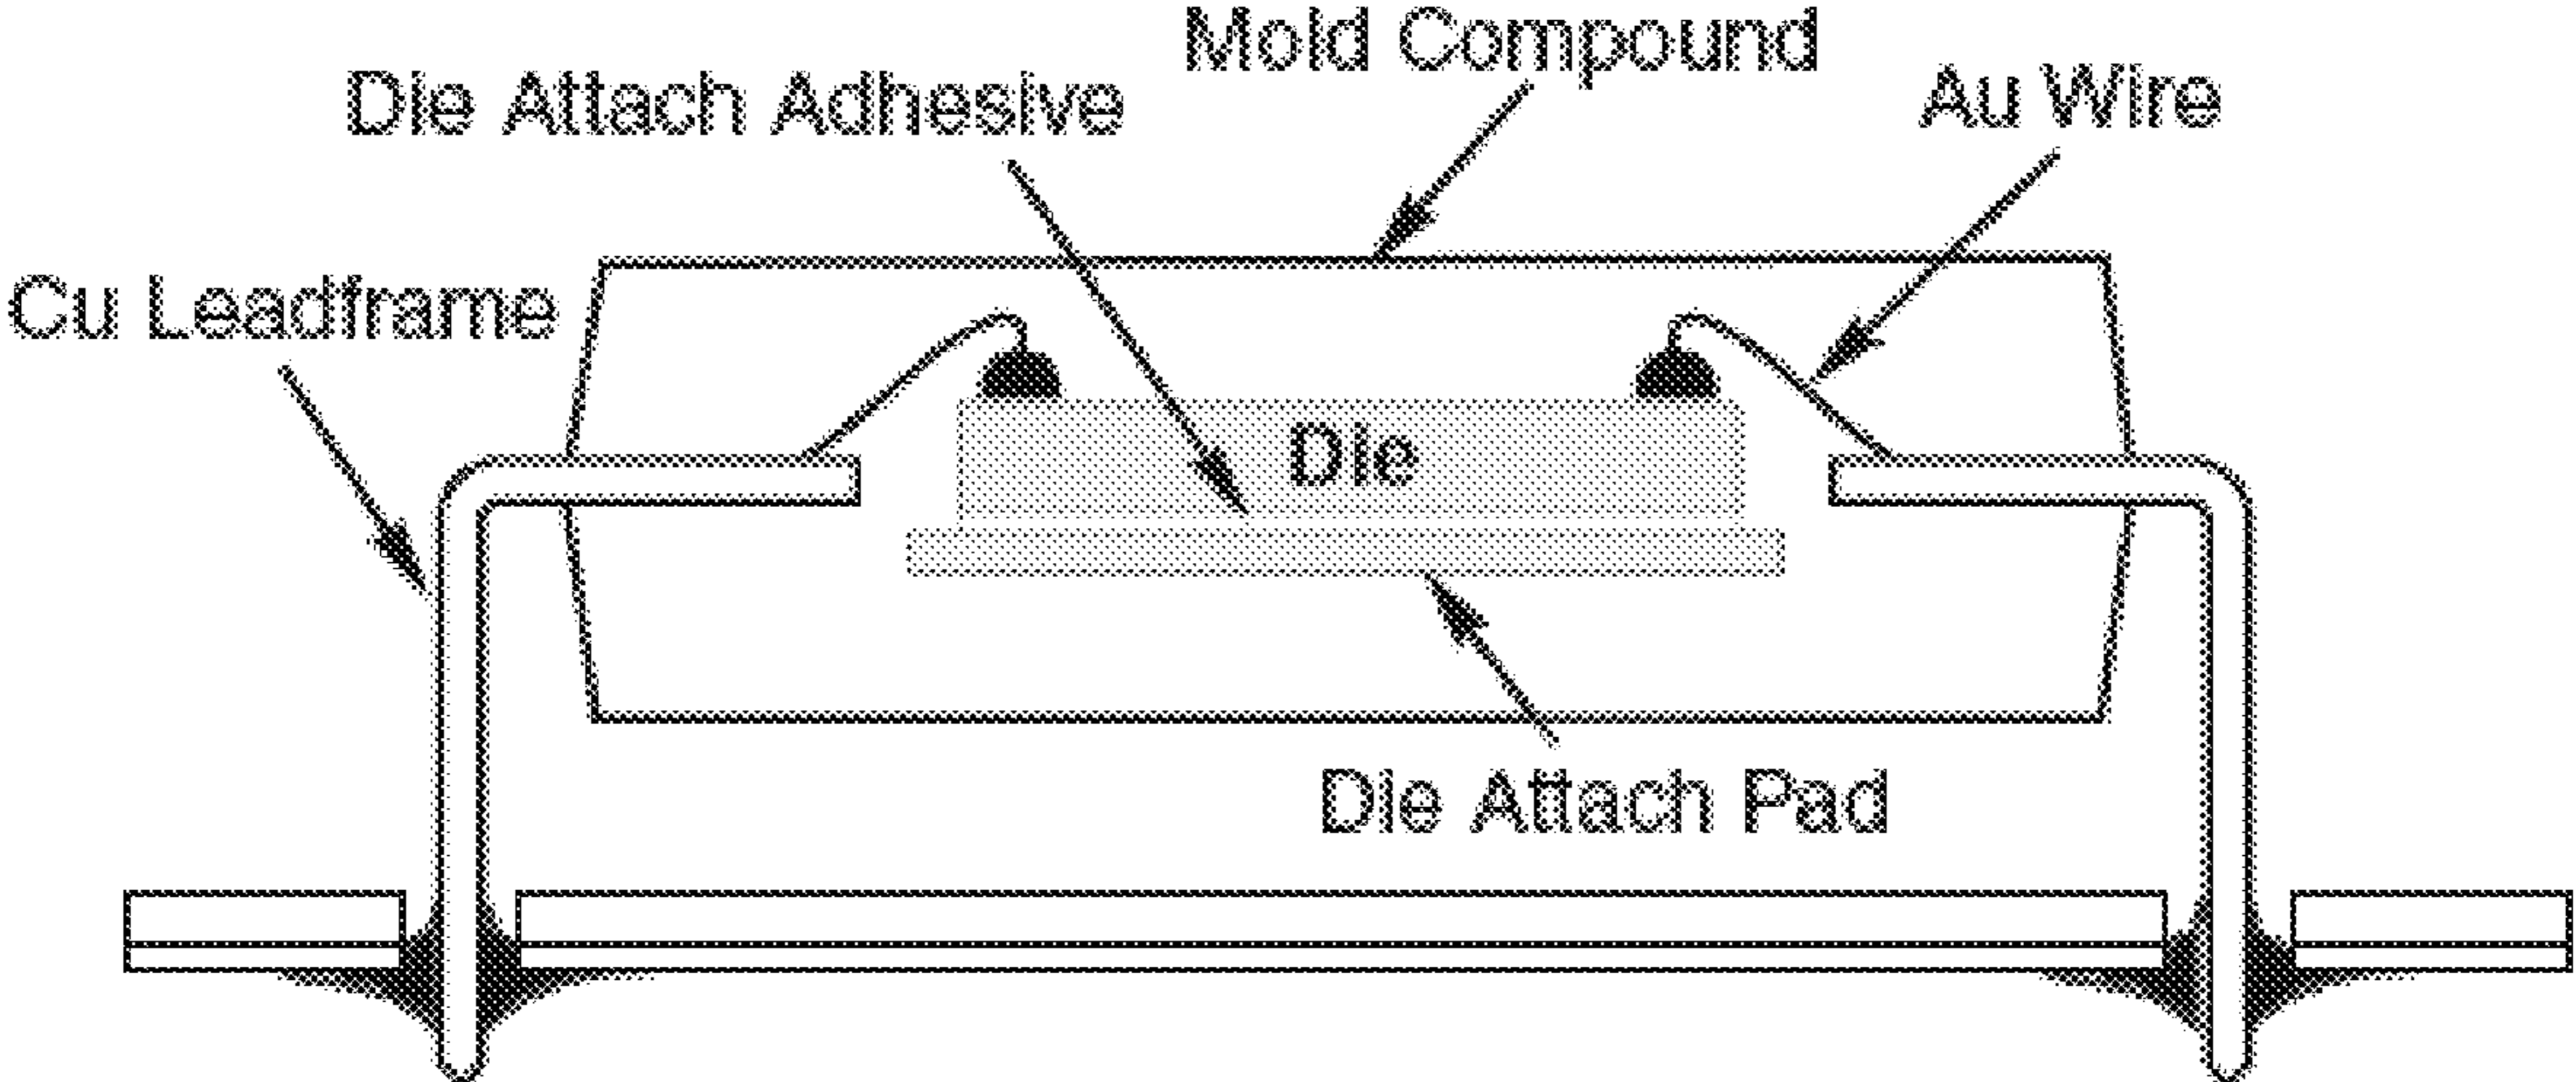
FIG. 1 is a cross-sectional view of a PDIP insertion mounted on a circuit board.

FIG. 1 is a cross-sectional view of the PDIP single sided insertion mounted. It has a die attached to a pad, encapsulated in a mold compound. The die is attached to a pair of copper leads though gold wires. The lead terminals are inserted into holes in the CEM-1 board and affixed to the board by respective solder fillets.

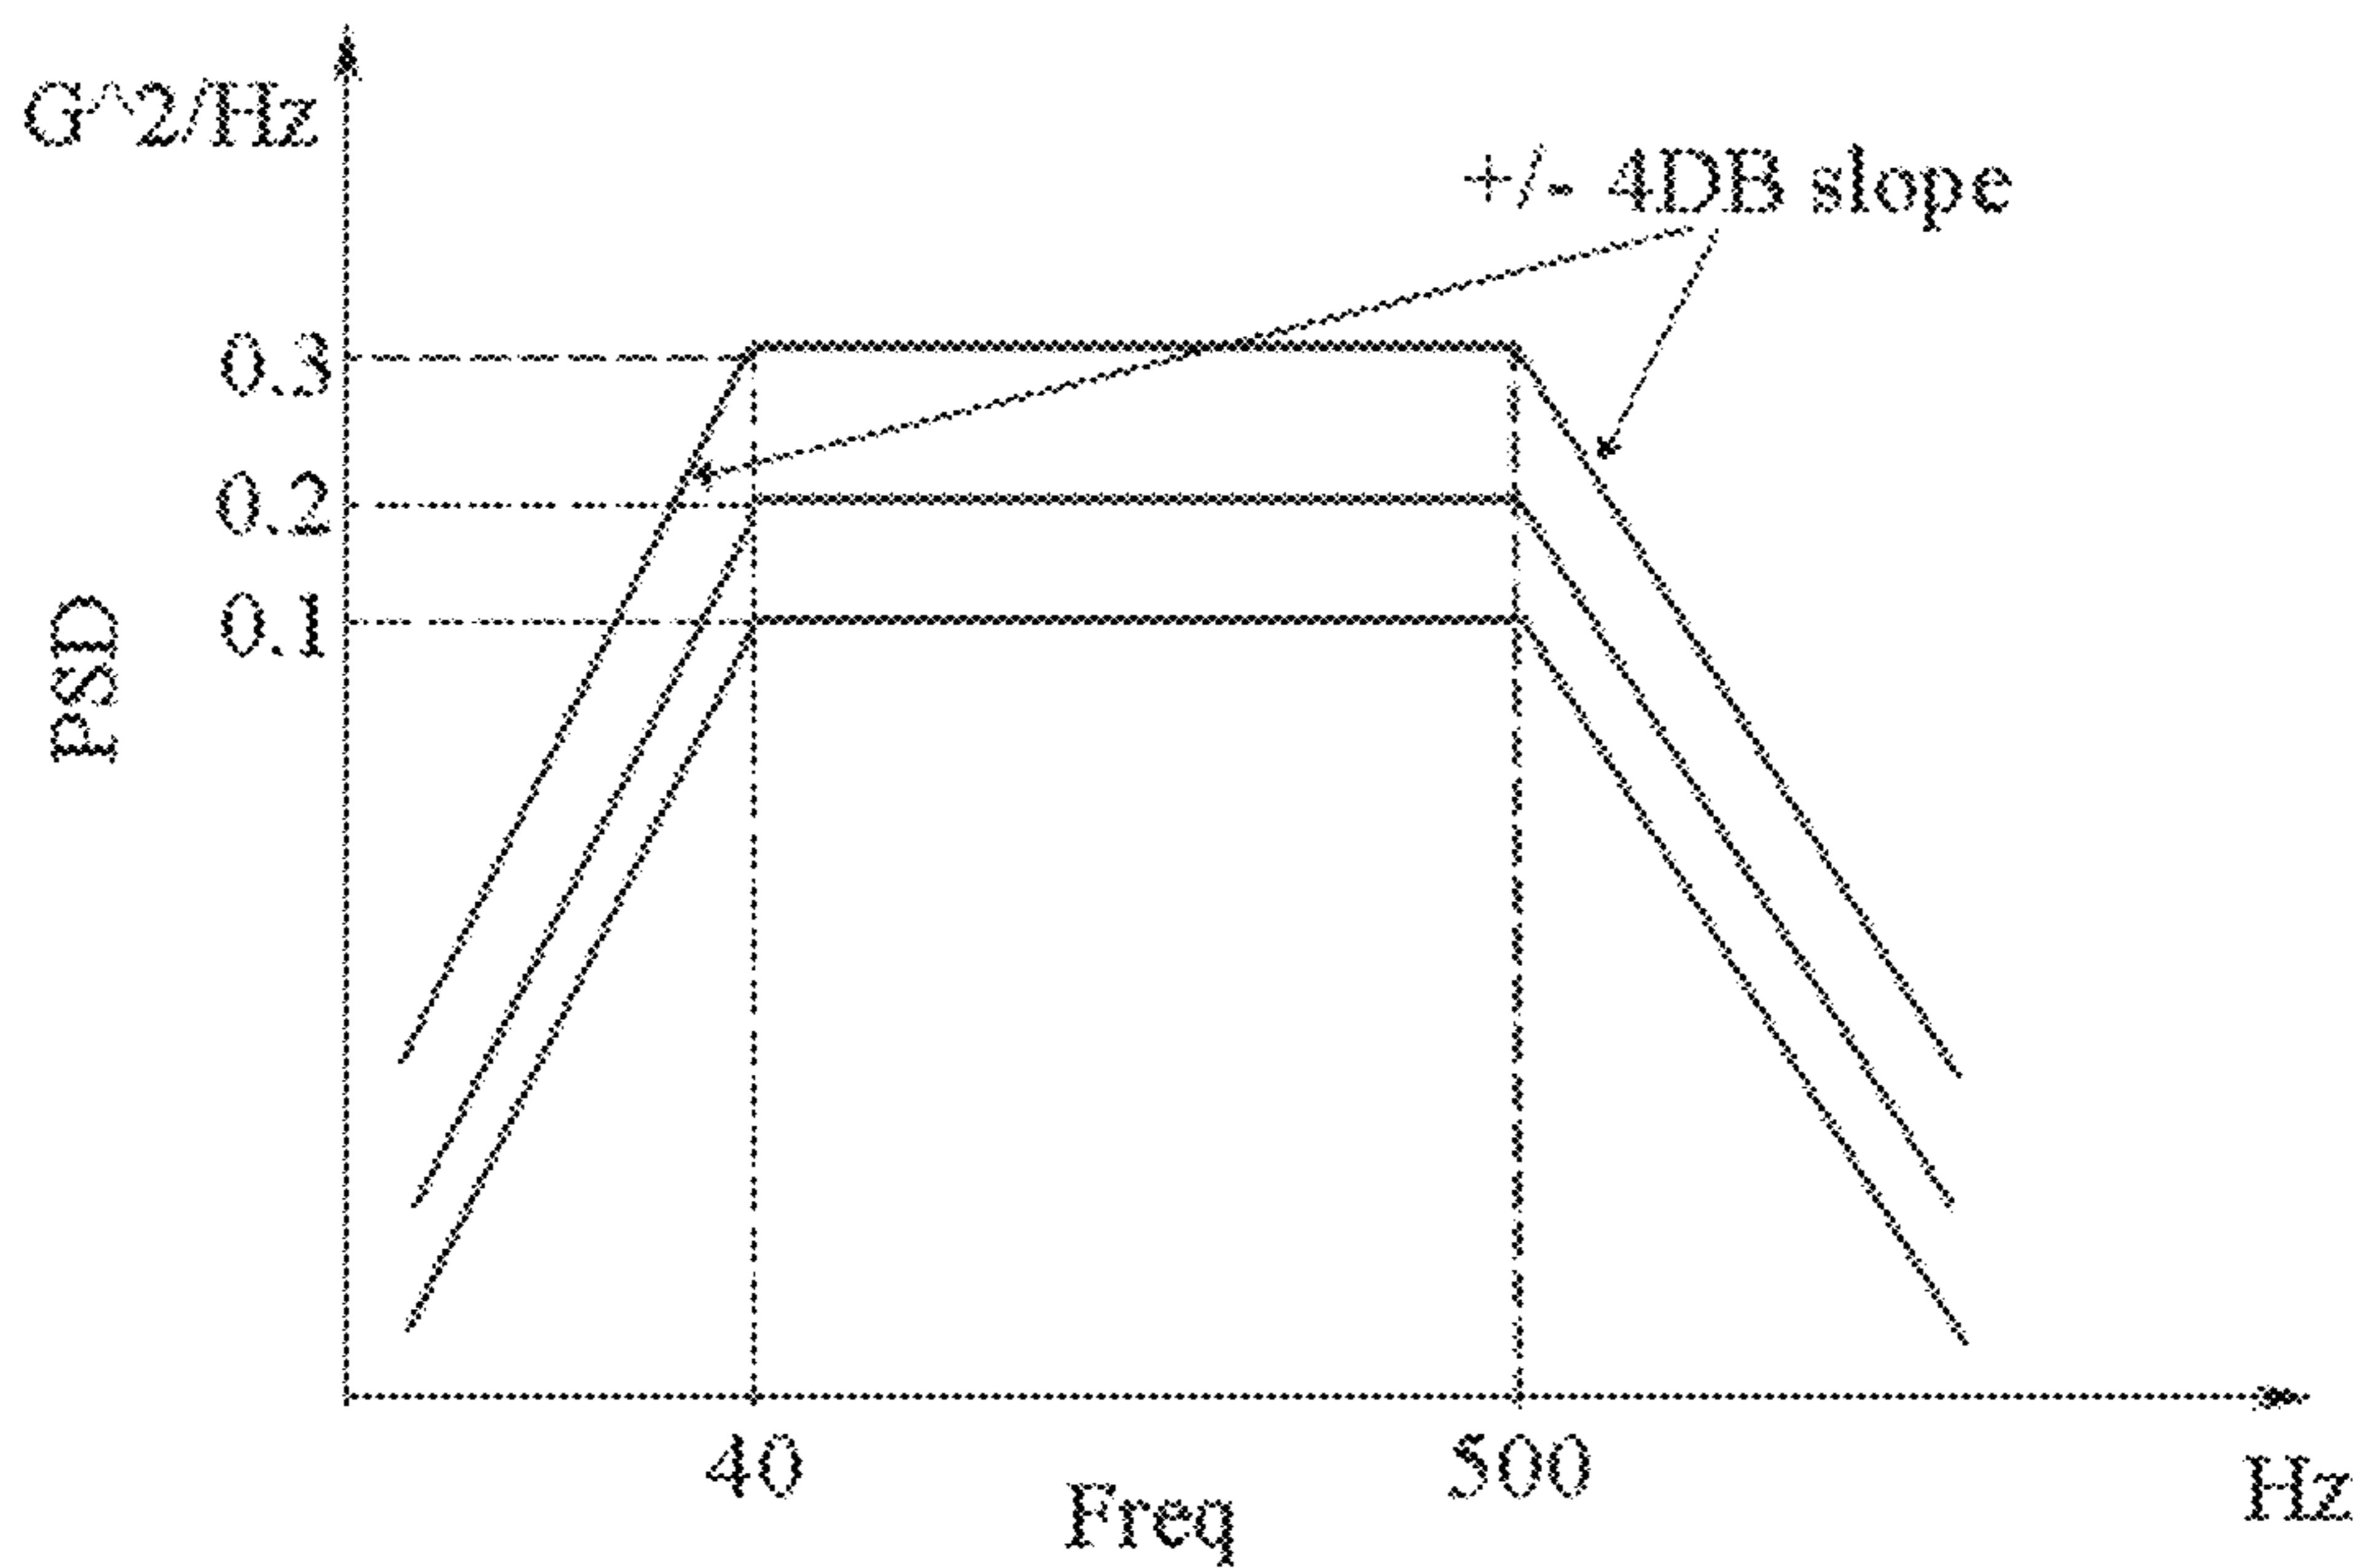
FIG. 2 shows a random vibration loading as a power spectral density (PSD) vs. vibrational frequency.

The random vibration loading is shown in FIG. 2 as a Power Spectral Density (PSD) vs. Frequency curve. The PSD level ranged from 0.1 to 0.3 G²/Hz during the tests. The frequency range was from 40 to 500 Hz.

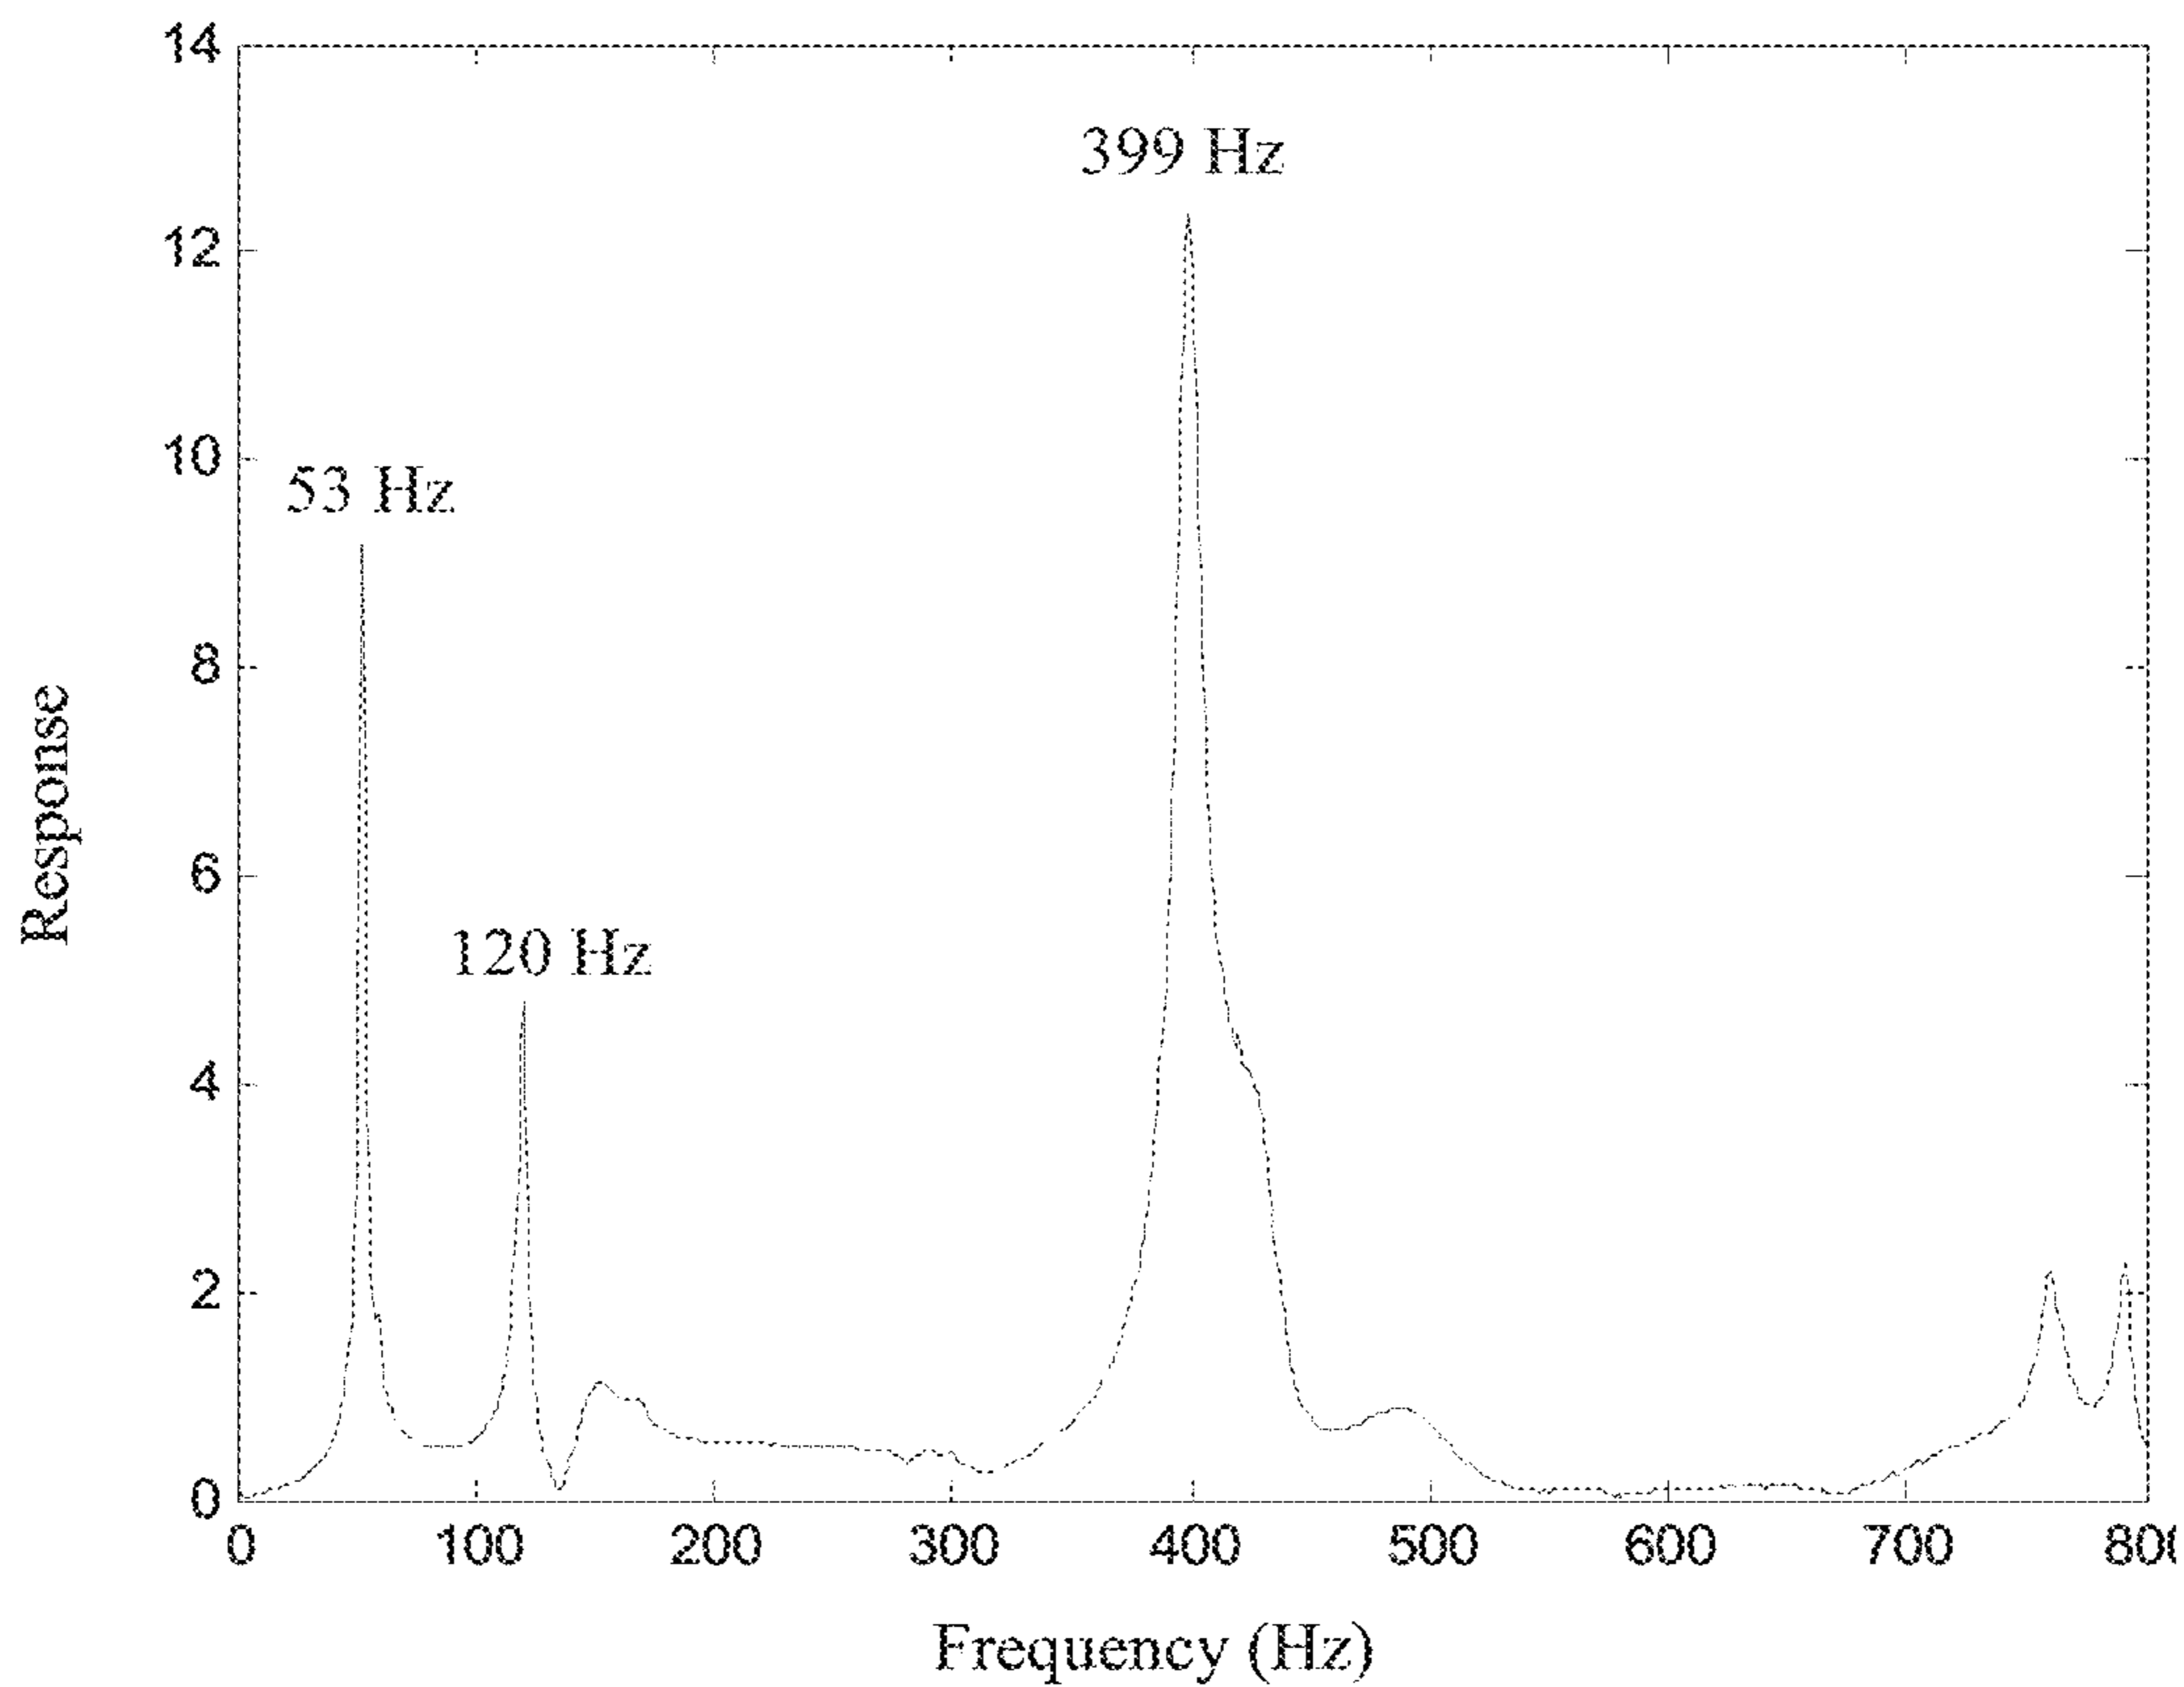
FIG. 3 illustrates the vibration response of the test vehicle that has a four-point support.

First, an appropriate random vibration frequency range covers the natural frequency of test vehicles so that the test samples have the maximum vibration response. Therefore, natural frequency measurement is important to vibration test design. FIG. 3 shows the frequency response of single sided insertion mount assemblies with 4-point support on the vibration shaker. The first mode natural frequency of the assembly is 53 Hz. The designed vibration frequency range, 40-500 Hz, satisfies the natural frequency coverage requirement. Therefore, this frequency range was used in all the tests.

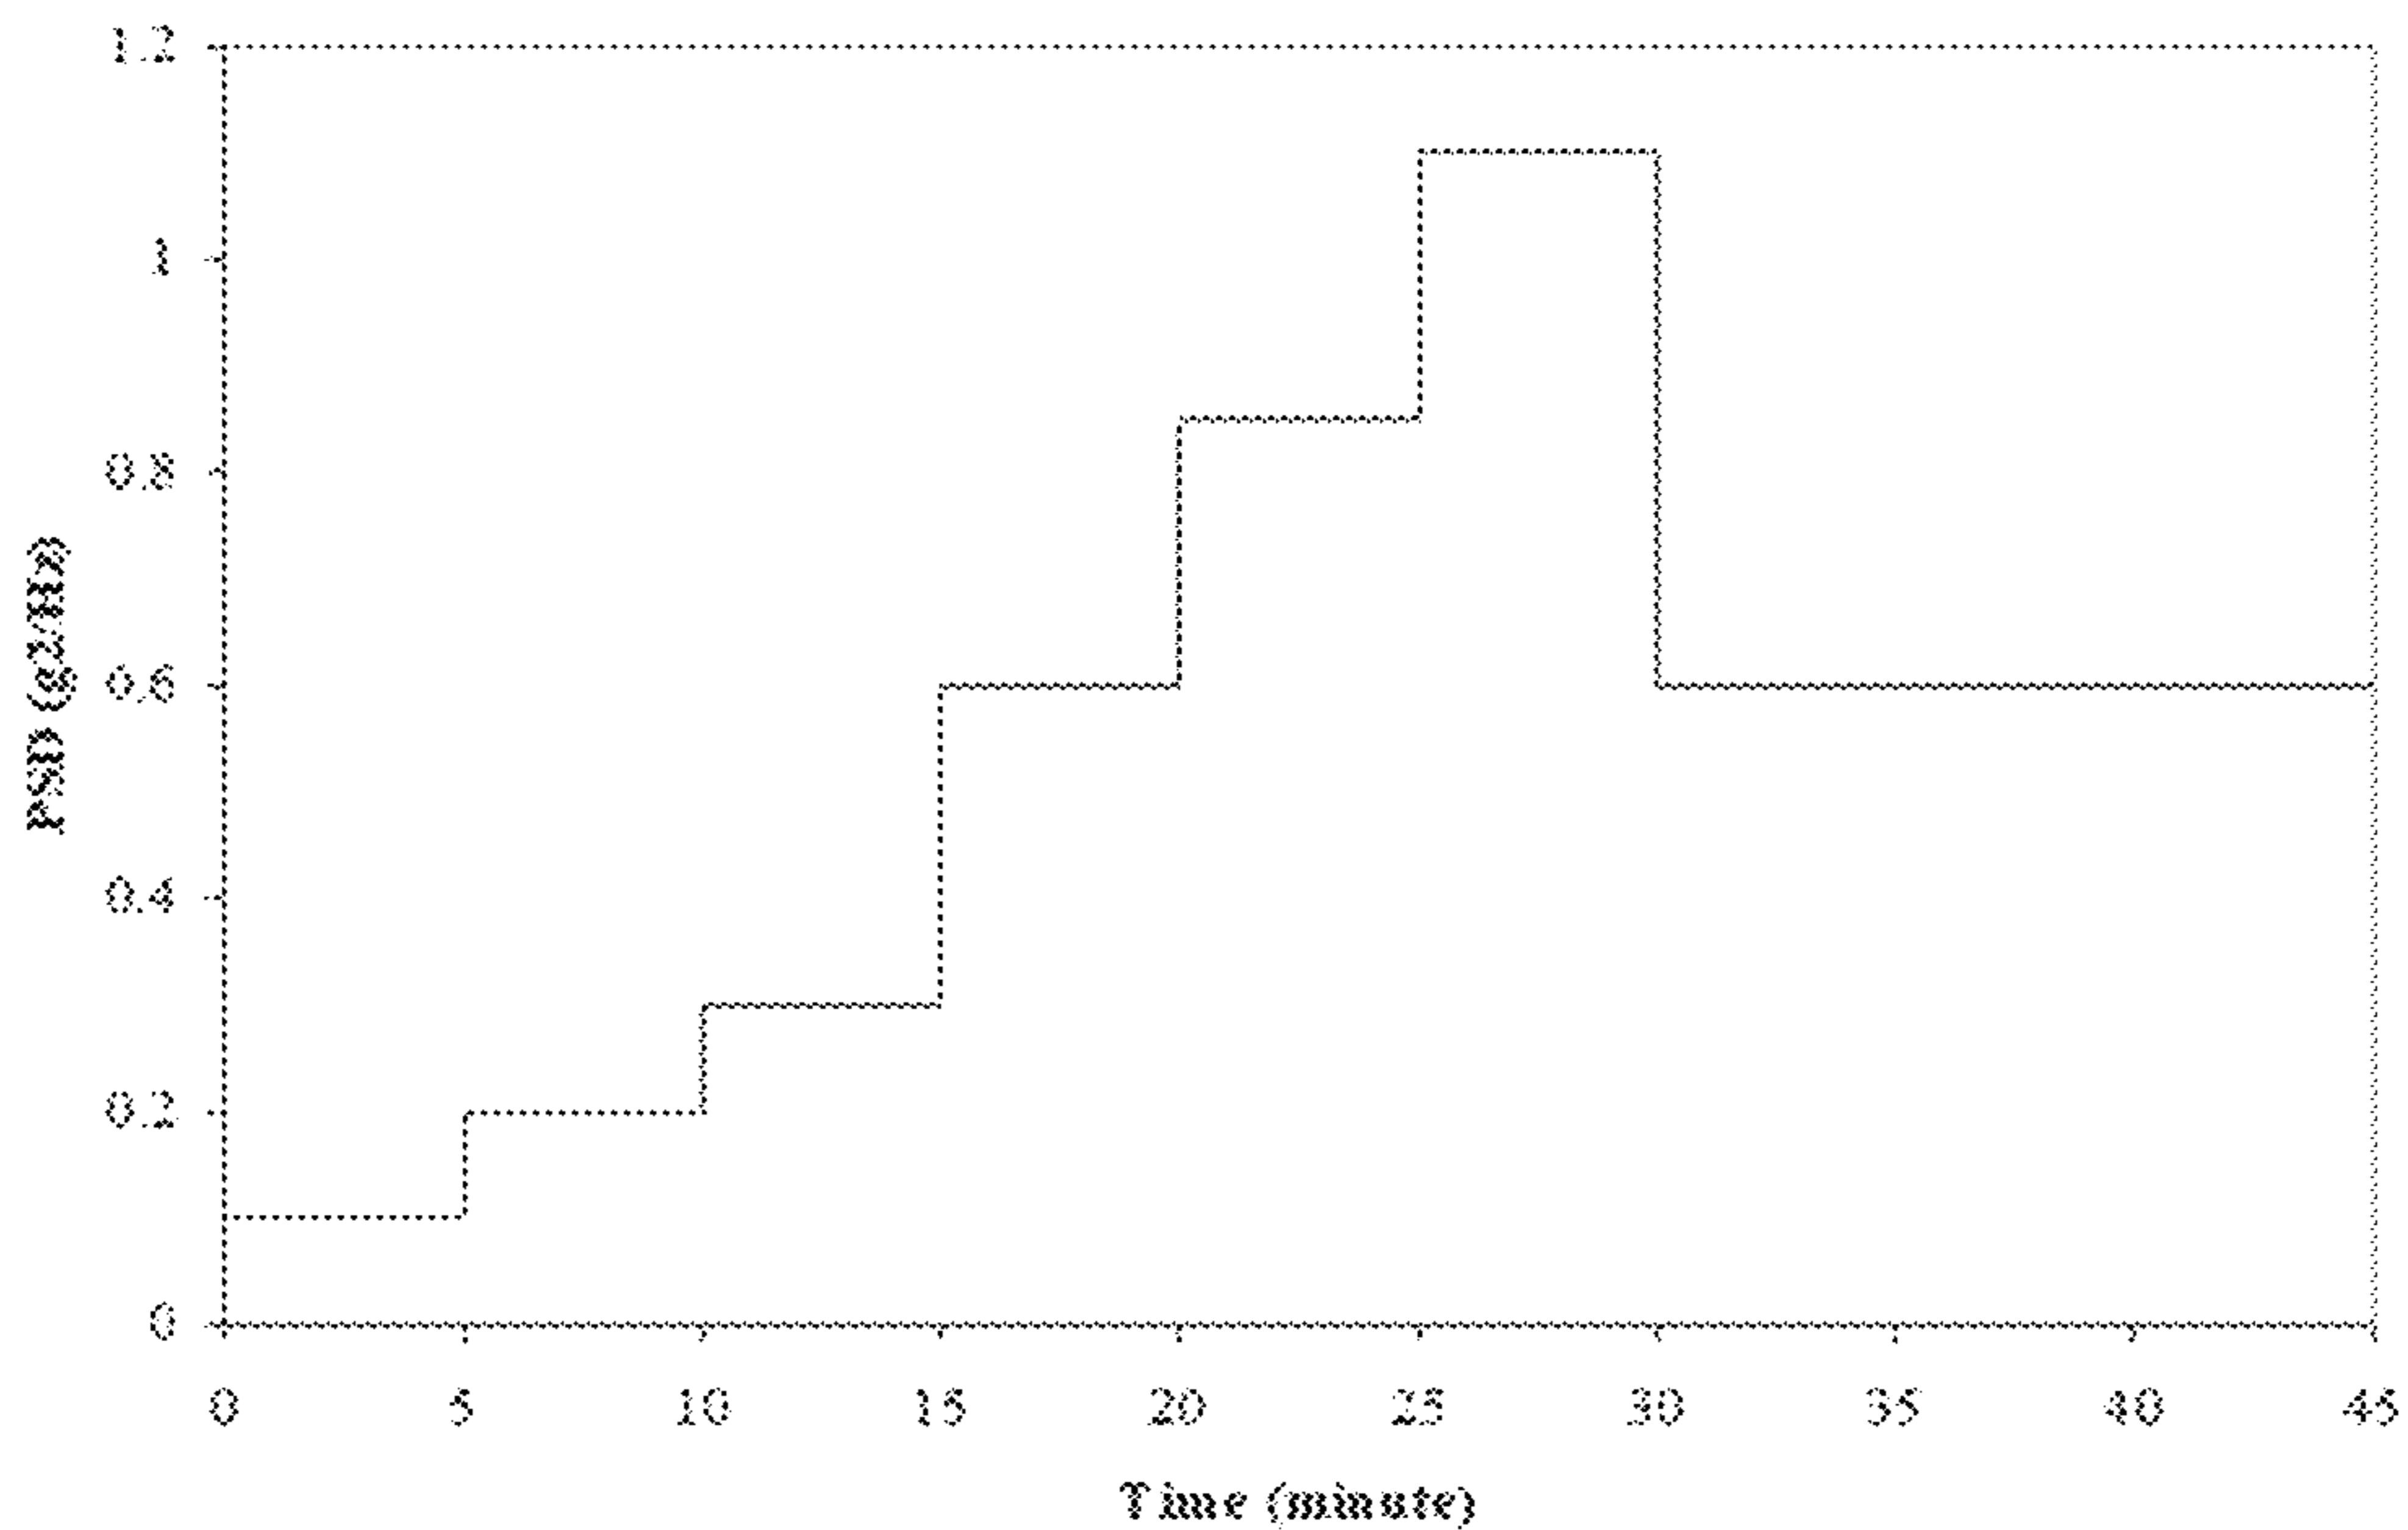
FIG. 4 shows a step stress loading plot used in measuring overstress limit of the test vehicle.

overstress limit for test vehicles, step stress test was first carried out on the SnPb/HASL assembly with a different boundary condition: two clamps supporting the short-edges of the board. The stress loading history is shown in FIG. 4. PSD level was stepped up from 0.1, 0.2, 0.3, 0.6, 0.85, 1.1 G²/Hz with 5 minutes dwell at each level. There were no failures observed. Then PSD level was dropped to 0.6 G²/Hz for 15 minutes vibration-test. Components then started to fail at the 14th minute and all components failed at the end of 15 minutes of vibration exposure.

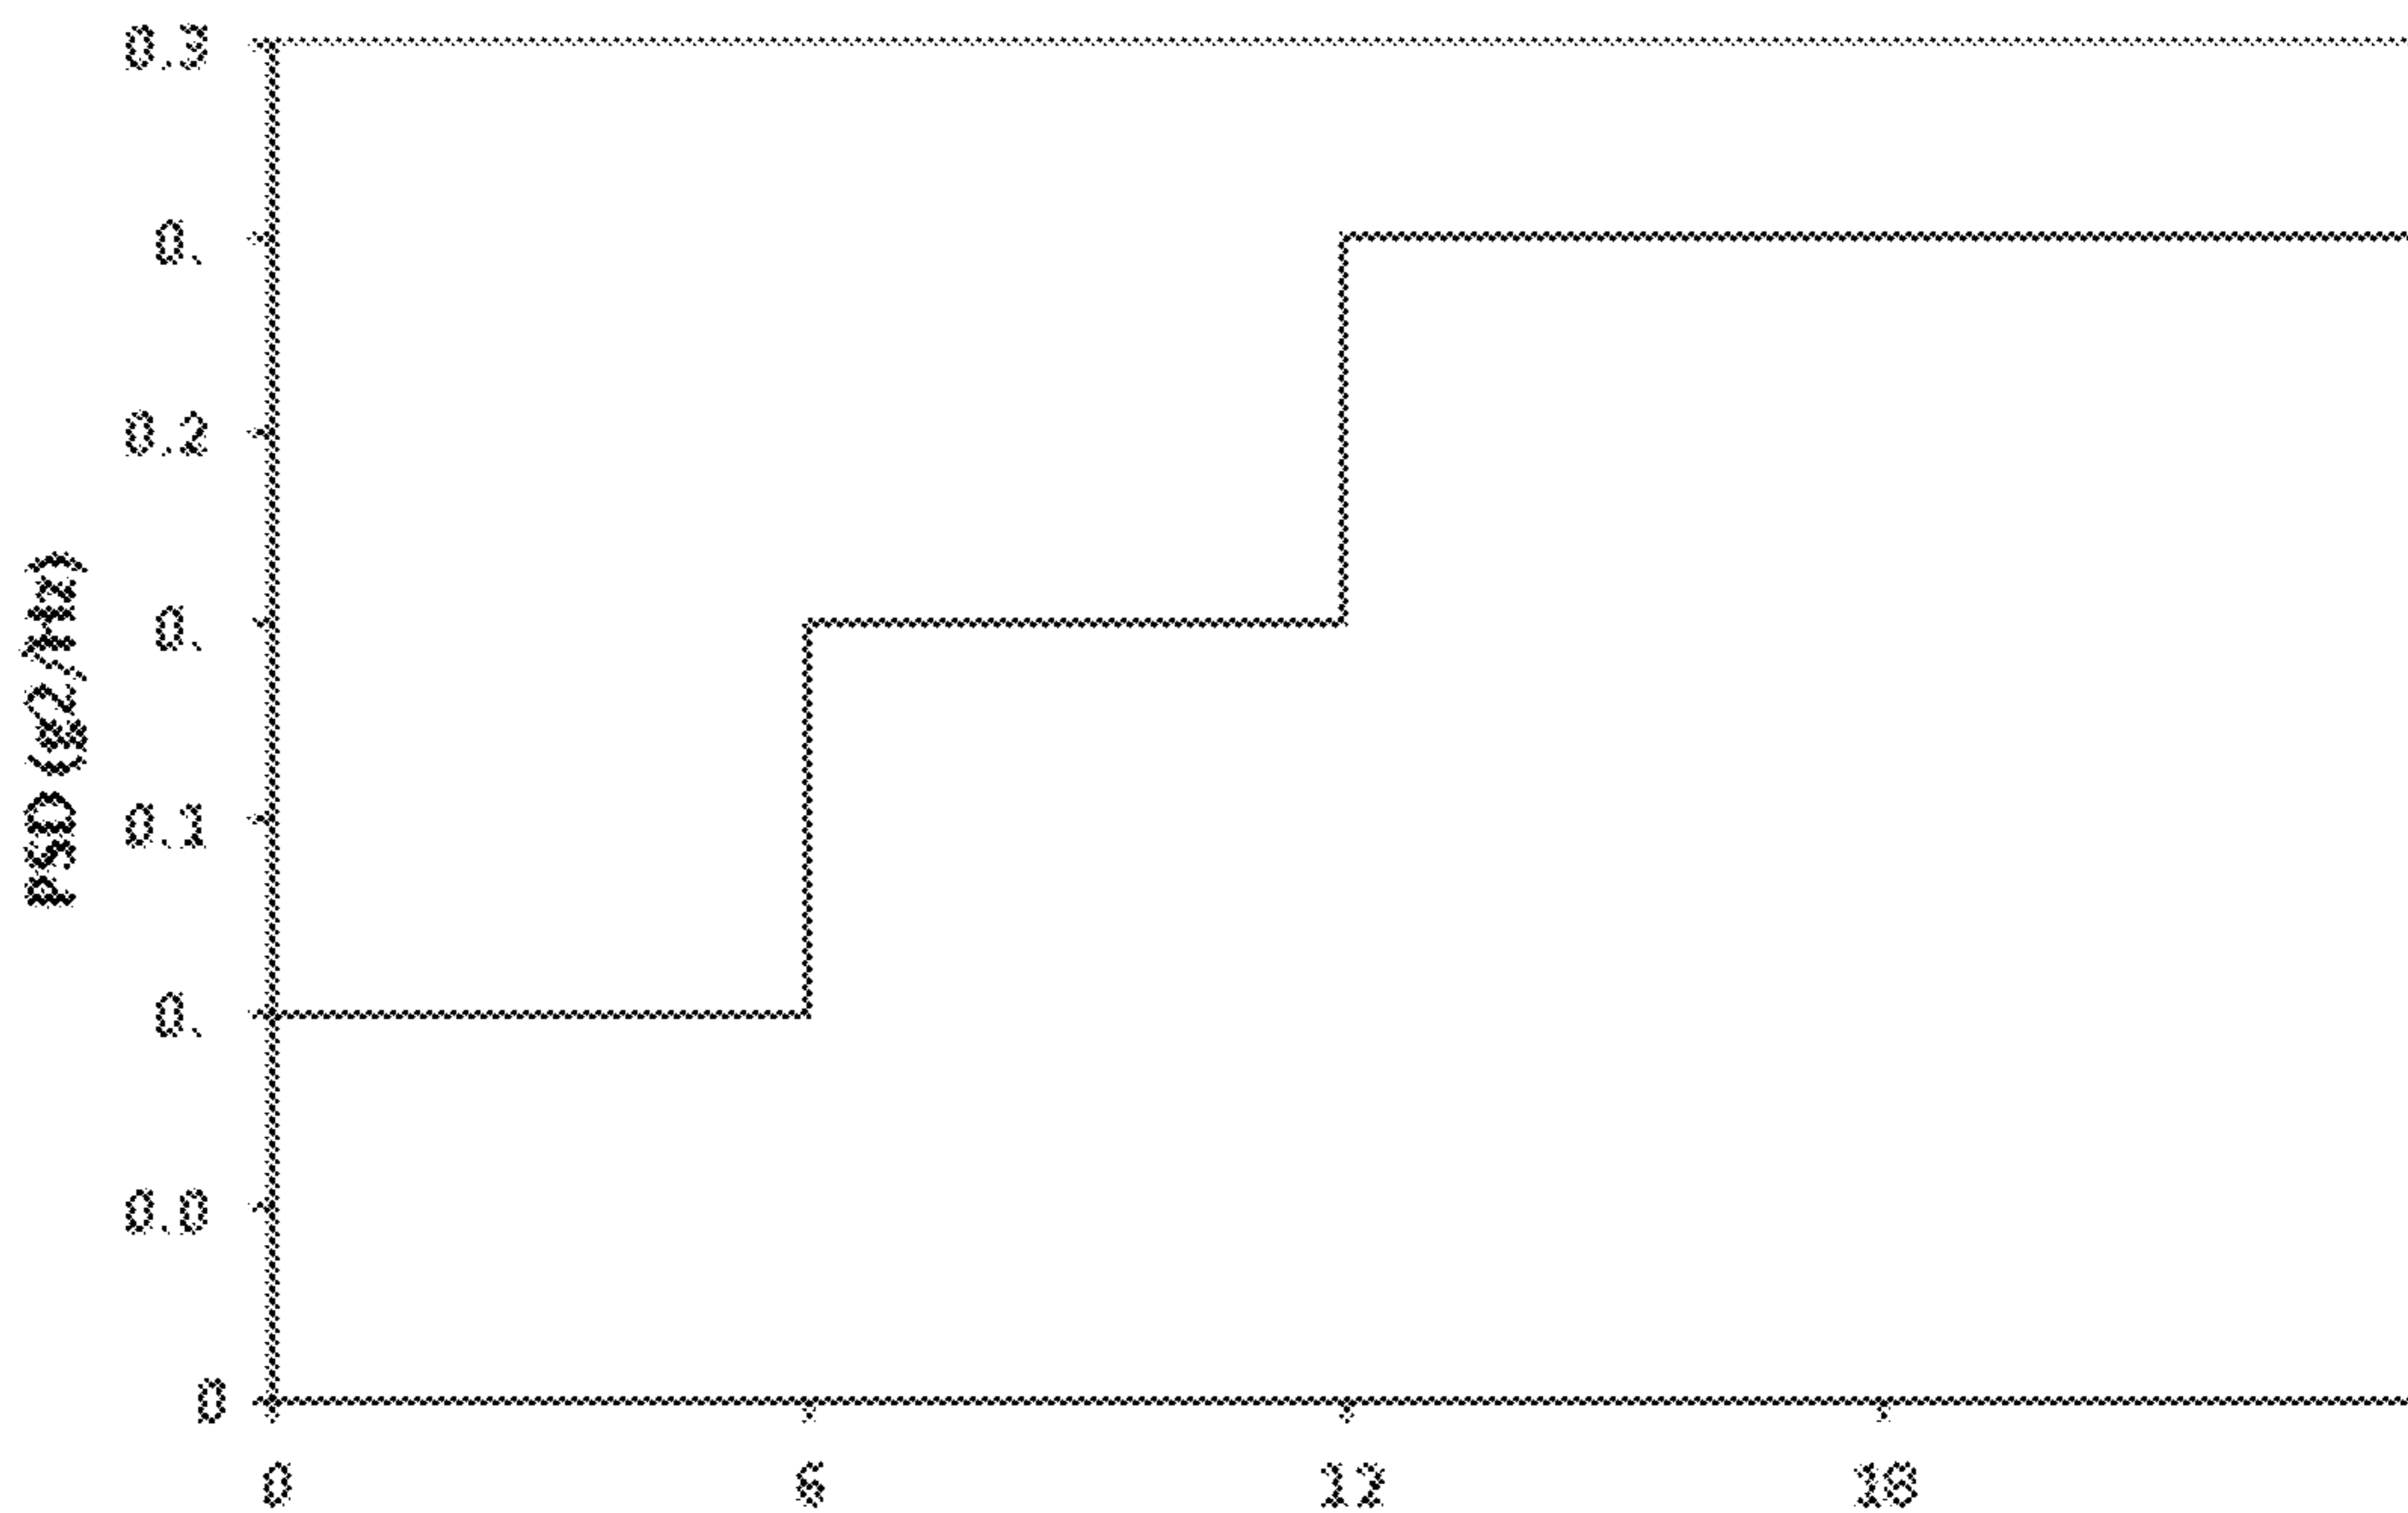
FIG. 5 shows a step stress loading plot used in assessing reliability of the electronic components.

The step stress chosen for vibration loading was set to 0.1, 0.2, and 0.3 G²/Hz with 6 hours exposure time at each level. If all components do not fail at the end of the test, another 6 hours of vibration exposure would be continued at 0.3 G²/Hz PSD level. The PSD history is shown in FIG. 5.

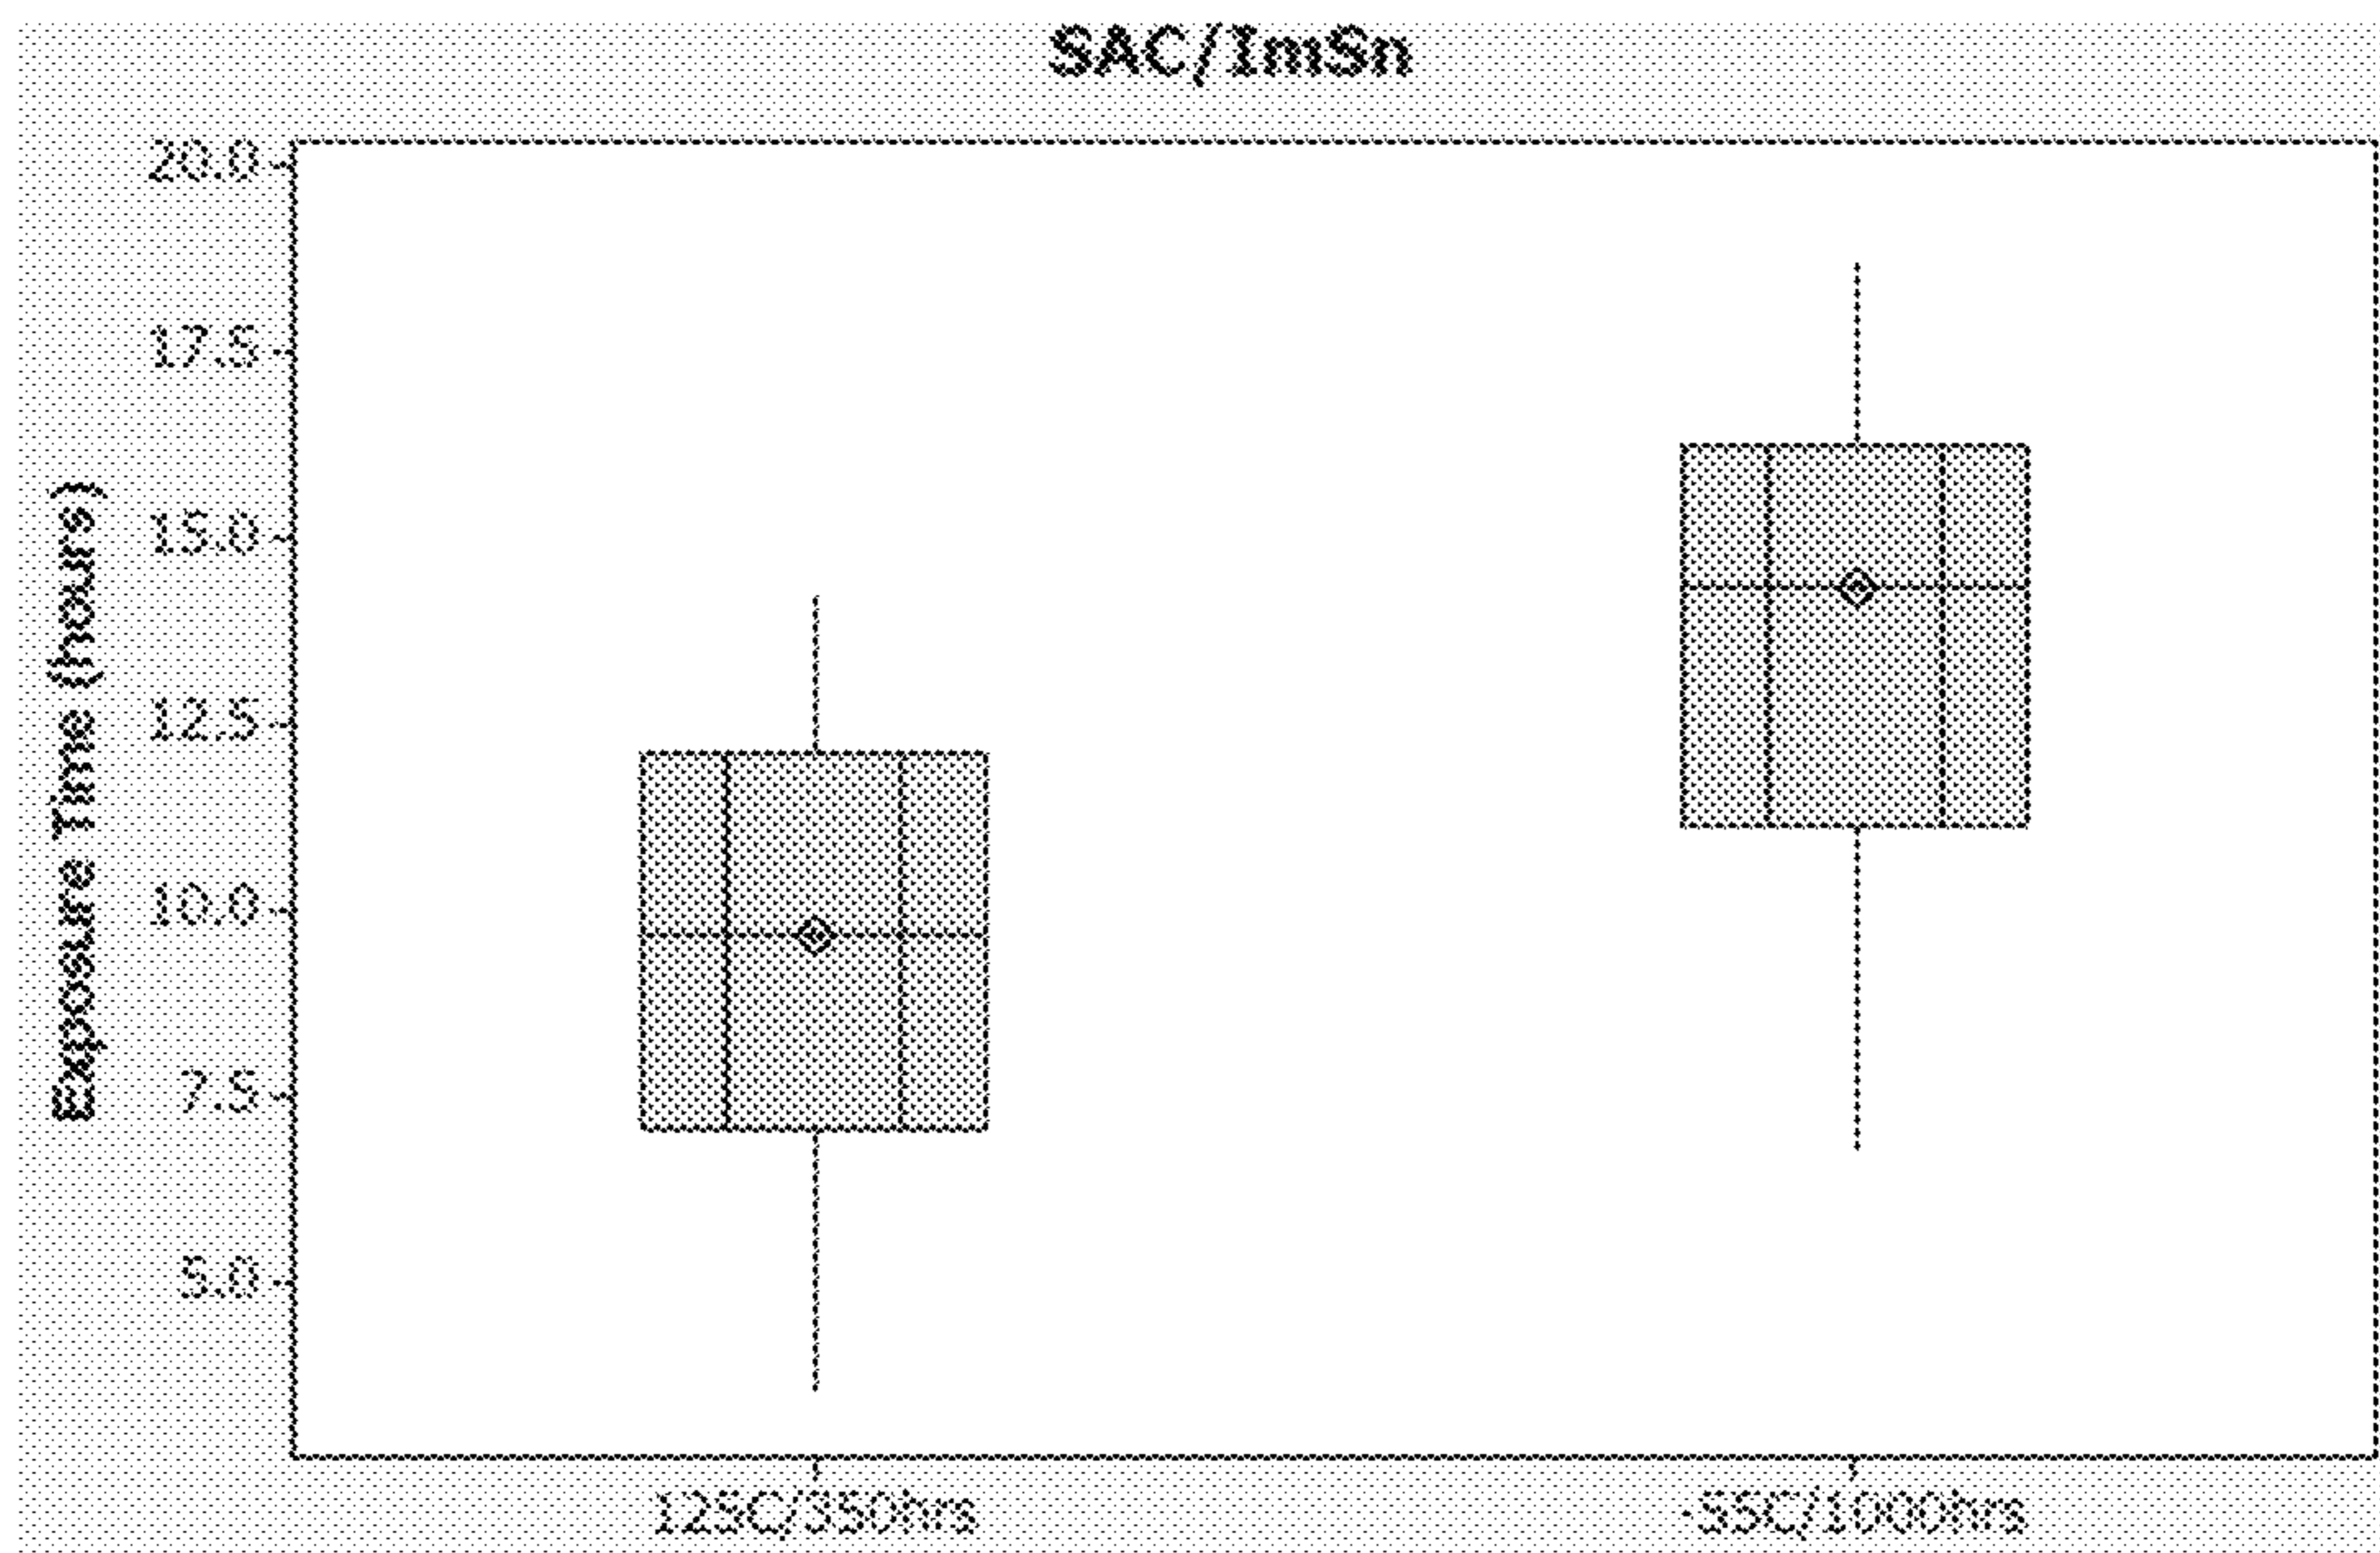
FIG. 6 illustrates test results for SAC/ImSn assemblies under two different aging conditions, namely at 125° C. for 350 hours and at -55° C. for 1000 hours.

Two SAC/ImSn assemblies aged at different temperatures were subjected to step stress tests. One was aged at -55° C. for 1000 hours and another at 125° C. for 350 hours. The test results shown in FIG. 6 clearly indicate that the high temperature aging decreases the solder joint fatigue life under a random vibration loading. Test results between these two assemblies show similarities in the spread of the data as the maximum and the minimum values are separated almost equally. However, the calculated means shows a large difference in the mean of the time to failure of the SAC/ImSn assembly when subjected to different aging conditions: -55° C./1000 hr ($\mu=13.72$ hrs) > 125° C./350 hr ($\mu=9.54$ hrs)
