(12) **United States Patent**
Zhan et al.

(54) **METHOD OF ASSESSING RELIABILITY OF ELECTRONICS ASSEMBLIES UNDER DRILLING VIBRATION CONDITIONS**

The present disclosure relates to electronic devices for drilling operations, particularly relates to methods and apparatus for assessing reliability of the printed circuit board assembly (PCBA) under drilling vibration conditions.

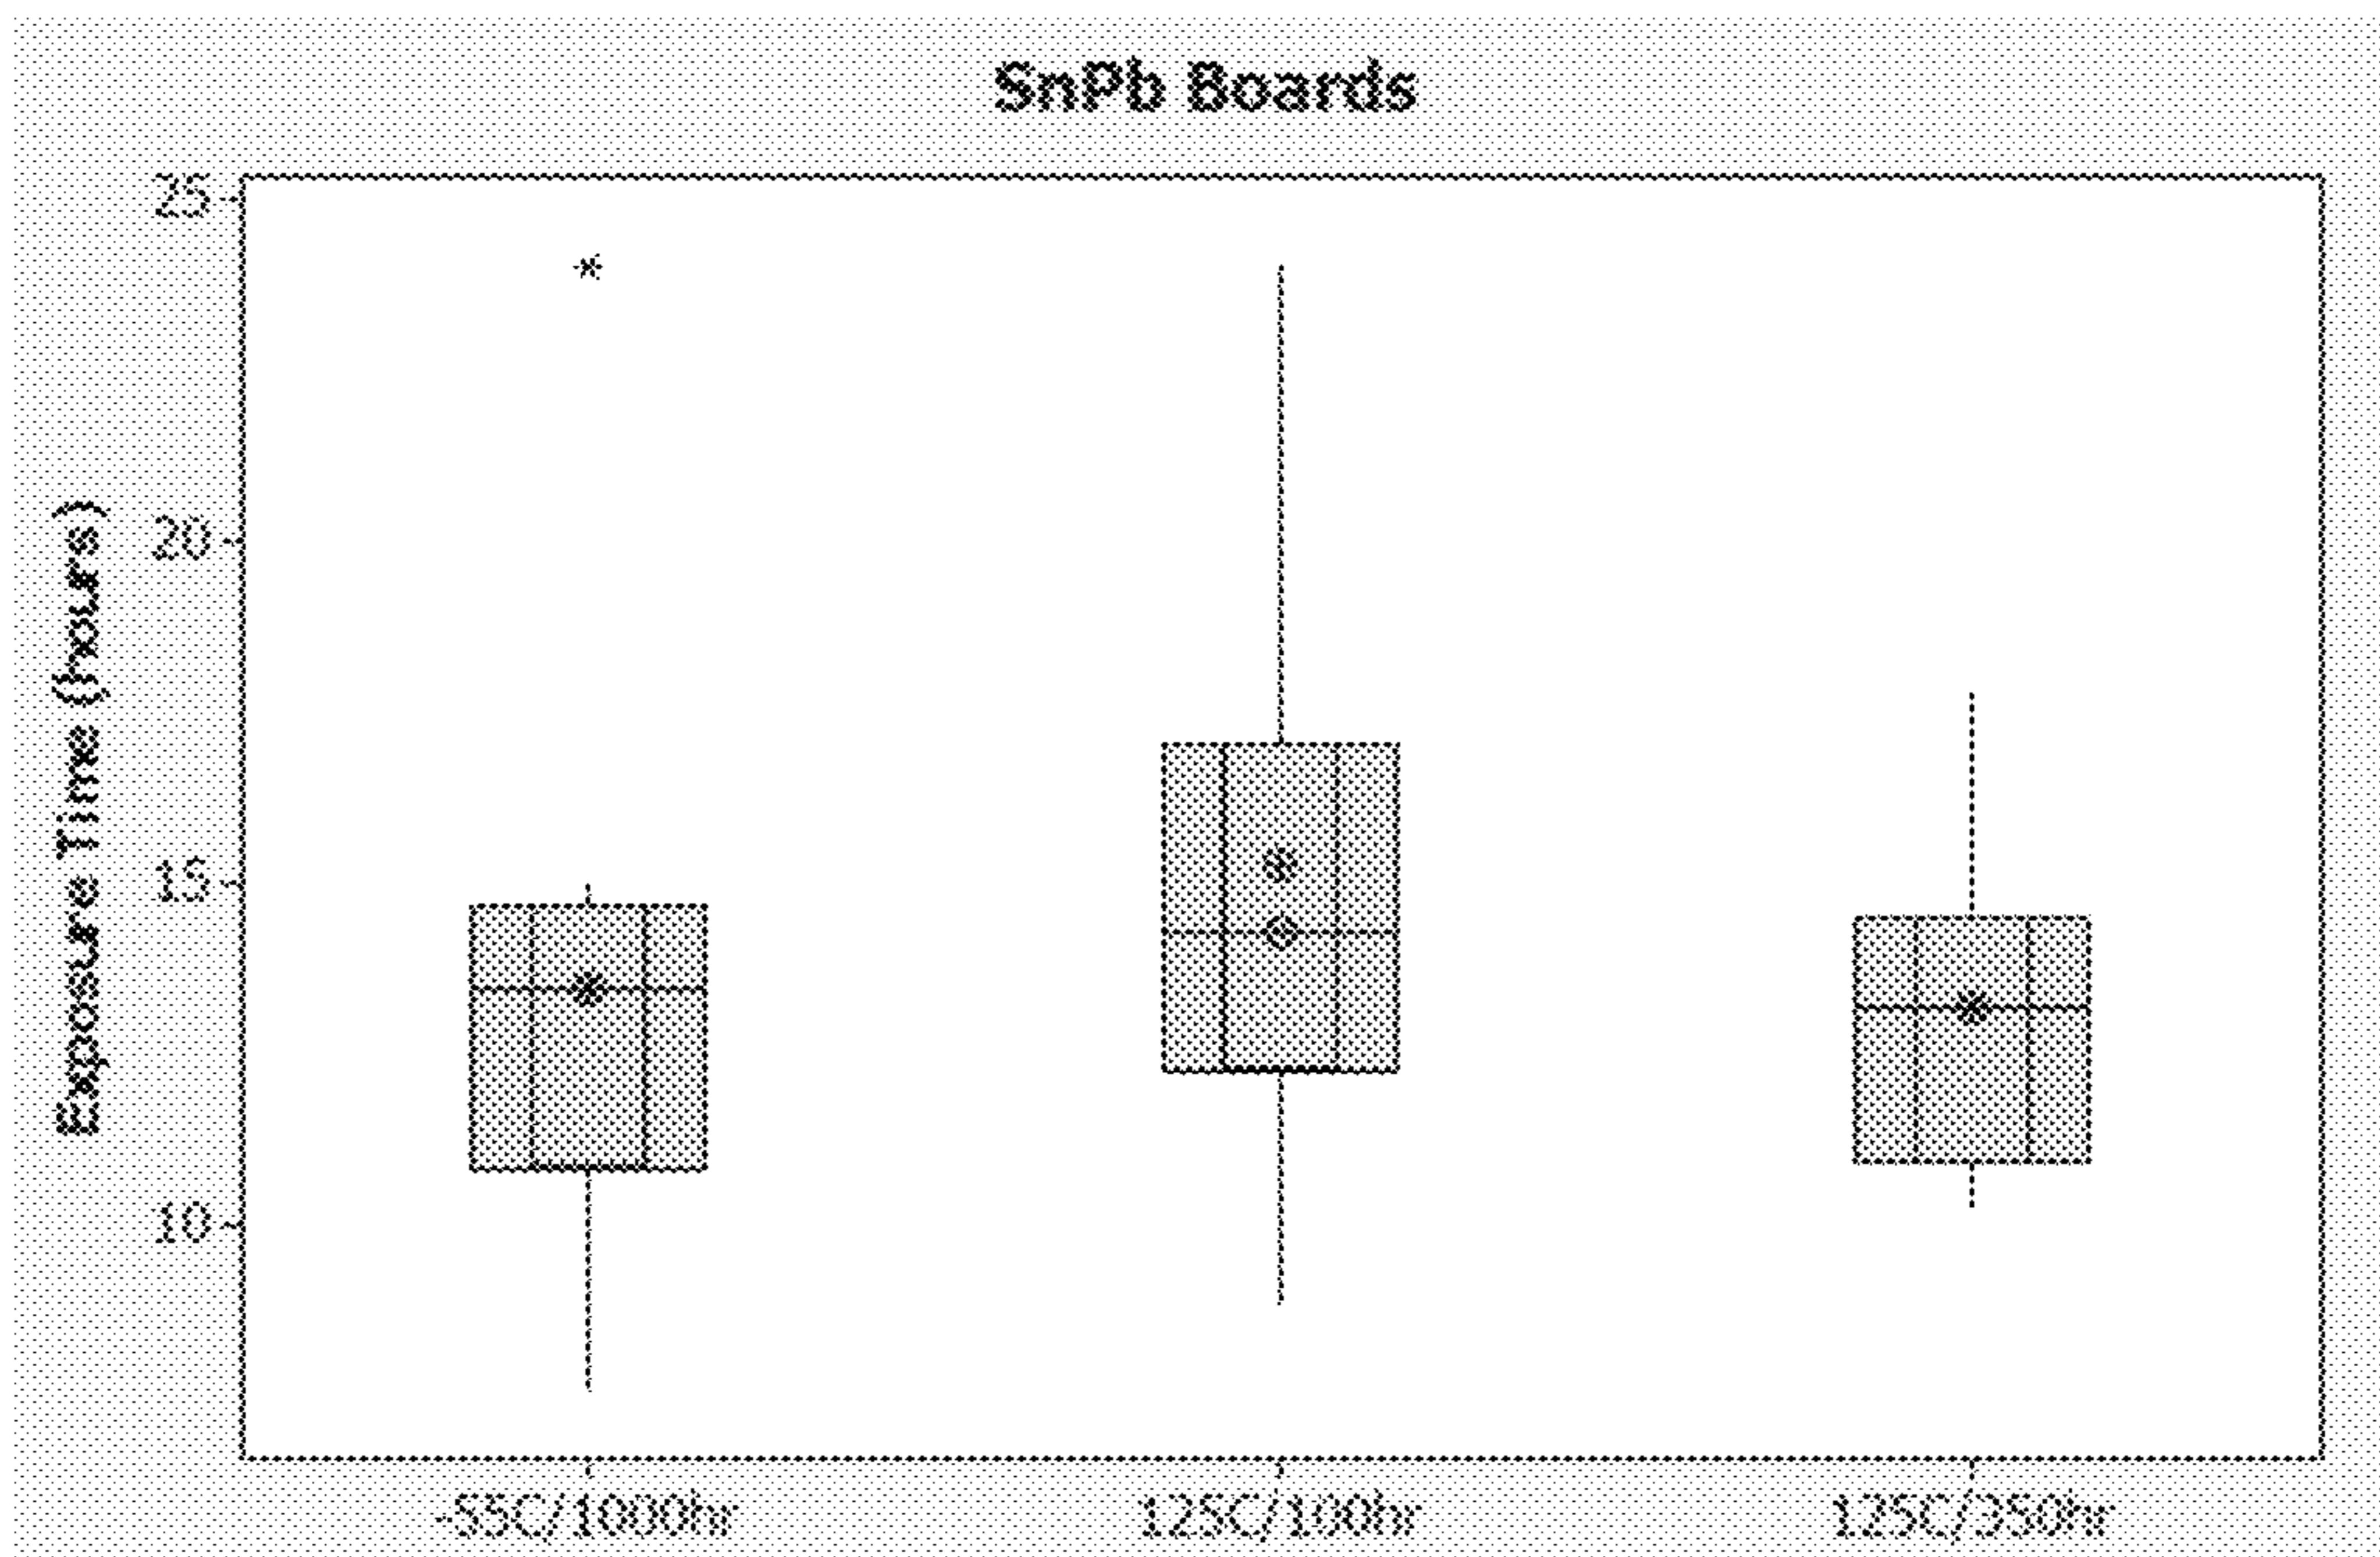
FIG. 7 illustrates test results for SnPb/HASL assemblies under three aging conditions, namely at -55° C. for 1000 hours, at 125° C. for 100 hours, and at 125° C. for 350 hours.

Three aged SnPb/HASL assemblies were subjected to step stress tests. One was aged at -55° C. for 1000 hours, one at 125° C. for 100 hours, and another at 125° C. for 350 hours. FIG. 7 shows a box plot with the test results under these three aging conditions. Different from the observations in the SAC test, SnPb test results did not clearly show the monotonic decreasing life trend while both aging temperature increased and aging time increased. It was observed at high temperature aging (125° C.) the life decreased while aging time extended, which is consistent with SAC performance. On the other hand, it was found the SnPb durability after 100 aging hours at 125° C. was better than the durability after 1000 hours at -55° C. The test results indicate that the SnPb reliability will be affected not only high temperature aging, but also low temperature aging.

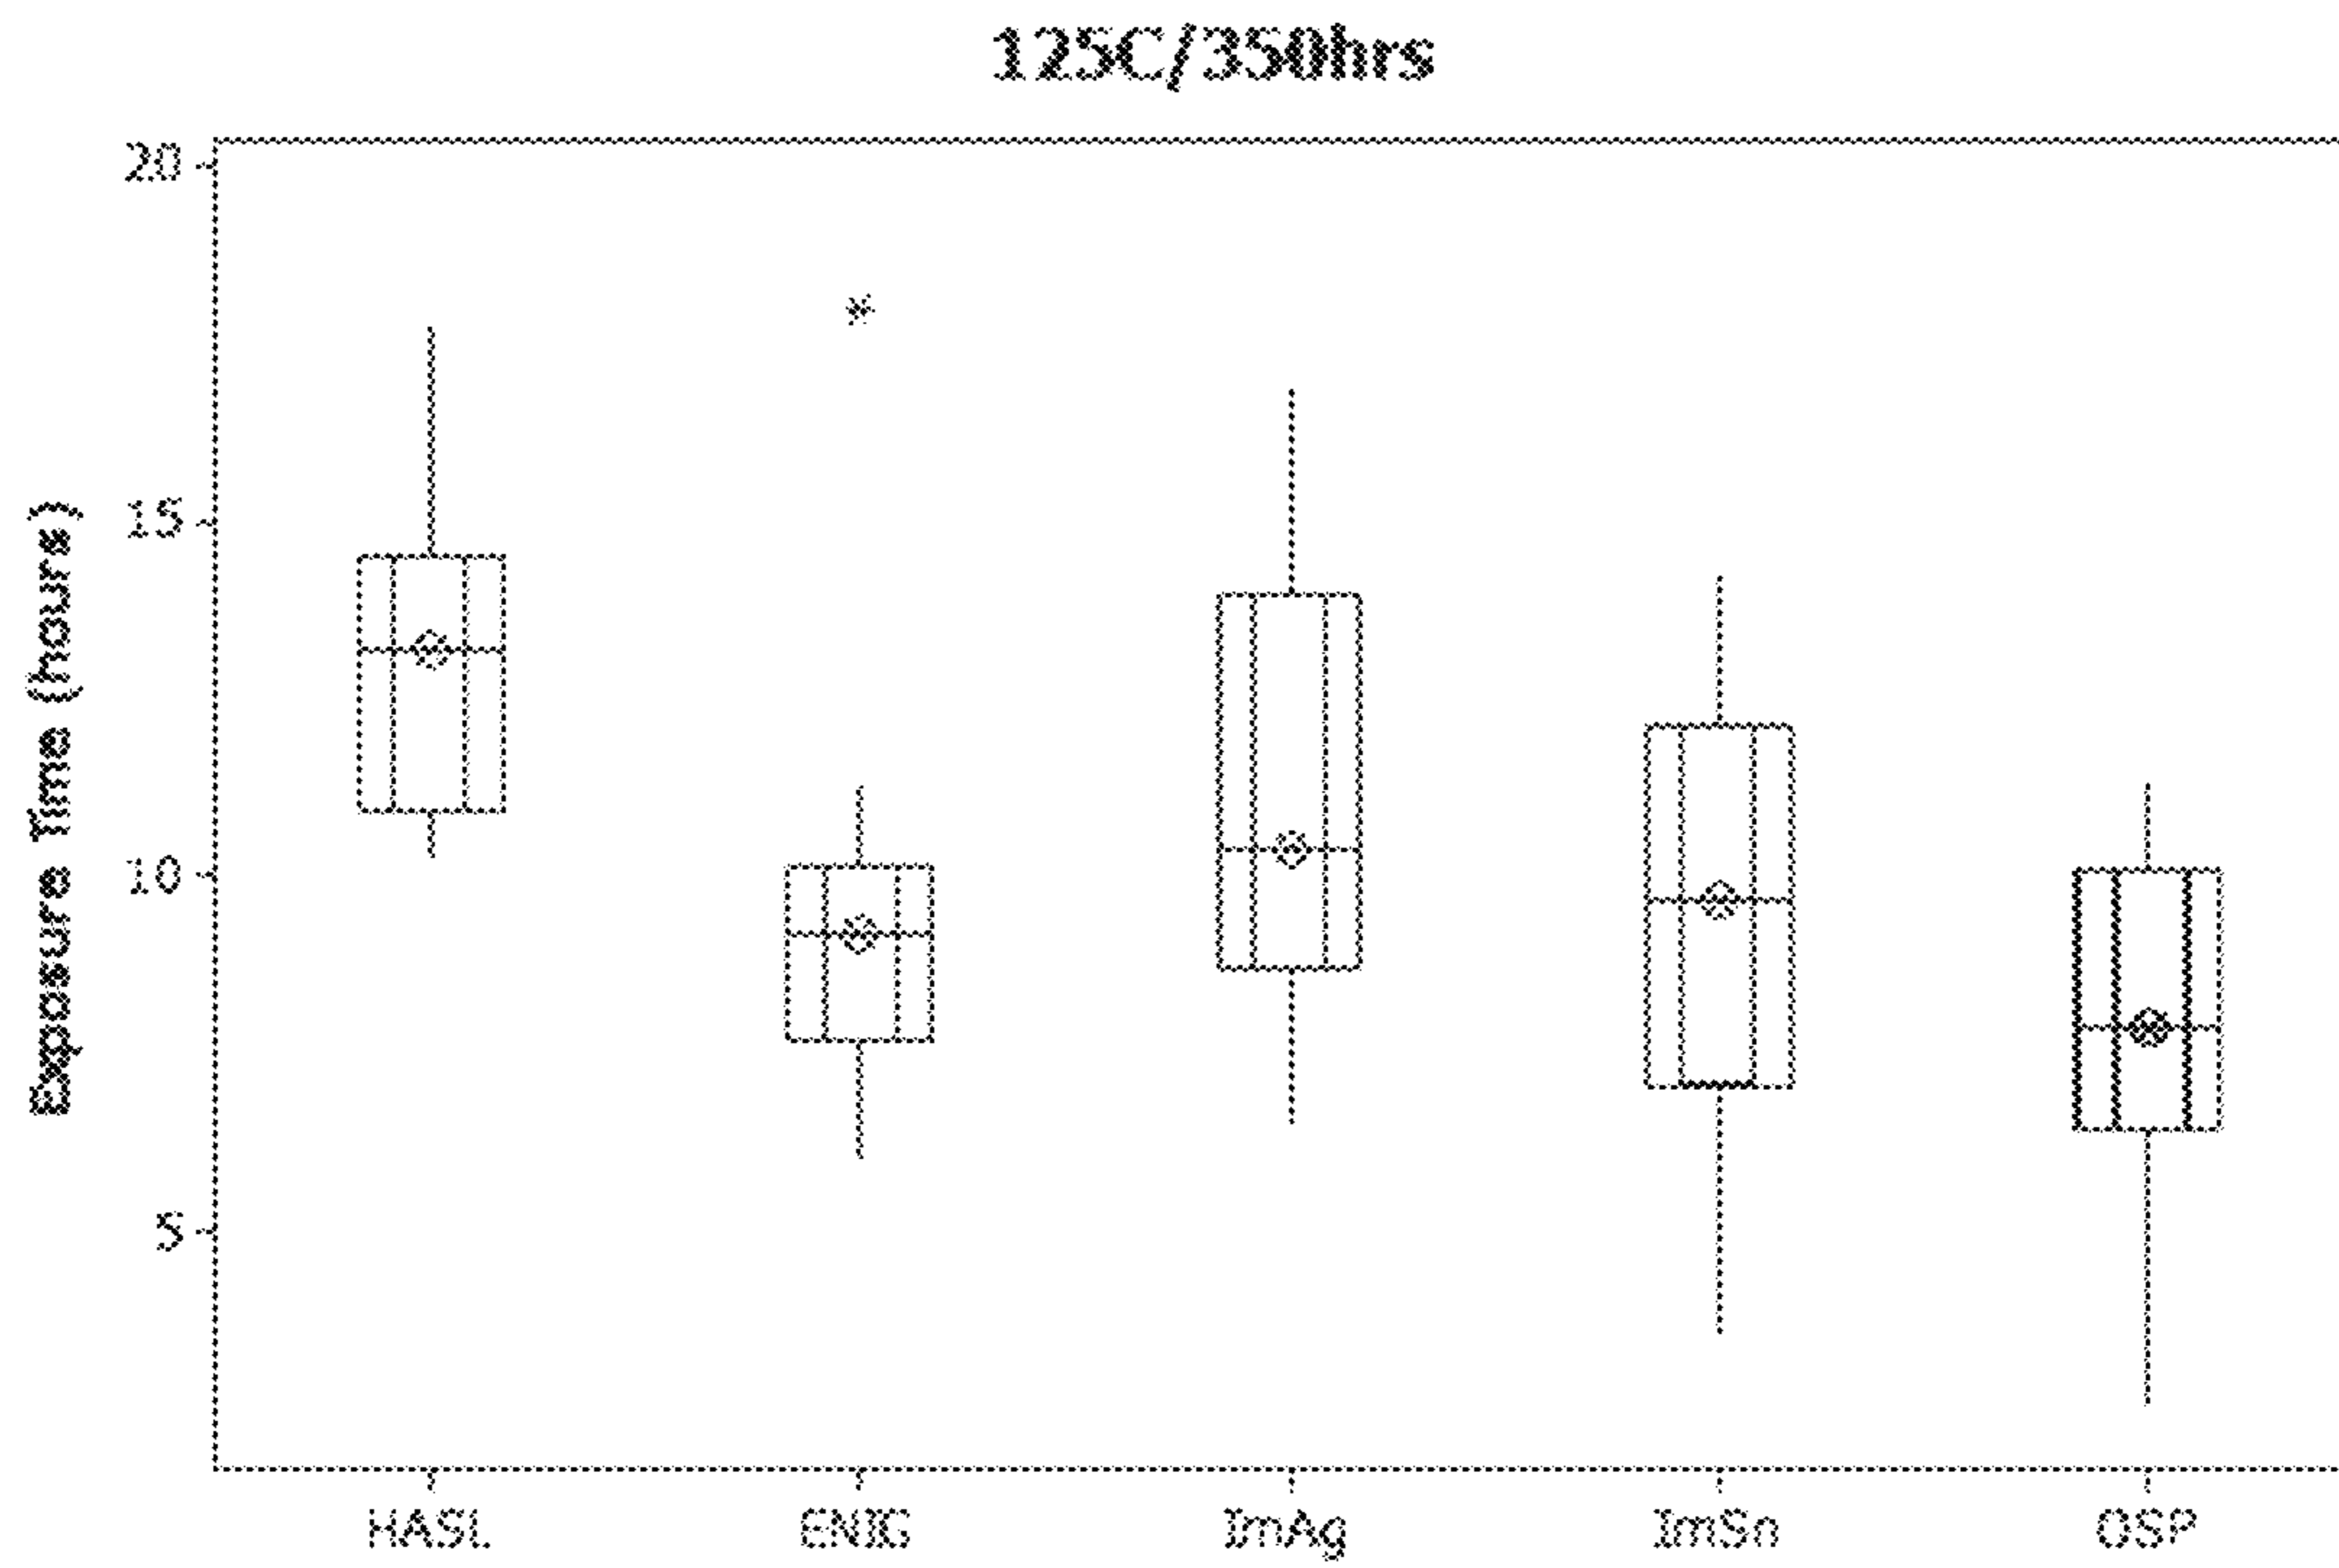
FIG. 8 illustrates test results for SnPb and SAC assemblies aged at 120° C. for 350 hours.

Aged SnPb and SAC assemblies with different PCB pad finishes were tested under a step stress condition. Aging temperature was 125° C. and duration was 350 hours. FIG.

8 shows the test results plotted in a box plot. The results show the SnPb/HASL assembly has slightly better durability than any of the SAC assemblies. The test results also showed PCB pad finish does affect the aged assembly performance. It can be seen that ImAg has the best durability and OSP has

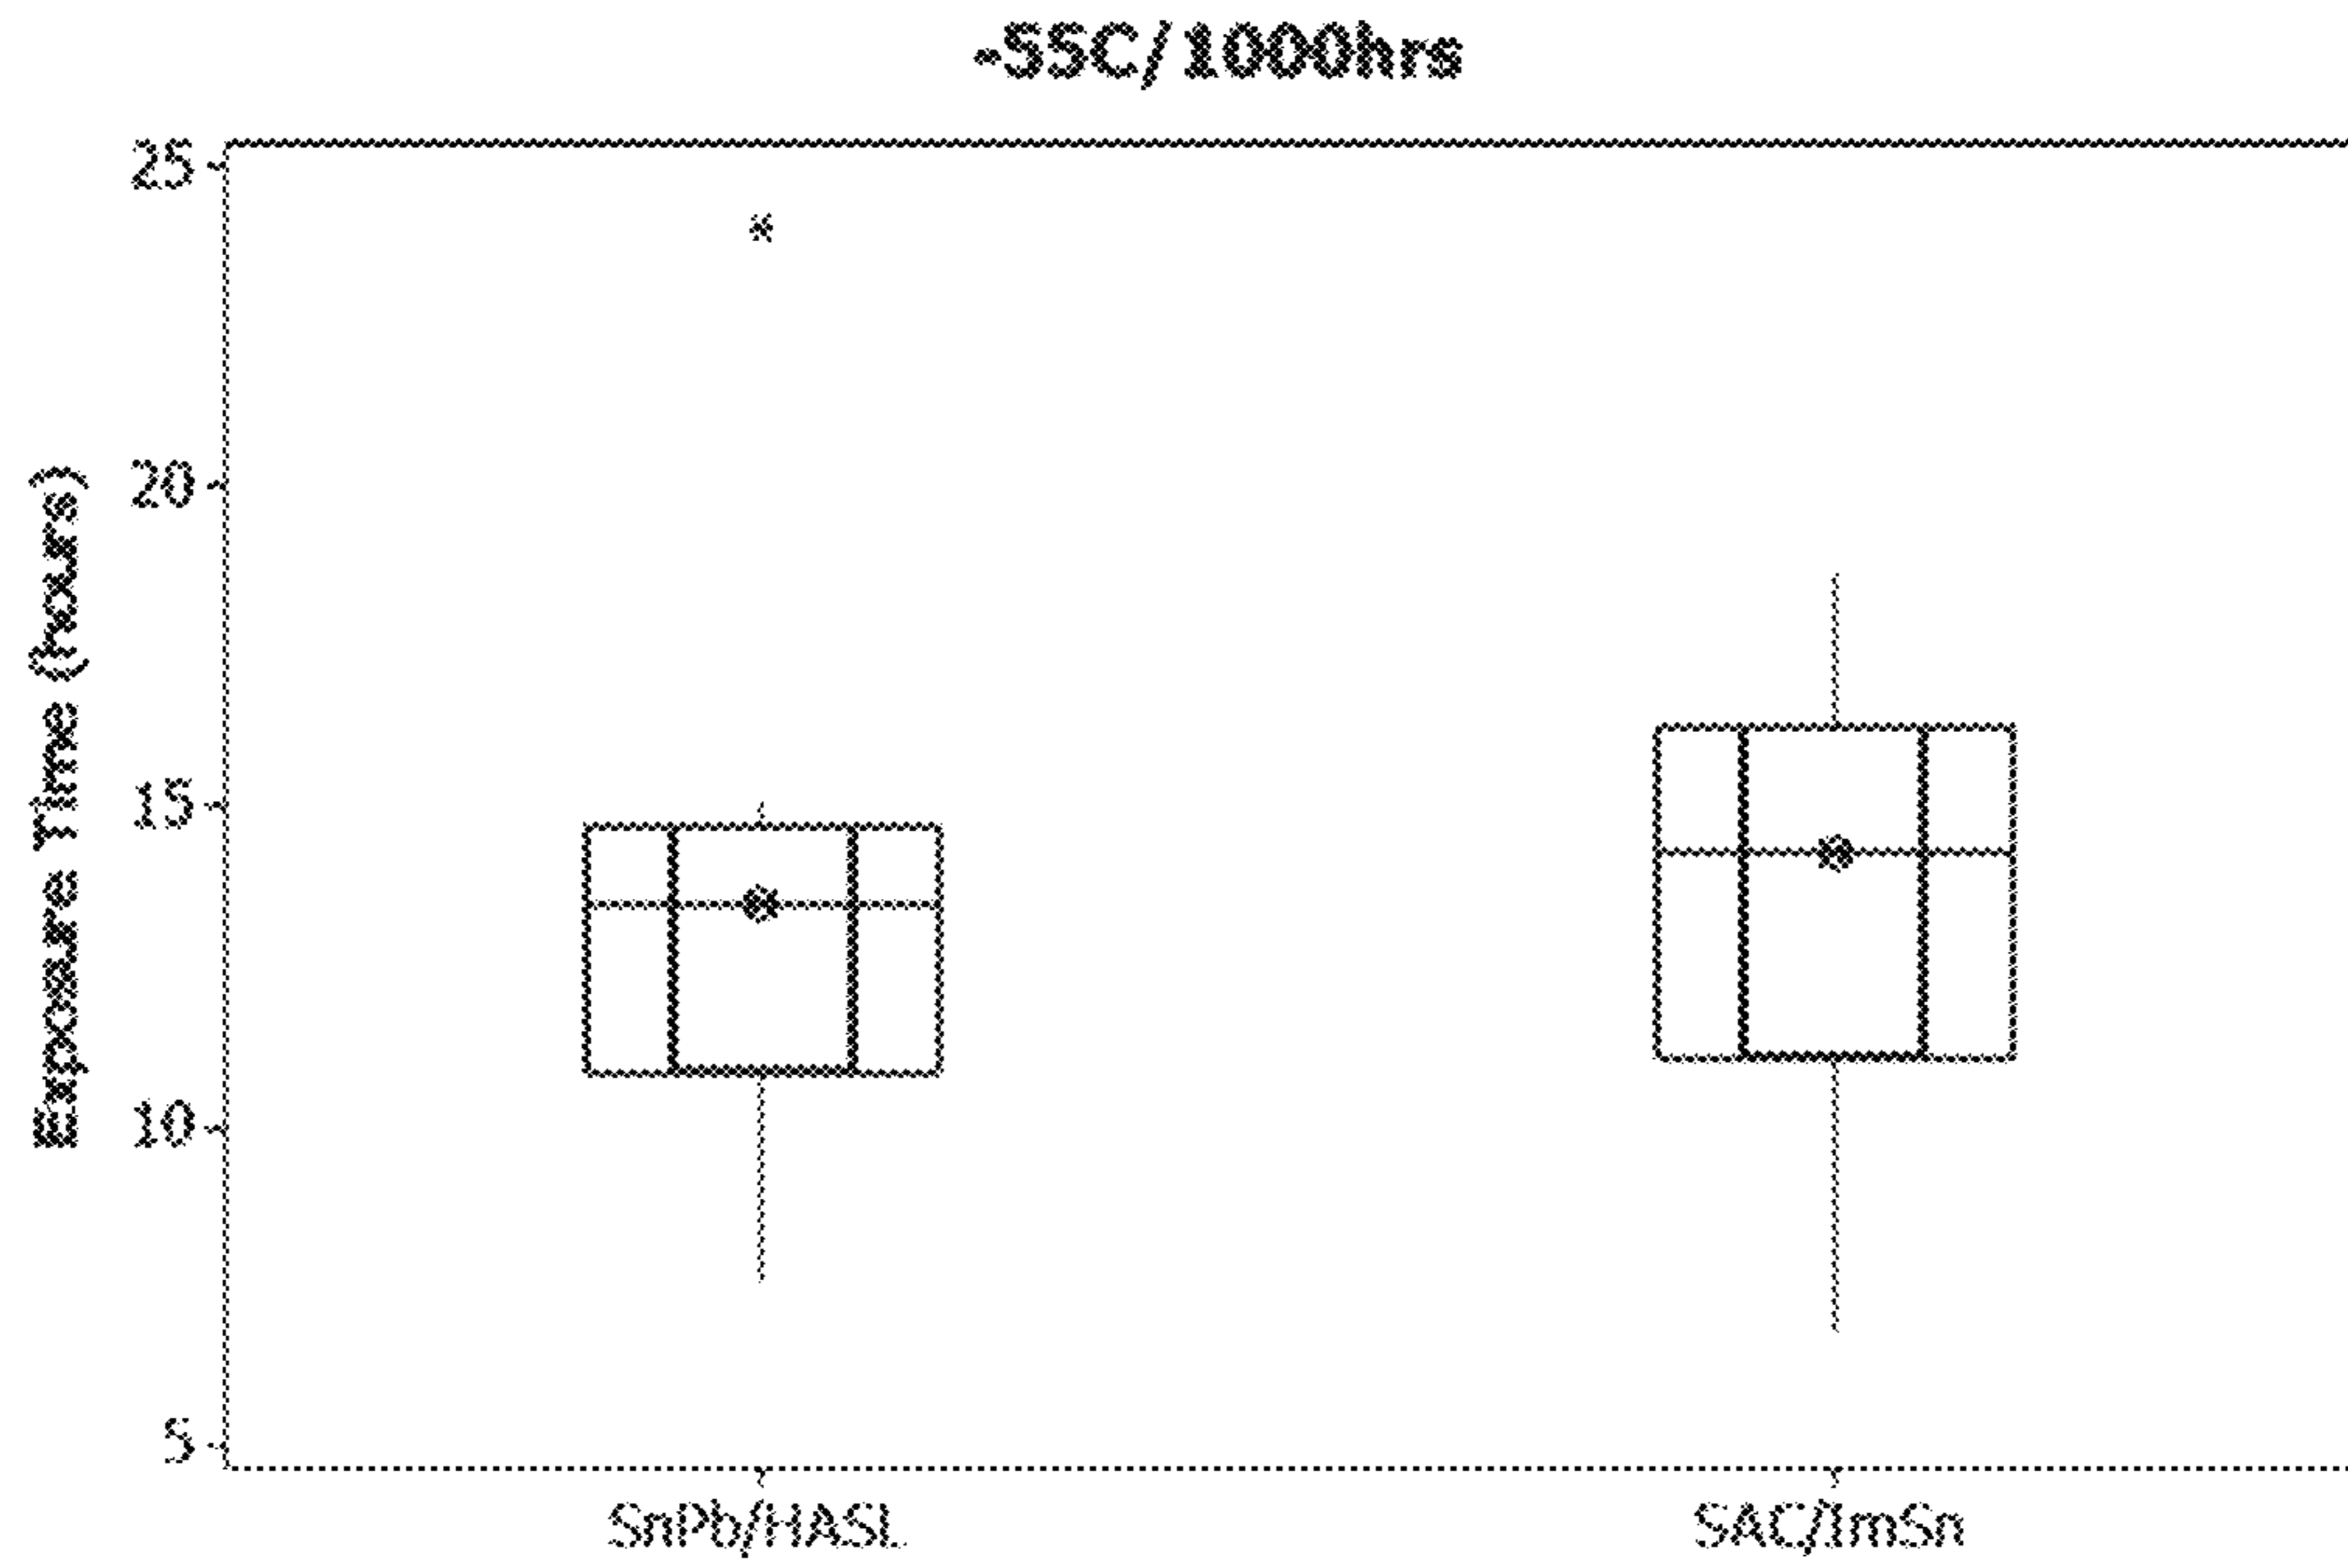
FIG. 9 illustrates test results for SnPb and SAC assemblies aged at -50° C. for 1000 hours.

Another comparison between equally aged SnPb and SAC assemblies with different PCB pad finishes is shown in FIG. 9. Here, SnPb/HASL is compared to SAC/ImSn subjected to the same aging condition of temperature -55°C . and duration was 1000 hours. The plot shows SnPb/HASL and SAC/ImSn assemblies have comparable results under this aging condition while the calculated mean of time-to-failure for both components are $\mu=13.72$ hrs (SAC/ImSn) and $\mu=13.45$ hrs (SnPb/HASL).

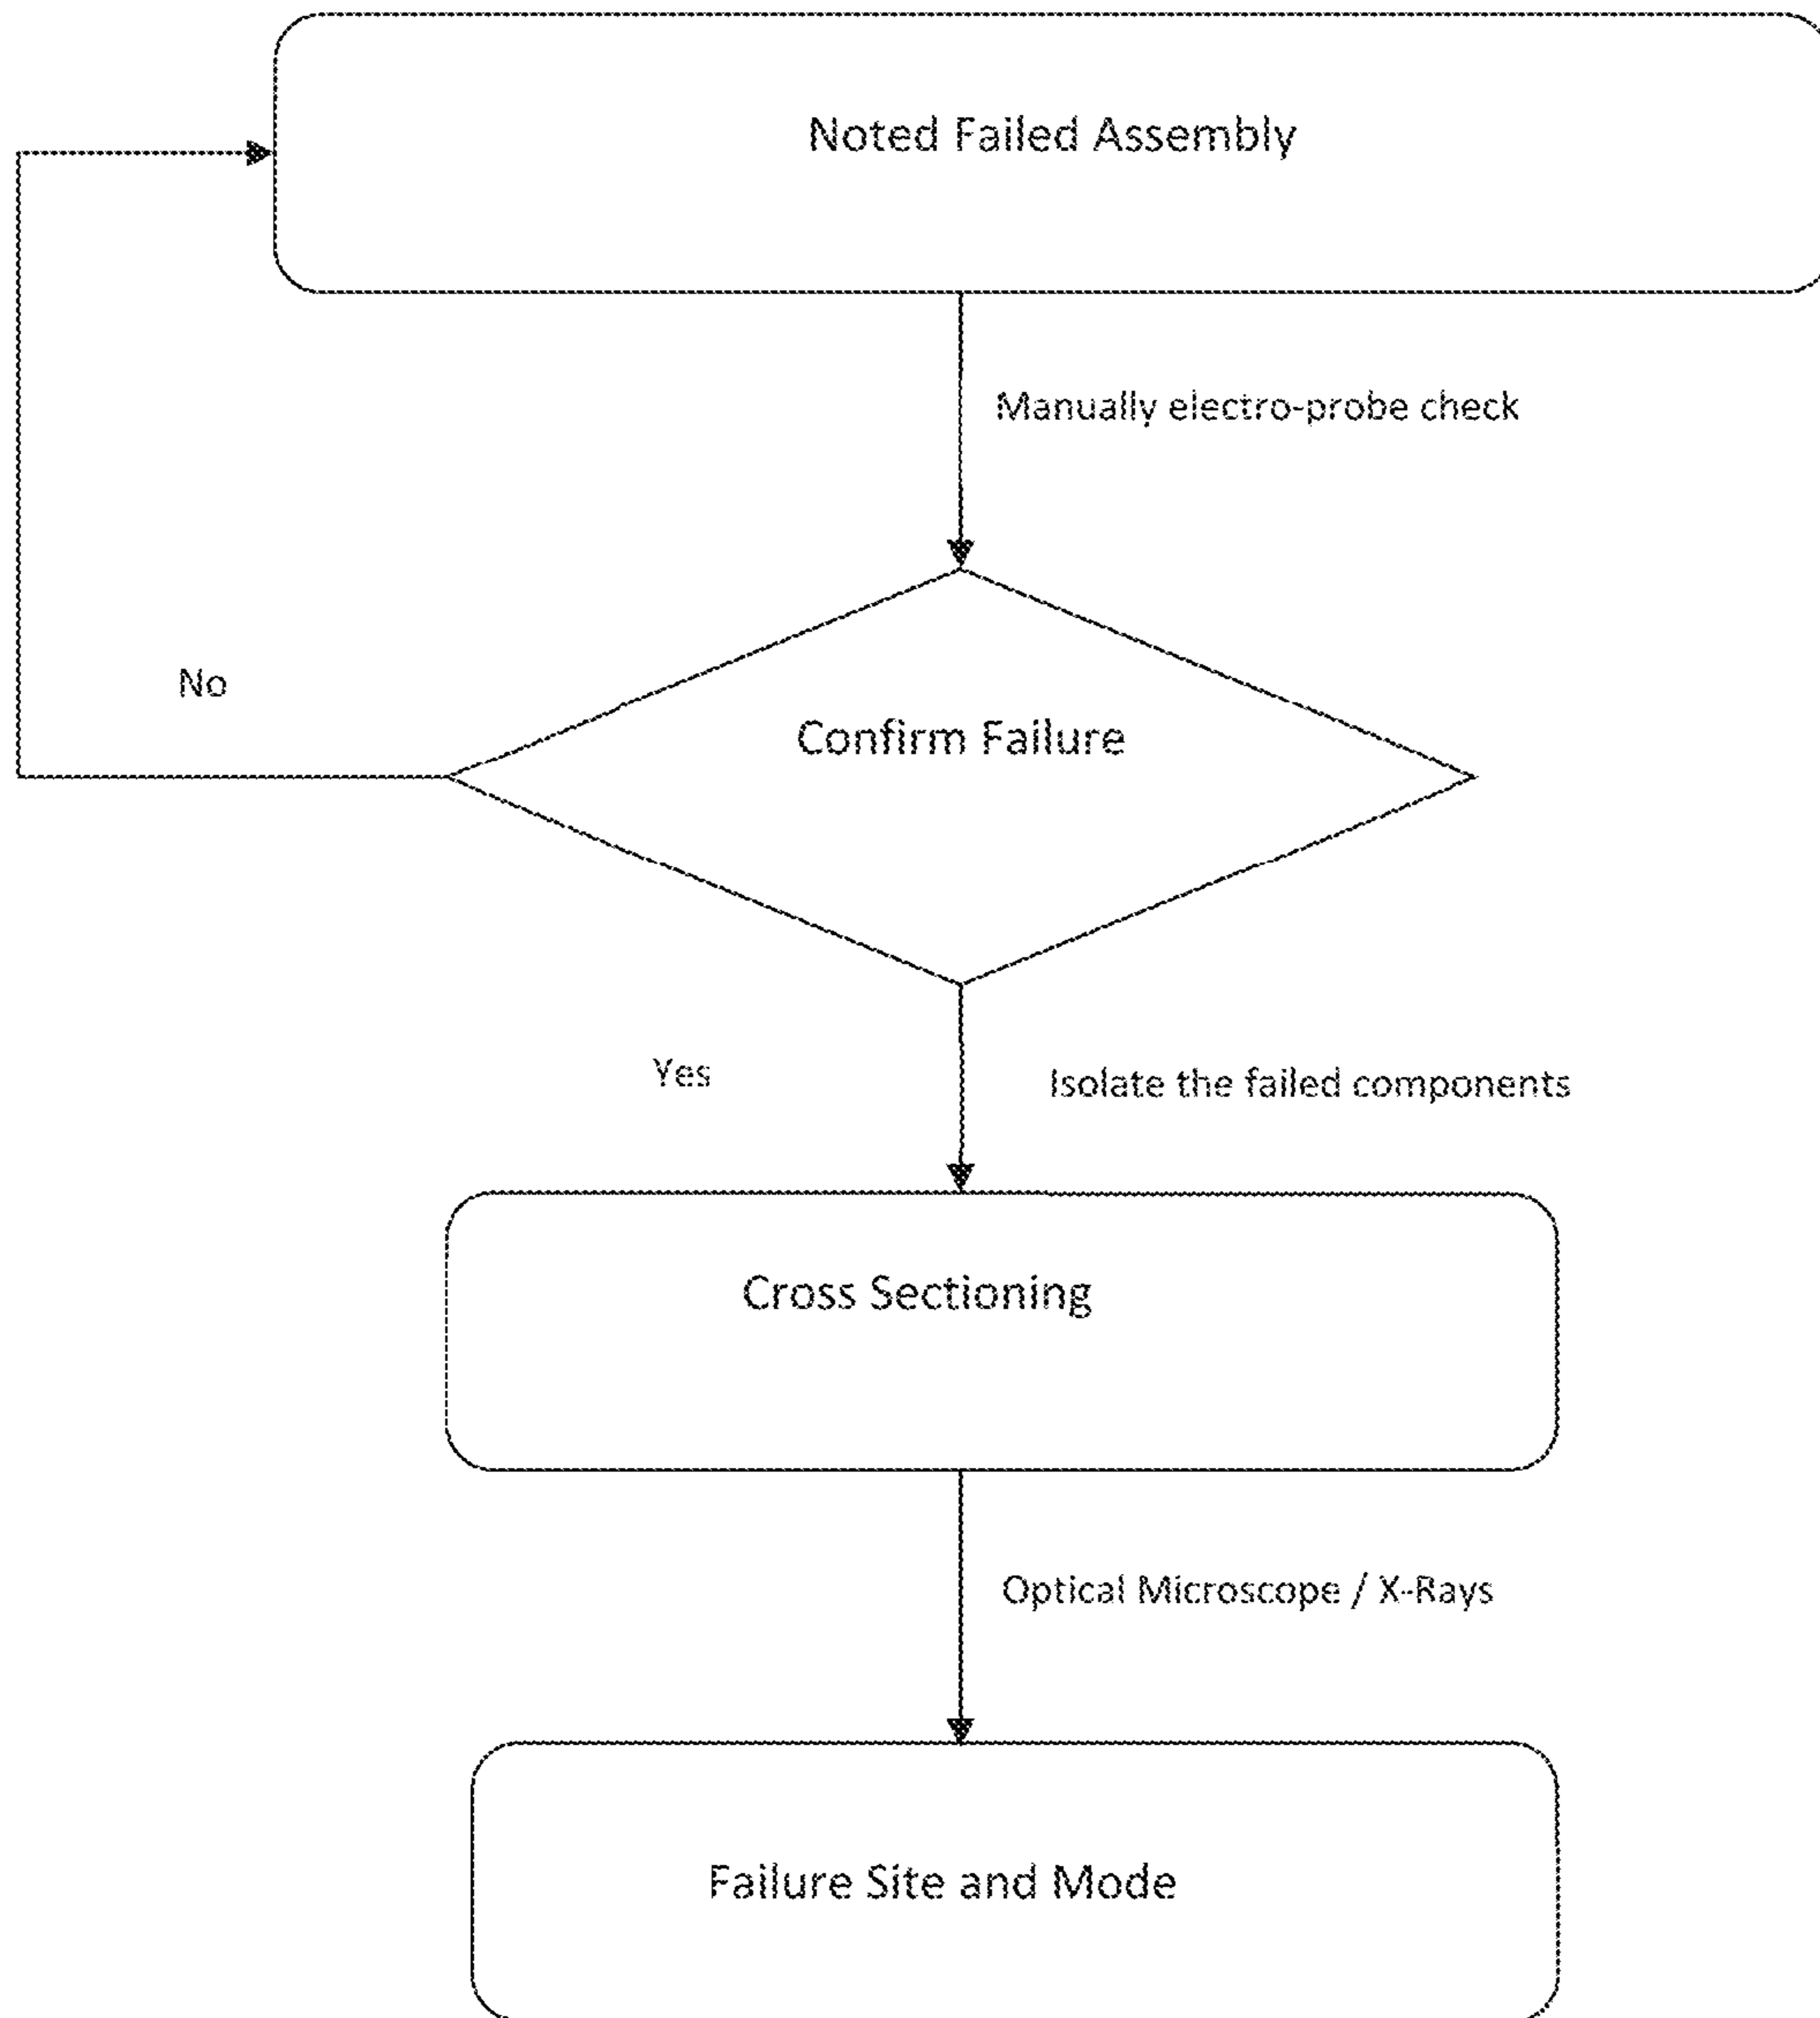
FIG. 10 is a flow chart for the process in failure analysis of the failed electronic components.

Failure analysis was performed on the failed parts after the test. In one embodiment, the failure analysis included three steps, which are shown in the flow chart in FIG. 10. The first step is to manually check the electrical resistance of each daisy chain while there is no load applied. The second step is to cut the failed components from the board and finally perform cross sectioning. The cross-sectioned of the failed component is then examined using a range of analytic tools and techniques, including optical microscope, X-ray, SEM, elemental analysis, etc.

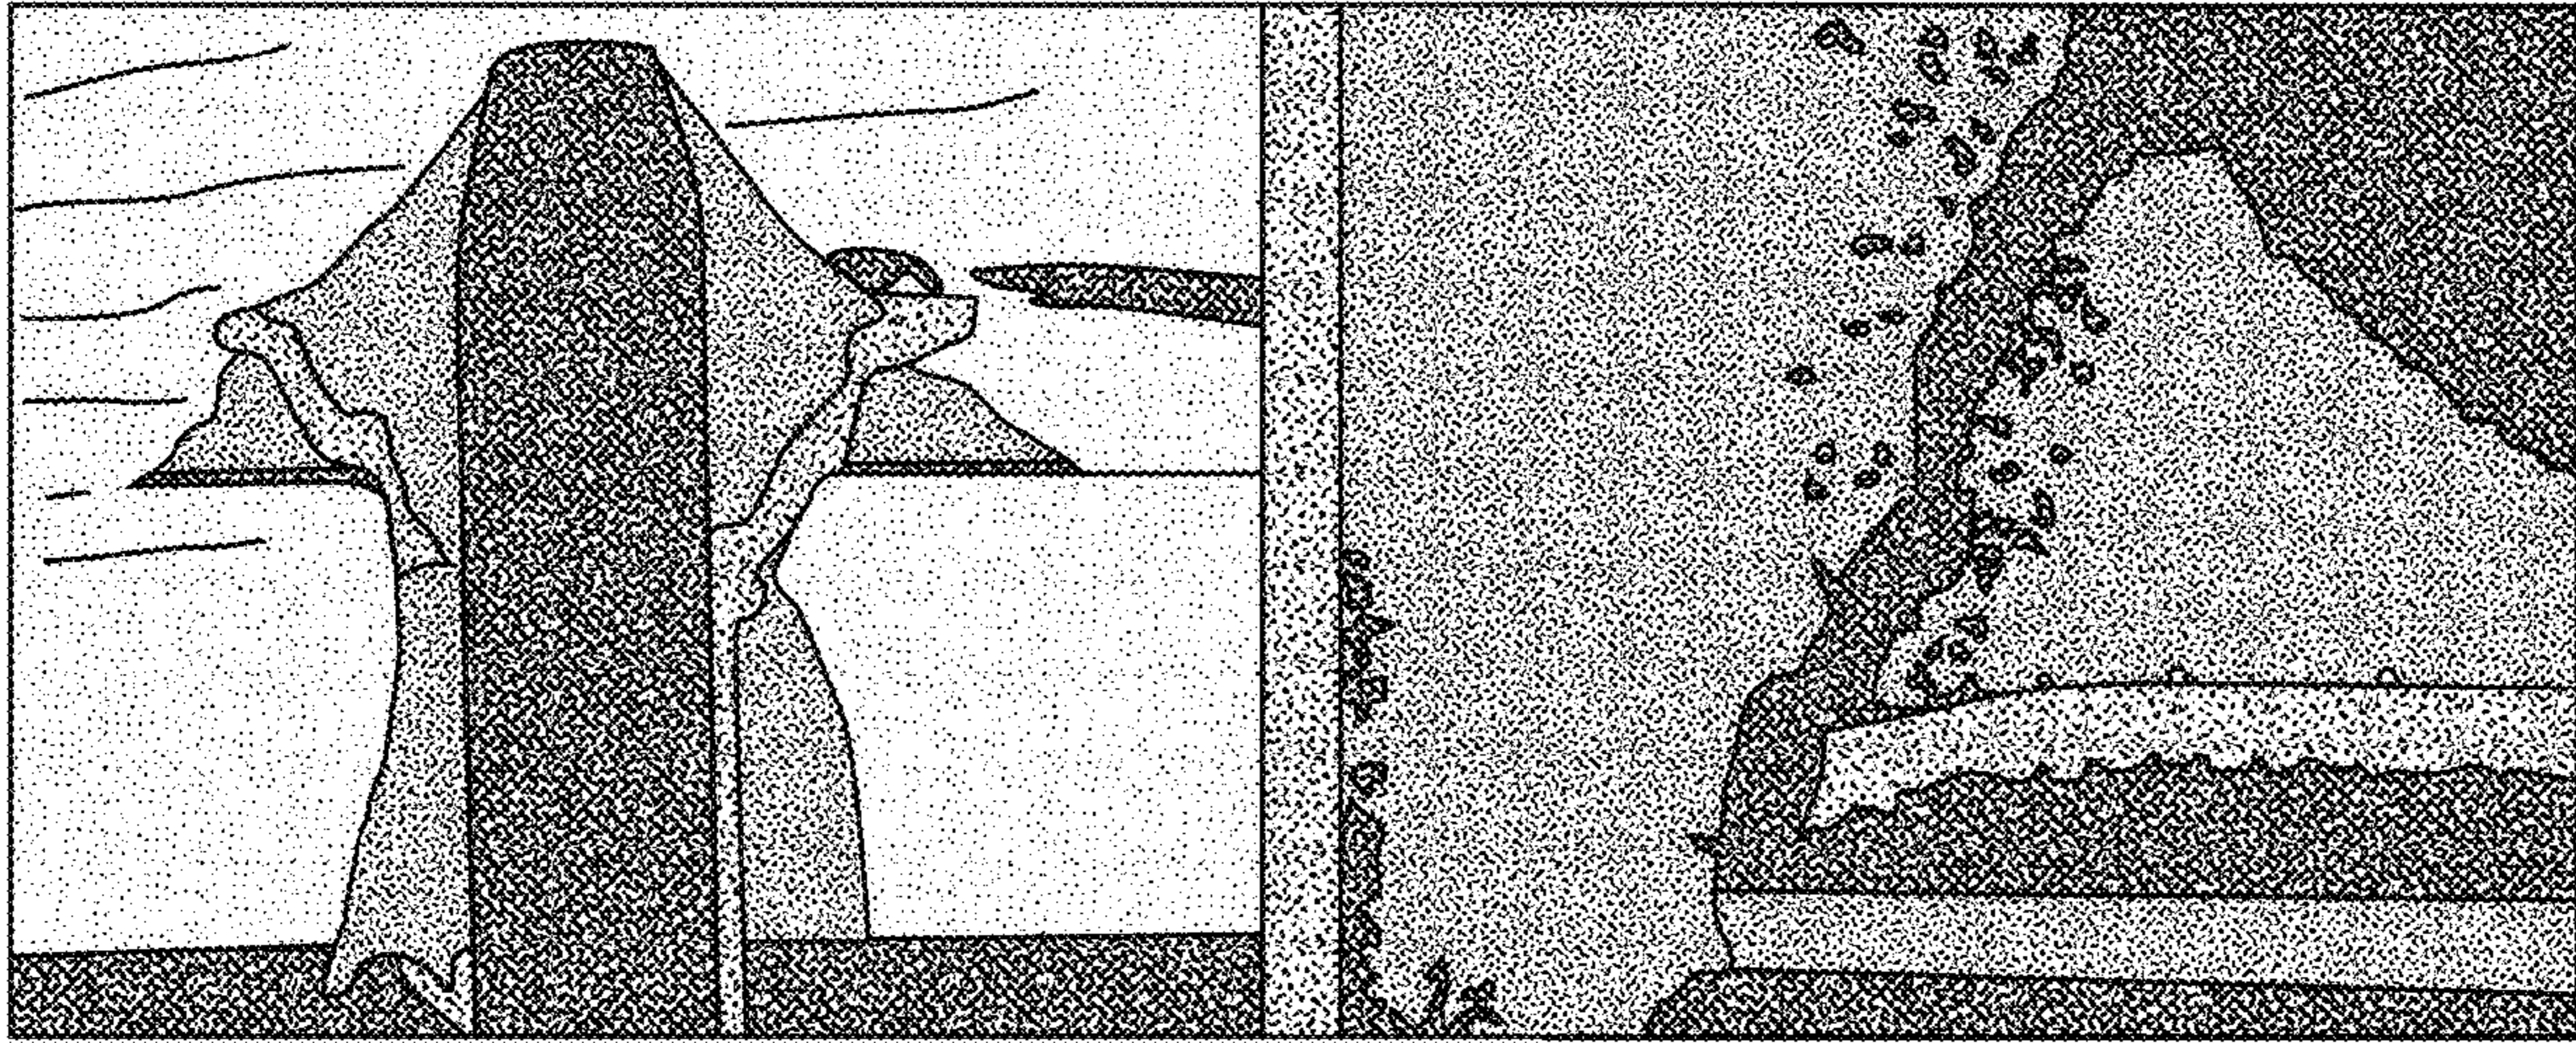
FIG. 11 shows two micrographs of failed SnPb and SAC assemblies aged at -55° C. for 1000 hours.

Failure of the solder joint in electronic products arose either when individual events exceed the strength of the solder joint or when the accumulation of damage due to cycling loading exceeds its fatigue strength. On thermally induced fatigue, a commonly seen failure is the fatigue cracking where 45° angle fractures propagate along the solder joint, as shown in FIG. 11. These fractures extended from the root of the solder fillet through the solder bulk.

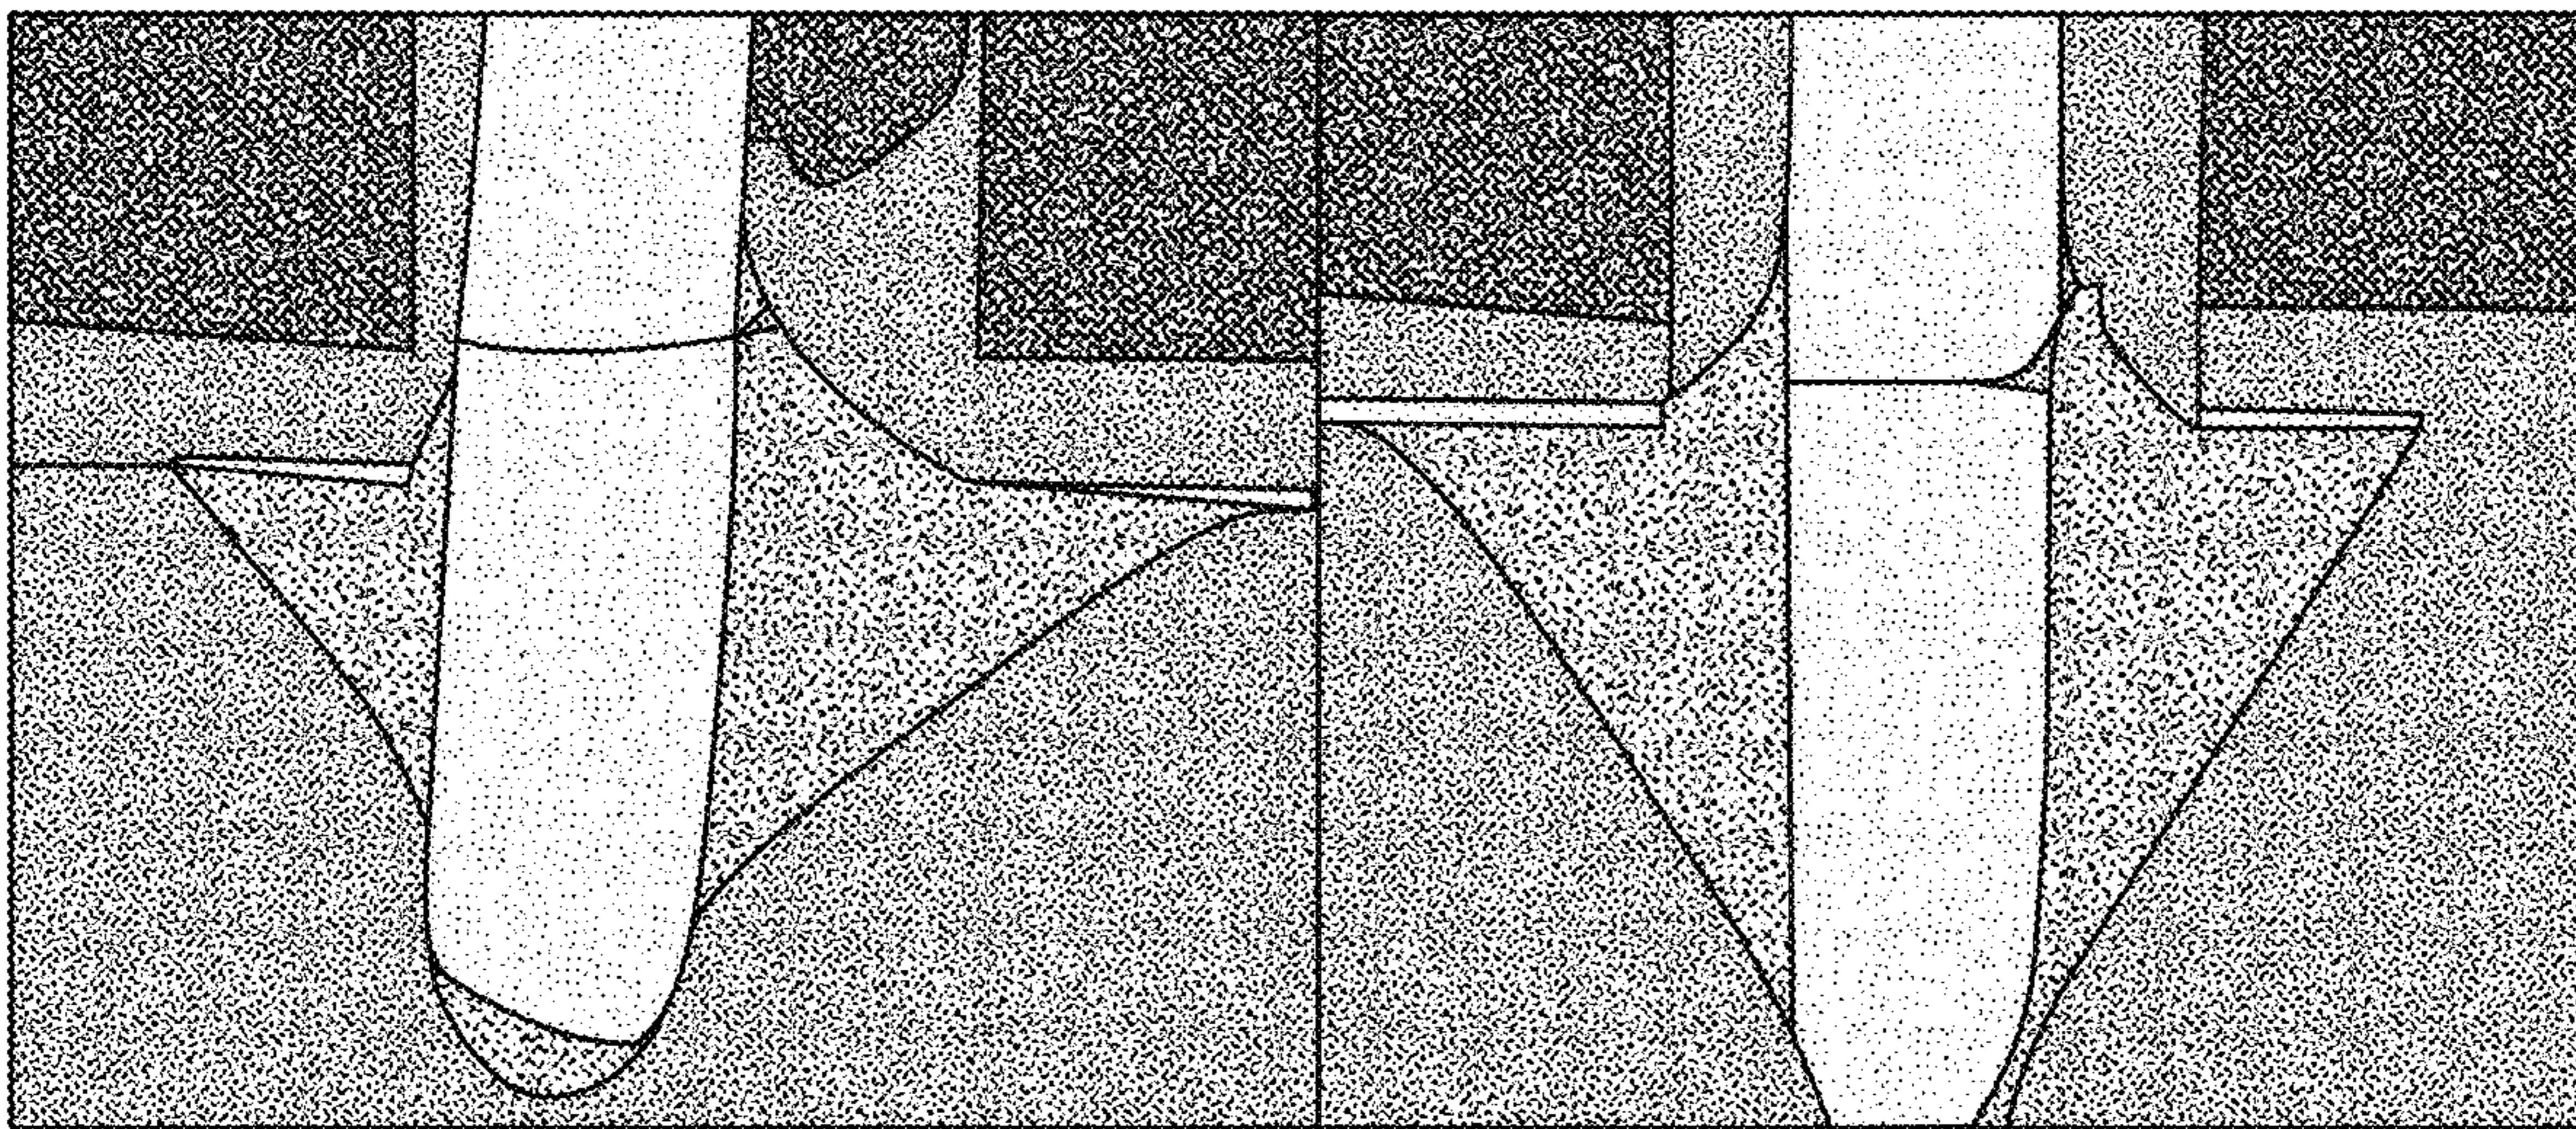
FIG. 12 are pictures showing fractured lead wires of the PDIP.

FIG. 12 shows two different cases in which the lead wire of the PDIP fractured. In most cases the failure was located in the pin just above the bottom surface of the board (about 1 or 2 mm). Also, these failures were found in either or both of the leads that are closer to the center line of the board. This area of the board is where the largest curvature displacement was found during the vibration loading. In fact, 78% of the failures have been found in this location.

The assembly characteristics for these two assemblies are SAC/ImSn—(aging condition: 125°C . for 100 hours) and SAC/ImSn—(aging condition: -55°C . for 1000 hours).
