(12) **United States Patent**
Zhan et al.

(54) **METHOD OF ASSESSING RELIABILITY OF ELECTRONICS ASSEMBLIES UNDER DRILLING VIBRATION CONDITIONS**

The present disclosure relates to electronic devices for drilling operations, particularly relates to methods and apparatus for assessing reliability of the printed circuit board assembly (PCBA) under drilling vibration conditions.

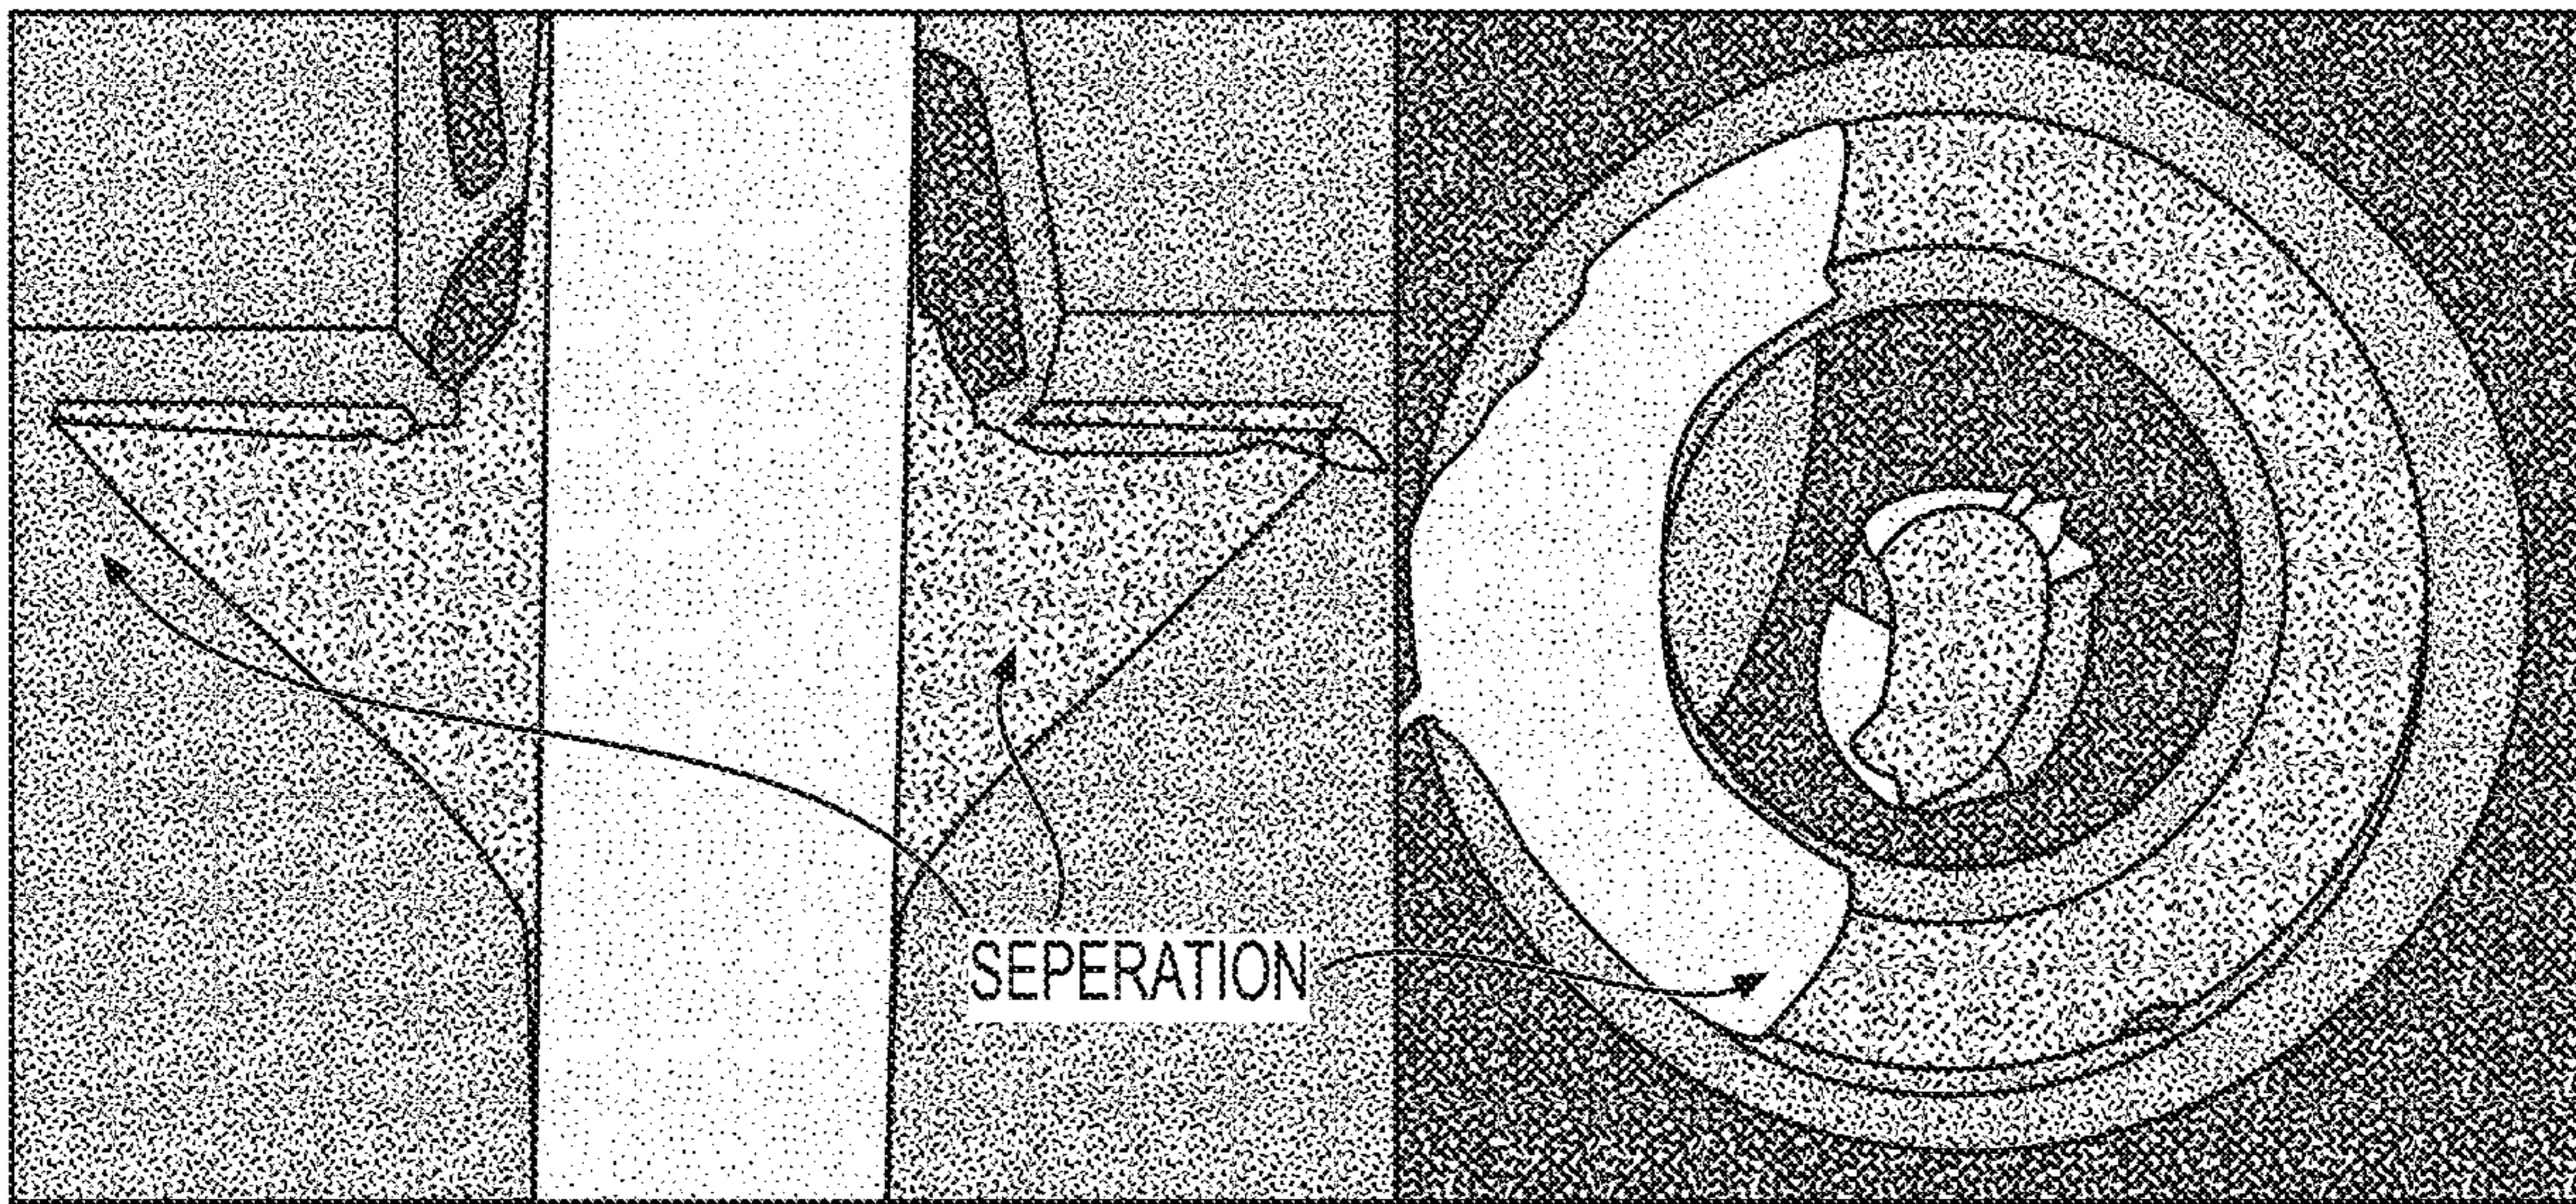
FIG. 13 are pictures showing separation between the solder and the board pad.

FIG. 13 shows crack/separation between the solder and the board pad (left) and separation between the pad and the board (right). Both of these failures were also found at pins located closer to the center line of the board. In the left picture, it is clear that the separation is found at the intermetallic. The solder material and board finish (in case of Pb-free assemblies) could have an influence in occurrence of this failure.

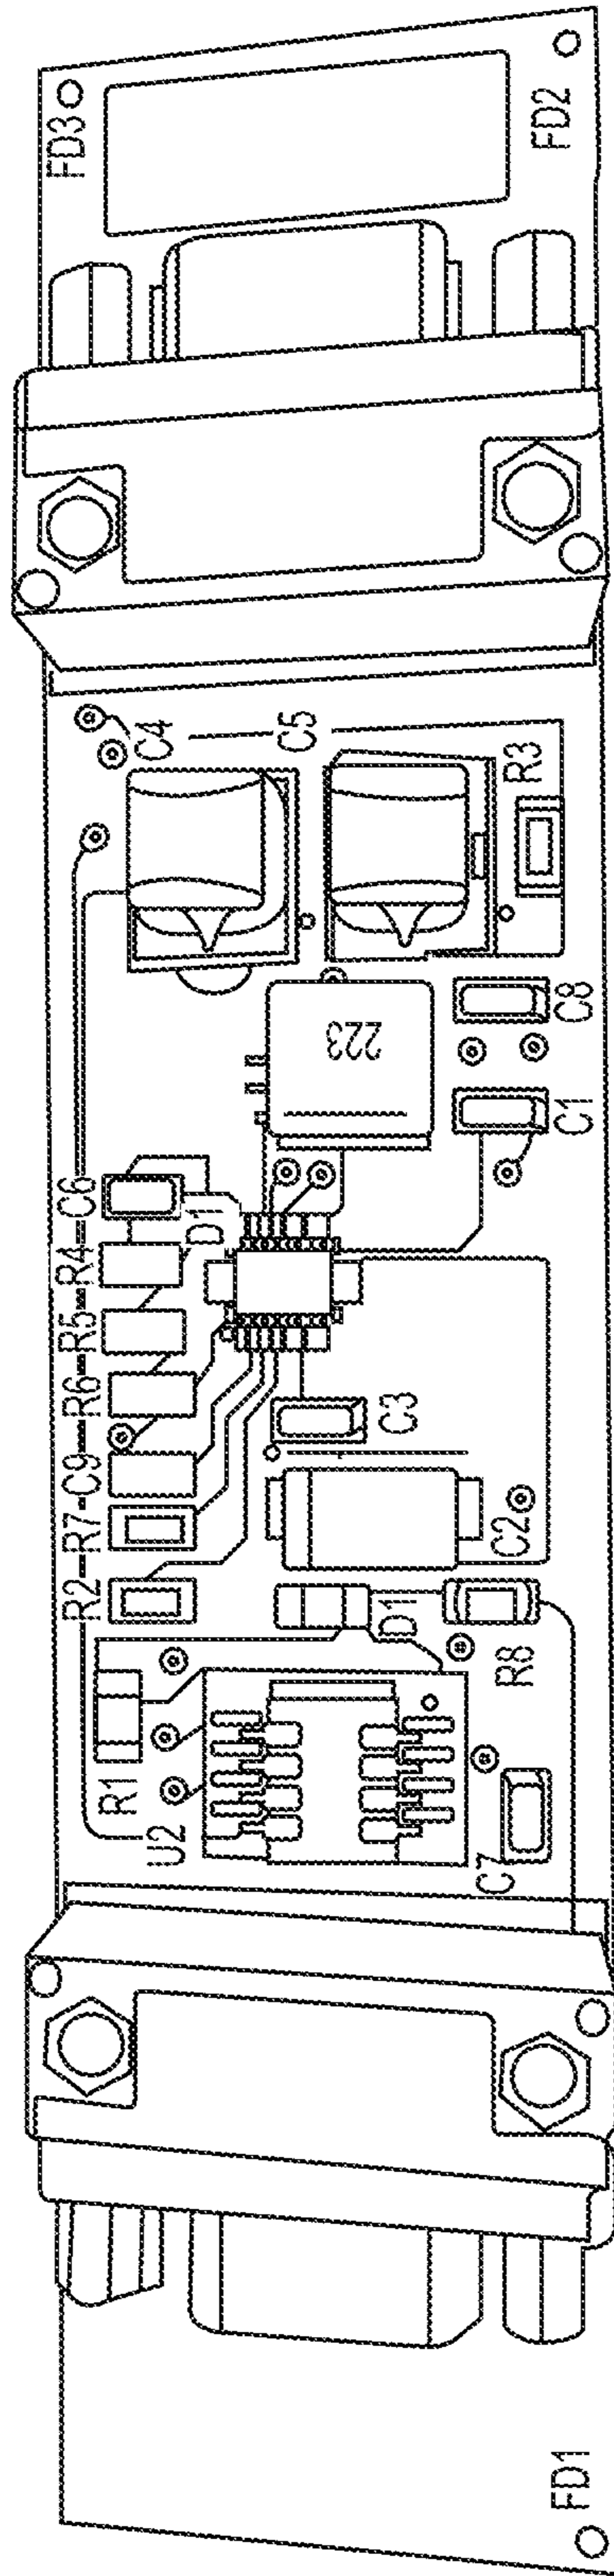
FIG. 14 is a picture of the PCBA of the current disclosure for being tested for durability.

A PCBA of the disclosure was tested at 200°C . for high temperature survivability. FIG. 14 is a picture of the tested PCBA. It is connected with a load box set for 5 VDC at 400 mA. LabVIEW was used to control and log data from the power supply. The PCBA was tested continuously for 797 hours at 200°C . in an oven before it failed to meet the requirements set on the load box. FIG. 15 shows data from the last week of testing, indicating a sudden drop of voltage after being in the oven at 200°C . after a cumulative 797 hours.

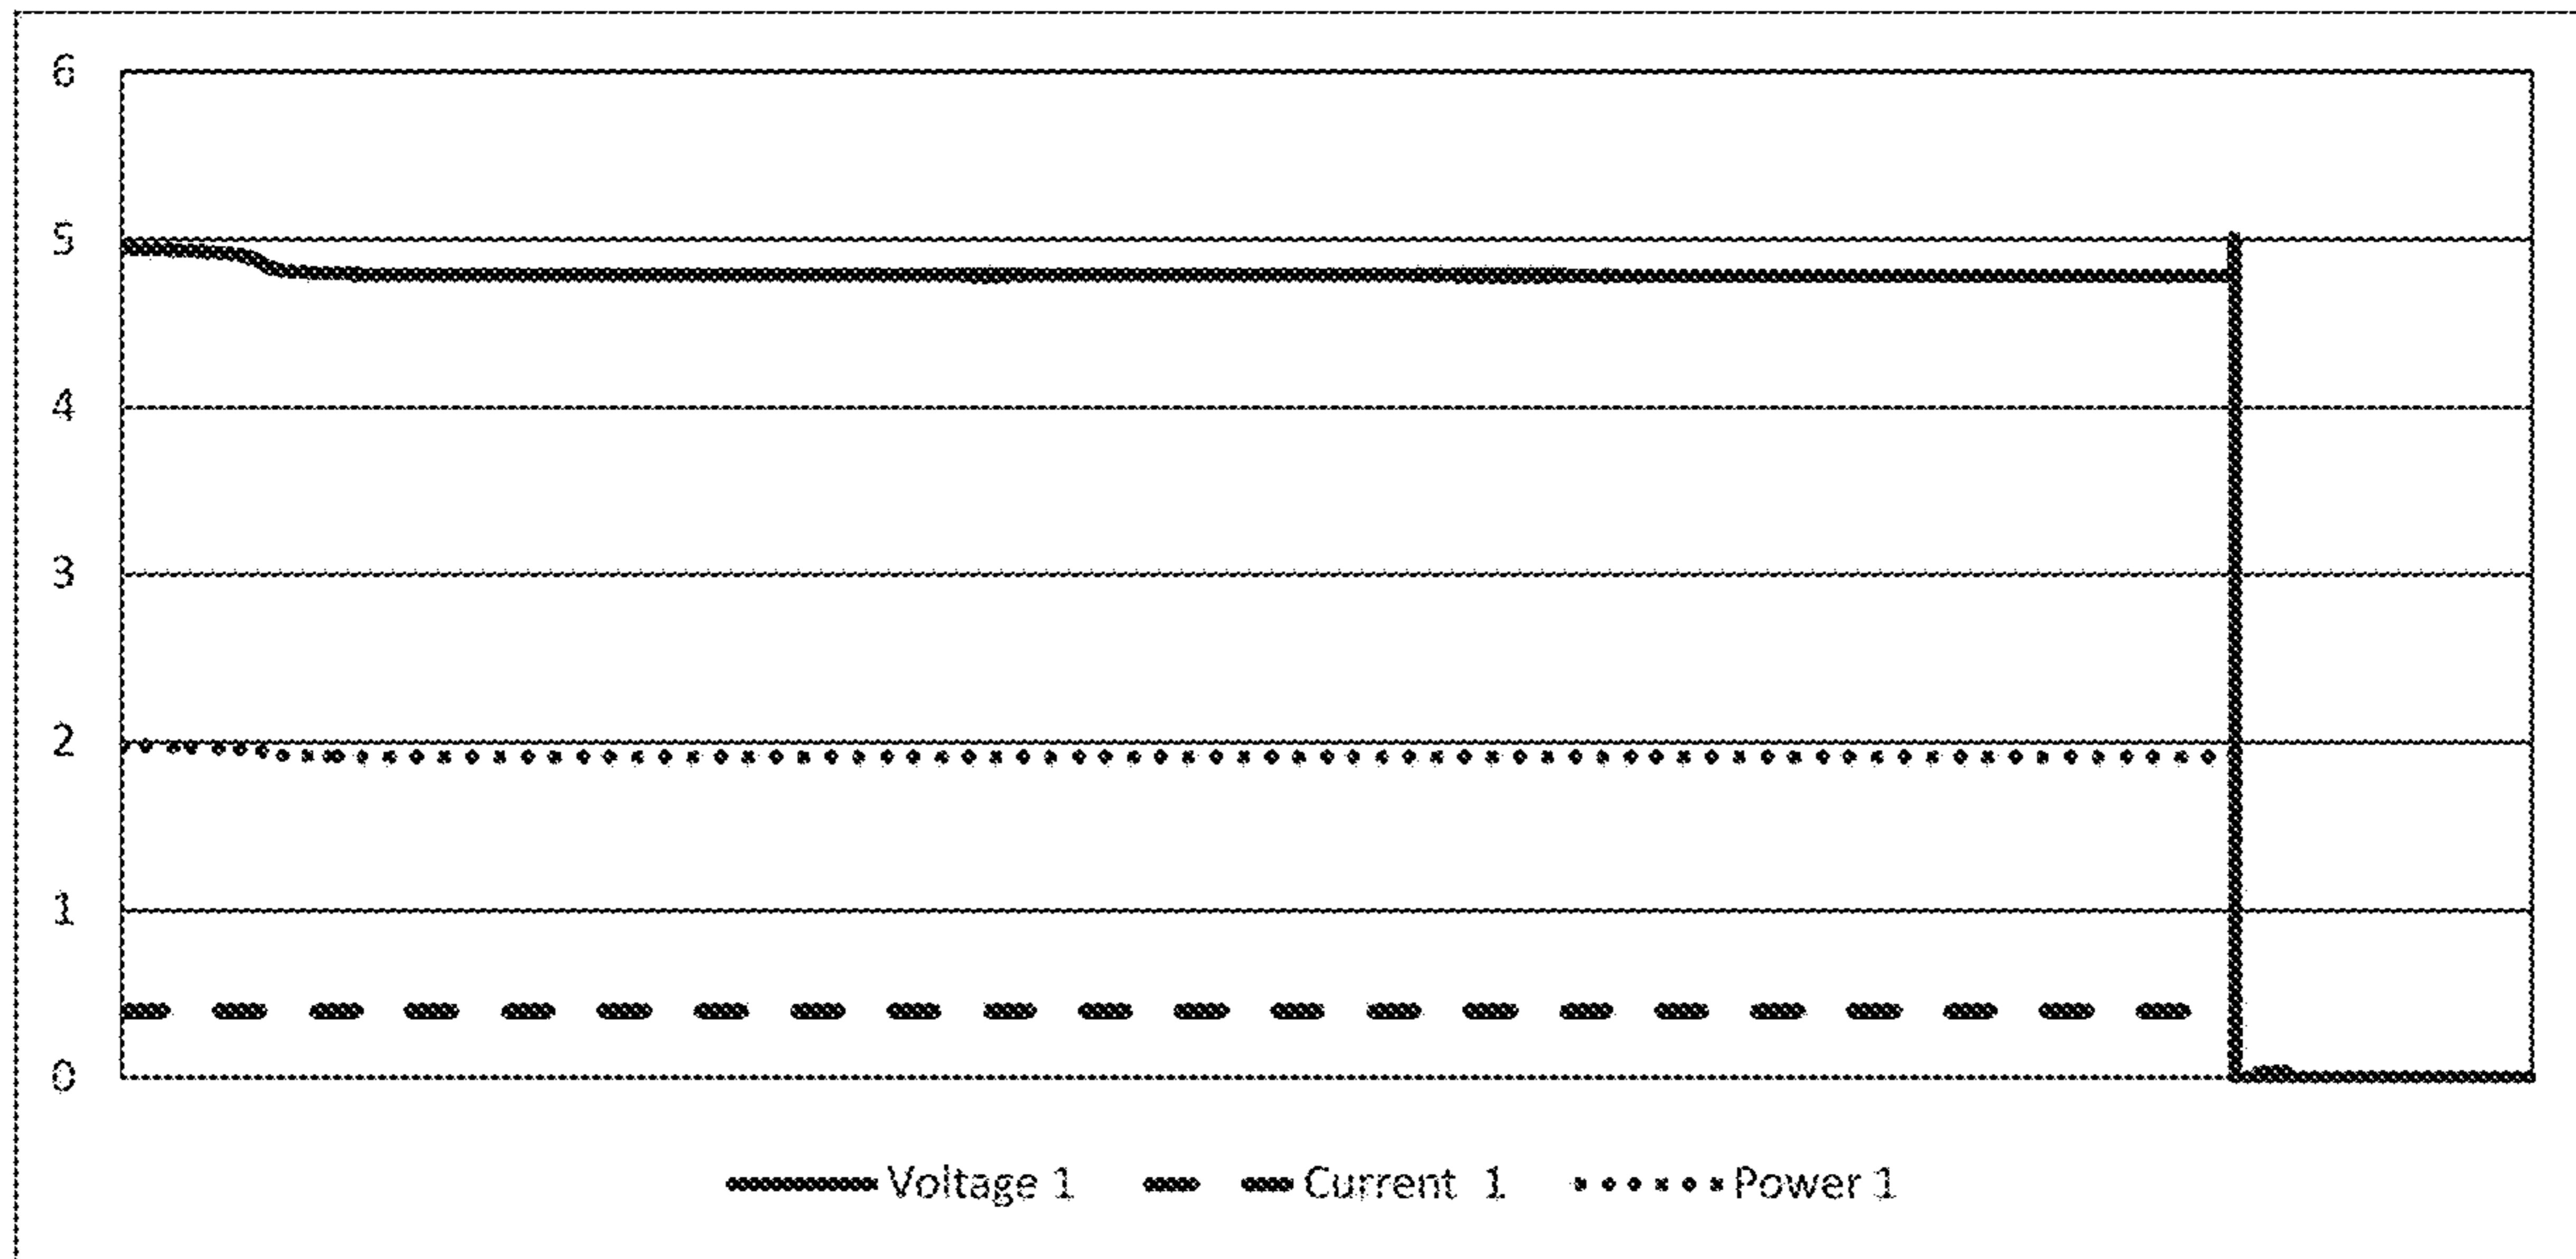
FIG. 15 is a plot showing data at the end of the durability test of the PCBA at 175° C.

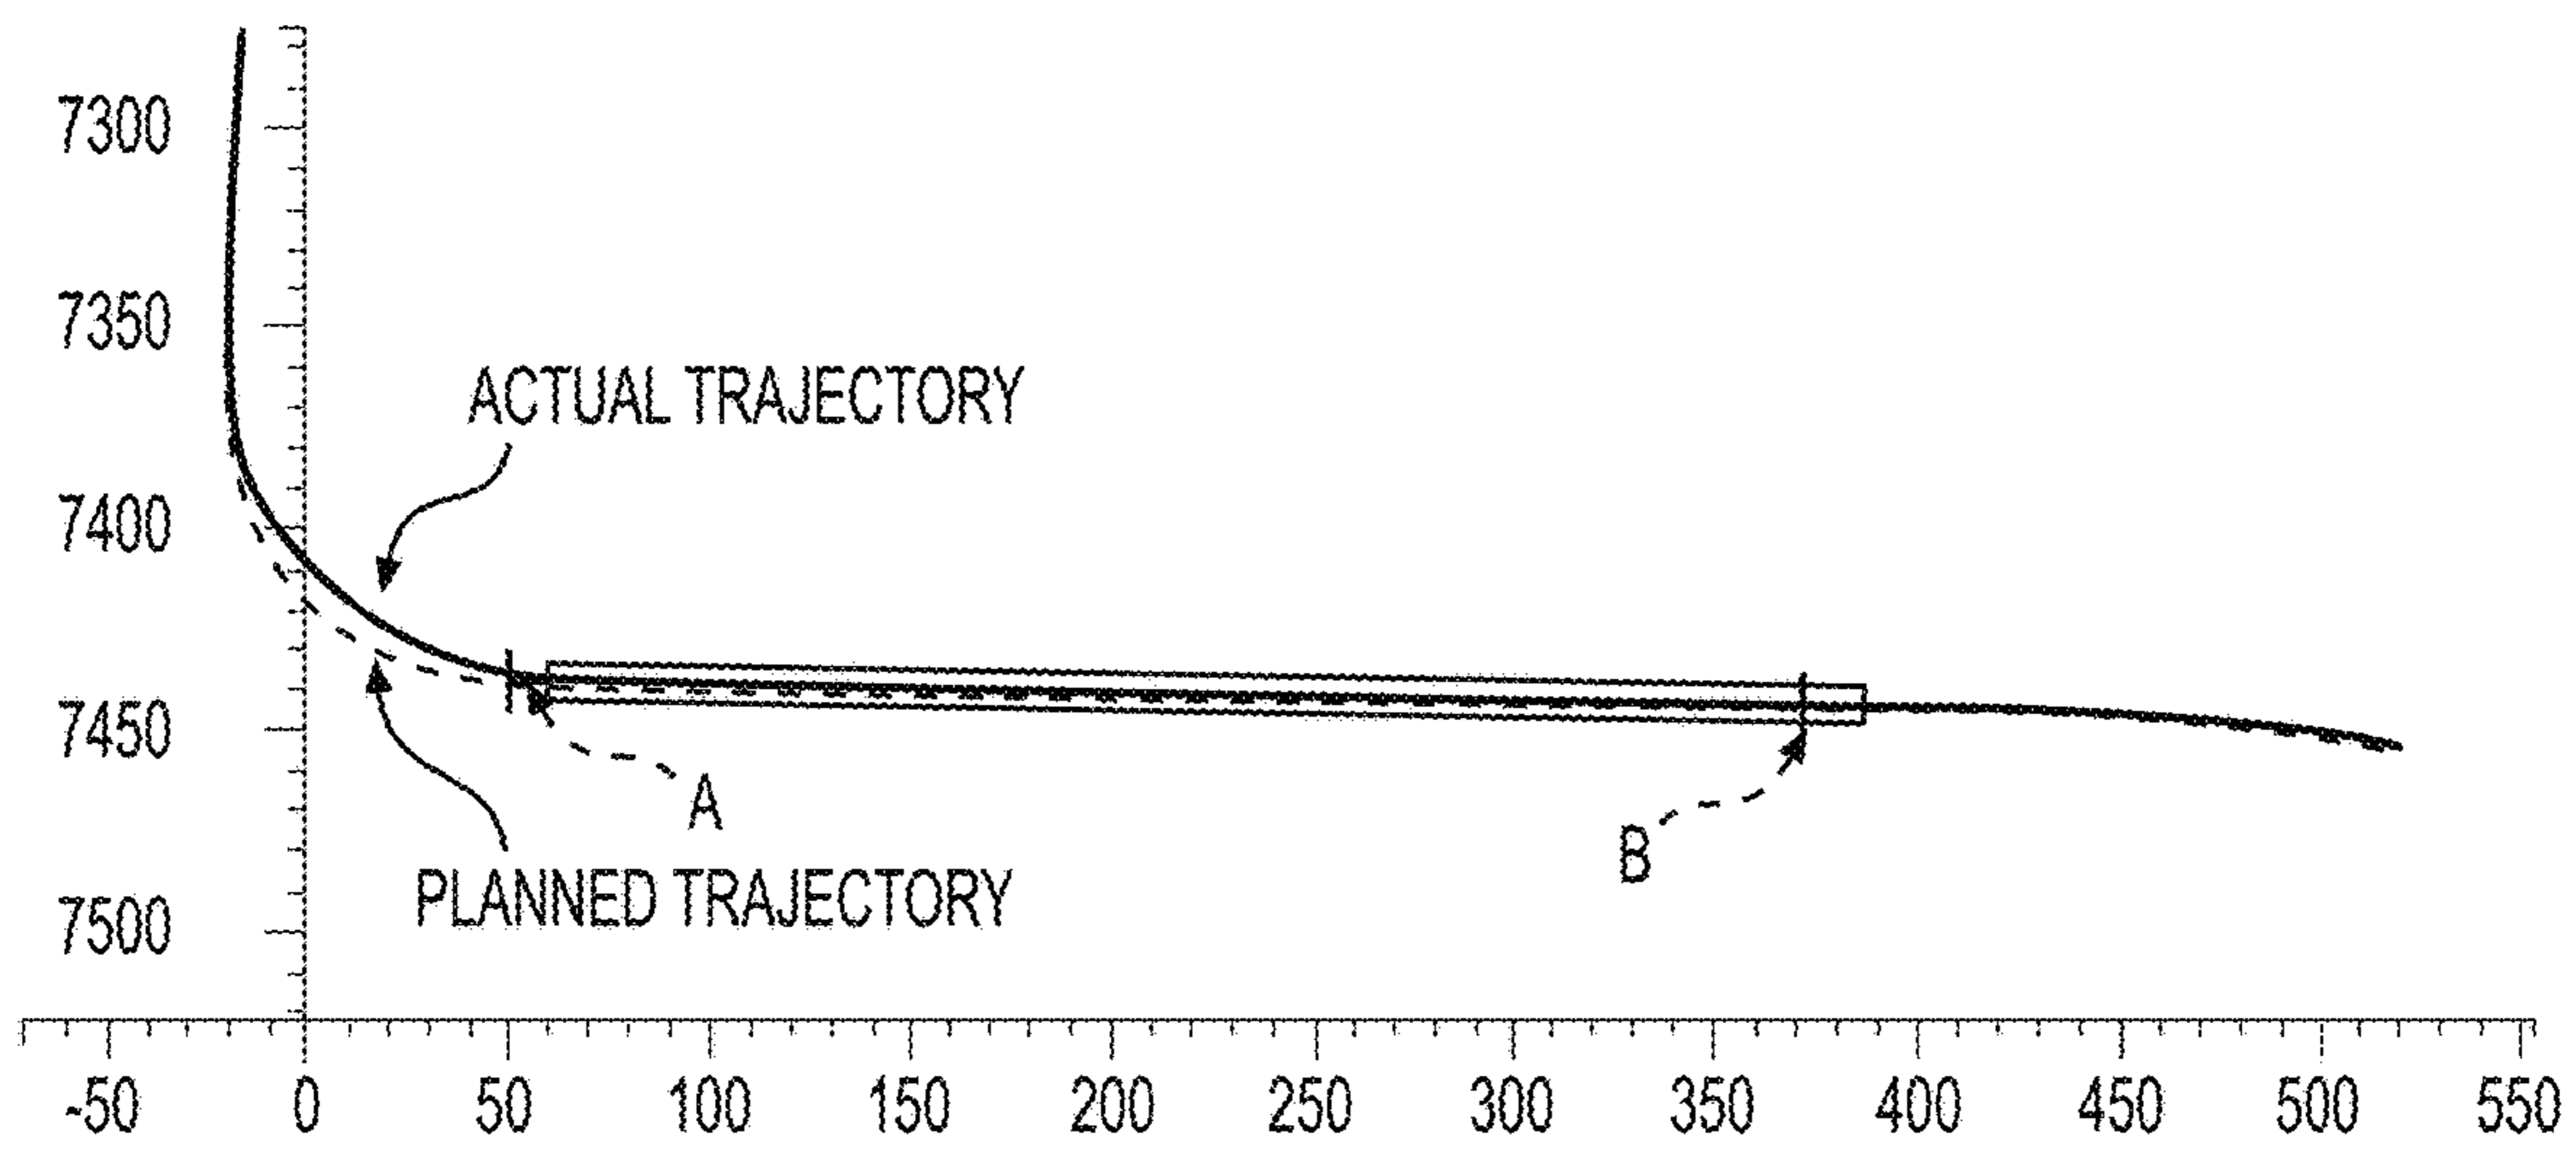
FIG. 16 shows a section of the profile of directional drilling in a field test.
