US011112051B2

(54) **FLARED-END AUTOMOTIVE ENGINE COOLANT PIPE REPAIR STENT AND METHOD FOR REPAIRING AN ENGINE**

A repair kit and associated method for repairing an automotive coolant pipe for fluid-conducting within an engine block of an engine includes at least a repair stent with a flared end, sealant and instructions for performing the method. The method includes draining coolant from the engine, removing the water pump from the engine without removing the timing chain cover of the engine, inserting the repair stent including a sealant through the coolant passage, wherein the coolant passage extends through the timing chain cover into the engine, re-assembling the water pump to the engine and adding coolant to the engine.

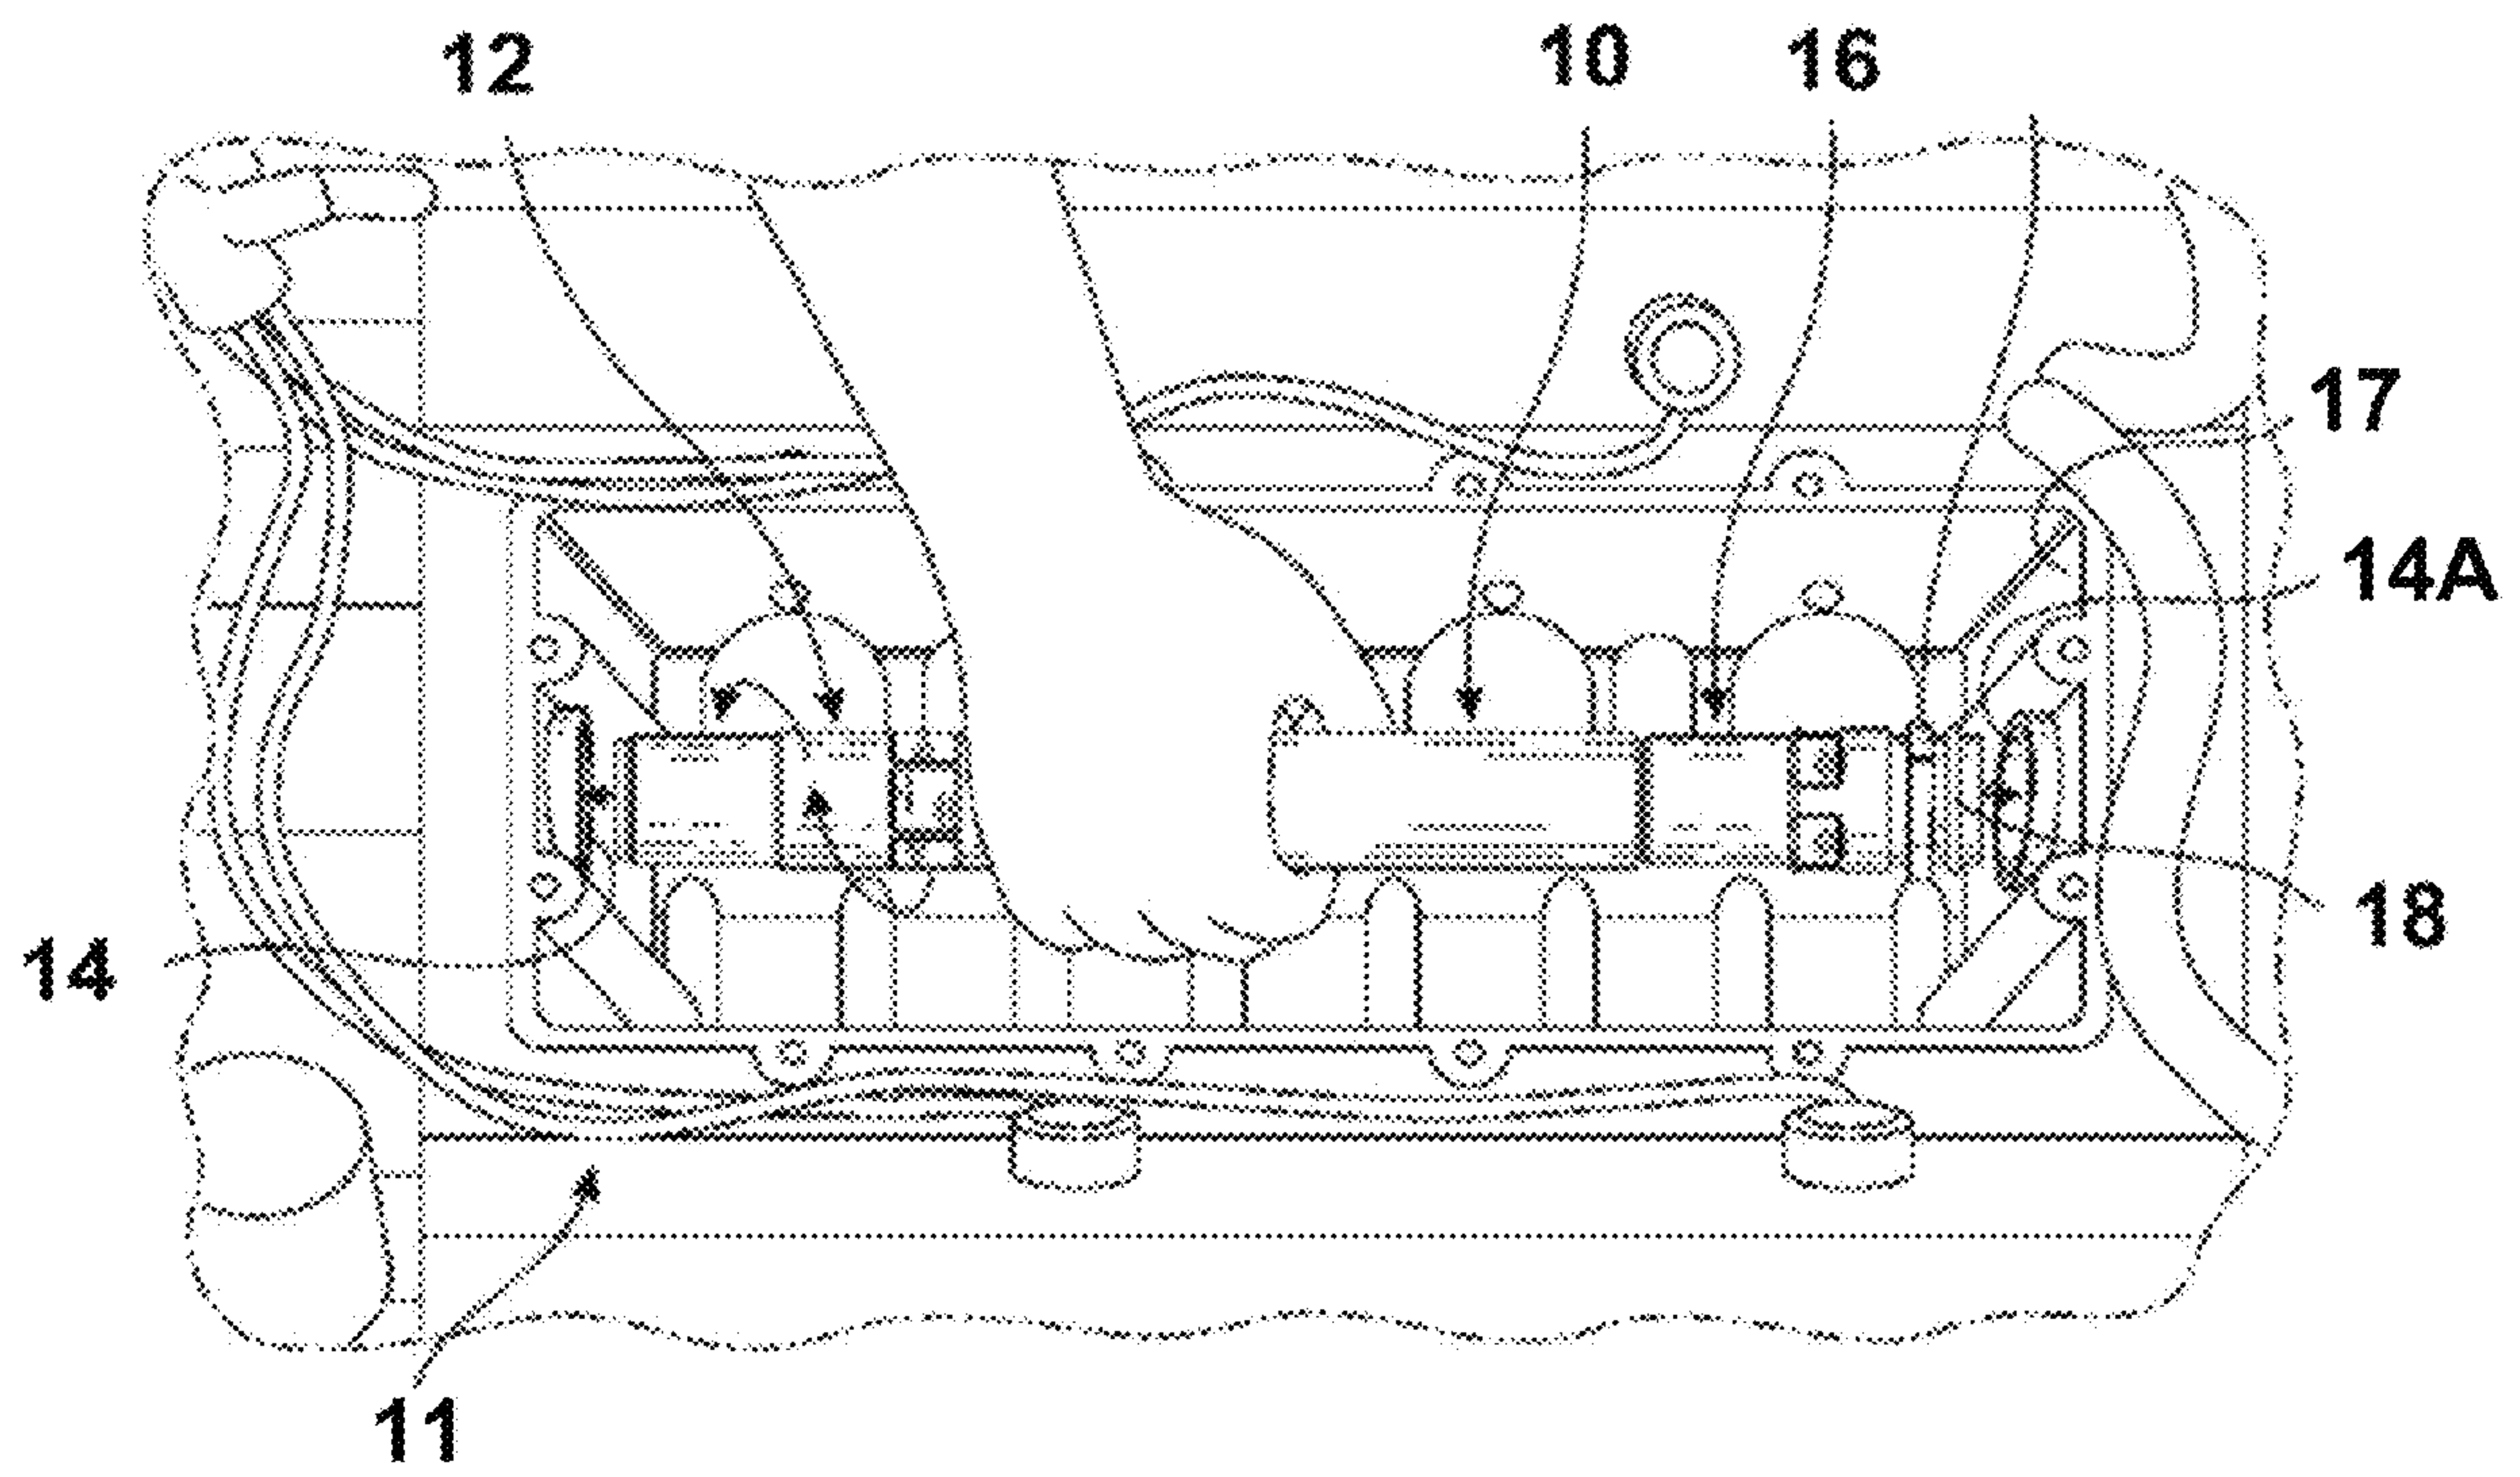
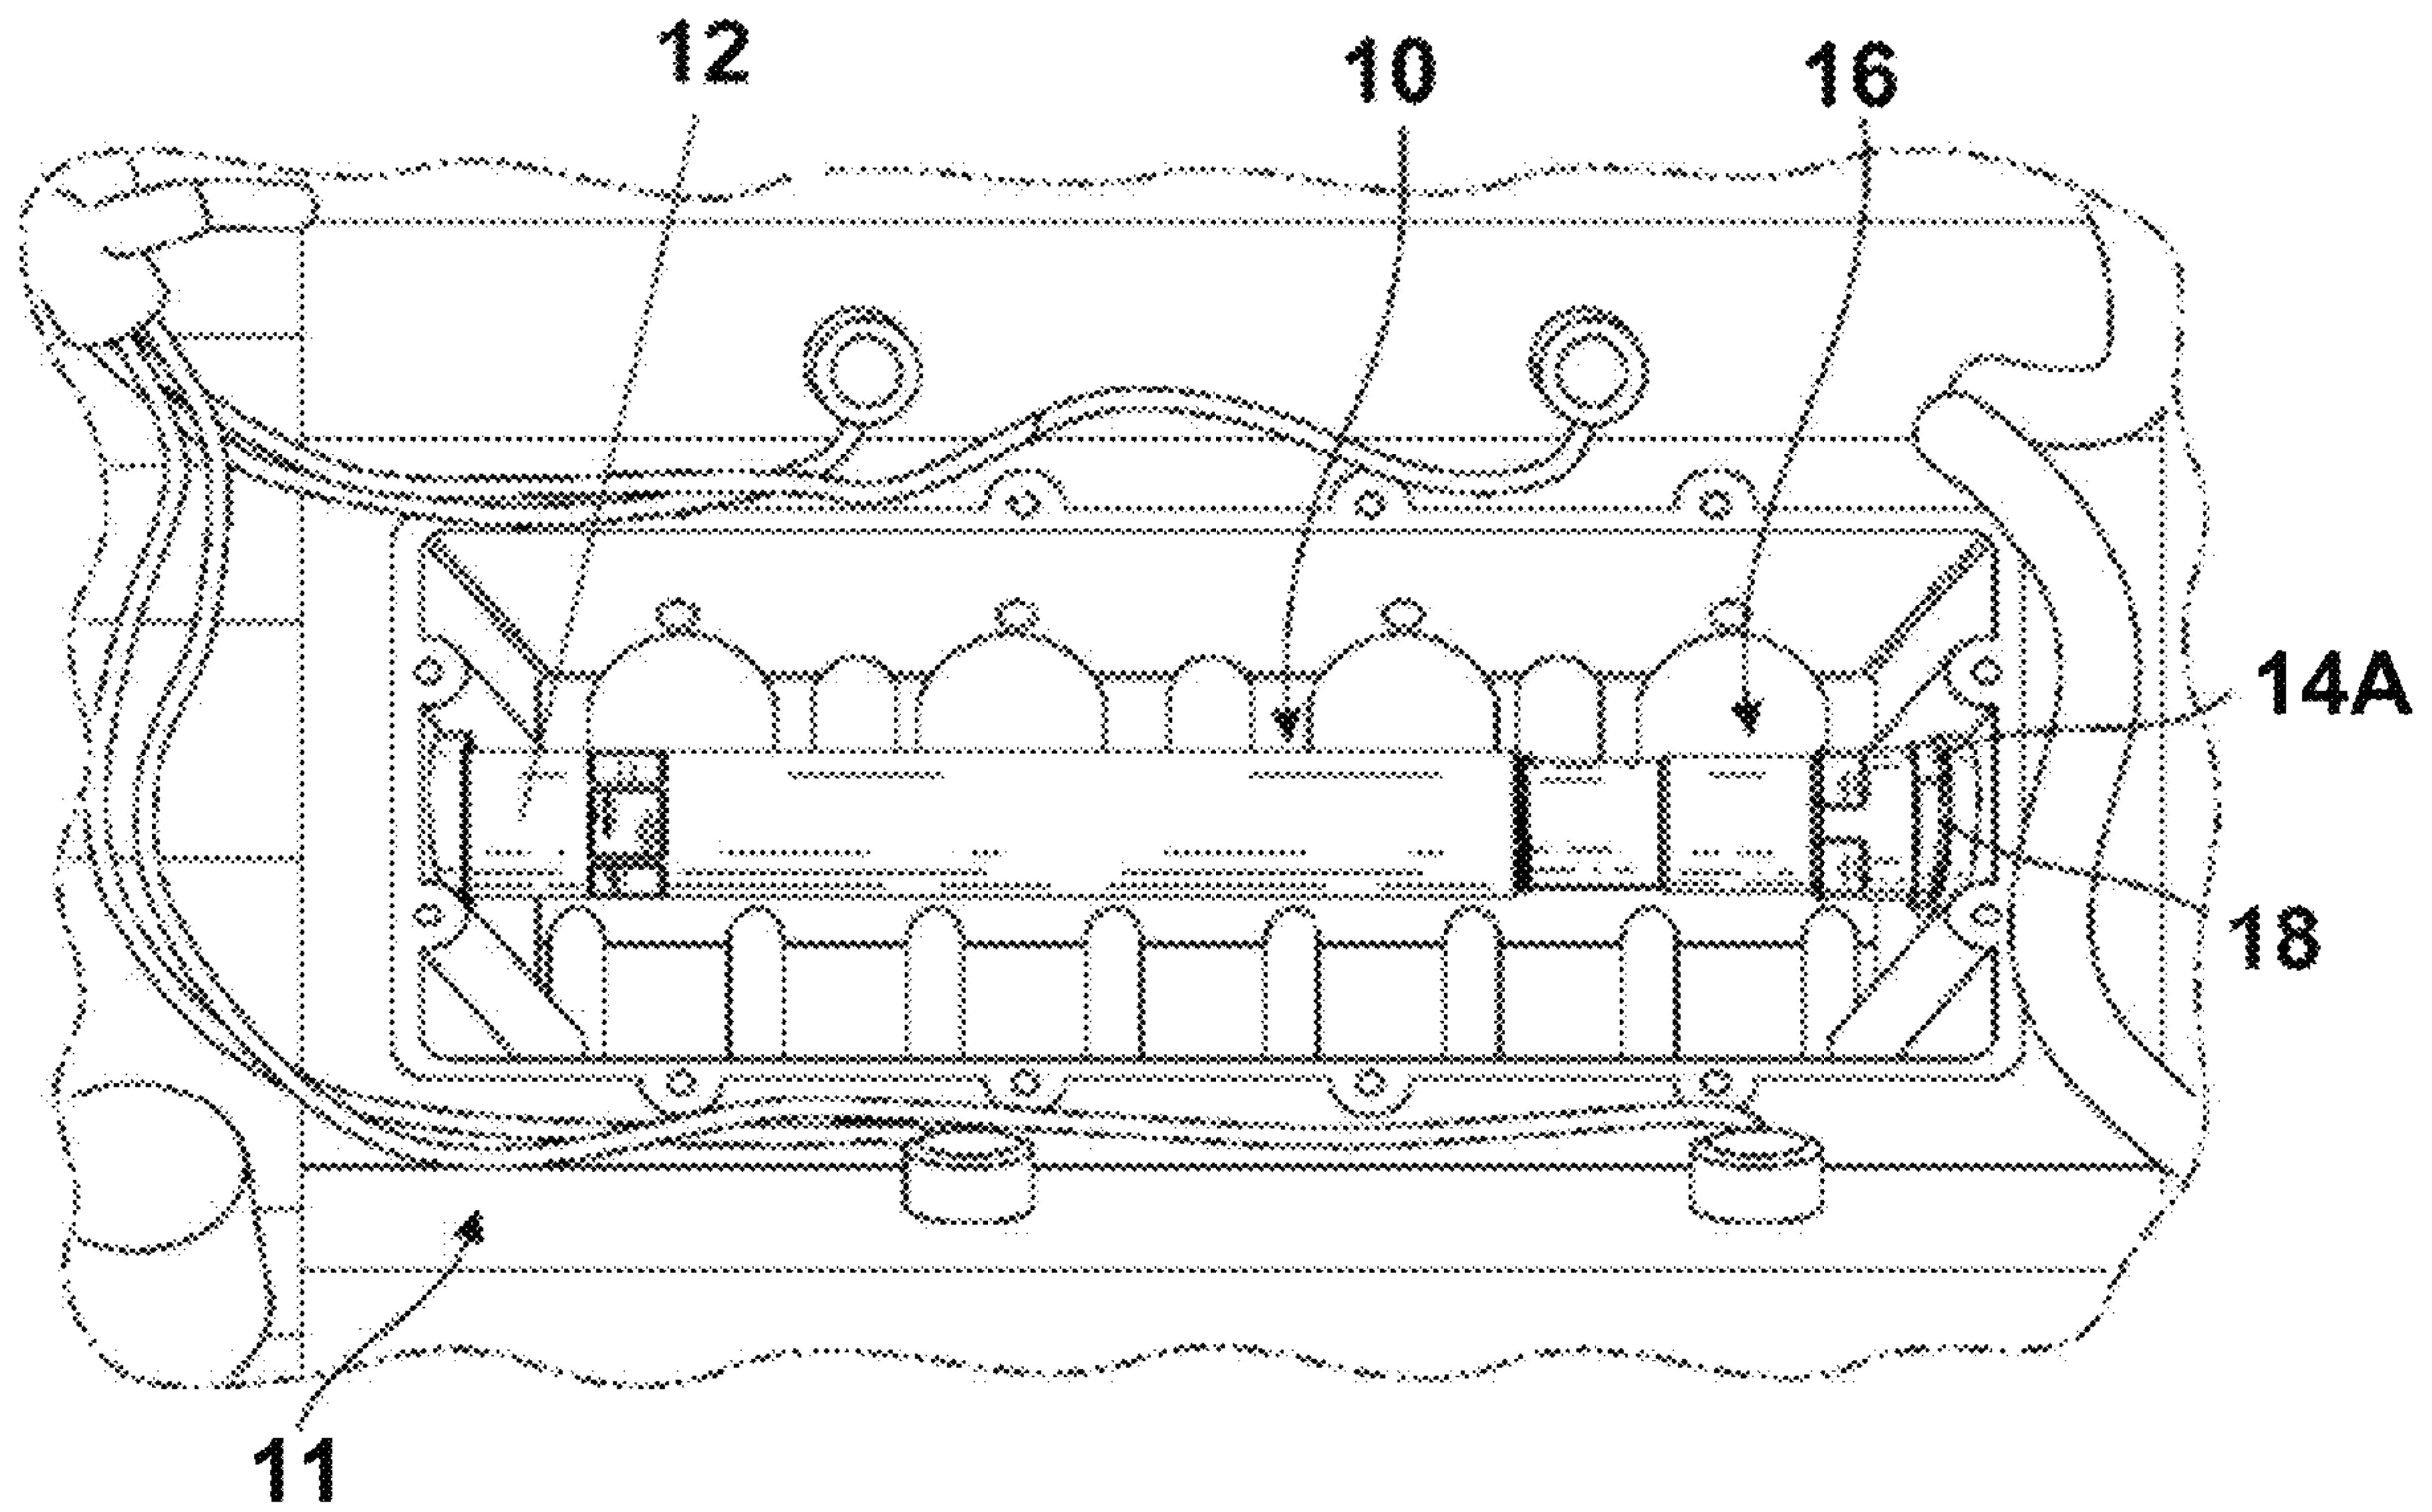
Fig. 1
(Prior Art)

FIGS. 1 and 2 show a replacement coolant transfer pipe **10** that is marketed by All German Auto as “the expanding cooling pipe,” in accordance with the disclosure in U.S. Pat. No. 8,464,424. The expanding cooling pipe is shown as being installed in an engine block **17** of a BMW automobile having an N62 engine **11**. Installation of the replacement coolant transfer pipe **10** is similar to that of the installation method for the collapsible BMW coolant transfer pipe, described above. Installation of the replacement coolant transfer pipe **10** also requires the removal of the intake manifold, and then requires cutting out the old coolant transfer pipe inside the engine block before the replacement coolant transfer pipe **10** can be installed.

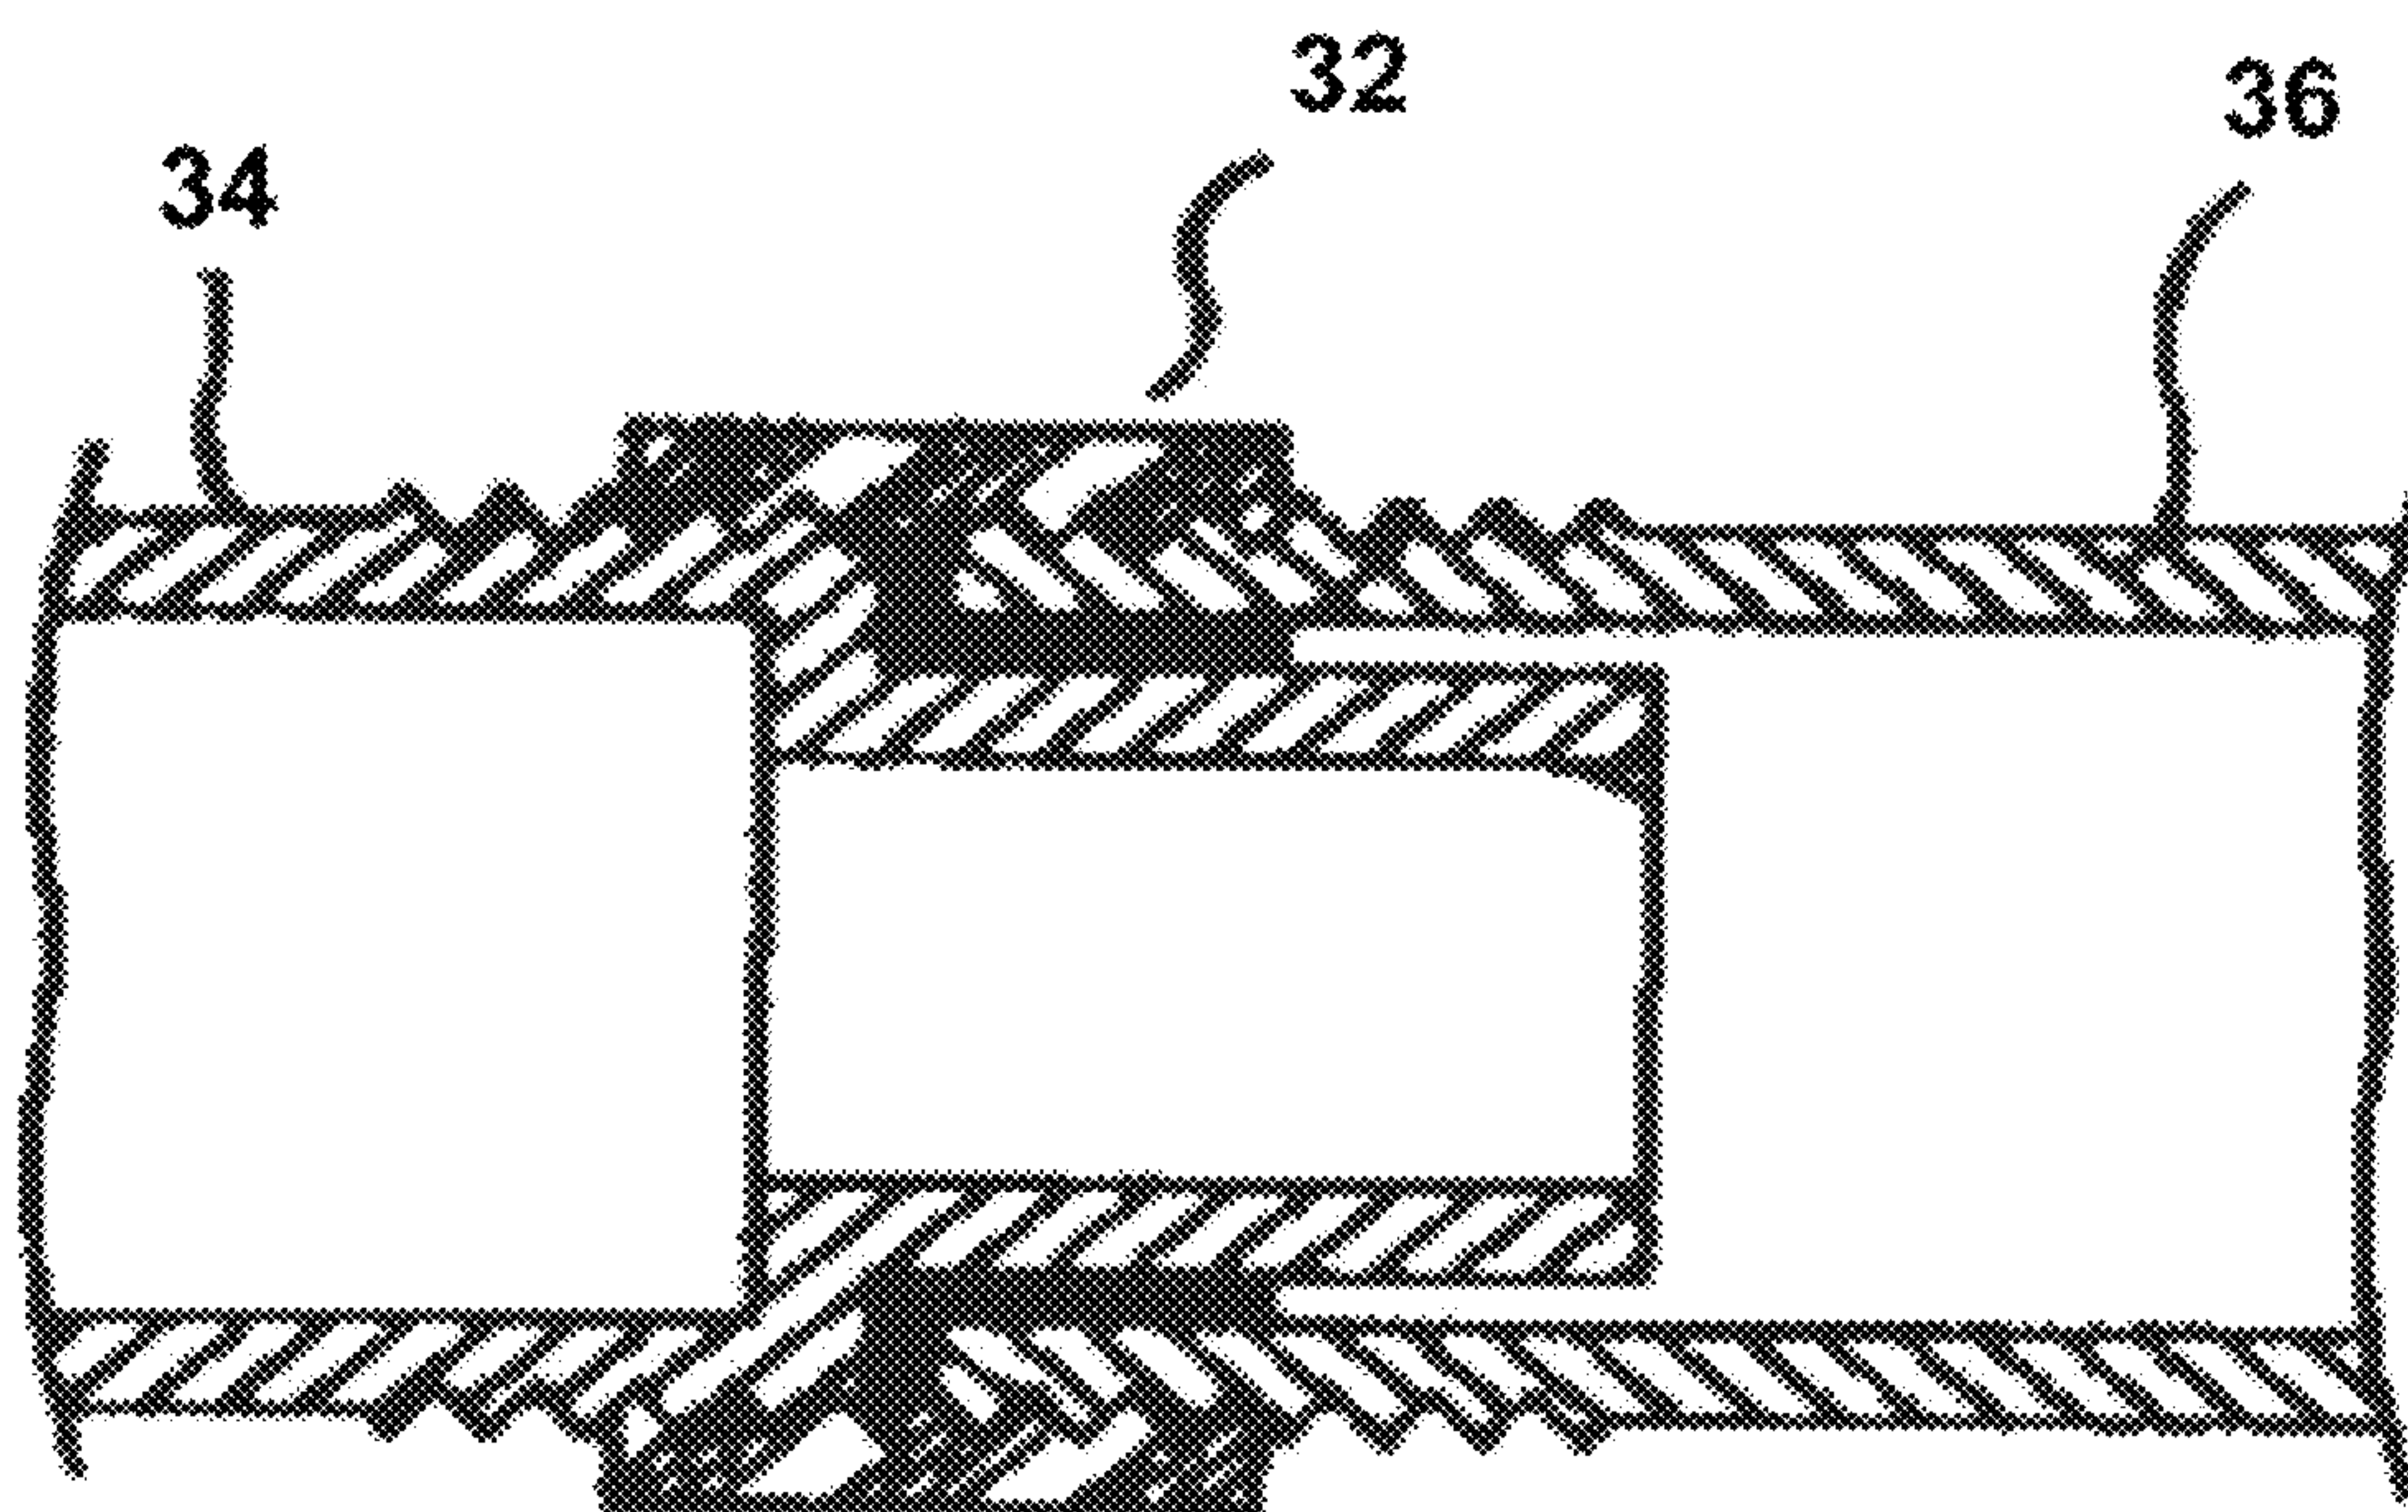
Fig. 4
(Prior Art)

Korean Patent publication KR 100143619 of Daewoo Motor Co. LTD., illustrated in FIG. **4**, discloses a pipe fitting **32** wherein a projecting part of a first pipe **34** can be inserted into a second pipe **36**. The joined portion is coupled with the fitting **32** to prevent a coolant from leaking through the gap between the first pipe **34** and the second pipe **36**. However, this arrangement involves a plurality of parts and is only as good as the integrity of the coupling. Compression and expansion can affect the integrity of the coupling. Also, such an arrangement cannot prevent coolant leakage at the front seal.

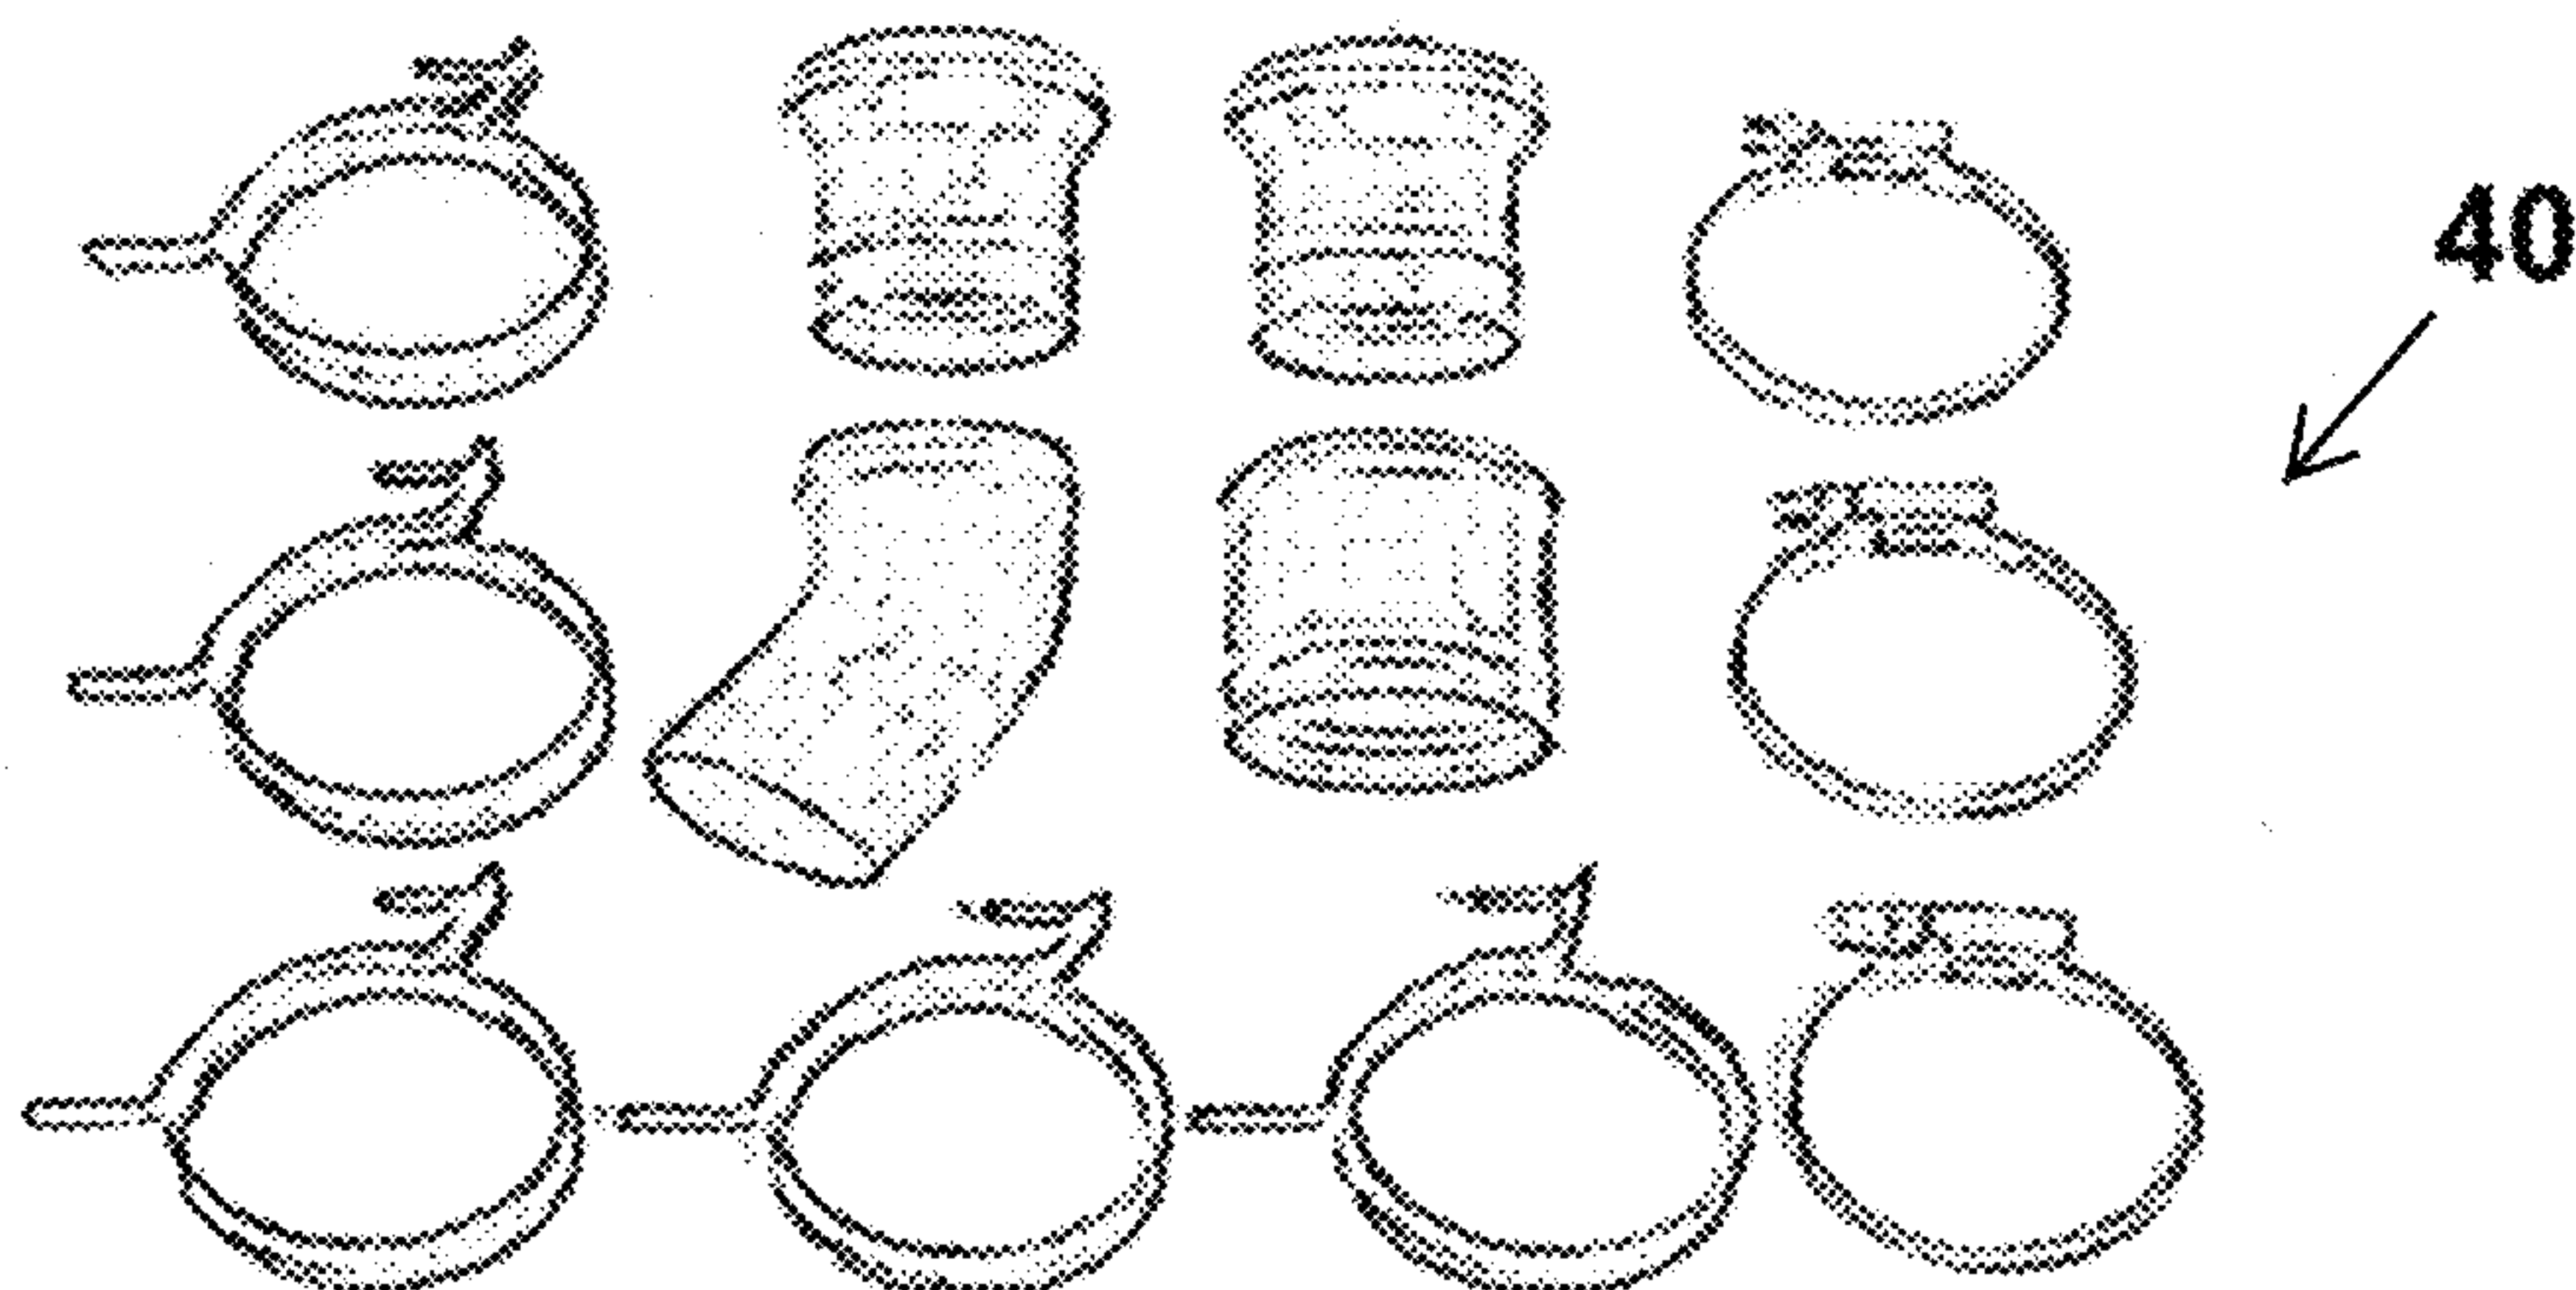
Fig. 5
(Prior Art)

A GoWesty coolant pipe repair kit, illustrated in FIG. **5**, provides a collection **40** of Brass fittings, screw clamps and spring clamps. However, these are suited only for repairing radiator coolant pipes located outside the engine block in Vanagons.

FIG. **5** is an illustration of components of a coolant pipe repair kit available from GoWesty, in accordance with the prior art;

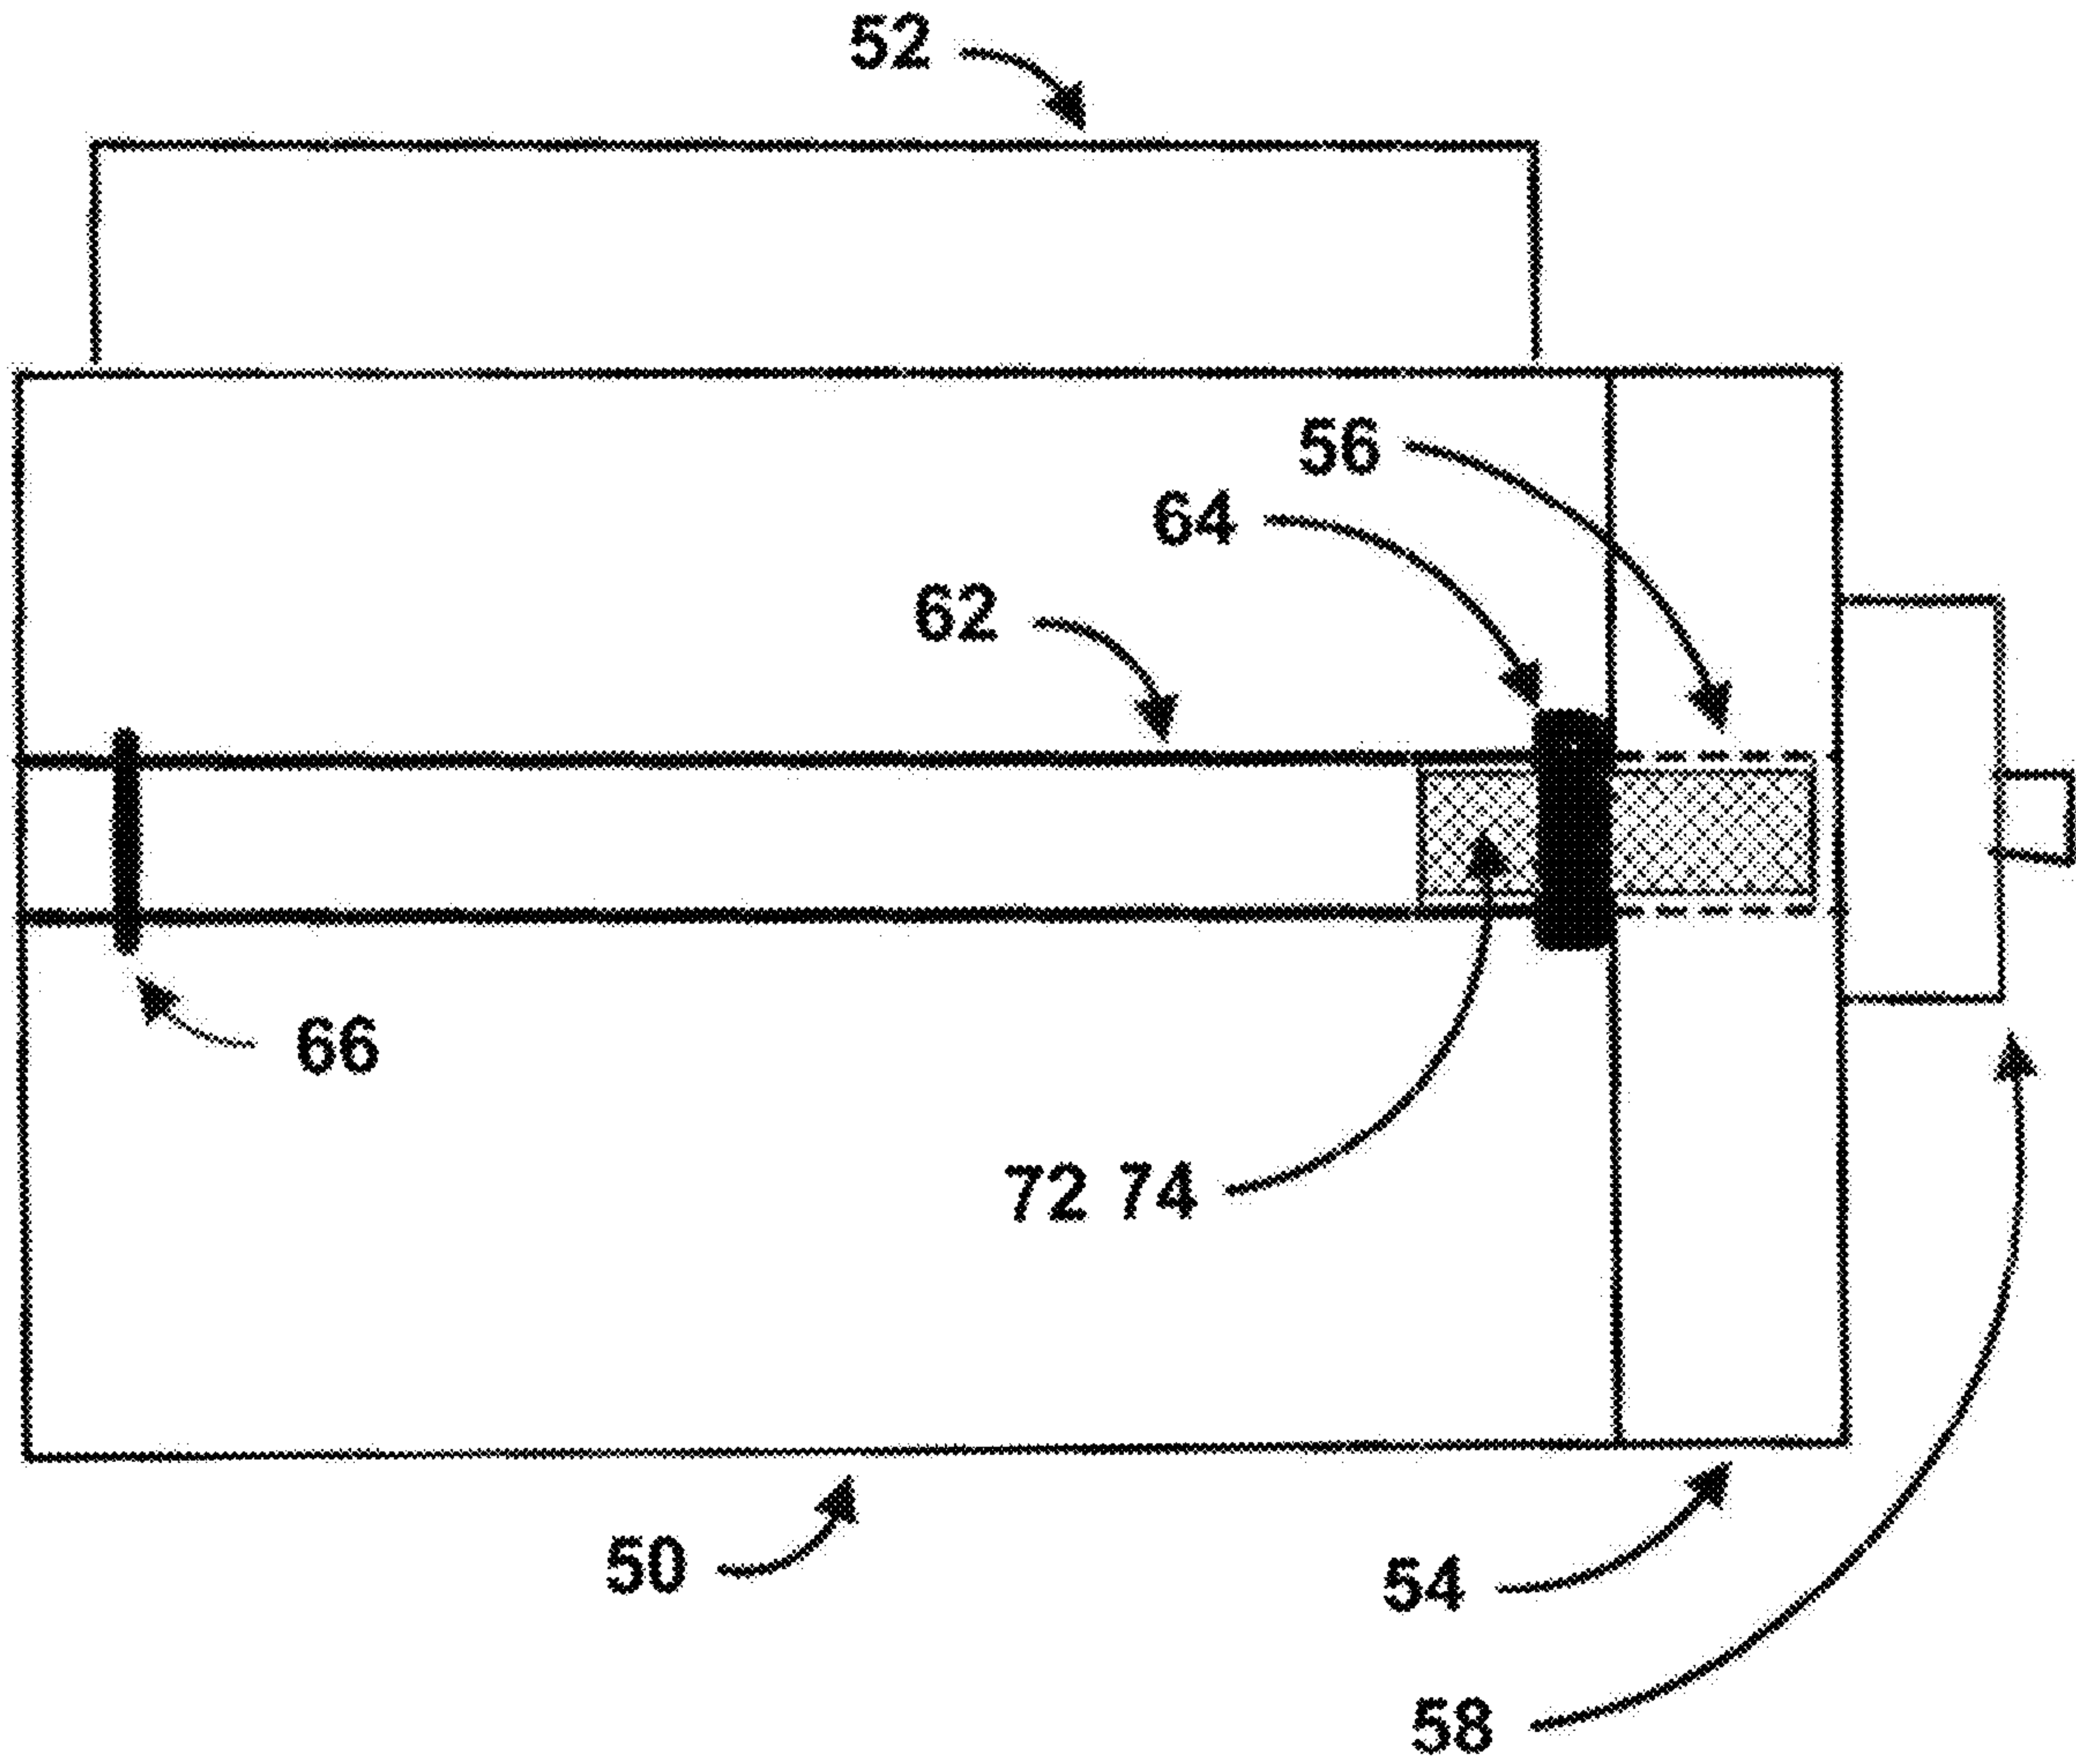
Fig. 7

FIG. **7** is a side pictorial view of the conventional engine block of FIG. **6** illustrating application of an apparatus and method for repairing a leaking front seal and coolant transfer pipe, in accordance with the present disclosure;

FIG. 7 shows a unique apparatus and method for repairing the leaking front seal 64 and coolant transfer pipe 62, without the need to remove the intake manifold 52 or the timing cover 54, thereby saving many hours of expensive labor and costly parts and materials. After removing the water pump 58, a repair tube insert 72 may be coated with sealant 74 and inserted through the timing cover coolant passage 56 directly into the coolant transfer pipe 62.

The repair tube insert 72 when coated with sealant 74 creates a bond and seal between the timing cover coolant passage 56, the coolant transfer pipe 62 and the front seal 64, in order to stop coolant from leaking into the engine block 50. The original front seal 64 and the coolant transfer pipe 62 do not need to be removed from the engine block 50, and remain in place.
