US011112051B2

(54) **FLARED-END AUTOMOTIVE ENGINE COOLANT PIPE REPAIR STENT AND METHOD FOR REPAIRING AN ENGINE**

A repair kit and associated method for repairing an automotive coolant pipe for fluid-conducting within an engine block of an engine includes at least a repair stent with a flared end, sealant and instructions for performing the method. The method includes draining coolant from the engine, removing the water pump from the engine without removing the timing chain cover of the engine, inserting the repair stent including a sealant through the coolant passage, wherein the coolant passage extends through the timing chain cover into the engine, re-assembling the water pump to the engine and adding coolant to the engine.

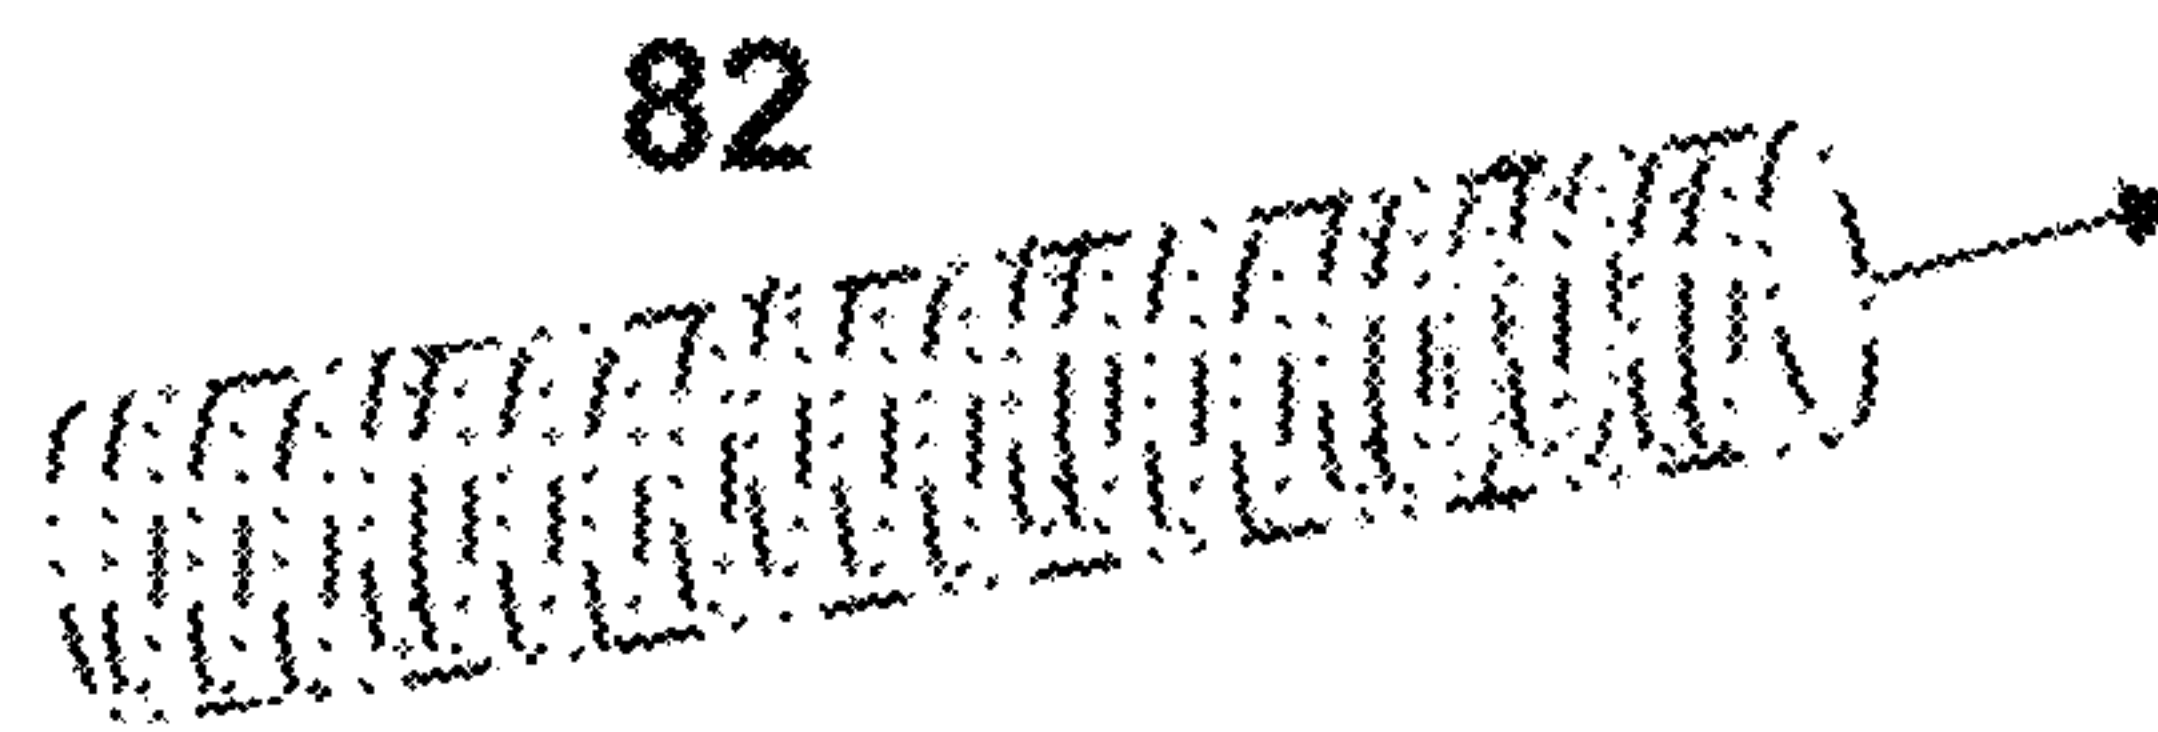
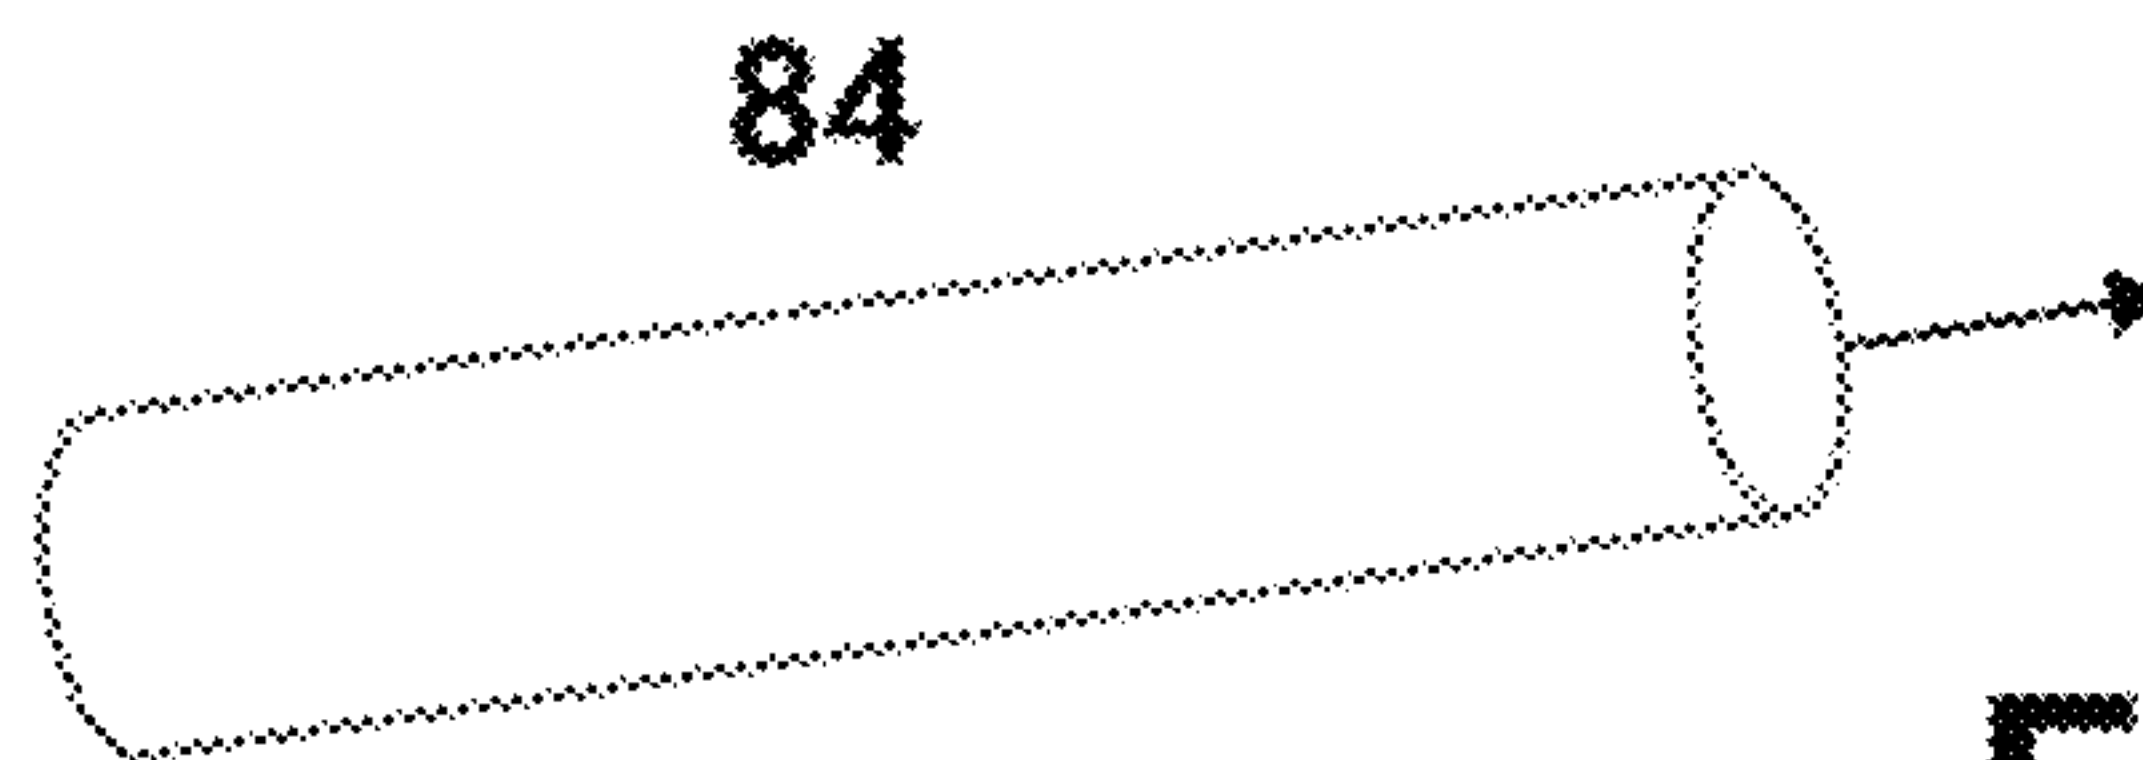
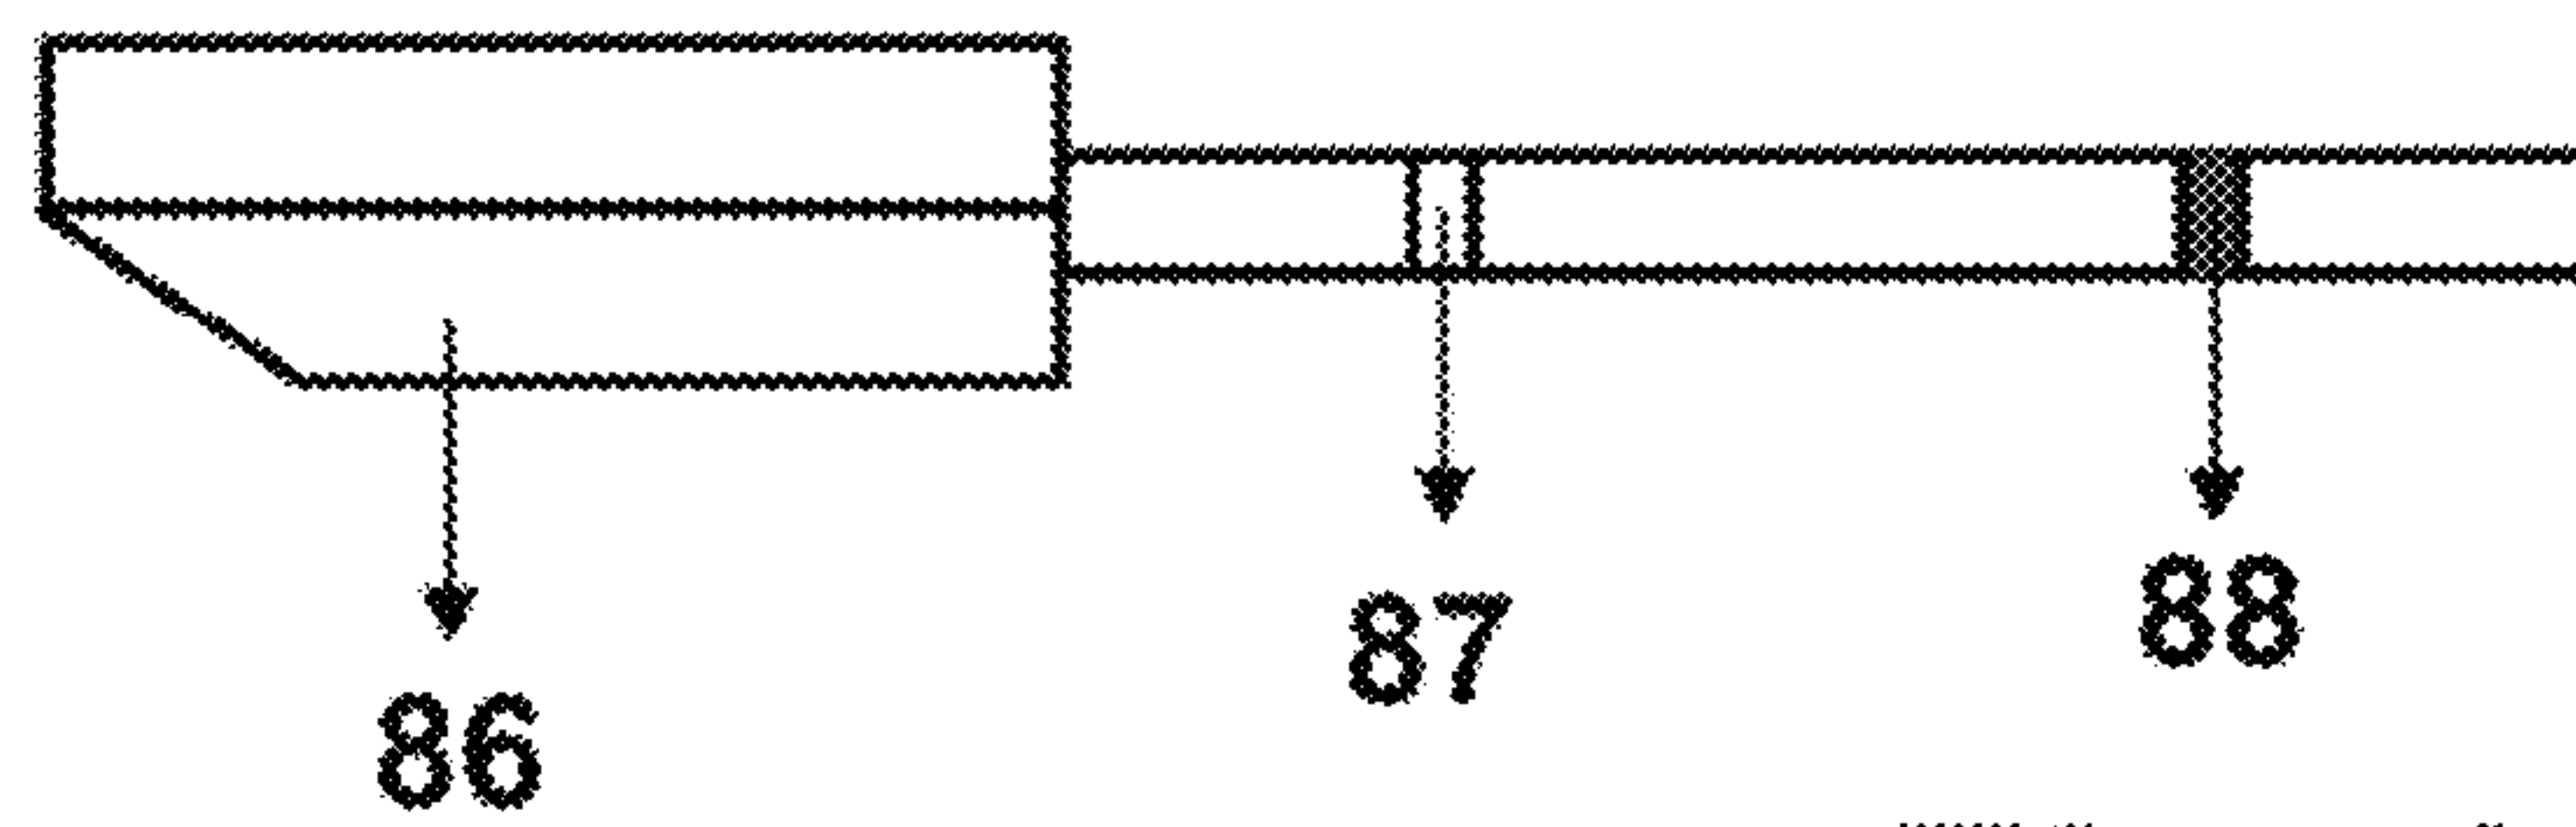
FIGS. **10A-10C** illustrate repair kit components, including a sanding rod, a cleaning rod and an sponge applicator brush, in accordance with the present disclosure; and

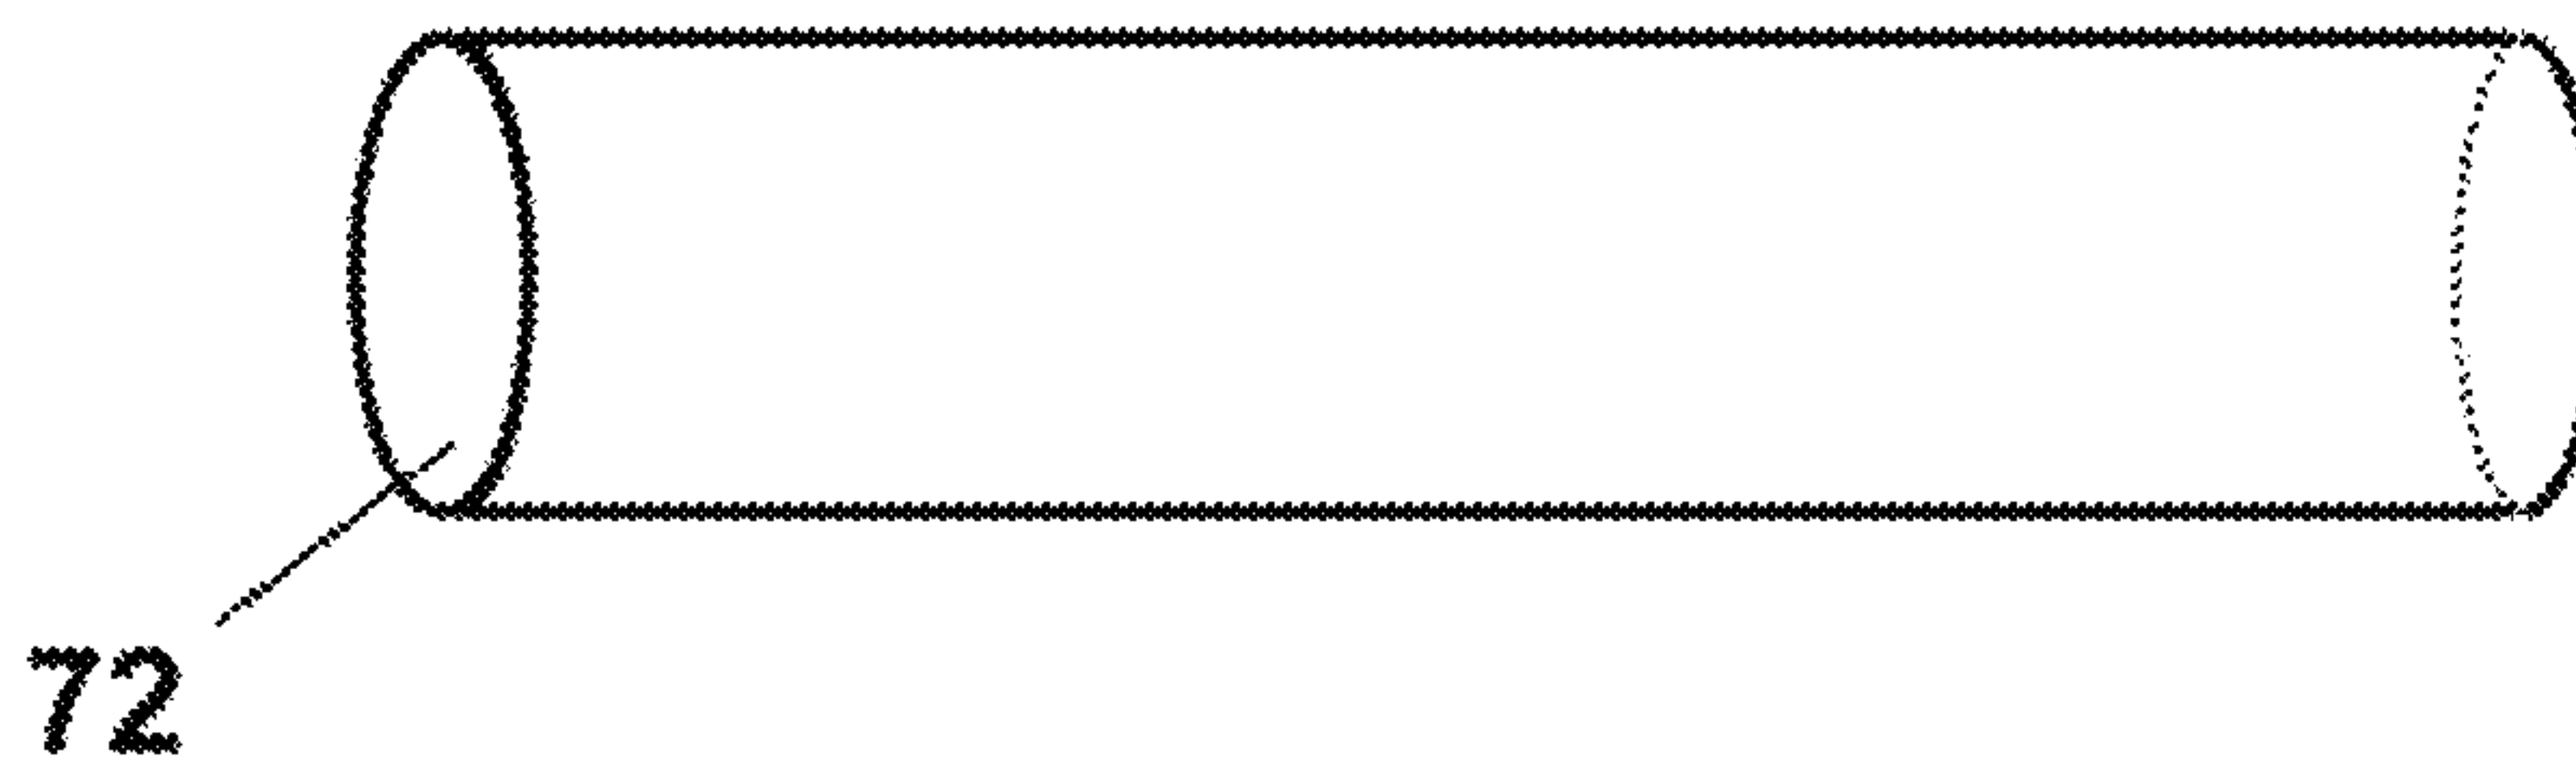
Fig. 11A

The sealant 74 may be a silicon-containing product or silicone based material, epoxy based material, petroleum based product, or any other material or gasket that will provide a watertight seal between the repair tube insert 72, the coolant transfer pipe 62, the front seal 64, and the timing cover coolant passage 56. The repair tube insert 72 or "stent 72" is an open ended, hollow cylindrical tube with circular ends. FIG. 11A illustrates the structure of the stent 72. In an

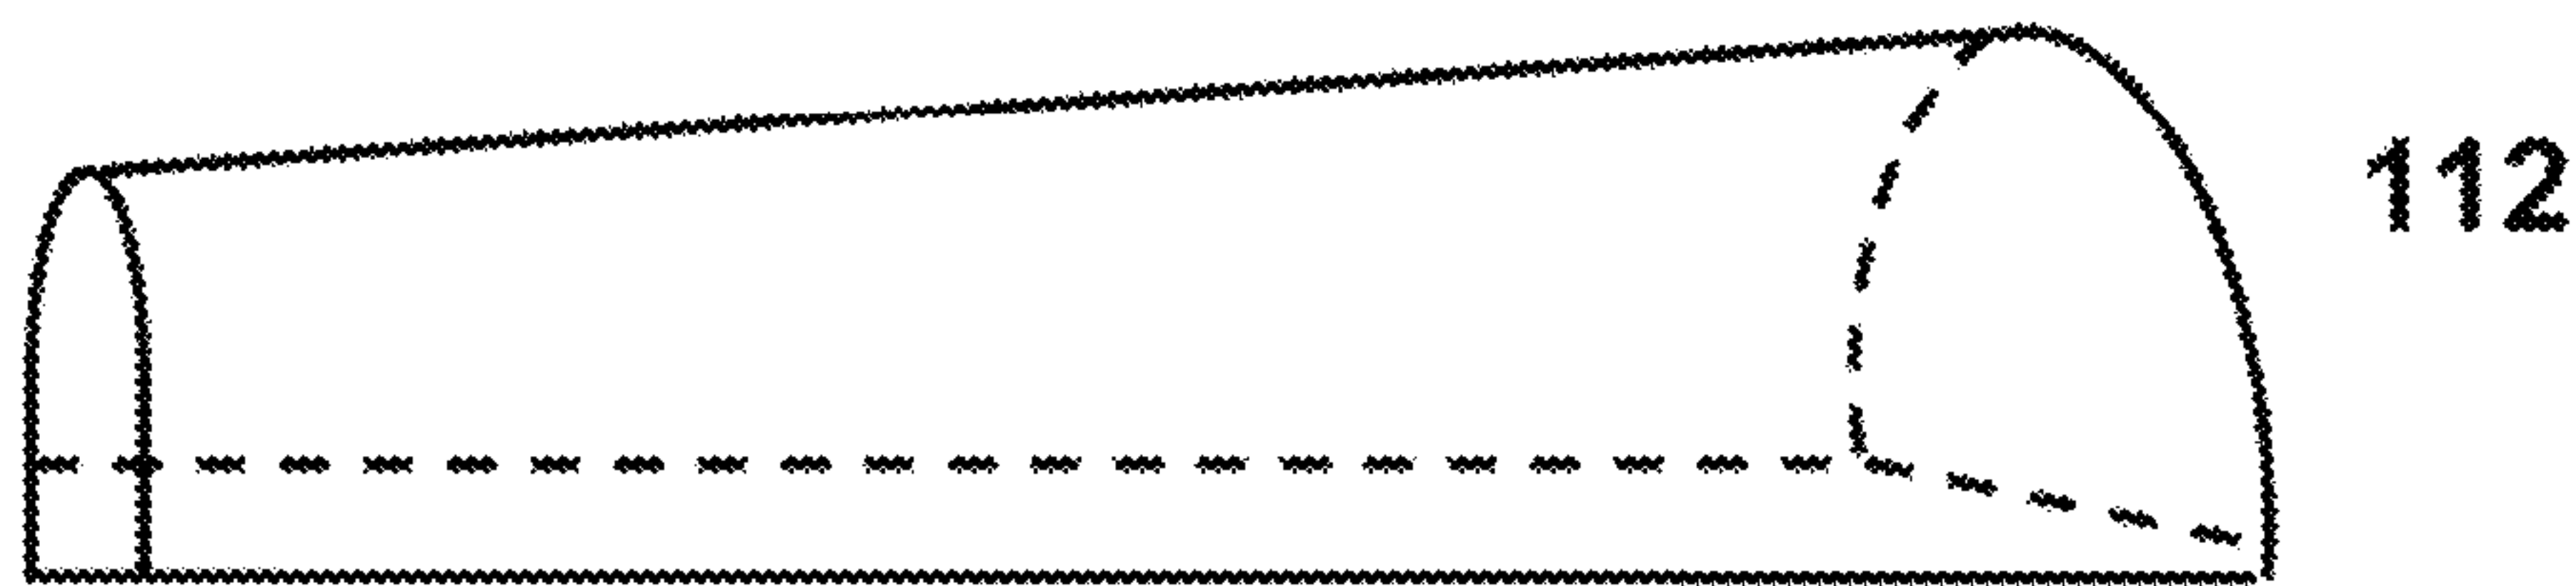
Fig. 11J

FIG. **11J** illustrates the structure of a stent **112**, which is a hollow semi-cylindrical or semi-oval tube having semi-circular or semi-oval ends, as the case may be; has a flat flared bottom side and a tapering top side. There could be several other variations in the shape and geometry of the repair tube insert and all such embodiments would still be deemed to be within the scope and teachings of the instant disclosure.

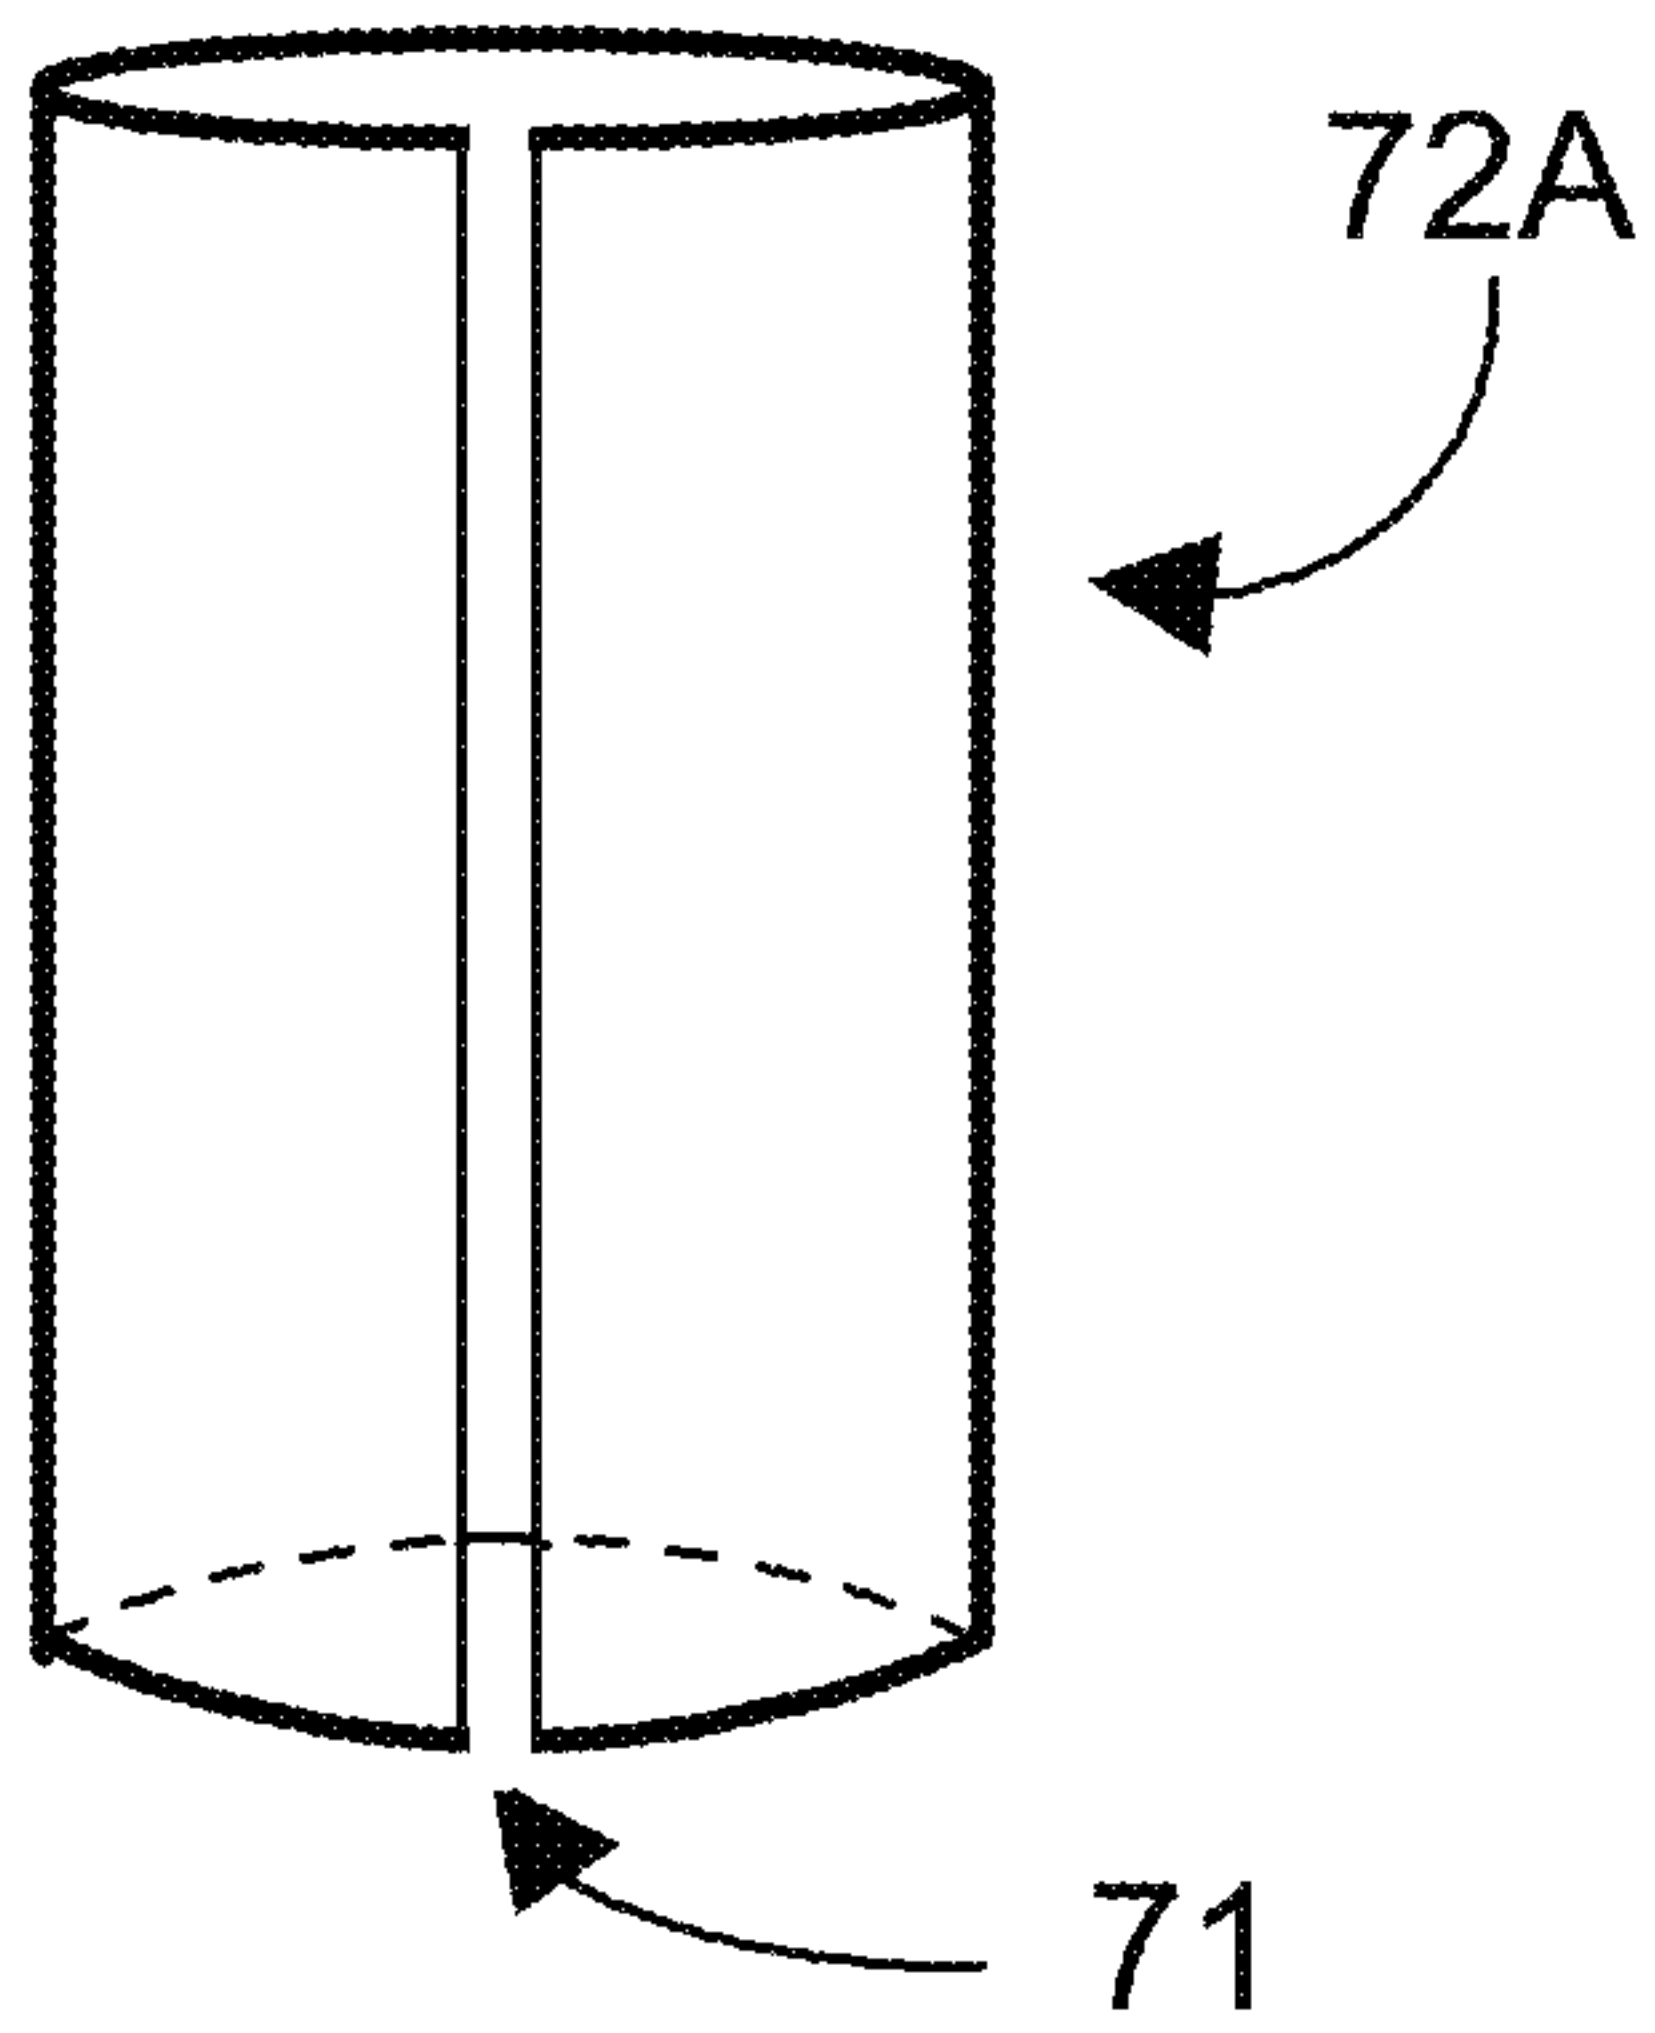
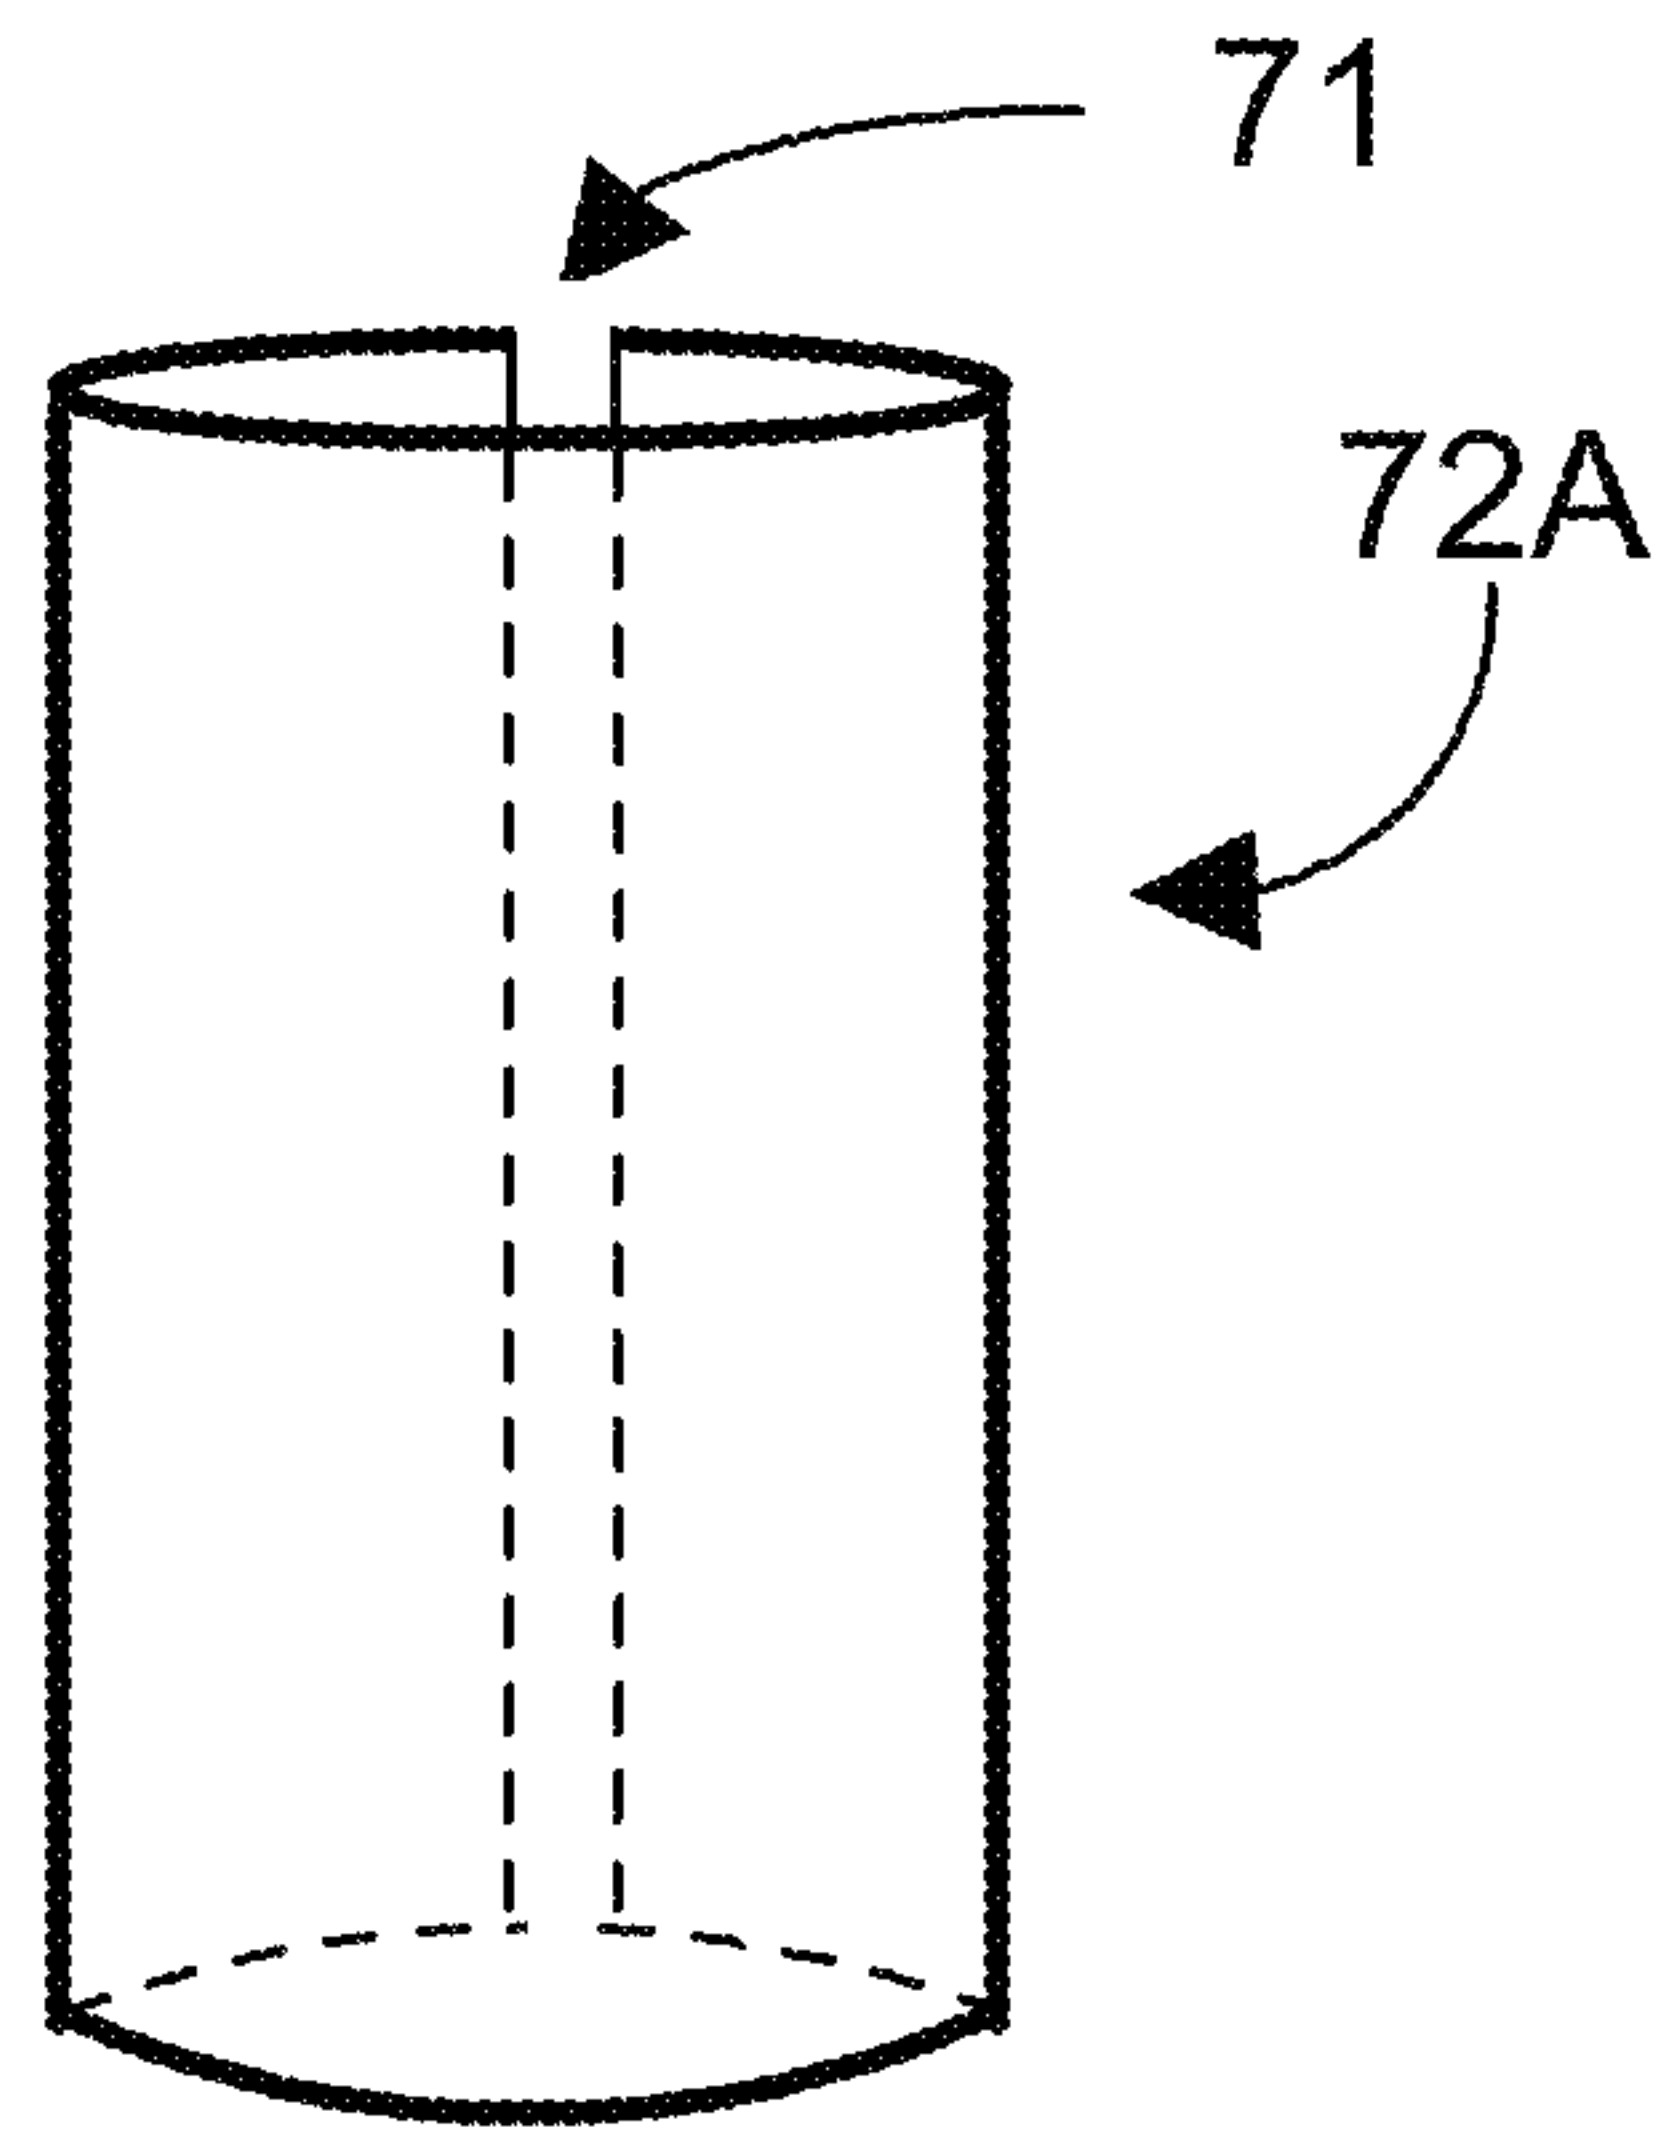
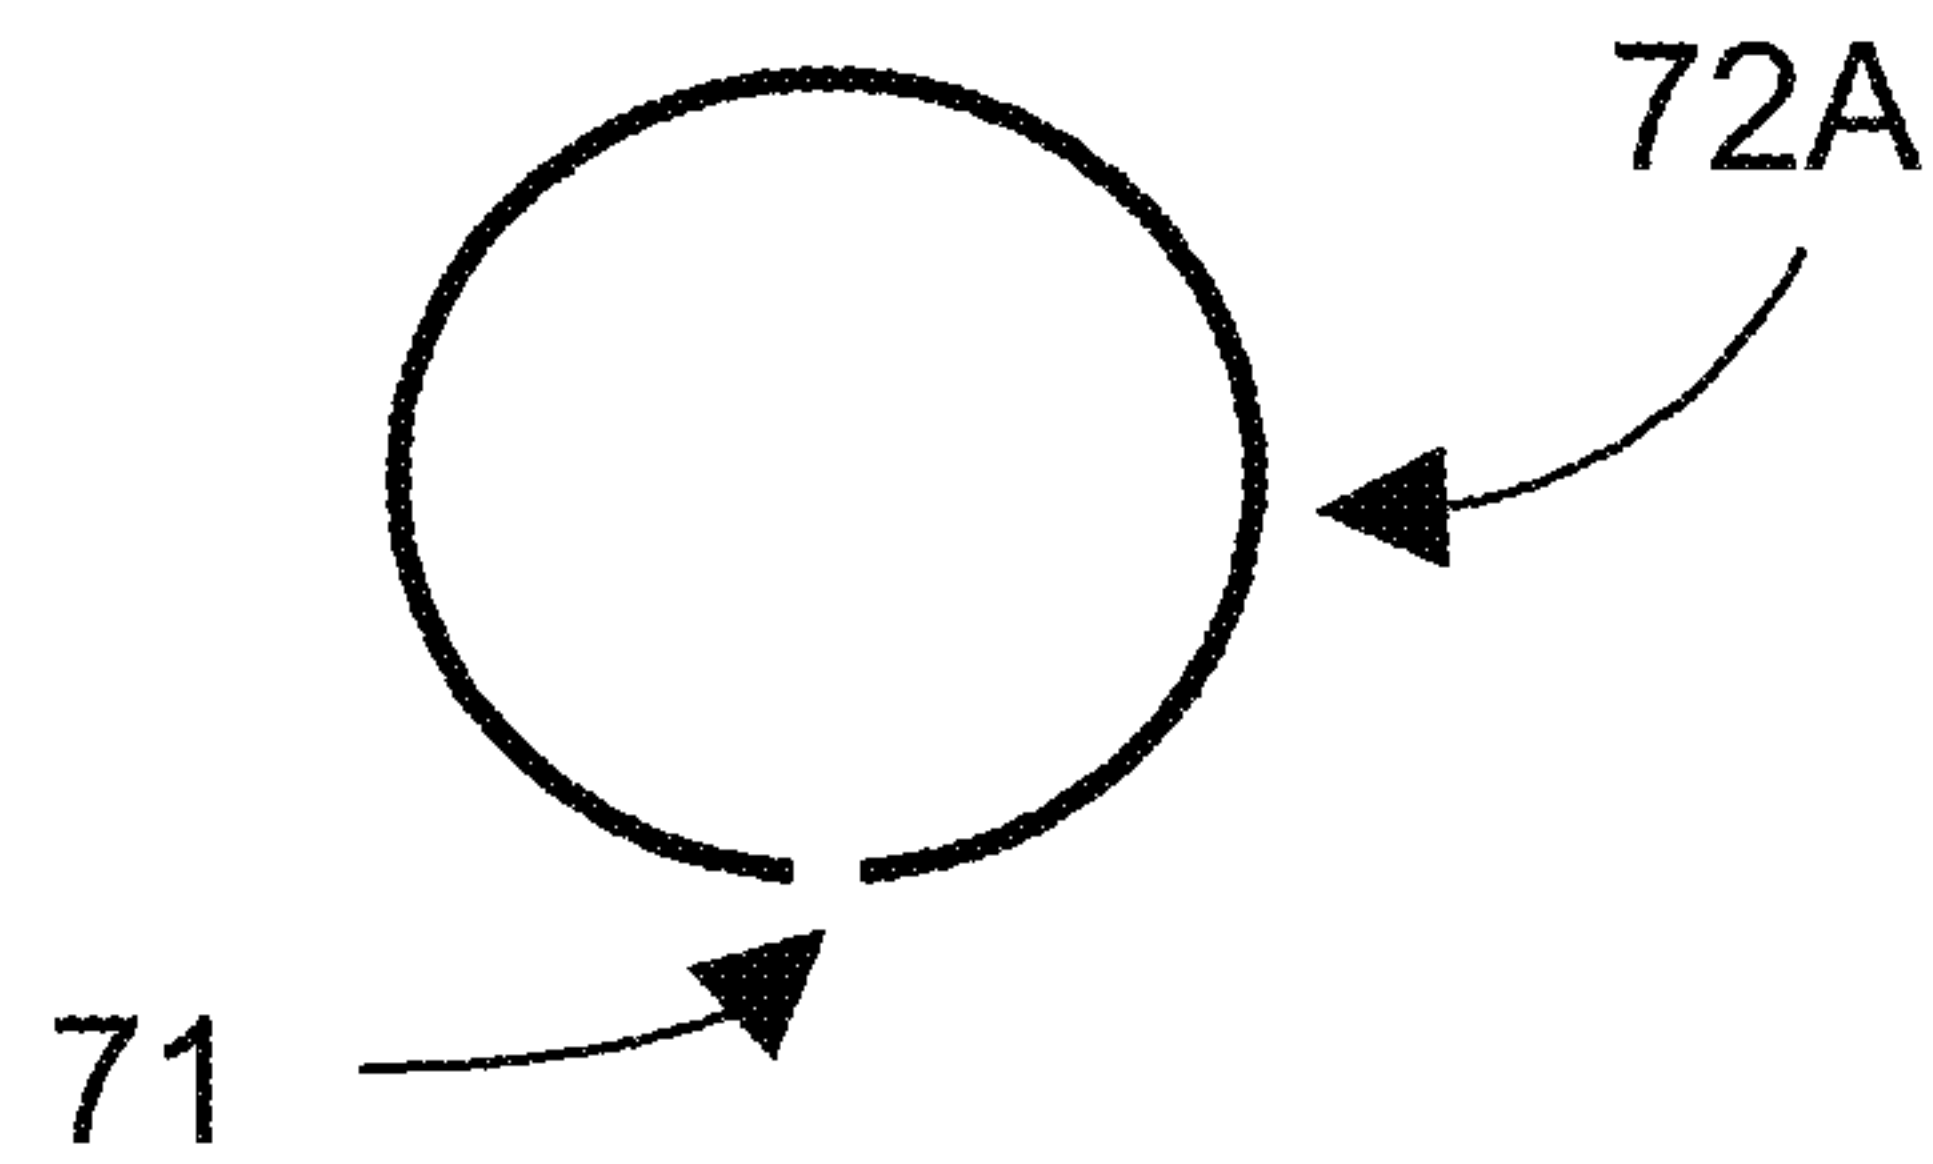
FIGS. **12A-12C** are a front perspective view, a back perspective view and an end view, respectively, of a repair tube insert in accordance with another embodiment of the present disclosure.

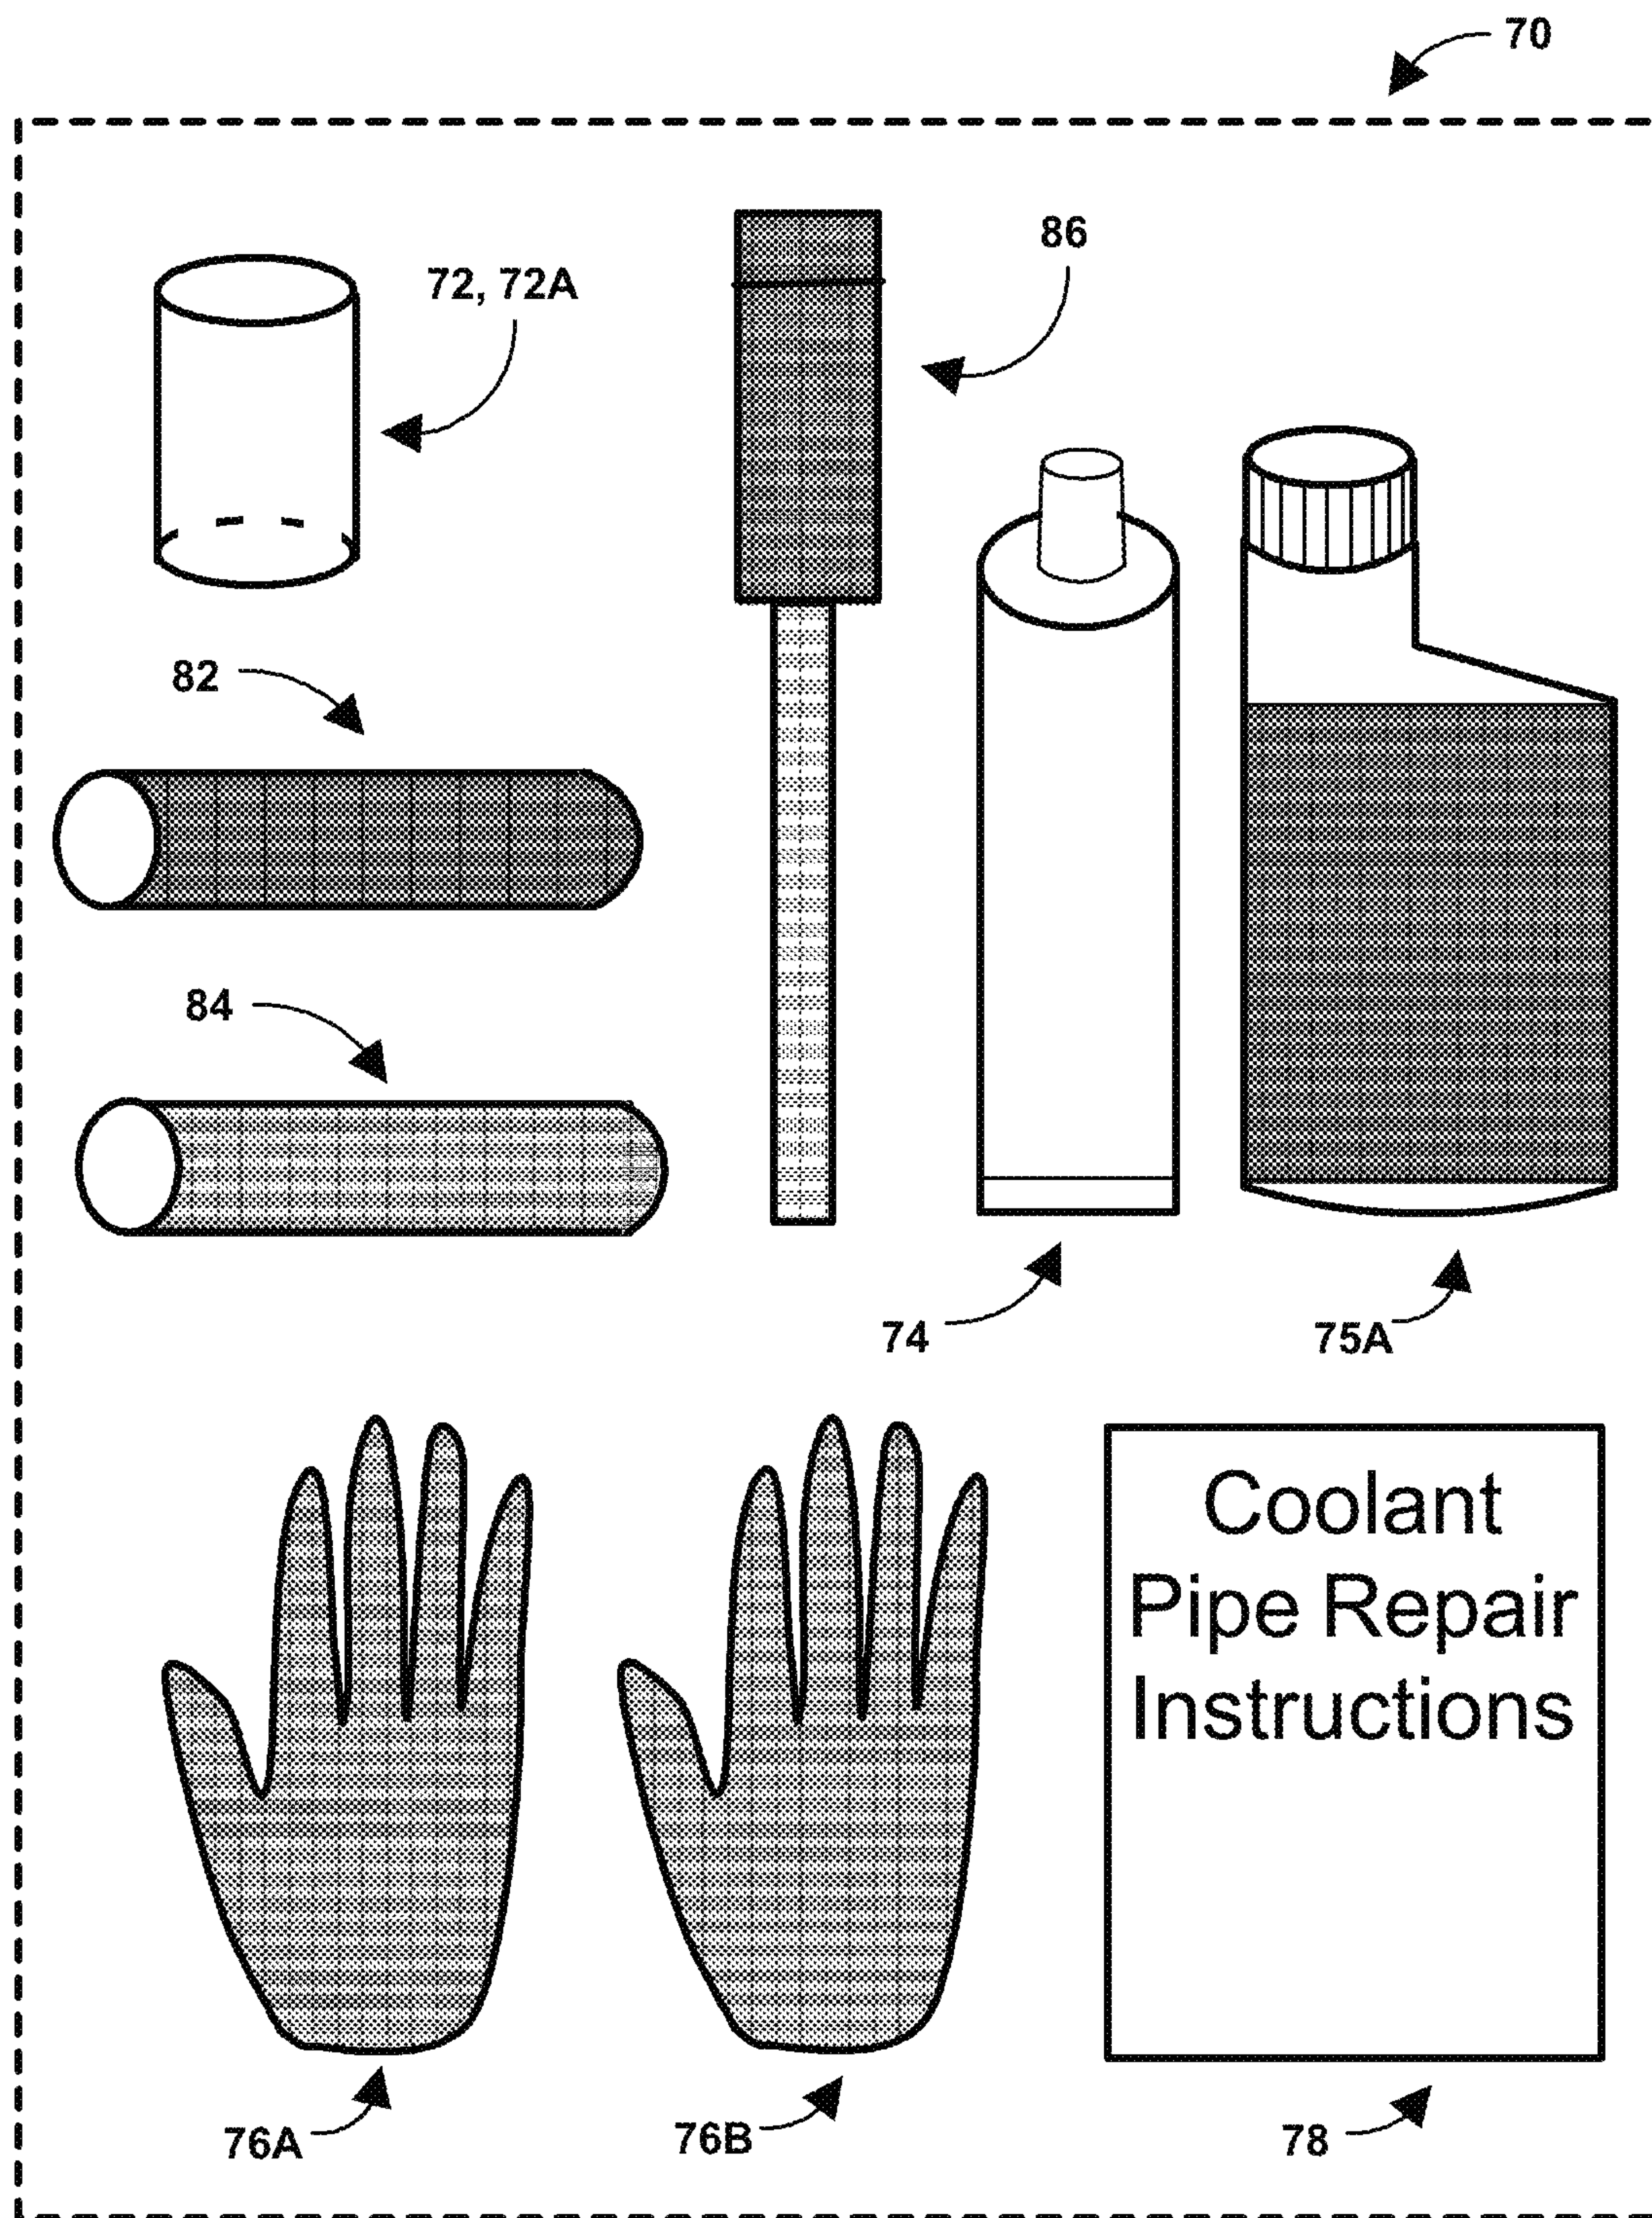
FIG. **13** illustrates a repair kit in accordance with yet another embodiment of the present disclosure.

The repair kit or apparatus disclosed herein is illustrated in FIG. 13 and comprises at least one open ended, hollow repair tube insert or stent 72 (or 72A as described in further detail below), at least one cleaning rod 84, at least one sanding rod 82, one or more sponge applicator brushes 86, at least one pair of rubber work gloves 76A, pairs of disposable rubber gloves 76B, at least one tube or pack of coolant pipe repair sealant 74A, at least one bottle or jar of cooling system sealer/coolant pipe O-ring conditioner 75, and detailed written instructions 78 with illustrations. The cooling system sealer/coolant pipe O-ring conditioner 75 are optional, as it is not necessarily required to achieve the objectives of the repair disclosed herein. The cooling system sealer and conditioner 75 is not required to stop the "weep hole" leak from the front seal on the coolant transfer pipe. The front seal leak is repaired by the stent 72. However, cooling system sealer/coolant pipe O-ring conditioner 75, is designed to condition the seals of the coolant transfer pipe, valley pan and gasket, as well as the gaskets of the rear coolant passage cover.
