US011112051B2

(54) **FLARED-END AUTOMOTIVE ENGINE COOLANT PIPE REPAIR STENT AND METHOD FOR REPAIRING AN ENGINE**

A repair kit and associated method for repairing an automotive coolant pipe for fluid-conducting within an engine block of an engine includes at least a repair stent with a flared end, sealant and instructions for performing the method. The method includes draining coolant from the engine, removing the water pump from the engine without removing the timing chain cover of the engine, inserting the repair stent including a sealant through the coolant passage, wherein the coolant passage extends through the timing chain cover into the engine, re-assembling the water pump to the engine and adding coolant to the engine.

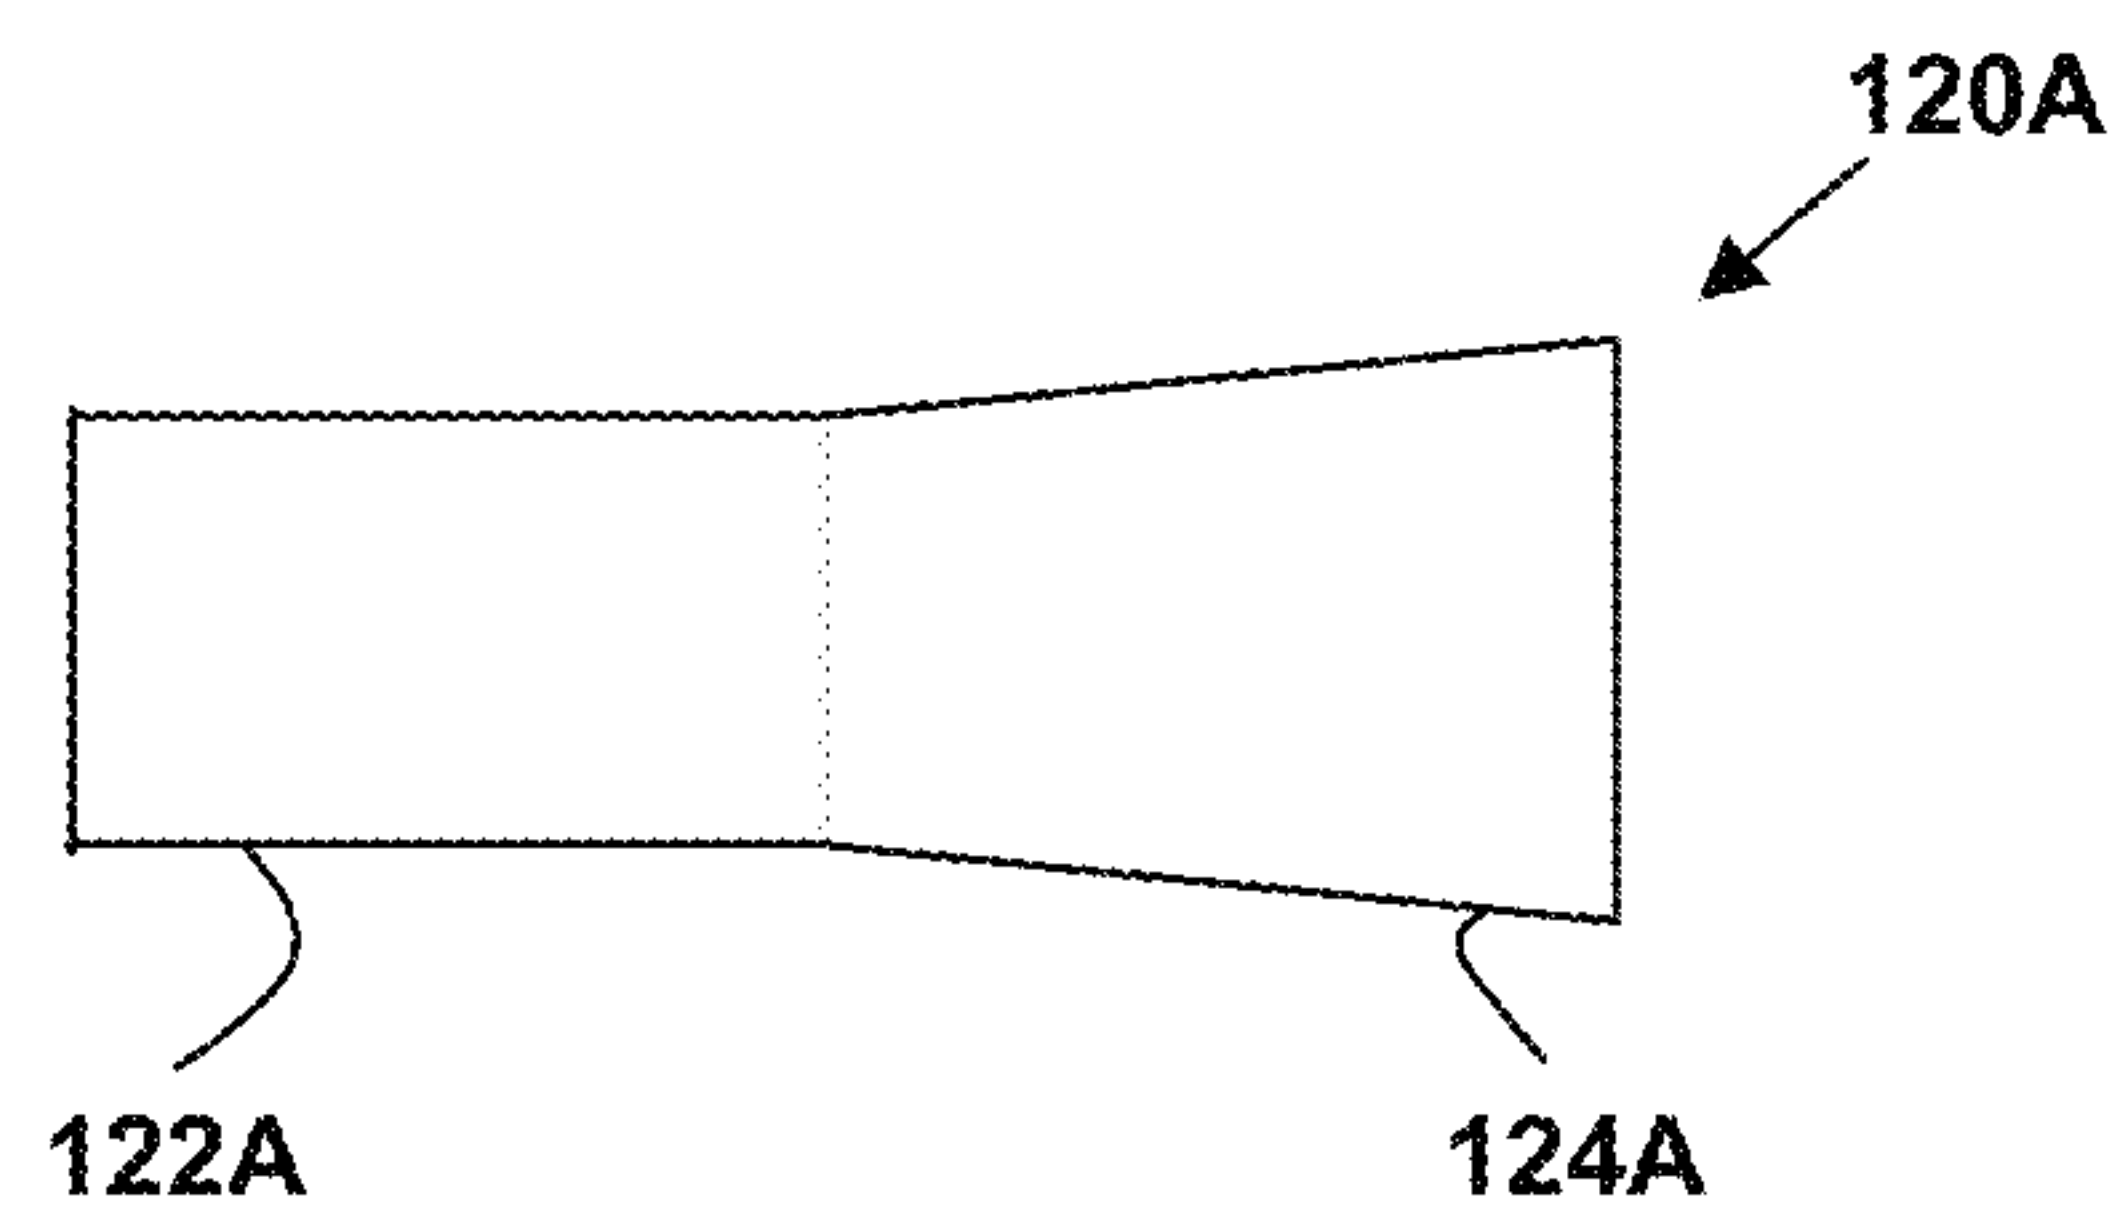
Fig. 14A

Referring now to FIG. **14A** a flared repair stent **120A** is shown, which may be installed according to the above described methods. Flared repair stent **120A** has a cylindrical portion **122A** having a circular profile of even radius, and a flared portion **124A** having a conical profile with an increasing radius in the direction of the end of flared repair stent **120A** to the right end of the Figure. Flared repair stent **120A** is generally made from a flexible material such as rubber, silicone or a high-temperature thermoplastic. Installation of flared repair stent **120A** is accomplished as described above, including applying sealant, but flared portion **124A** is compressed by hand before extending flared repair stent **120A** though a coolant passage having a diameter smaller than the diameter range of flared portion **124A**. After flared repair stent **120A** is slid into place, flared portion **124A** expands to contact the walls of the remote end of the coolant passage, providing an enhanced seal.

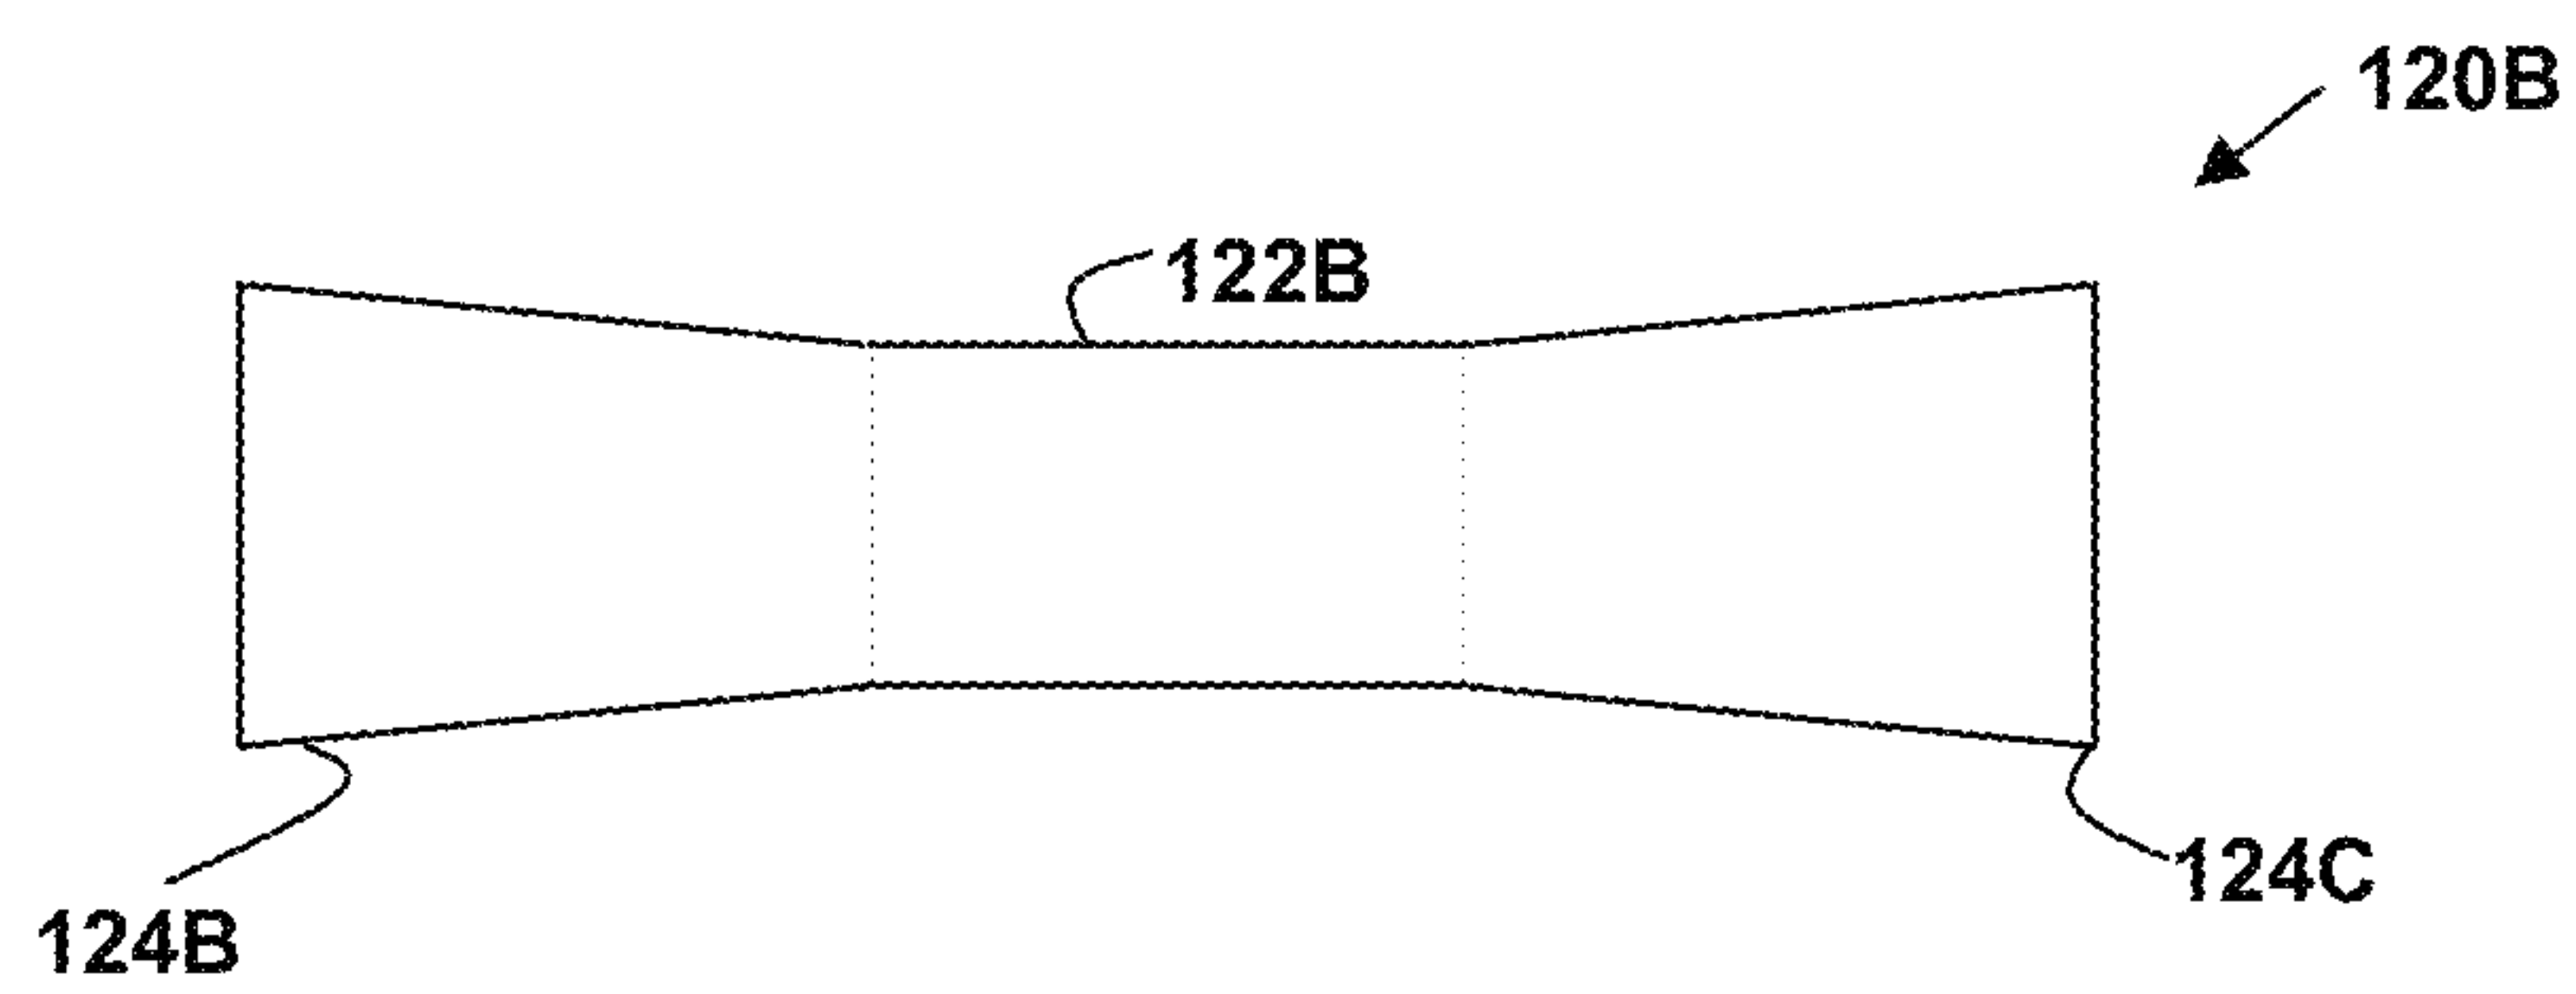
Fig. 14B

Referring now to FIG. **14B**, another flared repair stent **120B** is shown in accordance with an alternative embodiment of the disclosure. Flared repair stent **120B** has a central cylindrical portion **122B** and two flared portions **124B** and **124C**, one at each end. While the profiles of flared portions **124B** and **124C** are matched in the Figure, this is not a limitation of the disclosure, and flared portions **124B** and **124C** may have different conical profiles and length. In an alternative version of flared repair stent **120B**, central cylindrical portion **122B** is reduced in length or eliminated entirely, providing a flared repair stent **120B** with two flared

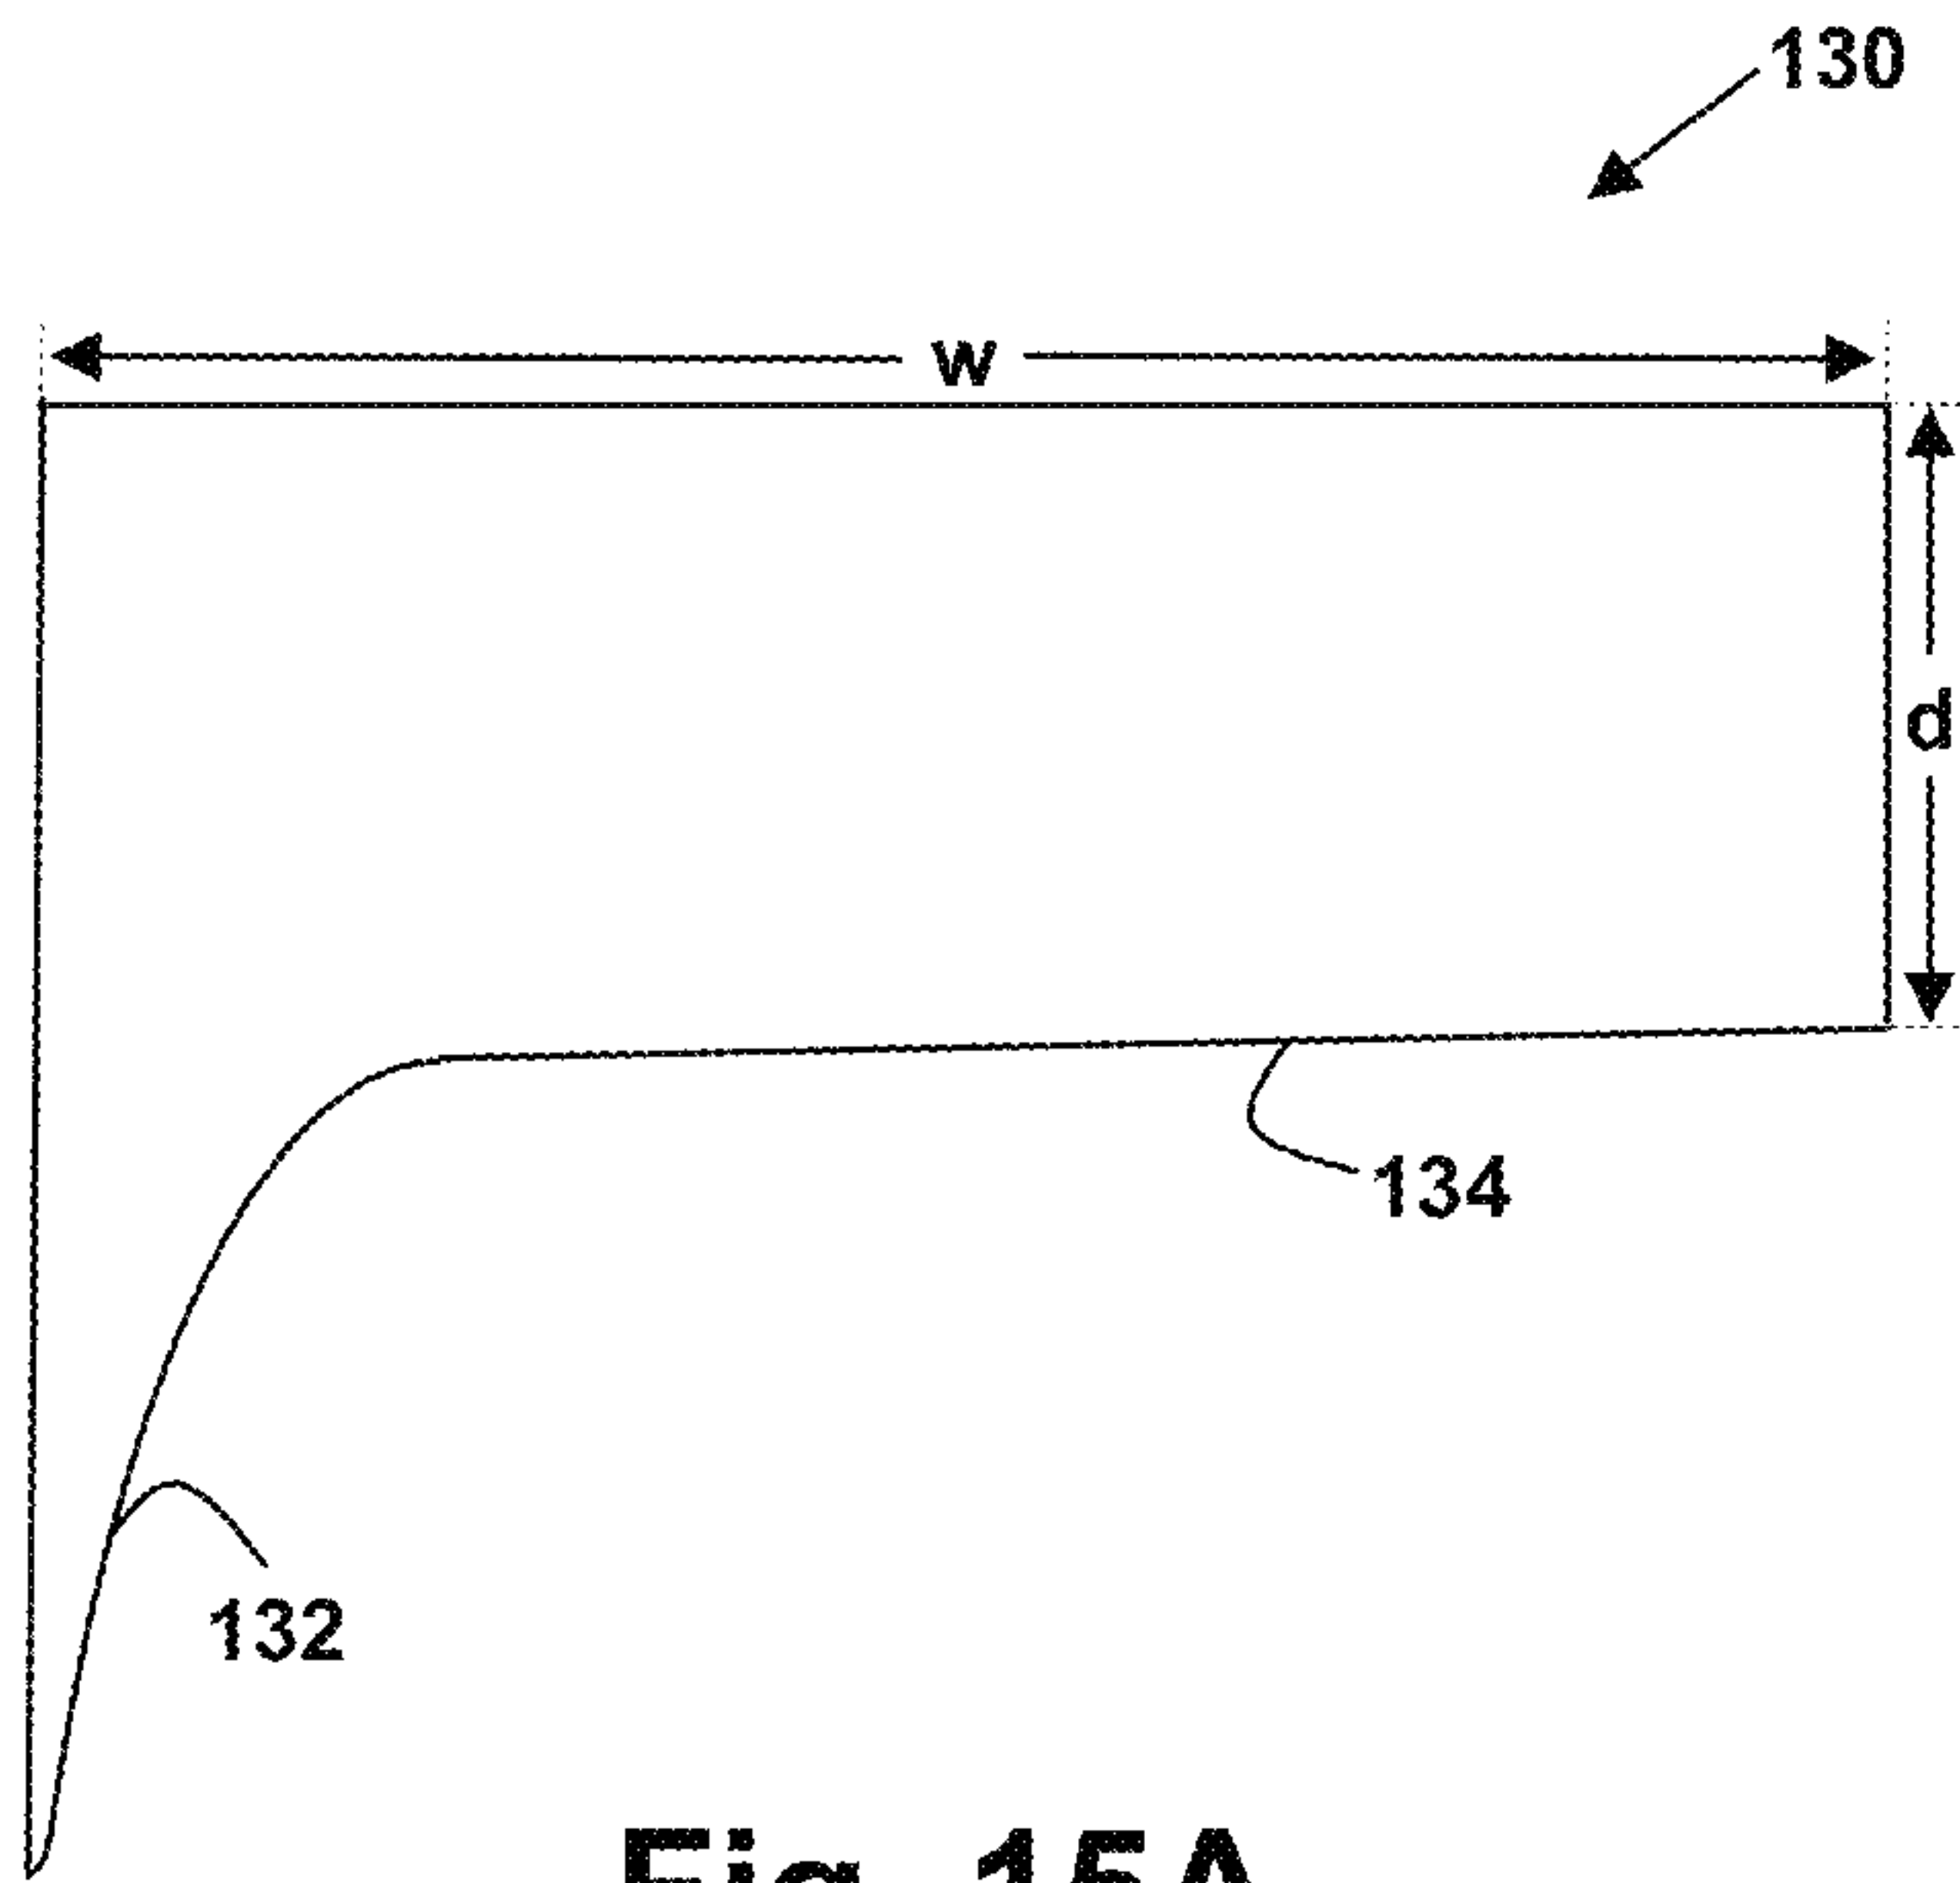
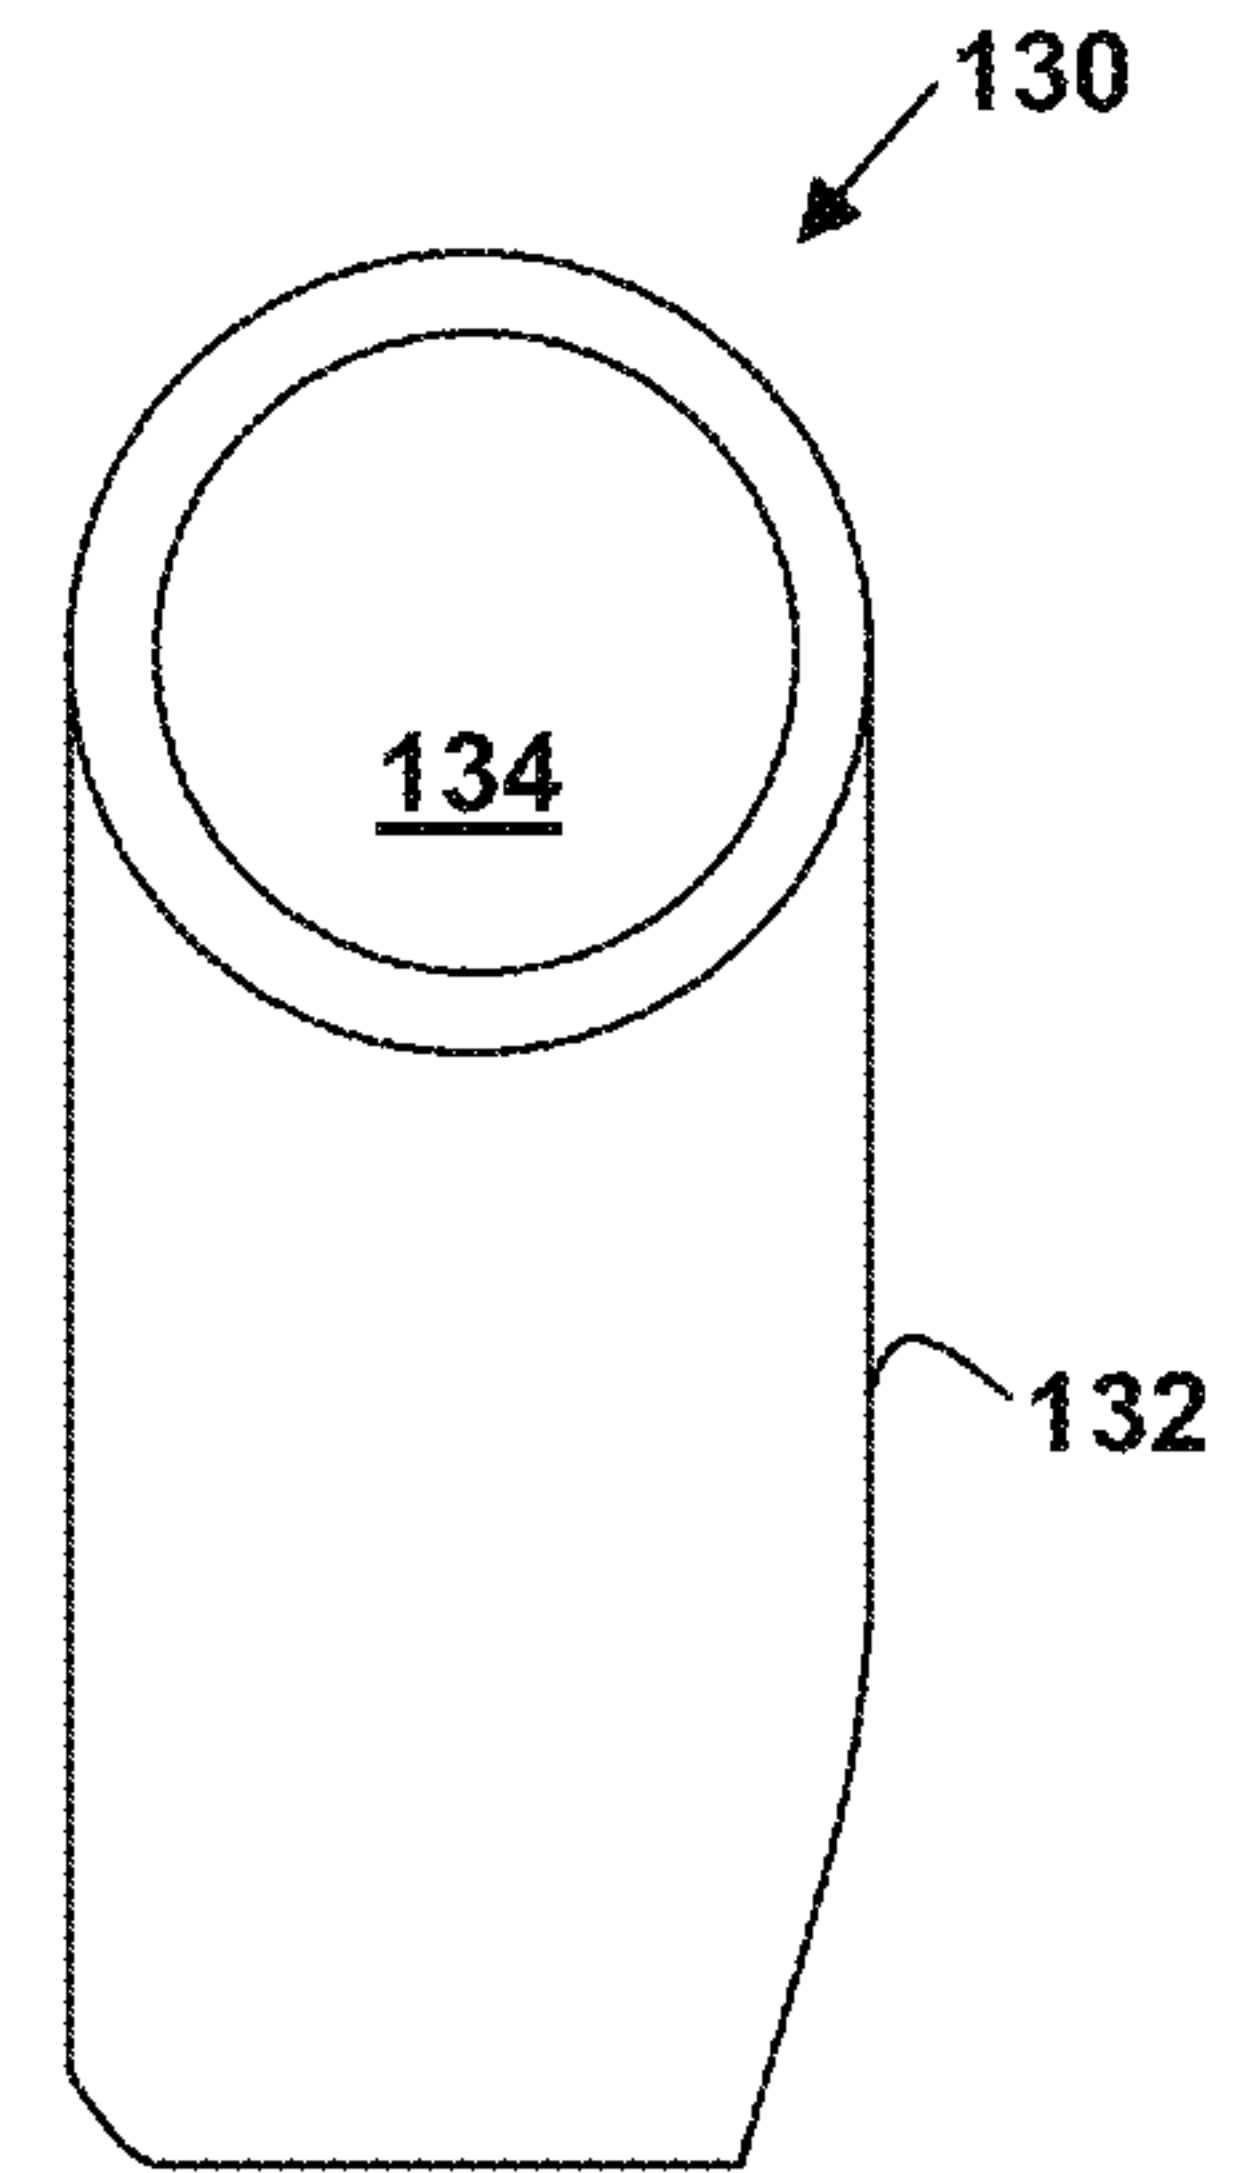
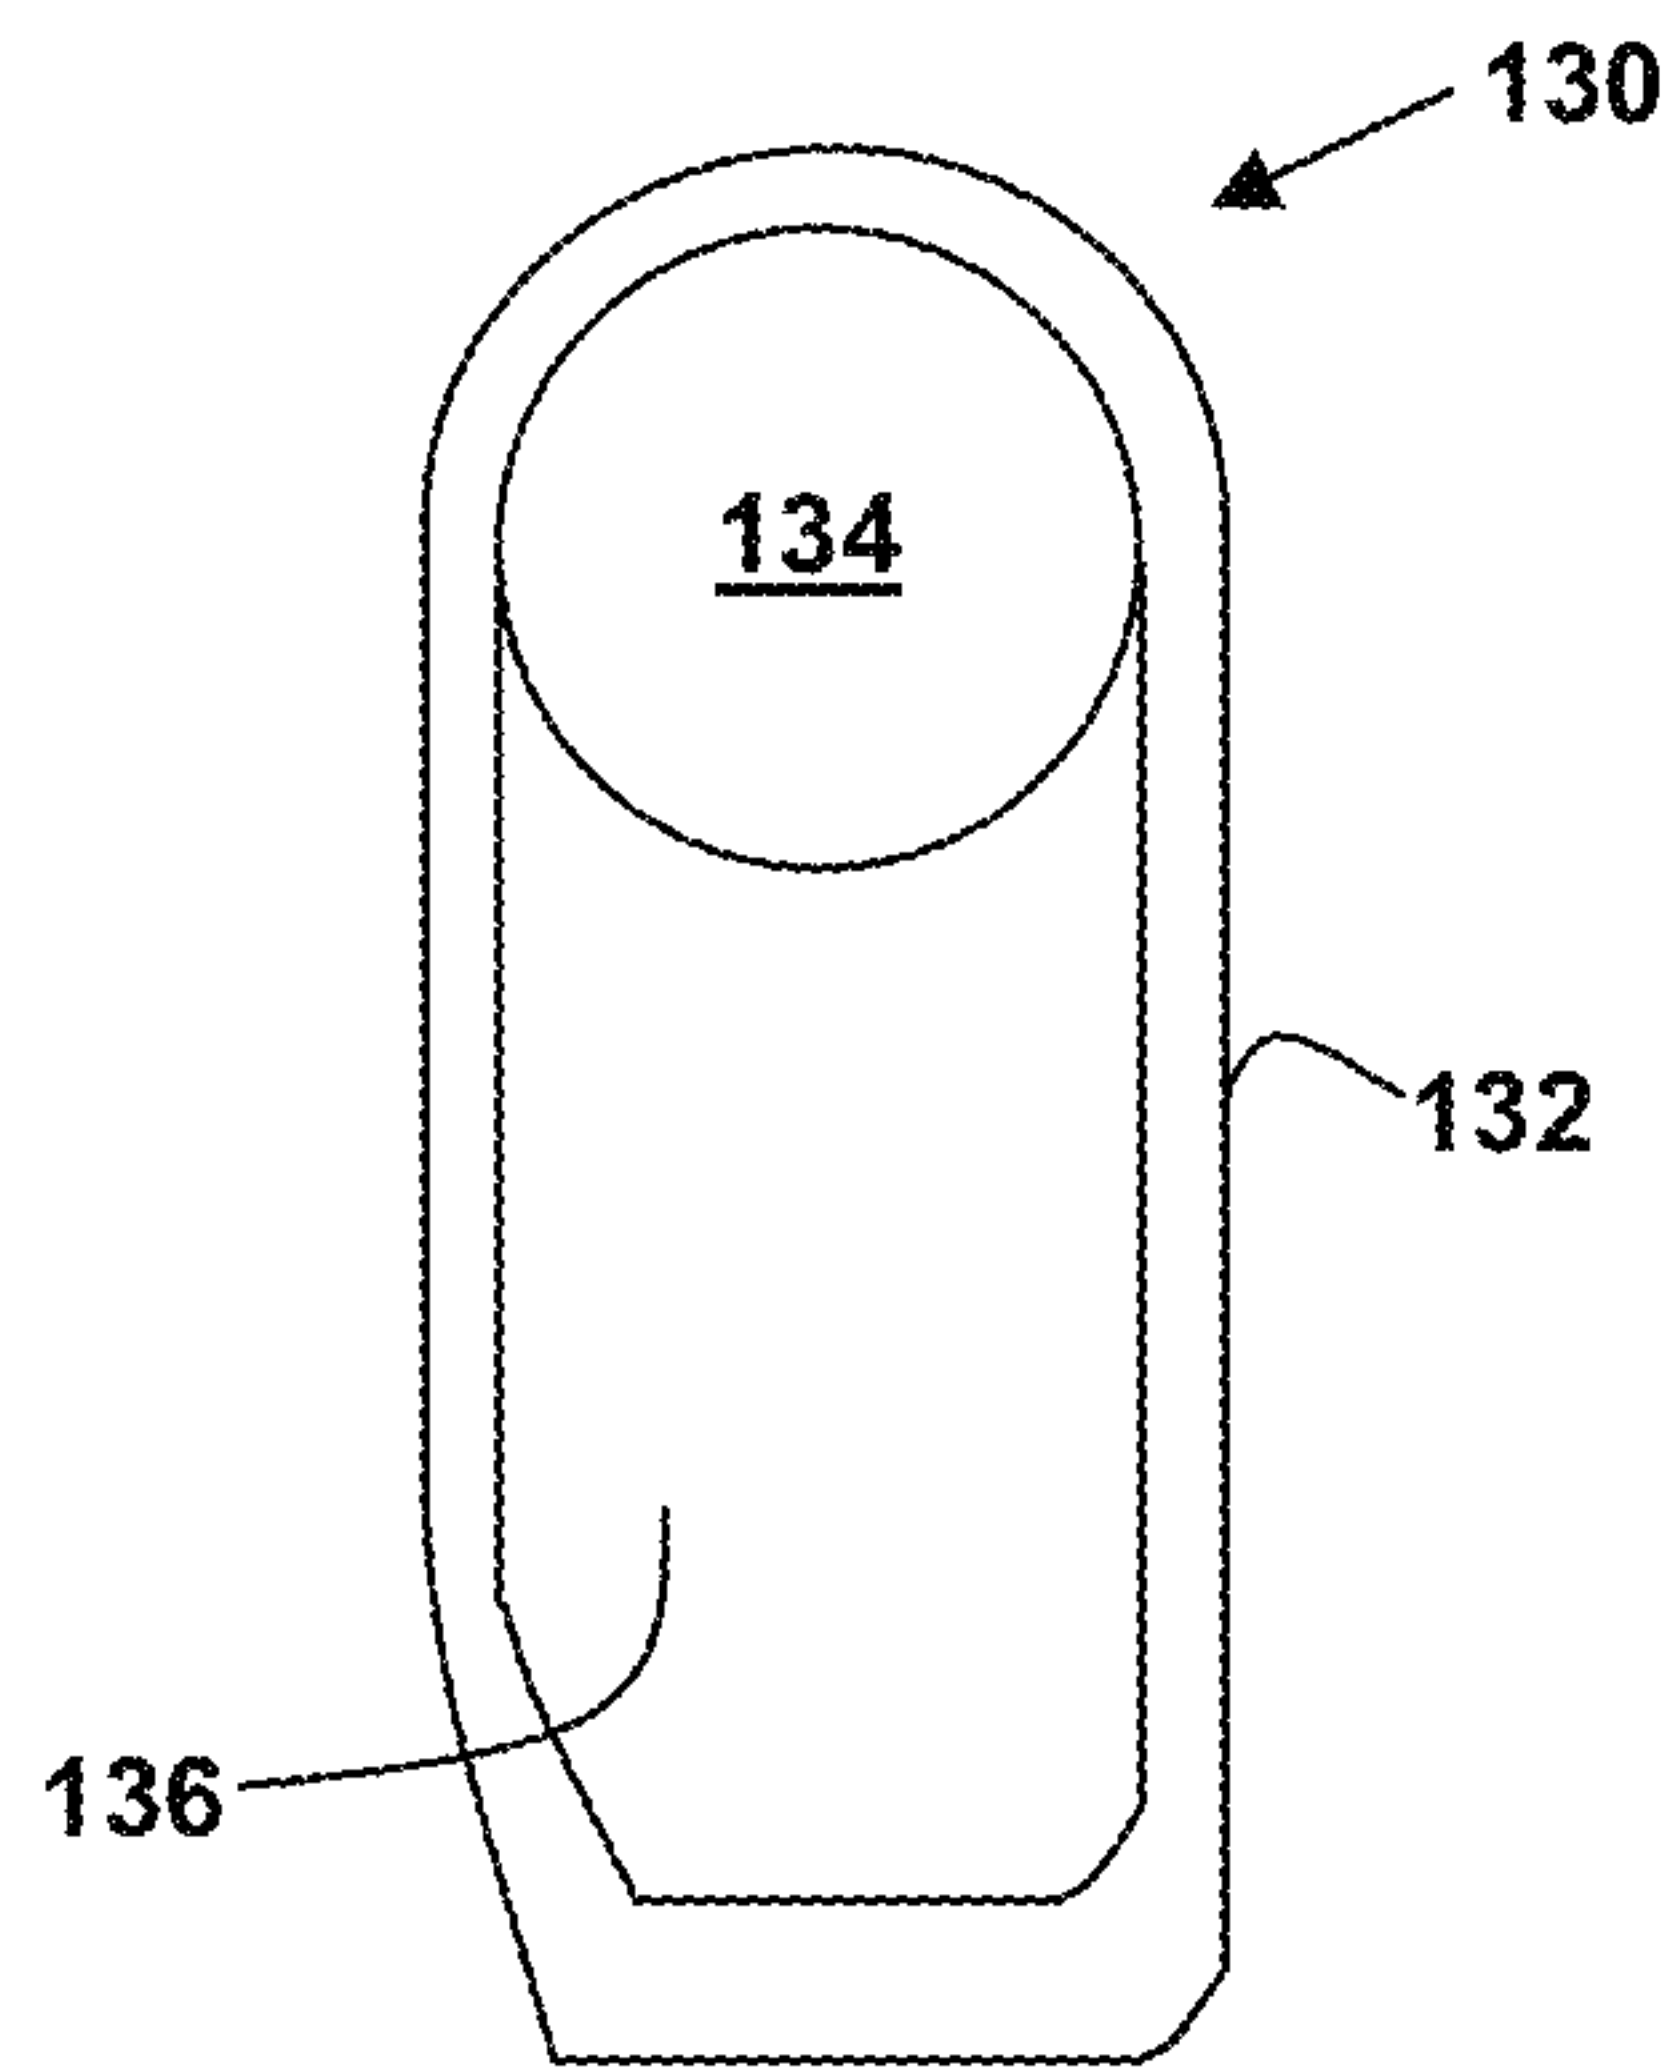
Referring now to FIGS. 15A-15C, a side view, a first end view and a second end view of a flared repair stent 130 are shown, in accordance with another example of the disclosure. Flared repair stent 130 may be made of metal such as cast aluminum, or may be made from a flexible material such as rubber, silicone, or a high-temperature thermoplastic. Flared repair stent 130 has a flared portion 132 that curves inward to a cylindrical portion 134. i.e., the radius of flared repair stent 130 reduces according to the shape of a parabola in the illustrated embodiment, but other curvature may be employed as needed to match the curvature of an expansion 137 of coolant passage 142 (FIG. 17) in which flared repair stent 130 is designed for installation. Flared portion 132 has a first partial cylindrical profile 133 that extends a profile of cylindrical portion 134 along an upper portion of length w of the first flared portion and a lower portion 135 that is an expanding profile along which flared 132 portion expands in cross-sectional area toward a second end of the flared portion 132, according to a parabolic shape in the figure as described above. At the exit end of flared repair stent 130, the expanding profile of flared portion 132 expands to a substantially rectangular cross-section to the point where the partial cylindrical profile of the upper portion terminates. Length w of flared repair stent 130 is also adjusted to accommodate various designs, but is generally between 50 mm and 100 mm in length. For example, in a design adapted for repairing the coolant passage of a BMW N63, an N73 engine or an N74 engine, length w is 60 mm, while the diameter d of cylindrical portion 134 is 32 mm. For a BMW N62 engine, length w is 75 mm and diameter d is 32 mm. FIG. 15C shows the interior of flared portion 132 of flared repair stent 130, including an inner chamber 136 that is sloped to direct coolant in the same manner as the wall of the water pump cover (not shown) directs the coolant originally, i.e., the curvature of inner chamber 136 substantially matches the curvature of the exterior surface of flared portion 132 as seen in FIG. 15A, at least along the portion of inner chamber 136 nearing cylindrical portion 134.
