US011112051B2

(54) **FLARED-END AUTOMOTIVE ENGINE COOLANT PIPE REPAIR STENT AND METHOD FOR REPAIRING AN ENGINE**

A repair kit and associated method for repairing an automotive coolant pipe for fluid-conducting within an engine block of an engine includes at least a repair stent with a flared end, sealant and instructions for performing the method. The method includes draining coolant from the engine, removing the water pump from the engine without removing the timing chain cover of the engine, inserting the repair stent including a sealant through the coolant passage, wherein the coolant passage extends through the timing chain cover into the engine, re-assembling the water pump to the engine and adding coolant to the engine.

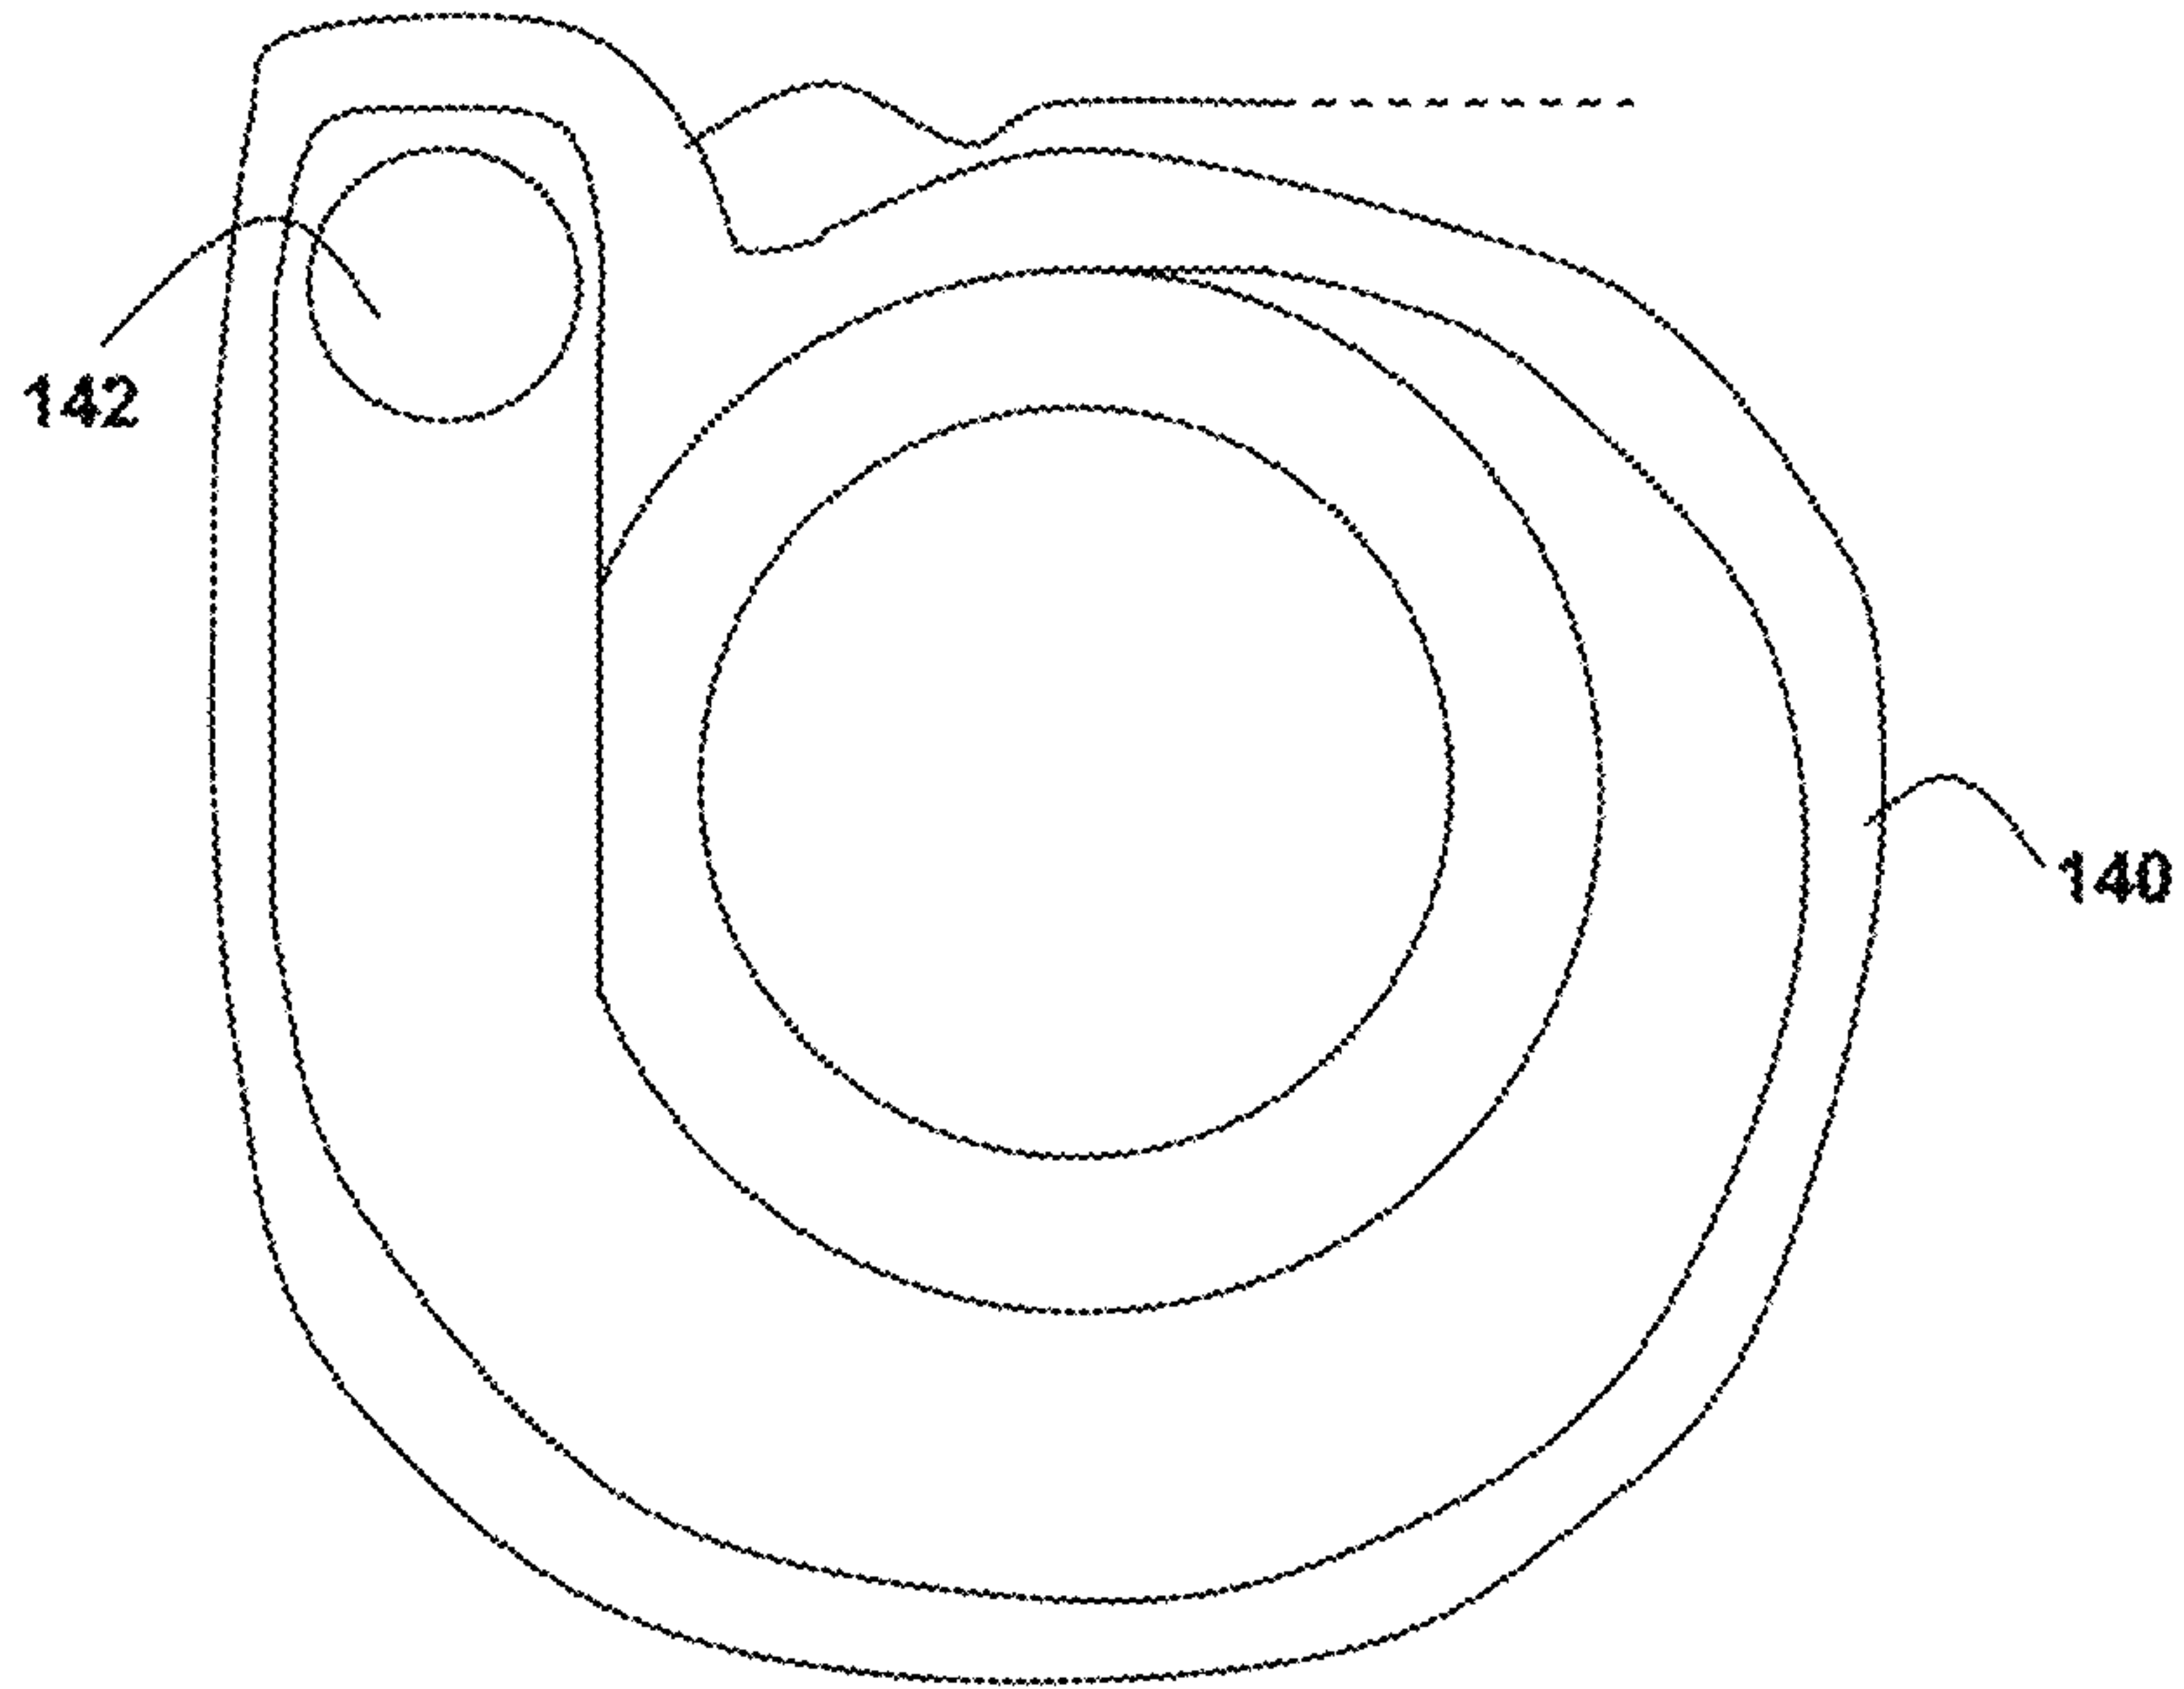
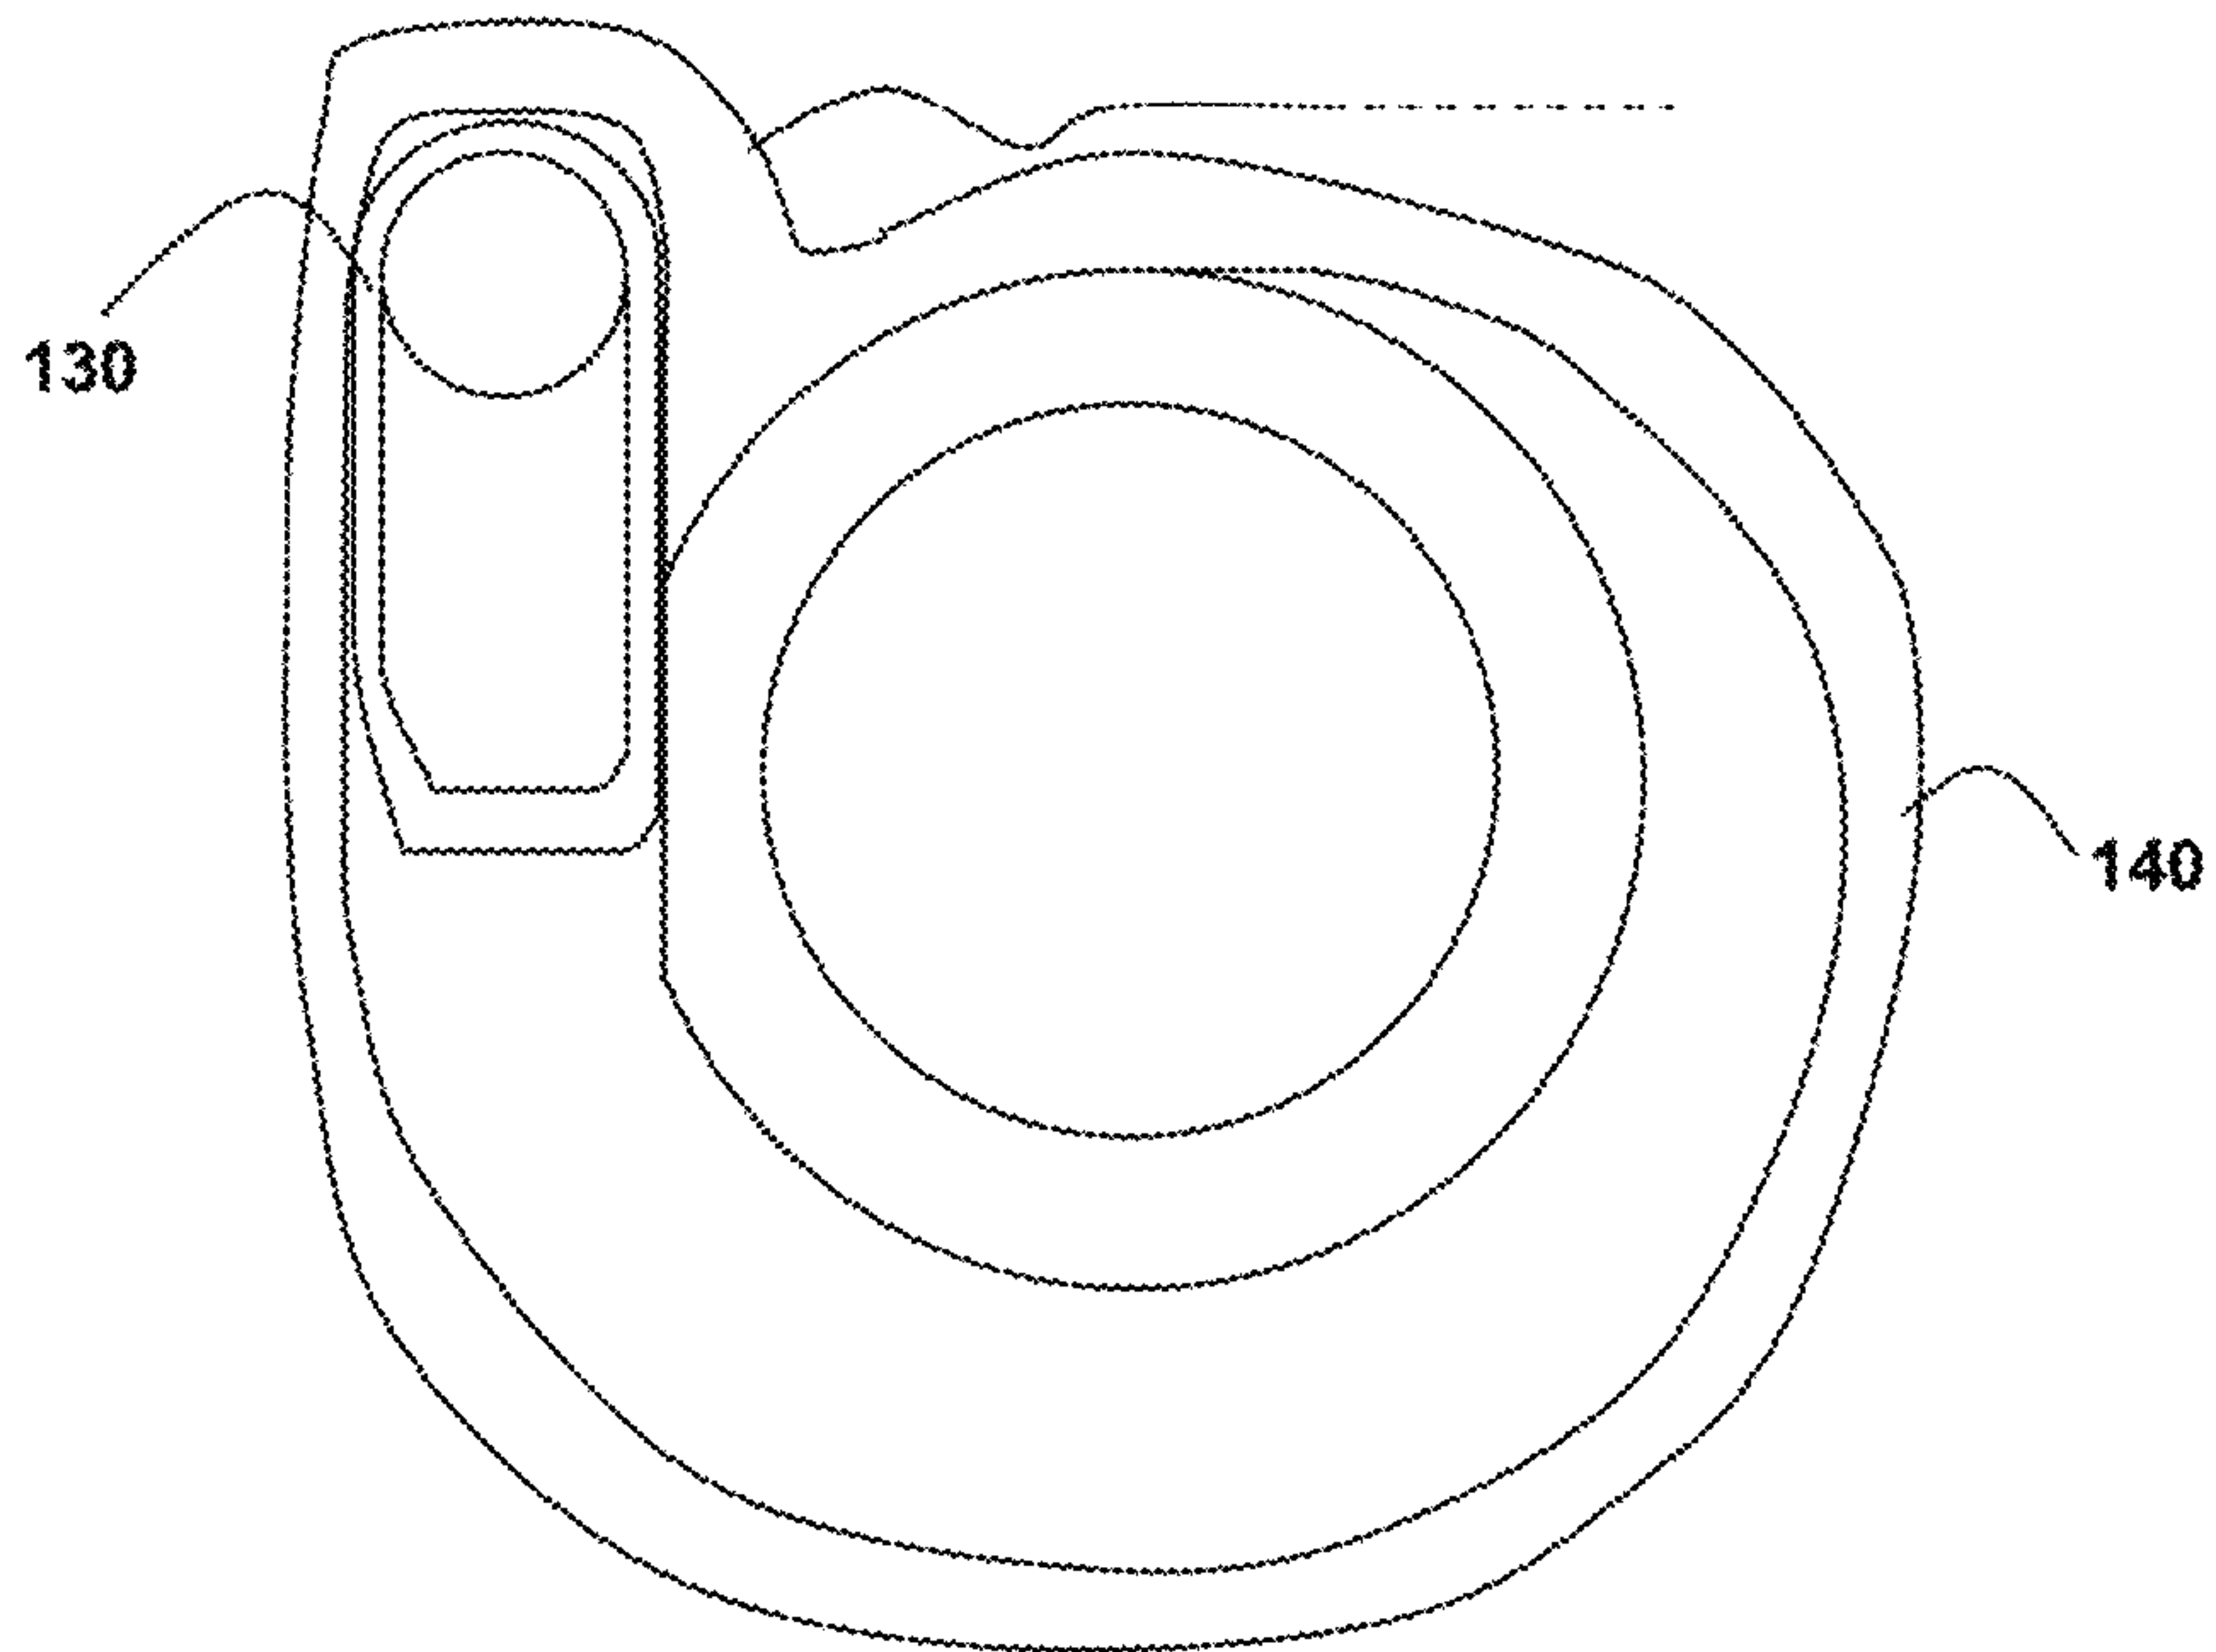
Referring now to FIGS. 16A and 16B, which show an interior view of timing chain cover 140, an installation of flared repair stent 130 into timing chain cover 140 is illustrated. In the particular engines listed above, the cooling system does not use a coolant transfer pipe to convey coolant, i.e., a coolant passage 142 in timing chain cover 140 extends directly to the engine block. FIG. 16A shows a pertinent portion of timing chain cover 140 without flared repair stent 130 installed, including an outer flange 141 that defines a wall of a coolant channel 142A, and FIG. 16B shows timing chain cover 140 with flared repair stent 130 in place. Referring to FIG. 17, a cross-section of an installation of timing chain cover 140 to an engine block 150 is shown, with cylindrical portion 134 of flared repair stent 130 extending from timing chain cover 140 through a gasket 154, which is generally the site of a coolant leak, into engine block 150. Flared repair stent 130 is secured within timing chain cover 140 and the coolant passage of engine block 150 by a sealant 152 is pre-applied to flared repair stent 130 as described above.

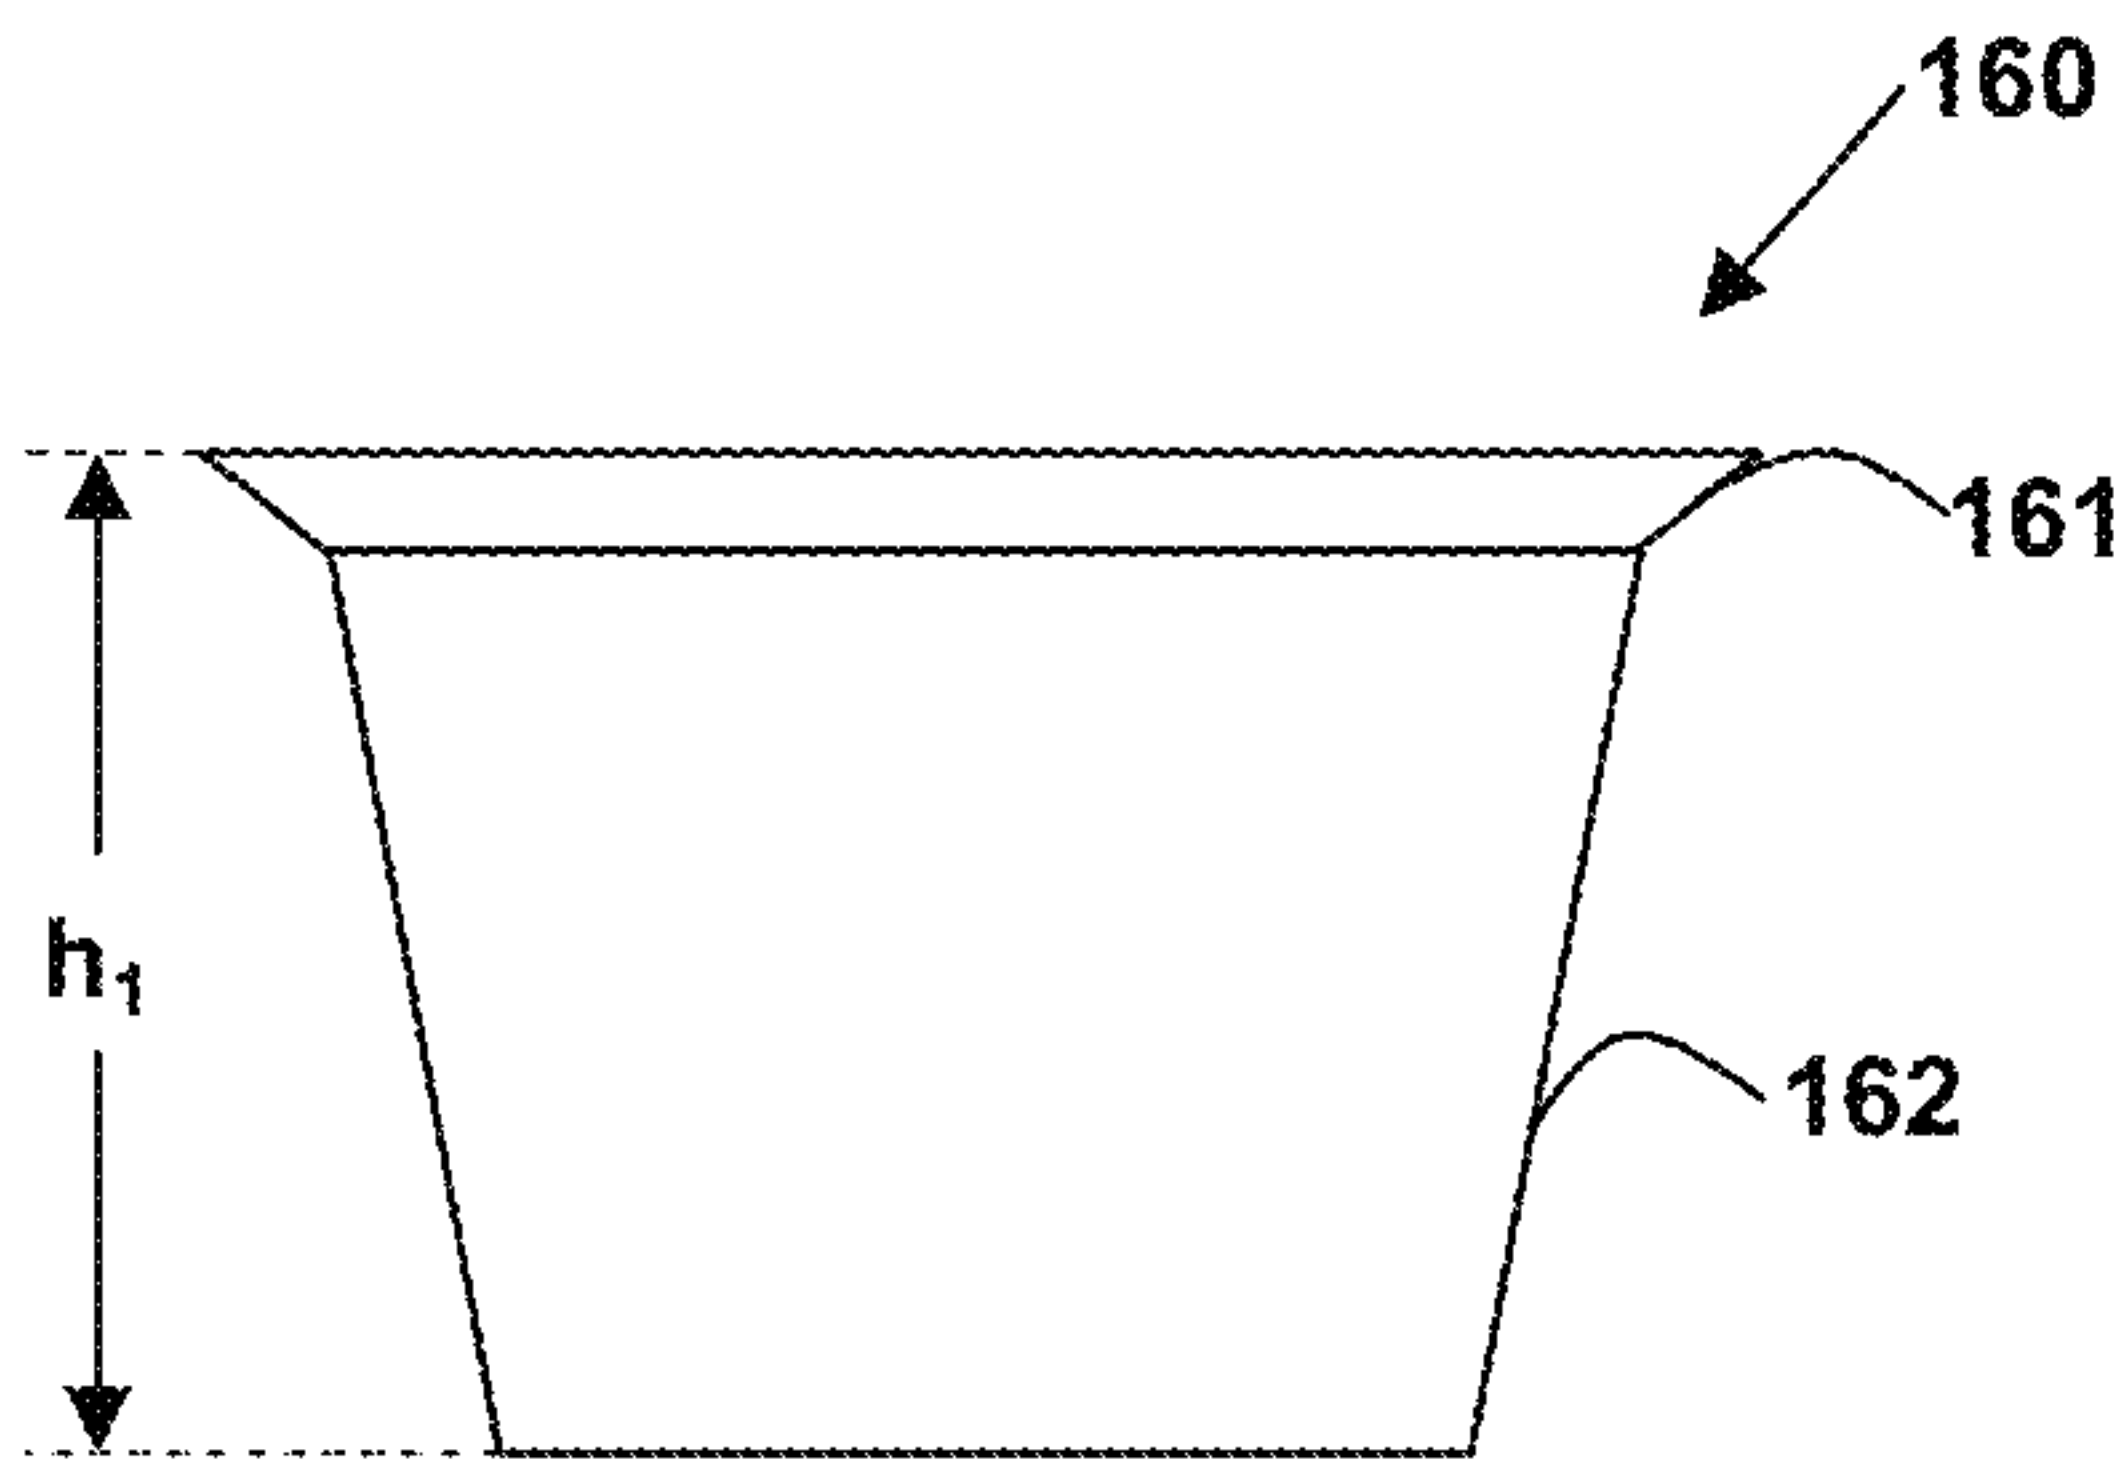
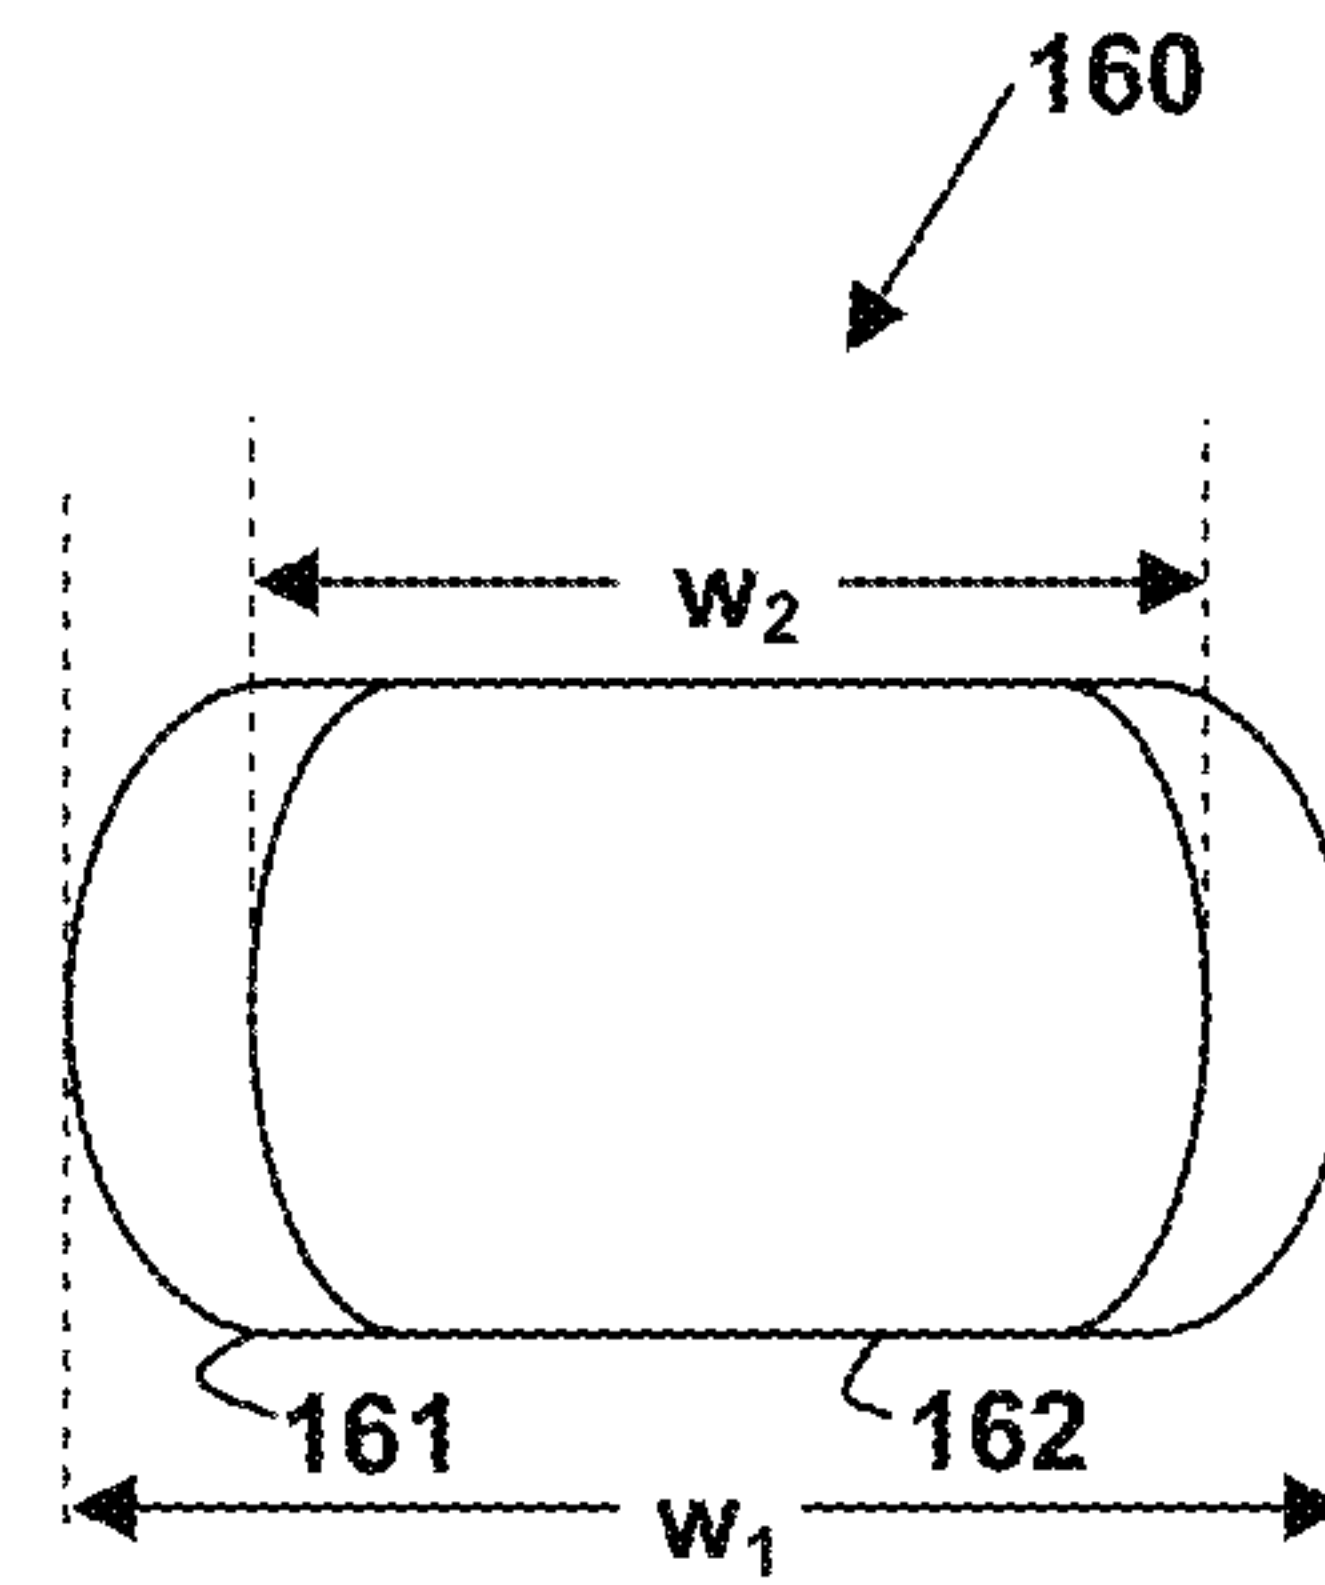
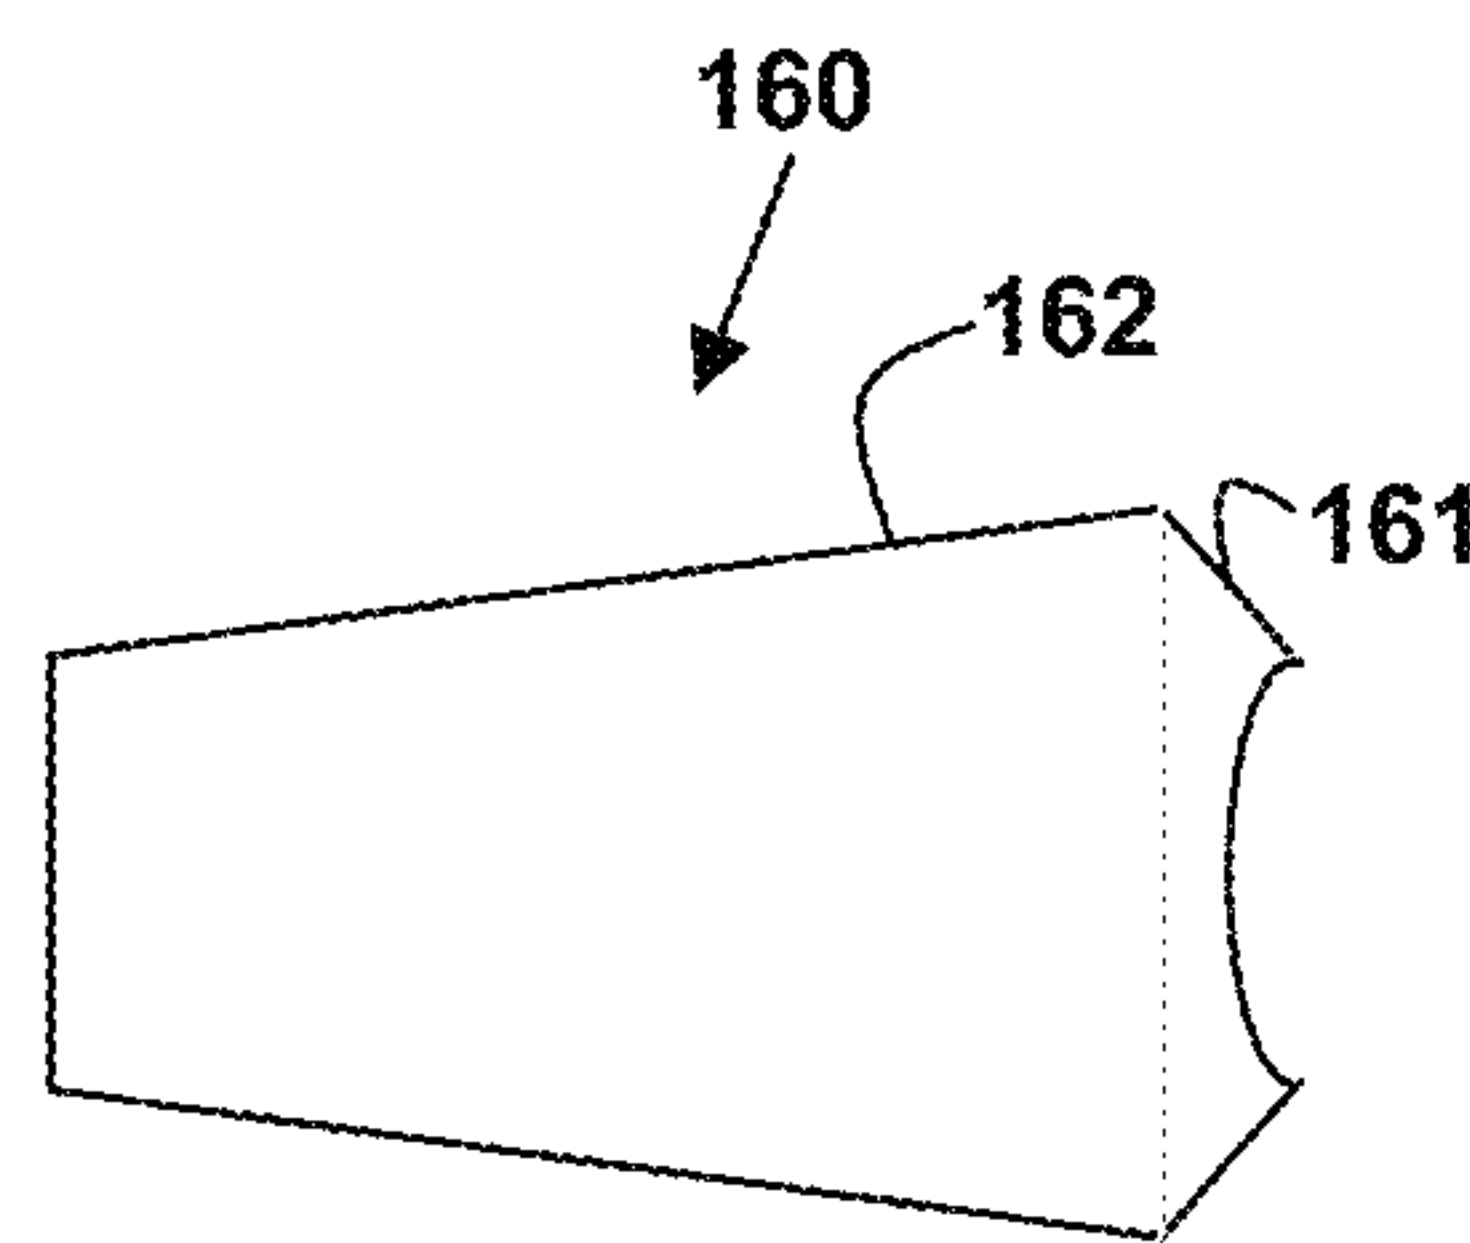
Referring now to FIGS. 18A-18C, another example flared repair stent 160 is illustrated in accordance with an embodiment of the disclosure, which is made of flexible material such as rubber, silicone or a high-temperature thermoplastic. Flared repair stent 160 has a dual trapezoidal profile in top view FIG. 18A, with the wider flared portion 161 inclined

inward at the top and bottom of the large end of flared repair stent 160 as illustrated in side view FIG. 18C. A narrower flared portion 162 tapers to the other end of flared repair stent 160. Flared repair stent 160 has an oval-shaped cross-section as illustrated in FIG. 18B and is suitable for installation in BMW N-63 V-8 engines, in which the return coolant passes back through the timing chain via a return passage (i.e., through gasket 154 in FIG. 17), which may also develop leaks. Flared repair stent 160 is installed in the return passage of the N63 V-8 engine to repair the leak, according to the methods disclosed above. The length h_1 of flared repair stent 160 is 45 mm, the width w_1 of wider flared portion 161 is 65 mm, and the width w_2 of narrower flared portion 162 is 45 mm.
