(10) **Patent No.:** **US 11,199,592 B2**  
(45) **Date of Patent:** **Dec. 14, 2021**

(54) **ROBOTIC MAGNETIC FLUX LEAKAGE INSPECTION SYSTEM FOR EXTERNAL POST-TENSIONED TENDONS OF SEGMENTAL BRIDGES AND ROADWAYS**

(71) Applicant: **INFRASTRUCTURE PRESERVATION CORPORATION**,  
Clearwater, FL (US)

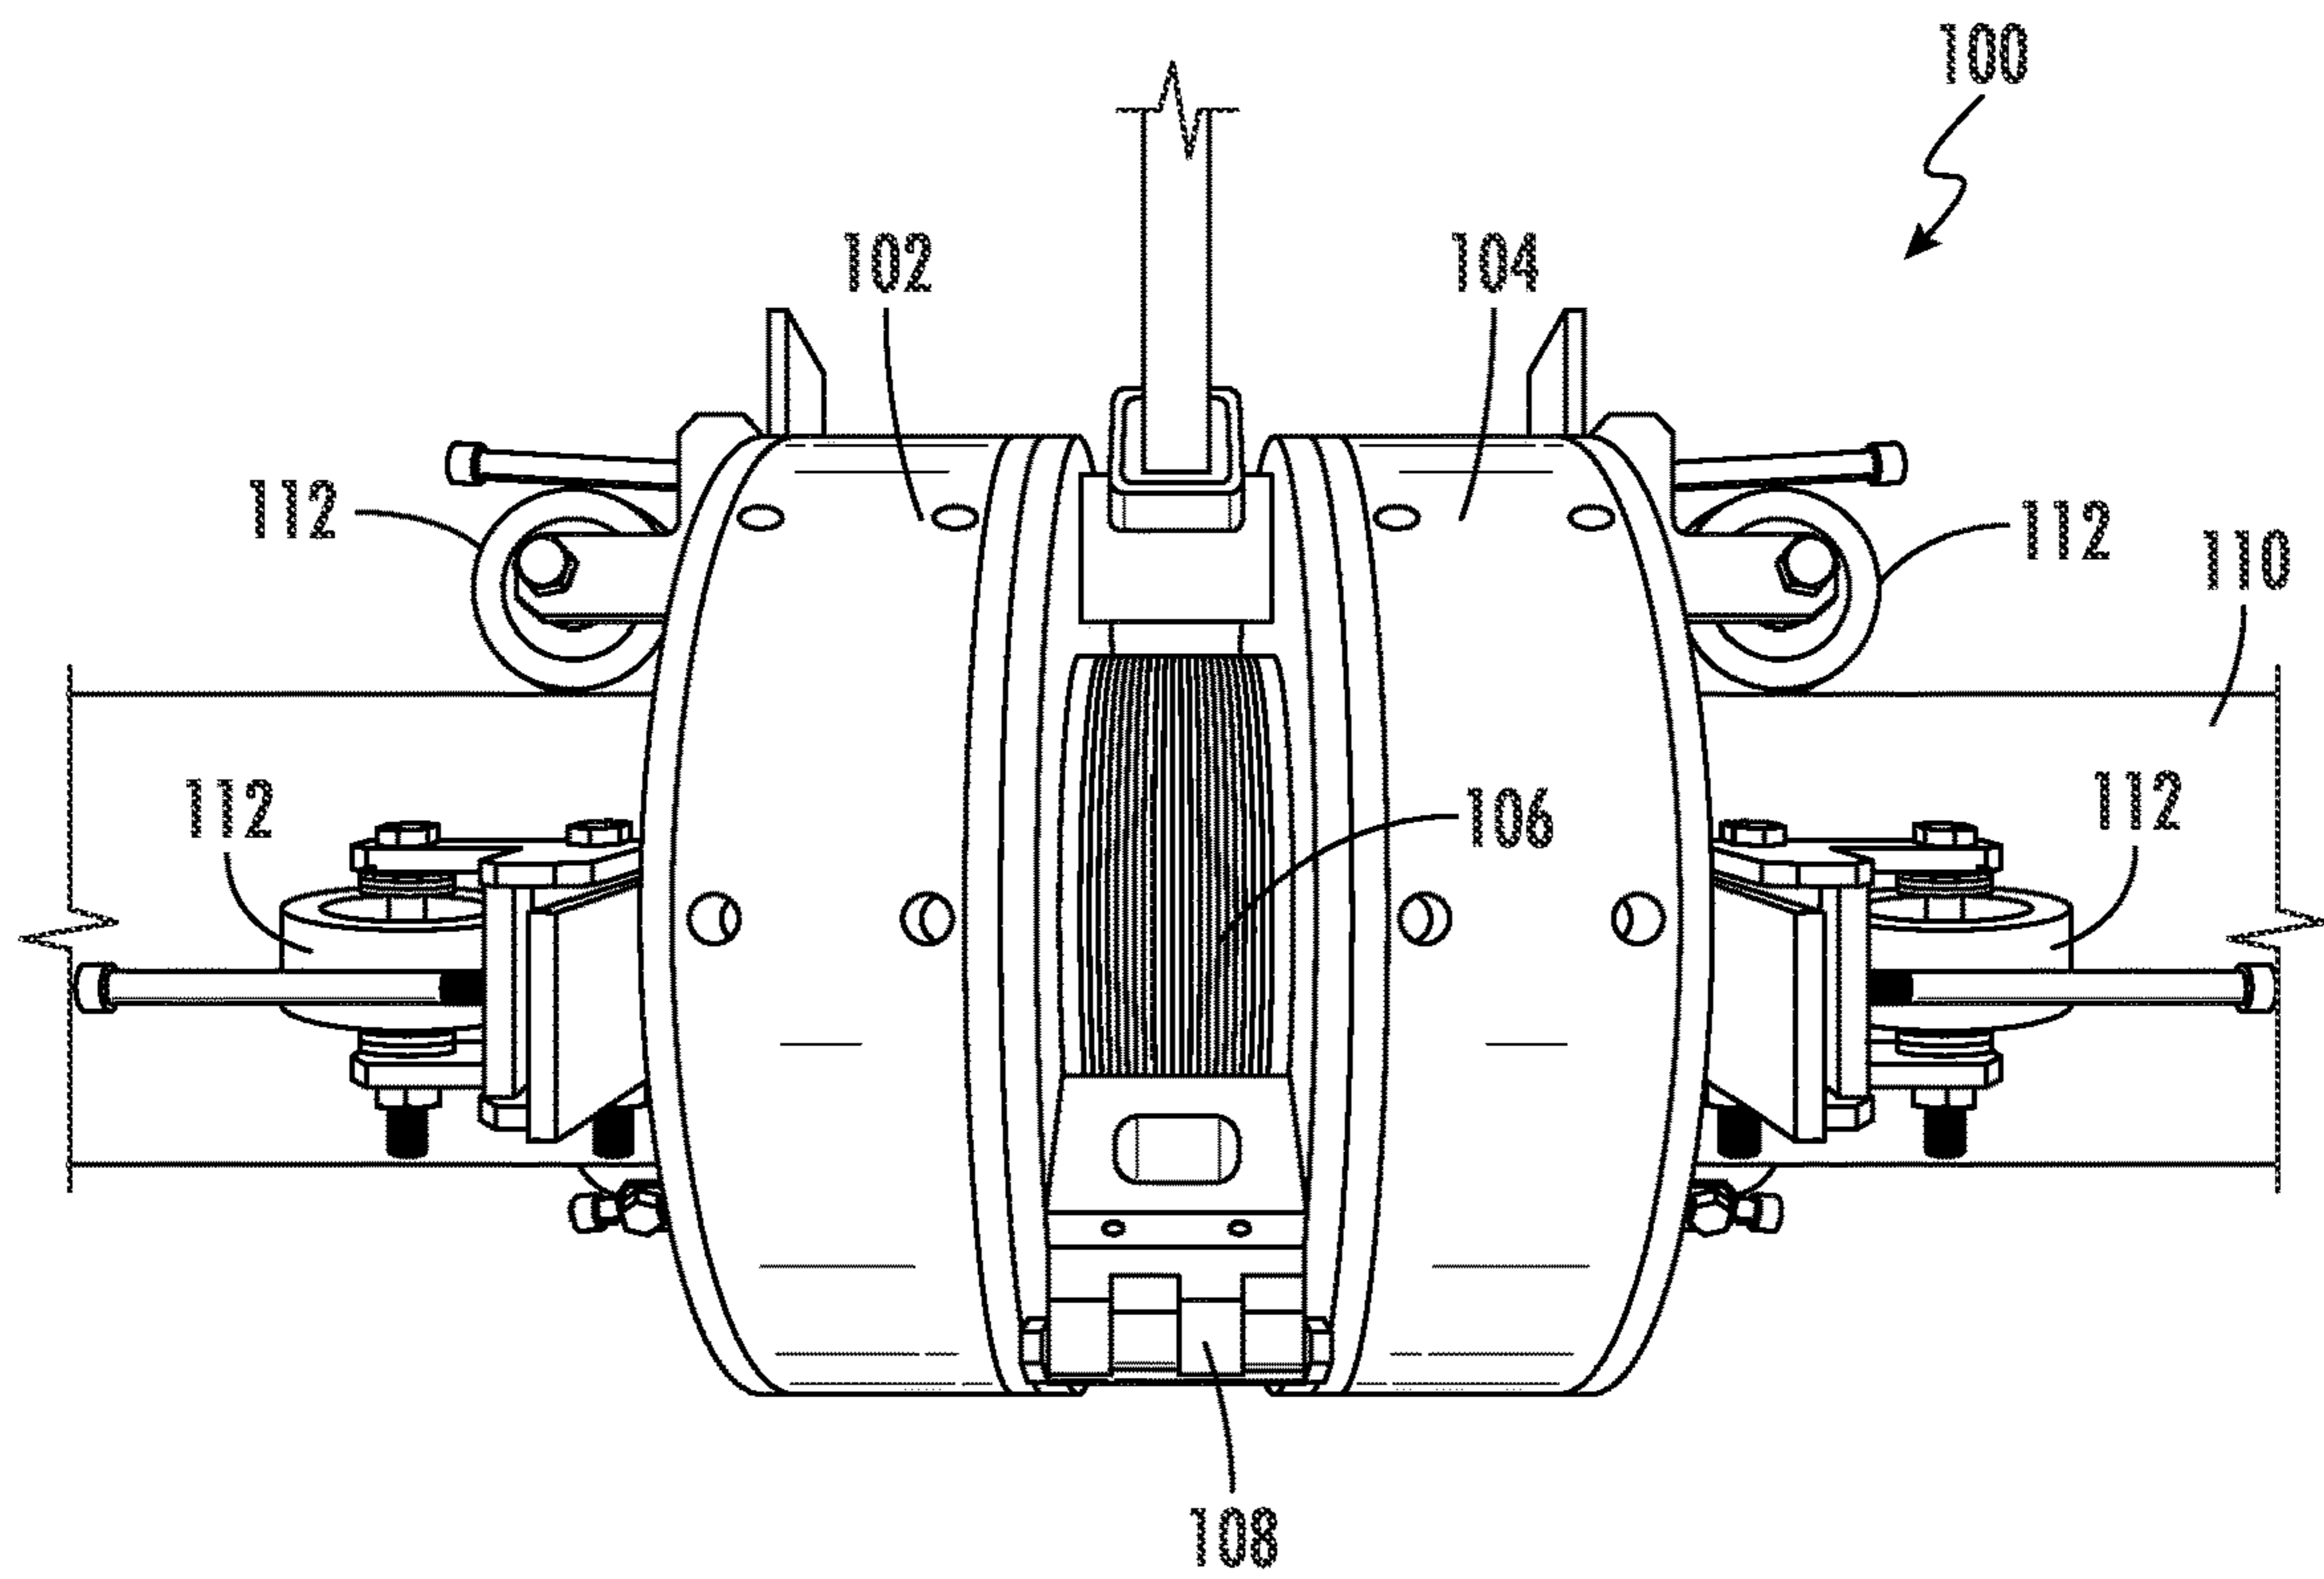
FIG. 1 is a elevational side view of a first embodiment of a sensing device of the present invention secured around a tendon;

Referring now to FIGS. 1-4, the robotic system includes a sensing device **100**, which may be a wireless and battery operated mobile transport. In a particular embodiment, the sensing device **100** is coupled completely around (360 degrees) a bridge tendon **110** and travels along the bridge tendon **110** performing an inspection of the condition of the steel cables within the bridge tendon **110**.

A first embodiment of the sensing device **100** is shown in FIG. 1 secured around the bridge tendon **112** and performing an inspection. The sensing device **100** may be self-propelled, and operate on battery power with wireless connectivity to a control station. Alternatively, the sensing device

The sensing device **100** includes a first magnet **102** having a first polarity and a second magnet **104** having a second polarity. The first and second magnets **102**, **104** may comprise sets of rare-earth magnets grouped in measurement channels, where each of which delivers a cross-sectional magnetic field. The sensing device **100** also includes a sensor array **106** that has a curved or arcuate shape as shown in FIGS. **1** and **2** and may be coupled to a processor that is configured to analyze raw voltage measurements from the sensor array **106** using algorithms and provide analysis and export of graphical data. The sensor array **106** is configured to detect the magnetic flux leakage perpendicular to a surface of the bridge tendon **110**. The sensor array **106** comprises an inductive coil sensor or Hall effect sensor configured to detect the magnetic flux leakage to indicate a discontinuity within the bridge tendon **110**.

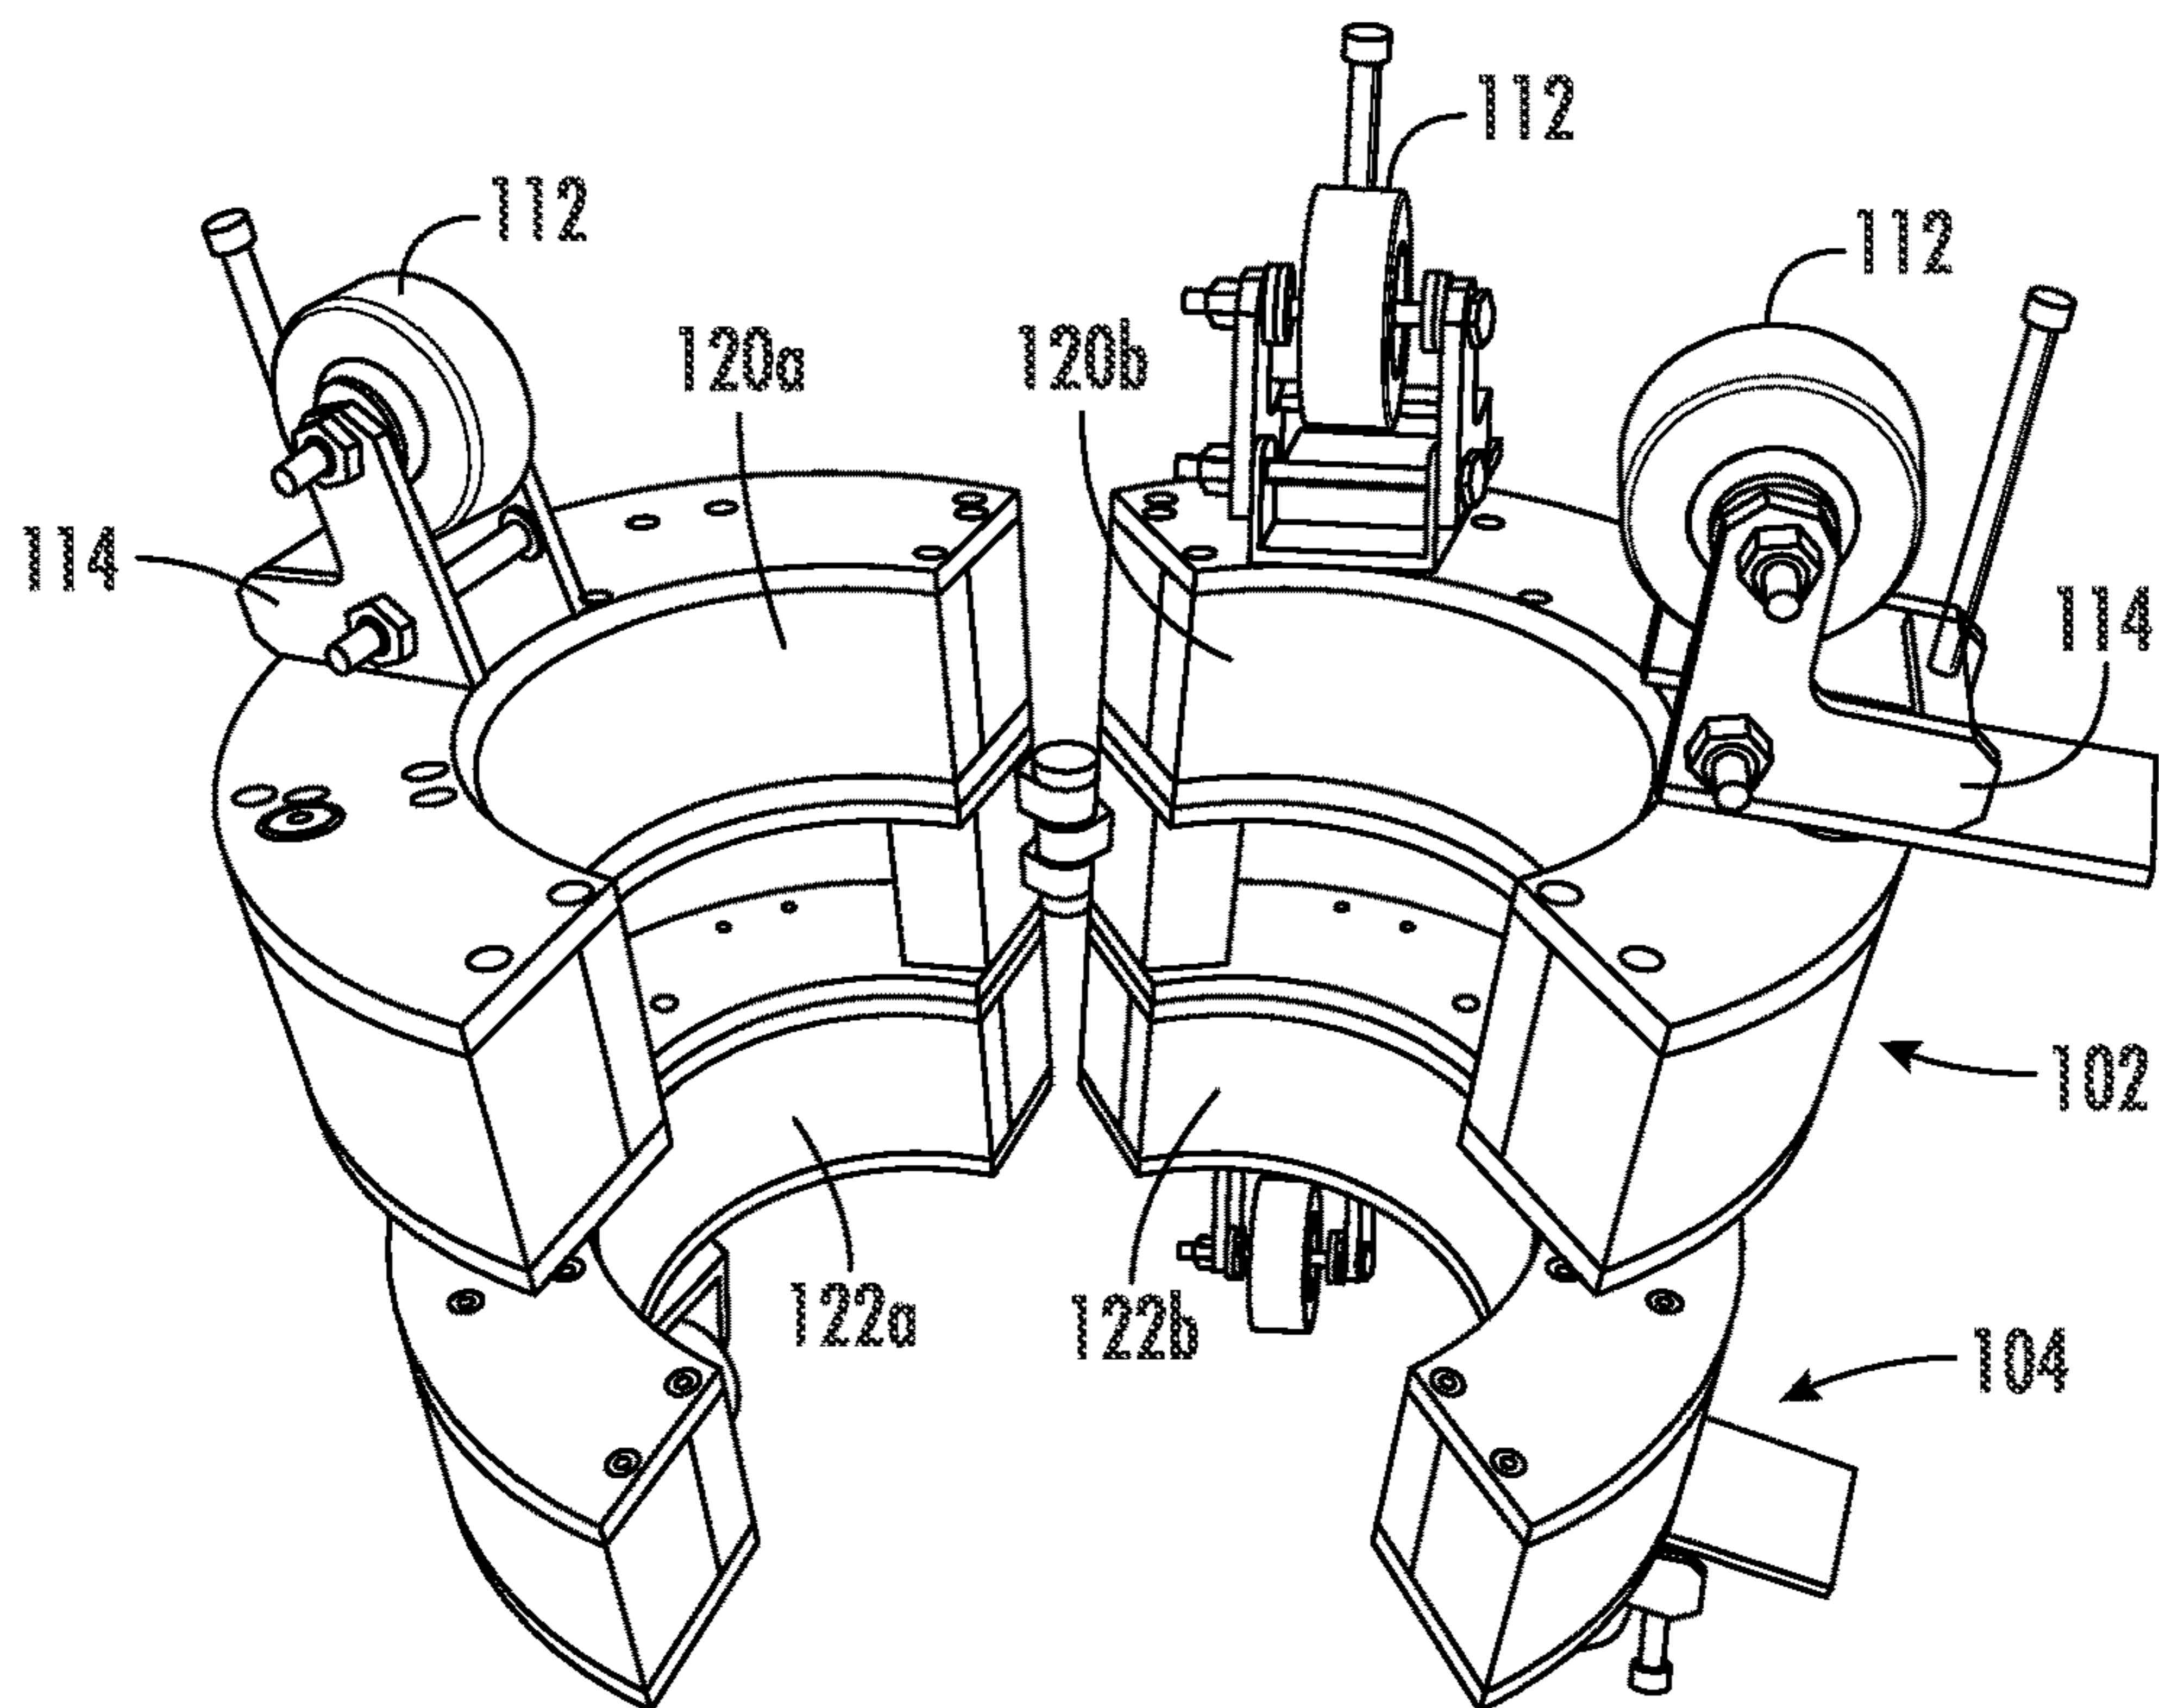
FIG. 2 is a top perspective view of the sensing device in an open position;

As shown in FIGS. **2** and **4**, the first magnet **102** has a curved or arcuate shape and comprises two halves **120a**, **120b**, that are hingedly coupled to each other by clasp **108**. Similarly, the second magnet **104** has a curved or arcuate shape and comprises two halves **122a**, **122b** that are hingedly coupled to each other by clasp **108**. Accordingly, the first and second arcuate magnets **102**, **104** can be swung apart so that the sensing device can be secured completely around the bridge tendon **110**.

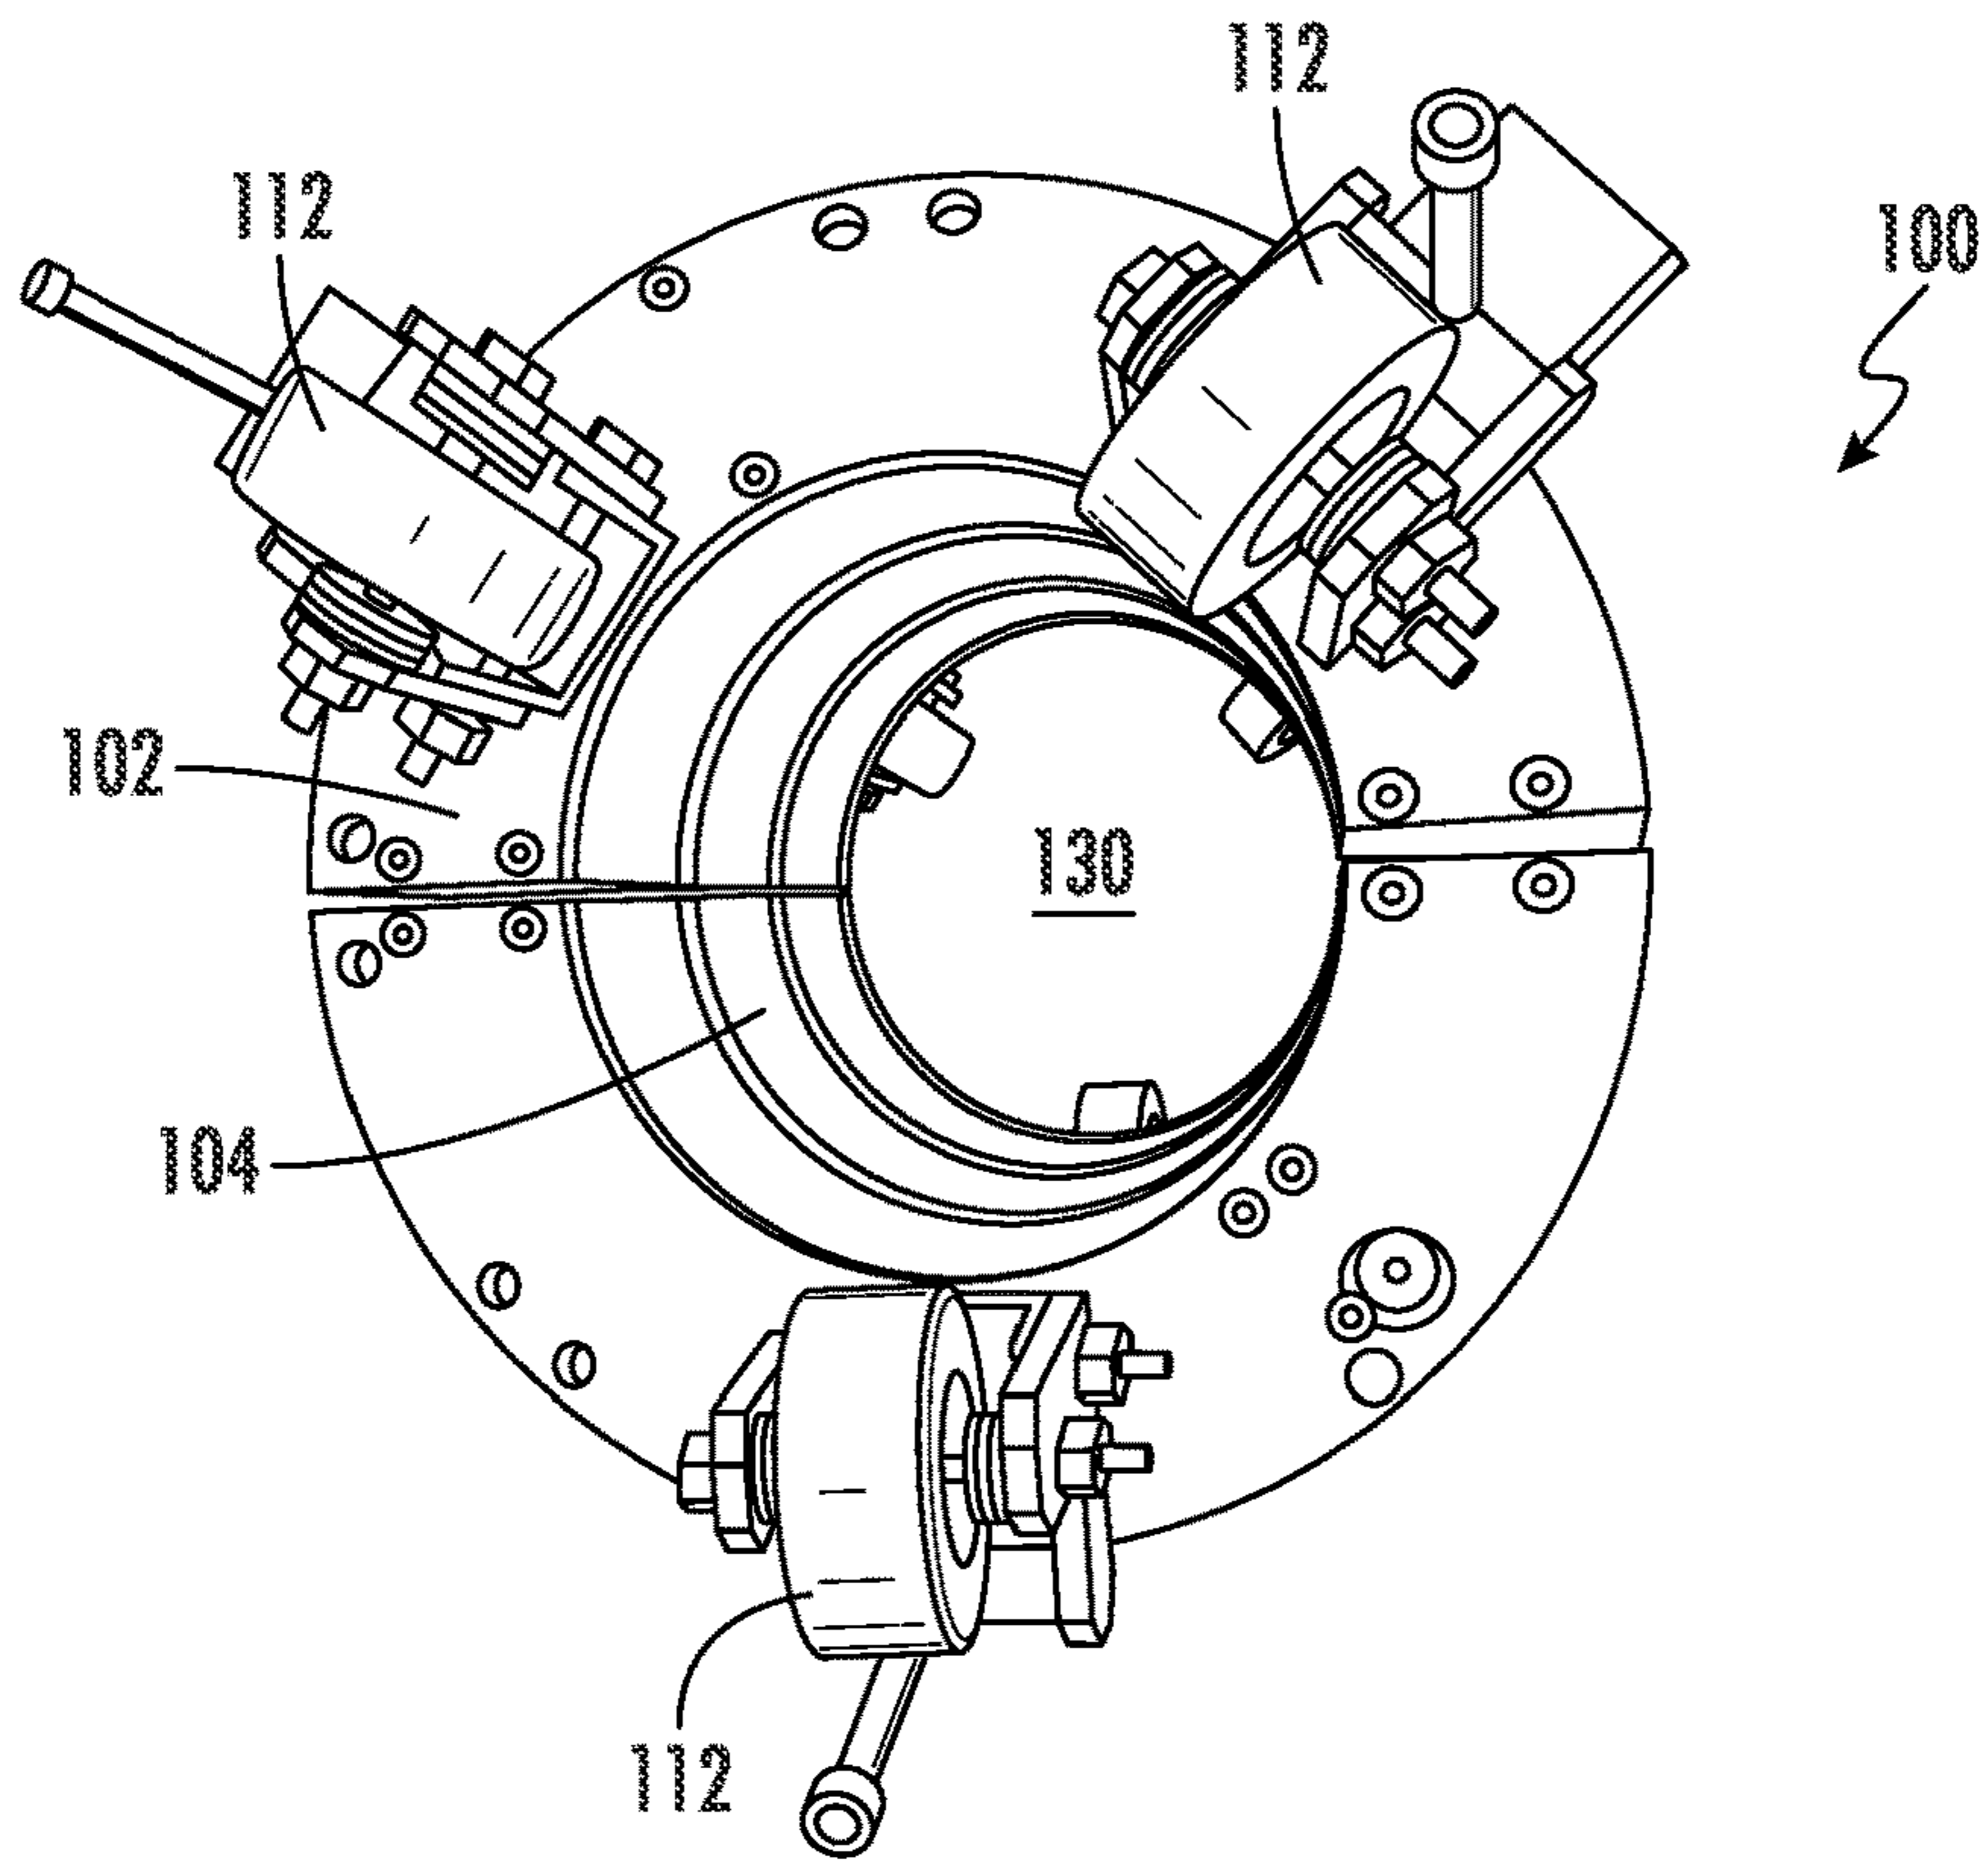
FIG. 3 is a top perspective view of the sensing device in a closed position;

Once the sensing device **100** is secured to the bridge tendon **110** creating a center aperture **130** as shown in FIG. **3**, the wheels **112** can be adjusted using respective wheel clamps **114** so that the first and second magnets **102**, **104** can be rolled along the bridge tendon **110** passing adjacent within a few inches of the exterior surface of the bridge tendon **110**.

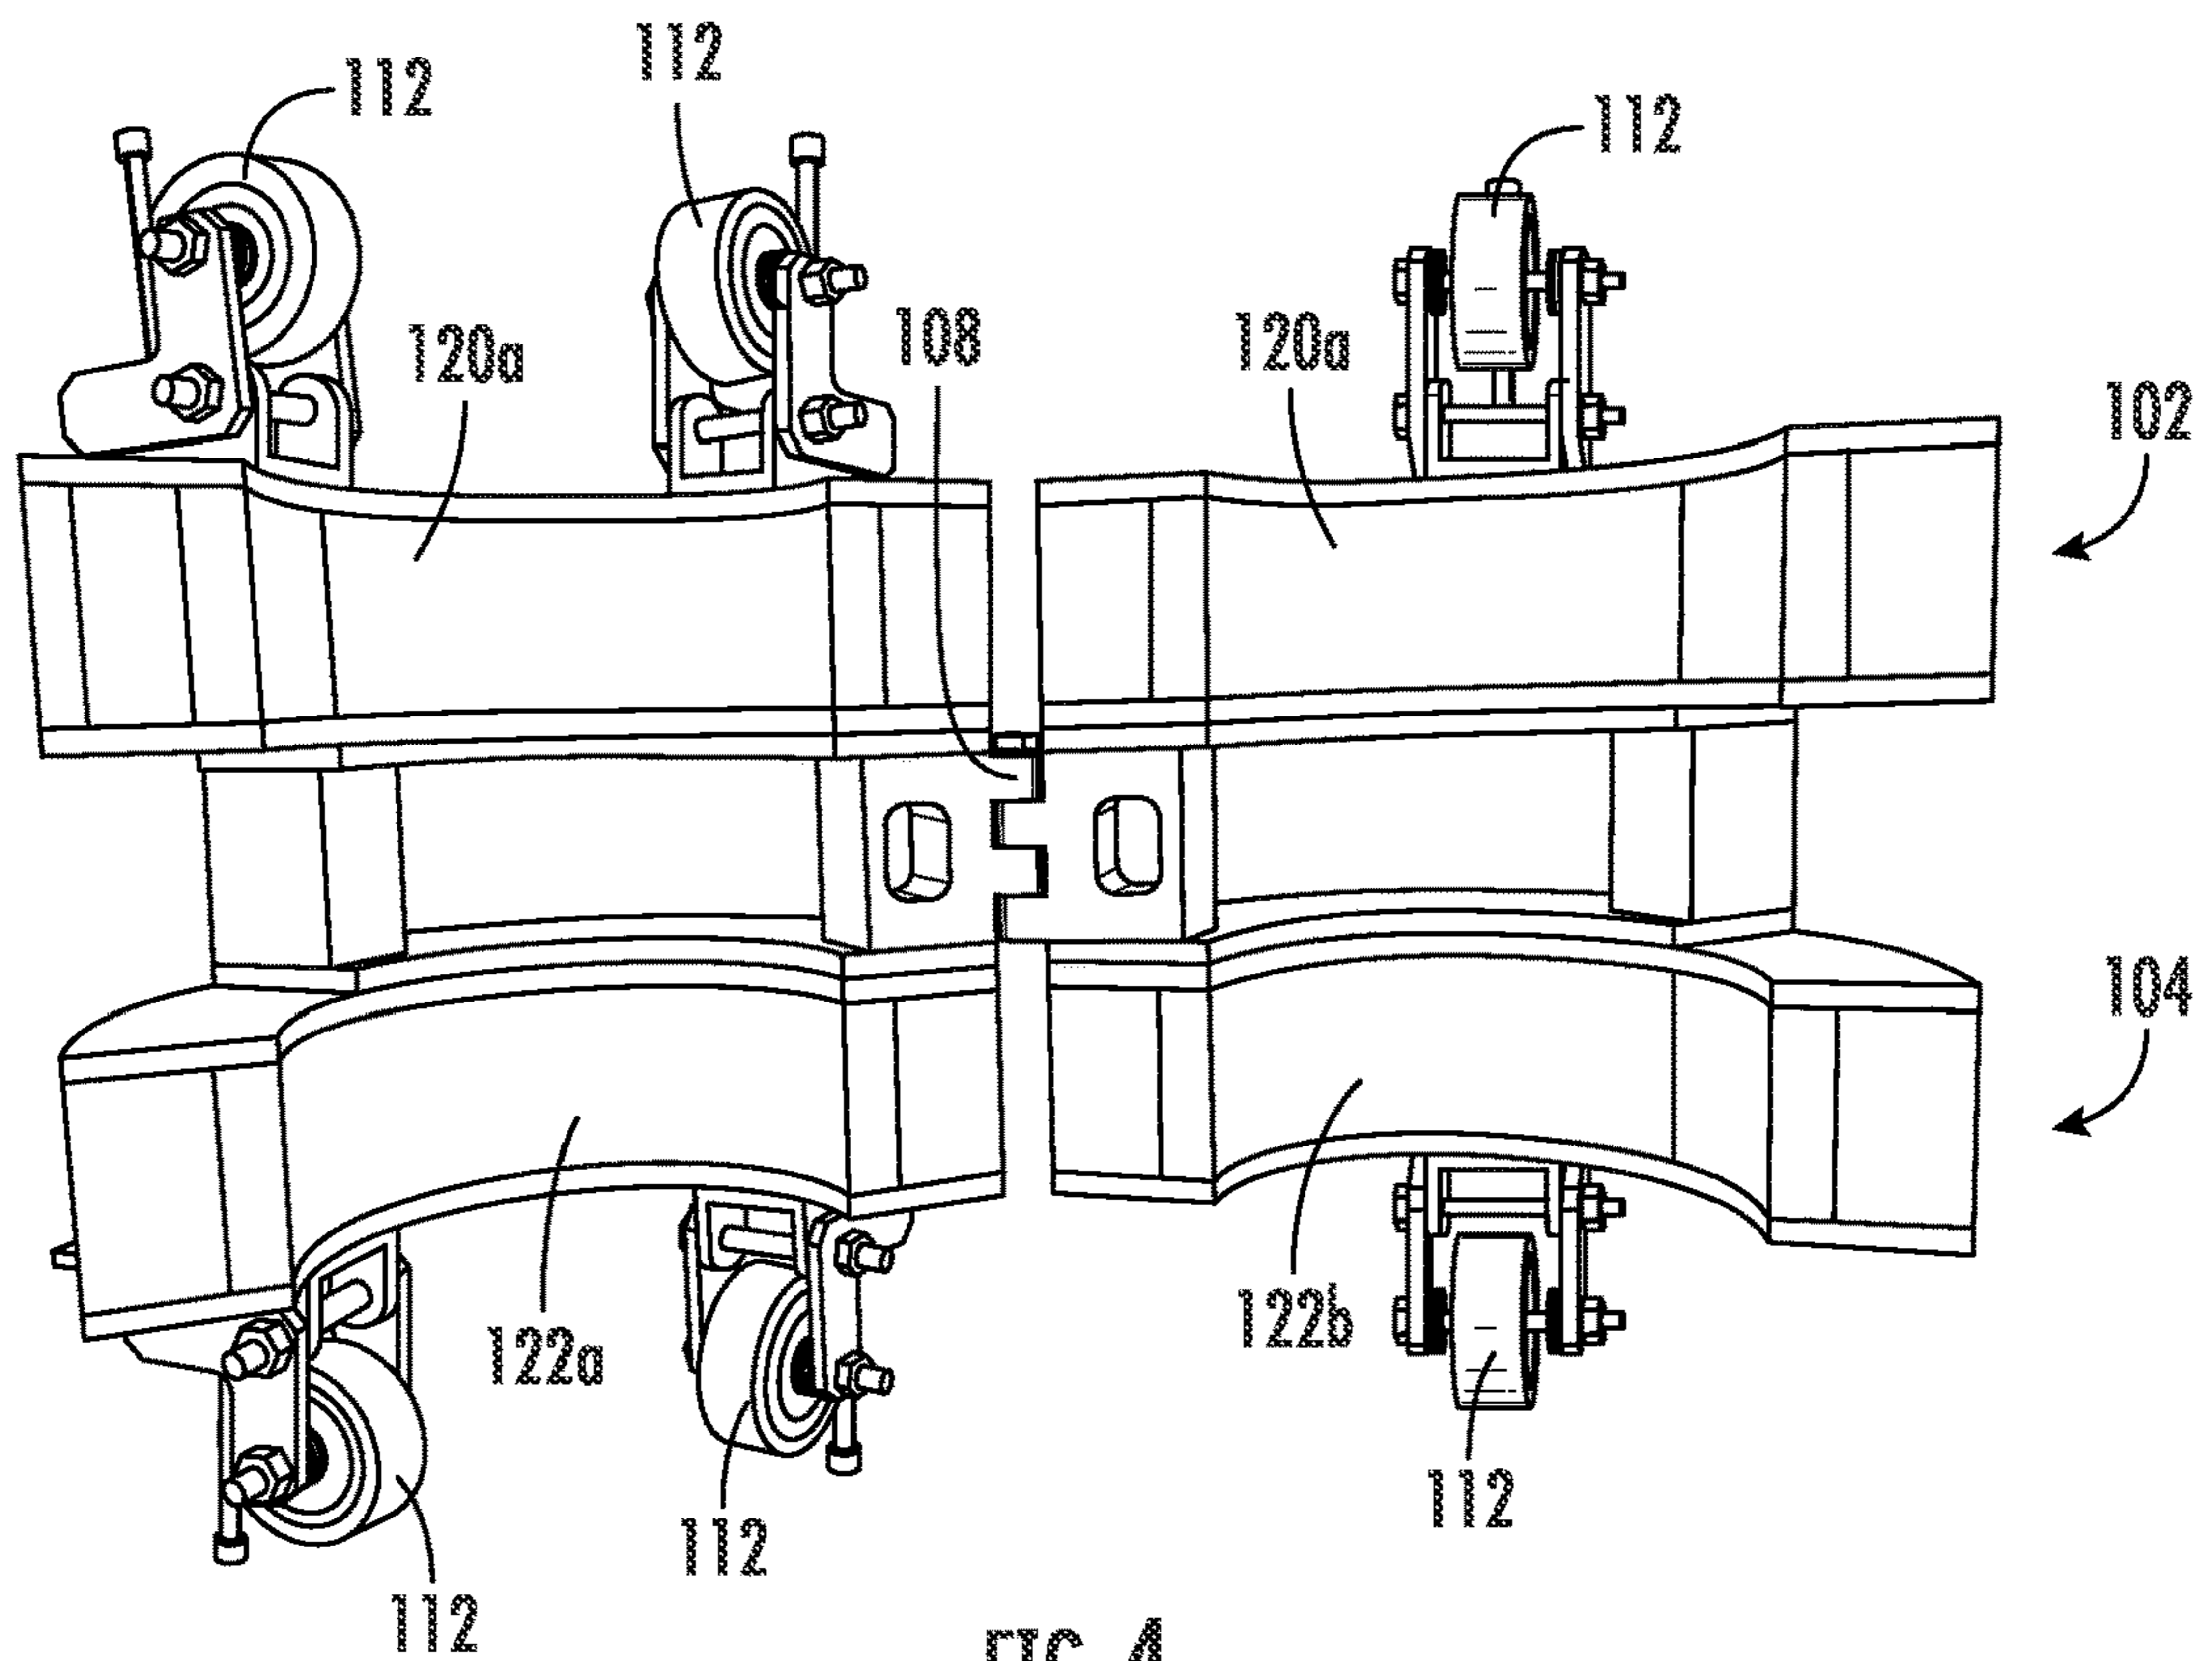
FIG. 4 is an elevational side view of the sensing device in an open position;

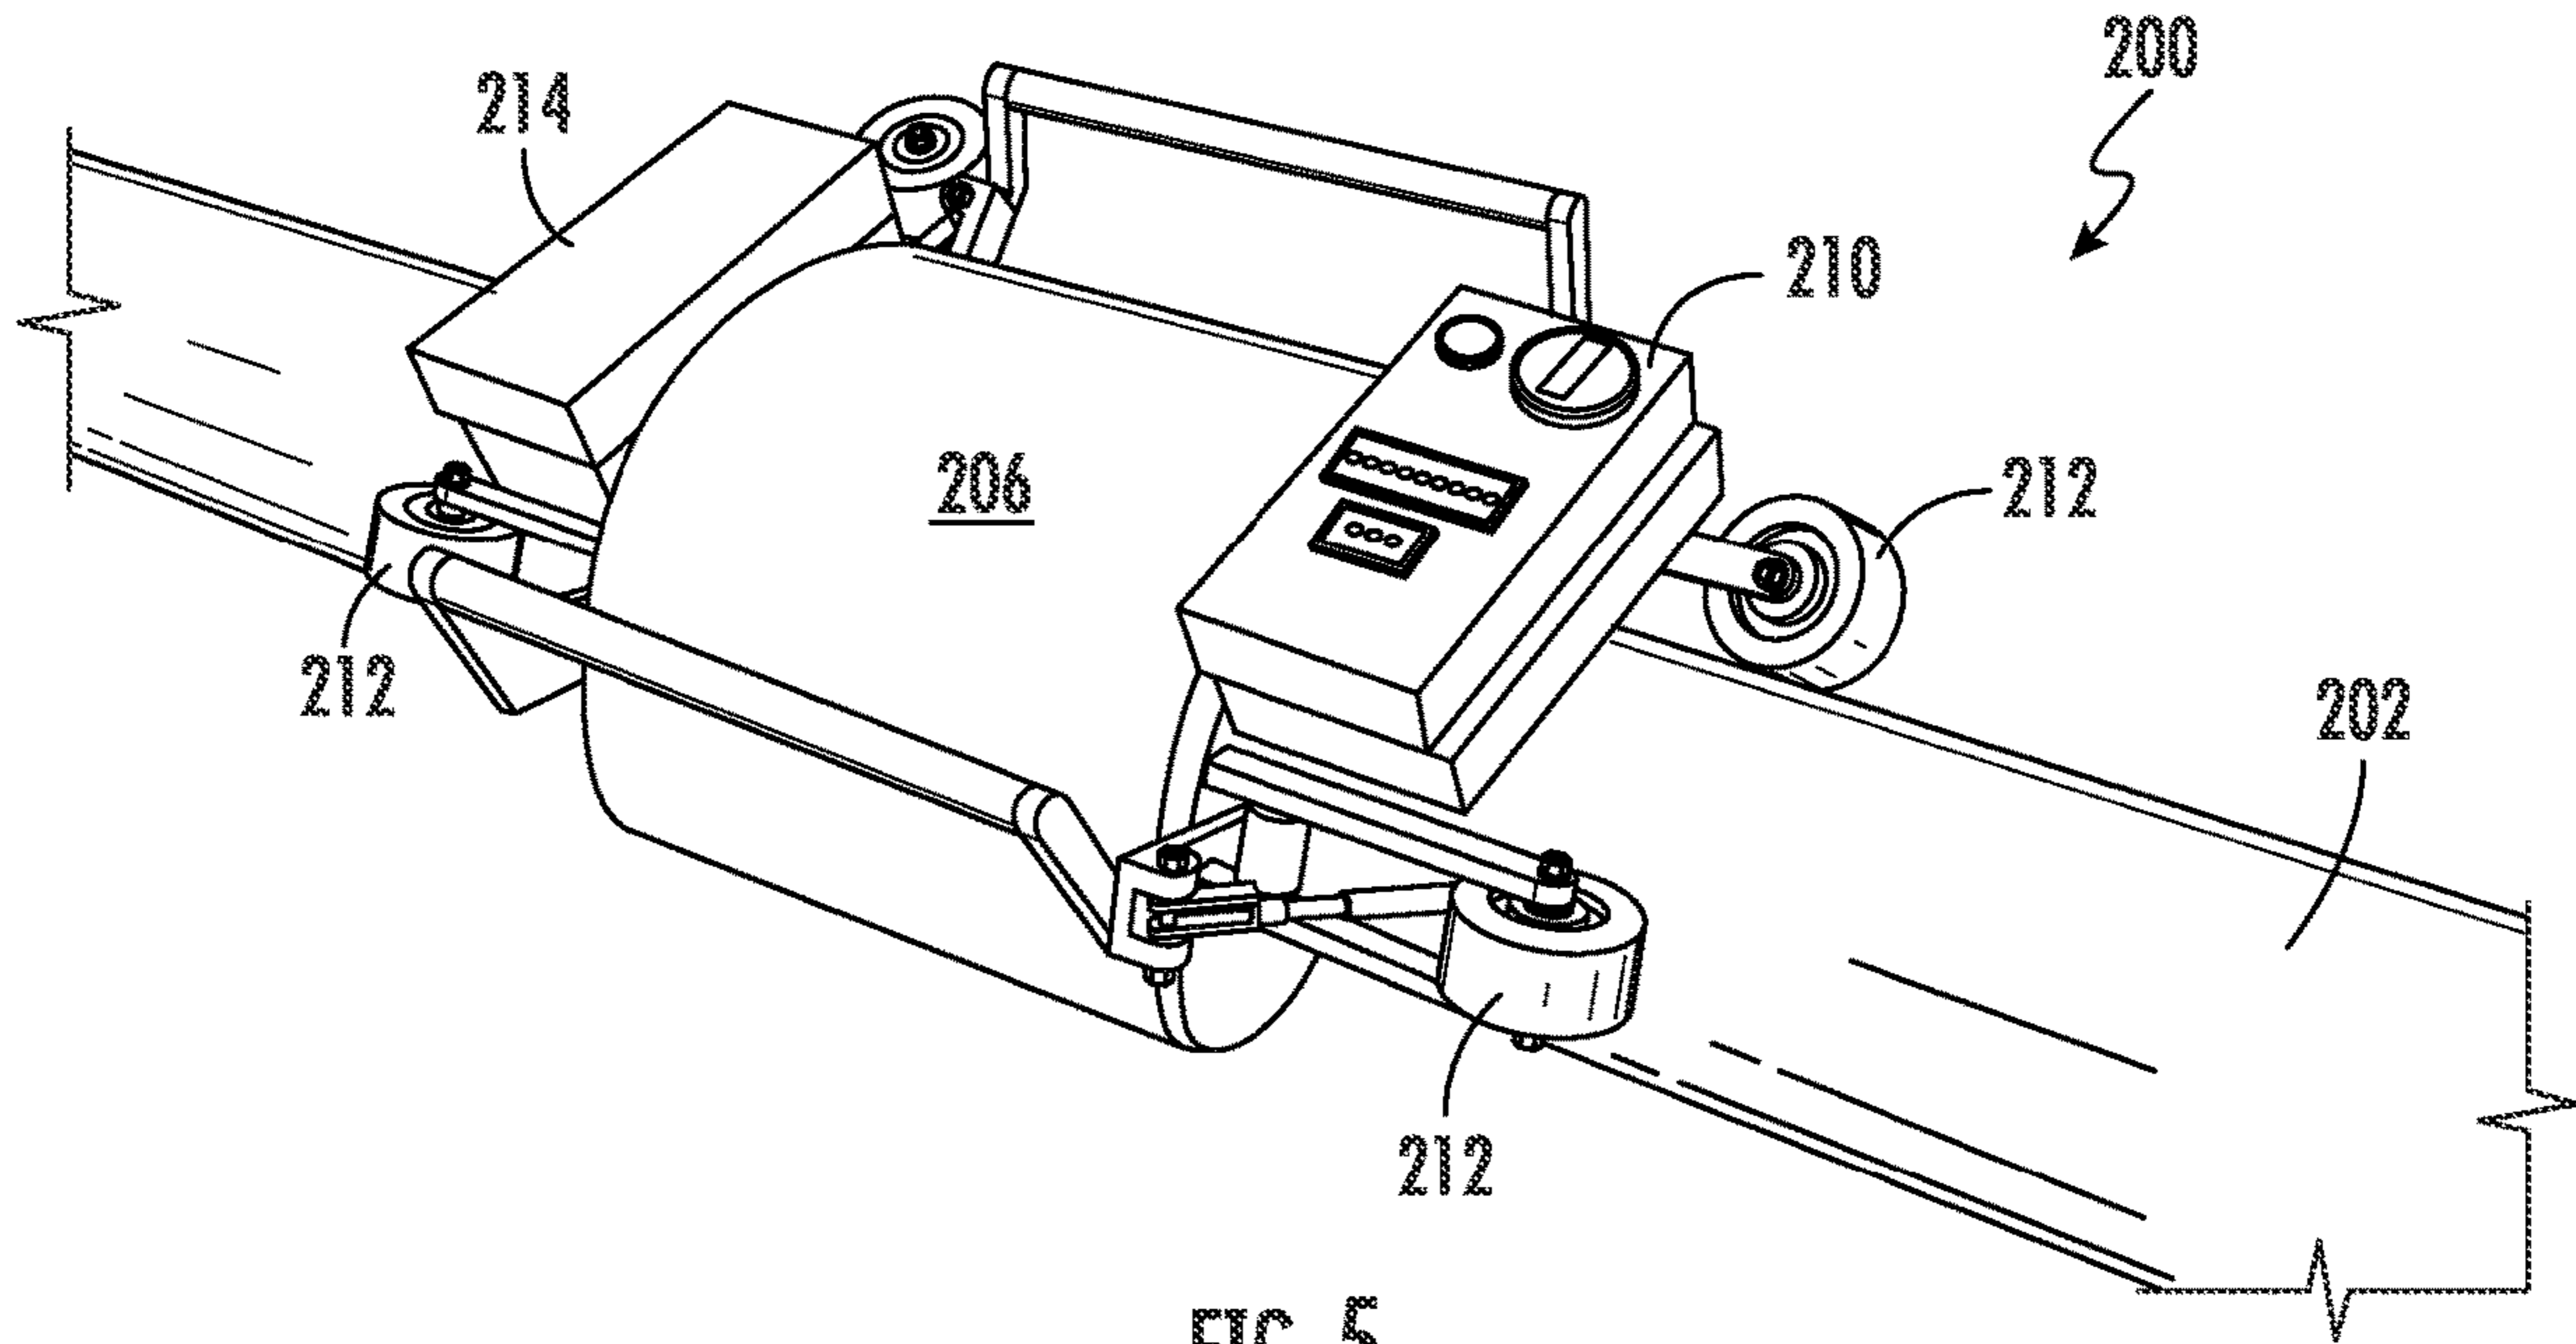
FIG. 5 is a perspective view of a second embodiment of the sensing device secured around a tendon;

The second embodiment of the sensing device **200** is shown in FIGS. **5-8**. In contrast to the first embodiment described above, the sensing device **200** is configured to surround about 240 degrees around the bridge tendon **202** (with 360 degrees being completely around). As shown in FIG. **6**, the sensing device **200** includes a housing **206** and grab rails **208** that can be used by the inspector to roll the sensing device **200** along the bridge tendon **202** using the wheels **212**. A sensor display **210** having a processor and coupled to a sensor **218** is proximate a first end of the sensing device **200** and a battery pack **214** is proximate to a second end of the sensing device **200**. In addition, the sensing device **200** may include a location device **215** to determine the location of the sensing device **200** on the bridge tendon **202**.

This is an important feature of sensing device **200** in that a significant amount of bridge tendons **202** are about one inch off the floor (bottom slab) or against the wall (box web) and cannot be inspected by a sensing device that completely surrounds the bridge tendon **202**.

The sensing device **200** includes a first magnet **216** that has a curved or arcuate shape and having a first polarity, and a second magnet **220** that has a curved or arcuate shape and having a second polarity which are configured to generate a magnetic field. The magnetic field is sufficient to penetrate substantially through the cross section of the bridge tendon **202** so that all of the cables contained therein are evaluated.
