(10) **Patent No.:** **US 11,199,592 B2**  
(45) **Date of Patent:** **Dec. 14, 2021**

(54) **ROBOTIC MAGNETIC FLUX LEAKAGE INSPECTION SYSTEM FOR EXTERNAL POST-TENSIONED TENDONS OF SEGMENTAL BRIDGES AND ROADWAYS**

(71) Applicant: **INFRASTRUCTURE PRESERVATION CORPORATION**,  
Clearwater, FL (US)

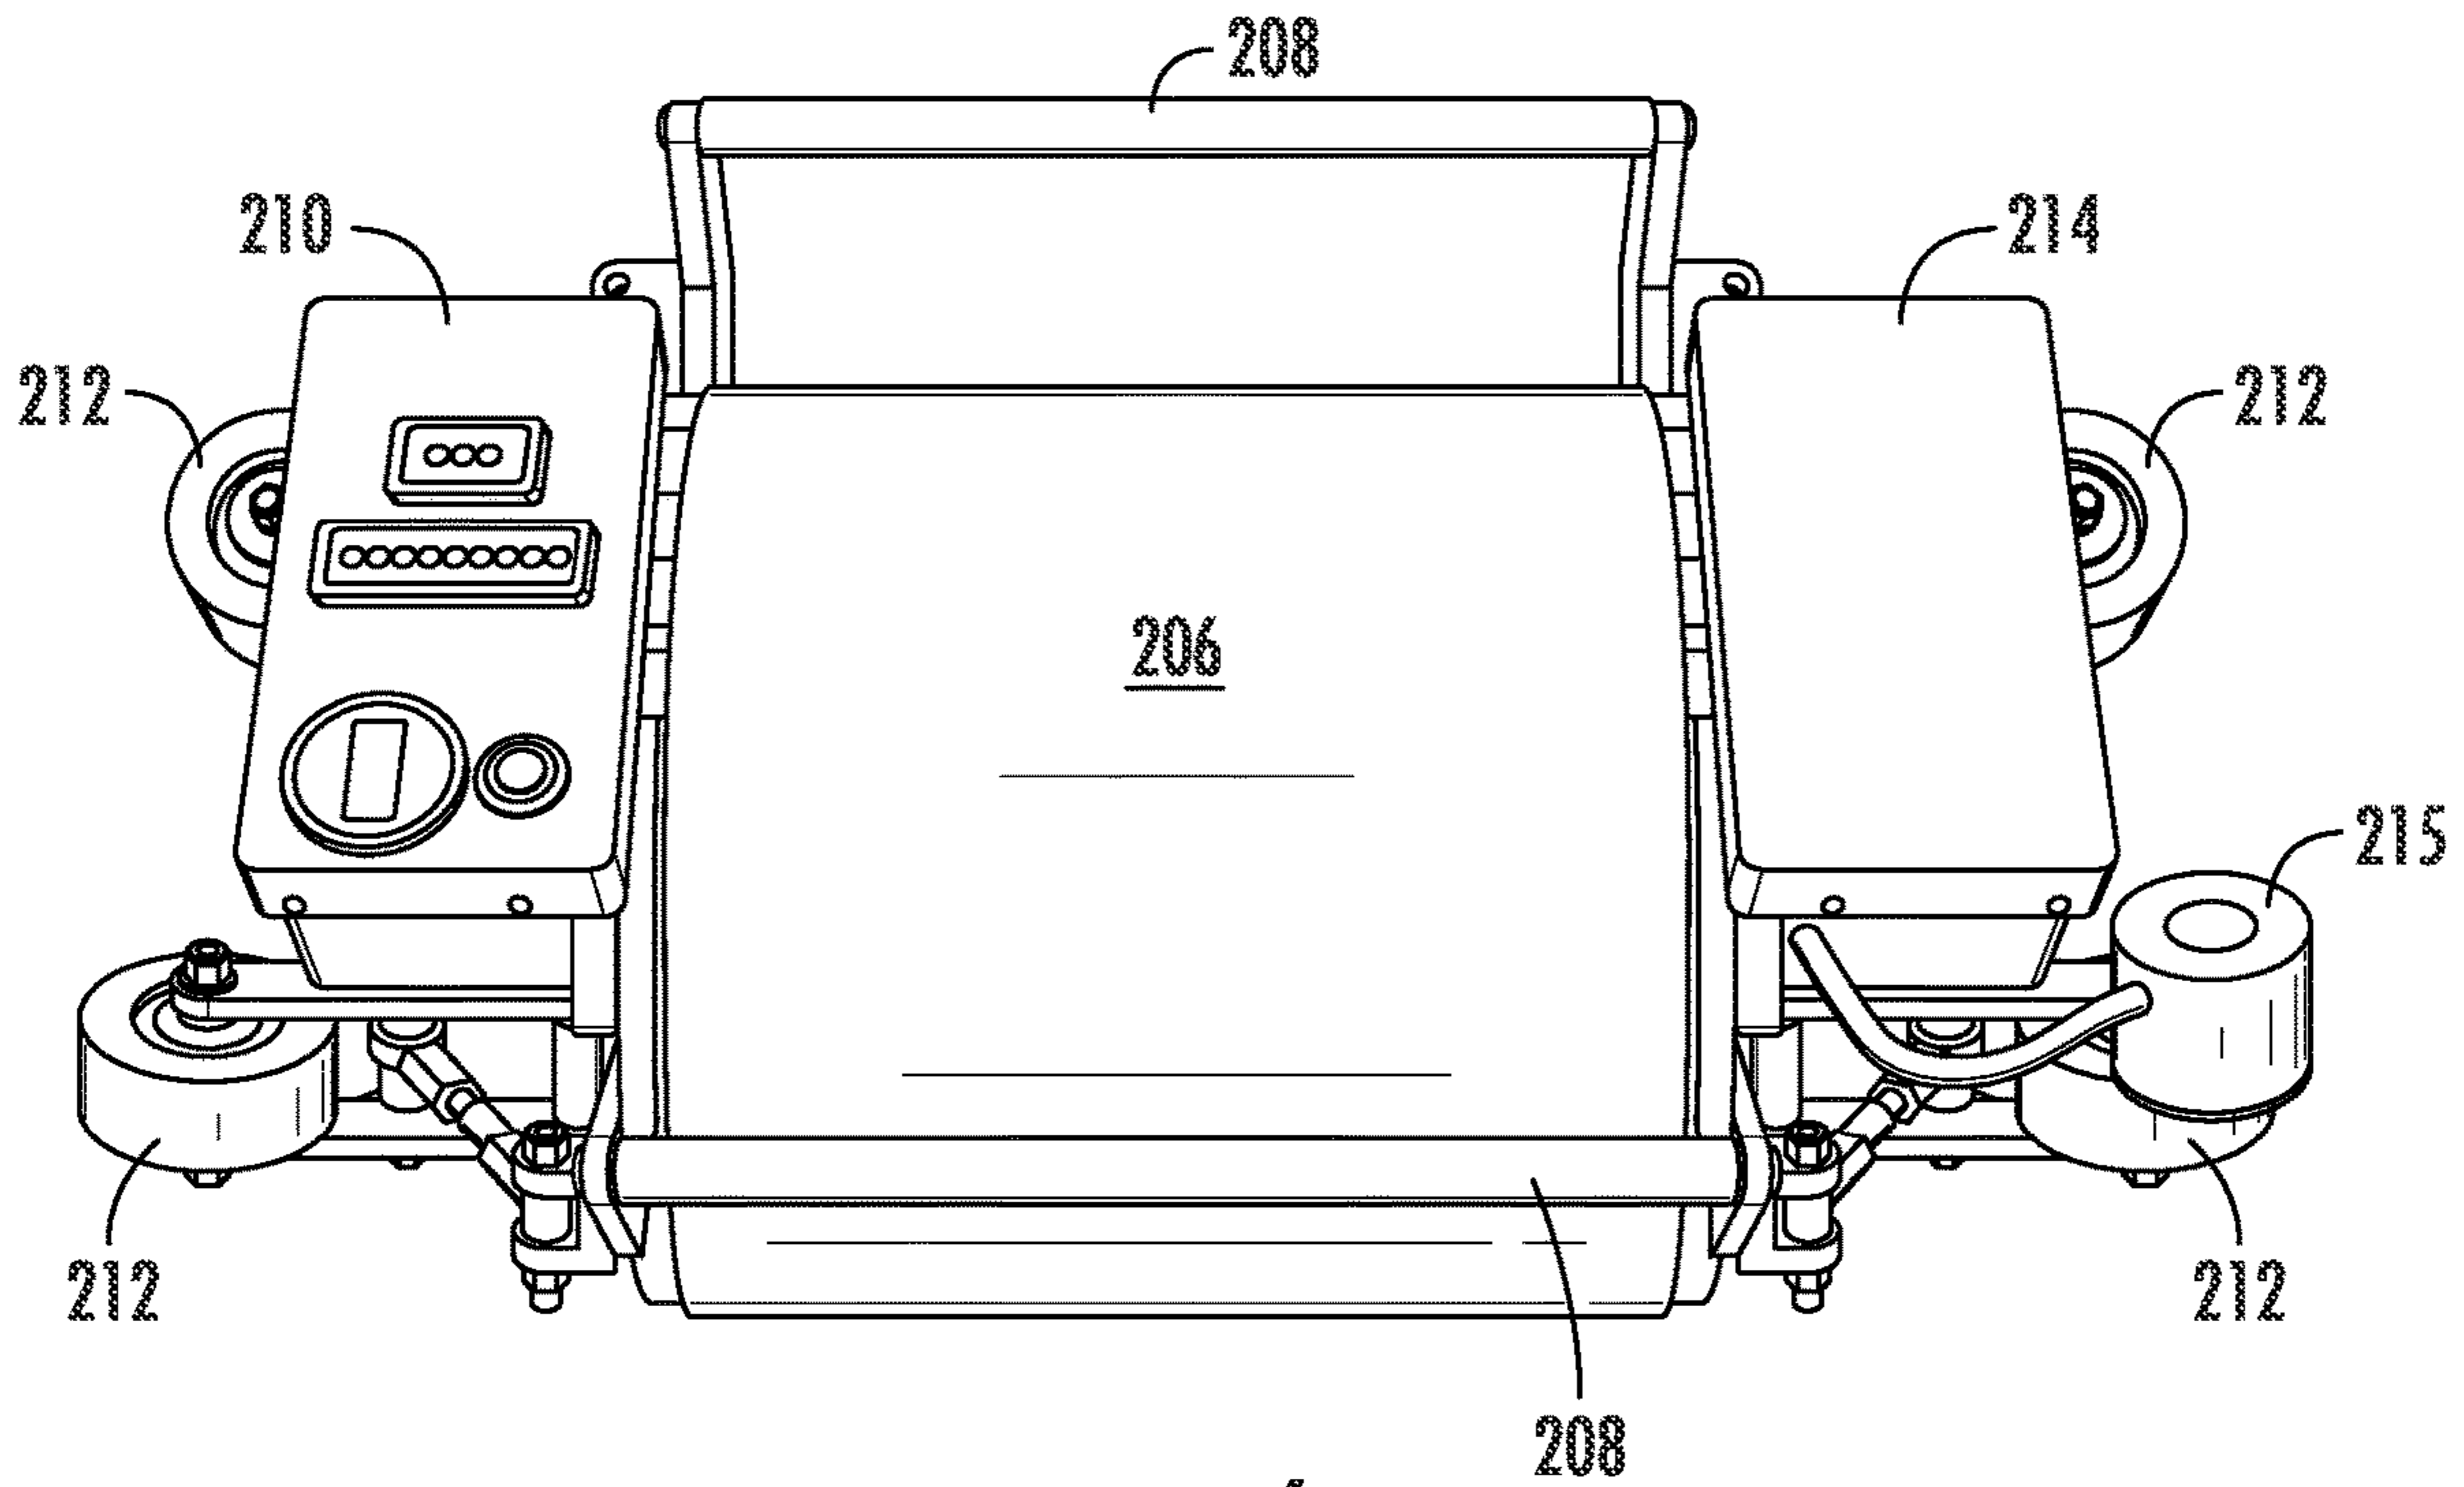
FIG. 6 is an elevational side view of a closed side of the sensing device;

The second embodiment of the sensing device **200** is shown in FIGS. **5-8**. In contrast to the first embodiment described above, the sensing device **200** is configured to surround about 240 degrees around the bridge tendon **202** (with 360 degrees being completely around). As shown in FIG. **6**, the sensing device **200** includes a housing **206** and grab rails **208** that can be used by the inspector to roll the sensing device **200** along the bridge tendon **202** using the wheels **212**. A sensor display **210** having a processor and coupled to a sensor **218** is proximate a first end of the sensing device **200** and a battery pack **214** is proximate to a second end of the sensing device **200**. In addition, the sensing device **200** may include a location device **215** to determine the location of the sensing device **200** on the bridge tendon **202**.

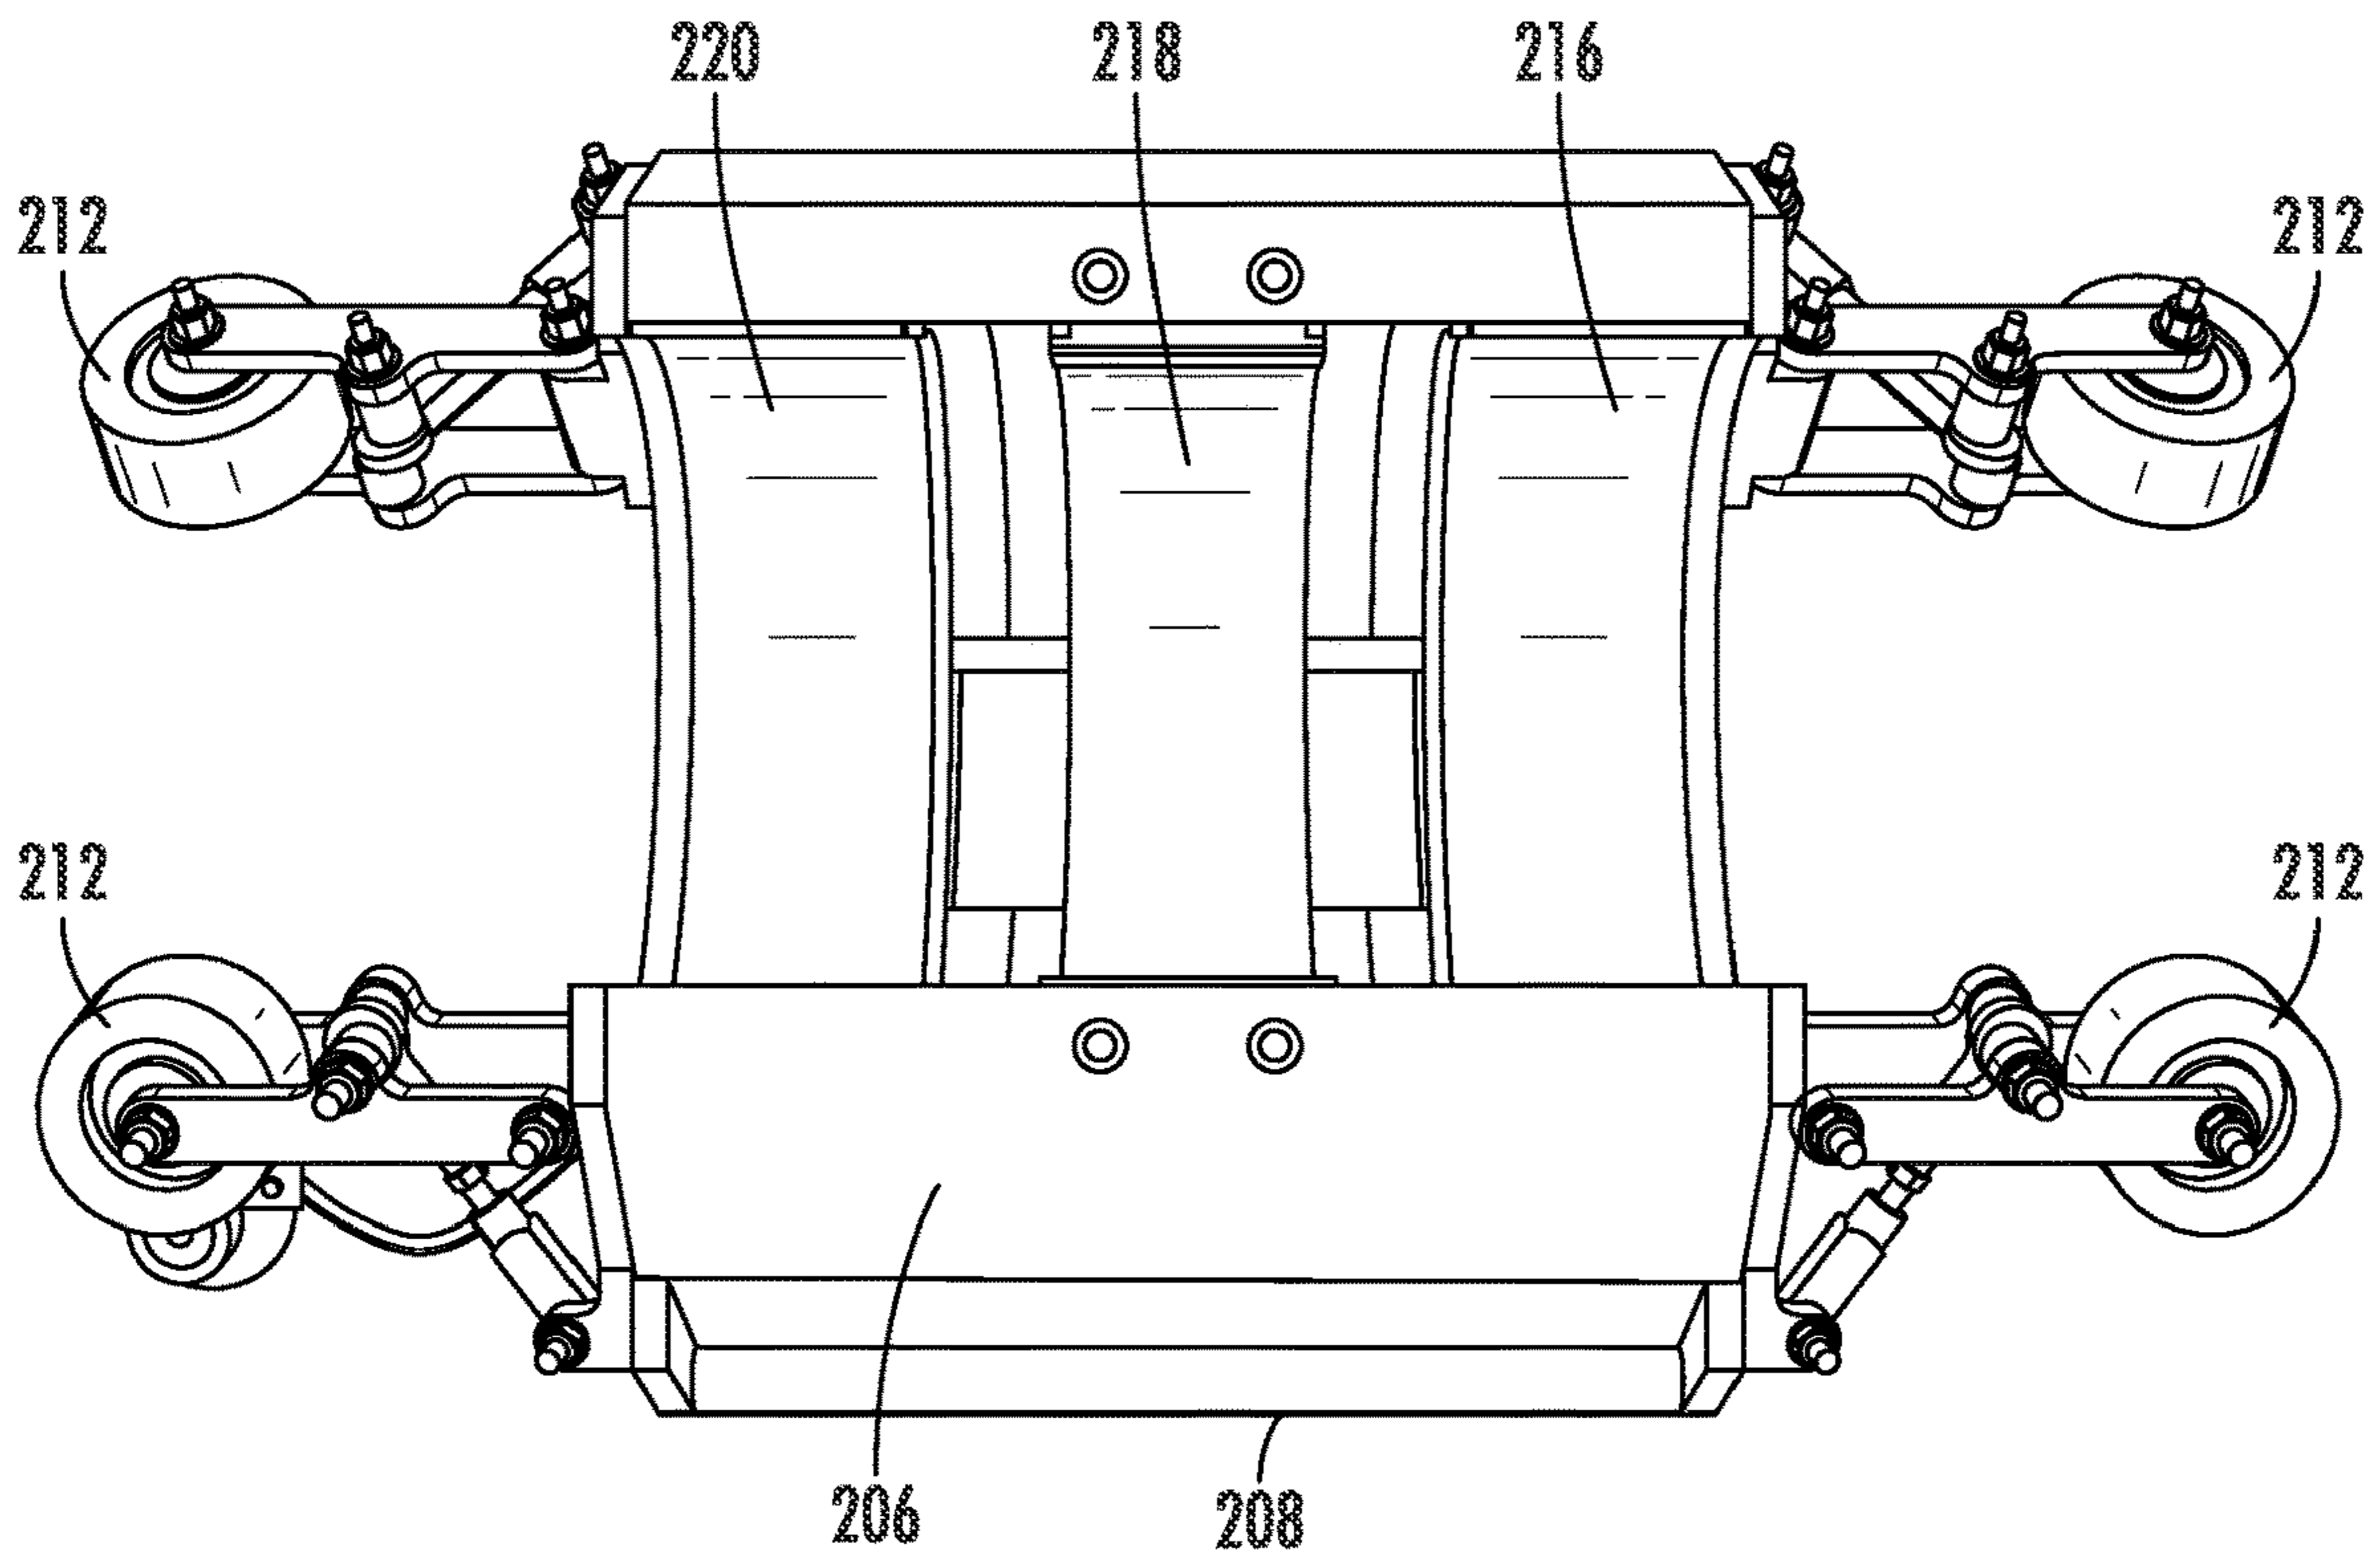
FIG. 7 is an elevational side view of an open side of the sensing device;

In particular, the sensing device **200** comprises an annulus sector shape of 240 degrees and having a 120 degree opening as shown in FIGS. **7** and **8**. In other aspects of the

For example, the results of measurements from the sensor **218** that has a curved or arcuate shape as shown in FIGS. **7** and **8** (e.g. raw voltage measurements) are plotted along a measurement line **302** and where magnetic flux leakage is detected is shown in portion **304** of the graph **300**. A correlating chart reflects loss of magnetic area (LMA) values **306**. As can be seen in FIG. **9**, portion **308** of the graph **300** indicates a relative loss of magnetic area that should be flagged for further inspection and/or repair.

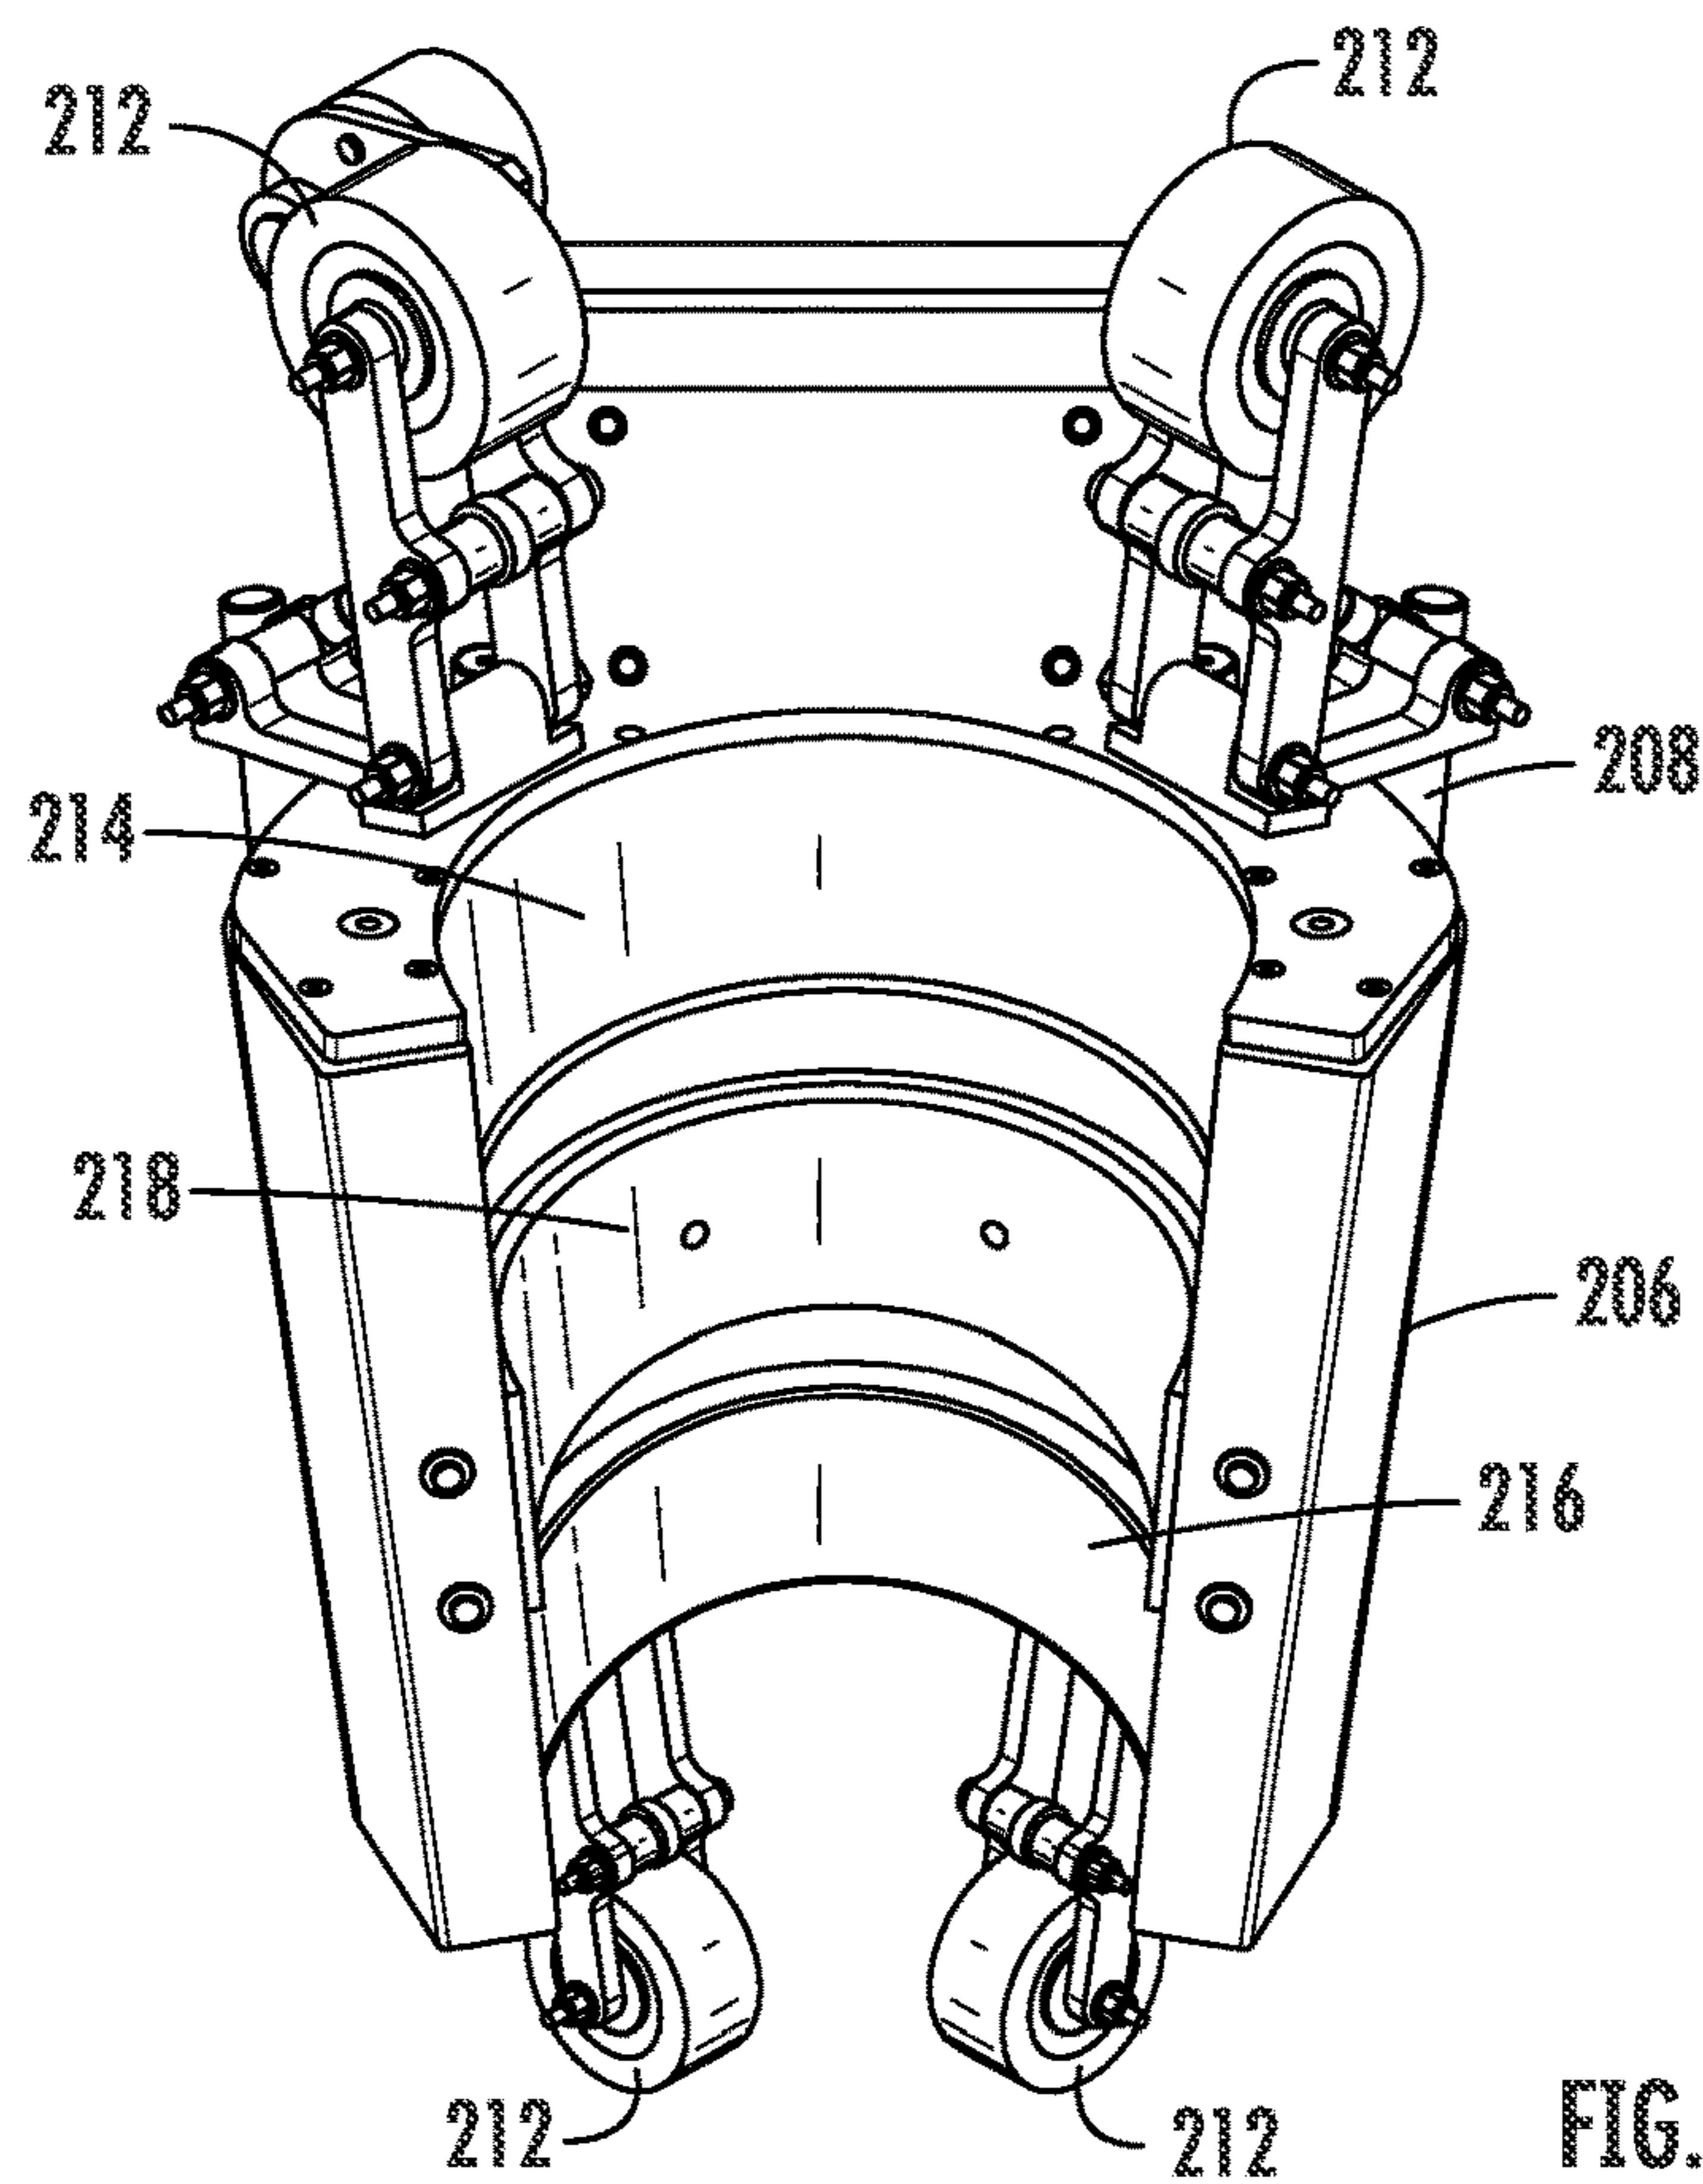
FIG. 8 is a top perspective view of the sensing device; and

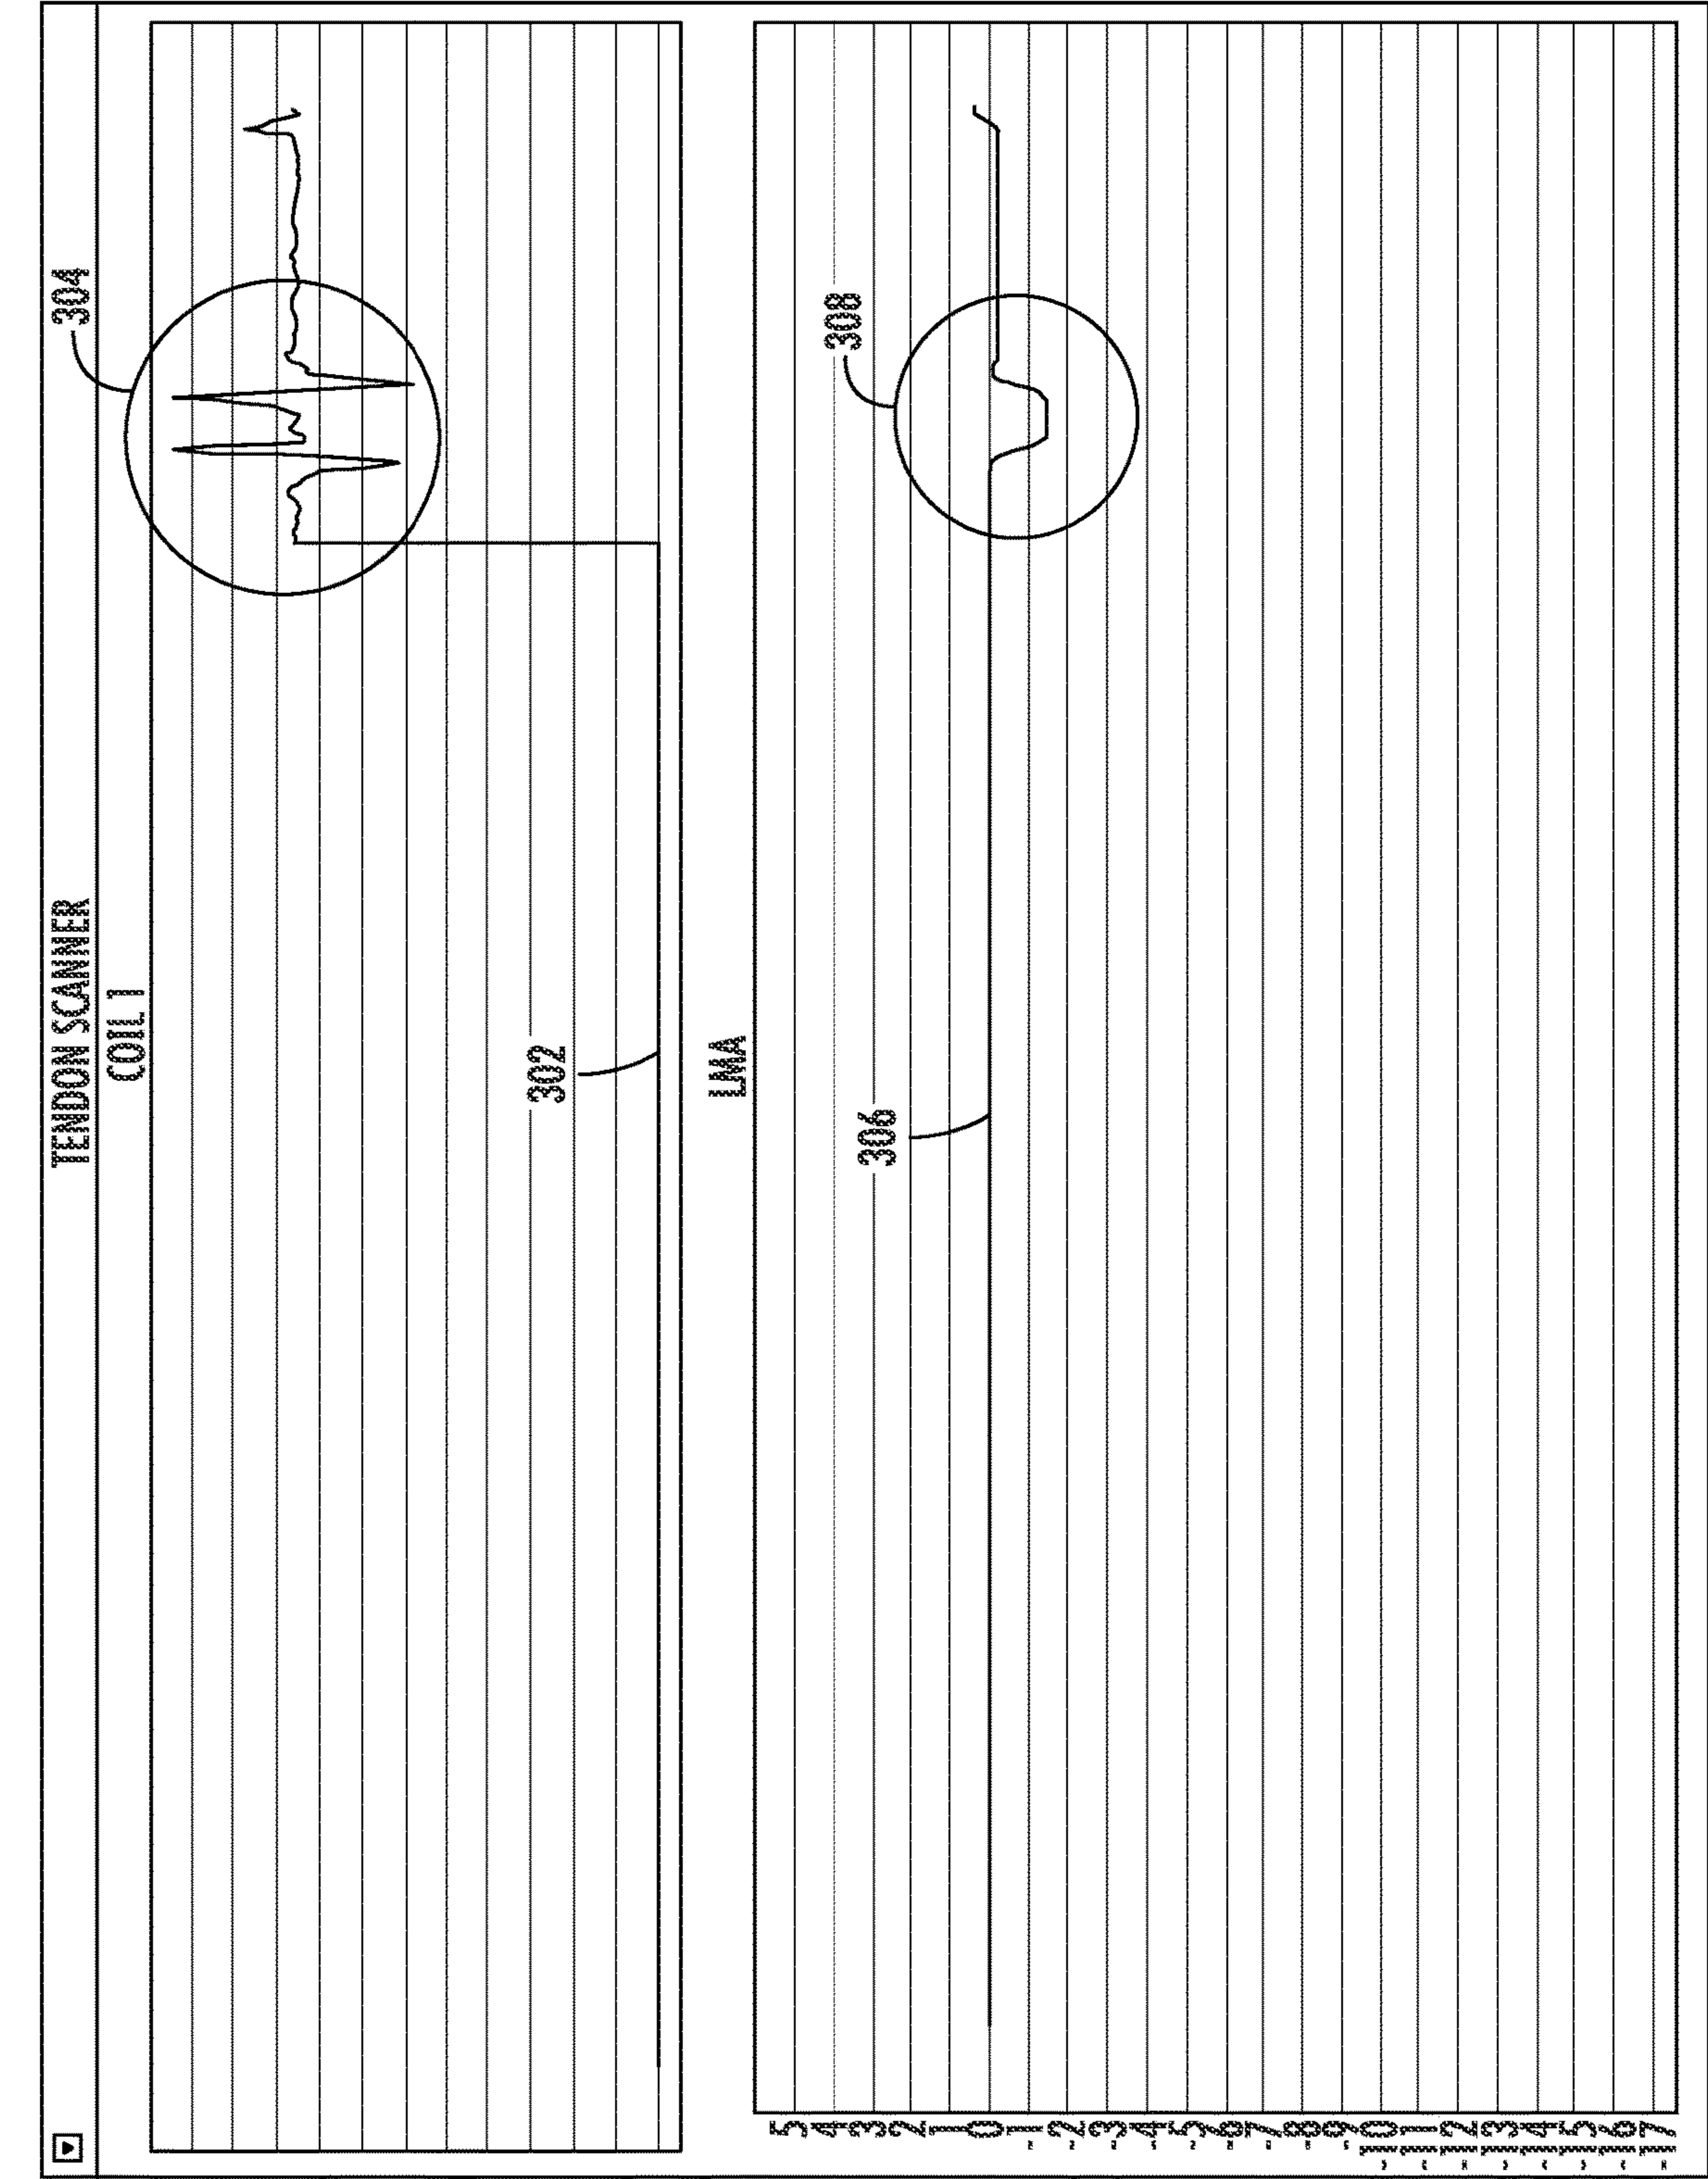
FIG. 9 is an exemplary graph generated by the sensing device.

In a particular illustrative embodiment, the sensing device **100** uses the magnetic flux leakage (MFL) method described above to generate a visual indicator of the condition of the bridge tendon **110**. For example, the visual indicator may be a two dimensional graph (as shown in FIG. **9** discussed below) that indicates where the discontinuity within the bridge tendon **112** is located and to what degree. The sensing device **100** takes multiple measurements of the magnetic field at the periphery of the bridge tendon **110** and combines these measurements to provide information of the magnetic properties of the process volume to indicate the extent of loss of magnetic area. This correlates to the amount of steel within the bridge tendon **100** that may be damaged.

Referring now to FIG. **9**, results of a non-destructive evaluation of external post-tensioned tendons of segmental bridges can be generated in a graph **300** to make it easy to interpret by the inspector. The results are included as part of a bridge tendon condition assessment report that is generated using the inspection results from the sensing device **200** and identifies locations and sizes of these discontinuities. By accurately detecting deficient areas within the external post-tensioned tendons of segmental bridges, repairs can be made more quickly and can be more efficiently conducted.
