(10) **Patent No.:** **US 11,485,106 B2**  
(45) **Date of Patent:** **Nov. 1, 2022**

(54) **FIRE HOSE AND MATERTAL THEREFORE**

Described herein are fire hoses incorporating new combi-  
nations of materials to increase the hose's resilience. Resil-  
ient hoses include those made with silicone-coated fabrics or  
with thermally-resistant fabrics or both.

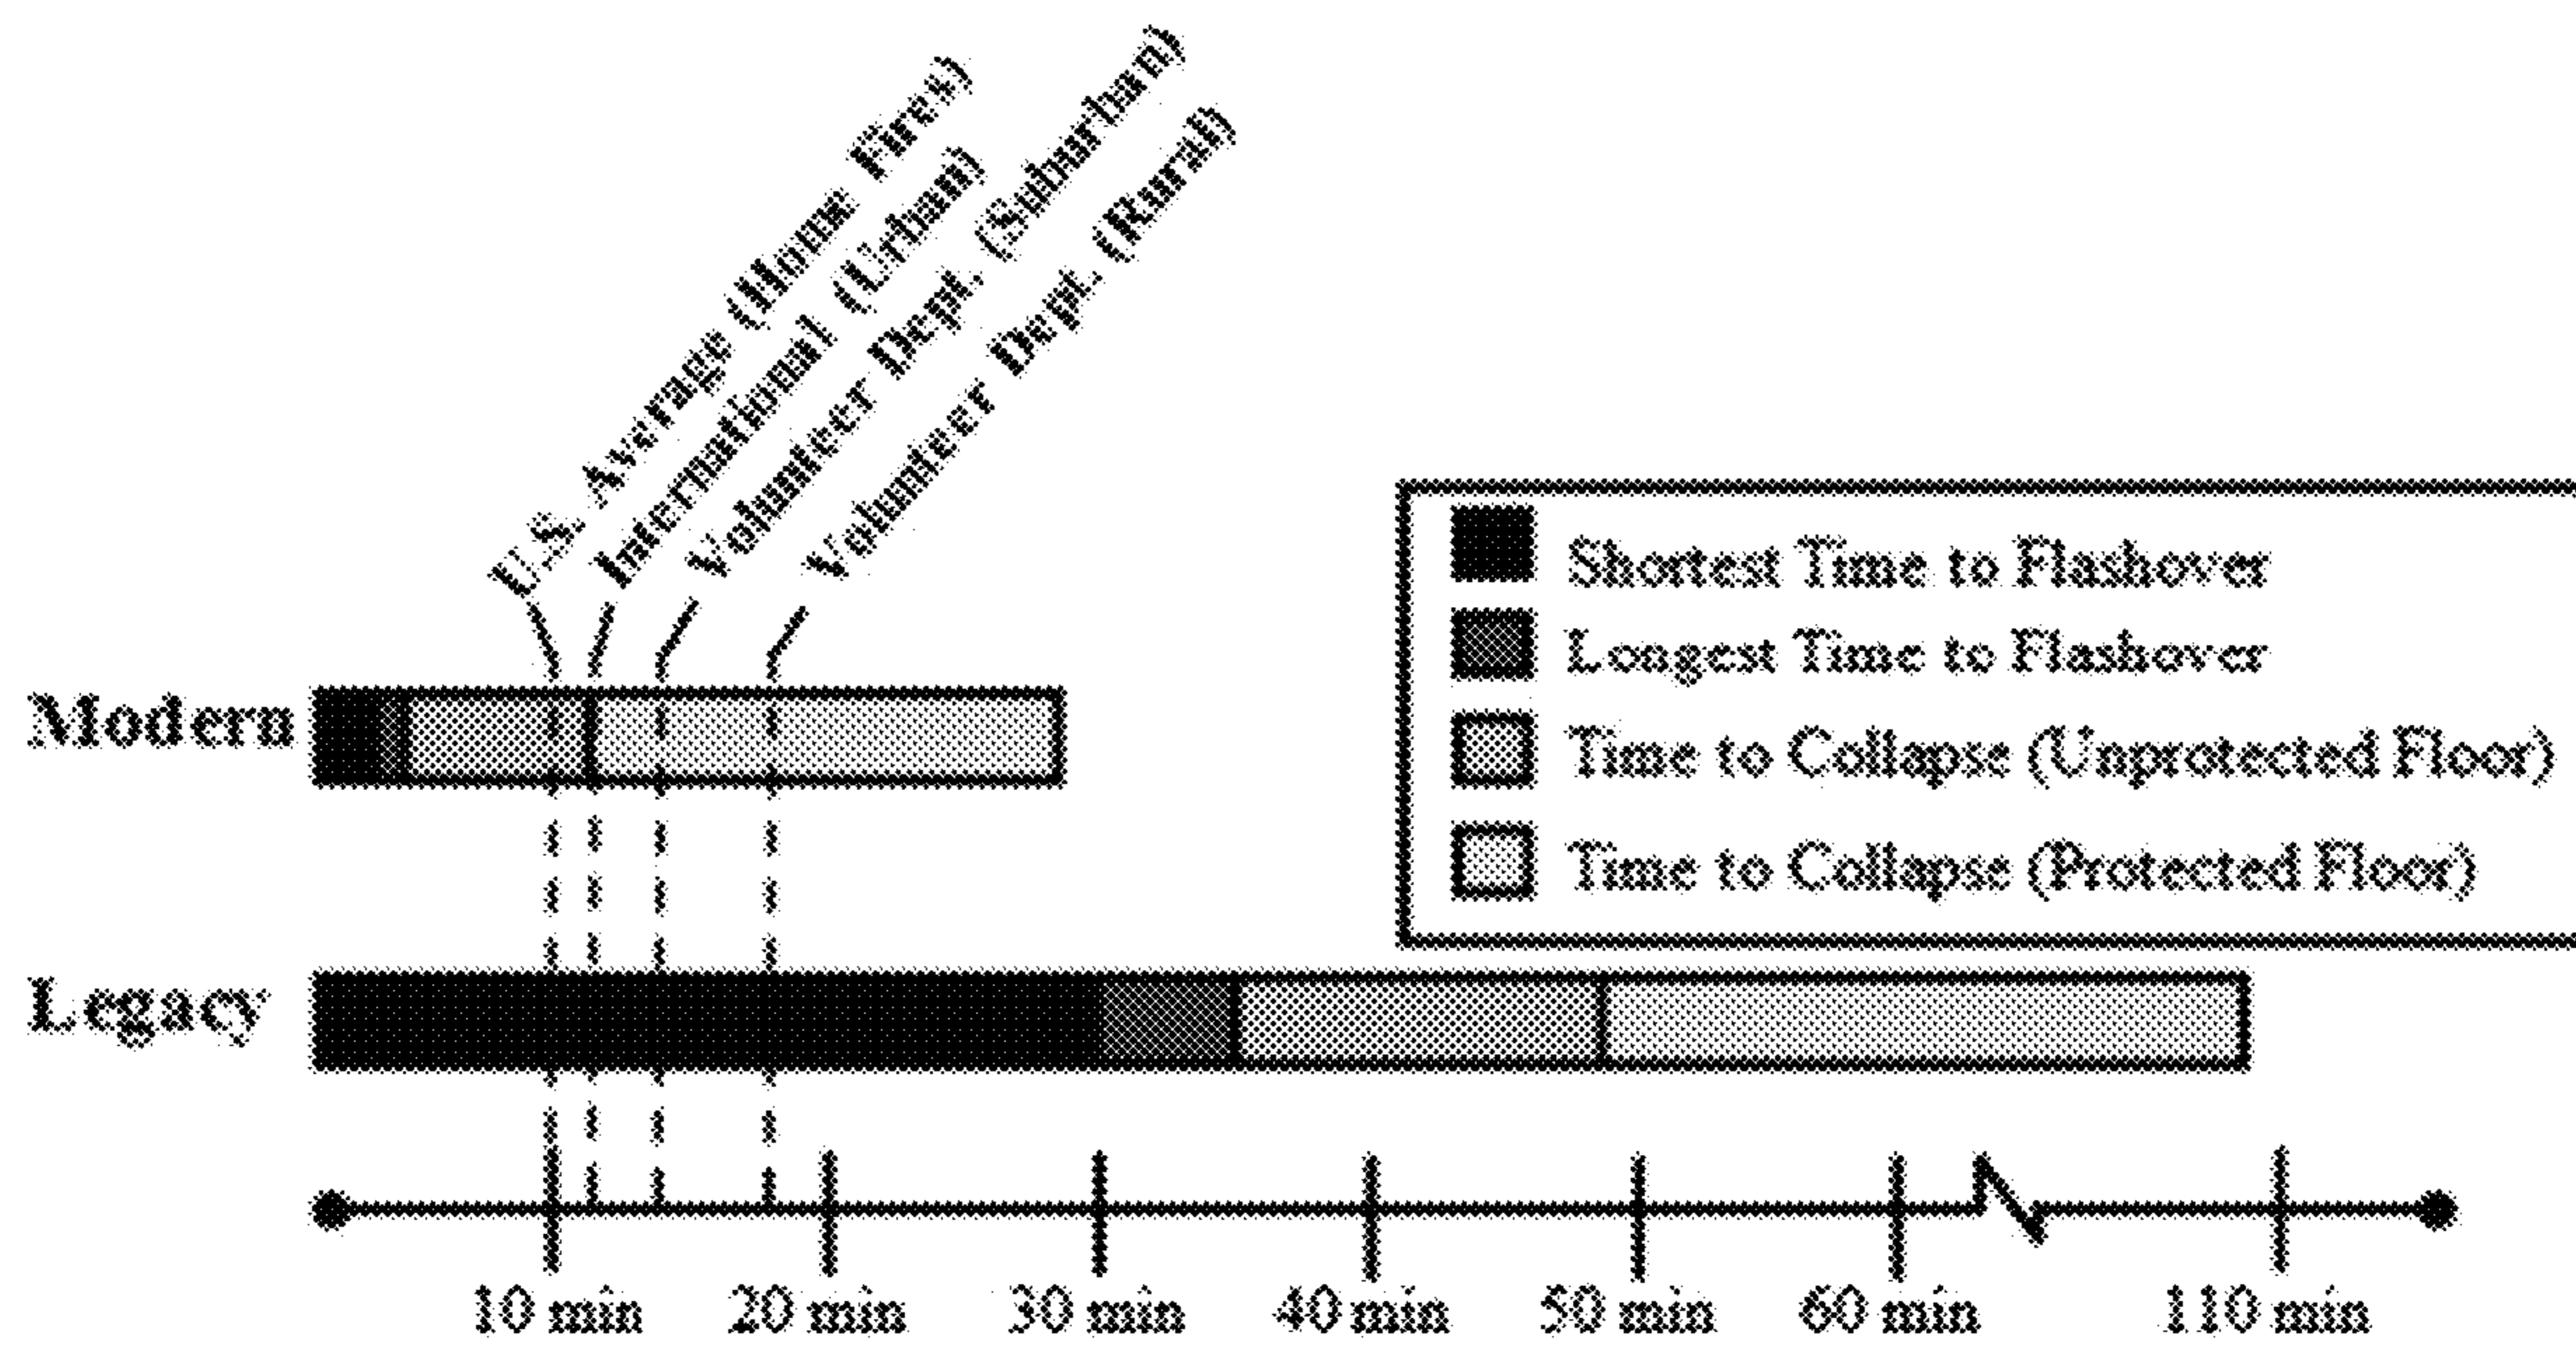
FIG. 1 shows a comparison of modern vs legacy safe operational timelines and department arrival times (Ahrens M., Home structure fires. National Fire Protection Association, Quincy (2010)).

Firefighters and their equipment are exposed to extreme conditions in the operating environment. These conditions have changed over time due to changes in construction methods and materials. These changes have resulted in increased thermal exposures within a reduced operational timeline, as shown in FIG. 1. As response times have not significantly changed, the available safe operational time for firefighters has been reduced and their equipment is potentially subject to greater thermal exposure. (Ahrens M (2010) Home structure fires. National Fire Protection Association, Quincy; Fahy R F (2010) US fire service fatalities in structure fires, 1977-2009. National Fire Protection Research Foundation, Quincy)

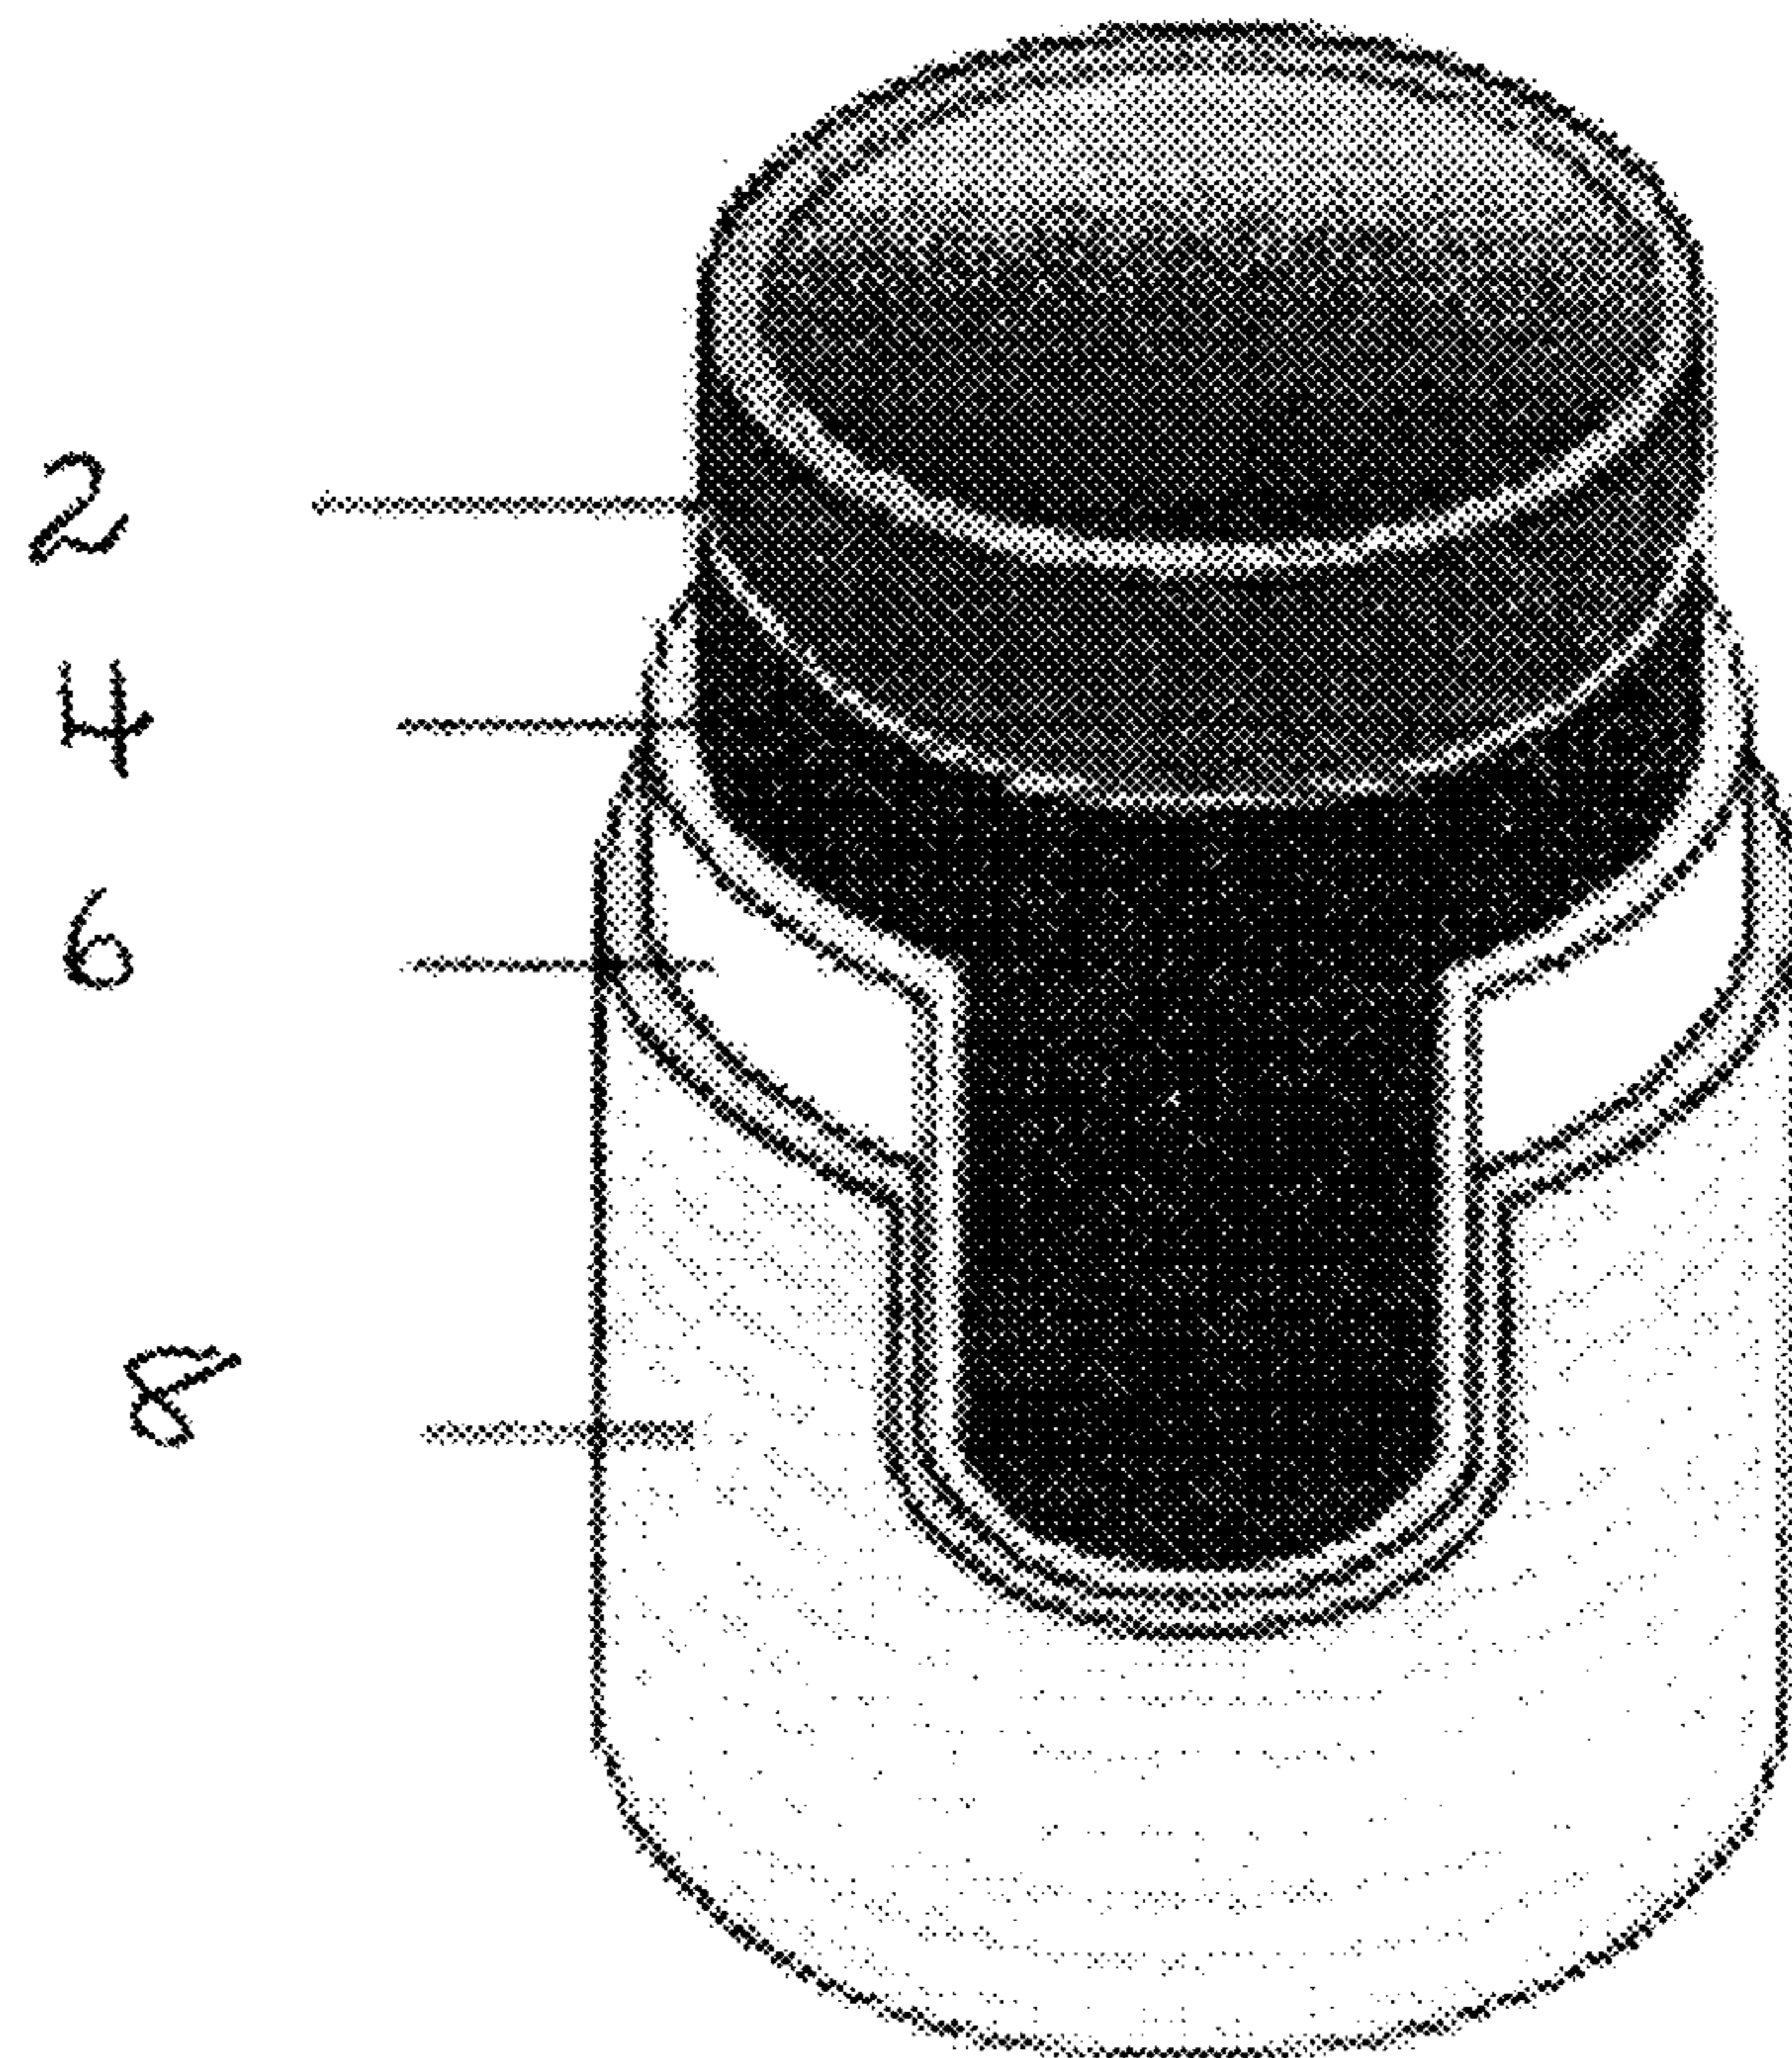
FIG. 2 shows a diagram of one embodiment of the invention.

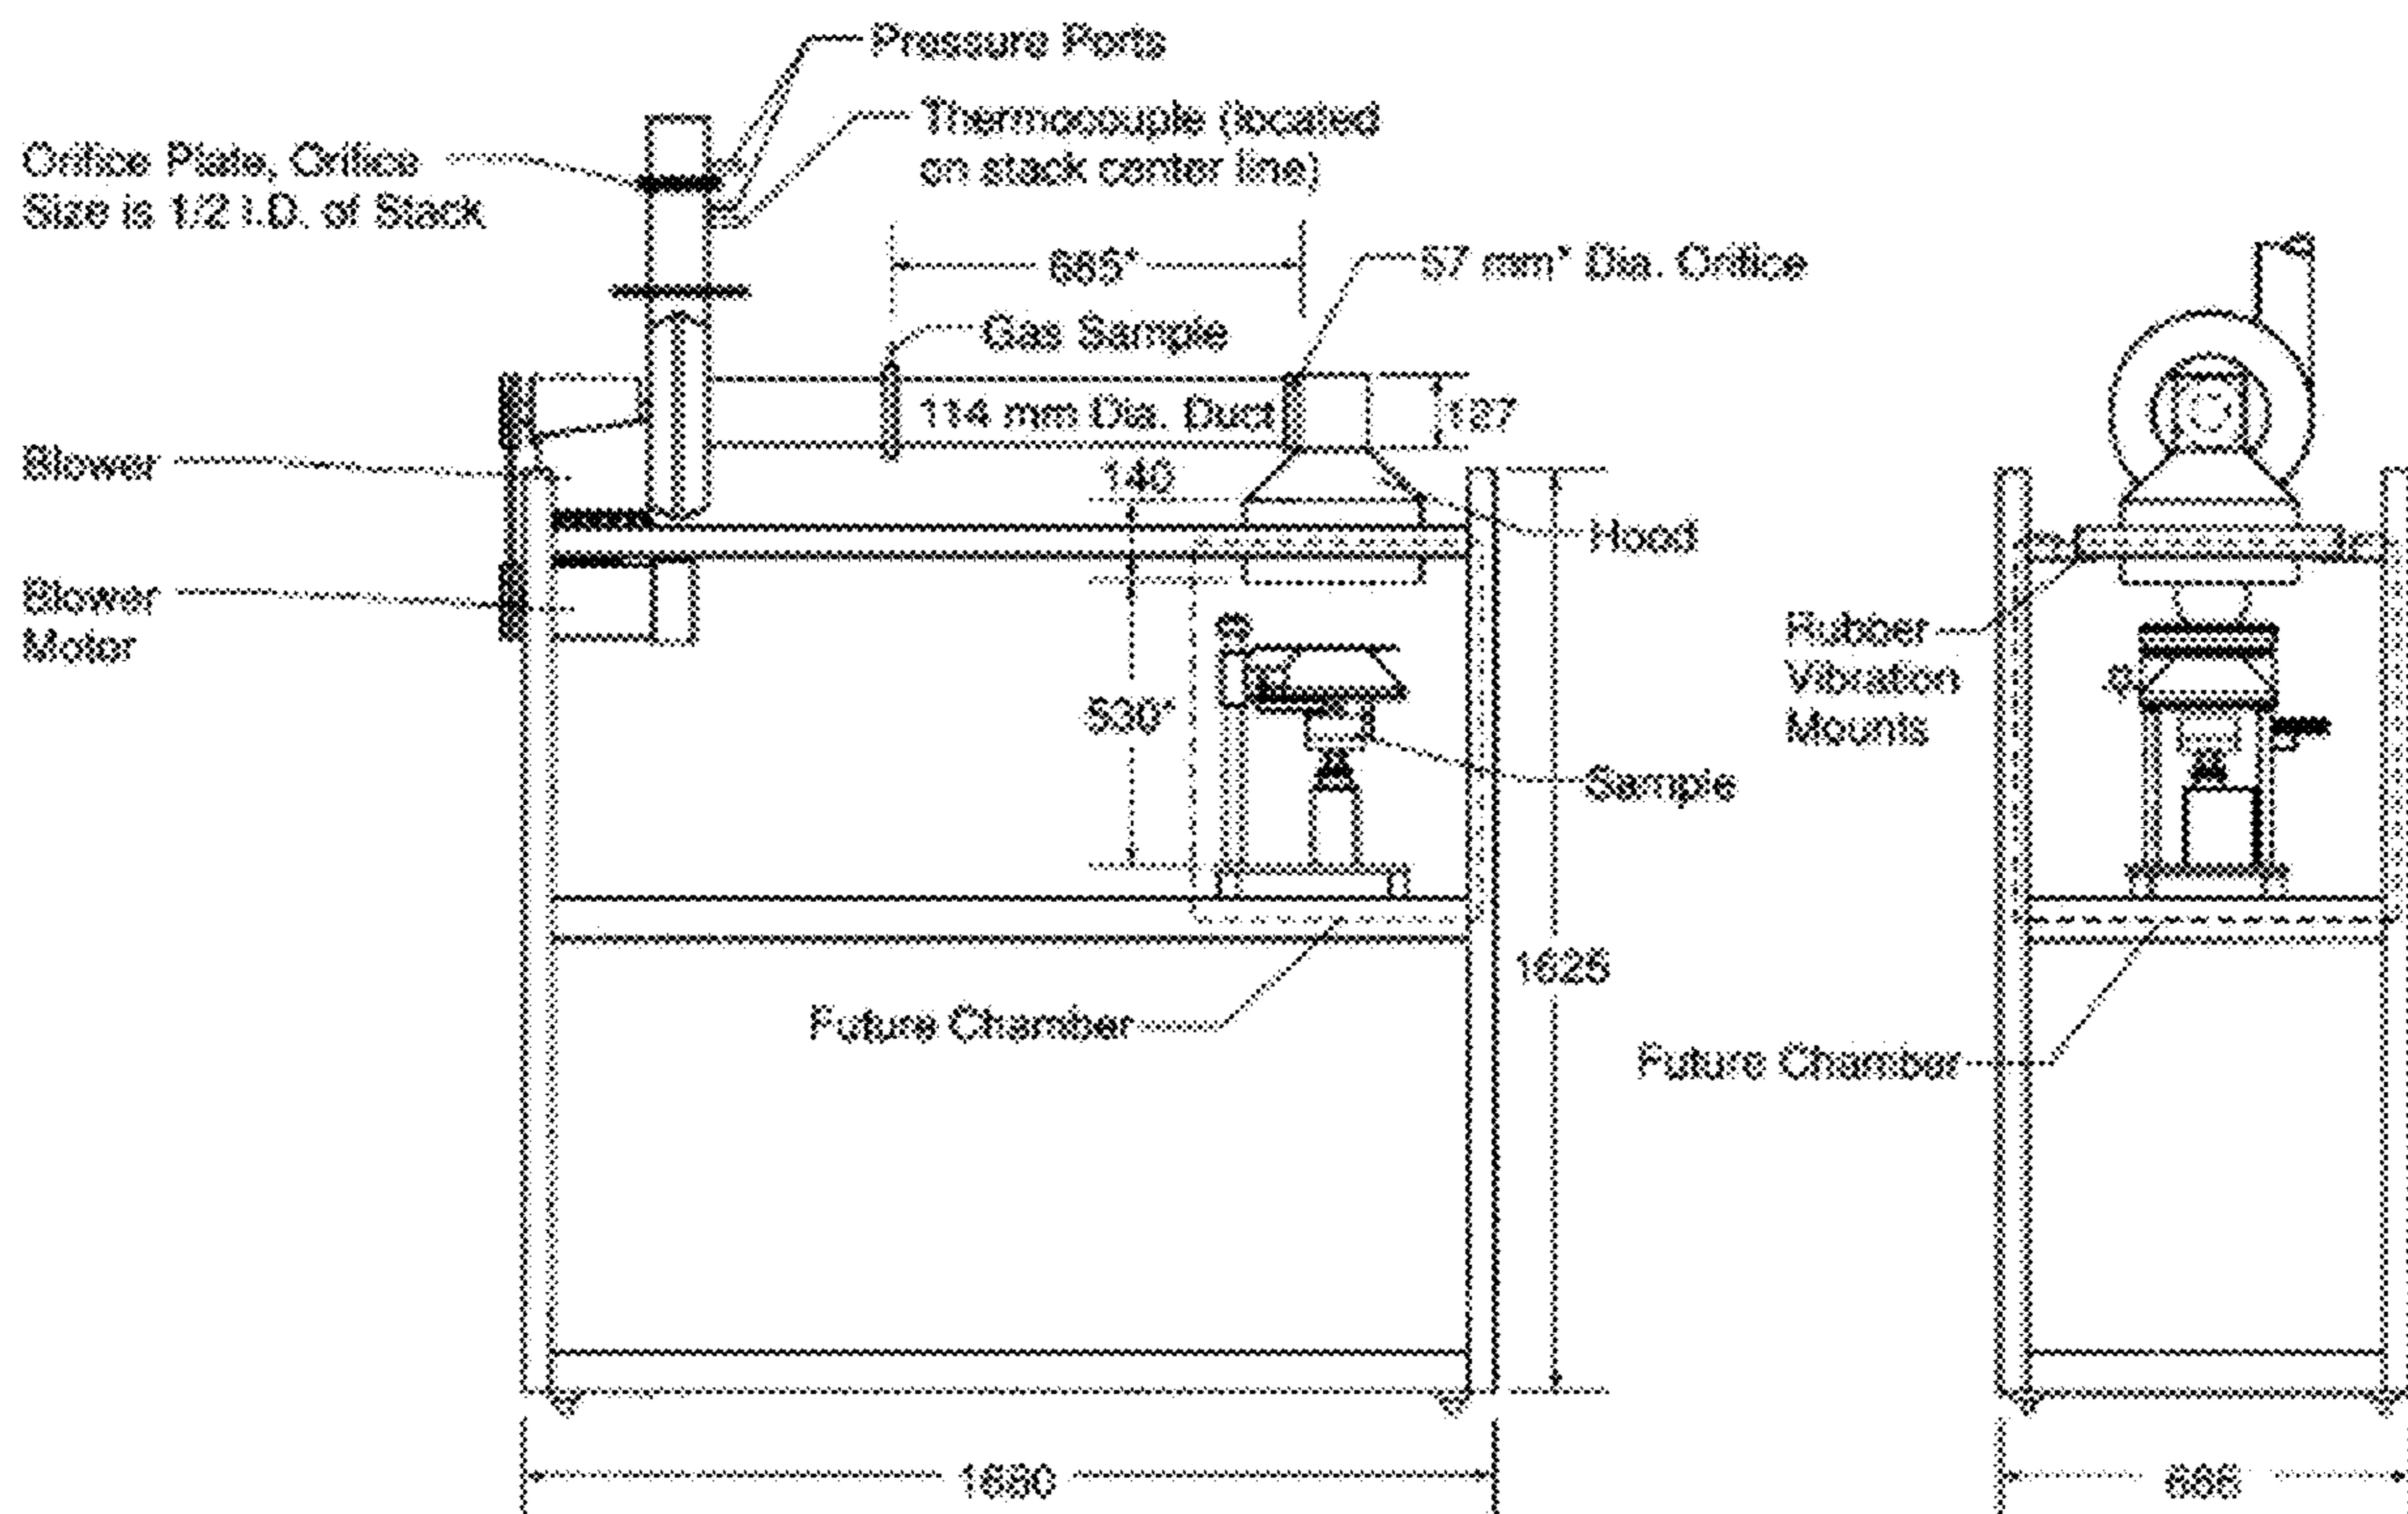
FIG. 3

A total of seven materials from various manufacturers were tested at varying heat fluxes using the ASTM E 1354 cone calorimeter, shown in FIG. 3. The cone calorimeter approach of ASTM E 1354 enables a variety of measurements of a burning sample. Such measurements can include smoke and soot production, oxygen consumption and concentration, ignition delay, mass loss rate, toxic gas production, temperature and pressure of the exhaust gas flow, and effective heat of combustion. The gas analyzer used in typical oxygen consumption calorimetry extracts samples of exhaust gases, scrubs it of combustion products, and determines the oxygen concentration.

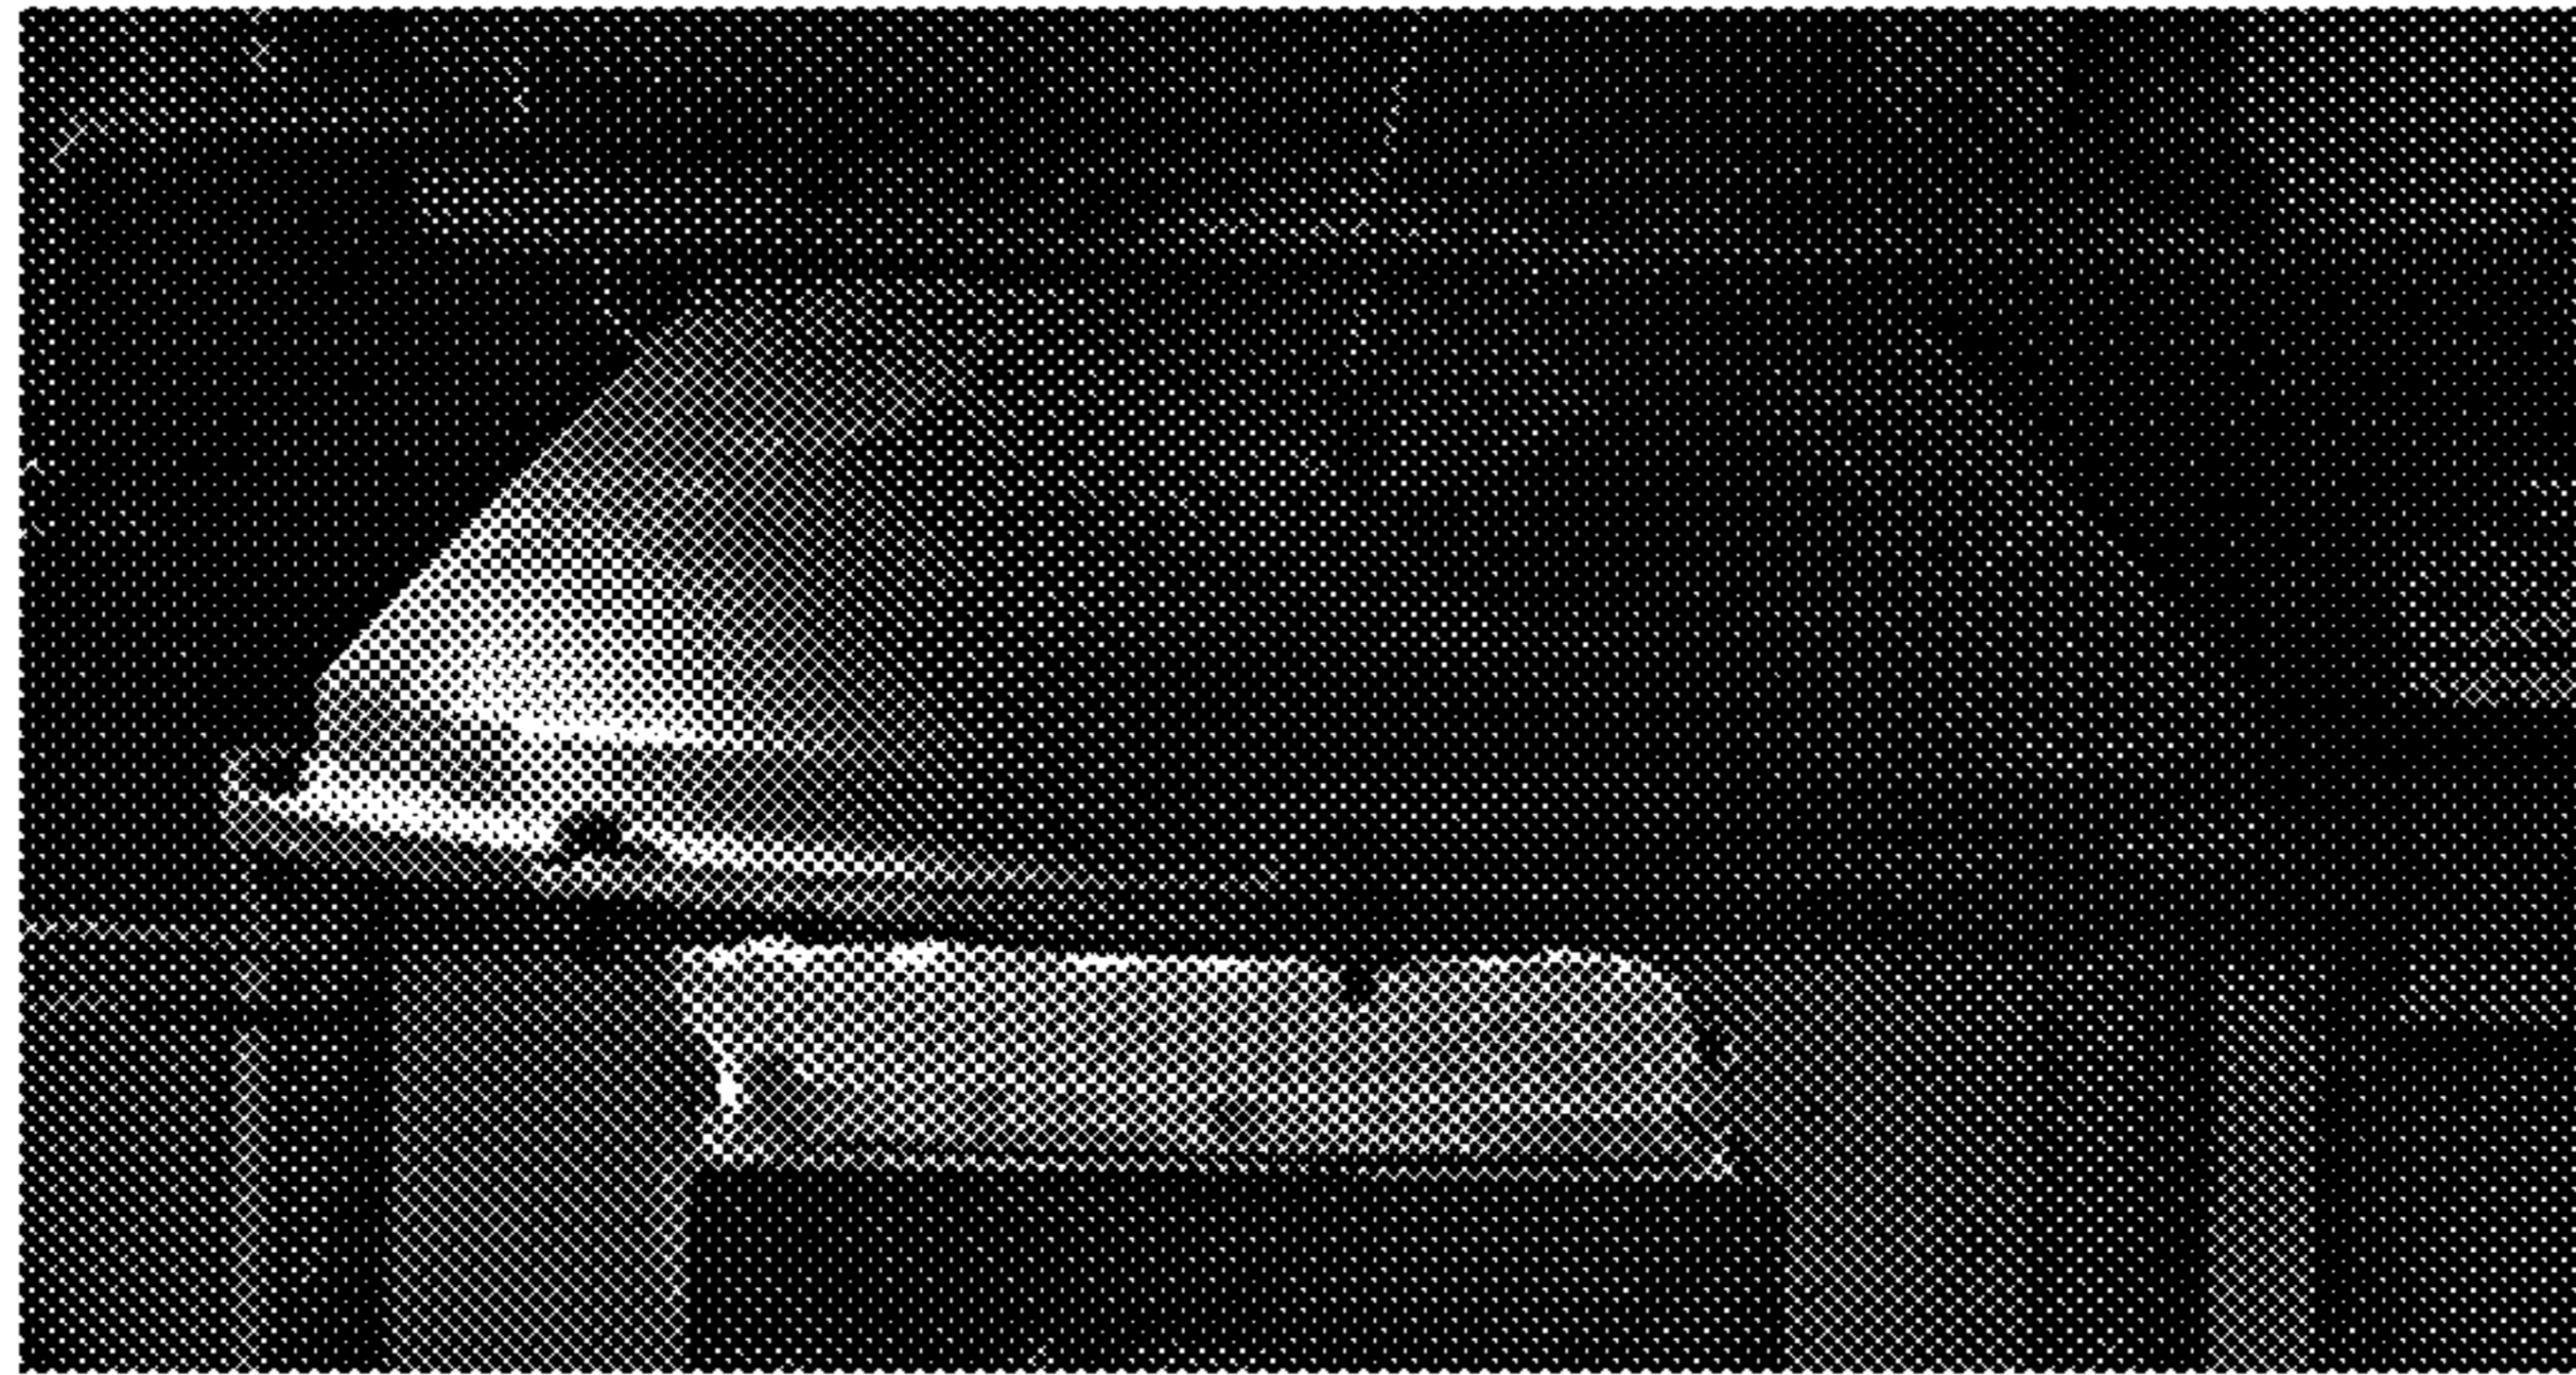
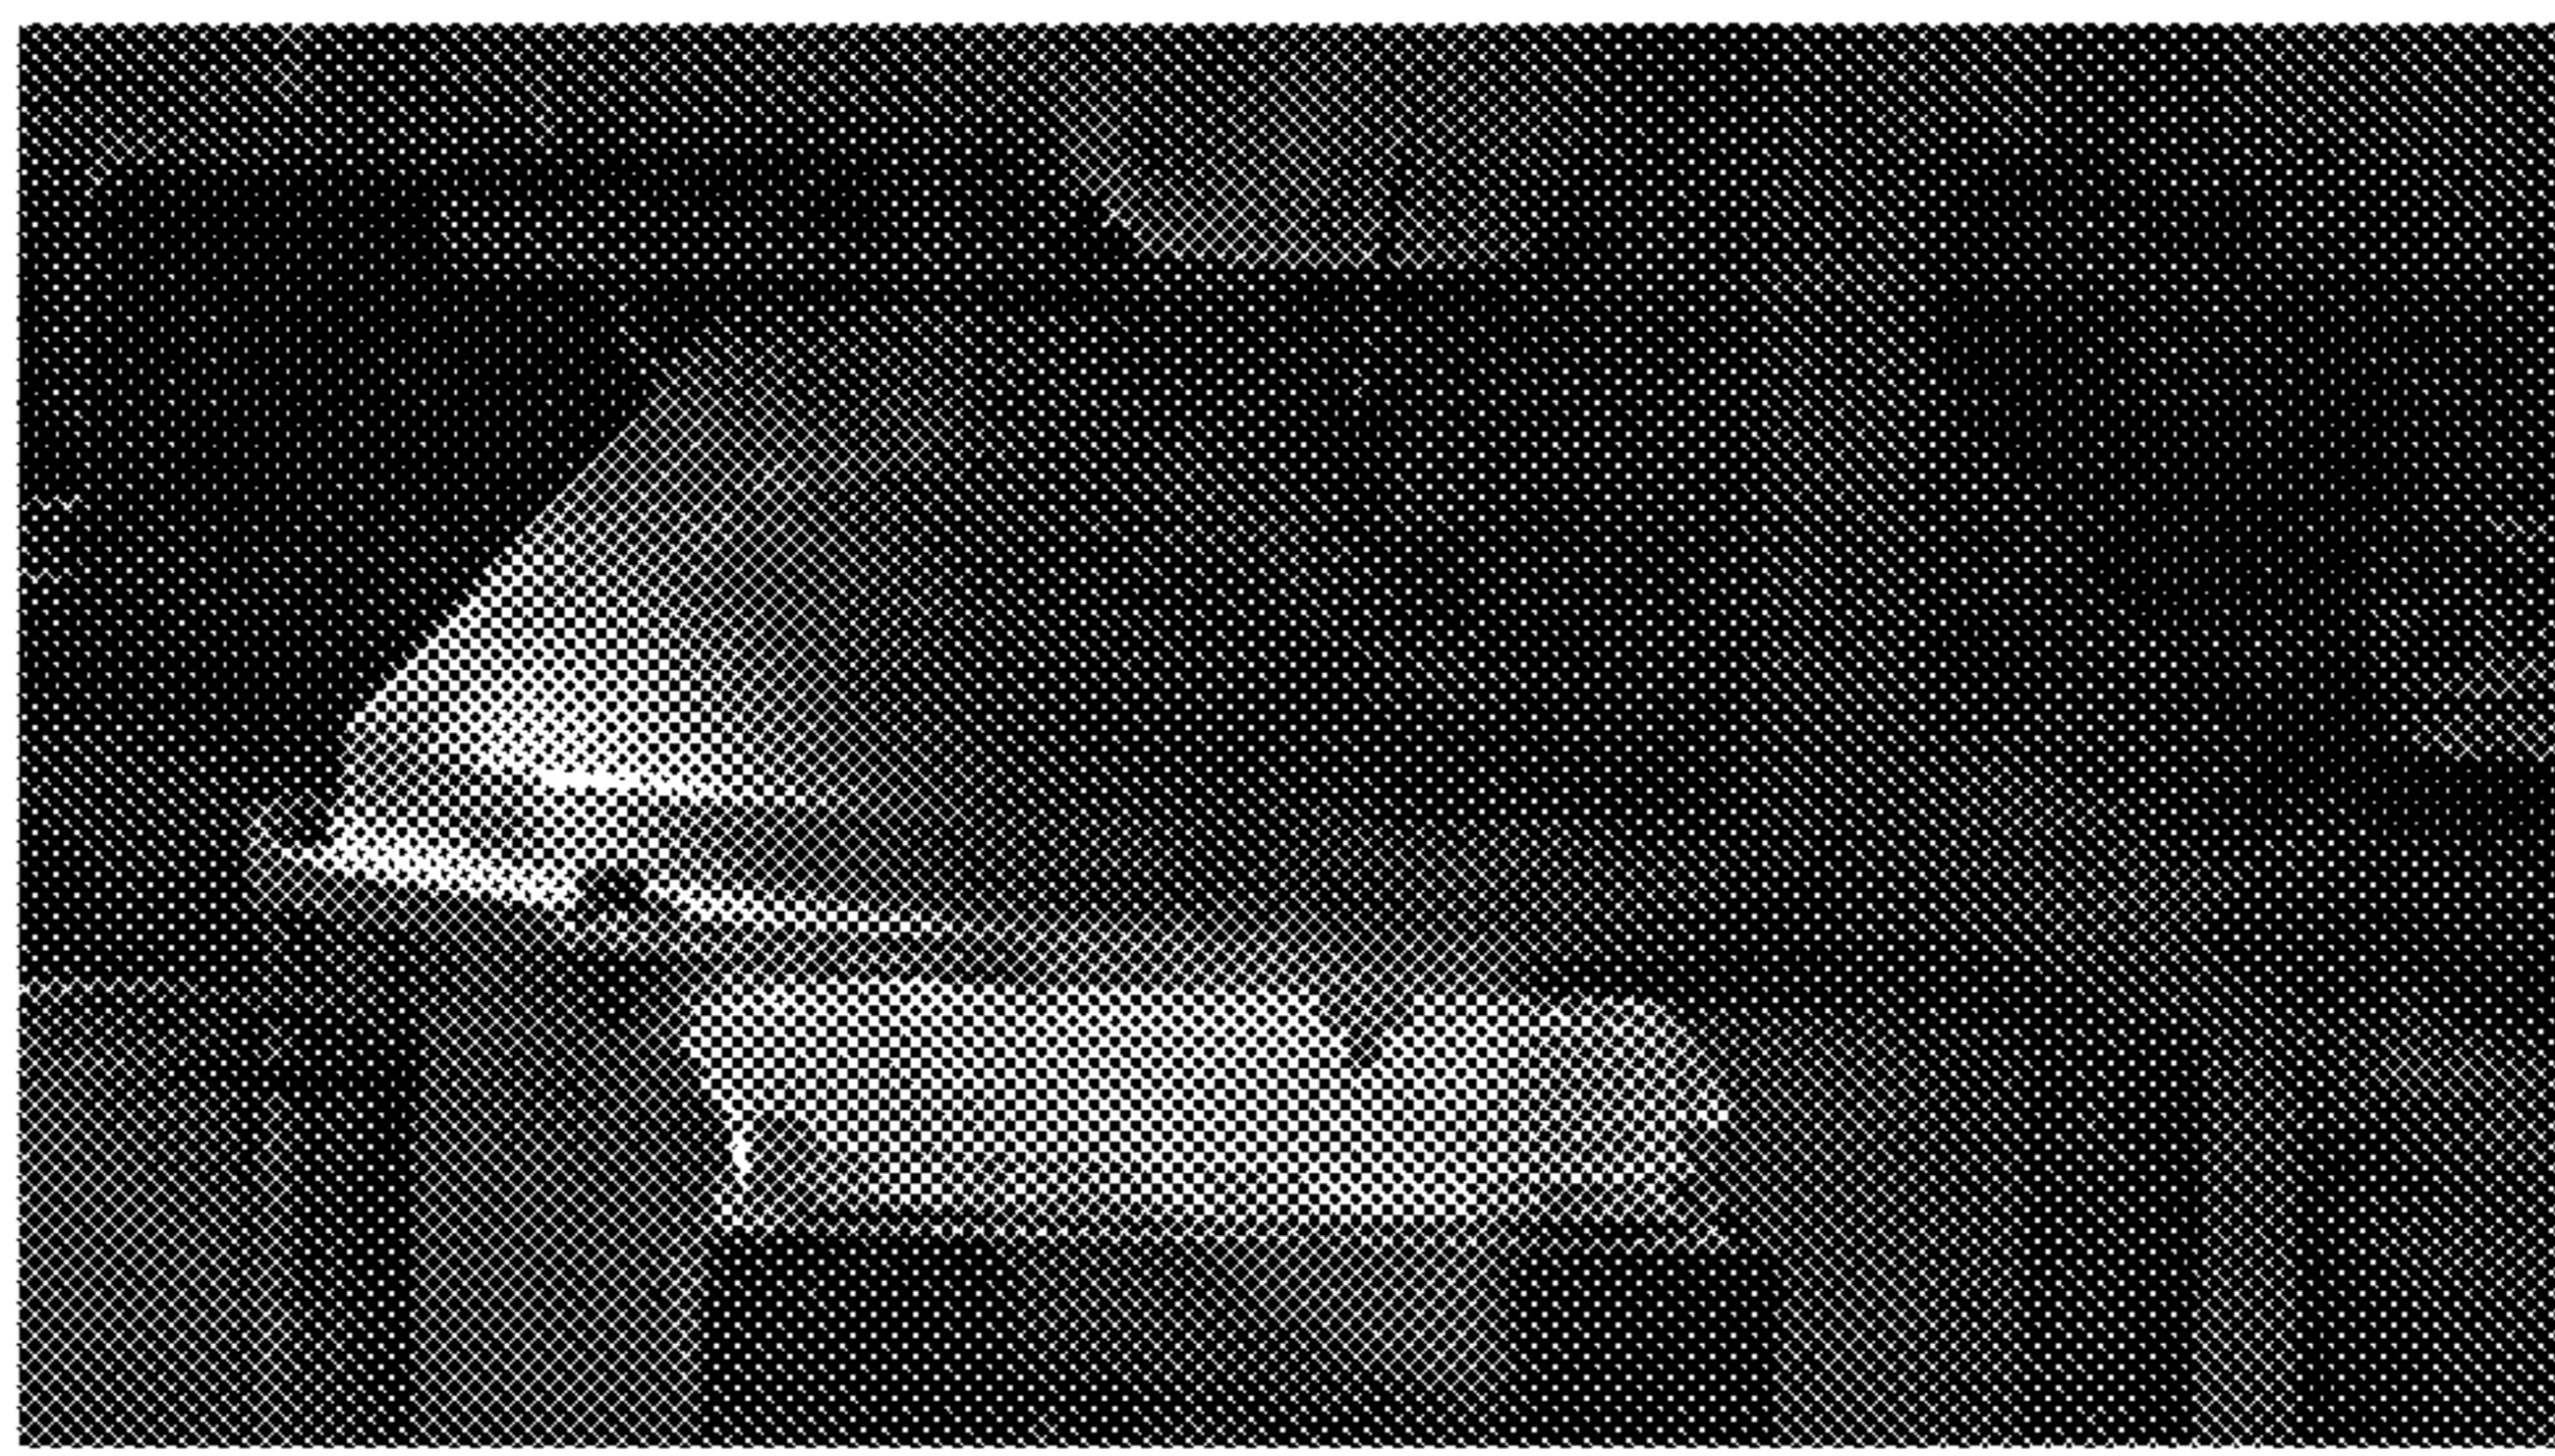
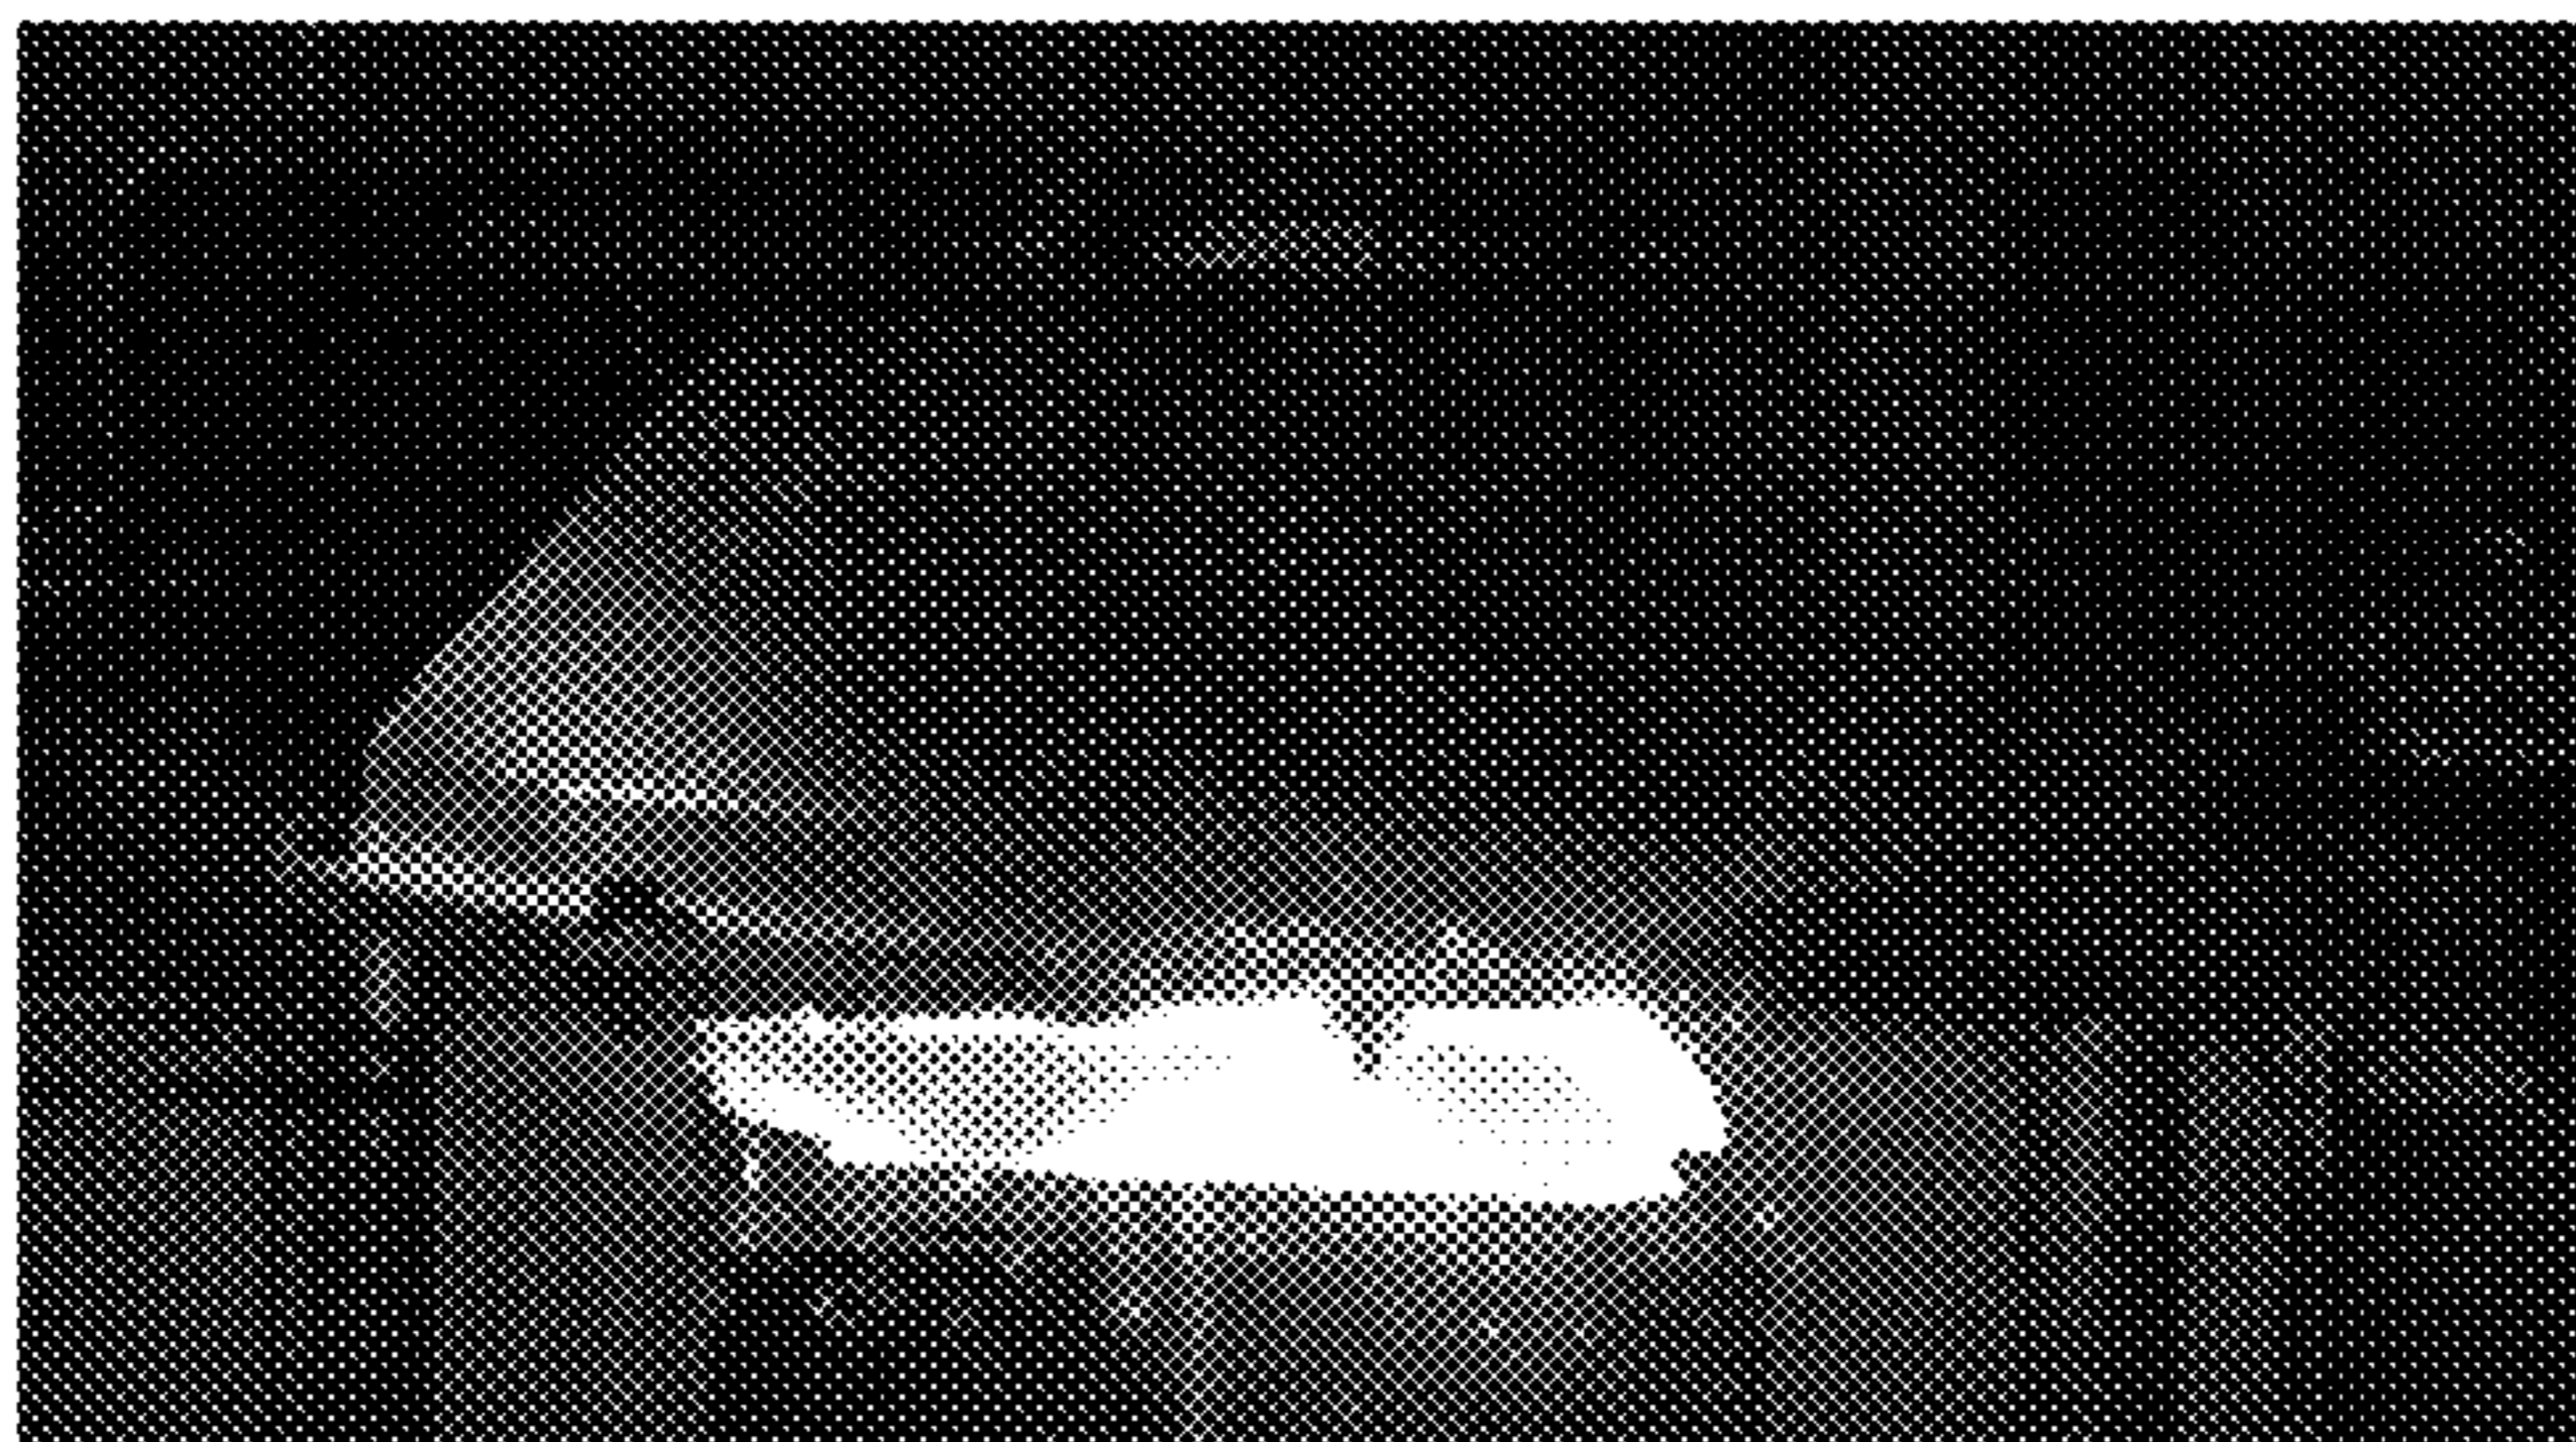
FIG. 4A

FIG. 4A-FIG. 4D show sample behaviors in the cone calorimeter; initial heating (FIG. 4A); off-gassing (FIG. 4B); ignition (FIG. 4C); and extensive thermal degradation (FIG. 4D).

Observations were made throughout the course of the experiment to determine the time for the surface of the material to "off-gas", discoloration to occur, thermal degradation (such as curling of corners, swelling, blistering, or effects after ignition), ignition (sustained and non-sustained), and burn-through of the sample. FIG. 4 provides examples of the observed sample behavior.
