(10) **Patent No.:** **US 11,485,106 B2**  
(45) **Date of Patent:** **Nov. 1, 2022**

(54) **FIRE HOSE AND MATERTAL THEREFORE**

Described herein are fire hoses incorporating new combi-  
nations of materials to increase the hose's resilience. Resil-  
ient hoses include those made with silicone-coated fabrics or  
with thermally-resistant fabrics or both.

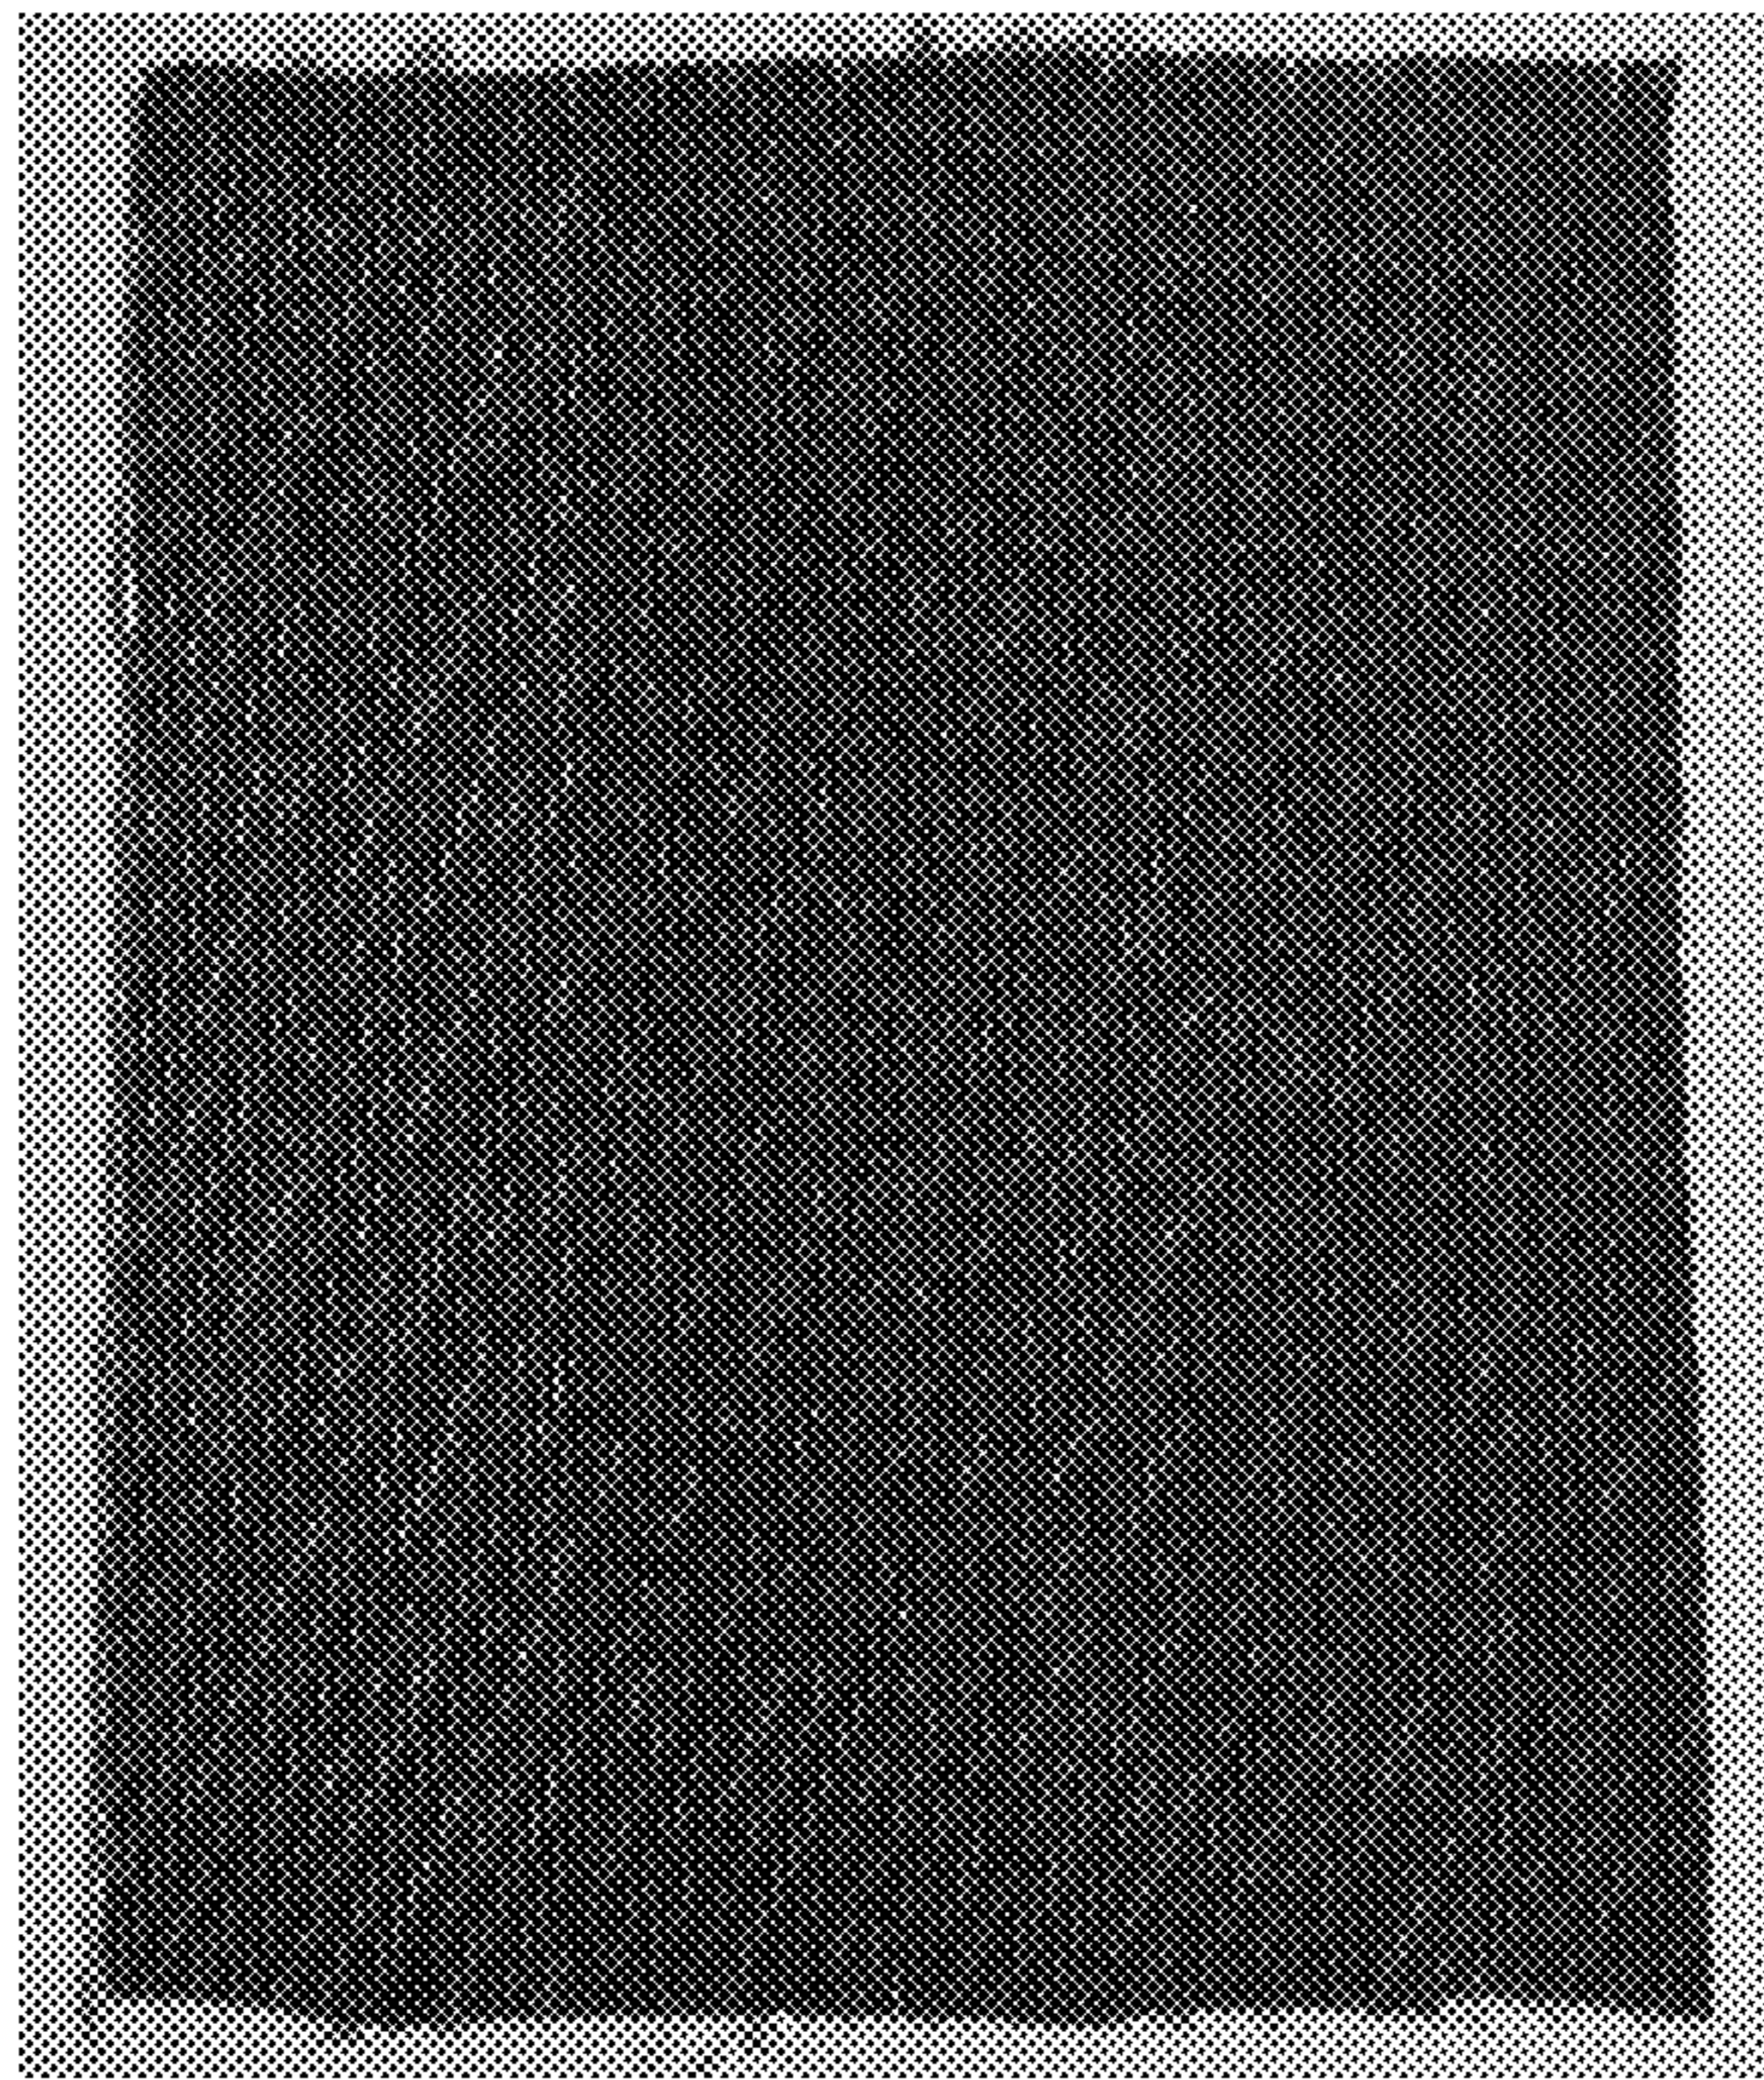
**FIG. 5**

FIG. 5 shows a sample of Material A prior to testing.

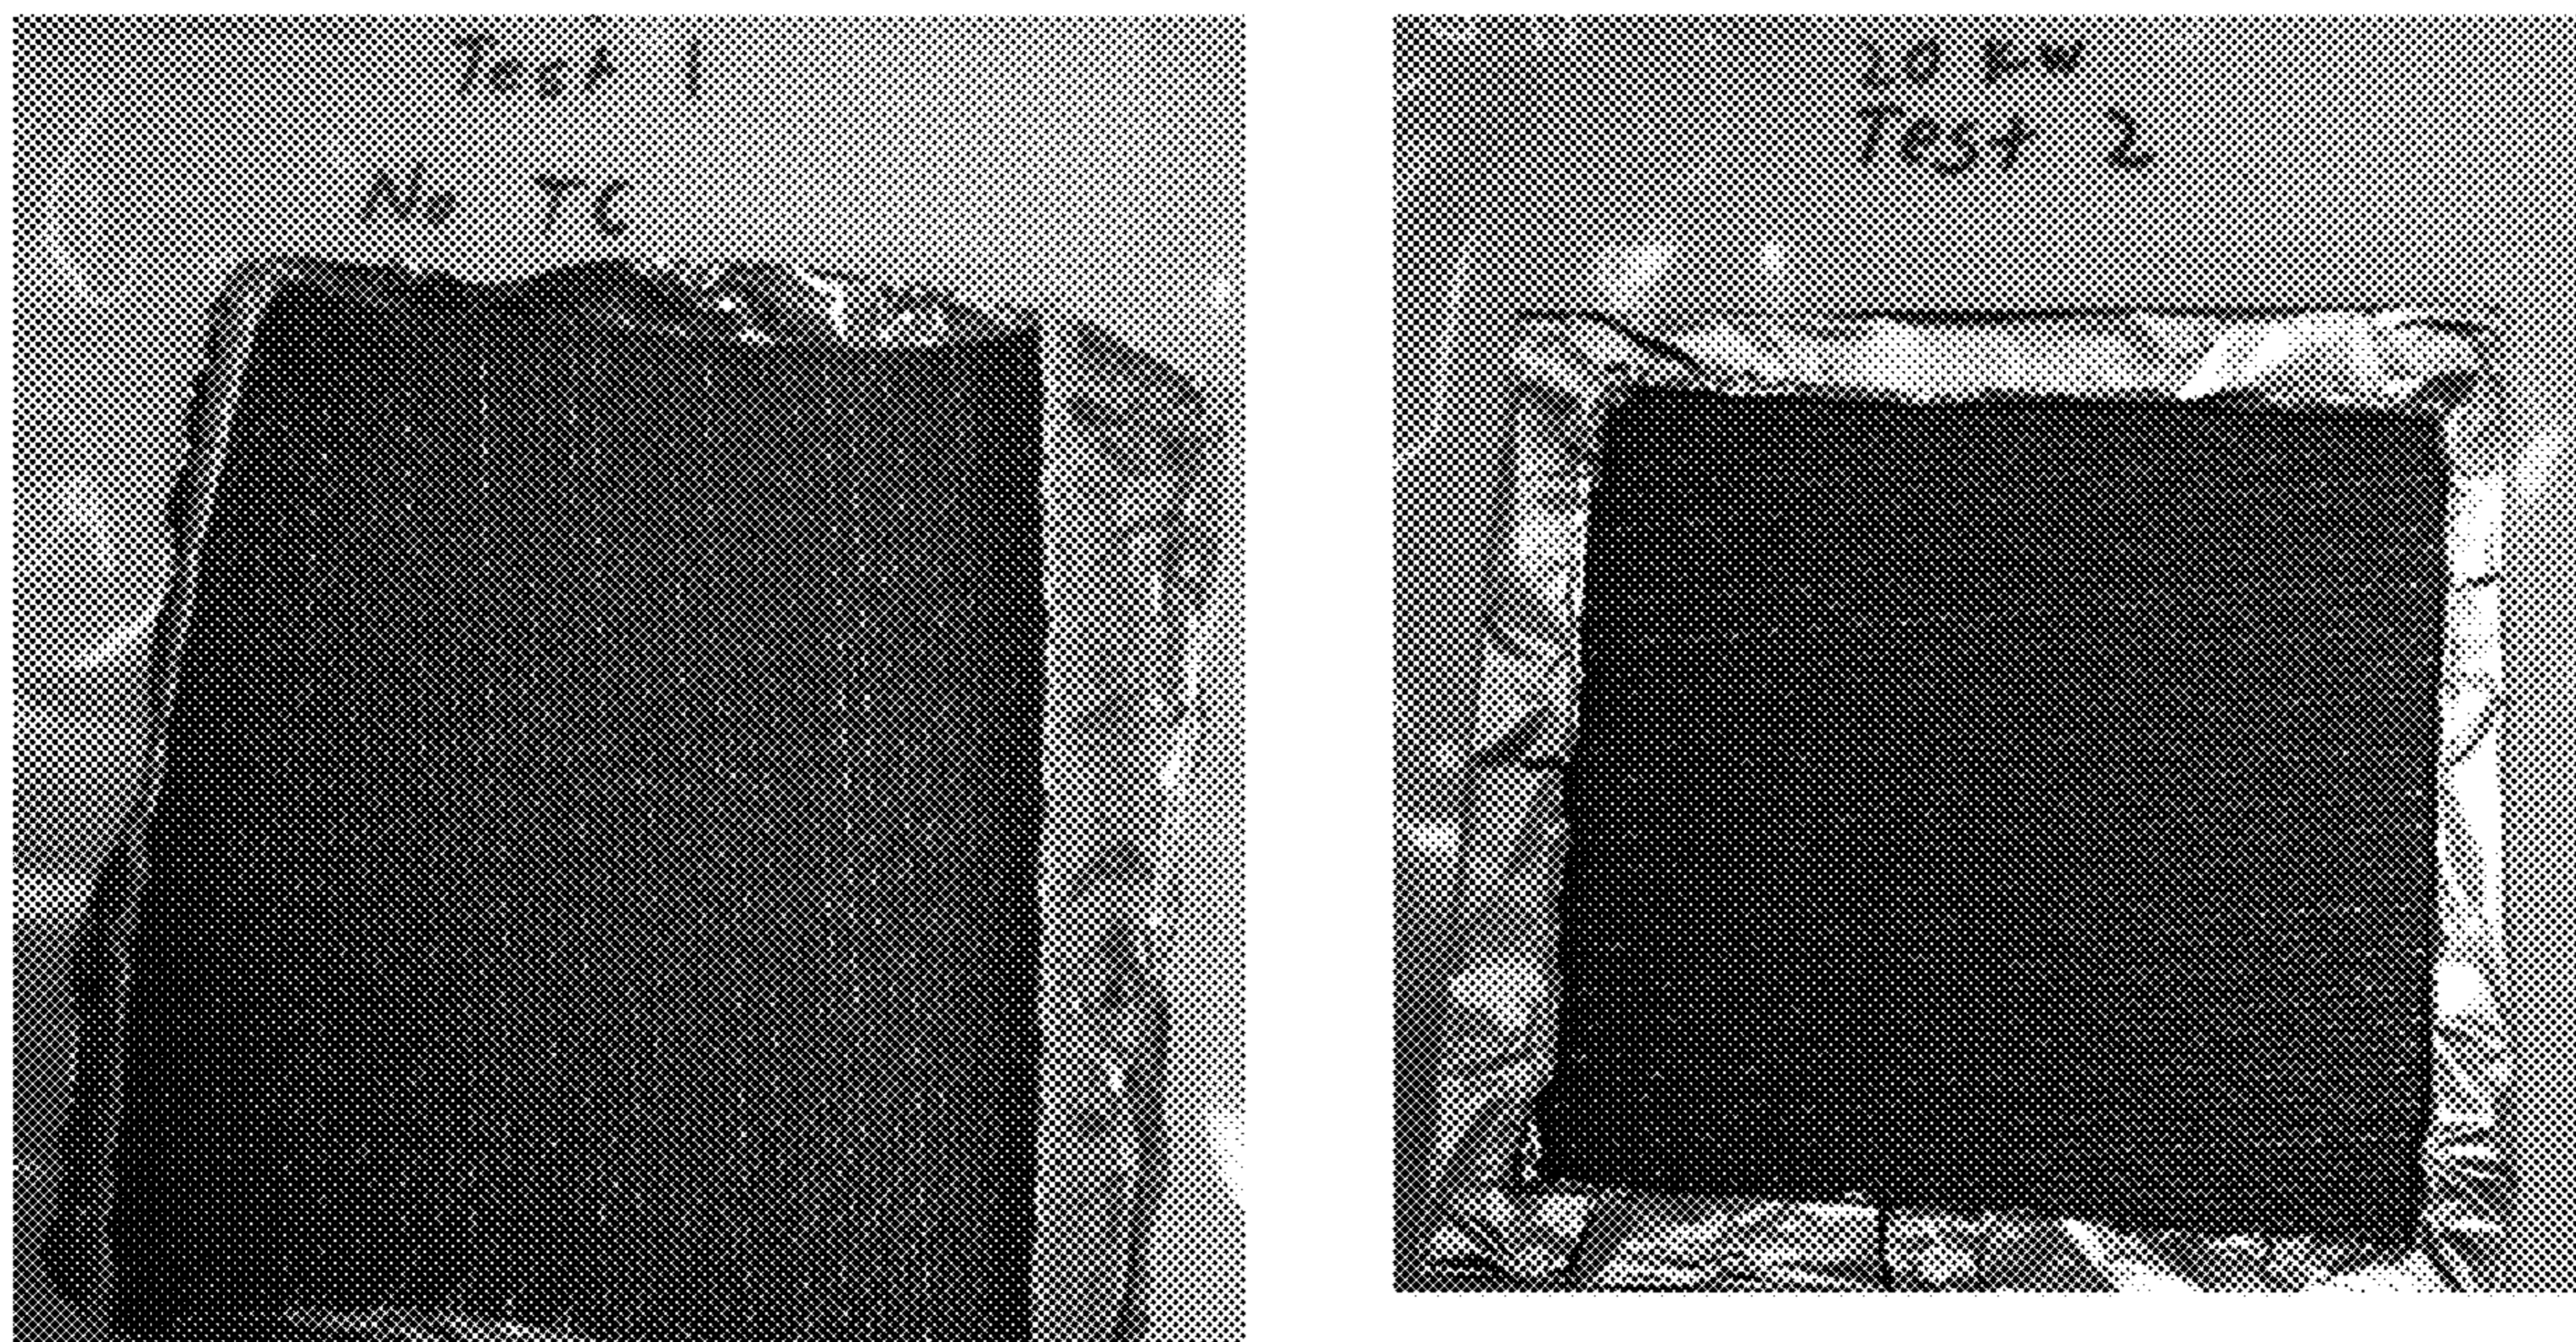
For both Test 1 and Test 2, visible off-gassing was observed. When the samples were being removed from underneath the cone, a purplish tint was observed, but the samples returned to the original reddish color after a few minutes. Both samples felt significantly more rough and appeared less red than prior to being heated. When the samples were moved in a flexible way, they felt slightly less flexible (more rigid) and a "crackling" sound was heard when bent. FIG. 6 shows the state of the samples after being removed from the calorimeter.

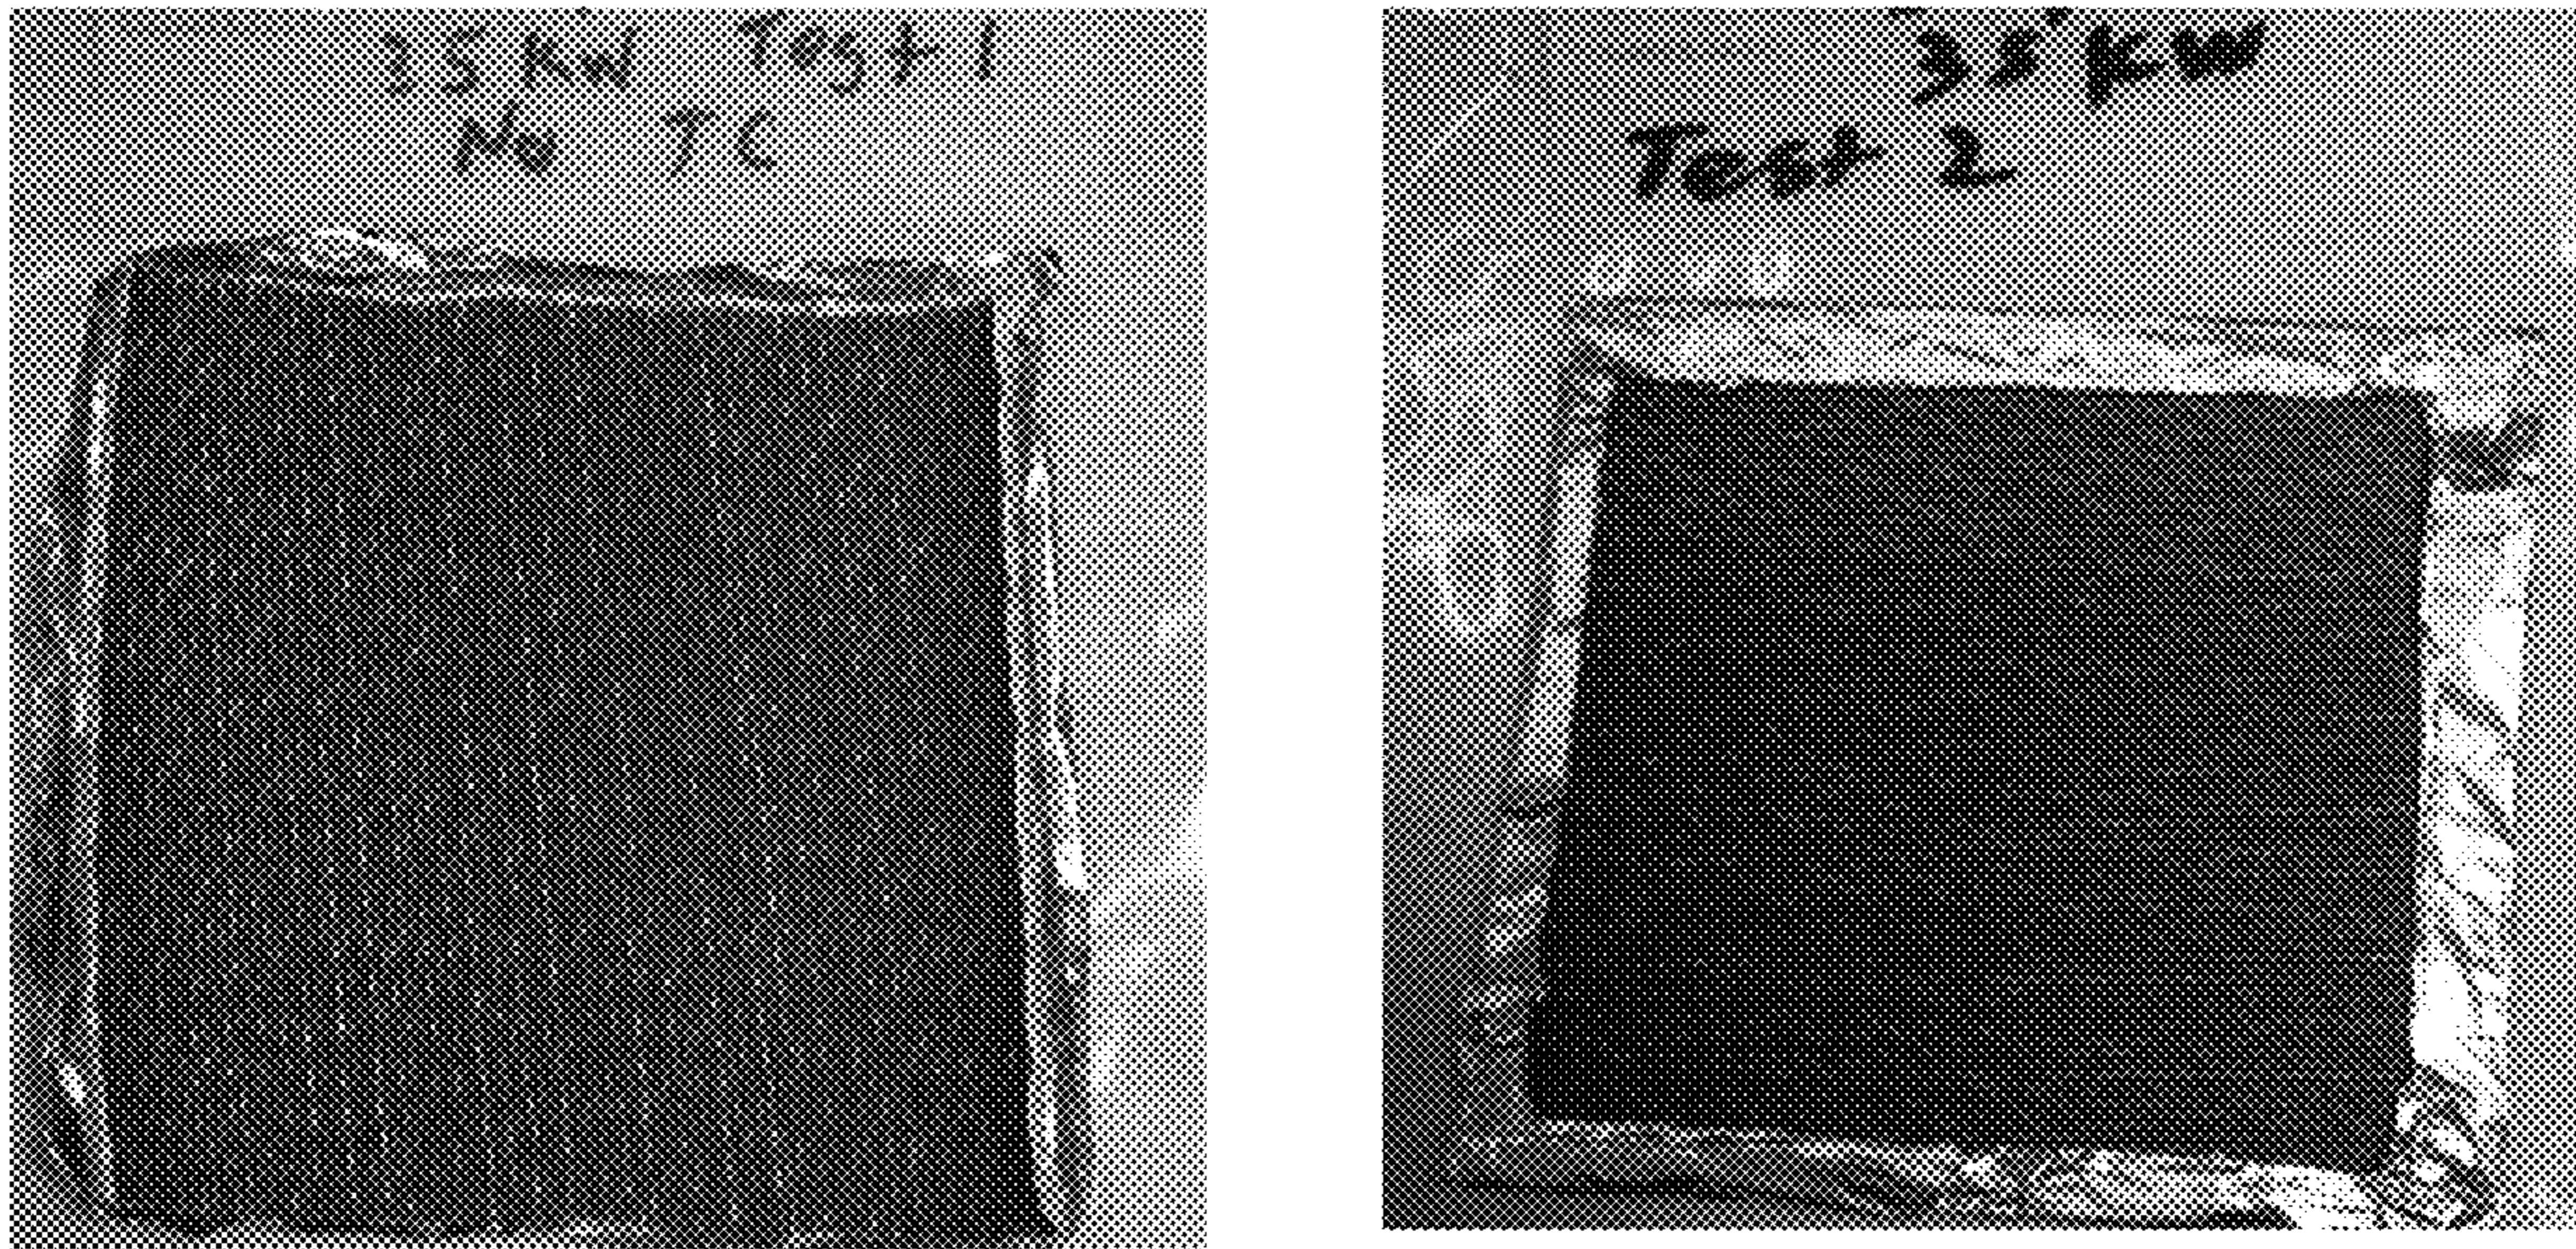
FIG. 7 shows Material A samples after 35 kW/m<sup>2</sup> radiant heating (showing Test 1 (left) and Test (right)).

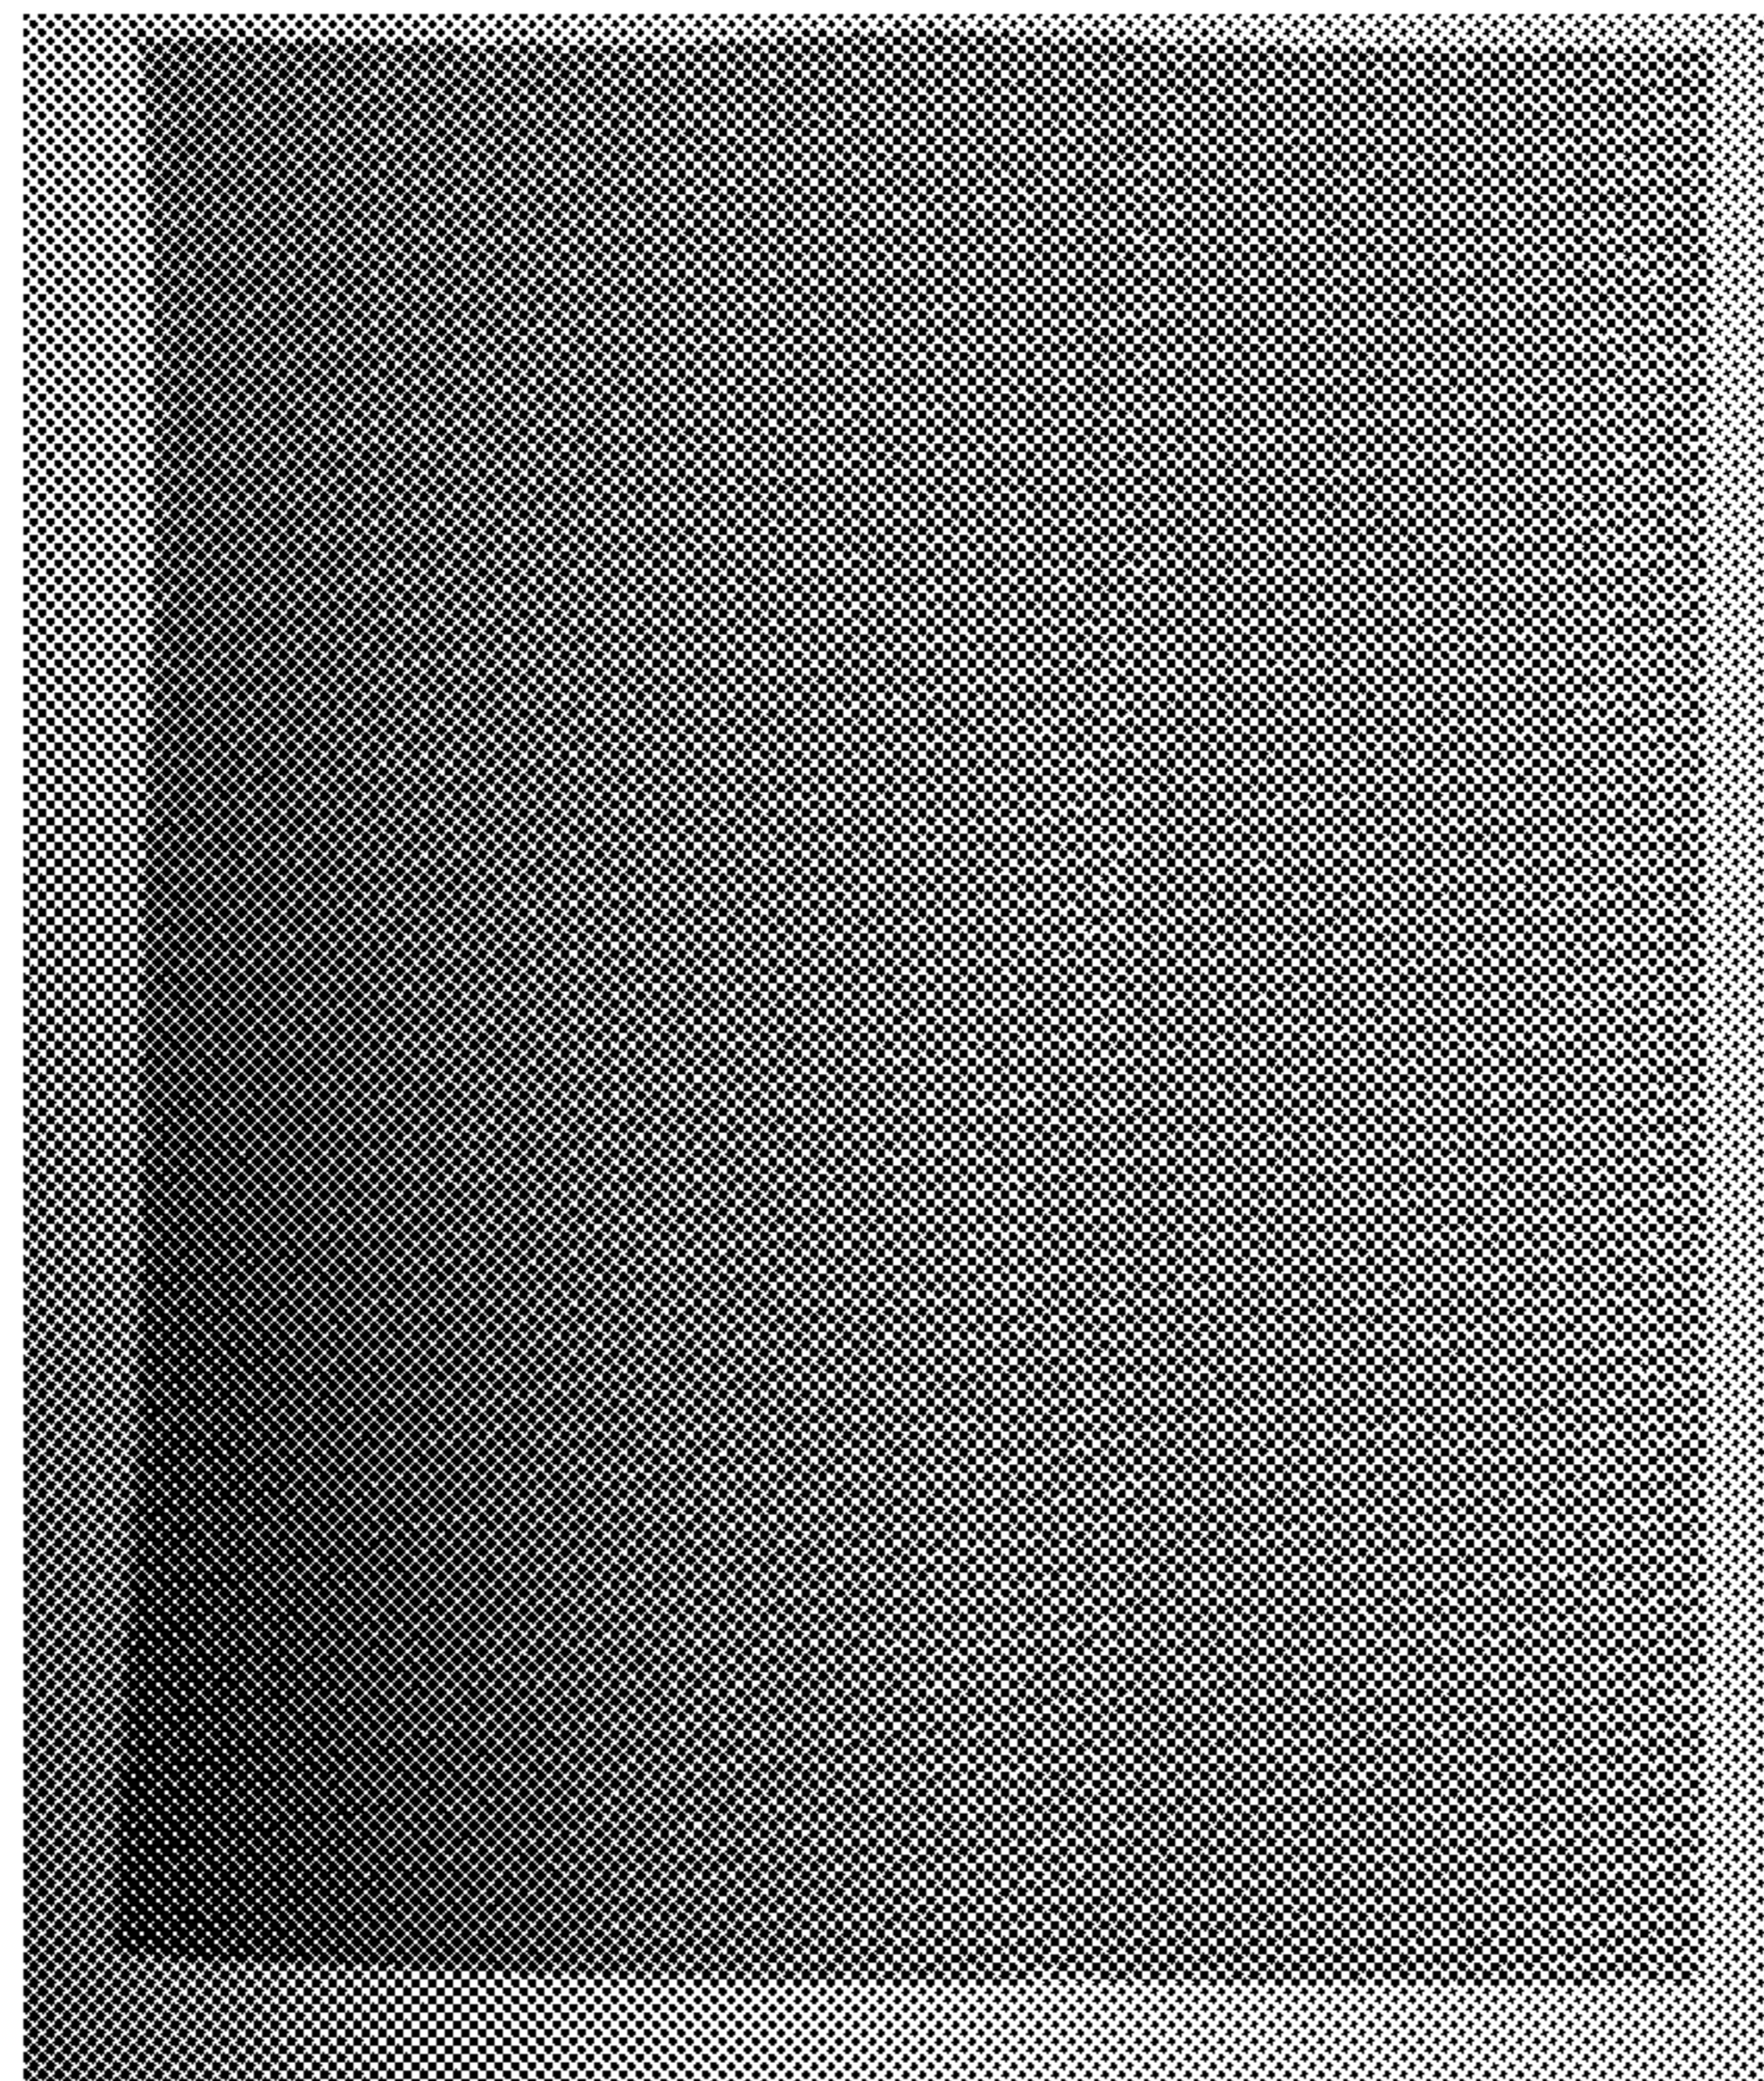
**FIG. 9**

FIG. 9 shows a sample of Material B prior to testing.

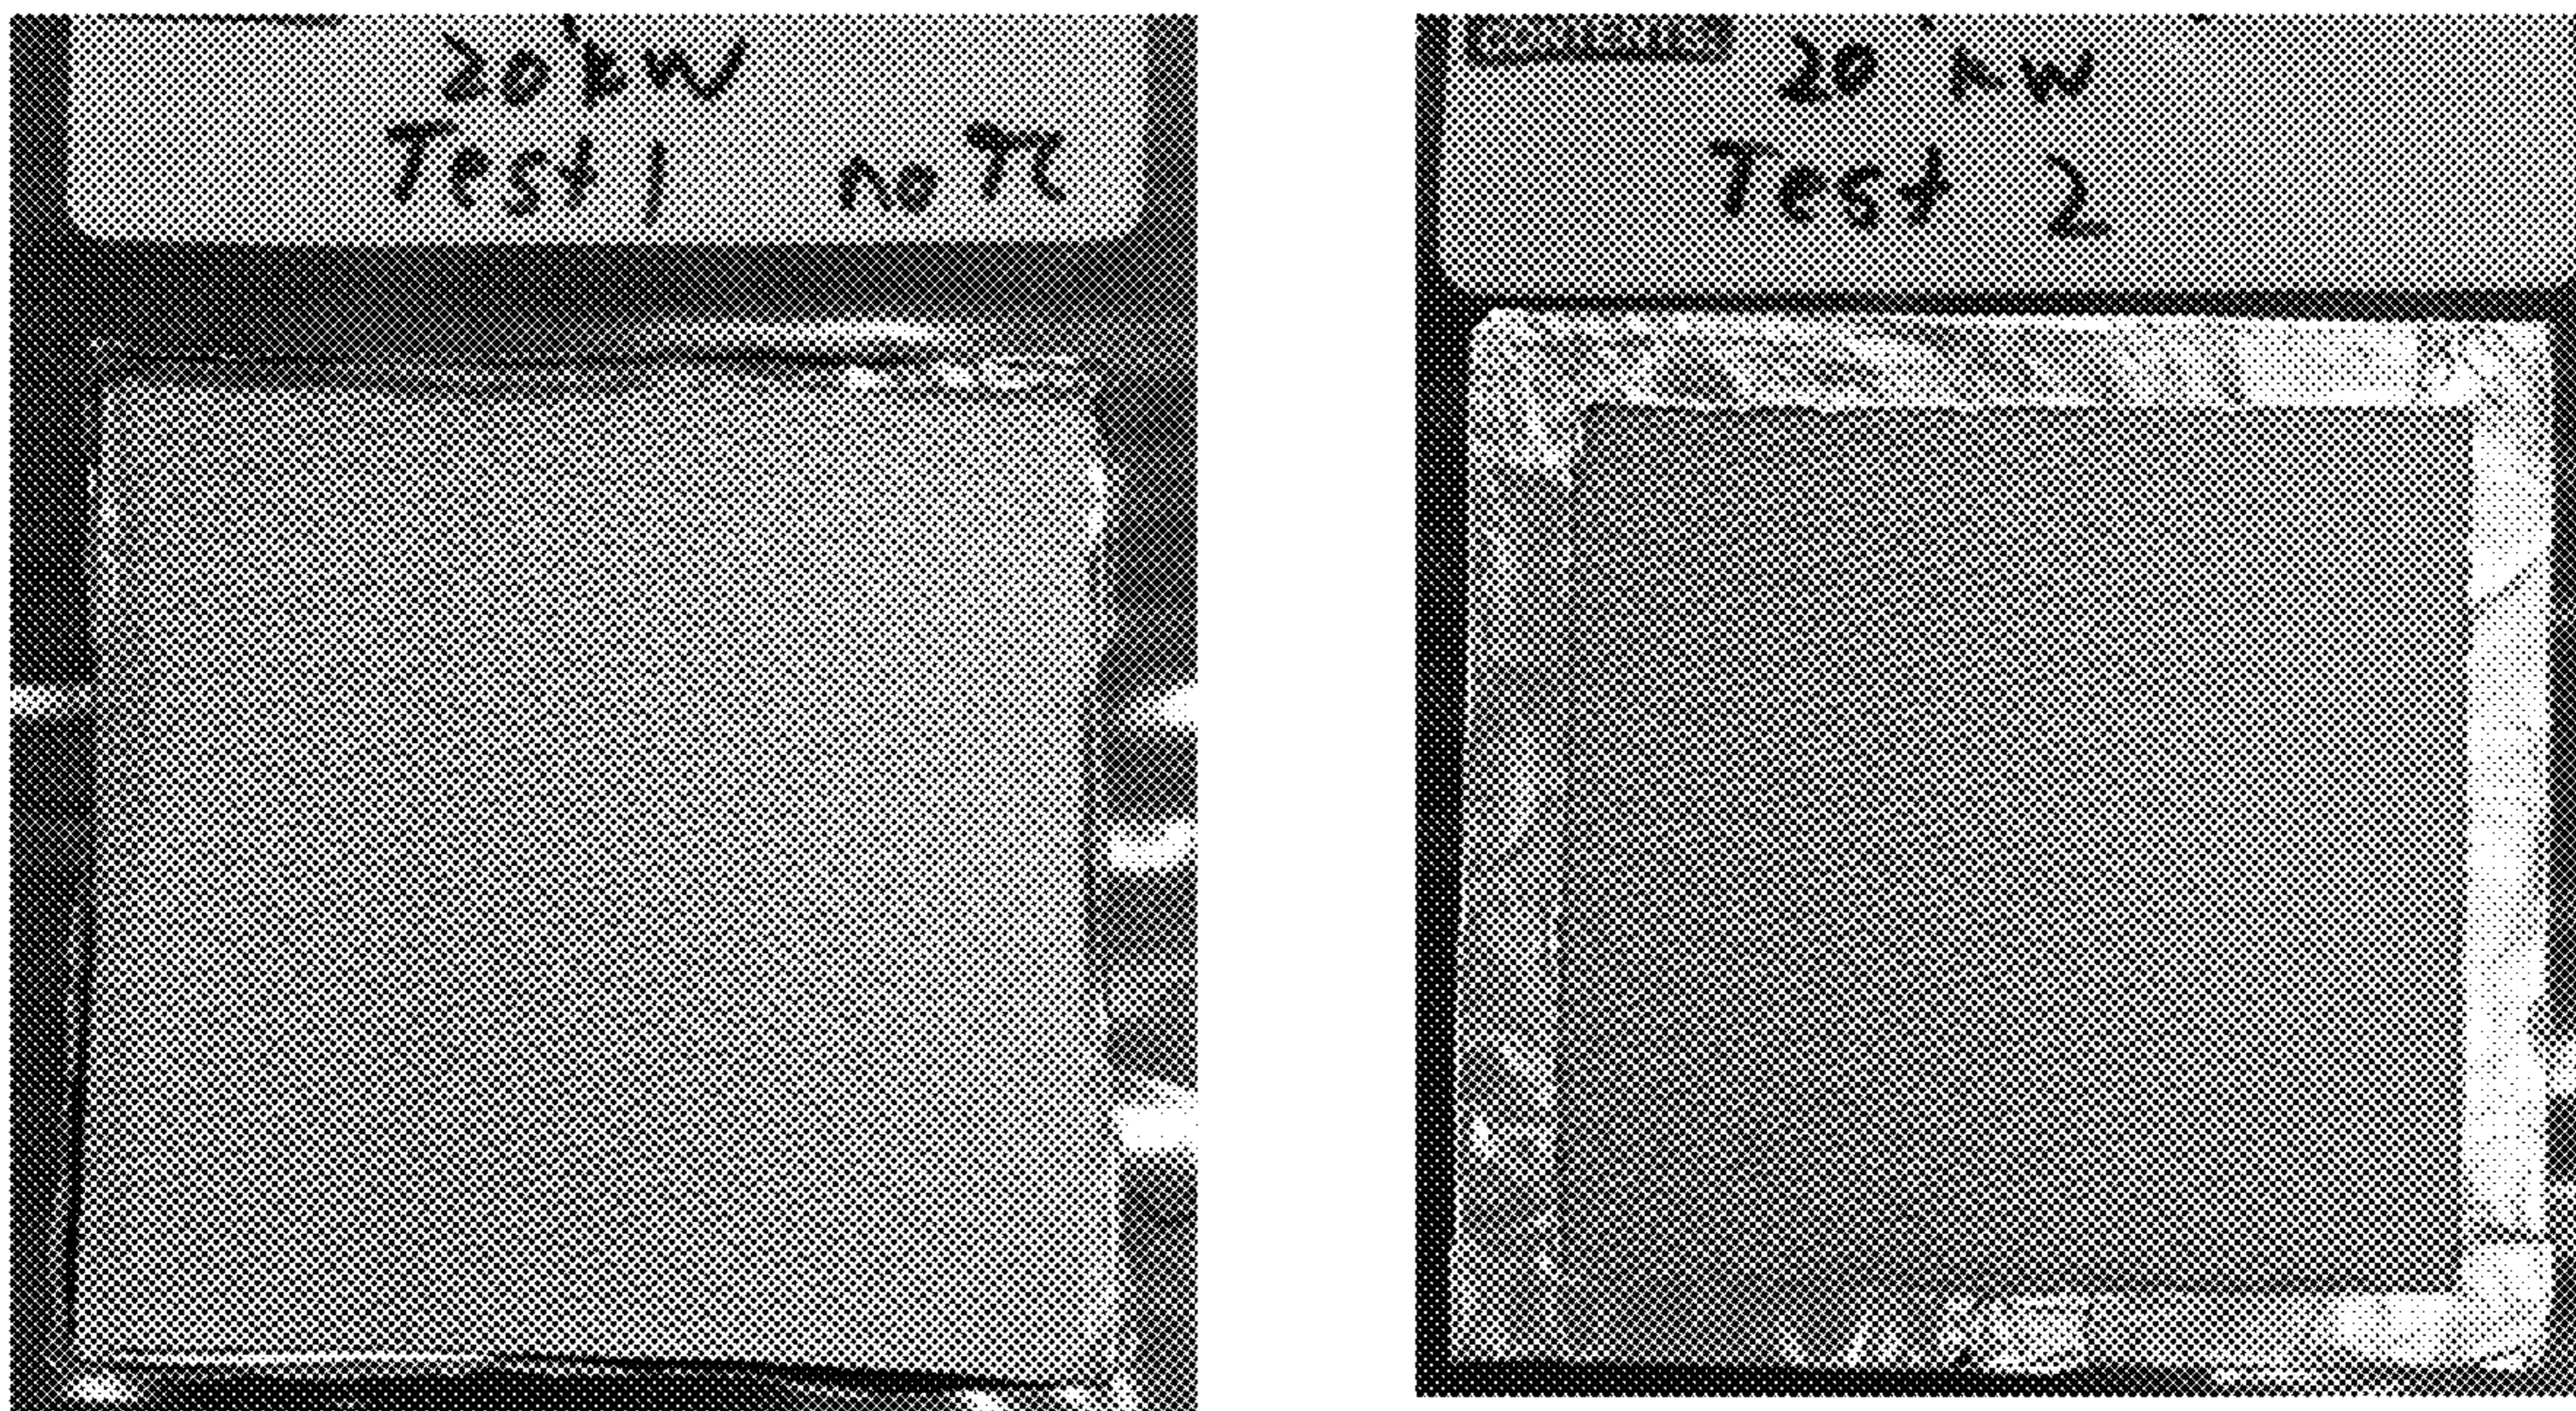
FIG. 10 shows Material B samples after 20 kW/m<sup>2</sup> Radiant Heating (showing Test 1 (left) and Test 2 (right)).

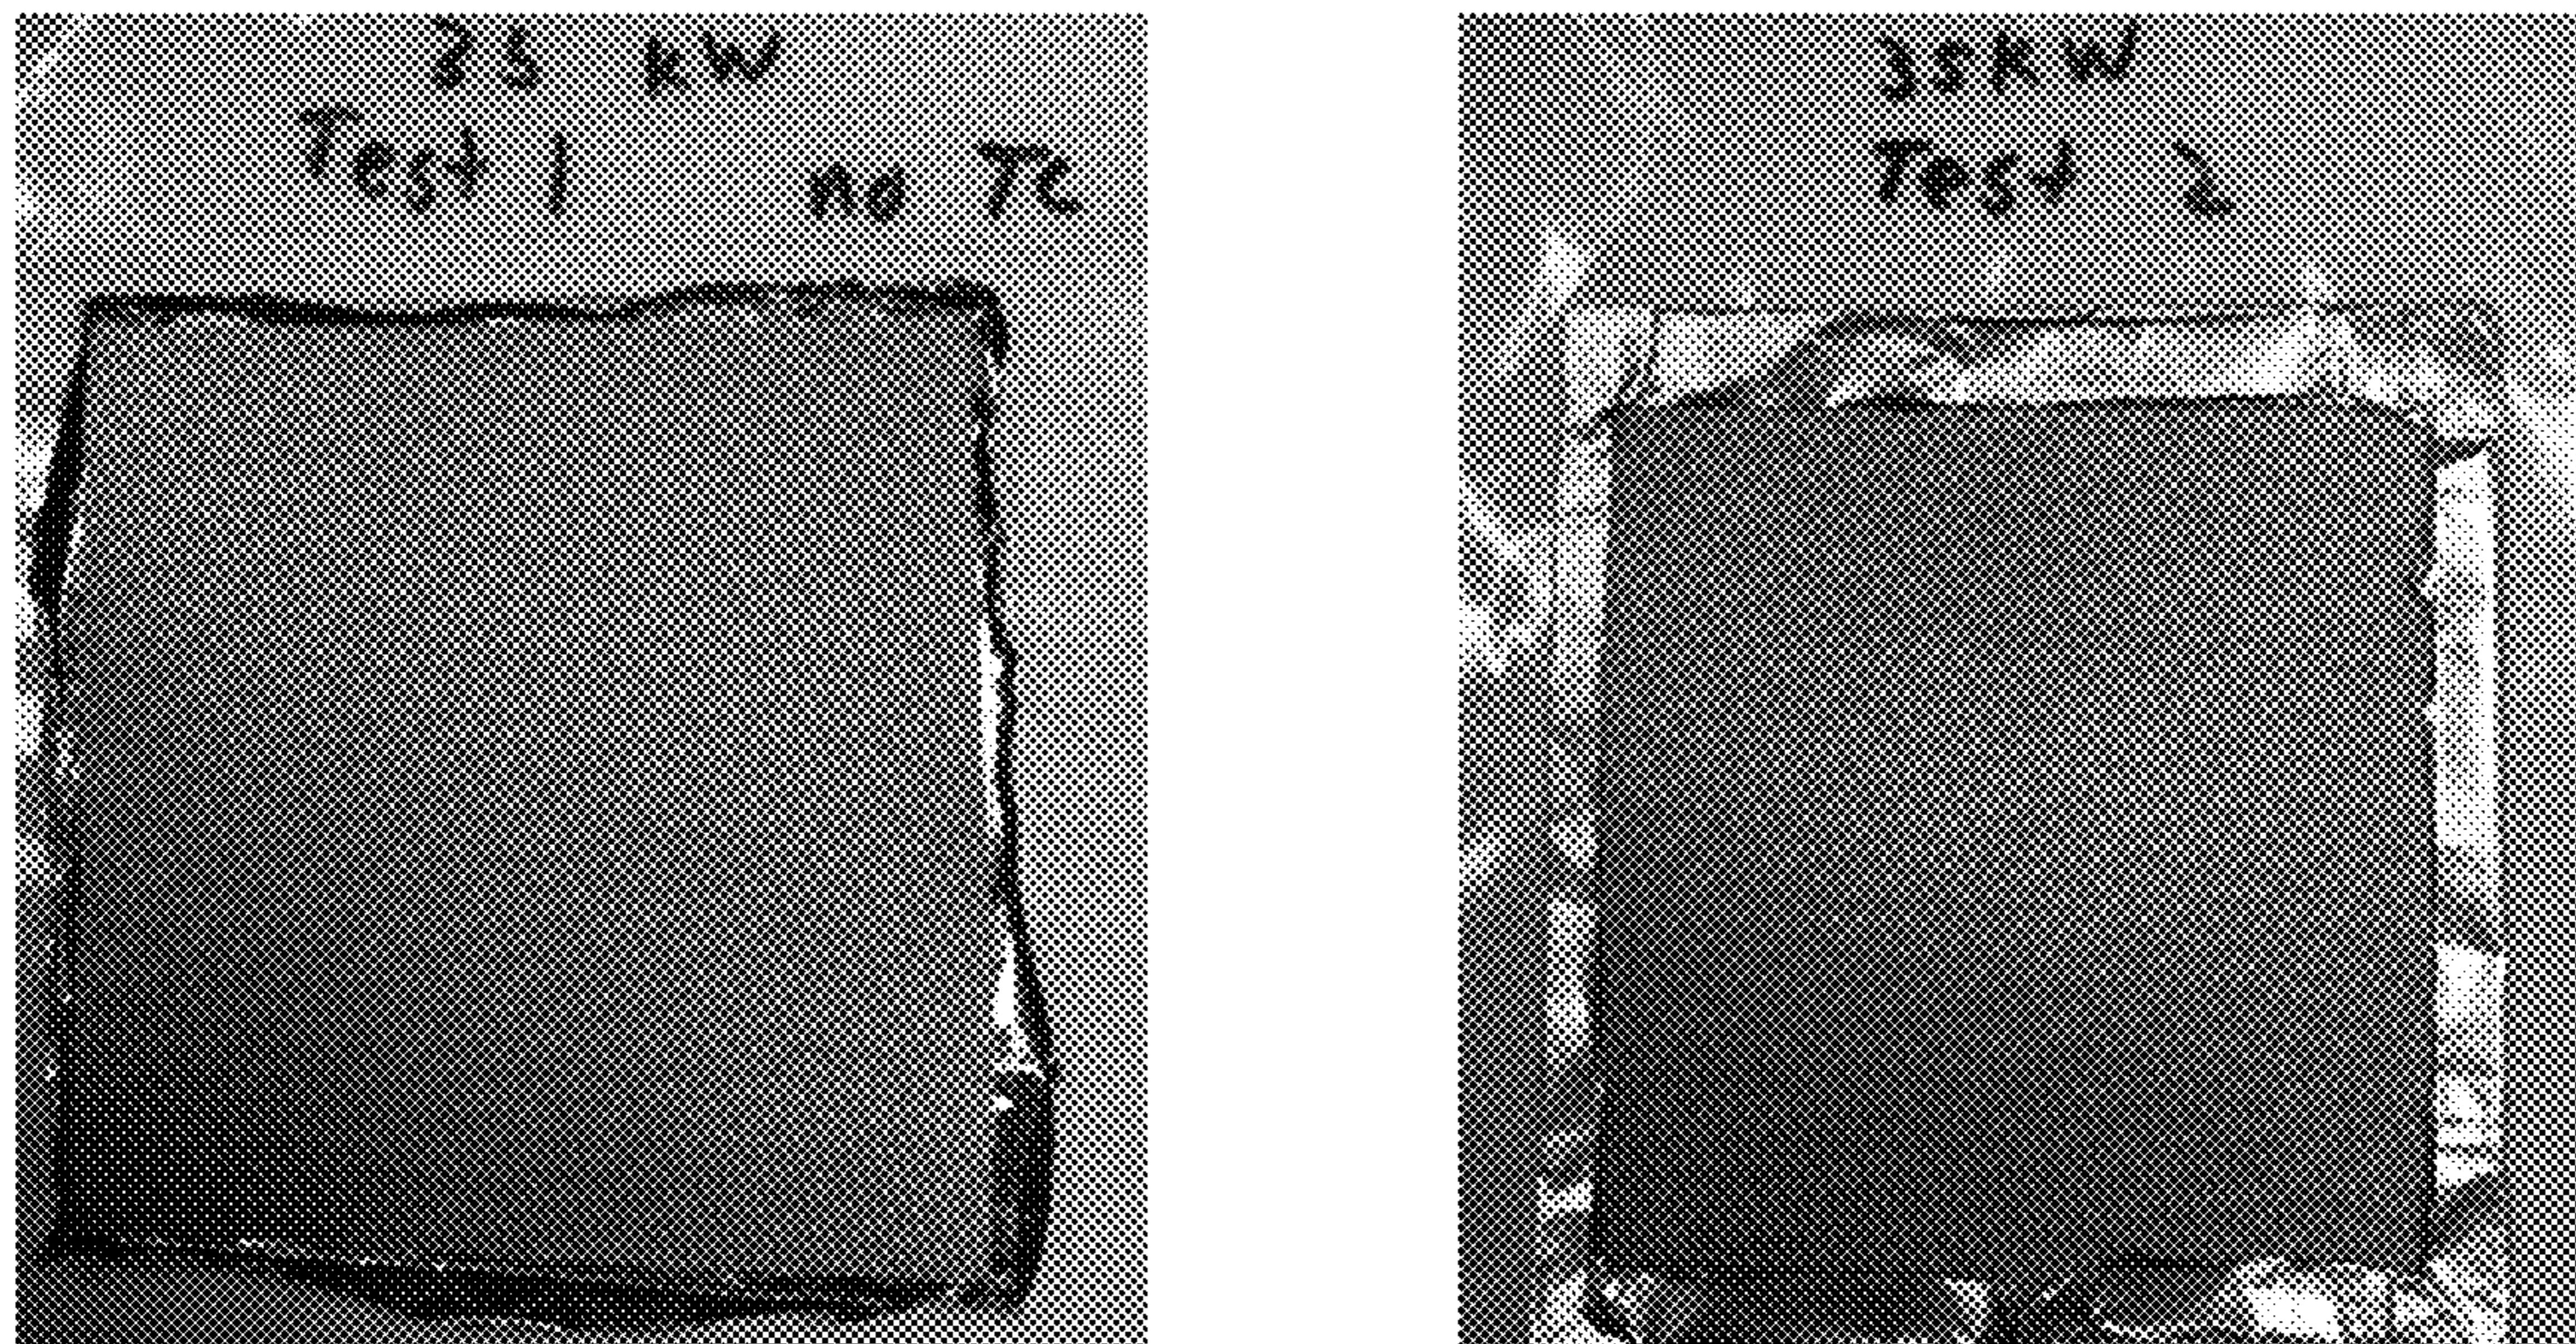
FIG. 11 shows Material B samples after 35 kW/m<sup>2</sup> radiant heating (showing Test 1 (left) and Test 2 (right)).
