(10) **Patent No.:** **US 11,485,106 B2**  
(45) **Date of Patent:** **Nov. 1, 2022**

(54) **FIRE HOSE AND MATERTAL THEREFORE**

Described herein are fire hoses incorporating new combi-  
nations of materials to increase the hose's resilience. Resil-  
ient hoses include those made with silicone-coated fabrics or  
with thermally-resistant fabrics or both.

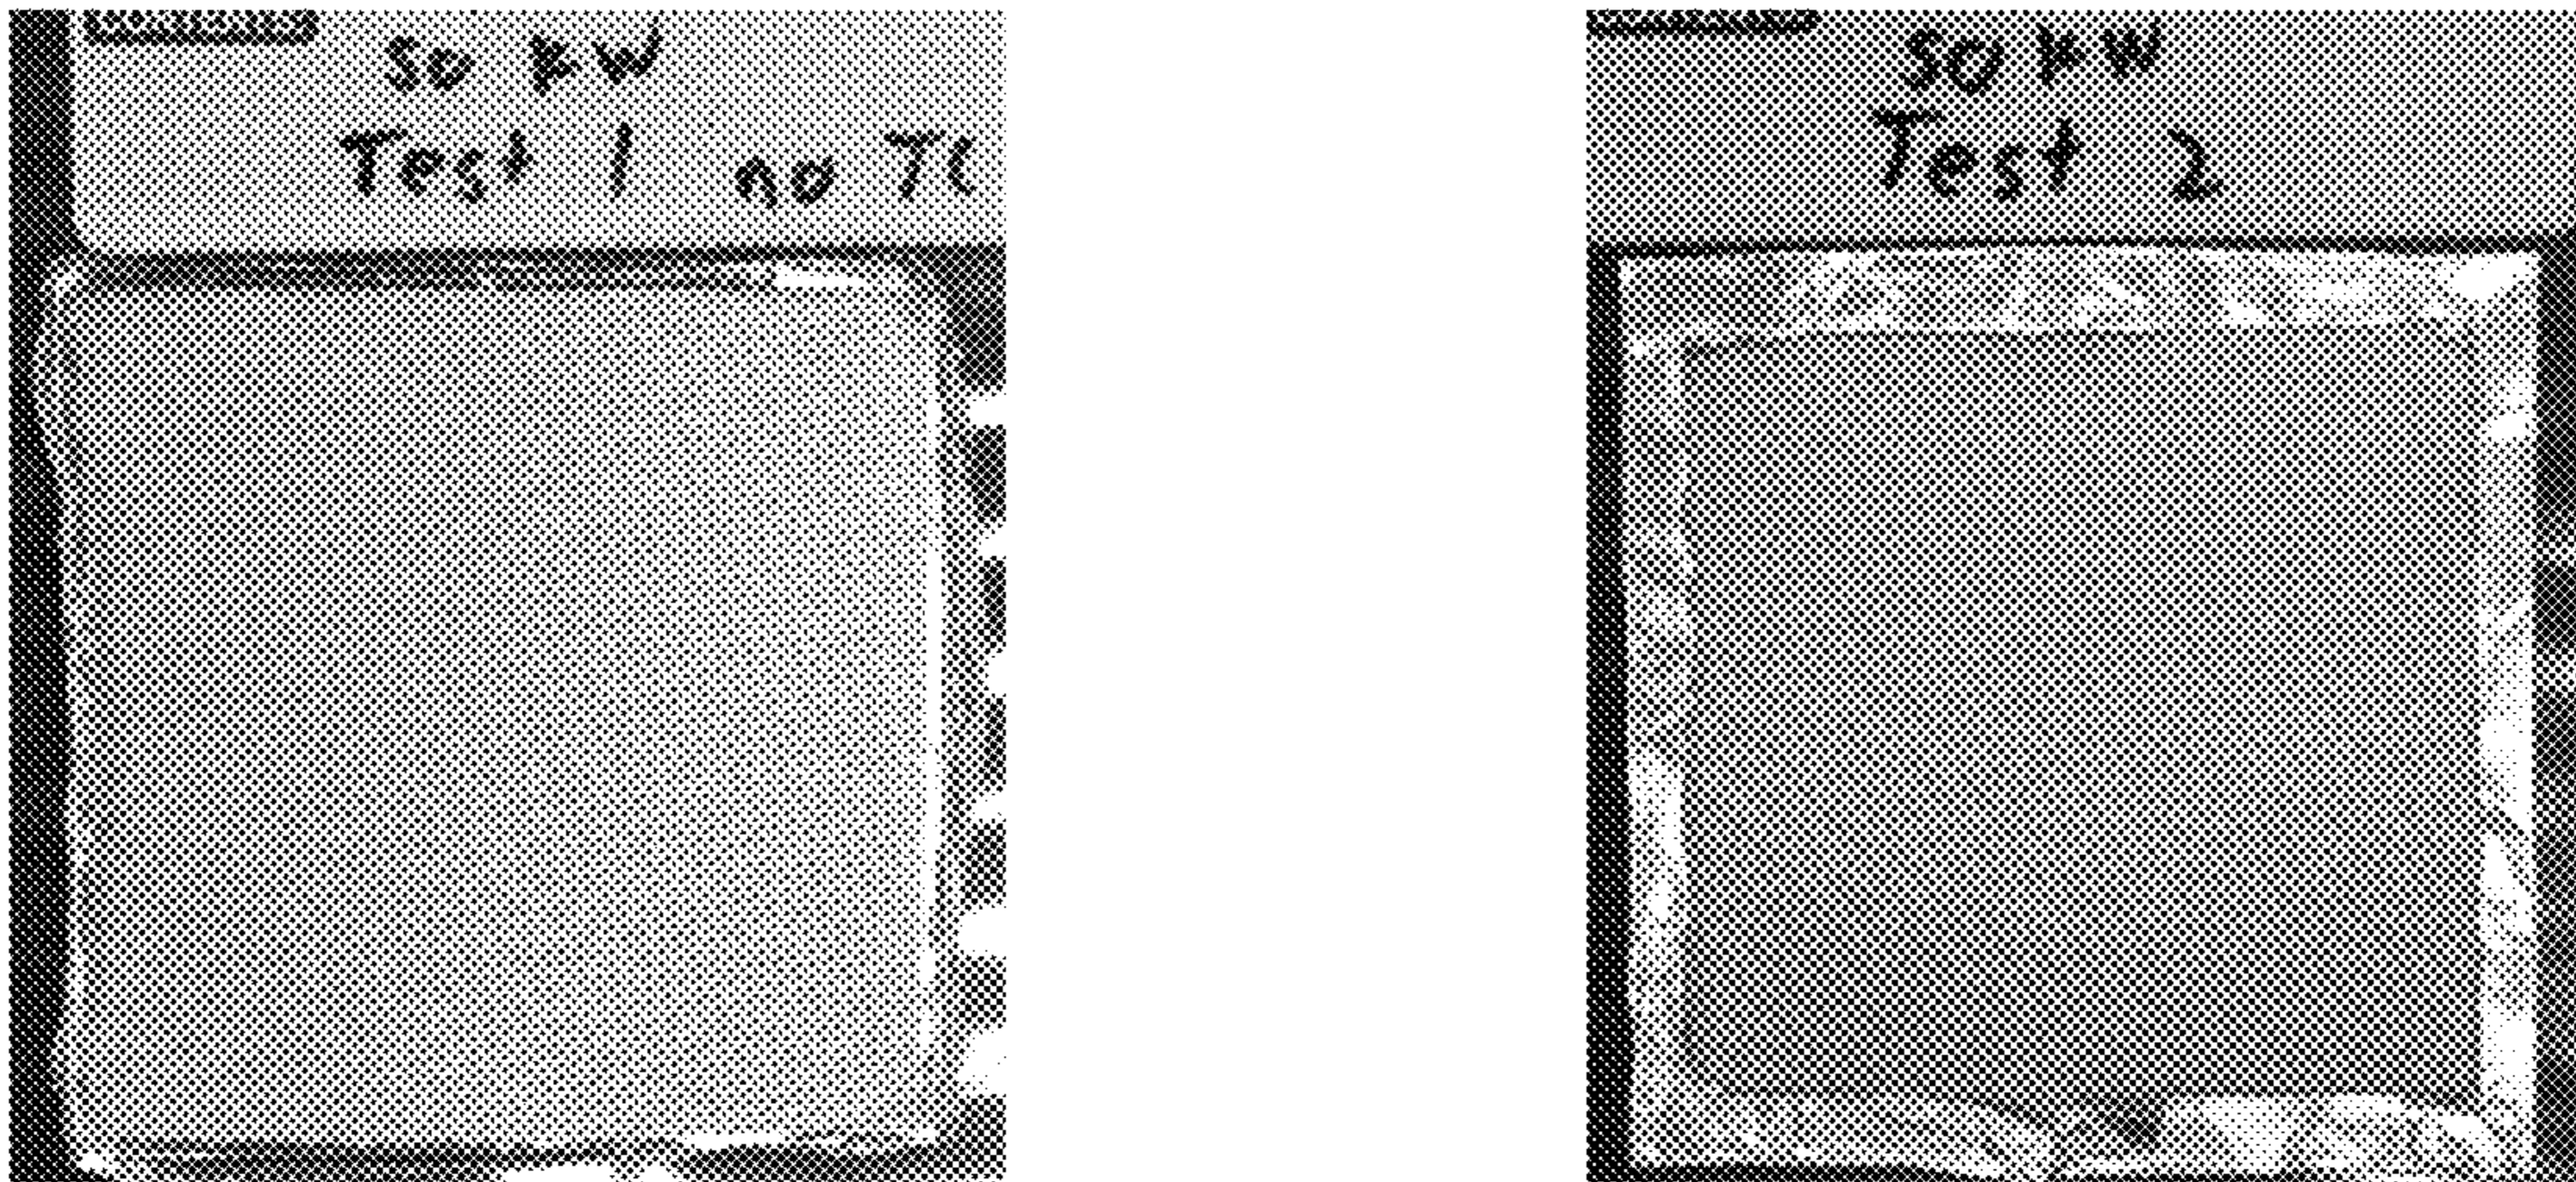
FIG. 12 shows Material B samples after 50 kW/m<sup>2</sup> radiant heating (showing Test 1 left) and Test 2 (right)).

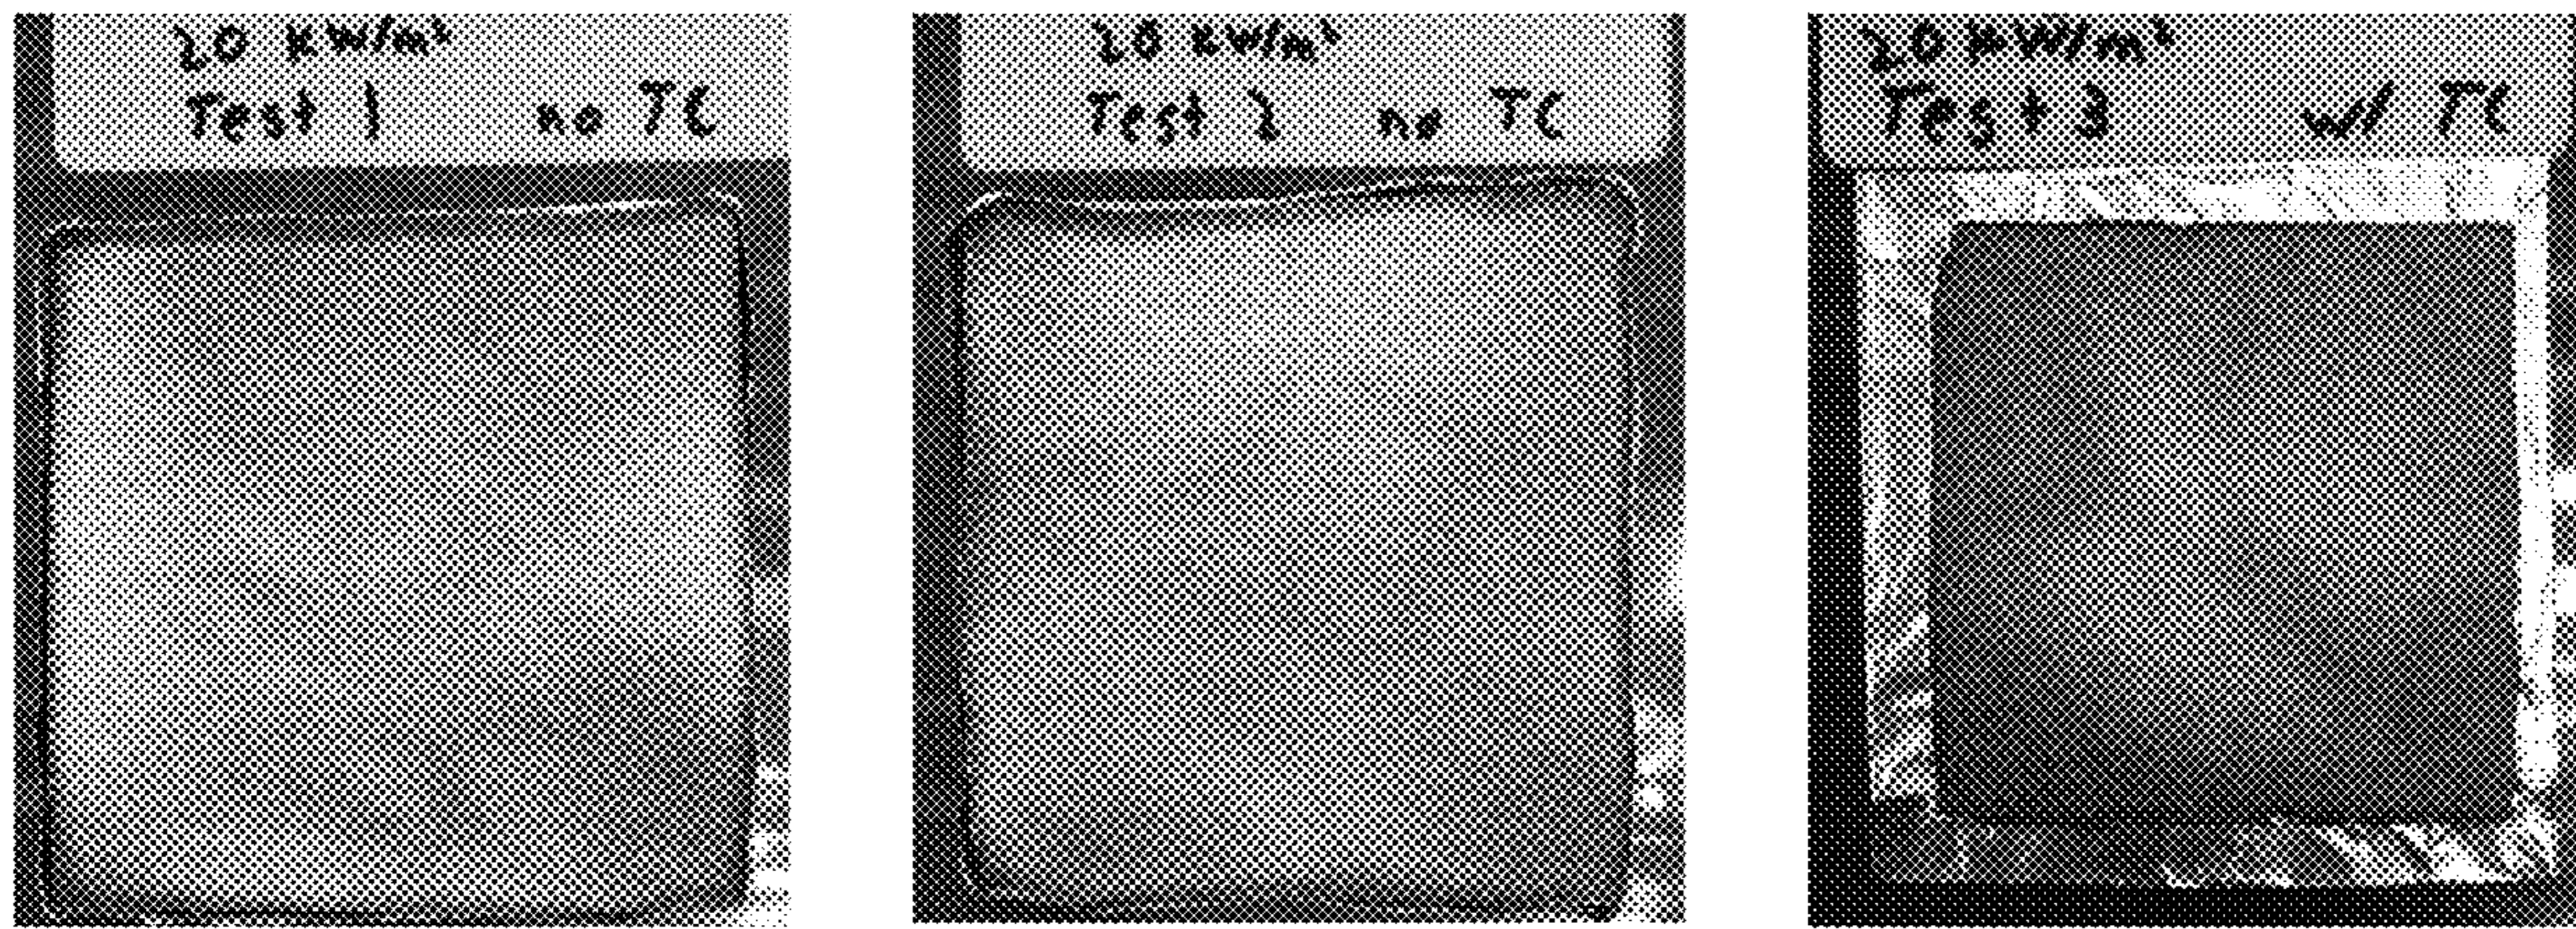
FIG. 14 shows Material C samples after 20 kW/m<sup>2</sup> radiant heating (showing Test 1 (left), Test 2 (center), and Test 3 (right)).

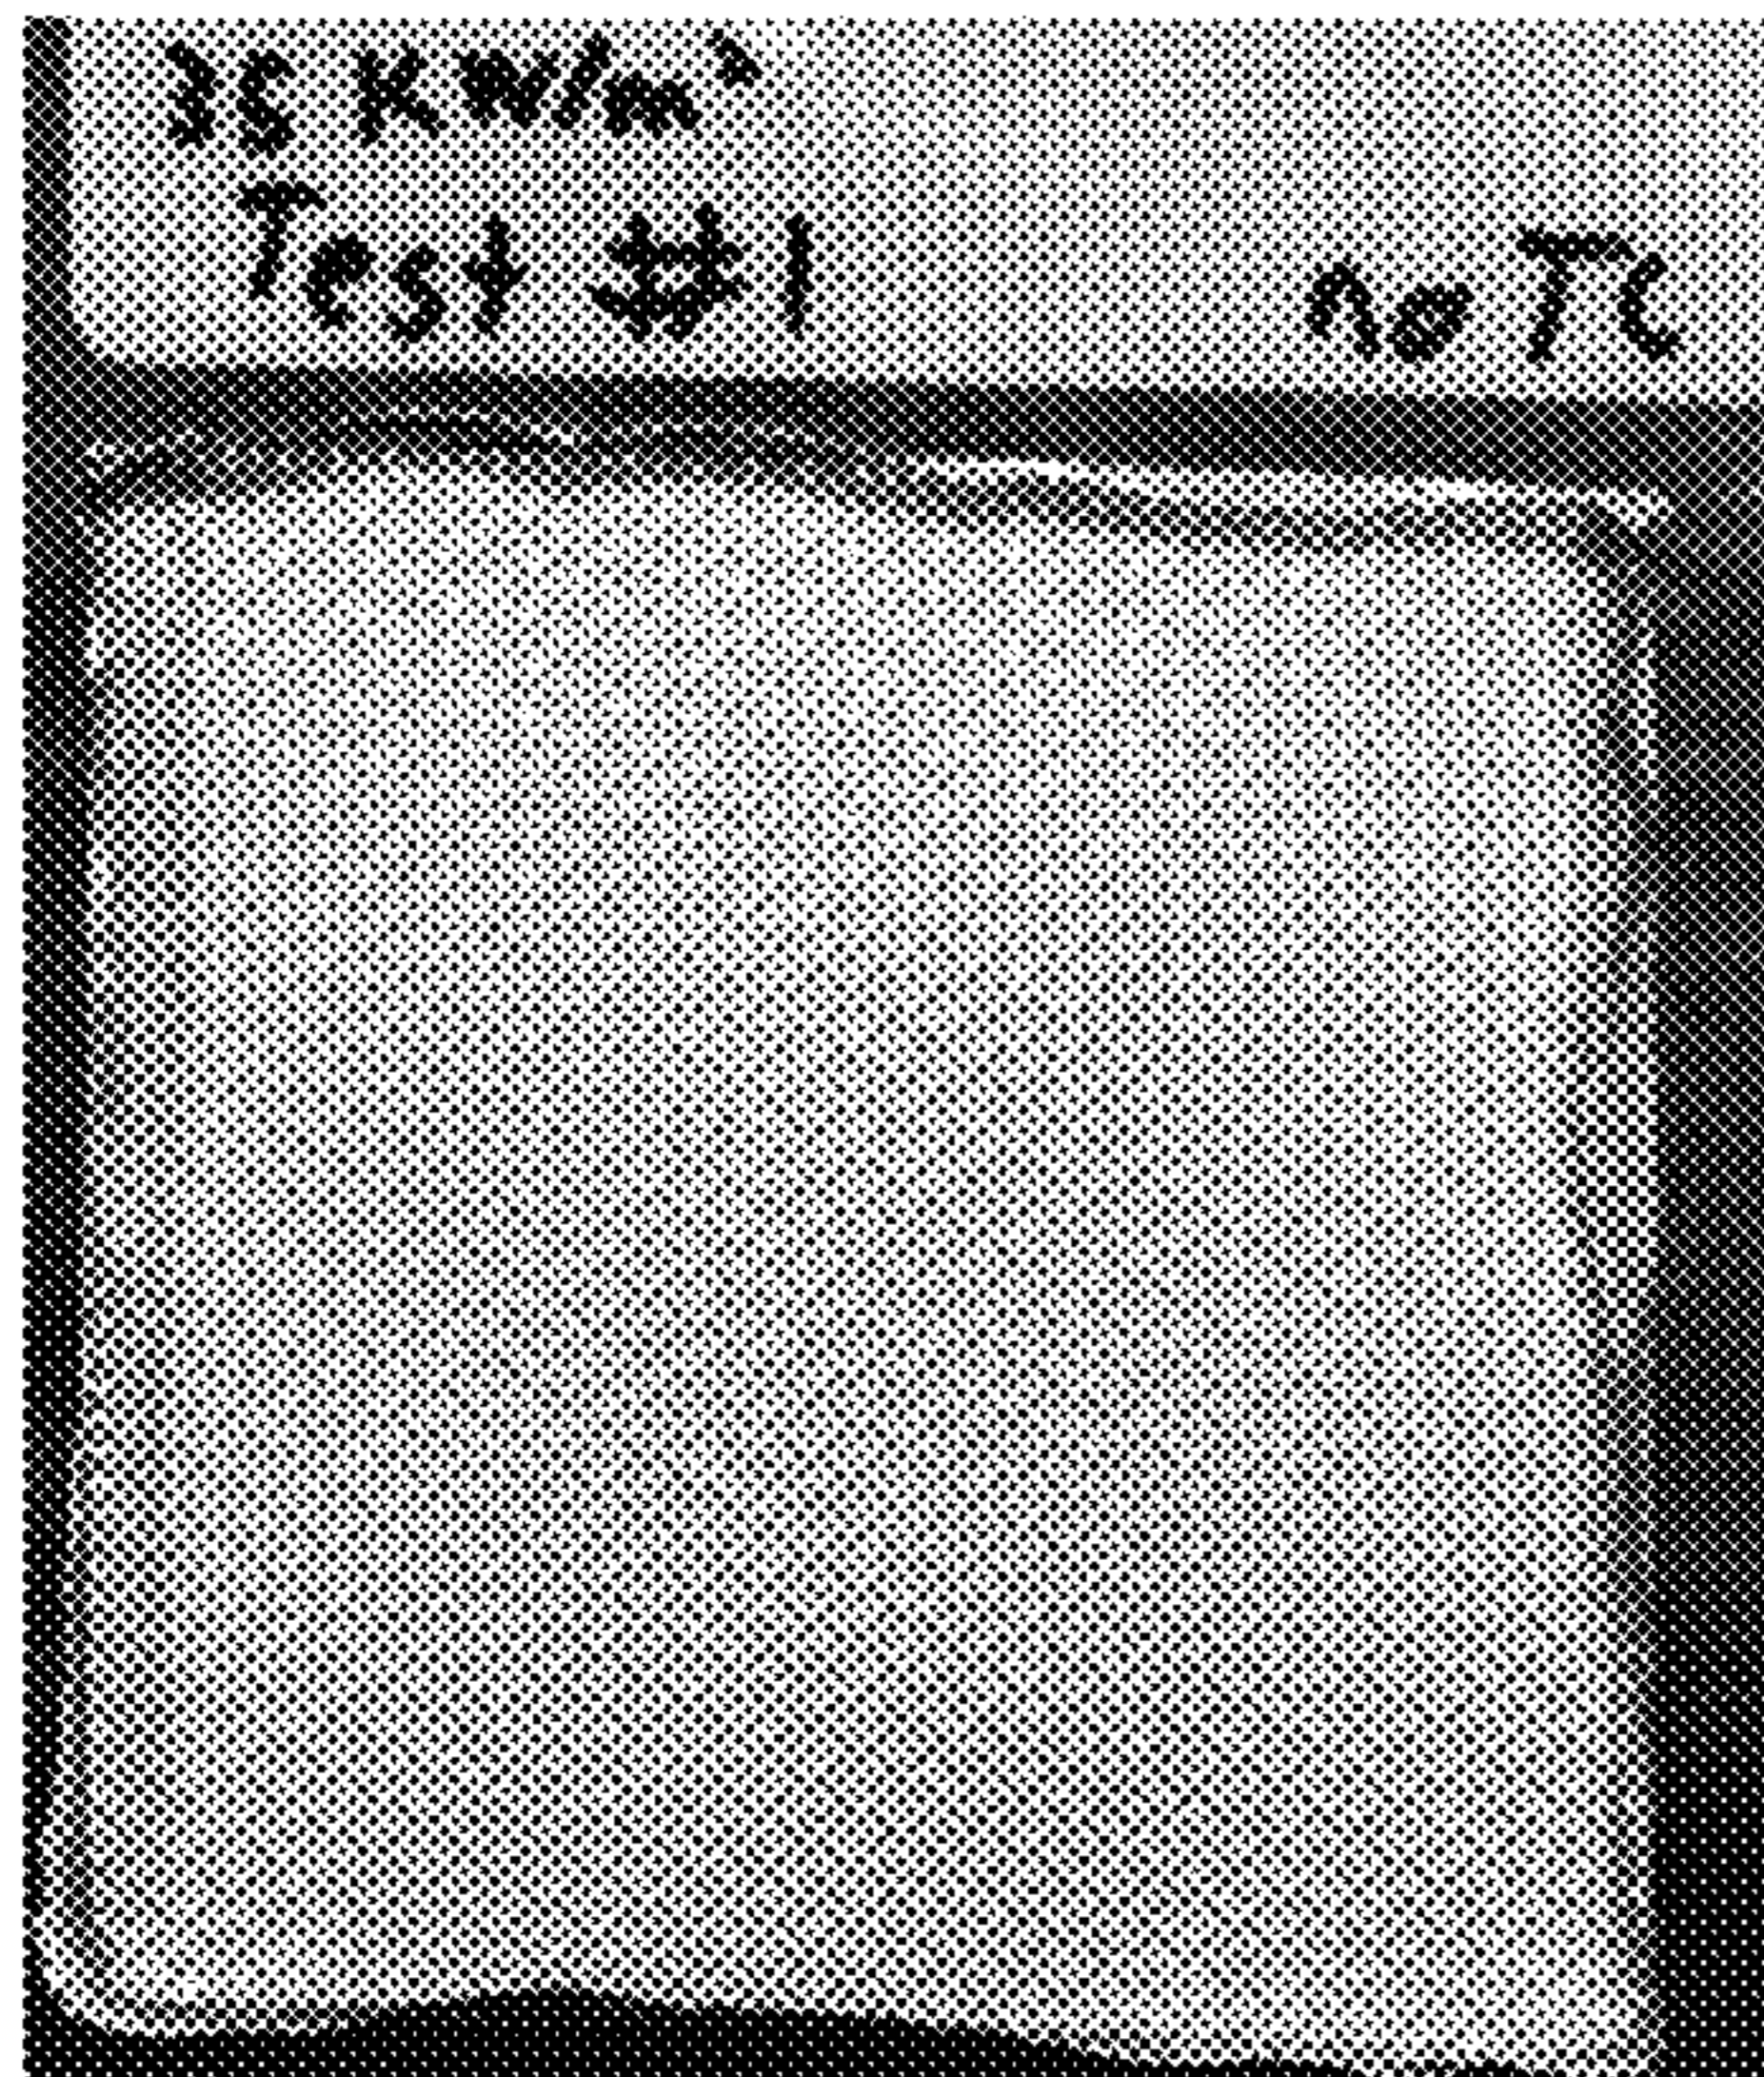
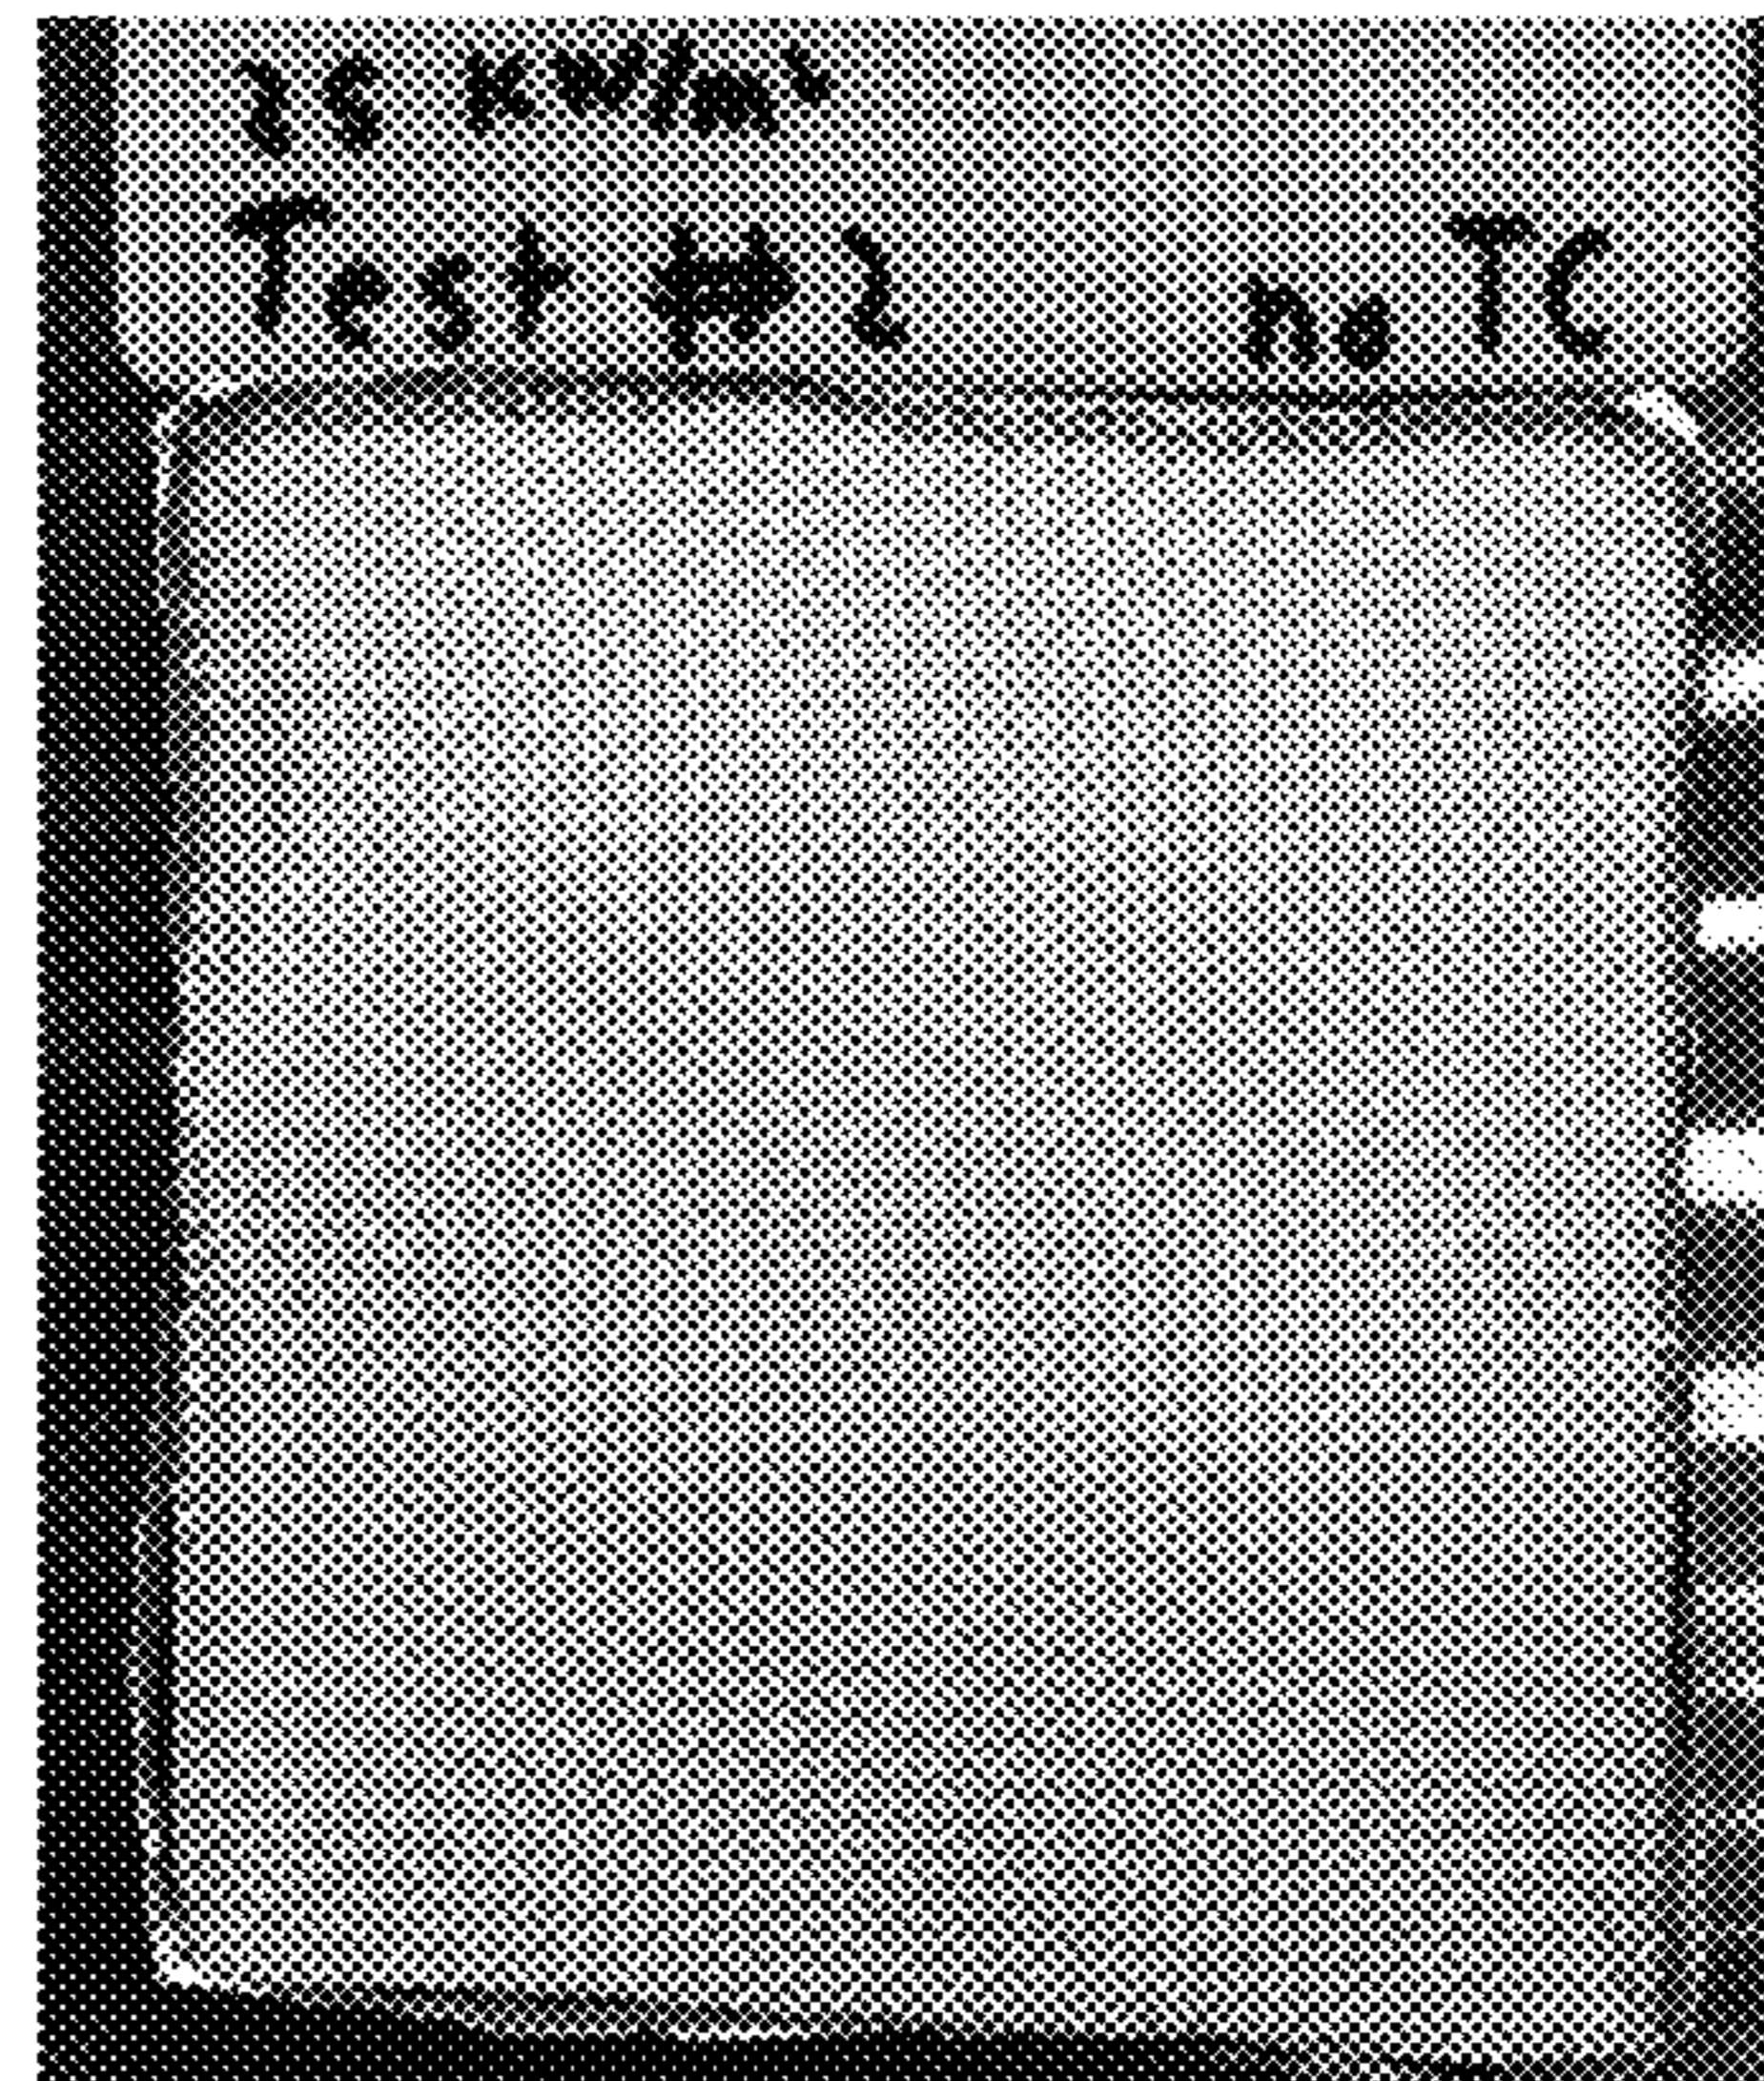
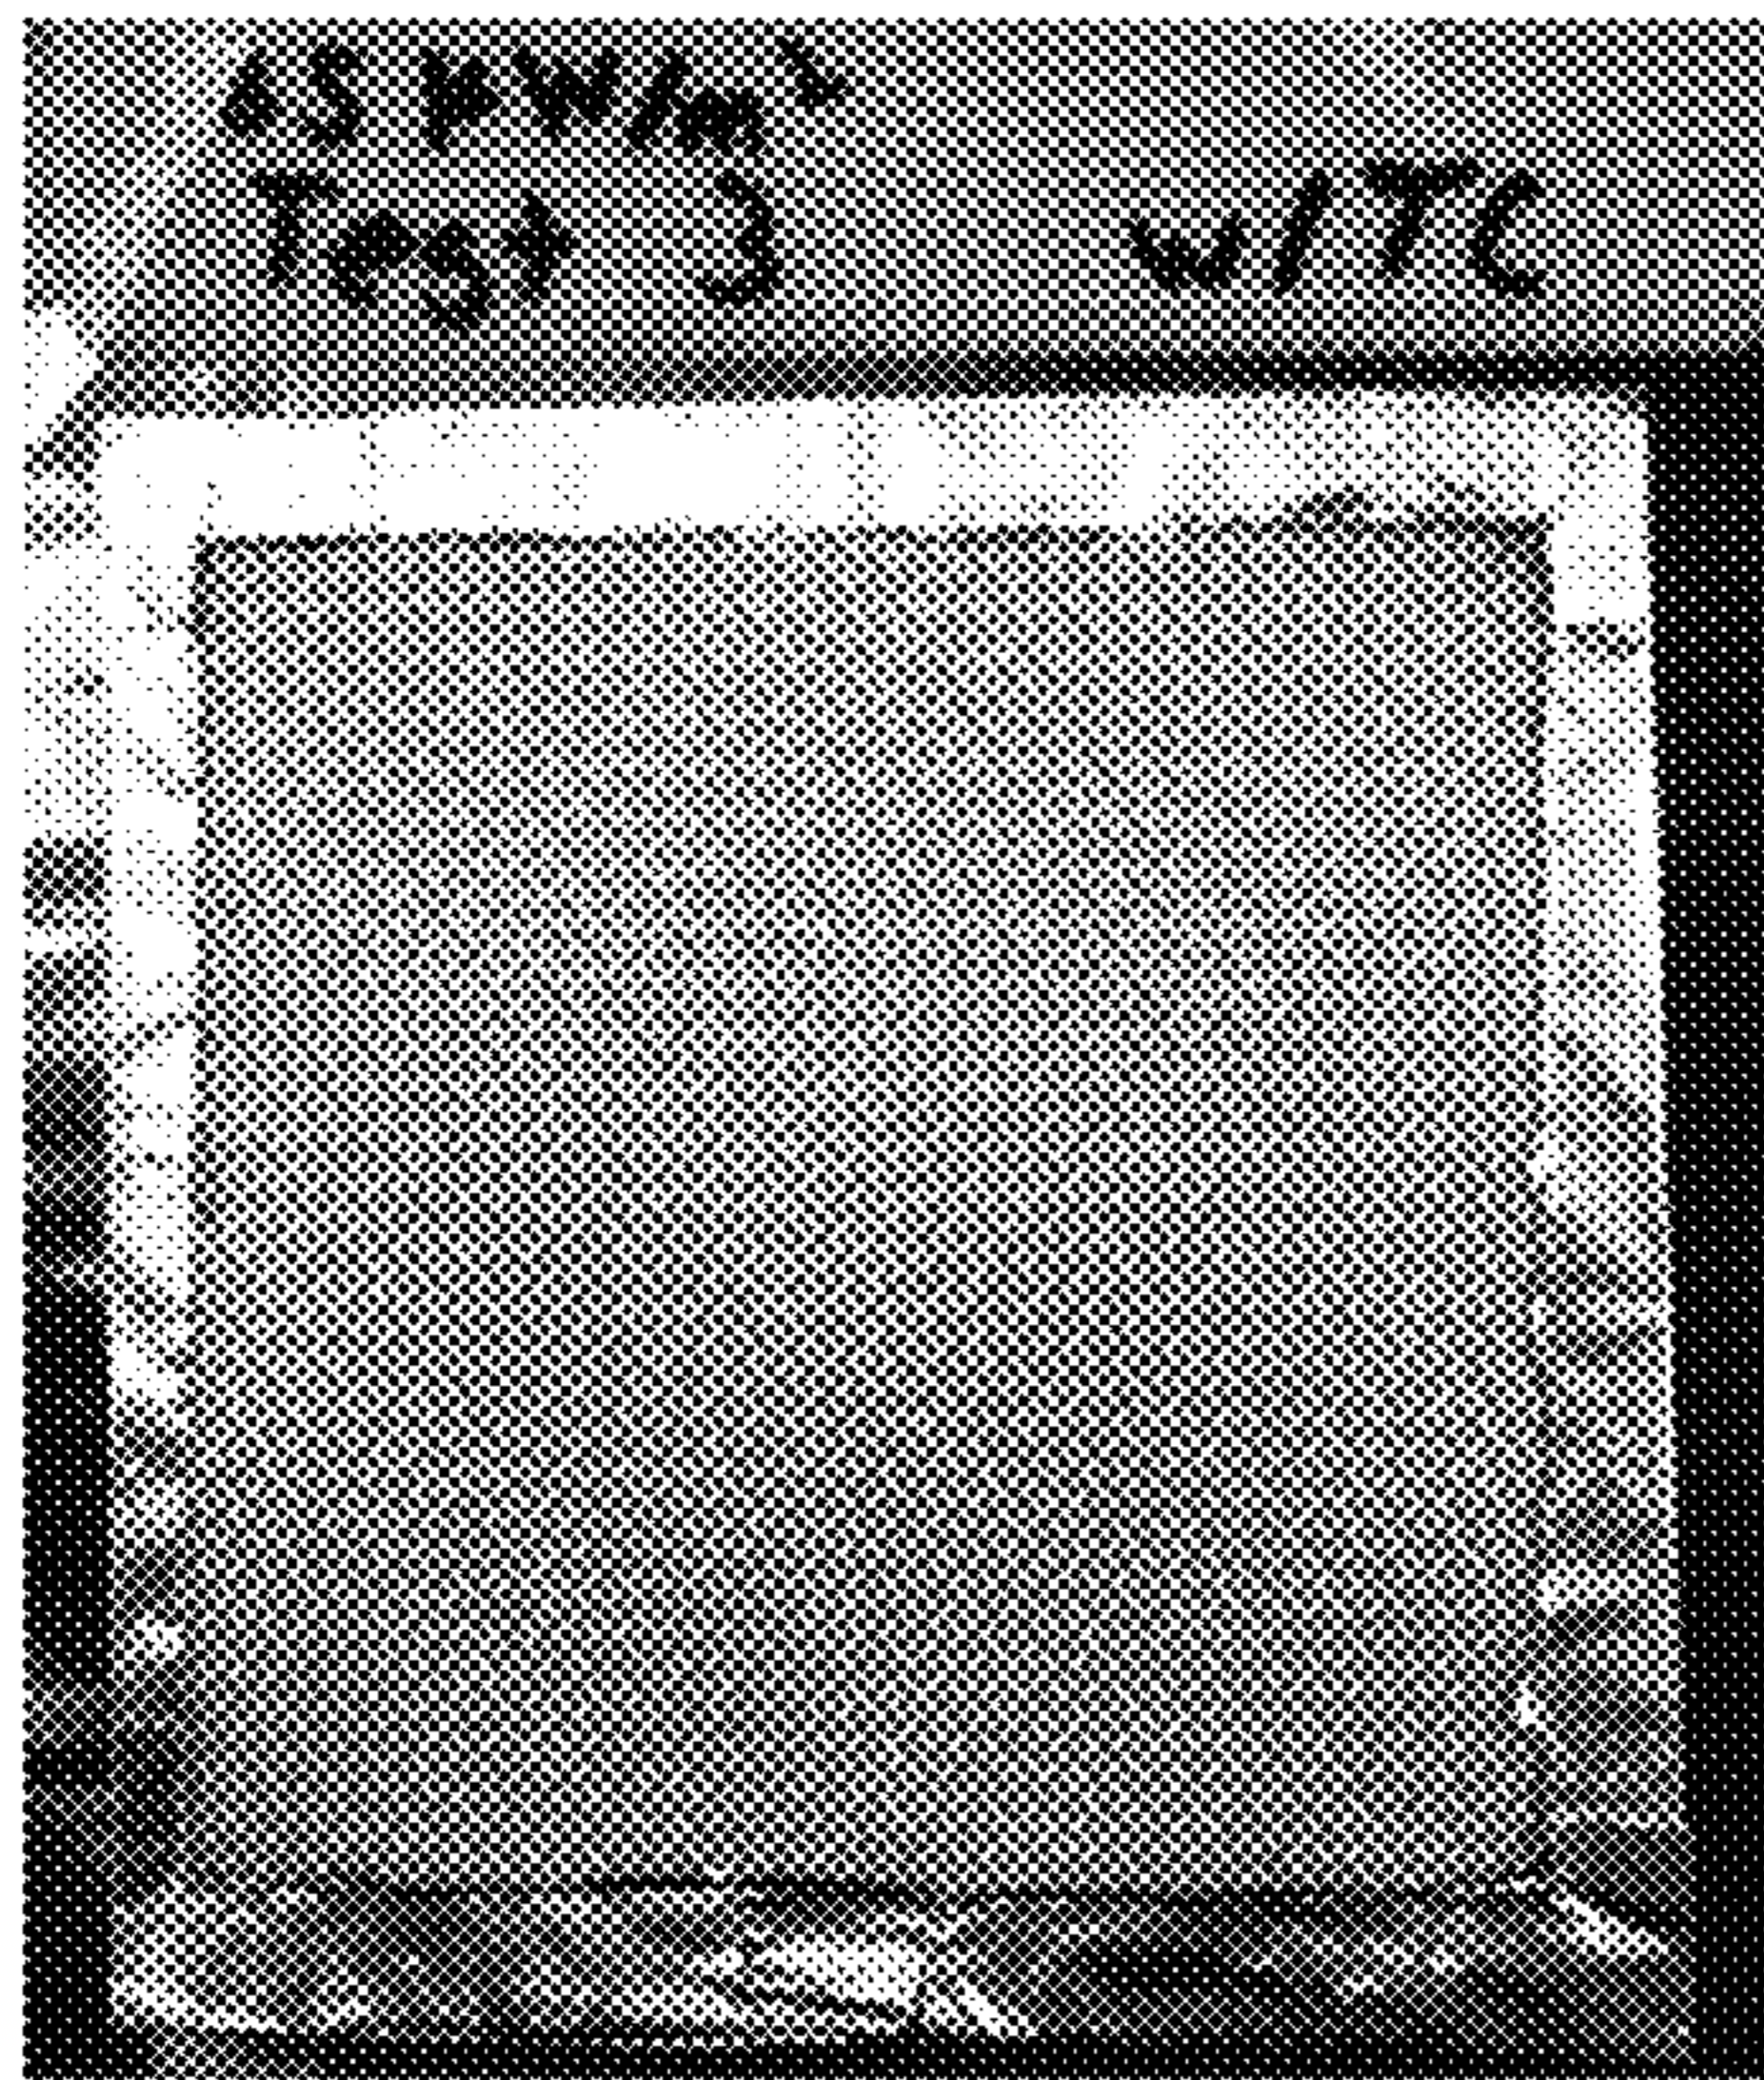
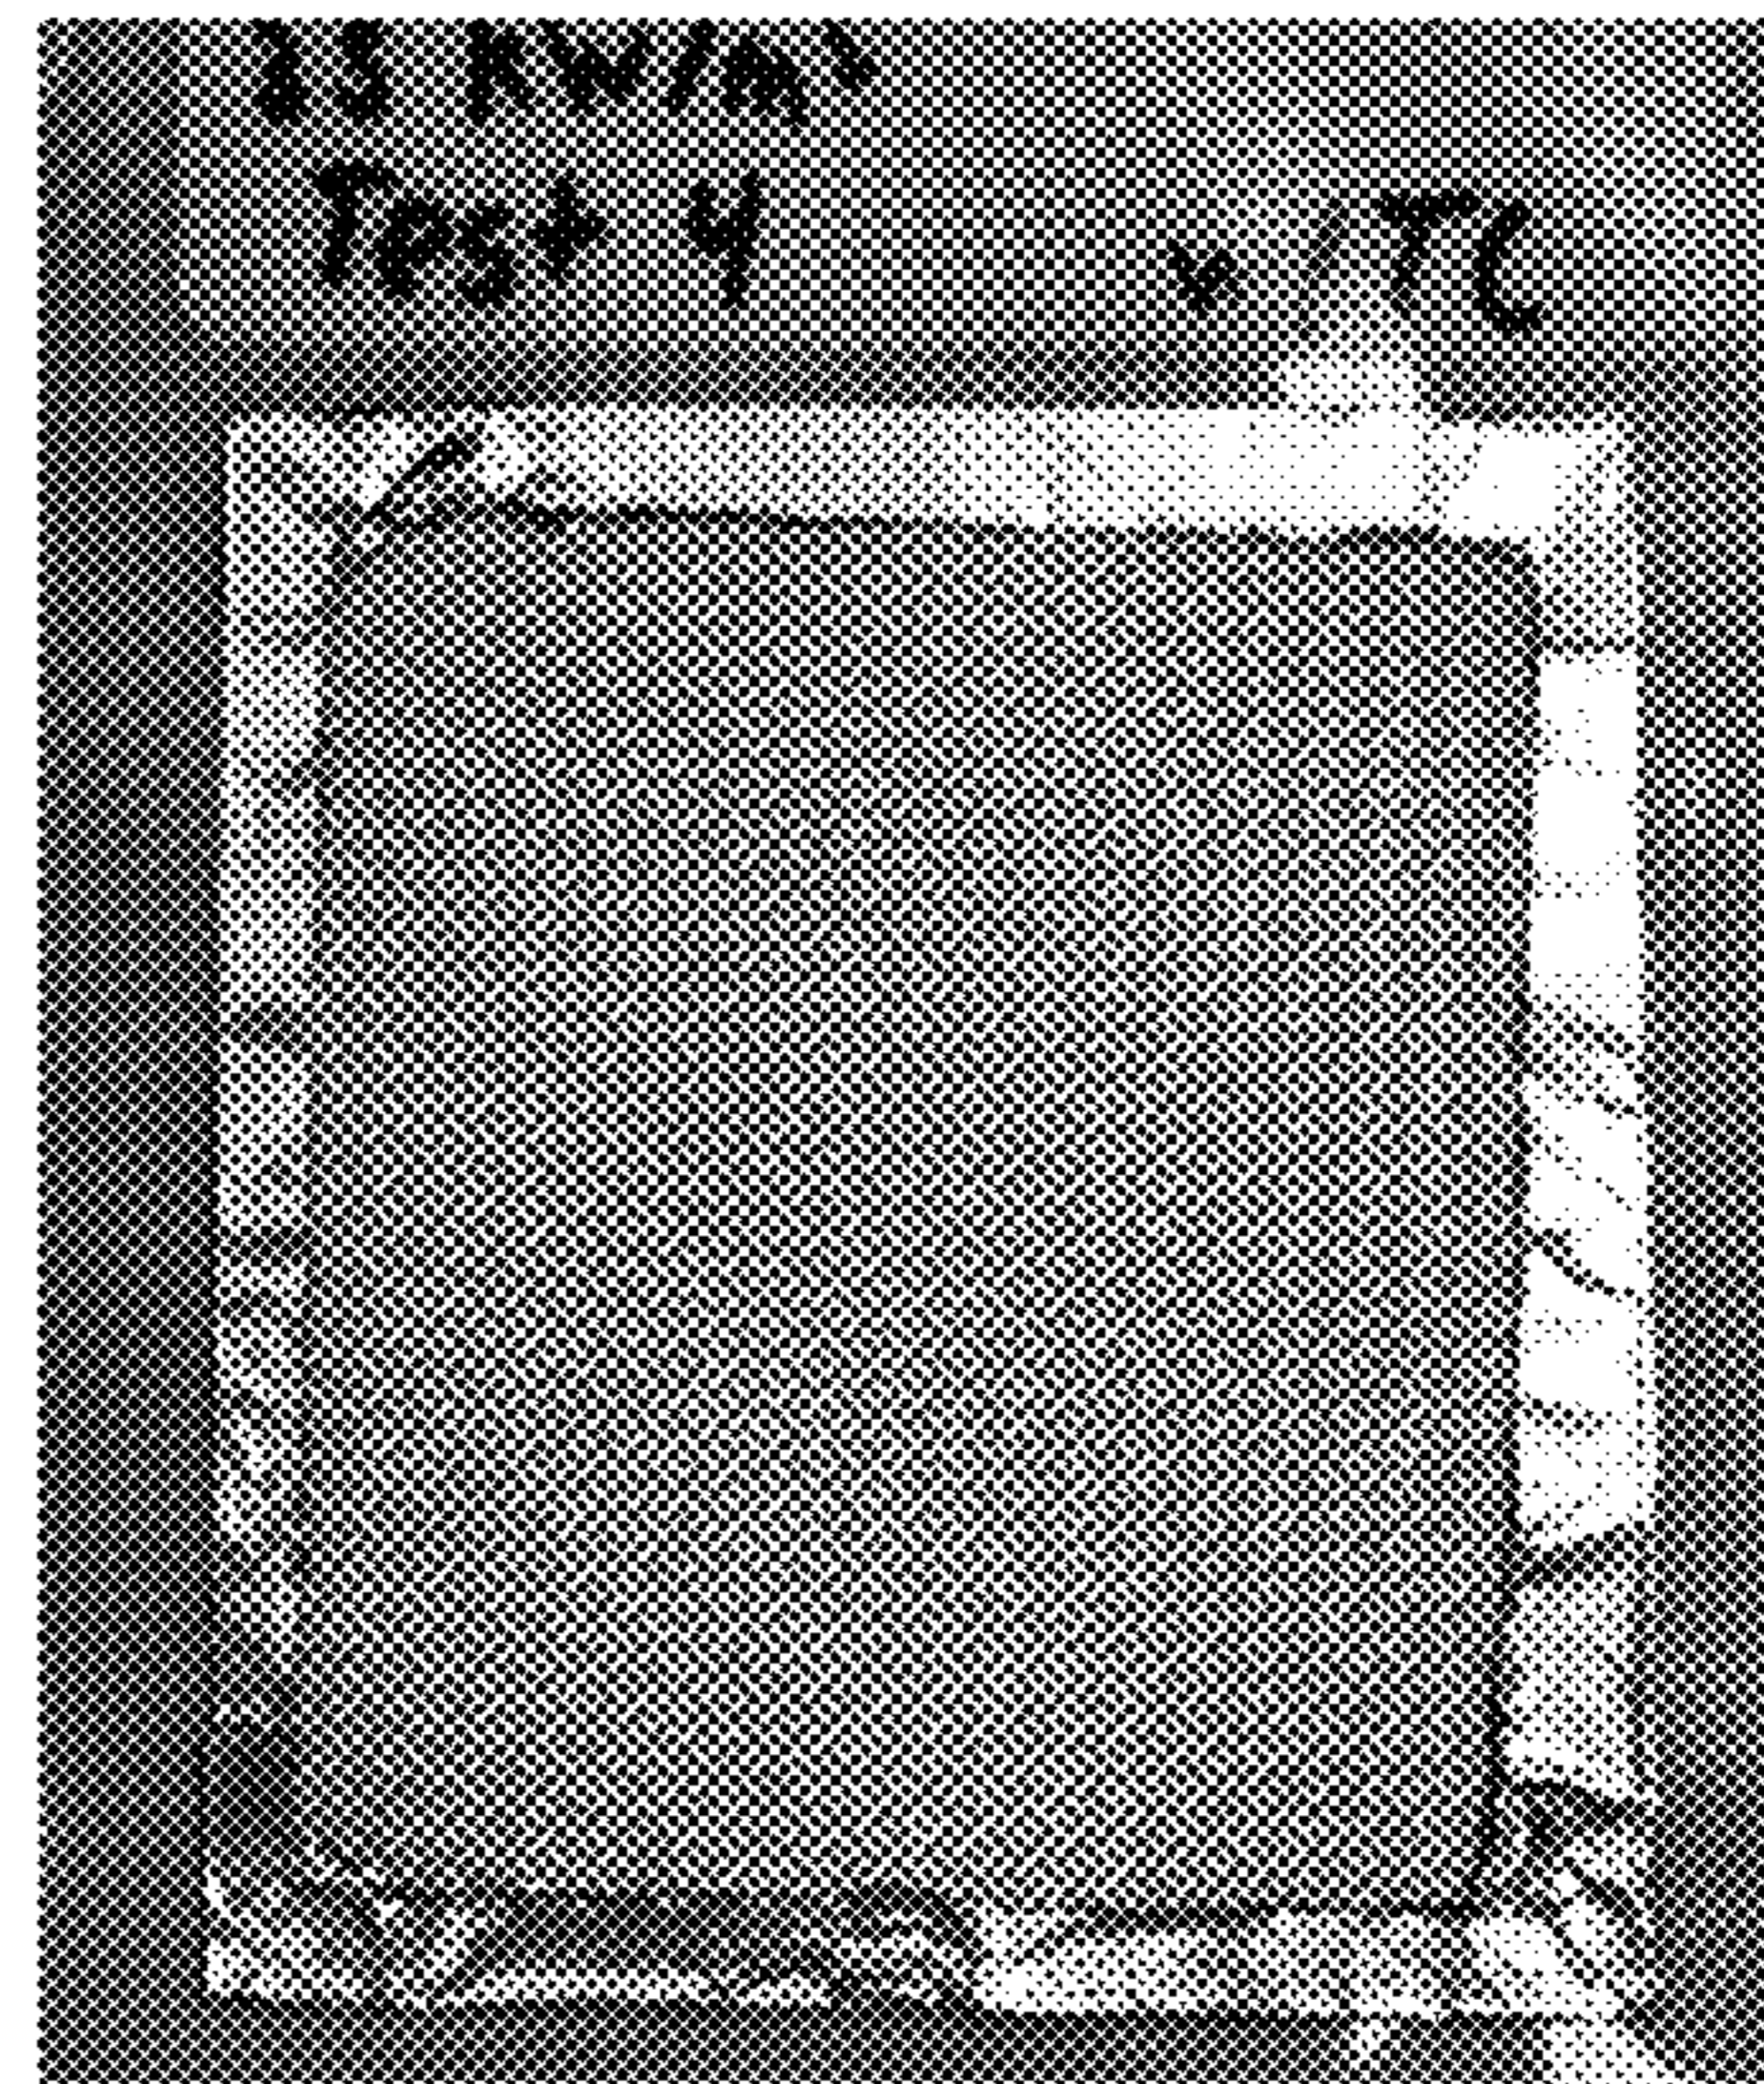
FIG. 15 shows Material C samples after 35 kW/m<sup>2</sup> radiant heating (showing Test 1 (top left), test 2 (top right), test 3 (bottom left), and test 4 (bottom right)).
