(10) **Patent No.:** **US 11,485,106 B2**  
(45) **Date of Patent:** **Nov. 1, 2022**

(54) **FIRE HOSE AND MATERTAL THEREFORE**

Described herein are fire hoses incorporating new combi-  
nations of materials to increase the hose's resilience. Resil-  
ient hoses include those made with silicone-coated fabrics or  
with thermally-resistant fabrics or both.

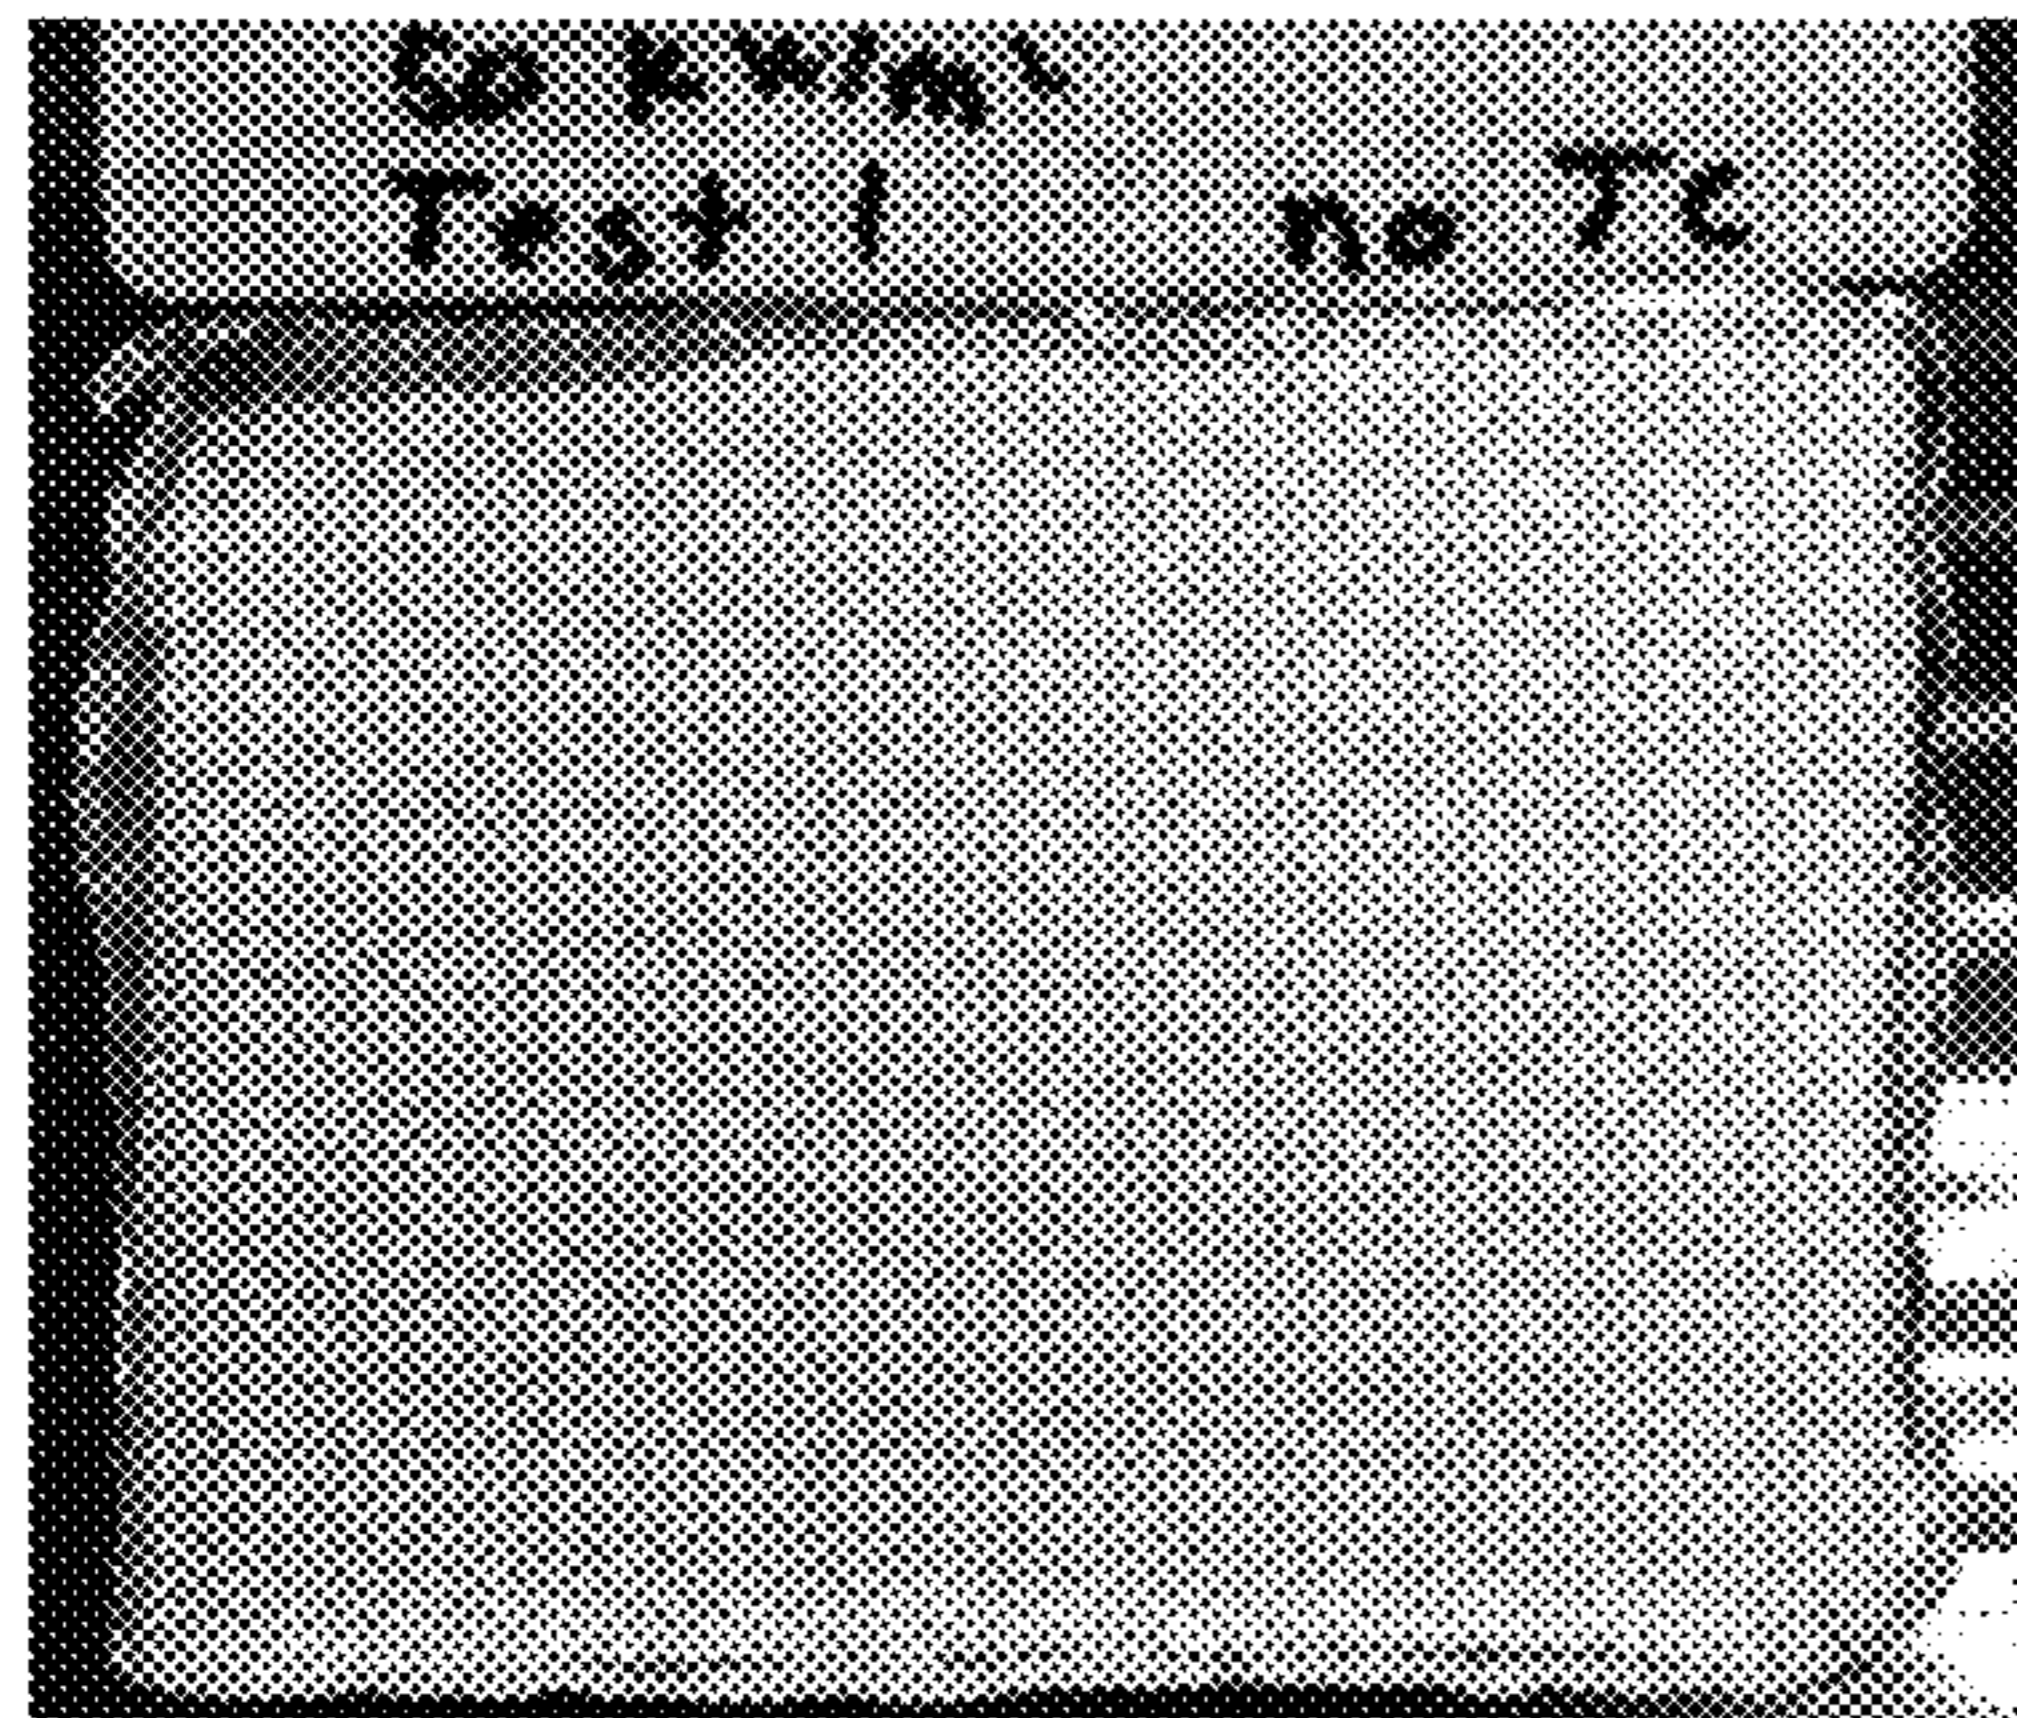
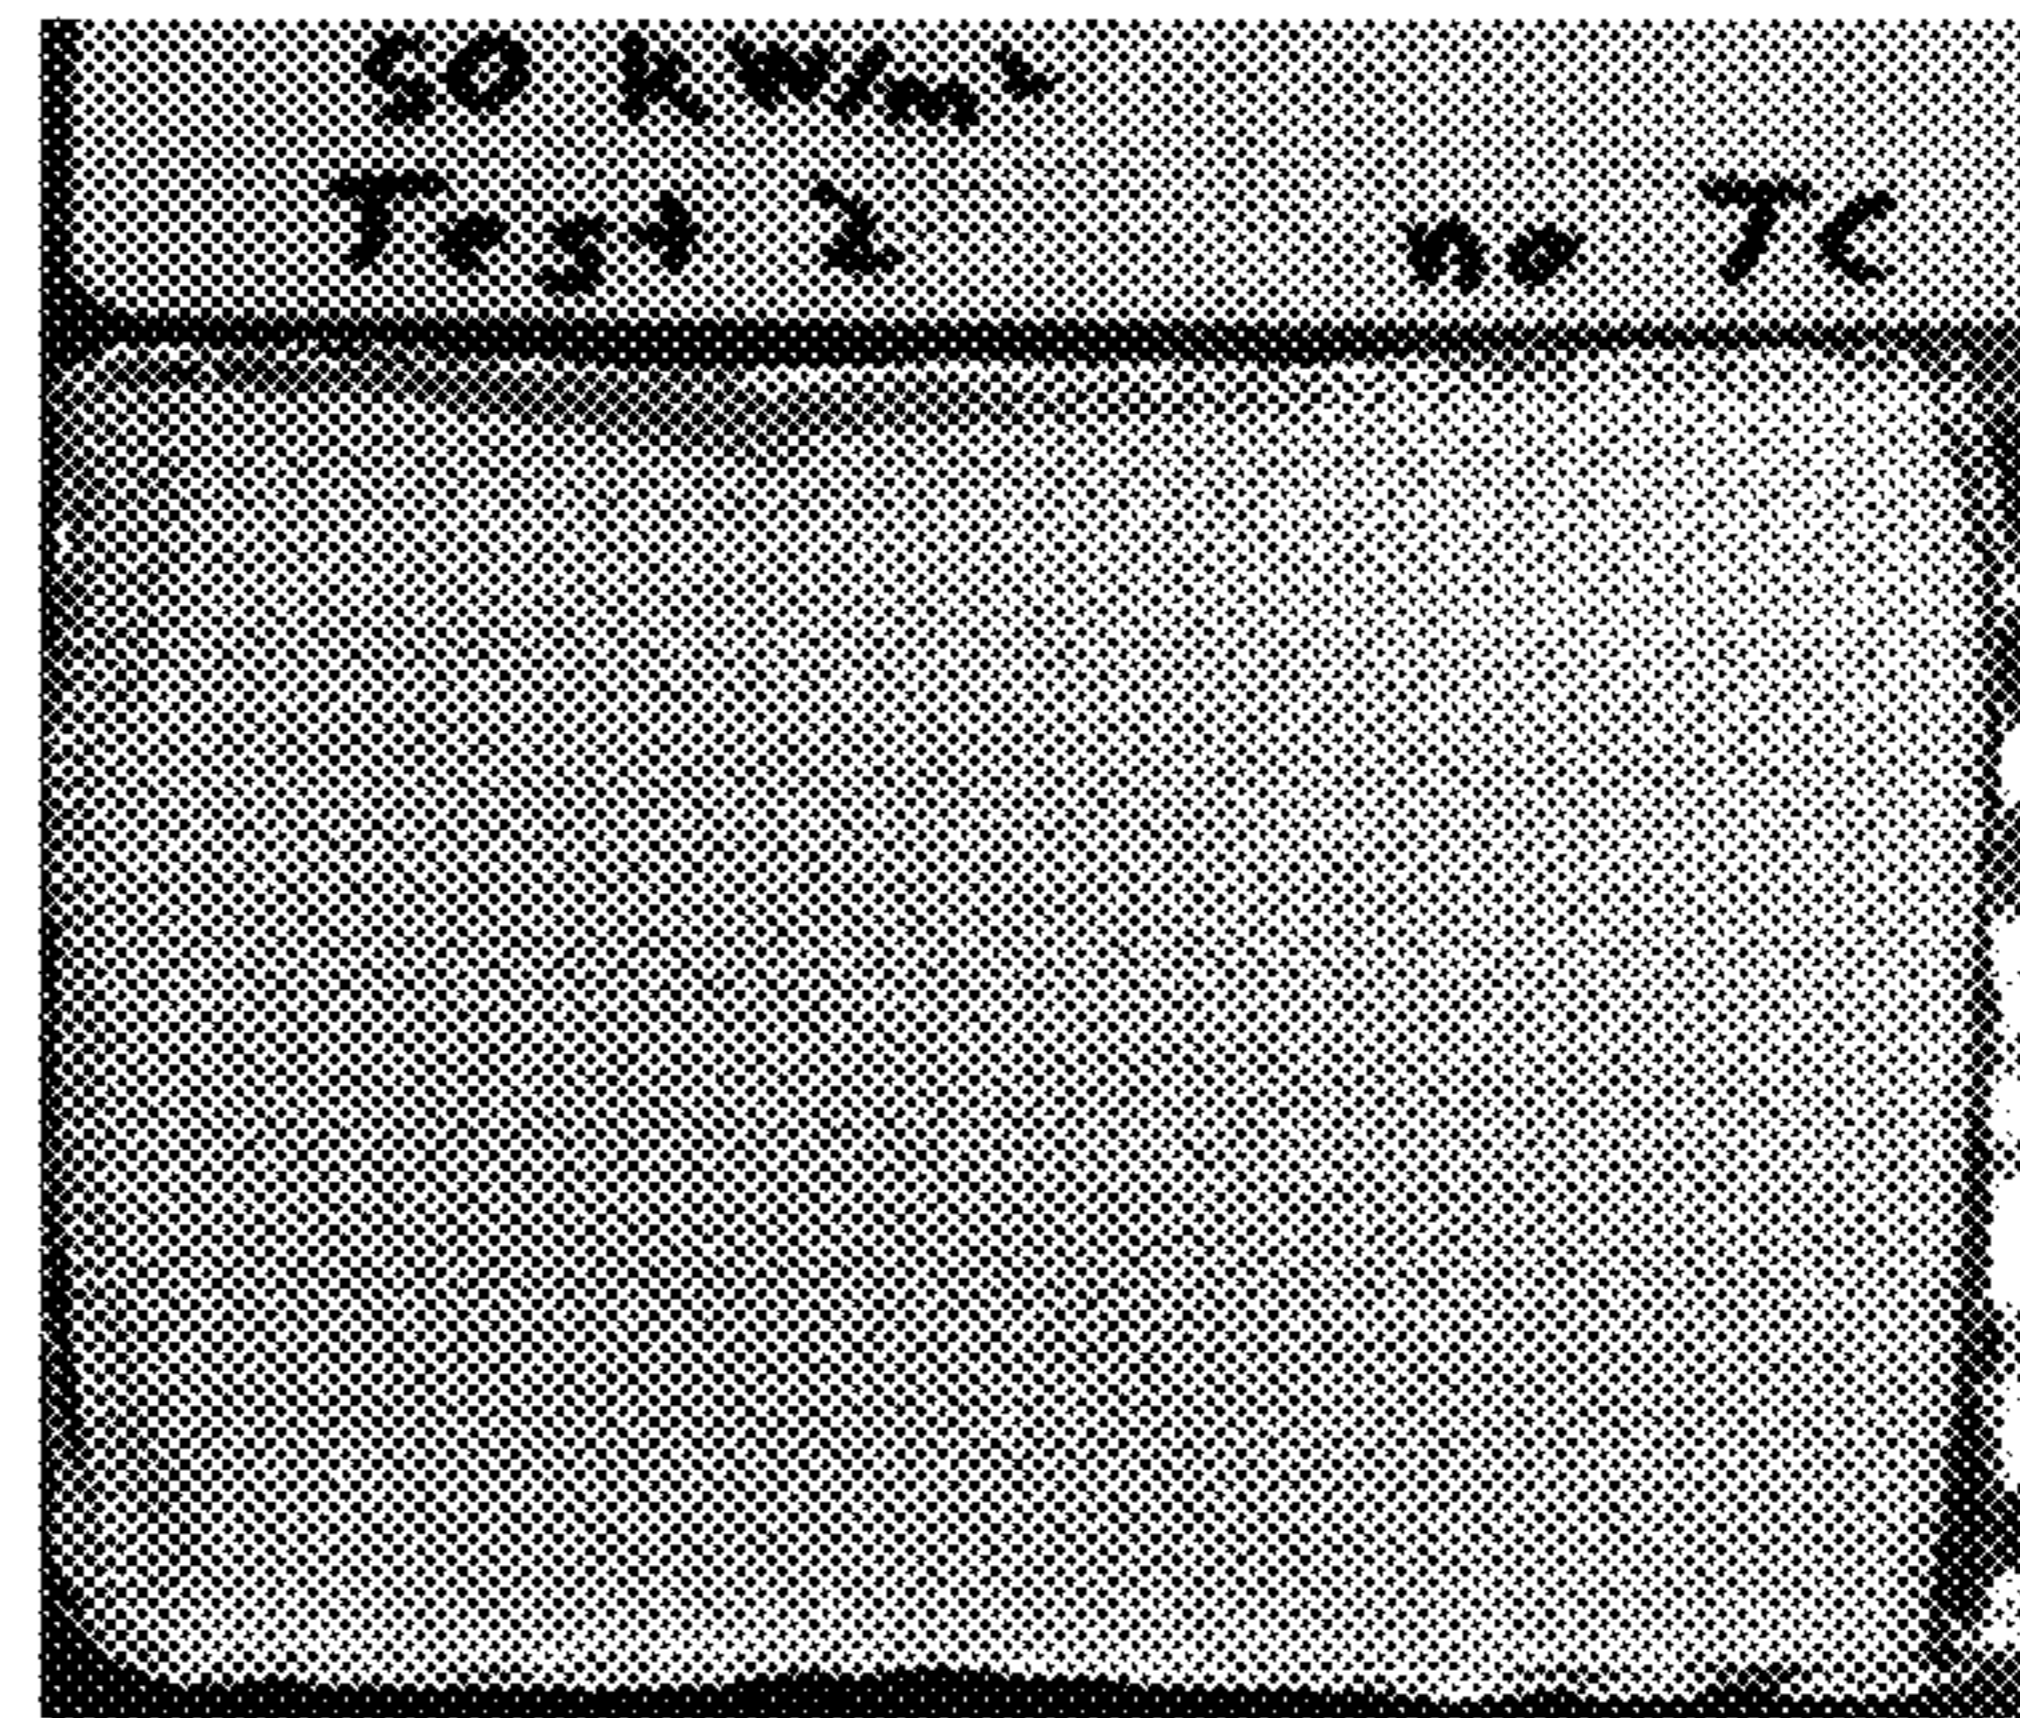
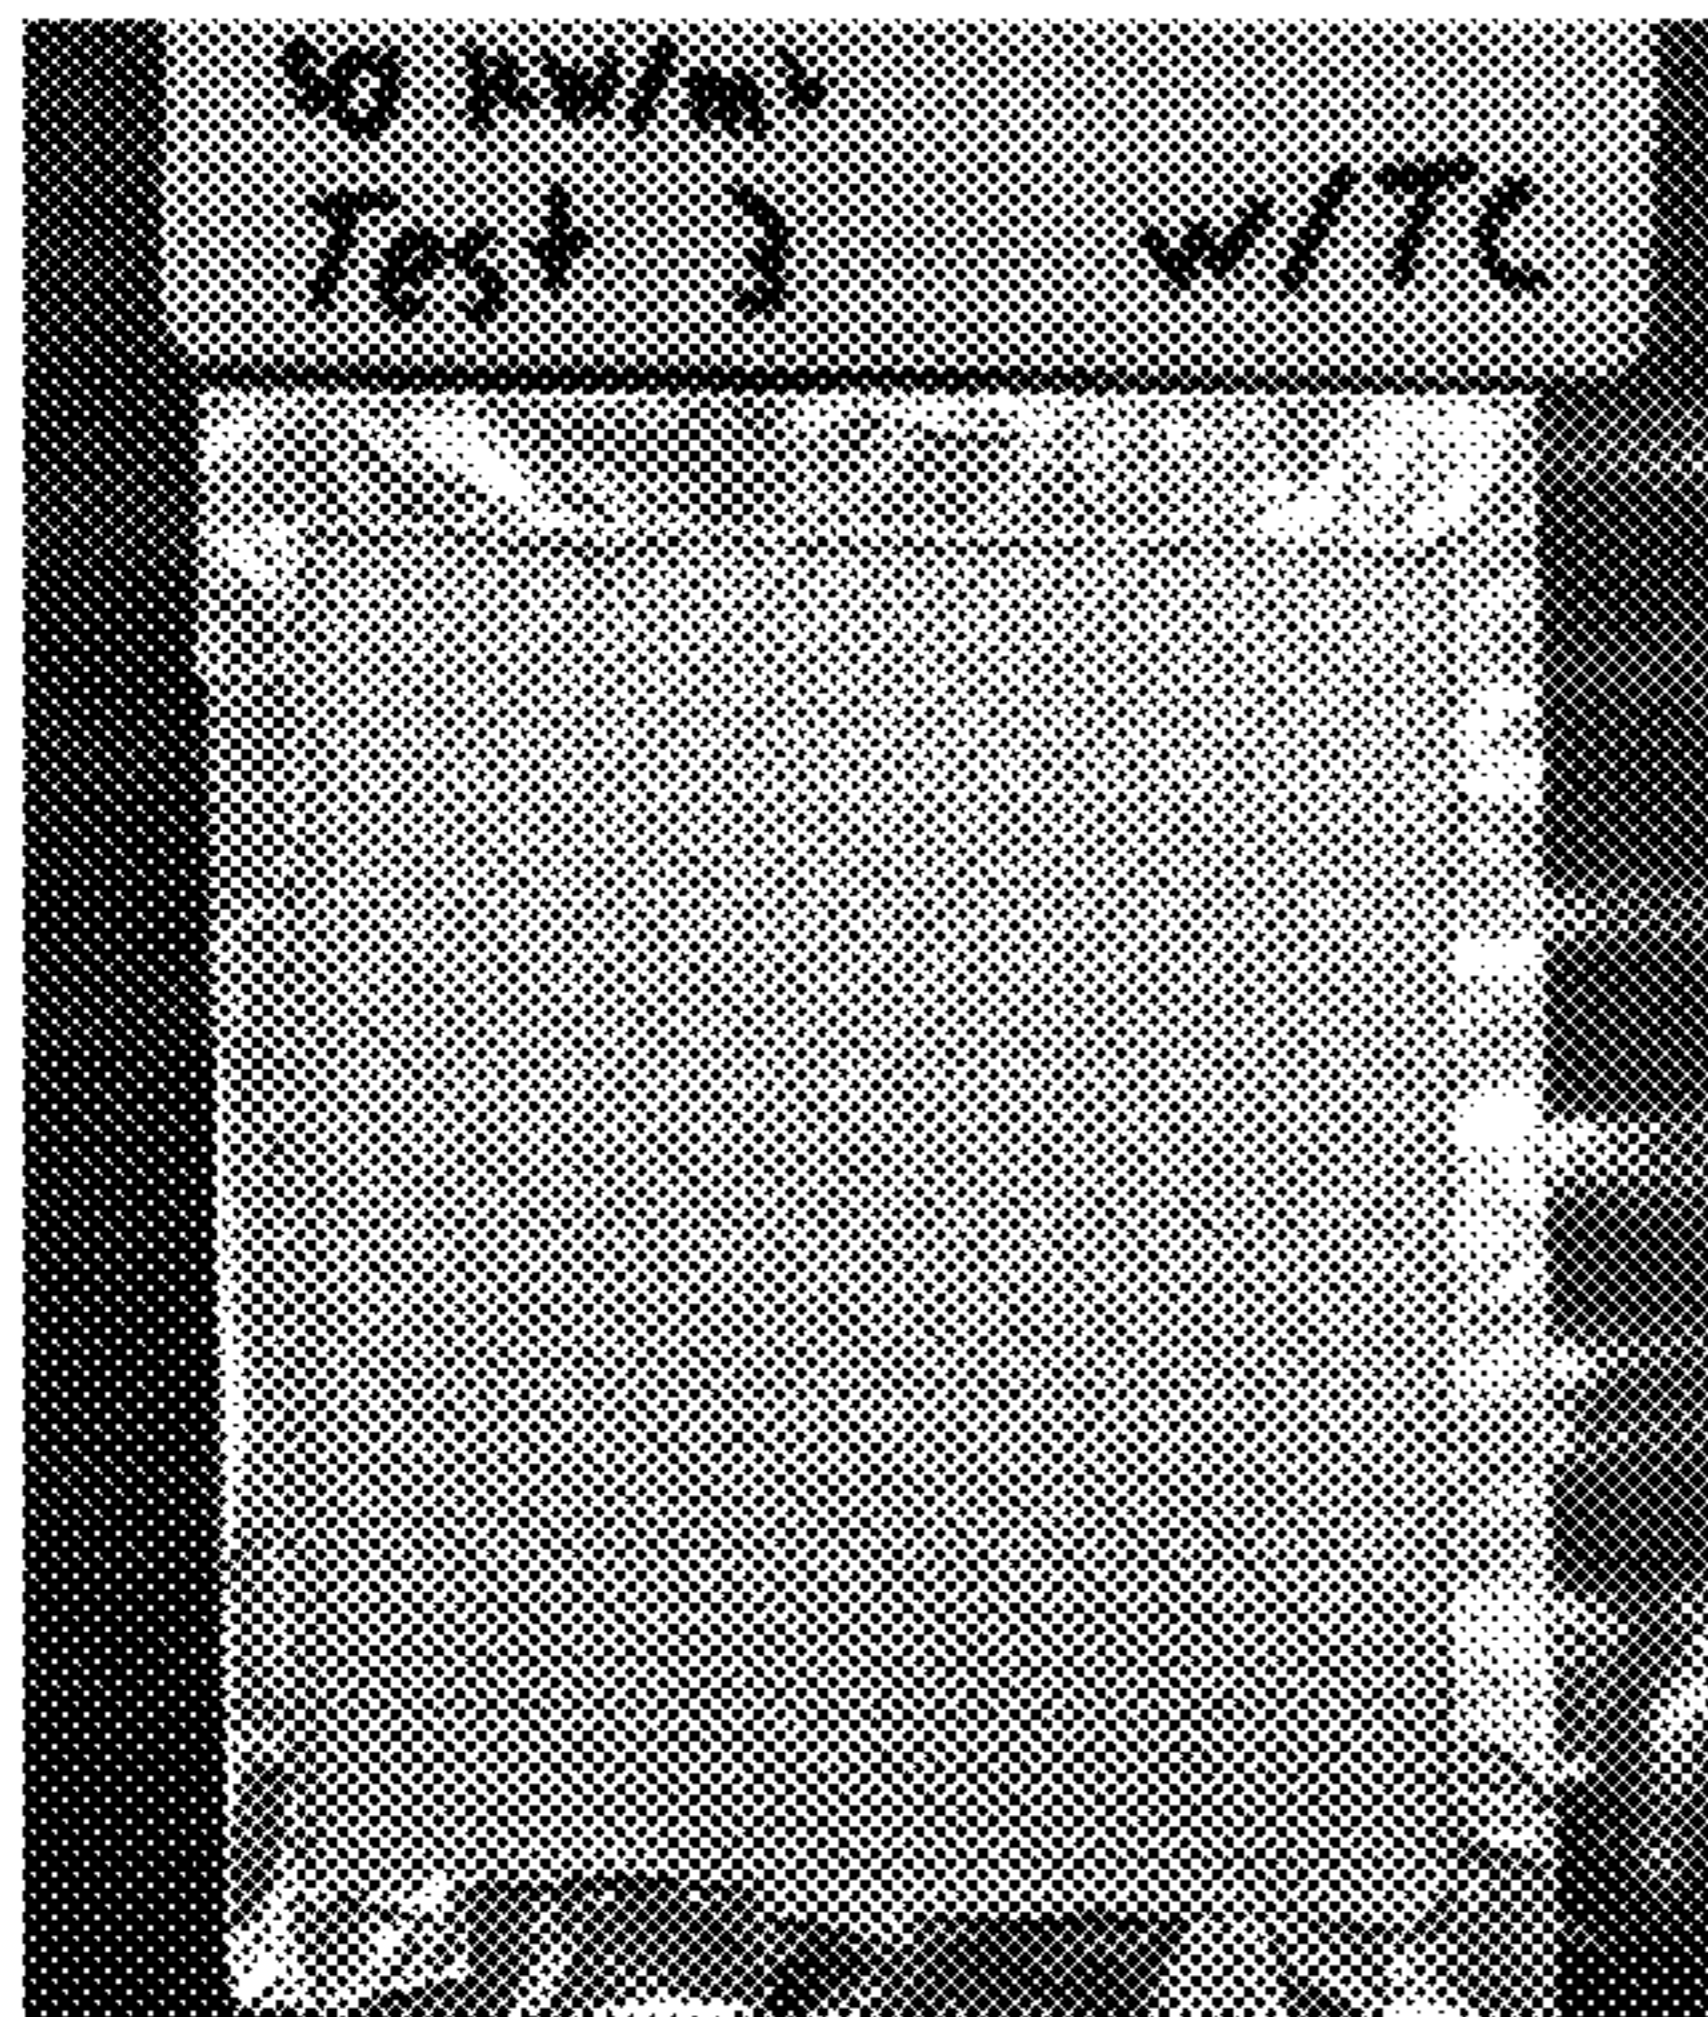
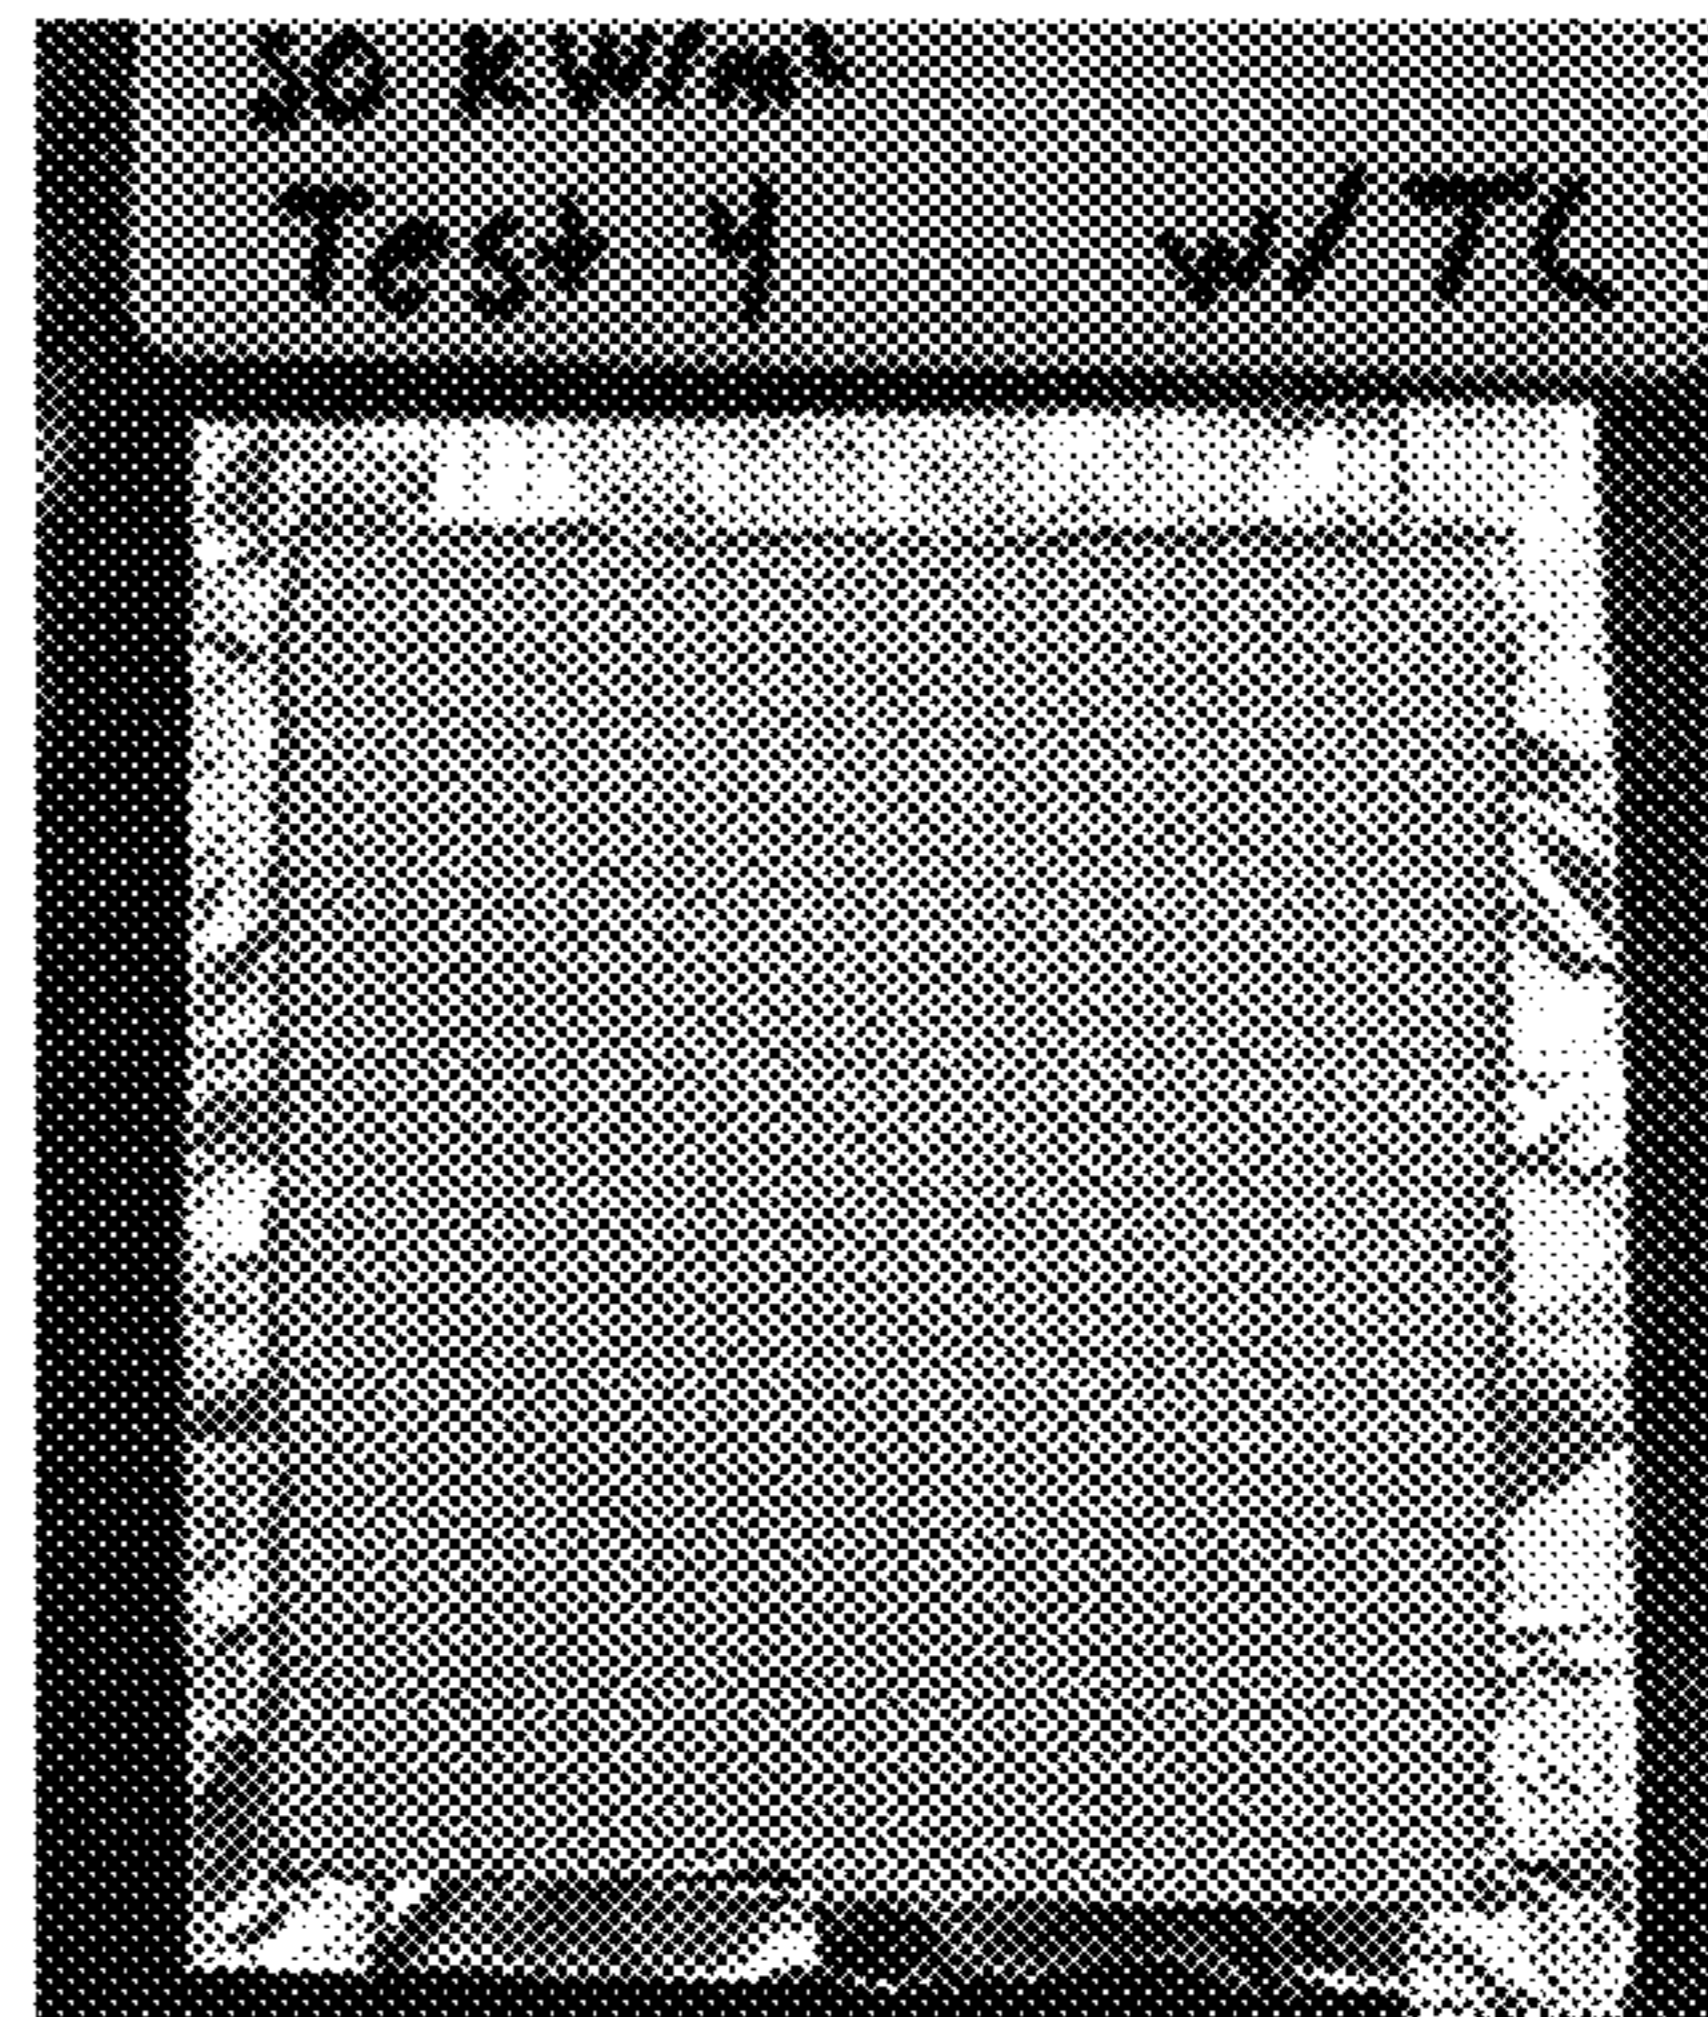
FIG. 16 shows Material C samples after 50 kW/m<sup>2</sup> radiant heating (showing Test 1 (top left), Test 2 (top right), Test 3 (bottom left), and Test 4 (bottom right)).

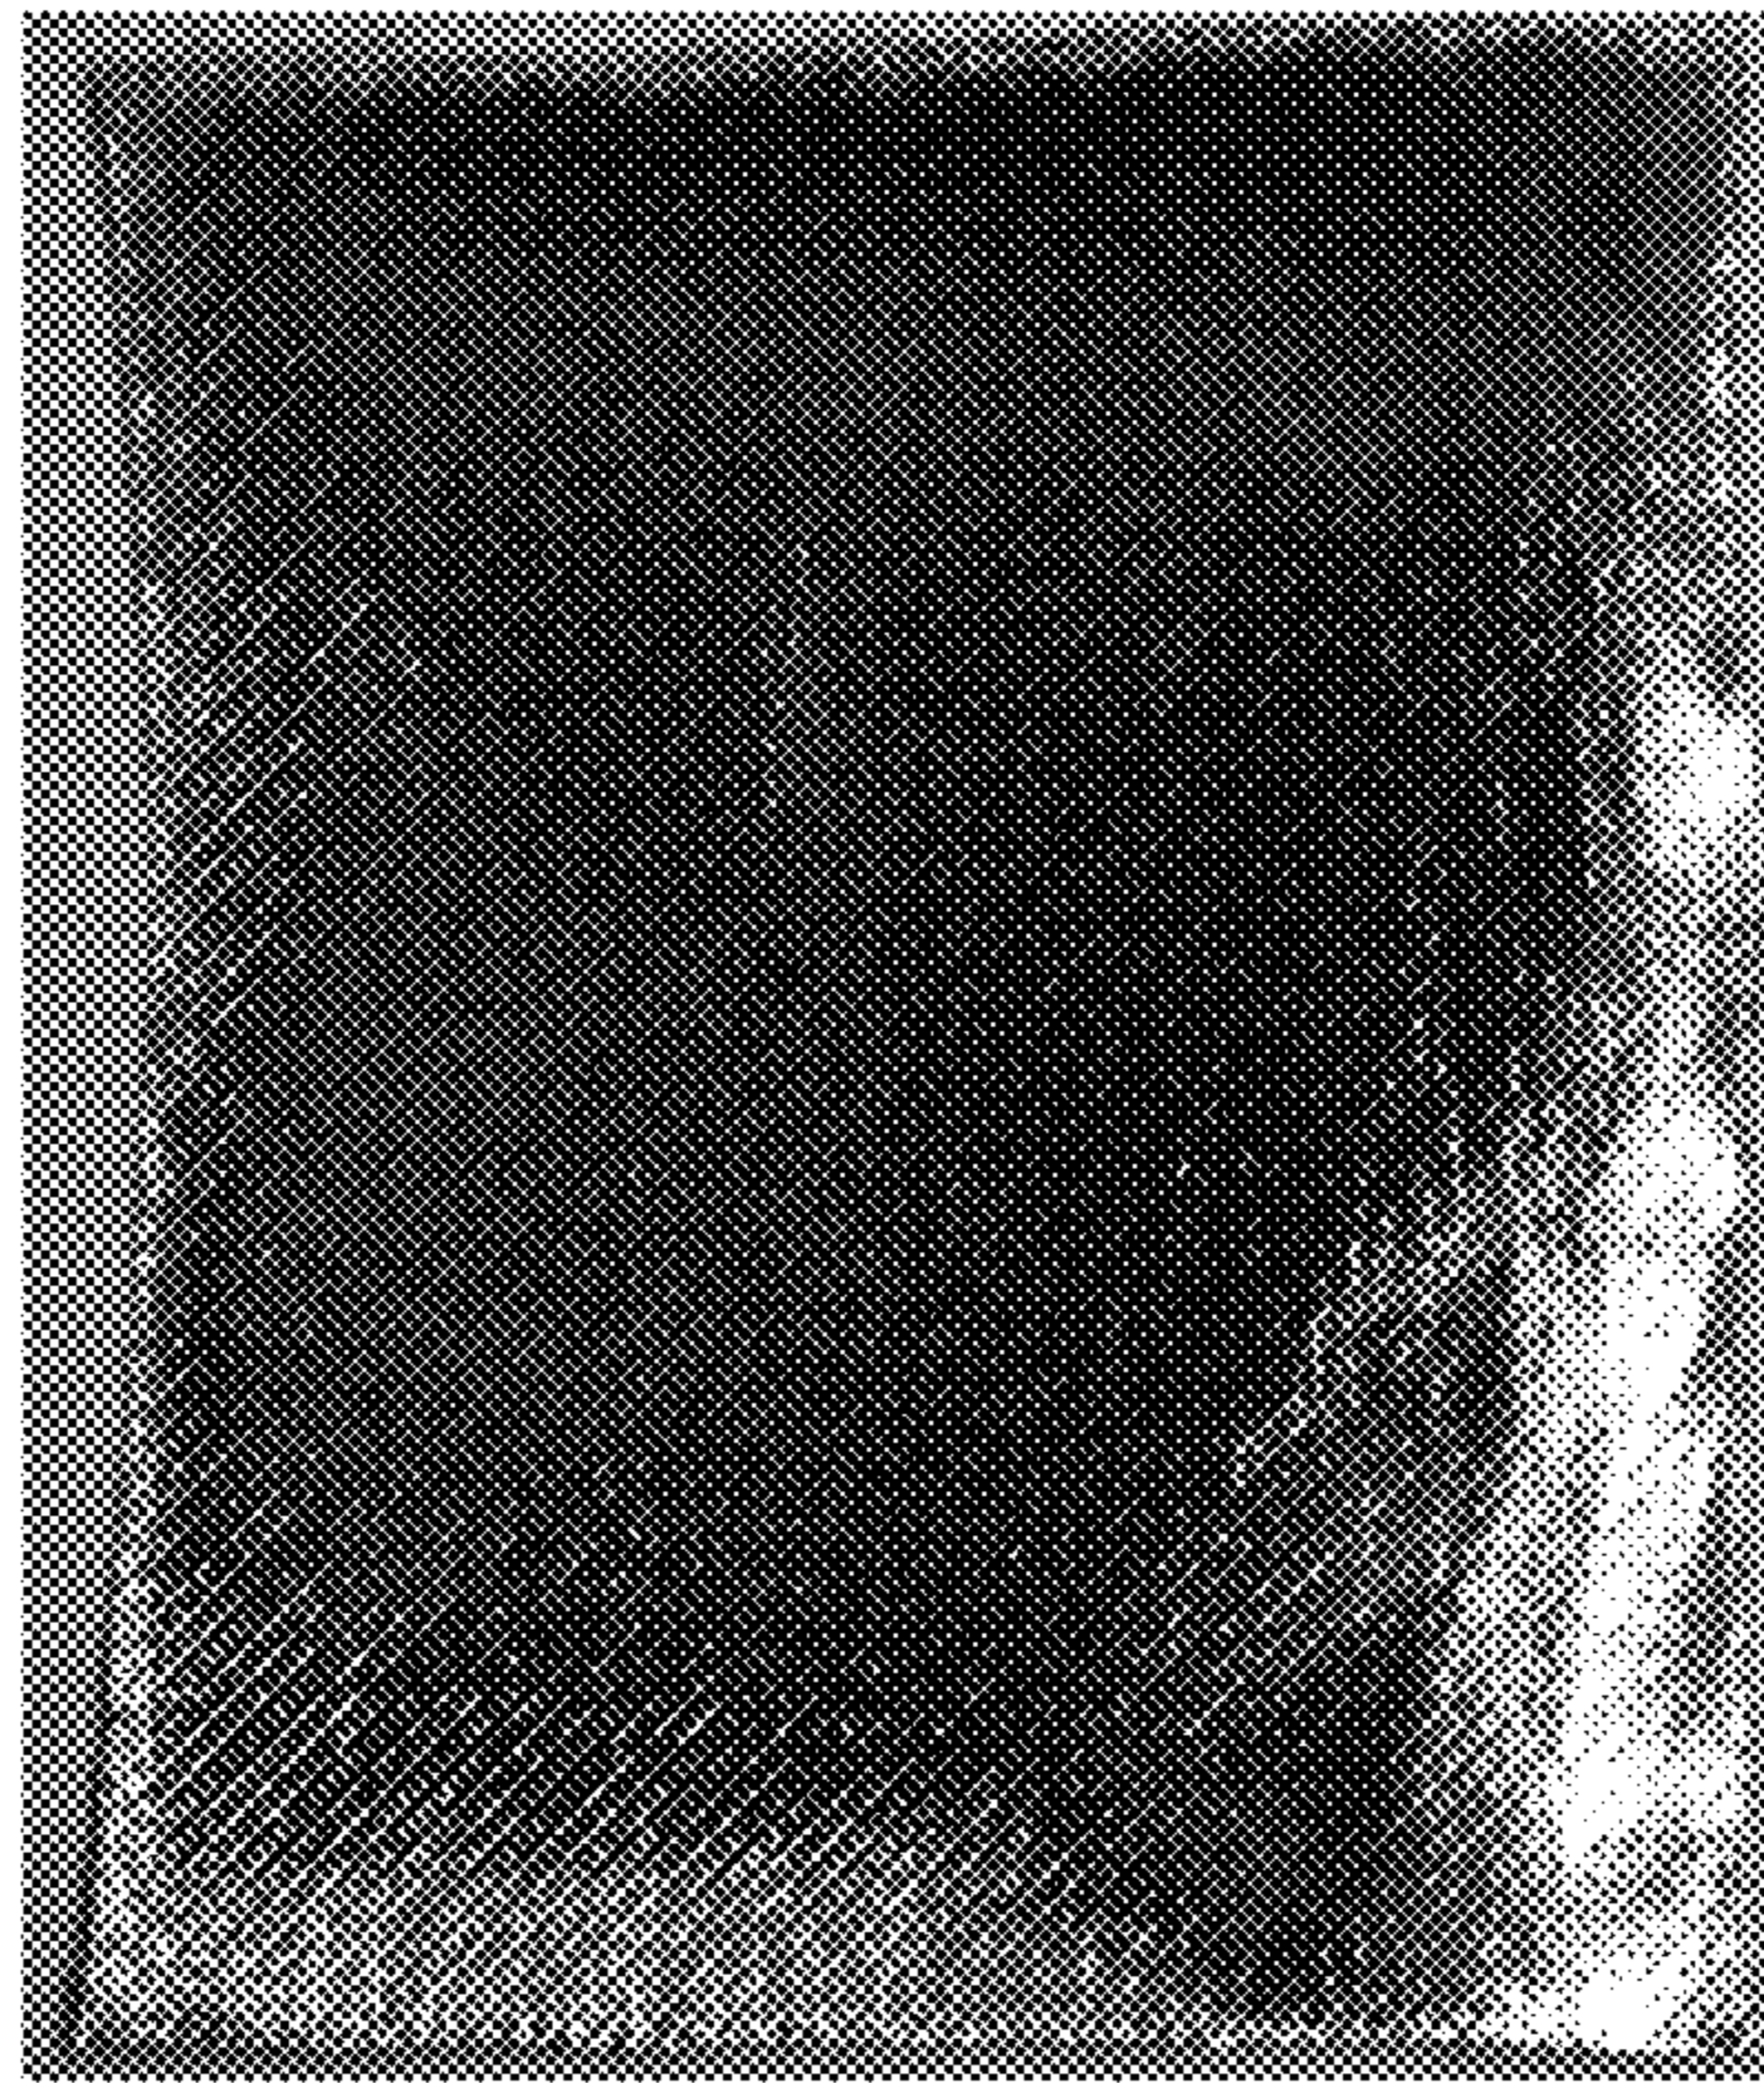
**FIG. 17**

FIG. 17 shows a sample of Material D prior to testing.

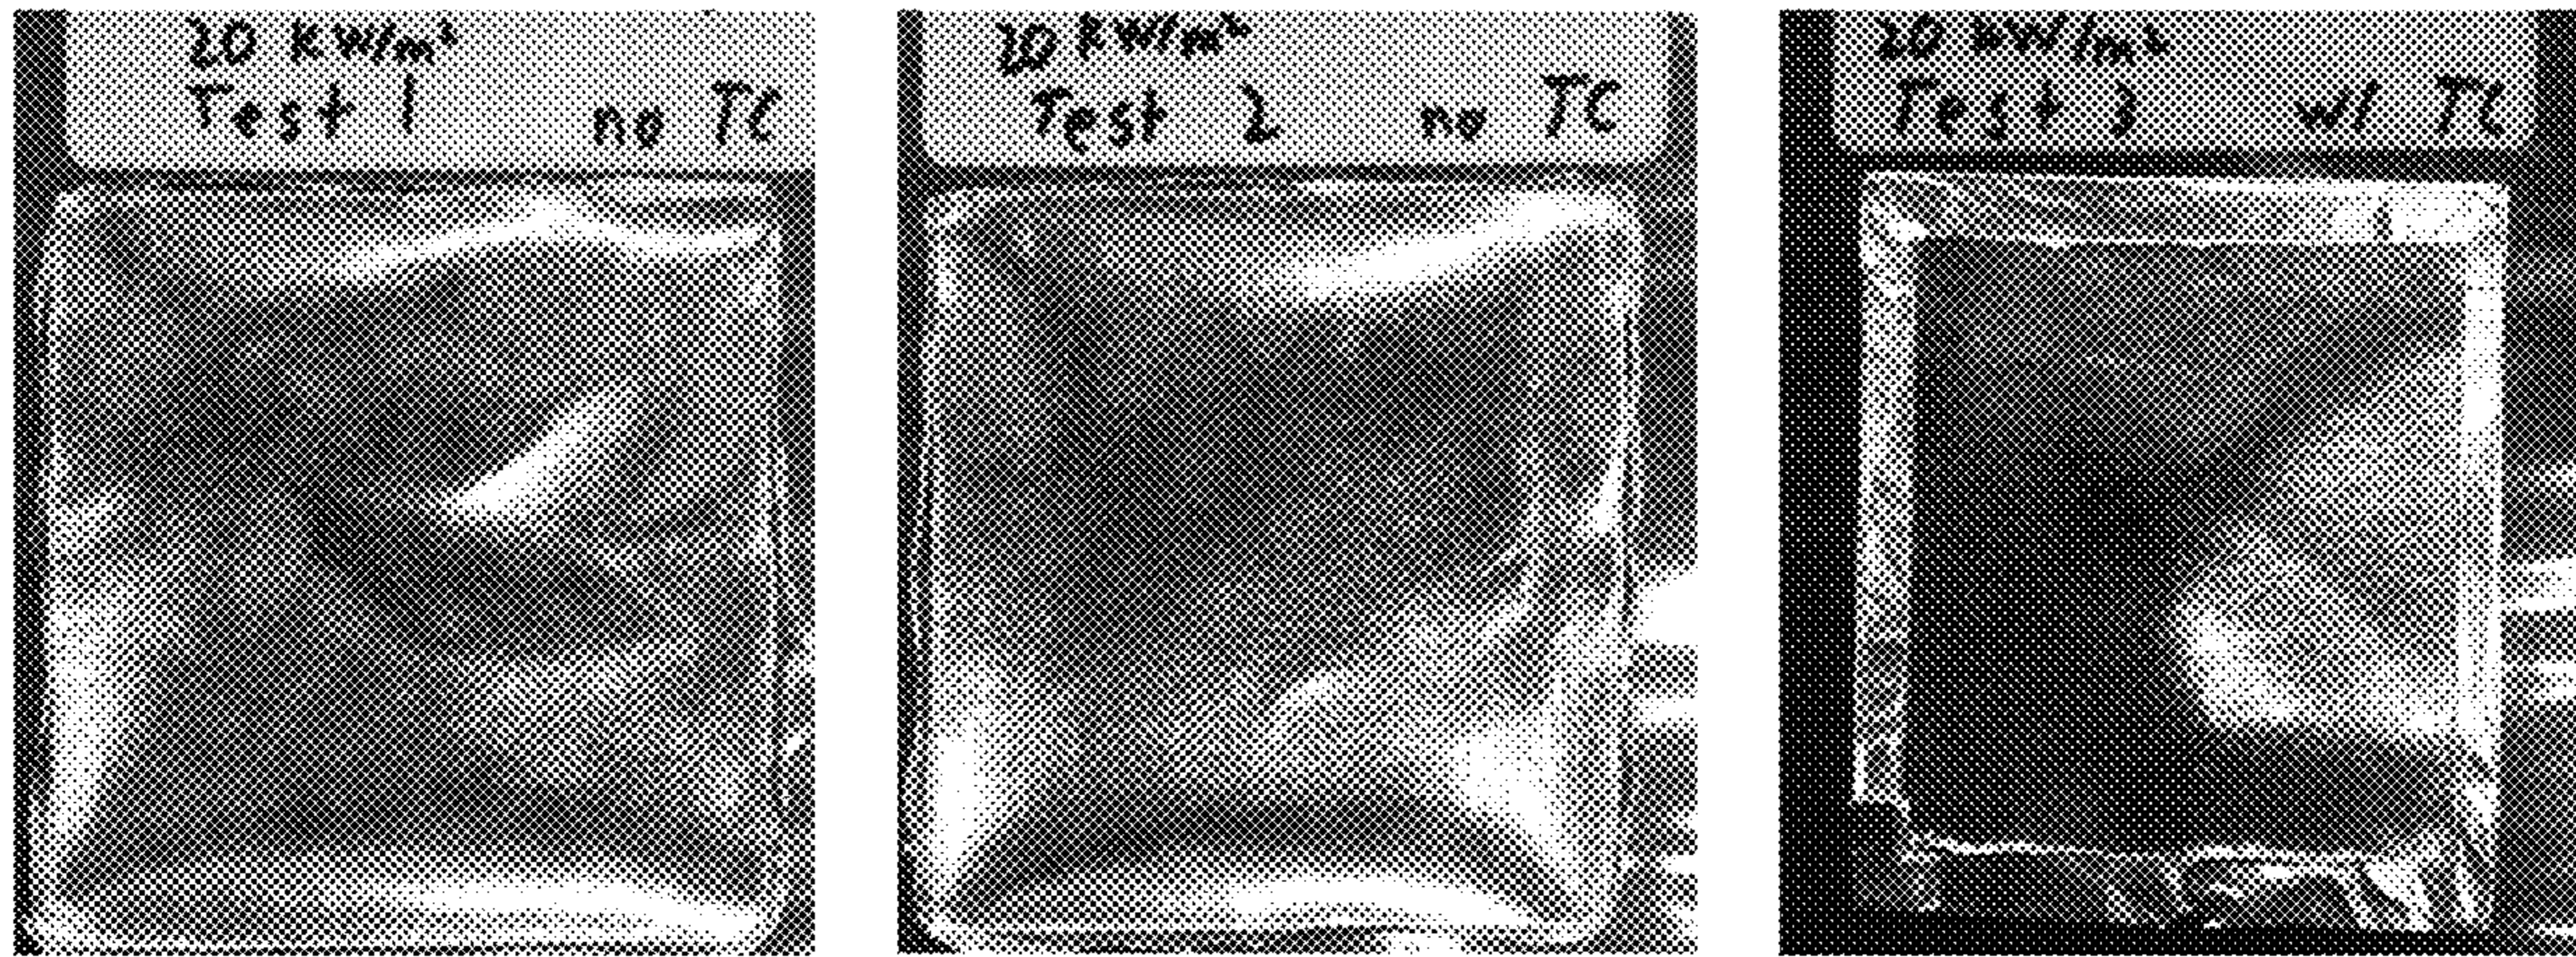
FIG. 18 shows Material D samples after 20 kW/m<sup>2</sup> radiant heating (showing Test 1 (left), Test 2 (center), and Test 3 (right)).

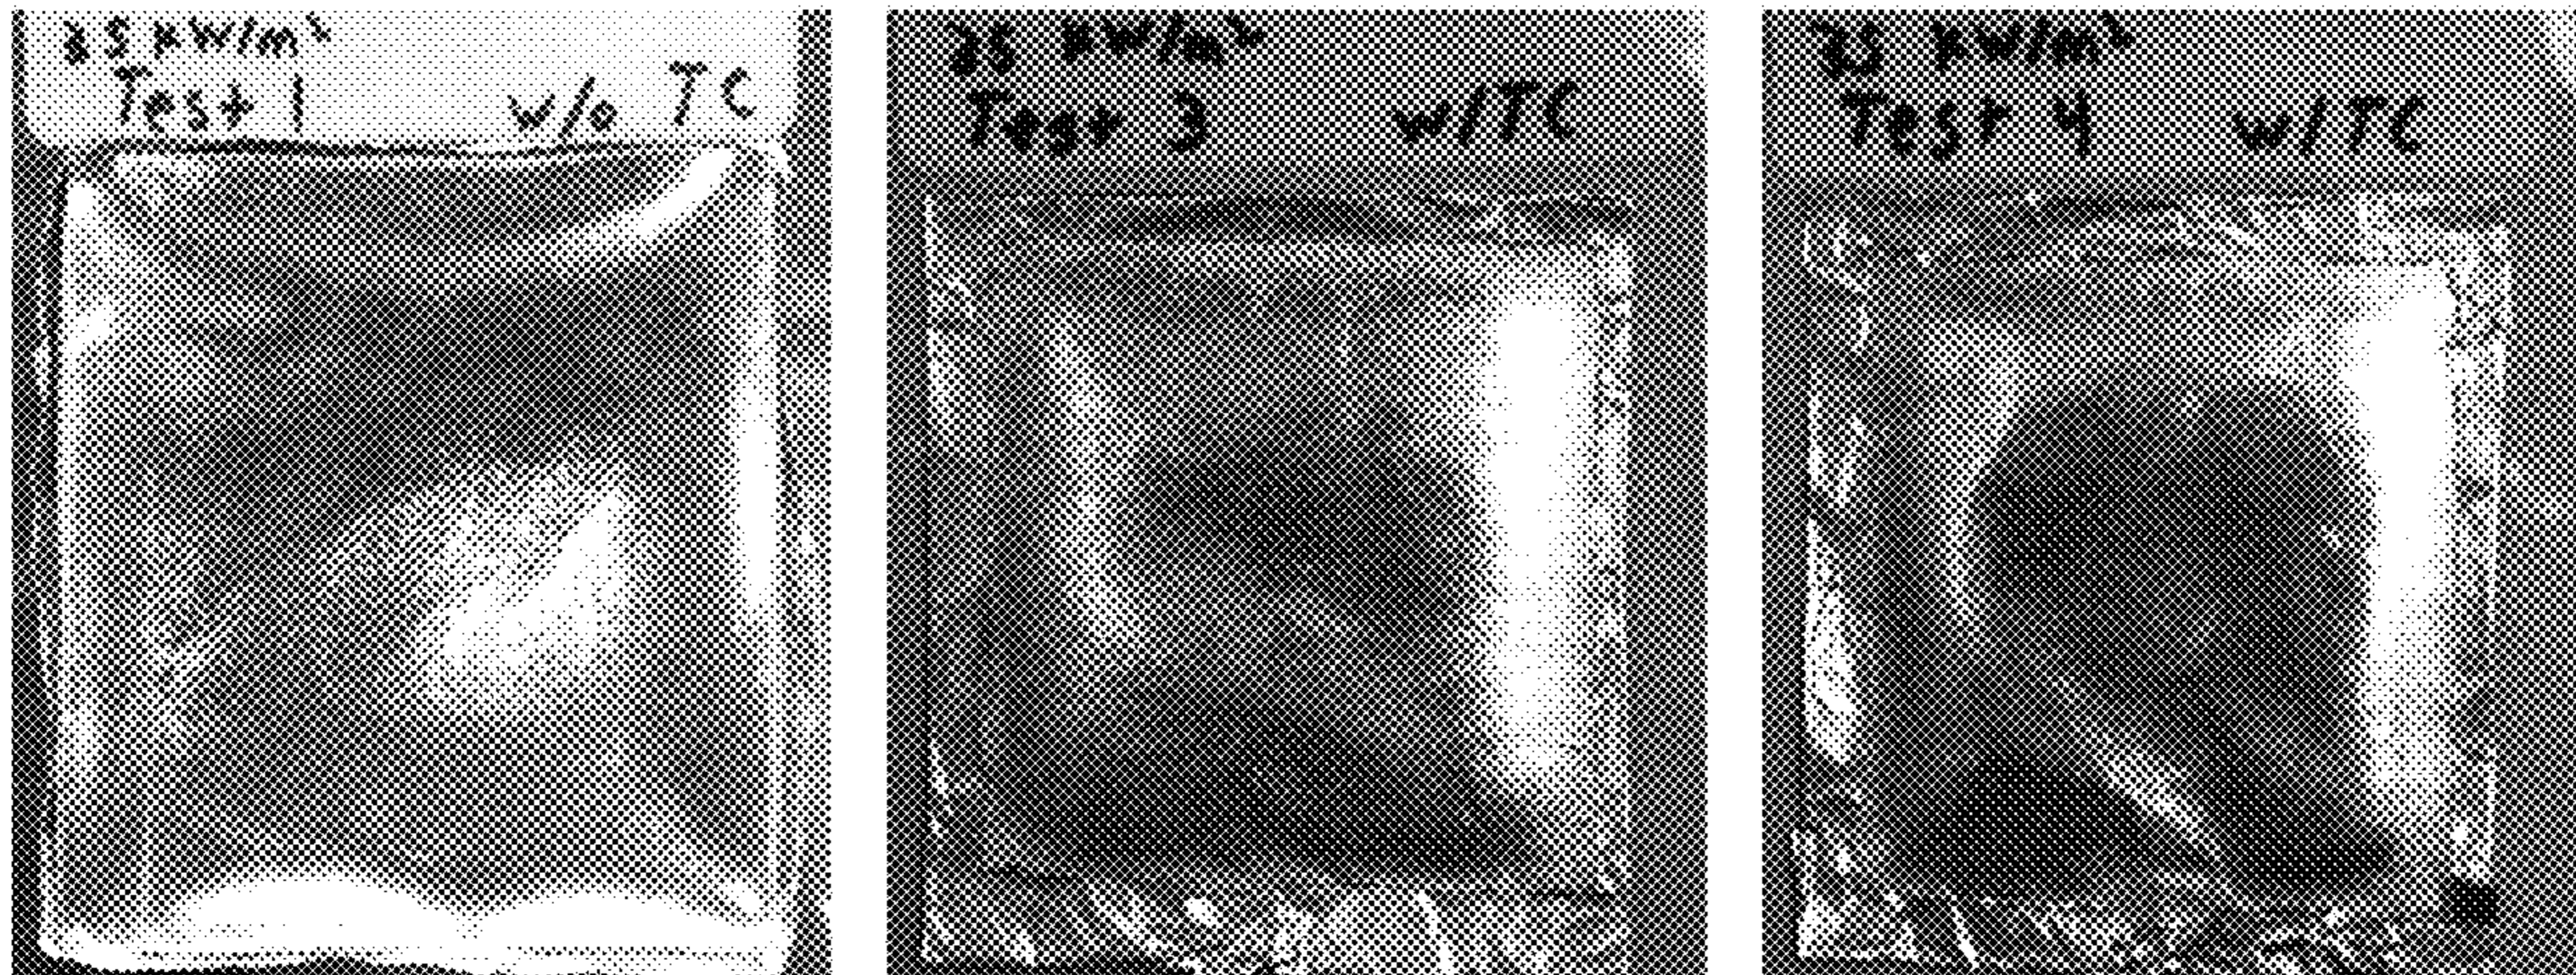
FIG. 19 shows Material D samples after 35 kW/m<sup>2</sup> radiant heating (showing Test 1 (left), Test 3 (center), and Test 4 (right) samples).
