(10) **Patent No.:** **US 11,485,106 B2**  
(45) **Date of Patent:** **Nov. 1, 2022**

(54) **FIRE HOSE AND MATERTAL THEREFORE**

Described herein are fire hoses incorporating new combi-  
nations of materials to increase the hose's resilience. Resil-  
ient hoses include those made with silicone-coated fabrics or  
with thermally-resistant fabrics or both.

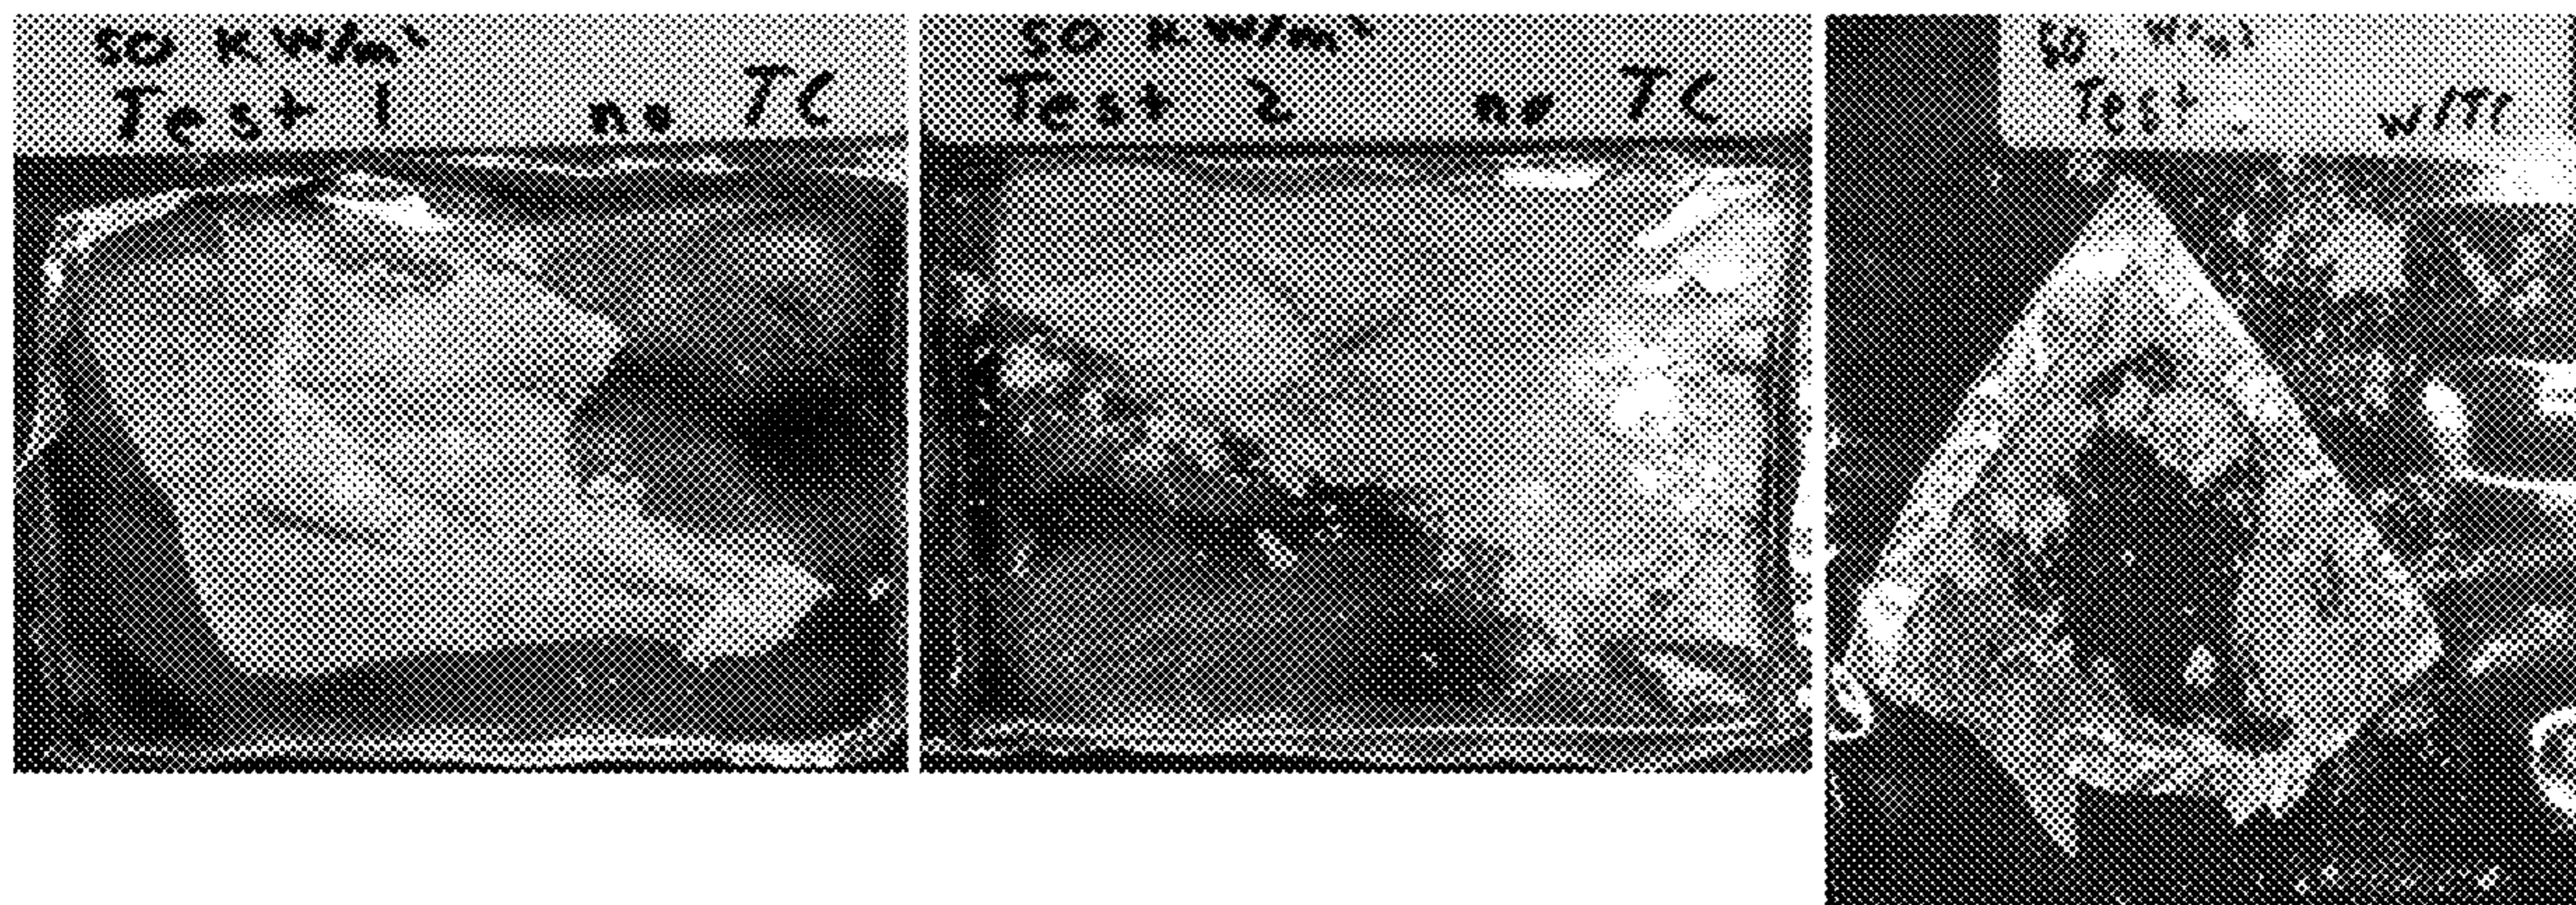
FIG. 20 shows Material D samples after 50 kW/m<sup>2</sup> radiant heating (showing Test 1 (left), Test 2 (center), and Test 3 (right)).

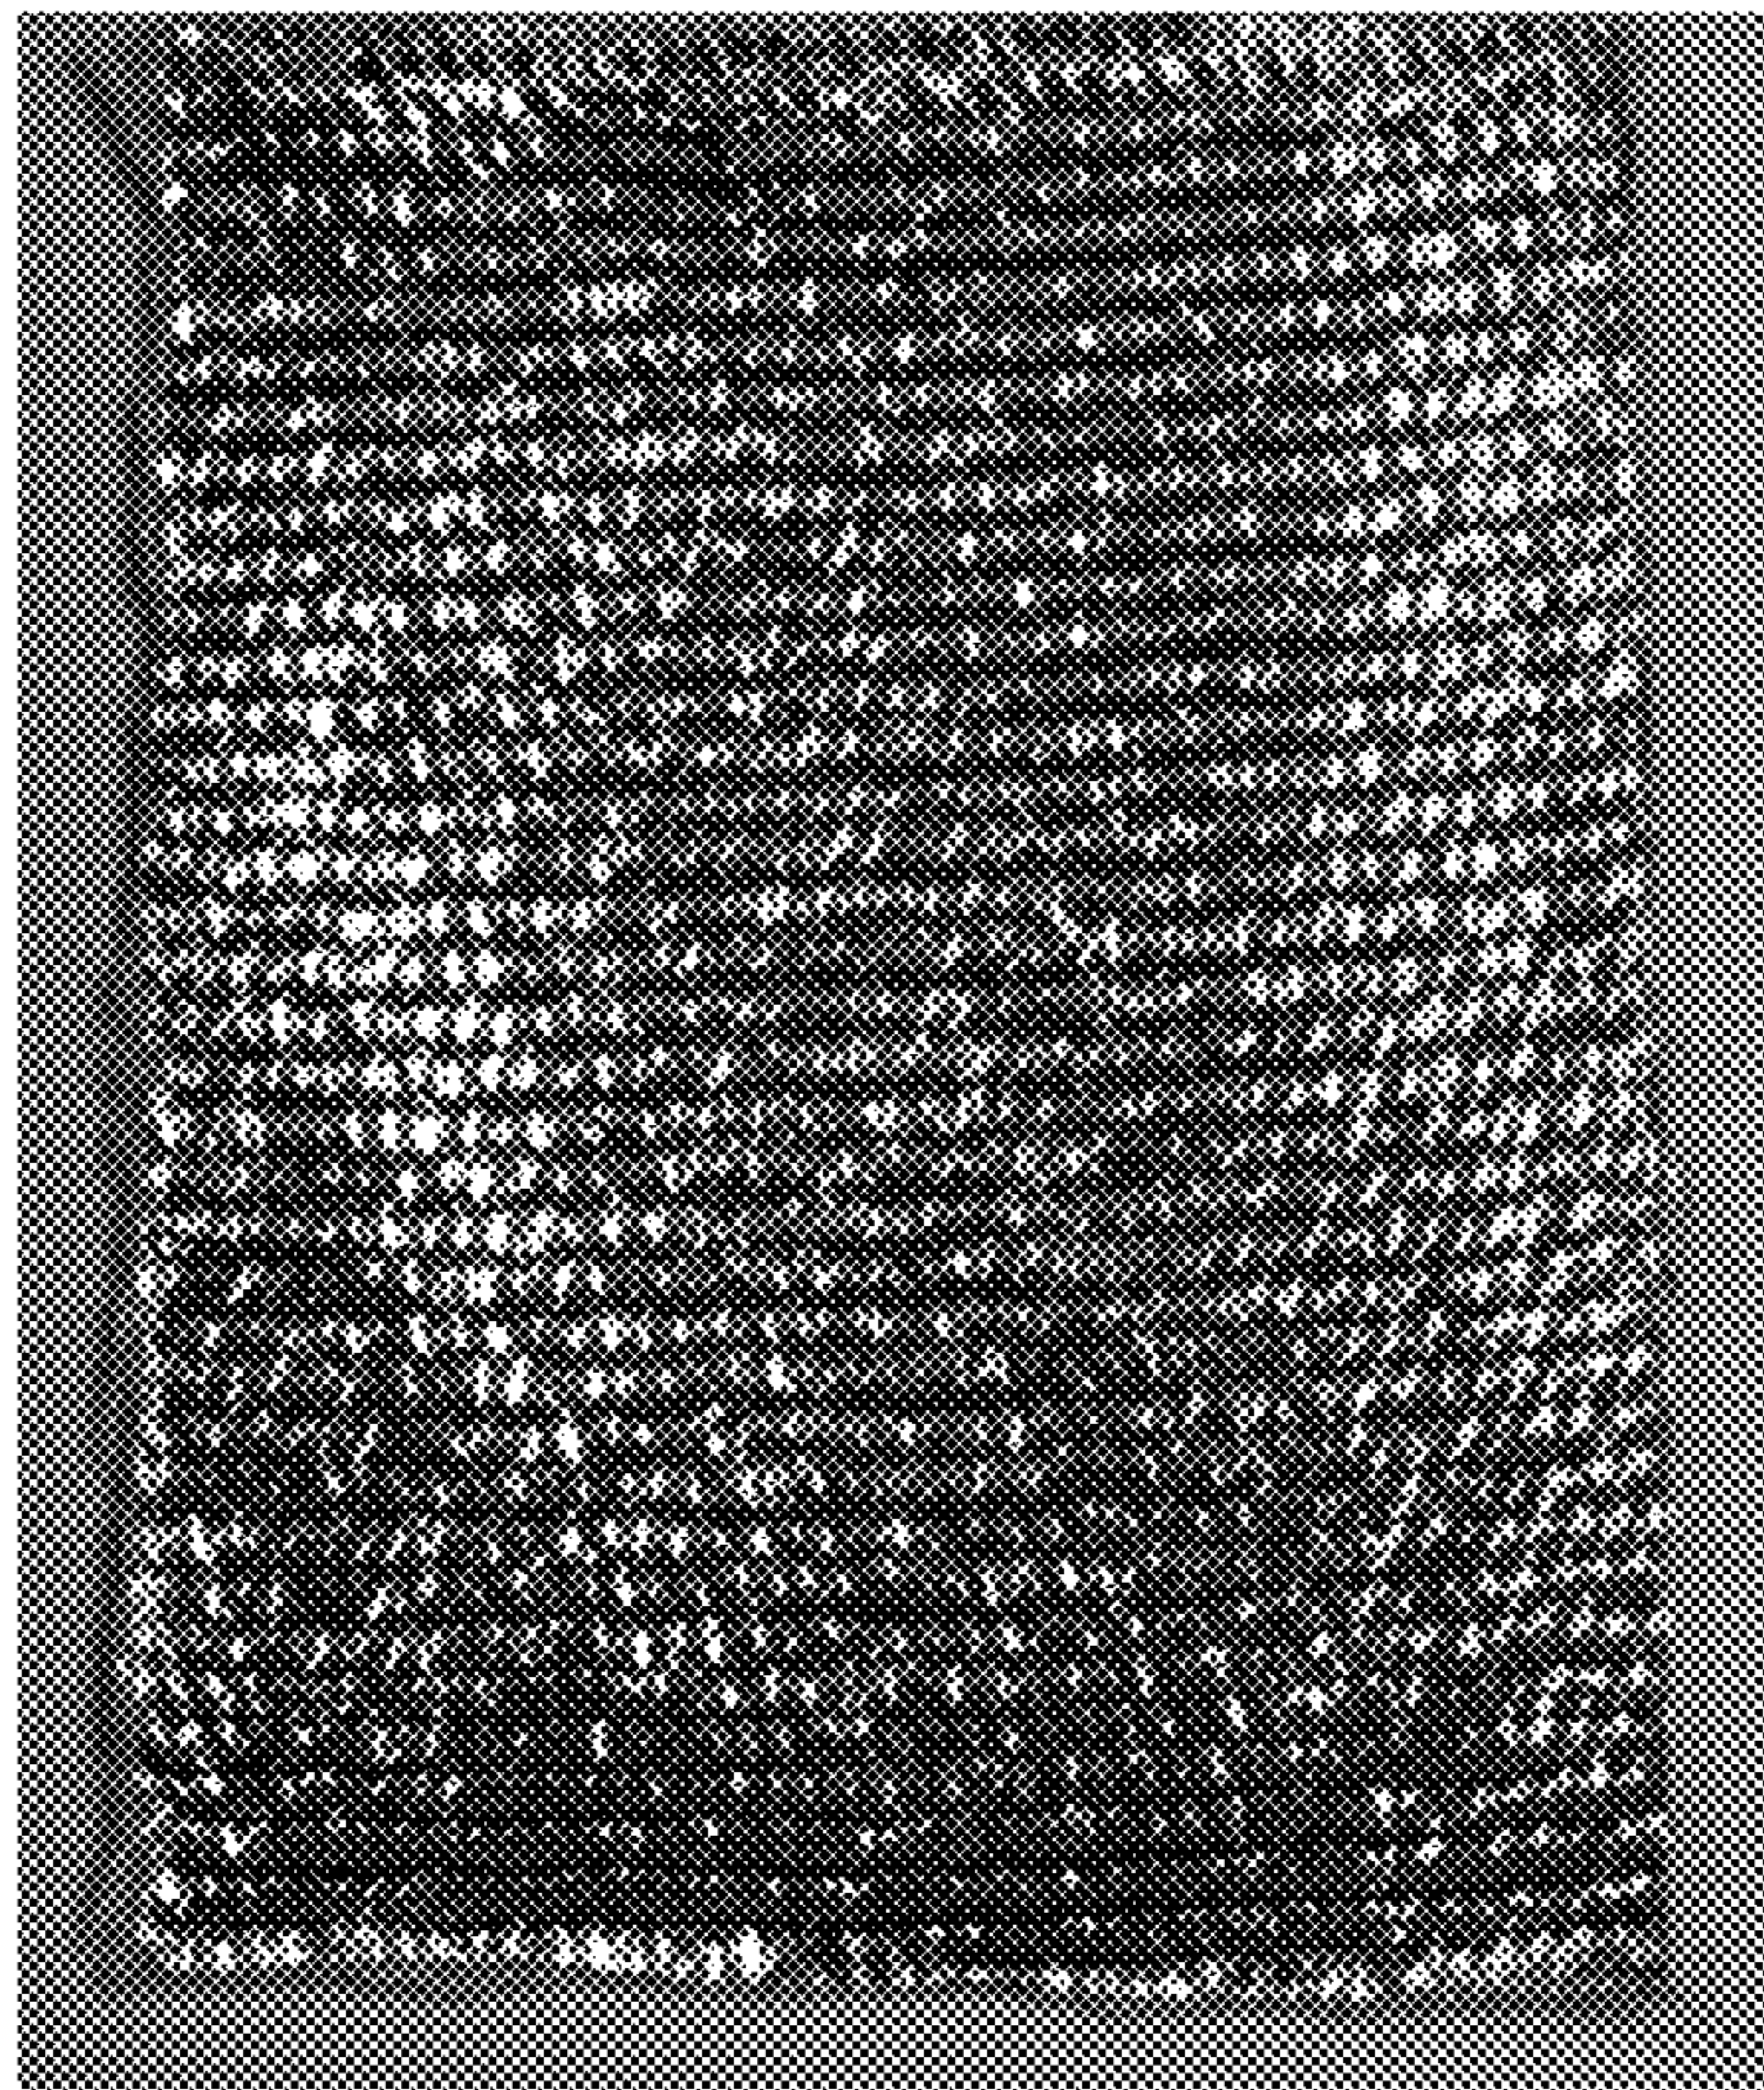
**FIG. 21**

FIG. 21 shows a sample of Material E prior to testing.

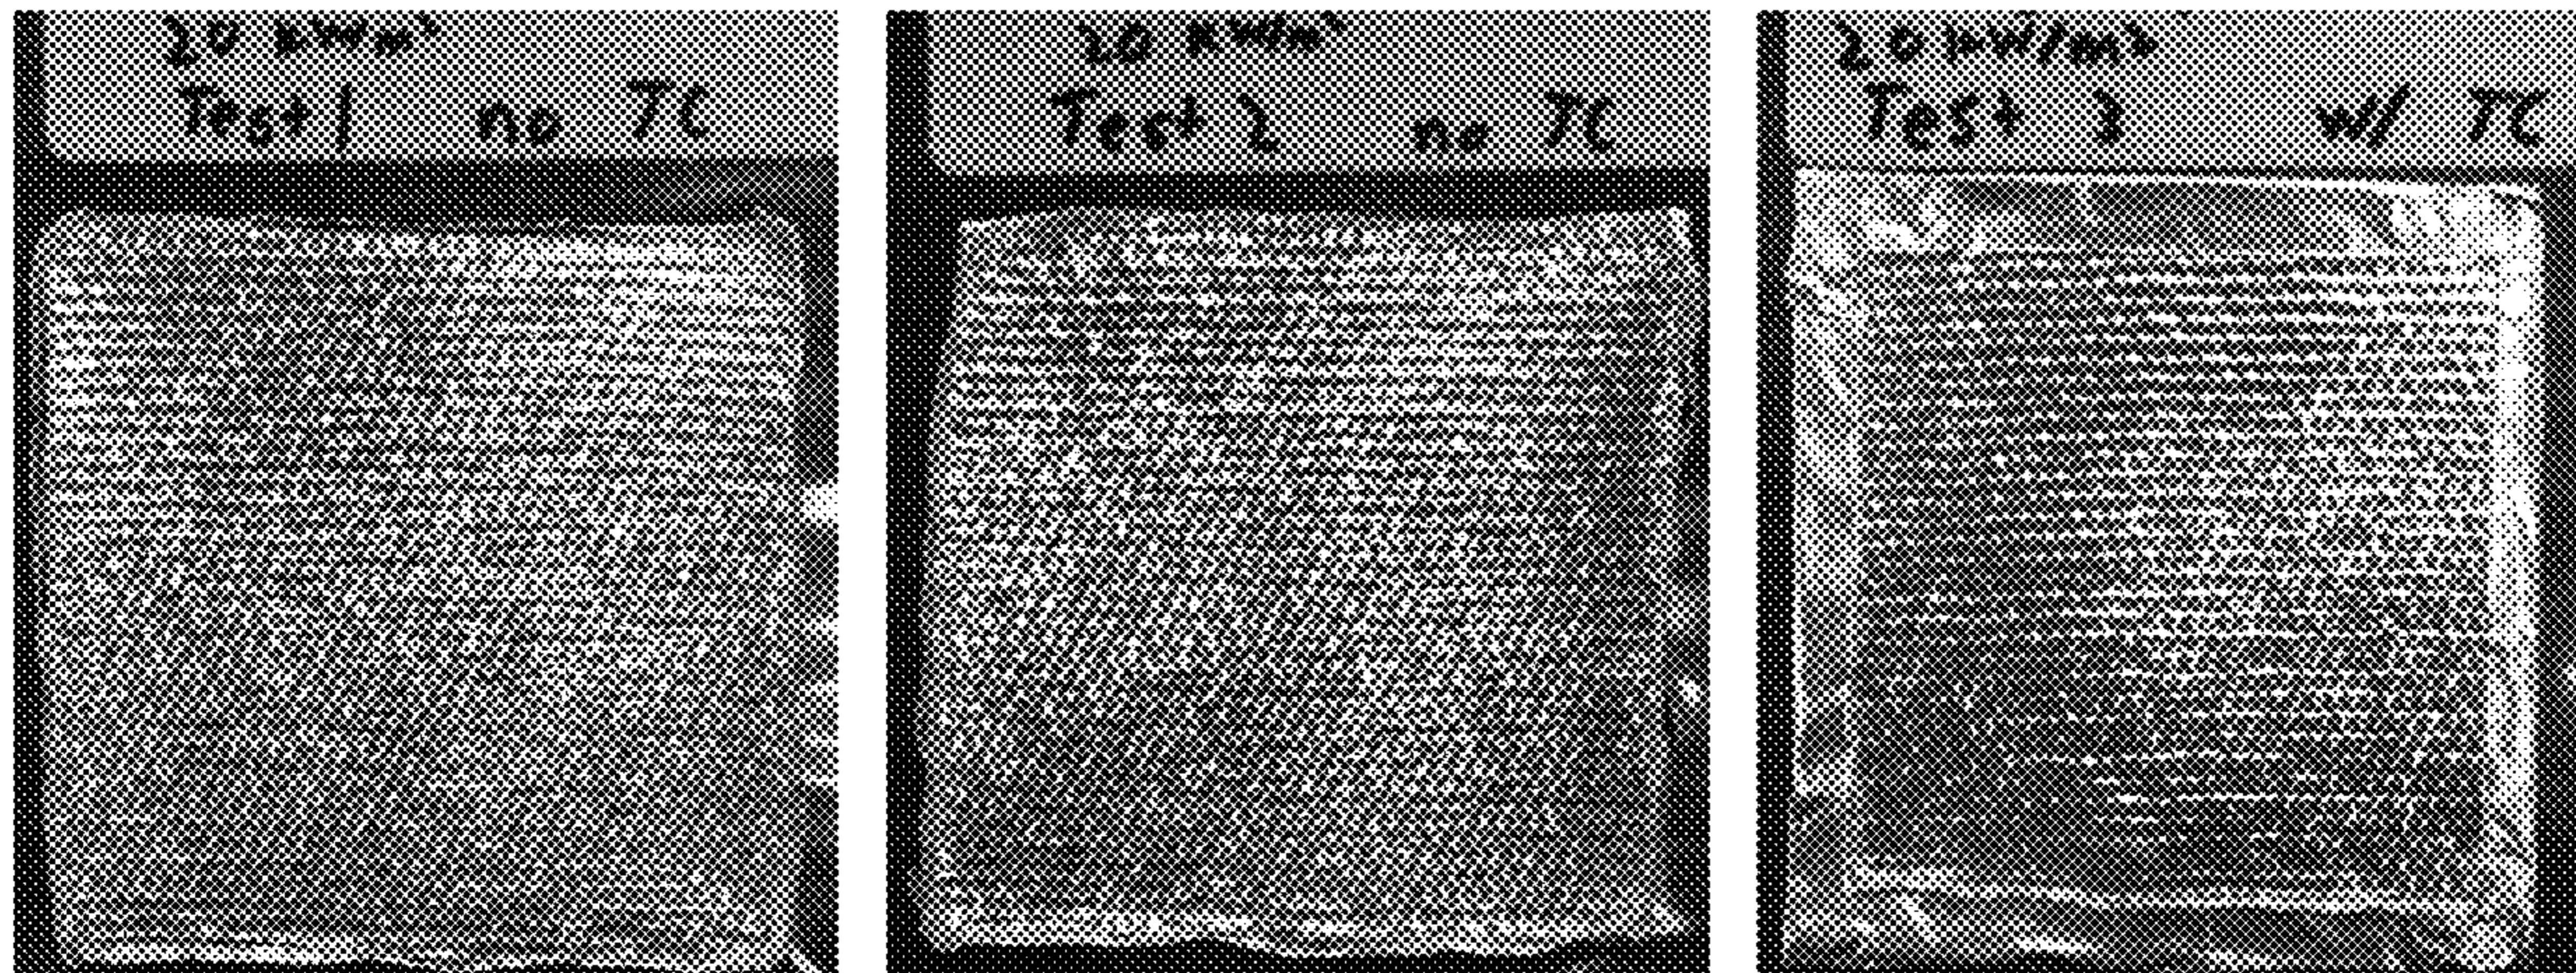
FIG. 22 shows Material E samples after 20 kW/m<sup>2</sup> radiant heating (showing Test 1 (left), Test 2 (center), and Test 3 (right)).
