(10) **Patent No.:** **US 11,485,106 B2**  
(45) **Date of Patent:** **Nov. 1, 2022**

(54) **FIRE HOSE AND MATERTAL THEREFORE**

Described herein are fire hoses incorporating new combi-  
nations of materials to increase the hose's resilience. Resil-  
ient hoses include those made with silicone-coated fabrics or  
with thermally-resistant fabrics or both.

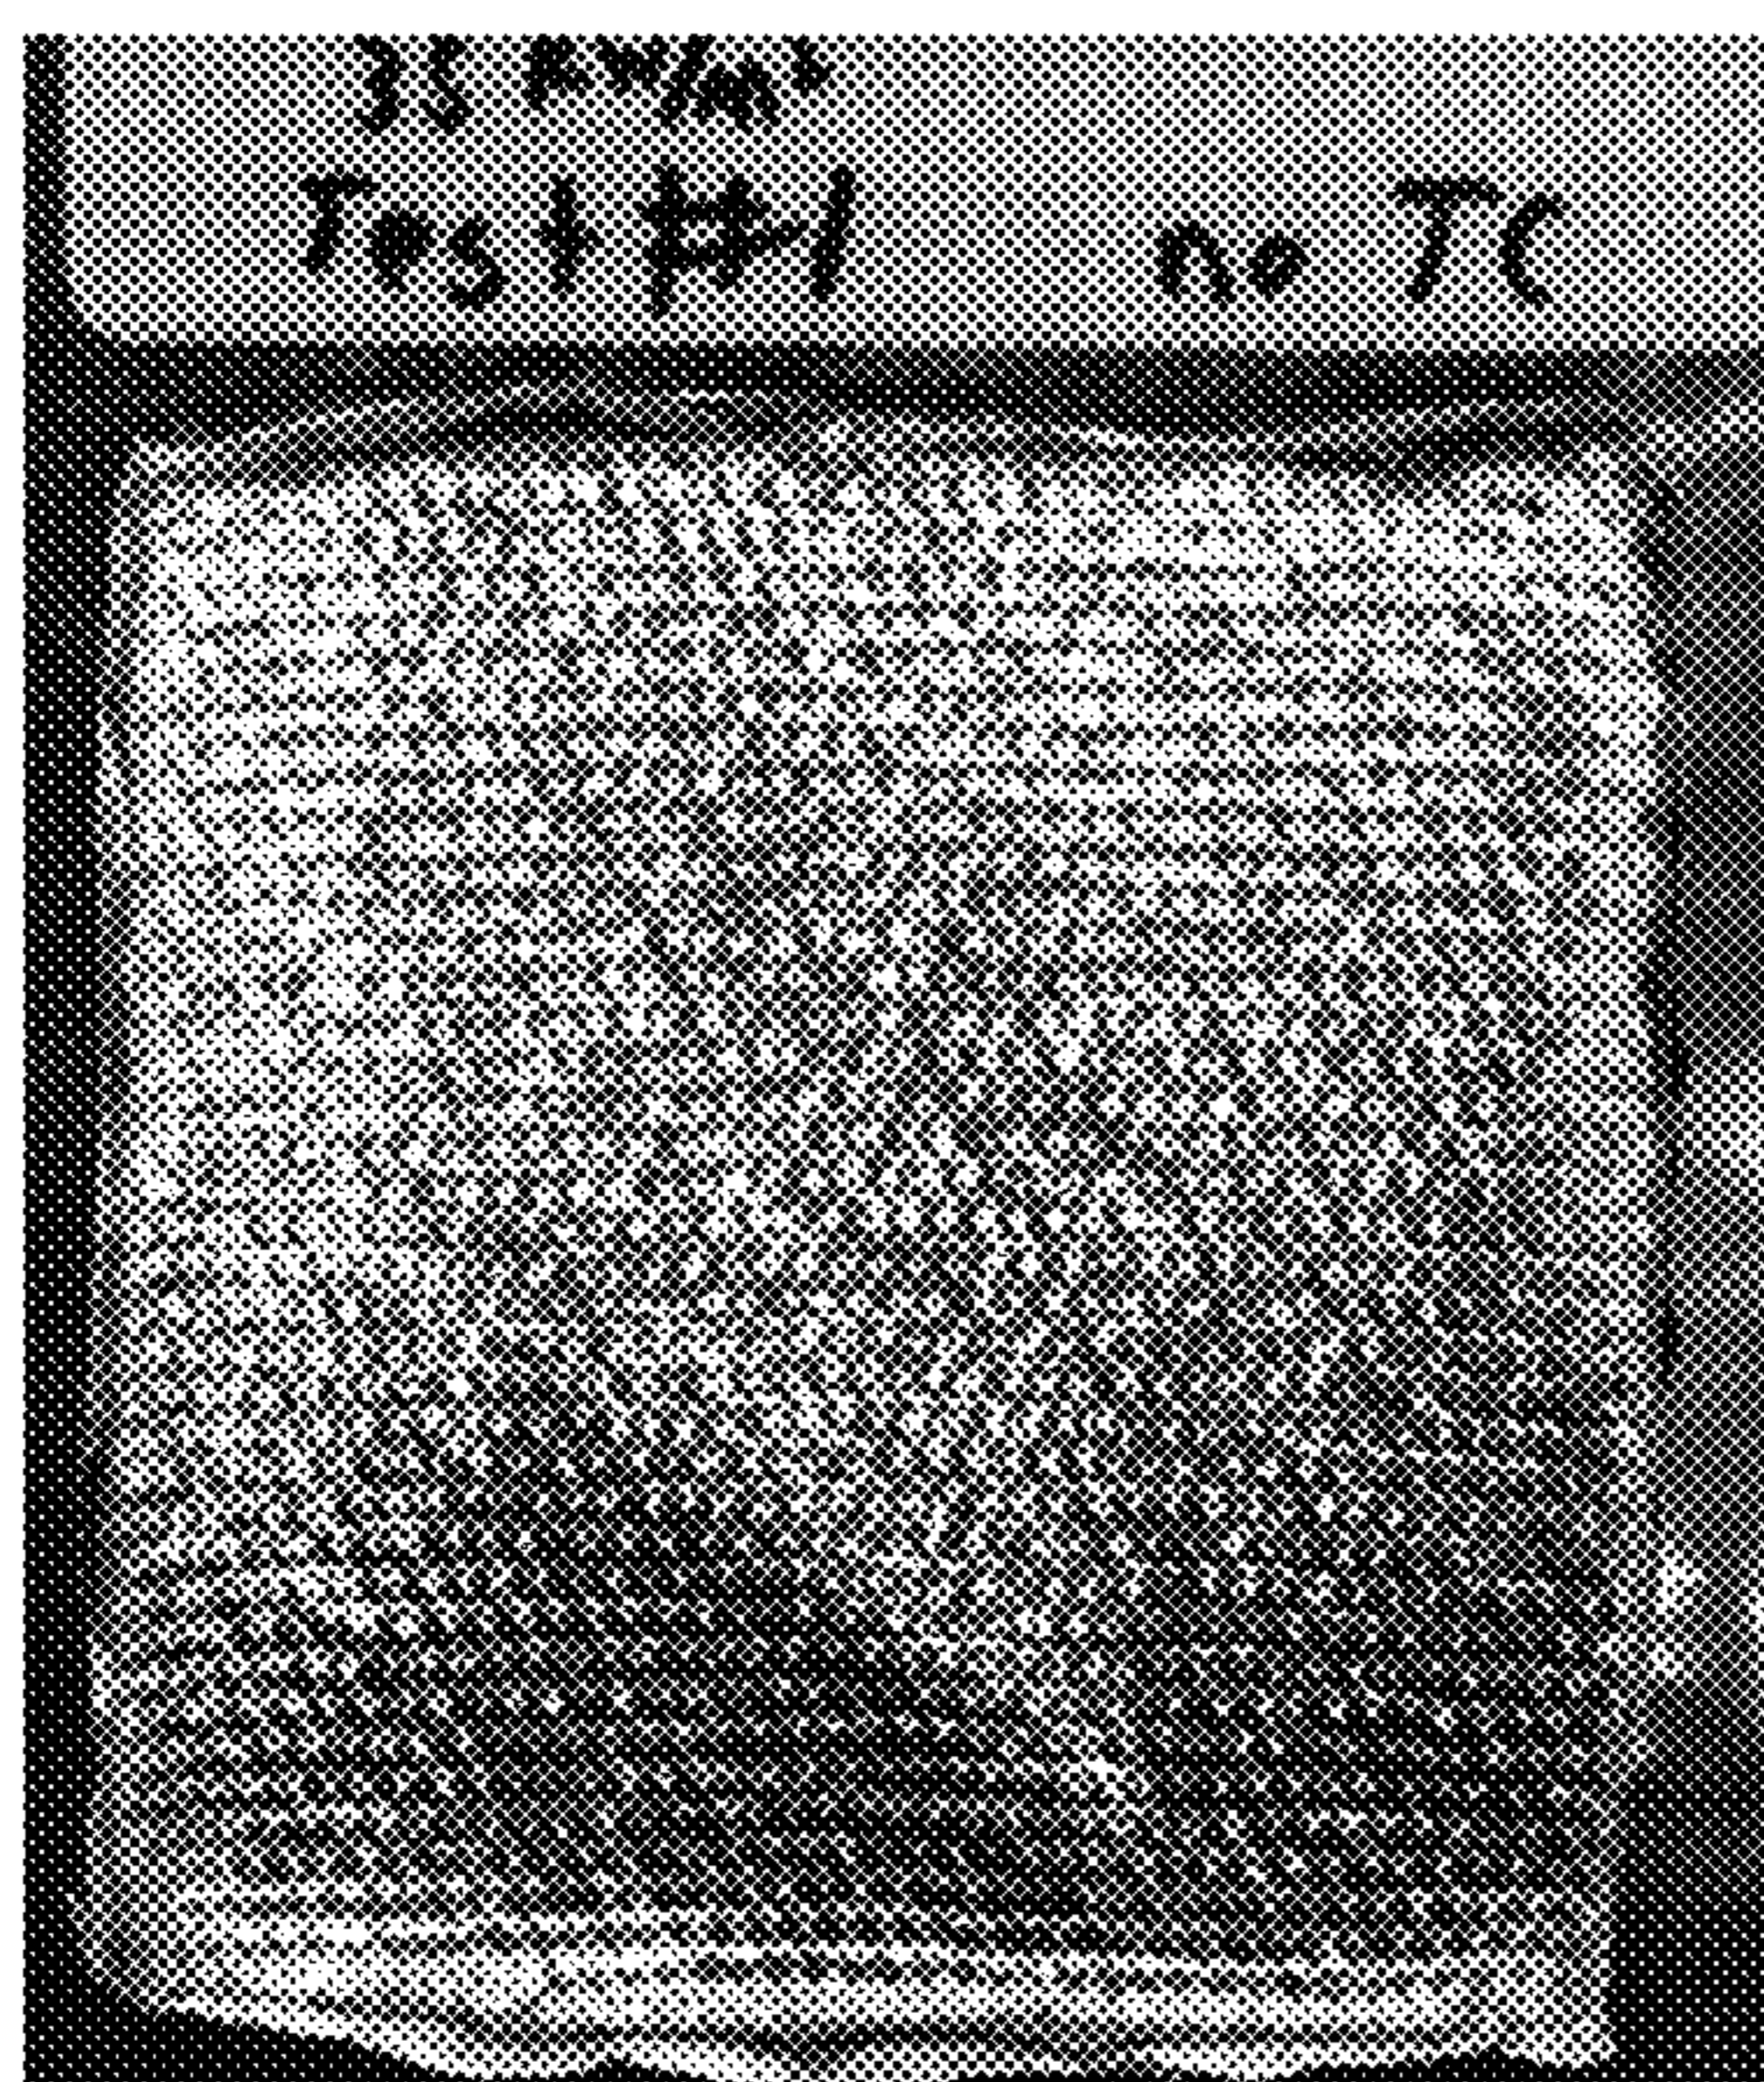
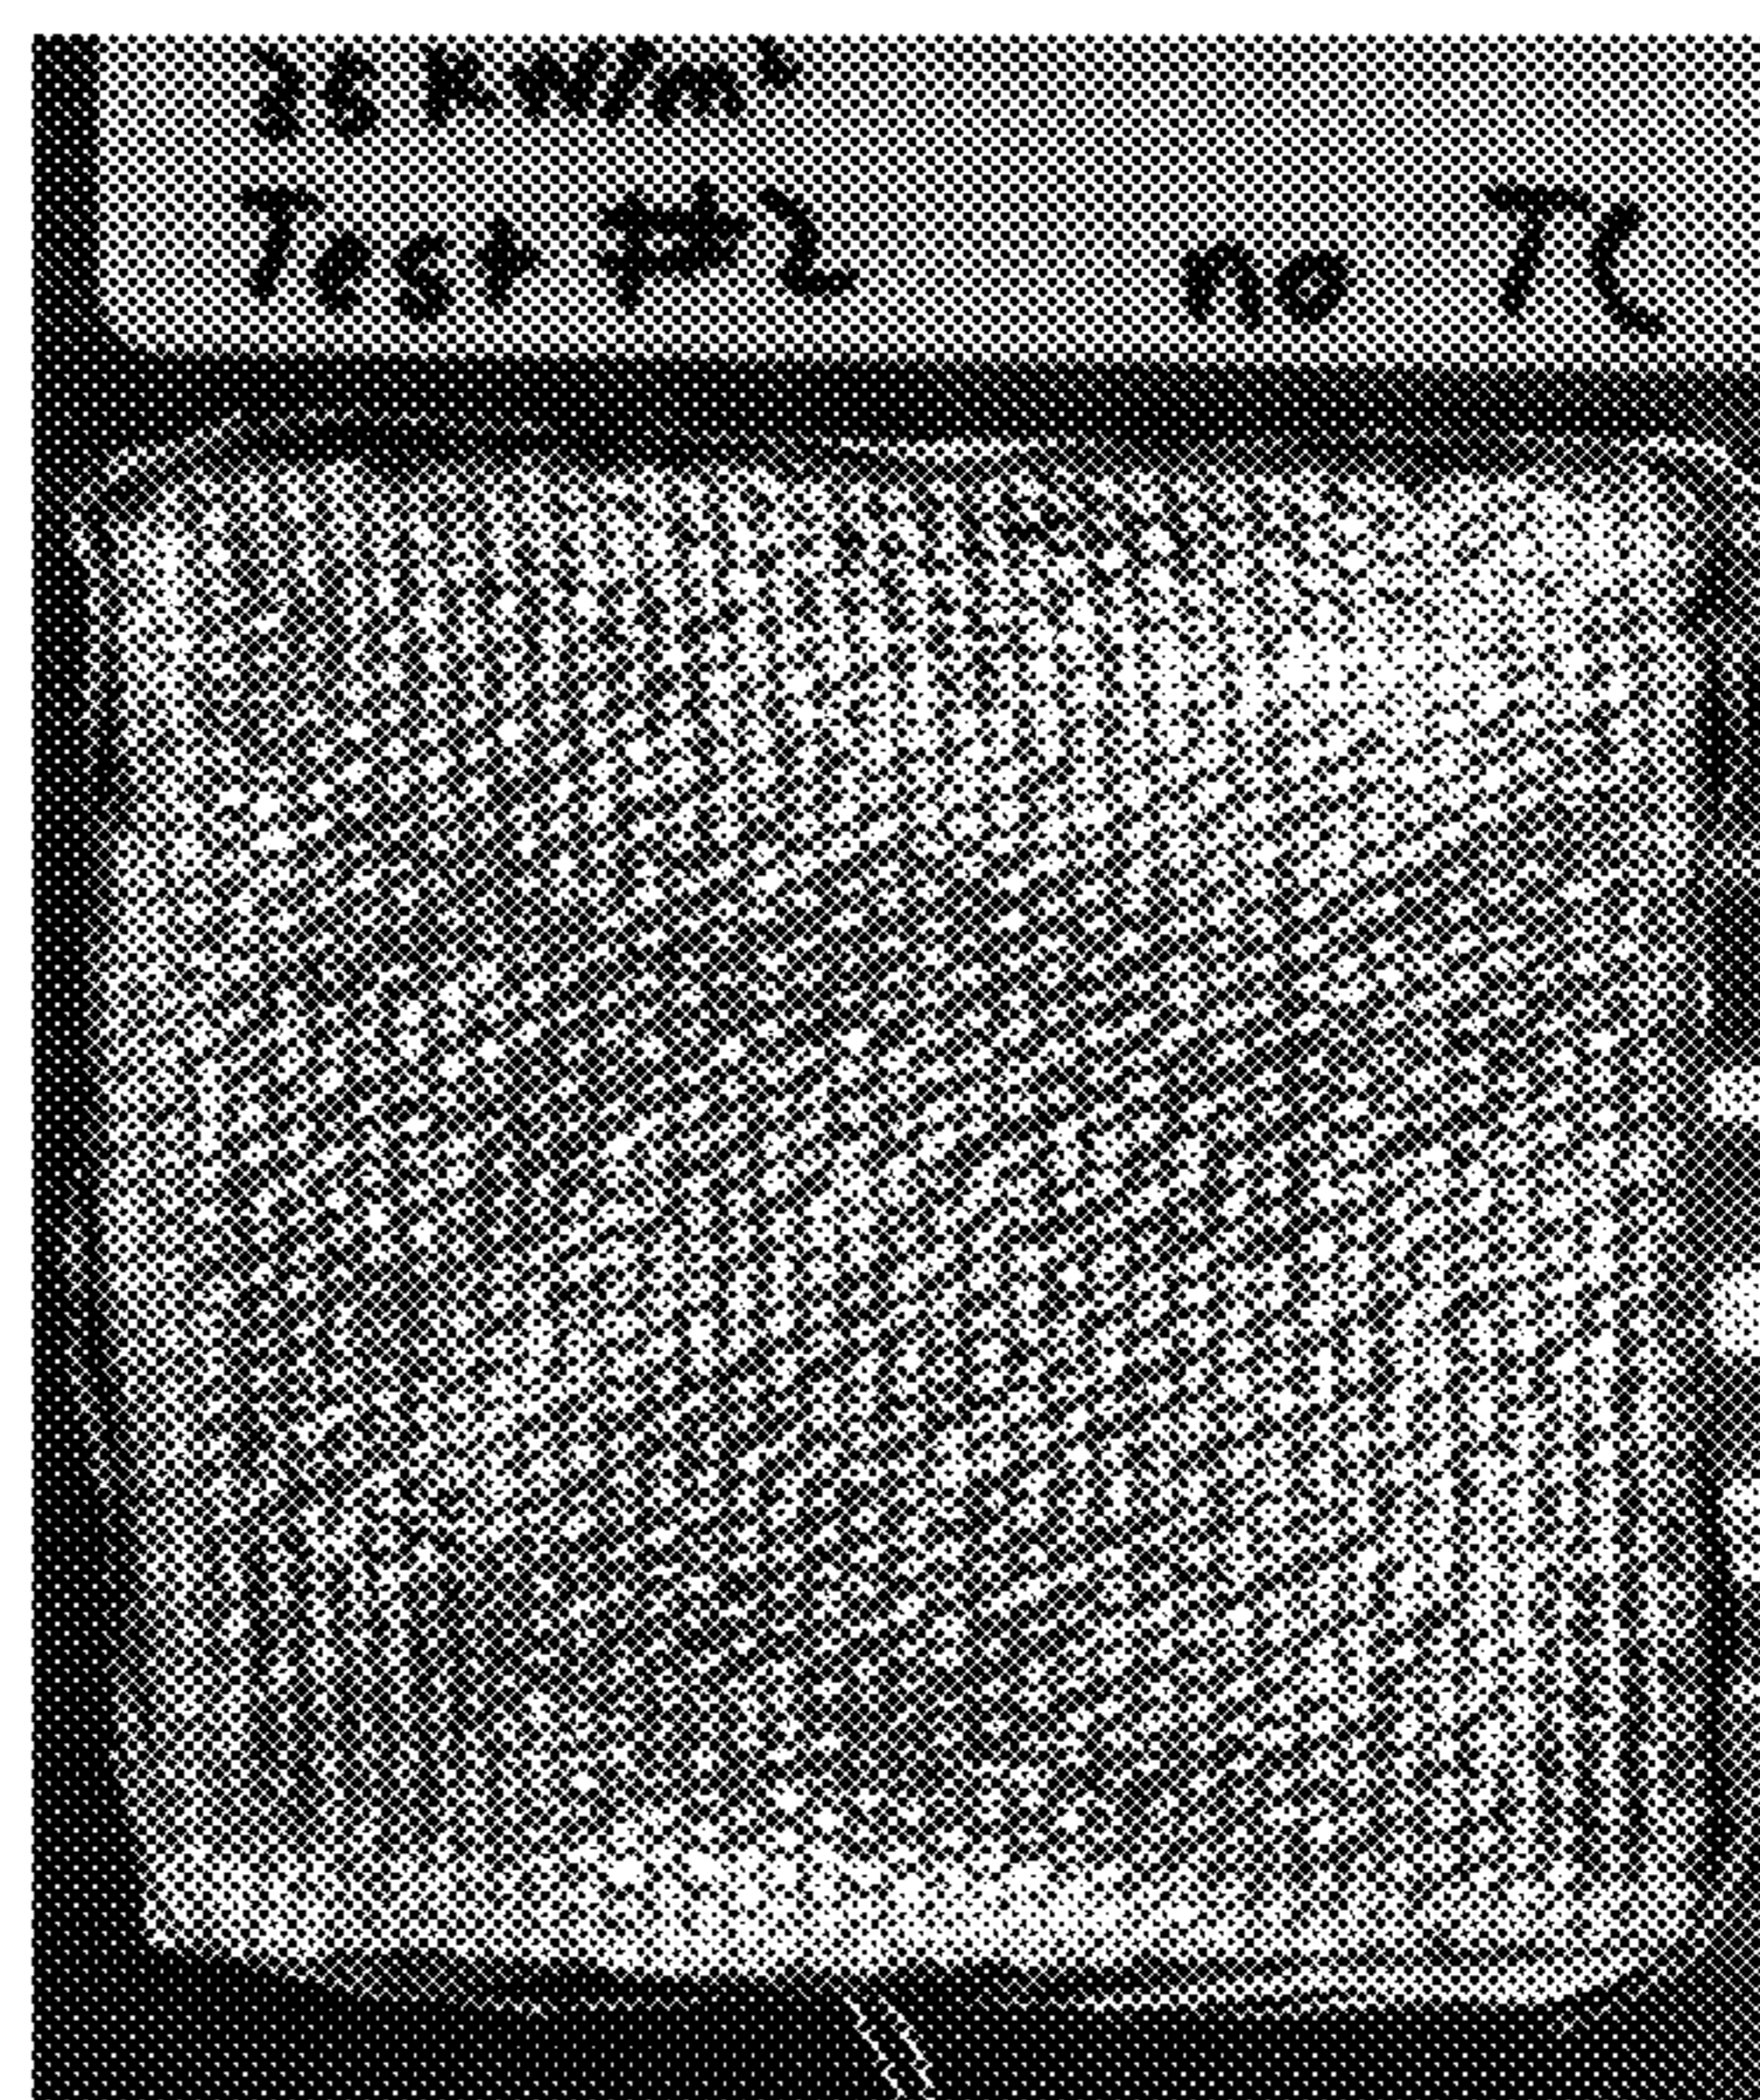
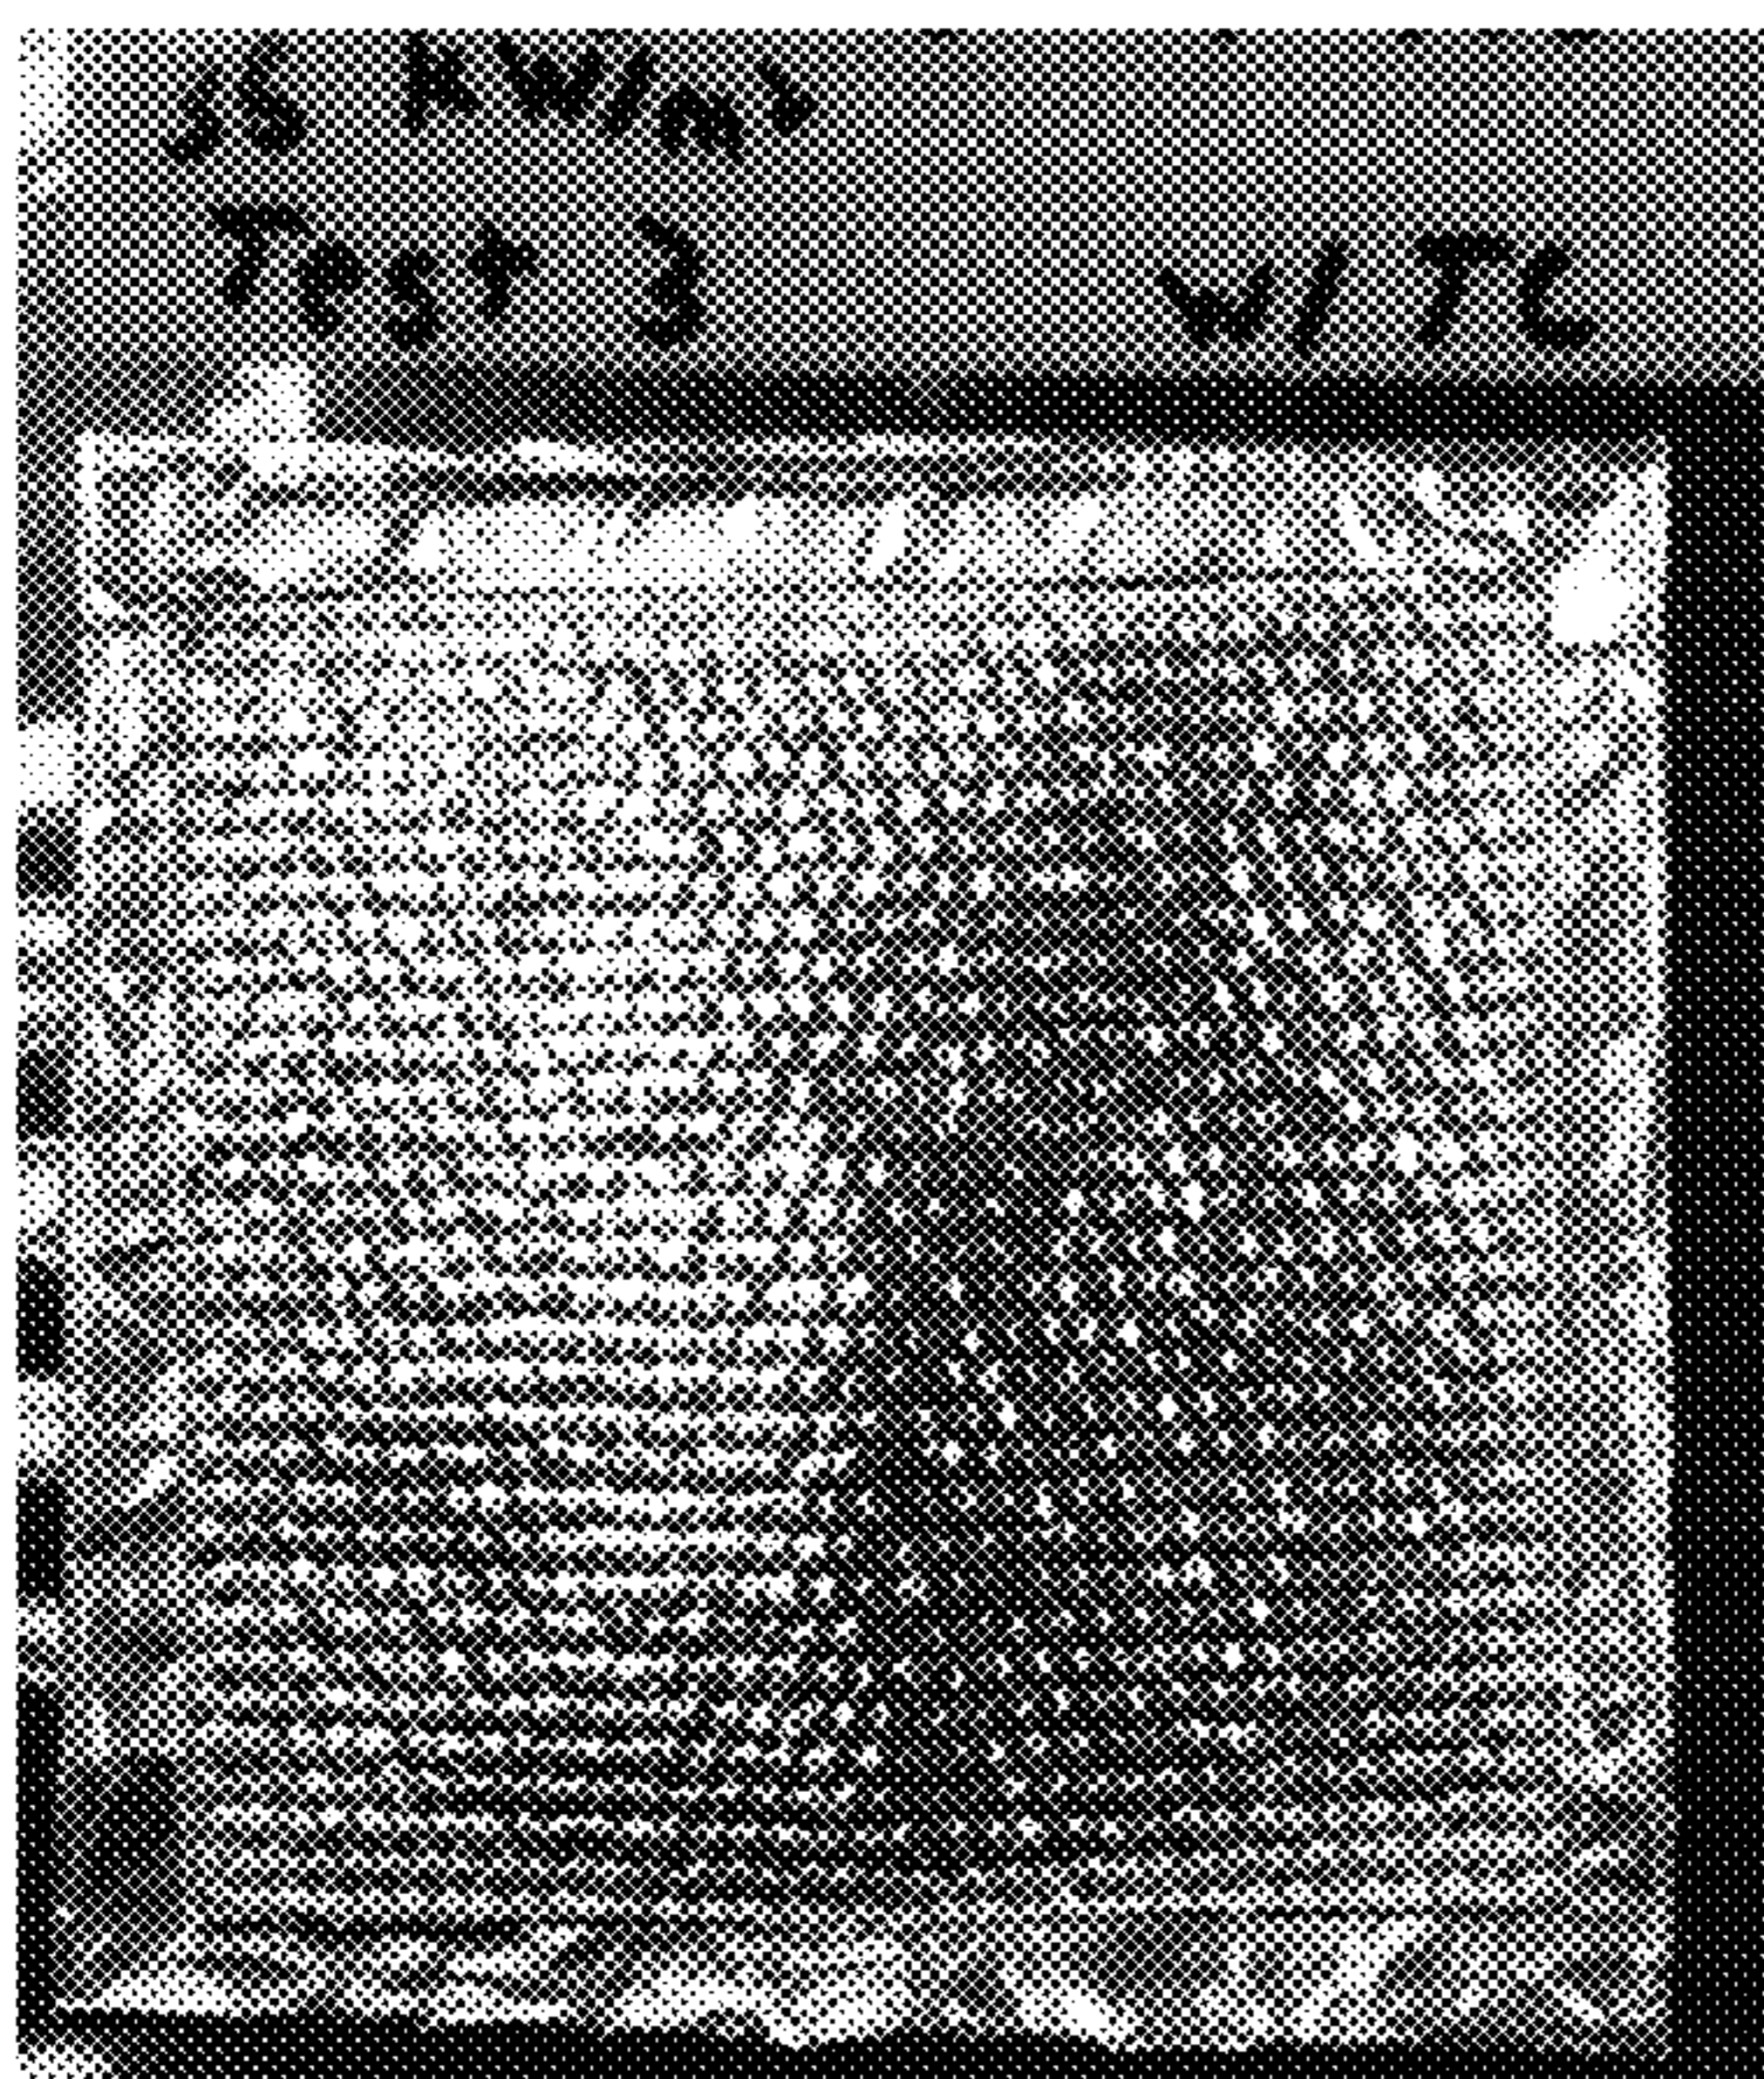
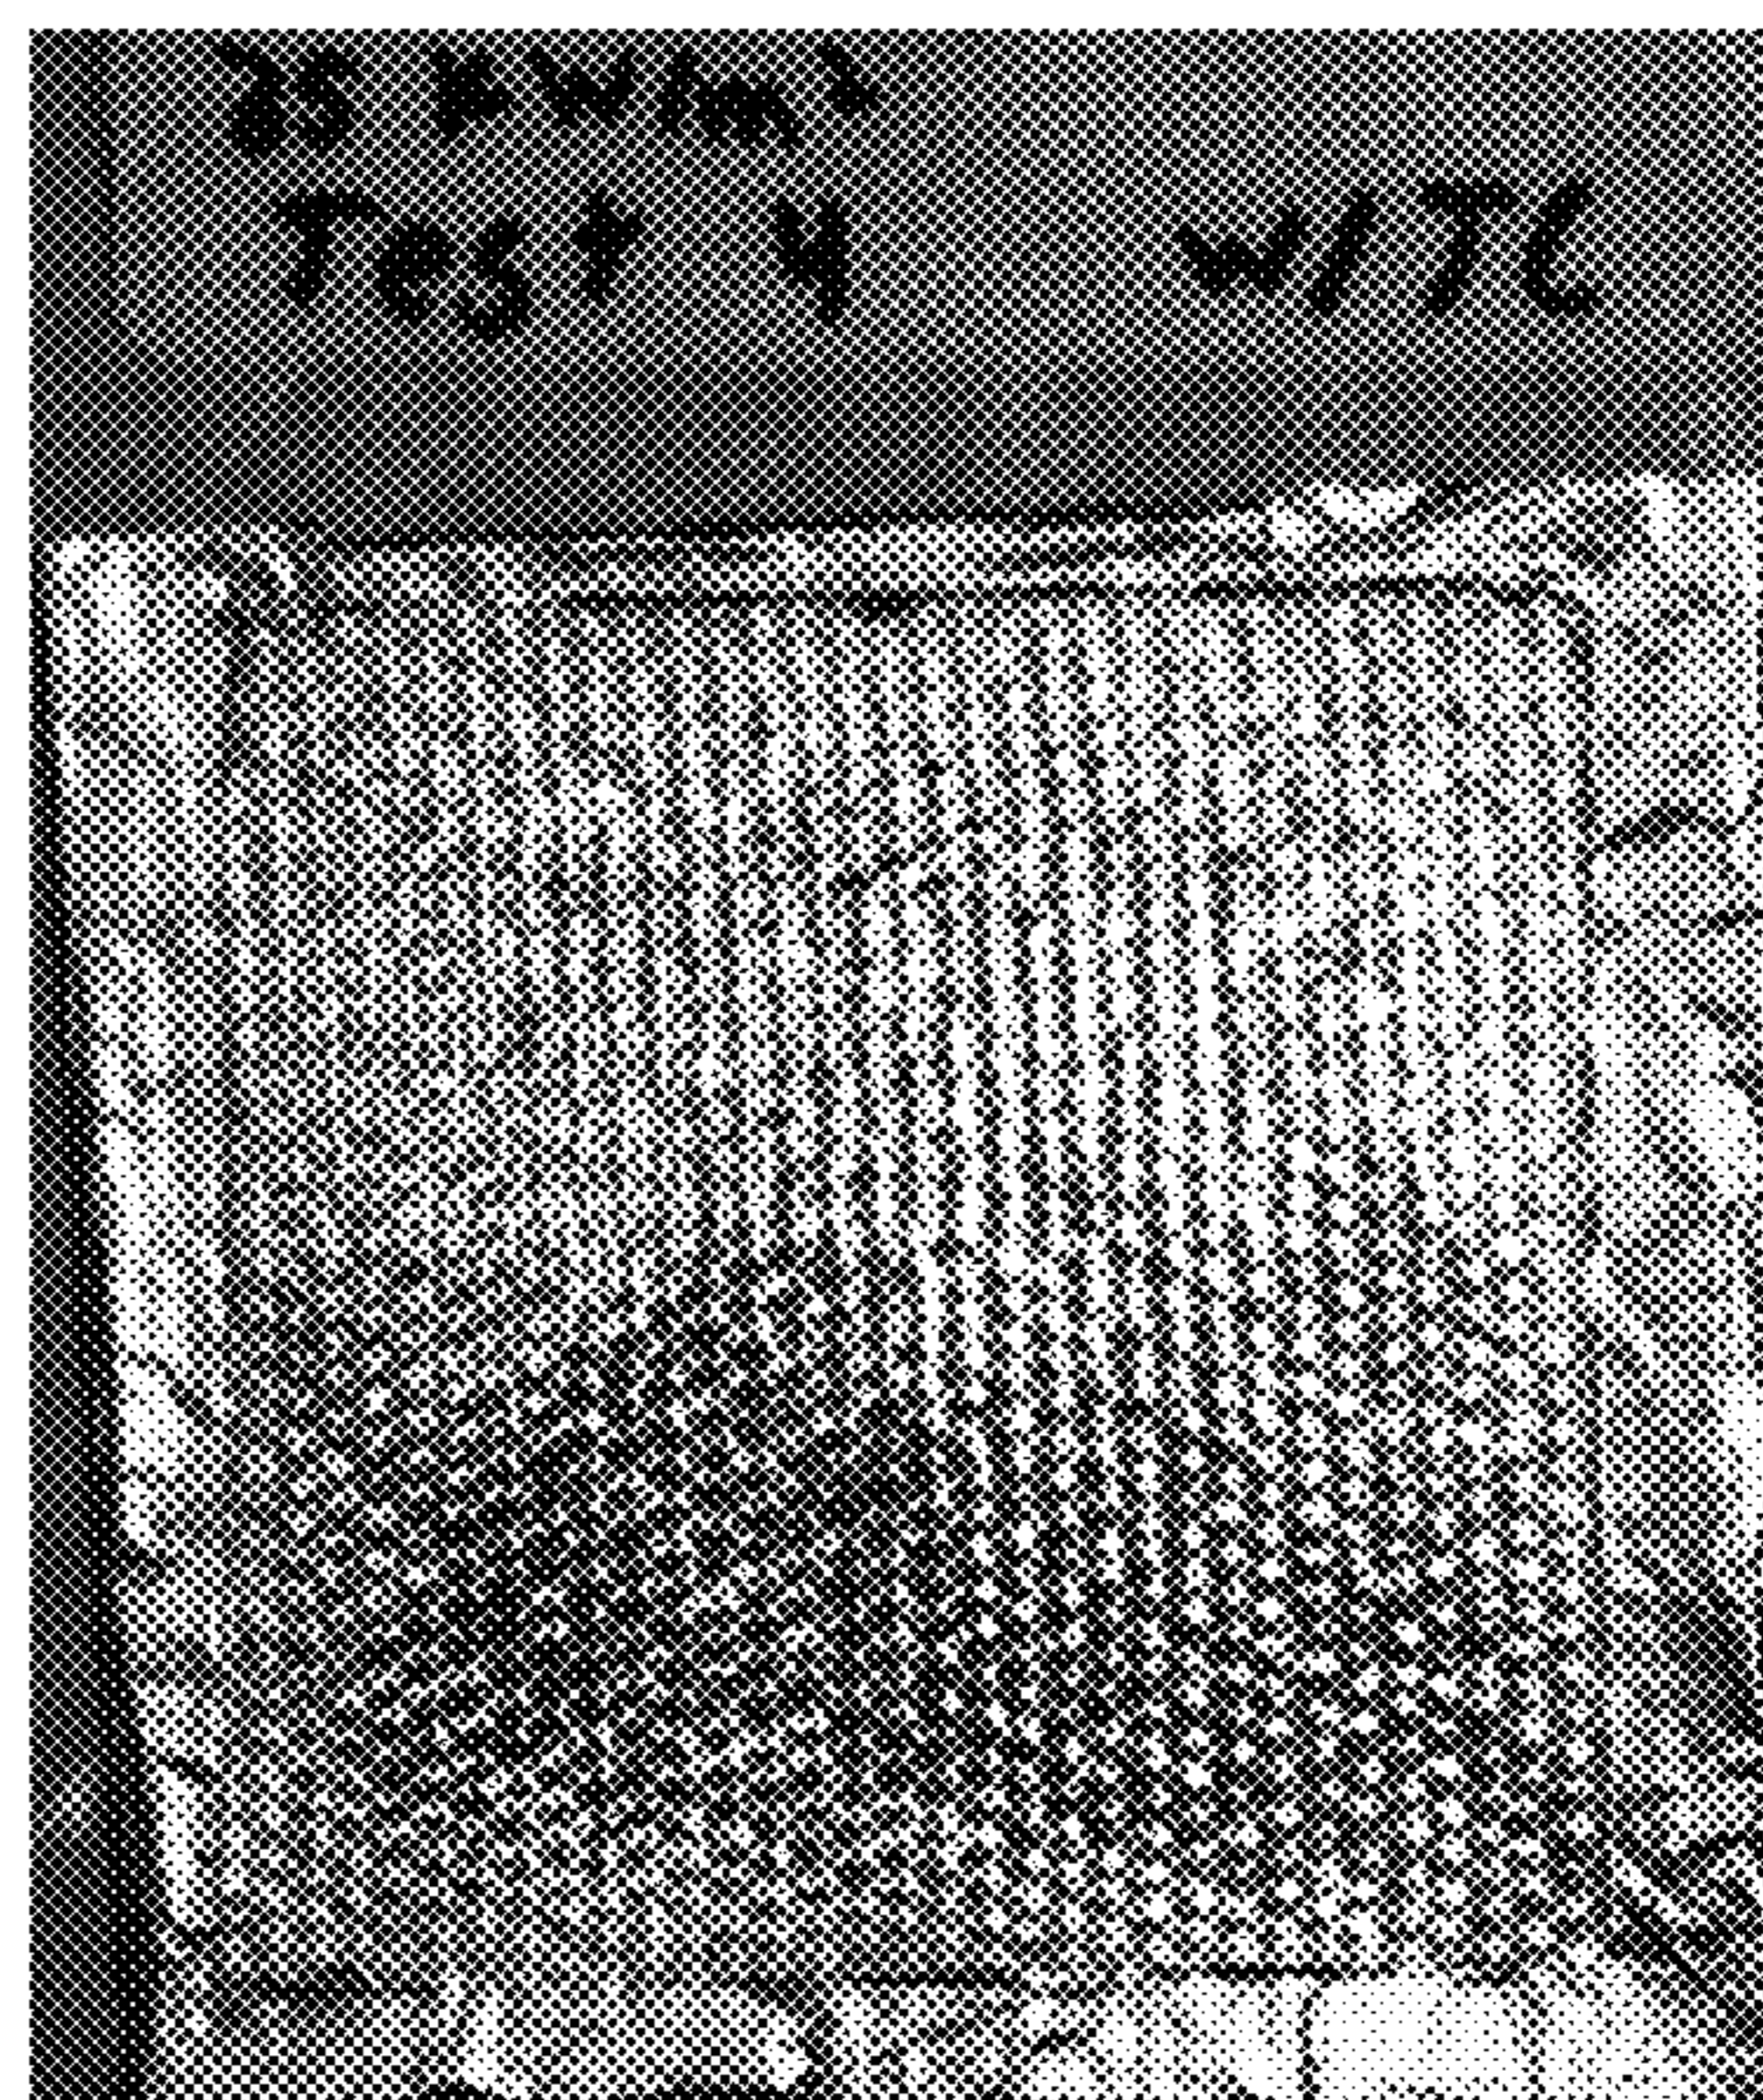
FIG. 23 shows Material E samples after 35 kW/m<sup>2</sup> radiant heating (showing Test 1 (top left), Test 2 (top right), Test 3 (bottom left), and Test 4 (bottom right)).

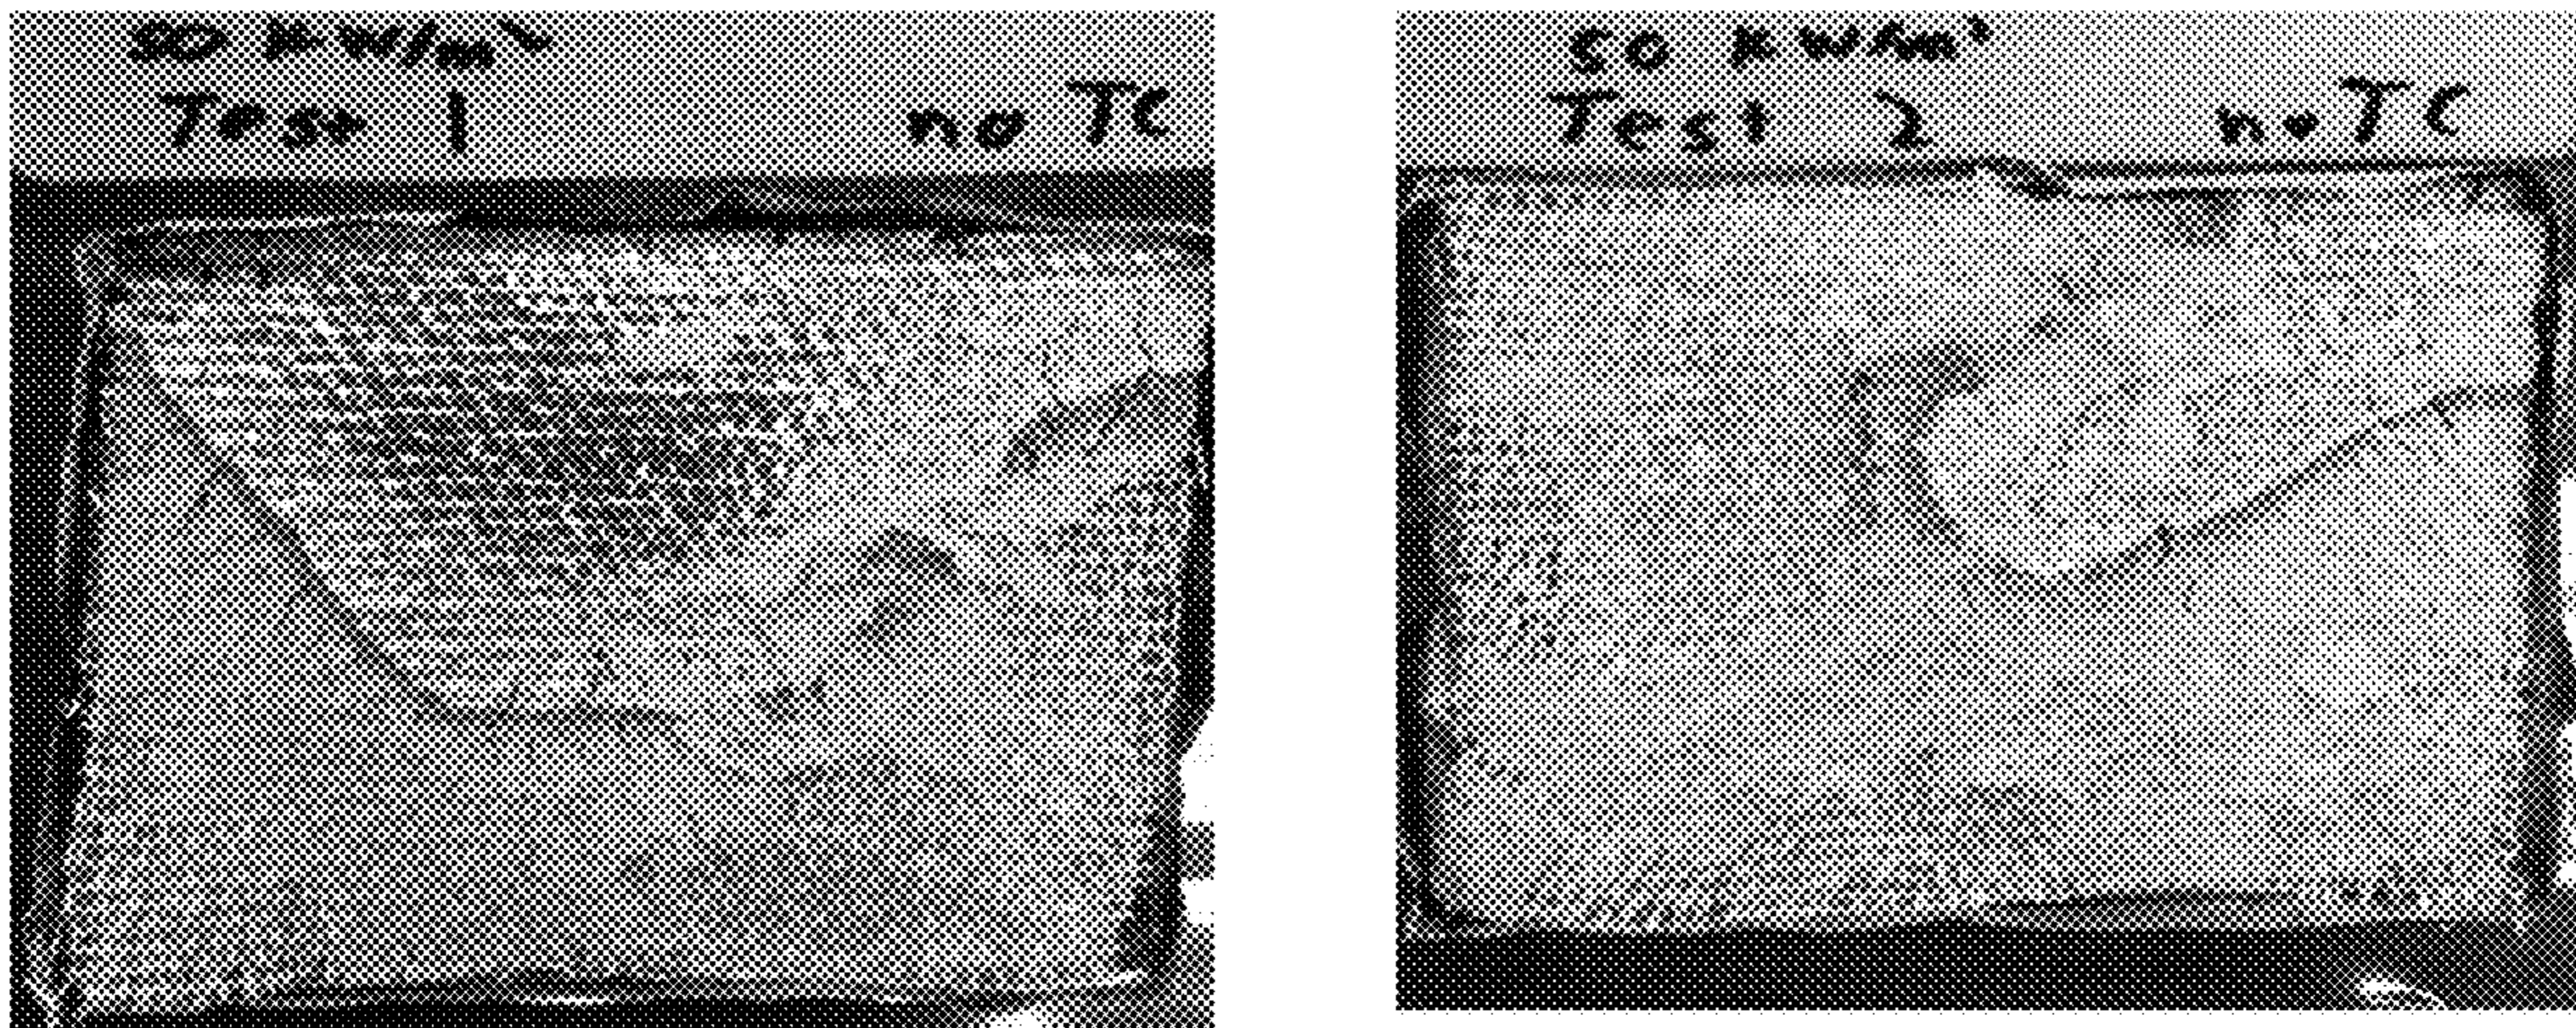
FIG. 24 shows Material E samples after 50 kW/m<sup>2</sup> radiant heating (showing Test 1 (left) and Test 2 (right)).

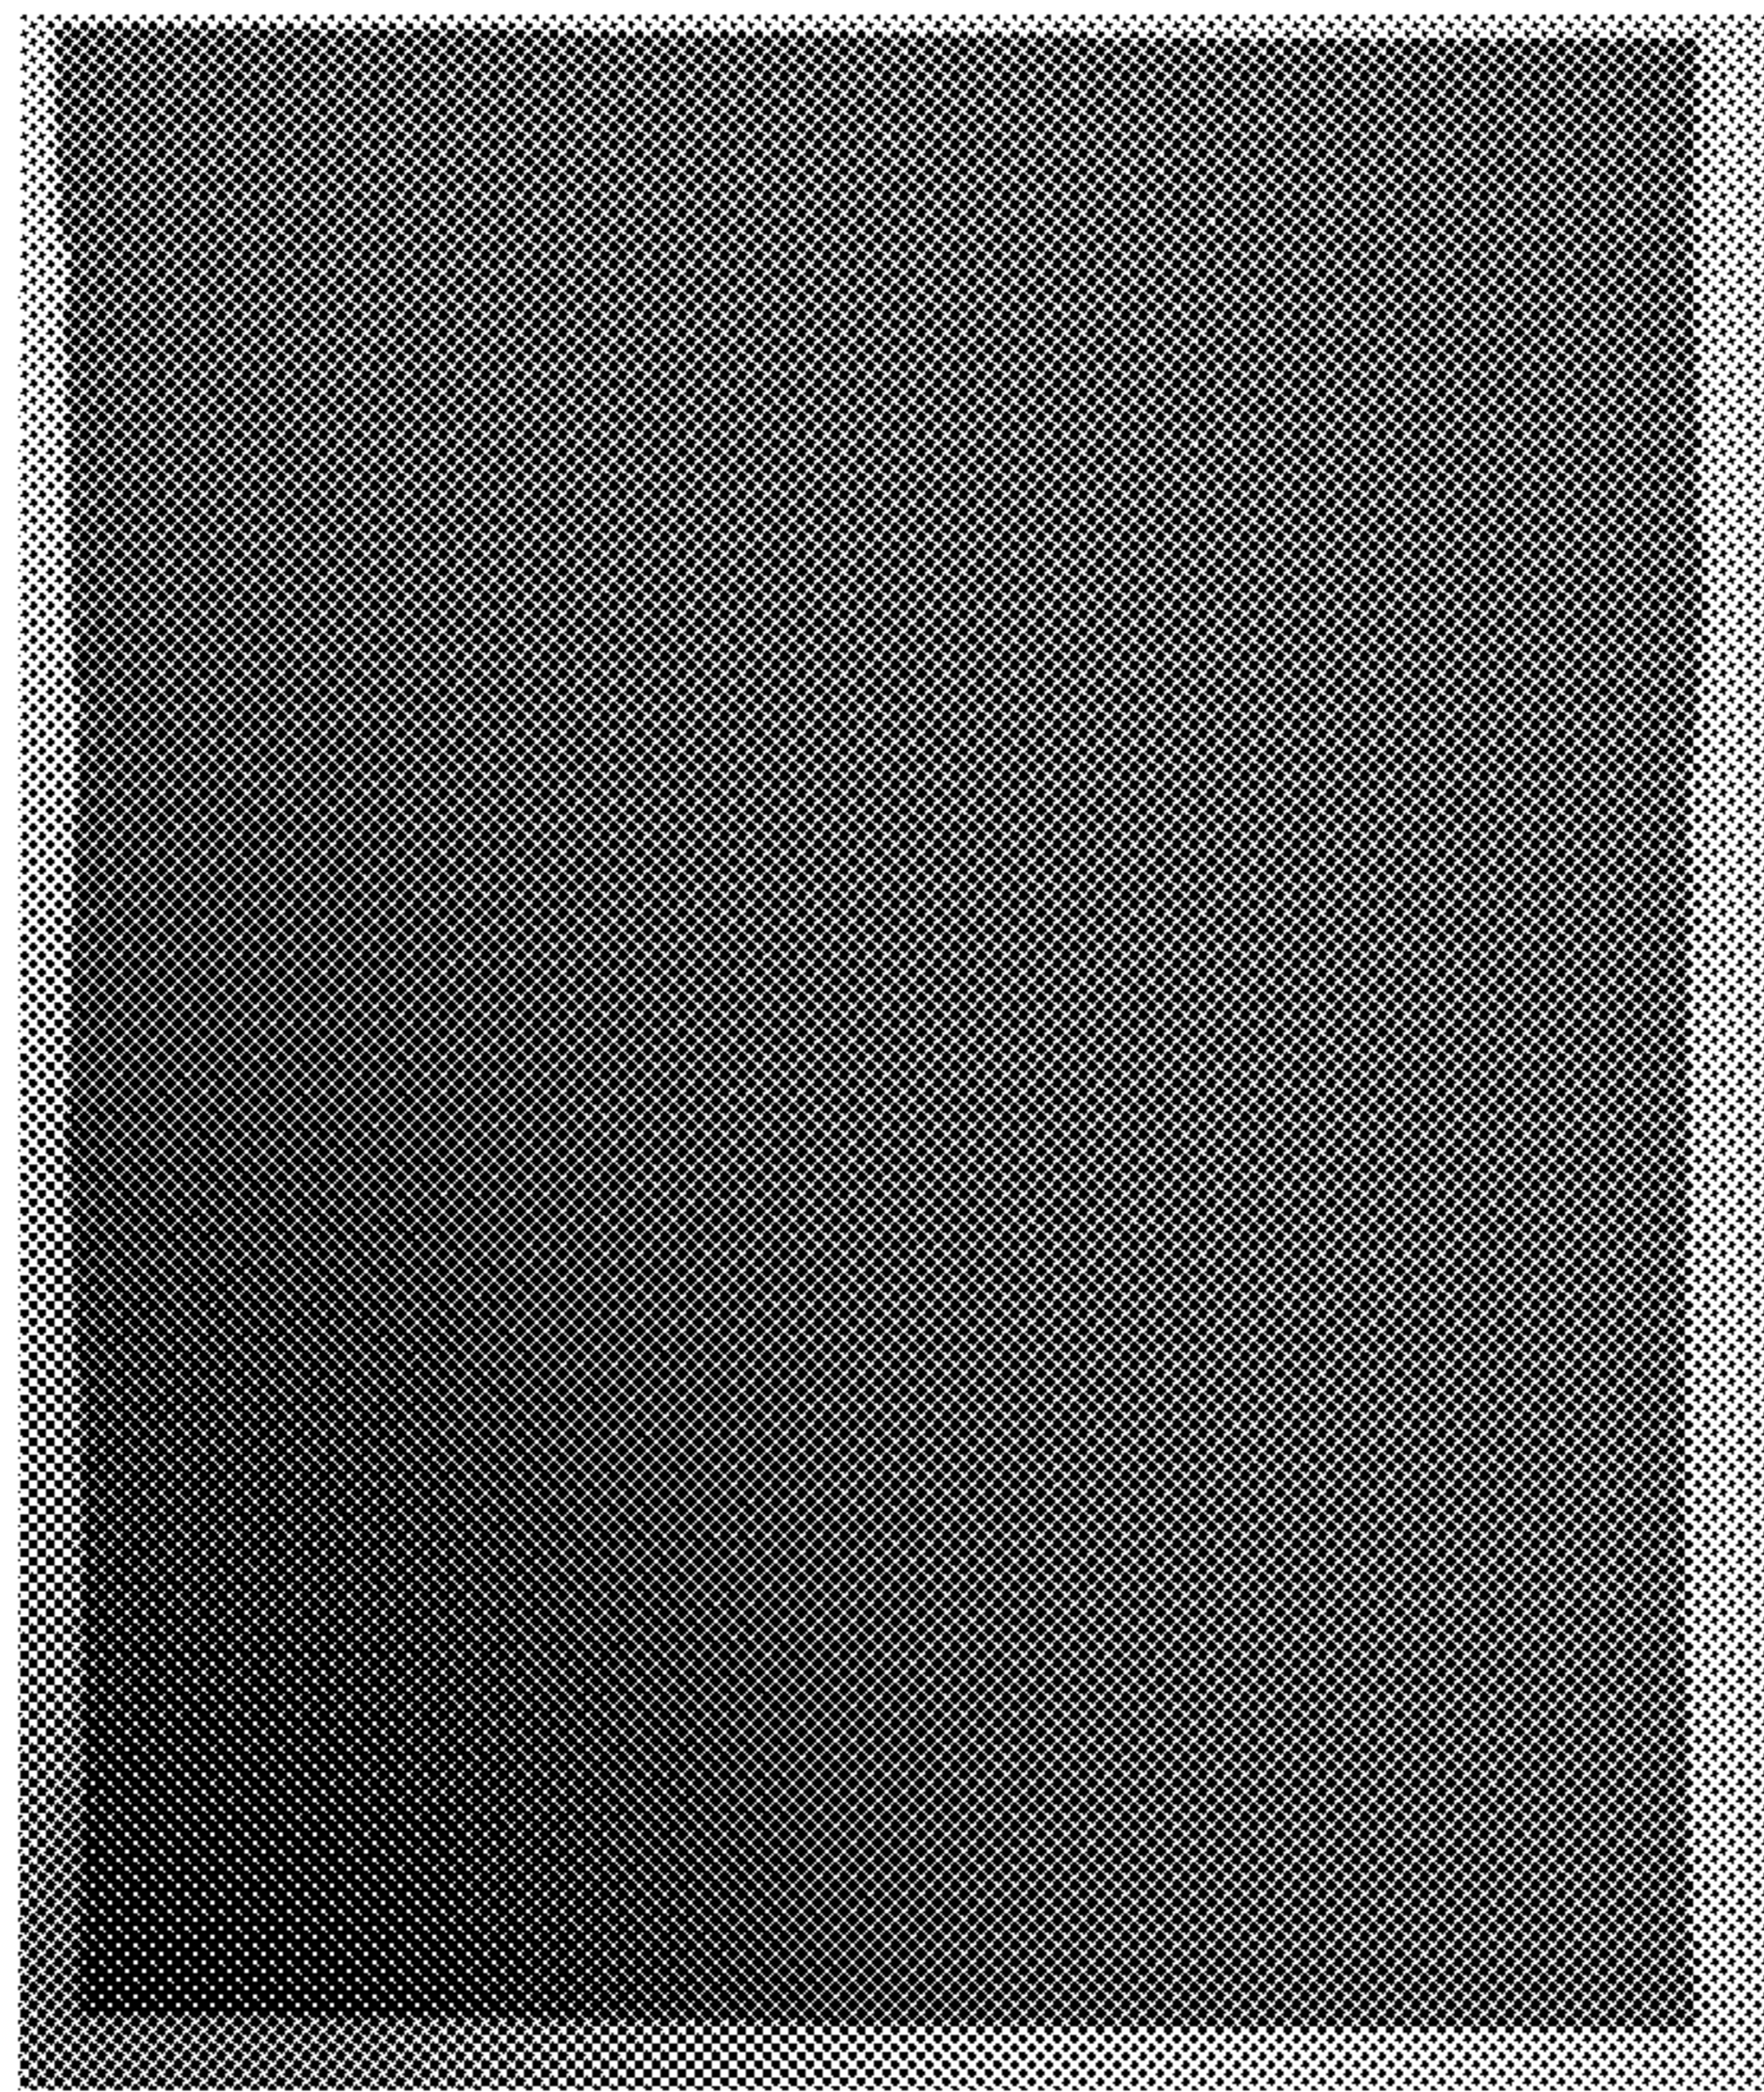
**FIG. 25**

FIG. 25 shows a sample of Material F prior to testing.
