(10) **Patent No.:** **US 11,485,106 B2**  
(45) **Date of Patent:** **Nov. 1, 2022**

(54) **FIRE HOSE AND MATERTAL THEREFORE**

Described herein are fire hoses incorporating new combi-  
nations of materials to increase the hose's resilience. Resil-  
ient hoses include those made with silicone-coated fabrics or  
with thermally-resistant fabrics or both.

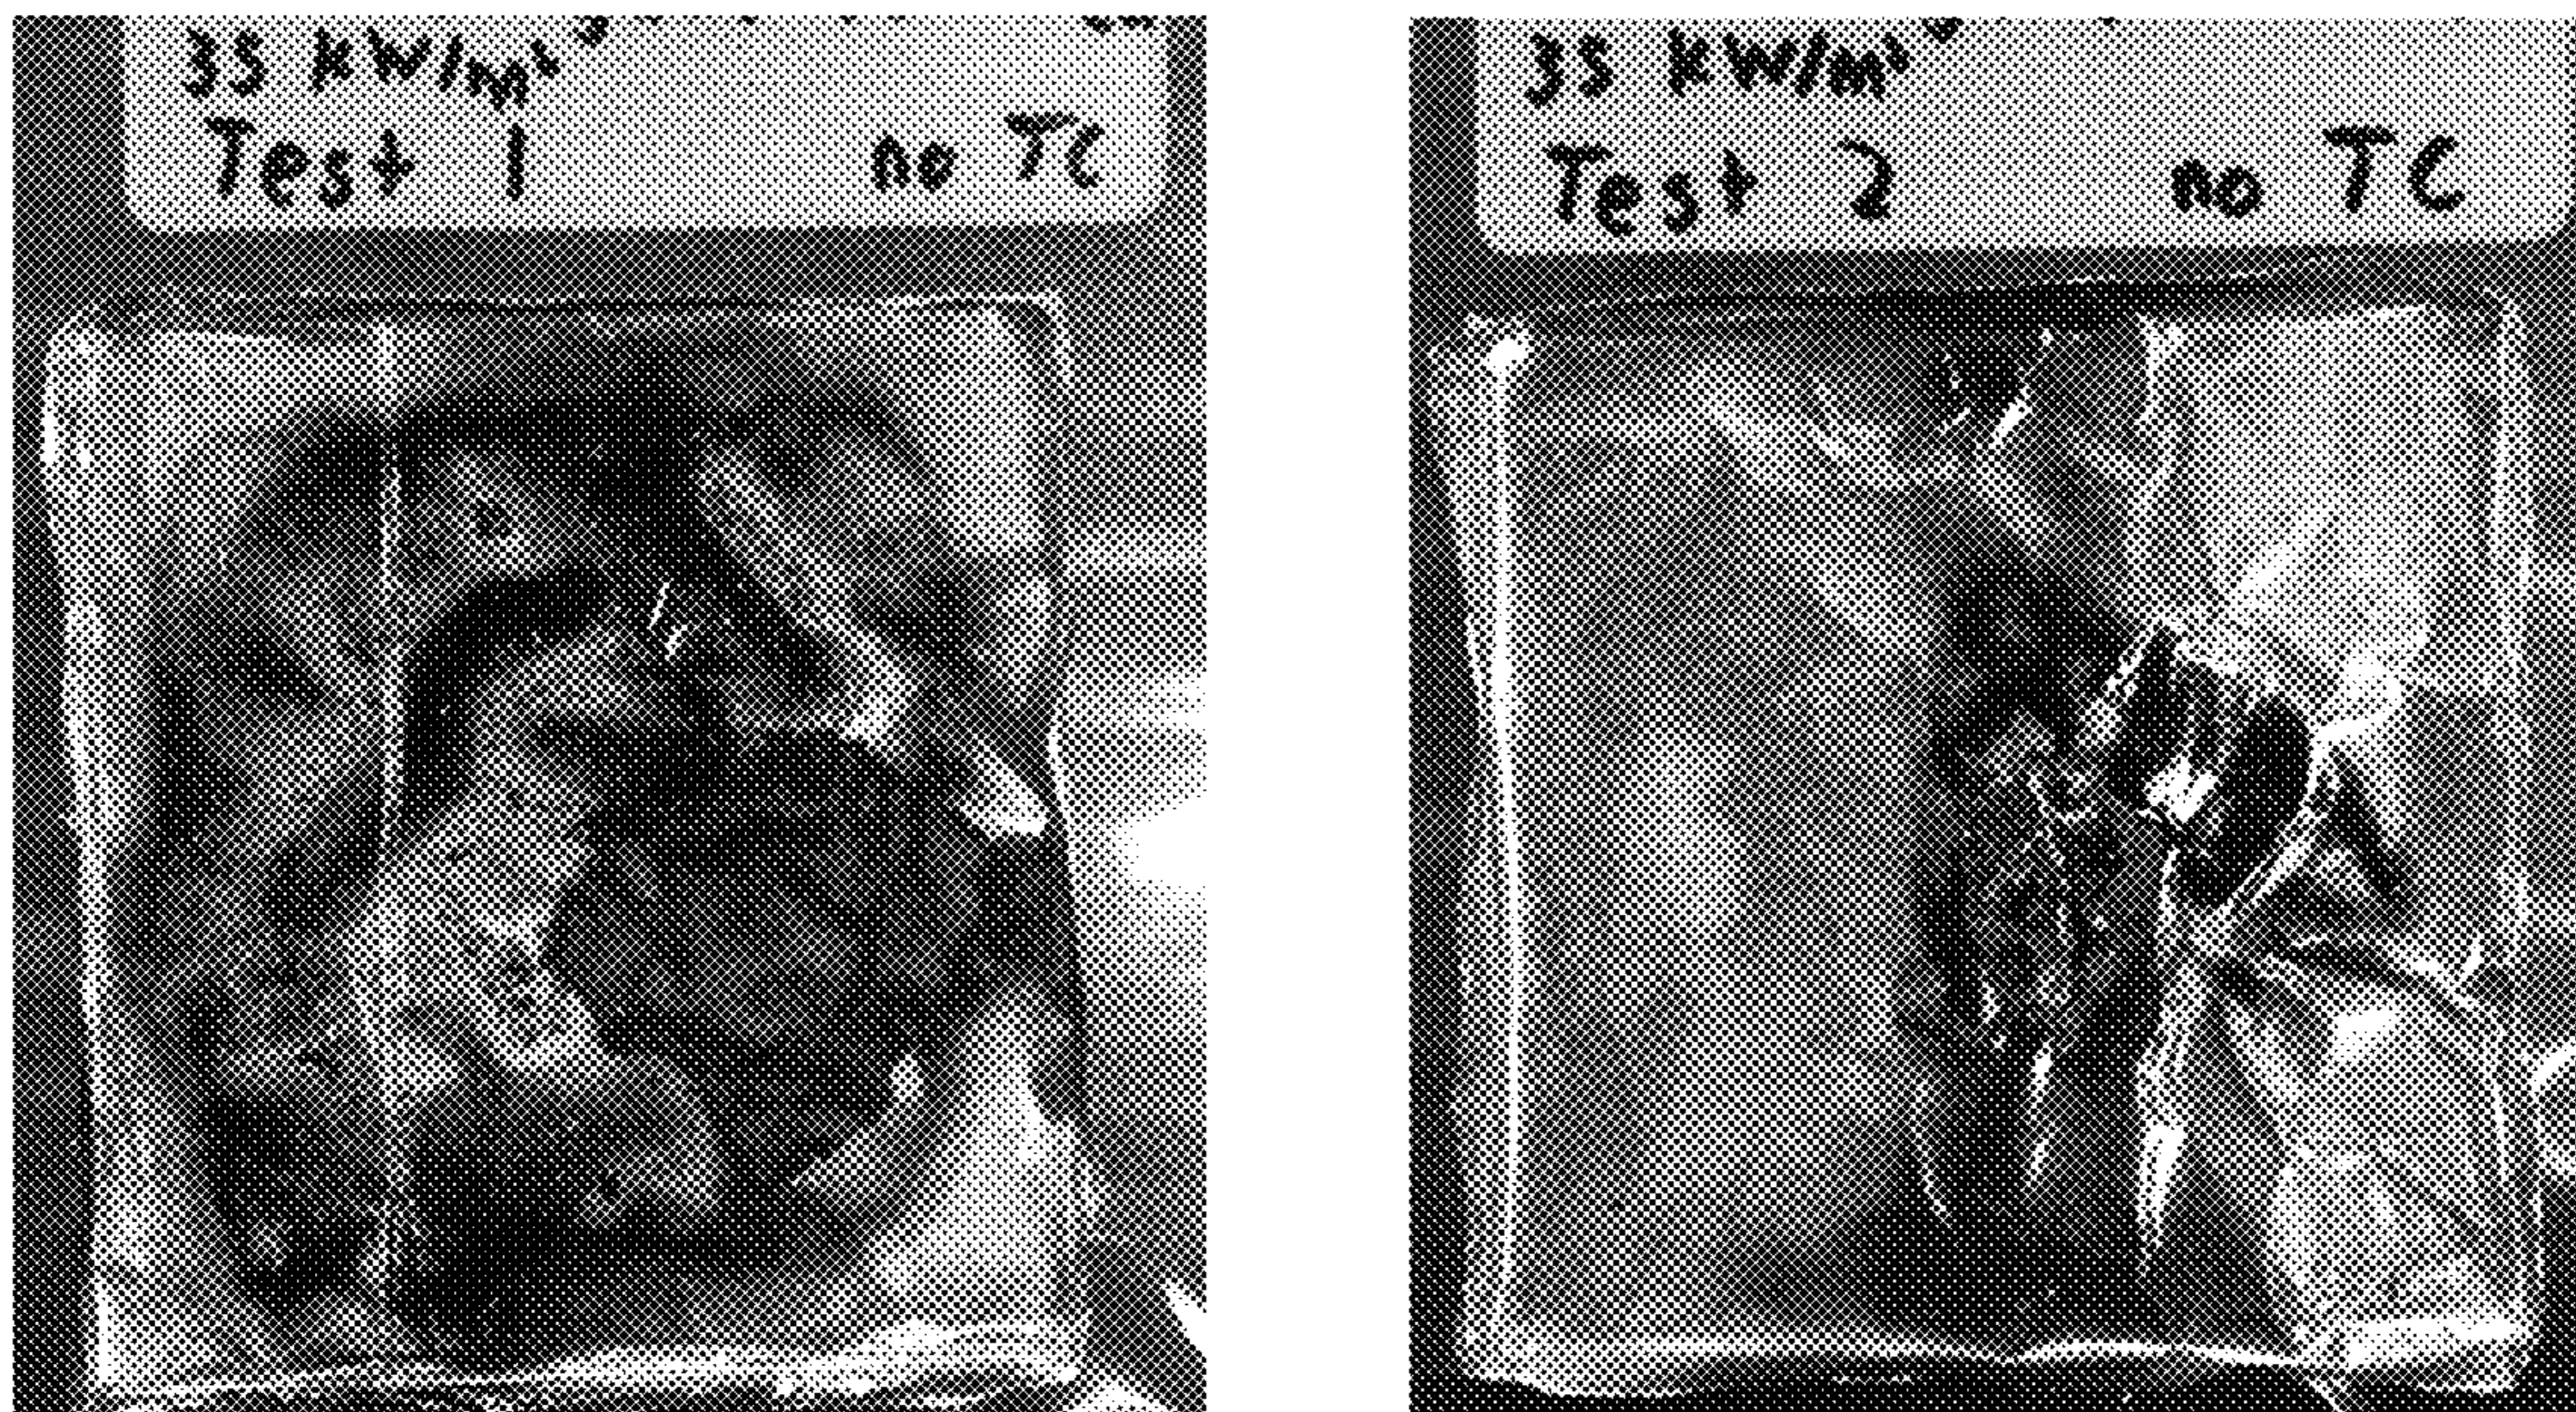
**FIG. 28**

FIG. 28 shows a sample of Material G prior to testing.

Material G is a cloth-like material that is red on both the top and bottom. FIG. 28 shows a sample of the material prior to testing.

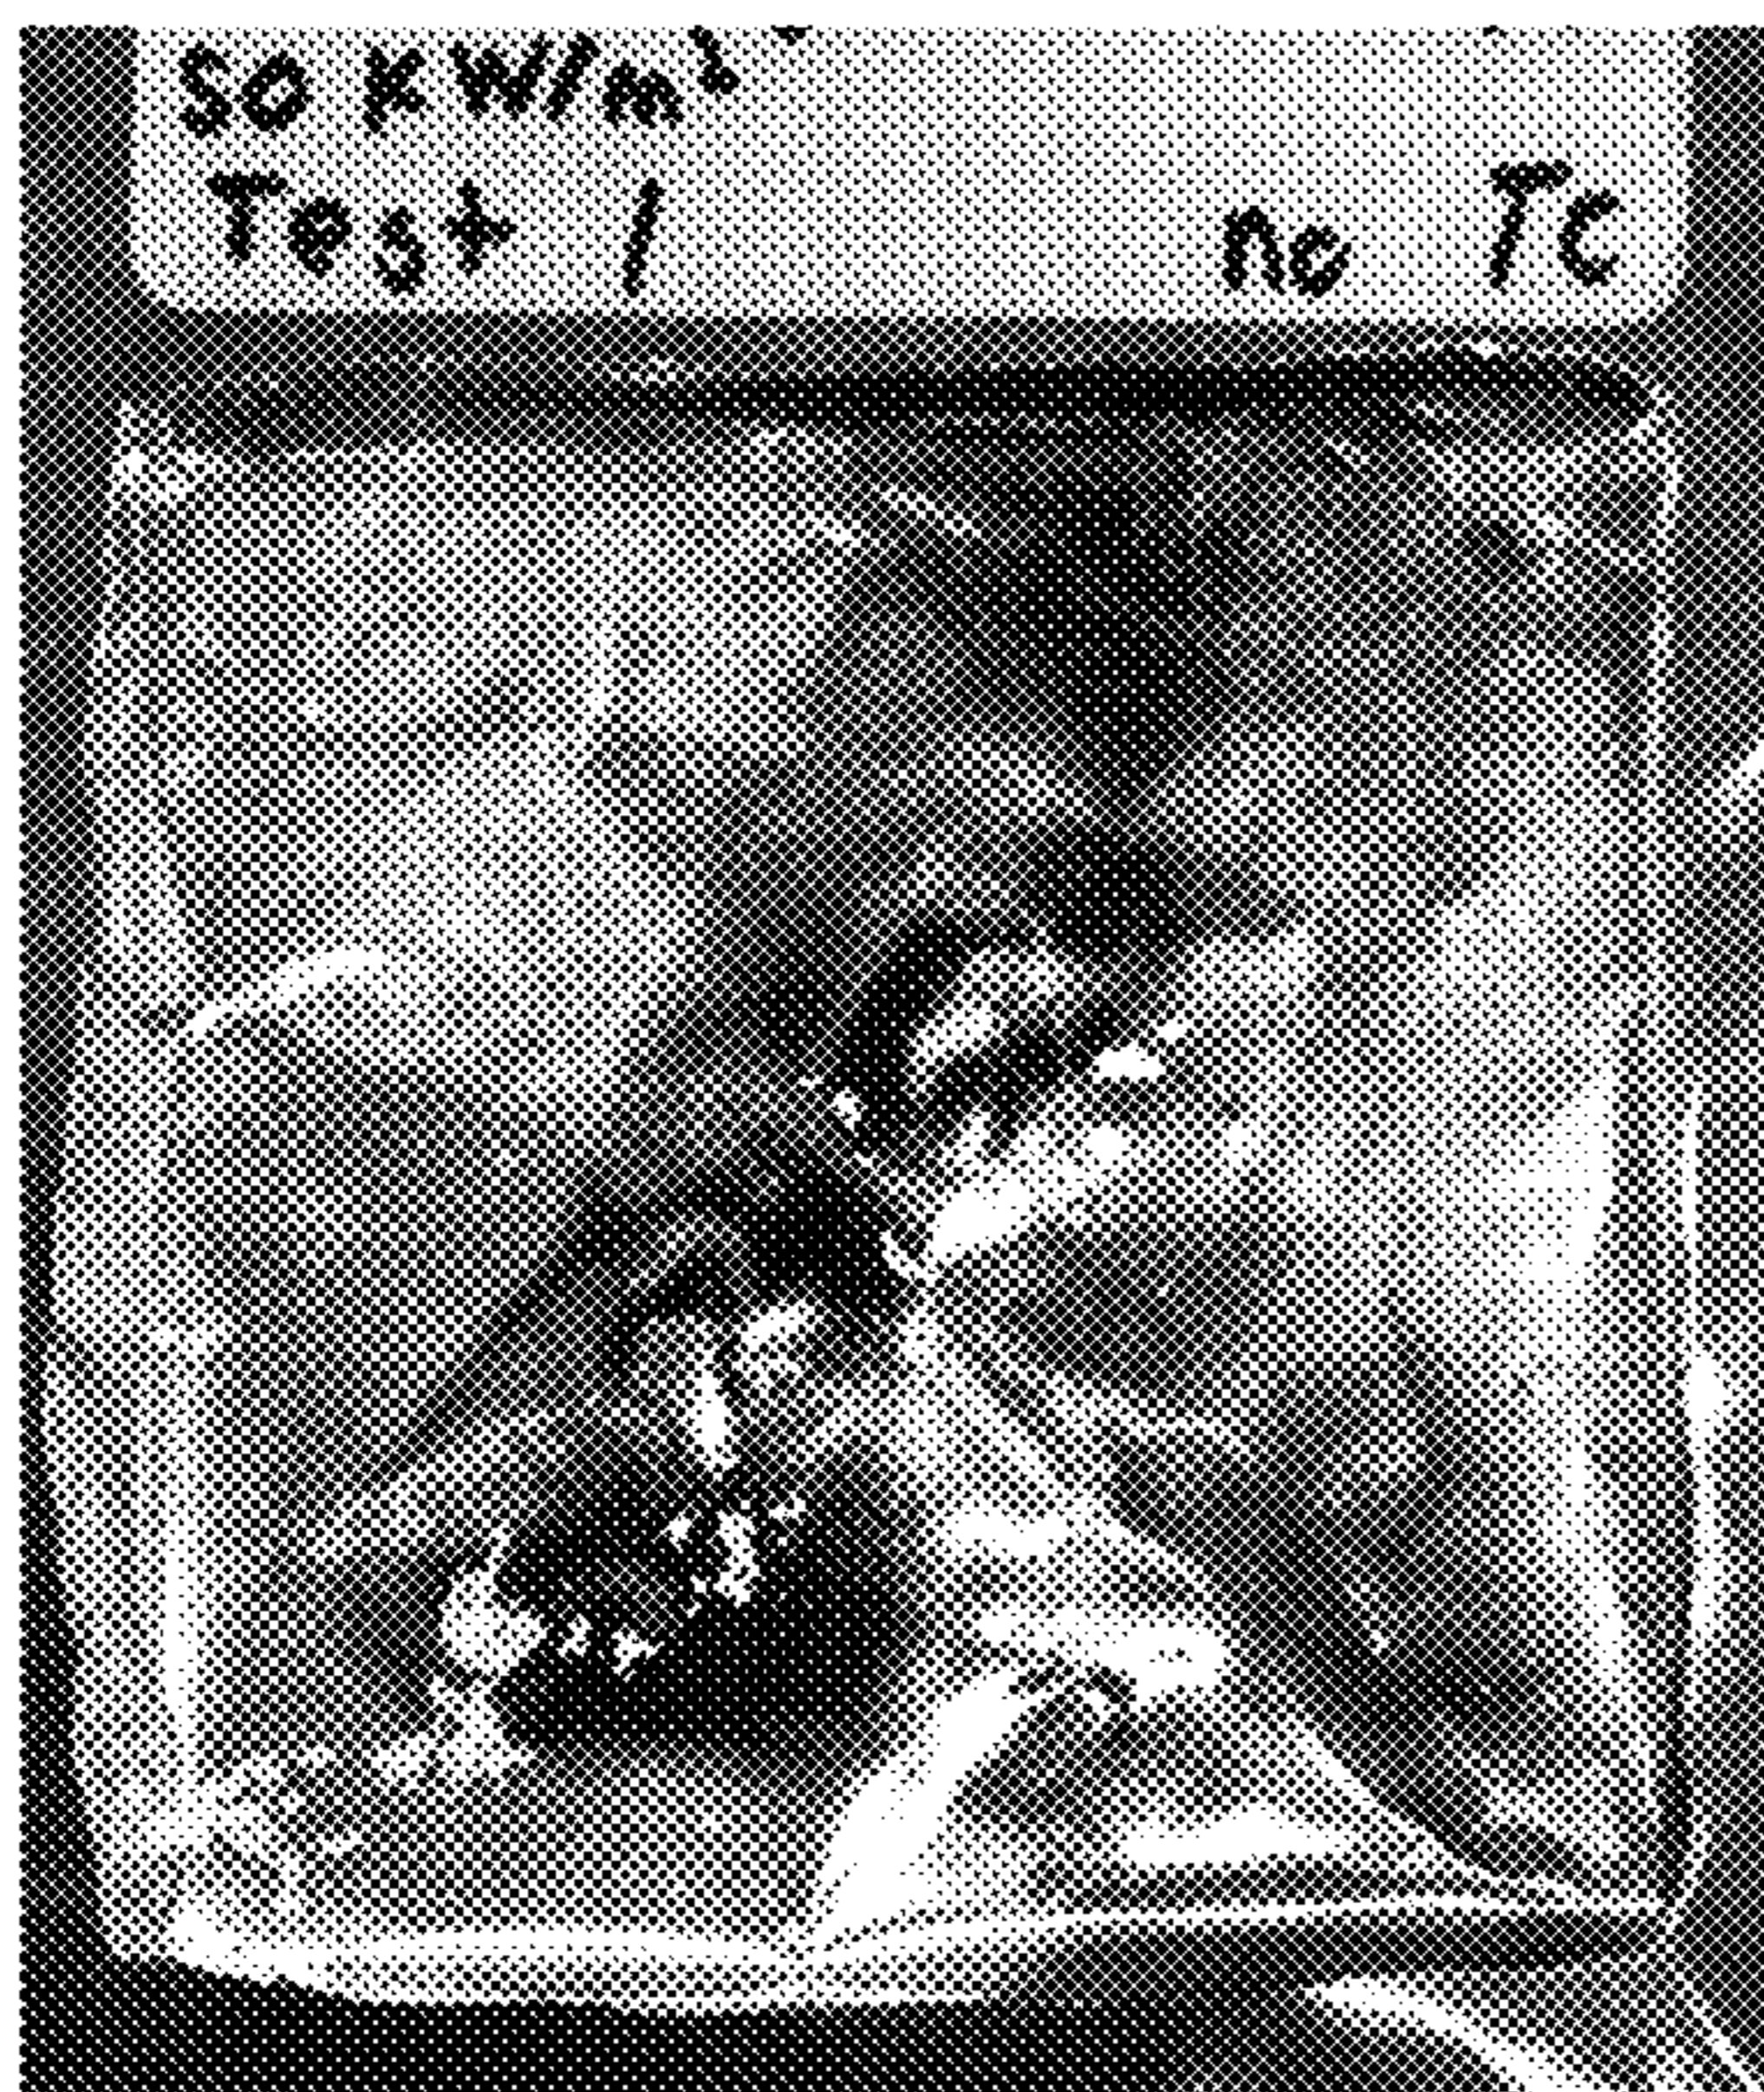
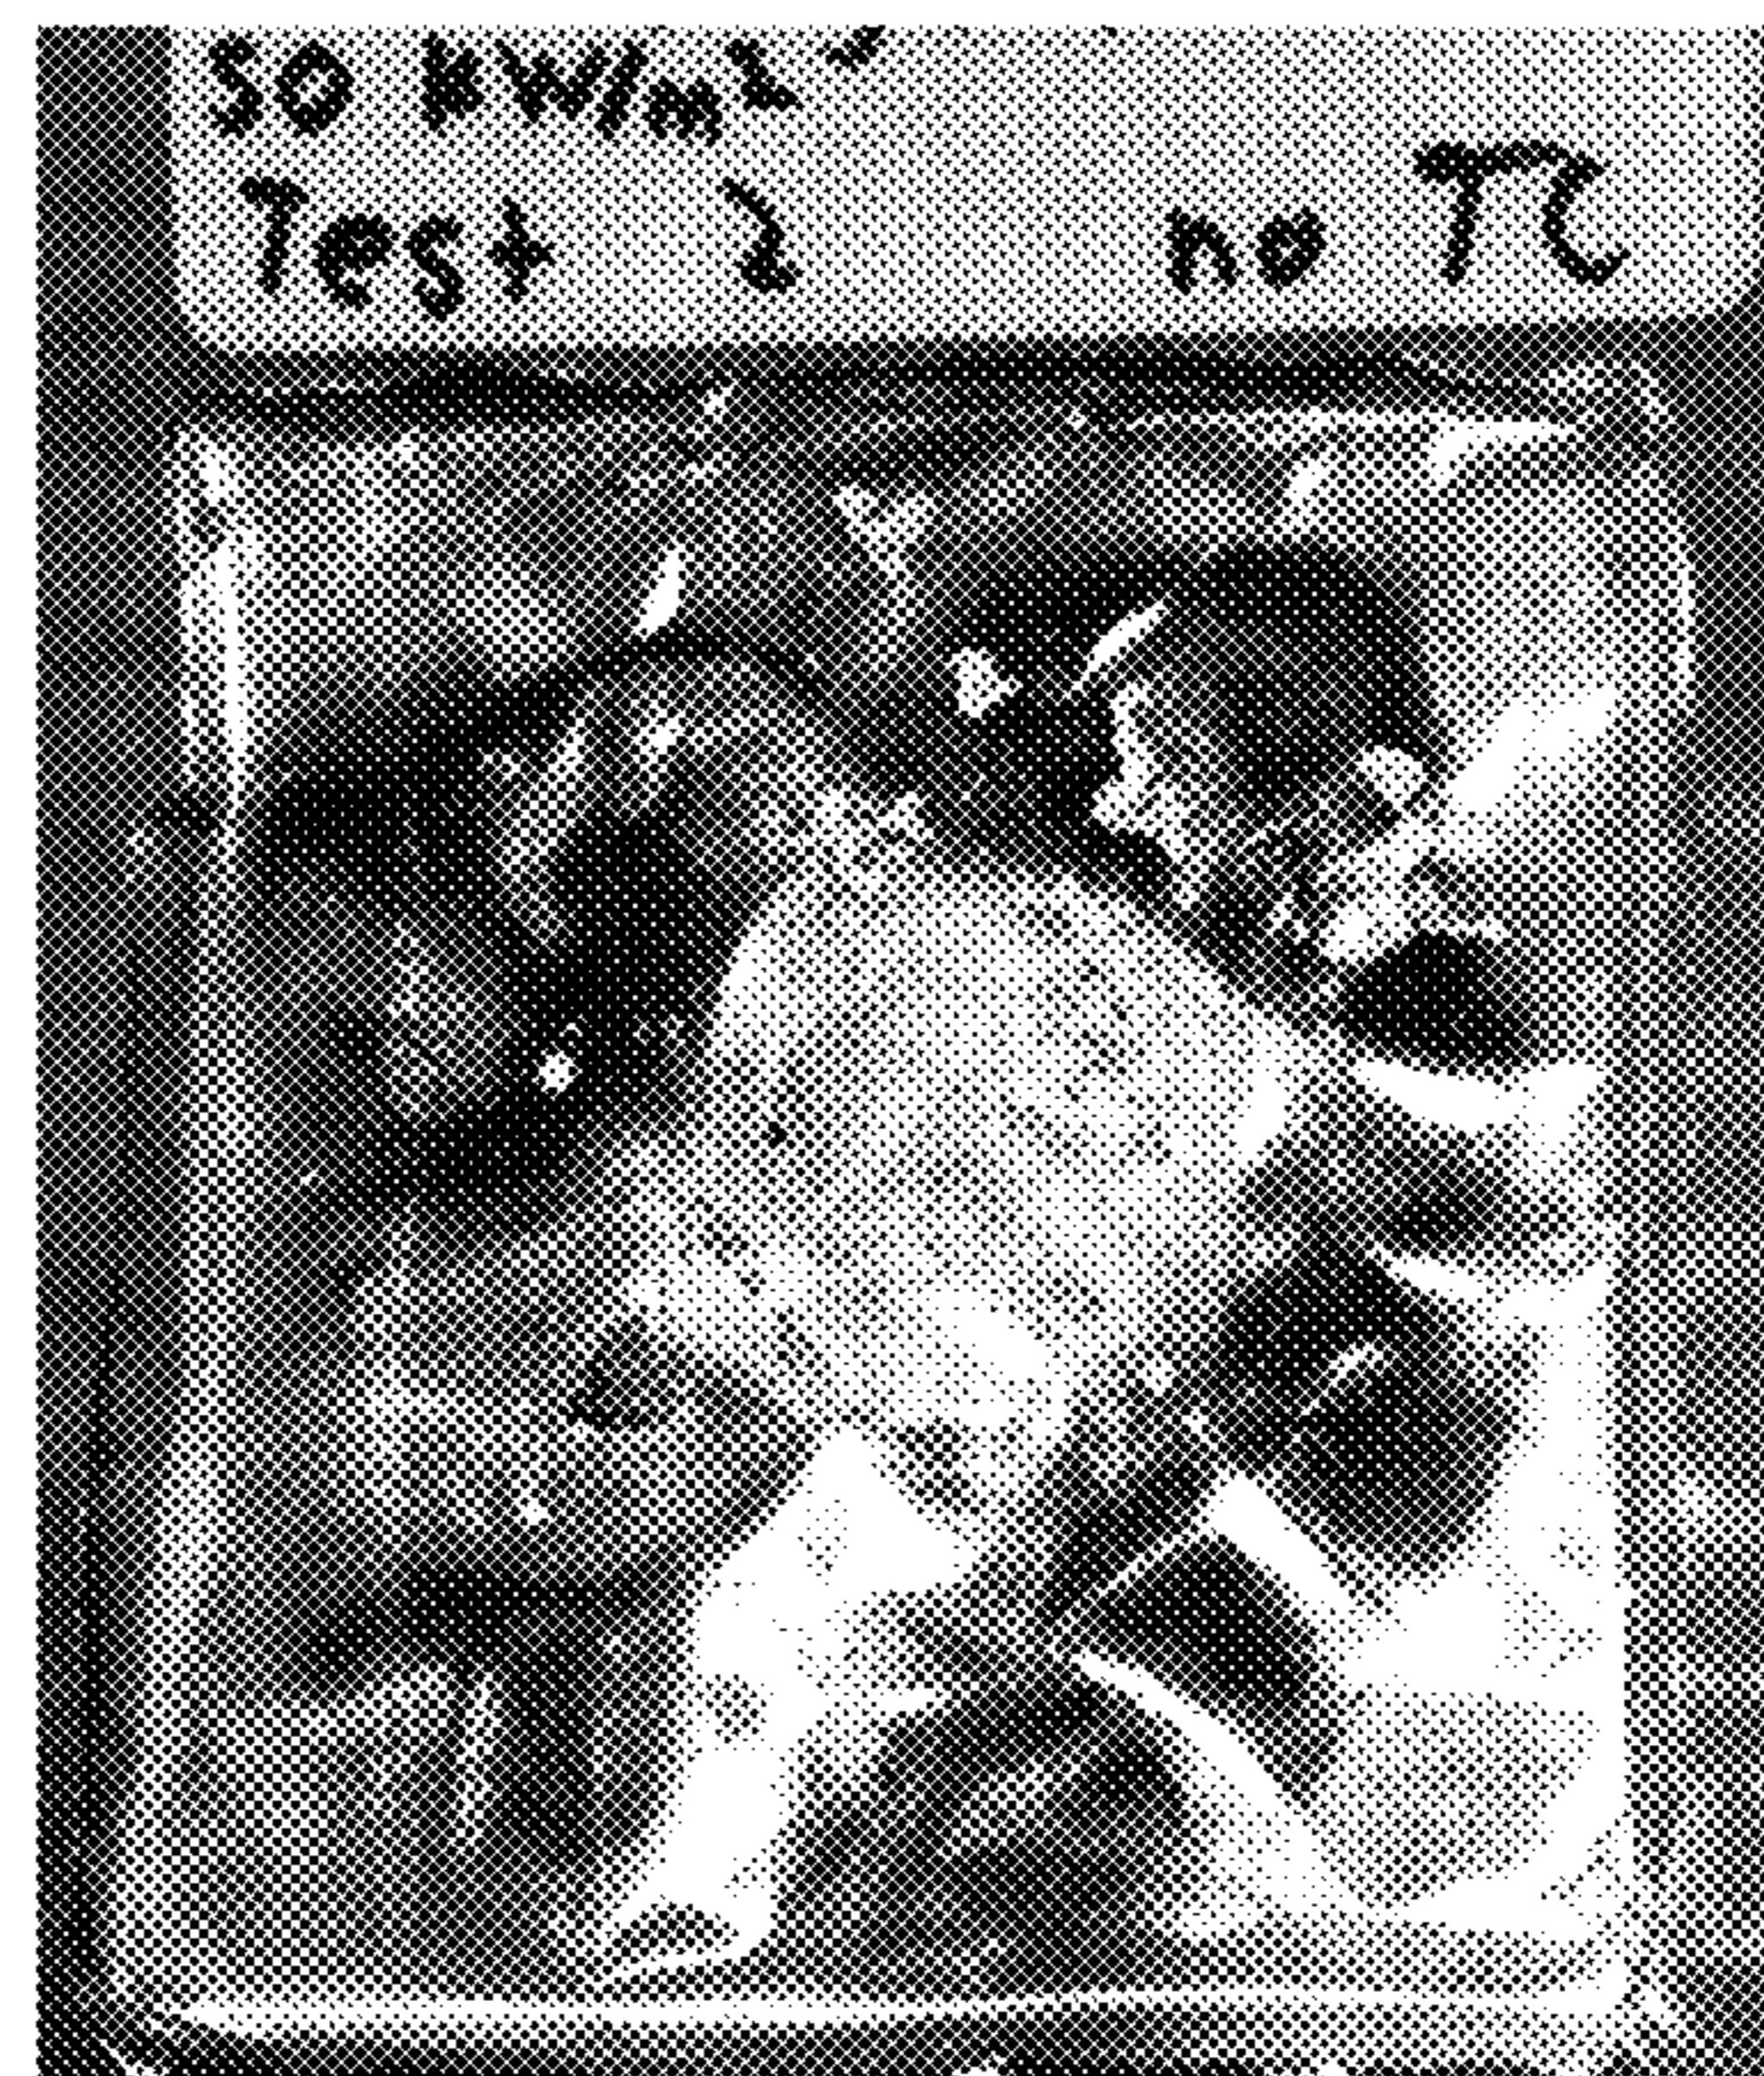
FIG. 29 shows Material G samples after 35 kW/m<sup>2</sup> radiant heating (showing Test 1 (left) and Test 2 (right)).

FIG. 29 shows the state of the samples after being removed from the calorimeter.

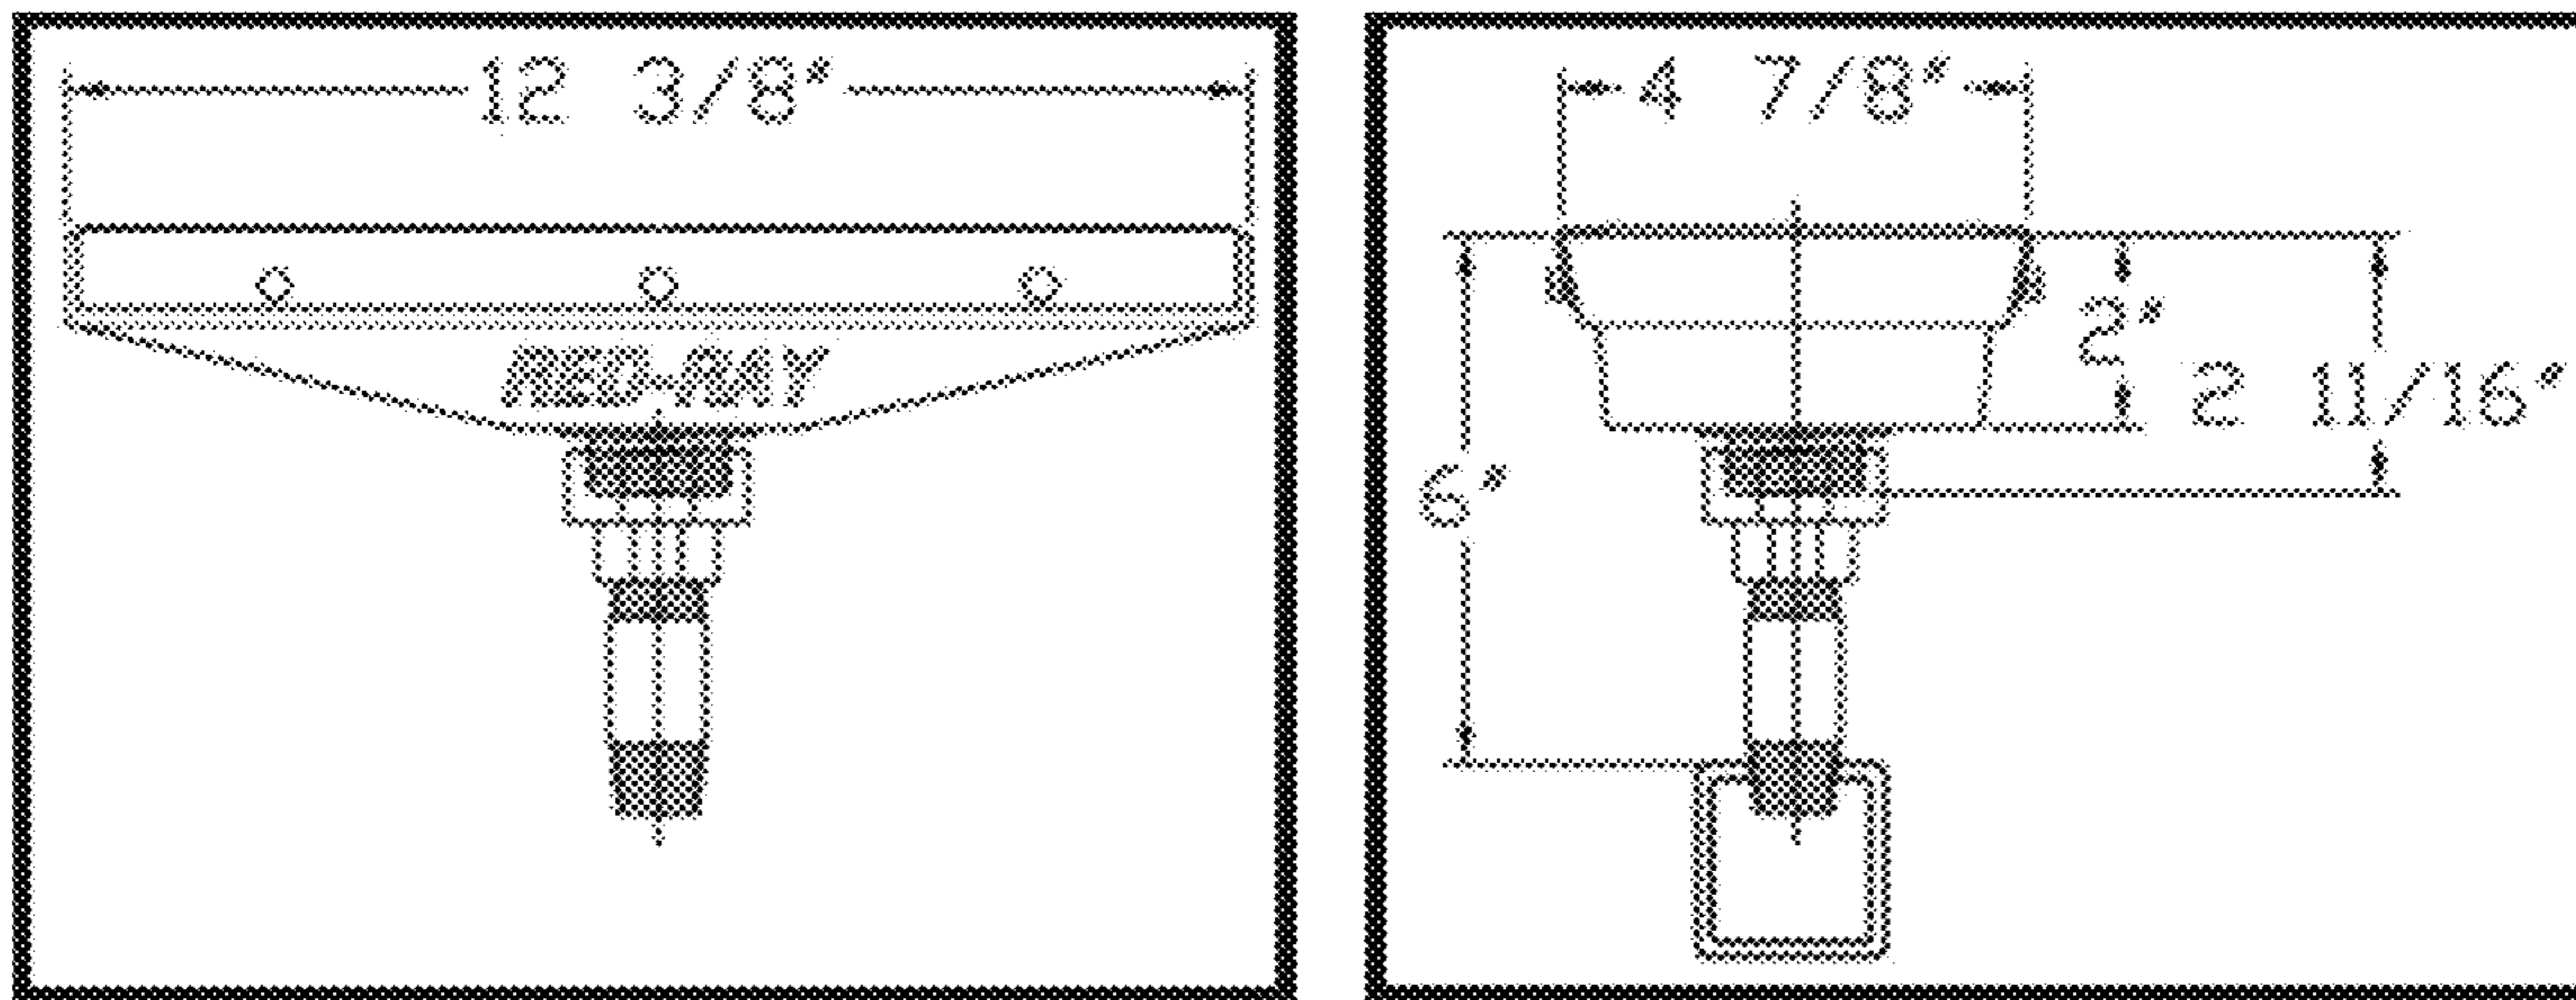
FIG. 31 shows the dimensions of Red-Ray MR-12 Infra-  
red Burner for full-scale testing.

The infrared burner utilized was a surface combustion, gas-fired burner with a high heat flux density and low combustion velocity that achieves an emitter temperature of nominally 1700° F. Test specimens were subjected to a predetermined external heat flux of 30 kW/m<sup>2</sup>. The 30 kW/m<sup>2</sup> heat flux selected matched the "low" heat flux value found in the ATF full-scale experiments to result in hose failure and was similar to the intermediate heating value at which the samples were tested in the cone calorimeter tests.

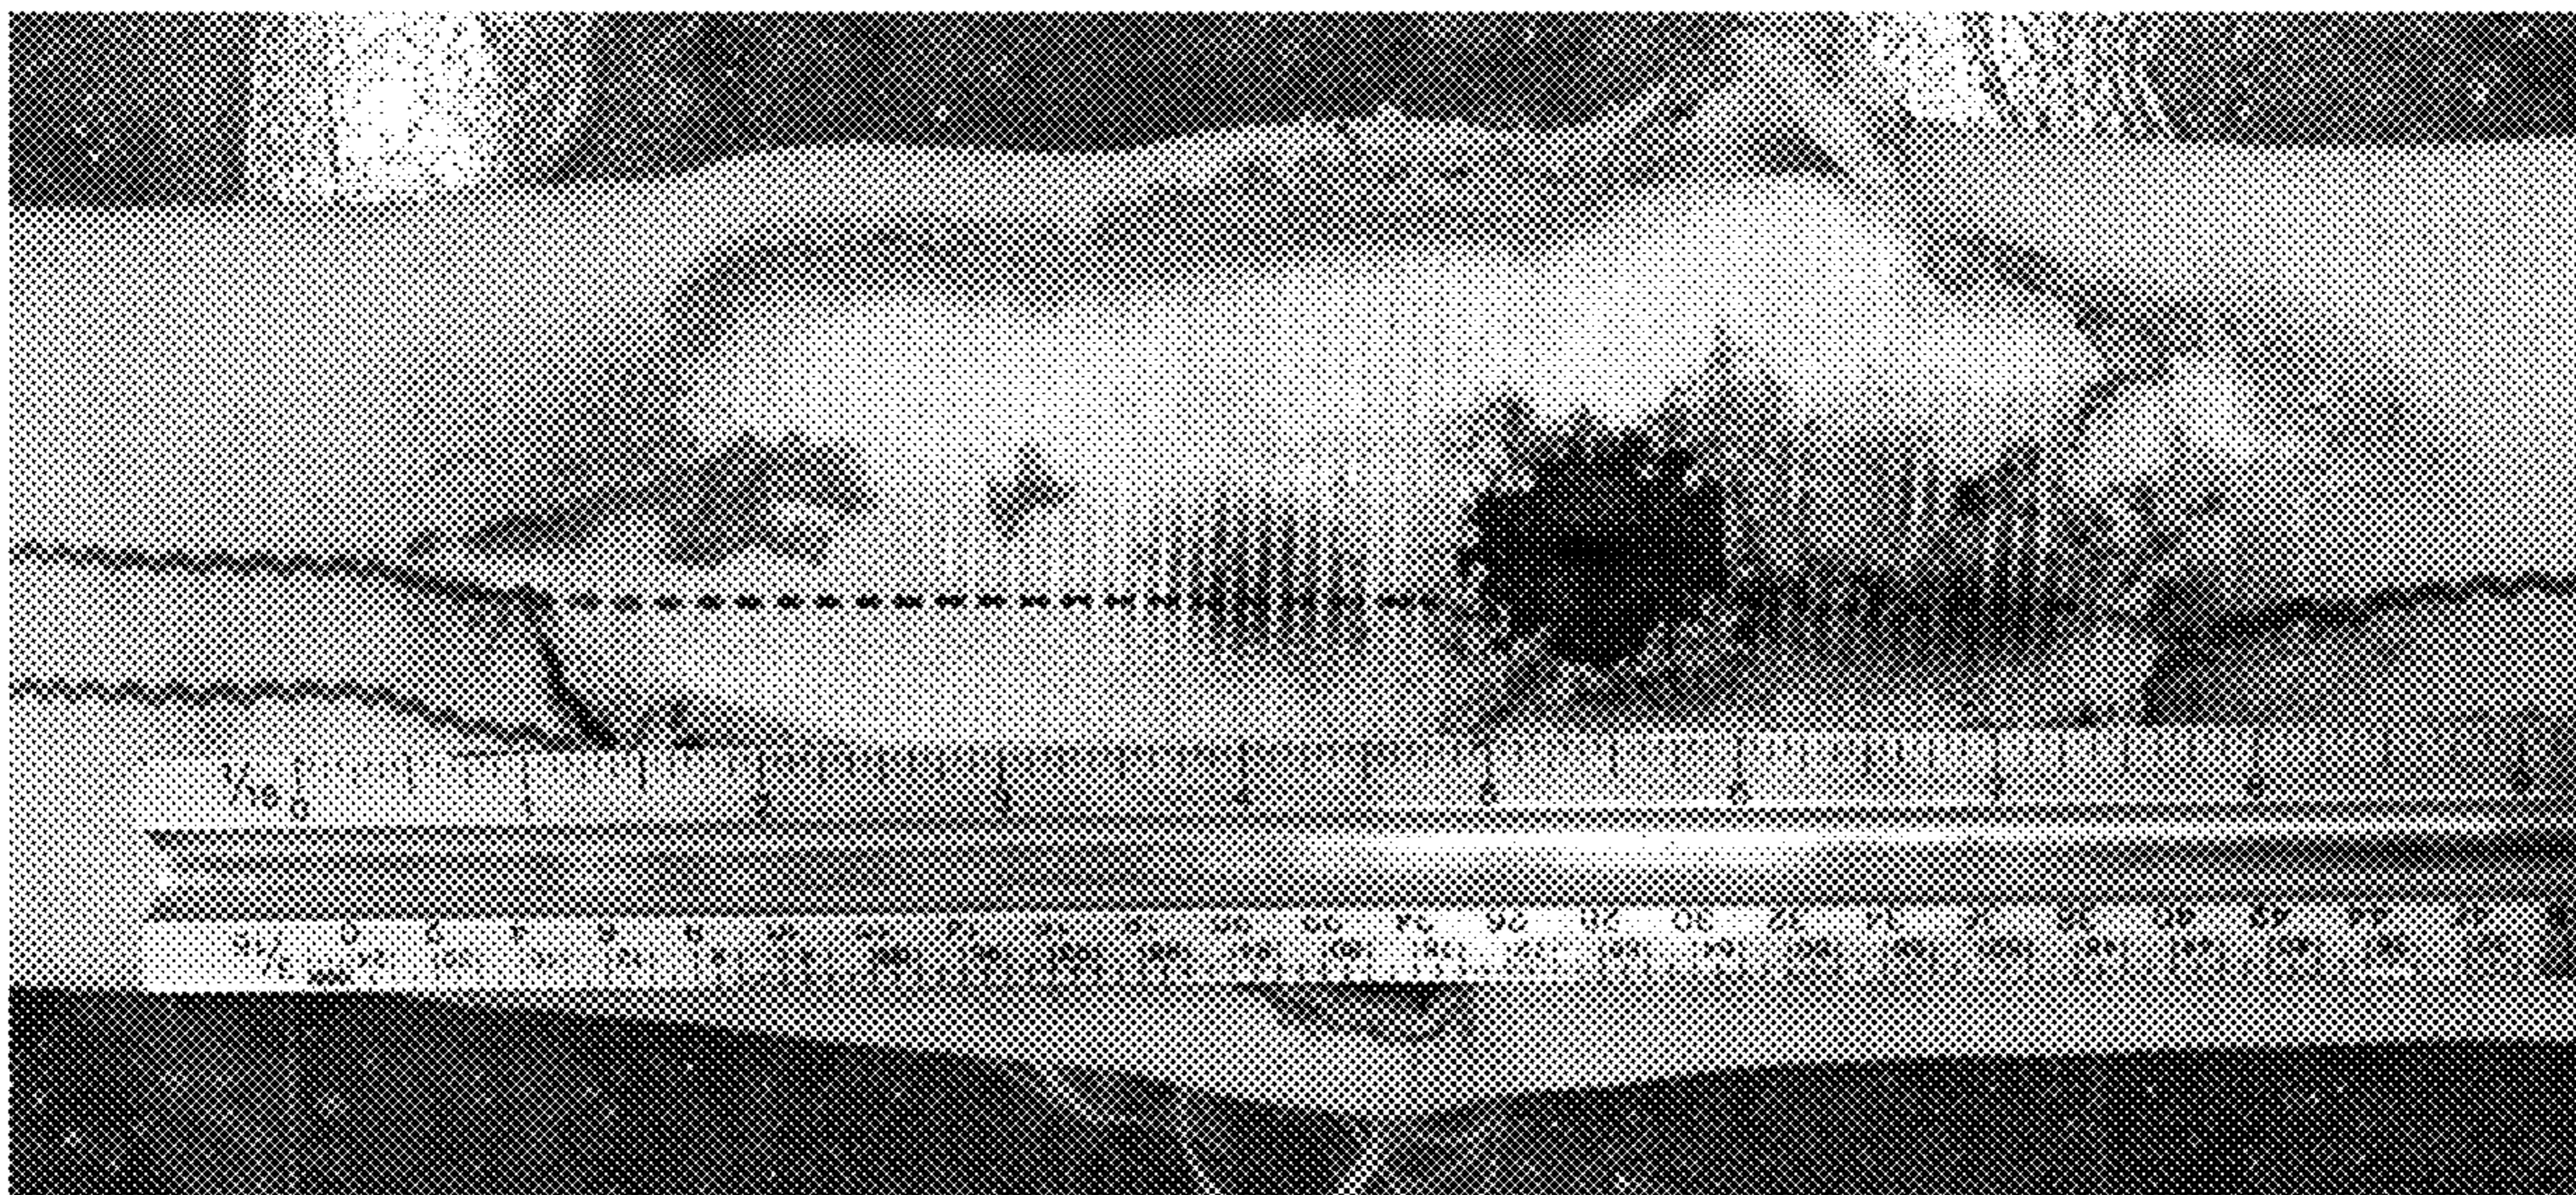
FIG. 33 shows a large hole failure.

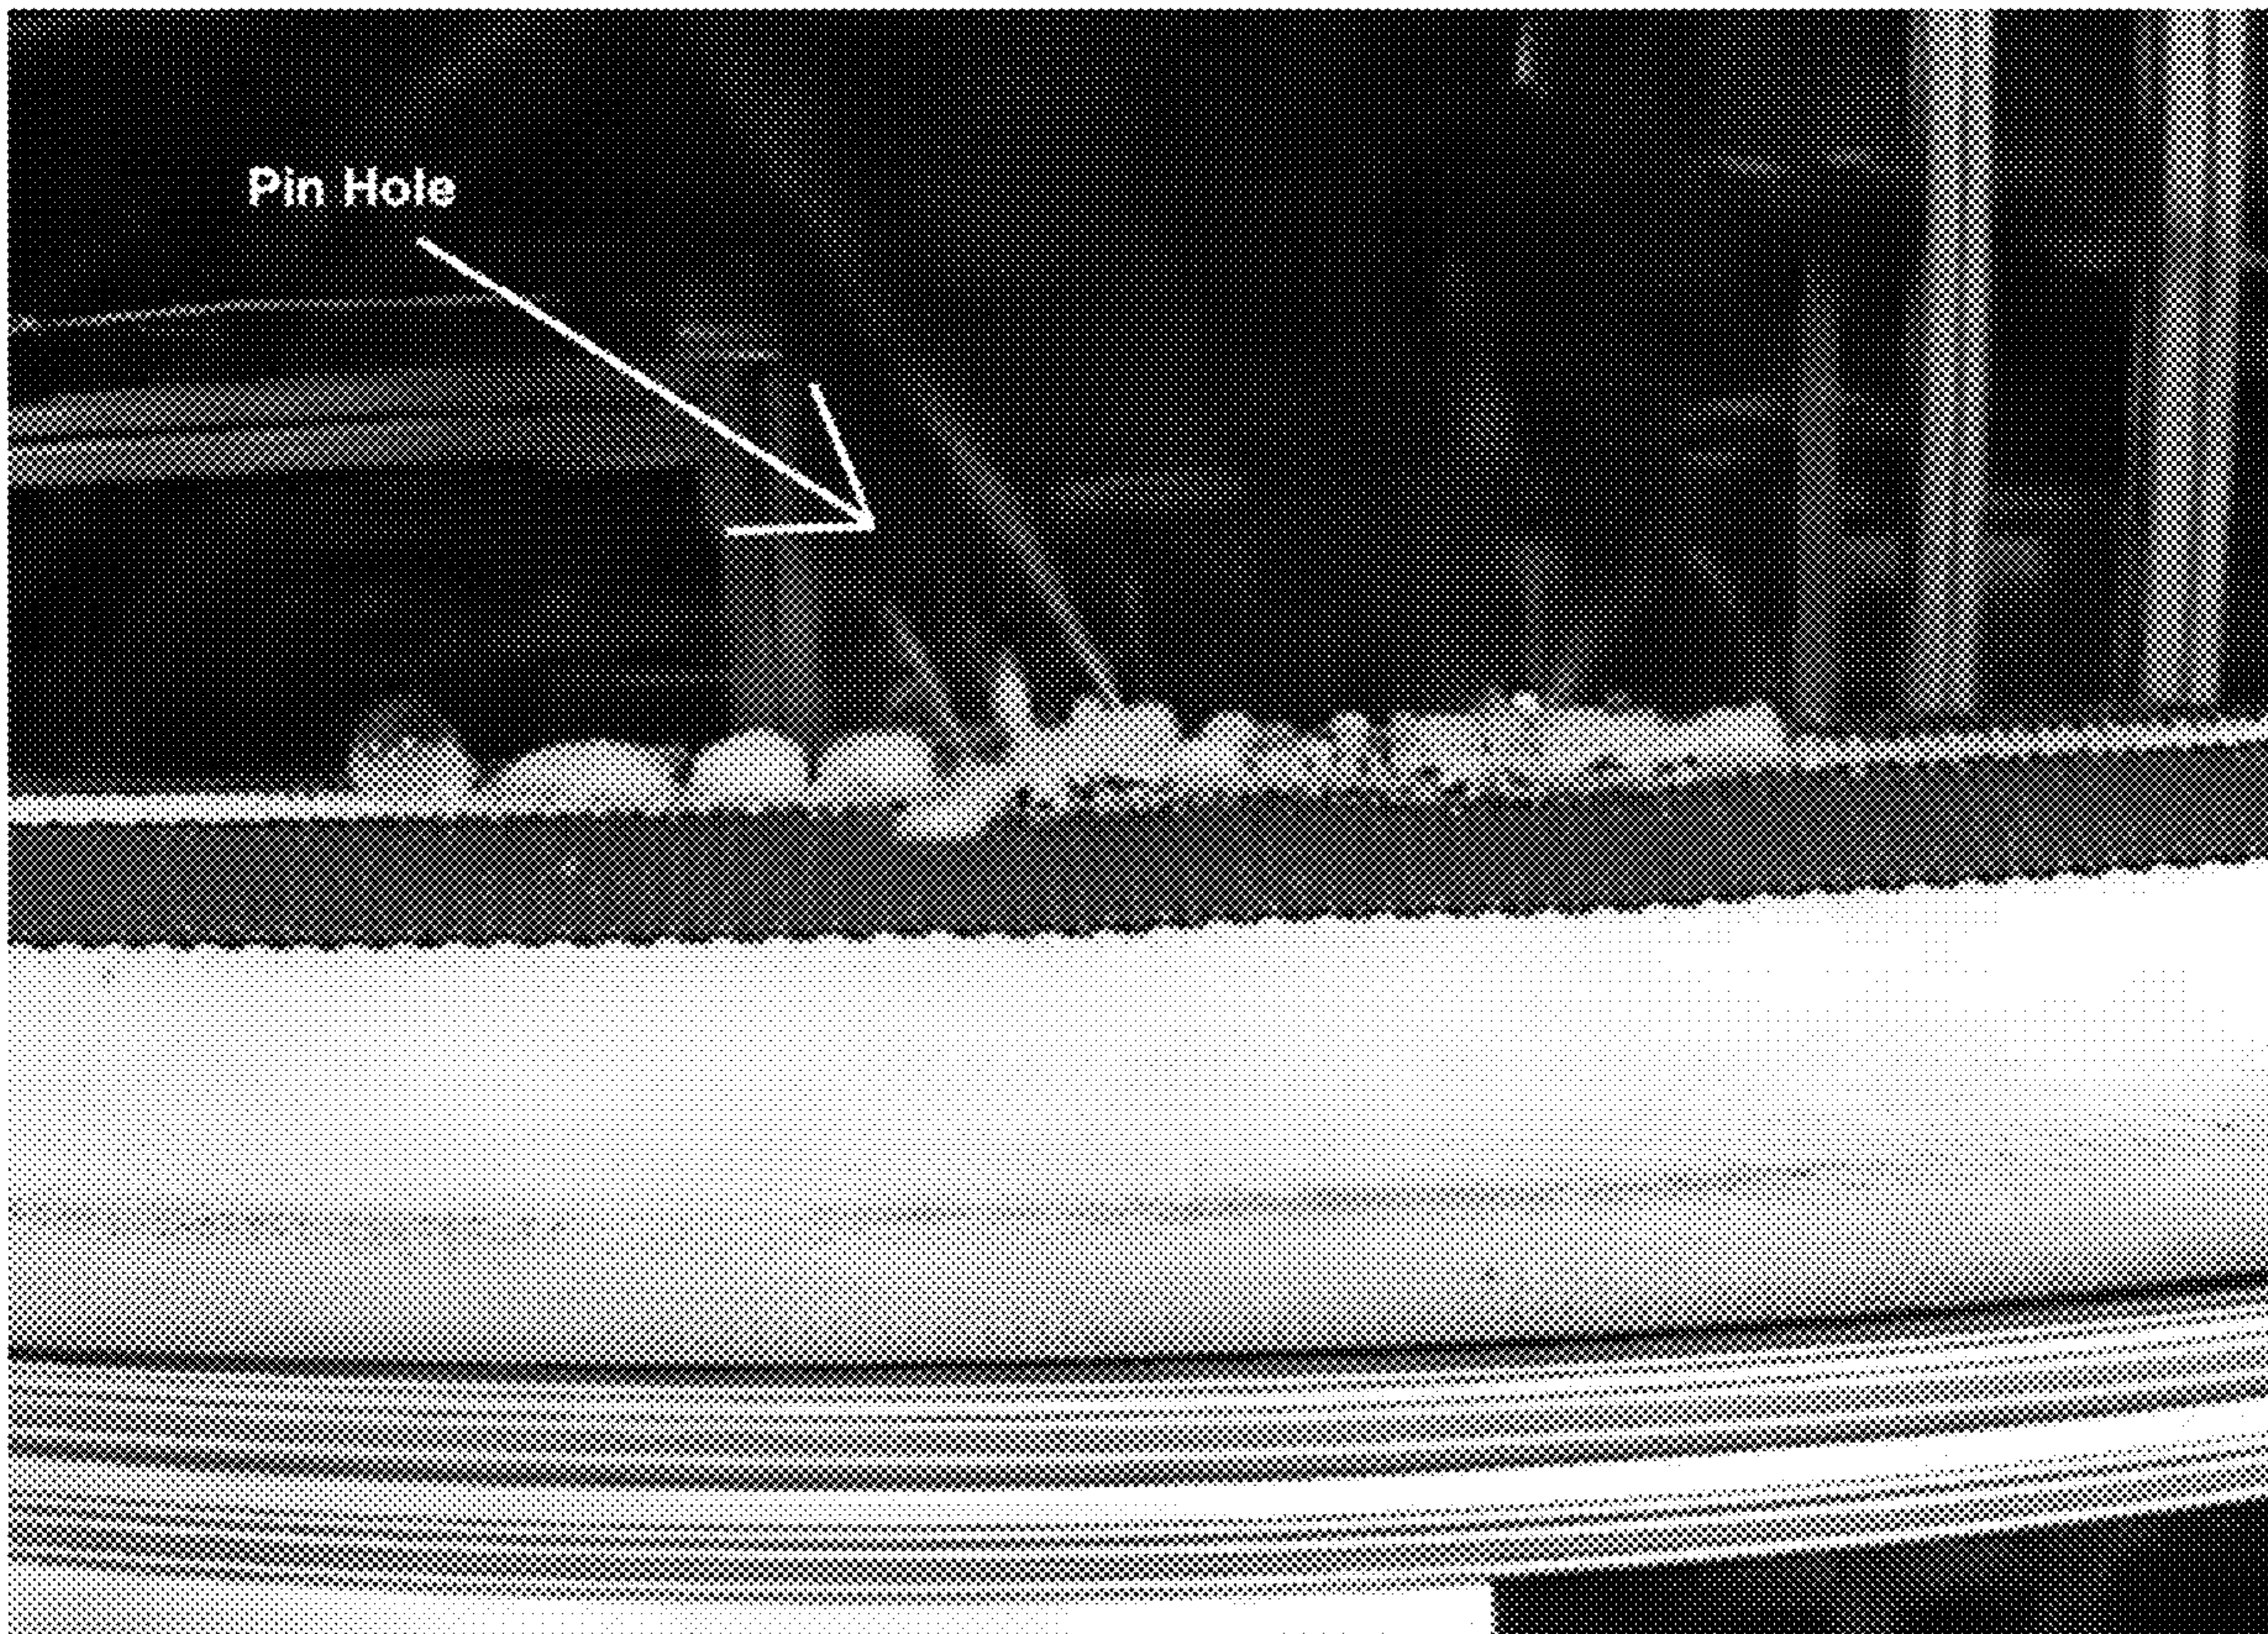
FIG. 34 shows a pin hole failure.
