(10) **Patent No.:** **US 11,485,106 B2**  
(45) **Date of Patent:** **Nov. 1, 2022**

(54) **FIRE HOSE AND MATERTAL THEREFORE**

Described herein are fire hoses incorporating new combi-  
nations of materials to increase the hose's resilience. Resil-  
ient hoses include those made with silicone-coated fabrics or  
with thermally-resistant fabrics or both.

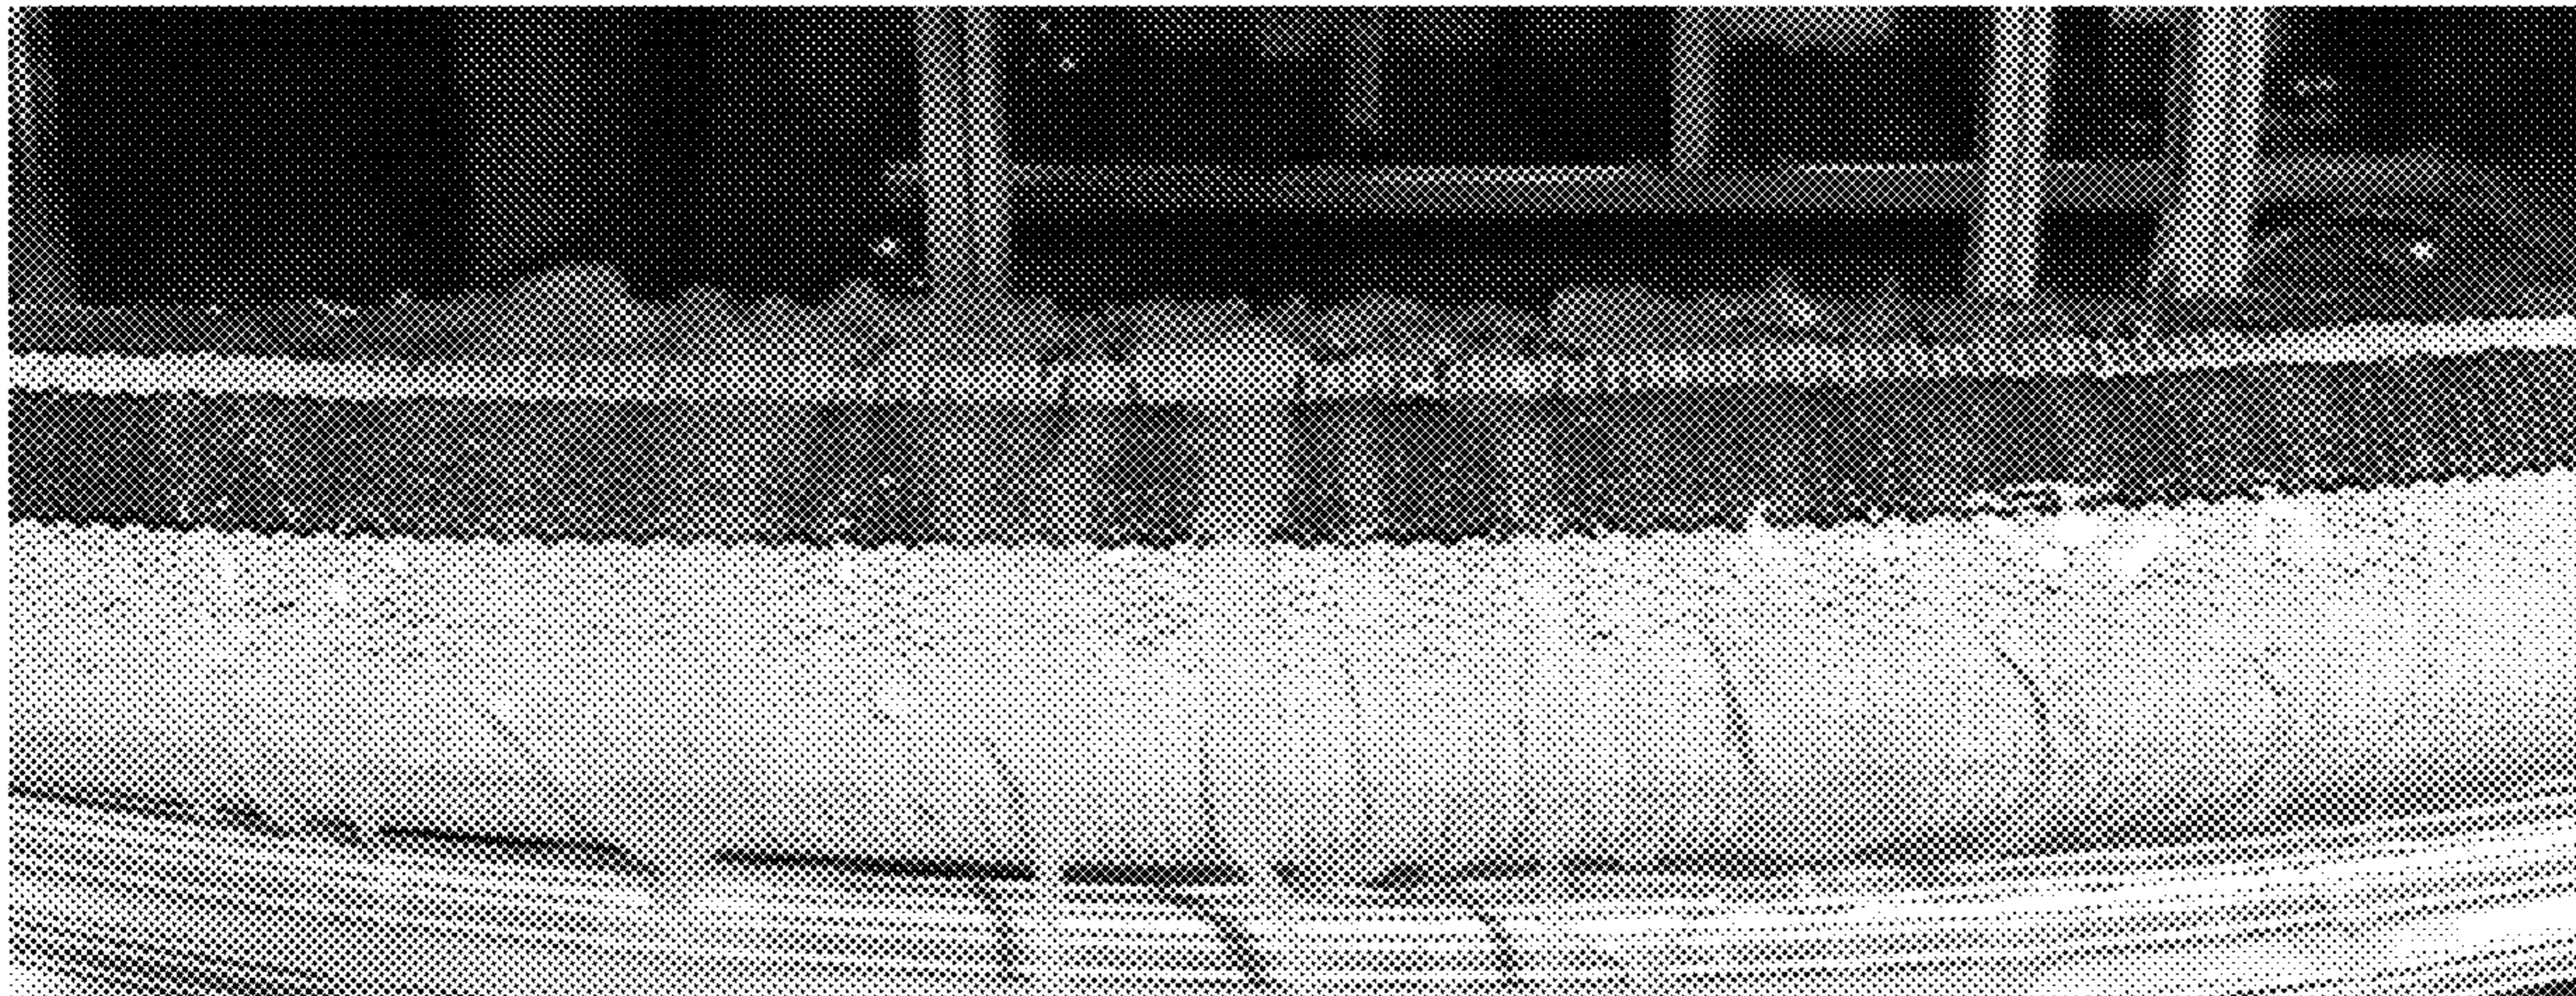
**FIG. 35**

FIG. 35 shows a weeping failure.

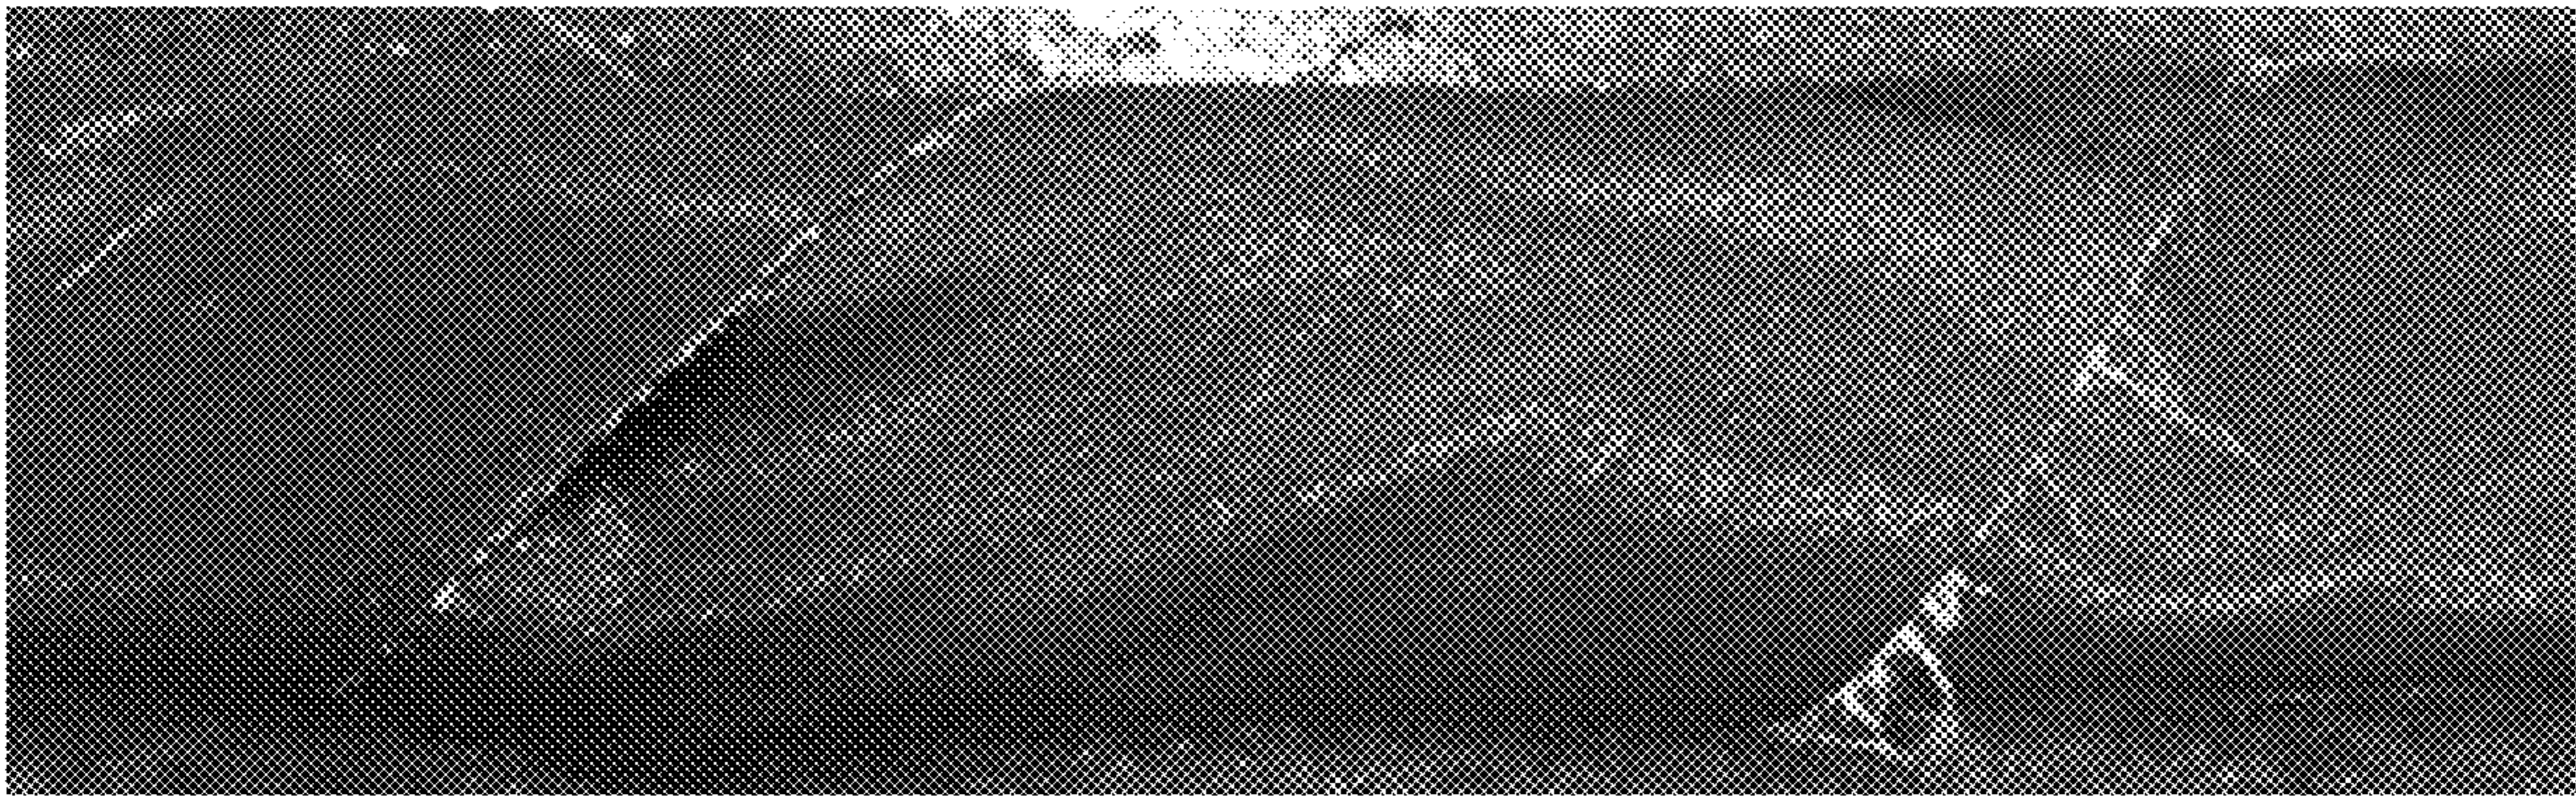
FIG. 36 shows a first prototype of Material 'A'.

In small-scale testing, material 'A' showed no signs of thermal insult after a prolonged exposure to a high heat flux. From this material, several prototype hoses were constructed and tested at Fire & Risk Alliance (FRA), the results of which are shown in Table 4, below. The first test conducted at FRA was a baseline test of a generic rubber lined fire hose to ensure the apparatus was calibrated and functioning as expected. Tests 2 and 3 were tested with the red side of material 'A' facing towards the infrared burner and can be seen in FIG. 36. The tests were run for a duration of 20 minutes after which the radiant heat source was removed, and the sample observed to have no signs of testing with no change to the material itself. Test 4 is material 'Dupre A' inverted to test if the backside of the material holds up as well as the front side, the results of which can be seen in FIG. 37. The black marks around the material were left from the outer jacket burning away and not a representation of how material 'A' reacts to the heat flux exposure. Test 4 was concluded after 20 minutes of testing under 30 (kW/m<sup>2</sup>) and showed no change to the physical properties of the material. In each test of material 'A' the sample leaked due to the method of assembly, as the hose was not a sleeve, but the material itself did not burn through, ignite, or show signs of thermal degradation during the test.

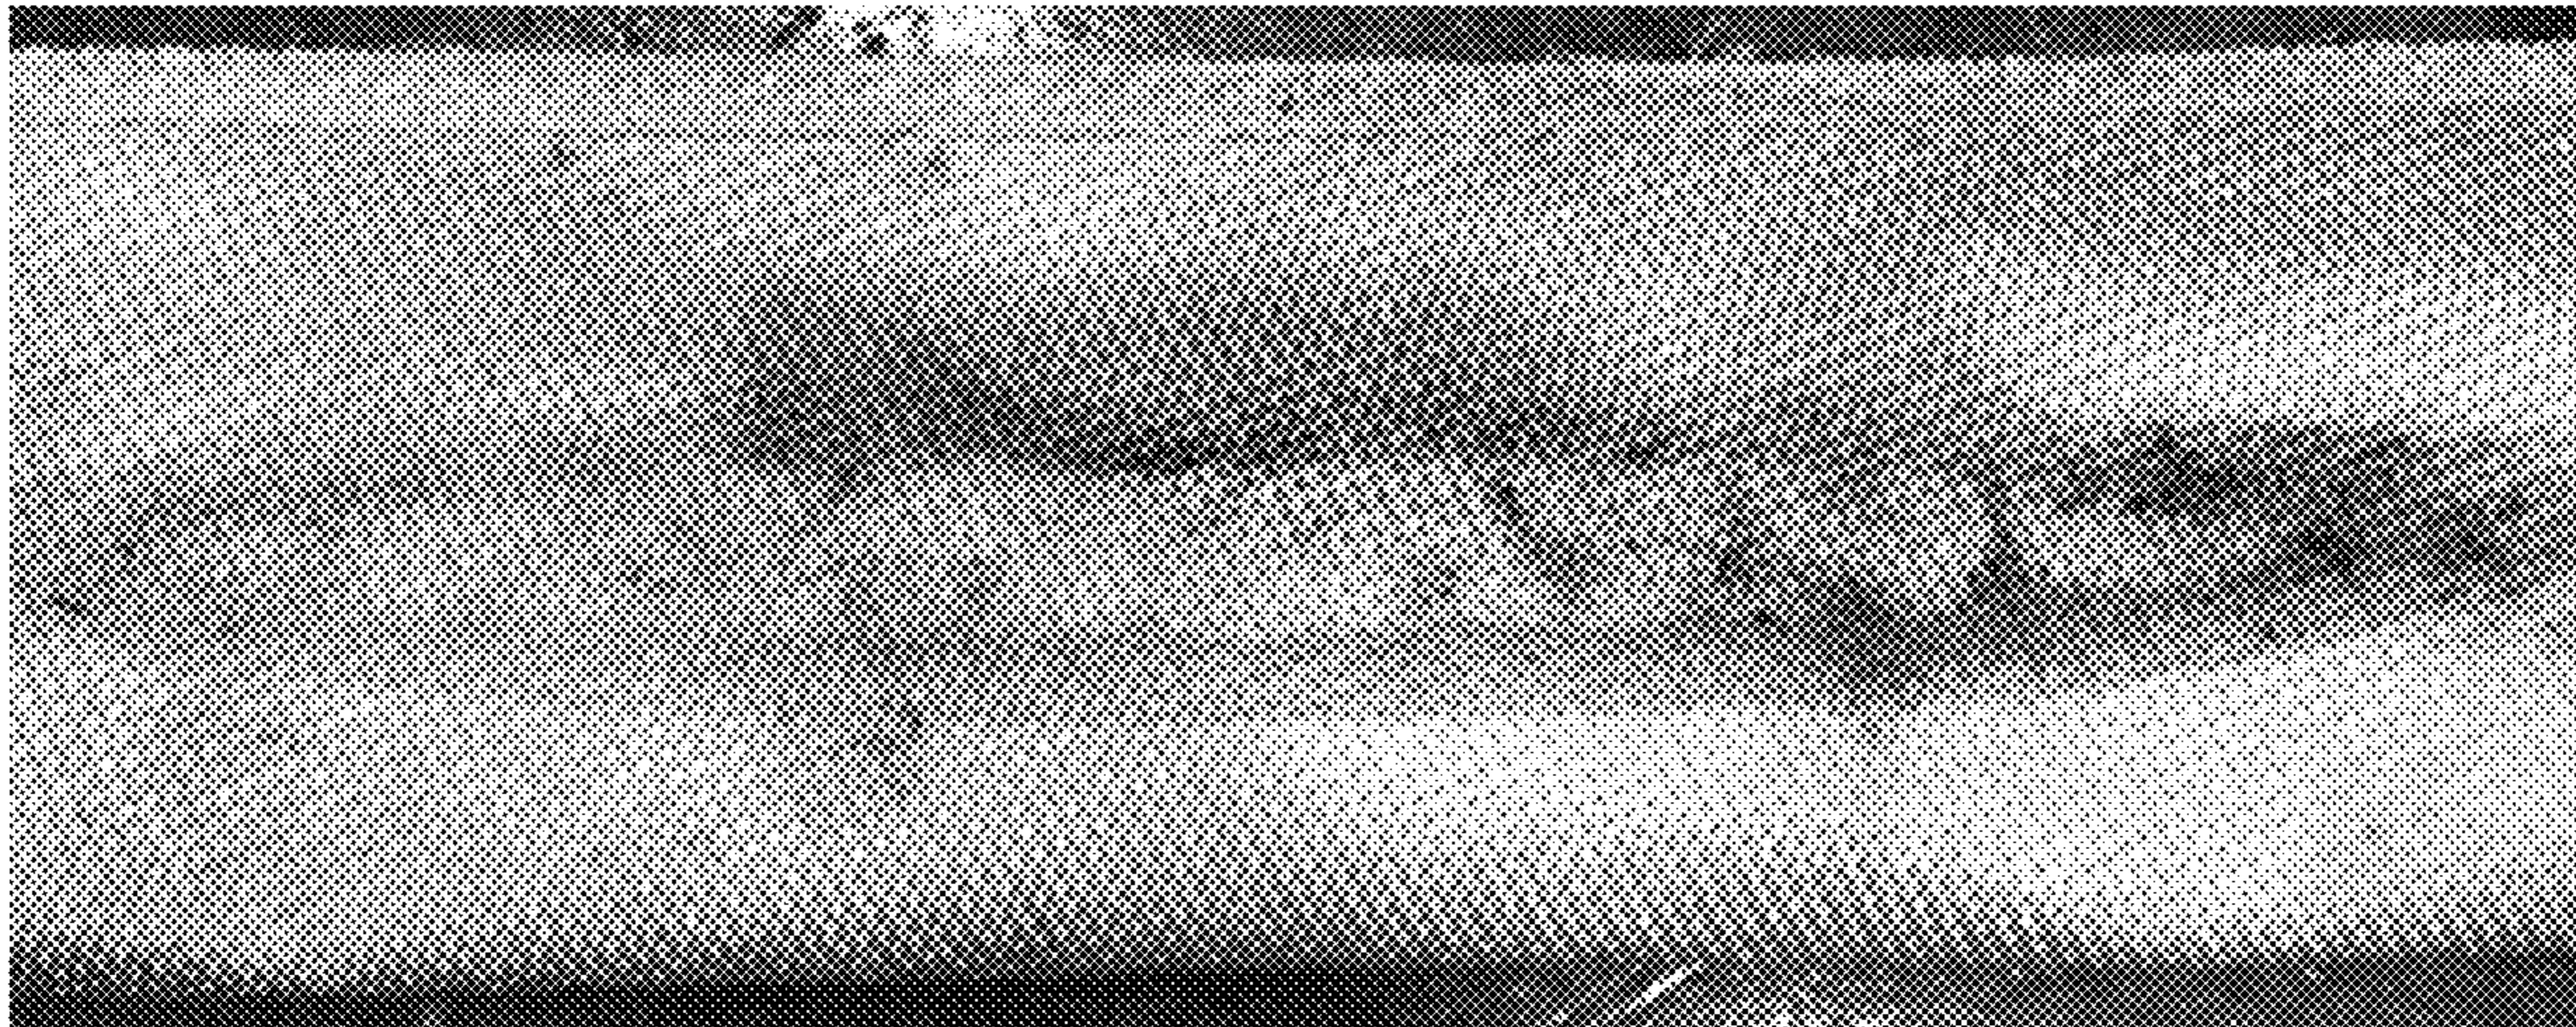
**FIG. 36**

FIG. 37 shows a second prototype 2 of Material 'A'.
