(10) **Patent No.:** **US 11,753,099 B2**
(45) **Date of Patent:** **Sep. 12, 2023**

(54) **LEANING VEHICLE**

This leaning vehicle that turns in a leaning posture and has a leaning frame structure made of a material containing fiber-reinforced resin can achieve weight reduction and help reduce changes in ride quality. The vehicle includes a rear structure that leans to the left during a left turn and leans to the right during a right turn with respect to the left-right direction of the vehicle, and is made of a material containing carbon-fiber-reinforced resin, and a leaning frame structure damage notification unit that, when the rear structure receives an impact caused by a fall of the vehicle in the left direction or the right direction, and the impact damages a non-visible part of the rear structure, makes a notification of the damage.

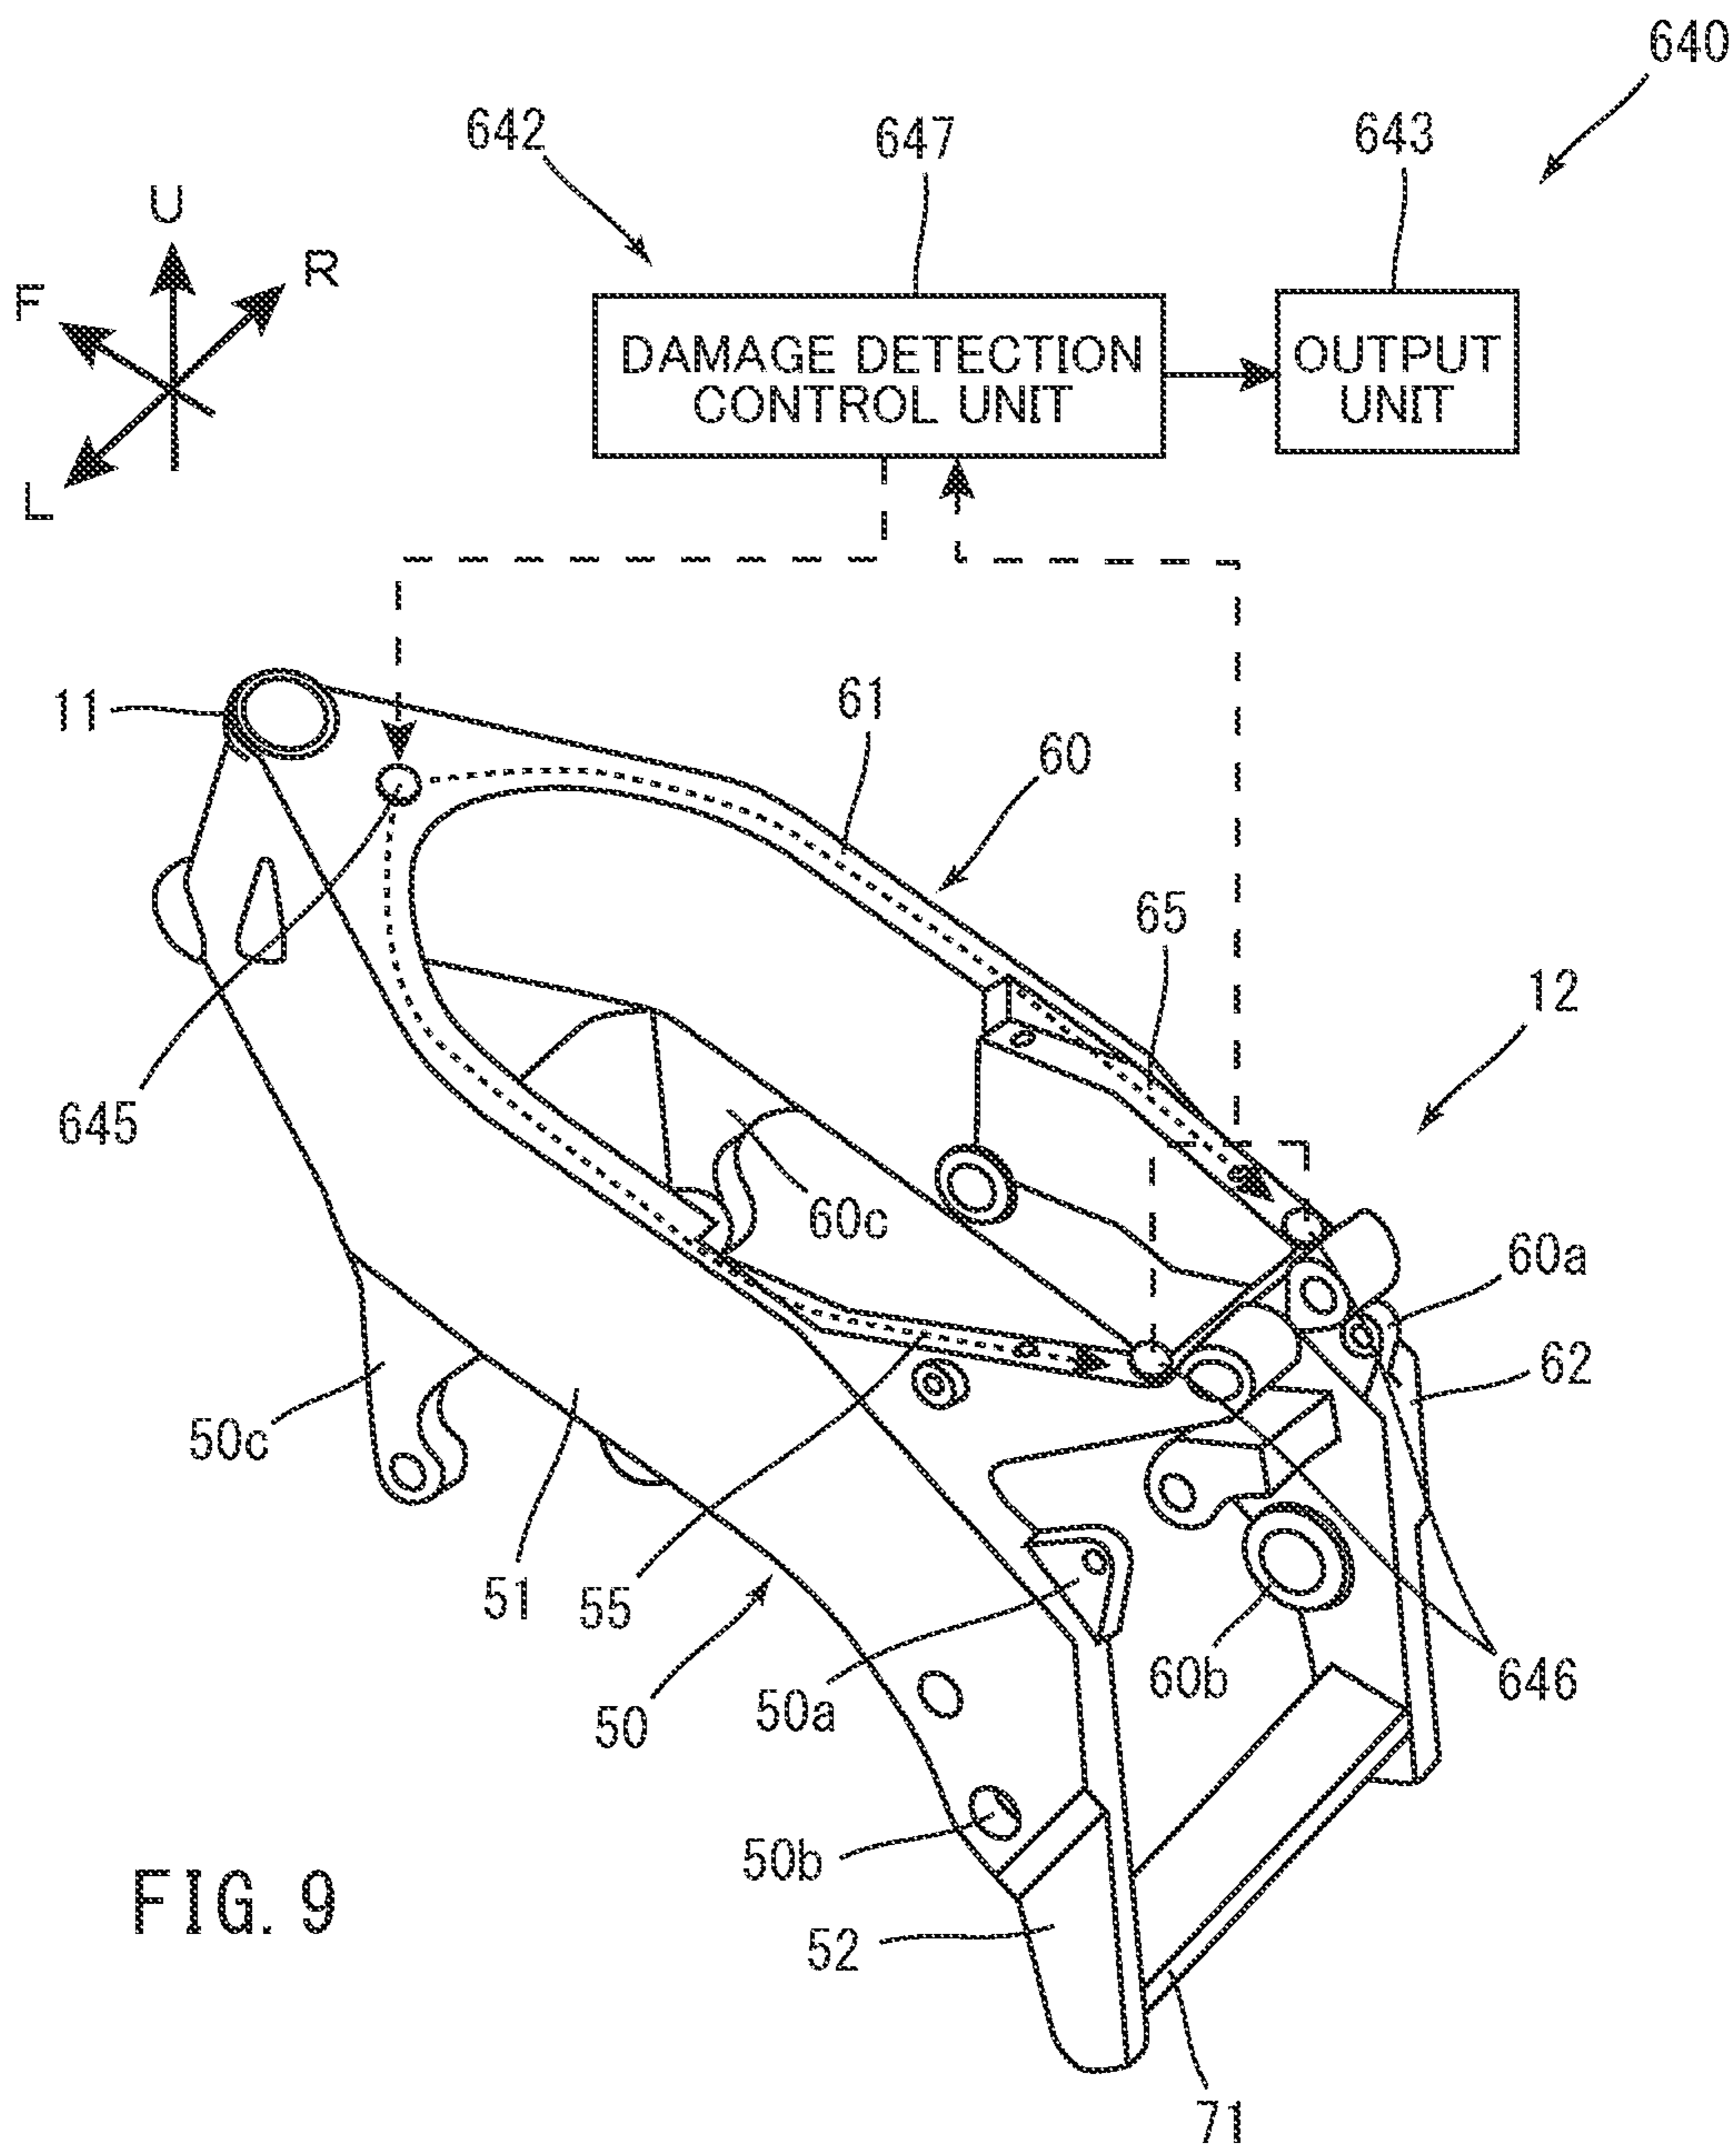
FIG. 9 illustrates an example arrangement of an ultrasonic wave transmission device and an ultrasonic wave detection device when a leaning frame structure damage notification unit according to the fifth embodiment detects damage in a main frame.

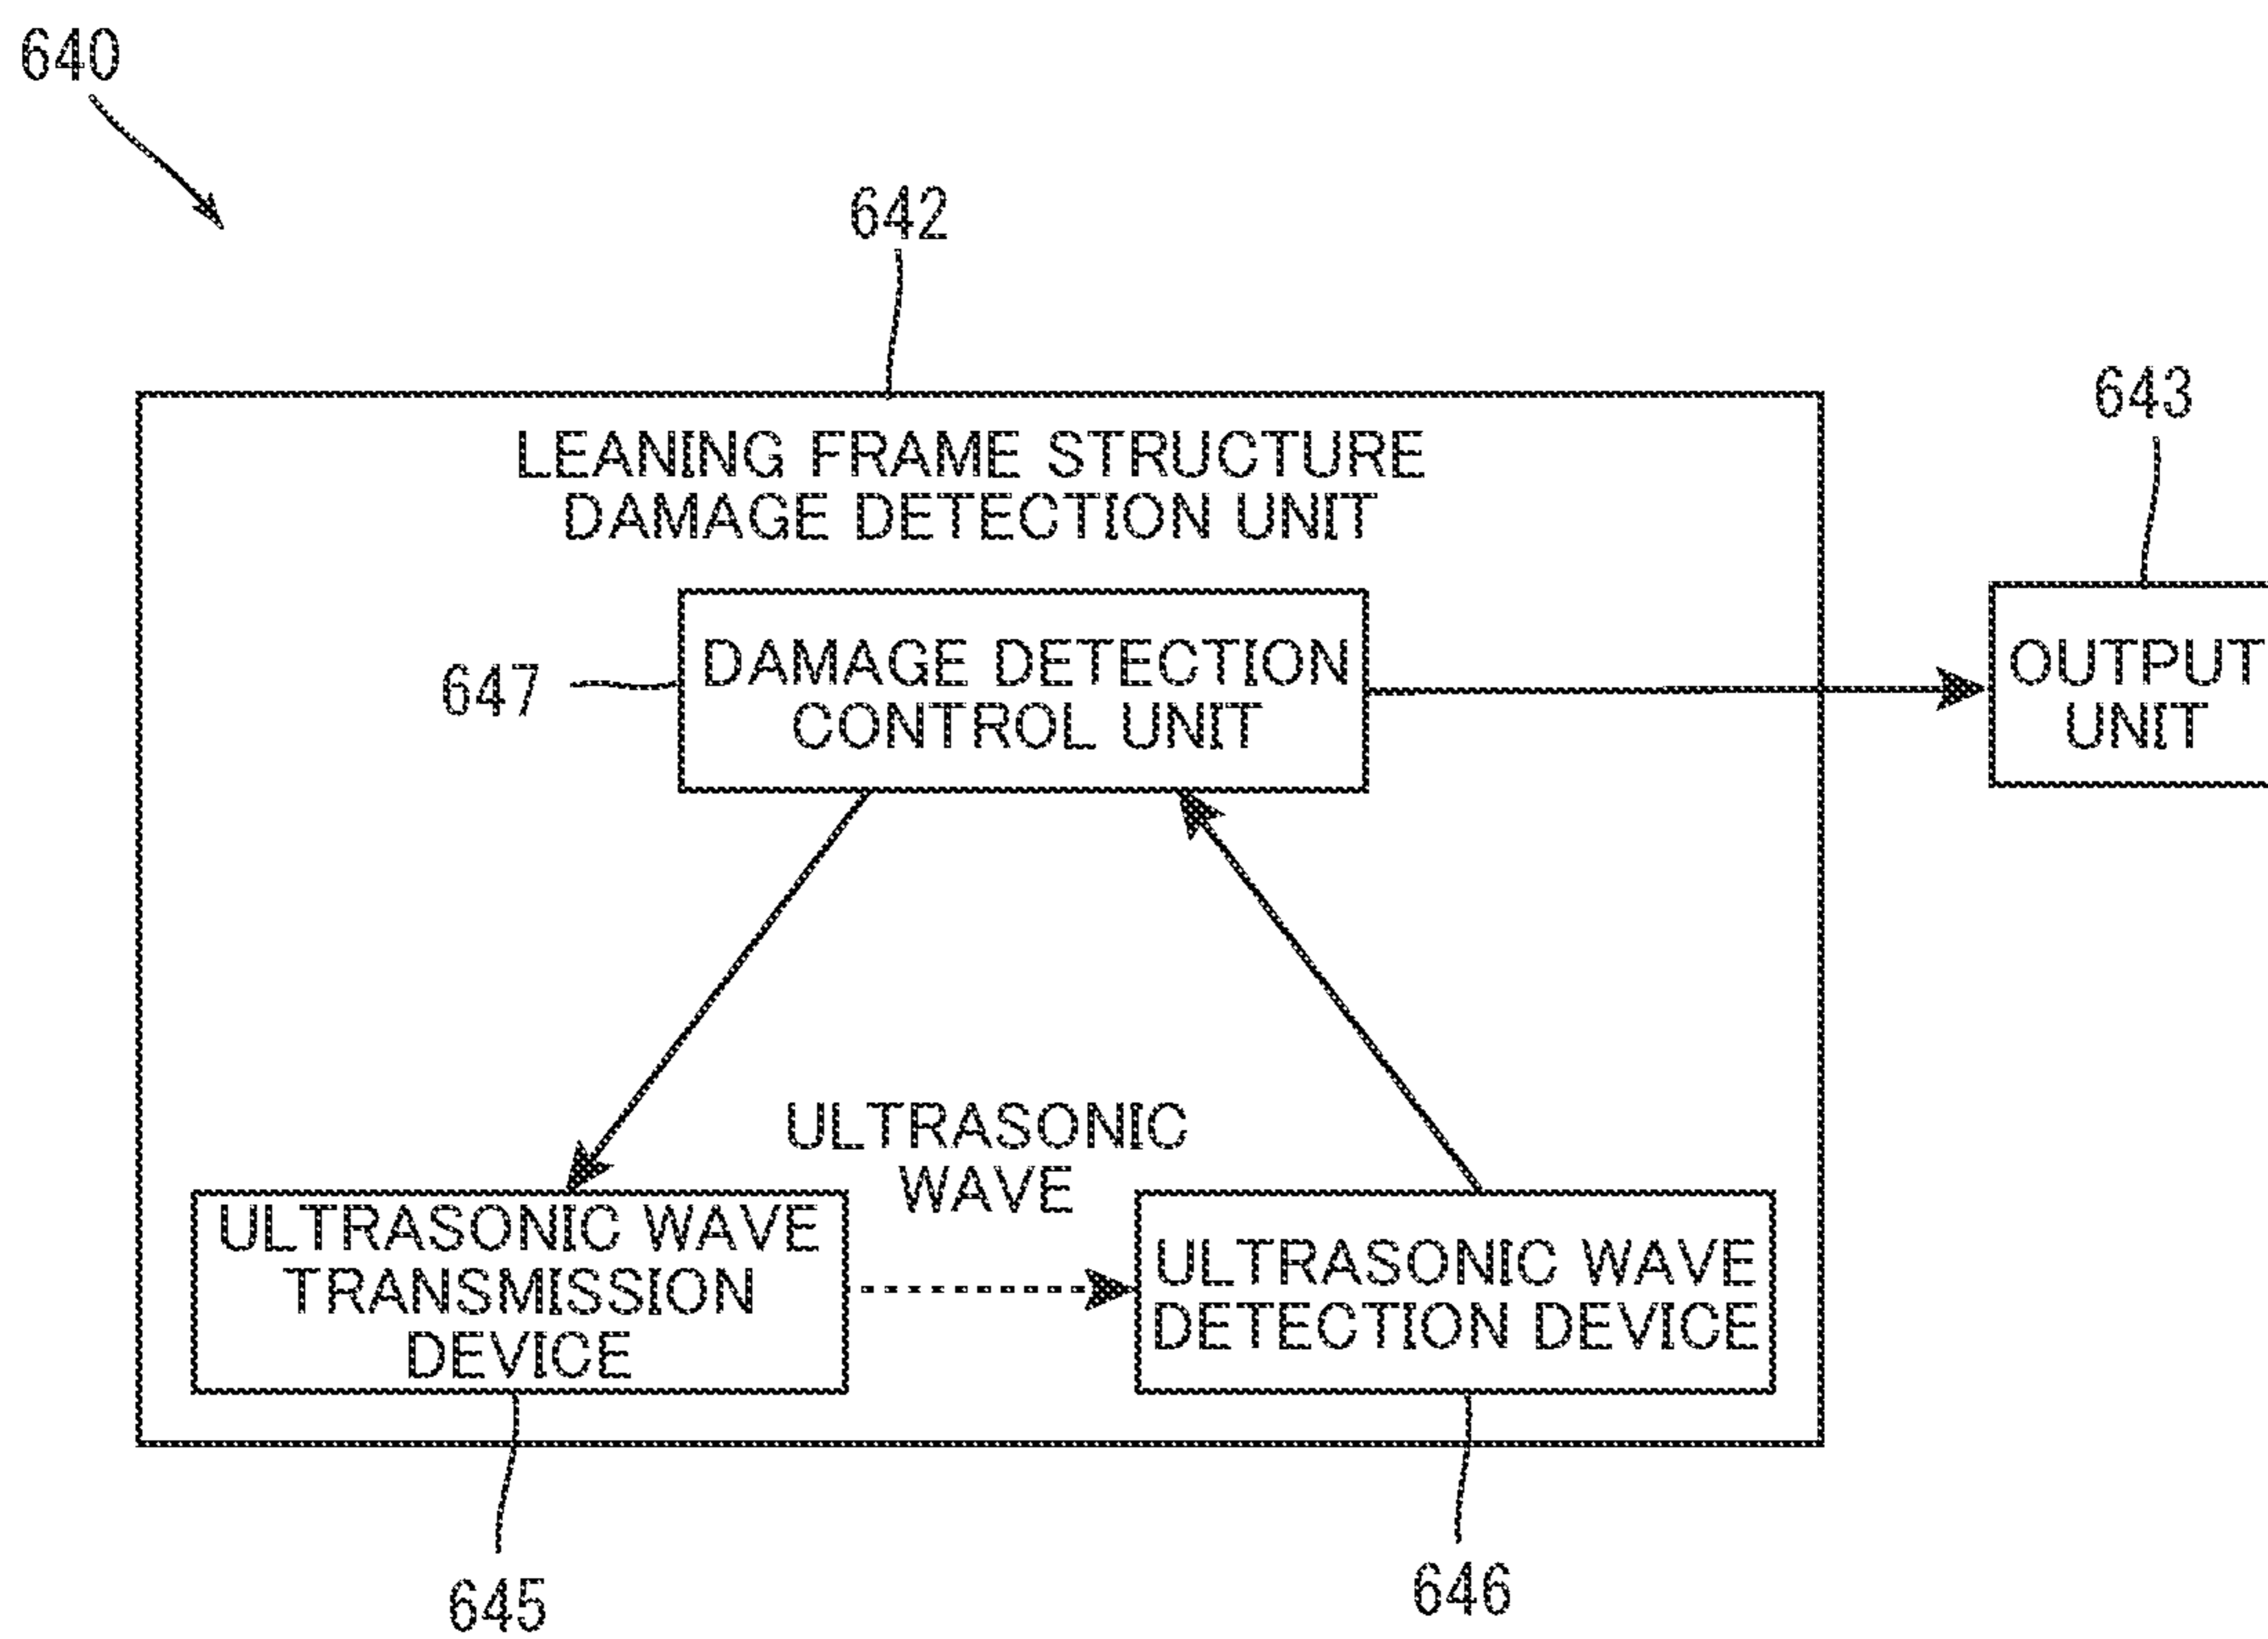
FIG. 10 is a functional block diagram showing a configuration of the leaning frame structure damage notification unit.

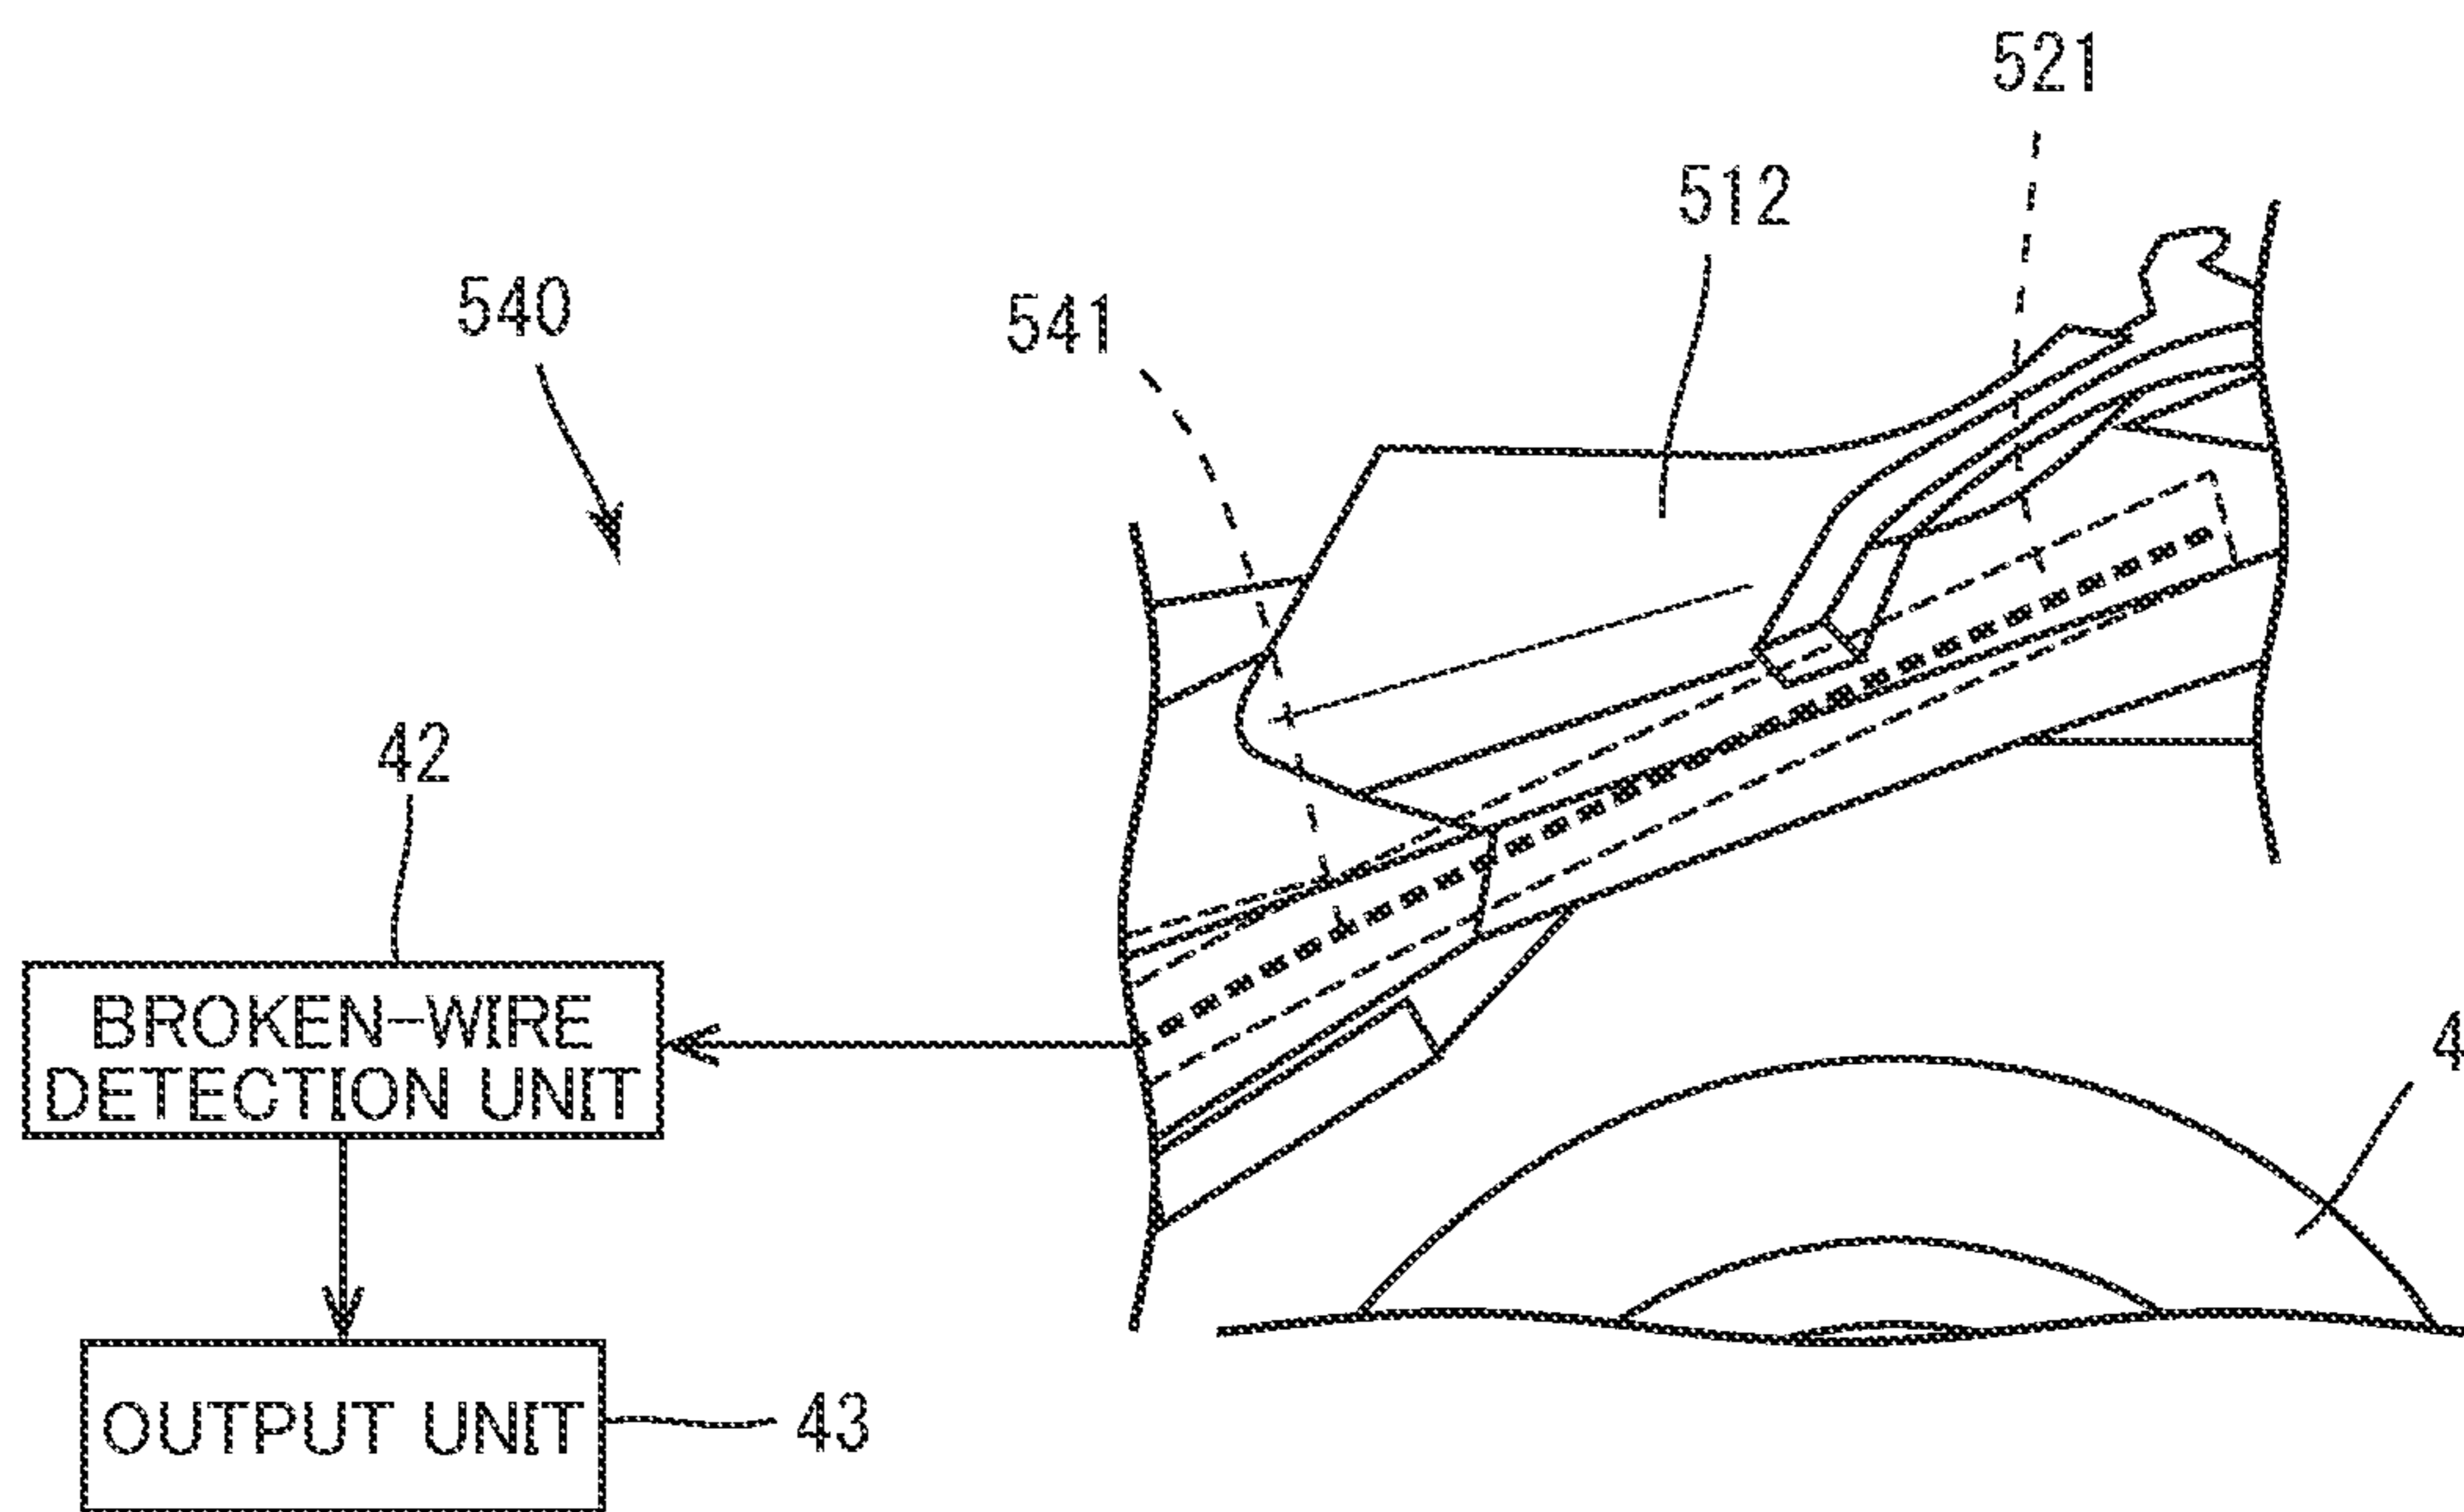
FIG. 17 schematically illustrates a configuration of a leaning frame structure damage notification unit of a vehicle according to the other embodiments.

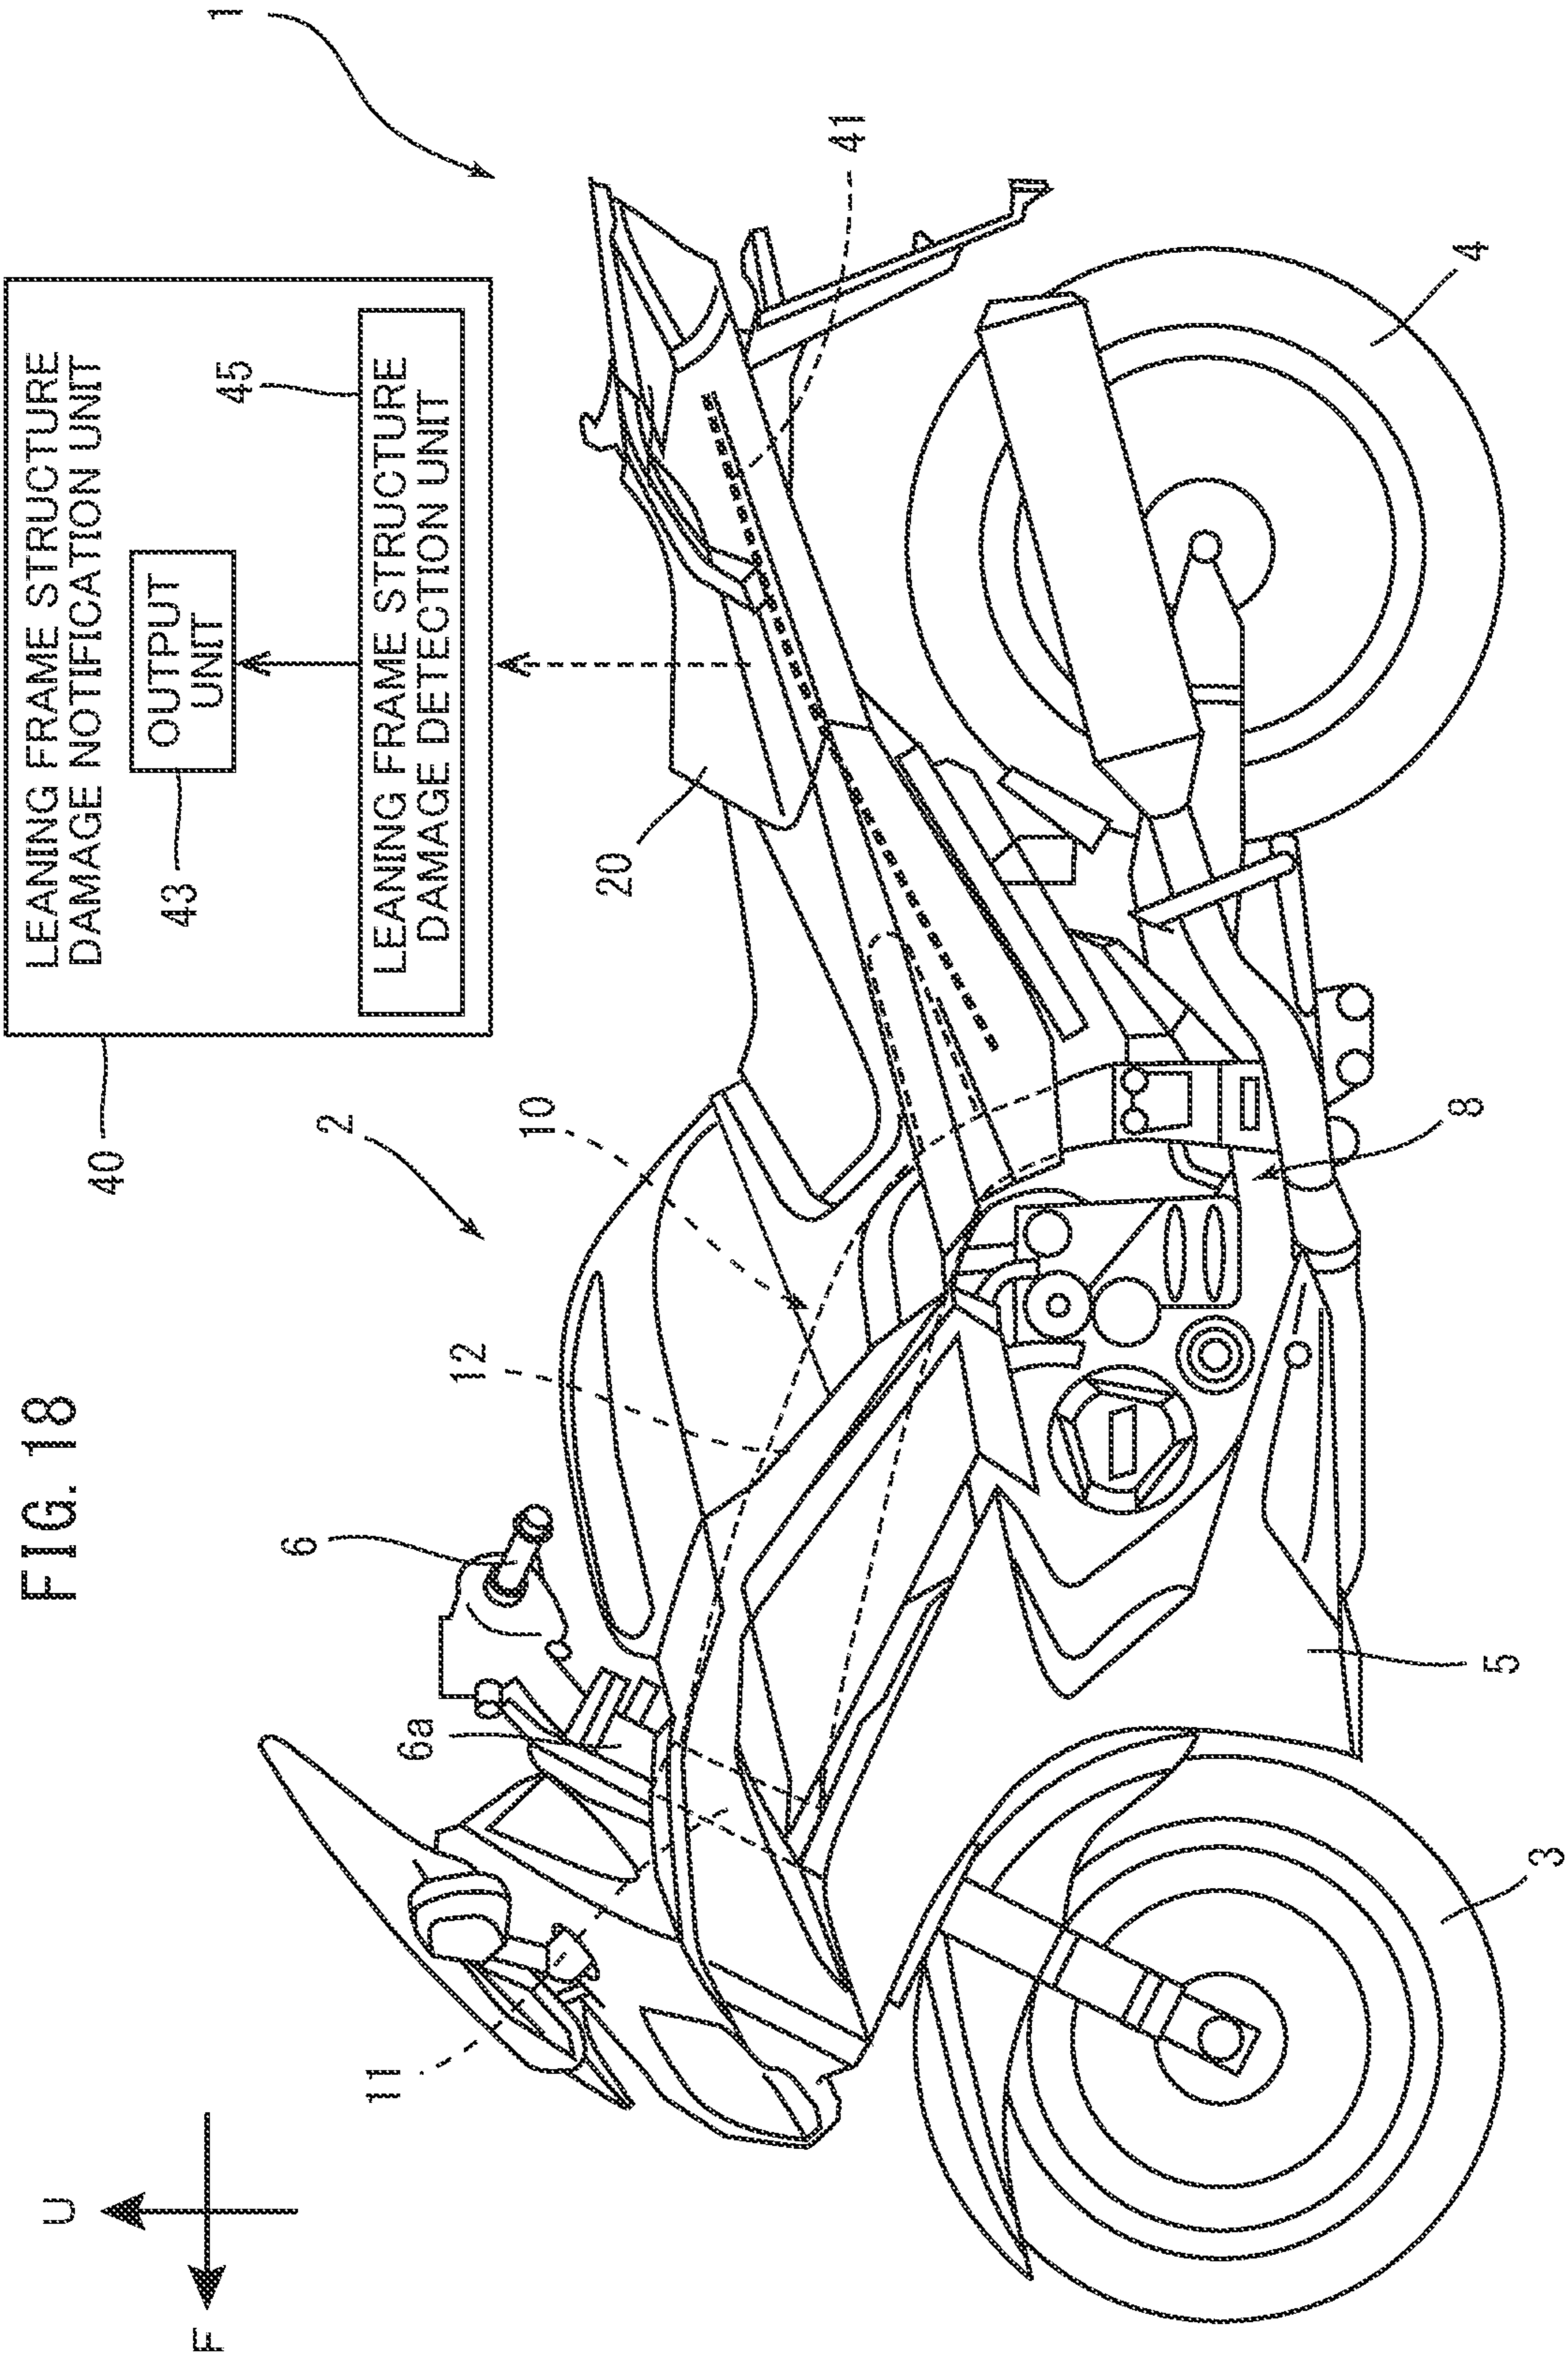
FIG. 18 schematically illustrates a configuration of a leaning frame structure damage notification unit and a vehicle.
