(10) **Patent No.:** **US 11,753,099 B2**
(45) **Date of Patent:** **Sep. 12, 2023**

(54) **LEANING VEHICLE**

(71) Applicant: **YAMAHA HATSUDOKI**
KABUSHIKI KAISHA, Iwata (JP)

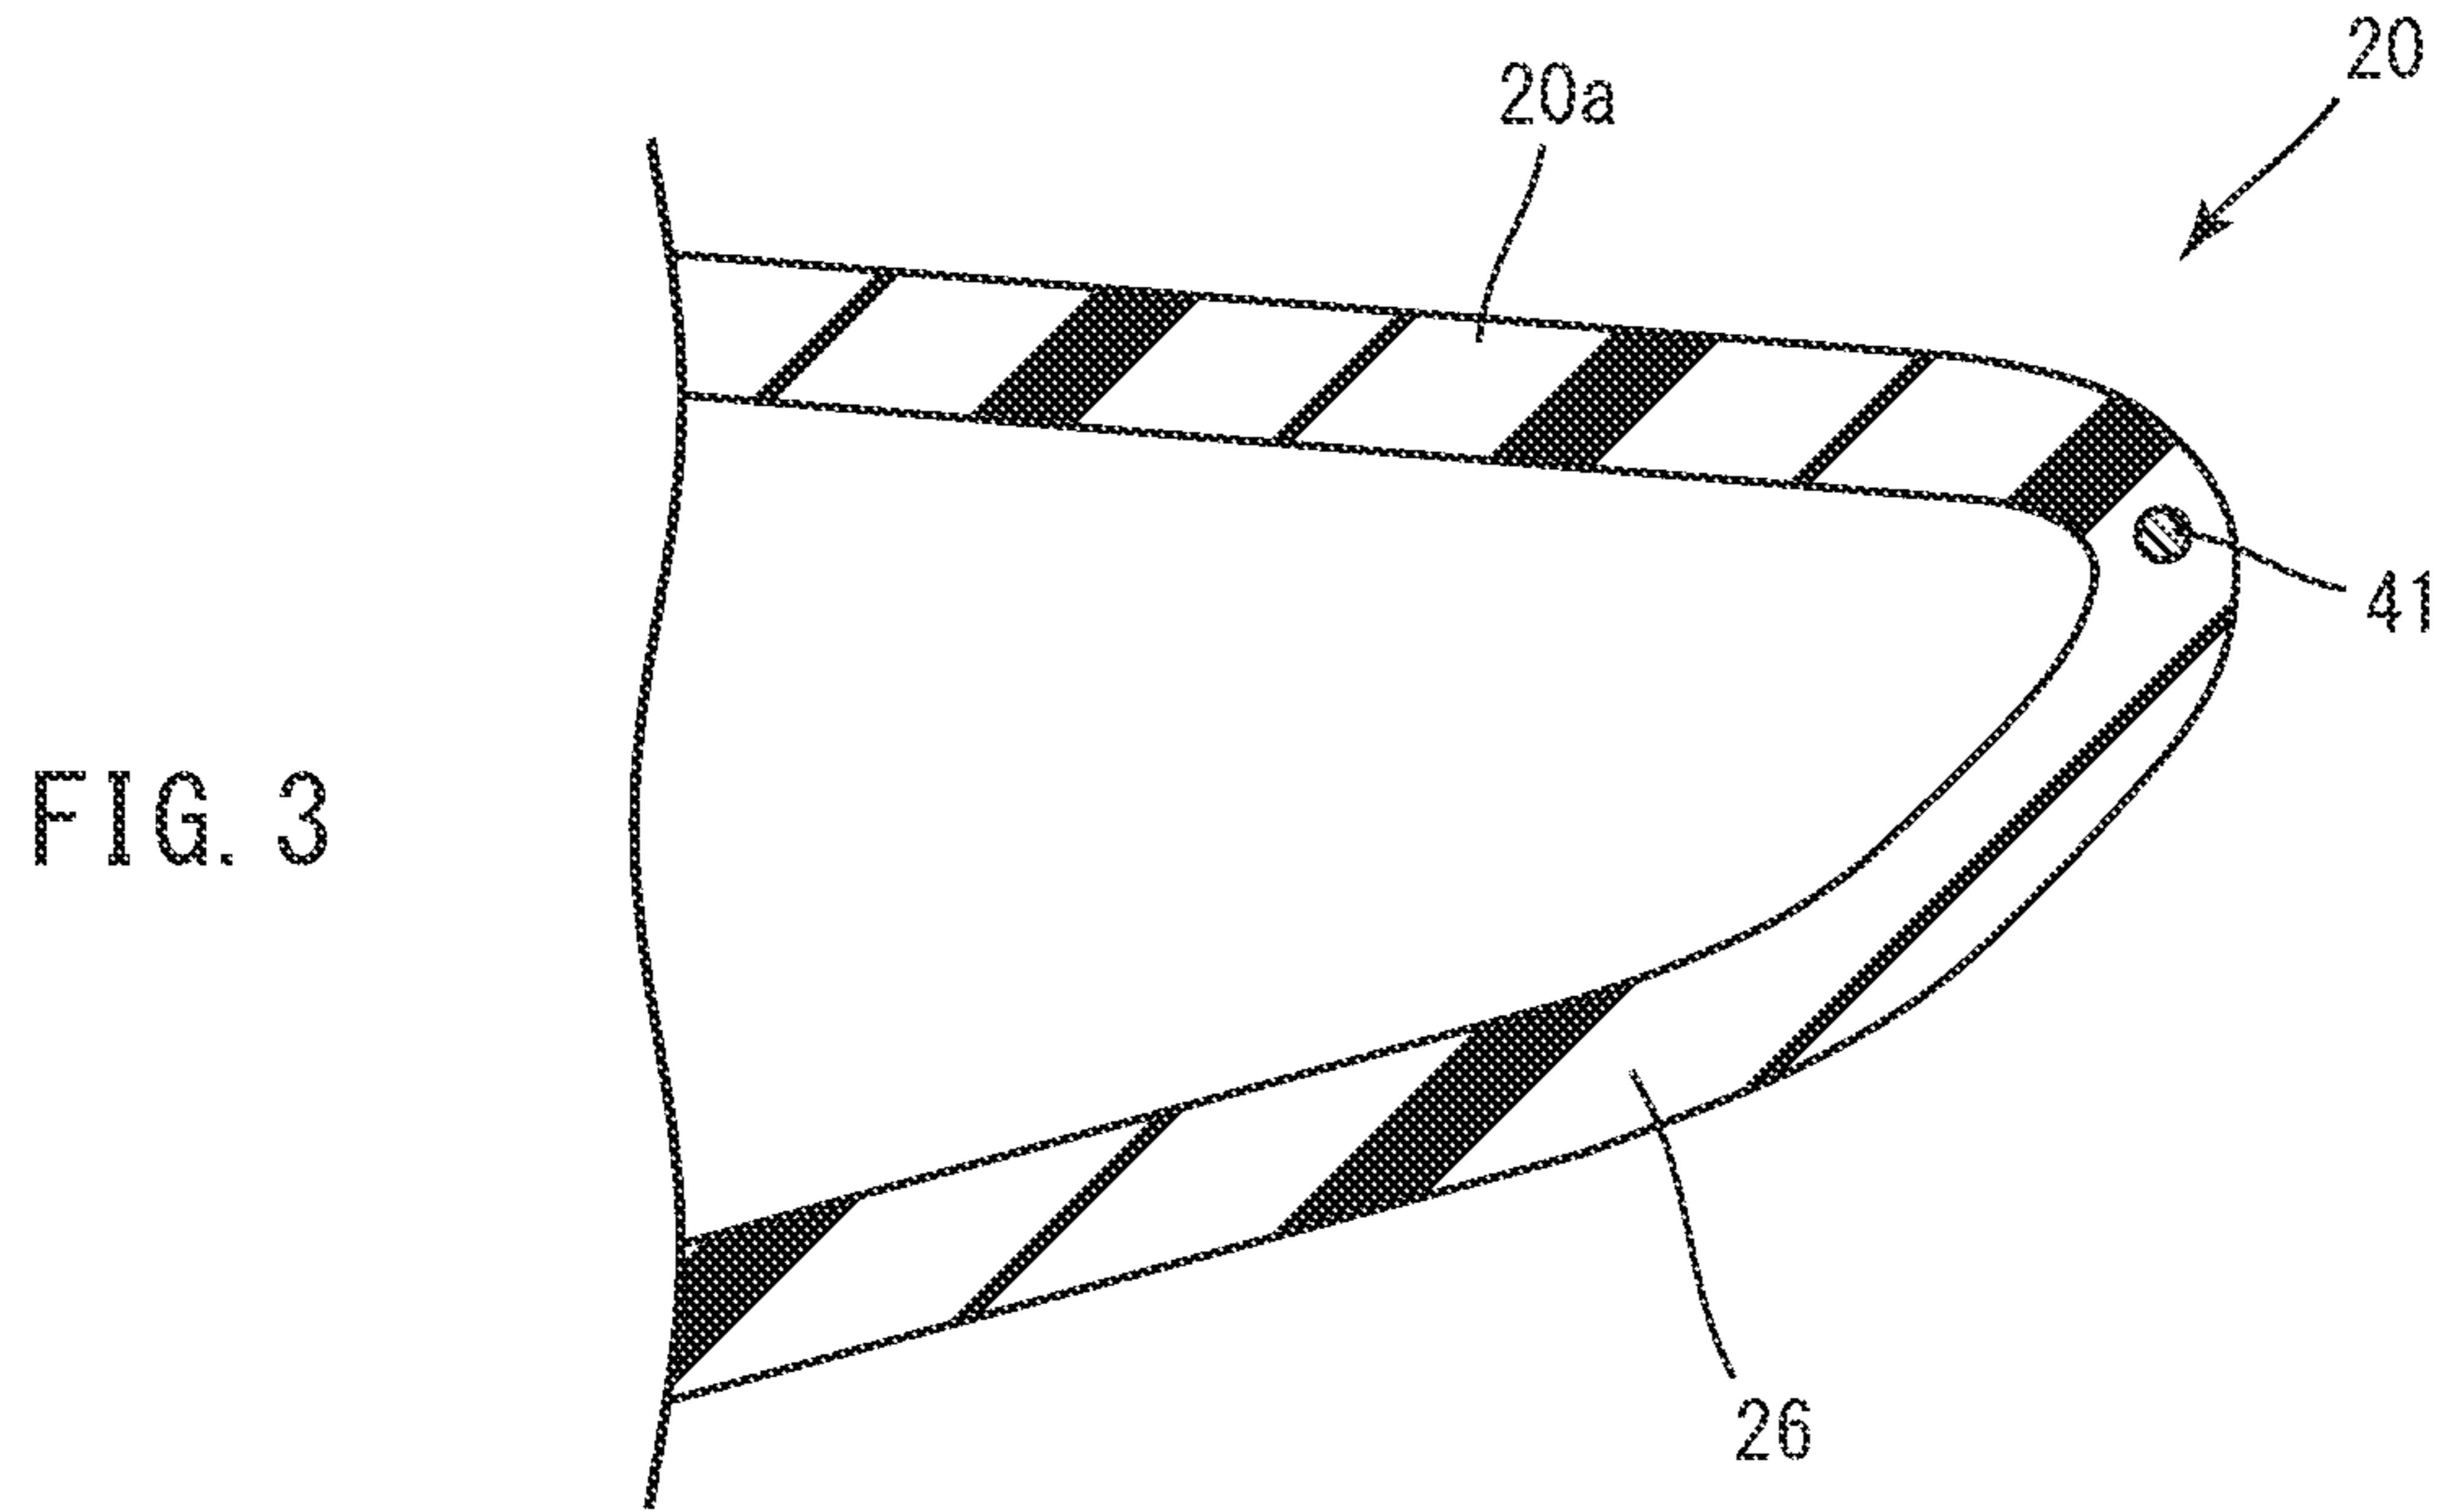
FIG. 4 schematically illustrates a configuration of a leaning frame structure damage notification unit.

In this embodiment, the vehicle **1** includes a leaning frame structure damage notification unit **40** that detects damage in an inner part of the rear structure **20**, and makes a notification of the damage. The leaning frame structure damage notification unit **40** includes a leaning frame structure damage detection unit **45** and an output unit **43**. The leaning frame structure damage detection unit **45** includes a detection wire **41** (state changing portion), a broken-wire detection unit **42** (leaning frame structure damage detection control unit), and detection terminals **41a**, **41b** located at the opposite ends of the detection wire **41**.

The leaning frame structure damage notification unit **40** detects a break in the detection wire **41** by allowing the broken-wire detection unit **42** of the leaning frame structure damage detection unit **45** to detect a signal between the detection terminals **41a** and **41b**, and notifies the rider or the like of the detection result through the output unit **43**. FIG. **5** is a functional block diagram of the leaning frame structure damage notification unit **40**. FIG. **18** illustrates a schematic configuration of the leaning frame structure damage notification unit **40** and the vehicle **1**.

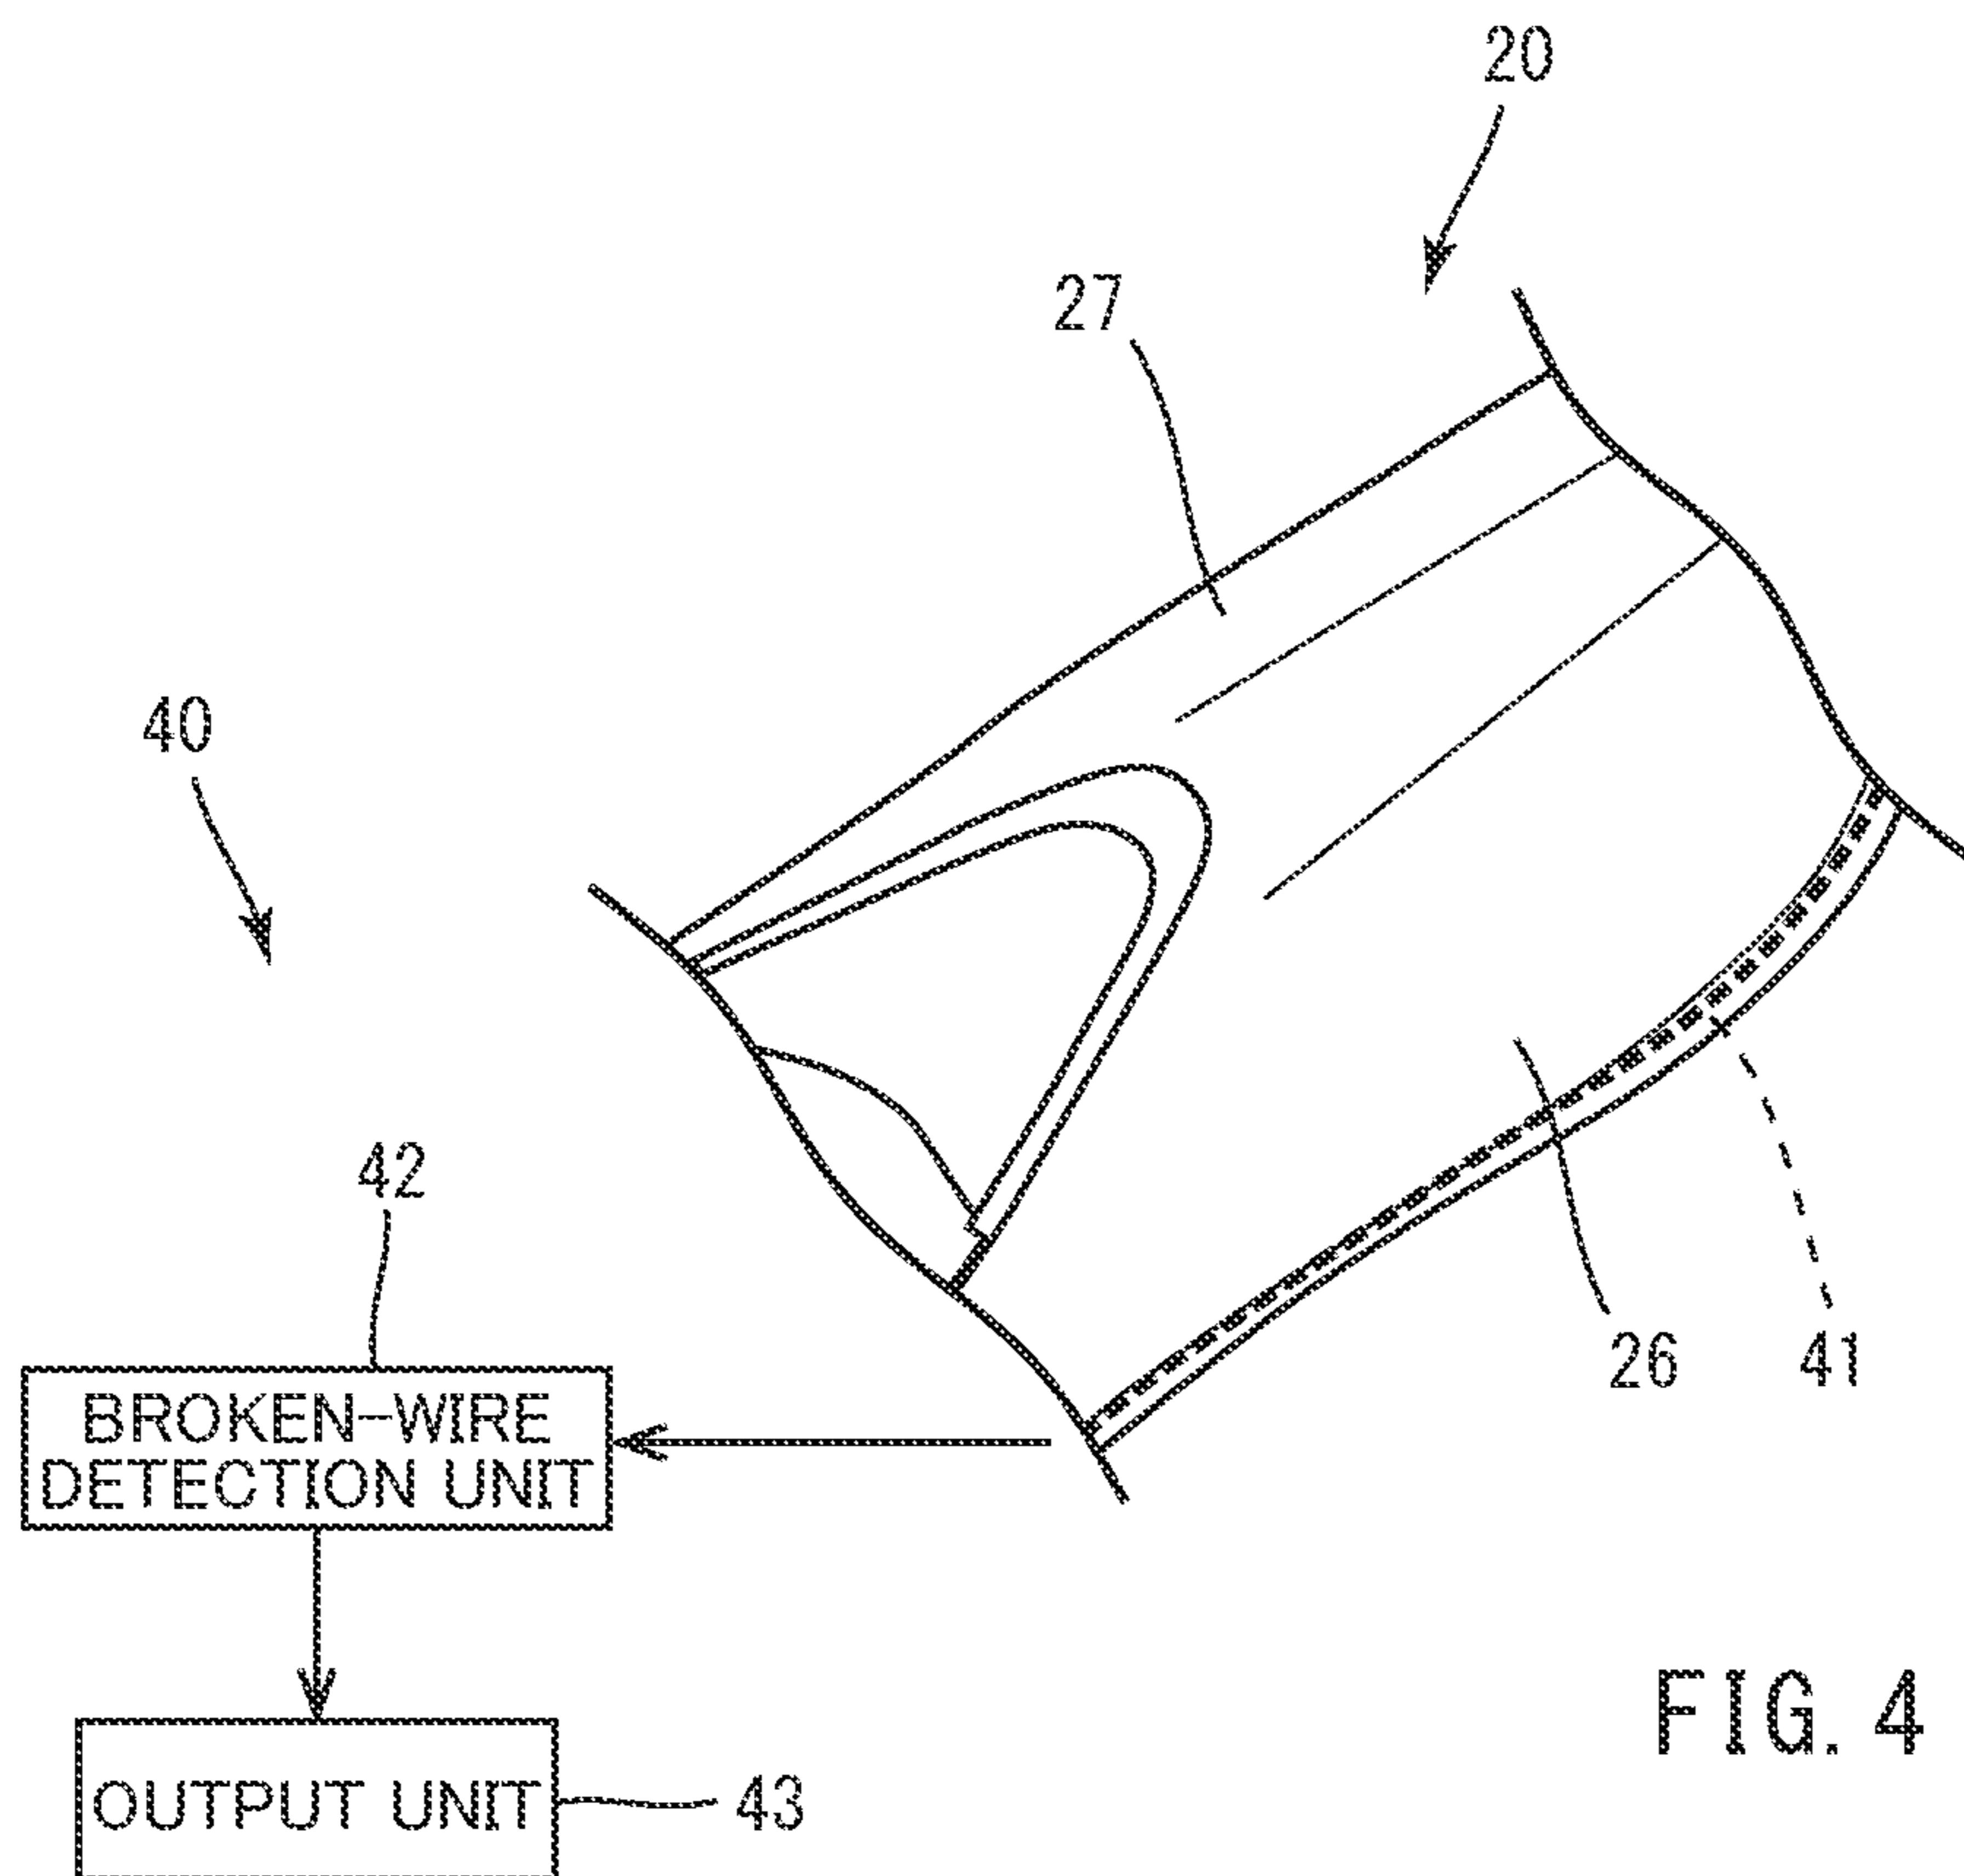
FIG. 5 is a functional block diagram showing the configuration of the leaning frame structure damage notification unit.

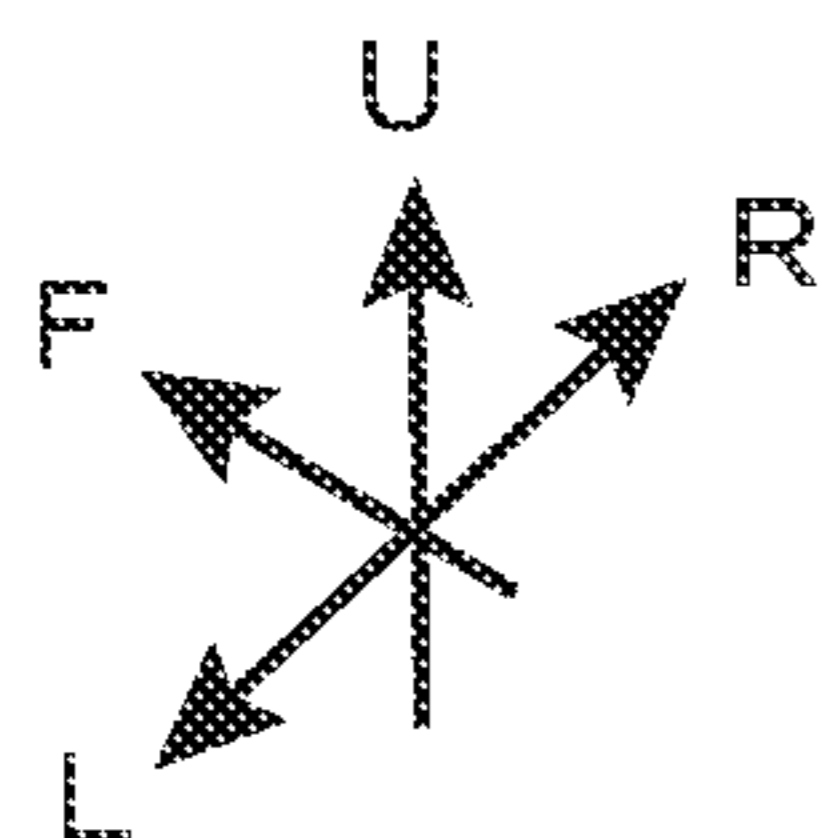
FIG. 11 illustrates another example arrangement of an ultrasonic wave transmission device and an ultrasonic wave detection device of a leaning frame structure damage notification unit according to a modification of the fifth embodiment, and is equivalent to FIG. 9.

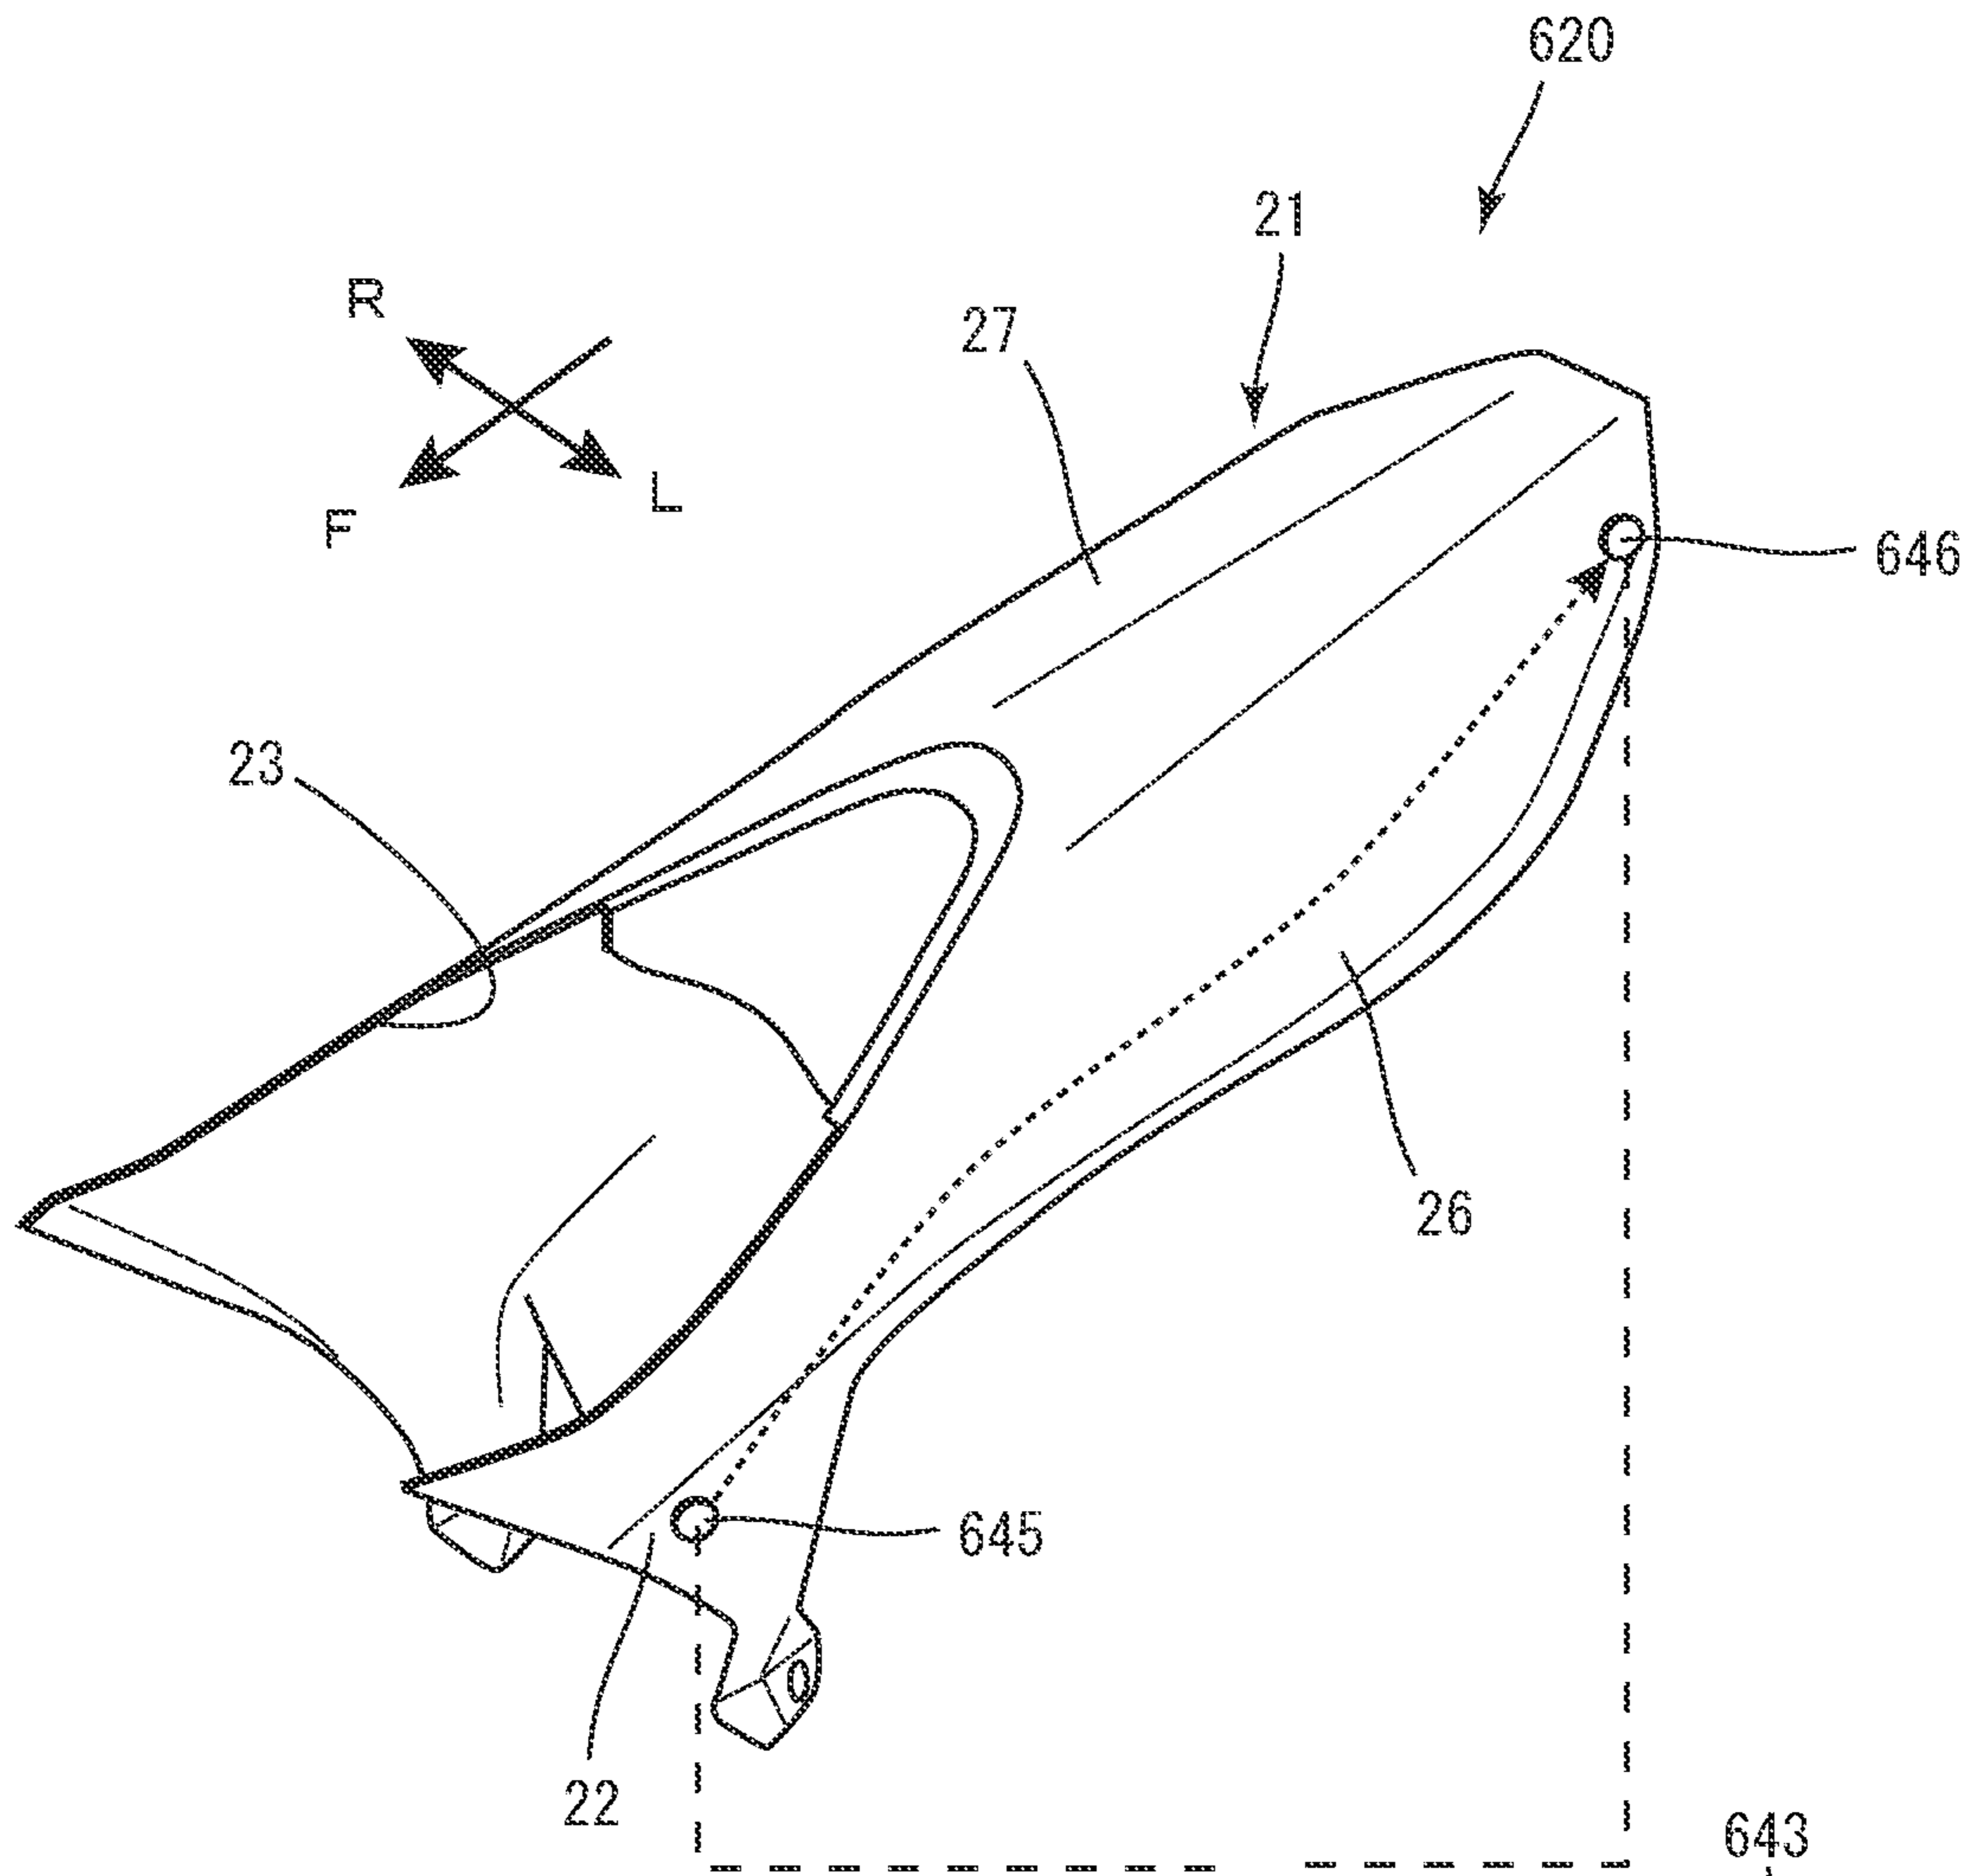
FIG. 14 illustrates another example arrangement of the ultrasonic wave transmission device and the ultrasonic wave detection device of a leaning frame structure damage notification unit according to a modification of the fifth embodiment.

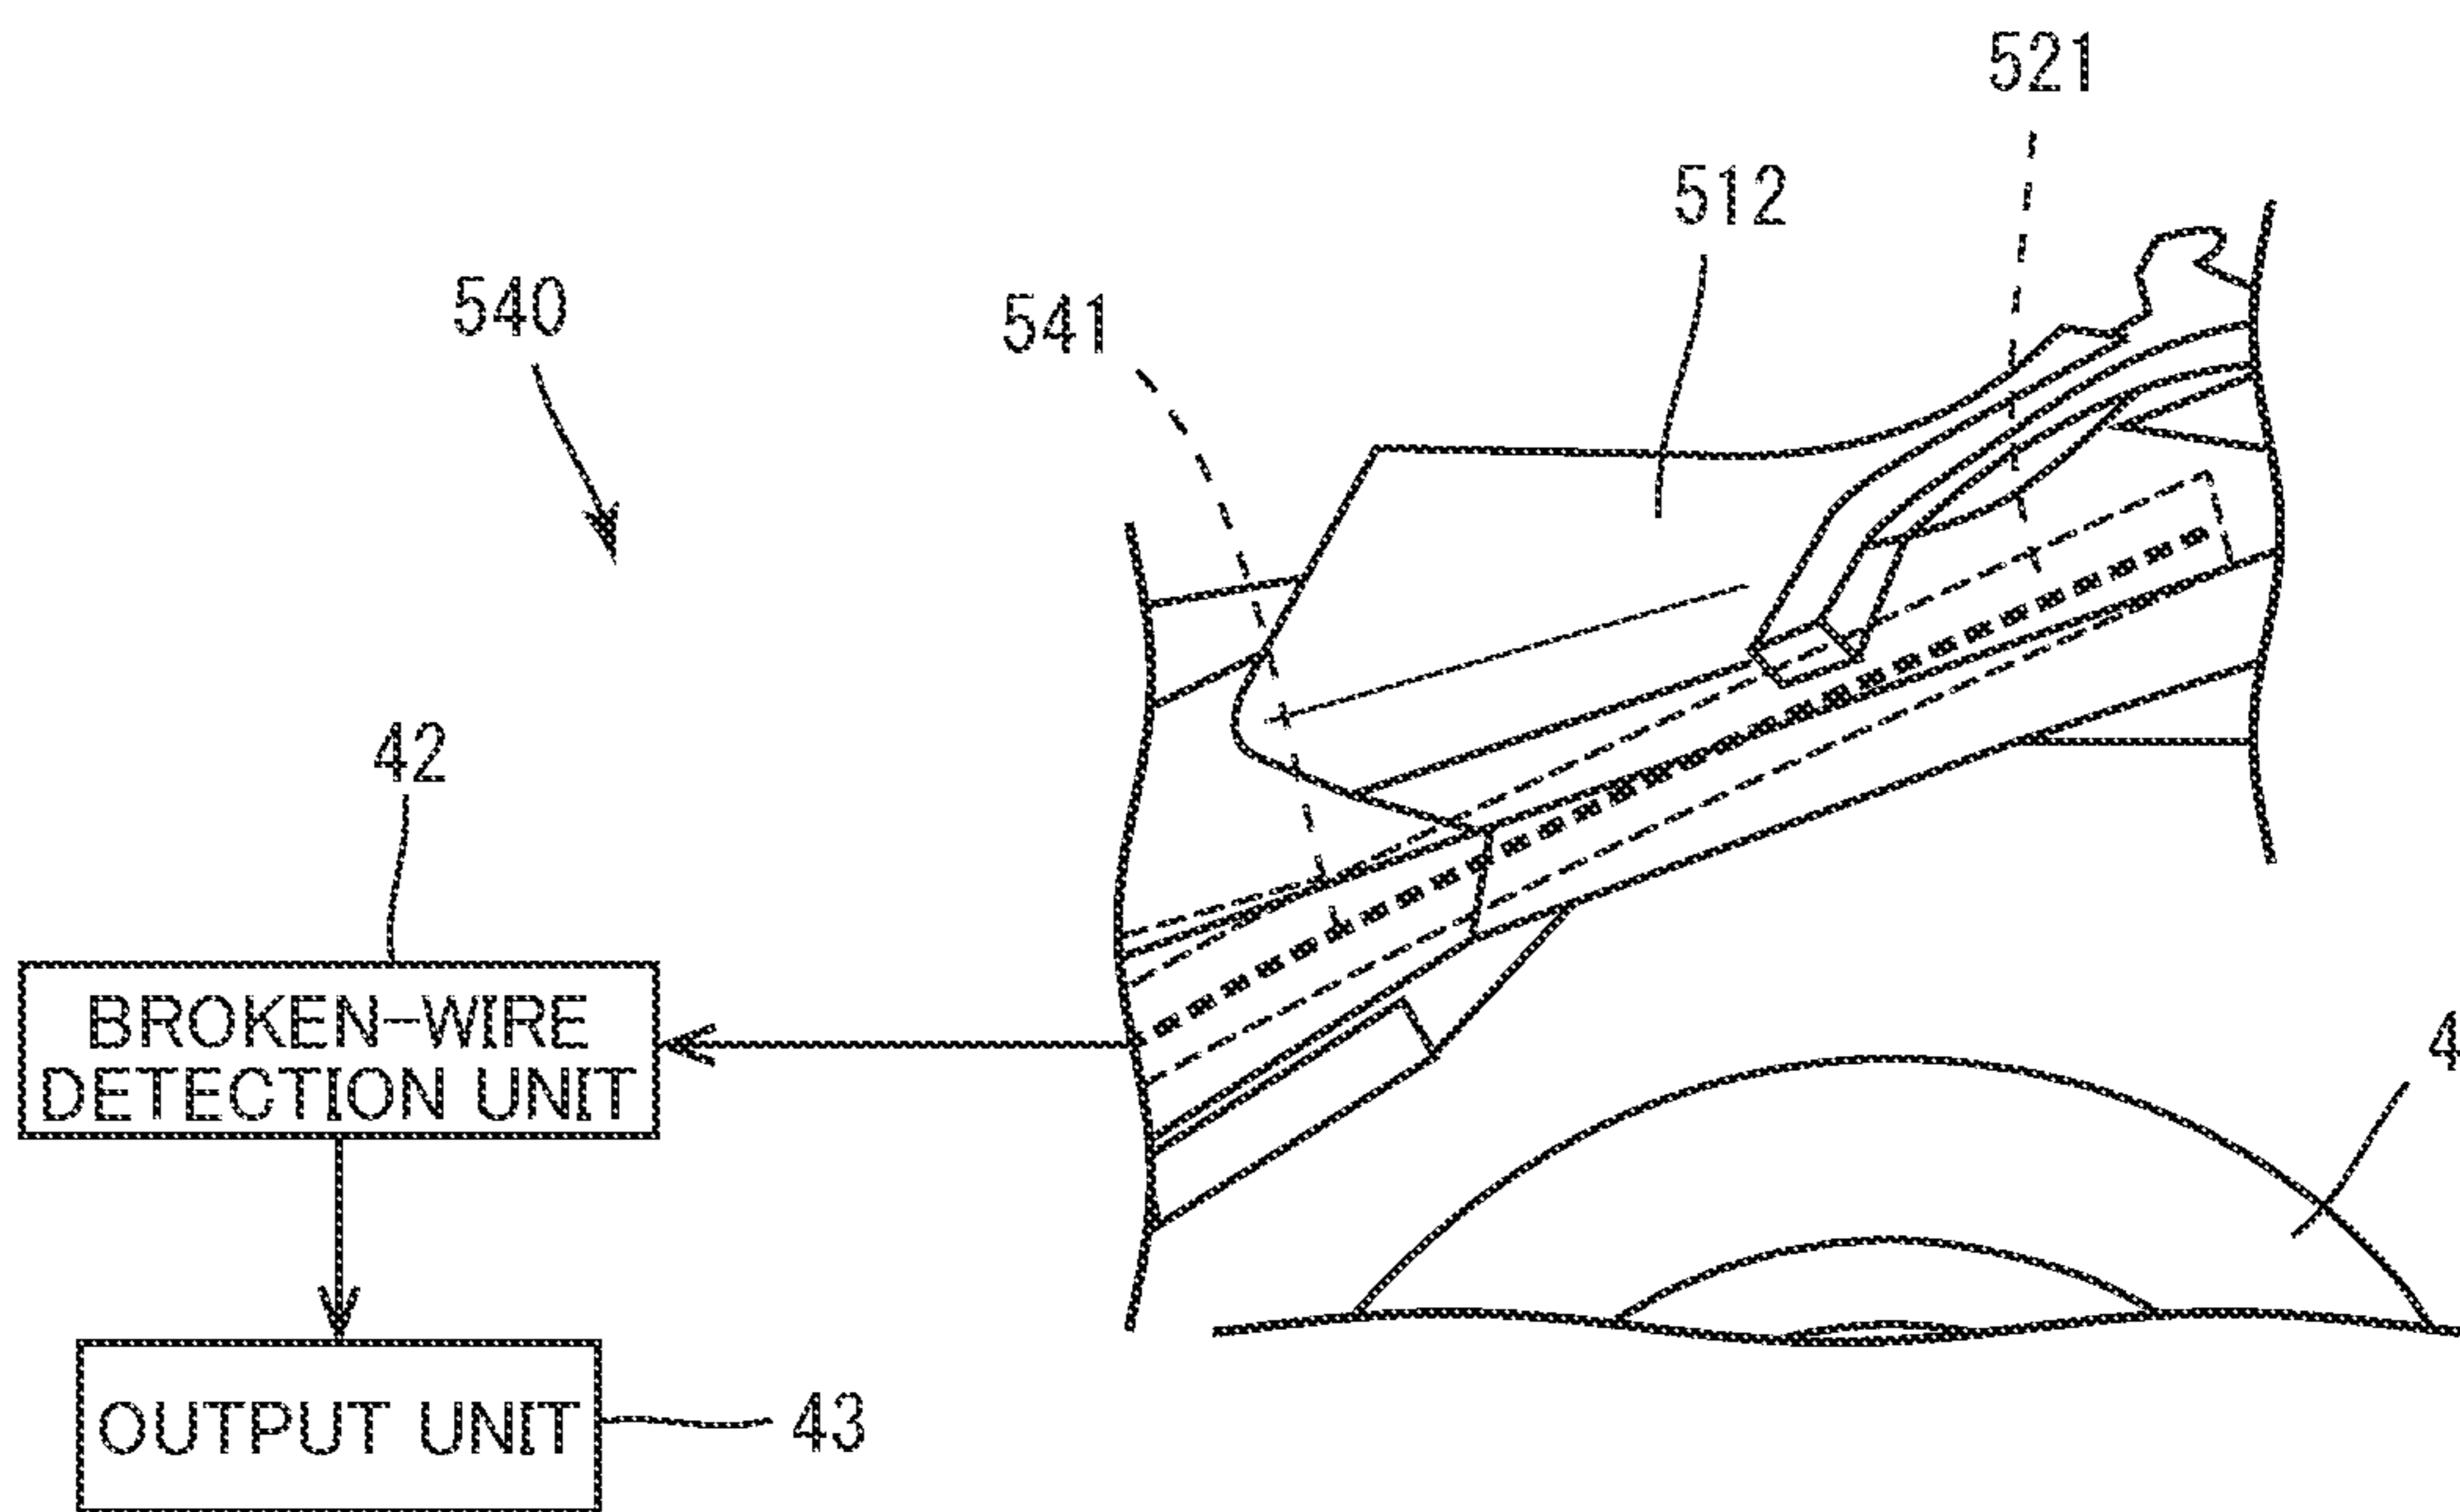
FIG. 17 schematically illustrates a configuration of a leaning frame structure damage notification unit of a vehicle according to the other embodiments.

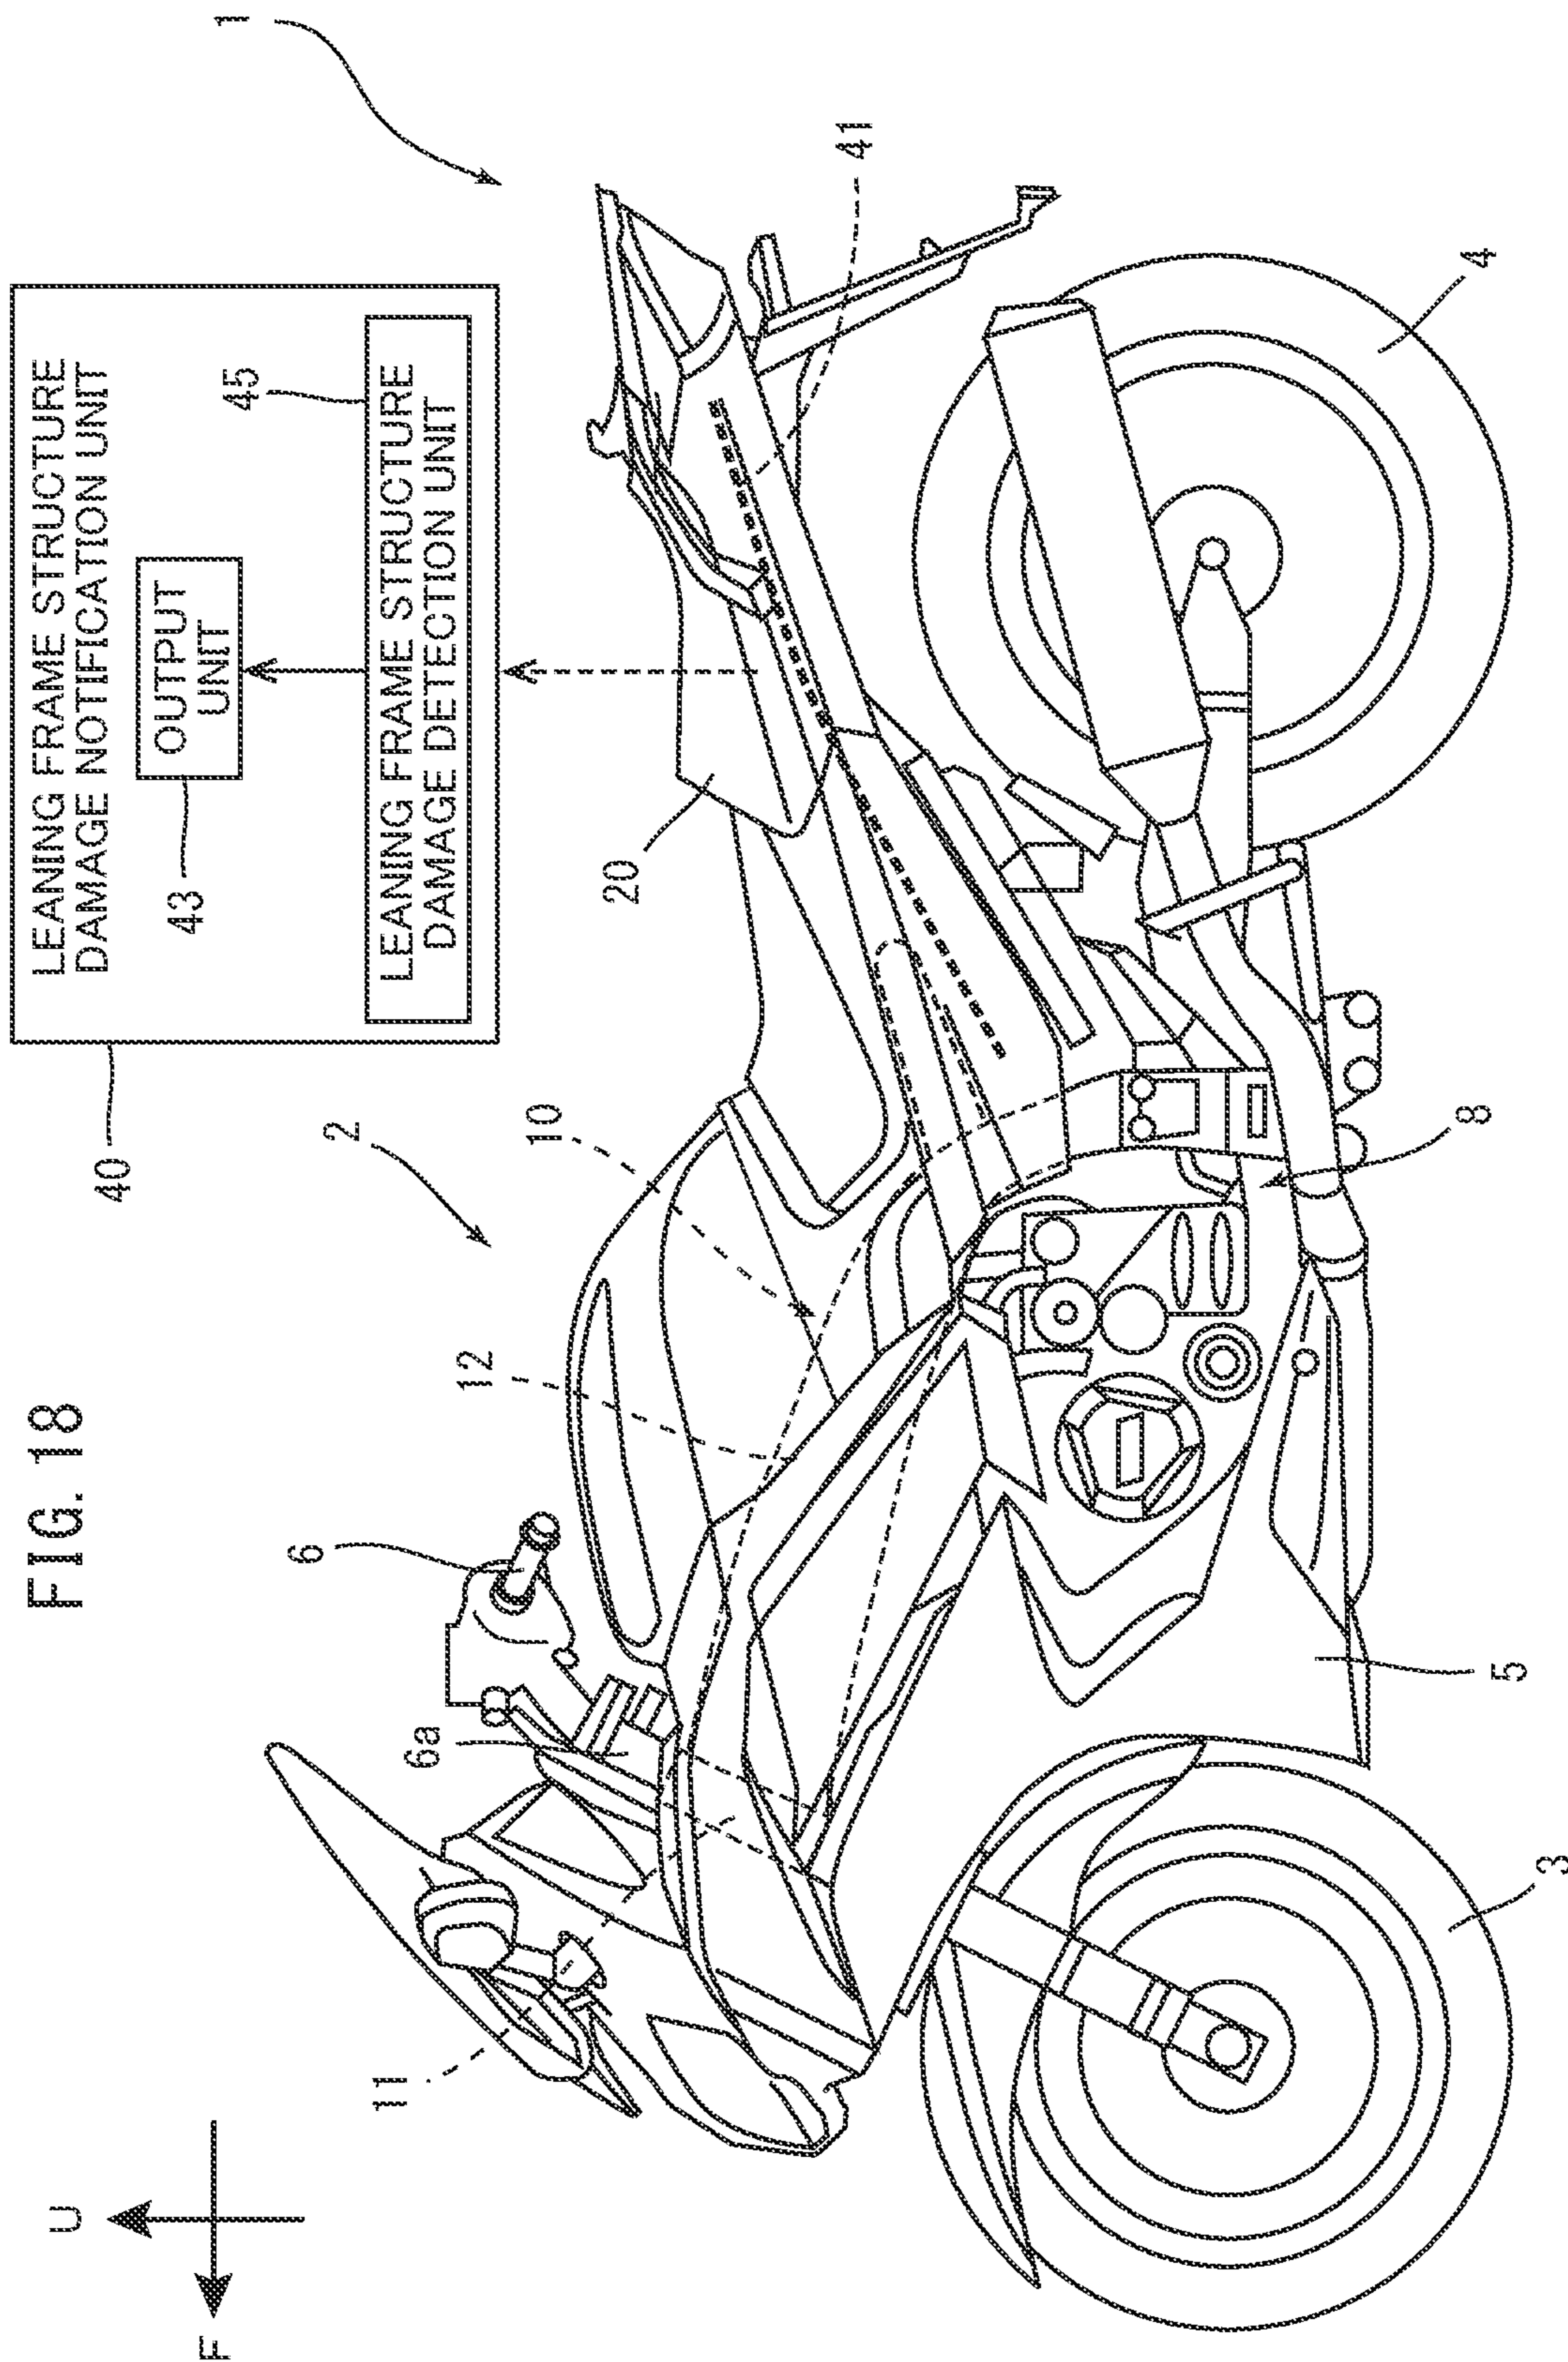
FIG. 18 schematically illustrates a configuration of a leaning frame structure damage notification unit and a vehicle.
