(10) **Patent No.:** **US 11,967,056 B2**
(45) **Date of Patent:** **Apr. 23, 2024**

(54) **SYSTEMS, METHODS AND APPARATUSES FOR DETECTING AND ANALYZING DEFECTS IN UNDERGROUND INFRASTRUCTURE SYSTEMS**

(71) Applicant: **INFRASTRUCTURE DL, LLC**,
Dousman, WI (US)

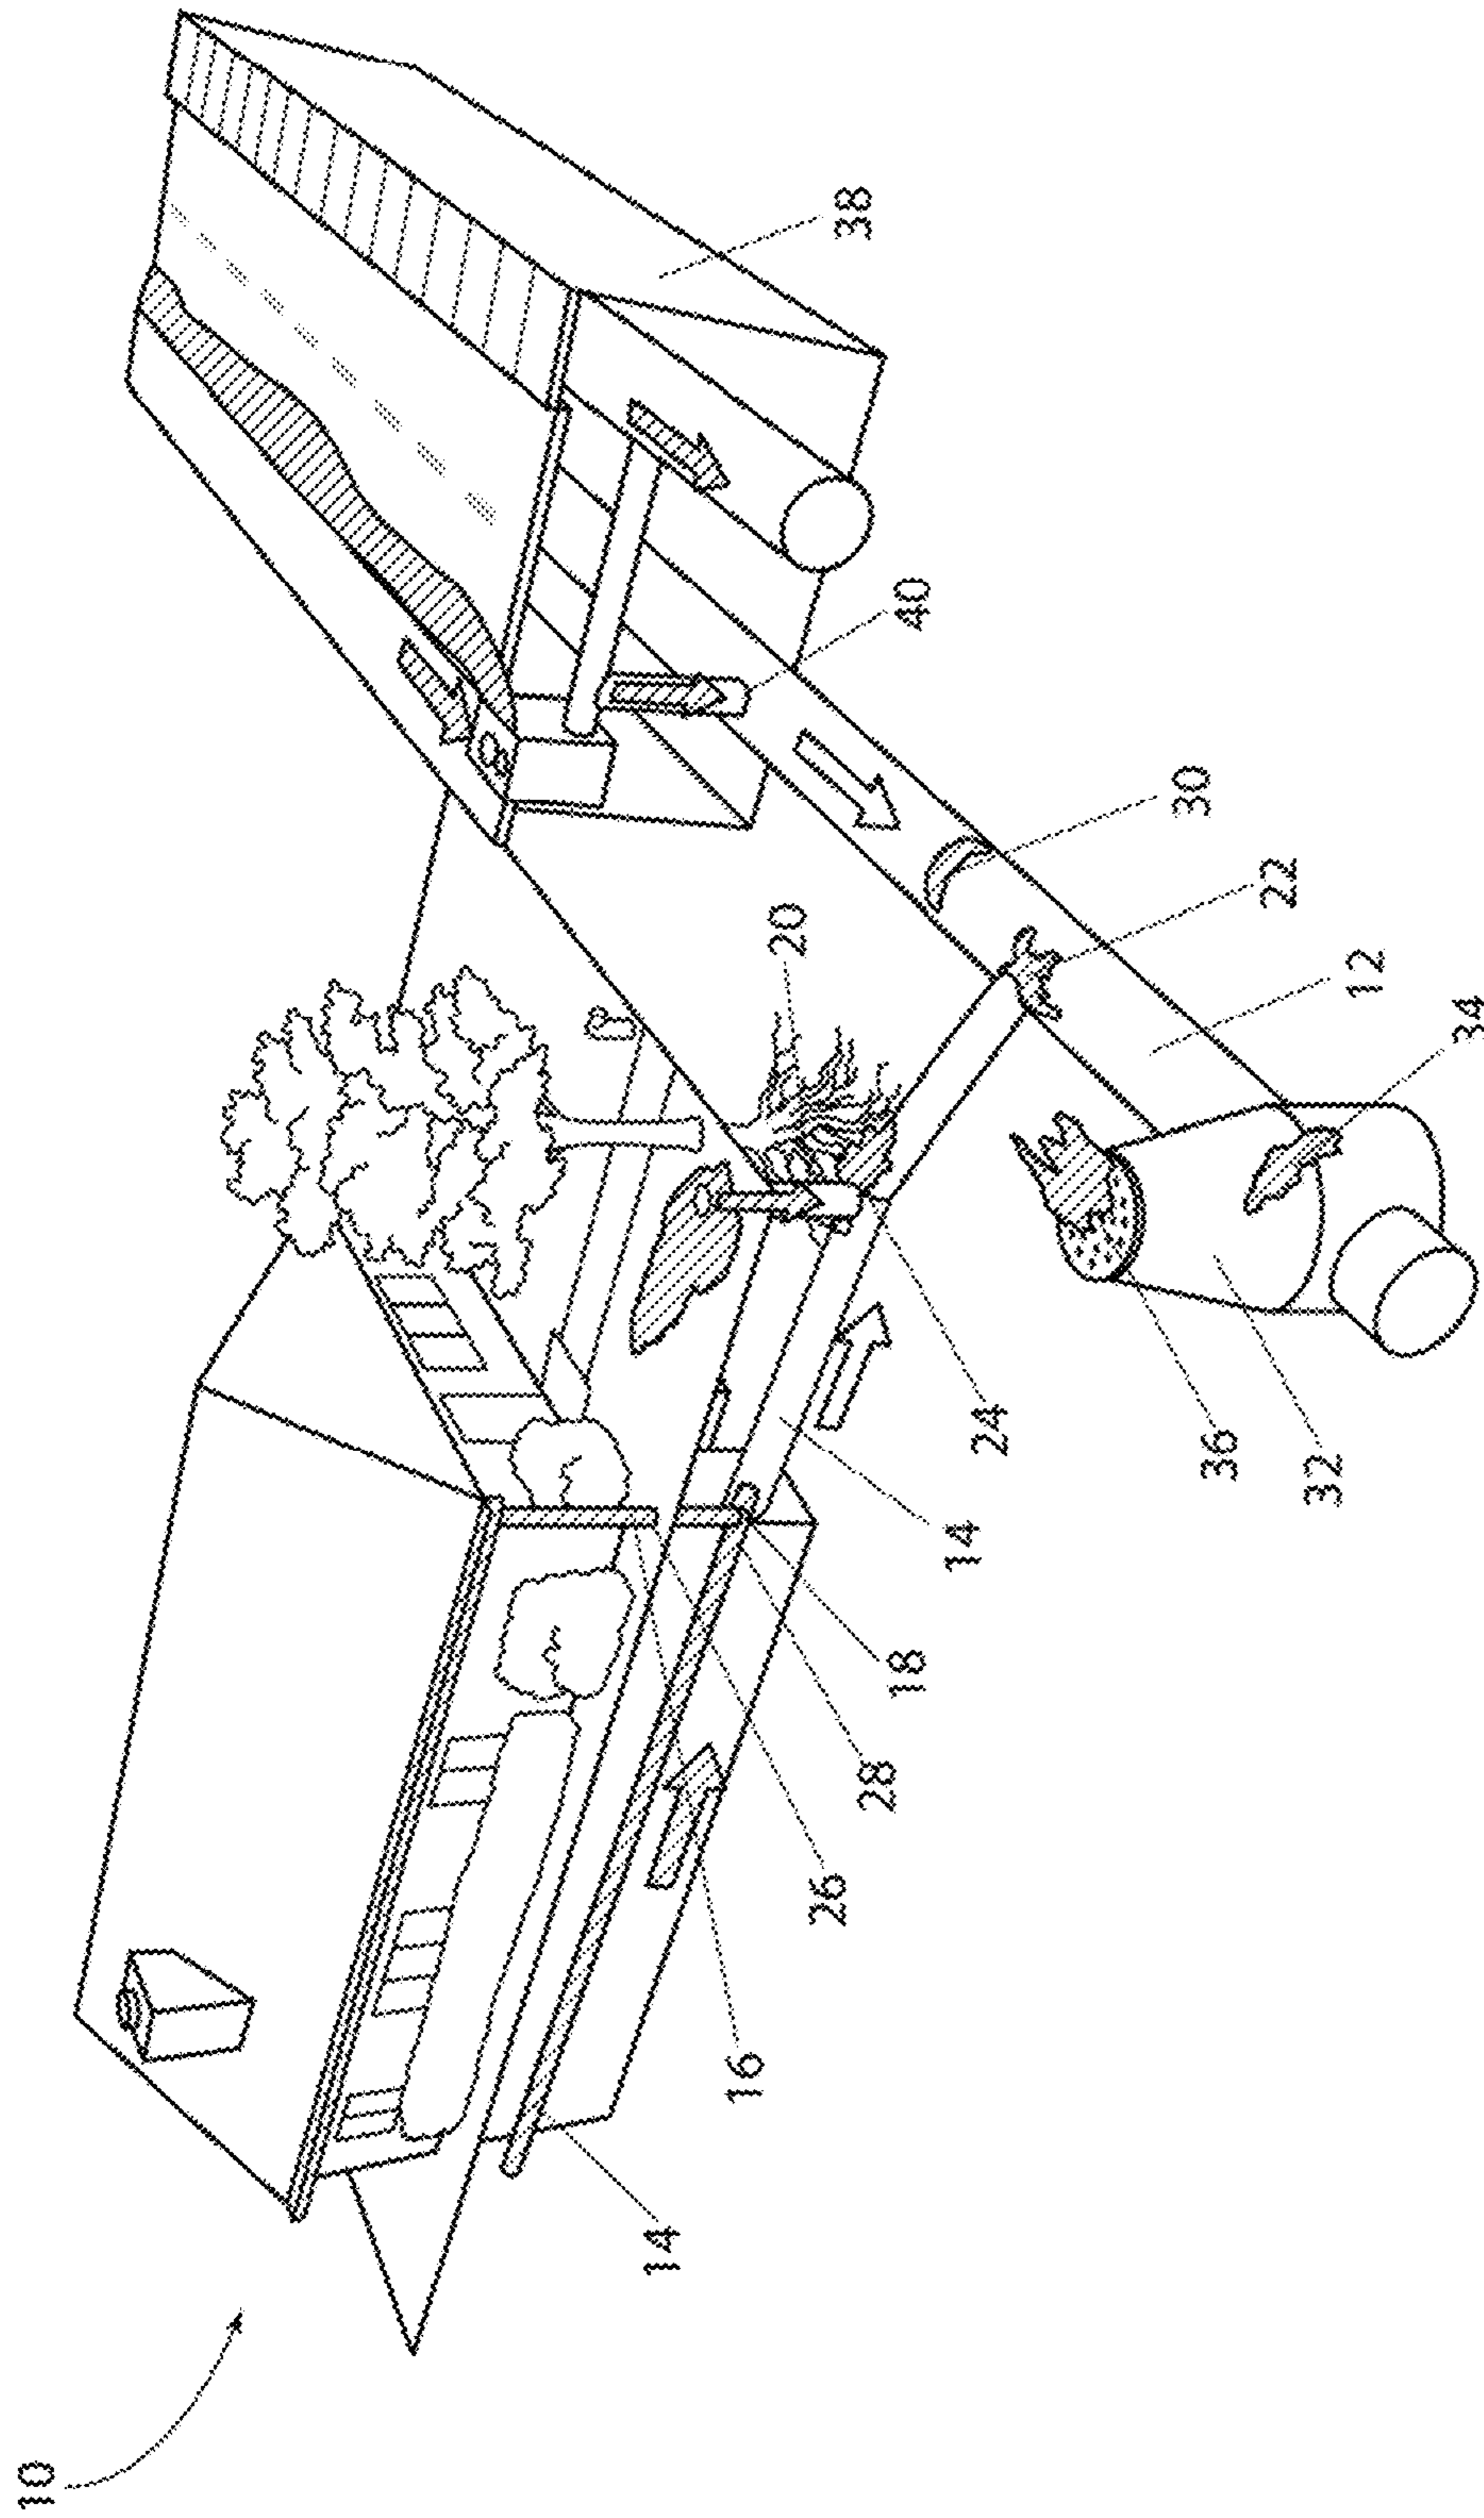
Fig. 1

FIG. 1 is a perspective view of a sewer system depicting various areas where faults or defects may occur in the sewer system.

FIG. 1 depicts a typical municipal sewer system 10 with various potential defects in the sewer system. The system generally comprises a sewer main 12, with one more laterals 14 connected to the sewer main 12. The laterals 14 are connected to individual drains or accesses in a typical sewer systems. For example, the lateral could be connected to a roof drain 16, a foundation drain 18, and/or a lateral cleanout 20. Each of these elements and connections may be the basis for a defect.

Joints can also separate where two sections of sewer pipe are connected to one another. These separated joints, cracks or broken pipes can be formed for varying reasons, such as tree roots encroaching on the sewer lines, soil settlement, utilities directional drilling or landscaping. For example, the connection 22 of the lateral 14 to the sewer, the connection 24 of the lateral 14 to the lateral cleanout 20, the connection 26 of the roof drain 16 to the lateral 14, or connection 28 of the foundation drain to the lateral 14 could all be sources of defects in the sewer main 12.

The defects can also include a crack 30 in a pipe, e.g. in the sewer main 12. In addition to such defects, defects can also occur when there are defective manholes 32, such as a deteriorated manhole 34 or a faulty manhole cover 36, which have similar and varying defects in vertical sewer structures that are connected to the horizontal sewer system.

Defects also often times occur at the junction where a storm sewer 38 connects 40 to the sewer main. Many times the defects are not readily apparent and are more noticeable when there is a large flow of water. For example, during a storm, the flow from several laterals 14 in a municipality may overwhelm the sewer main 12, which may reveal defects that would otherwise not be detectable during normal operating parameters. In each of these situations, it is advantageous to not only properly point out a defect, but also assess the severity of the defect.

Referring to FIG. 1, the noted lateral cleanout 20 is shown, with tree roots being the cause of the defect. As mentioned above, an operator could be examining the sewer during the day or at night, in clear or cloudy situations, where the tree and the tree roots may or may not be noted or related to the sewer defect. Depending on the significance given to the cleanout 20 and the related tree roots by the CCTV operator, the reviewing engineer or project manager could give different levels of seriousness to the defect. The present invention addresses such disparities.

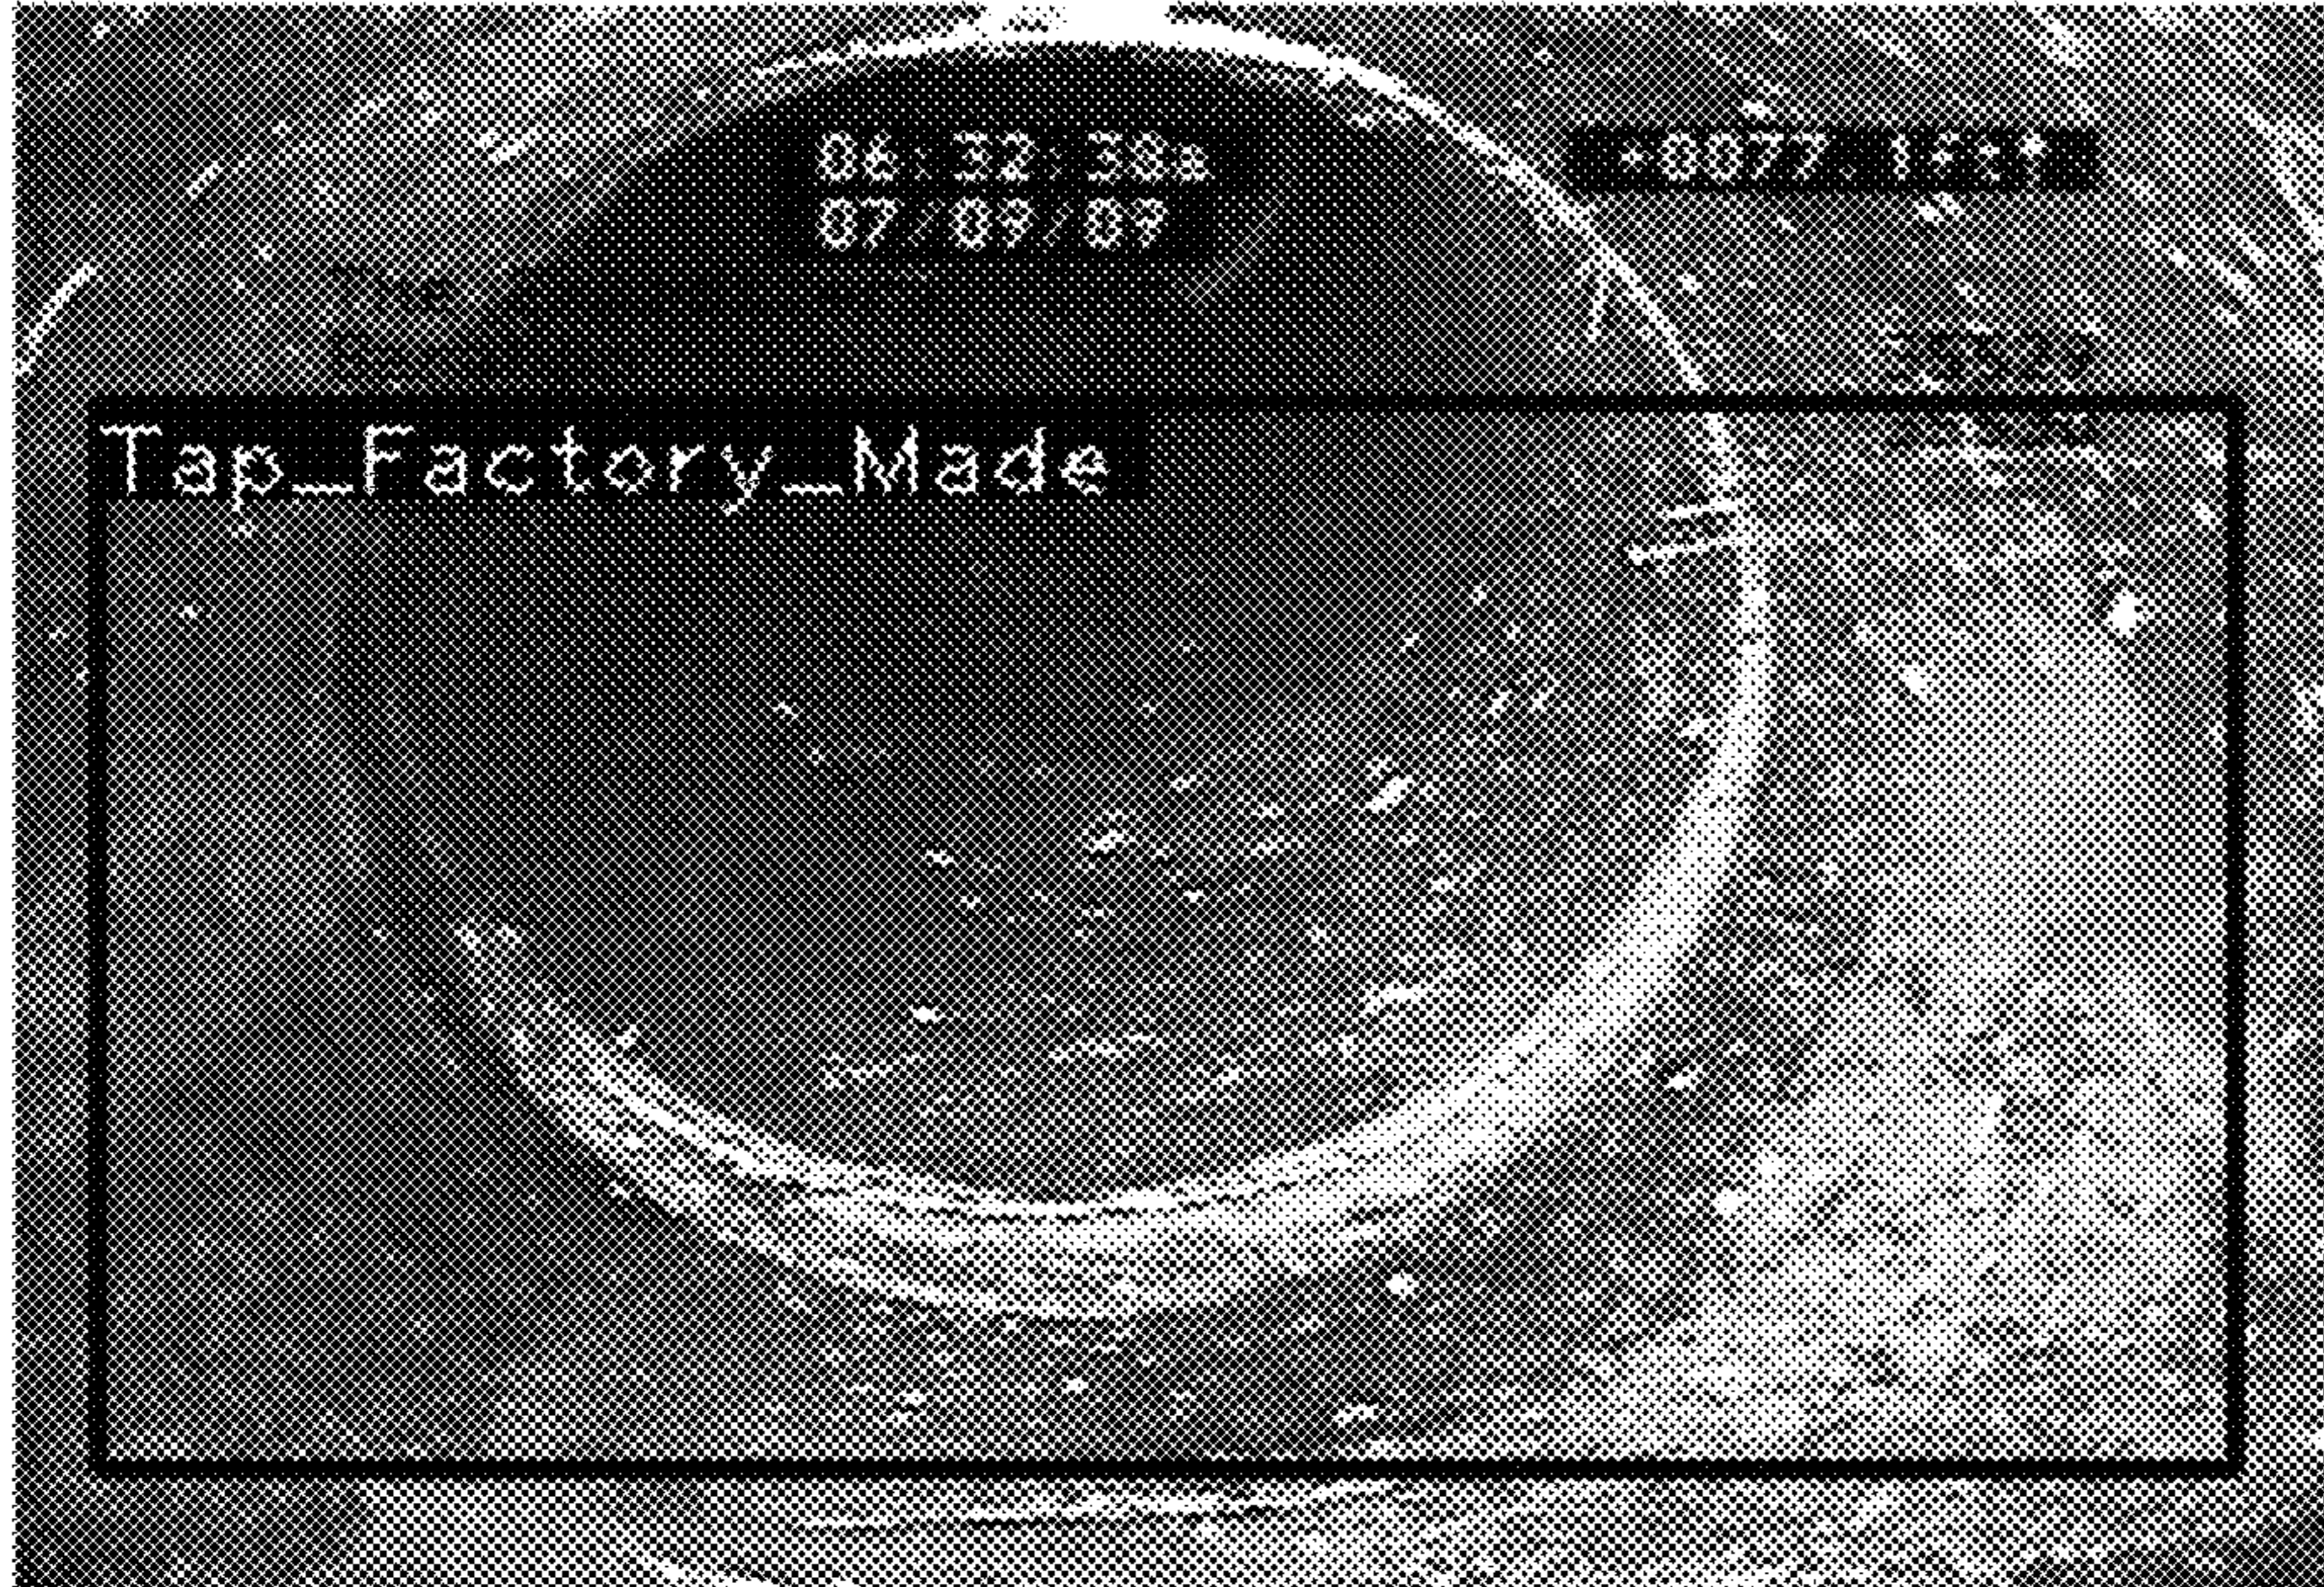
Fig. 2

FIG. 2 provides a camera view of a sewer pipe with a defect shown.

For example FIGS. 2-5 show various defects and bounding boxes within a sewer pipe taken from a video of the sewer pipe. FIG. 2 shows a frame and a bounding box of a sewer pipe having a factory made tap, for example a preformed pipe fitting built into the sewer during construction. Depending on the person reviewing the video, the tap may be viewed as a different type of defect, e.g. a break-in, and may be analyzed or assessed compared to a second person reviewing the video. The present invention provides a proper labeling and assessment of the area as a factory made tap, regardless of the person reviewing the video and removes potential mislabeling of the area or defect.

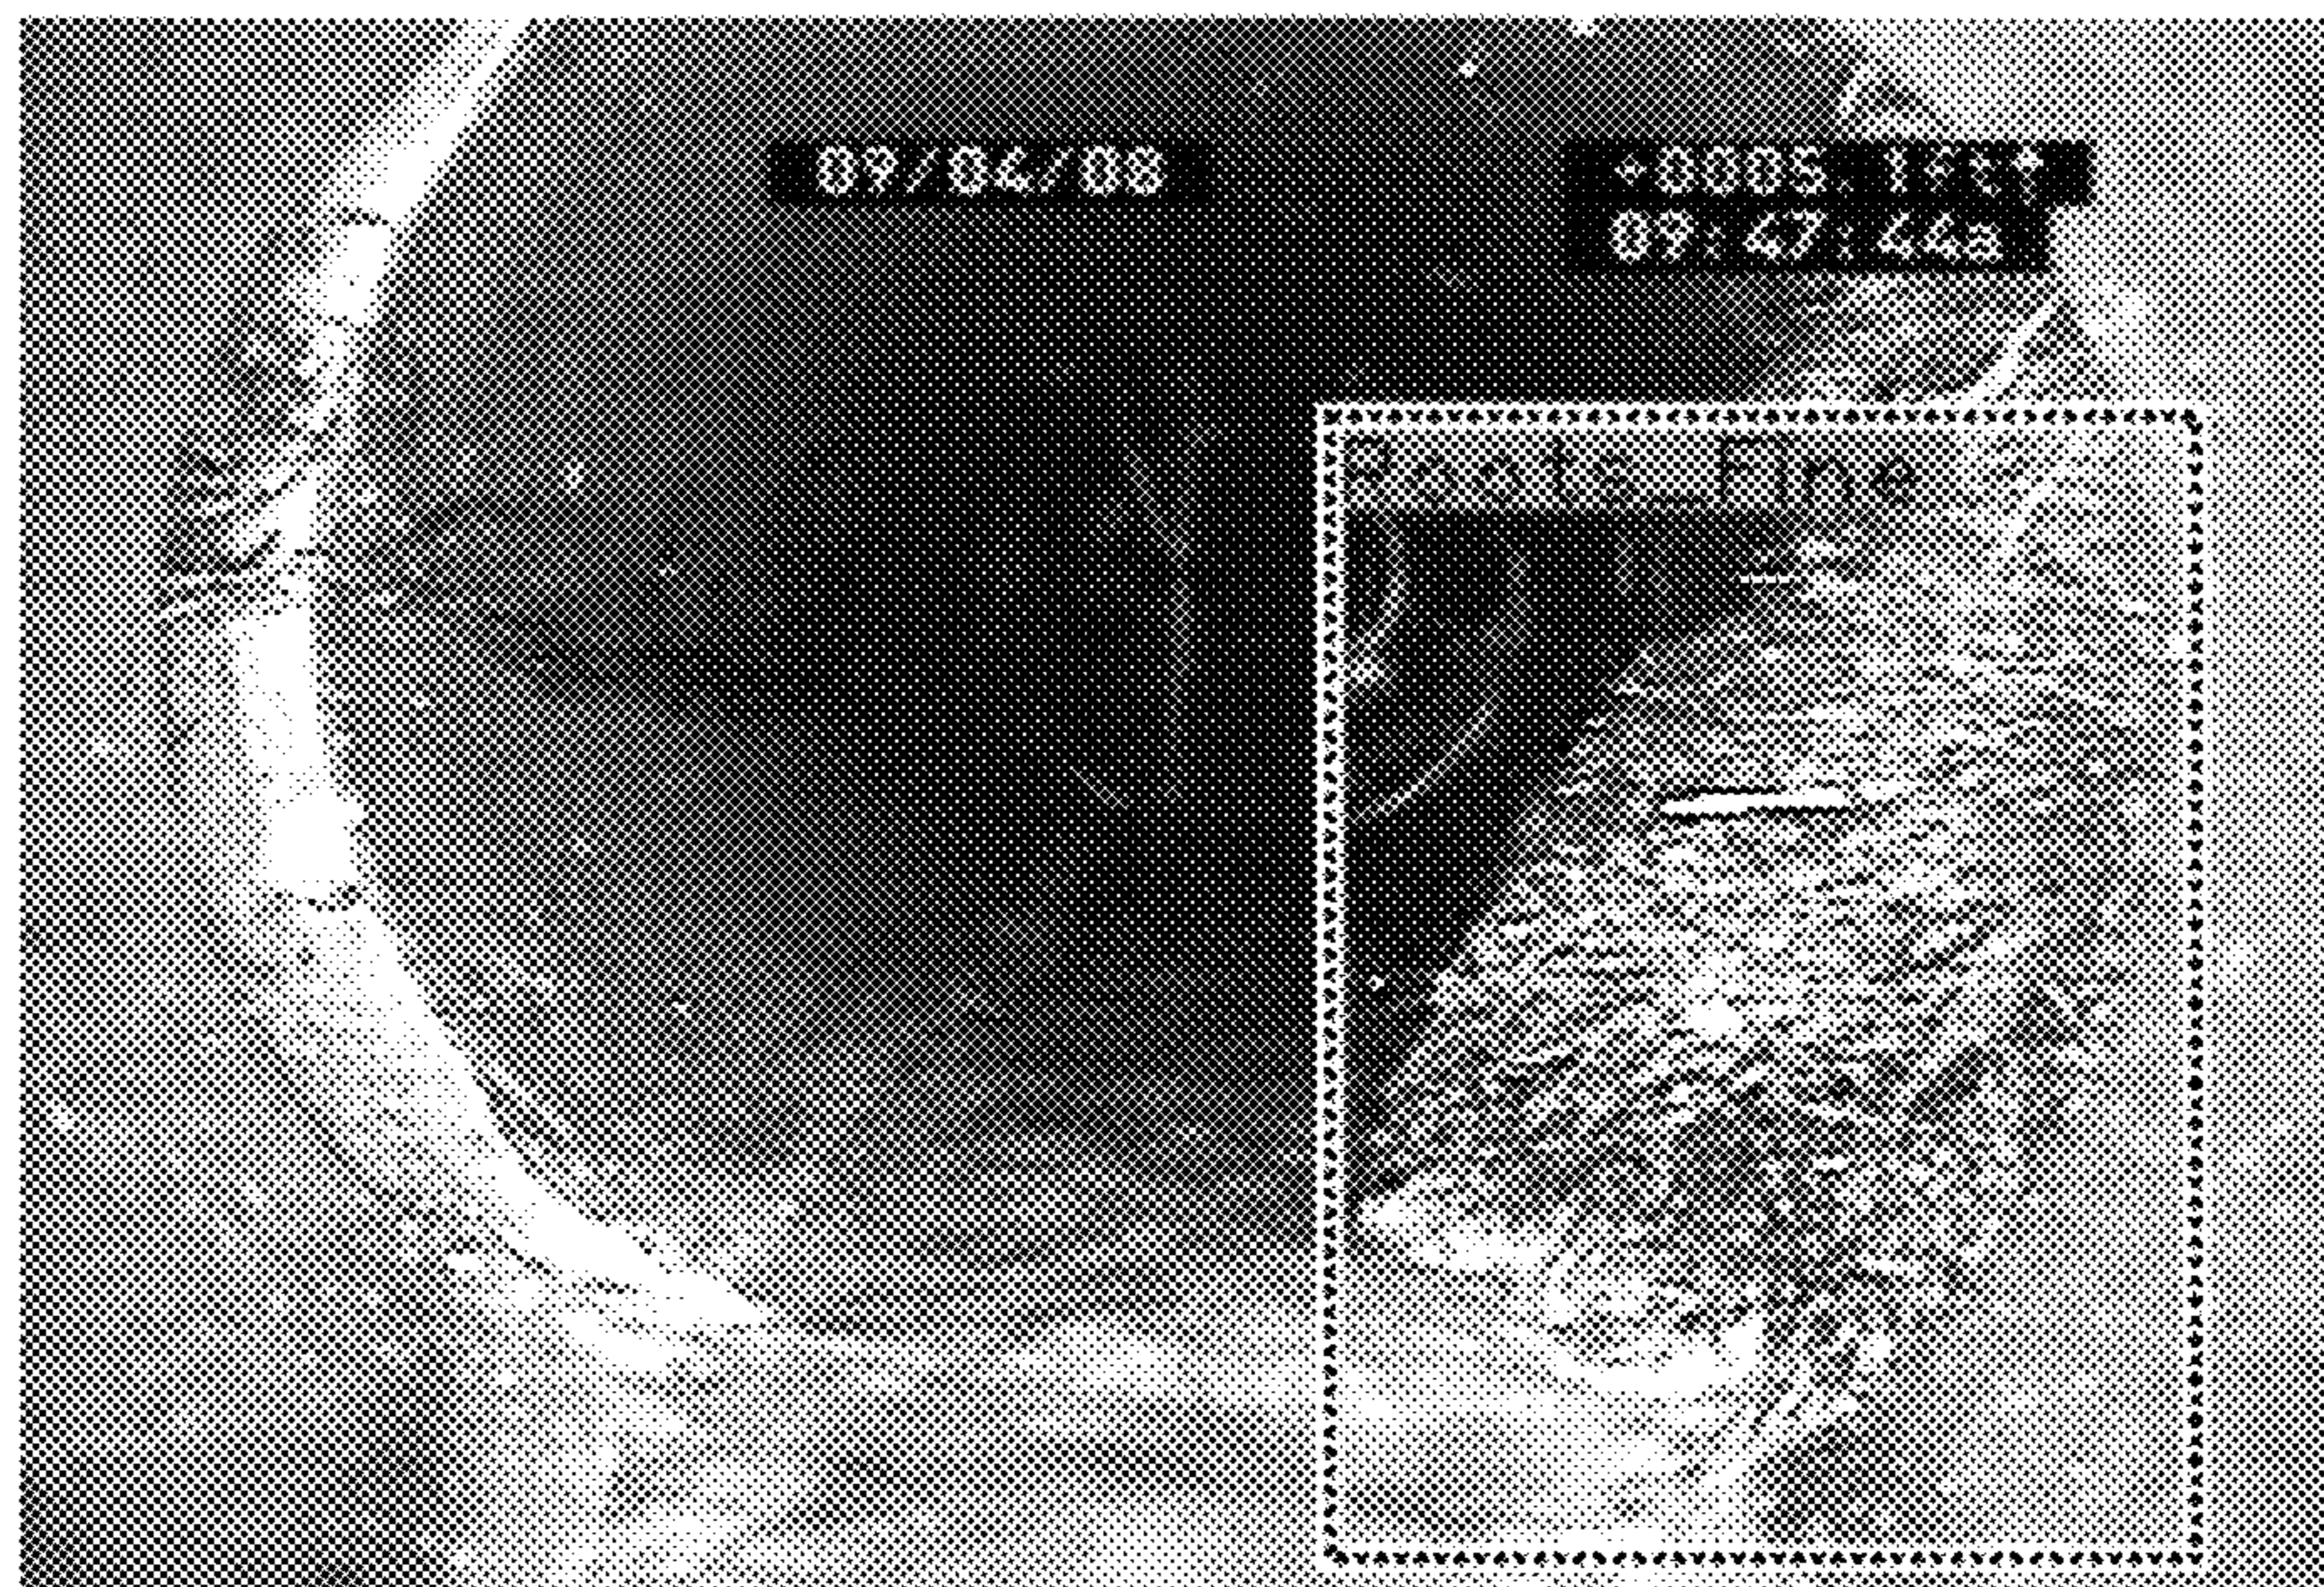
Fig. 3

FIG. 3 provides a camera view of a sewer pipe with a further defect shown.

Similarly, FIGS. 3-6 show roots encroaching within the sewer pipe. As noted from the captured bounding boxes, the defects range from root encroachment on the lower range of concern (fine) (FIGS. 3 and 4) to root encroachment of high concern (heavy ball of roots) (FIG. 6) and root encroachment of a level of concern in between (medium) (FIG. 5).

As discussed, personal observations may provide a different analysis than noted in the Figures. FIG. 3 may be perceived as being a more severe root encroachment than FIG. 5 from what is shown in the frame. The reviewer may incorrectly label FIG. 5 as "fine" and FIG. 3 as "medium". The review potentially would not have taken into account the potential length and overall area of the root encroachment may not be fully appreciated from the observation. The present invention addresses such omissions and incorrect analysis, as the method and process take out such subjective reviews.

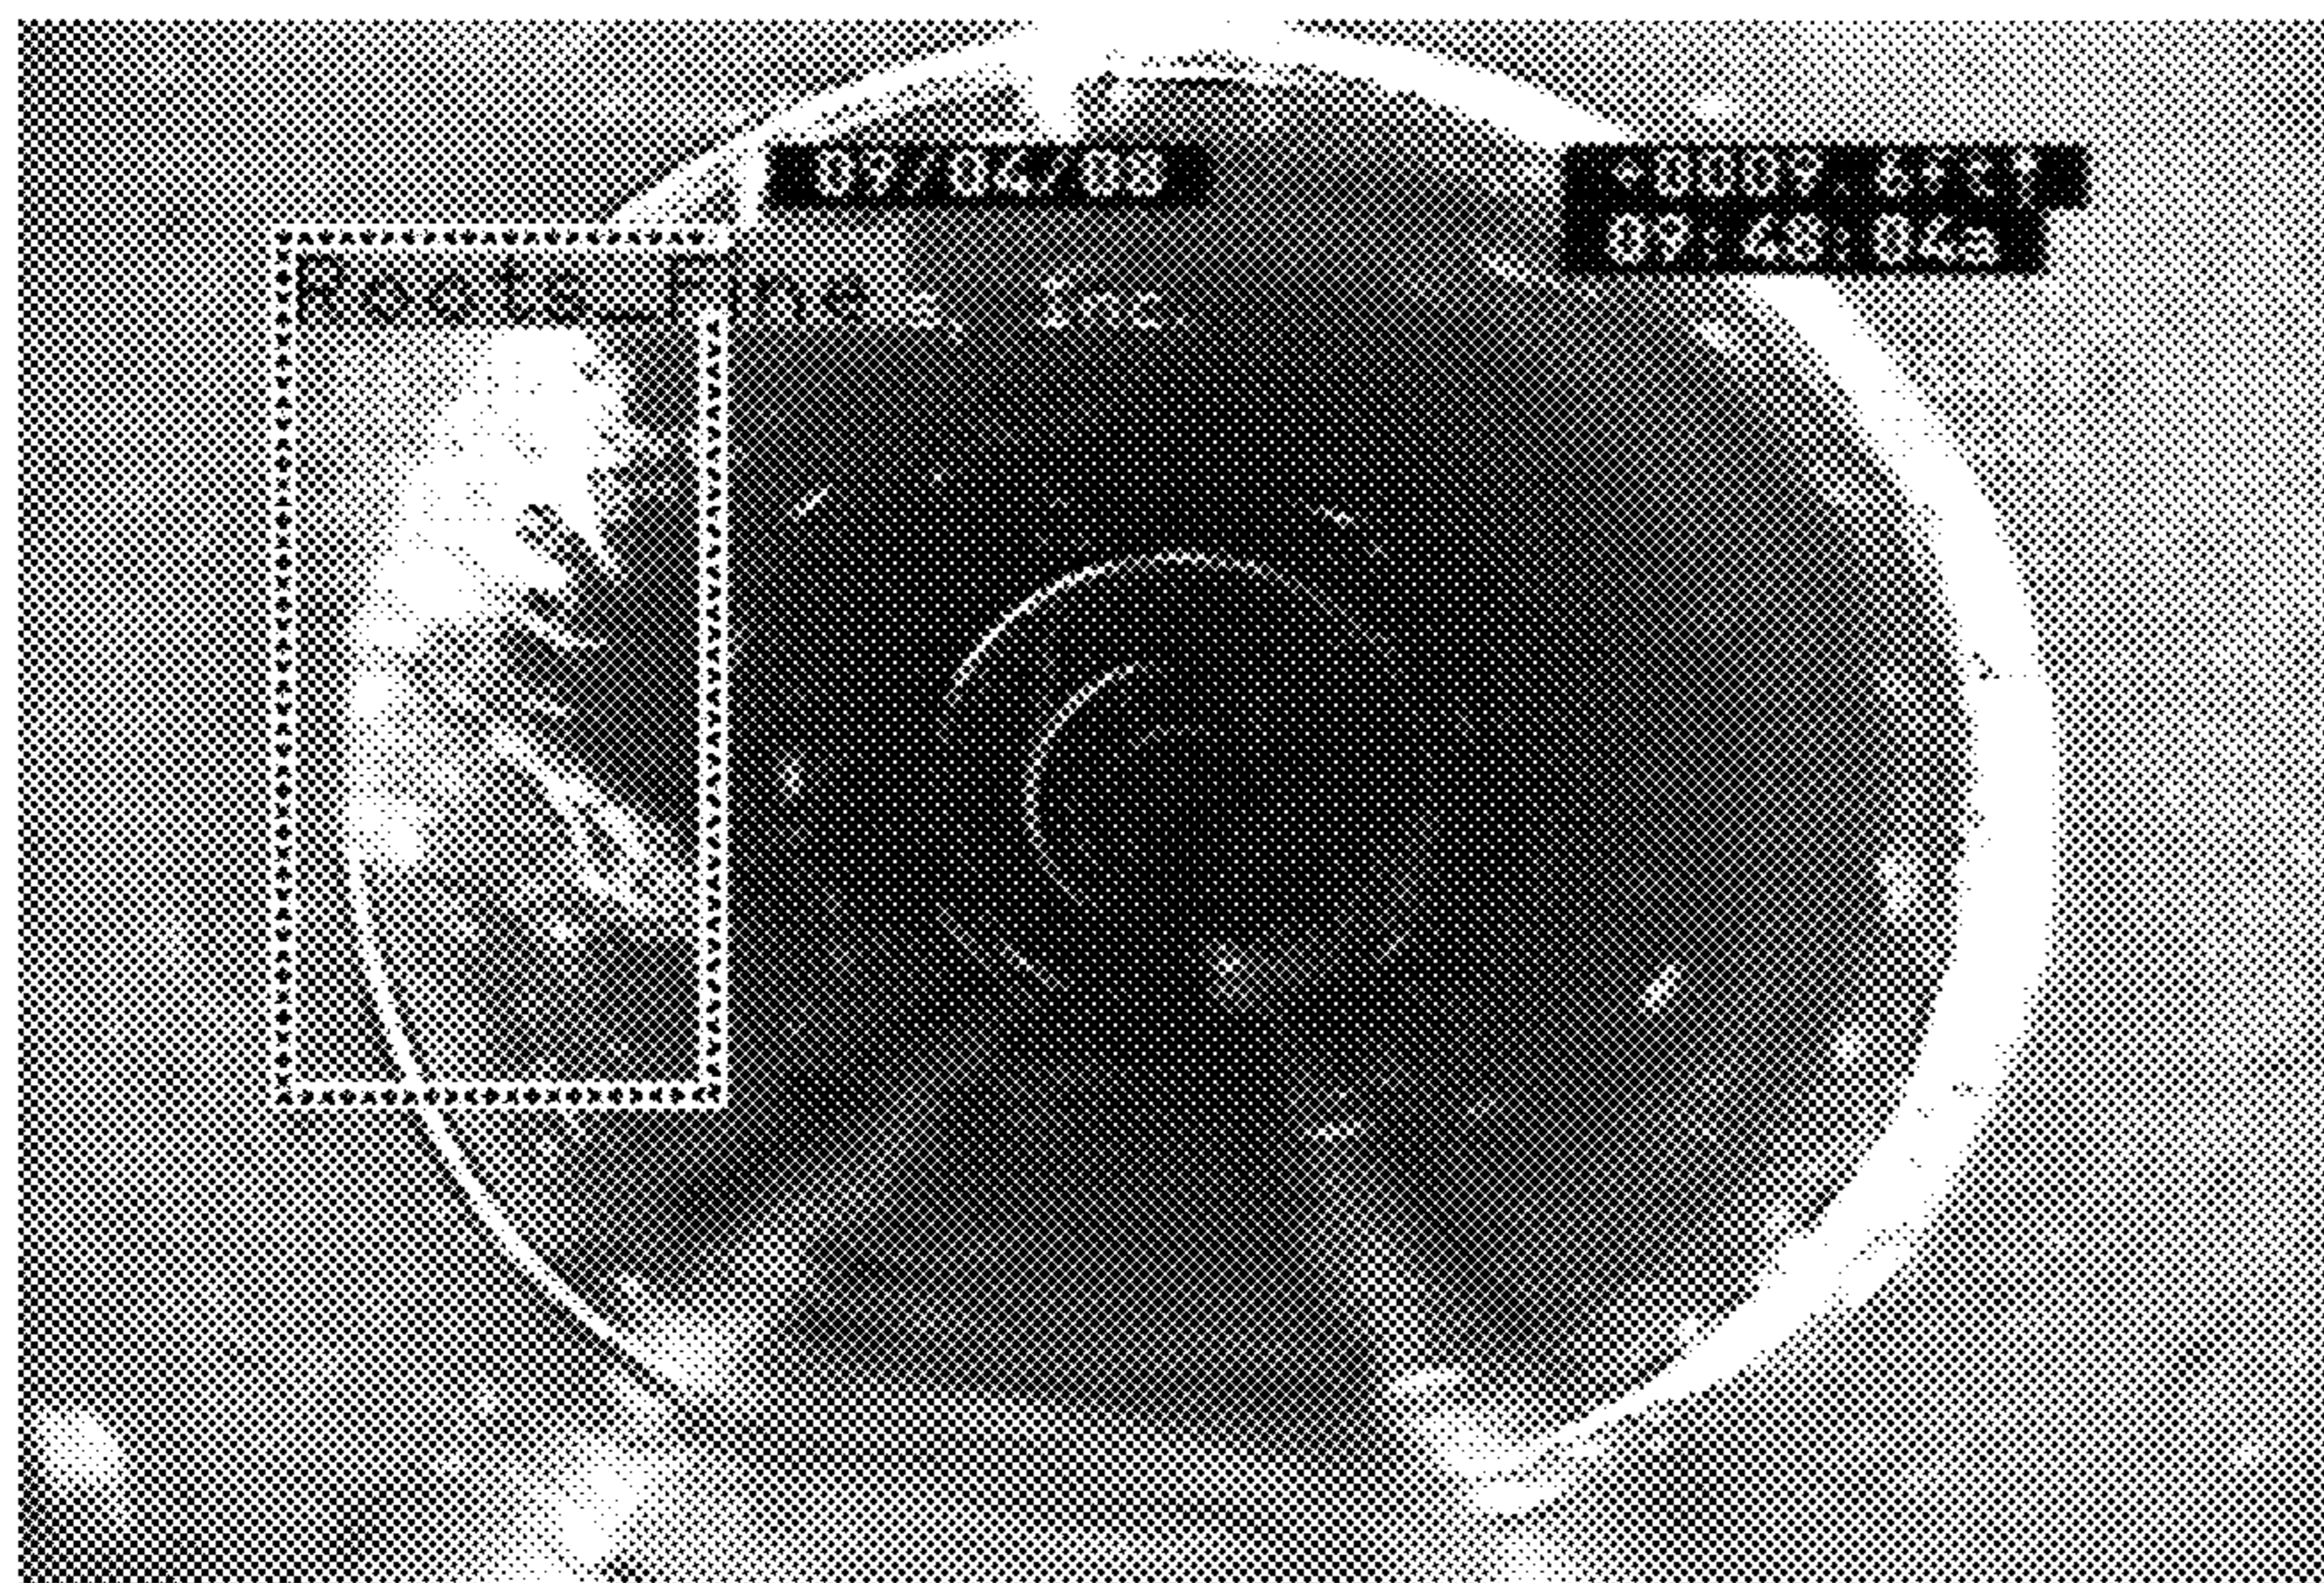
Fig. 4

FIG. 4 provides a camera view of a sewer pipe with another defect shown.

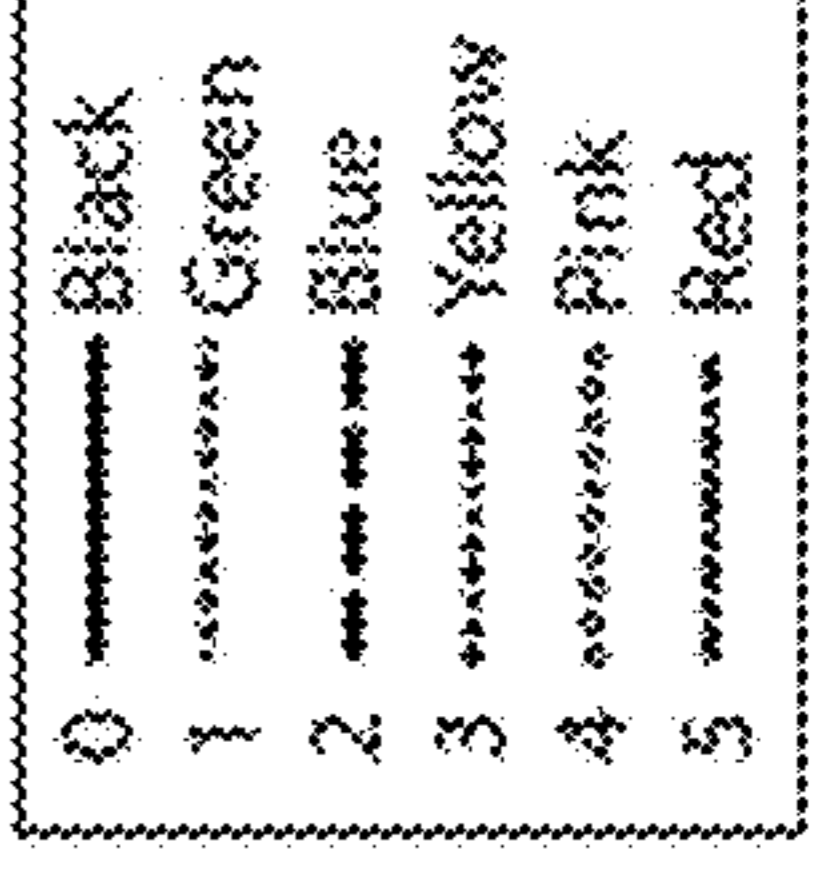
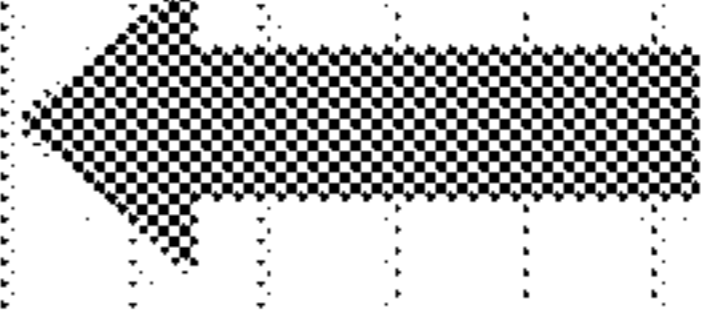
Fig. 11

When an end user clicks on the hyperlinked image, an image will display with the corresponding box around the defect, giving the user quick access to view the defect.

FIGS. 11-12B provide further reports that can be generated according to the present invention. FIG. 11 demonstrates a spreadsheet analyzing video footage of a sewer system. The video was recorded and analyzed as described above, with the various recorded and analyzed defects listed in the spreadsheet. The defects are listed by location, type of defect, severity, and overall pipe grade for the pipe up to that location. In conjunction with the processed video, each of the defects has a link to the specific frame in the video for that defect, as well as a link to the entire video.

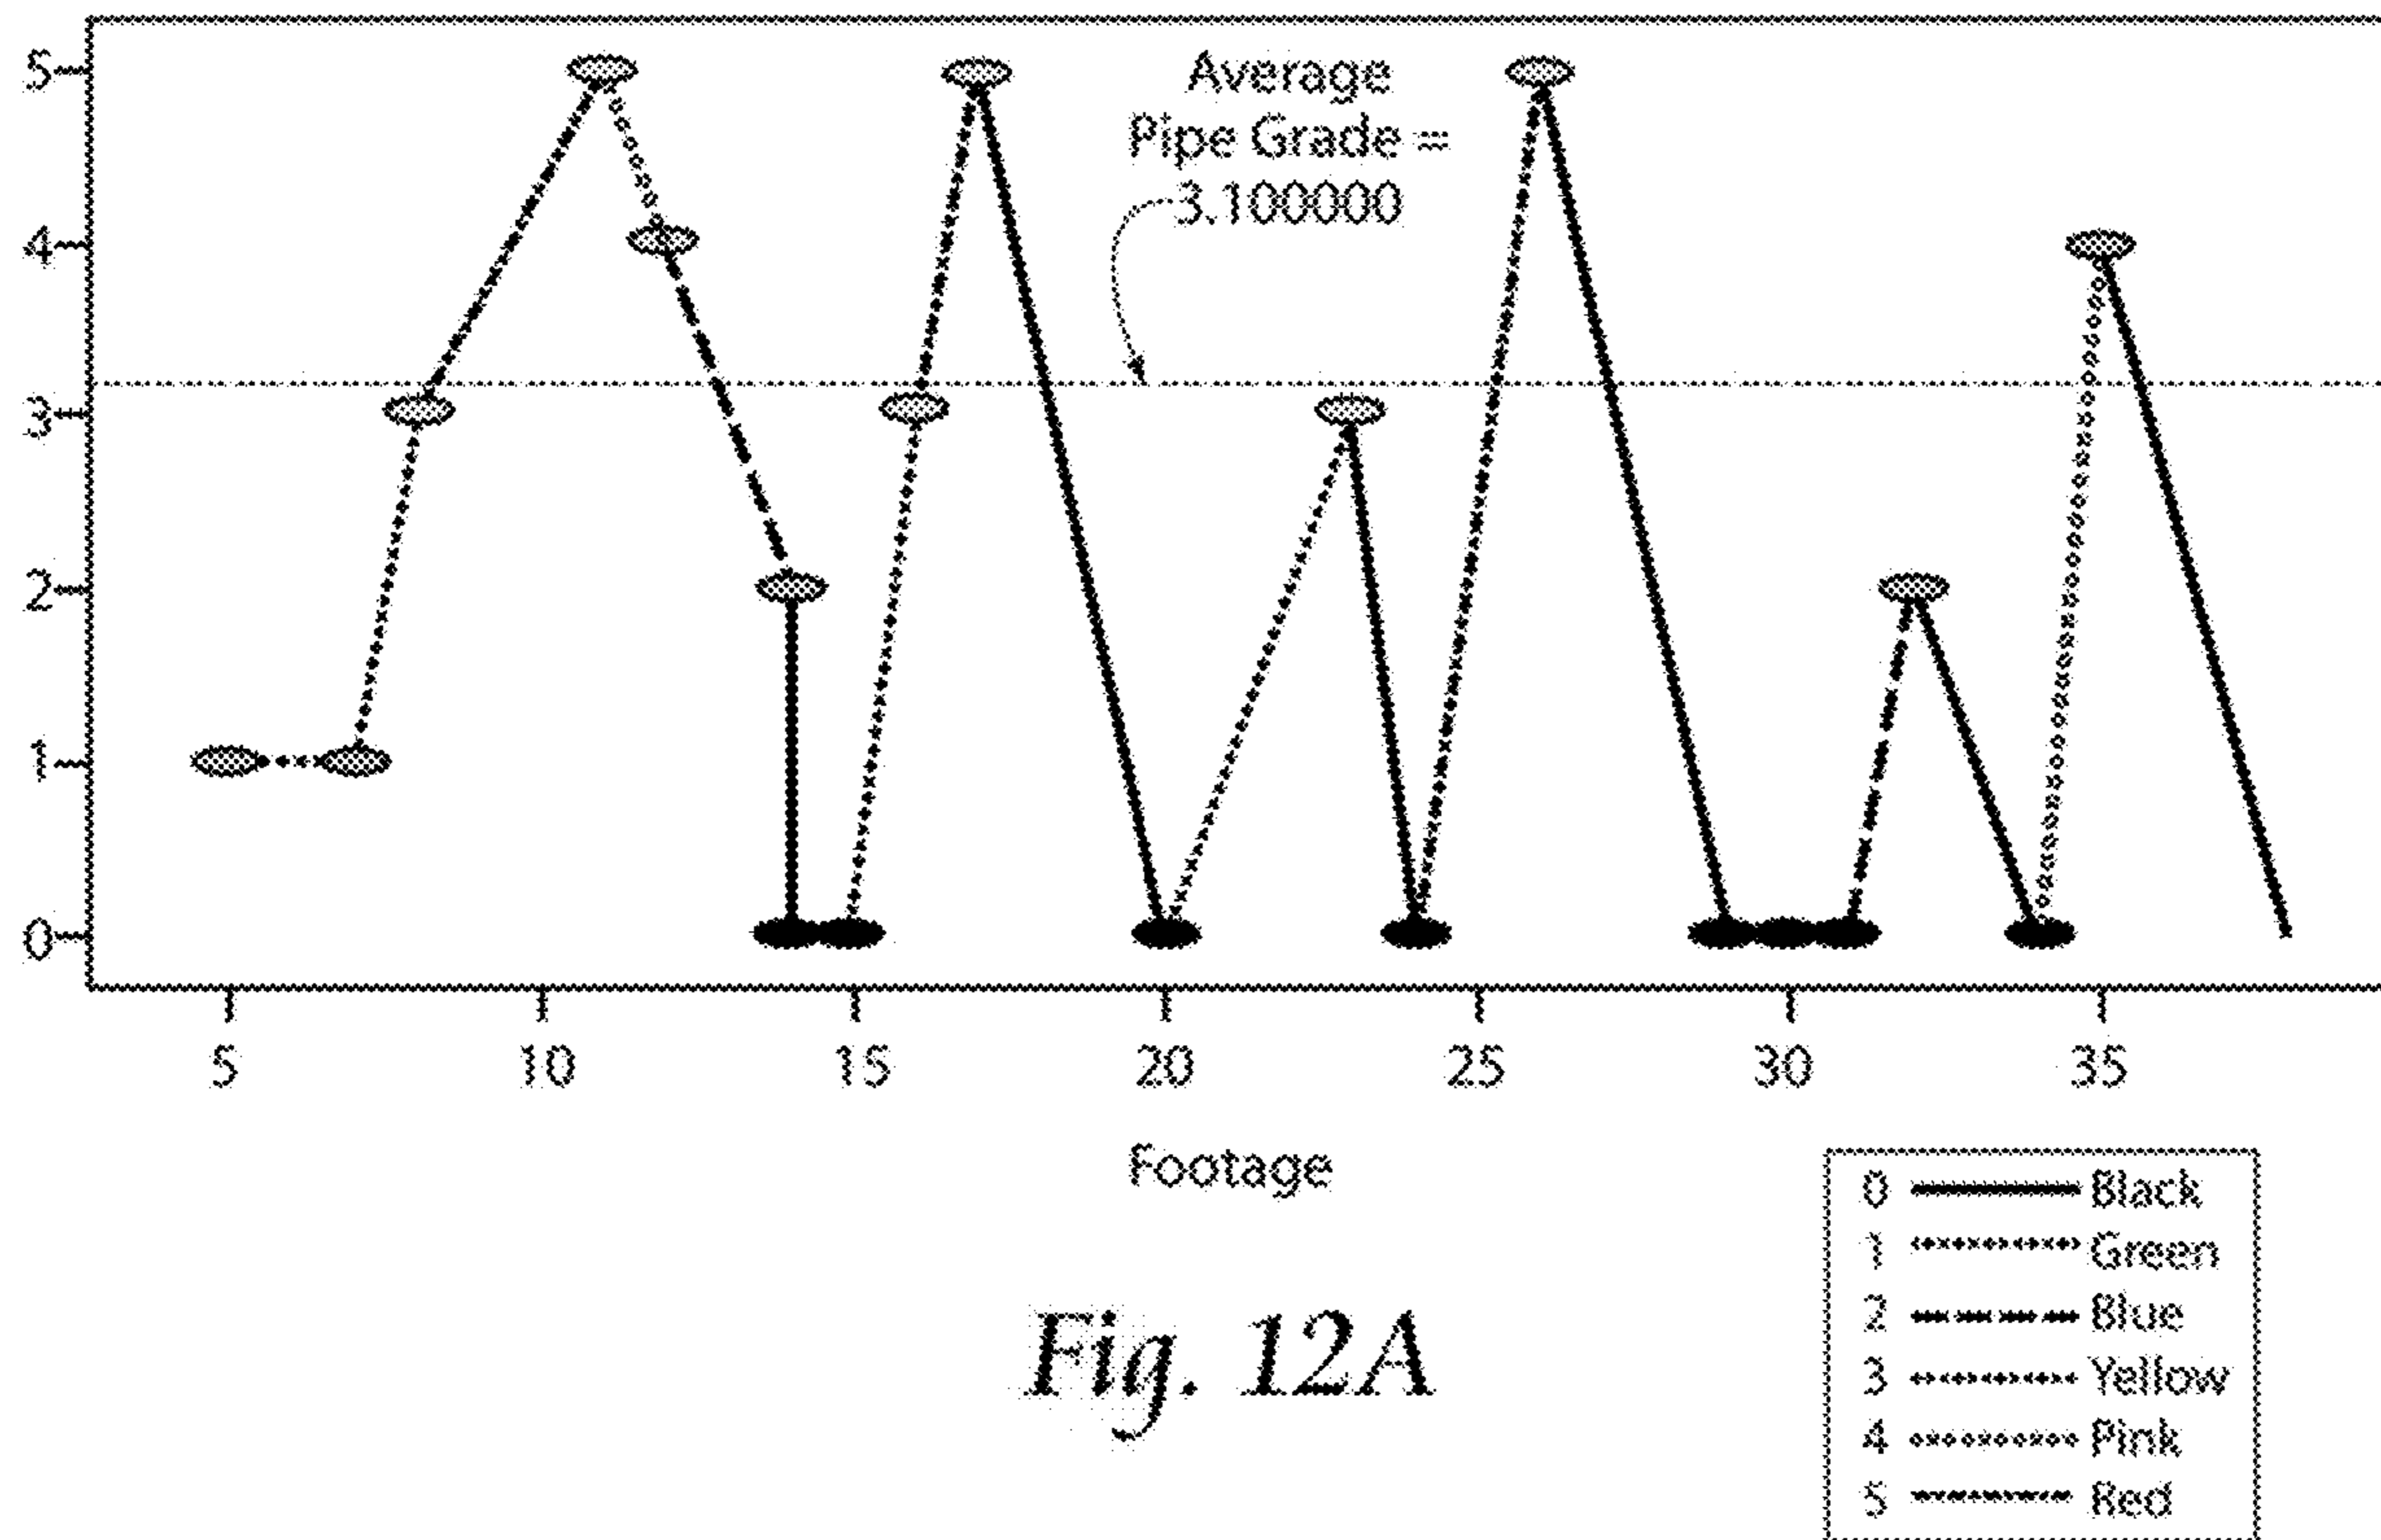
Fig. 12A

FIGS. 12A and 12B are graphs of the video footage analyzed in FIG. 11. The graph would likely accompany the spreadsheet in FIG. 11 and be used together with the spreadsheet. As noted above with respect to FIG. 10, the graphs and spreadsheets also give a rating from 0-5 for the severity of a defect, with a color code used as well (0=black, 1=green, 2=blue, 3=goldenrod (yellow), 4=magenta (pink), and 5=red). FIG. 12A plots the various defects noted in FIG. 11 with respect to the severity of the defect. For example, the plot point at five feet and a severity of 1 (green) corresponds to the first defect (roots fine) noted on the spreadsheet in FIG. 11. Likewise, the defect at eleven feet and severity of 5 (red) corresponds to a joint defect. FIG. 12A also graphs the overall average plot grade for the pipe (3.166, yellow). FIG. 12B correlated to the graph in FIG. 12A, showing where the laterals are located along the length of the sewer pipe. Together, the three Figures demonstrate provide an objective report that can be used in determining sewer pipe quality over time. When a future report is generated by the present invention for the same sewer pipe, the average pipe grade can be compared to determine how the grade has changed over time. An objective assessment is available, since there is a very high level of confidence that the comparison is an apples to apples comparison.
