[54] **METHOD FOR NON-DESTRUCTIVE TESTING OF SEMICONDUCTOR ARTICLES**

[75] Inventor: Gary Markovits, Poughkeepsie, N.Y.

[73] Assignee: International Business Machines Corporation, Armonk, N.Y.

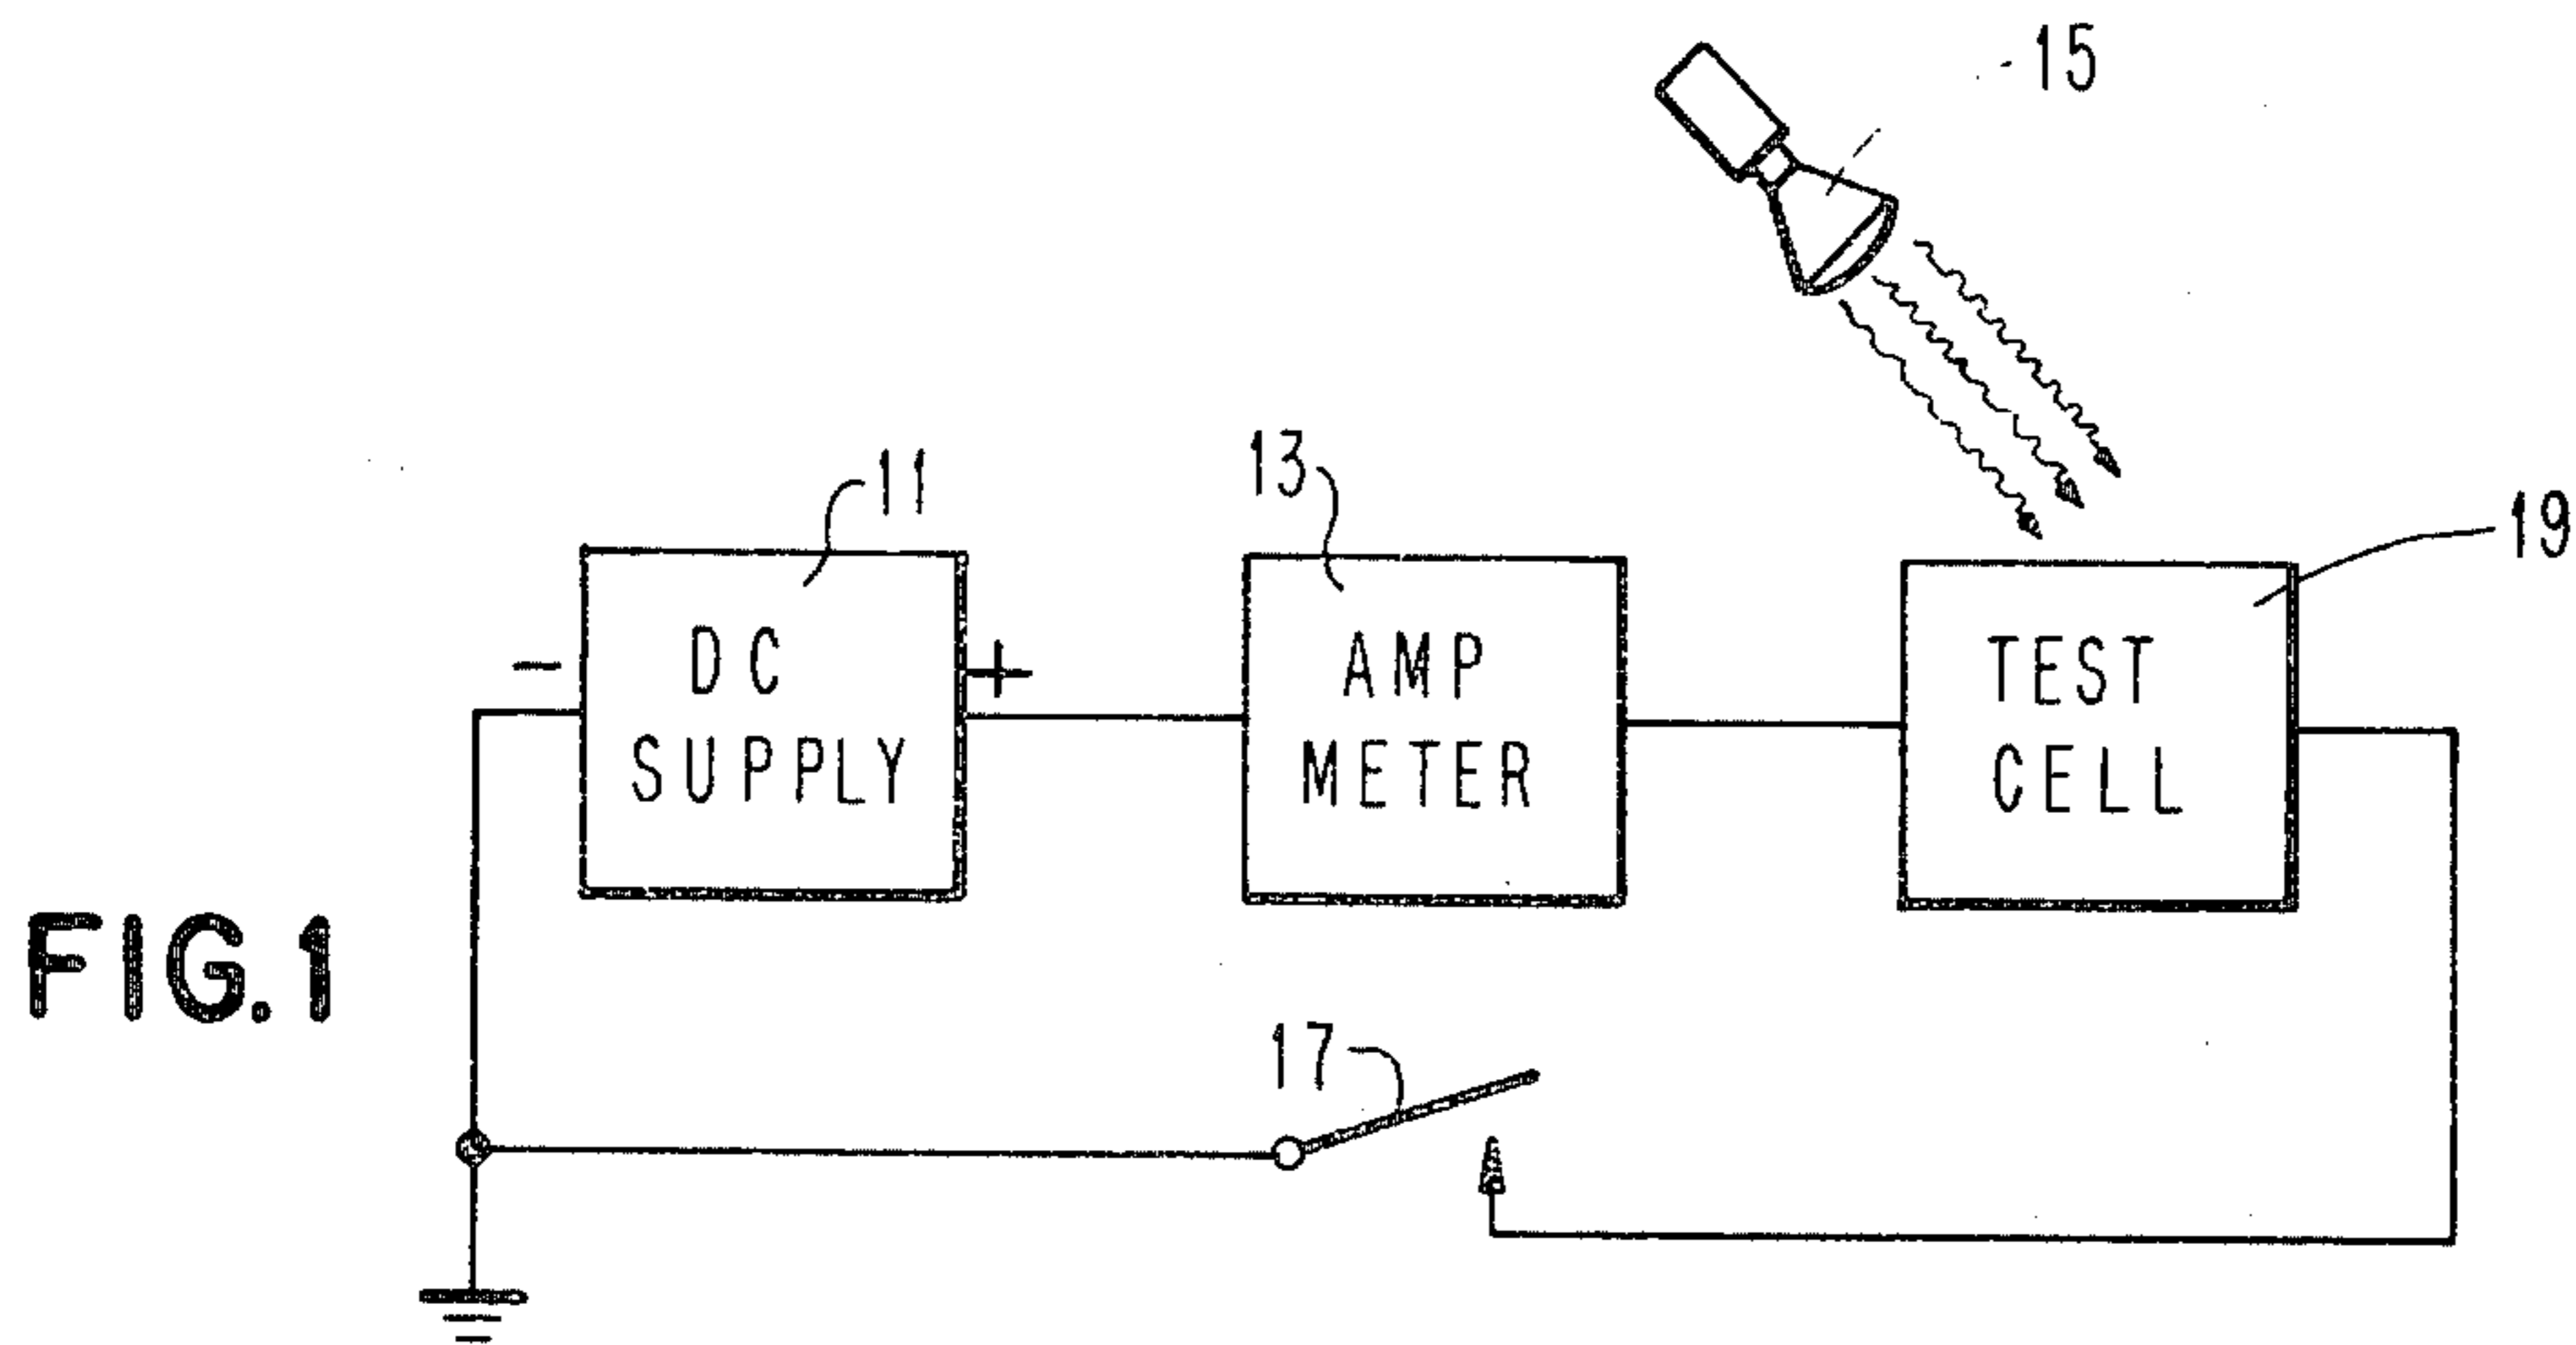
FIG. 1 is a schematic diagram of an apparatus suitable for carrying out the process of the invention.

Turning now to FIG. 1, an apparatus suitable for carrying out the process of the invention includes DC supply 11 capable of providing up to about 65 volts, ampmeter 13, test cell 19, and a white light source 15 which will provide up to at least 80 foot candles of illumination at the wafer surface. A suitable source is a tungsten flood lamp of 75 watts. A switch 17 is also provided. The details of test cell 19, which can be of polytetrafluoroethylene, is shown in FIG. 2. Cell 19 is constructed in a way to leave one entire surface 20 of semiconductor wafer 21 exposed to the electrolyte solution 23 so that the hydrogen bubble pattern for the whole wafer can be developed at one time. Wafer 21 is mounted in cell 19 which is provided with an O-ring vacuum seal 25. Wafer 21 is held in place by vacuum chuck 27 against a graphite impregnated sponge 29 which insures a large area of uniform electrical contact to the backside of wafer 21. Sponge 29 is connected to the cathode of the DC supply by wire 31. The anode is a platinum wire 33 which extends into solution 23.

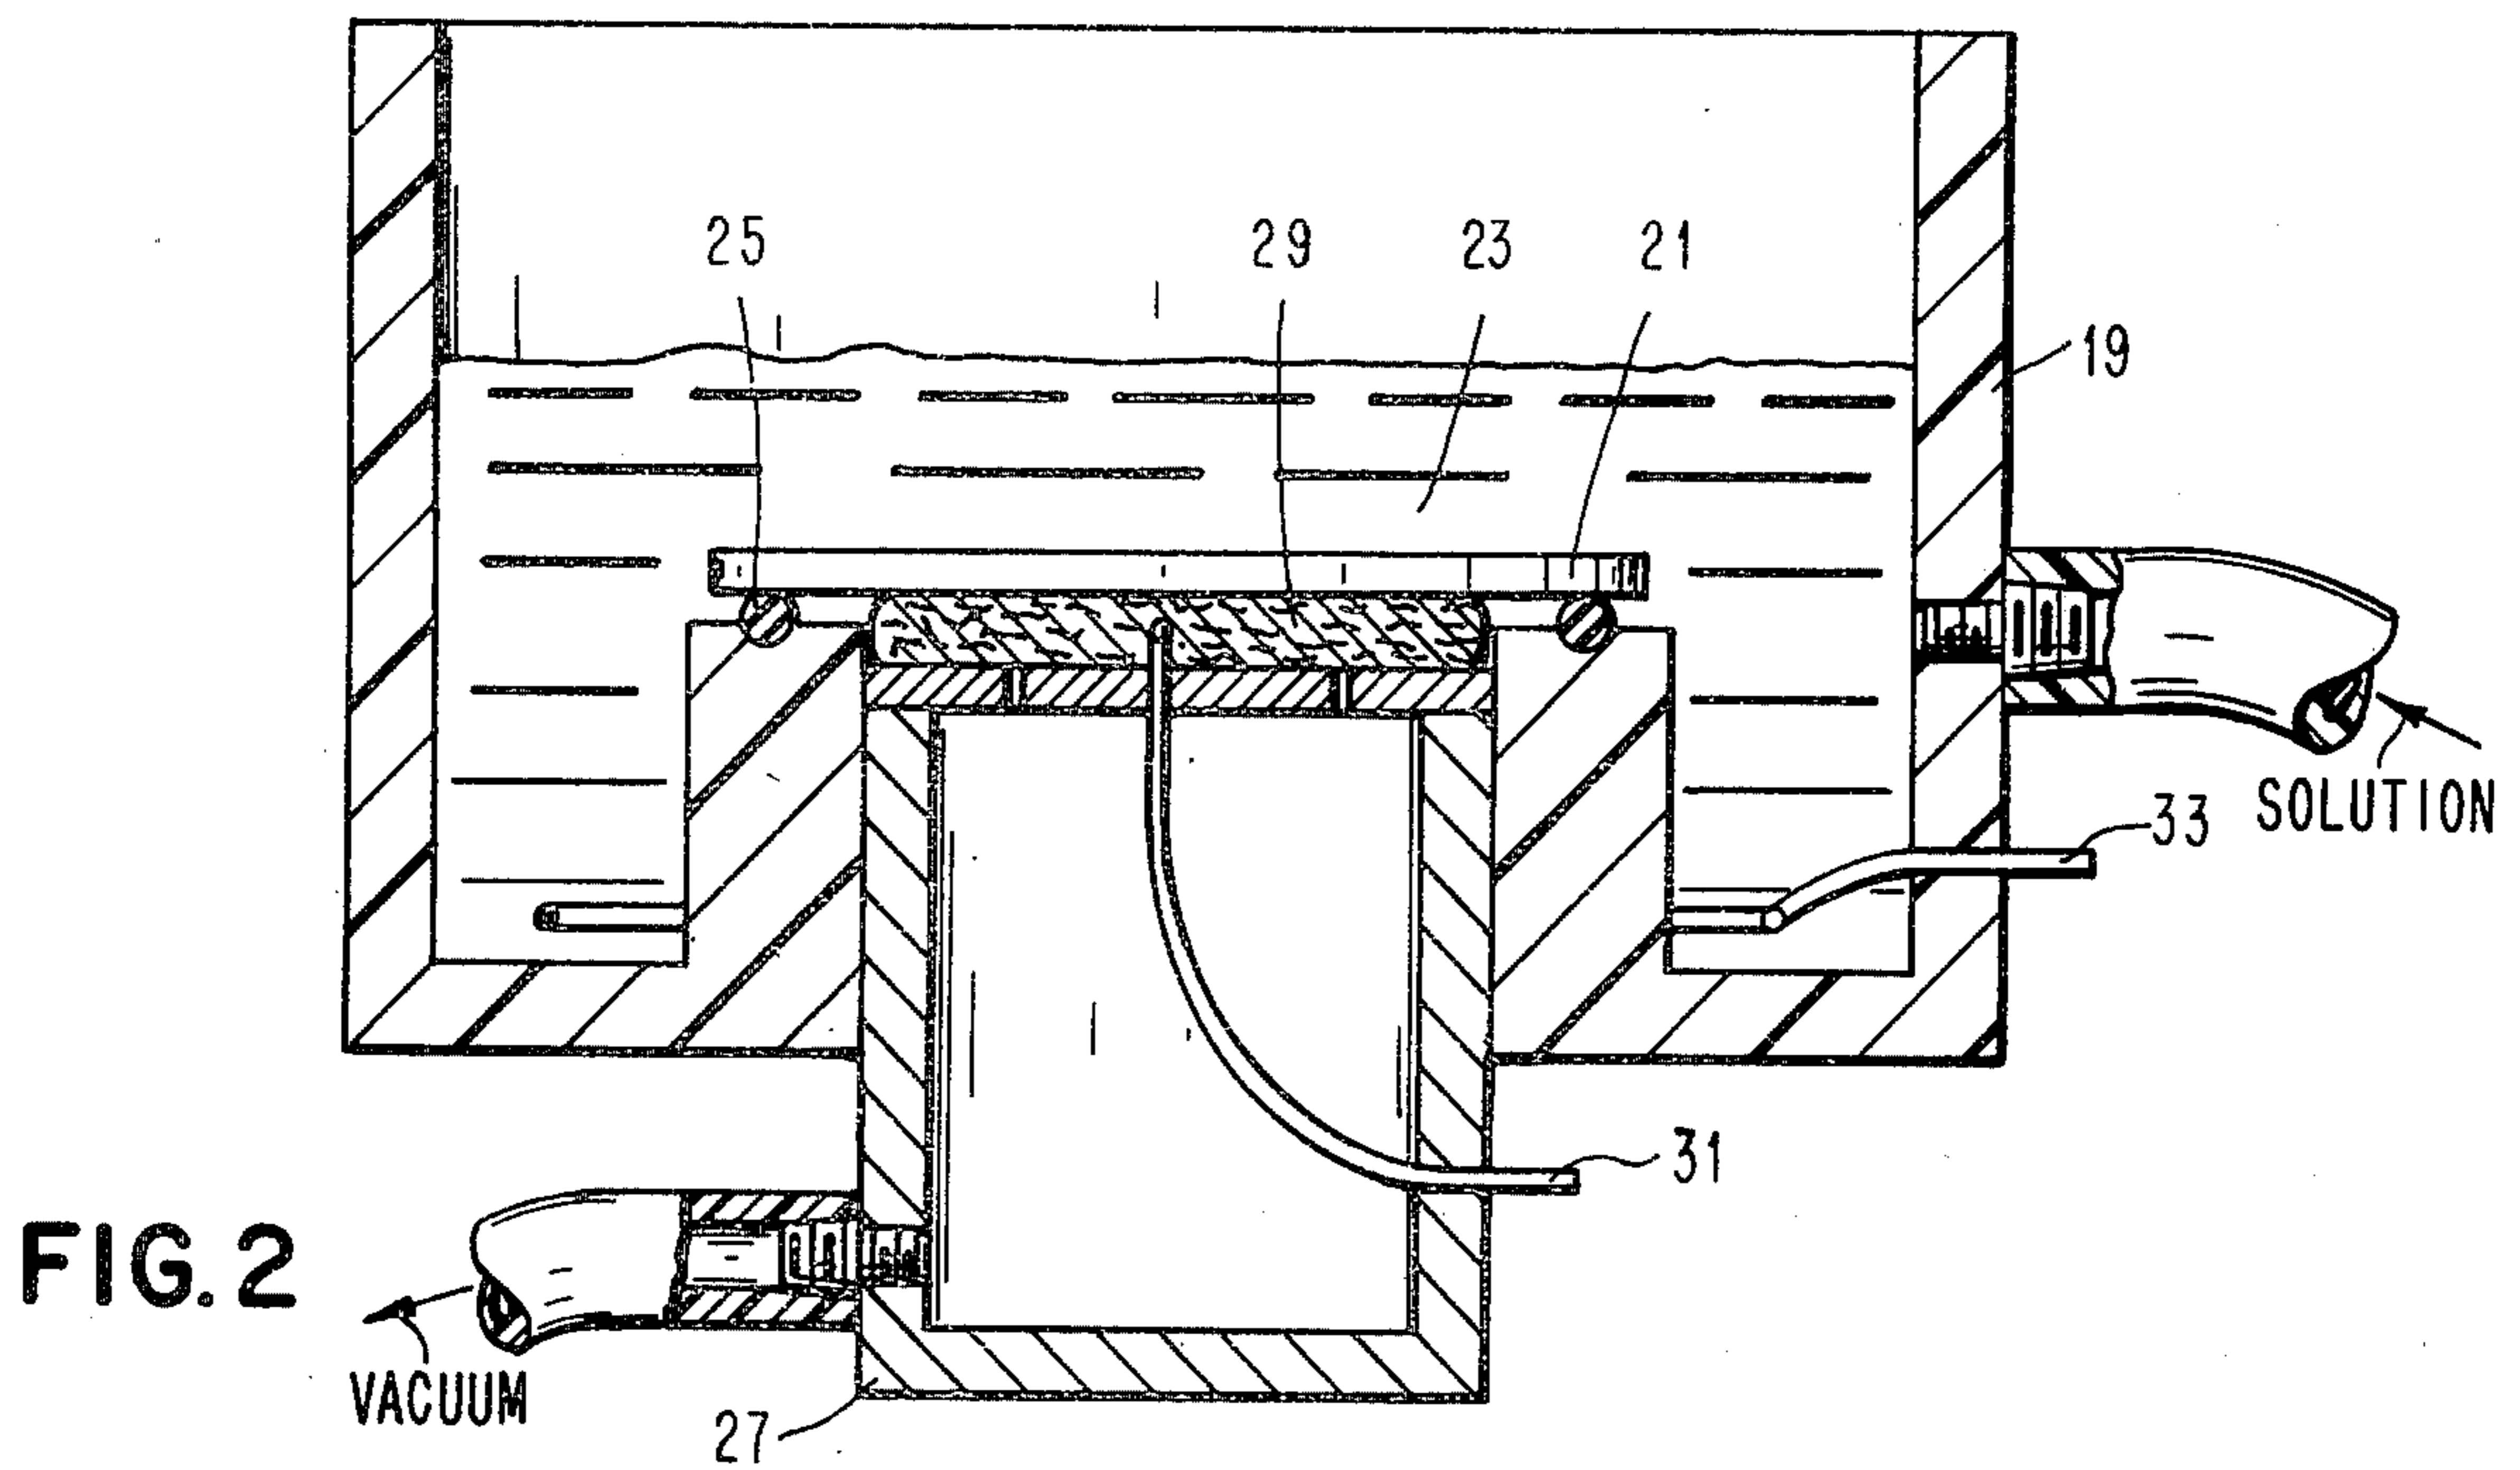
FIG. 2 is an elevational view, partially in section, of a test cell suitable for use in carrying out the process of the invention.

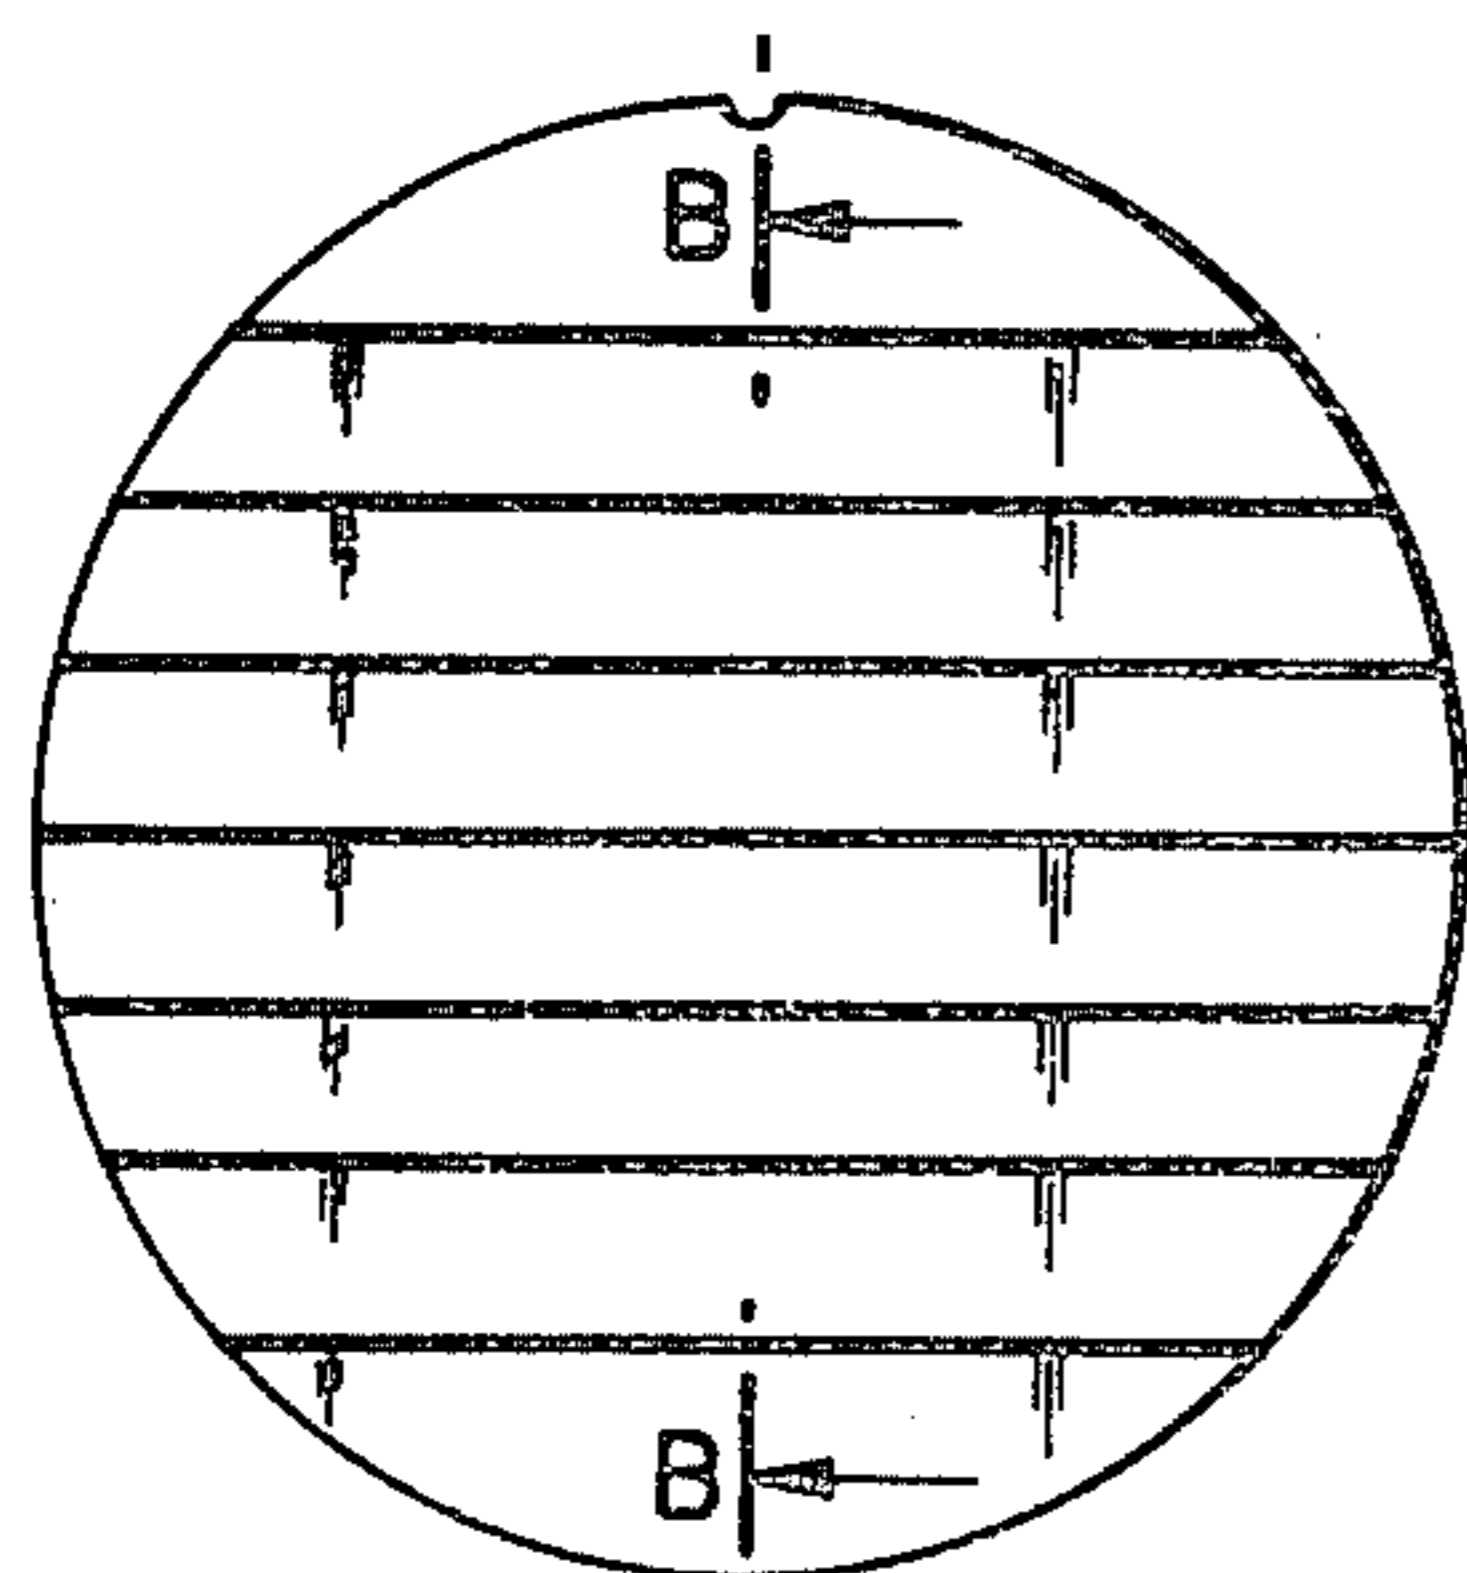
FIG. 3A is a plane view illustrating a step etched semiconductor wafer in which increasing amounts of material are removed from successive steps.

A damaged P-type 2 ohmcentimeter monocrystalline silicon wafer was step etched as illustrated in FIGS. 3A and 3B with the depth of the steps being shown in Table I.

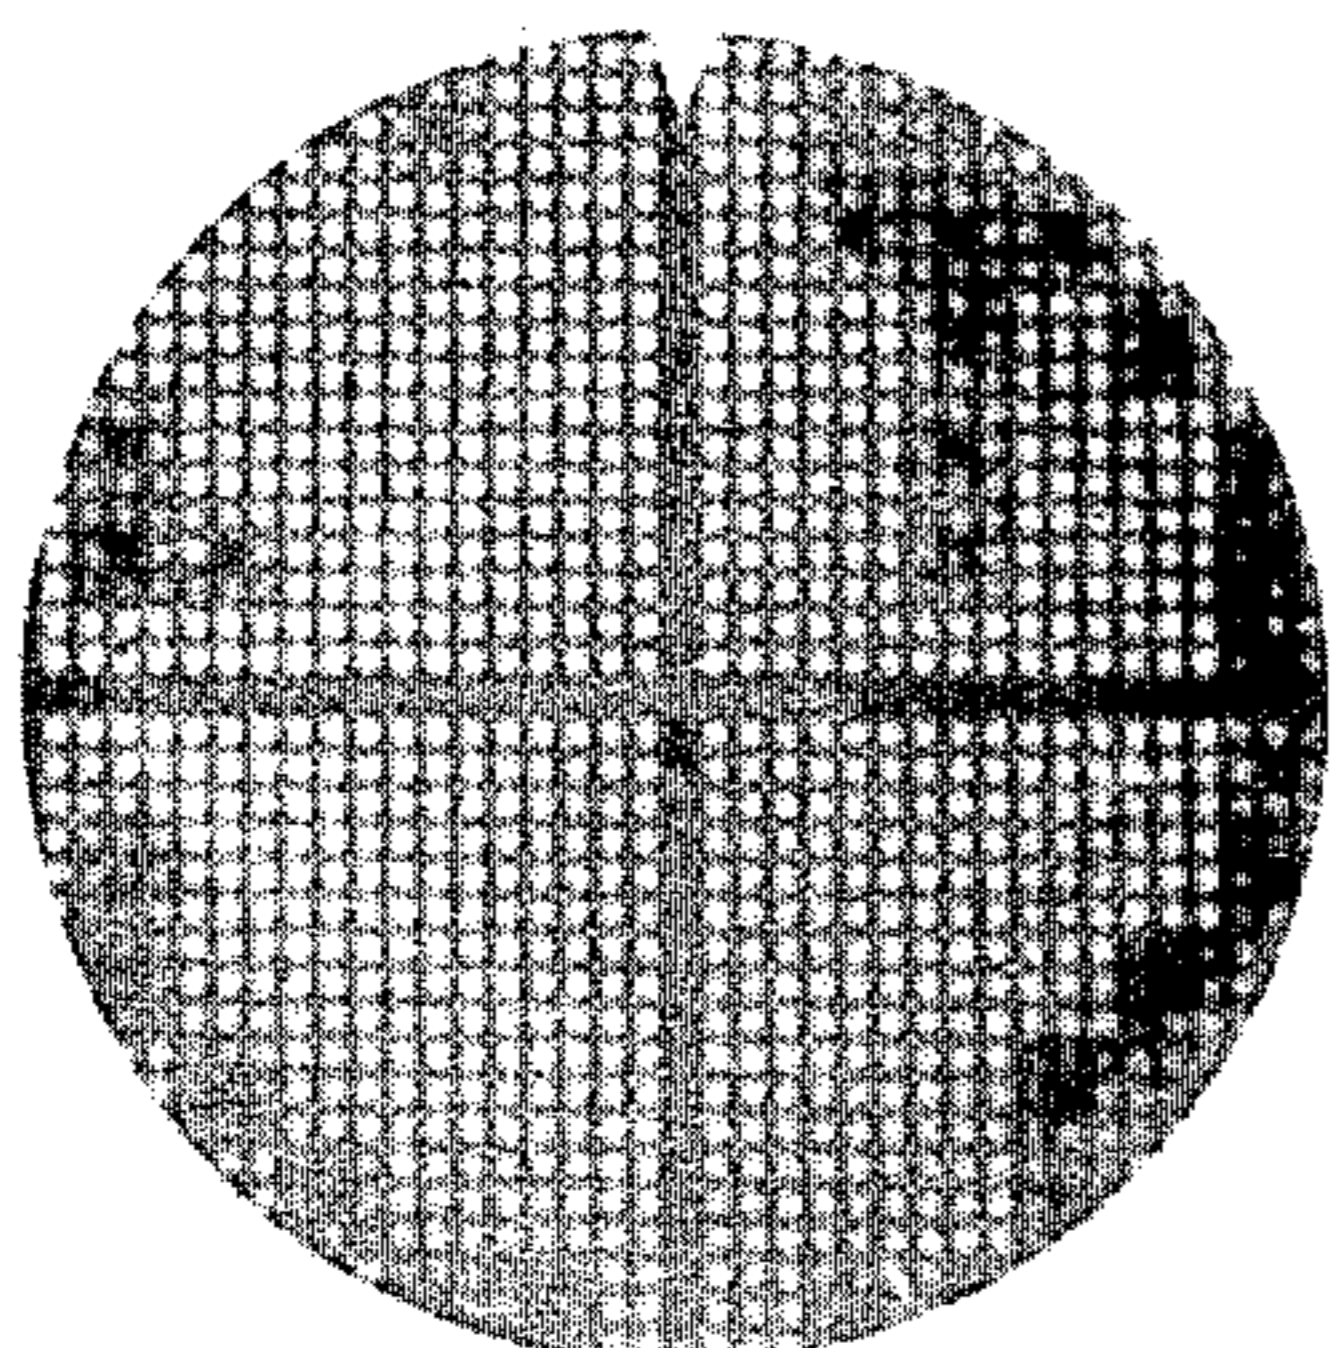
FIGS. 6A—D are photographs (6A—6C) illustrating hydrogen bubble patterns obtained at different illumination and bias voltage conditions as compared to a re-

touched photograph (6D) of the same P-type silicon wafer illustrating electrical defect site locations as determined by capacitor leakage current measurements.

The cleaned substrate was placed in the test cell 19 in a 2% by volume sulfuric acid solution and a negative 5 volt bias was applied for 5 seconds in the dark. The results are shown in FIG. 6A where no hydrogen formation was noted. The current was 9 ma. Next a negative bias of 5 volts for 5 seconds was applied with an illumination at the wafer surface greater than 250 foot candles. The current was 112 ma and in FIG. 6B small bubbles developed in the lower left and upper right hand quadrants of the substrate surface. It can be seen that the bubbles noted in the lower left hand quadrant of FIG. B do not correspond with the defects on the capacitor leakage current map of FIG. 6D. Next, the wafer was subjected to a 60 volt negative bias for 5 seconds with an illumination at the wafer surface of about 60 foot candles in accordance with the process of the invention. The hydrogen bubble pattern which was developed was photographed and is illustrated in FIG. 6C. It can be seen that the defect sites as determined by the bubble test (FIG. 6C) are in good correspondence with those shown in FIG. 6D where defects are noted around the perimeter of the substrate and extending into the upper right hand quadrant.

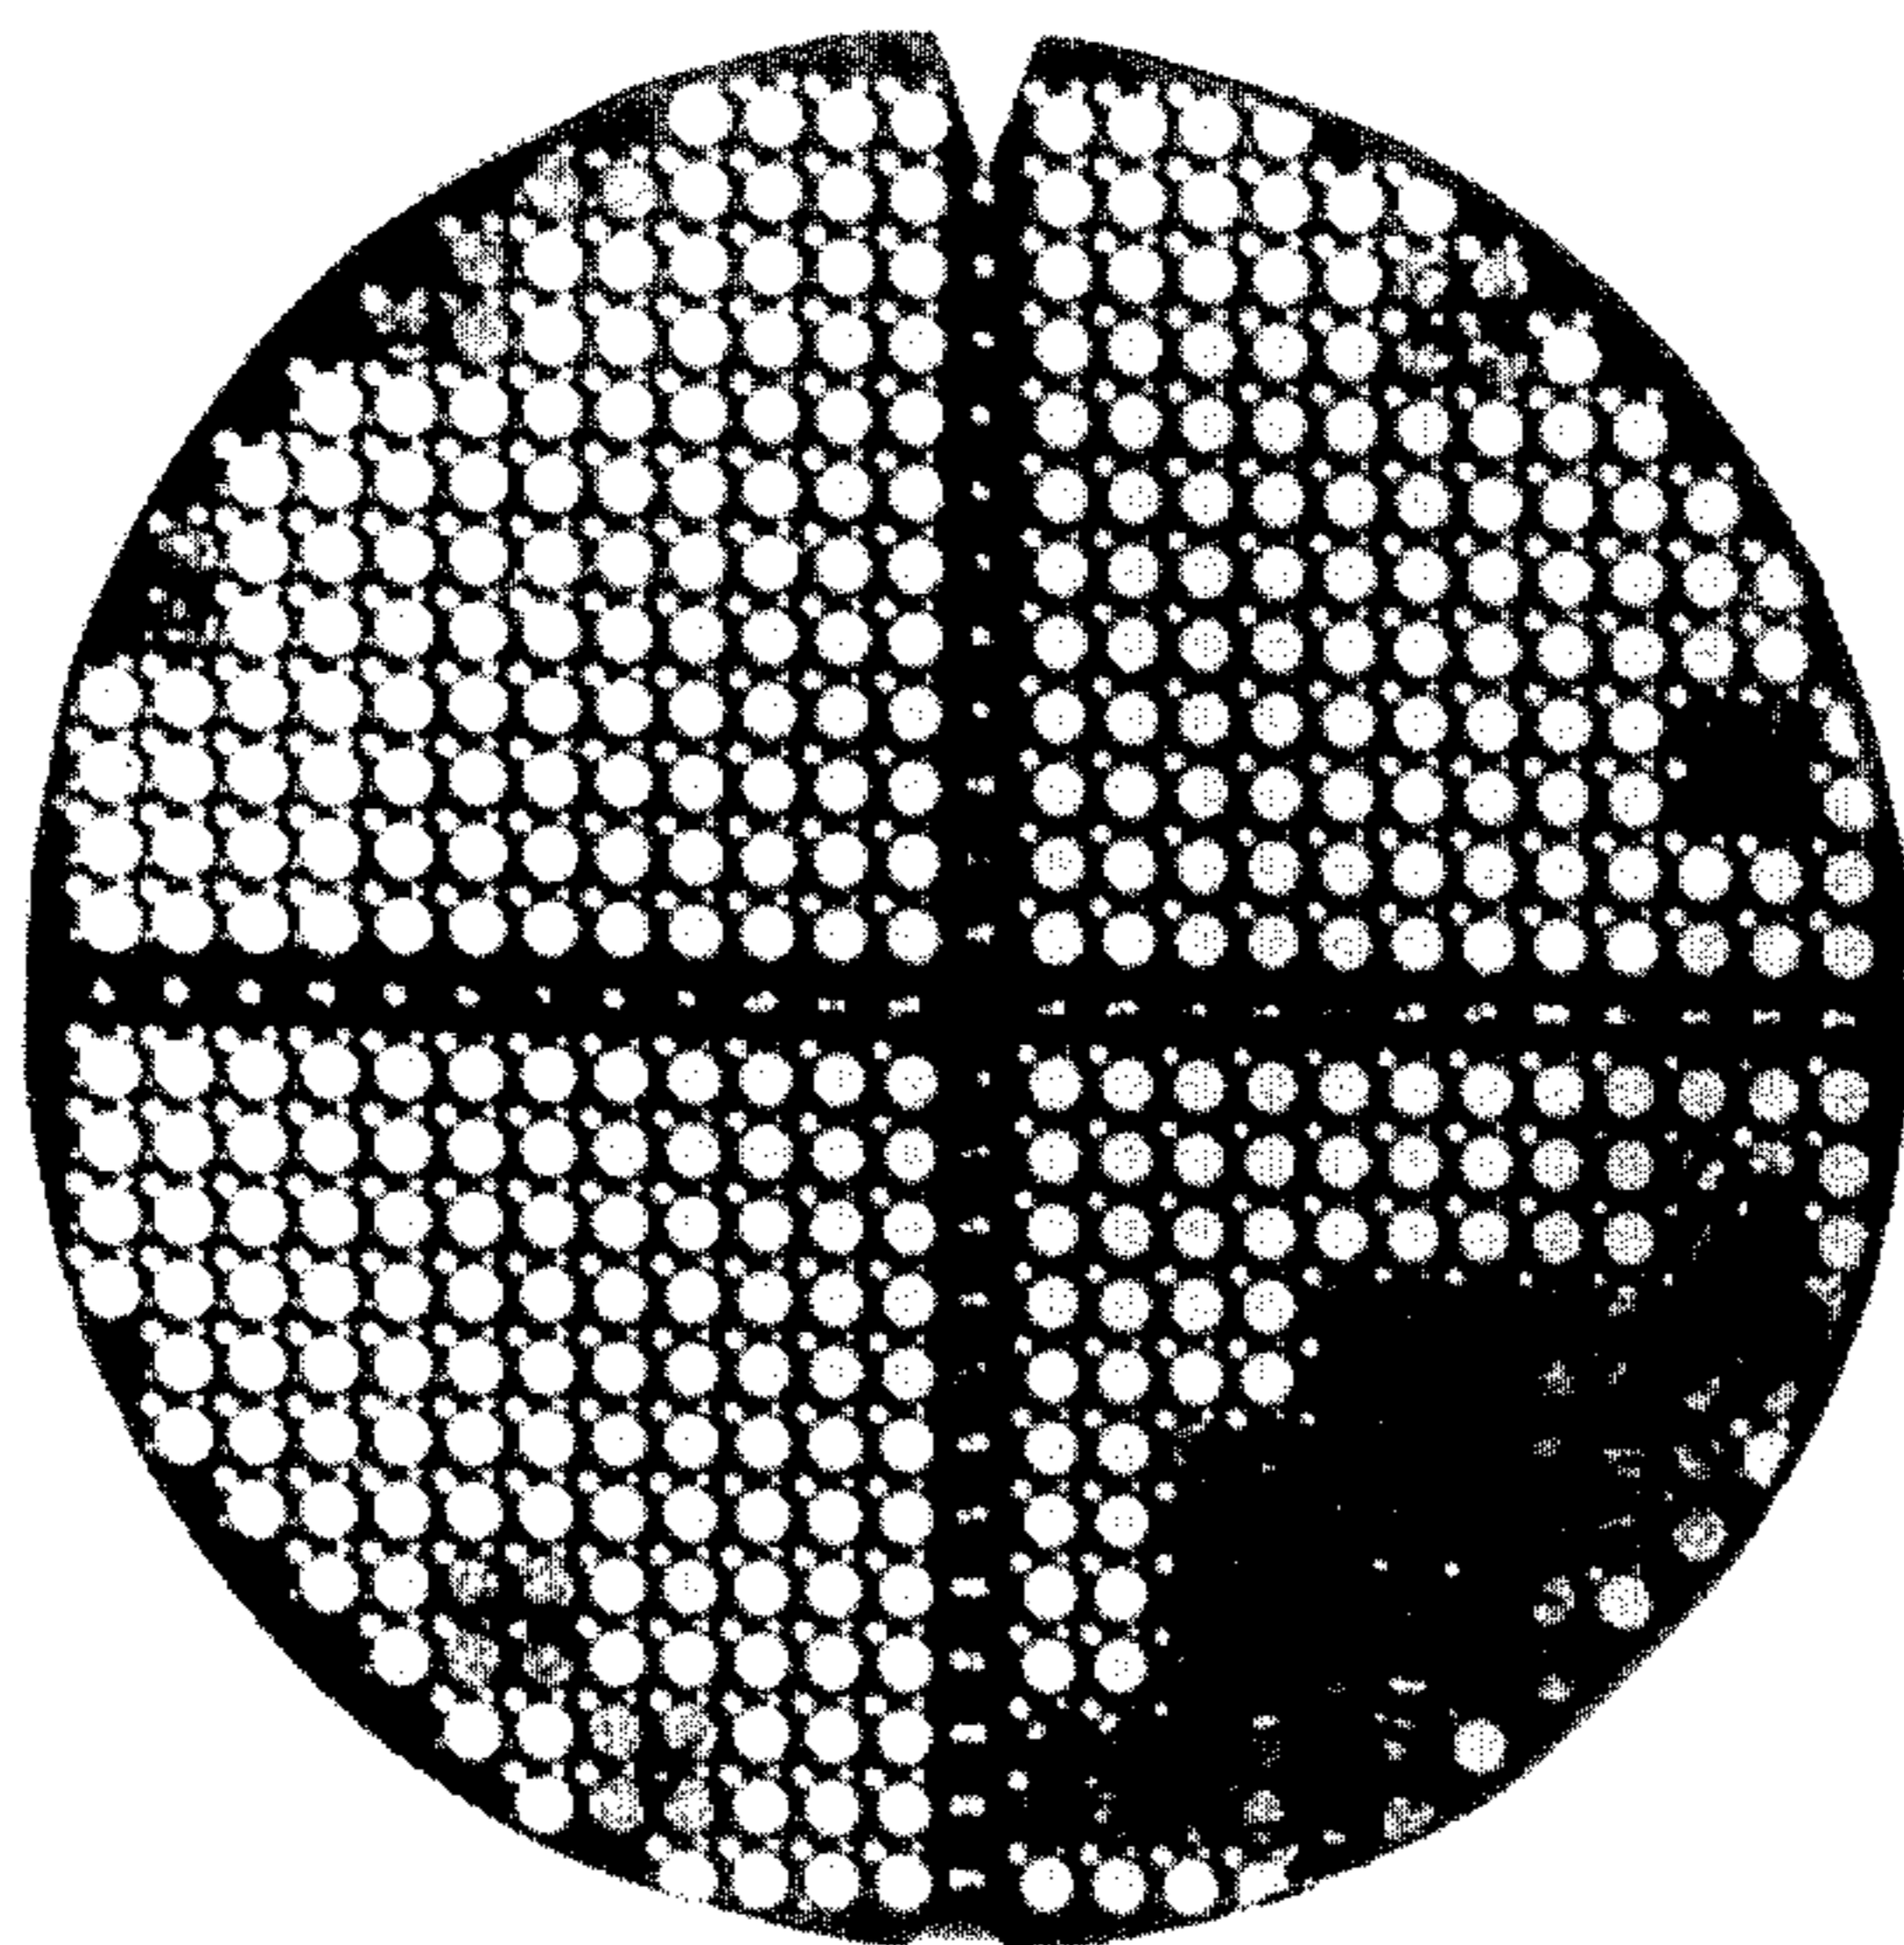
FIG. 8B is a retouched photograph of the wafer of FIG. 7A illustrating electrical defect site locations as determined by capacitor leakage current measurements.

This example illustrates the use of the process of the invention to locate electrically active defects in a P-N junction structure. A 20 ohm cm P-type silicon substrate having an N<sup>+</sup> blanket subcollector diffused region which is covered by an N<sup>-</sup> epitaxial layer was provided with an approximately 4,000 Å thick layer of thermal oxide on which aluminum dots were deposited. Capacitor leakage currents were measured and a map of the leakage currents which were greater than 6 nanoamps is illustrated in FIG. 8B. The greater than 6 nanoamp dots have been darkened with ink in the photograph.
