[54] **METHOD FOR NON-DESTRUCTIVE TESTING OF SEMICONDUCTOR ARTICLES**

[73] Assignee: International Business Machines Corporation, Armonk, N.Y.

A non-destructive method of mapping damage sites in the surface of a semiconductor article, such as a silicon wafer, establishes an interface between the semiconductor and a dilute acid electrolyte. The semiconductor article is negatively biased with respect to the electrolyte and the semiconductor surface is evenly illuminated. The biasing voltage and the illumination intensity are chosen such that small hydrogen bubbles, which stick to the surface of the semiconductor article, are produced at the damage sites. The locations of the bubbles are detected and recorded.

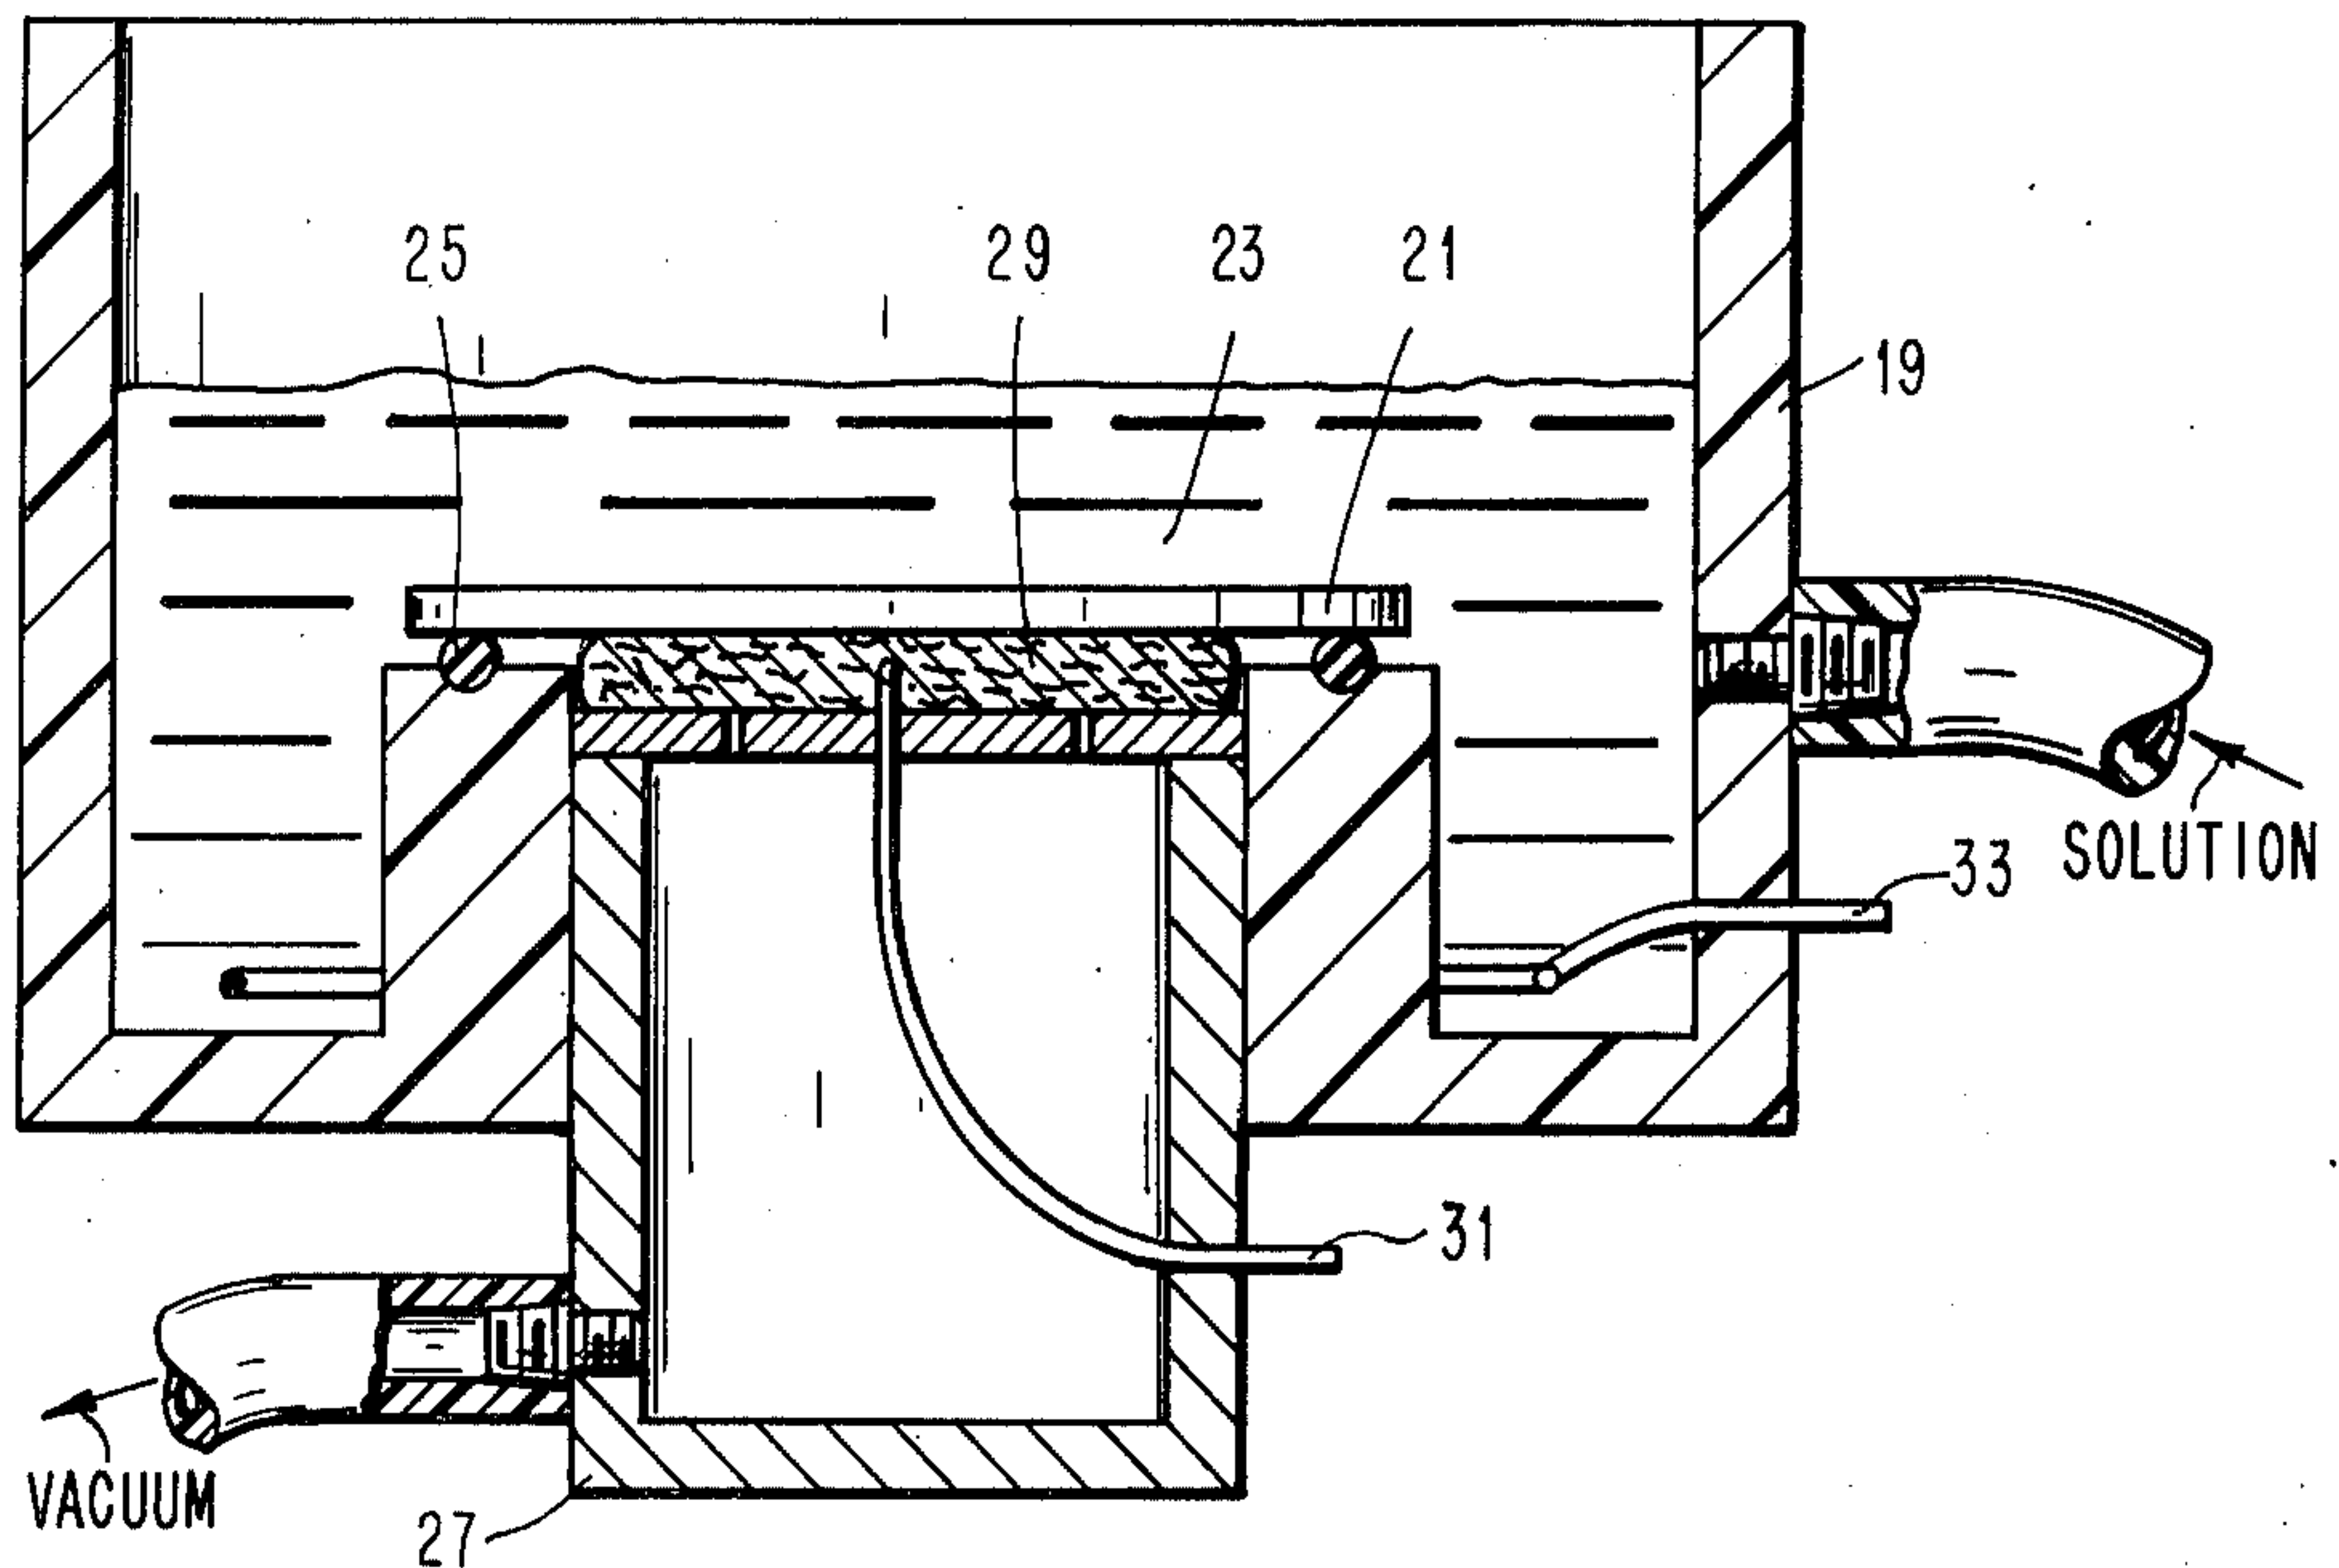
FIG. 1 is a schematic diagram of an apparatus suitable for carrying out the process of the invention.

Turning now to FIG. 1, an apparatus suitable for carrying out the process of the invention includes DC supply 11 capable of providing up to about 65 volts, ampmeter 13, test cell 19, and a white light source 15 which will provide up to at least 80 foot candles of illumination at the wafer surface. A suitable source is a tungsten flood lamp of 75 watts. A switch 17 is also provided. The details of test cell 19, which can be of polytetrafluoroethylene, is shown in FIG. 2. Cell 19 is constructed in a way to leave one entire surface 20 of semiconductor wafer 21 exposed to the electrolyte solution 23 so that the hydrogen bubble pattern for the whole wafer can be developed at one time. Wafer 21 is mounted in cell 19 which is provided with an O-ring vacuum seal 25. Wafer 21 is held in place by vacuum chuck 27 against a graphite impregnated sponge 29 which insures a large area of uniform electrical contact to the backside of wafer 21. Sponge 29 is connected to the cathode of the DC supply by wire 31. The anode is a platinum wire 33 which extends into solution 23.

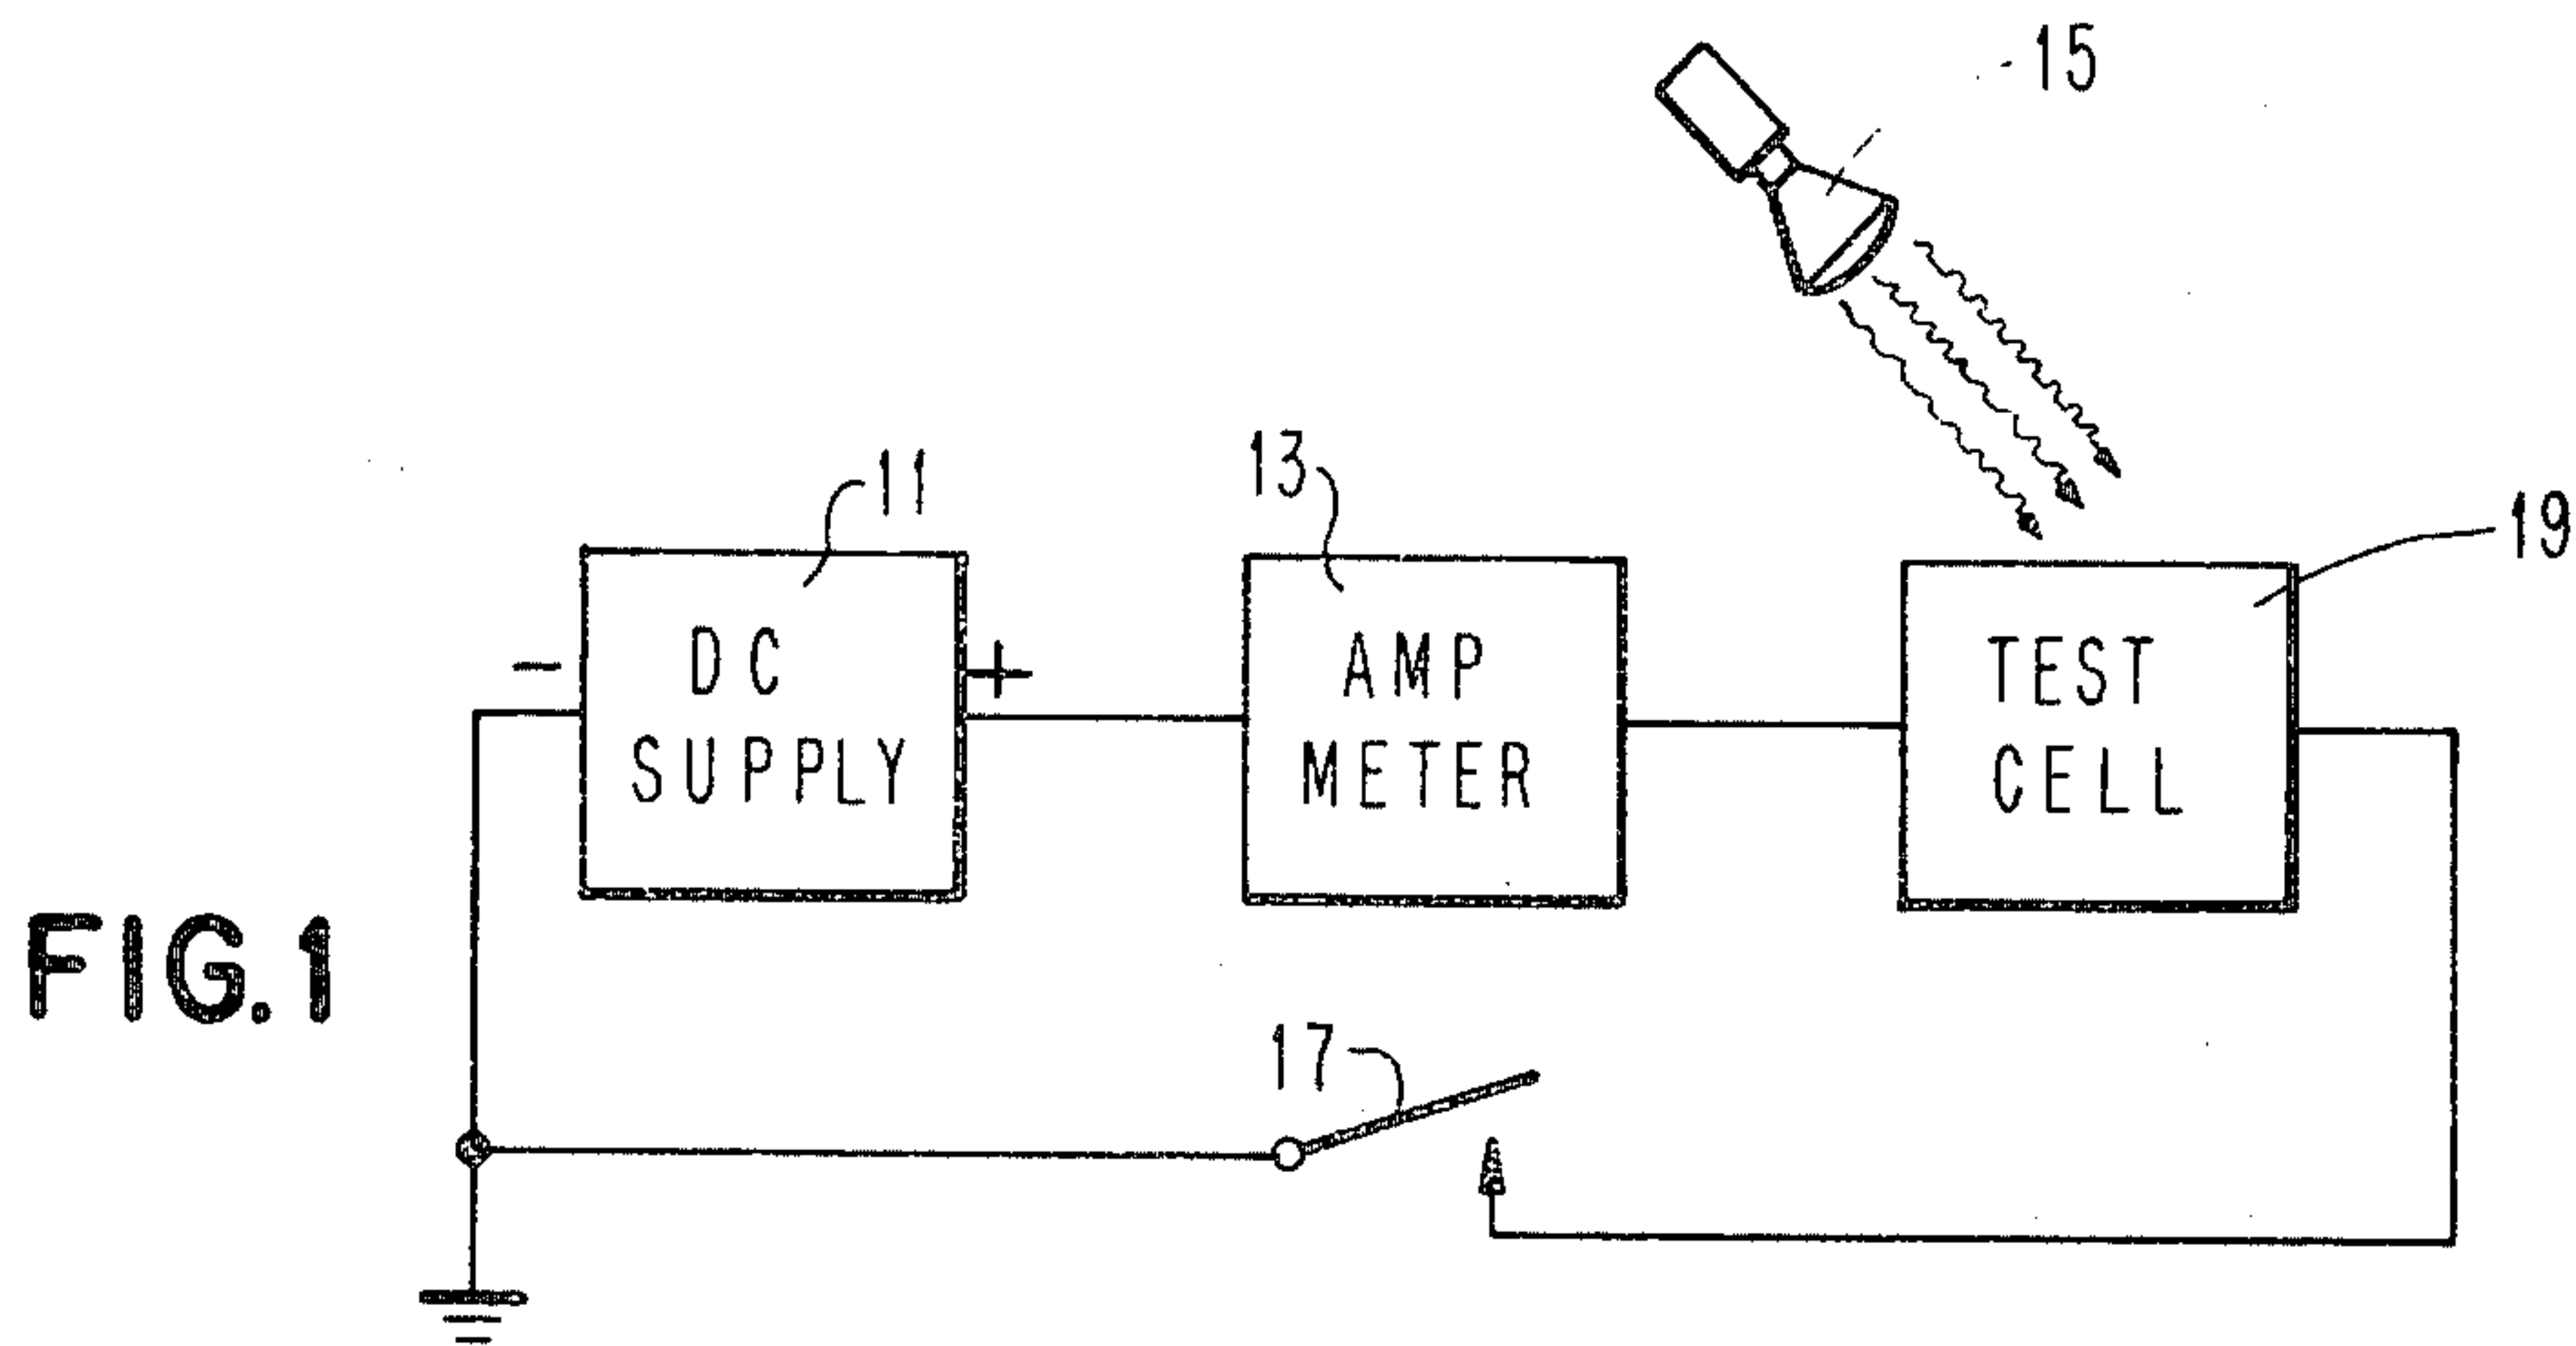
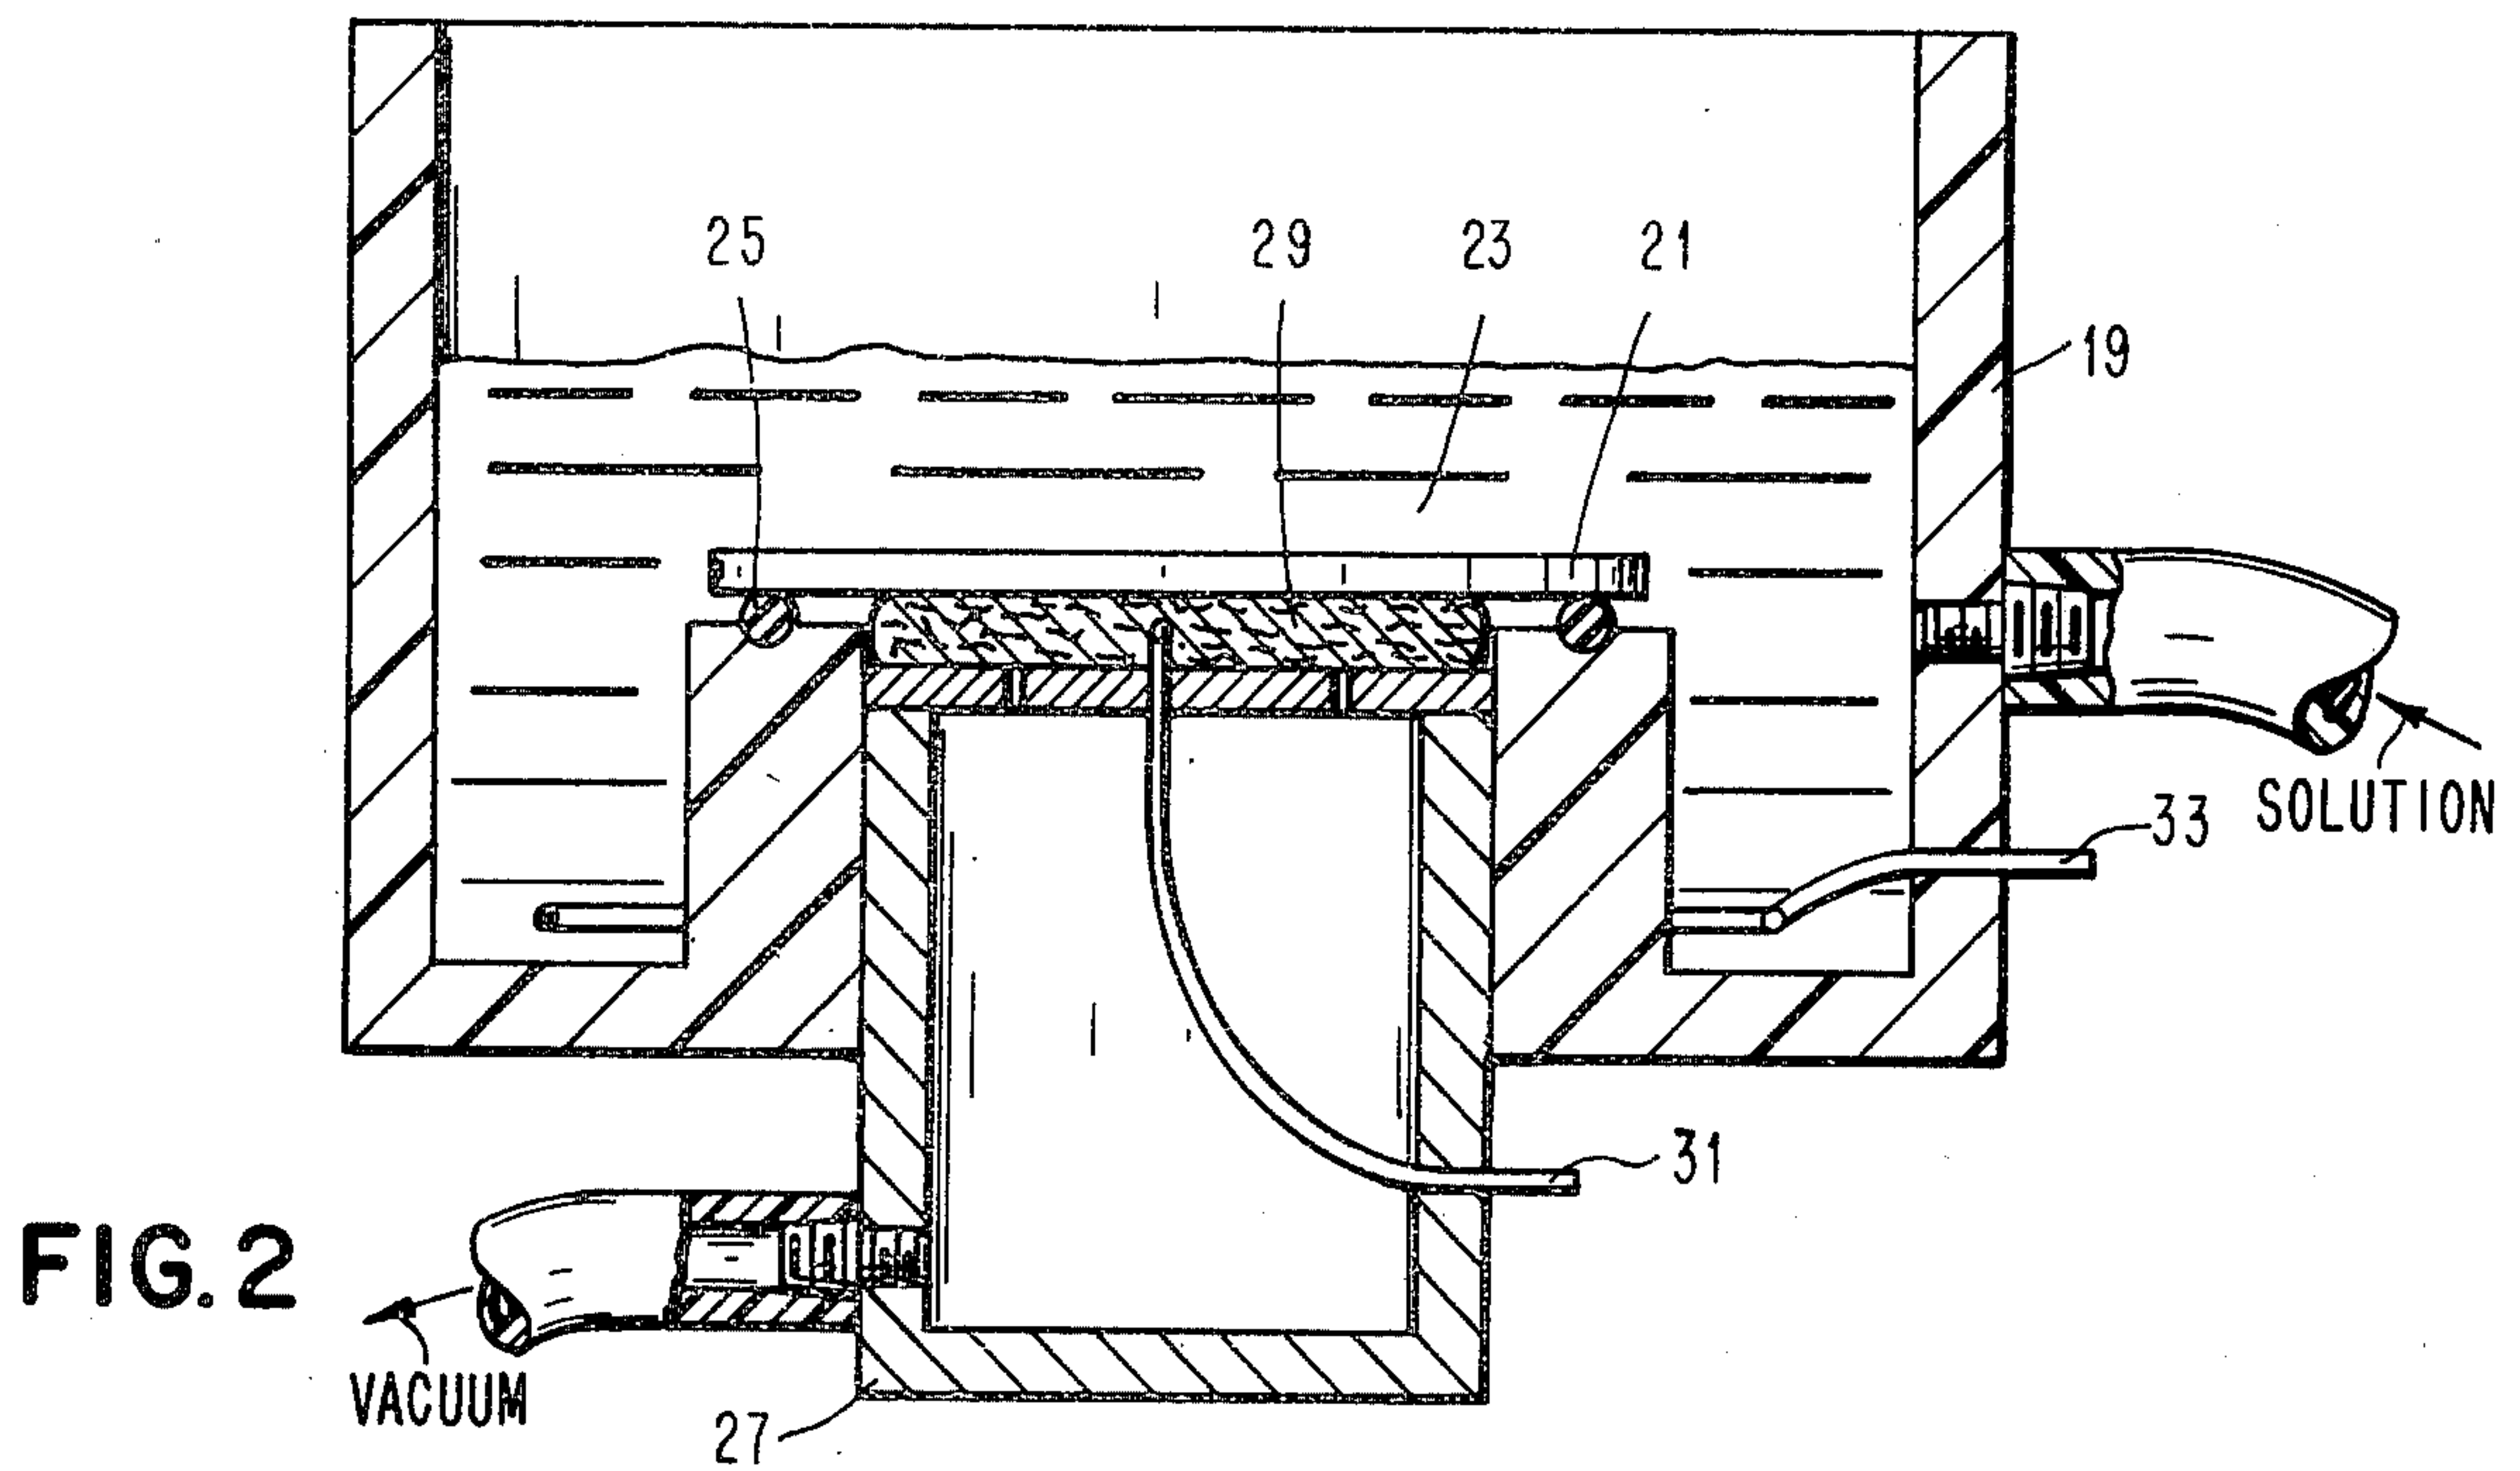
FIG. 2 is an elevational view, partially in section, of a test cell suitable for use in carrying out the process of the invention.

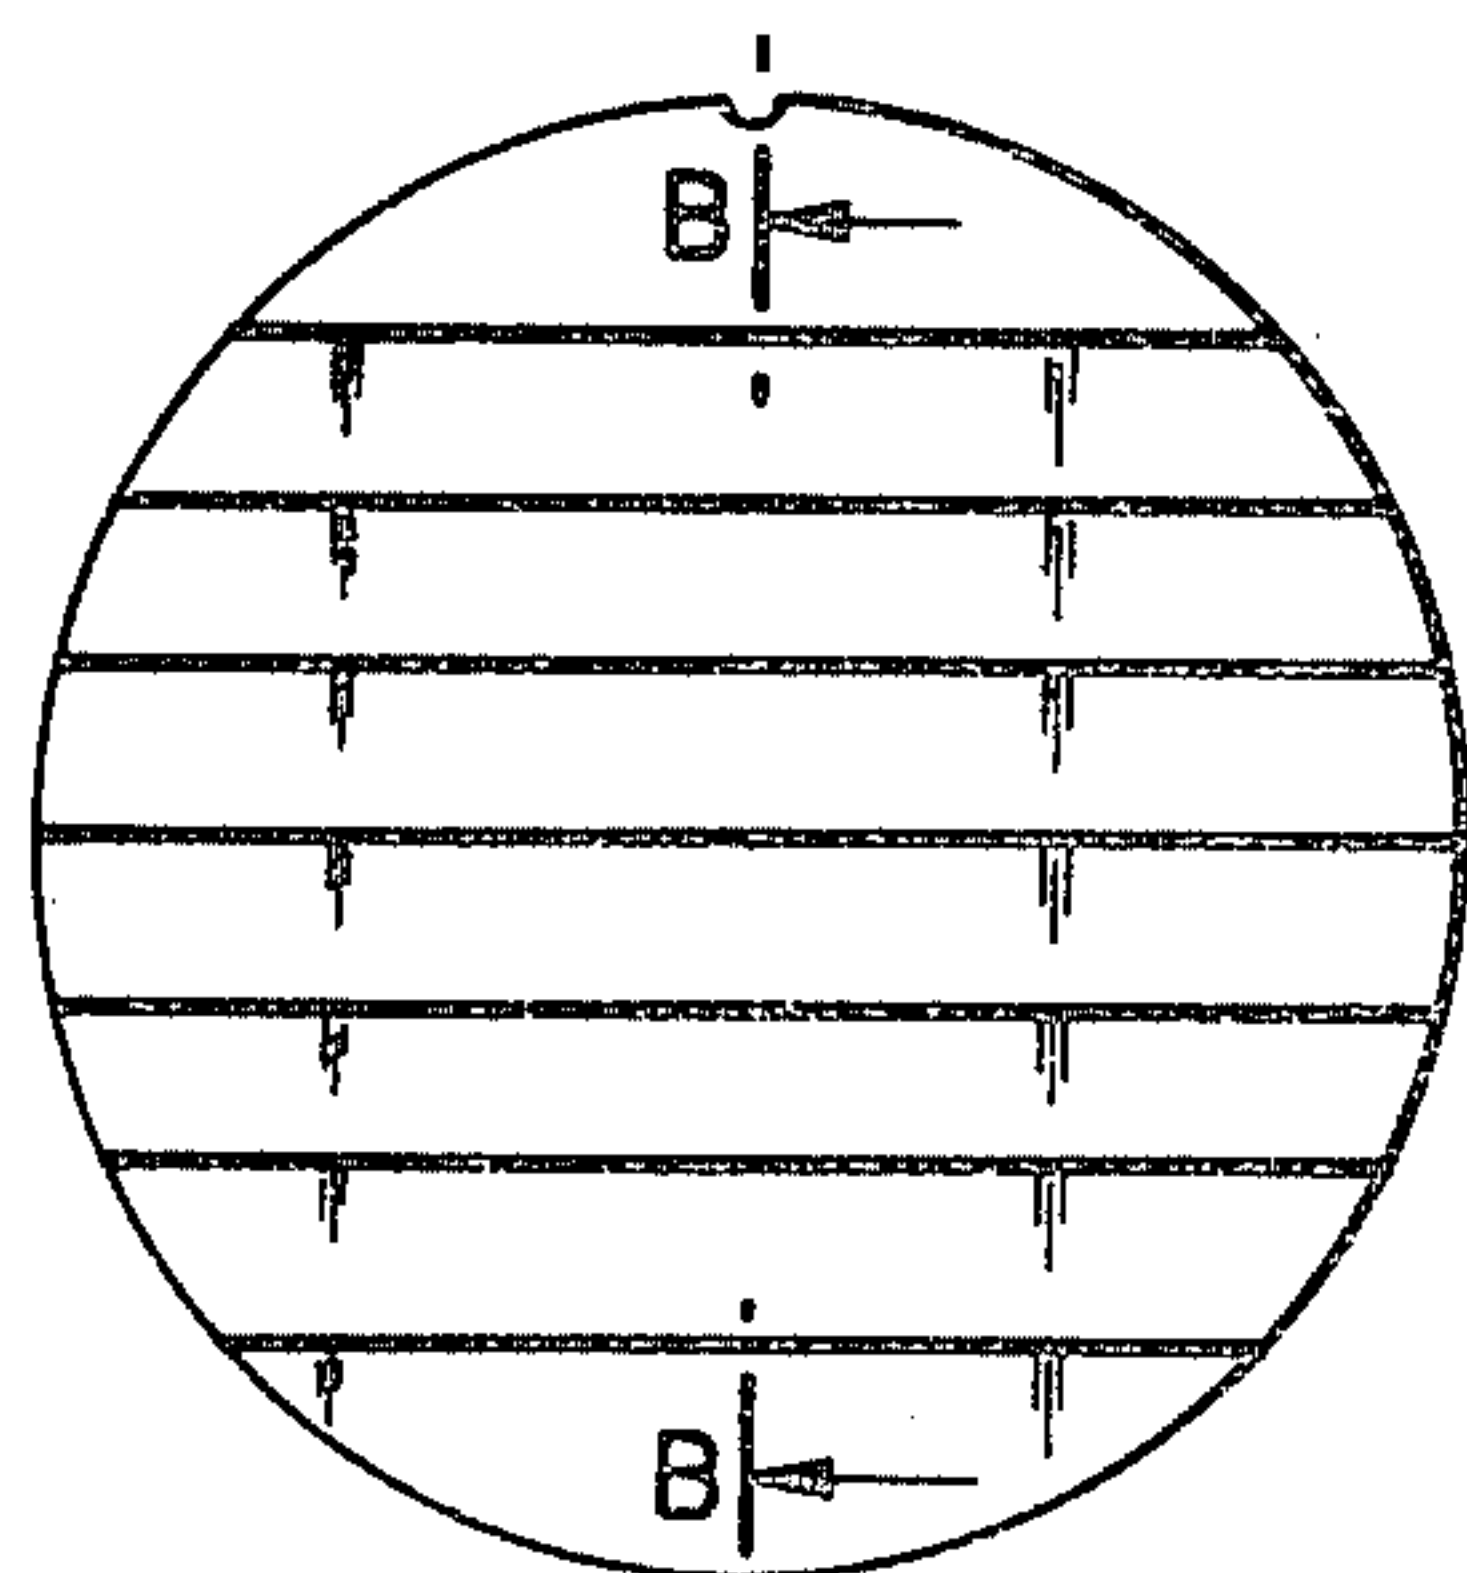
FIG. 3A is a plane view illustrating a step etched semiconductor wafer in which increasing amounts of material are removed from successive steps.

FIG. 3B is a cross-sectional view of the wafer of FIG. 3A along line B—B.

A damaged P-type 2 ohmcentimeter monocrystalline silicon wafer was step etched as illustrated in FIGS. 3A and 3B with the depth of the steps being shown in Table I.

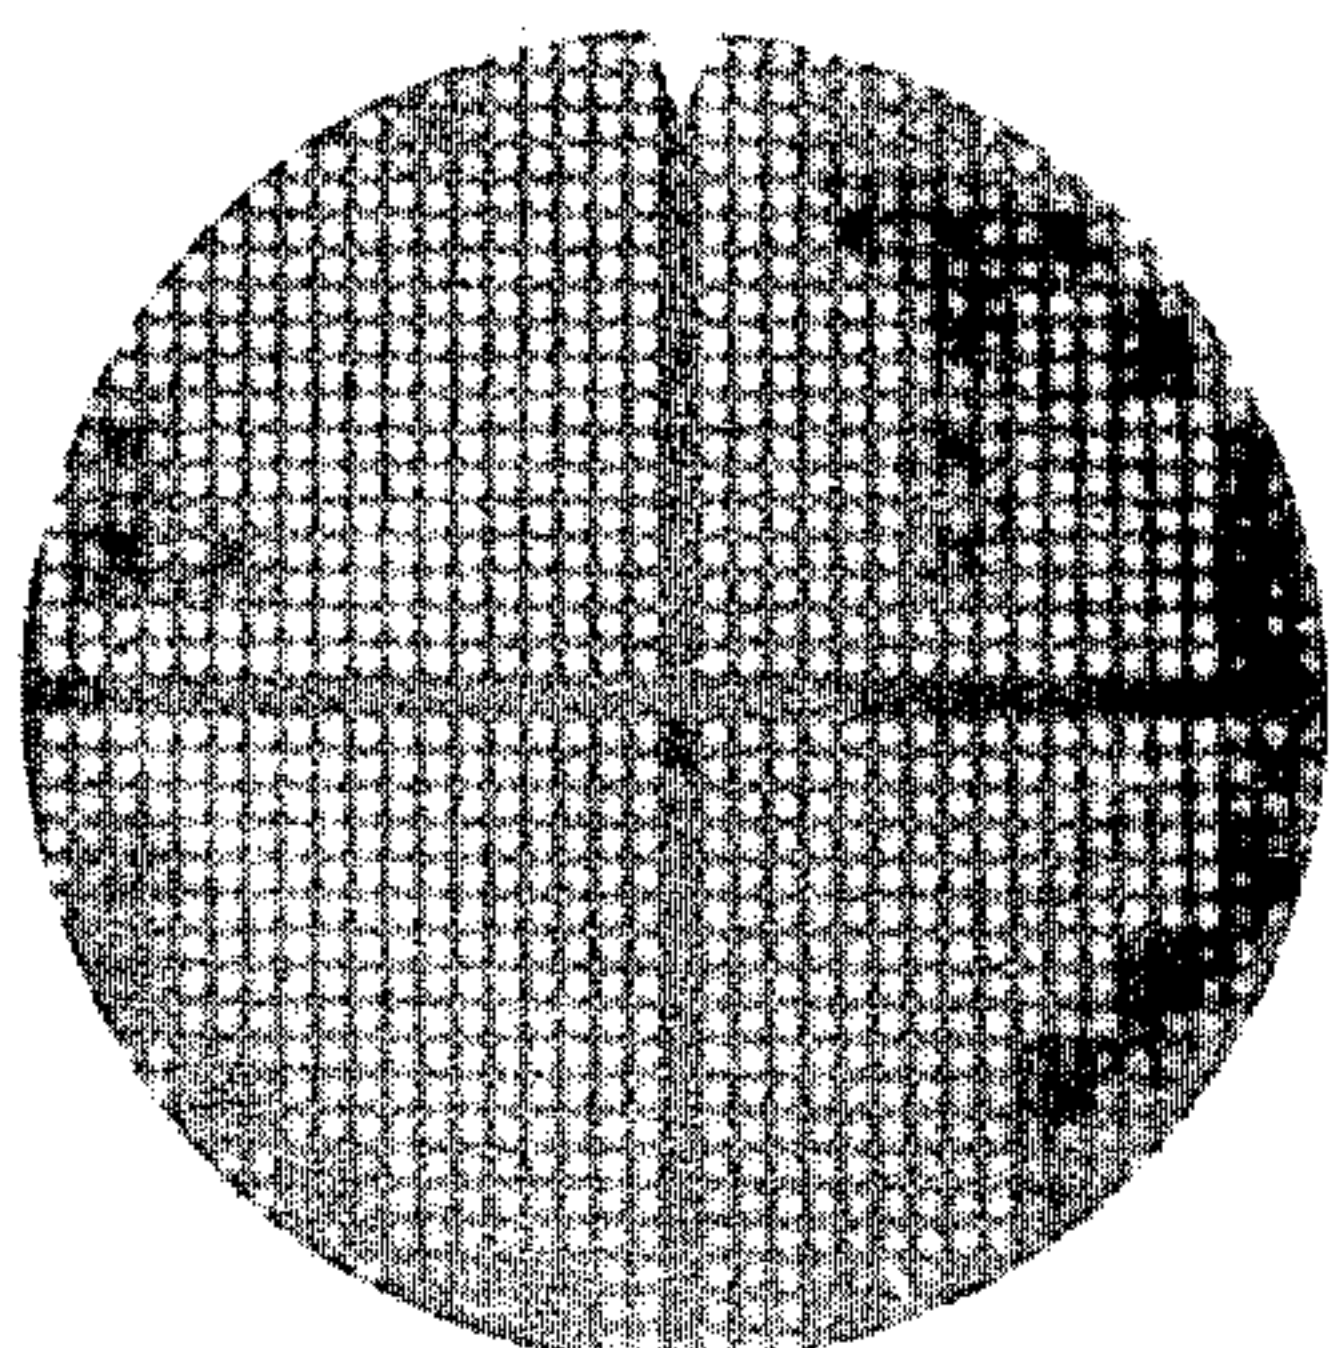
FIGS. 6A—D are photographs (6A—6C) illustrating hydrogen bubble patterns obtained at different illumination and bias voltage conditions as compared to a re-

touched photograph (6D) of the same P-type silicon wafer illustrating electrical defect site locations as determined by capacitor leakage current measurements.

The cleaned substrate was placed in the test cell 19 in a 2% by volume sulfuric acid solution and a negative 5 volt bias was applied for 5 seconds in the dark. The results are shown in FIG. 6A where no hydrogen formation was noted. The current was 9 ma. Next a negative bias of 5 volts for 5 seconds was applied with an illumination at the wafer surface greater than 250 foot candles. The current was 112 ma and in FIG. 6B small bubbles developed in the lower left and upper right hand quadrants of the substrate surface. It can be seen that the bubbles noted in the lower left hand quadrant of FIG. B do not correspond with the defects on the capacitor leakage current map of FIG. 6D. Next, the wafer was subjected to a 60 volt negative bias for 5 seconds with an illumination at the wafer surface of about 60 foot candles in accordance with the process of the invention. The hydrogen bubble pattern which was developed was photographed and is illustrated in FIG. 6C. It can be seen that the defect sites as determined by the bubble test (FIG. 6C) are in good correspondence with those shown in FIG. 6D where defects are noted around the perimeter of the substrate and extending into the upper right hand quadrant.

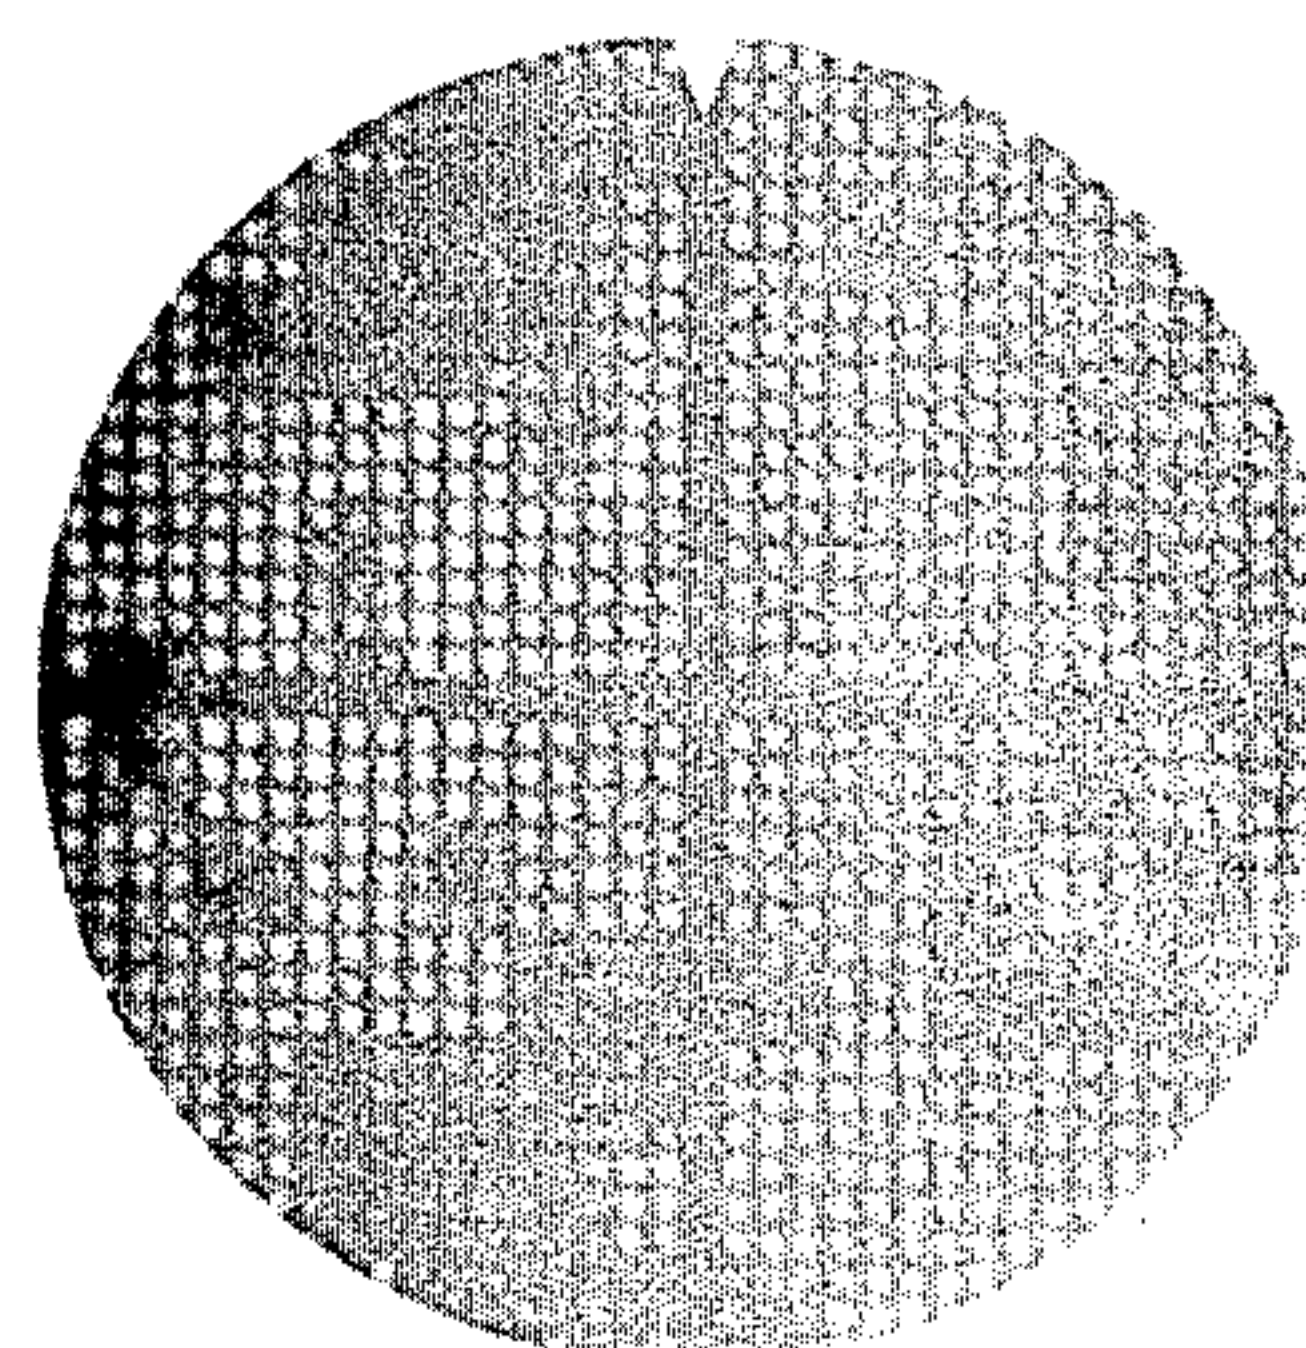
FIGS. 7A-D are photographs (7A-7C) illustrating hydrogen bubble patterns obtained at different illumination and bias voltage conditions compared to a retouched photograph (7D) of the same P-type silicon wafer illustrating electrical defect site locations as determined by capacitor leakage current measurements.

currents were measured on every third dot. The map of capacitor leakage currents greater than 6 nanoamps is illustrated in FIG. 7D. After stripping the aluminum and oxide, the substrate was cleaned in detergent and HF as described above. The sample was bubble tested in test cell 19 with the electrolyte being 2% volume sulfuric acid in deionized water. At a negative bias of 5 volts for 5 seconds in the dark no hydrogen formation was noted as illustrated in FIG. 7A. The current was 3 ma. At a negative bias of 5 volts for 5 seconds with an illumination at the wafer surface of greater than 250 foot candles, only a very small amount of hydrogen was formed (FIG. 7B). The current was 120 ma. Under the bubble test conditions of the invention with a negative bias of 60 volts for 5 seconds at about 60 foot candles a hydrogen bubble pattern was formed as illustrated in FIG. 7C. It can be seen that there is good correlation between the bubble pattern of FIG. 7C and that of the capacitor leakage map illustrated in FIG. 7D.

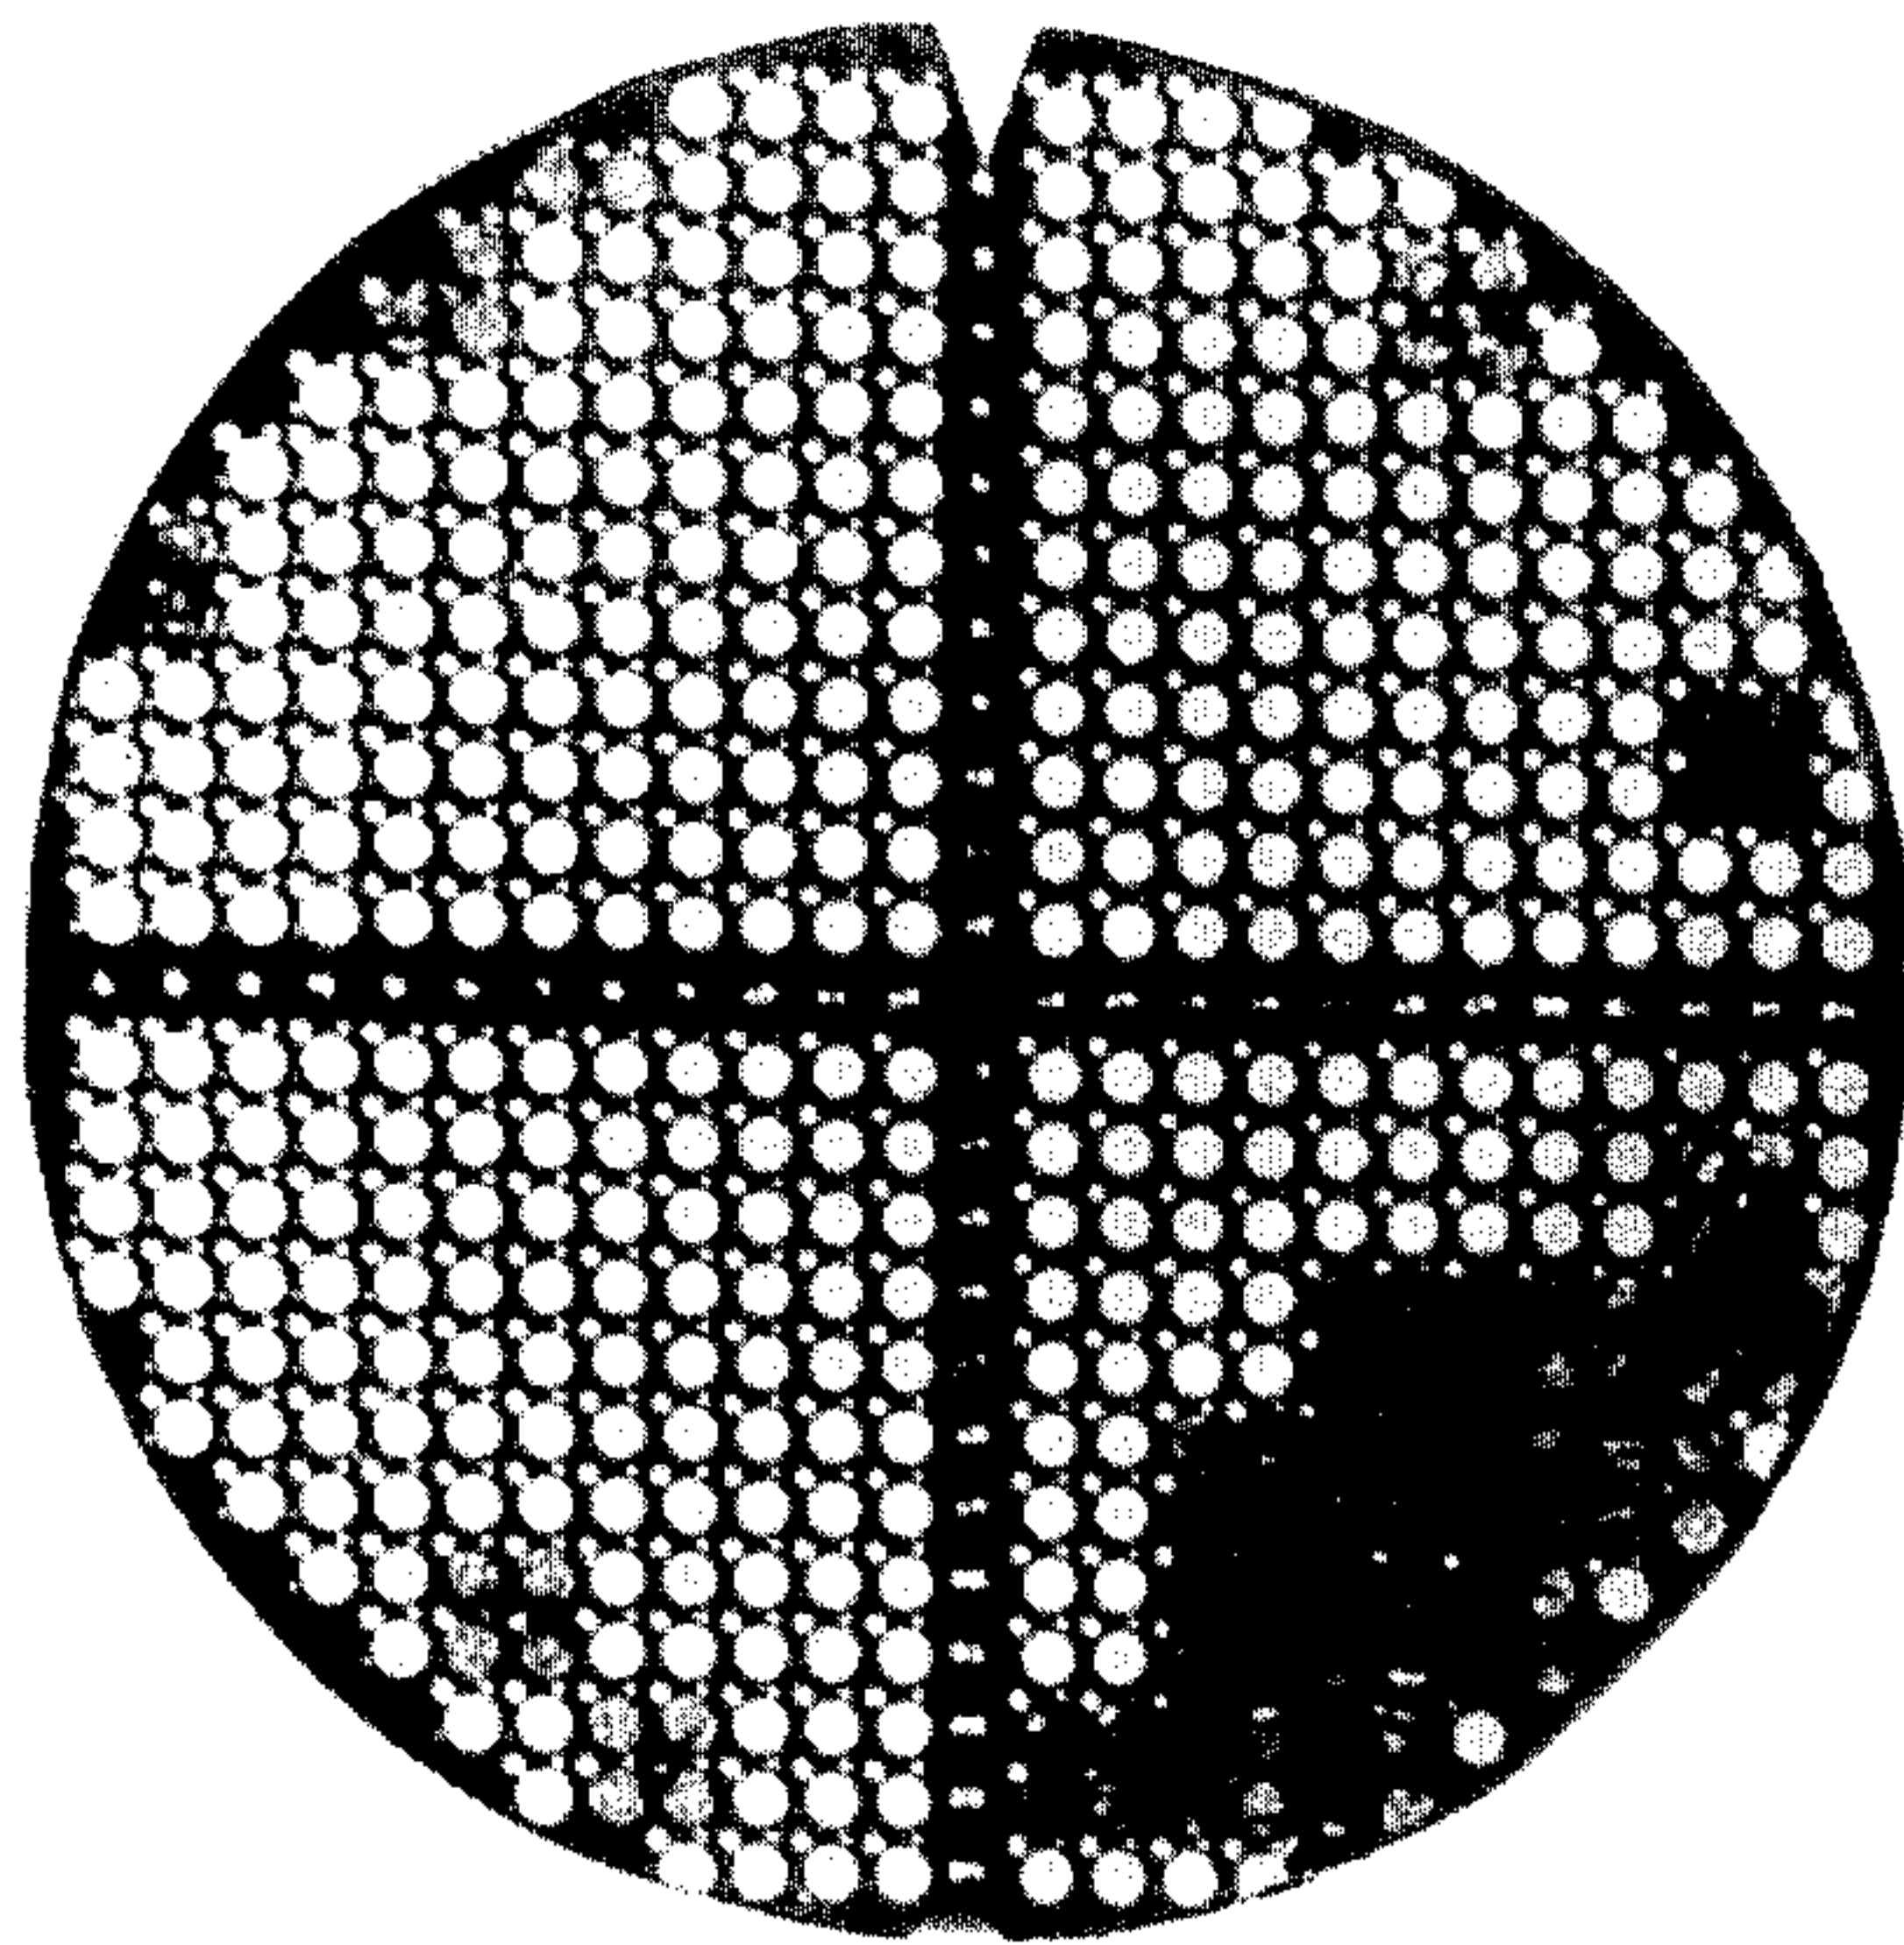
FIG. 8B is a retouched photograph of the wafer of FIG. 7A illustrating electrical defect site locations as determined by capacitor leakage current measurements.

This example illustrates the use of the process of the invention to locate electrically active defects in a P-N junction structure. A 20 ohm cm P-type silicon substrate having an N⁺ blanket subcollector diffused region which is covered by an N⁻ epitaxial layer was provided with an approximately 4,000 Å thick layer of thermal oxide on which aluminum dots were deposited. Capacitor leakage currents were measured and a map of the leakage currents which were greater than 6 nanoamps is illustrated in FIG. 8B. The greater than 6 nanoamp dots have been darkened with ink in the photograph.
