[54] METHOD OF REPAIRING SURFACE DAMAGE TO POROUS REFRACTORY SUBSTRATES

[73] Assignee: The United States of America as represented by the Administrator of the National Aeronautics and Space Administration, Washington, D.C.

A method of repairing damage to a porous refractory material coated with a glass coating (16) comprising applying hydrolyzed tetraethyl orthosilicate to the damaged area, curing said tetraethyl orthosilicate, applying to said damaged area a pliable filler (30) comprised of hydrolyzed tetraethyl orthosilicate and powdered refractory substrate (11) and heating the damaged area to cure filler (30).

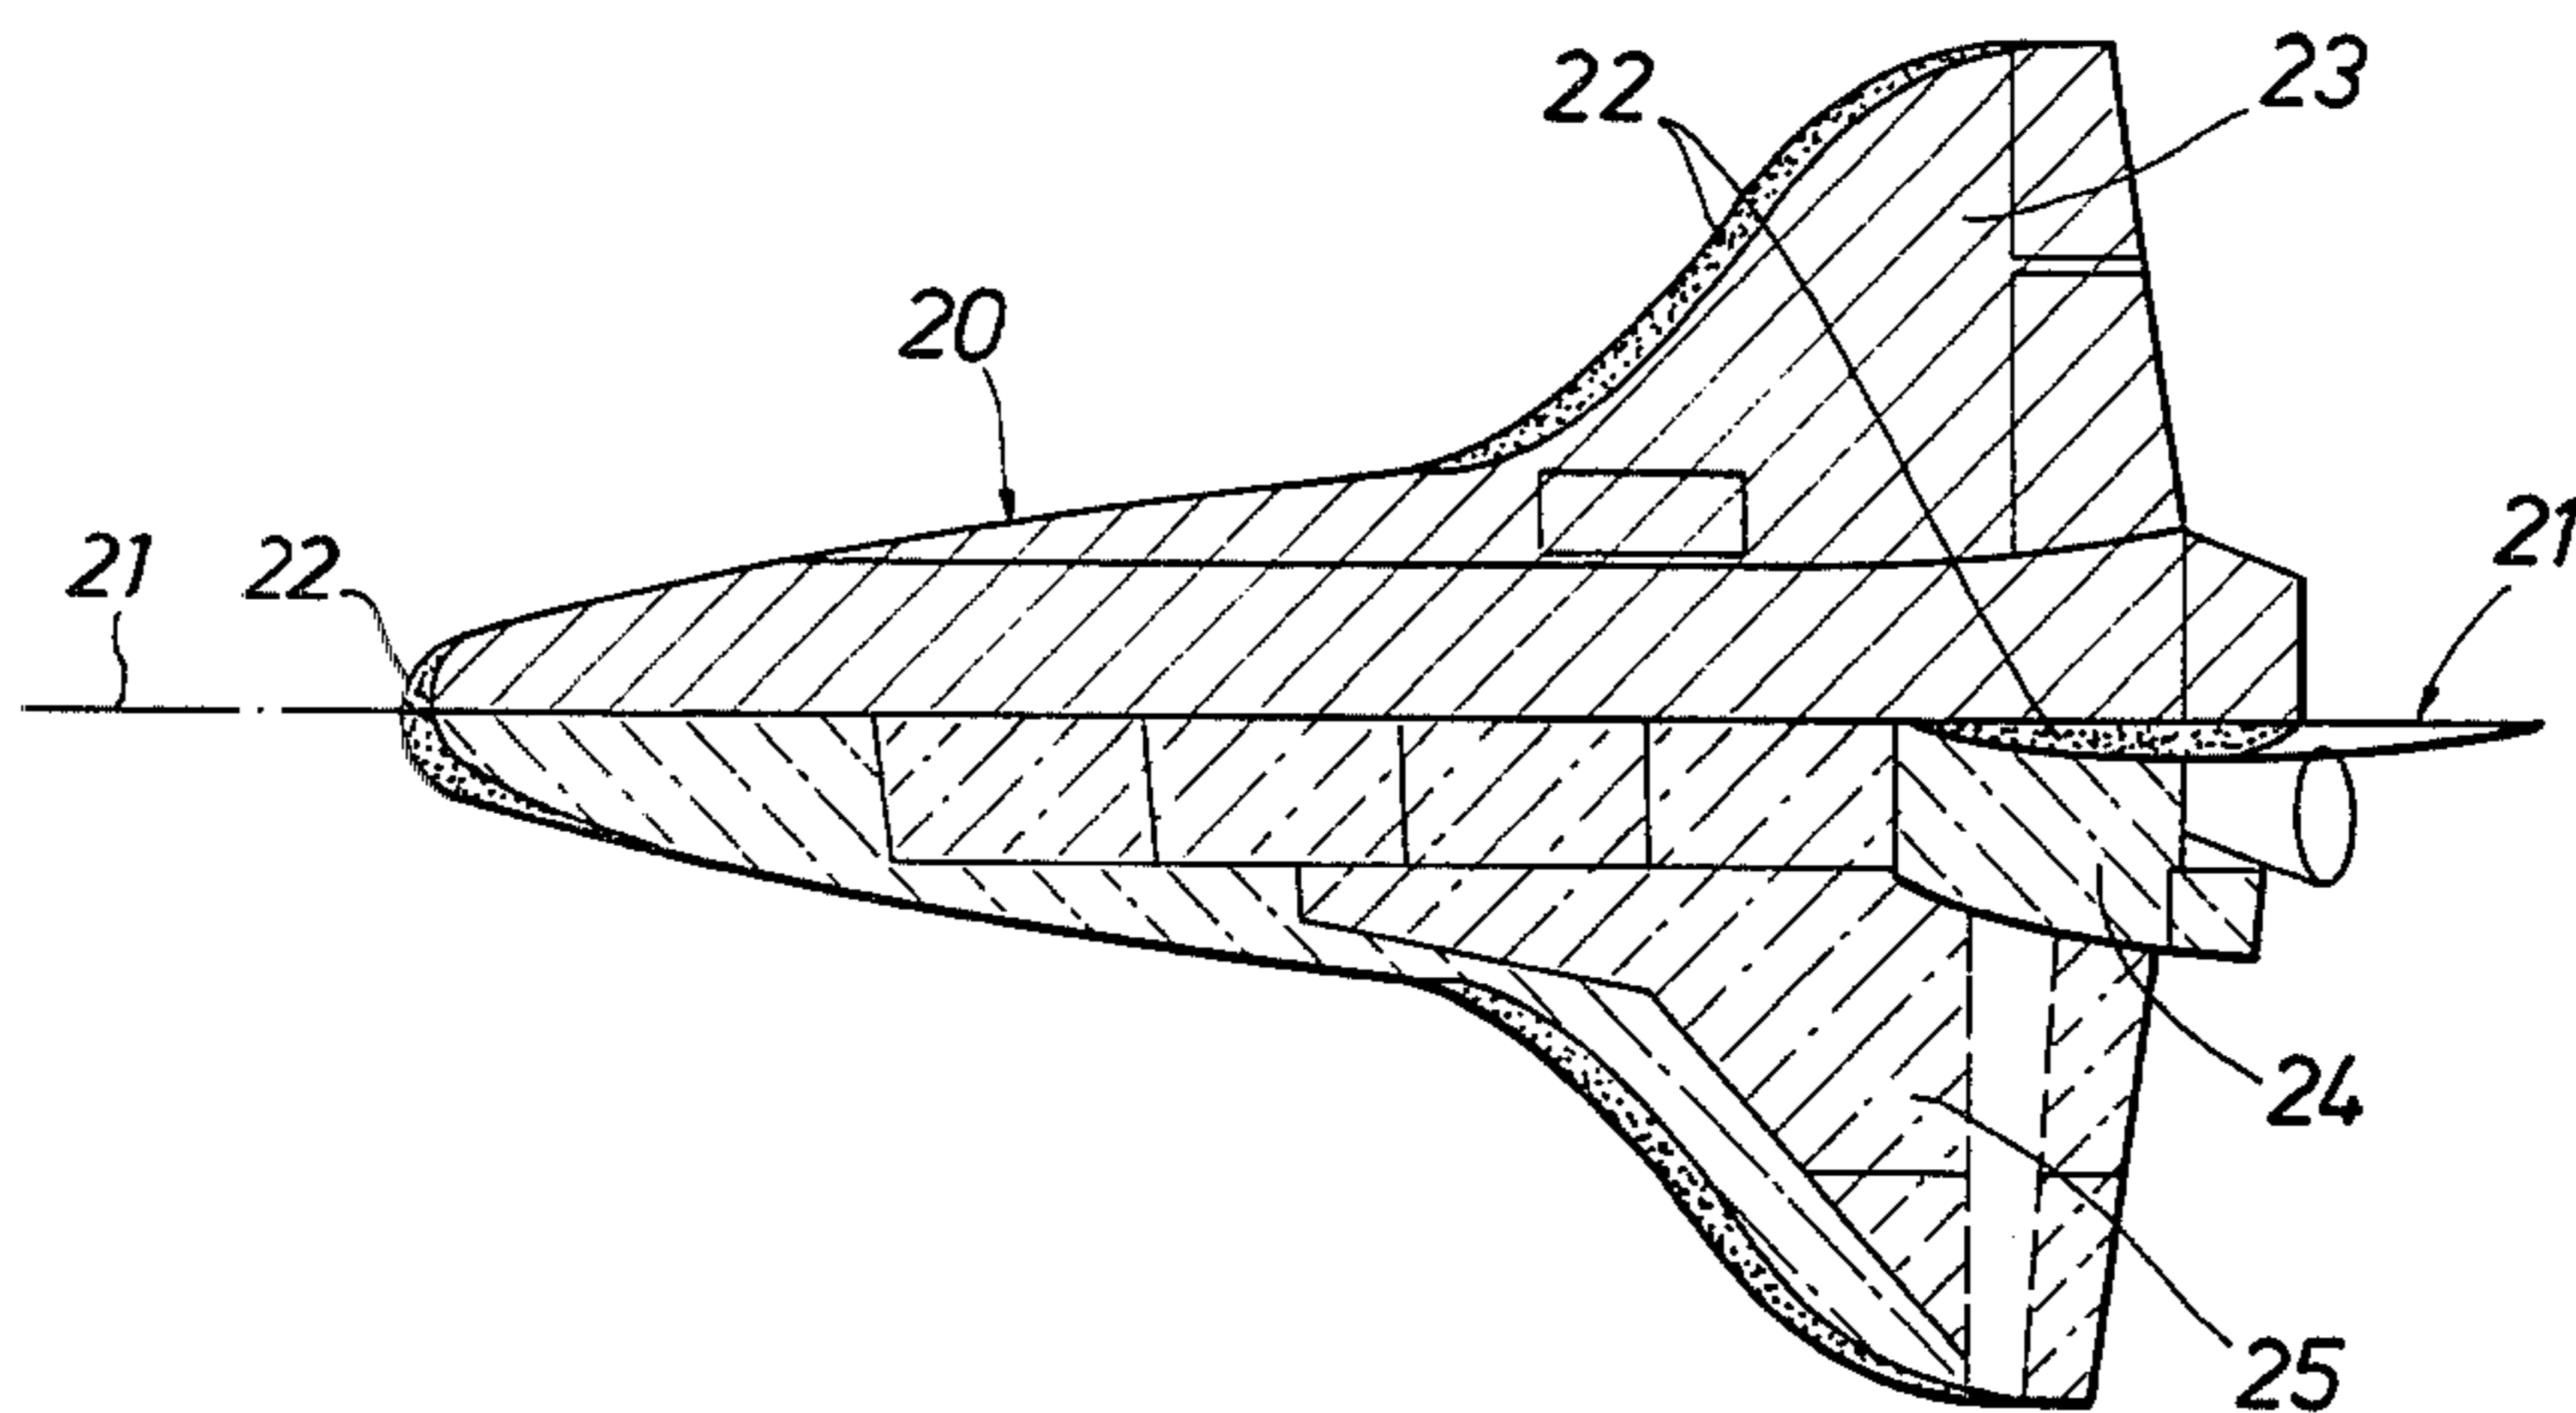
FIG. 1 is a plan view of a space shuttle orbiter showing the thermal protection system.

Referring first to FIG. 1, an orbiter vehicle 20 is illustrated, the portion of the vehicle above the horizontal line 21 representing the lower surface of the vehicle and the portion of the vehicle below the horizontal line 21 representing the upper surface of the vehicle. The line 21 represents a vertical plane through the vehicle. In FIG. 2, a side view of the vehicle is illustrated. The orbiter 20 is shaded in four areas with the dotted area representing a coated reinforced carbon-carbon insulation area 22, the line shaded area representing a high temperature re-usable surface insulation area 23, a first line-dot-line shading representing a low temperature re-usable surface insulation area 24 and a second line-dot-line shading representing a flexible or re-usable

surface insulation area 25. The area 22 on the nose cap and leading edges of the wings is capable of withstanding the effects of temperature in excess of 2300° F. The area 23 which is most of the lower surface will withstand the effects of surface temperature in the range of 1200° F. to 2300° F. The area 24 which includes the side surfaces of the tail and the forward top and sides of the vehicle will withstand the effects of surface temperature in the range of 700° F. to 1200° F. The area 25 which is the upper surface of the wings, the top and rearward sides of the vehicle will withstand the effects of surface temperatures up to 900° F. With the exception of area 22 on the nose cap and leading edges of the wings, the high temperature areas are protected by re-usable surface insulation (RSI) tiles such as the L1-900 tiles discussed above. As noted, remaining portions of the top side of the vehicle, wings and fuselage, may reach temperatures approaching 1200° F. and are protected by a silica insulation and organic material with sufficient thermal stability. The tiles are formed of 99.7% pure silica fibers 1 to 10 microns thick. The fibers are rigidized into a solid block by ceramic bonding. For example, a slurry containing fibers mixed in water may be flame cast to form soft, porous blocks to which colloidal silica binder is added. When the porous blocks are sintered at 2400° F., a rigid block is produced which is cut and machined to the precise dimensions to form the individual tile. Ninety percent of the tile is formed of voids and 10% fibers thereby permitting lightweight tiles to be formed. Depending upon the location on the vehicle, the tiles are provided with glass coatings exhibiting varying optical properties. Thus, the coatings may be either a darkened surface to be optically absorbing or a white surface so as to be optically reflective. Additionally, the tiles are usually treated with a silane impregnating agent to provide waterproofing.

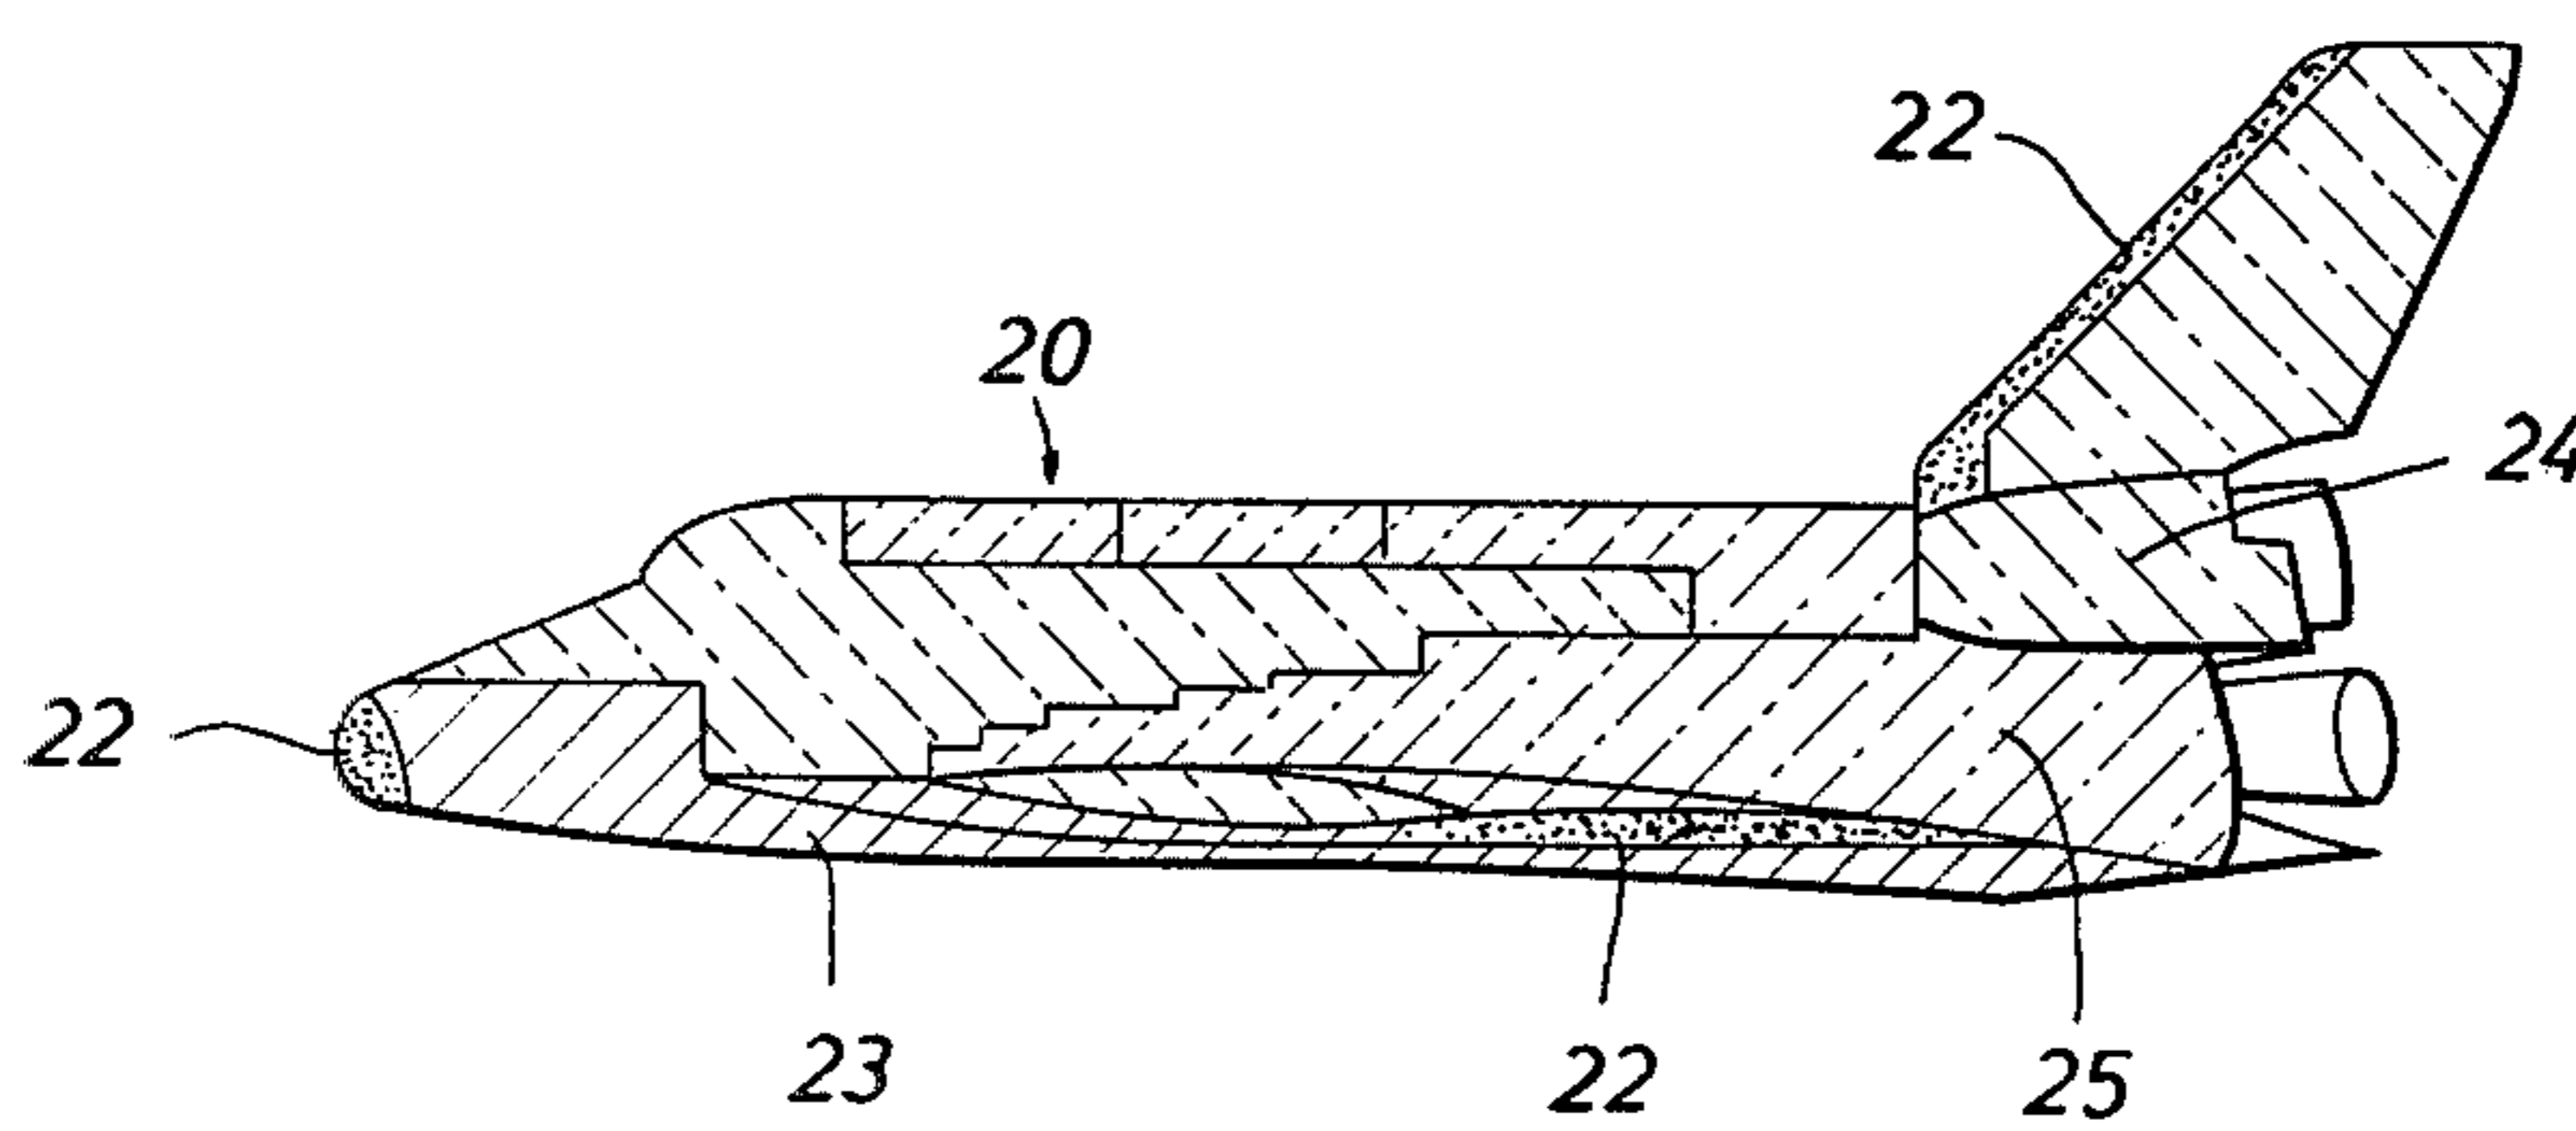
FIG. 2 is a side view of the orbiter shown in FIG. 1.

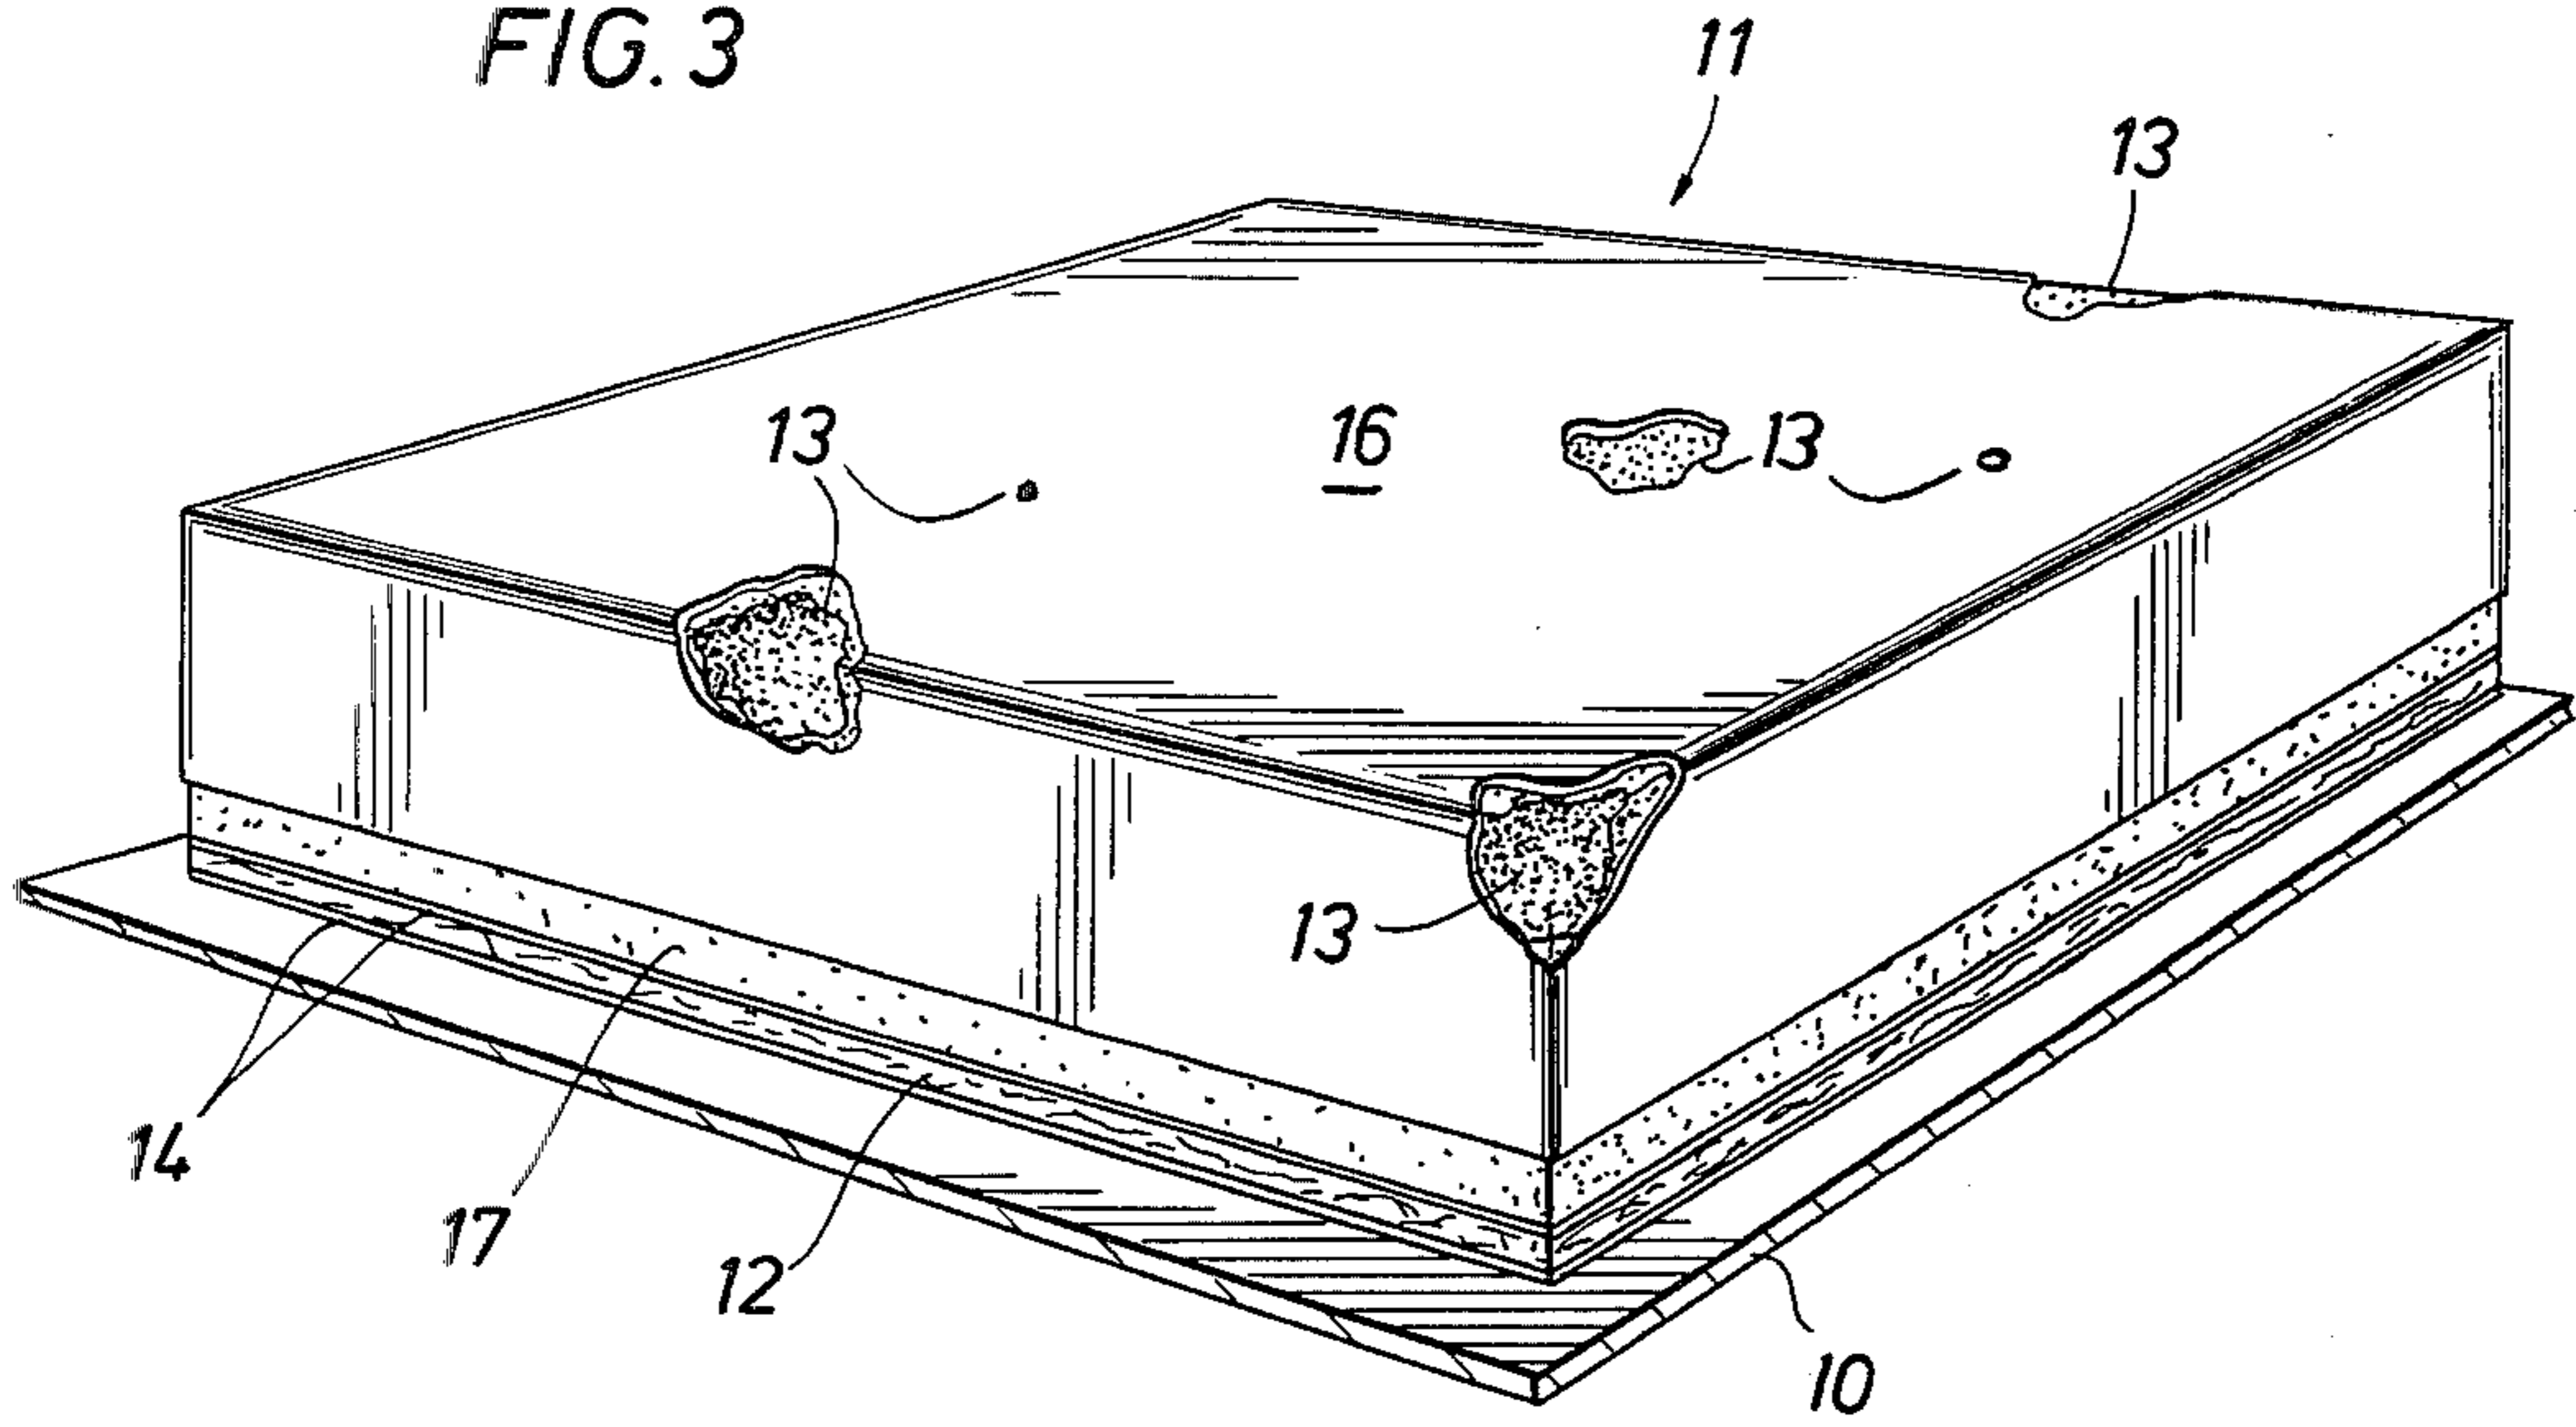
FIG. 3 is a simplified pictorial representation illustrating how the insulating tile is attached to the structure of the space shuttle.

Referring now to FIG. 3 there may be seen a pictorial representation of the system of attaching the high purity silica tiles to the metallic outer surface 10 (aluminum alloy) of the vehicle. The tiles, shown generally as 11, are approximately 6×6 inches, with varying thickness depending upon specific vehicle location and heat load. Accordingly, it will be apparent from FIG. 3 that the tiles 11 form a thermal shield over the surface 10. Furthermore, it will be apparent from consideration of the structure depicted in FIG. 3 that tiles 11 will be subject to damaging structural stresses arising because of the difference in coefficient of thermal expansion between the metal 10 of the vehicle and the material from which the tiles 11 are fabricated, as well as deflections of the structure due to mechanical (both aerodynamic and internal pressure) loads unless such loads are isolated. Accordingly, in attaching each of the tiles 11 to the metallic surface 10 an intermediate layer of material, such as a felt pad 12, is interposed to act as a strain isolator. Although the temperature during re-entry may be 2300° F., the effective temperature for strain isolator pad 12 will be 500° F. due to the insulating characteristics of the tile. To attach tile 11 to pad 12 and pad 12 to the outer aluminum surface 10 of the shuttle orbiter, thin layers 14 (generally less than 10 mils.) of a silicone adhesive are utilized. A suitable adhesive is methylphenyl silicone (RTV 560 manufactured by the General Electric Company). As can be seen with reference to FIG. 3, tile 11 is coated with a borosilicate glass coating 16 which extends over the outer surface and sides of tiles 11 but which leaves exposed a peripheral rim 17 of the rigidized fibrous block of tile 11. The glass coating

is more fully described in U.S. Pat. No. 4,093,771, incorporated herein by reference for all purposes. The coating and refractory material are very delicate and damage ranging from pin size to approximately 1 square inch occurs due to handling and installation and testing of the tiles. Over 10,000 areas requiring repair have occurred on space shuttle orbiter tiles. The construction and precise method of attachment of the various components shown in FIG. 3 is more fully described in U.S. Pat. No. 4,124,732, incorporated herein by reference for all purposes. FIG. 3 also shows how the tiles may be damaged, the damaged areas being designated as 13. The damaged area 13, is a portion of the tile in which the glass coating 16 and a portion of the rigidized fibrous blocks may be broken away. As mentioned, the damage may be as small as a pin prick or may be over an inch in diameter. As to depth, the damage may affect only the coating 16, with the tile material untouched, or may extend approximately an inch in depth.

It will be apparent that damaged areas 13 will at a minimum have a possible portent on the optical profile during orbit and if substantial produce a negative thermal gradient during reentry. In a severe case of damage, there can be burn through of tile 11, adhesive layers 14, strain isolation pad 12, and ultimately burn through of the metallic surface 10 of the spacecraft. In critical locations damage can result in loss of tiles followed by structural failure. Therefore, it is essential that the integrity of the thermal protection system be preserved. Replacement of all damaged tiles with new tiles would result in significant additional costs and add to the complexity of refurbishment of the space shuttle between missions.

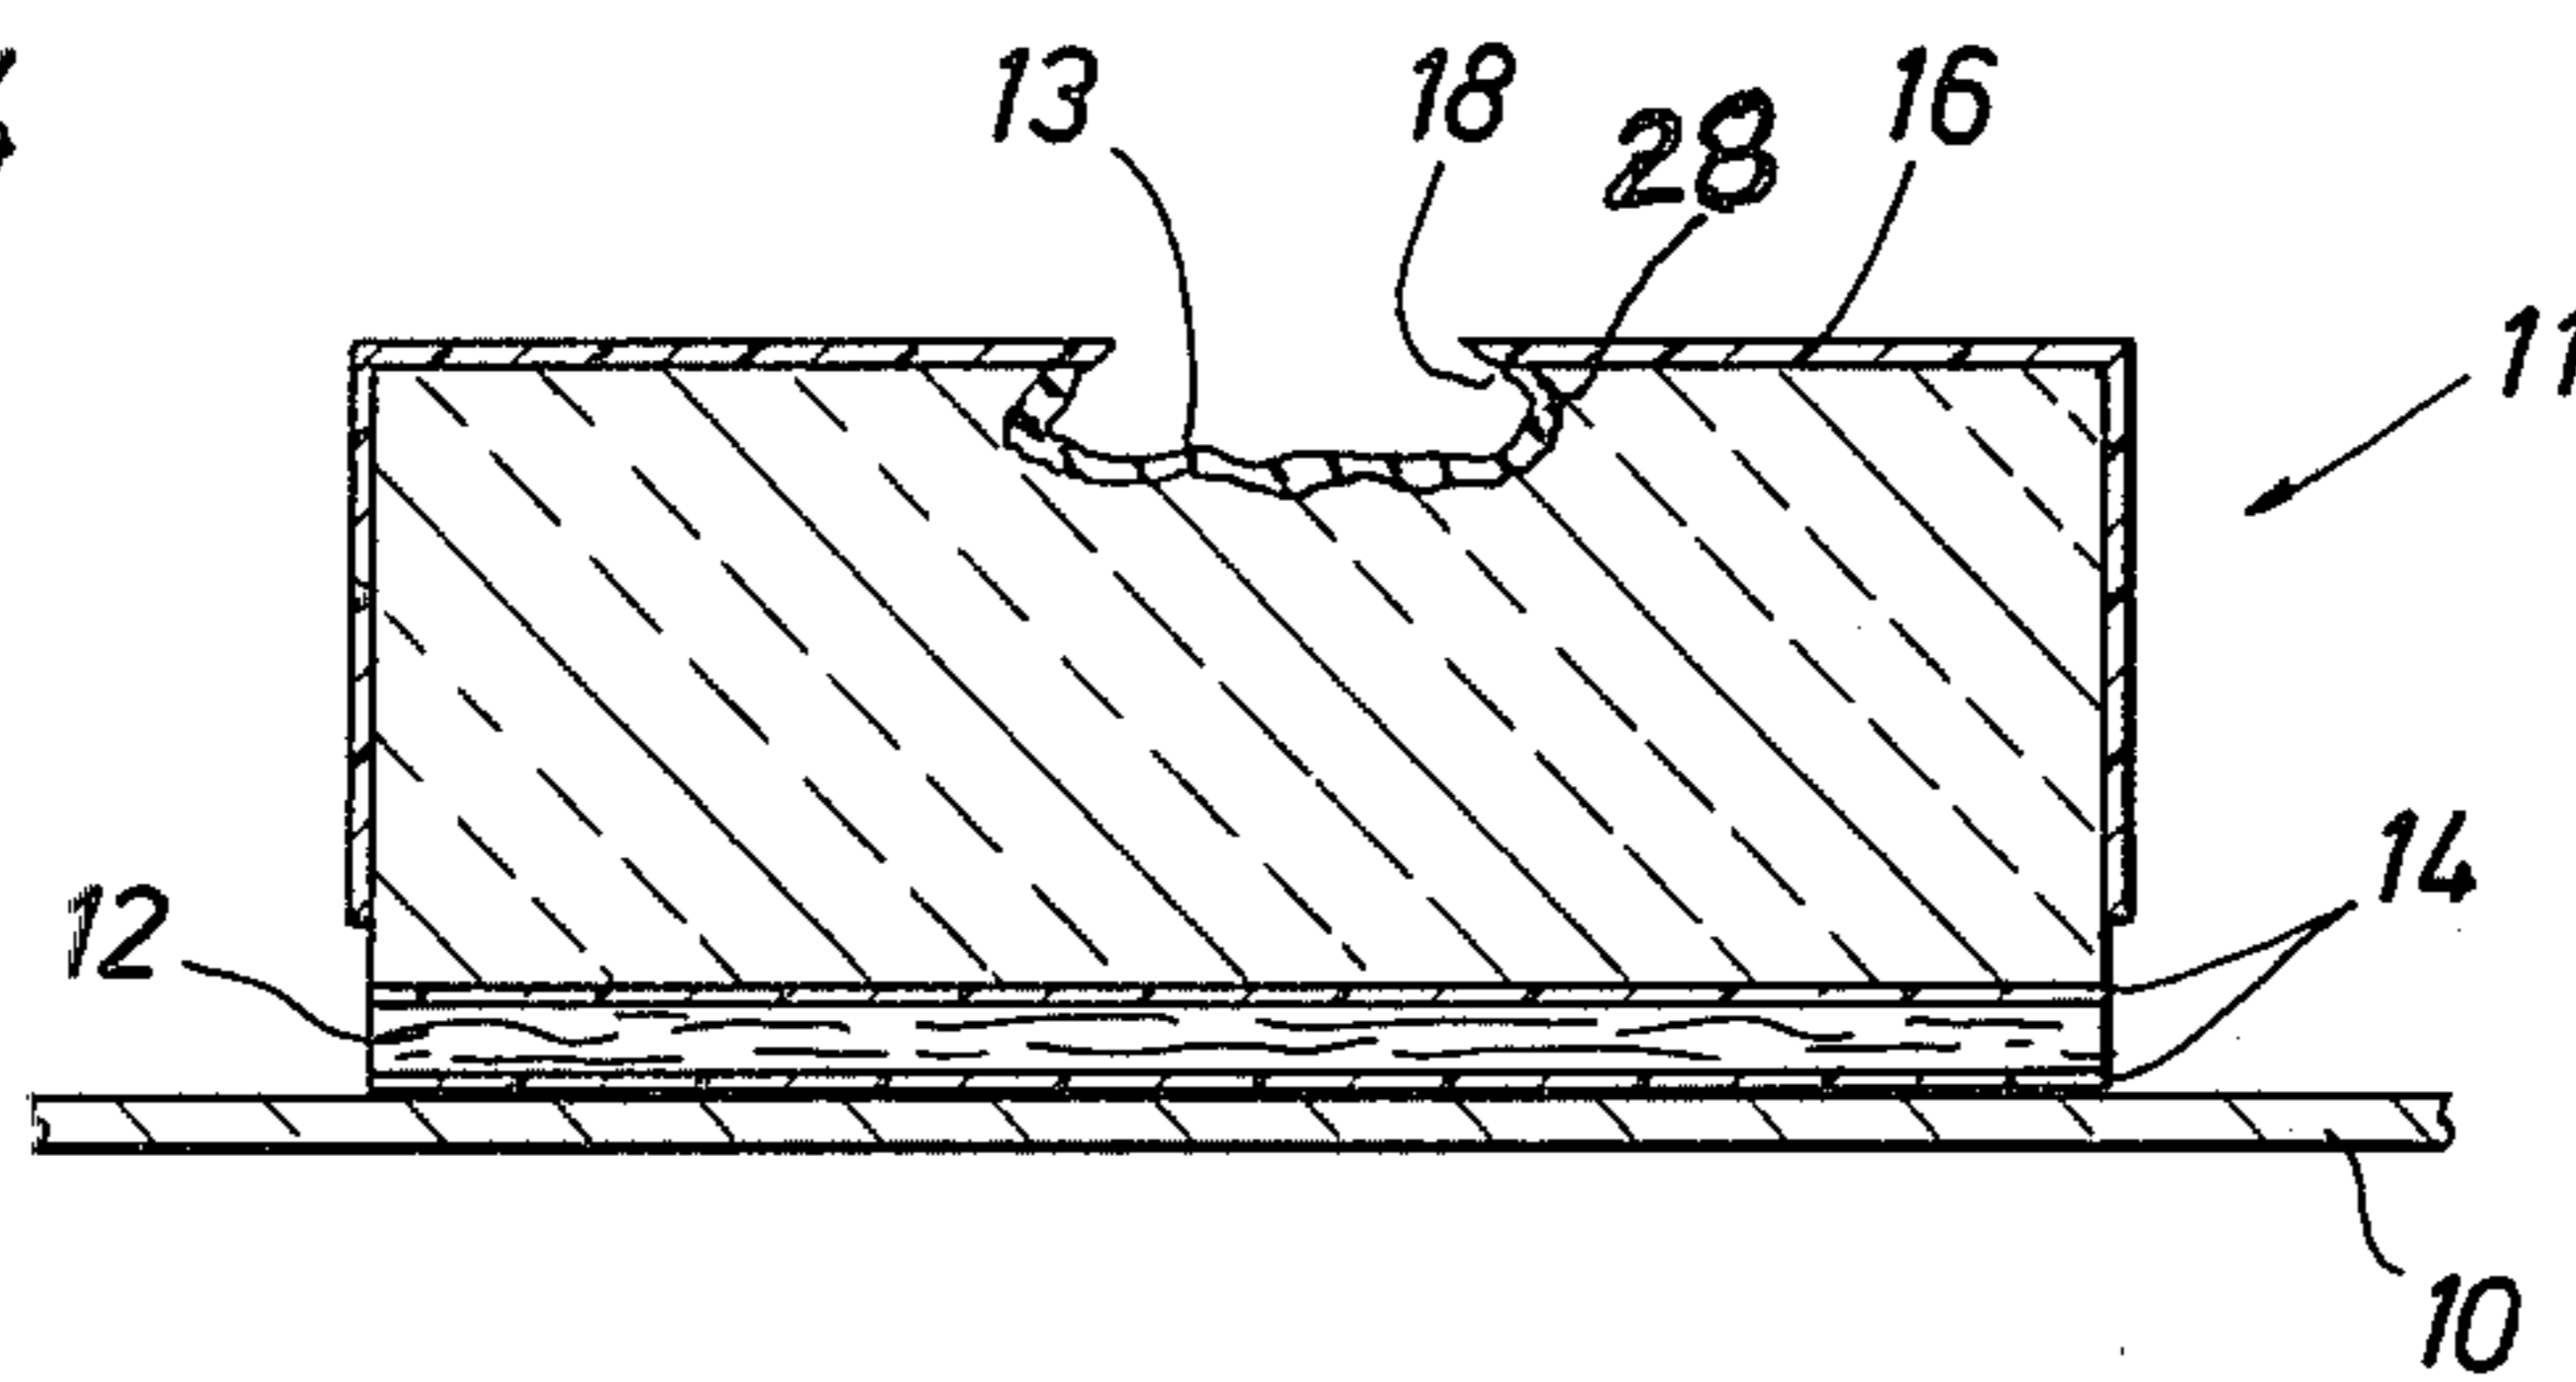
FIG. 4 is a partial cross sectional view showing a damaged area on one of the tiles.

Referring now to FIGS. 4 and 5 there may be seen a simplified functional representation of the manner in which a damaged tile 11 is repaired. According to the repair method of the present invention, the damaged area 13 is preferably undercut around its periphery, as shown at 18. This "dovetailing" of the damaged area 13, while not absolutely necessary, aids in assuring that the filler used to repair damaged area 13 will be more securely locked in the cavity. All loose particles are removed from the cavity.

Hydrolyzed tetraethyl orthosilicate (TEOS) is applied to all of the exposed surfaces of damaged area 13 in a uniform, even coating. The TEOS penetrates the fibrous material to a depth of approximately 1/10 inch, see FIGS. 4 and 5. The hydrolyzed TEOS is then cured, preferably at 275° ± 15° F. for approximately one to five minutes. This results in a strengthened base for the support and retention of the repair. In effect the penetrated area 28 is densified. Once the hydrolyzed TEOS

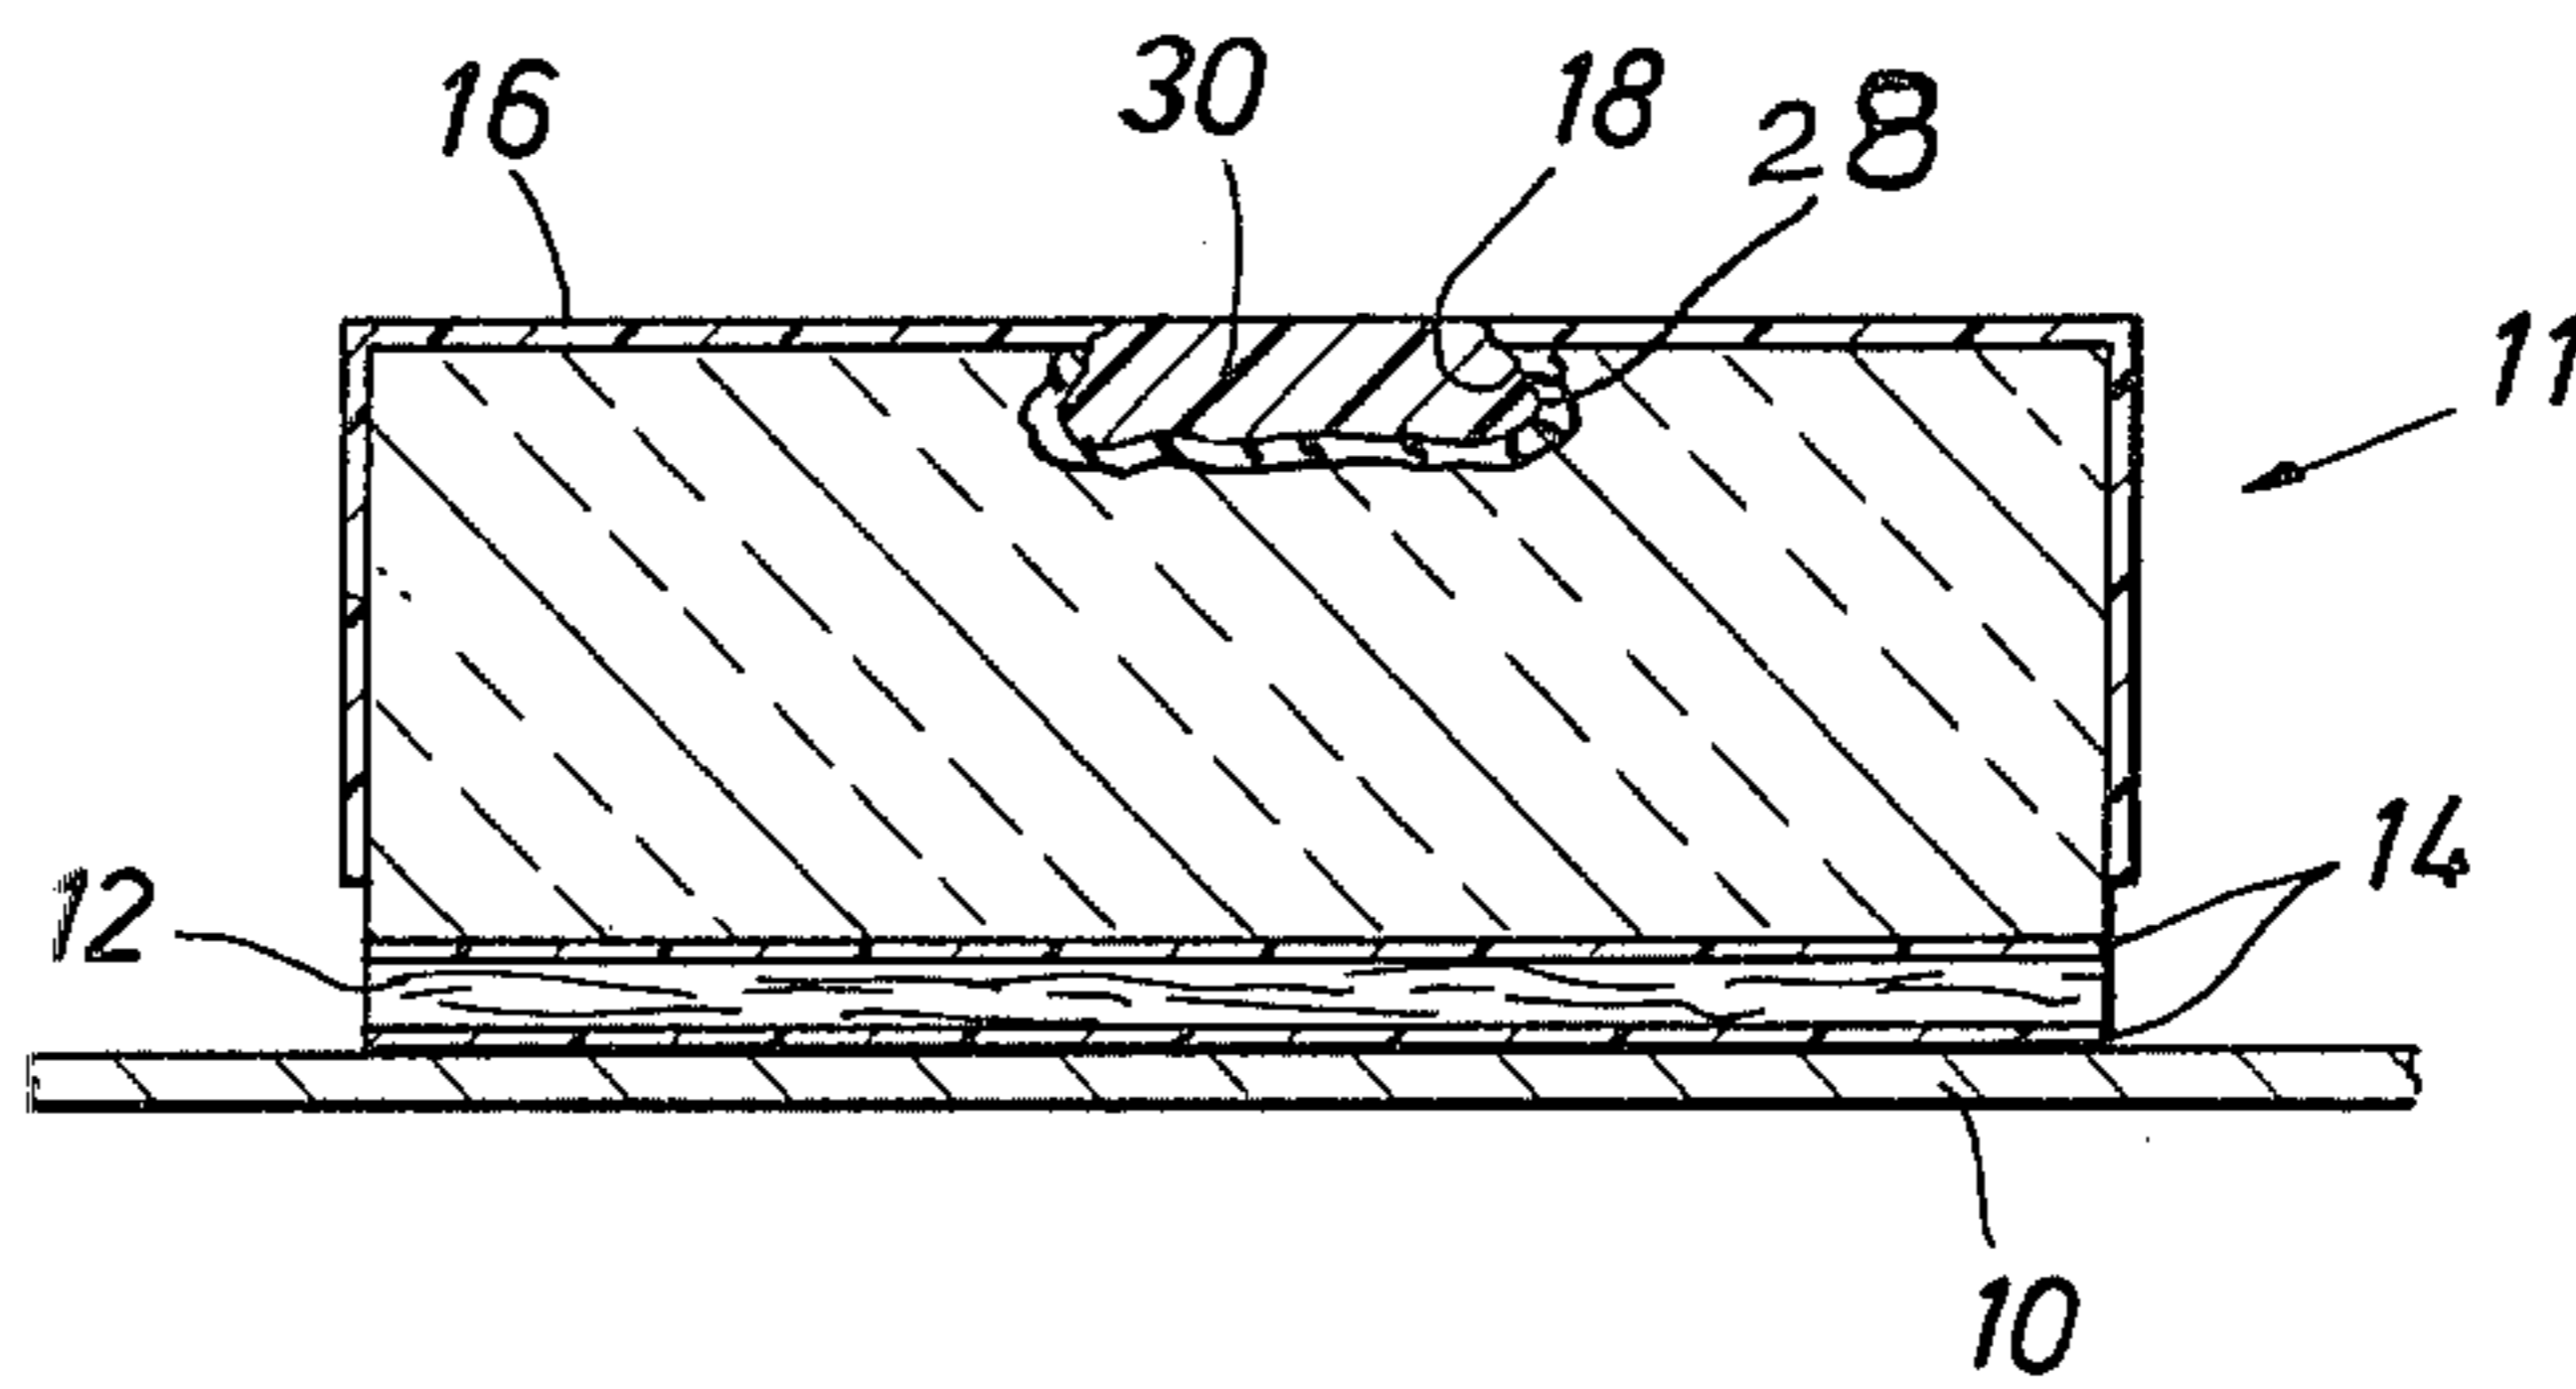
FIG. 5 is a view similar to FIG. 4 showing the damaged area repaired according to the method of the present invention.

application has cured, the damaged area is again wetted with hydrolyzed TEOS to provide a fresh adhesive surface. Following this application of TEOS a paste filler 30 comprised of liquid TEOS and a powder comprised of suitable refractory substrate is applied to the damaged area. The filler 30 is worked into the cavity of damaged area 13 is built to a level consistent with the original mold line of the tile which in this case would be the surface of the borosilicate glass coating 16. The filled area is then dried at approximately 120° F. ± 15° F. for approximately 5 minutes. Any filler material 30 which extends above the surface of the borosilicate glass coating 16 can be sanded off after curing. A coating of hydrolyzed TEOS may be applied to the required surface followed by curing at 275° F. ± 15° F. for about one minute to add additional adhesive properties. After curing, a coat of waterproofing silane agent (hexamethyldisilazane, such as, Dow Z-6079) is applied over the repaired surface.
