[54] **ELECTRICAL TESTING**

[73] **Assignee:** Standard Telephones and Cables, PLC, London, England

Insulation flaws in electrical components are detected by measurement of electrical leakage before and after immersion in a mobile ionizing solvent, e.g. a lower alkyl alcohol. A significant increase in leakage is indicative of a flaw, e.g. a crack in the insulation.

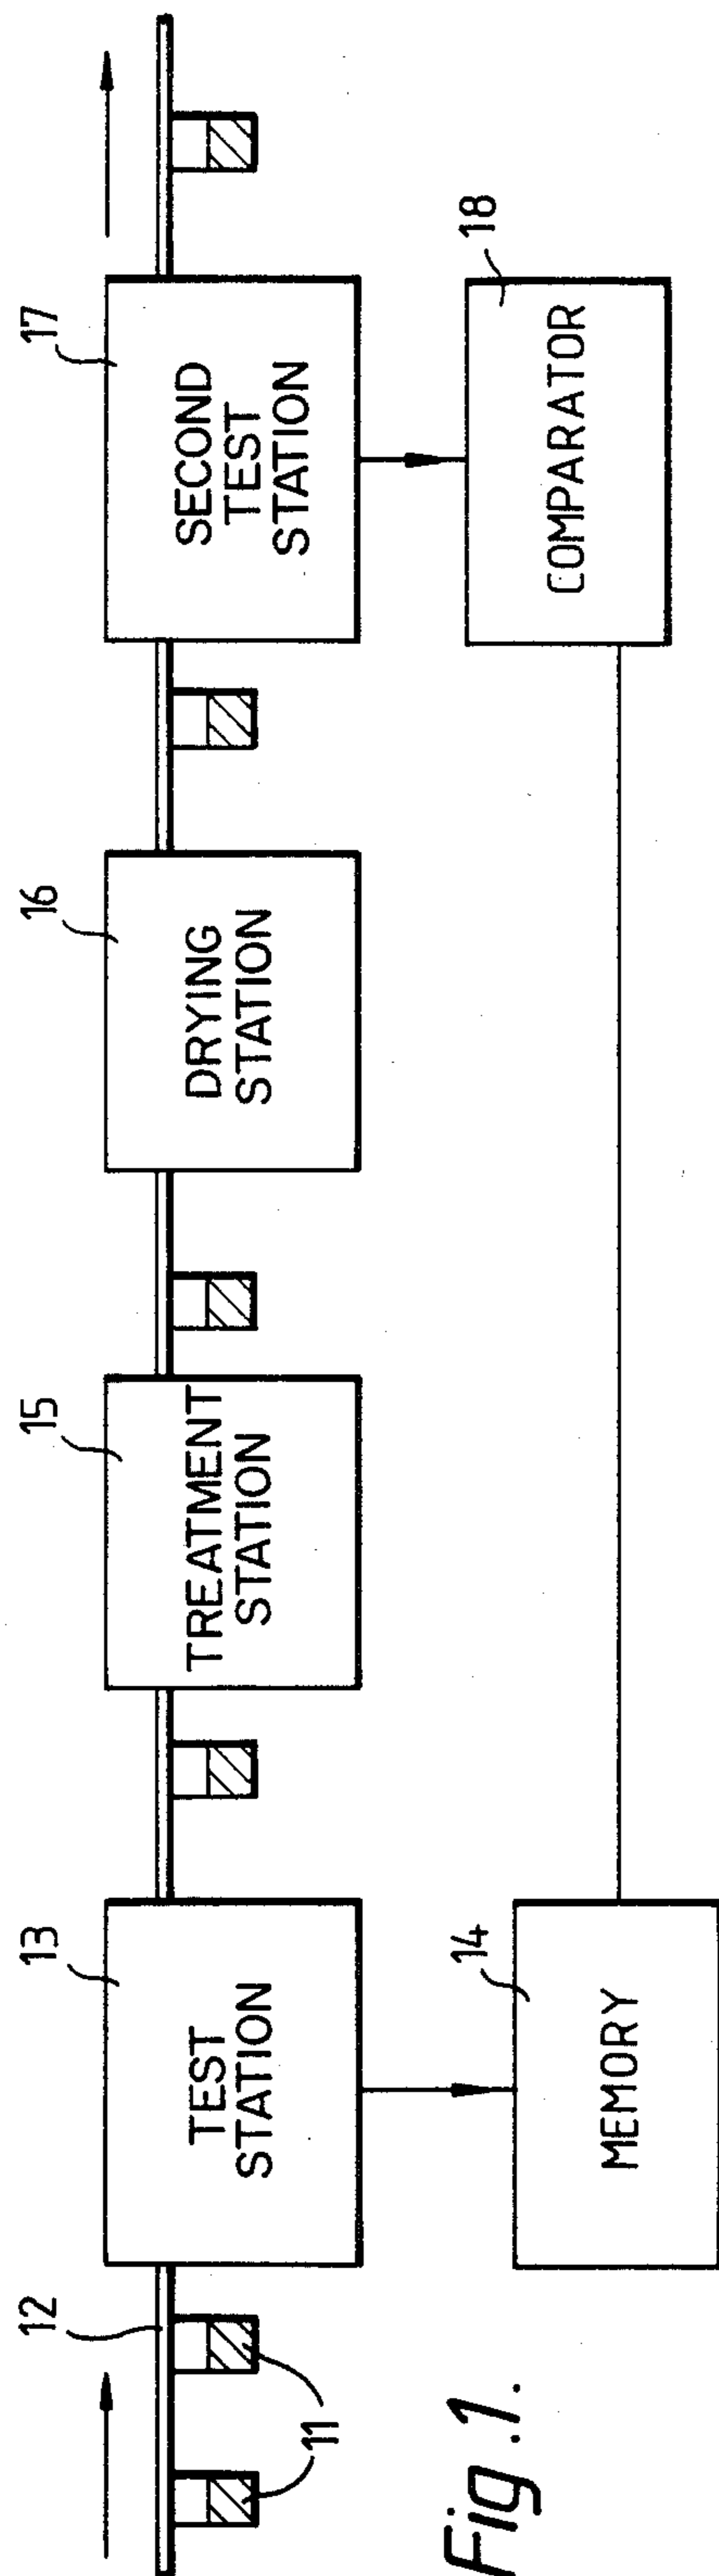
Fig. 1.

FIG. 1 is a schematic diagram of a capacitor measurement and test apparatus;

Referring to FIG. 1, capacitors 11 to be treated are mounted on a conveyor 12 and are carried through a first test station 13 where the electrical leakage of each capacitor 11 is measured and the result stored in a memory 14. The capacitors are then carried via a treatment station 15, where they are immersed in or sprayed with a mobile ionising solvent, to a drying station 16 whereby excess solvent is removed. Typically drying is effected in a current of air at ambient temperature. In some applications the capacitors may be preheated e.g. to 100° C. prior to immersion to enhance penetration by the solvent.

The treated capacitors are carried from the drying station 16 to a second test station 17. The electrical leakage current of each capacitor is again measured and is compared, via comparator 18, with the measurement for that capacitor recalled from the memory 14. If the second leakage current measurement is significantly higher than the first, i.e. the measurement differ by a predetermined magnitude, then that capacitor is directed to a reject bin. In this way ceramic capacitors, and particularly multilayer ceramic capacitors, may be screened to remove those whose dielectric is imperfect.

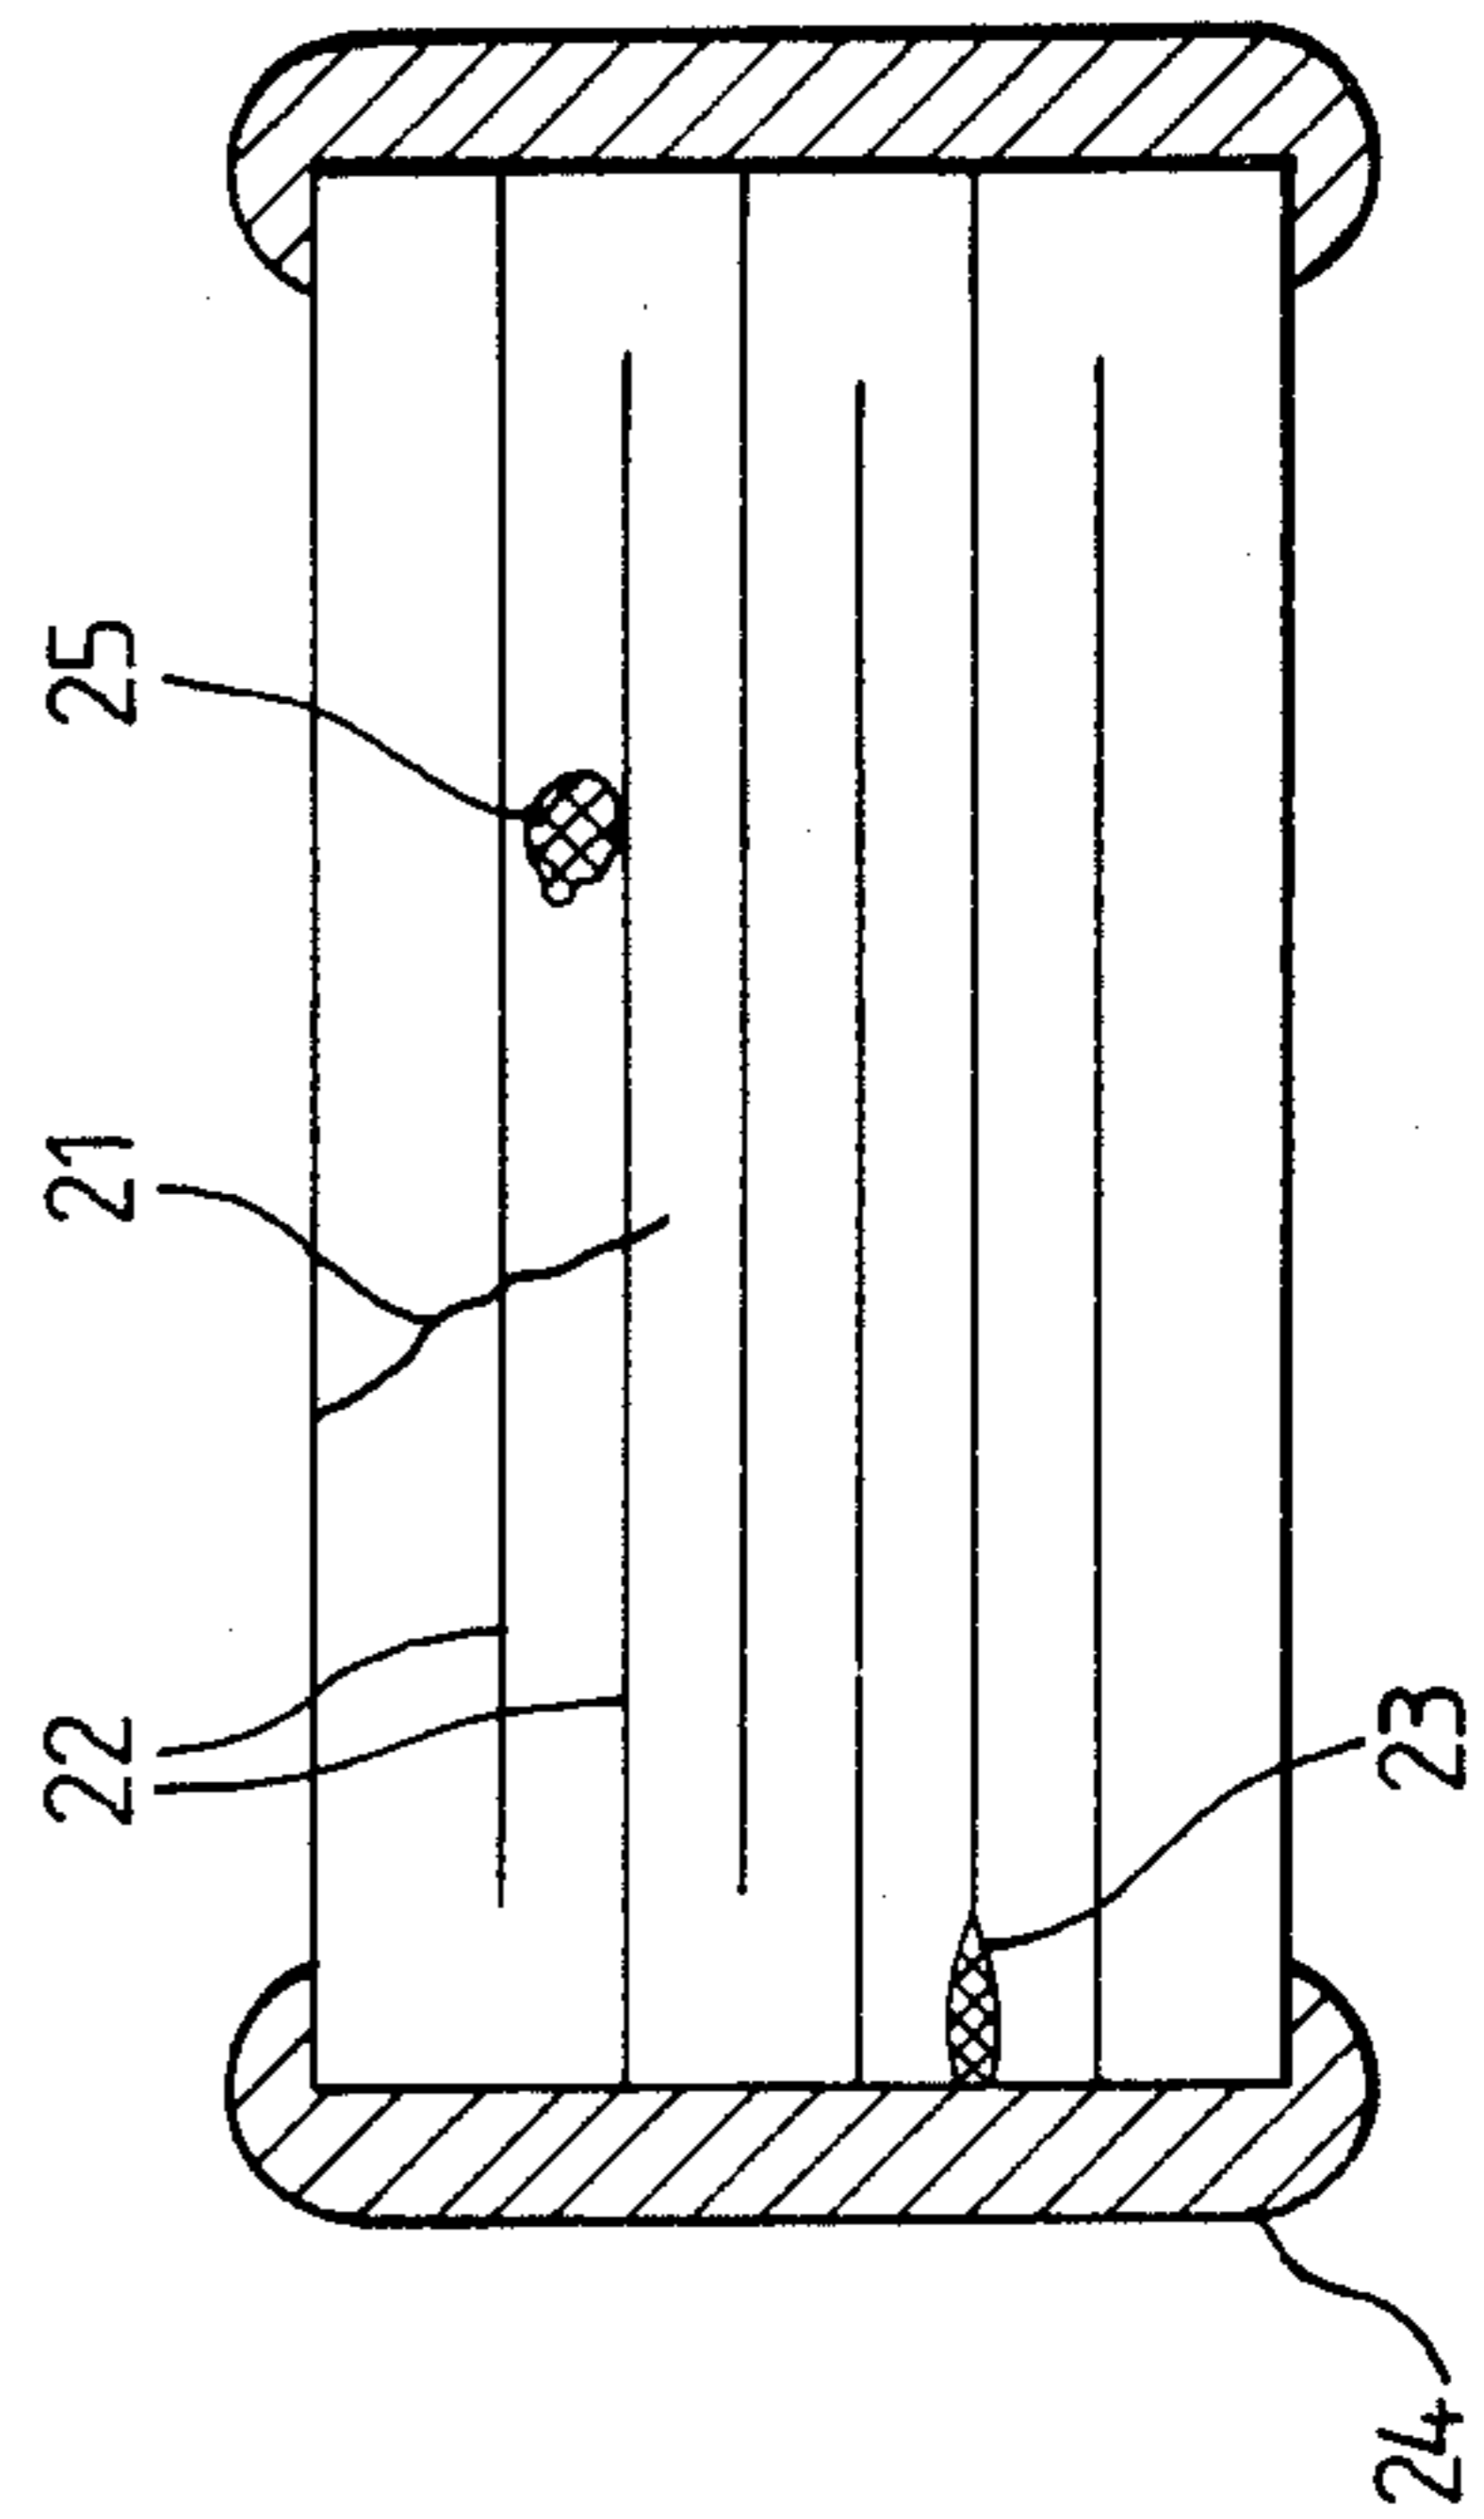
Fig. 2.

and FIG. 2 is a cross-section of a multilayer capacitor illustrating typical dielectric faults.

It has been found possible to differentiate between types of defect in multilayer ceramic chip capacitors according to the relative behaviour of the post-immersion insulation resistance and the reference value. These defects are illustrated in FIG. 2. A simple crack between two opposing internal electrodes will have an effect as described in the above example. The insulation resistance recovers to the reference value as the liquid evaporates from the crack. The time to recovery is dependent on the dimensions of the crack but is usually of the order of minutes.

If the defect bridging the electrodes is linked fine porosity, as is often the case in the Z5U dielectric, the recovery time is very long and in extreme cases there may be no noticeable recovery after several hours.

Another type of defect, known as a knit line fault, can also be detected. This is in effect a non-lamination of successive dielectric layers and is seen as a crack extending from one end termination of the device to an internal electrode of the opposite polarity. Since the end termination material (usually silver) is normally different from the internal electrode material the result of the test has a polarity dependence. If, for example, the end termination (silver) is positive and the internal electrodes, say Palladium/silver, are negative, silver migration can readily occur in the presence of methanol along the knit line crack from the end termination and a silver dendrite can grow back from the internal electrode to the end termination. This results in an insulation resistance that decreases with time. If the polarity is reversed this rapid migration does not occur and the test behaviour is the same as that for a simple crack between internal electrodes.
