United States Patent [19]

4,913,558

METHOD AND APPARATUS FOR DETECTING LEAKS AND OTHER DEFECTS ON SEWERS AND THE LIKE CHANNELS

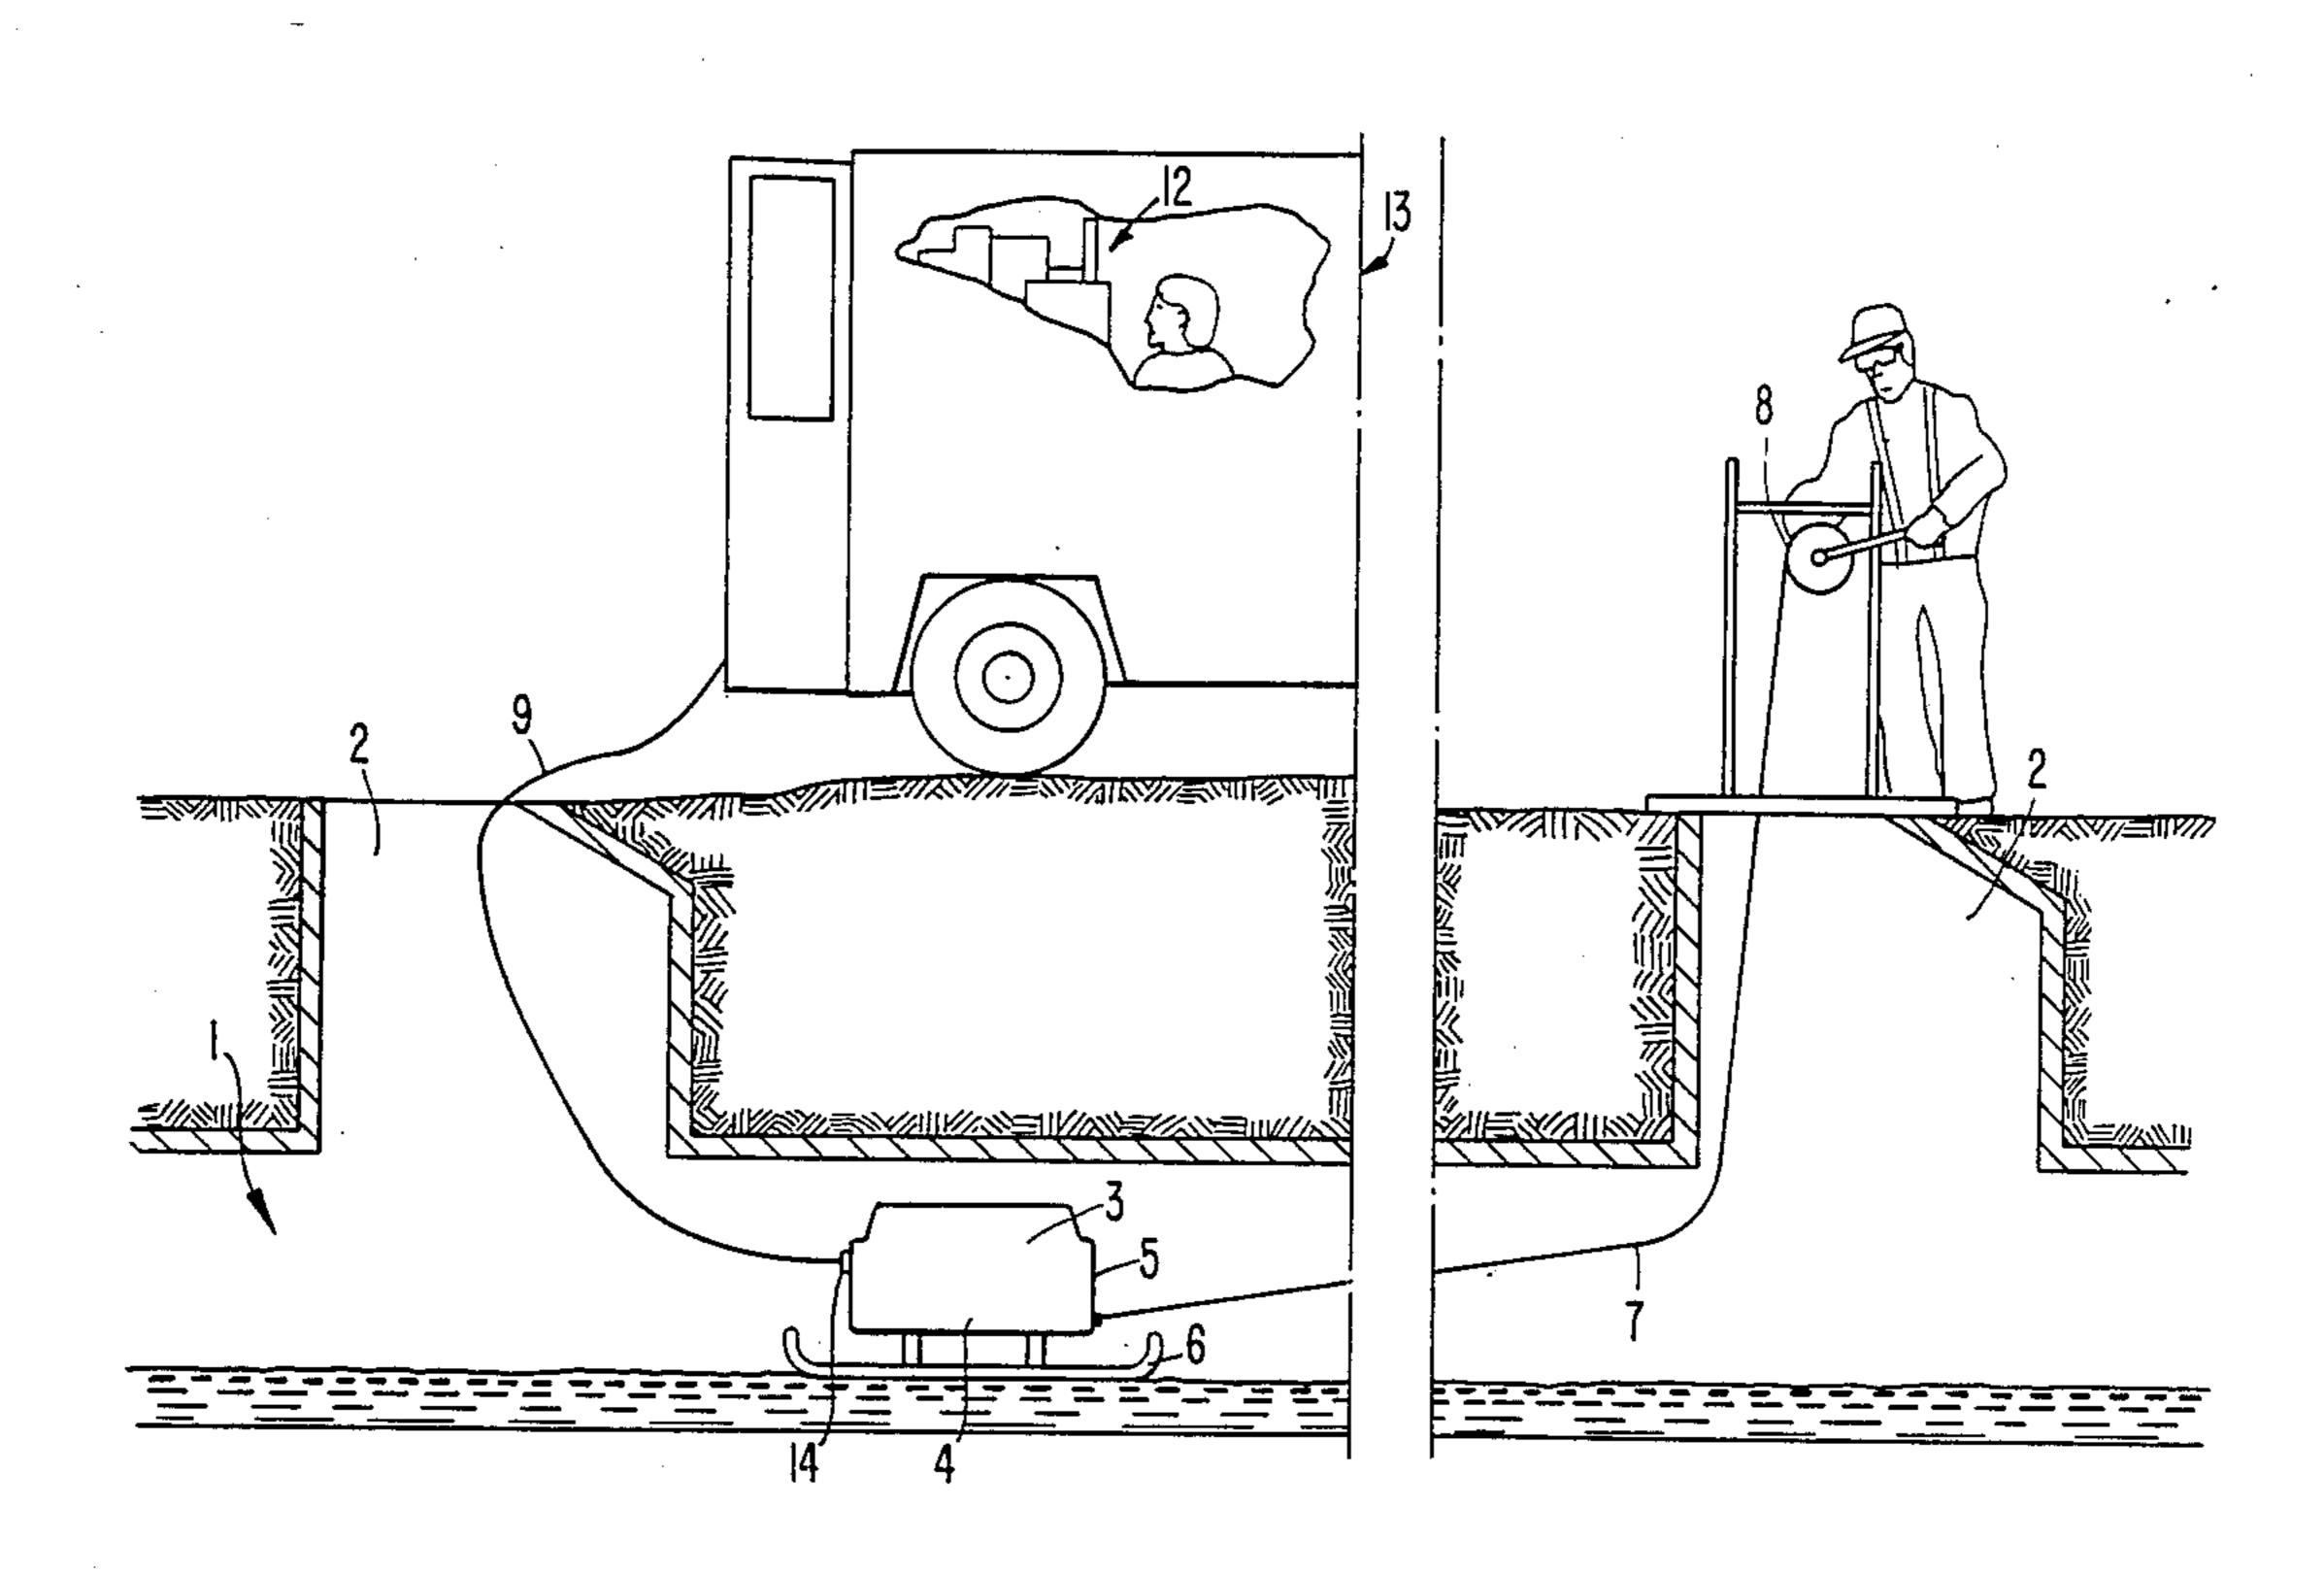
FIG. 1 is a highly schematic view, partly in section, illustrating the inspection method and apparatus of the invention,

With reference to FIG. 1 a sewer with waste water is 10 23 and 24 respectively. designated 1 and manhole wells are designated 2. The cable 25 connec

An IR scanning device 3 is mounted inside a water-proof protecting shell 4 with a window 5 and carried by a sledge 6. A pulling wire 7 coupled to a winch 8 is attached to the sledge and a communication cable 9 15 rolled off and on a reel 10 with a metering device 11, FIG. 2, connects the scanning unit 3 with a central unit 12 housed inside a van 13.

Inspection of a section of a sewer 1 normally takes place between two inspection wells 2. The pulling wire 7 is fetched at the downstream well by a forerunner floated downstream from the upstream well and after lowering the scanning device 3 enclosed in the shell 4 into the sewer 1 the scanning device 3 is pulled on its sledge 6 along the sewer. The advance is controlled by the metering device 10-11 indicating the length of cable 9 rolled off. The signal from the IR scanning device 3 is received by the display unit 16 and is recorded by the VTR 18 and the signals from the metering device 10-11 are computed by the IDT 20 and fed to the display unit 16. The distance figures can be read on the display and also be recorded on the VTR 18.

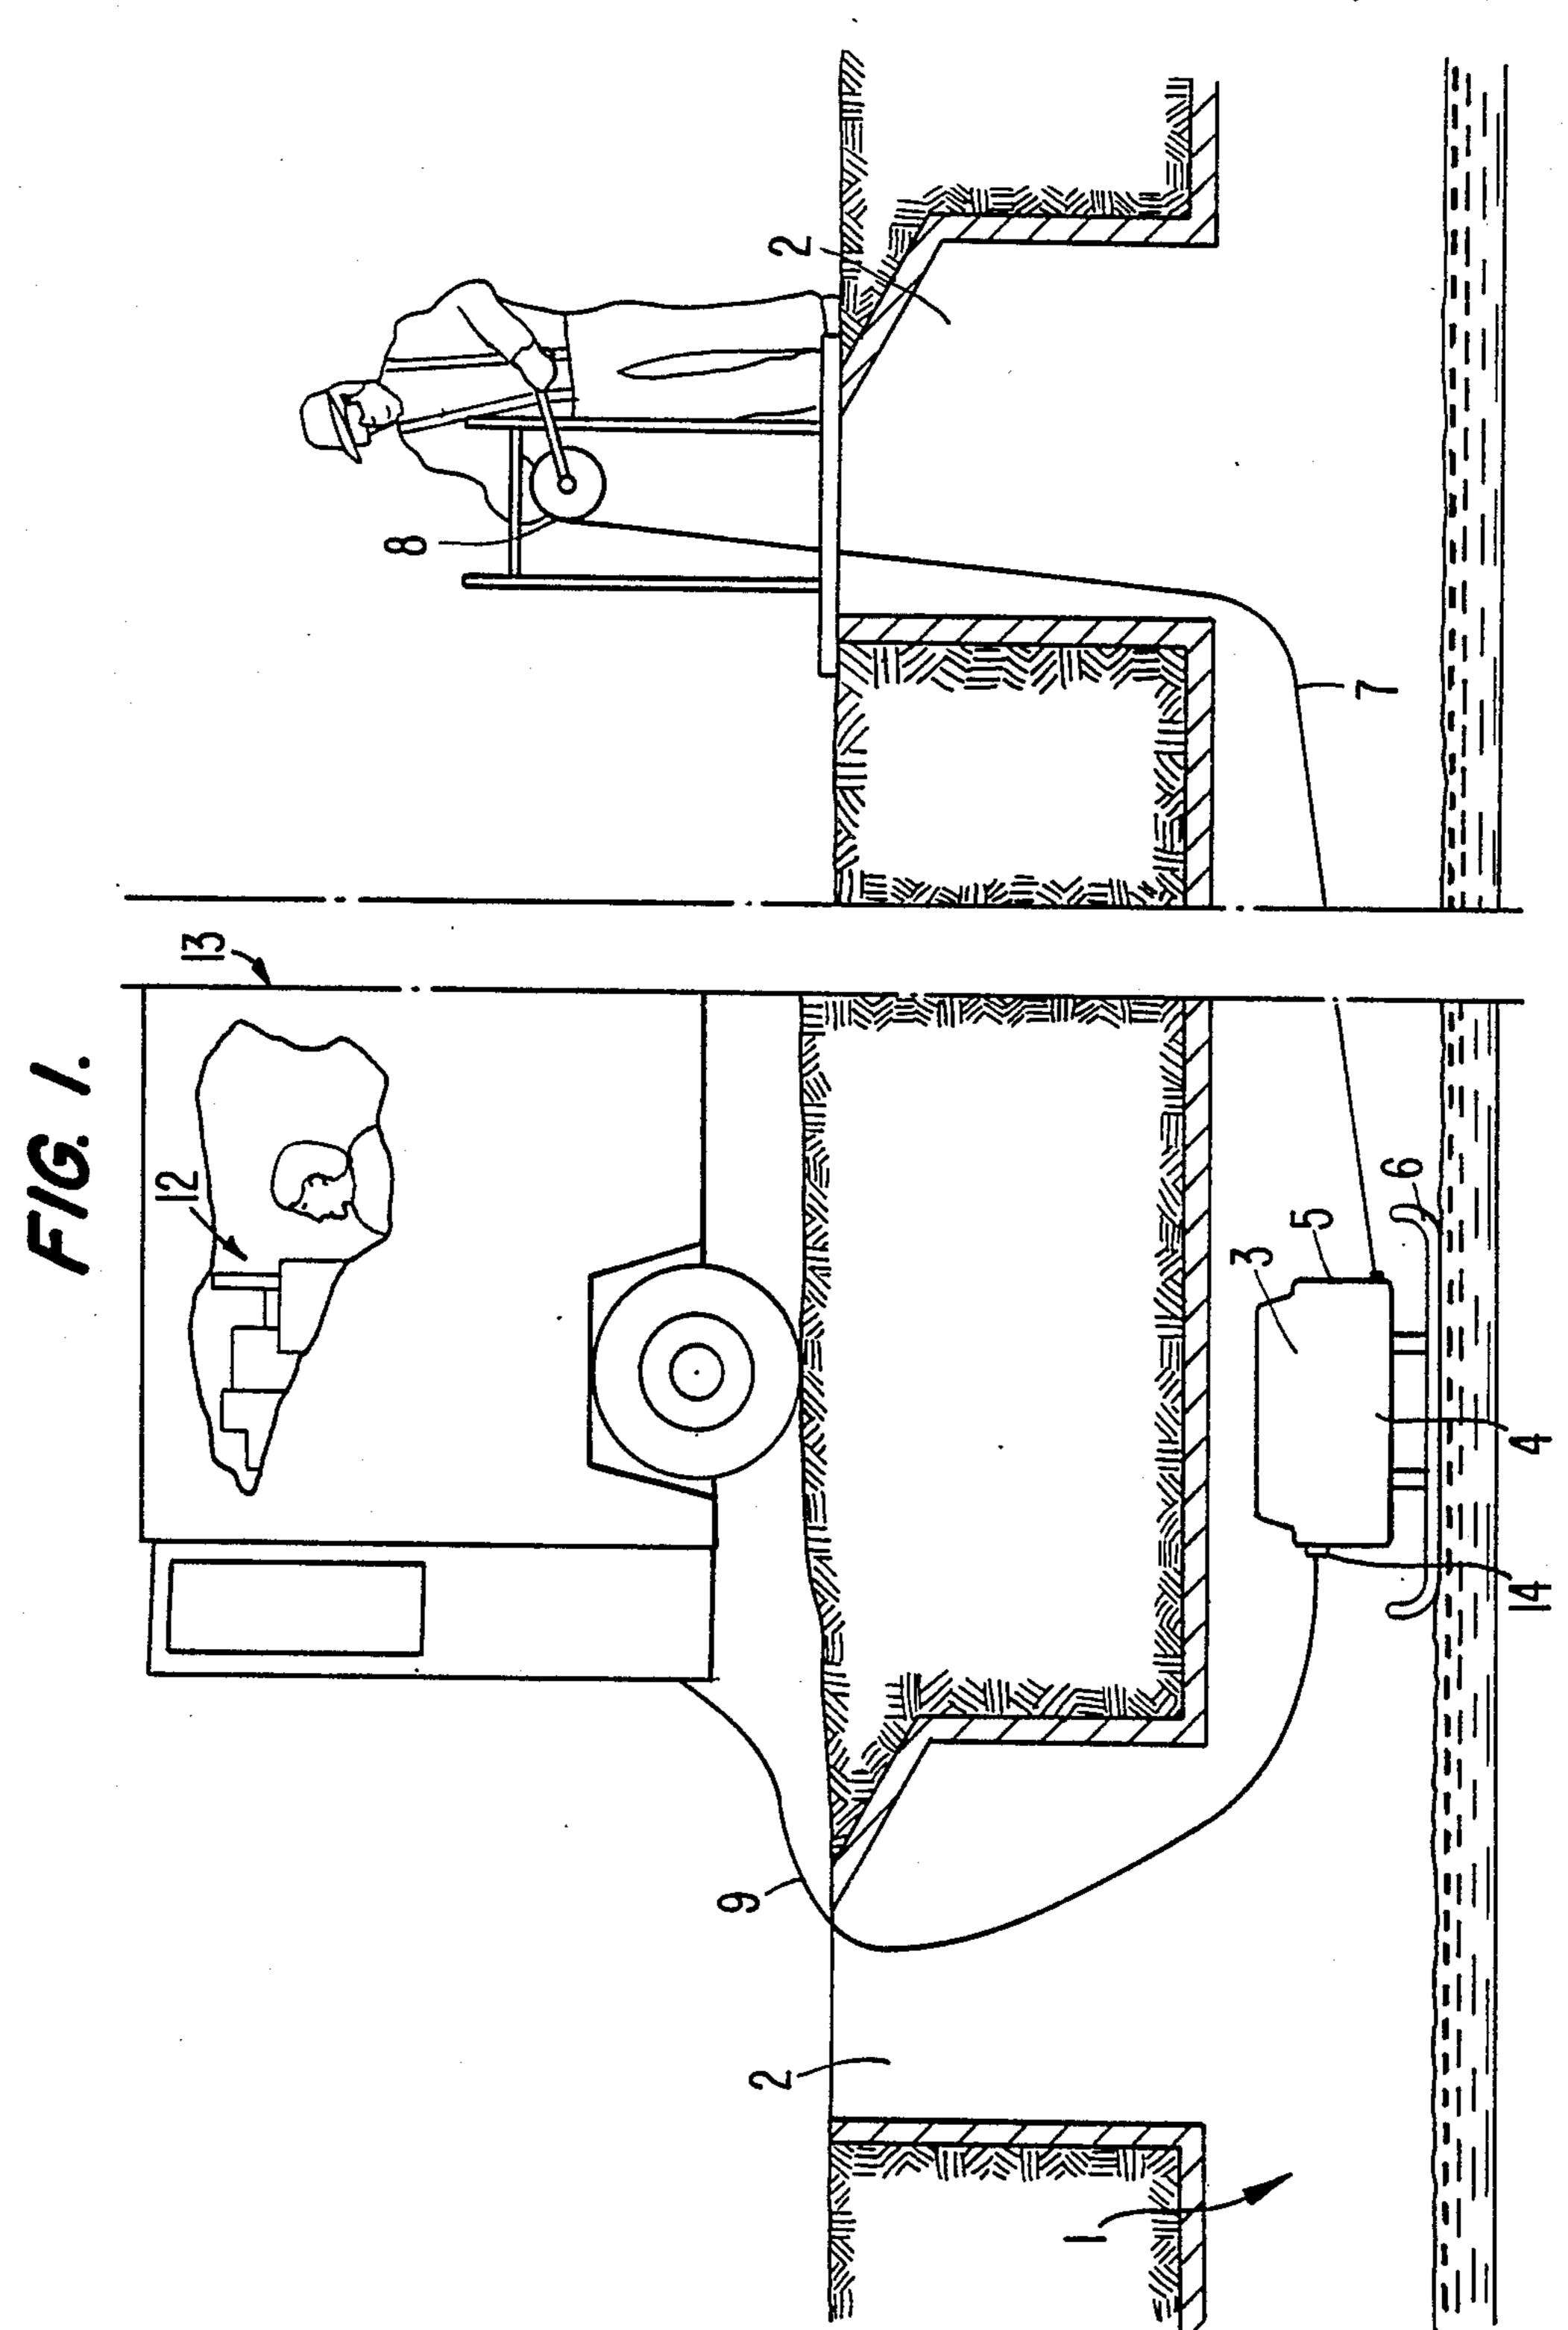
FIG. 2 is a diagram illustrating the arrangement of the electronic system,

In FIG. 2, the part to the left the double dash-dotted line indicates the scanner unit 3 inside the sewer and the part to the right of same dash-dotted line the so called 65 central unit designated 12 in FIG. 1.

by a connector 14. Inside the van 13 is found the cable reel 10 with its metering device 11 adapted to count the length of cable reeled off (or on). The cable 9 is via a connector box 15 connected to a display unit 16 in turn via a two way cable connection 17 connected to a video tape recorder VTR 18. The metering device 11 is connected, via cable 19, to an interface, an image data terminal (IDT) 20, cooperating over a BCD unit 21 with another IDT 22—both IDTs having so called C videos 23 and 24 respectively.

The cable 25 connects the IDT 20 with a discon 26 and a monitor 27 and with the display unit 16.

In a modified embodiment, the IR sensing device is combined with a TV camera and an appropriate light source indicated in dashed lines in FIG. 2. Such TV camera is also connected with the central unit, which is equipped with a display means, such as 16', for the TV image and furthermore with an electronic apparatus for displaying the IR image on top of the TV image or vice versa to form a combined image. Such a combined IR and TV image is more easily read by the operator and gives both the leak indicating temperature image and a visual picture of the location and shape of the damage or leak. The IR camera and the TV camera might of course be used one at a time but the best result is attained if they are used simultaneously.

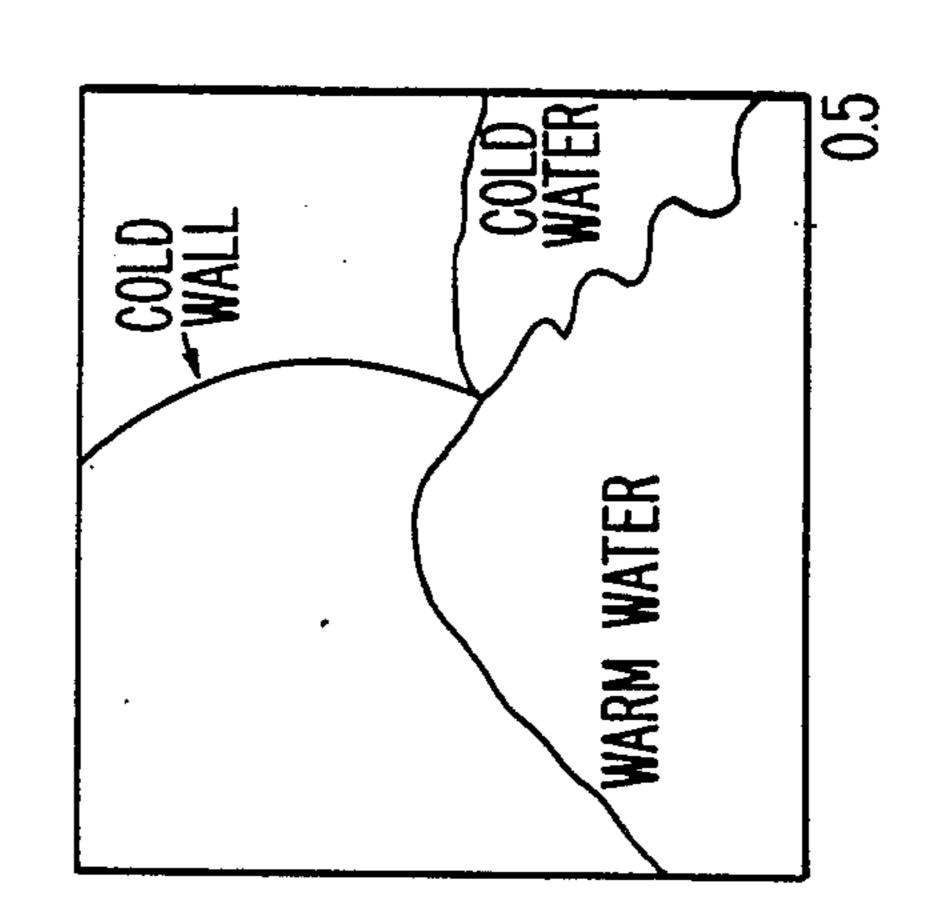
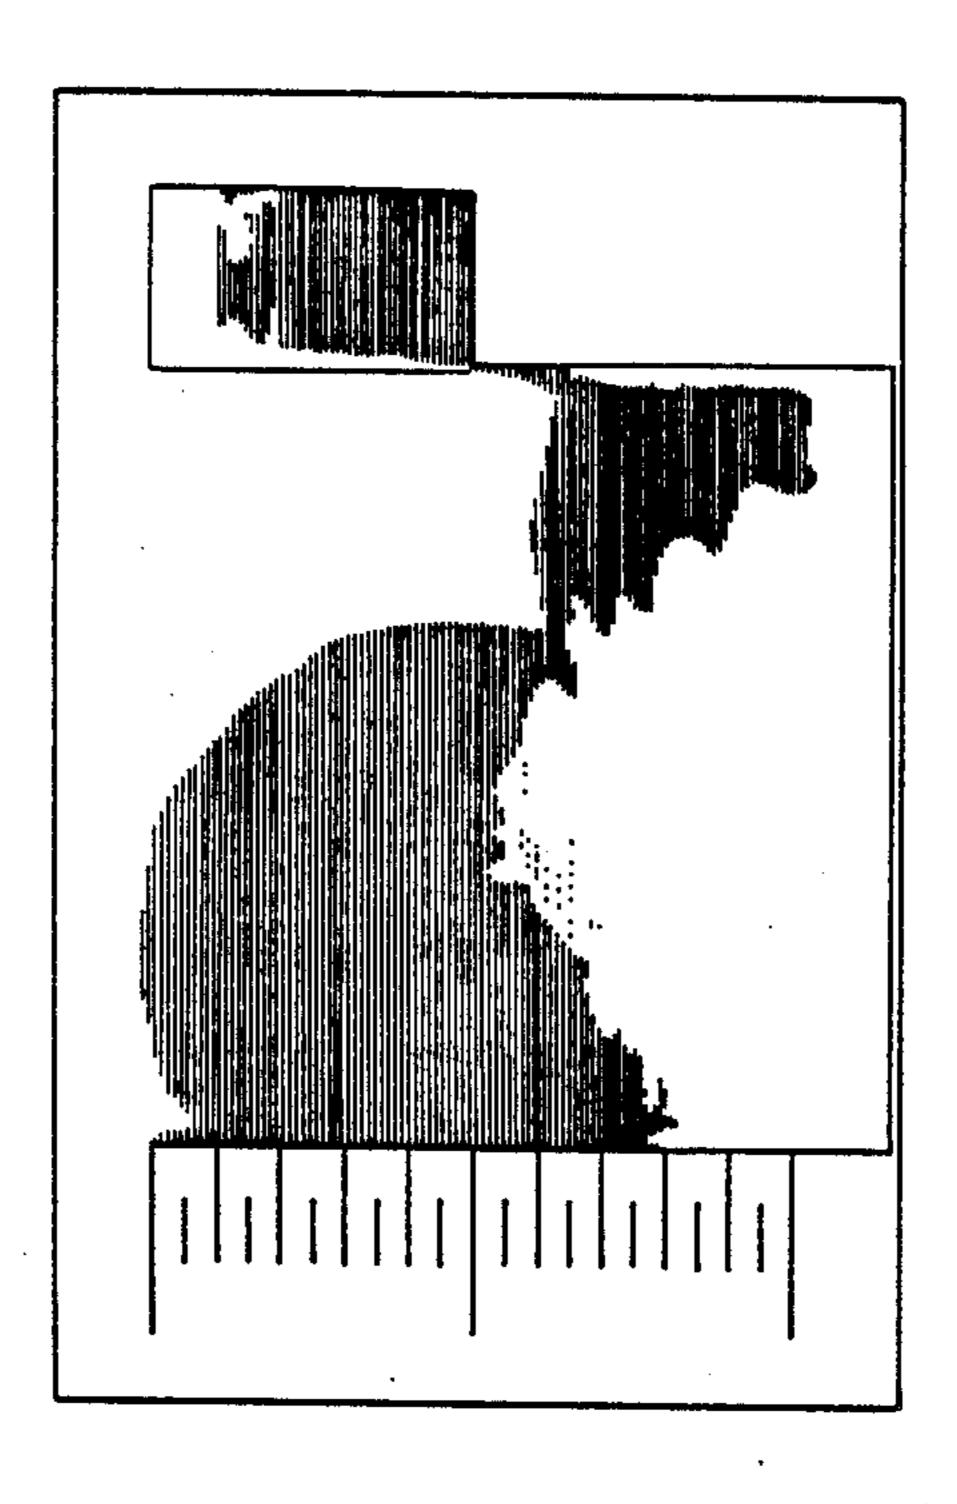
FIGS. 3 and 3a illustrate two flows of water joining at a manhole, the left flow warm and the right flow cold. The wall of the sewer is cold.

The thermograms shown on FIGS. 3-6 are results from an inspection of a sewer 100 meters in length and chosen at random and show detection of some examples of faults.

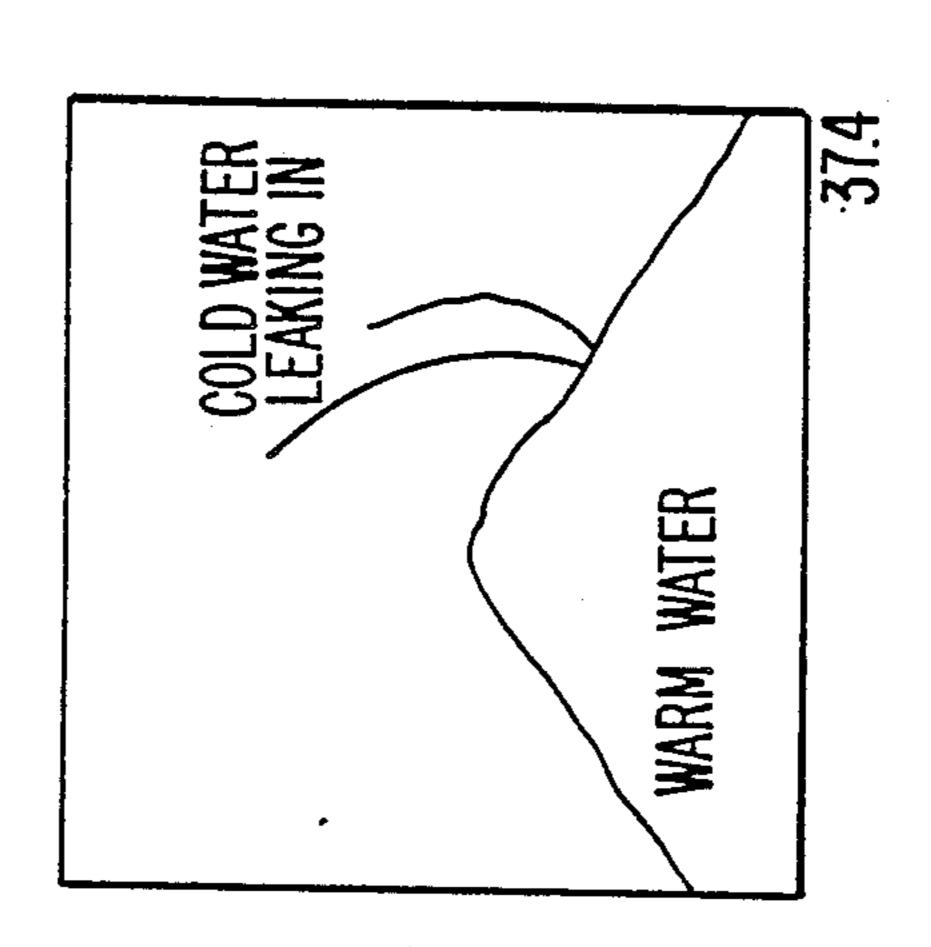
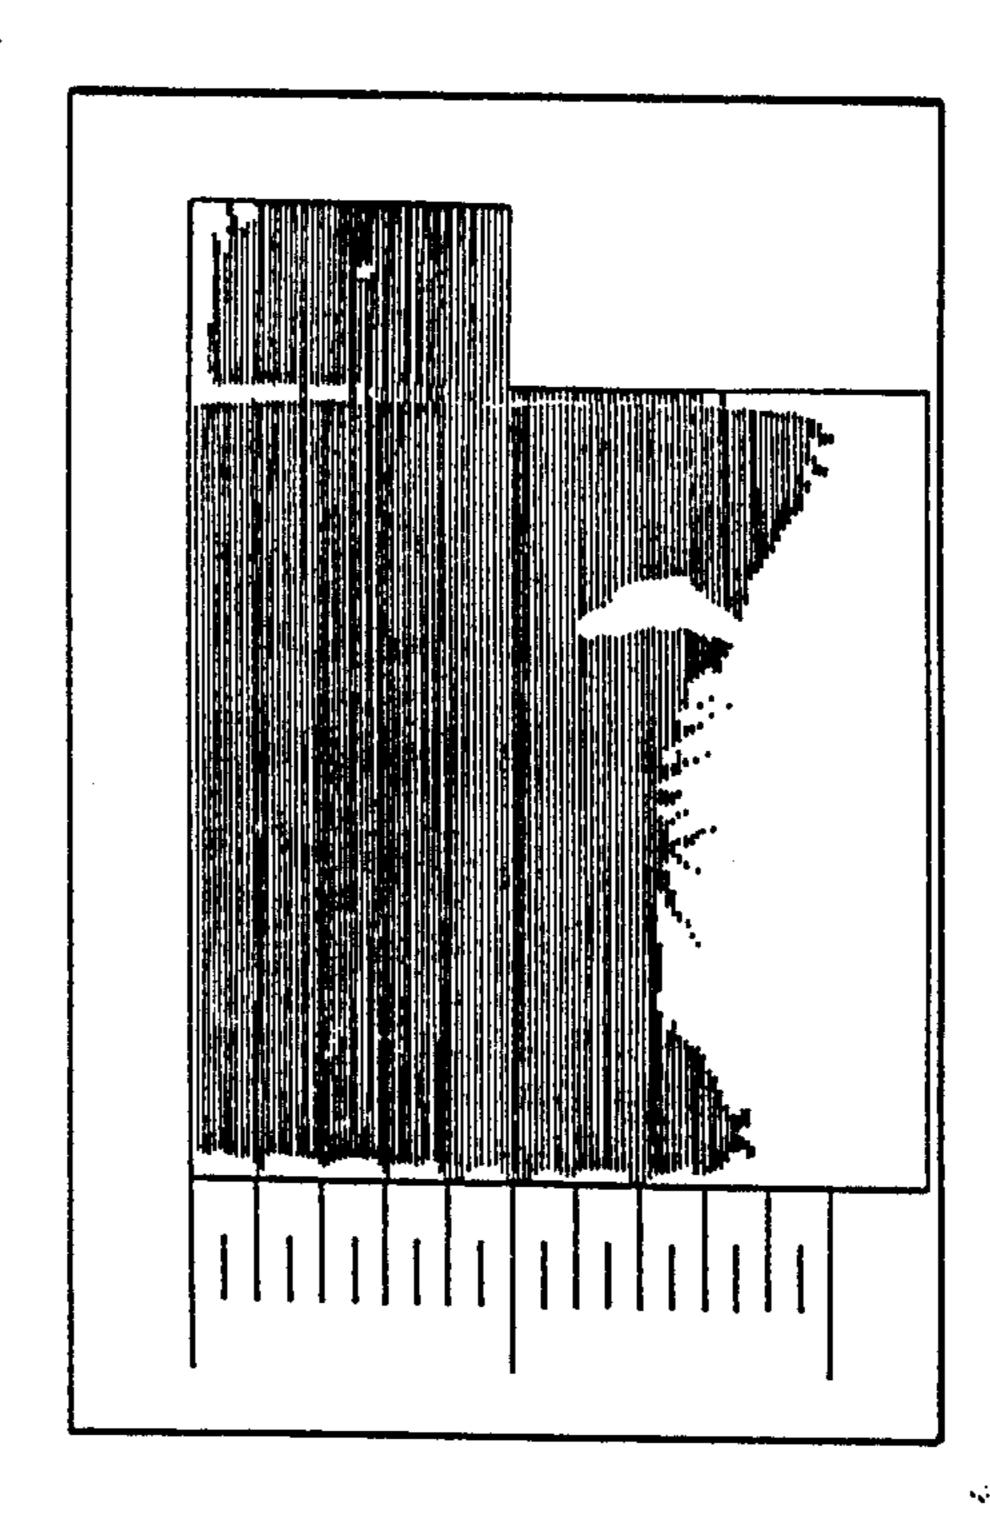
FIGS. 4 and 4a show an area including a joint and a finger-like light area (dark in the actual thermogram but shown light for clarity of illustration) indicates colder surface water leaking in.

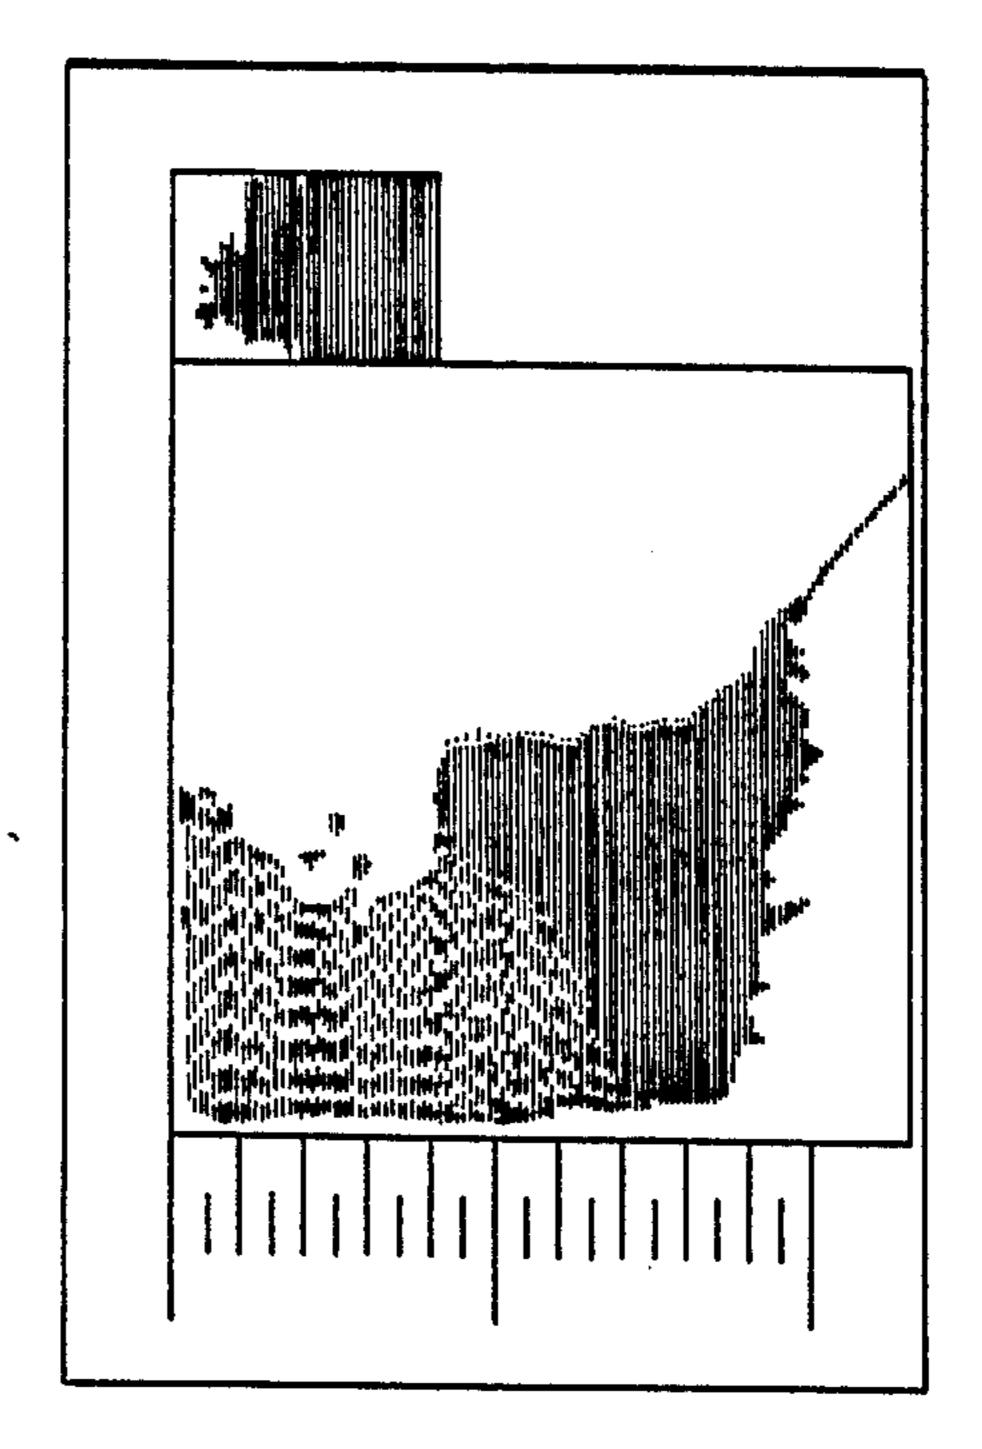
FIG. 5a.

FIGS. 5 and 5a show the influence of cold water surrounding and penetrating a displaced joint. Colder surface water seeps in along the joint.

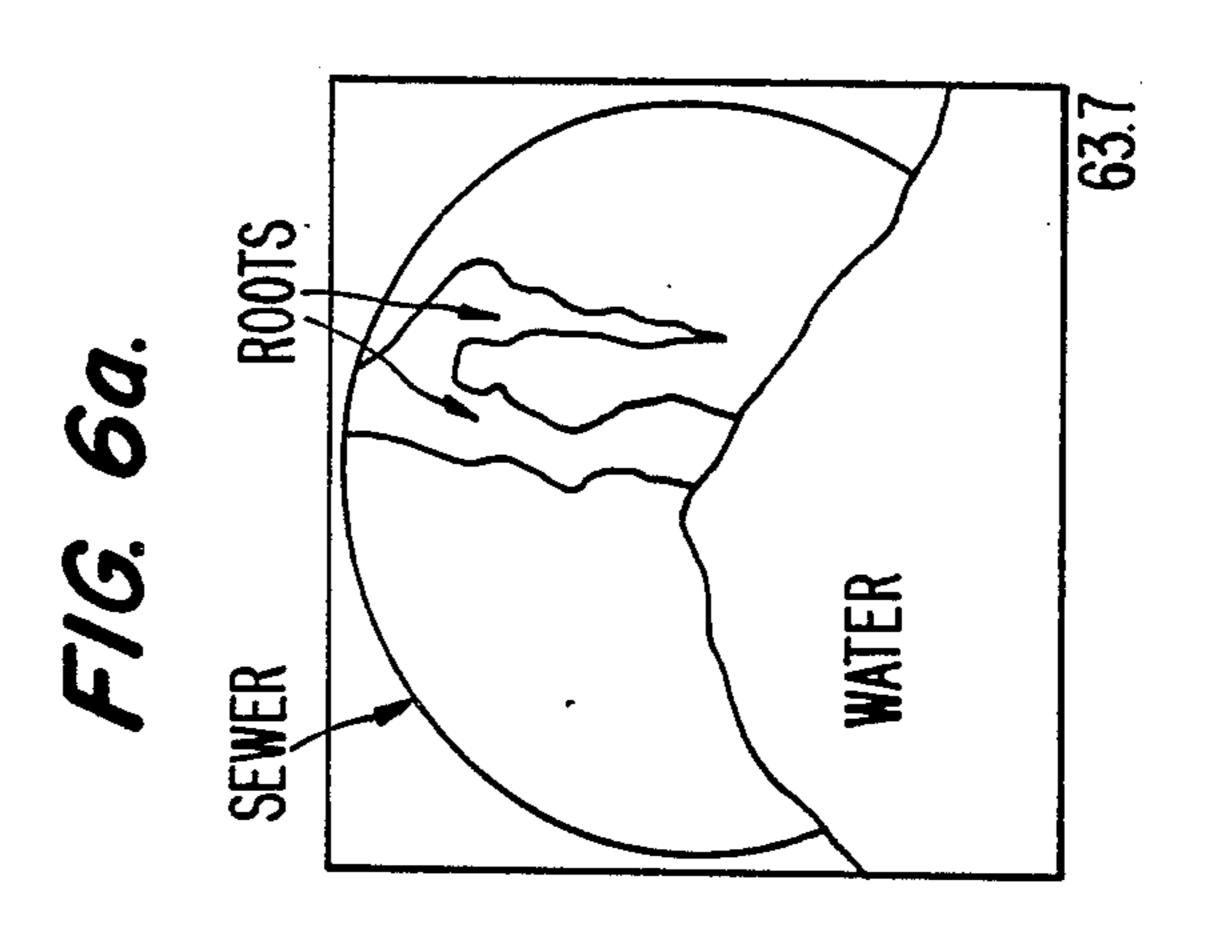
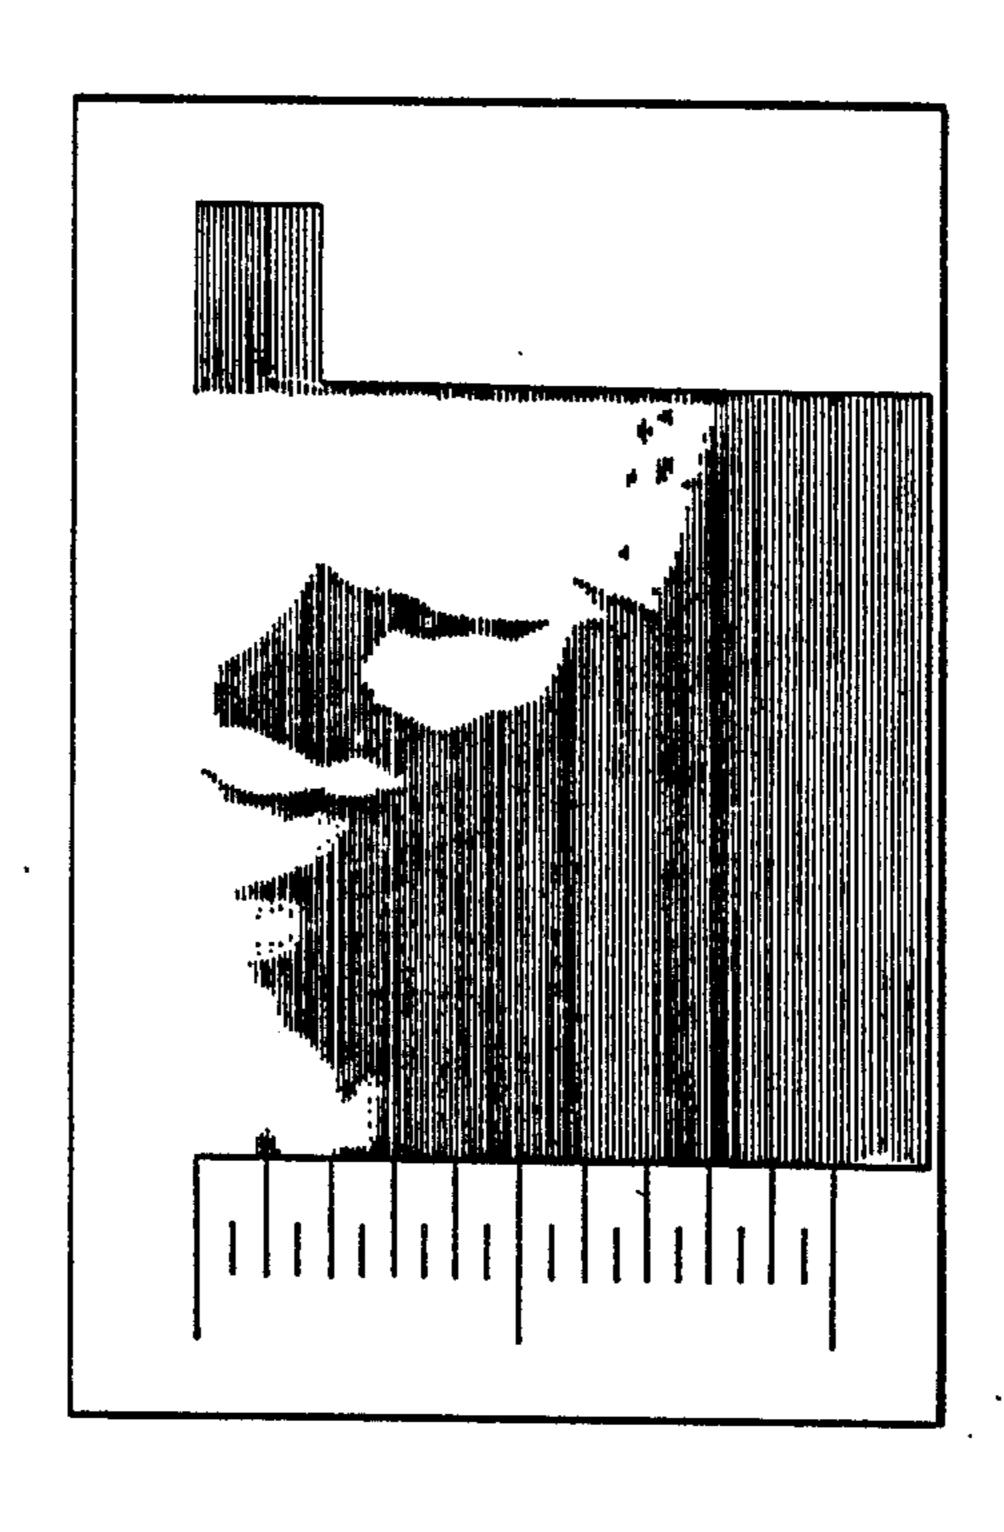
F/G. 6.

FIGS. 6 and 6a illustrate how roots have penetrated the sewer wall but not yet to an extent causing leakage. The roots taking water from the contents of the sewer are warmer than the wall behind kept cooler by the surrounding filling material.
