[54] ENGINE MOUNT INCLUDING ENGINE MOUNT FAILURE INDICATOR

[73] Assignee: Rolls-Royce plc, London, England

When a breakage occurs to the connecting links which connect a gas turbine engine to aircraft structure, the engine drops onto a fail/safe mounting. The drop is minimal in magnitude and the invention provides a visual means for appreciating that the drop and therefore the breakage, has occurred. Relative movement between engine and airframe frees a pop up member and enables it to project beyond the engine envelope, for observation by inspection.

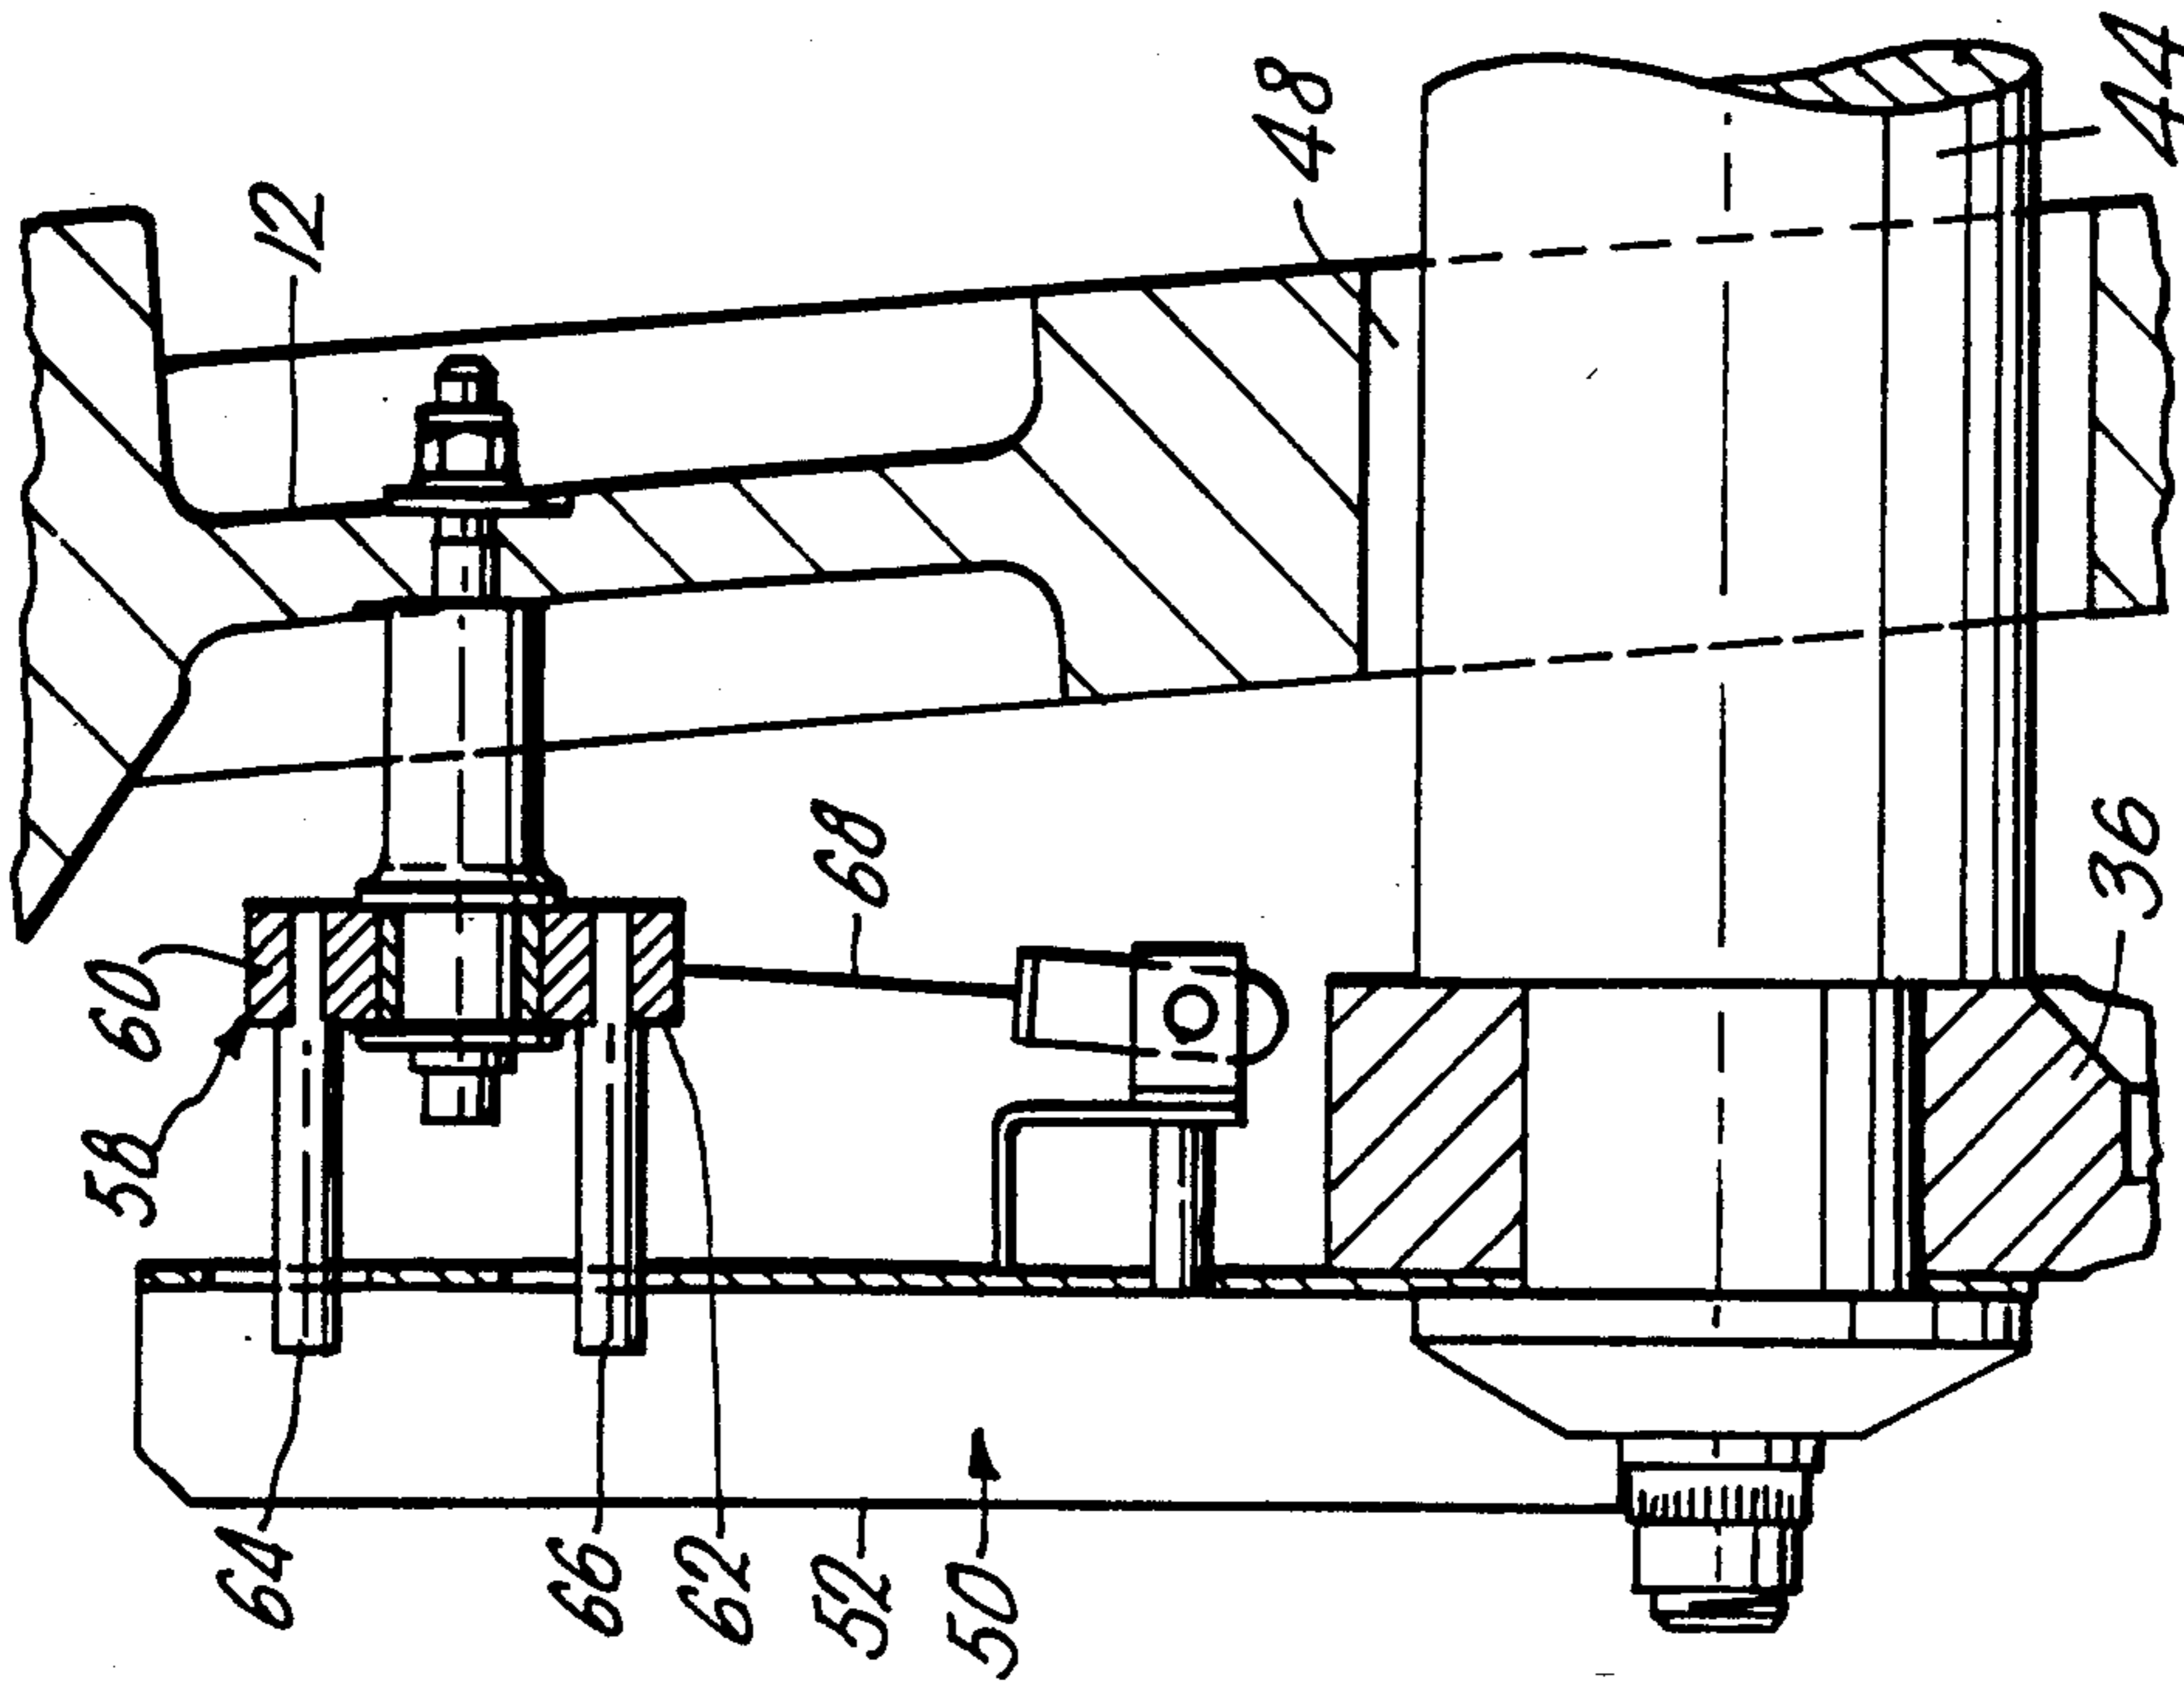
Fig. 5.

FIG. 5 is a view on line 5—5 of FIG. 4 and FIG. 6 is a cross sectional view of a portion of the apparatus in accordance with the present invention.

The pin 44 has a bracket 50 fastened to its extremity. The mode of fastening is seen more clearly in FIG. 5. The bracket 50 has a peripheral flange 52 for stiffening purposes.

A lever 58 is pivotally connected intermediate its ends to that part of the pylon 12 which has the clearance hole 48 therein. Again the pivot connection of the lever 58 is best seen in FIG. 5. The lever 58 has opposed lobes 60 and 62 formed laterally of its pivot axis and each lobe has one of two pins 64 and 66 fixed to it.

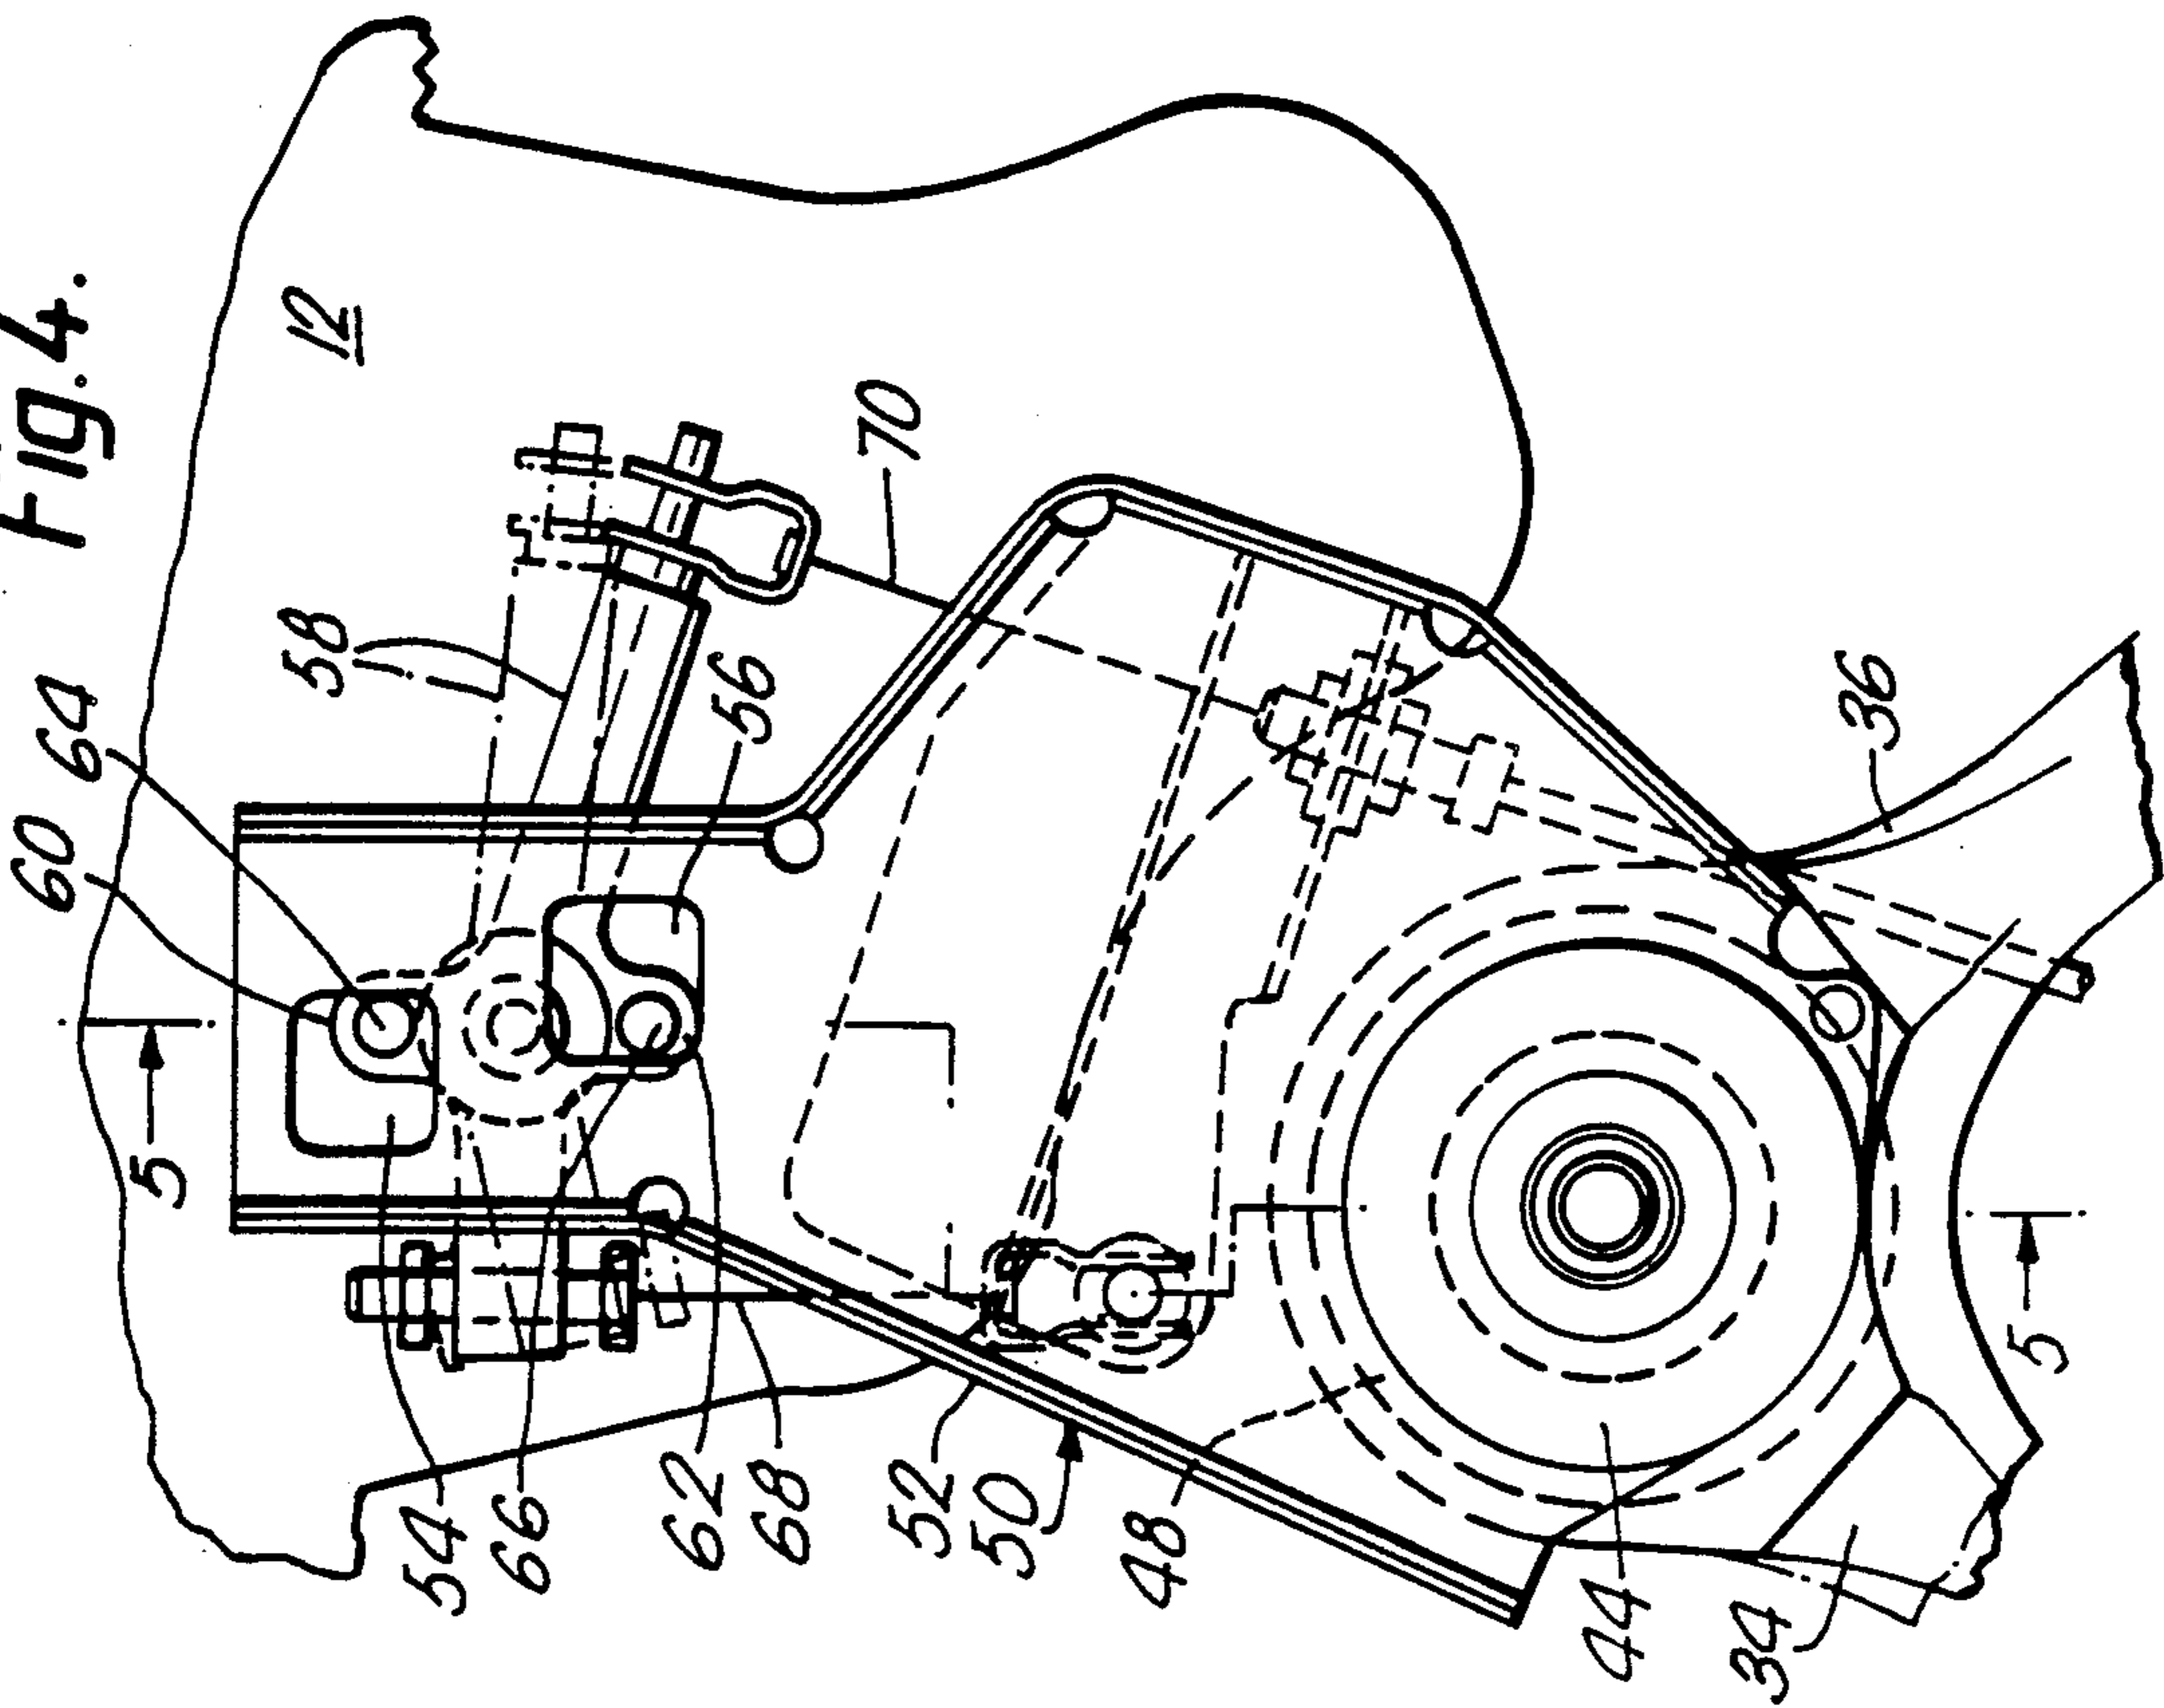
Fig. 4.

FIG. 4 is a view in the direction of arrow 4 in FIG. 1.

The upper end portion of the bracket 50 has a pair of rectangular cut outs 54 and 56 formed therein.

The free extremities of the pins 64 and 66 project through respective cut outs 54 and 56. In so doing, one side of pin 64 engages the right hand side of the cut out 54 as viewed in FIG. 4, and the opposite side of pin 66 engages the left hand side of the cut out 56.

During operation of the engine 10, if one or both of the links 34, 36 (FIG. 4) should break, the engine 10 will drop and so will the pin 44, onto the side of the bore in the pylon 12. This will result in the wire 68 being pulled downwards, which in turn will pivot the lever 58 counter-clockwise as viewed in FIG. 4, to the position shown in chain dotted lines. The wire 70 will thus be pulled upwards and this movement is transmitted thereby, to the piston 86 (FIG. 6) which will withdraw from the groove 92 in the piston 80. The spring 82 will then urge the piston 80 upwards so that its end protrudes beyond the wall structure (74) and thus provides a (visual indication) that the engine has dropped and therefore, the mounting is damaged.

Should the torque link 38 break, the engine 10 will develop a turning movement about its axis. In this case, the bracket 50 will move bodily in an arcuate path in the same direction of rotation. Depending on that direction of rotation, a side of one or other of the cut outs 54, 56 will exert a force on its respective pin 64 or 66 and cause the lever 58 to rotate in an anti-clockwise direction. The arrangement is such that the lever 58 always rotates in the said counter-clockwise direction as viewed in FIG. 4. It follows that the wire 70 will always be pulled and that will cause the pistons 86 and 80 to be moved as described hereinbefore. If however, the connections of the wires 68 and 70 were reversed, then the bracket would have to be adapted so that those edges of the windows 54 and 56 which are opposite the edges shown engaging the pins 64 and 66, will engage the pins 64 and 66.
