[54] **ENGINE MOUNT INCLUDING ENGINE MOUNT FAILURE INDICATOR**

[73] Assignee: **Rolls-Royce plc, London, England**

[57] ABSTRACT

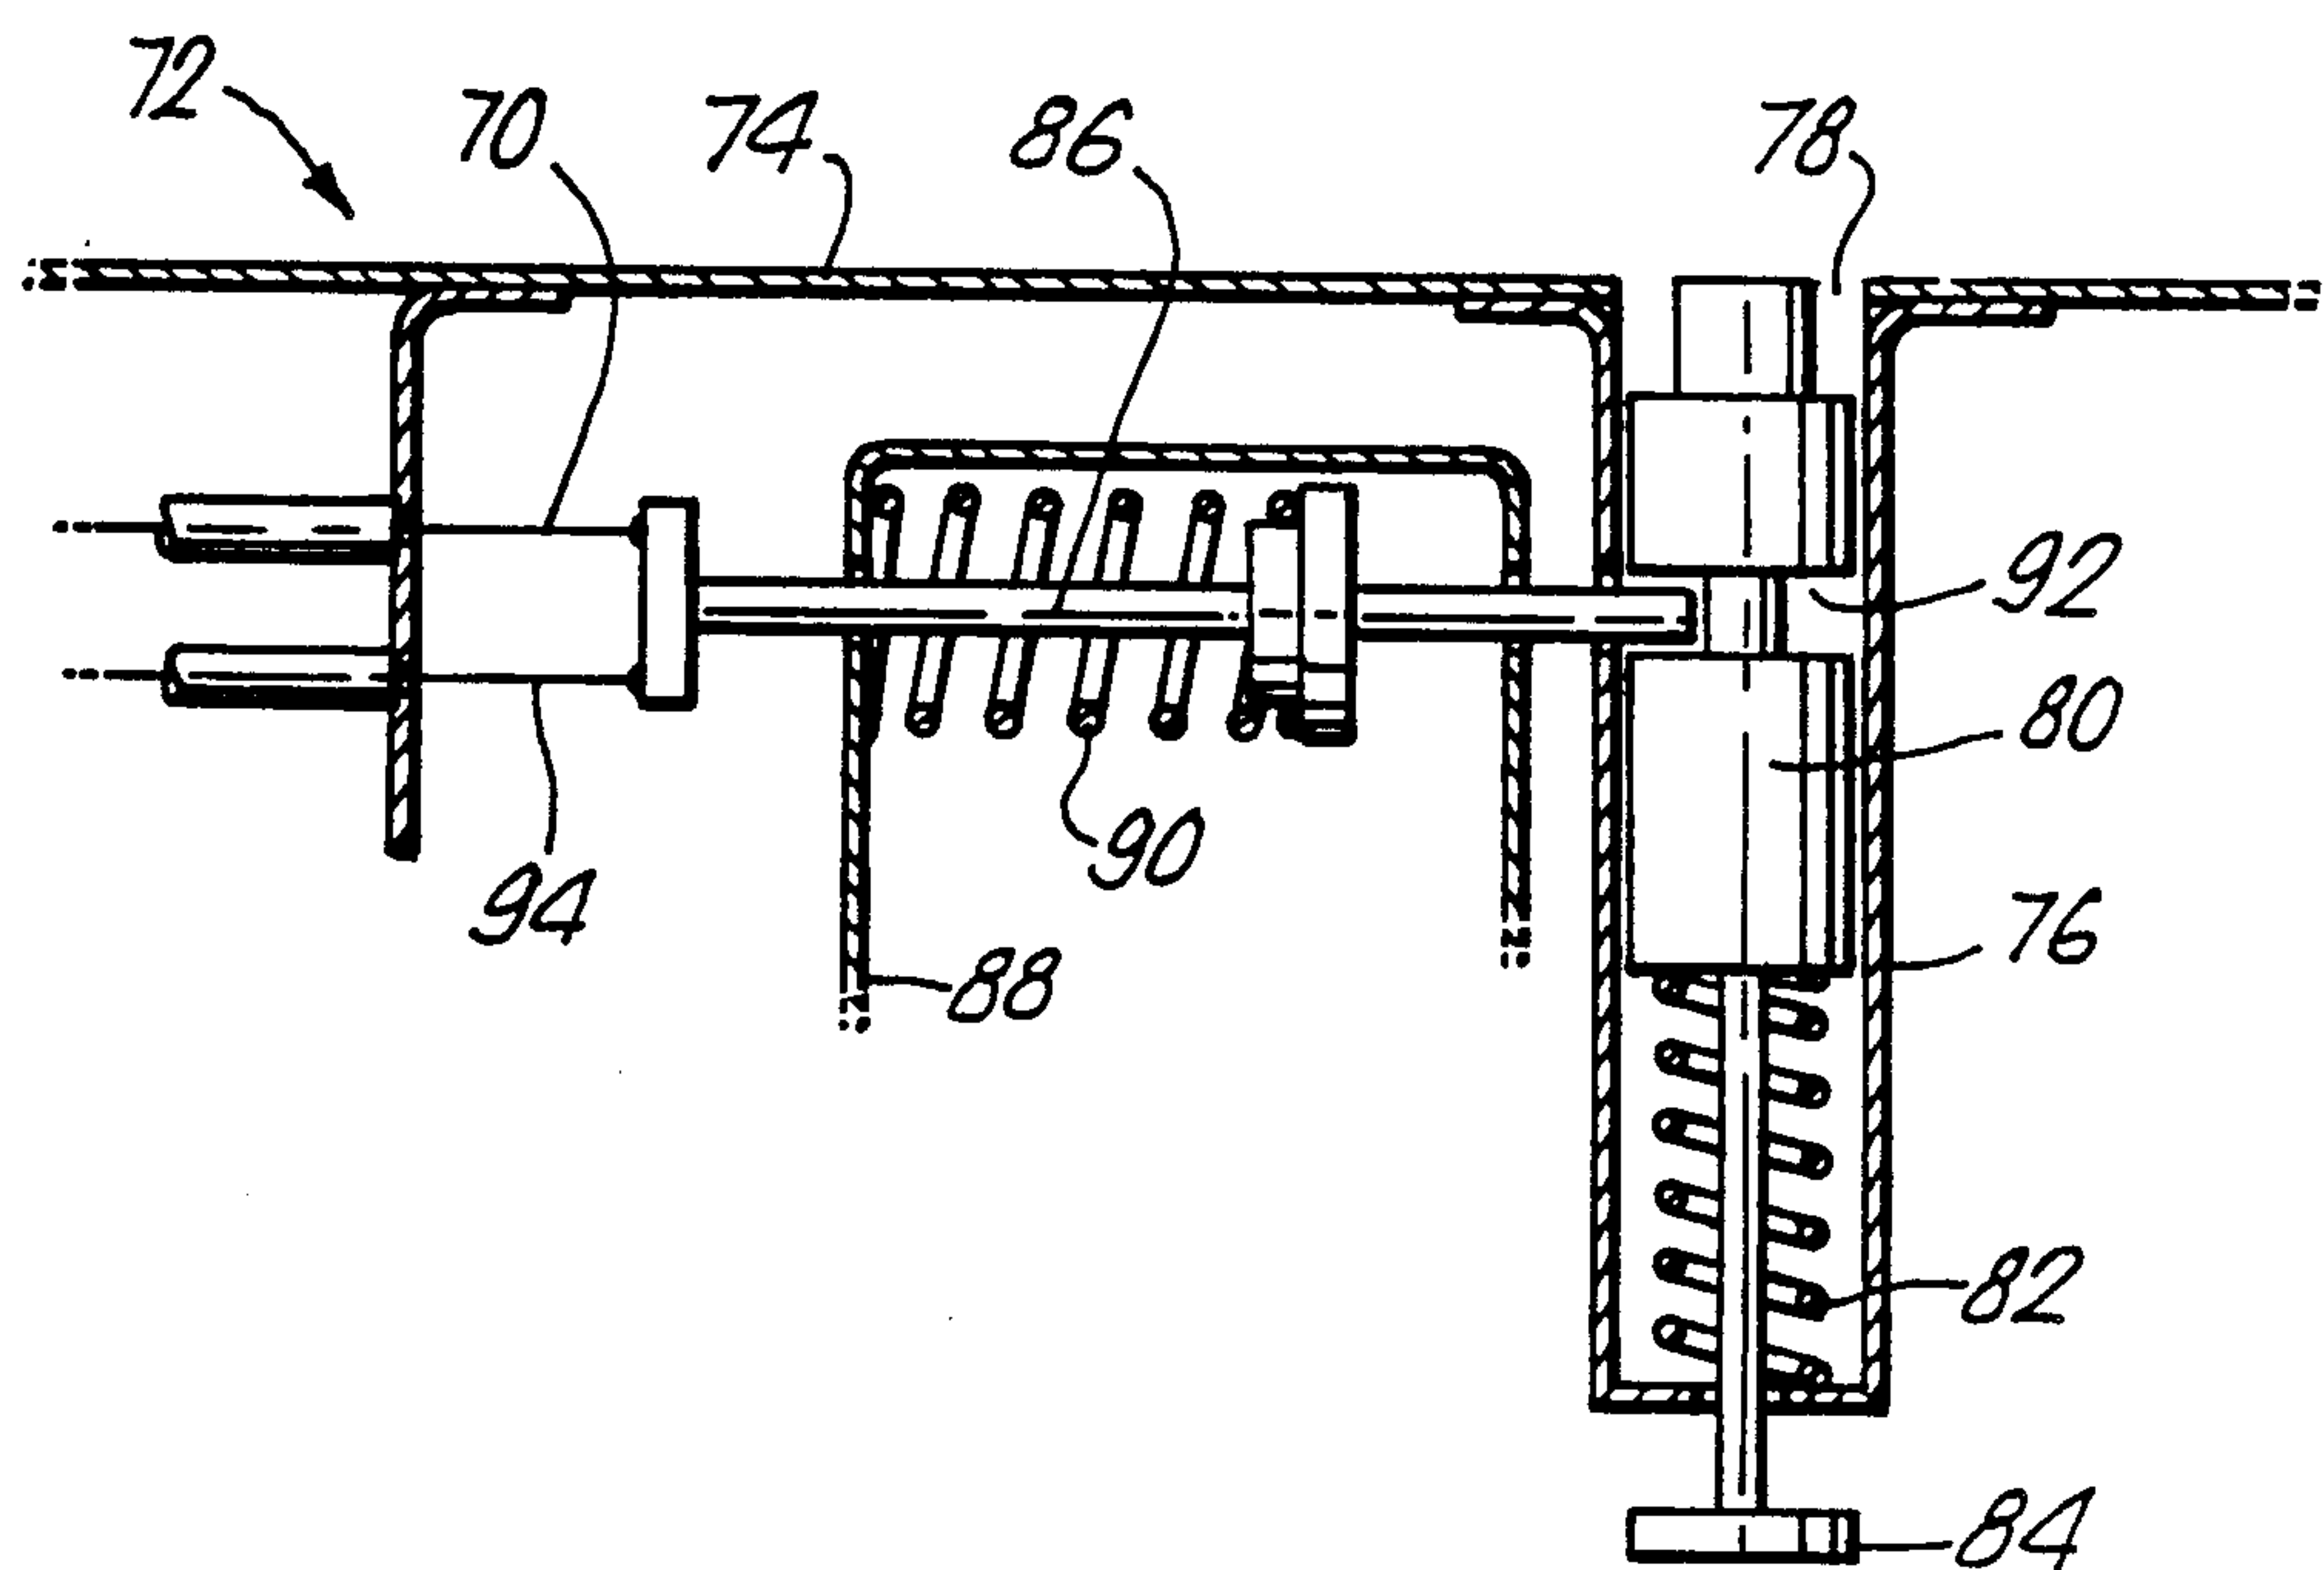
Fig. 6.

FIG. 5 is a view on line 5—5 of FIG. 4 and FIG. 6 is a cross sectional view of a portion of the apparatus in accordance with the present invention.

via a wire 70 and a device 72 (FIG. 6) which will be described hereinafter with reference to FIG. 6.
