US005549925A

[54] **HYBRID MICROCIRCUIT
GLASS-TO-METAL SEAL REPAIR PROCESS**

[73] Assignee: **Hughes Missile Systems Company**,
Los Angeles, Calif.

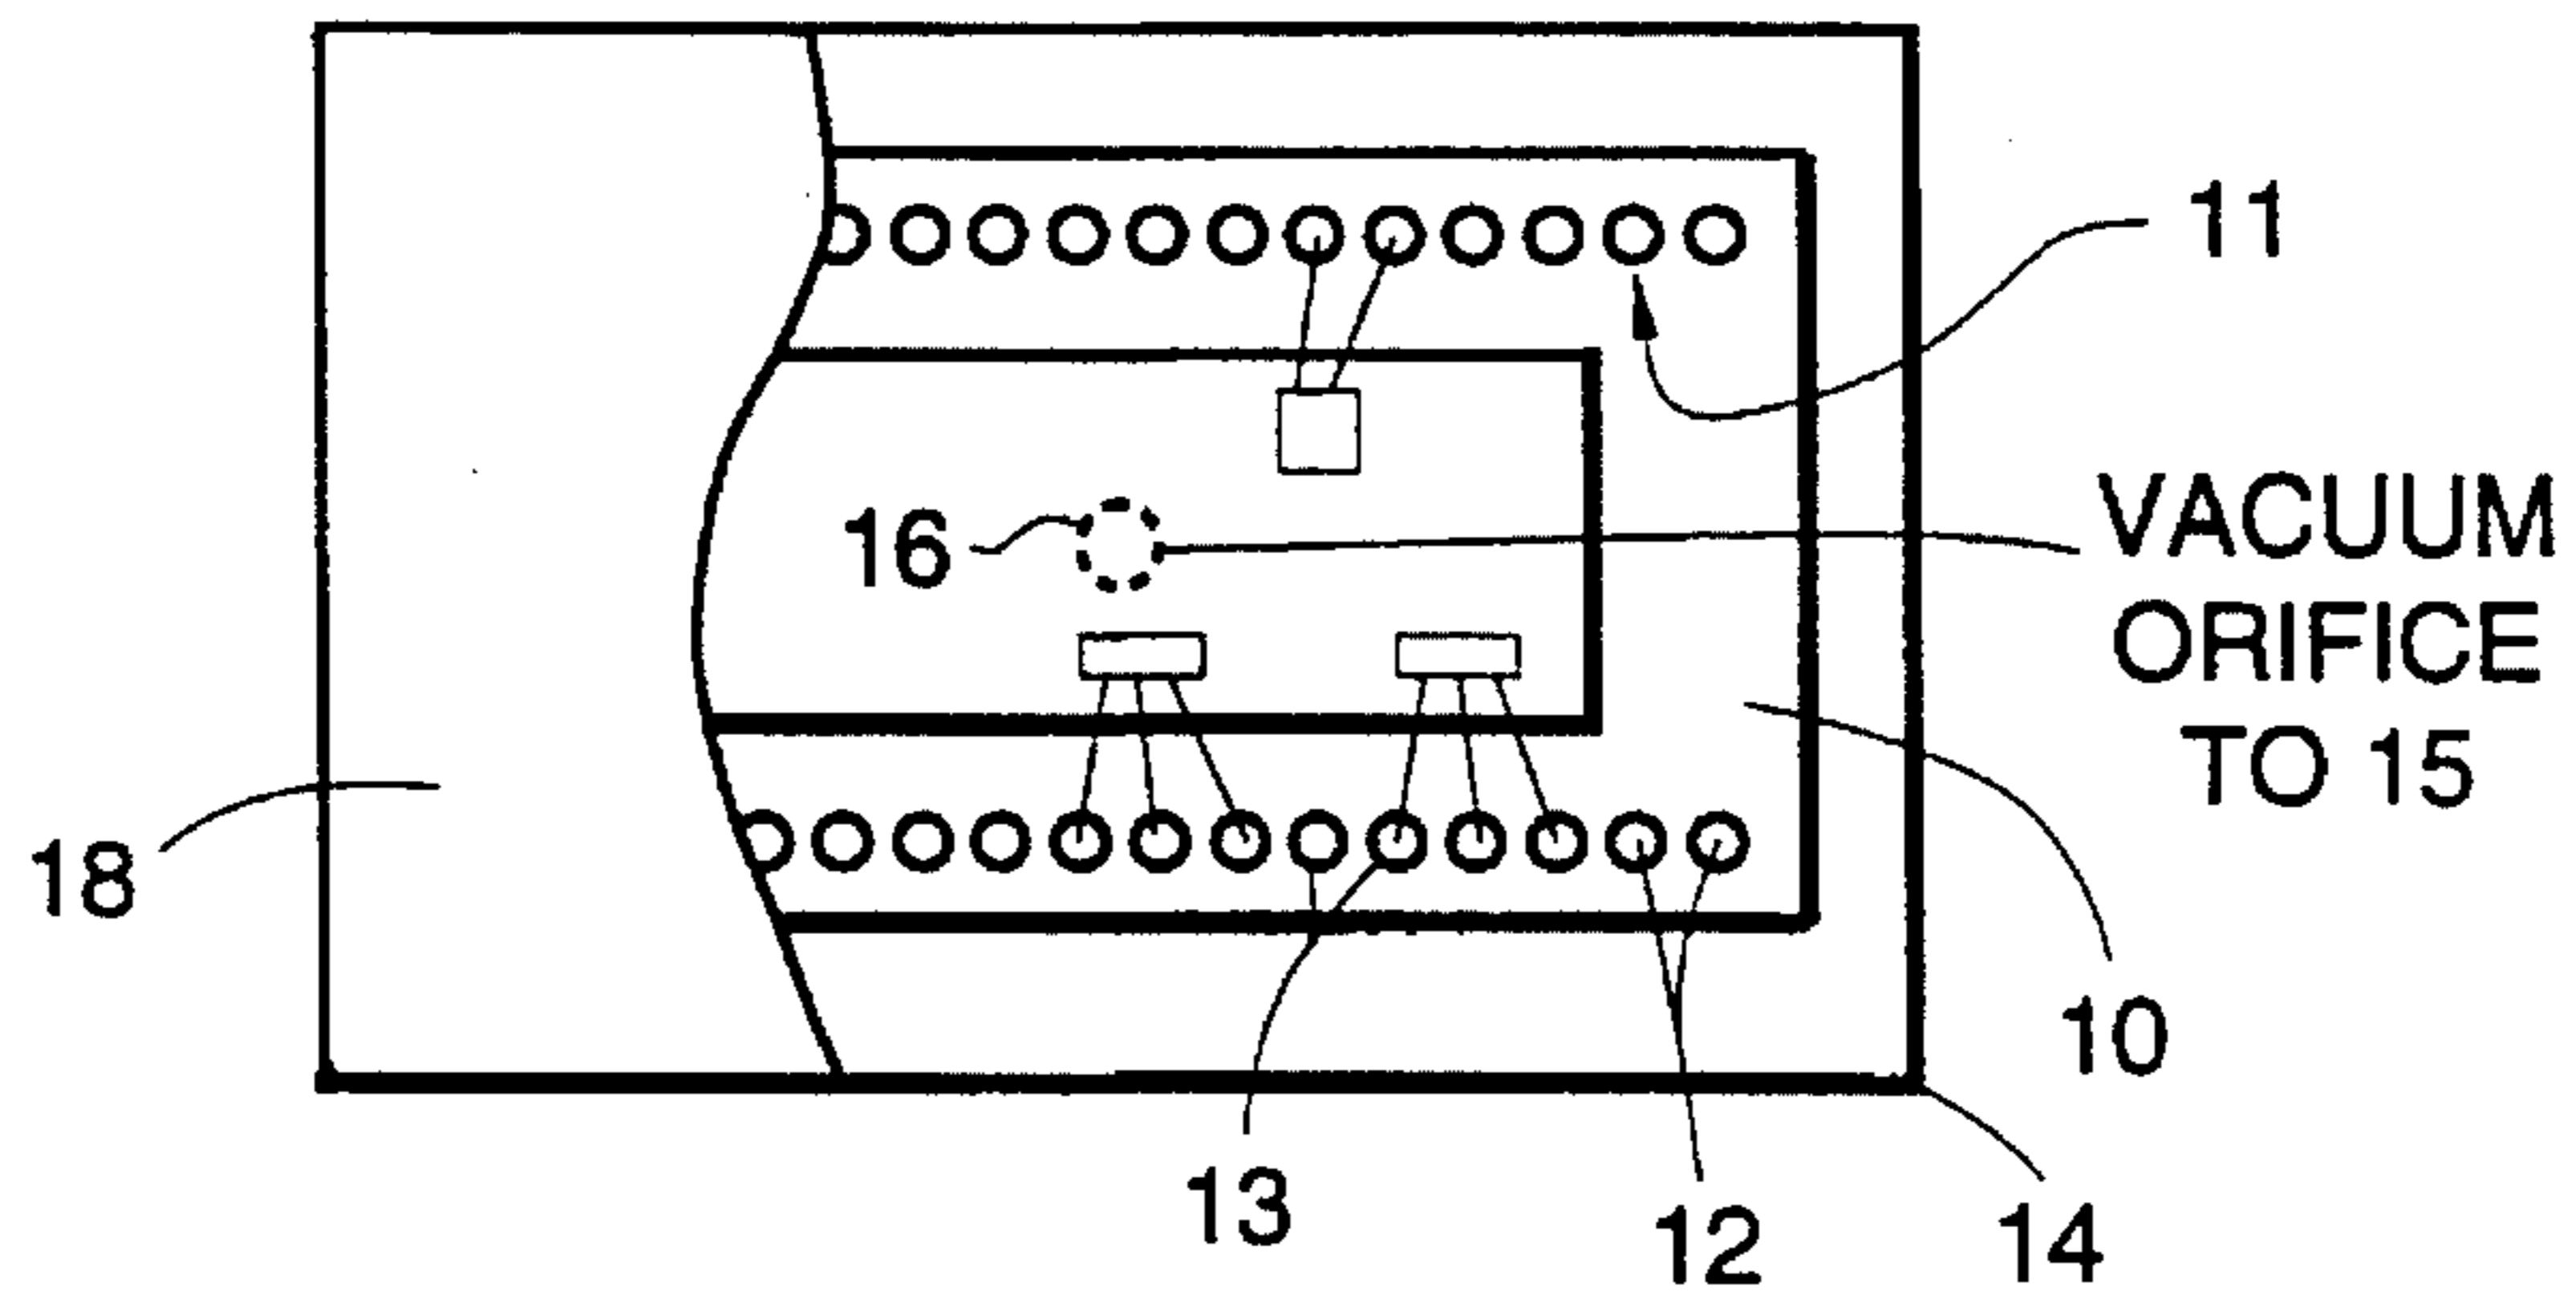
Fig. 1

FIGS. 1 and 2 illustrate a hybrid microcircuit header repair process in accordance with the principles of the present invention;

Referring to the drawing figure, FIGS. 1 and 2 illustrate top and side views of a hybrid microcircuit header 10 having leaking glass-to-metal seals 13 that are to be repaired using a repair or sealing process 20 or procedure 20 in accordance with the principles of the present invention. The hybrid microcircuit header 10 contains leaking glass-to-metal seals 13 that are repaired by the process 20.

As is shown in FIG. 1, the hybrid microcircuit header 10 contains electrical leads 12 that extend from the surface thereof and which permit electrical connections to be made to the hybrid microcircuit header 10. Each of the leads 12 is surrounded and sealed at the surface of the hybrid microcircuit header 10 by means of a glass-to-metal seal 13 that is comprised of glass material, which is deposited and fired during the fabrication process. For the purposes of clarity, FIG. 1a illustrates an enlarged view of one glass-to-metal seal 13 of the hybrid microcircuit header 10.

The present sealing process 20 is designed to repair leaking glass-to-metal seals 13 that are uncovered during leak testing of the complete hybrid microcircuit package of which the hybrid microcircuit header 10 of FIG. 1 forms a

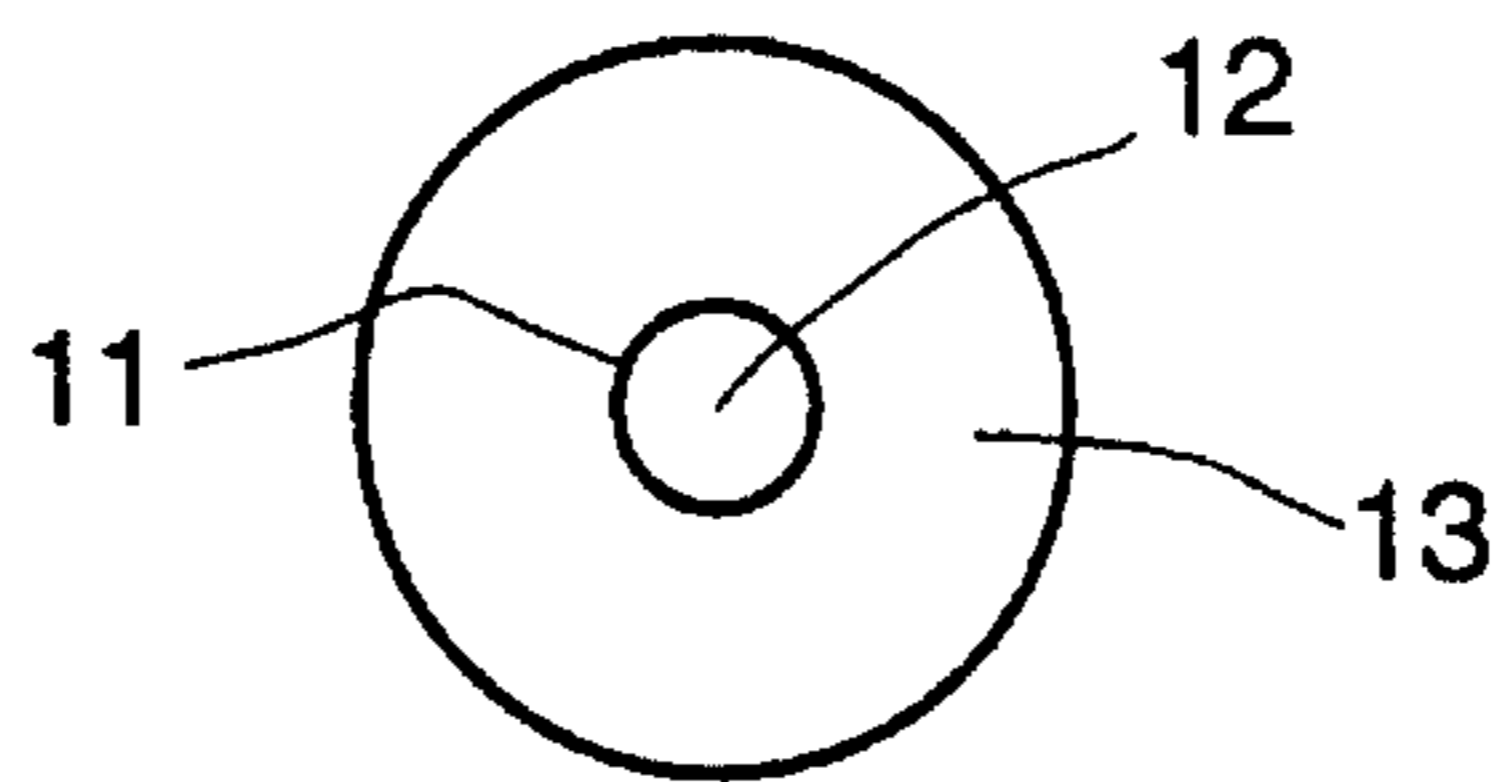
Fig. 1a

FIG. 1a illustrates an enlarged view of a glass-to-metal seal of the hybrid microcircuit header of FIGS. 1 and 2;

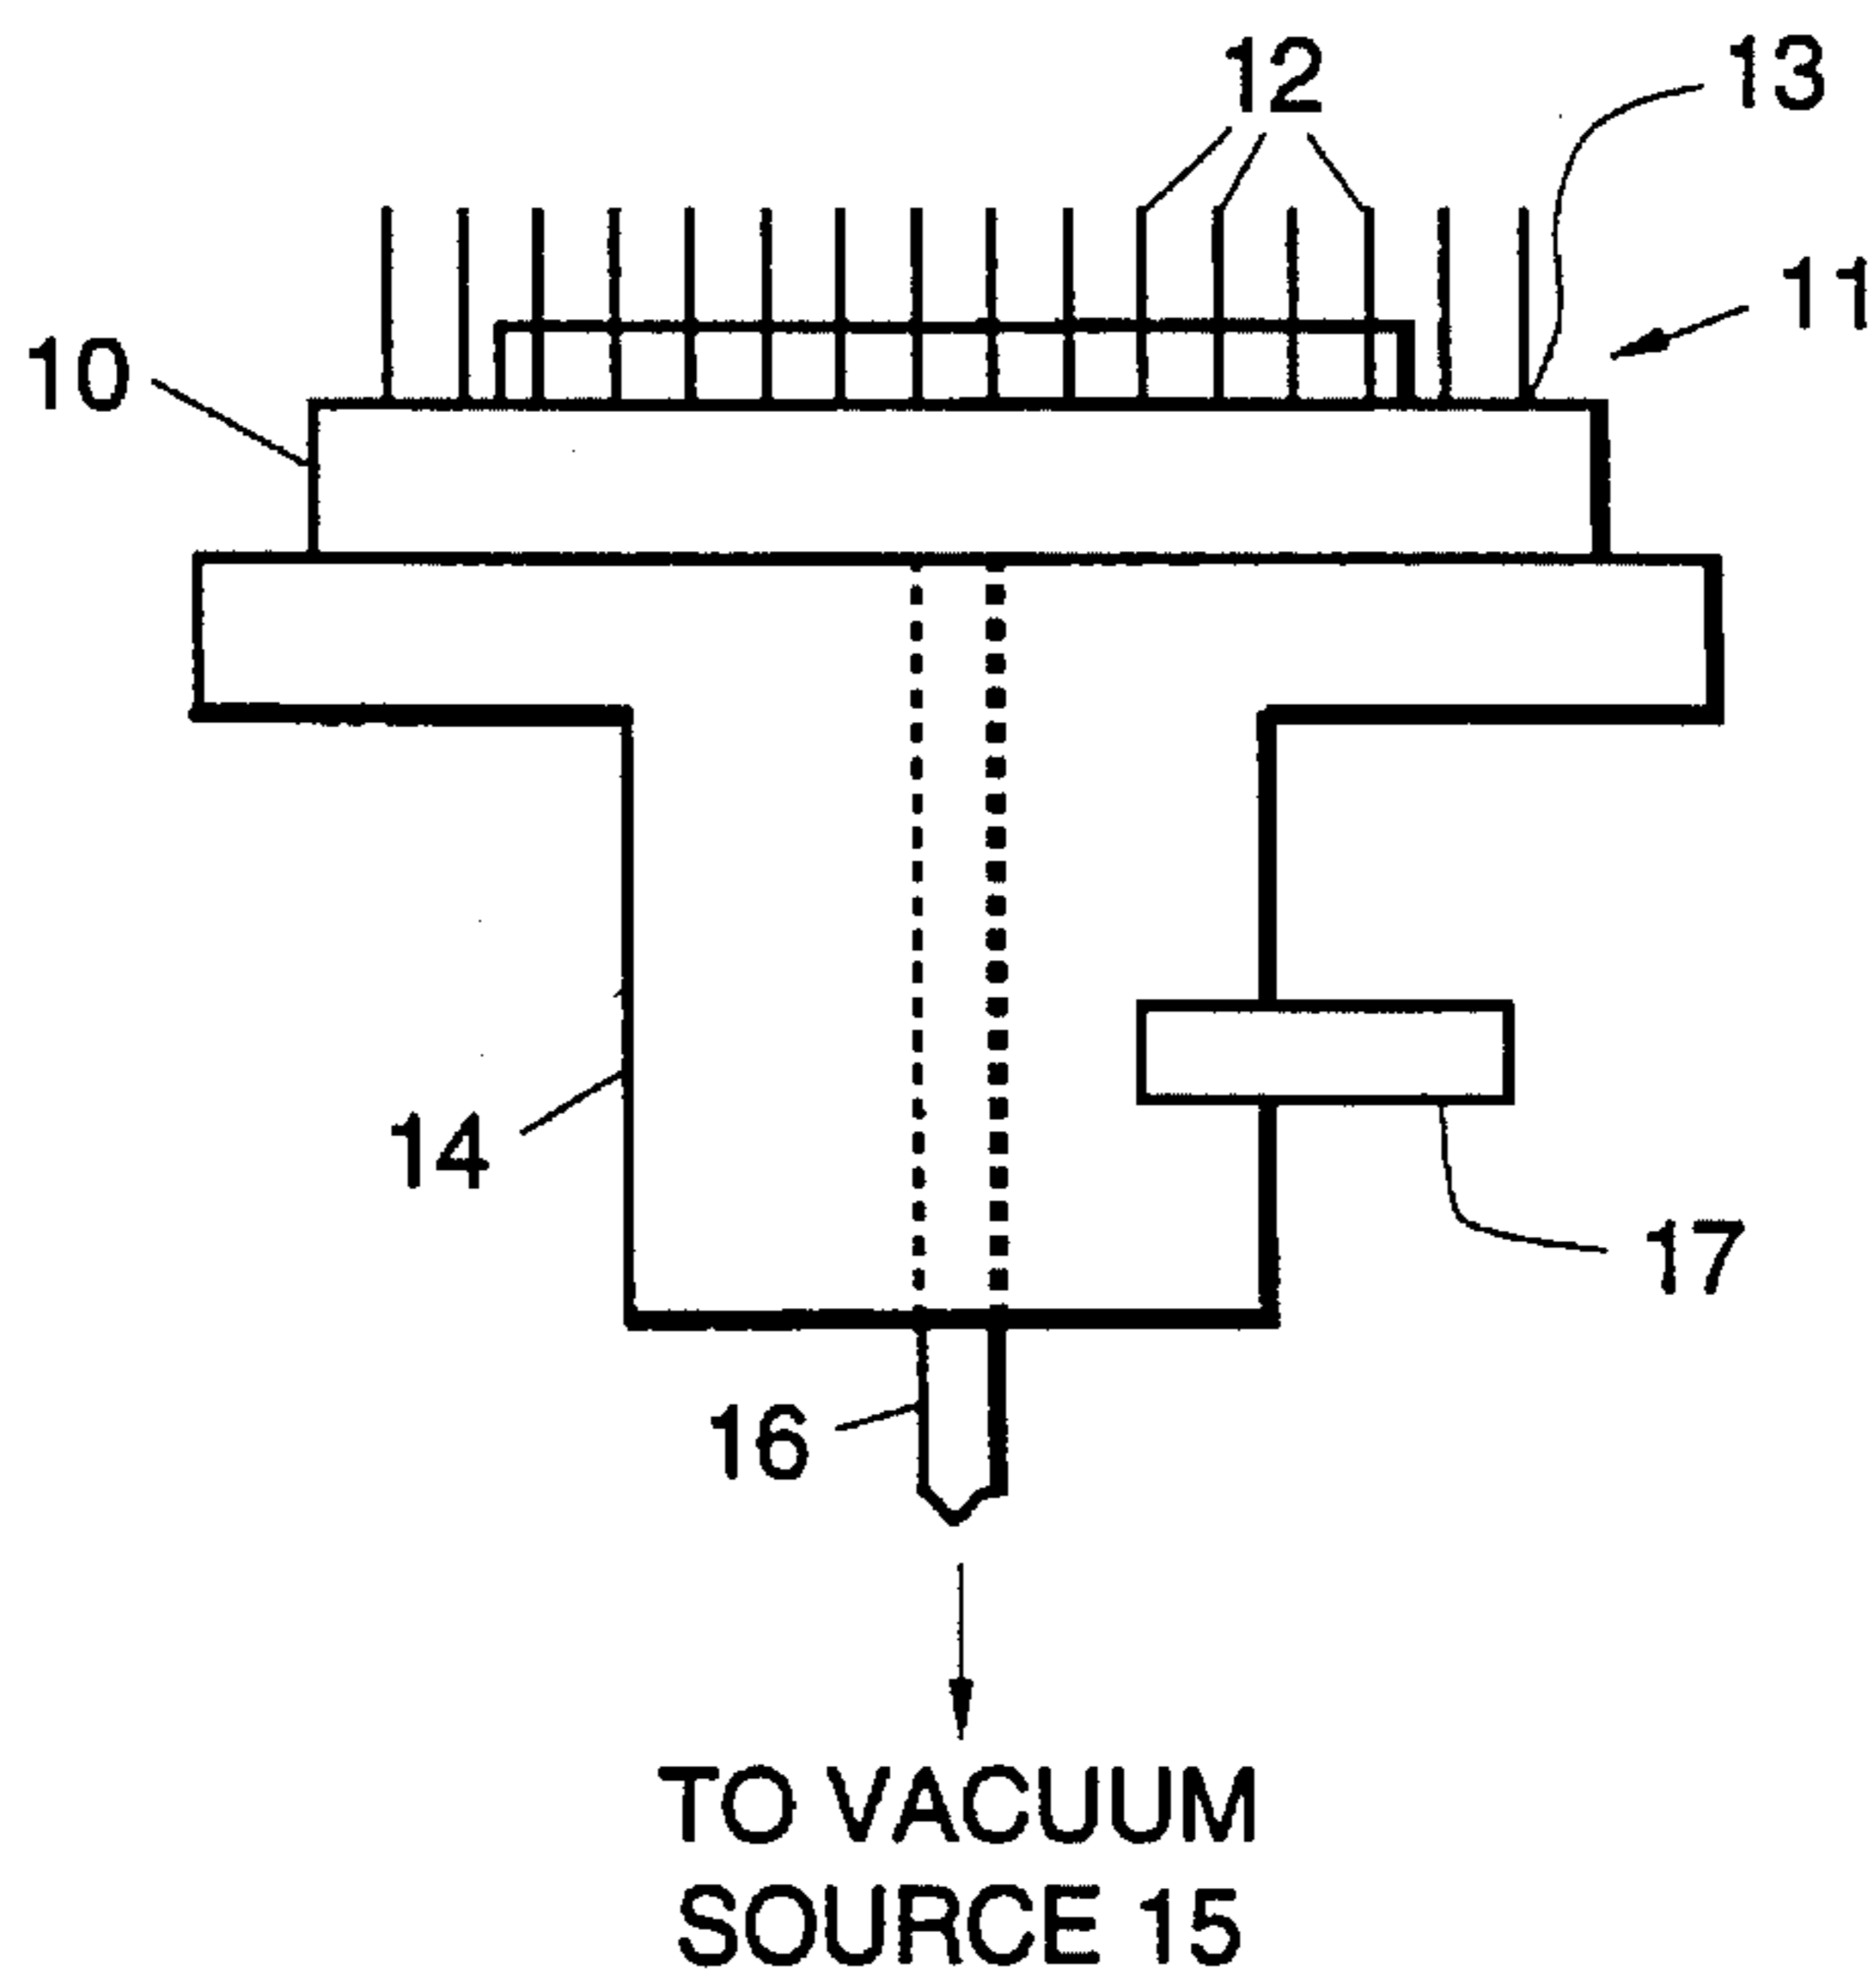
Fig. 2

part. As is shown in FIG. 2, in order to implement the present repair process 20, the hybrid microcircuit header 10, with its lid 18 removed, is attached to a platen 14 of a vacuum source 15, such as is provided by a Helium leak detector 17, for example. The platen 14 has one or more orifices 16 that permit a vacuum to be applied to the delidded hybrid microcircuit header 10.

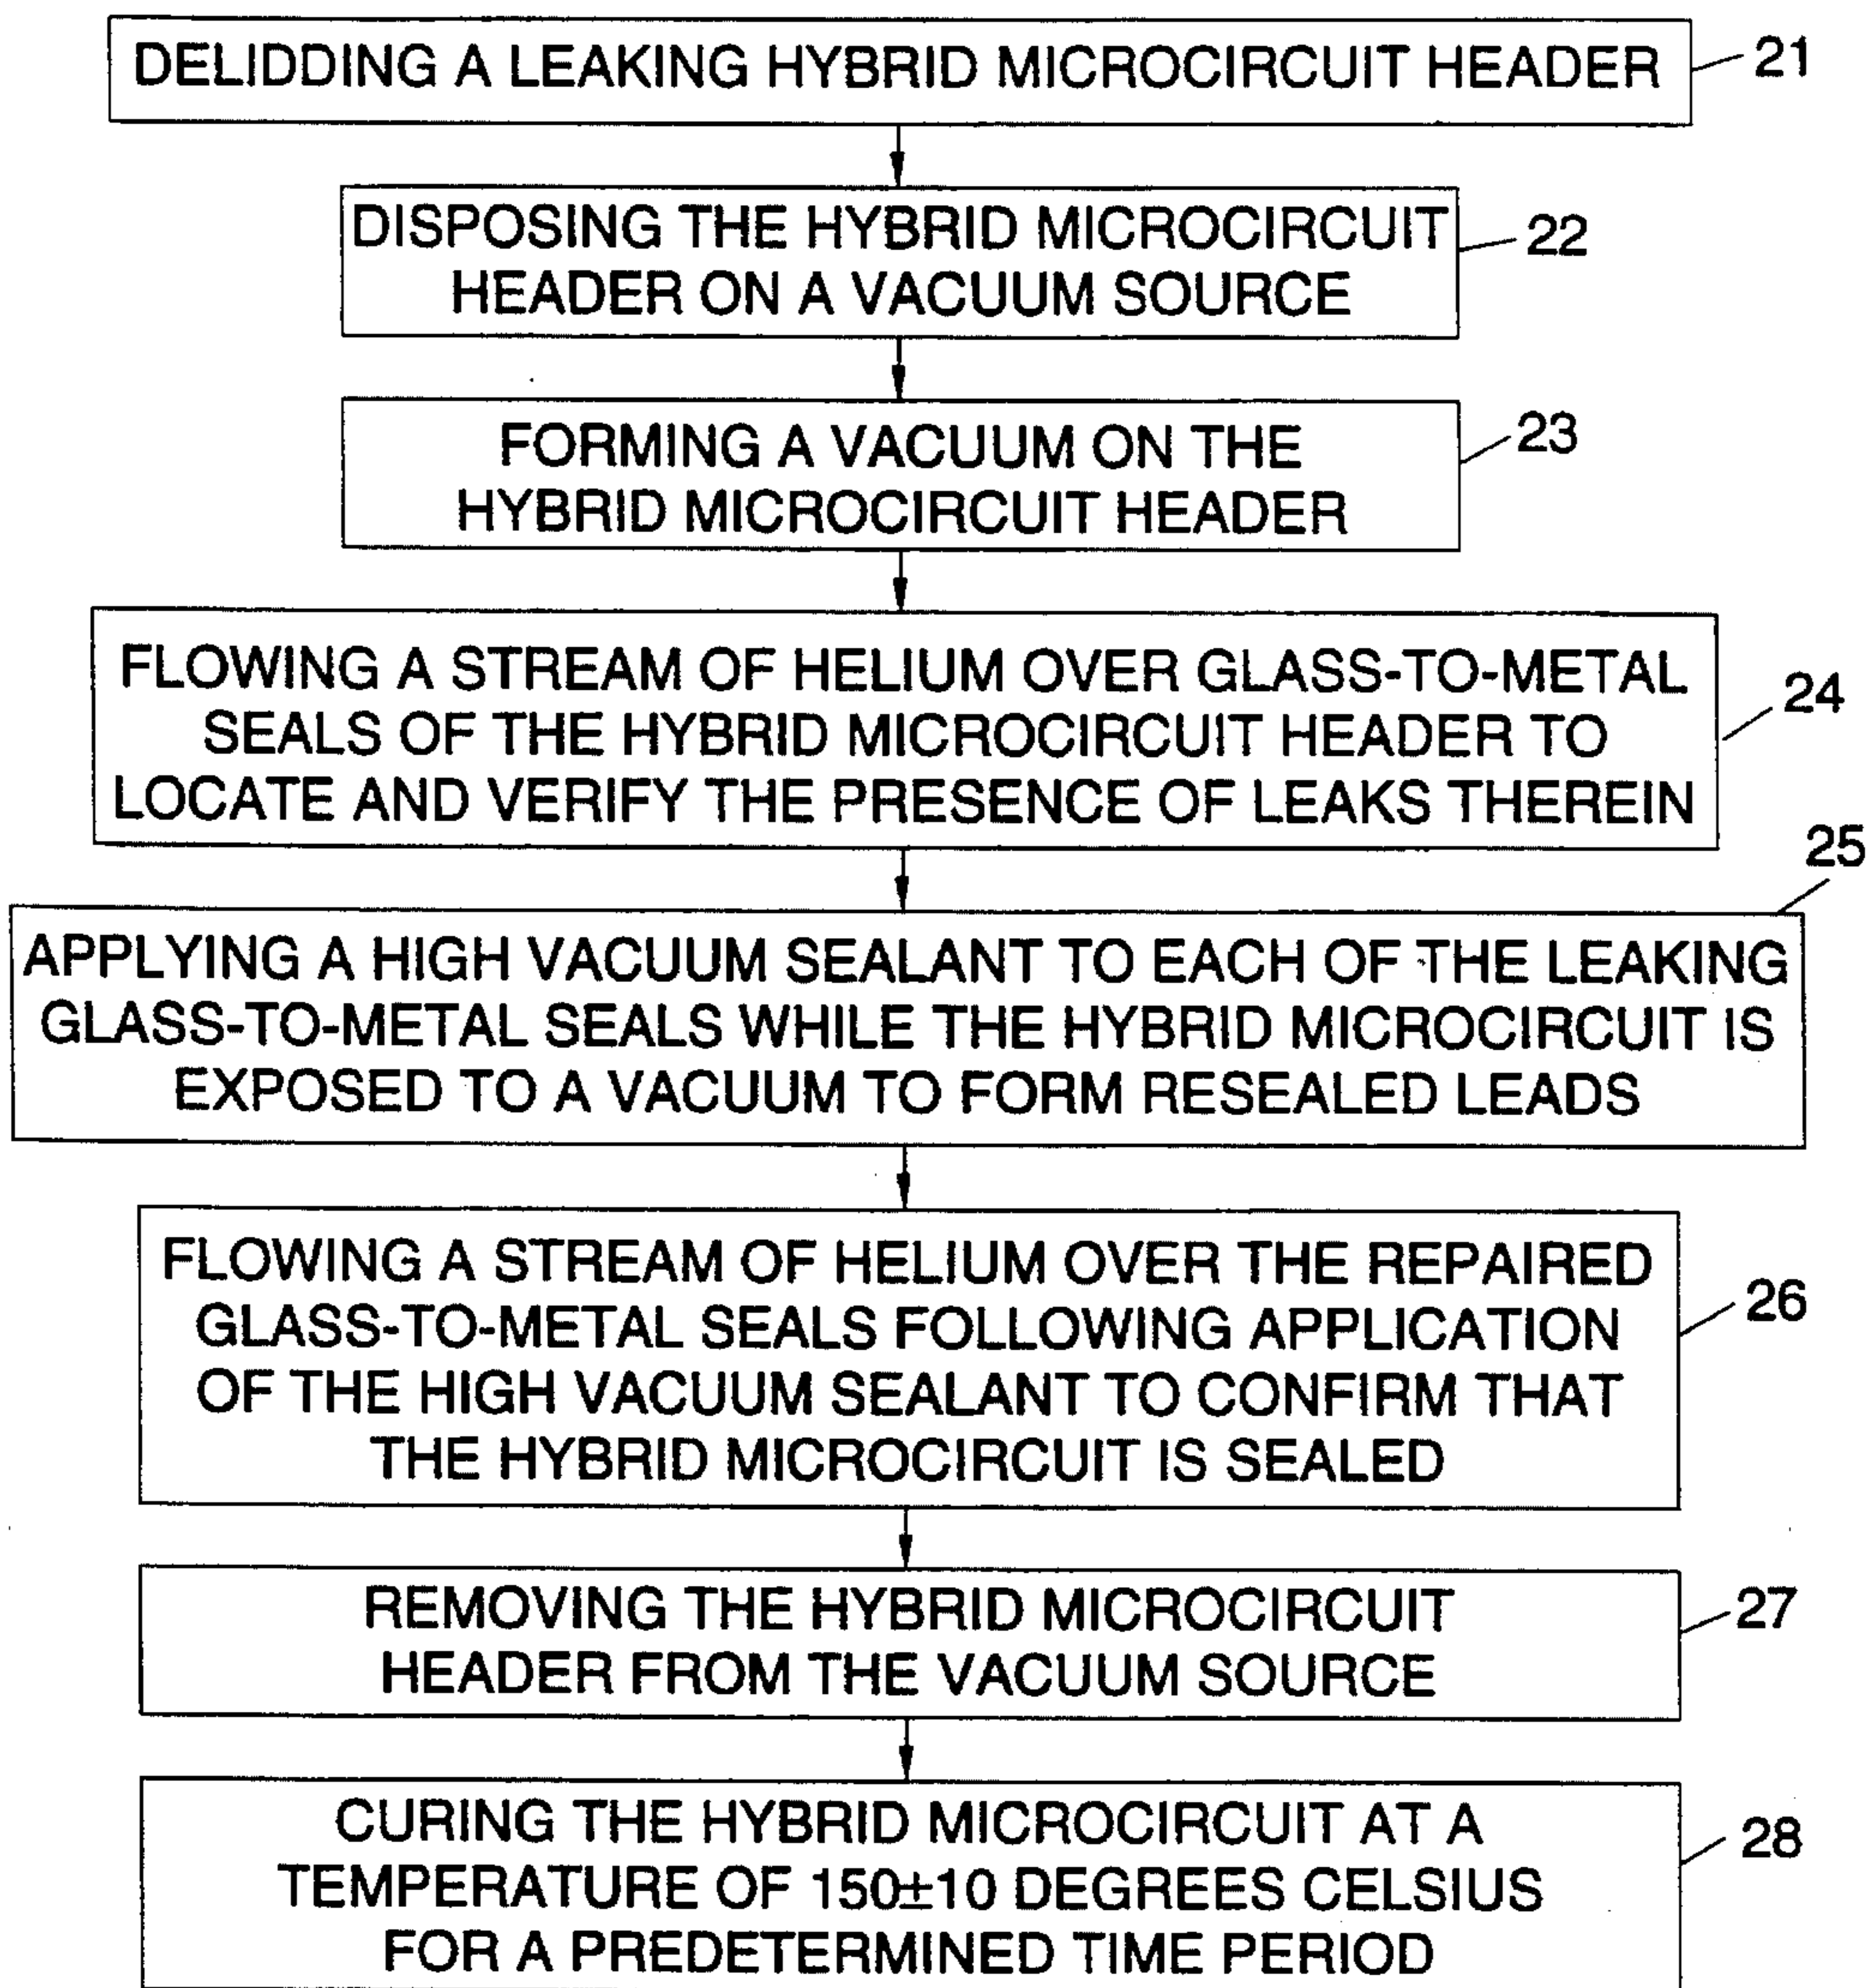
Fig. 3

FIG. 3 is a detailed flow diagram illustrating the hybrid microcircuit header repair process in accordance with the principles of the present invention; and

FIG. 3 is a flow diagram illustrating the repair process 20 in accordance with the principles of the present invention for repairing leaking glass-to-metal seal 13 of a hybrid microcircuit header 10. With reference to FIG. 3, the glass-to-metal seal 13 repair process 20 for repairing leaking hybrid microcircuit headers 10 comprises the following steps.

The failed hybrid microcircuit header 10 is first delidded 21 (its lid 18 or cover is removed) before performing the repair procedure. After delidding 21, the hybrid microcircuit header 10 is disposed 22, typically with its leads 12 pointing vertically, on a vacuum source 15. Then a vacuum is formed 23 on the hybrid microcircuit header 10 using the vacuum source 15, in the manner shown in FIG. 2. An open face helium leak detection system may be used as the vacuum source 15. A fine stream of helium is flowed 24 over the seals 13 to verify leaks in the seals 13 of the hybrid microcircuit header 10.

A small amount of high vacuum sealant 11 is then applied 25 to each leaking seal 13 while the hybrid microcircuit header 10 is exposed to the vacuum. The high vacuum sealant 11 may be applied 25 to each of the glass-to-metal seals 13 using a hypodermic syringe, for example. Following application of the high vacuum sealant 11, a stream of helium is flowed 26 over the leads 12 to confirm that the hybrid microcircuit header 10 is sealed.

The hybrid microcircuit header 10 is removed 27 from the vacuum source 15 and cured 28 in an oven at a temperature of 150 ± 10 degrees C. (302 degrees Fahrenheit) for 2 hours minimum. Following curing 28, the hybrid microcircuit header 10 is retested 29 for leaks using the Helium and vacuum source 15. Once the resealed hybrid microcircuit header 10 has passed the open face leak tests, the hybrid microcircuit header 10 is processed and tested through the remaining assembly processes beginning with the seam seal process (reattachment of the lid 18 or cover).

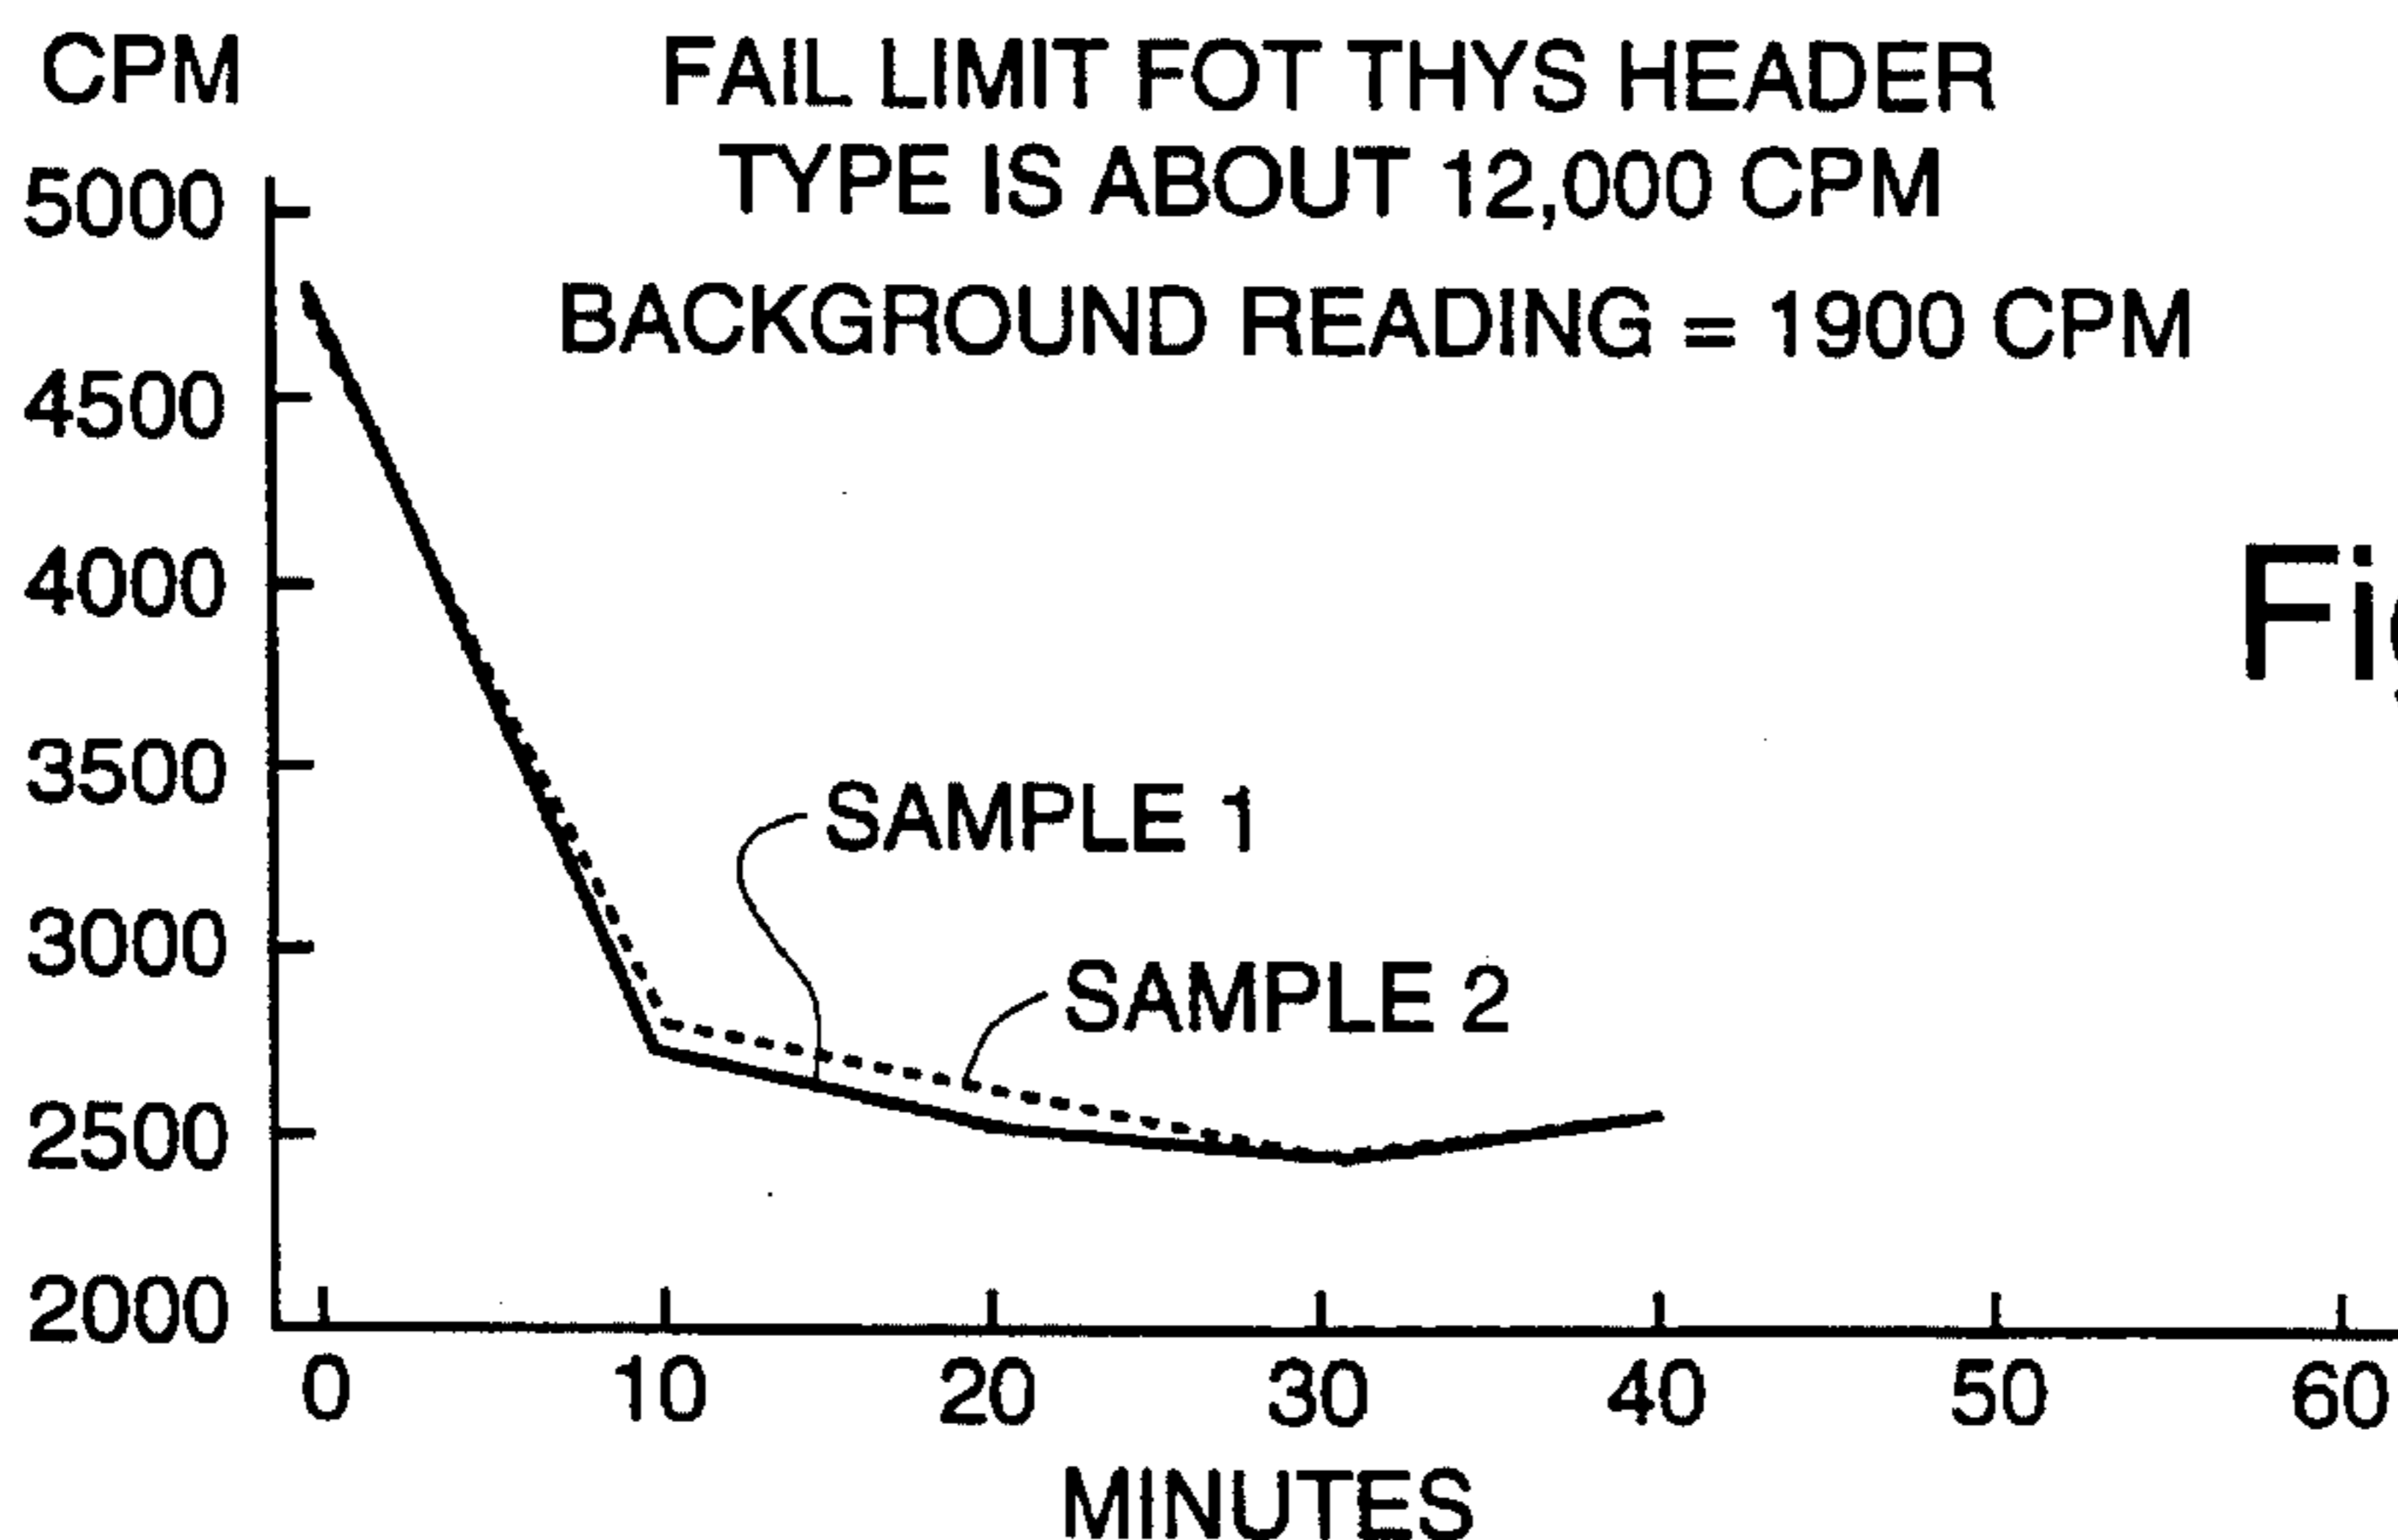
Fig. 4

FIG. 4 illustrates a radioactive decay test plot for hybrid microcircuit headers repaired using the present repair process.

Leak detection using Krypton gas was performed on one of the hybrid microcircuit headers 10 to determine the absorption rate of the radioactive gas into the sealant 11. Results of the test indicate that the counts per minute are well below desired limits, as is indicated in the radioactive decay test plot of FIG. 4.
