[11] Patent Number: **5,549,925**

[54] **HYBRID MICROCIRCUIT
GLASS-TO-METAL SEAL REPAIR PROCESS**

[73] Assignee: **Hughes Missile Systems Company**,
Los Angeles, Calif.

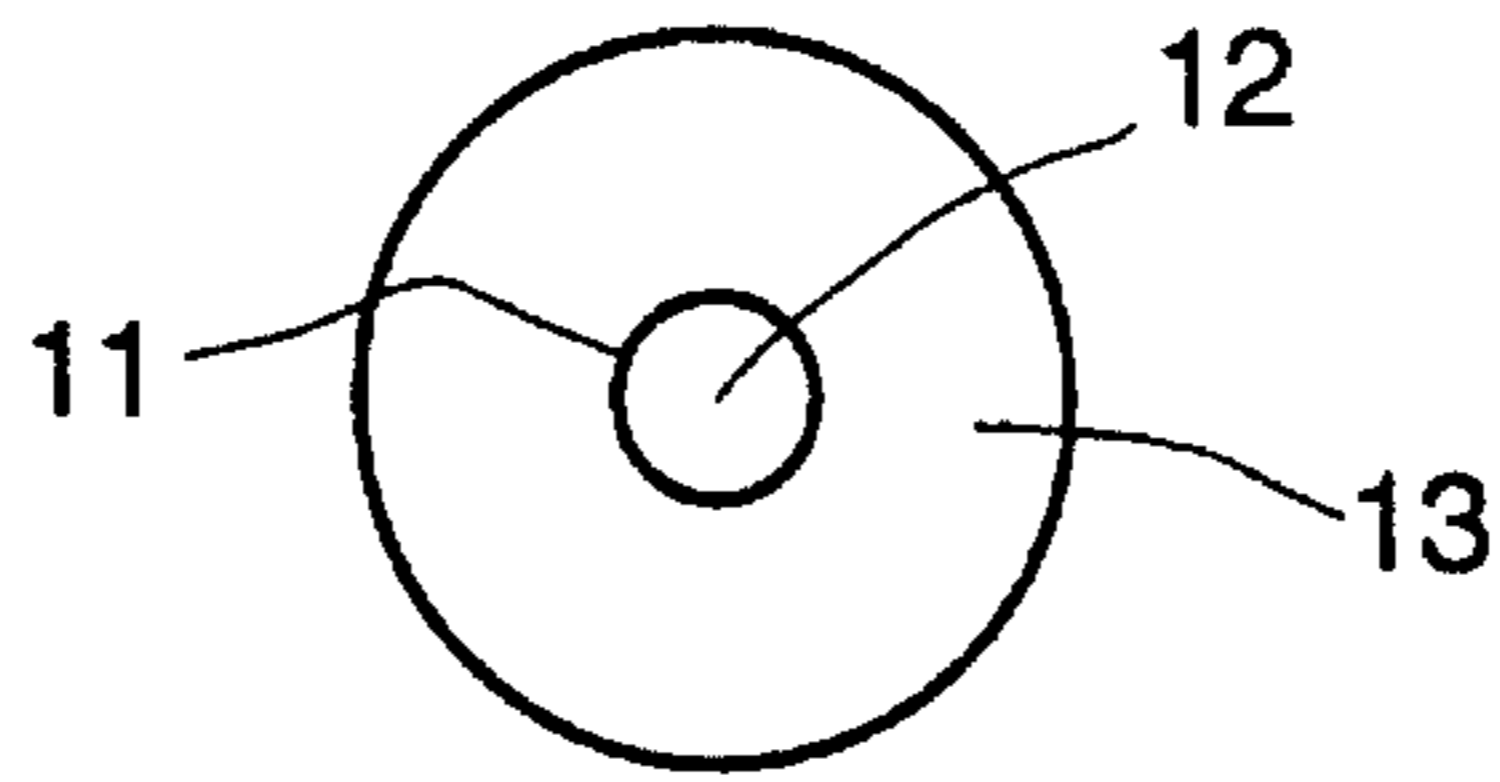
Fig. 1a

FIG. 1a illustrates an enlarged view of a glass-to-metal seal of the hybrid microcircuit header of FIGS. 1 and 2;

As is shown in FIG. 1, the hybrid microcircuit header 10 contains electrical leads 12 that extend from the surface thereof and which permit electrical connections to be made to the hybrid microcircuit header 10. Each of the leads 12 is surrounded and sealed at the surface of the hybrid microcircuit header 10 by means of a glass-to-metal seal 13 that is comprised of glass material, which is deposited and fired during the fabrication process. For the purposes of clarity, FIG. 1a illustrates an enlarged view of one glass-to-metal seal 13 of the hybrid microcircuit header 10.
