US005723078A

[54] **METHOD FOR REPAIRING A THERMAL BARRIER COATING**

[73] Assignee: **General Electric Company**, Cincinnati, Ohio

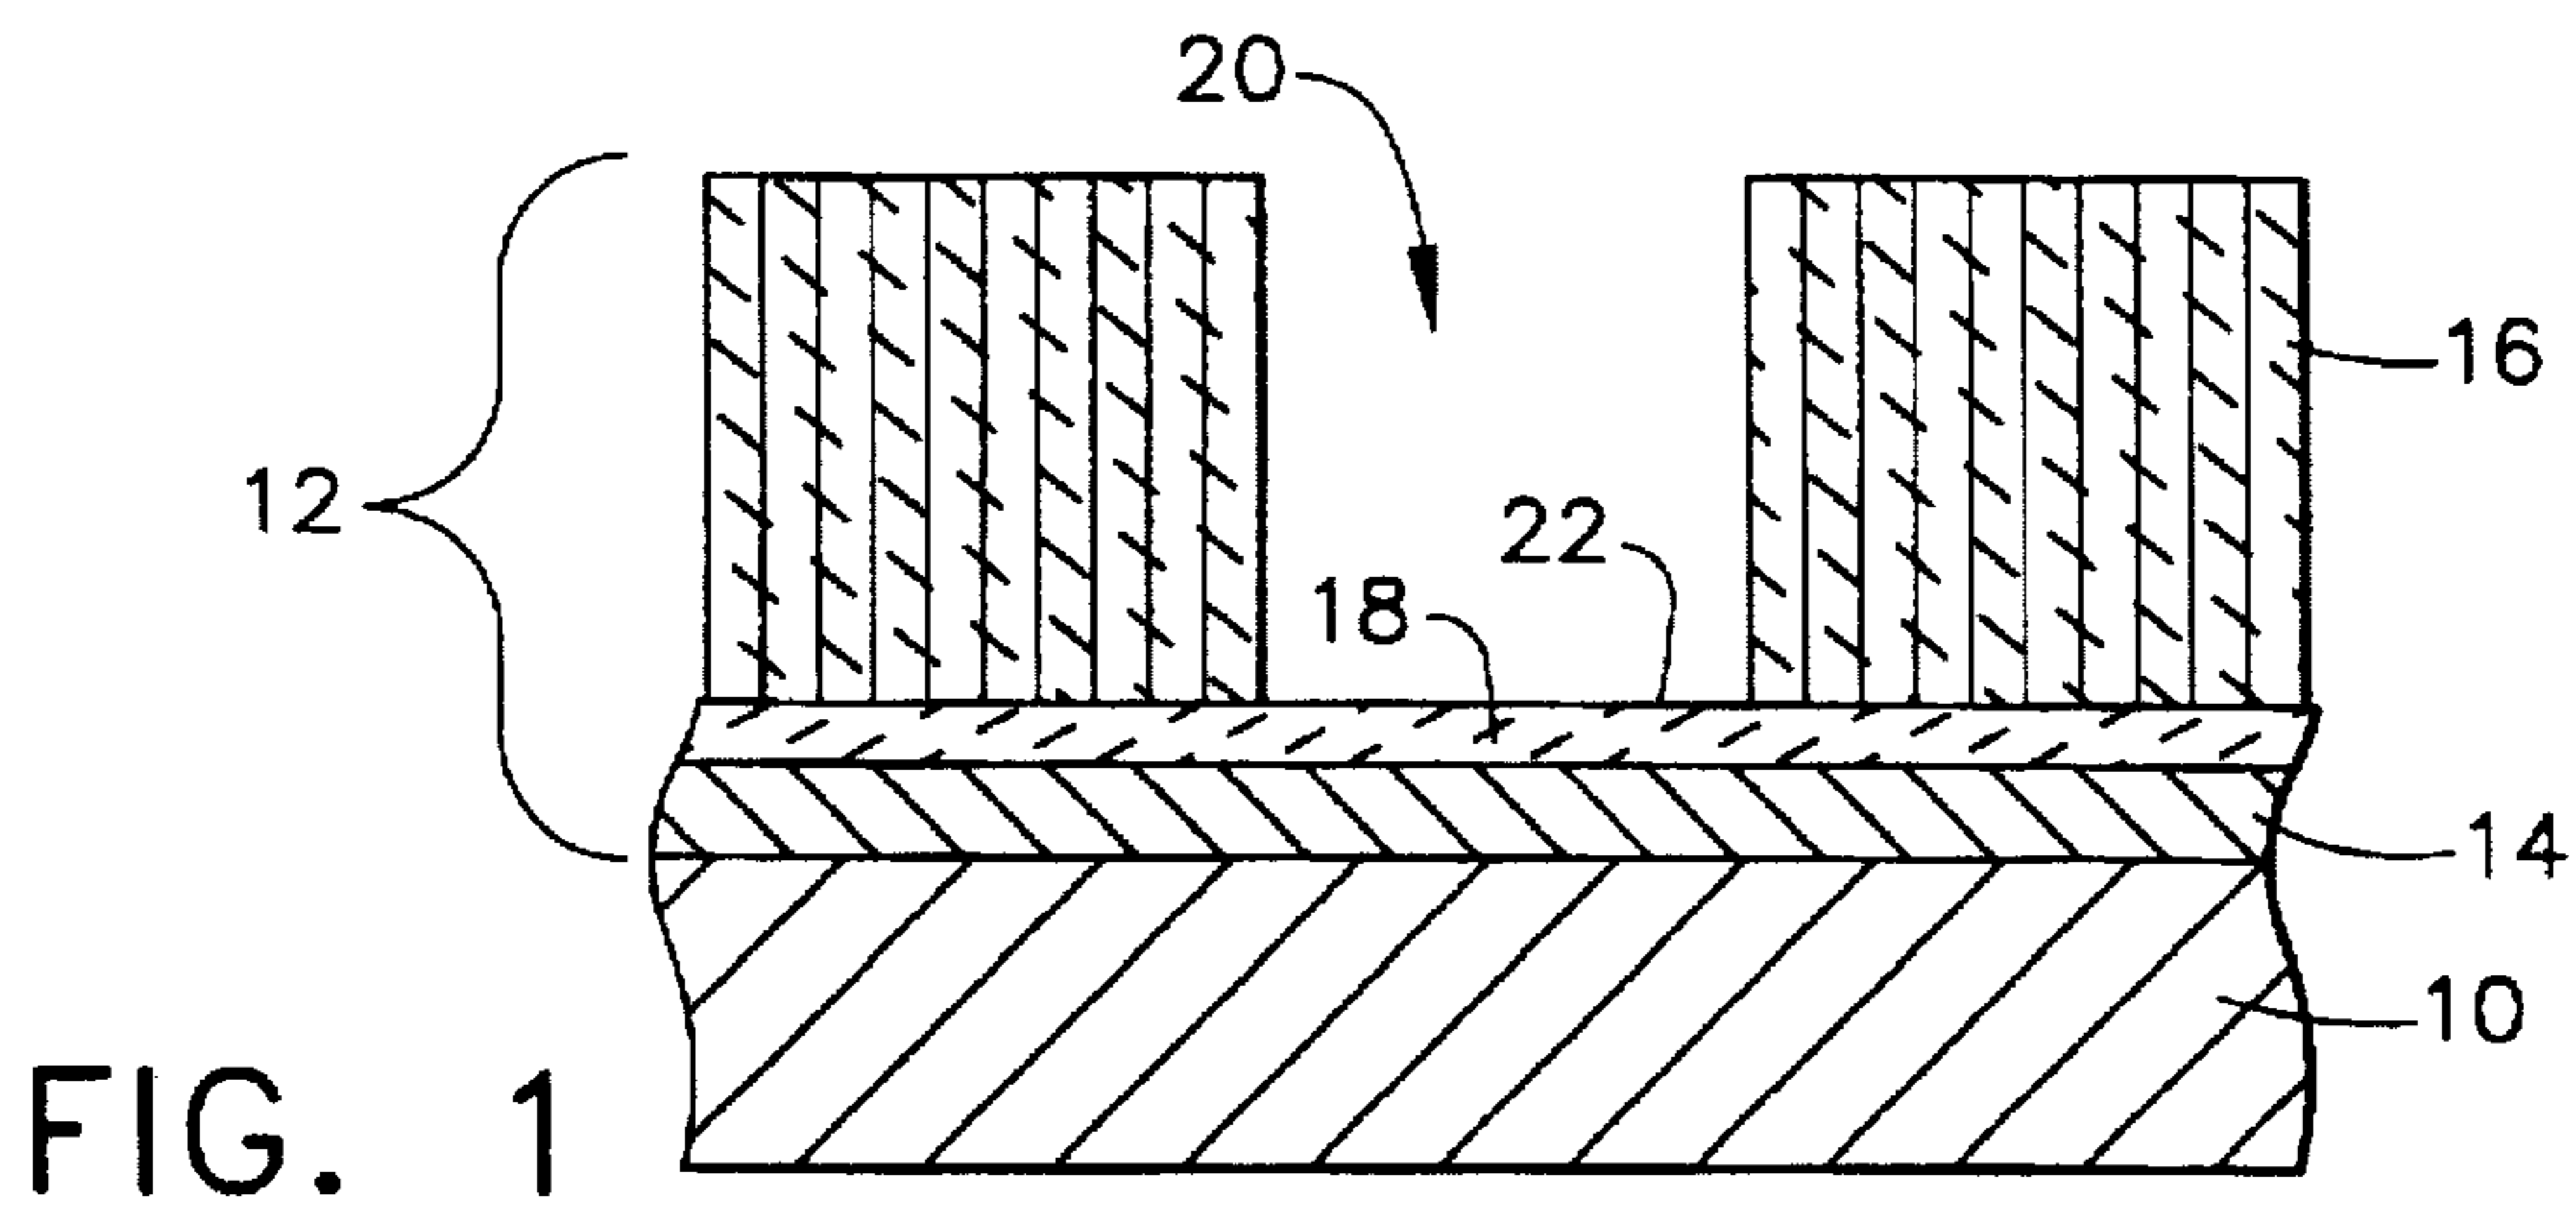
FIG. 1 shows a cross-sectional representation of a component that has suffered localized spallation; and

As represented in FIG. 1, the method of this invention is particularly suited for the repair of a thermal barrier coating system 12 composed of a metallic bond layer 14 formed on the surface of the article 10, and a columnar ceramic layer 16 overlaying the bond layer 14. As is the situation with high

temperature components of a gas turbine engine, the article 10 may be formed of a nickel-base or cobalt-base superalloy. The bond layer 14 is preferably formed of a metallic oxidation-resistant material, so as to protect the underlying article 10 from oxidation and enable the ceramic layer 16 to more tenaciously adhere to the article 10. A preferred bond layer 14 is formed by a nickel-base alloy powder, such as NiCrAlY, or an intermetallic nickel or platinum aluminide, which has been deposited on the surface of the article 10 to a thickness of about 20 to about 125 micrometers. Preferred methods for depositing bond layers of the type described above include vapor deposition techniques for aluminide coatings and low pressure plasma spray (LPPS) techniques for a NiCrAlY bond coat, though it is foreseeable that other deposition methods such as air plasma spray (APS) or physical vapor deposition (PVD) techniques could be used. Following deposition of the bond layer 14, an oxide layer 18 such as alumina may be formed on the surface of the bond layer 14 at an elevated temperature. The oxide layer 18 provides a surface to which the columnar ceramic layer 16 can tenaciously adhere, thereby promoting the resistance of the coating system 12 to thermal shock.

As a component of a gas turbine engine, surfaces of the article 10 are subjected to hot combustion gases during operation of the engine, and are therefore subjected to severe attack by oxidation, corrosion and erosion. Accordingly, the article 10 must remain protected from the hostile environment of the turbine section by the thermal barrier coating system 12, and loss of the ceramic layer 16 will lead to premature and often rapid deterioration of the article 10. Localized spallation 20 of the ceramic layer 16 is represented in FIG. 1, with the repair process of this invention being represented in FIGS. 2 and 3.

The repair method of this invention begins with cleaning the bond layer 14 exposed by the localized spallation 20 so as to remove oxides and any residual fragments of the ceramic and oxide layers 16 and 18. While various techniques can be used, a preferred method is to grit blast the exposed surface of the bond layer 14, such as by a technique known as pencil grit blasting. This step is selectively performed to ensure that the remaining ceramic layer 16 is not subjected to the procedure. It may be desirable to mask the surrounding ceramic layer 16 with, for example, tape masking, during the grit blasting operation. In addition to providing a level of protection to the ceramic layer 16, tape masking would also serve as a proof test for the integrity of the ceramic layer 16 immediately surrounding the spallation 20.

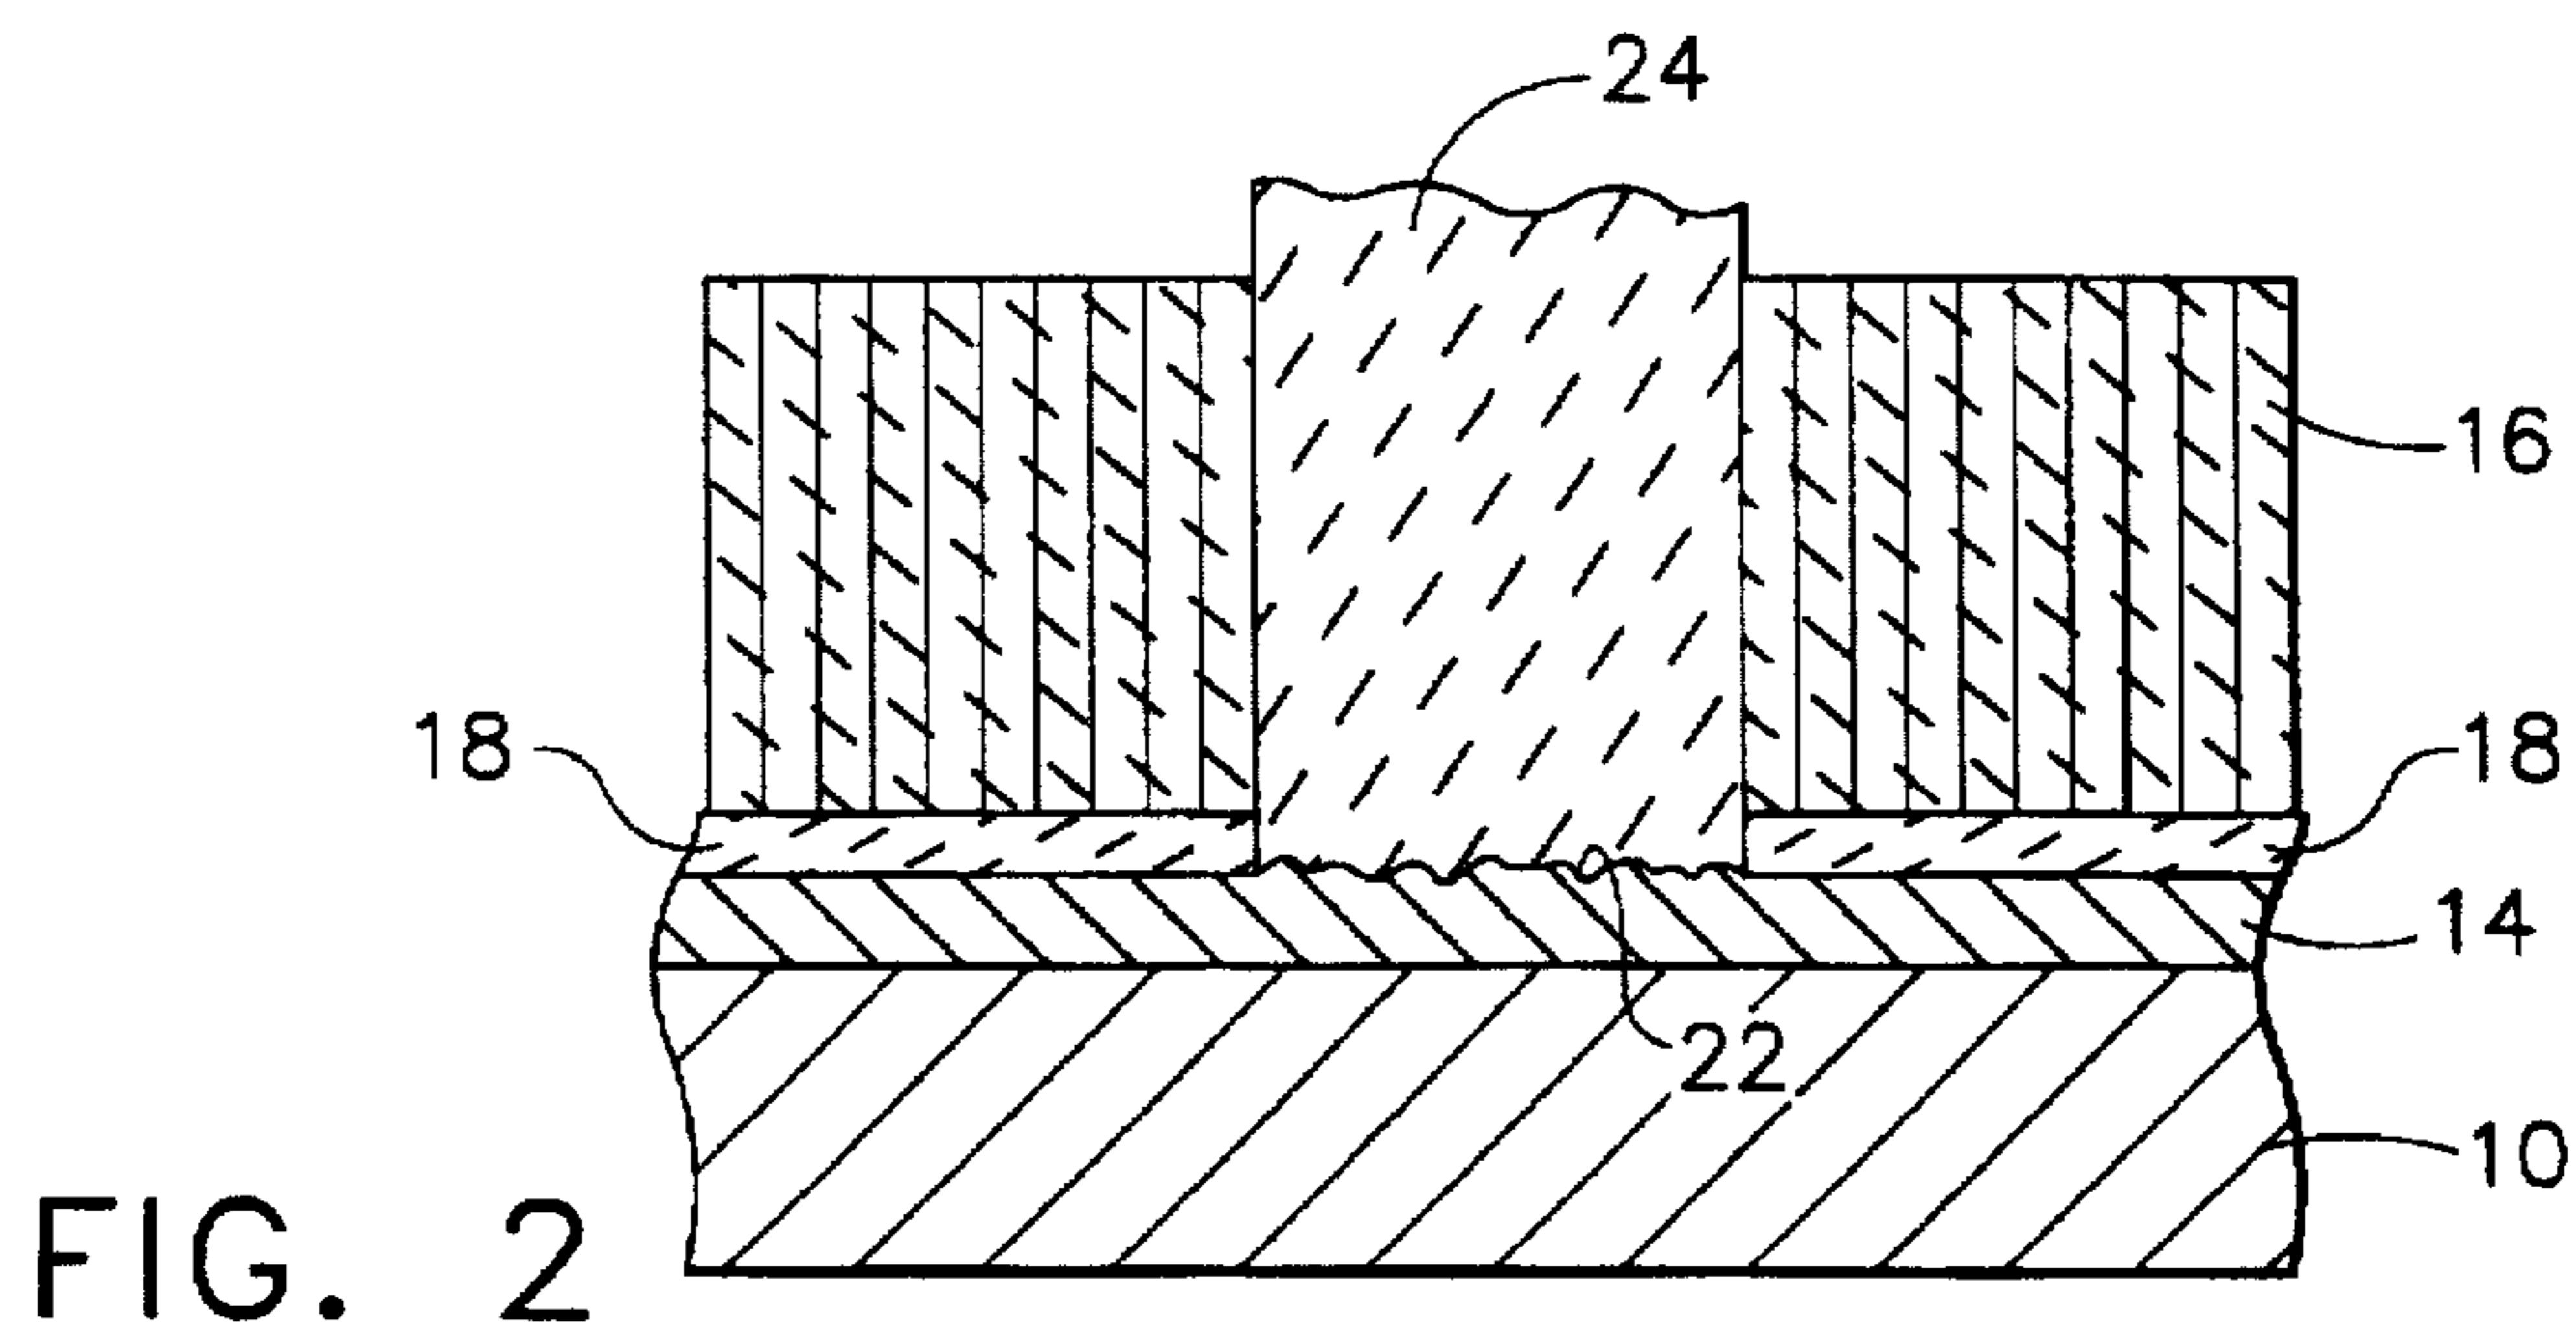
FIGS. 2 and 3 are cross-sectional representations of repair steps entailed in a preferred embodiment of this invention.

Once free of contaminants, the bond layer 14 is then treated such that its surface 22 becomes textured, as represented by FIG. 2. Preferred treating methods include grit blasting, micromachining, photolithography, laser etching and water jet techniques. Preferred grit blasting media include alumina, though other materials could be used. Suitable micromachining techniques include the use of

Finally, as represented in FIG. 2, a ceramic material is then deposited on the textured surface 22 of the bond layer 14 so as to form a ceramic repair layer 24 that completely covers the bond layer 14. A preferred deposition method is a plasma spray technique process, though physical vapor deposition techniques can be used to deposit the ceramic material such that the repair layer 24 has a columnar grain structure. With either technique, the ceramic layer 16 is masked to prevent deposition of the repair material on the ceramic layer 16. According to this invention, the preferred repair method is to form the repair layer 24 by plasma spray, the random ceramic grain structure of which is represented in FIGS. 2 and 3. Generally, masking of the surrounding surface of the ceramic layer 16 is less complicated if a plasma spray deposition technique is used. For example, if any holes are intentionally present in the article 10, such as cooling holes often present in airfoils to reduce their operating temperature, fibers can be placed in the holes or a gas can be flowed through the holes in order to prevent closure by the deposited ceramic. Furthermore, physical vapor deposition techniques generally result in the entire article 10 being heated to a high temperature, whereas plasma spray techniques directly heat only the localized region being repaired on the article 10.

Due to process control limitations, the ceramic material will typically be deposited until the surface of the repair layer 24 projects above the surrounding surface of the ceramic layer 16, as shown in FIG. 2. Afterwards, the surface of the repair layer 24 is polished or otherwise abraded until the repair layer 24 is substantially level with the ceramic layer 16, and the repair layer 24 merges with the ceramic layer 16 as portrayed in FIG. 3.
