[11] Patent Number: **5,972,424**

[54] **REPAIR OF GAS TURBINE ENGINE COMPONENT COATED WITH A THERMAL BARRIER COATING**

[73] Assignee: **United Technologies Corporation**, Hartford, Conn.

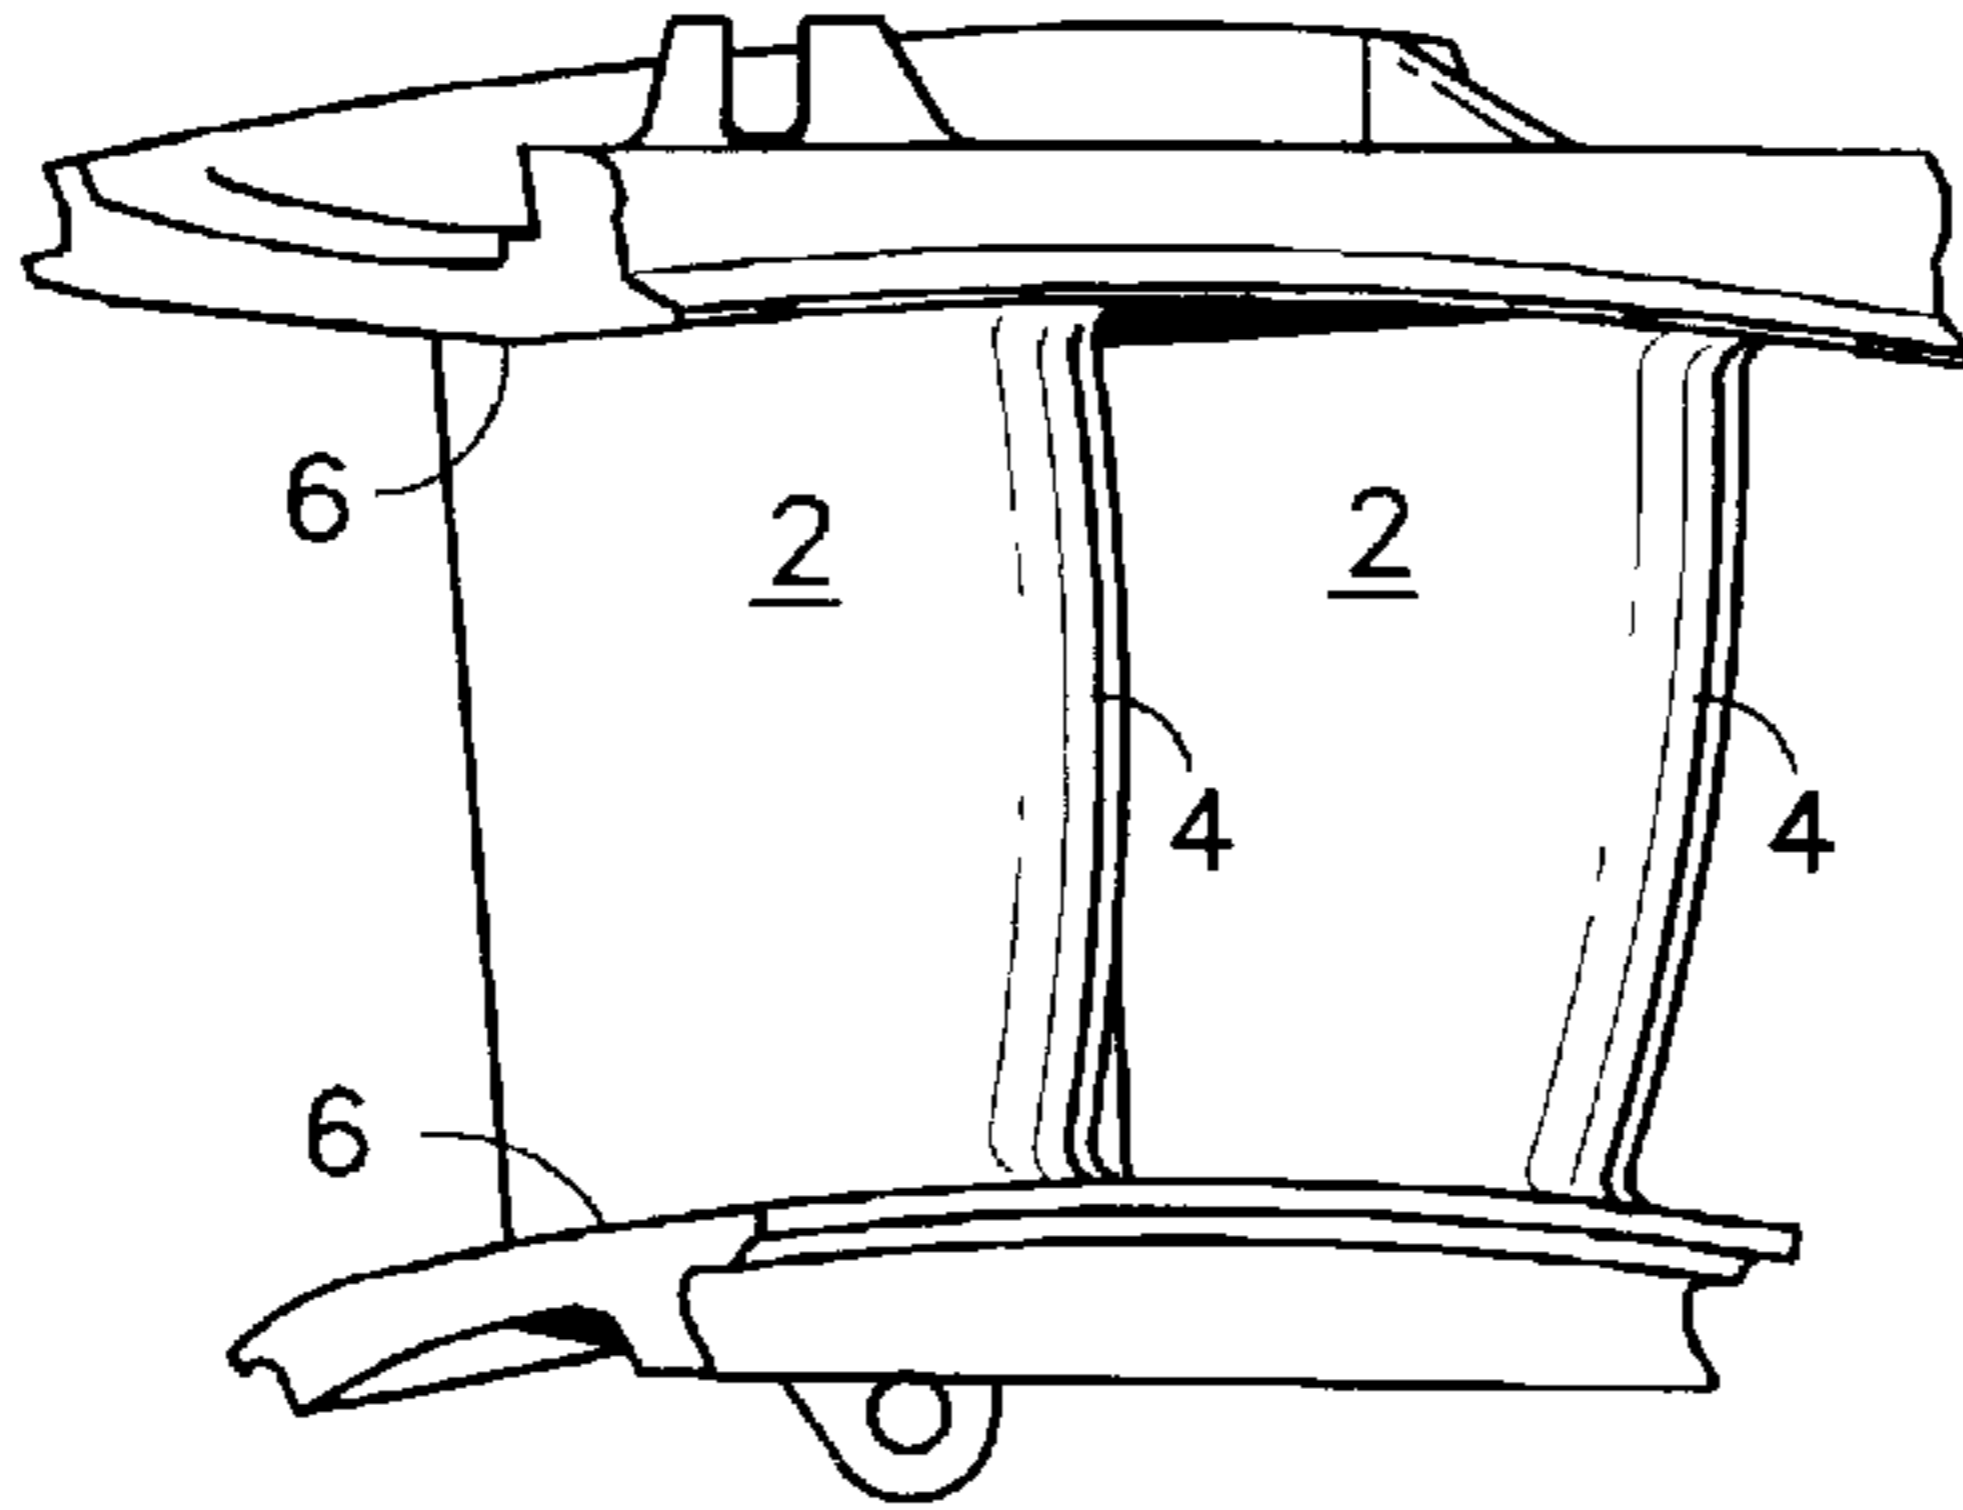
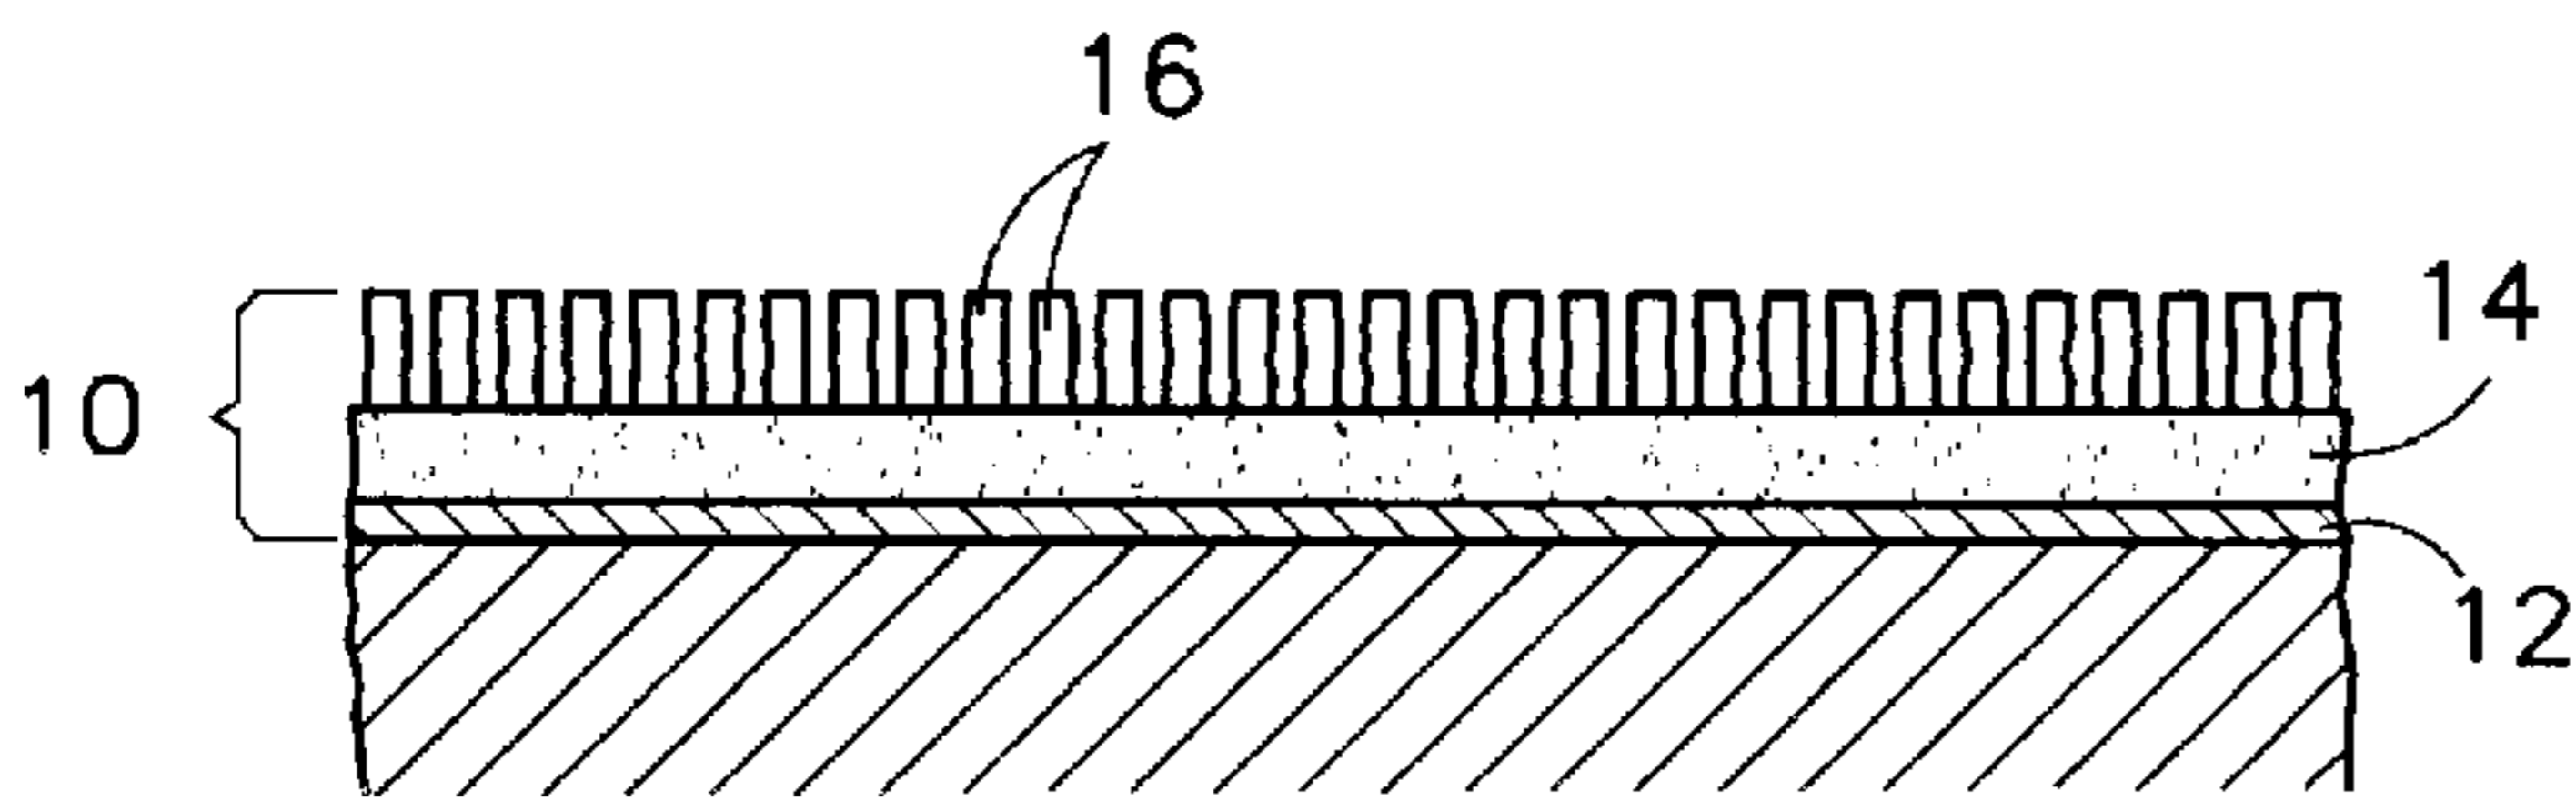
FIG. 2 is a view of a thermal barrier coating.

Next, the ceramic top coat should be applied. The aluminum oxide layer **14**, sometimes referred to as thermally grown oxide, may be formed on the flash coat by any method that produces a uniform, adherent layer. For example, the layer **14** may be formed by oxidation of Al in the flash coat at an elevated temperature before the application of the ceramic top coat **16**. Alternately, the aluminum oxide layer **14** may be deposited by chemical vapor deposition or any other suitable deposition method known in the art. The thickness of the aluminum oxide layer **14** may vary based its density and homogeneity. Preferably, the aluminum oxide layer **14** will about 0.004 mils to about 0.4 mils thick.

The ceramic top coat **16** may comprise a mixture of zirconium oxide and a stabilizer such as yttrium oxide ( $Y_2O_3$ ), magnesium oxide (MgO), calcium oxide (CaO), or a mixture thereof. Yttrium oxide is the preferred stabilizer. The ceramic top coat **16** should include enough stabilizer to prevent an undesirable zirconium oxide phase change (i.e. a change from a preferred tetragonal or cubic crystal structure to the less desired monoclinic crystal structure) over the range of operating temperature likely to be experienced in a particular gas turbine engine. Preferably, the ceramic top coat **16** will comprise a mixture of zirconium oxide and about 3 wt % to about 25 wt % yttrium oxide. Most preferably, the zirconium oxide abrasive coat will comprise about 6 wt % to about 8 wt % yttrium oxide or about 11 wt % to about 13 wt % yttrium oxide, depending on the intended temperature range.

The ceramic top coat **16** may have a plurality of columnar segments homogeneously dispersed throughout the abrasive coat such that a cross-section of the abrasive coat normal to the surface to which the top coat **16** is applied exposes a columnar microstructure typical of physical vapor deposited coatings. The columnar structure may have a length that extends for the full thickness of the ceramic top coat **16**. Such coatings are described in commonly assigned U.S. Pat. Nos. 4,321,310 to Ulion et al., 4,321,311 to Strangman, 4,401,697 to Strangman, 4,405,659 to Strangman, 4,405,660 to Ulion et al., 4,414,249 to Ulion et al., and 5,262,245 to Ulion et al., all of which are incorporated by reference. A columnar ceramic top coat **16** may be deposited by EB-PVD or any other physical vapor deposition method known to deposit columnar coating structures. Preferably, the ceramic top coat **16** of the present invention will be applied by EB-PVD because of the availability of EB-PVD equipment and skilled technicians. The ceramic top coat **16** should be applied a thickness sufficient to provide a strong bond with the surface to which it is applied.

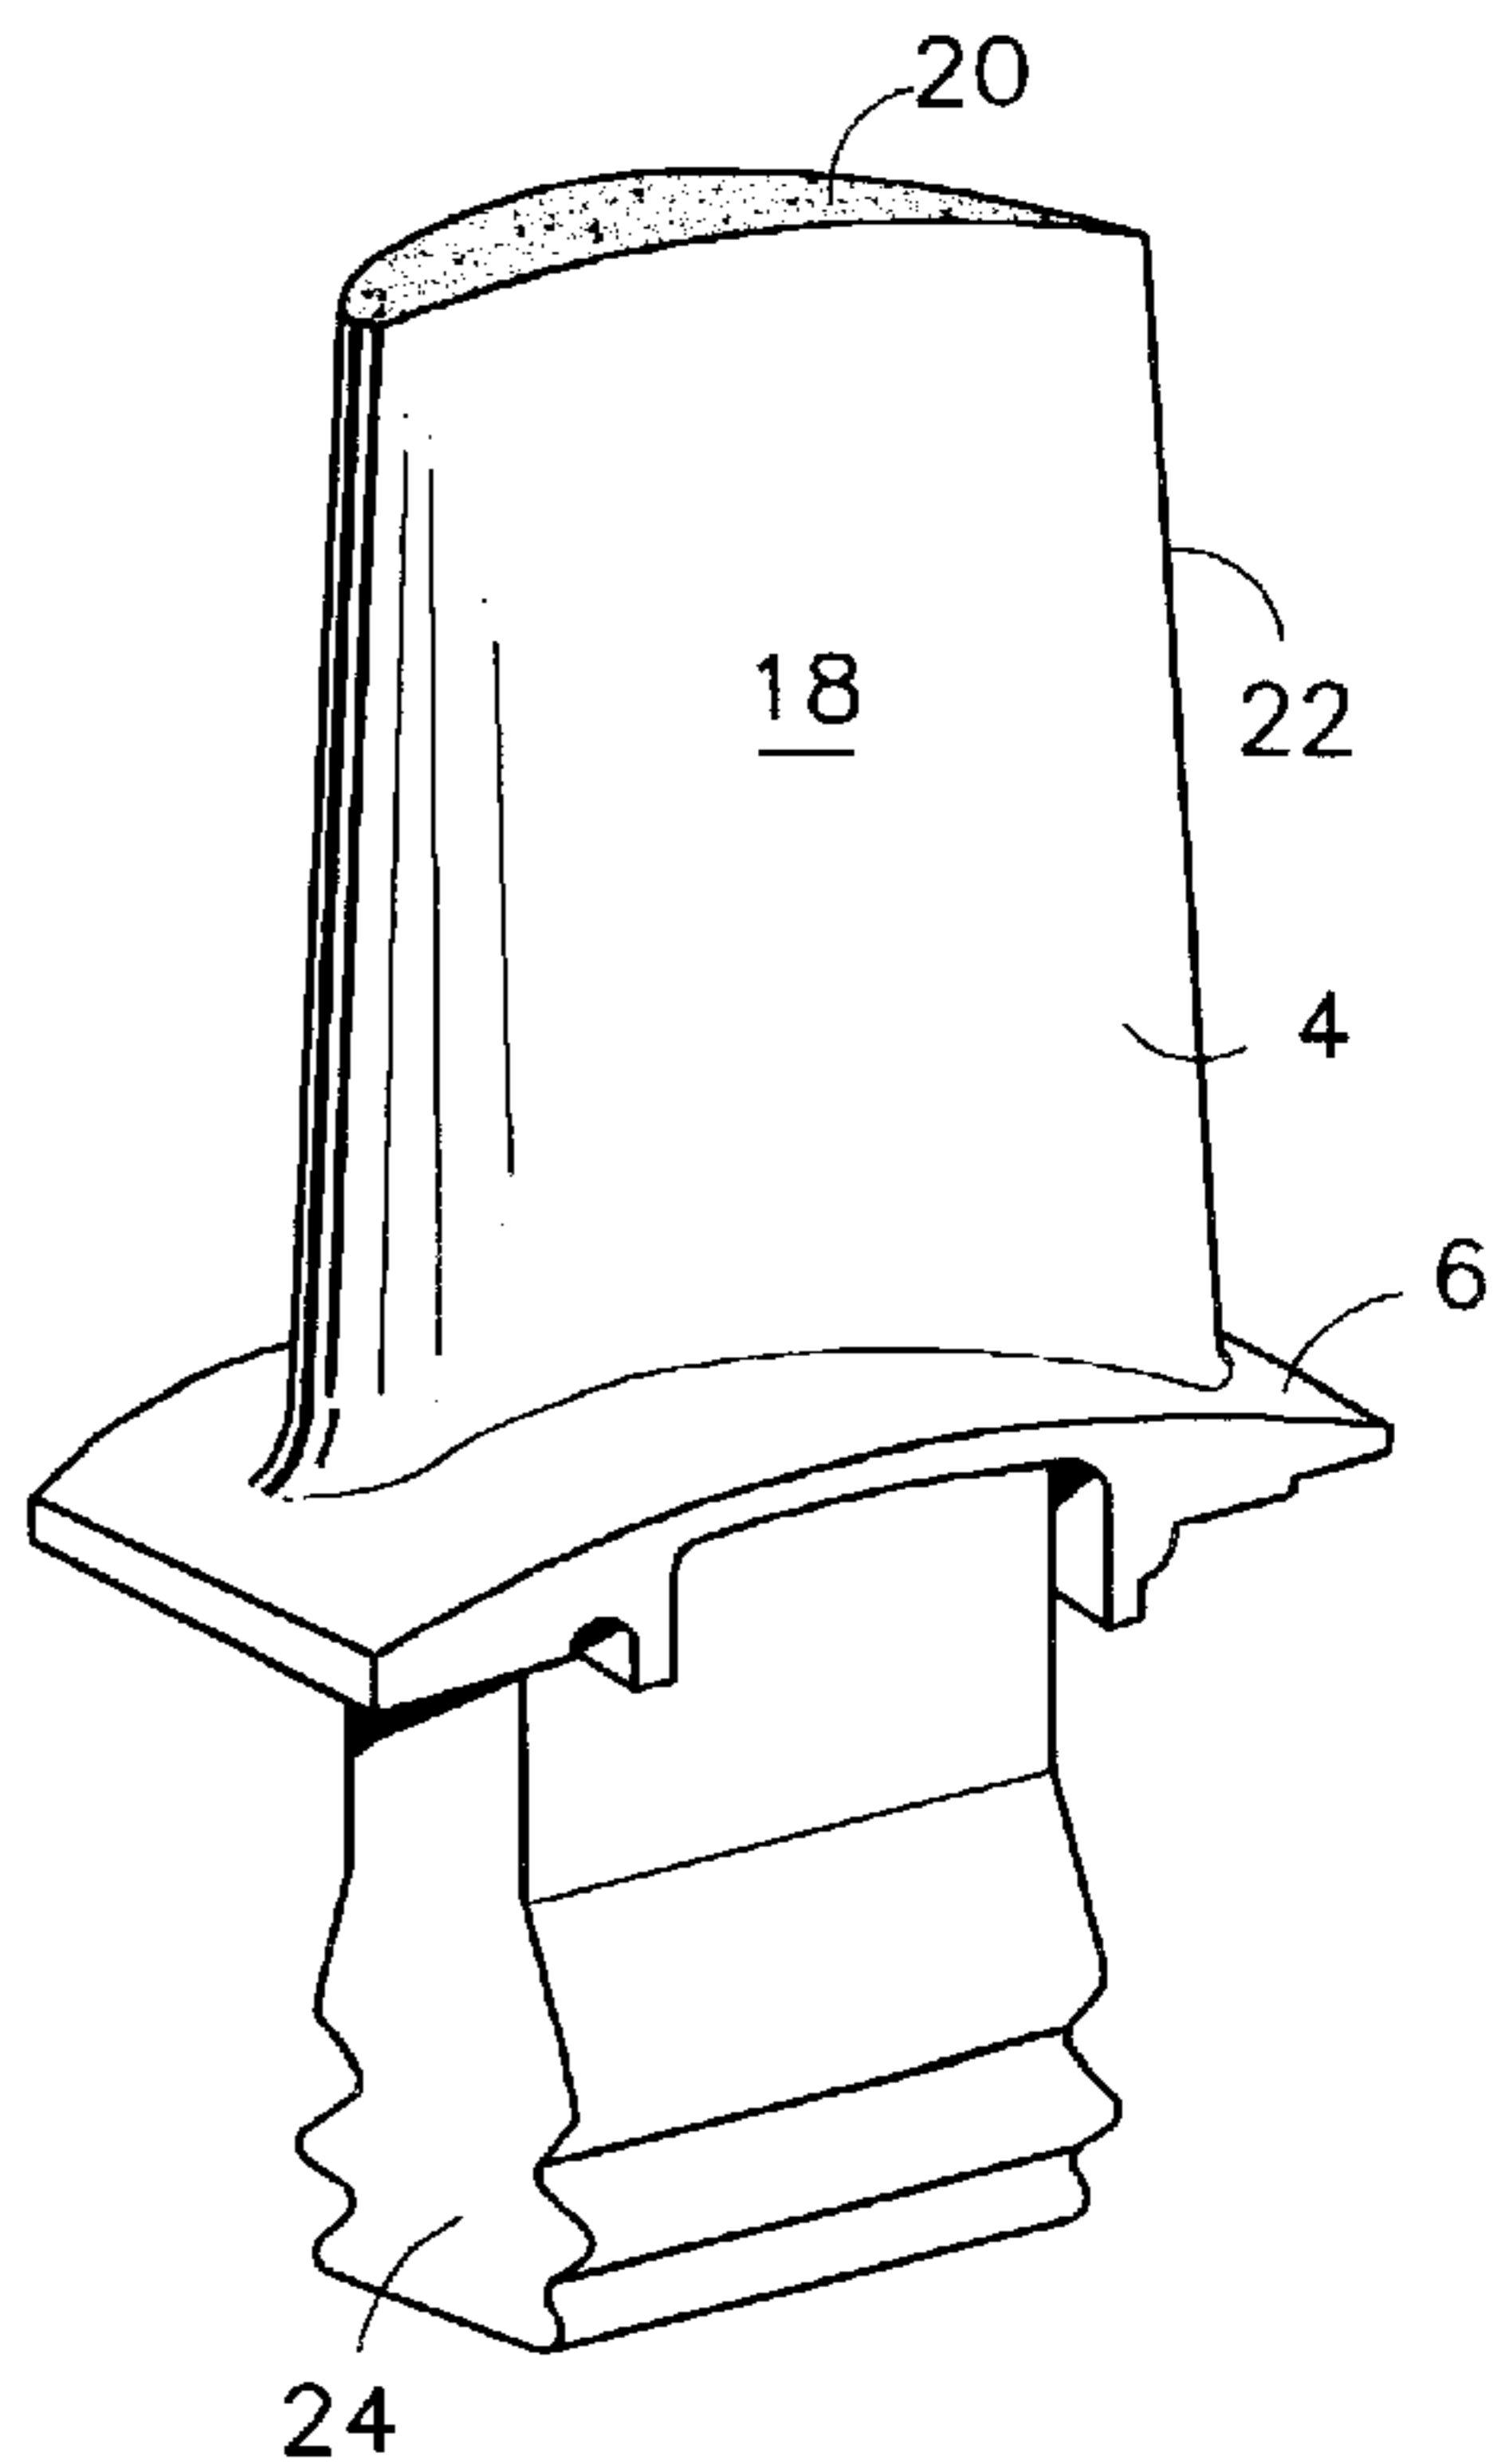
FIG. 3 is a perspective view of a typical gas turbine engine high pressure turbine blade.

FIG. 3 shows a typical high pressure turbine blade 18. The blade 18 comprises an airfoil section 4 bounded by single platform 6 and a tip 20 to which an abrasive material is bonded. A trailing edge 22 is positioned on the downstream side of the airfoil section 4. The blade 18 also includes a root 24 that is used to attach the blade 18 to a gas turbine engine. A plurality of cooling holes (not shown) are positioned on the airfoil section 4 to direct relatively cool air across the blade 18 to help it withstand the high temperatures to which it is exposed. Cooling holes also may be positioned in the platform 6 and tip 20. To further protect the blade 18 from high temperatures, the airfoil section 4 and platform 6 are coated with a thermal barrier coating.
