US006235352B1

(54) **METHOD OF REPAIRING A THERMAL BARRIER COATING**

(73) Assignee: **Electric Power Research Institute, Inc.**, Palo Alto, CA (US)

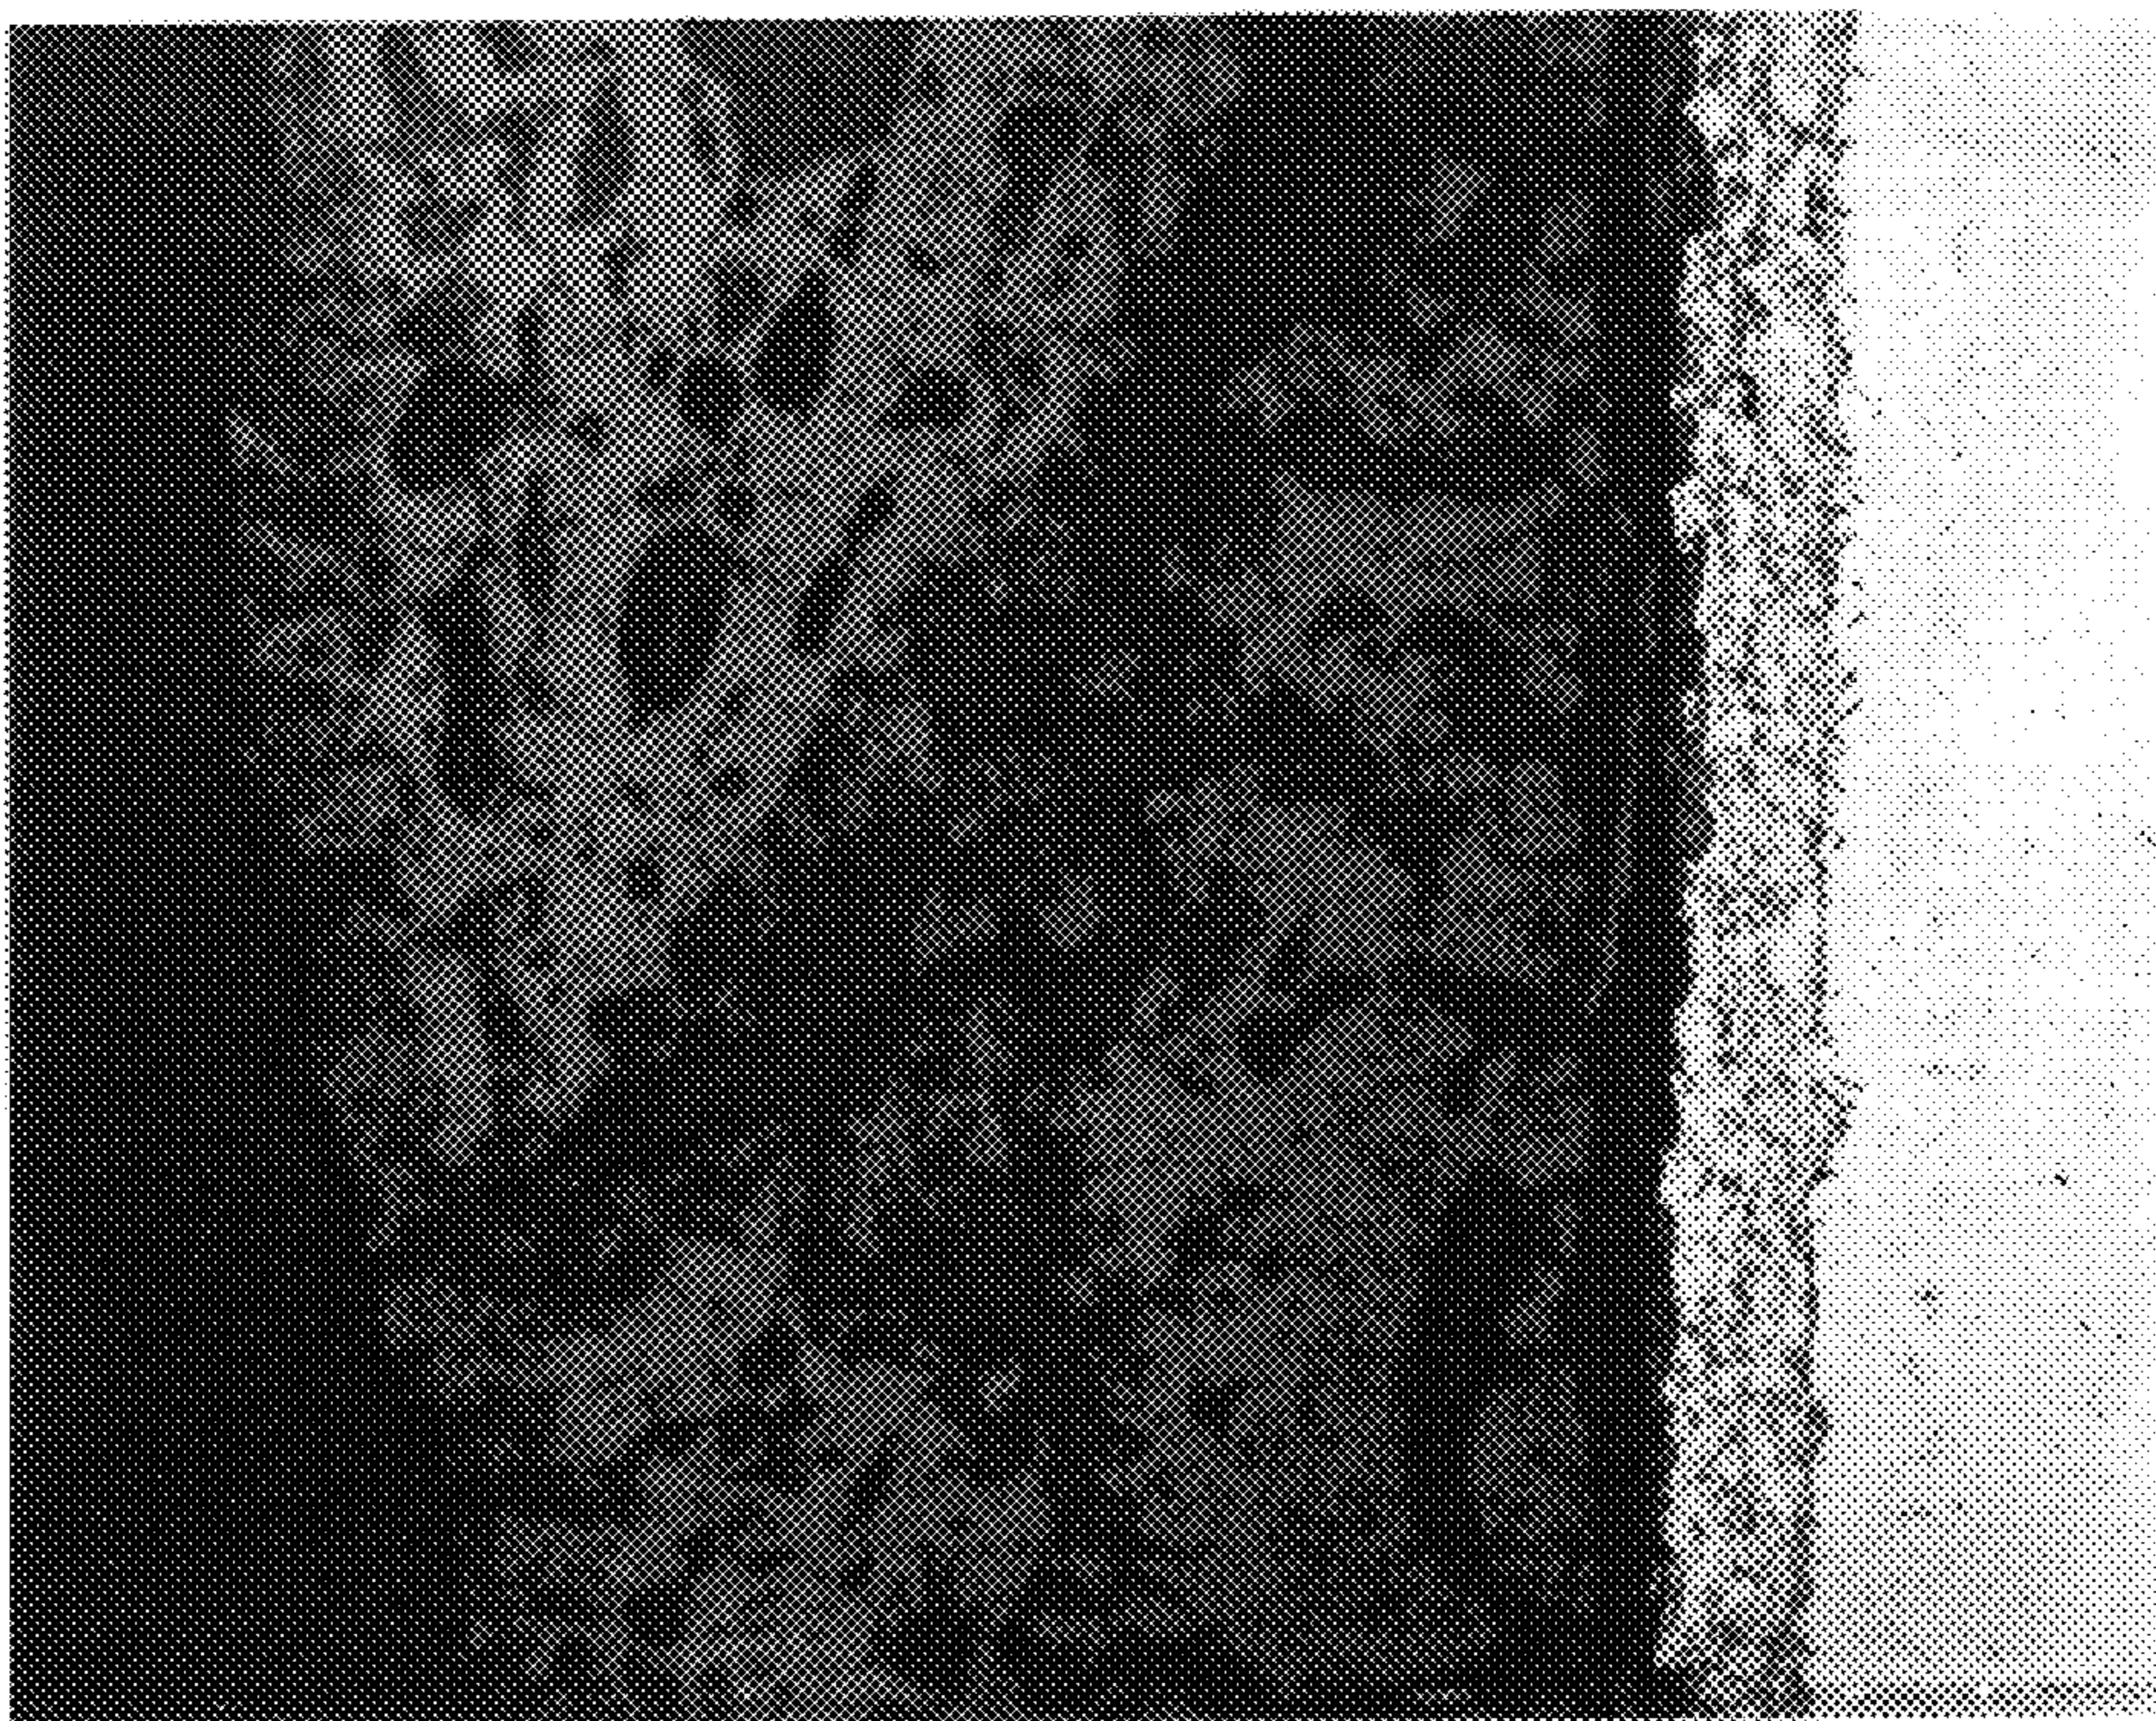
FIG. 5 is a microsection taken through the repair area of an HIT coated IN 738 specimen.

cycles of thermal exposure. FIG. 4 shows the microstructure of a repaired TBC on a HIT coated IN 718 specimens. FIG. 5 shows the microstructure of a repaired TBC on a HIT coated IN 738 specimen. FIG. 6 shows the microstructure of a repaired TBC Sermatech coated IN 718 specimen. FIG. 7 shows the microstructure of a repaired TBC Howmet coated GTD-111 specimen. In some areas, the repaired PSZ exhibited porosity, but no evidence of coating cracking was observed. The repaired PSZ was adherent to the various bond coats considered in this investigation and to any original TBC left over in the damaged regions. These results teach that PSZ sol-gels can be used for a simple, reliable spot repair of TBC coated turbine components.
