(10) **Patent No.:** **US 6,434,823 B1**
(45) **Date of Patent:** **Aug. 20, 2002**

- (54) **METHOD FOR REPAIRING A COATED ARTICLE**
- (75) Inventors: **Bhupendra Kumar Gupta**, Cincinnati;
Wayne Ray Grady, Fairfield;
Nripendra Nath Das, West Chester, all of OH (US)
- (73) Assignee: **General Electric Company**, Schenectady, NY (US)
- (*) Notice: Subject to any disclaimer, the term of this patent is extended or adjusted under 35 U.S.C. 154(b) by 0 days.

METHOD FOR REPAIRING A COATED ARTICLE

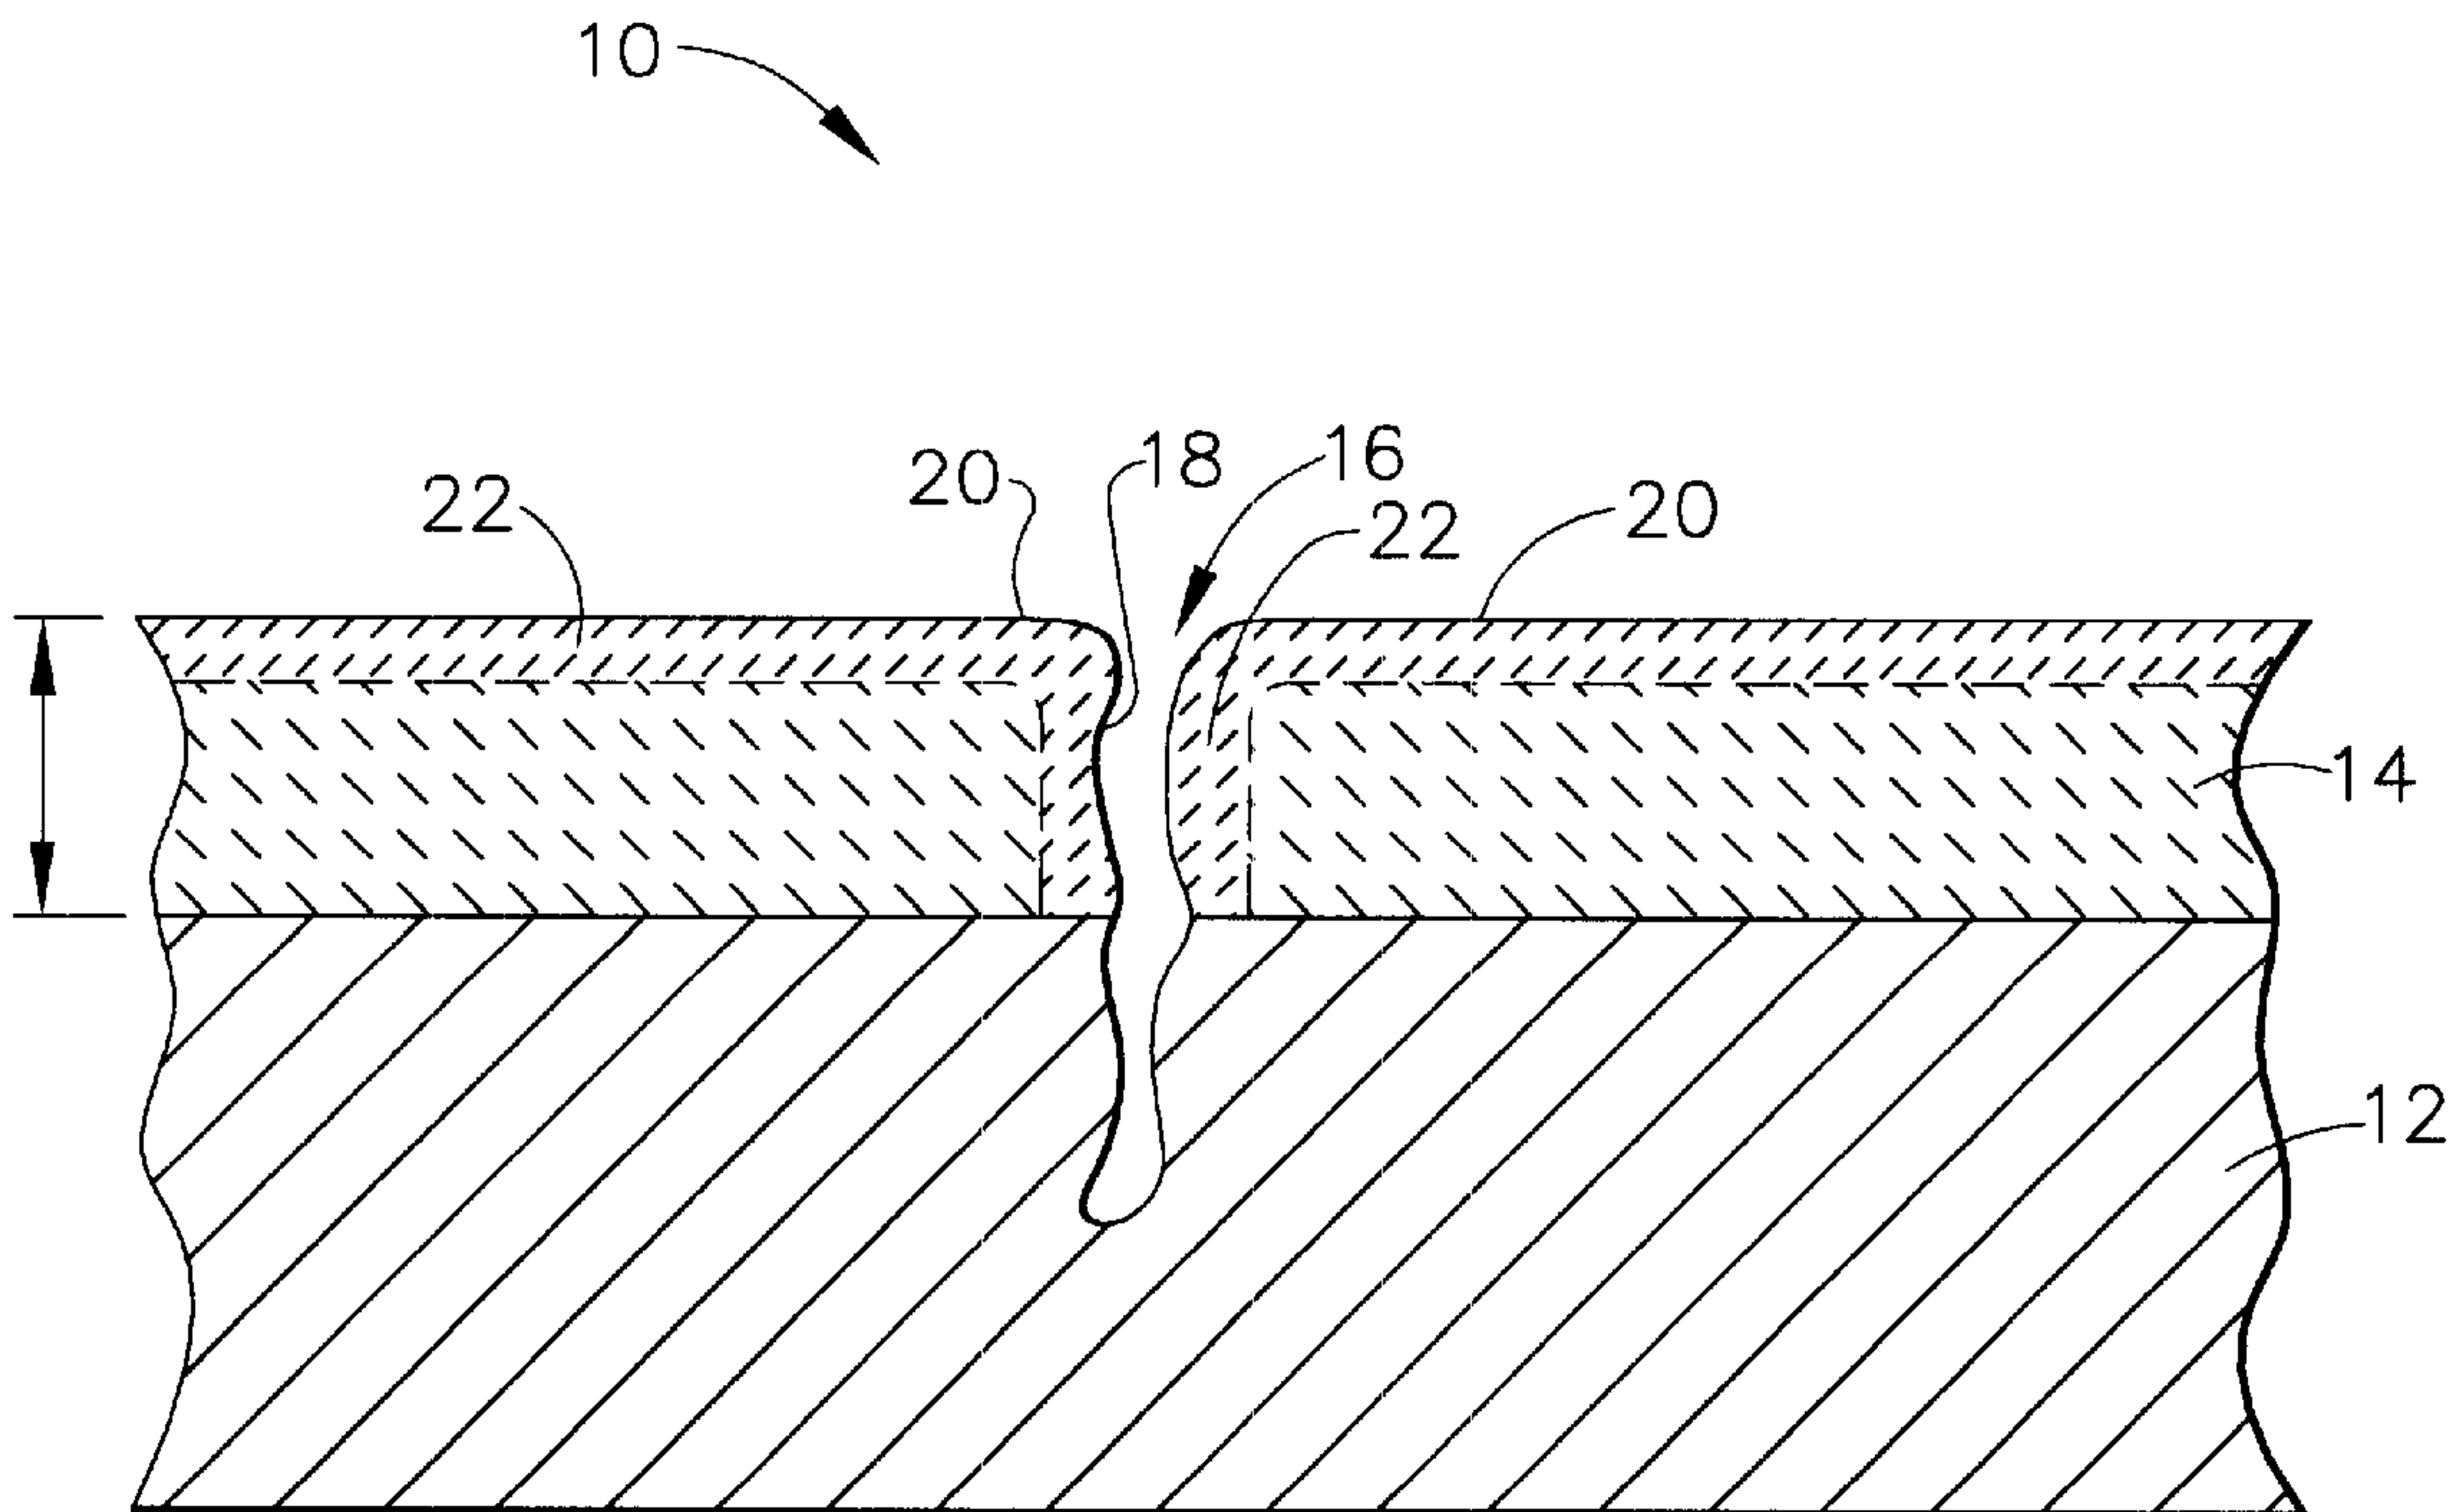
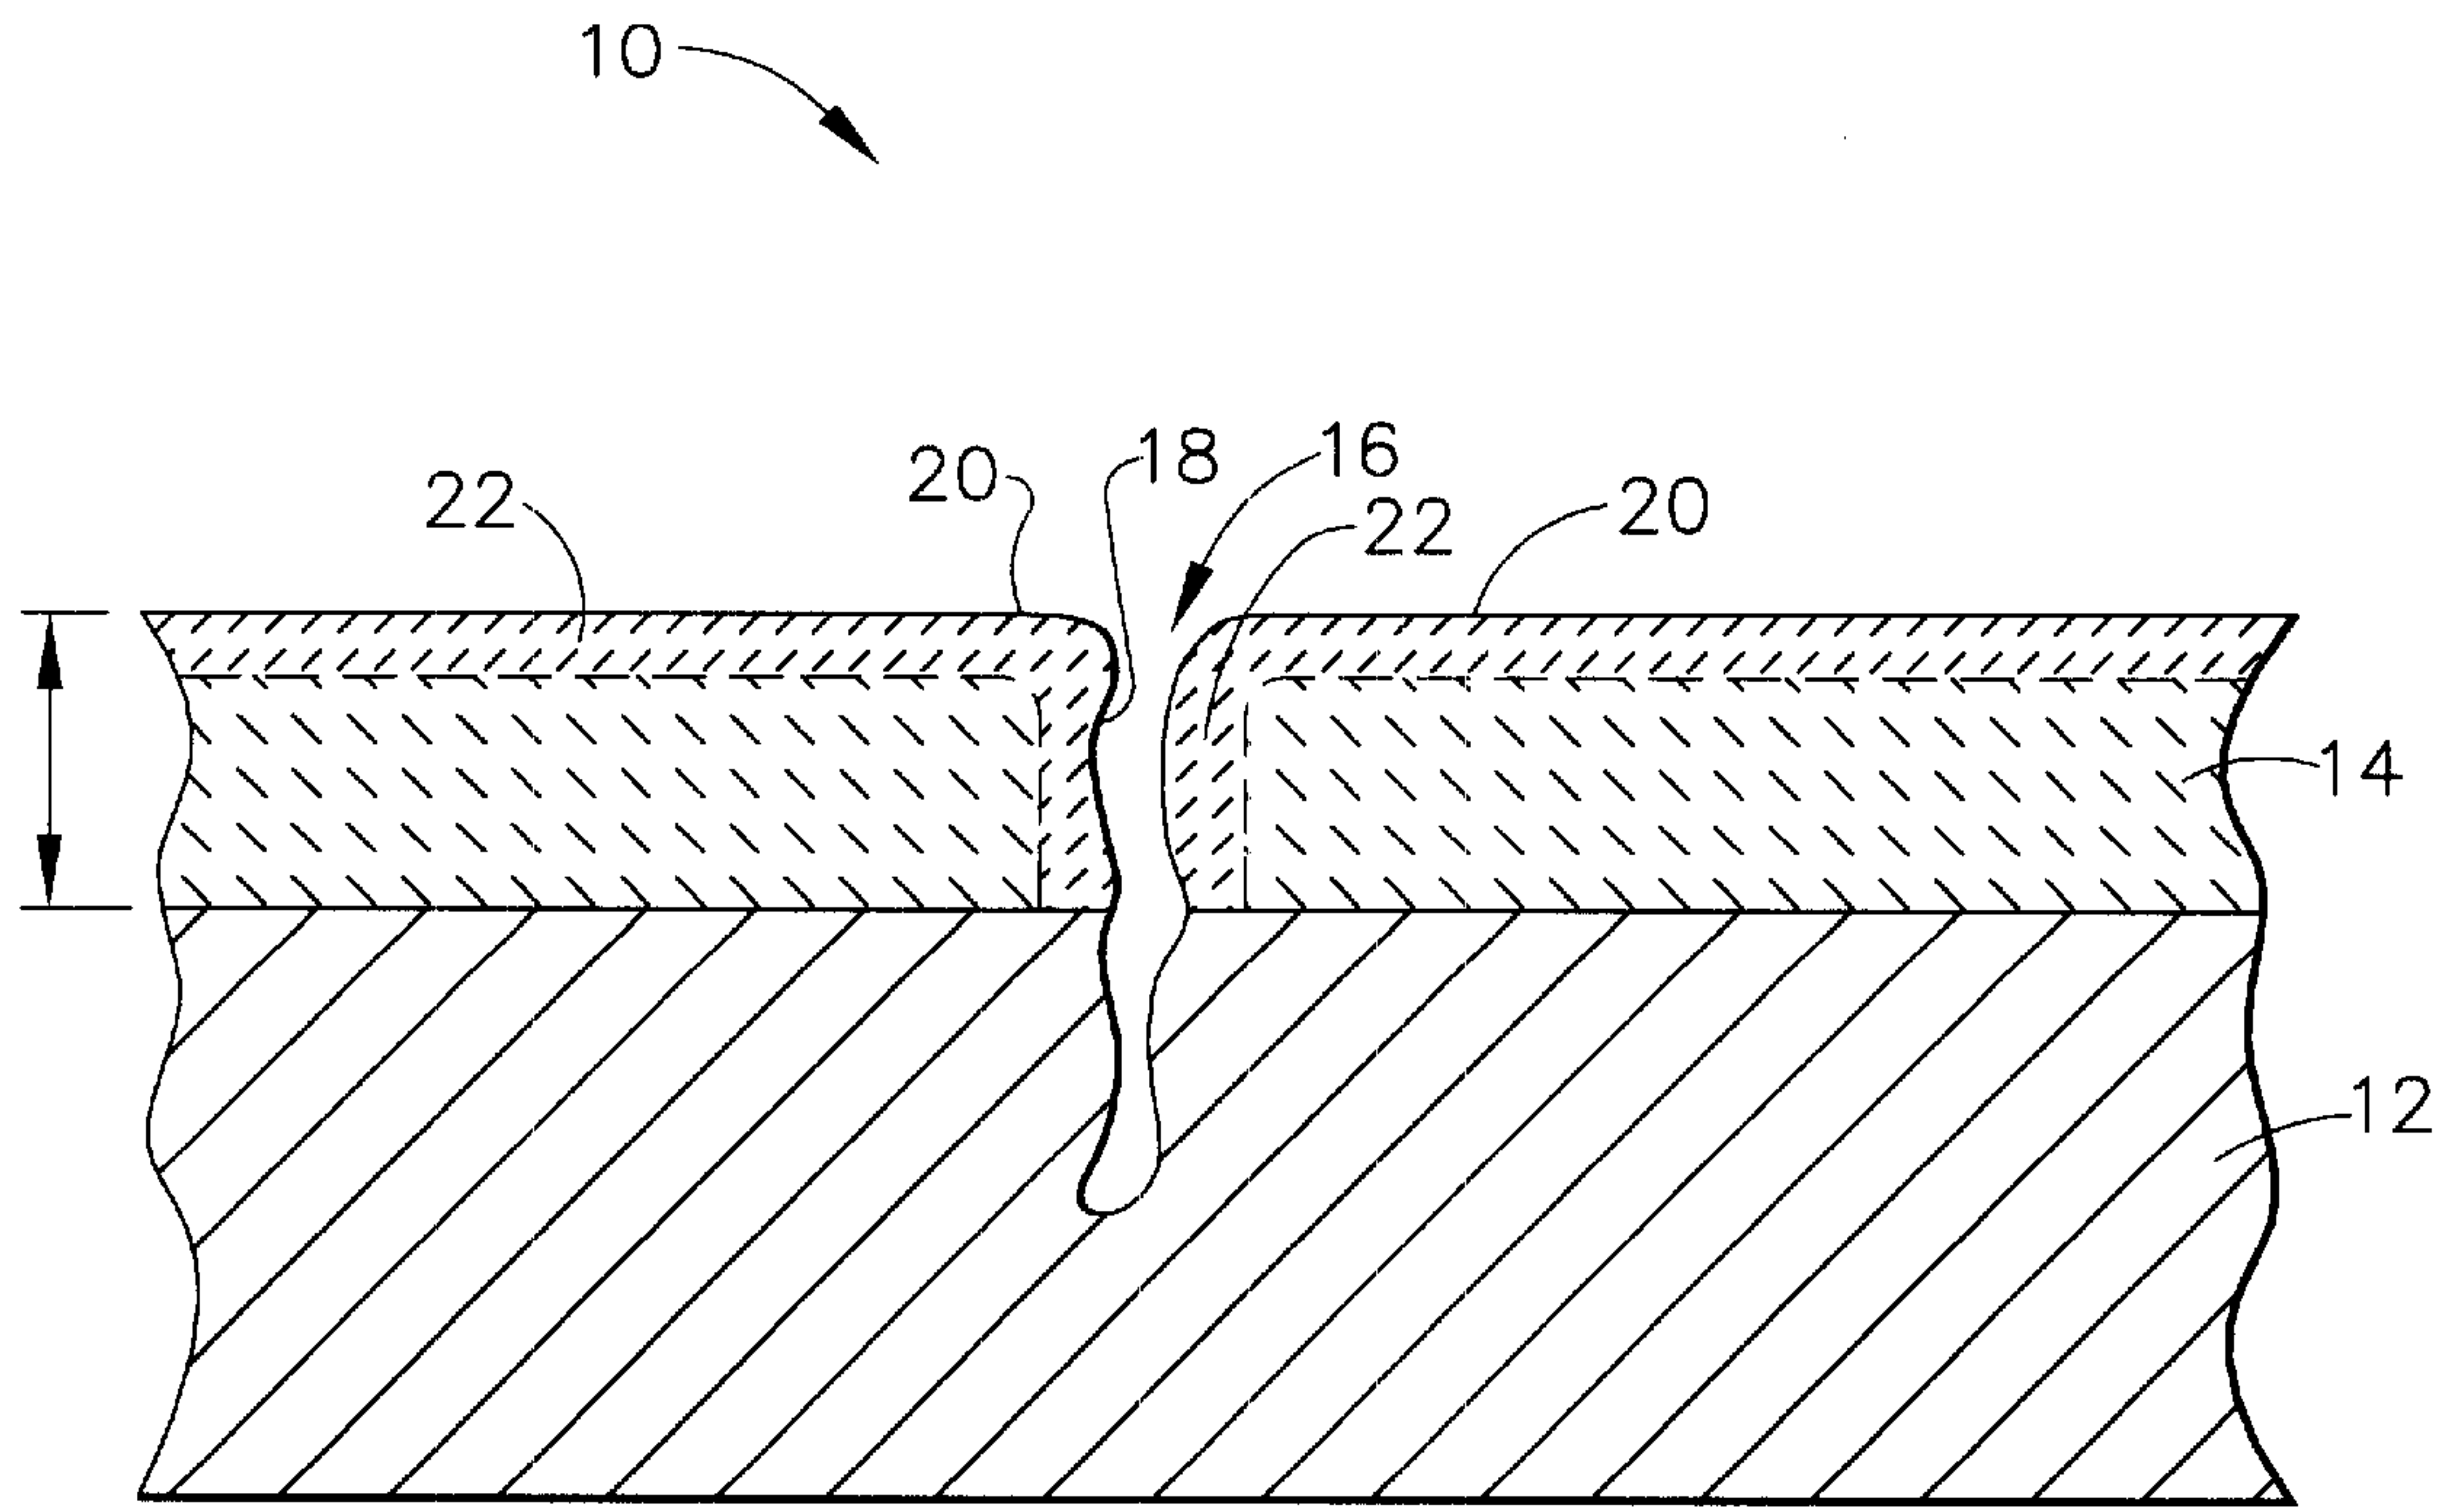
FIG. 1

The drawing is a fragmentary sectional view of a coated wall of an article including a fissure through the coating and extending into the substrate.

In the embodiment of the drawing, an article is shown generally at **10** in the form of a wall, for example an airfoil wall of a gas turbine engine blading member. Article **10** includes a substrate **12**, for example a Ni base superalloy, and an overlay type coating **14**, for example a commercial NiCrAlY alloy, disposed on substrate **12**. A fissure or crack shown generally at **16** has developed within coating **14** as a result of service operation and extends through coating **14** into substrate **12**. Formation of fissure **16** has exposed coating surface **18** of coating **14** within fissure **16**.

Generally as a result of high temperature exposure, surface oxides of certain elements in coating **14** will form on surface **18** of fissure **16** as well as on coating outer surface **20** of coating **14**. Practice of the method of the present invention can be used to remove such surface oxides, as described in the art. However, in addition, the present invention can deplete more than about 90 wt. % Al from the exposed coating surface **18** prior to repair, for the reasons discussed above, substantially without removal or dimensional change in the coating. A form of the present invention shown in the drawing depletes such Al from within exposed coating surface **18** within fissure **16** and from coating outer surface **20** adjacent fissure **16** to avoid formation of detrimental amounts of aluminum oxide at such surfaces during repair of fissure **16**. Such repair can include welding or brazing to close or heal fissure **16**, as well as repair of coating **14** by application of a replacement coating at least at the vicinity of fissure **16**. According to that form of the invention, a zone **22** depleted of more than 90 wt. % Al to a depth of at least about 7 mils is provided within exposed coating surface **18** within fissure **16**, and within surface **20** of coating **14** at least adjacent fissure **16**. It has been recognized that such depth of zone **22** is required to enable repair of the article without formation of detrimental aluminum oxide at surfaces **18** and **20**.

repair including at least one of welding, brazing and recoating. The fragmentary sectional view of the drawing shows one example of use of the present invention.
