### (54) METHOD OF REPAIRING ALUMINUM HEAT EXCHANGER

(73) Assignee: Denso Corporation, Kariya (JP)

A partly damaged aluminum heat exchanger such as an aluminum radiator is repaired by closing a hole in the damaged portion with an acrylic resin adhesive material. A certain area around the damaged portion is pressed down to form a cup-shaped depressed portion. The adhesive material is supplied to the depressed portion so that it is retained therein. Then, the adhesive material is hardened by curing it under the room temperature. The hardened adhesive material completely closes the hole with a sufficient thickness and strength because it is retained in the depressed portion. The adhesive material is cured in a relatively short time because the acrylic resin is used as the adhesive material.

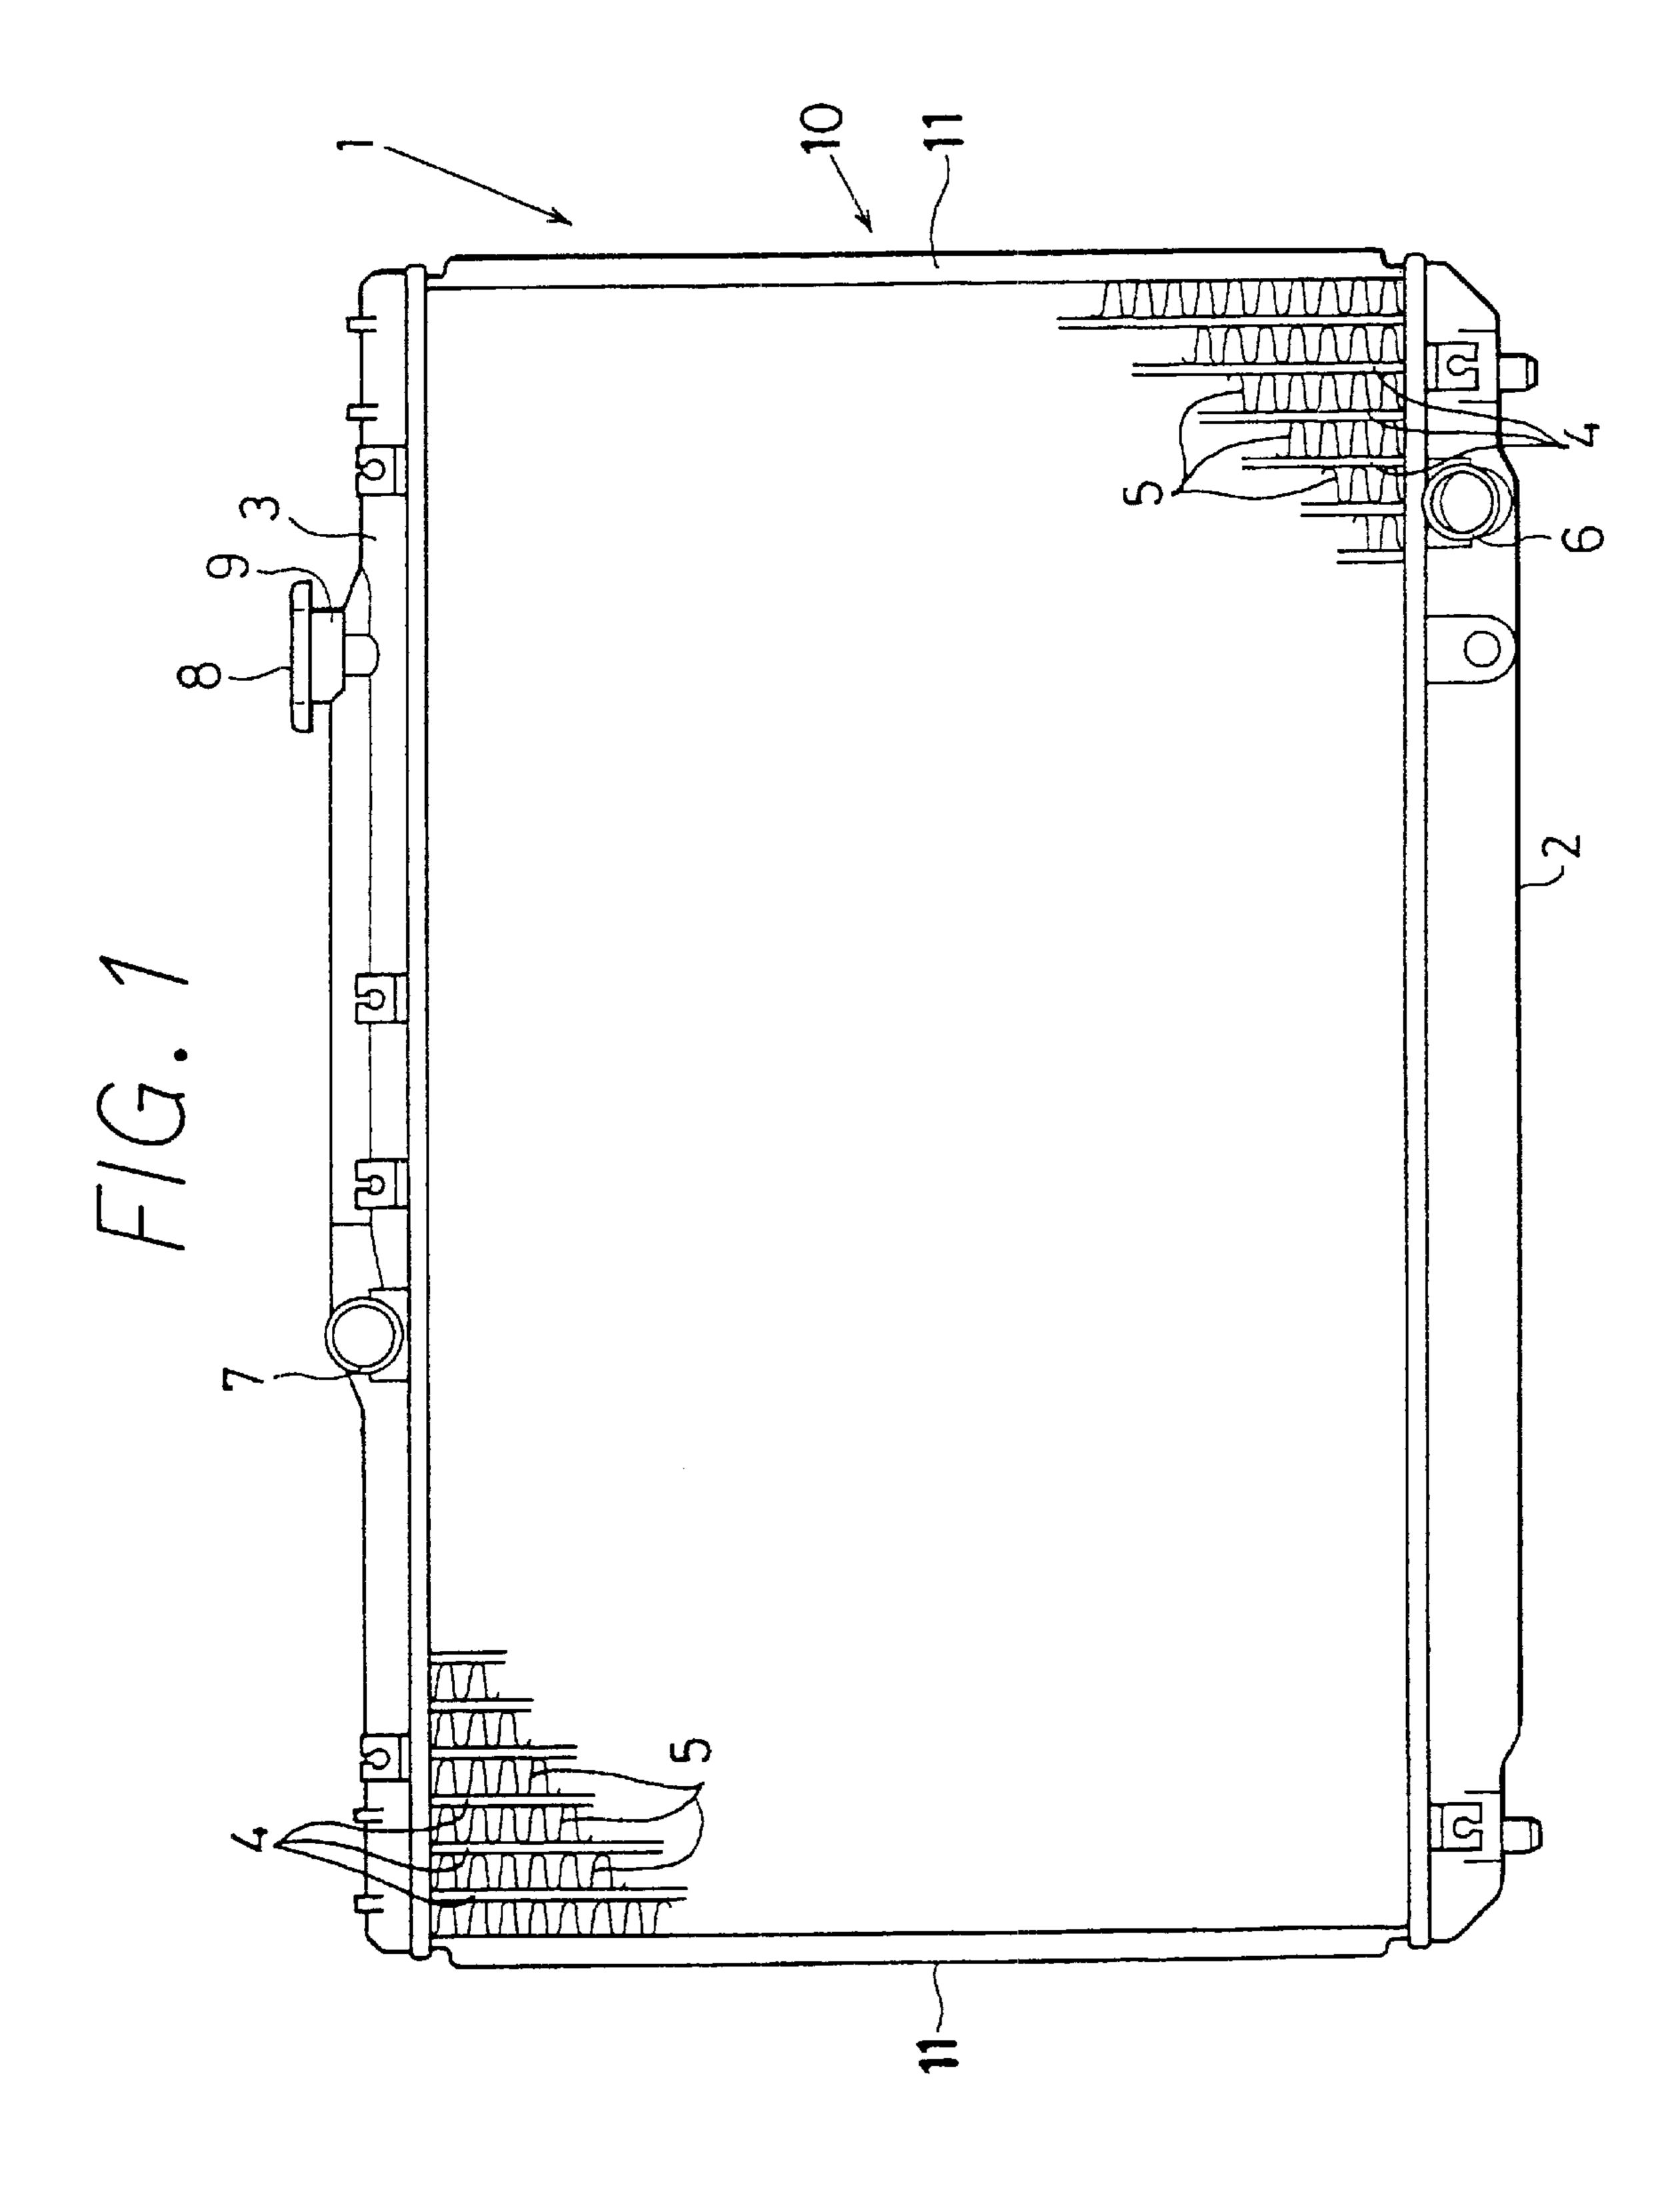
FIG. 1 is a front view showing an aluminum heat exchanger;

A preferred embodiment the present invention will be described with reference to FIGS. 1–3C. First, referring to FIG. 1, the structure of a heat exchanger to which the repairing method of the present invention is applied will be described. The aluminum heat exchanger 1 shown in FIG. 1 is used as a radiator for cooling an internal combustion engine of an automobile vehicle. The aluminum heat exchanger 1 is a conventional radiator composed of a lower tank 2, an upper tank 3 and a heat exchange core 10 having plural tubes 4 and plural corrugated fins 5. The tubes 4

connect the upper tank 3 and the lower tank 2, and the corrugated fins 5 are disposed between neighboring tubes. The tubes 4 and the corrugated fines 5 are alternately laminated and brazed together, forming the core 10.

The lower and upper tanks 2, 3 are respectively formed into an elongate cup-shape by pressing an aluminum alloy plate. An outlet pipe 6 is connected to a side of the lower tank 2, and an inlet pipe 7 is connected to a side of the upper tank 3. A supply pipe 9 for supplying additional coolant into the radiator 1 is also connected on the upper tank 3. A cap 8 having a pressure valve and a negative pressure valve is removably disposed to close an opening of the supply pipe 9.

The tube 4 having a flat-oval cross-section is formed, by presswork, from an aluminum alloy plate containing aluminum as a main component. The corrugated fin 5 is formed into a wave-shape, by roller-work, from the similar aluminum alloy plate containing aluminum as a main component. Louvers (not shown) are formed on the corrugated fin 5 for obtaining a high heat exchange efficiency.

At both sides of the core 10, side plates 11 are disposed to increase the mechanical strength of the core 10 and to serve as brackets for mounting the radiator on a vehicle. Hot coolant fed into the upper tank 3 from the engine flows down to the lower tank 2 through the tubes 4 and is supplied again to the engine. The hot coolant is cooled down in the radiator 1, while it flows down from the upper tank 3 to the lower tank 2, by exchanging heat between the coolant and cooling air flowing through the radiator in the direction perpendicular to the flat surface thereof.

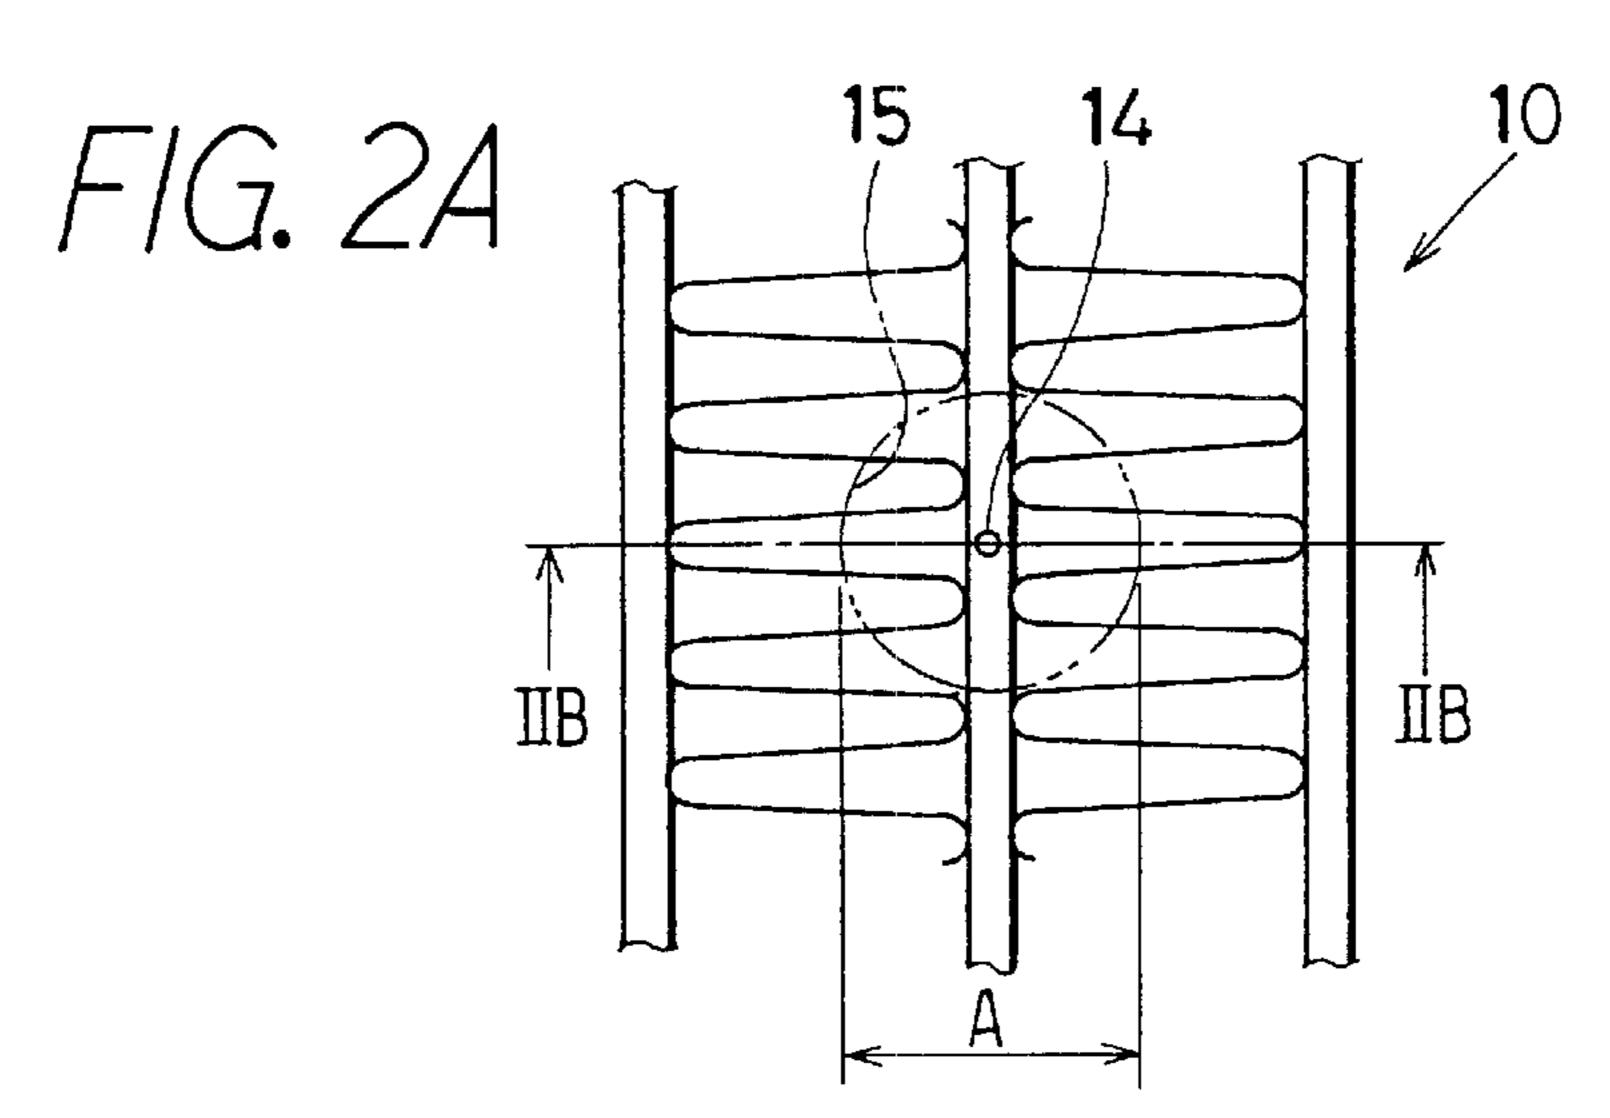
FIG. 2A is a partial front view showing a damaged portion of a heat exchanger tube and a depressed portion formed for repairing the damaged portion;

When the aluminum core 10 is damaged and the coolant in the heat exchanger leaks out, the aluminum core has to be repaired. First, a portion of the core 10 around the damaged portion 14, i.e., a hole formed in the tube 4, is deformed by hitting with a hammer or the like to form a depressed portion 15, as shown in FIGS. 2A and 2B. The depressed portion 15 is formed, so that the diameter "A" thereof becomes in a range of 2–20 times the diameter of the hole 14 and the depth "B" thereof becomes in a range of 1–8 mm.

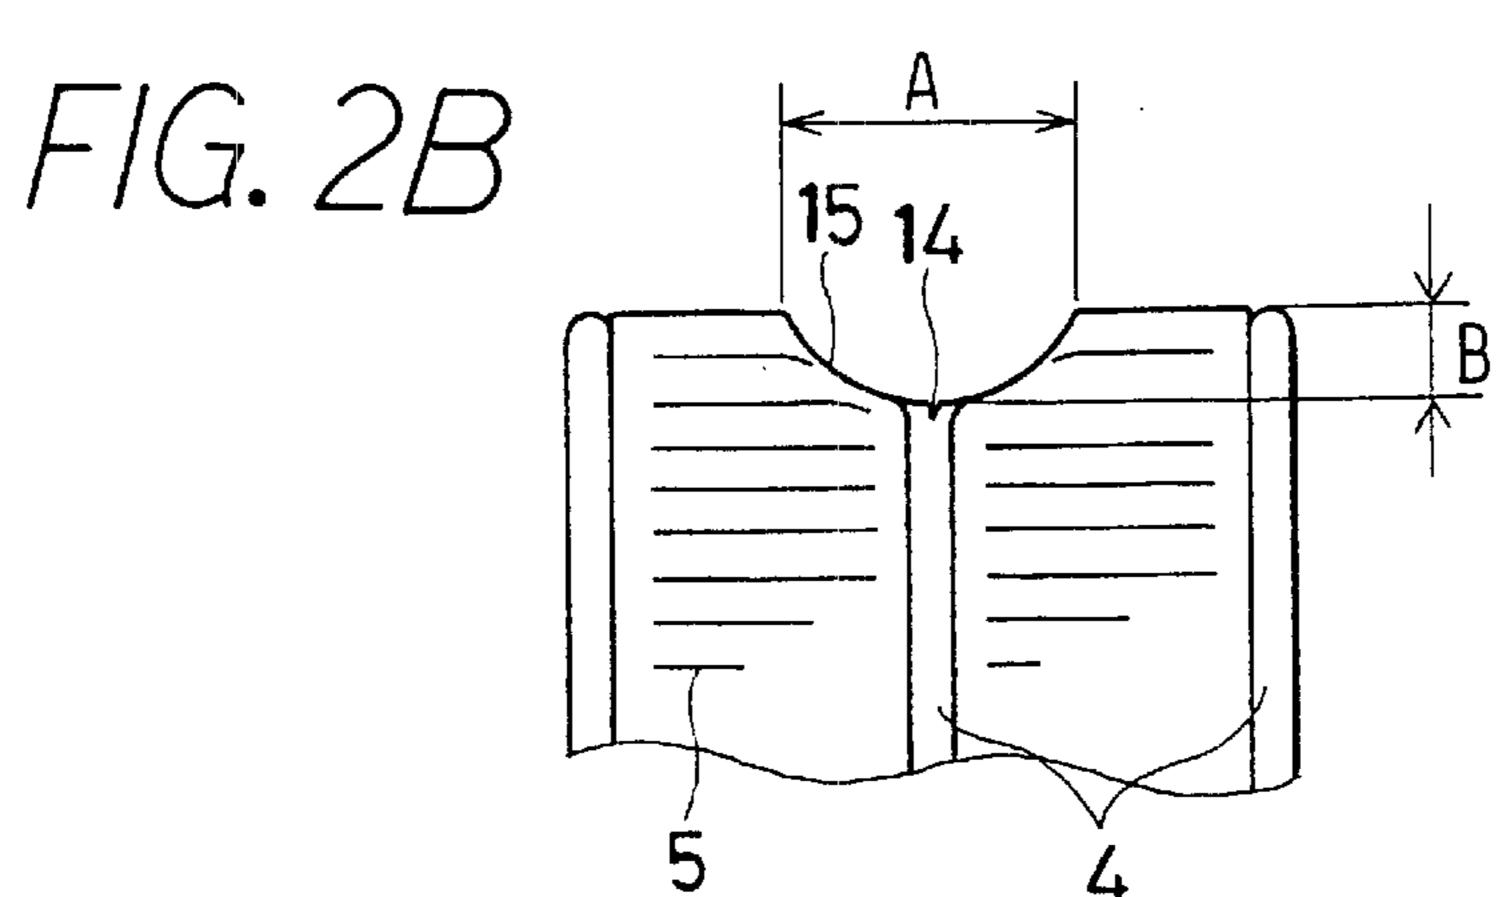
FIG. 2B is a cross-sectional view showing the depressed portion, taken along a line IIB—IIB in FIG. 2A;

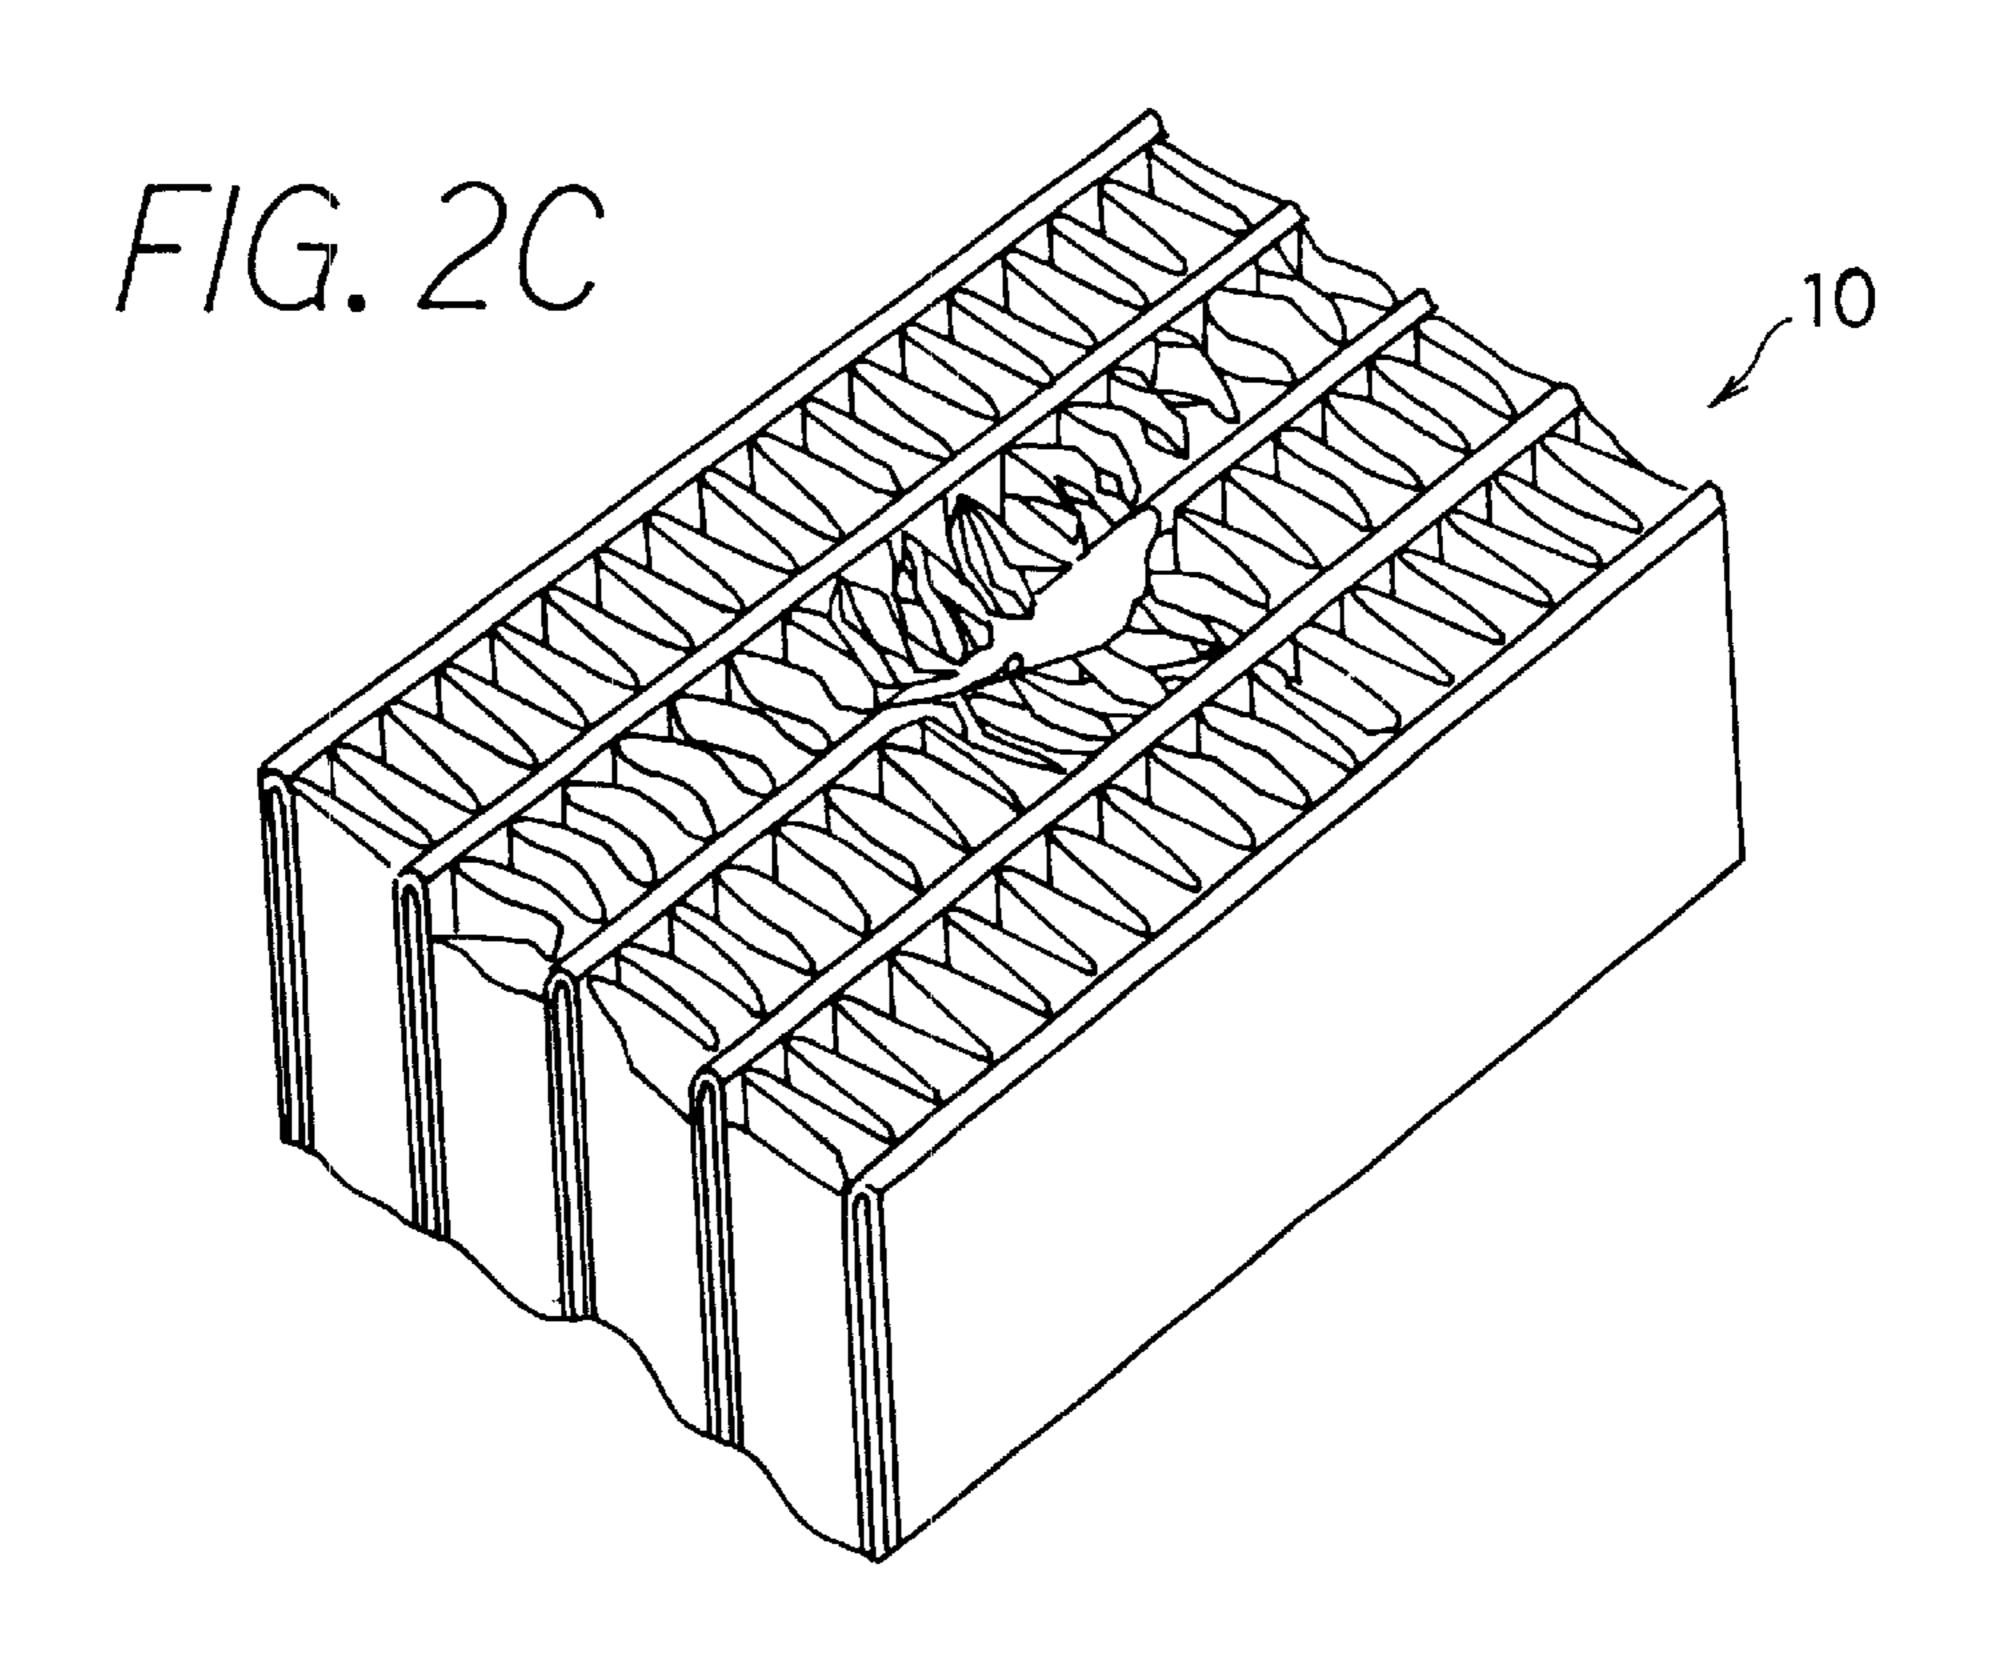
FIG. 2C is a perspective view showing the damage portion on a heat exchanger core;

A perspective view of the depressed portion 14 thus formed is shown in FIG. 2C. The aluminum corrugated fins 55 around the hole 14 are bent down and flattened to form a cup-shaped depressed portion 15. The cup-shaped depressed portion 15 is so made that the acrylic-resin-type adhesive material is retained therein while the adhesive material is being cured. The size of the depressed portion 15 has to be 60 sufficiently large to secure a certain thickness and an adhesive surface area of the adhesive material and to prevent the adhesive material from being pealed off.

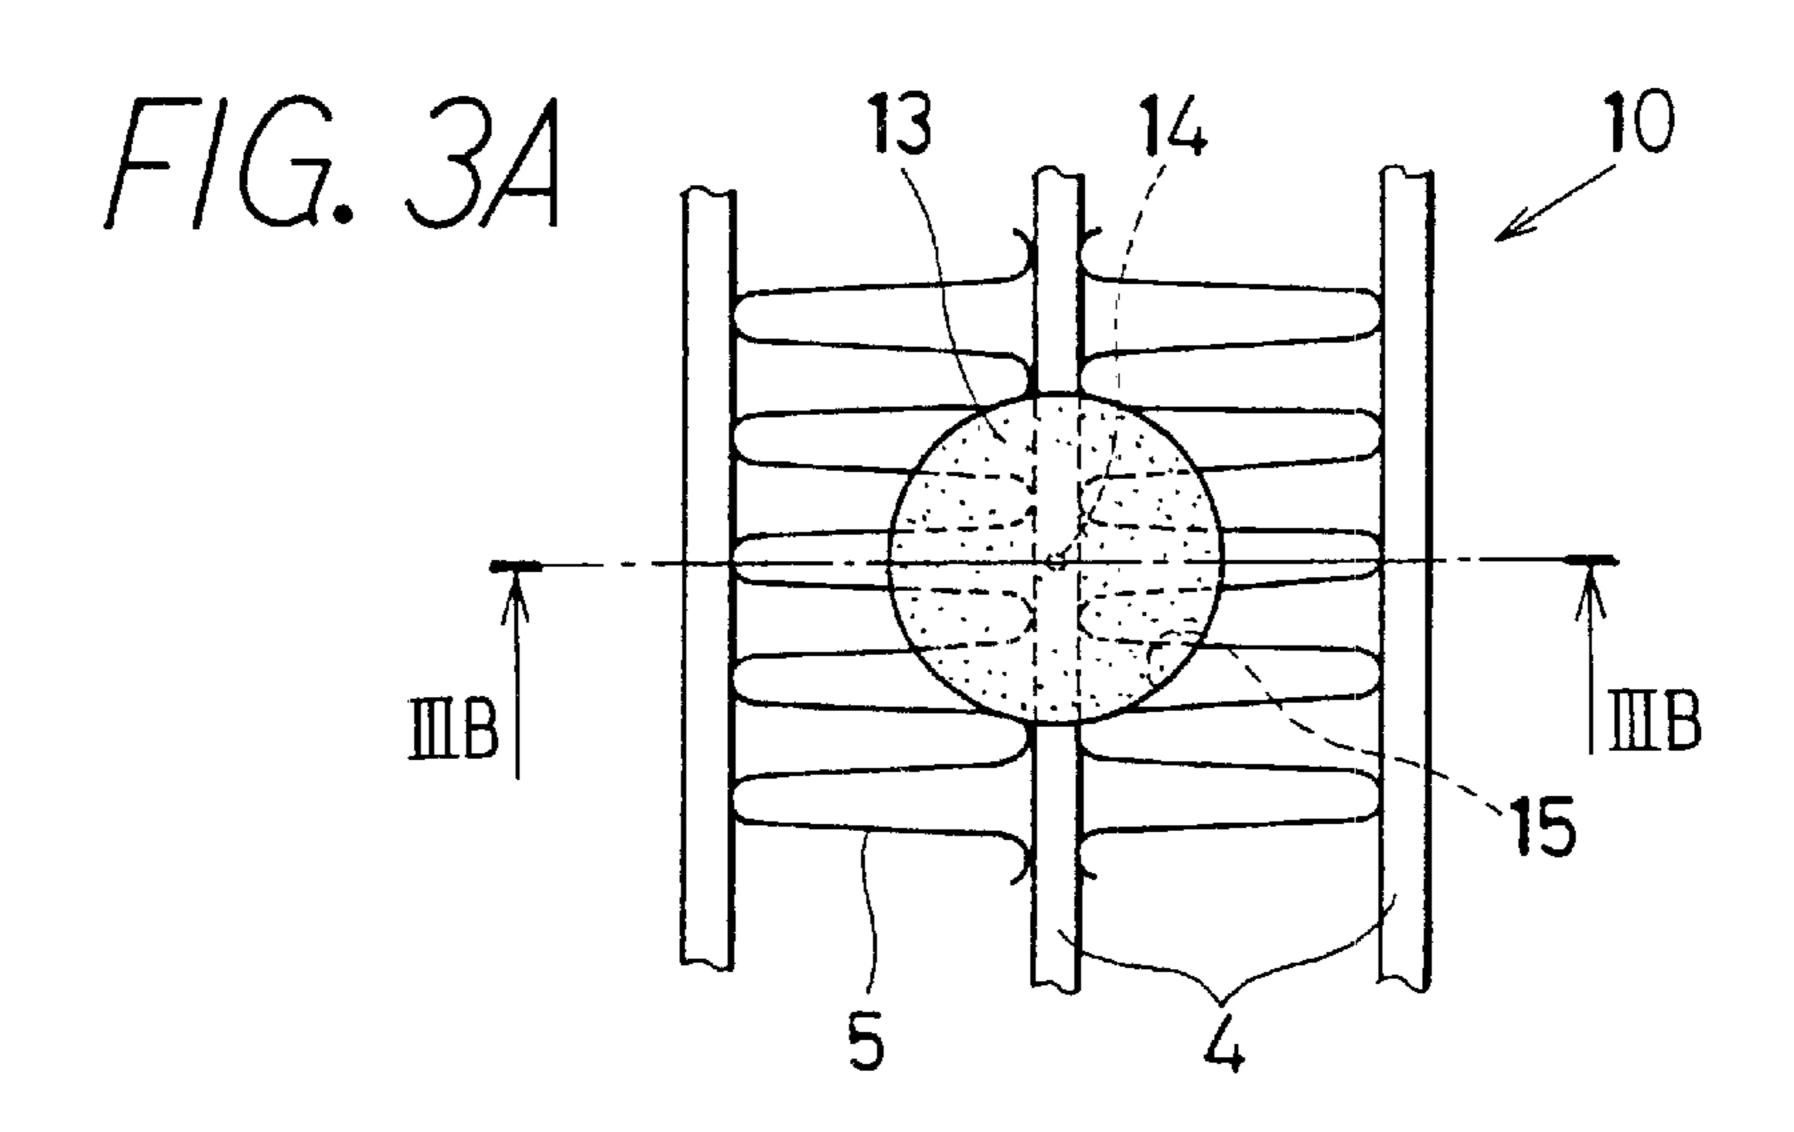
FIG. 3A is a partial front view showing a repaired portion with an adhesive material filling the depressed portion;

a form of paste, is supplied to the depressed portion 15, as shown in FIGS. 3A and 3B. The supplied adhesive material 13 is retained in the depressed portion 15, and some part thereof is impregnated into the corrugated fins 5 as shown in FIG. 3B. The adhesive material 13 is supplied so that the depth "C" of the impregnation measured from the surface of the core 10 becomes deeper than, e.g., 5 mm. To supply the adhesive material 13 to the depressed portion 15, the capsule containing the adhesive material may be set to a machine for injecting the adhesive material.

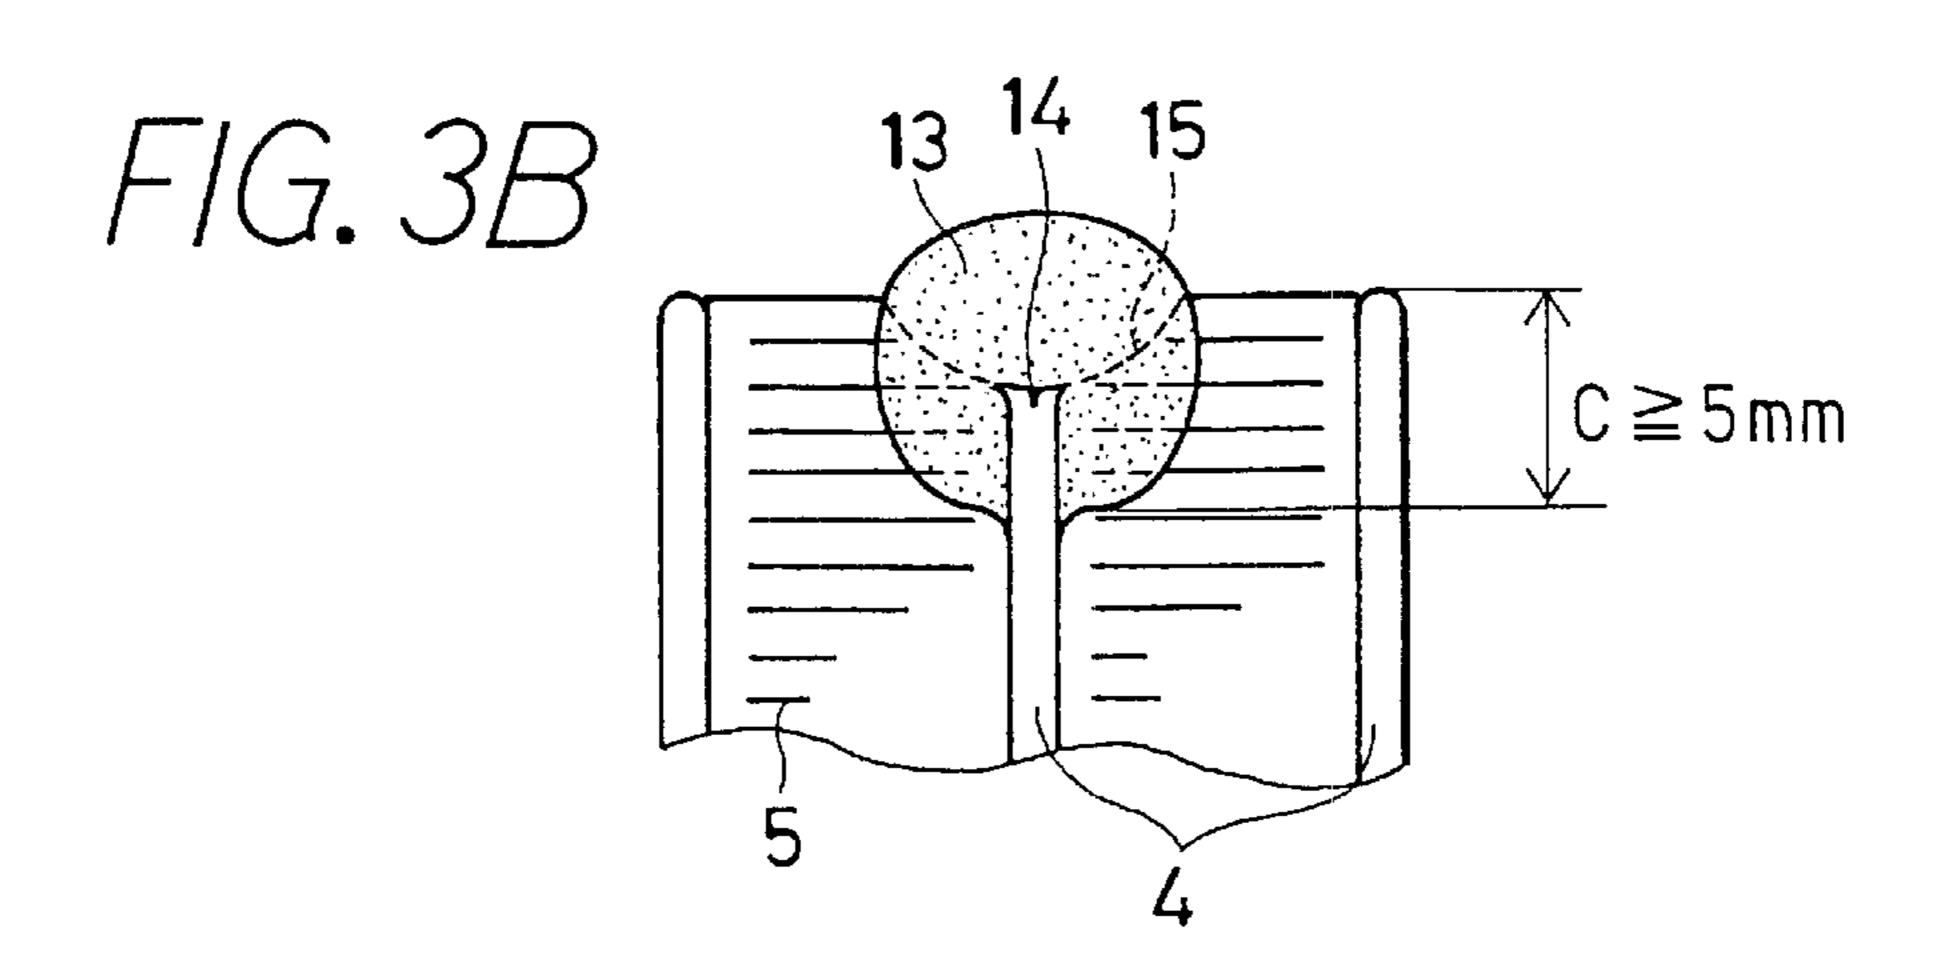
FIG. 3B is a cross-sectional view showing the repaired portion, taken along a line IIIB—IIIB in FIG. 3A;

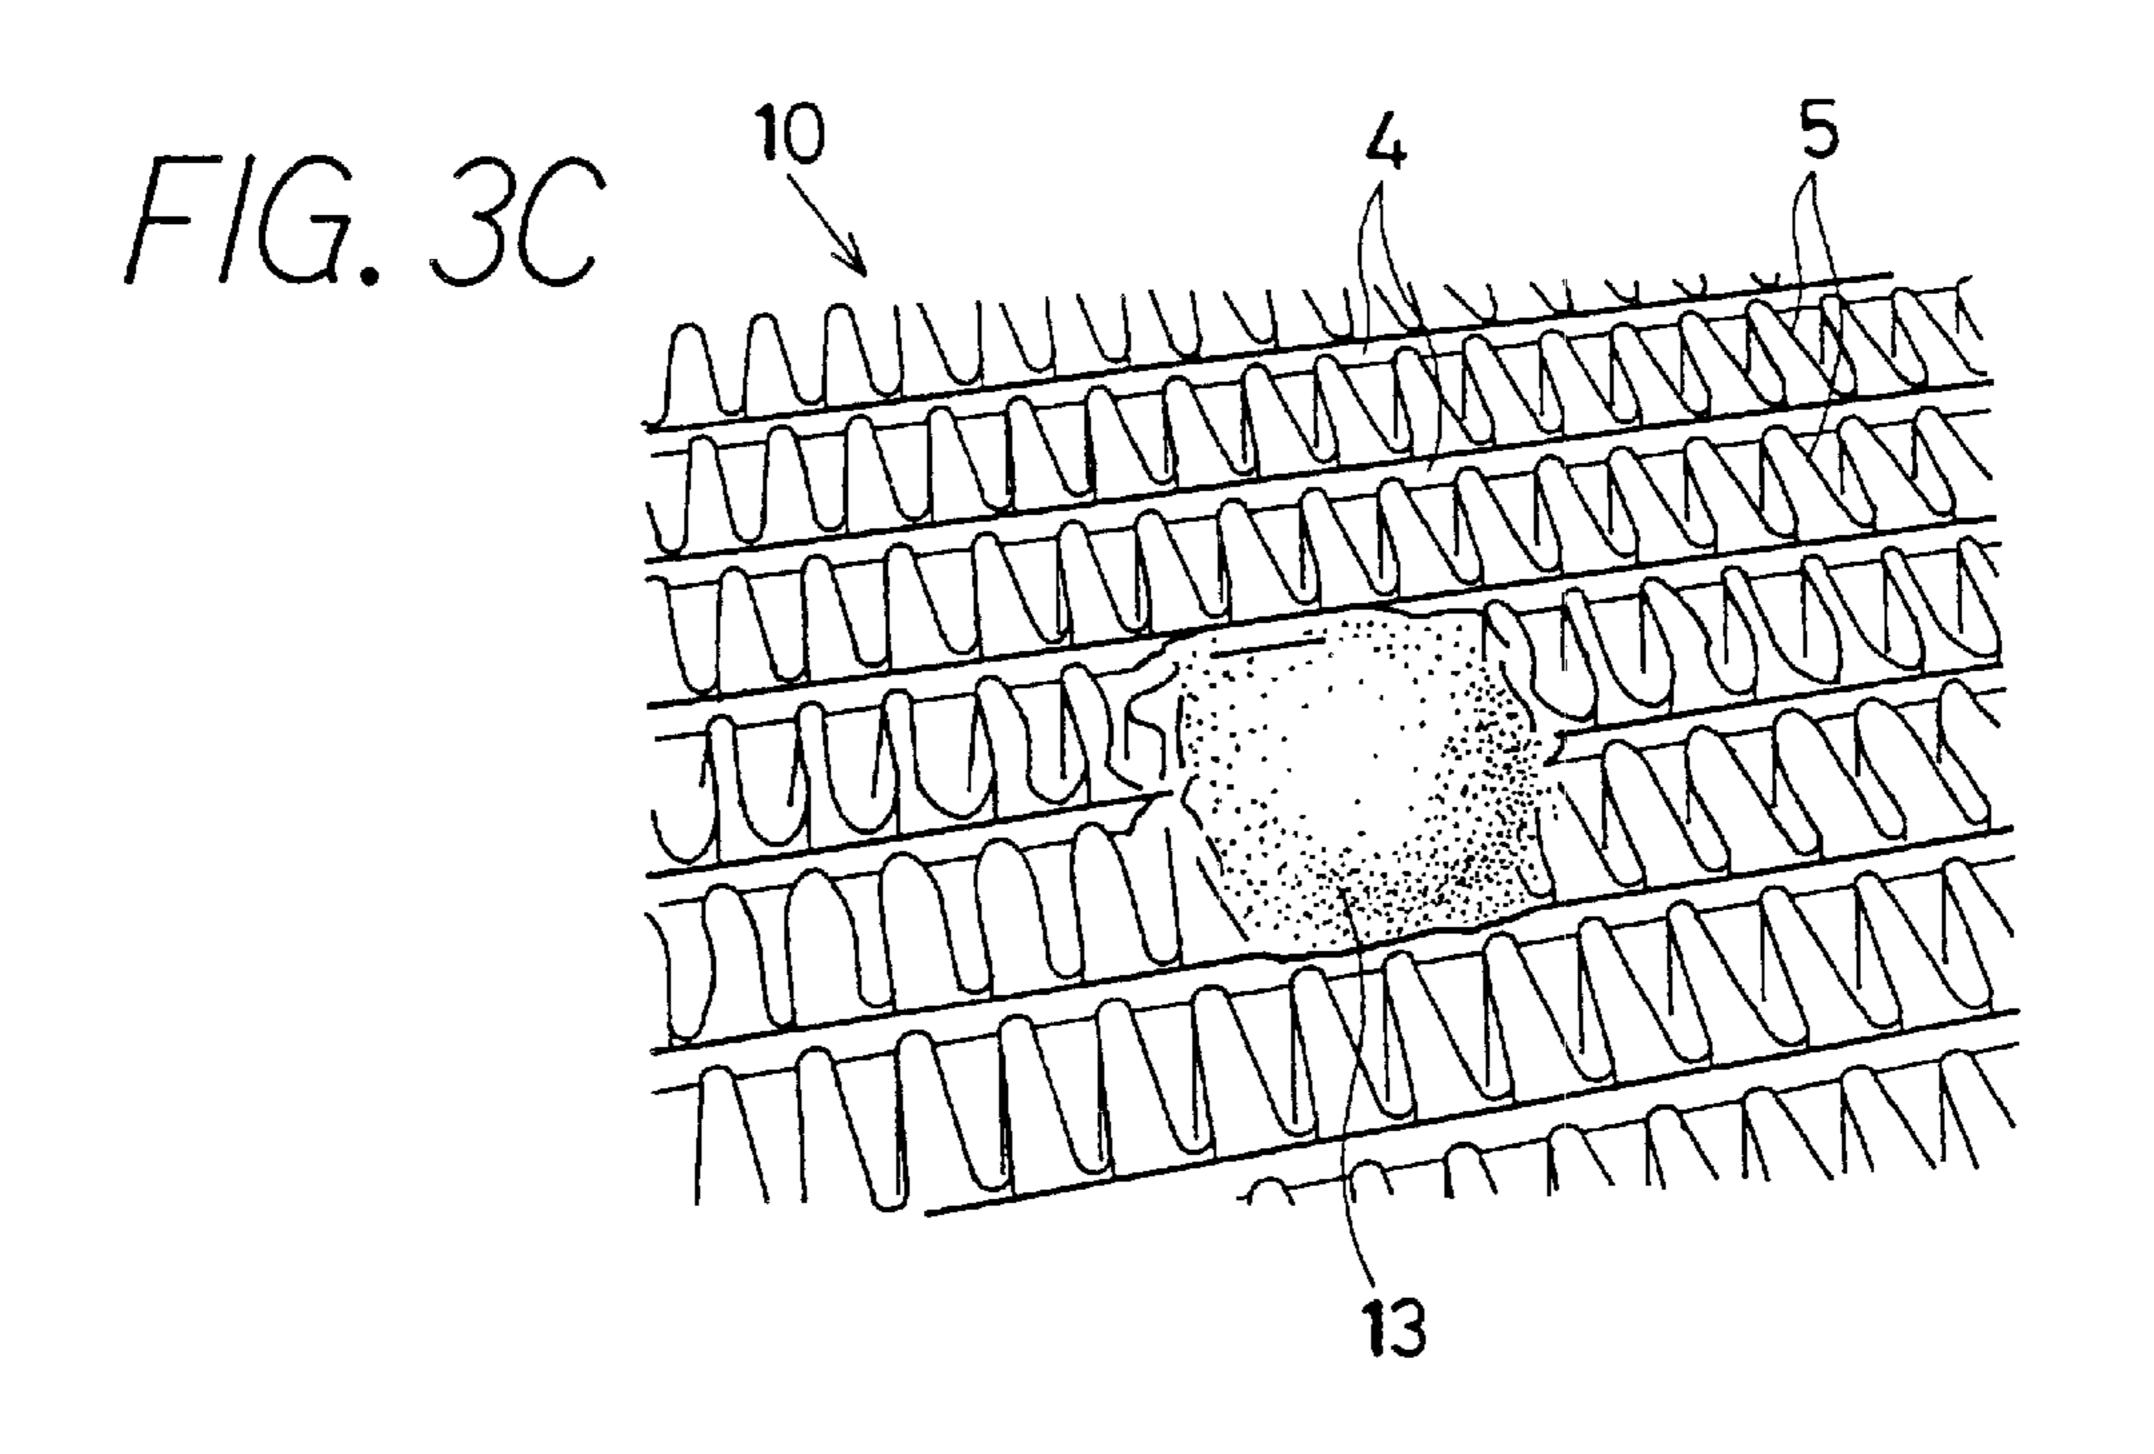
FIG. 3C is a perspective view showing the repaired portion;

The adhesive material 13 retained in the depressed portion 15 and impregnated into the corrugated fins 5 is cured under the room temperature for a predetermined period, e.g., for about 20 minutes. The hardened adhesive material 13 firmly closes the hole 14, and thus the repair work is completed. The reason why the acrylic-type resin is used as the adhesive material in place of a conventional epoxy-type resin is that the acrylic resin can be hardened under the room temperature in a shorter period. The adhesive material 13 includes a hardener in addition to the acrylic-type resin as the main component. FIG. 3C shows a perspective view of the portion repaired under the above-described method.

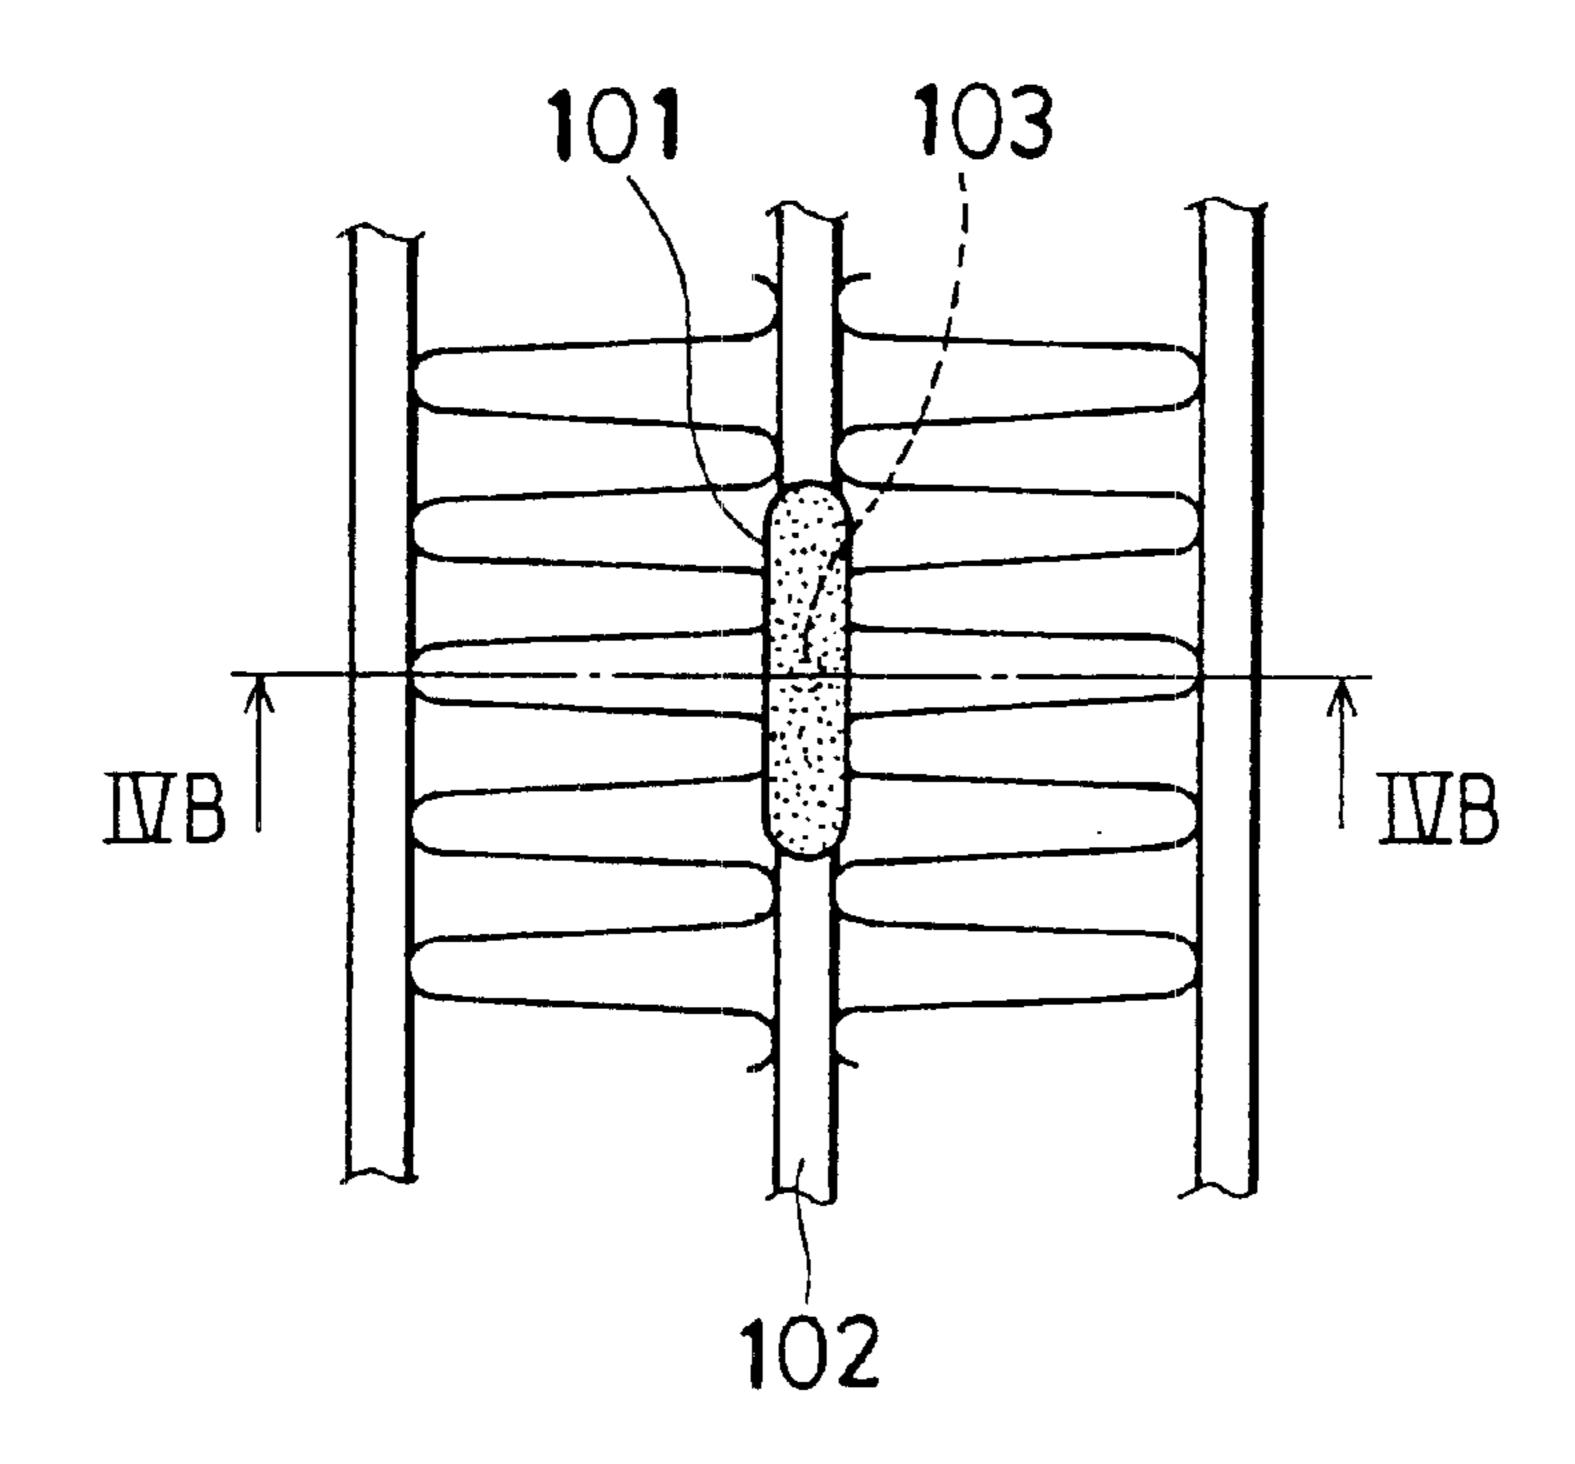
# F/G. 4A PRIOR ART

FIG. 4A is a partial front view showing a portion repaired under a conventional method; and

Further, the conventional repair work has not been sufficiently complete because the aluminum heat exchanger is repaired under a method as shown in FIGS. 4A and 4B. That is, the epoxy-resin-type adhesive material 101 is directly coated on a damaged aluminum tube 102 to close a hole 103 formed therein, and then the adhesive material is cured. Therefore, the adhesive material flows over the vicinity of the hole 103, thereby making the coated layer thin. The hole 103 is not completely closed, or the once coated adhesive material tends to be peeled off in a short time.

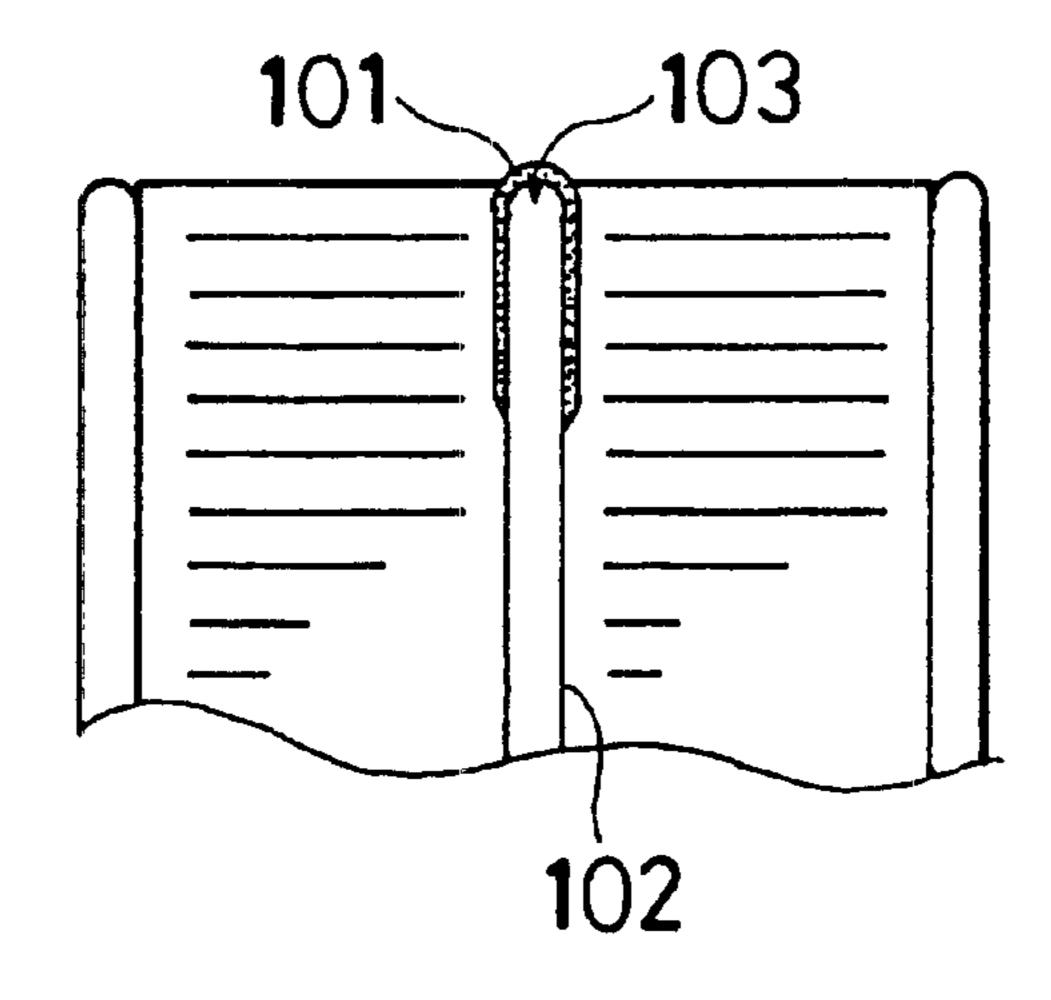
F/G. 4B PRIOR ART

FIG. 4B is a cross-sectional view showing the conventional repaired portion, taken along a line IVB—IVB in FIG. 4A.
