(12) **United States Patent**  
**Thomsen**

(10) **Patent No.:** **US 6,639,411 B1**  
(45) **Date of Patent:** **Oct. 28, 2003**

(54) **MICROACTUATED SUSPENSION MOTOR FAILURE DETECTION SYSTEM**

(73) Assignee: **Hutchinson Technology Incorporated**, Hutchinson, MN (US)

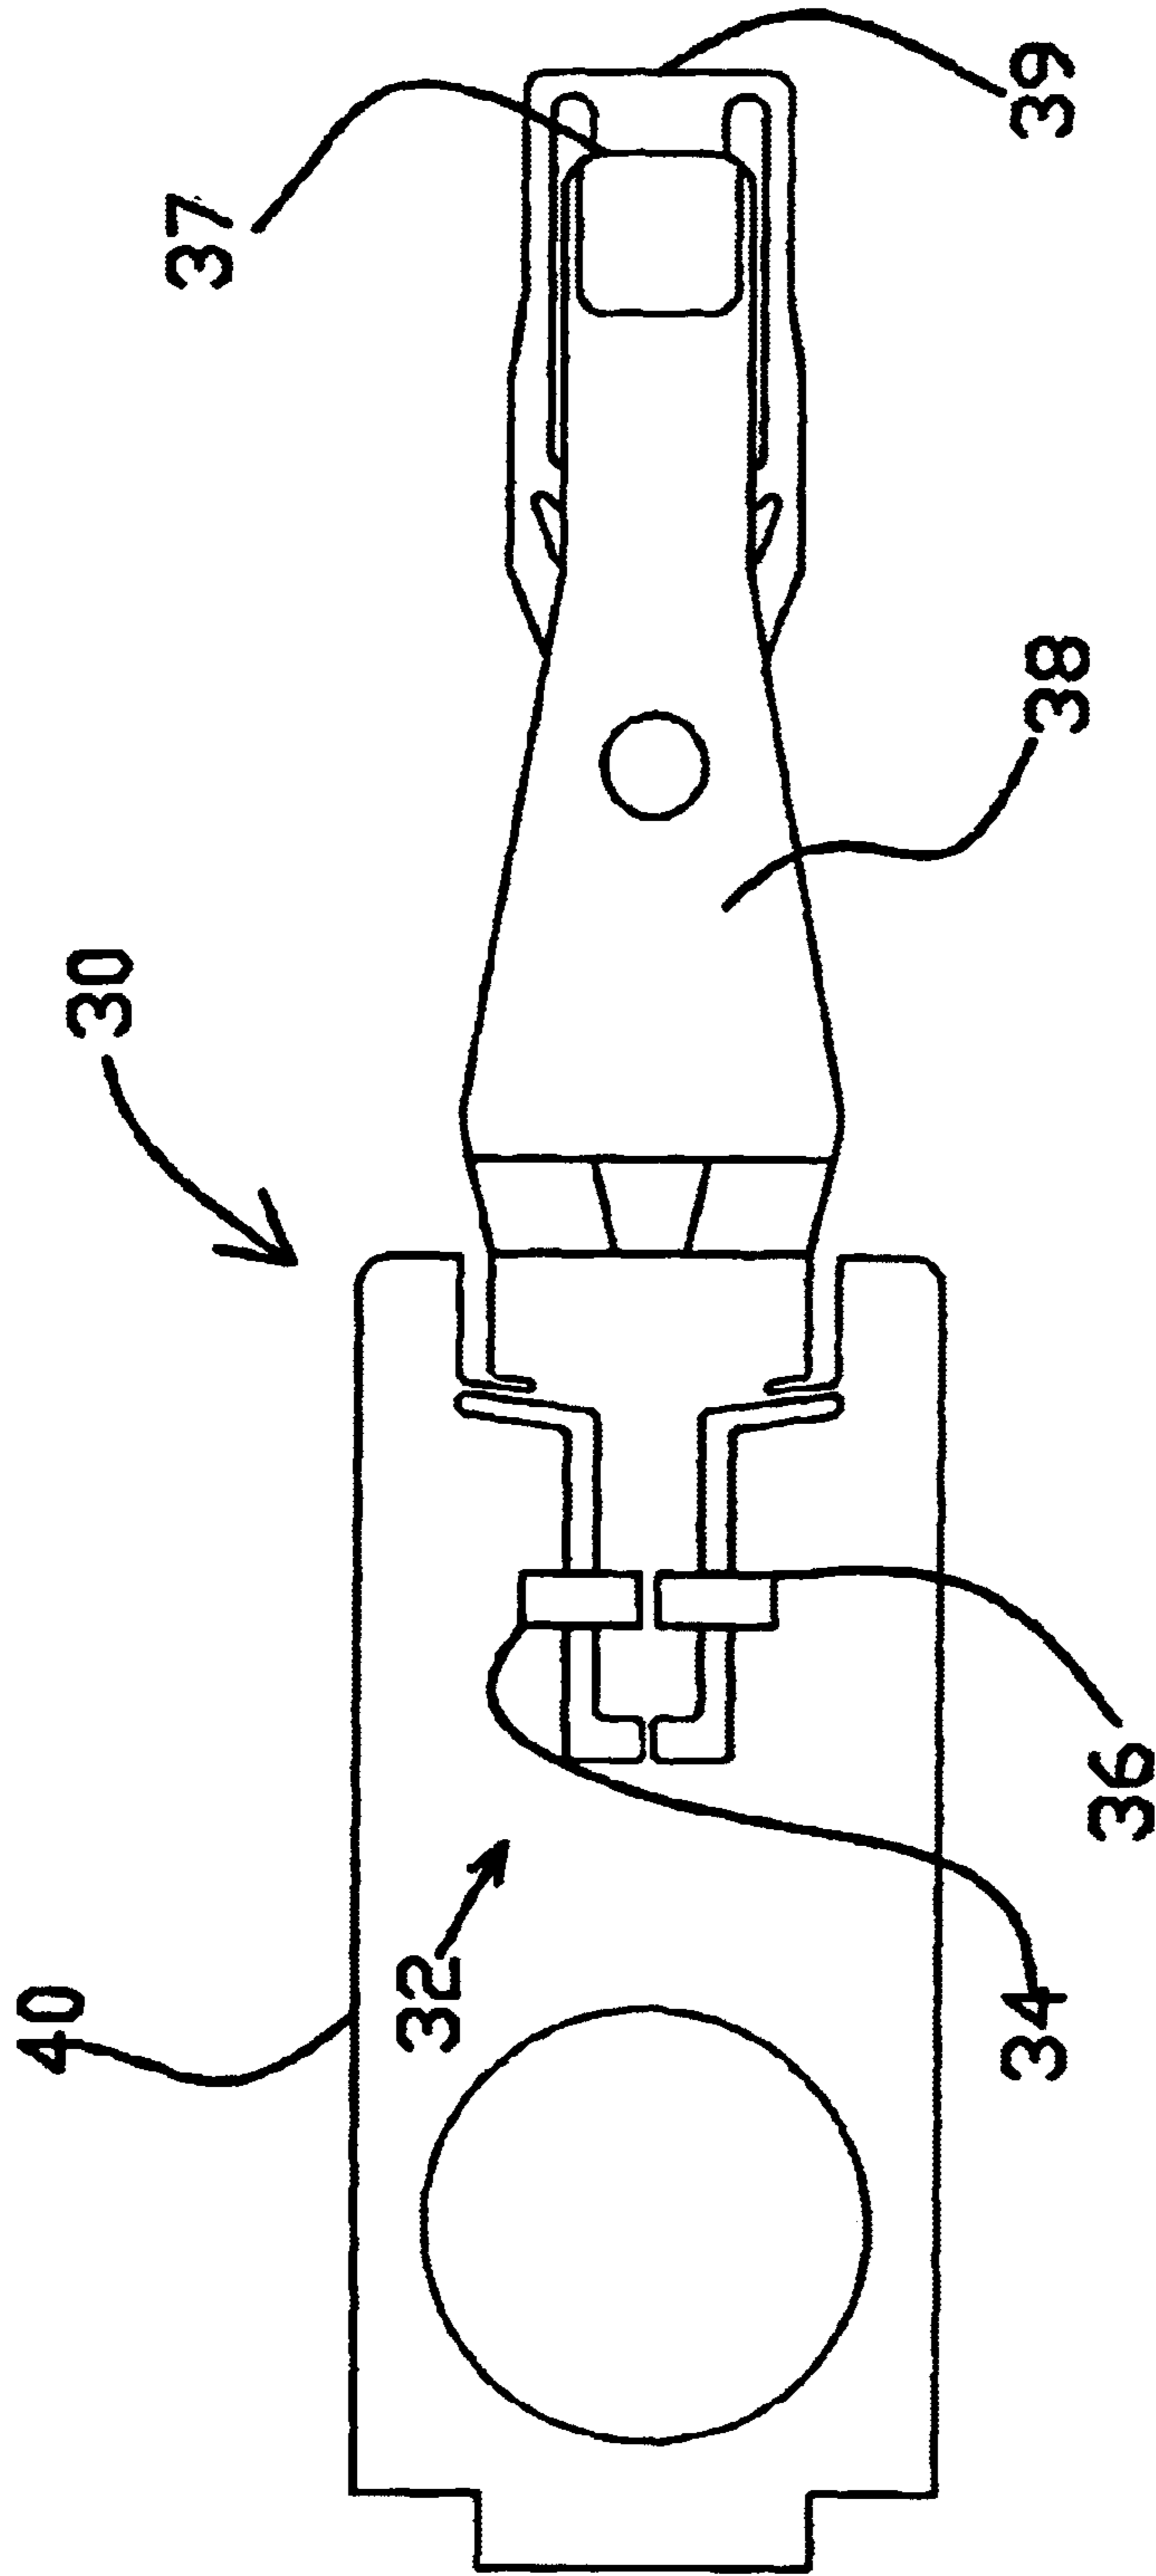
FIGURE 1  
Prior Art

FIG. 1 is a simplified plan view of a head suspension having microactuator motors to which the present invention is directed.

Microactuated suspensions are generally known and disclosed, for example, in the Krinke et al. U.S. Pat. No. 6,046,888. FIG. 1 is an illustration of one such microactuated suspension 30. The embodiment shown in FIG. 1 has an actuator or motor 32 formed by a pair of piezoelectric (PZT) elements 34, 36 for rotating or otherwise driving a load beam 38 with respect to a baseplate 40 in response to electric drive signals. Piezoelectric materials are also widely used as transducers of mechanical motion into electrical energy.

The suspension design shown in FIGS. 1 and 2 includes two PZT elements 34, 36 that act as the motor 32 and provide fine adjustment of a read/write head 37. It is to be understood that the motor region 32 is the area on the suspension where the PZT elements 34, 36 are bonded. Damage to the motor region causes changes in the suspension's structural characteristics. An electrical charge is created by applying stress to the PZT elements 34, 36. The method of the present invention, referred to as the "ringout" method, applies stress to the motor region 32 containing the PZT elements 34, 36 and monitors the resultant voltage across nodes 42, 44. If the motor region 32 has a defect, the output voltage changes depending on the failure mode. In the design shown in FIGS. 1 and 2, the PZT elements 34, 36 carry a small percentage of the suspension gram load.

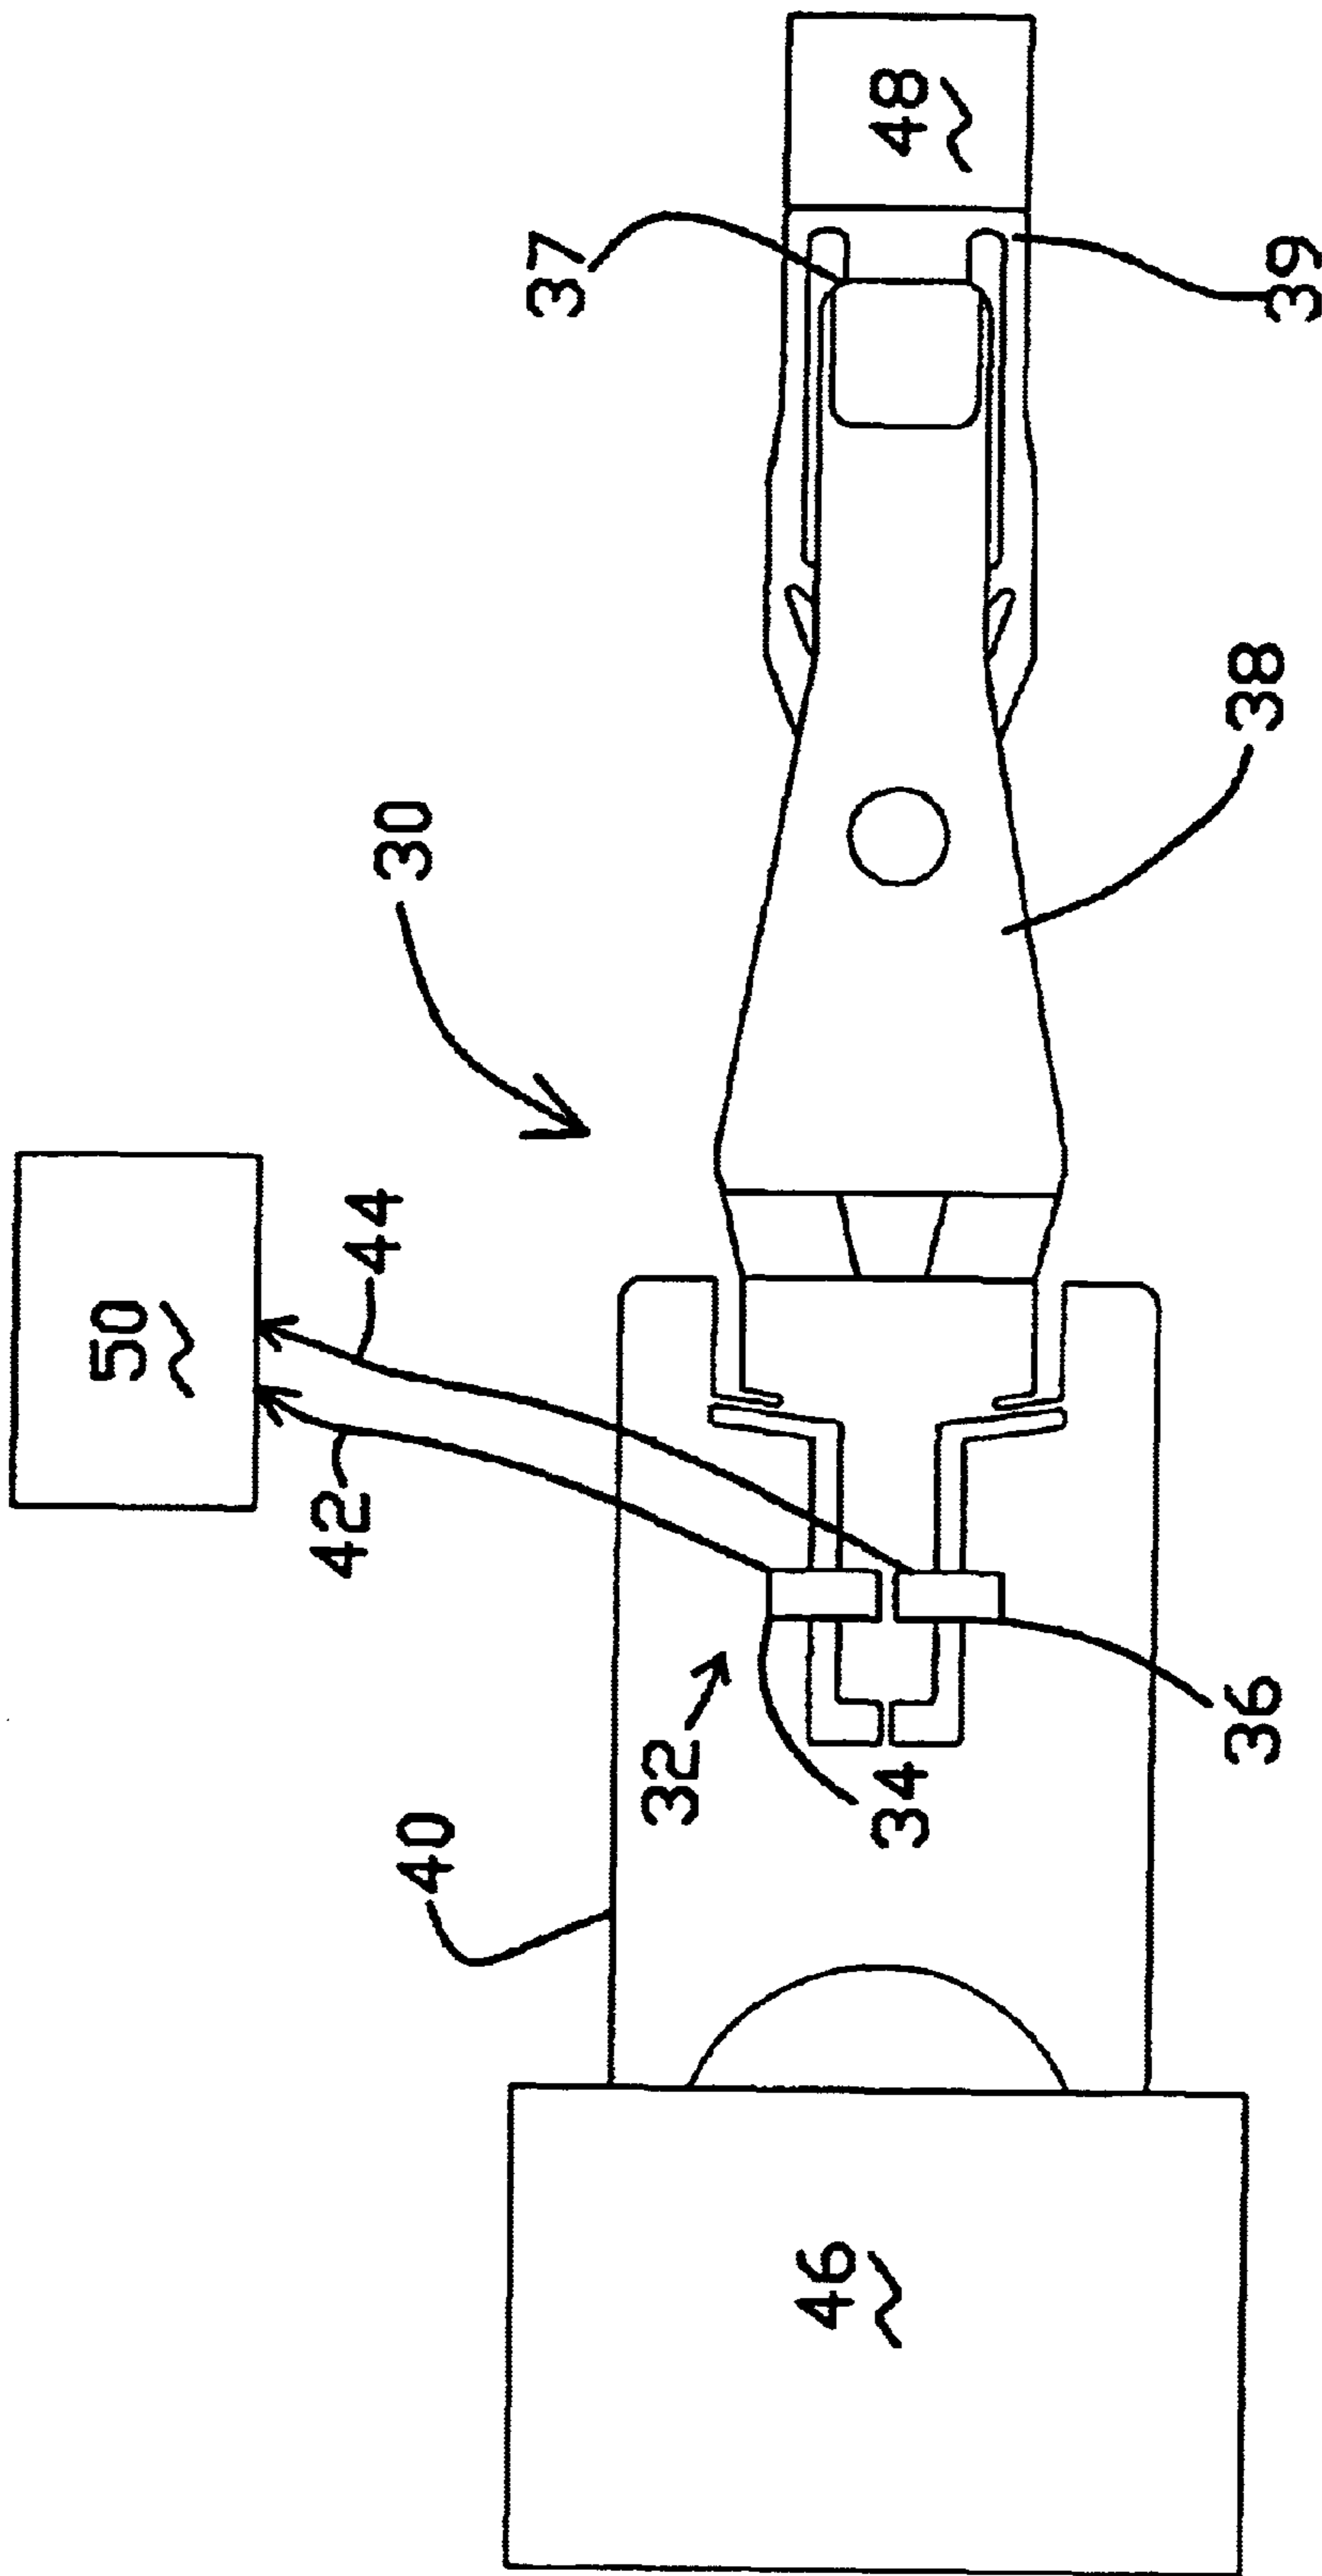
FIGURE 2

FIG. 2 is a schematic illustration of a microactuated suspension, together with a motor failure detection system according to the present invention.

FIG. 2 is a schematic illustration of a microactuated suspension and a “ringout” motor failure detection system in accordance with the present invention. As shown, the motor failure detection system generally includes a clamp 46, a motion actuator 48 and a signal processing system 50. The suspension baseplate is clamped to a datum or fixed location by the clamp 46. The motion actuator 48 engages a headlift (not shown) or other component of the load beam 38 or flexure 39 and raises or lowers (e.g., moves) the load beam 38 with respect to the baseplate 40 (within its range of elastic deformation). The motion actuator 48 then releases the load beam 38 or flexure 39, thereby allowing the load beam to vibrate in a periodic manner at its natural frequency. The clamp 46 and motion actuator 48 of this embodiment of the invention thereby cooperate to cause relative movement between the suspension portions that are being driven with respect to one another by the piezoelectric elements 34, 36 of the motor 32.

Referring to FIGS. 3a and 3b, as well as to FIG. 2, the electrical signal(s) produced by the motor in response to the movement on lines 42, 44 are monitored and evaluated by the signal processing system 50 to provide information representative of motor failure modes. Another embodiment of the invention (not shown) includes a motion actuator which engages a headlift on the suspension, and raises the suspension to its fly height before releasing the suspension and allowing the suspension to vibrate. The ringout method of the present invention takes advantage of this condition by applying stress to the PZT elements 34, 36 by lifting the part to flyheight while holding the base plate 40 stationary using a clamp 46. The part is then released, and the suspension 30 is allowed to freely resonate about its bending mode. The suspension design shown has the two PZT elements or motors 34, 36 connected in parallel. The voltage 52 measured at the trace is the sum of the voltages from the individual motors. Since the motors are poled in opposite directions, bending stresses will produce opposite charges on each motor. This electro-mechanical relationship is illustrated in FIG. 3c by disconnecting the wire between the two motors and displaying the output waveforms 54, 56 from each simultaneously as the part is tested. In this example, the peak voltage 58 from the right motor is approximately  $-5.7$  v, compared to  $+4.9$  v for the left motor peak voltage 60, as shown in FIG. 3c. The differing peak voltages are due to the fact that more stress is applied to the right motor because of the asymmetrical characteristics of the design, which is caused by the flexure being attached to one side of the suspension as opposed to being attached to the center of the part. When the load beam 38 is lifted to flyheight, stress is applied to both motors. A motor region failure mode, such as a cracked PZT motor or adhesive delamination, will change the applied stress in relation to the size and location of the fracture. The change in stress causes a proportional change in peak output voltage, which indicates the part is defective.

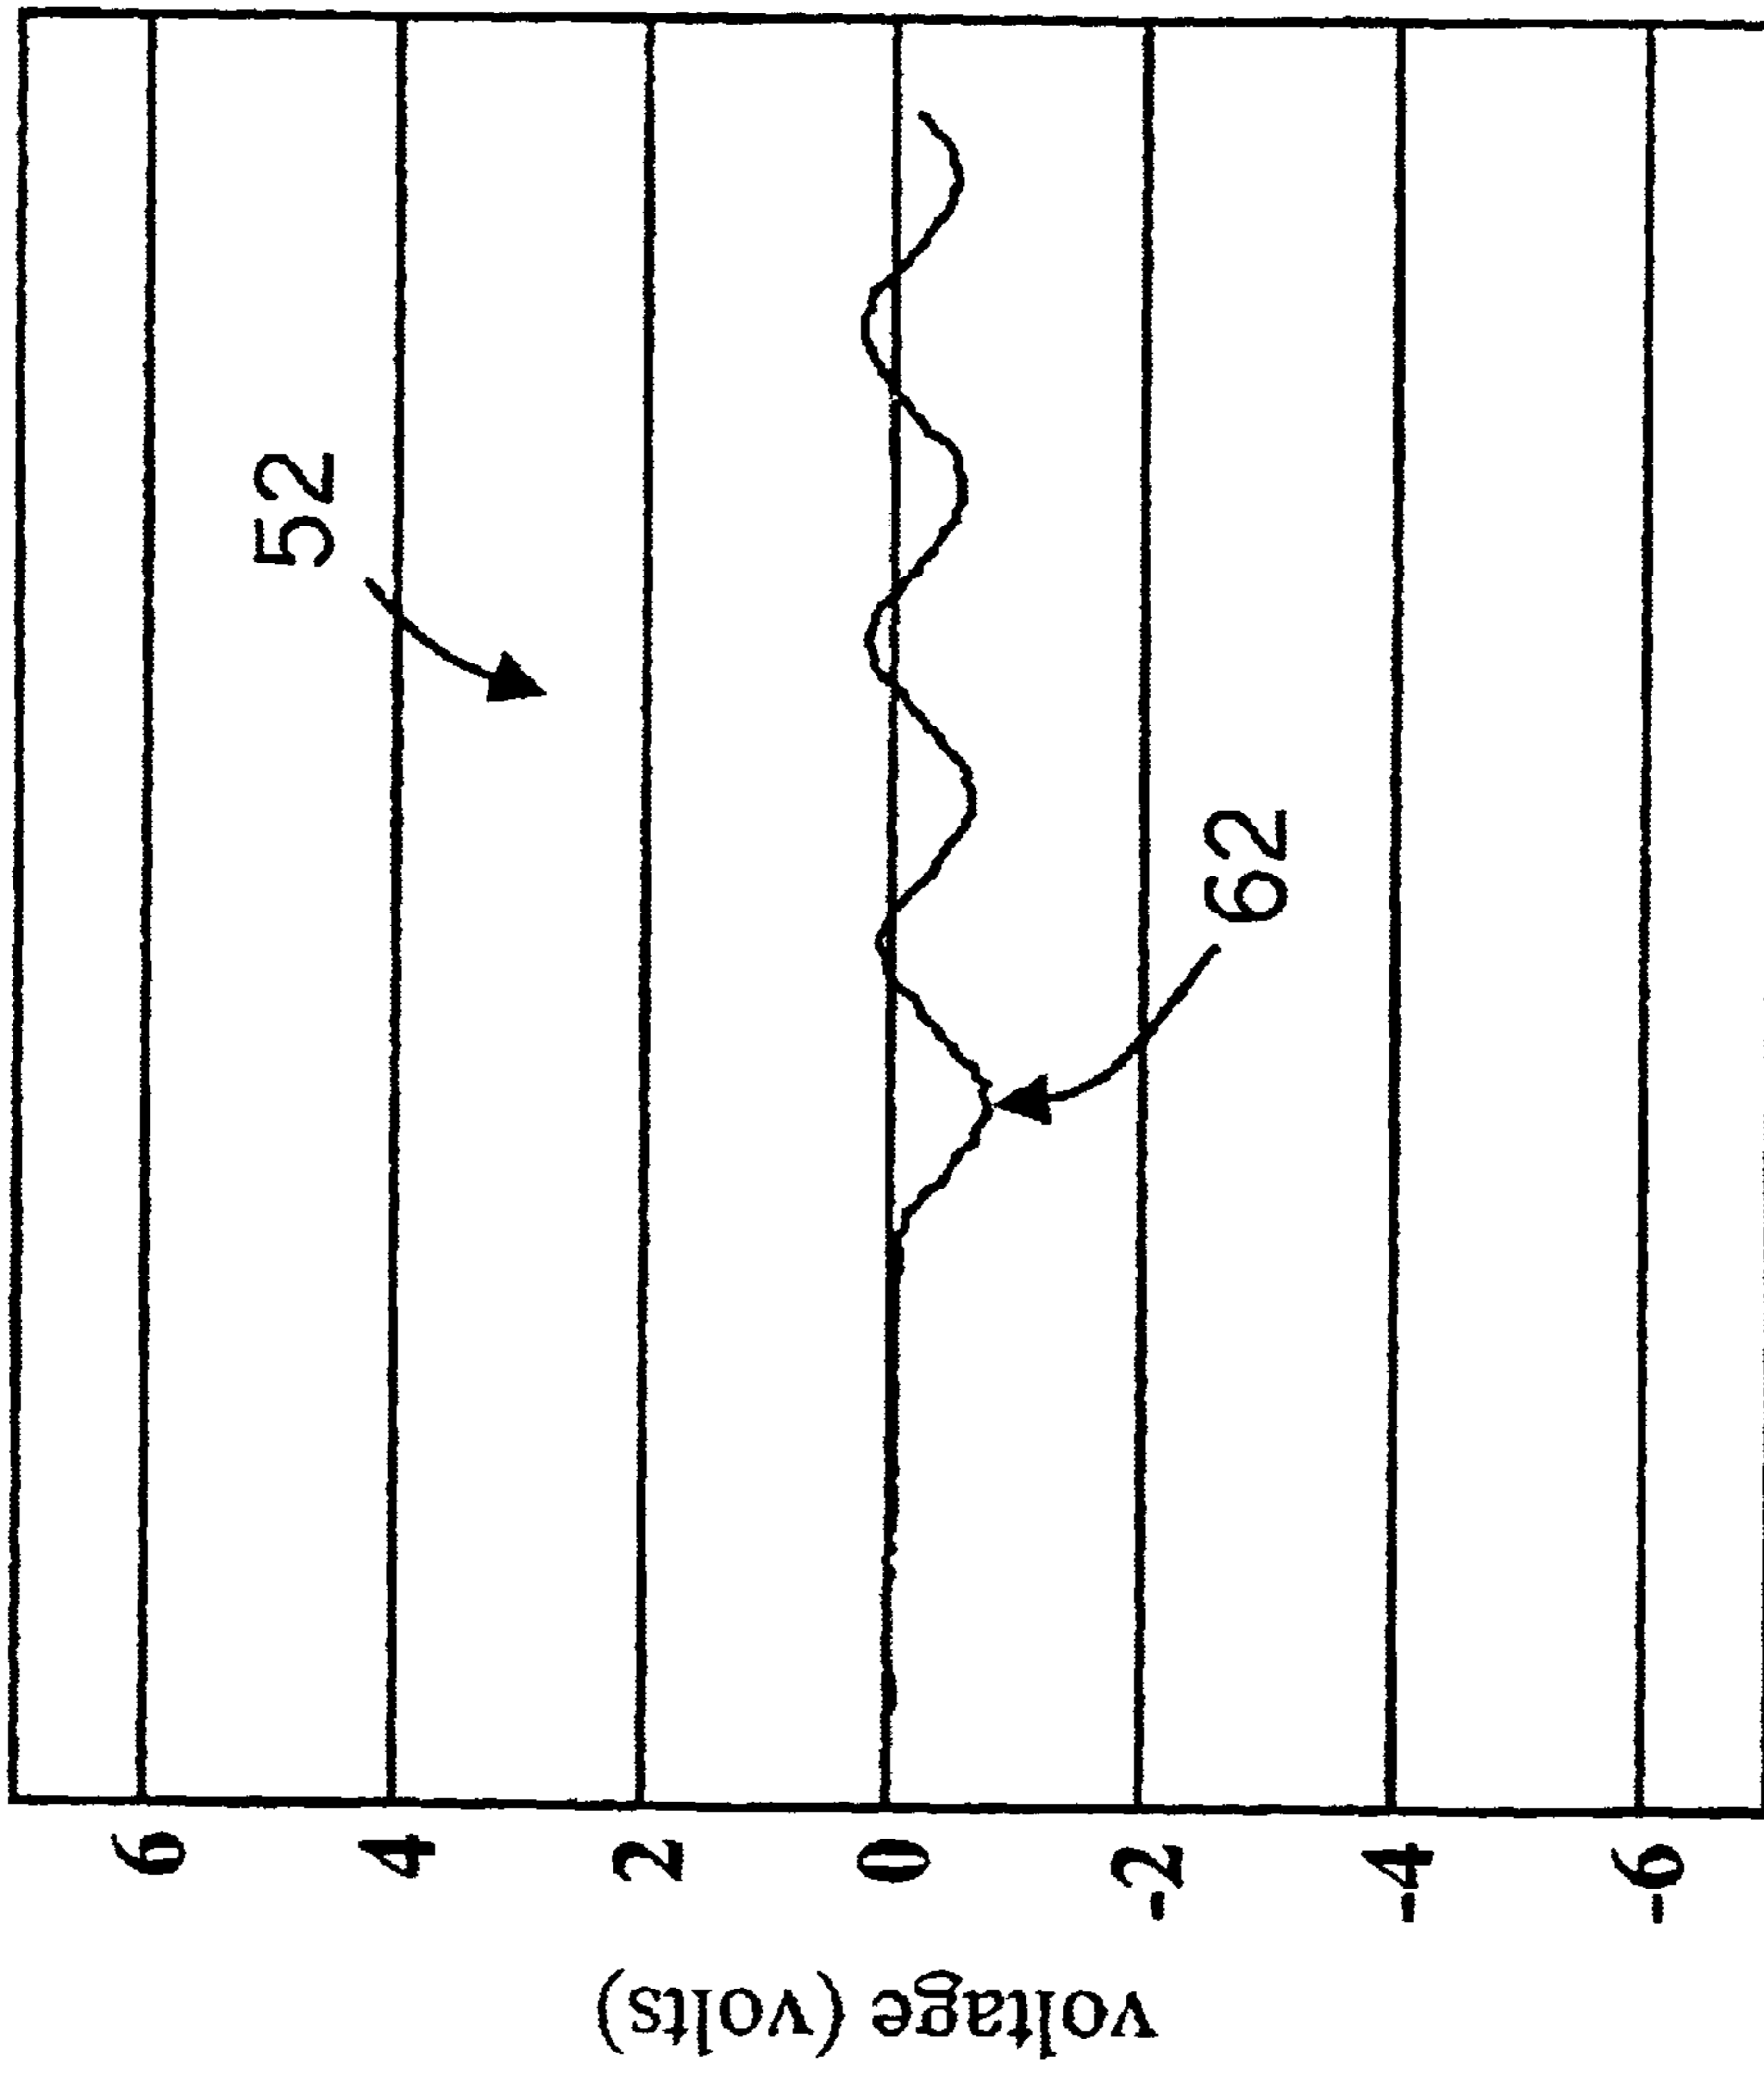
FIGURE 3a

FIG. 3a is an output waveform of a good part.

Returning to FIGS. 3a and 3b, the voltage waveform 52 of the PZT elements during a ringout test of a good part may be seen at two magnification levels. The first peak voltage 62 is used to determine if a defect exists; however, the entire waveform 52 provides additional information about the failure mode and may be used for that purpose. Note that the fundamental frequency for a good suspension (of the type shown) at free state is approximately 315 Hz in FIG. 3a and the first peak voltage measures  $-0.8$  v ( $\pm 0.2$  v). A digi-

tizing oscilloscope is connected to the PZT elements 34, 36 via the suspension trace and a 10 $\times$  oscilloscope probe. A rigid shim holds the part at flyheight. The shim is removed from the part and the suspension 30 is allowed to resonate in bending. If possible, the headlift feature on the part is used to elevate the part to flyheight. However, if no headlift exists extreme care is taken to both elevate the part on the flexure 39 and to release the part by removing the shim from the flexure 39.

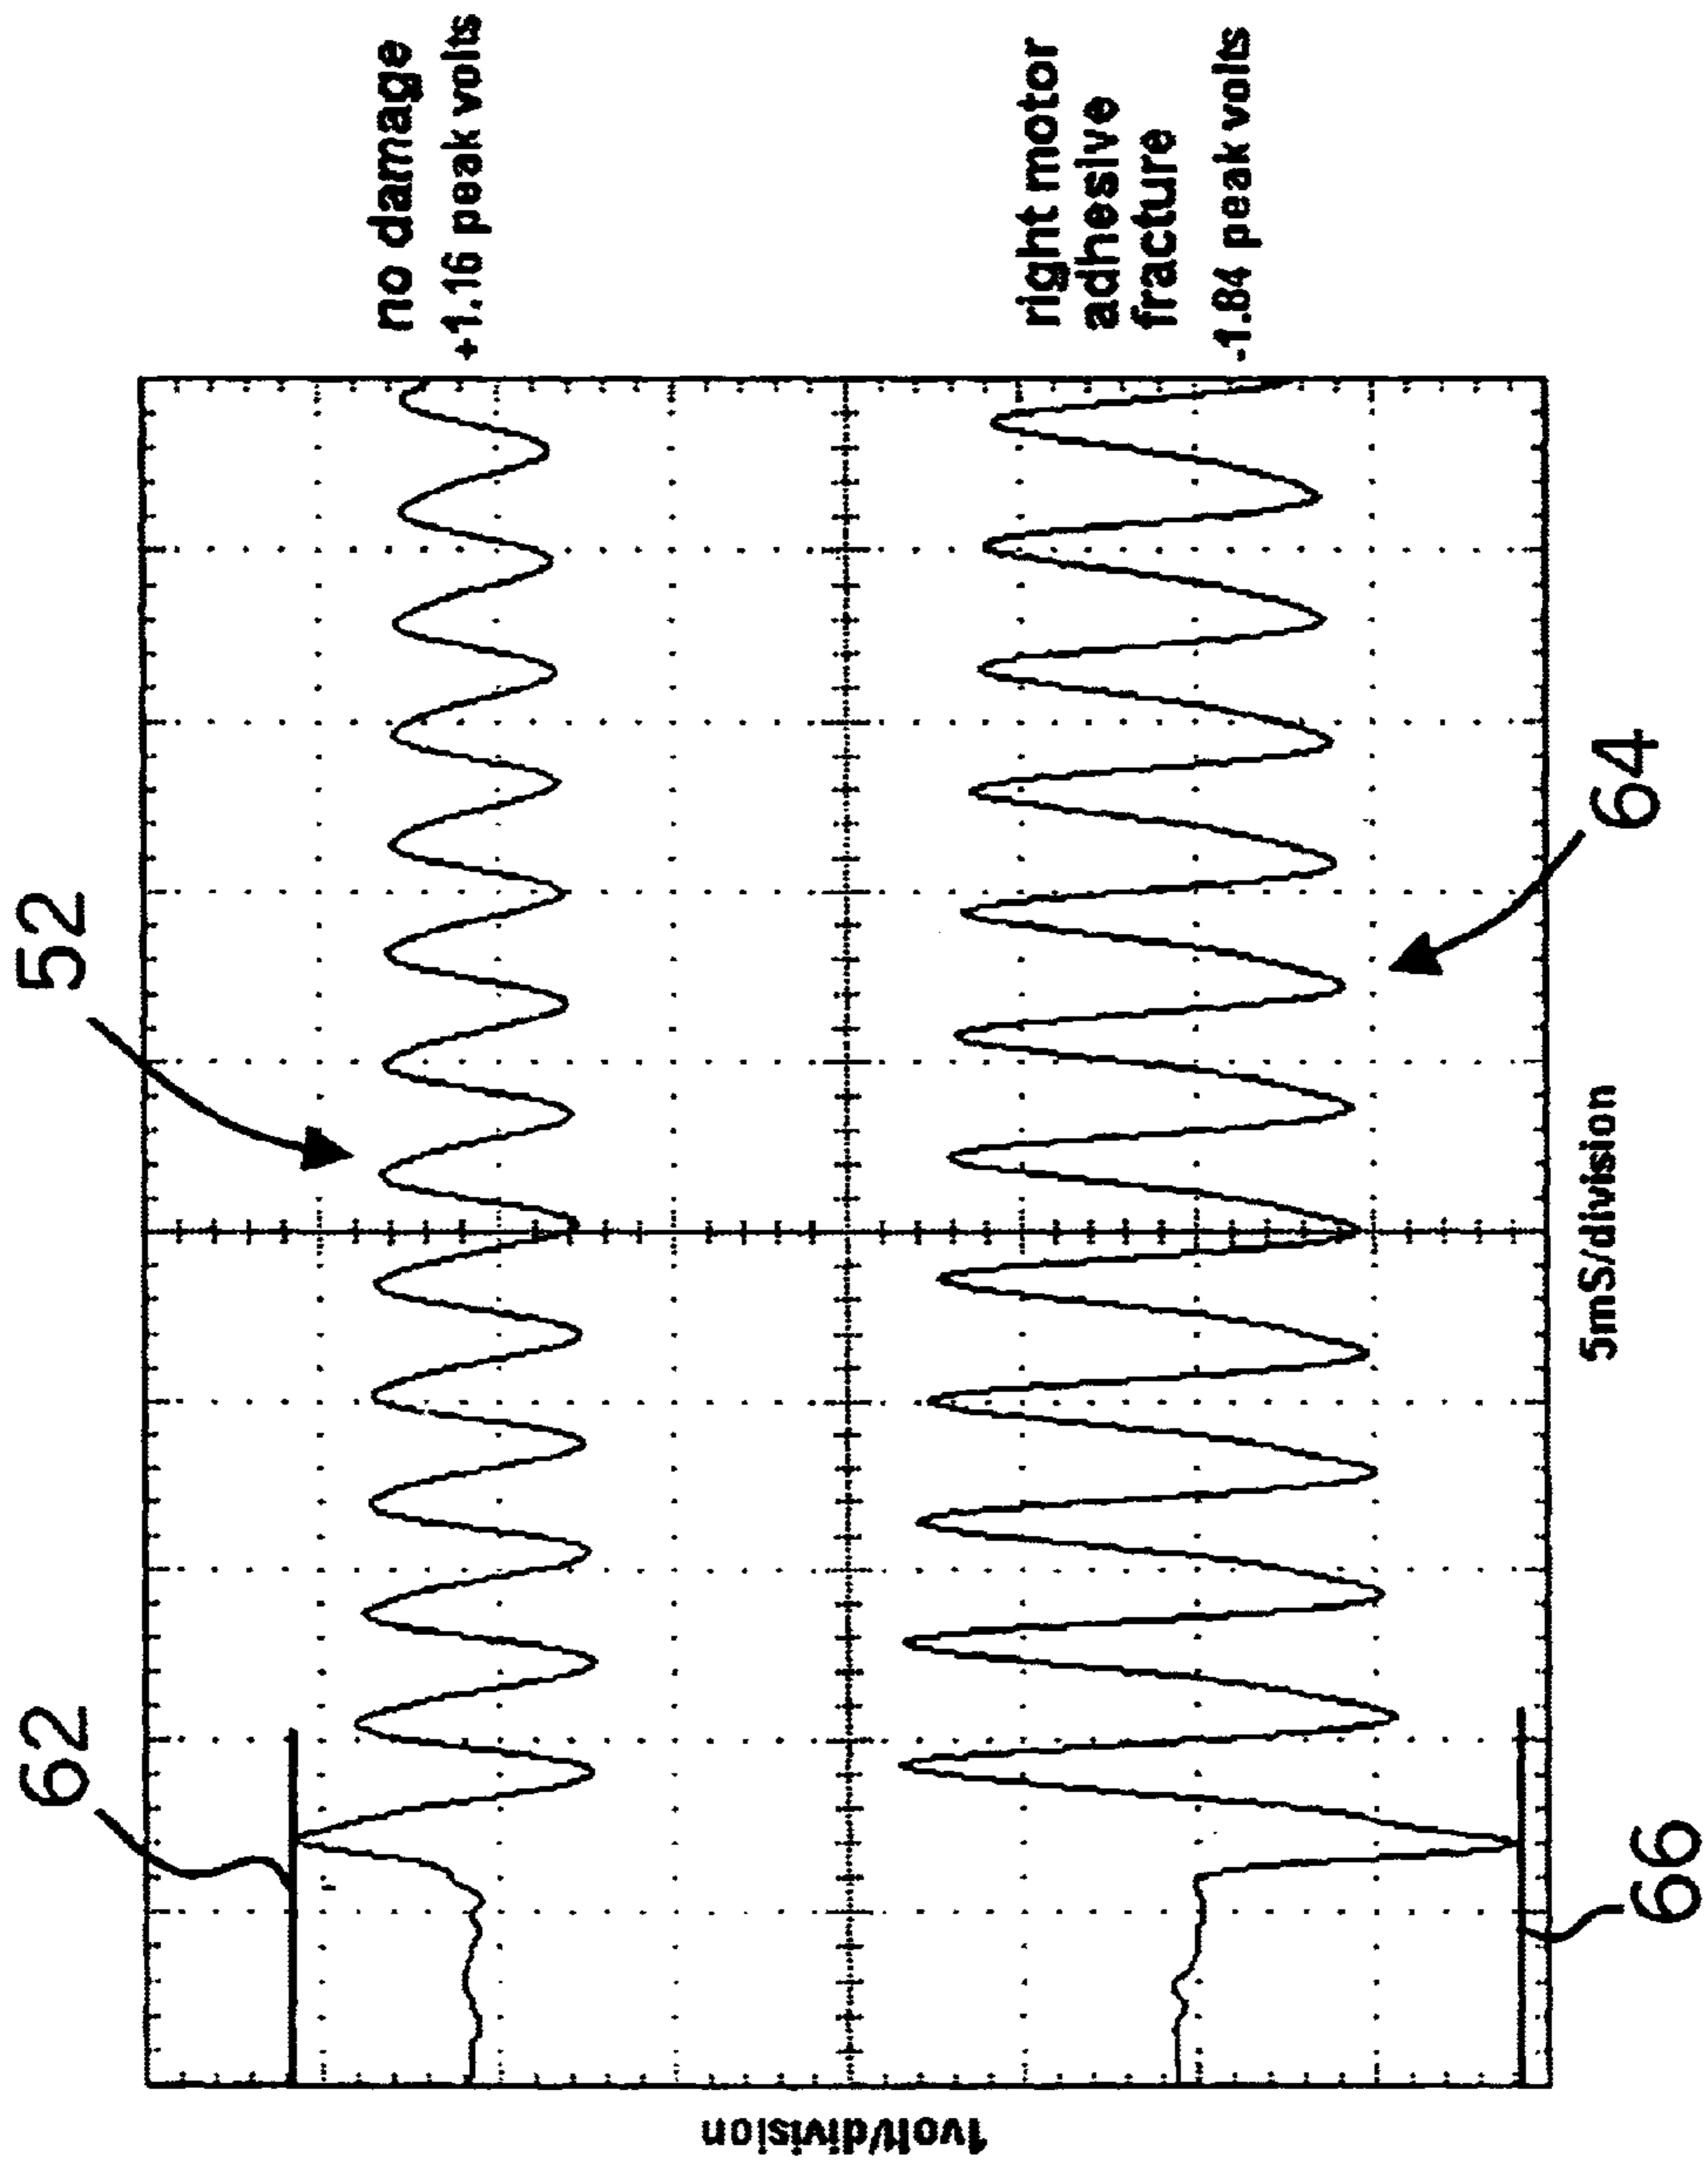
FIGURE 3b

FIG. 3b is a graph of electrical signals produced by a properly functioning and mounted microactuator motor and a motor having an adhesive fracture.

FIG. 3b is an inverted and expanded scale graph of the electrical signals produced by a properly functioning and mounted microactuator motor (“no damage”) at waveform 52. FIG. 3b also shows a waveform 64 for a motor having an adhesive fracture on one of its piezoelectric elements (“right motor adhesive fracture”). As shown, the peak level 62 of the signal produced by the properly functioning motor is relatively low compared to the peak level 66 of the motor having the failure mode.

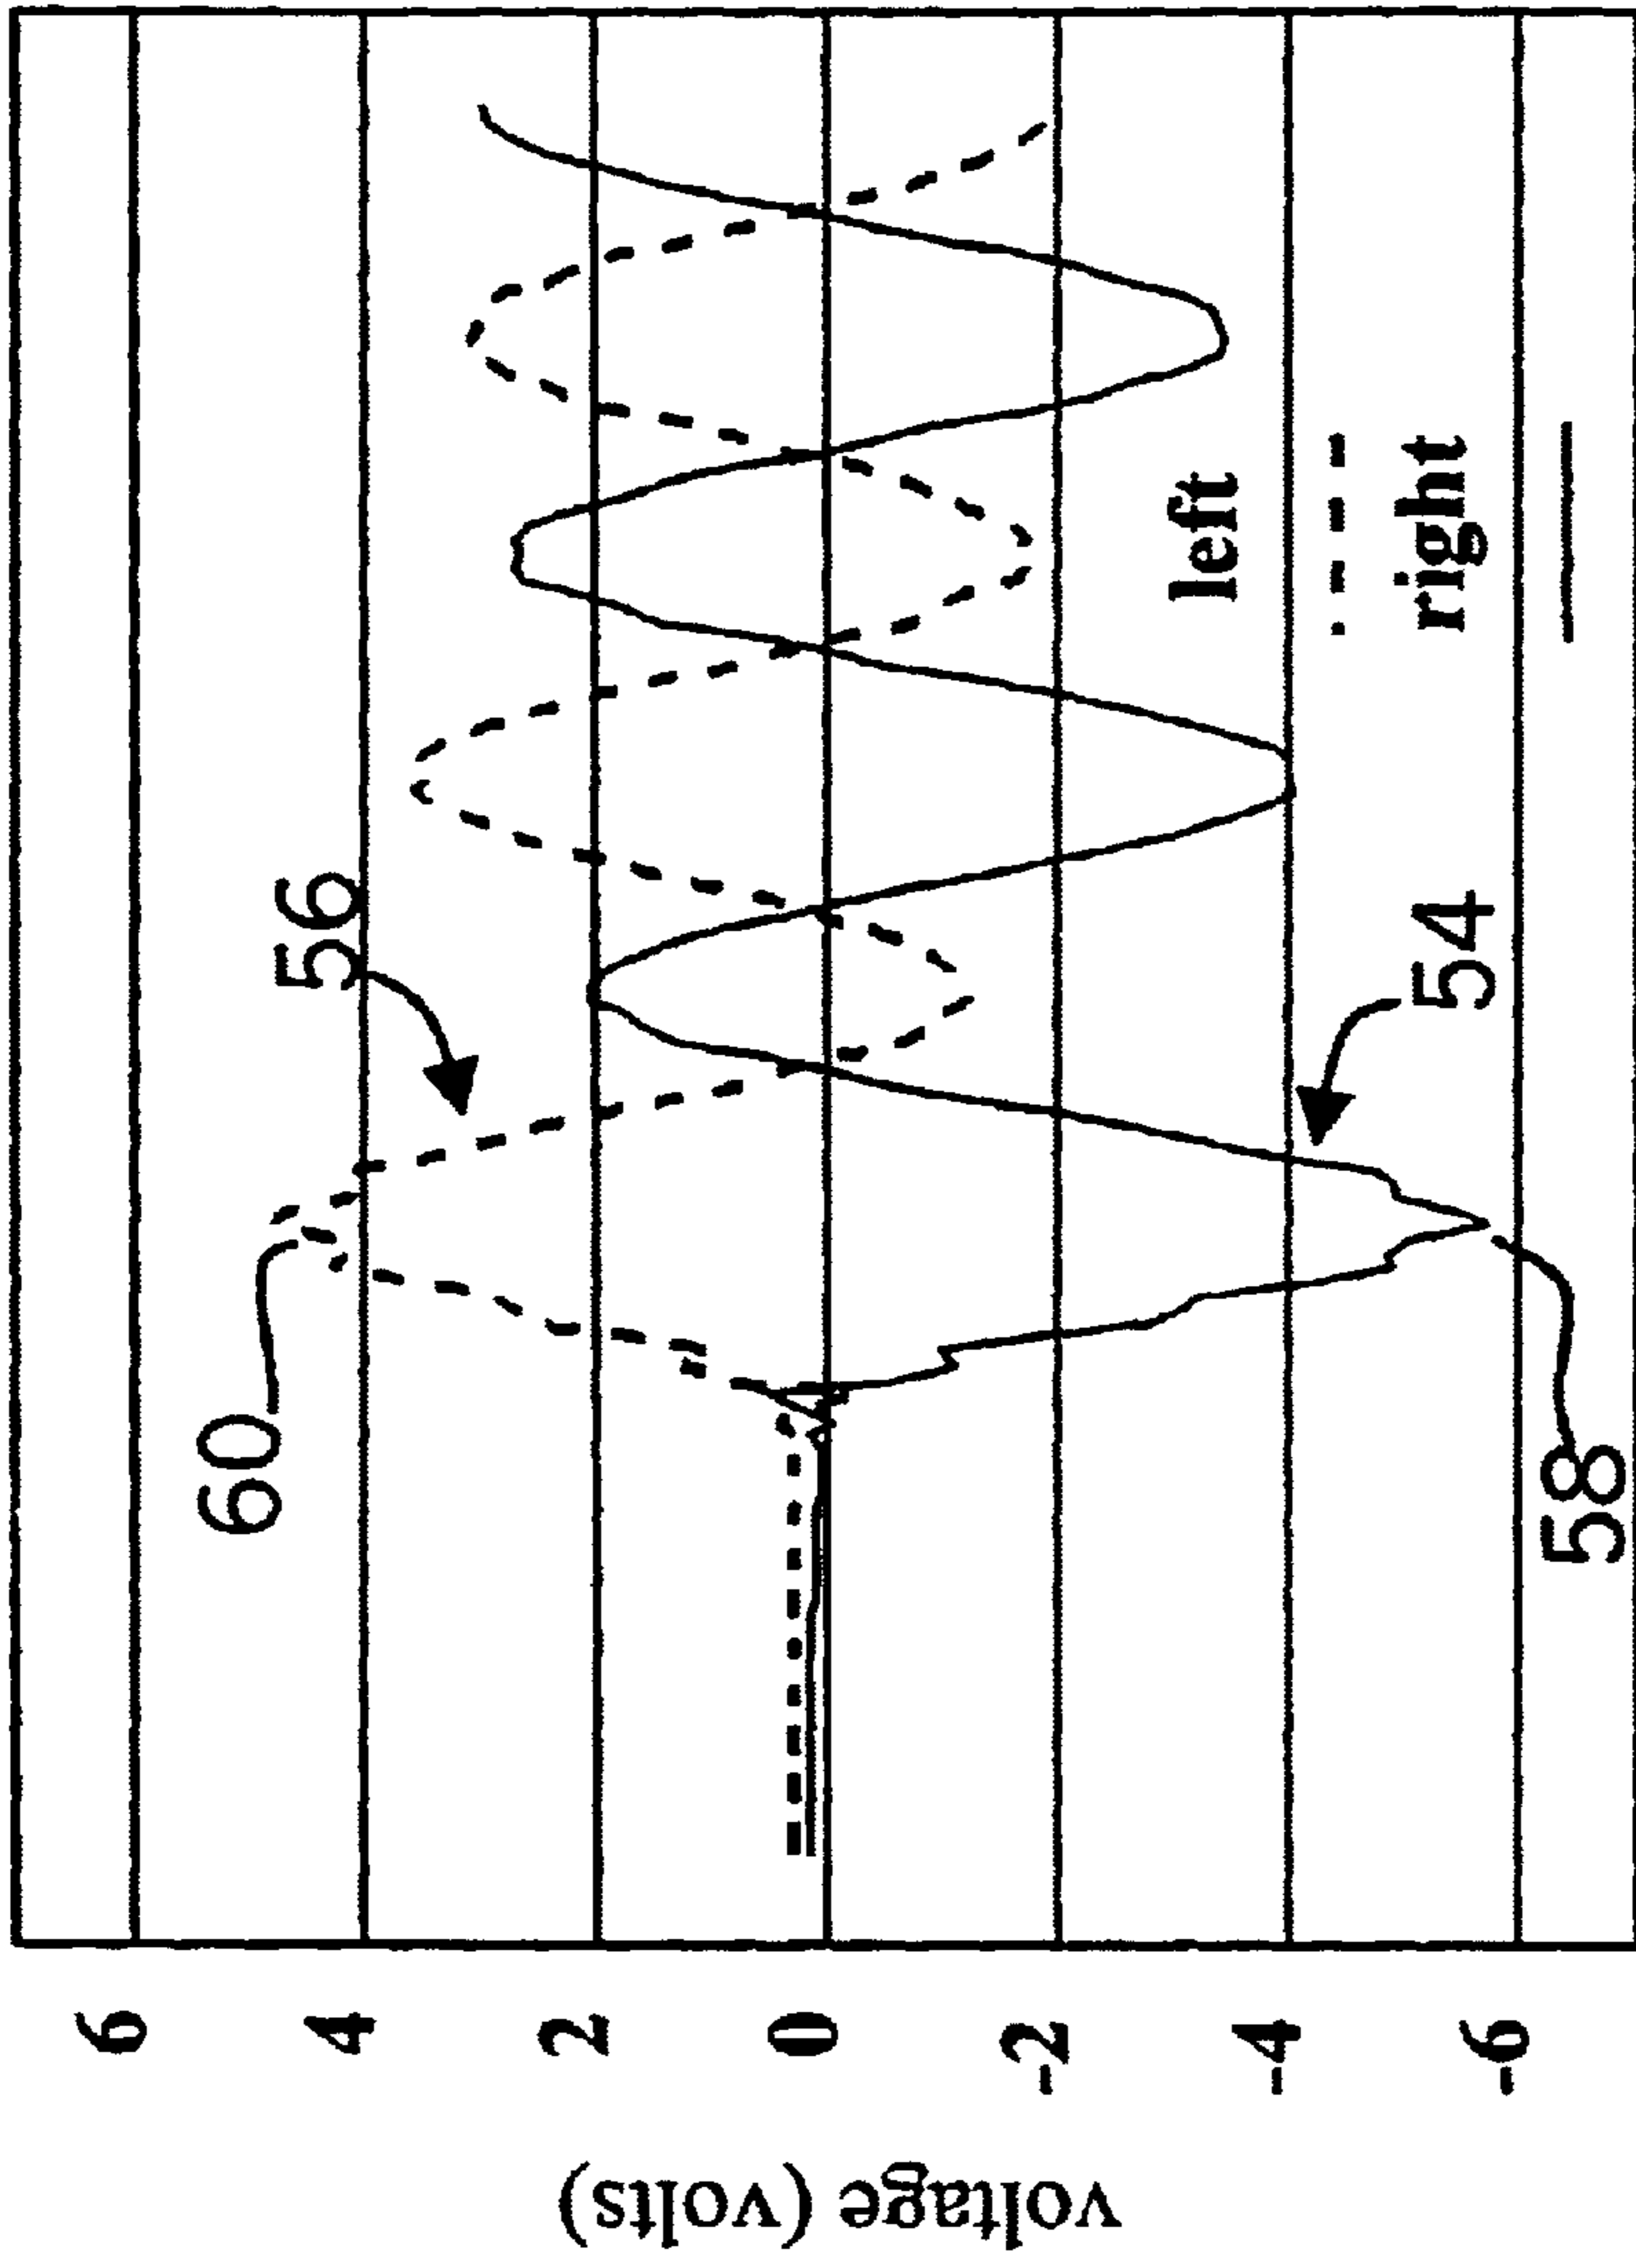
FIGURE 3C

FIG. 3c is an output waveform of a part with the wire disconnected between the motors.

FIG. 5 shows an output waveform 76 of a suspension that has a broken wire bond between the motors. An electrical connection remains between the trace and the right motor; hence, a resultant peak voltage 78 is similar to the result 58 shown in FIG. 3c for the right motor.
