(12) **United States Patent**  
**Thomsen**

(10) **Patent No.:** **US 6,639,411 B1**  
(45) **Date of Patent:** **Oct. 28, 2003**

(54) **MICROACTUATED SUSPENSION MOTOR FAILURE DETECTION SYSTEM**

(73) Assignee: **Hutchinson Technology Incorporated**, Hutchinson, MN (US)

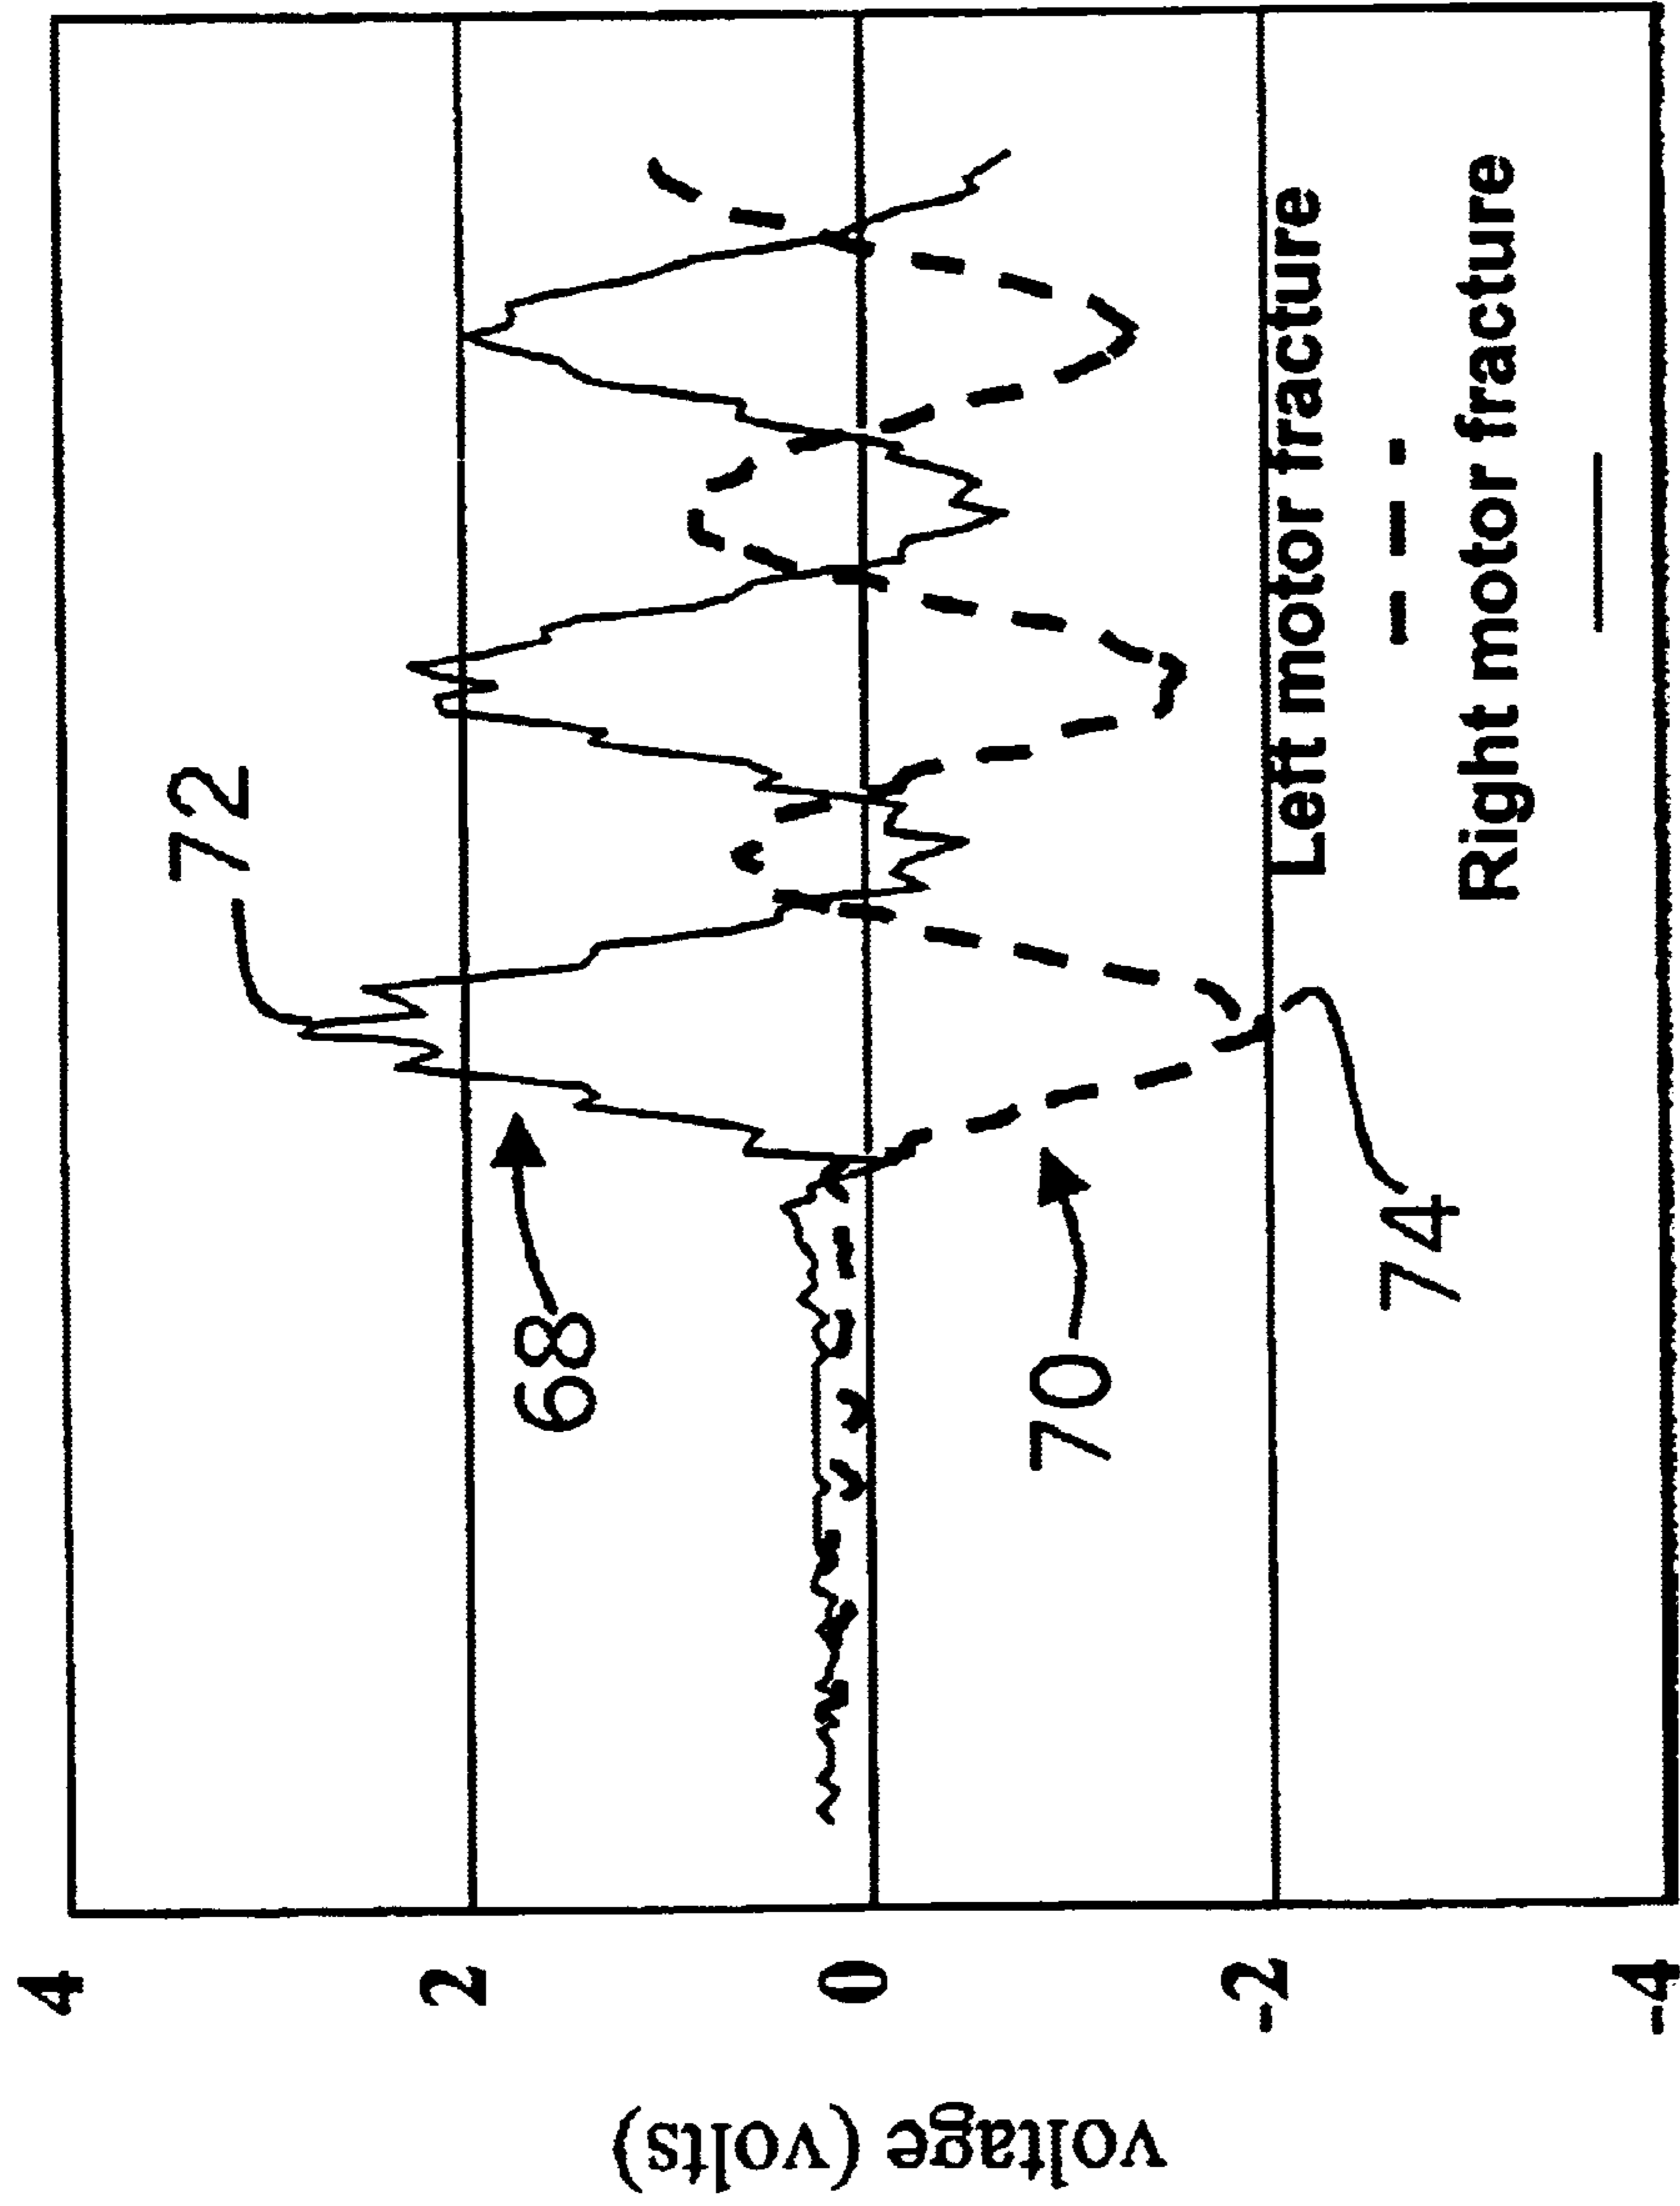
FIGURE 4

FIG. 4 shows the output waveforms for a suspension with a right and a left motor fracture.

FIG. 4 shows the output waveforms 68, 70 for a suspension with a right and left motor fracture. A right motor fracture produces a positive peak voltage 72 indicating the right motor is generating less voltage than normal. Adhesive delamination of the of the right motor will produce a similar output waveform and peak voltage. The output waveform 70 for a left motor fracture produces a negative peak voltage 74 indicating the left motor is generating less voltage than normal. Note that the peak voltages for both a left and right motor fracture are outside the range of voltages observed for parts with no defects, which is  $-0.8\pm 0.2$  v. Adhesive delamination of the left motor will produce a similar output waveform and peak voltage.

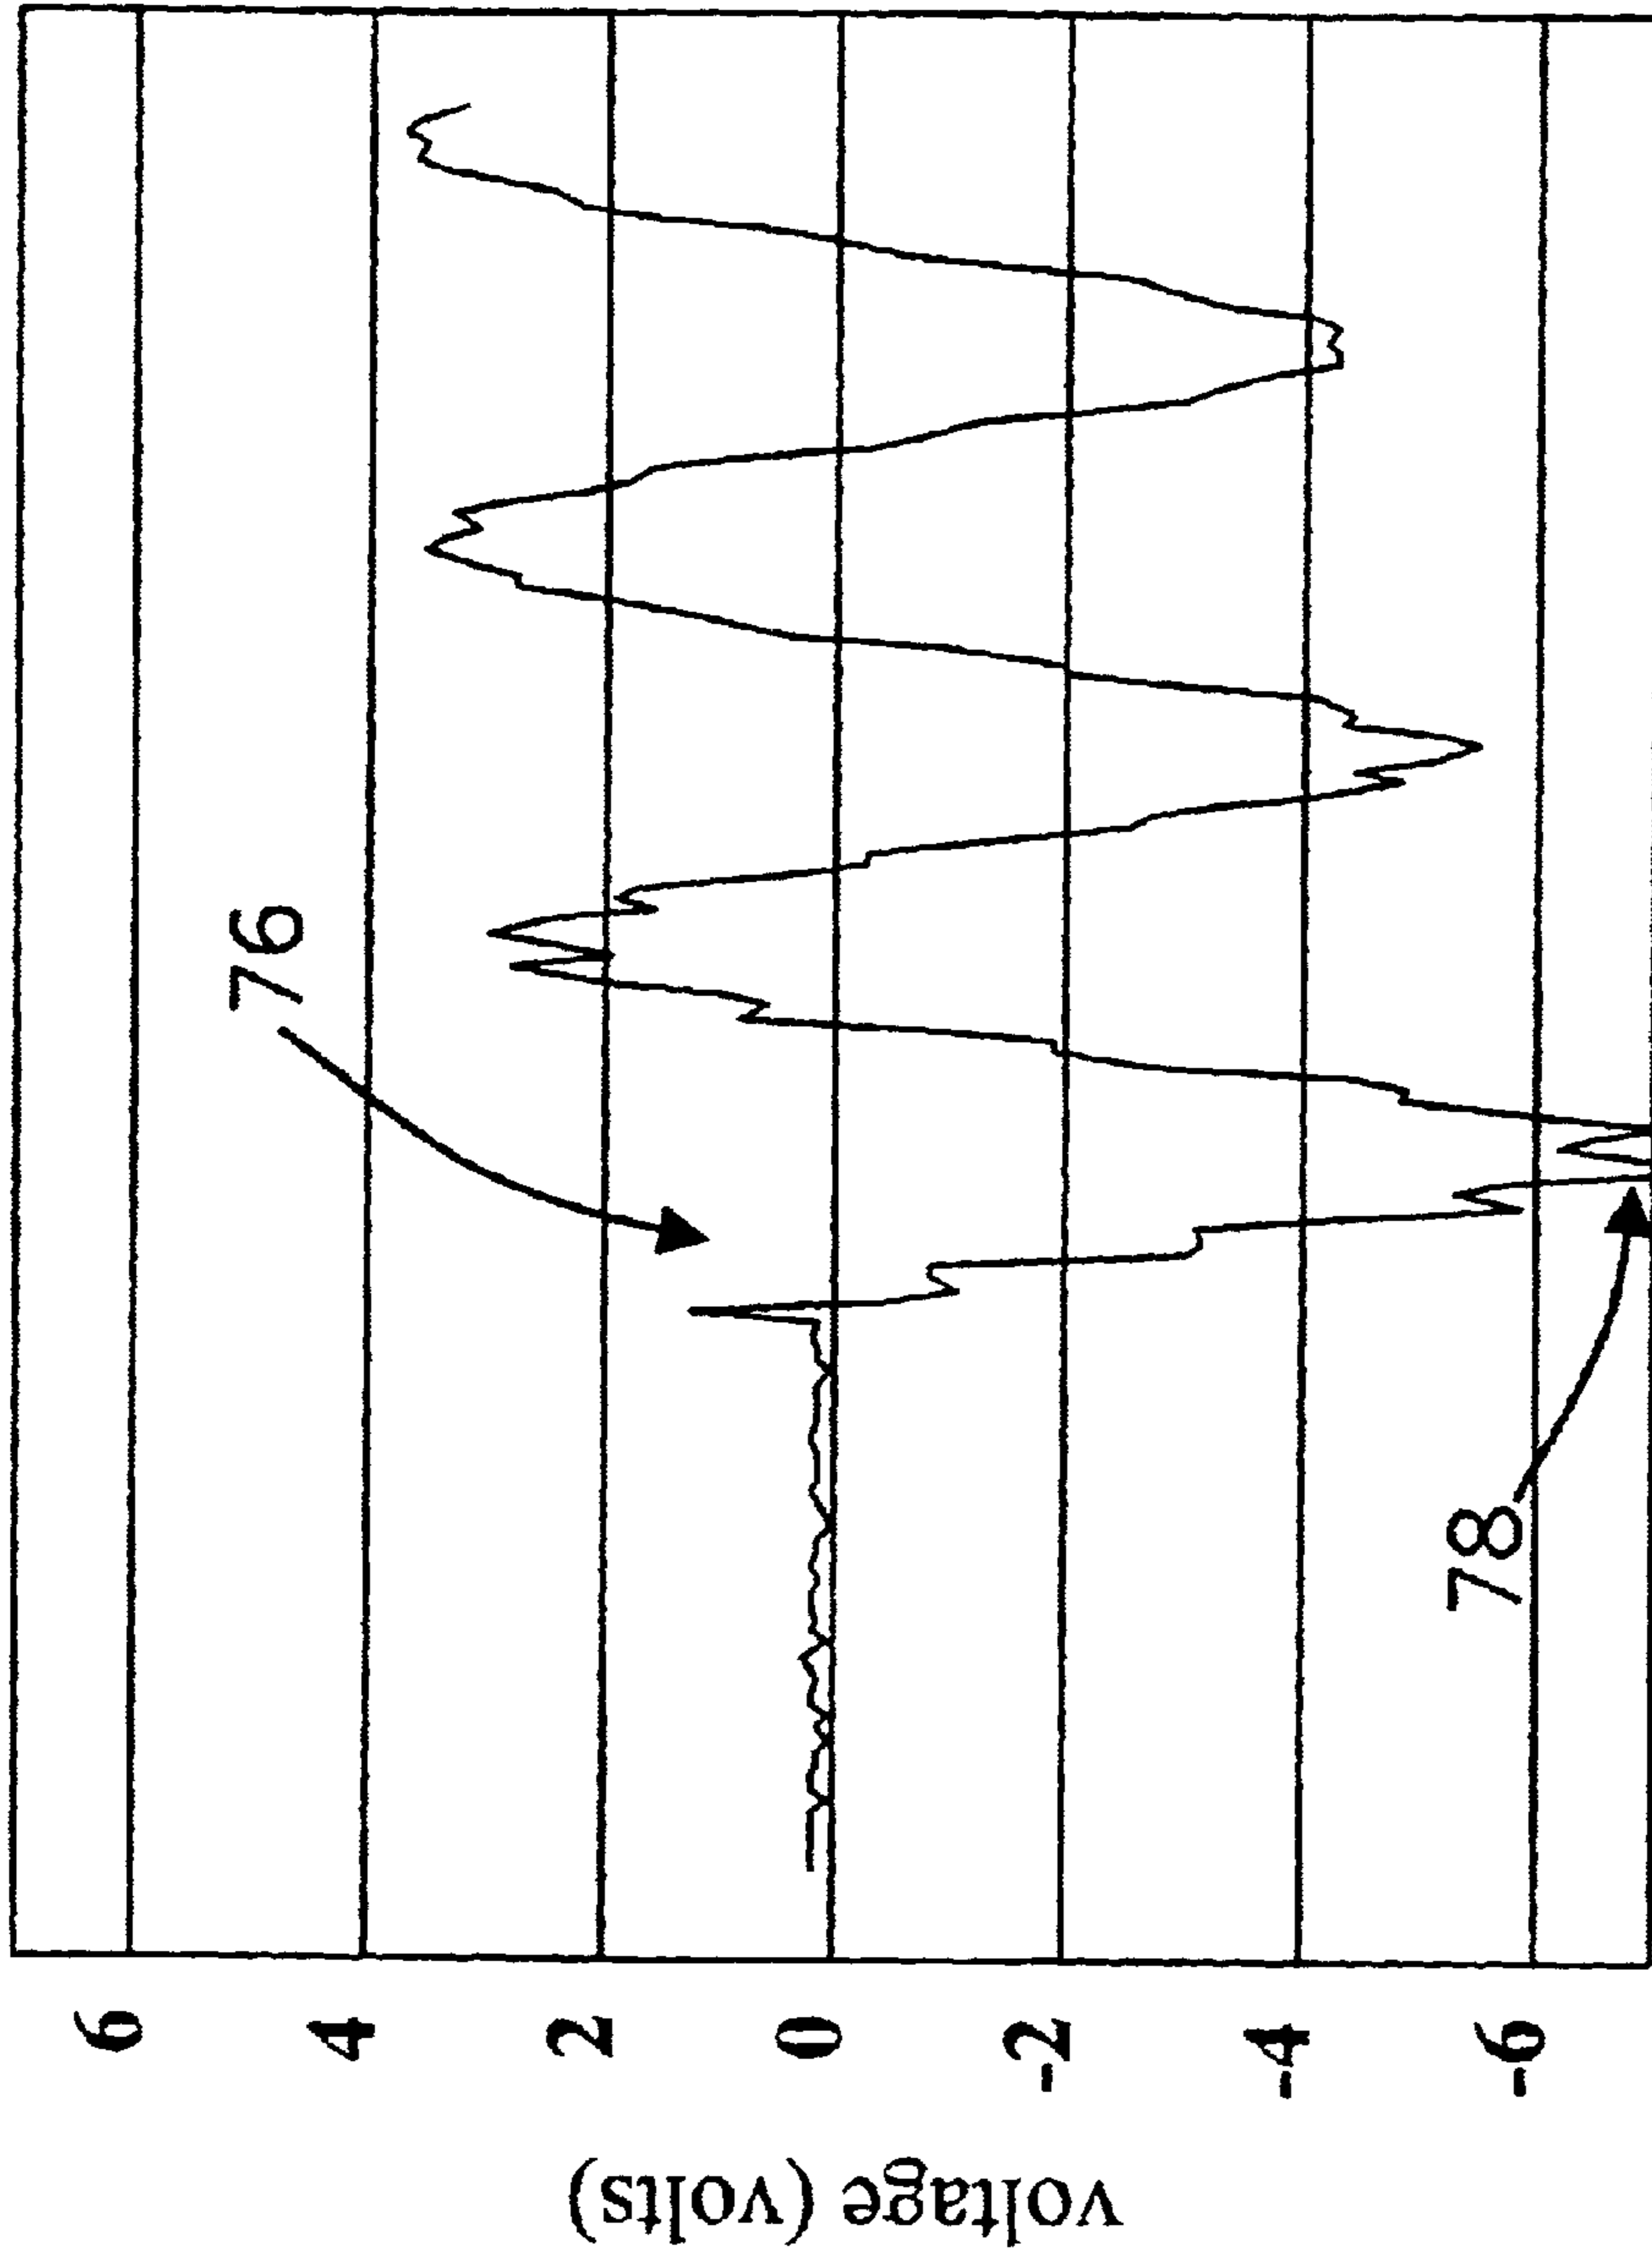
FIGURE 5

FIG. 5 shows the output waveform for a suspension that has a broken wire bond between the motors.

FIG. 5 shows an output waveform 76 of a suspension that has a broken wire bond between the motors. An electrical connection remains between the trace and the right motor; hence, a resultant peak voltage 78 is similar to the result 58 shown in FIG. 3c for the right motor.

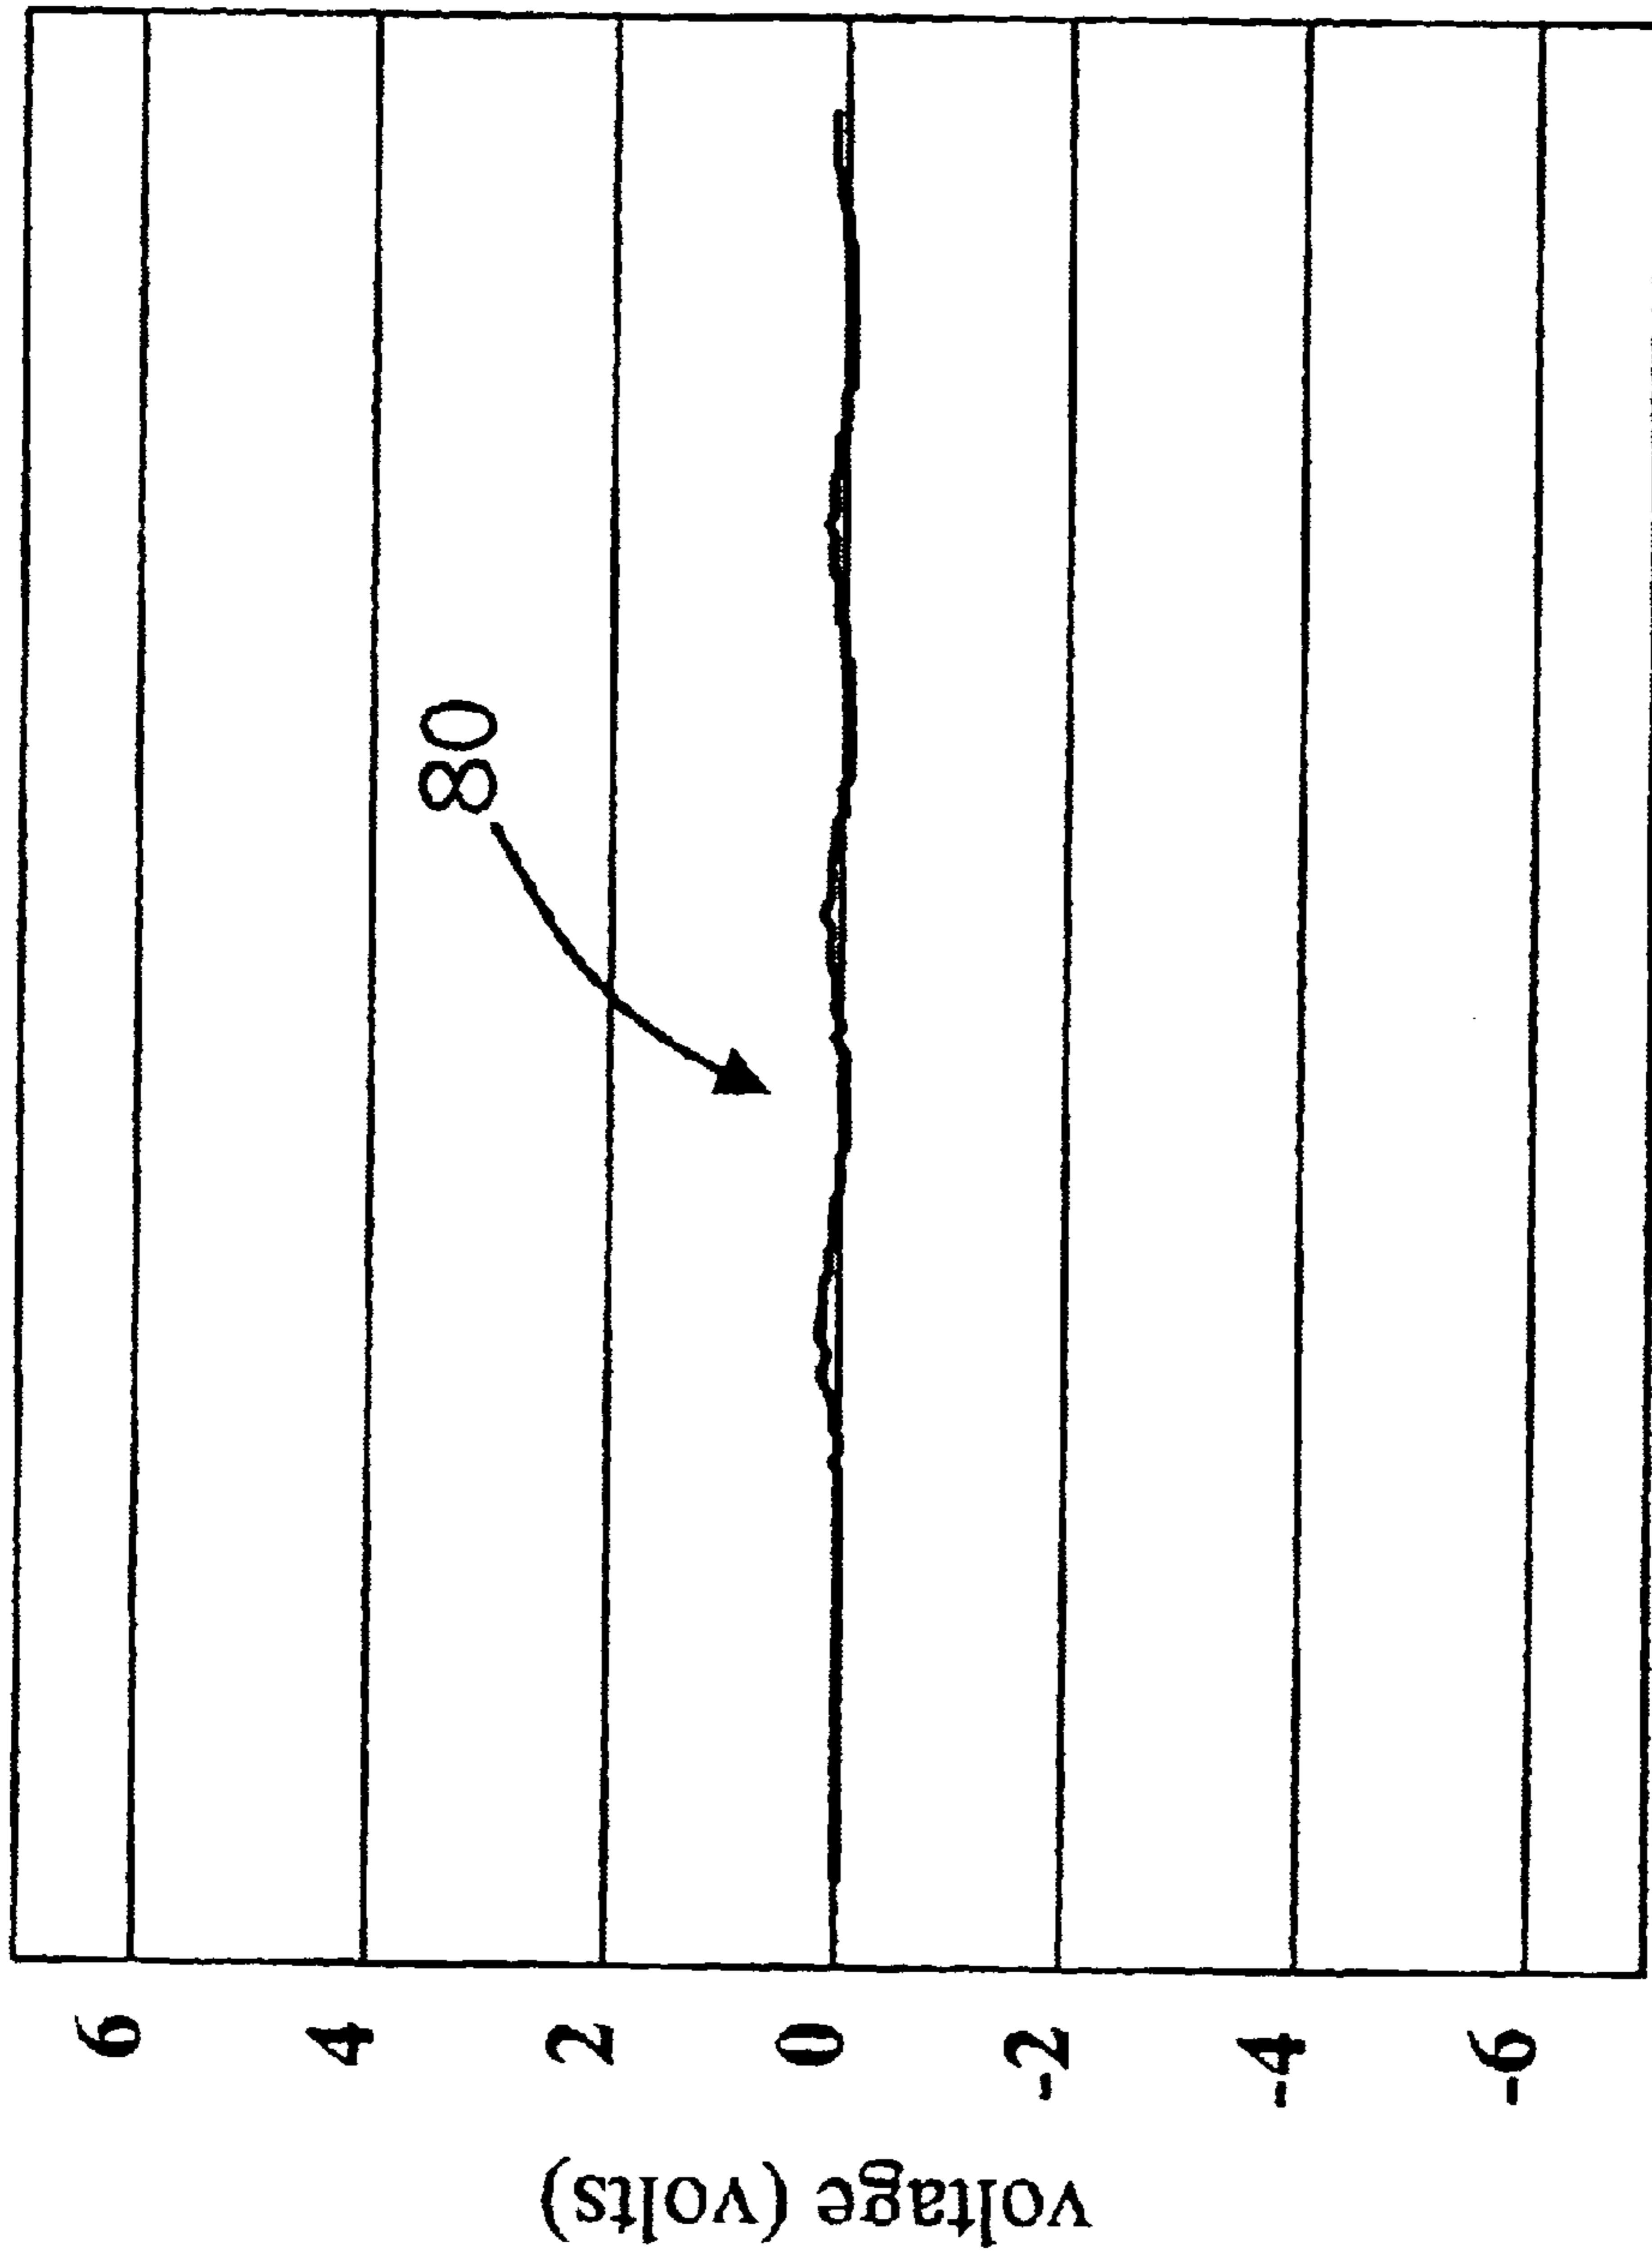
FIGURE 6

FIG. 6 shows the output waveform when both motors are depoled.

FIG. 6 shows an output waveform 80 when both motors are depoled. When PZT motors are depoled, they output a significantly lower voltage as the motors are flexed compared to PZT motors that are not depoled. Notice that the waveform 80 shows a significant reduction in peak voltage, which is easily detectable.

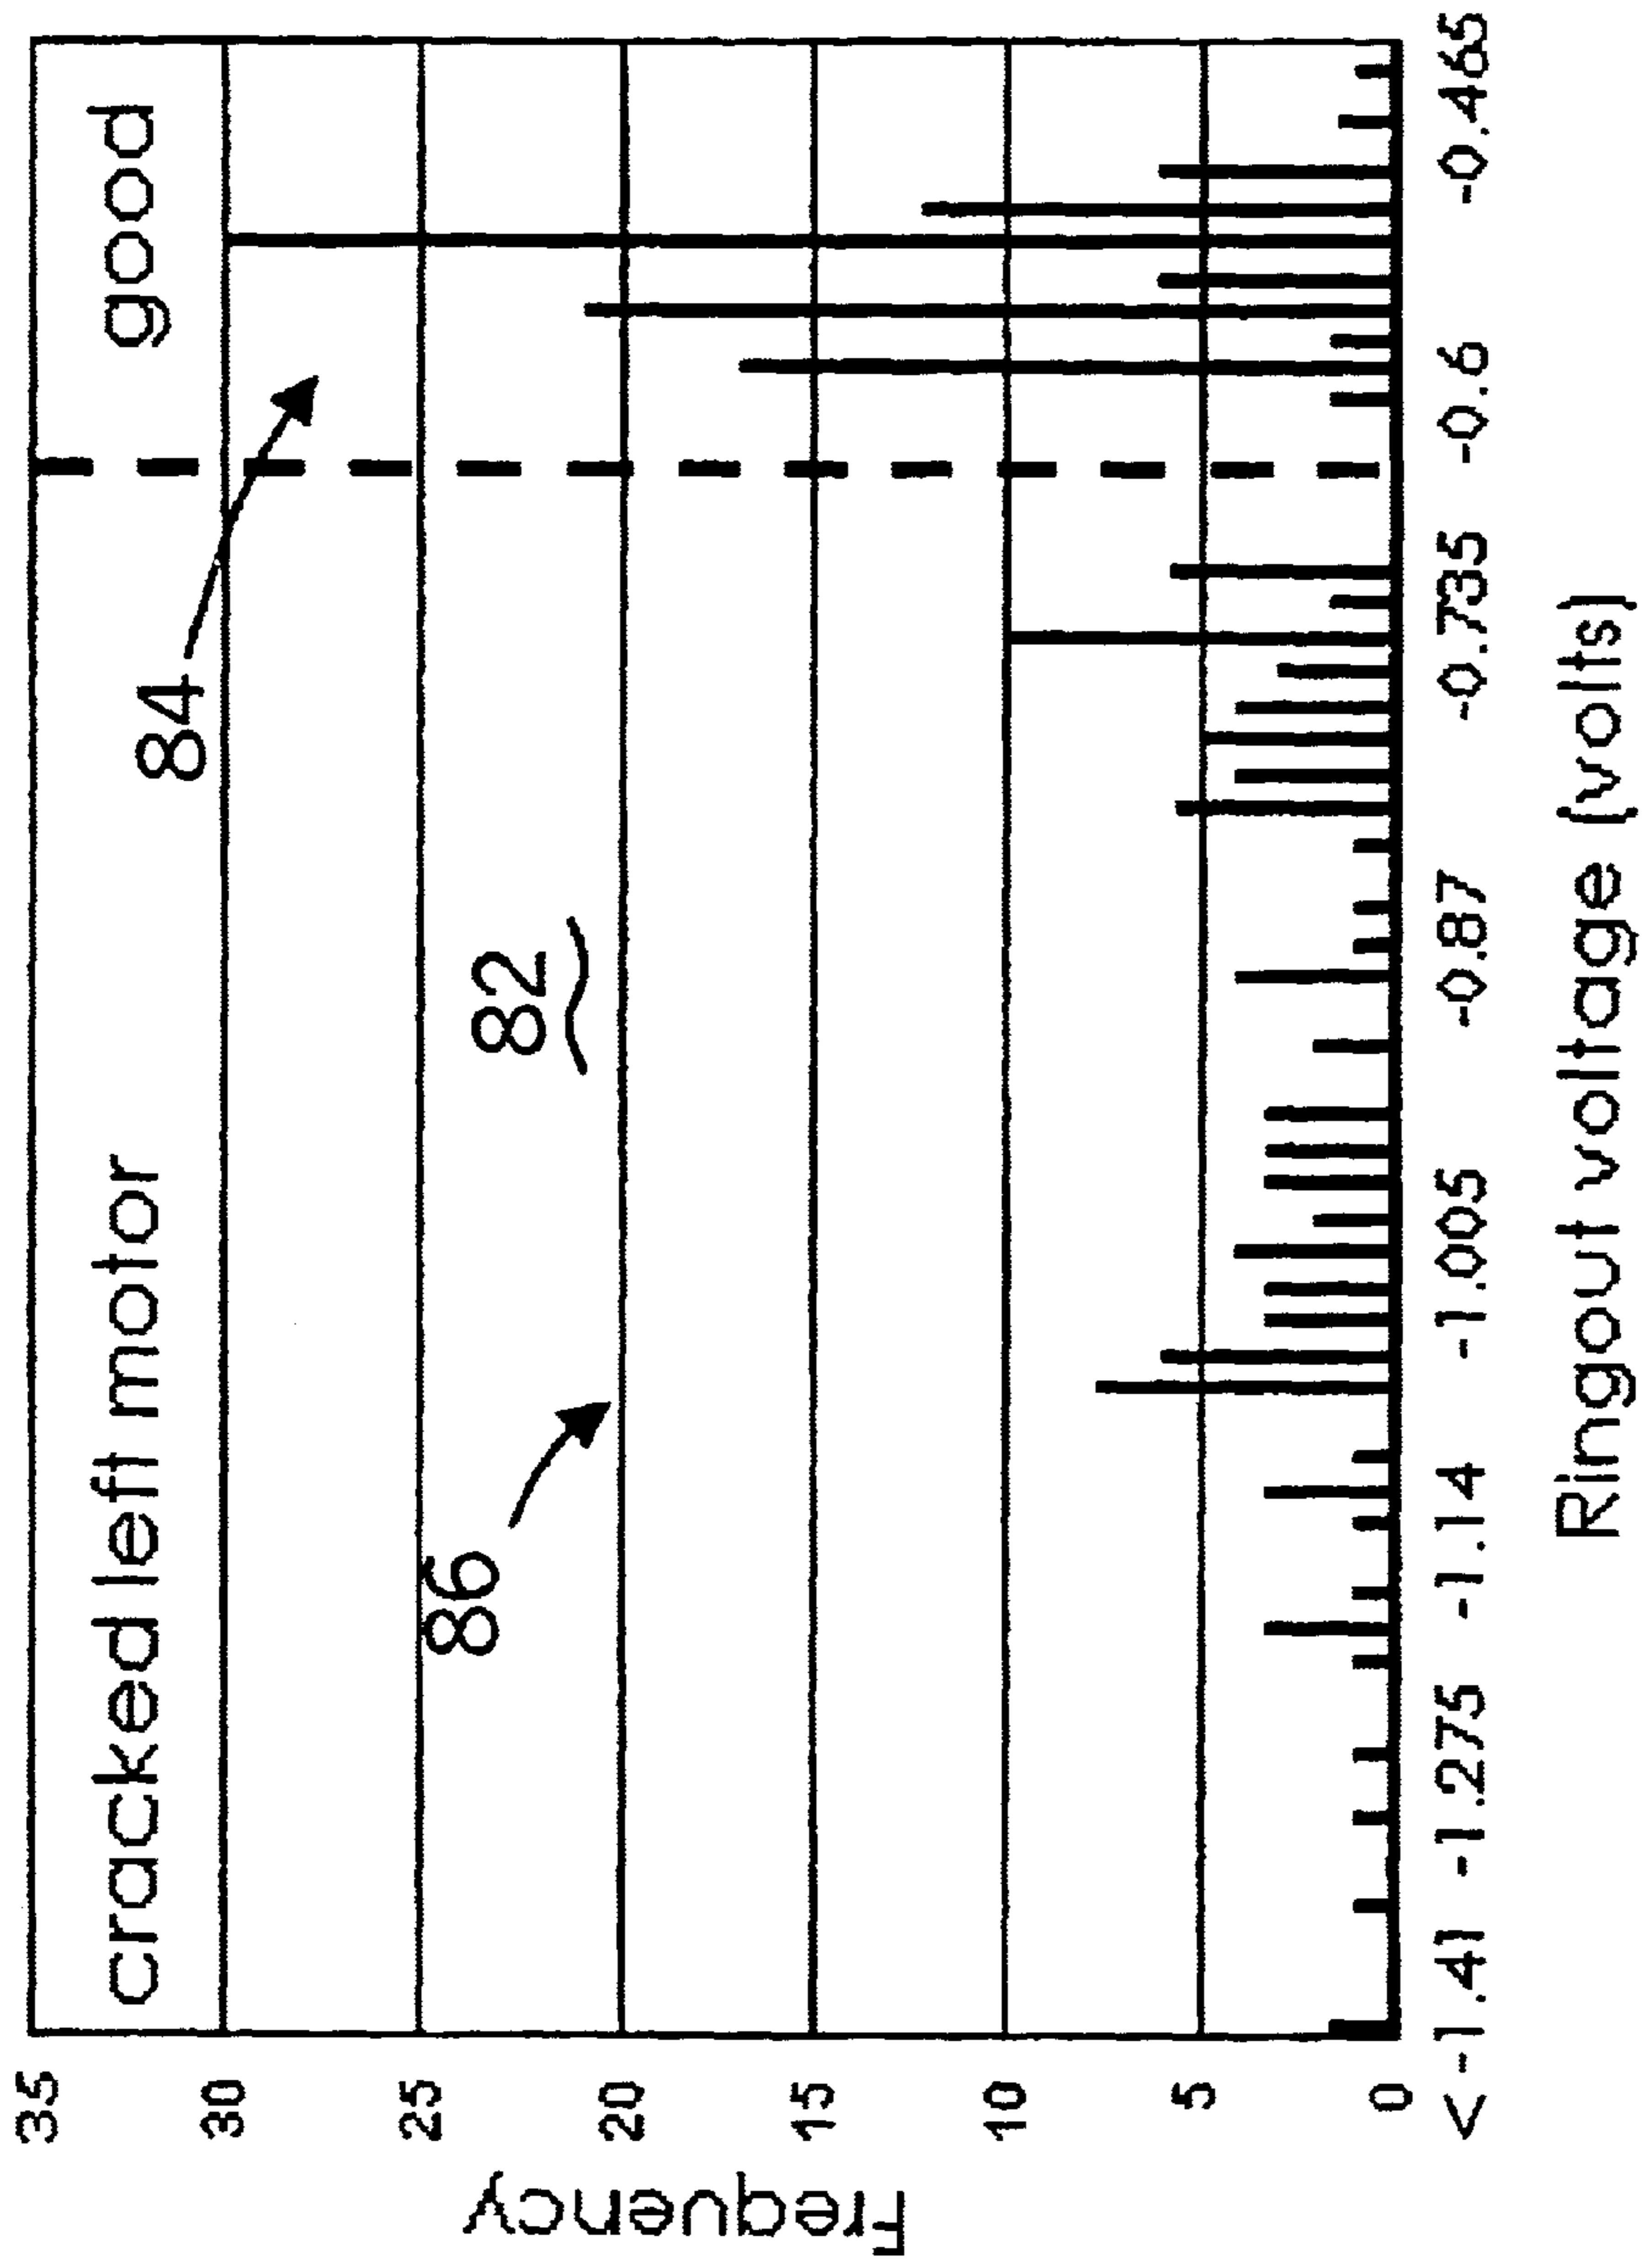
FIGURE 7

FIG. 7 is a histogram of good parts and parts with a cracked left motor.

FIG. 7 is a histogram 82 of good parts 84 and parts 86 with a cracked left motor which shows the separation/gap between the peak voltage of known good parts and the peak voltage of parts with a fractured left motor.

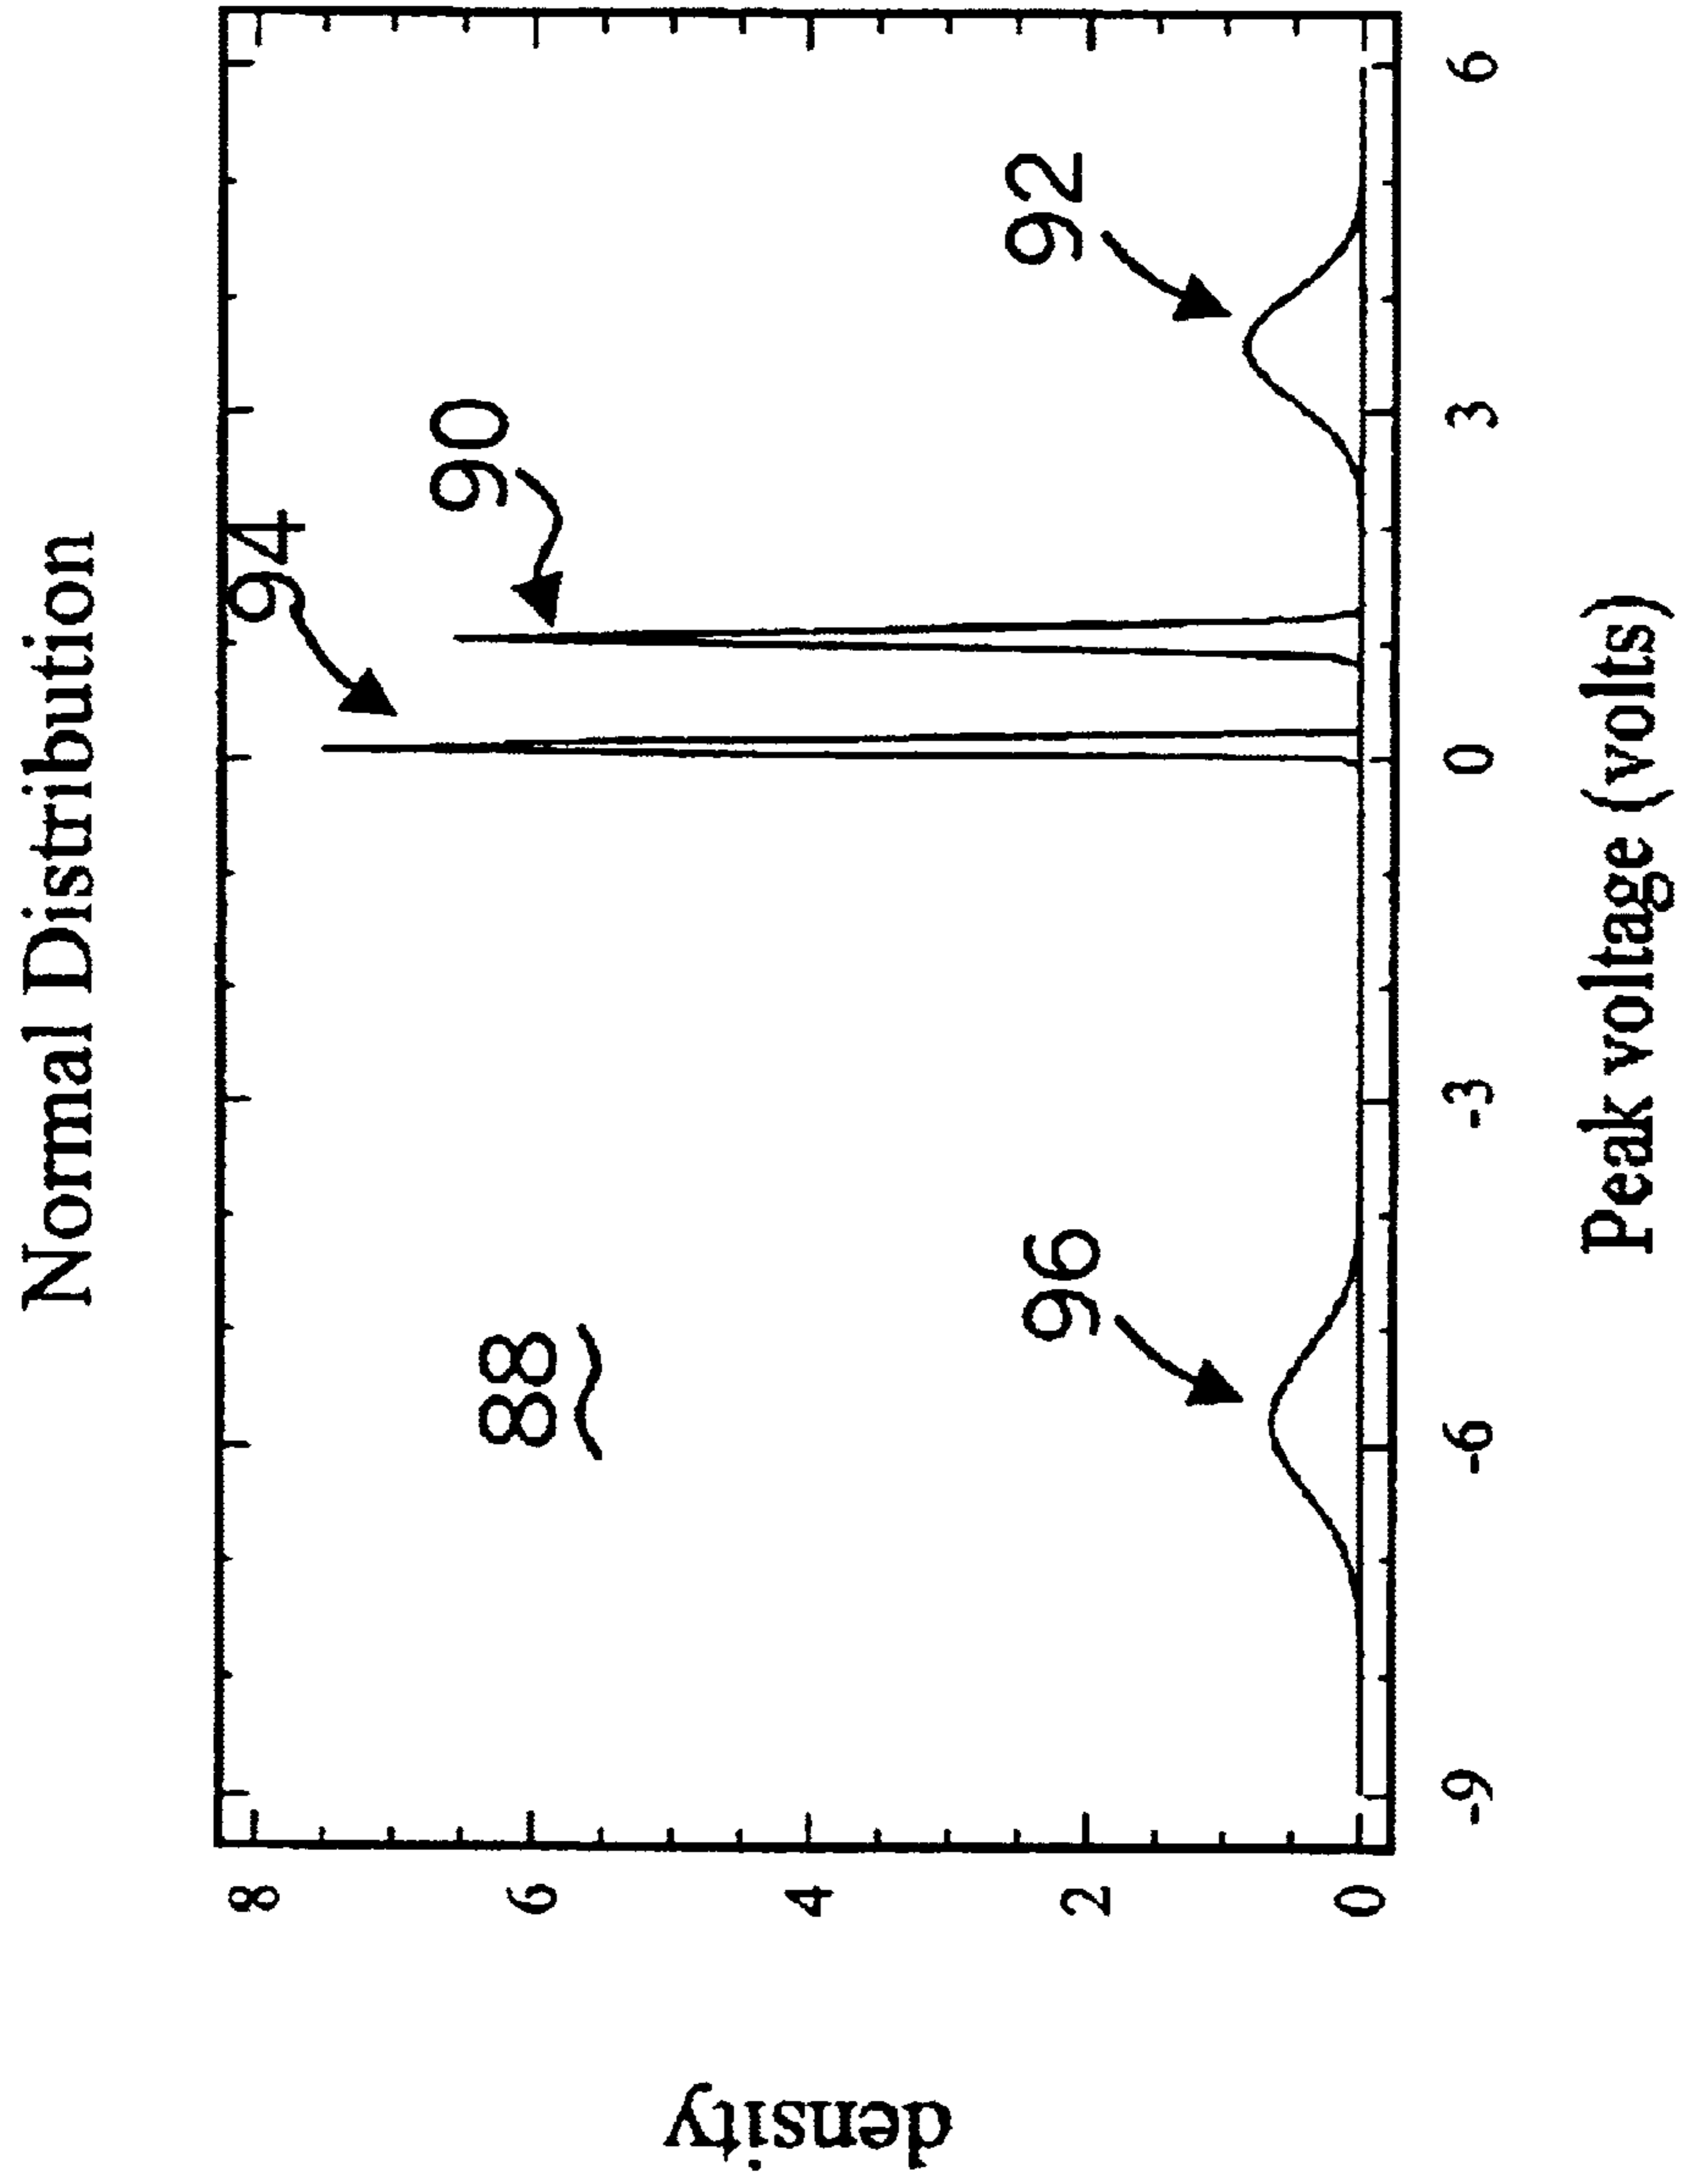
FIGURE 8a

FIG. 8a is a graph in the form of a histogram of signal characteristics of microactuator suspension failure tests for properly functioning suspensions and for suspensions having different failure modes.

Testing has shown that the ringout method can reliably detect defects on this type of suspension. FIG. 8a is a graph of a histogram illustrating the number (density) of occurrences and signal characteristics of microactuated suspension failure tests in accordance with the invention for properly functioning (“good”) suspensions (at 90) and suspensions having a number of different failure modes. The failure modes represented in FIG. 8a include motors having broken wire bonds (at 92), having depoled piezoelectric elements (at 94) and having elements that are poled the same (at 96). As shown, the peak signal distributions for the properly functioning and specific failure mode motors are relatively tight and distinguishable from one another. In particular, the peak signal level of good motors is at least about 1 volt (e.g., from “depoled” motors), and up to at least about 7 volts (from “poled same” motors), different in magnitude than the levels produced by the motors having the various failure modes. The mean and standard deviation for each of the distributions shown in FIG. 8a is listed in Table 1.

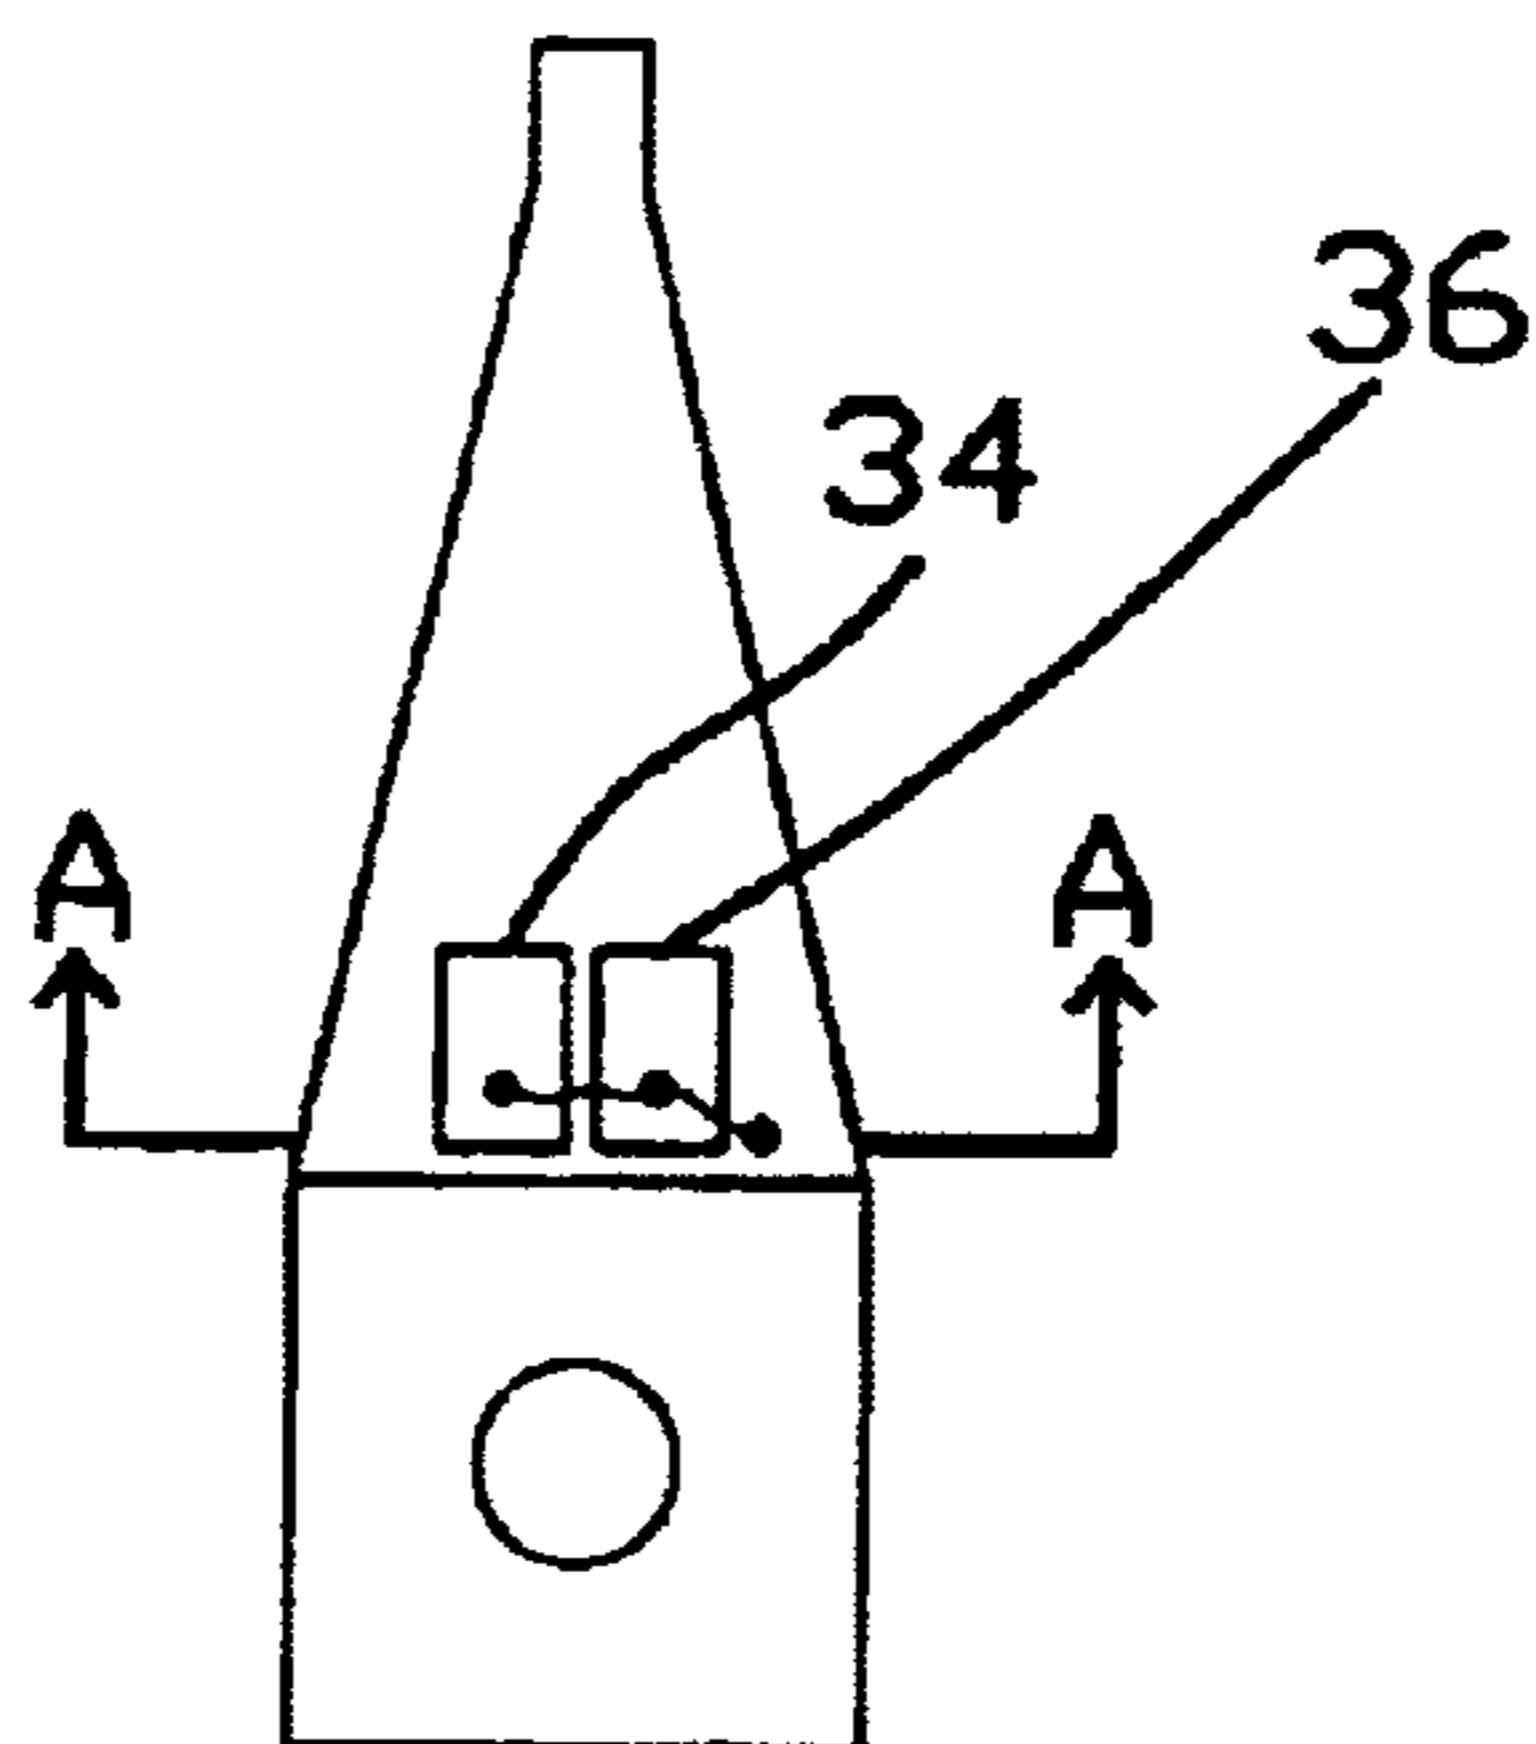
FIGURE 8b

FIG. 8b is a key for FIGS. 8c–8e.

FIG. 8b is a key to FIGS. 8c–8e. FIG. 8c shows a section view along line A—A of FIG. 8b with a wire 98 for a normal part. FIG. 8d shows a section view along line A—A of FIG. 8b for motors poled the same, and FIG. 8e shows a section view along line A—A of FIG. 8b for motors with a broken wire bond.
