(12) **United States Patent**  
**Thomsen**

(10) **Patent No.:** **US 6,639,411 B1**  
(45) **Date of Patent:** **Oct. 28, 2003**

(54) **MICROACTUATED SUSPENSION MOTOR FAILURE DETECTION SYSTEM**

(73) Assignee: **Hutchinson Technology Incorporated**, Hutchinson, MN (US)

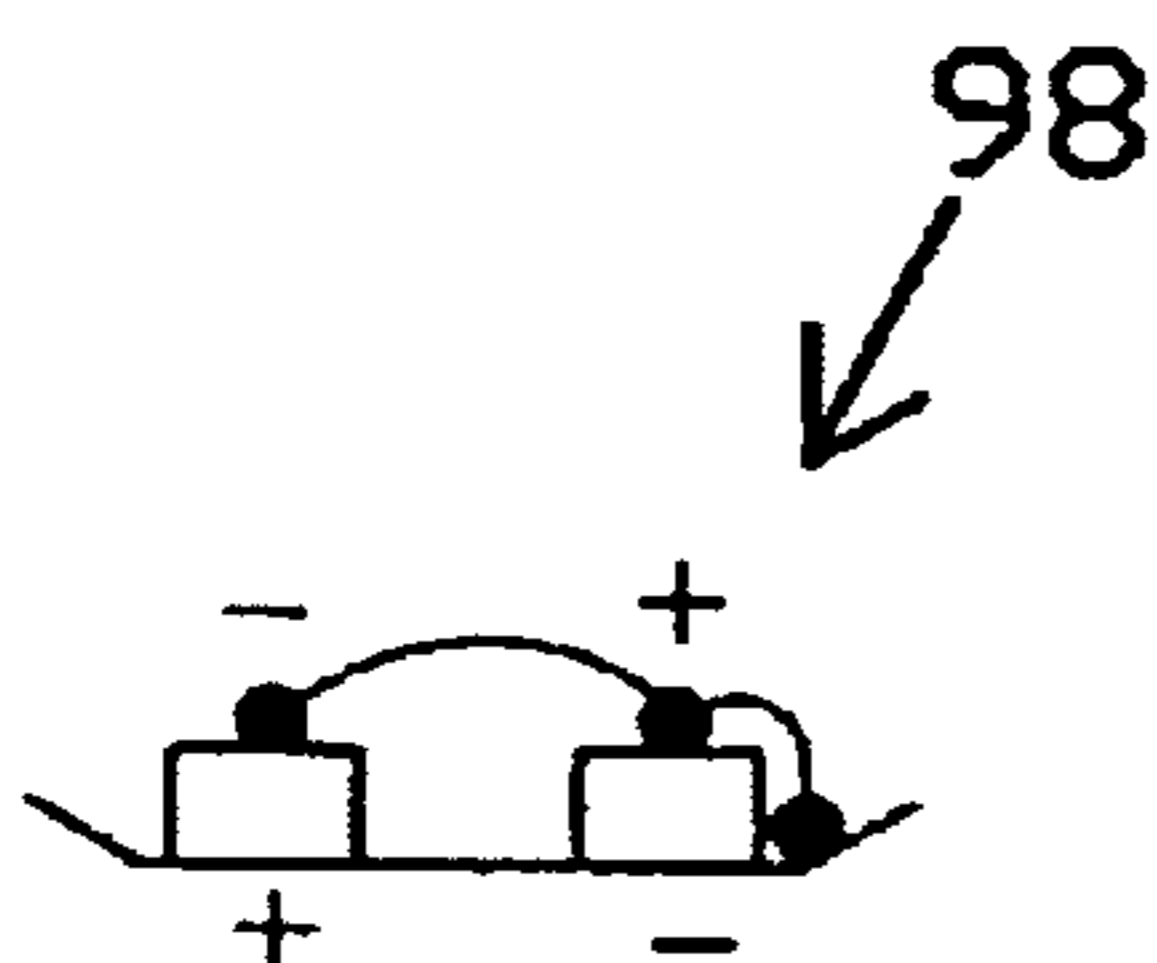
FIGURE 8c

FIG. 8c shows a section view along line A—A of FIG. 8b with a wire 98 for a normal part.

FIG. 8b is a key to FIGS. 8c–8e. FIG. 8c shows a section view along line A—A of FIG. 8b with a wire 98 for a normal part. FIG. 8d shows a section view along line A—A of FIG. 8b for motors poled the same, and FIG. 8e shows a section view along line A—A of FIG. 8b for motors with a broken wire bond.

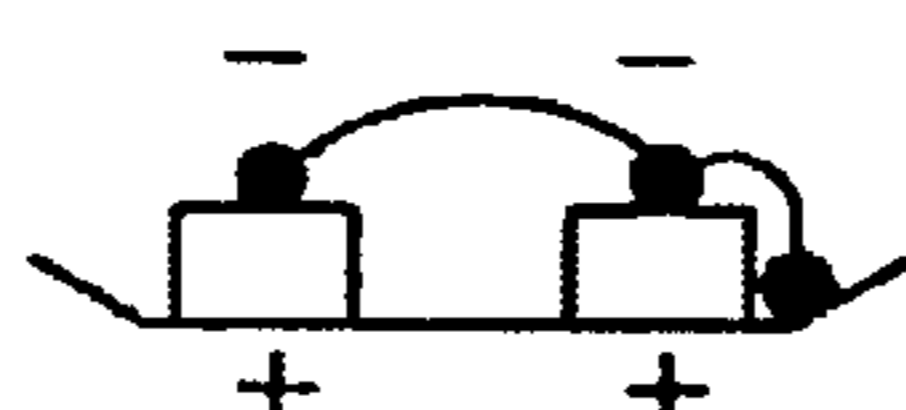
FIGURE 8d

FIG. 8d shows a section view along line A—A of FIG. 8b for motors poled the same.

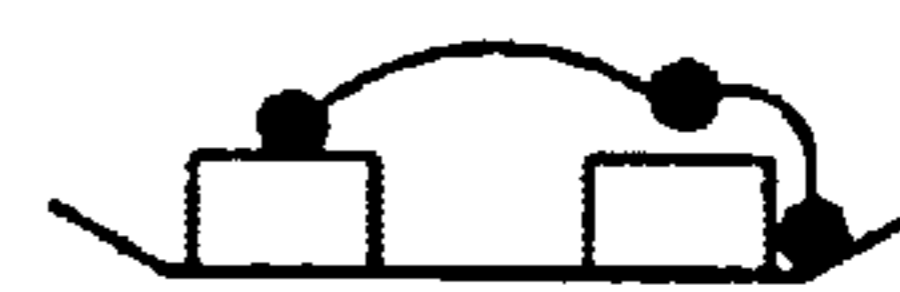
FIGURE 8e

FIG. 8e shows a section view along line A—A of FIG. 8b for motors with a broken wire bond.

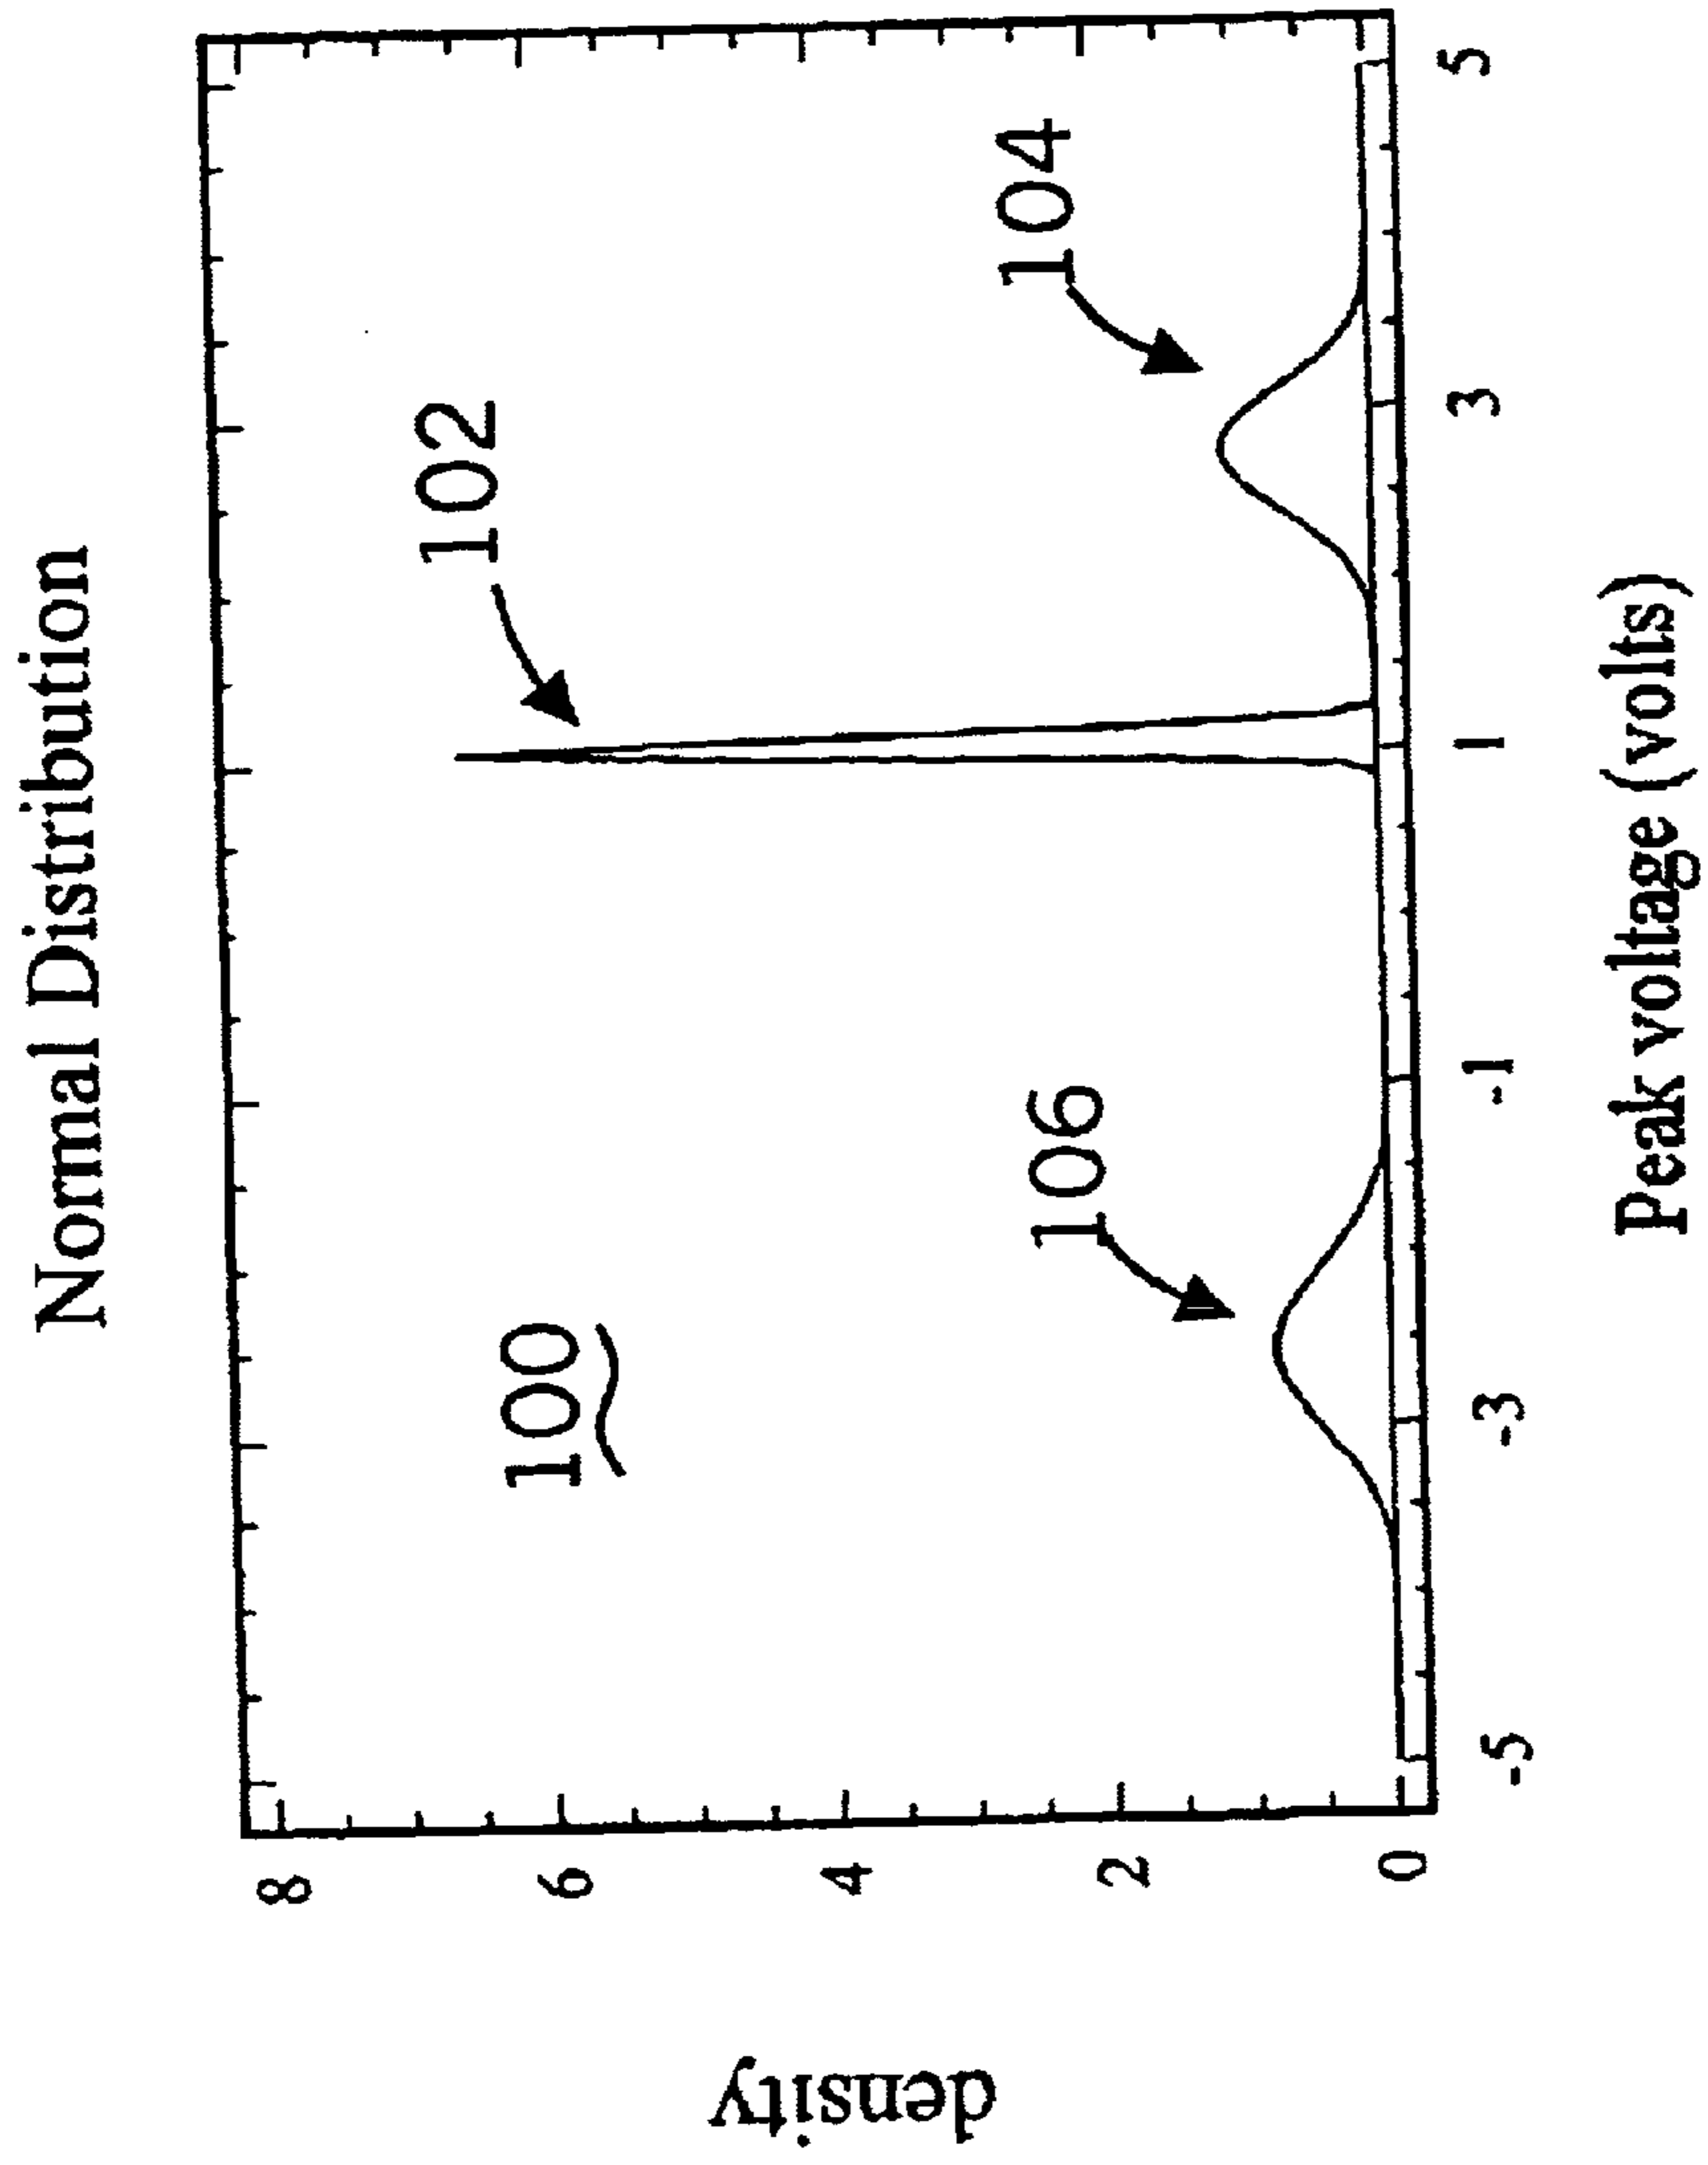
FIGURE 9

FIG. 9 is a graph in the form of a histogram of signal characteristics of microactuator suspension failure tests for properly functioning suspensions and for suspensions having fractures in one of the piezoelectric elements.

FIG. 9 is a graph of a histogram illustrating the number (density) of occurrences and signal characteristics of micro-actuated suspension failure tests in accordance with the invention for properly functioning (“good”) suspensions and suspensions having motors with fractures in one of either the left or right piezoelectric elements. Distribution 102 is for good parts, distribution 104 is for parts with an adhesive fracture at the left motor, and distribution 106 is for parts with an adhesive fracture at the right motor. The mean and standard deviation for each of these distributions is shown in Table 2.

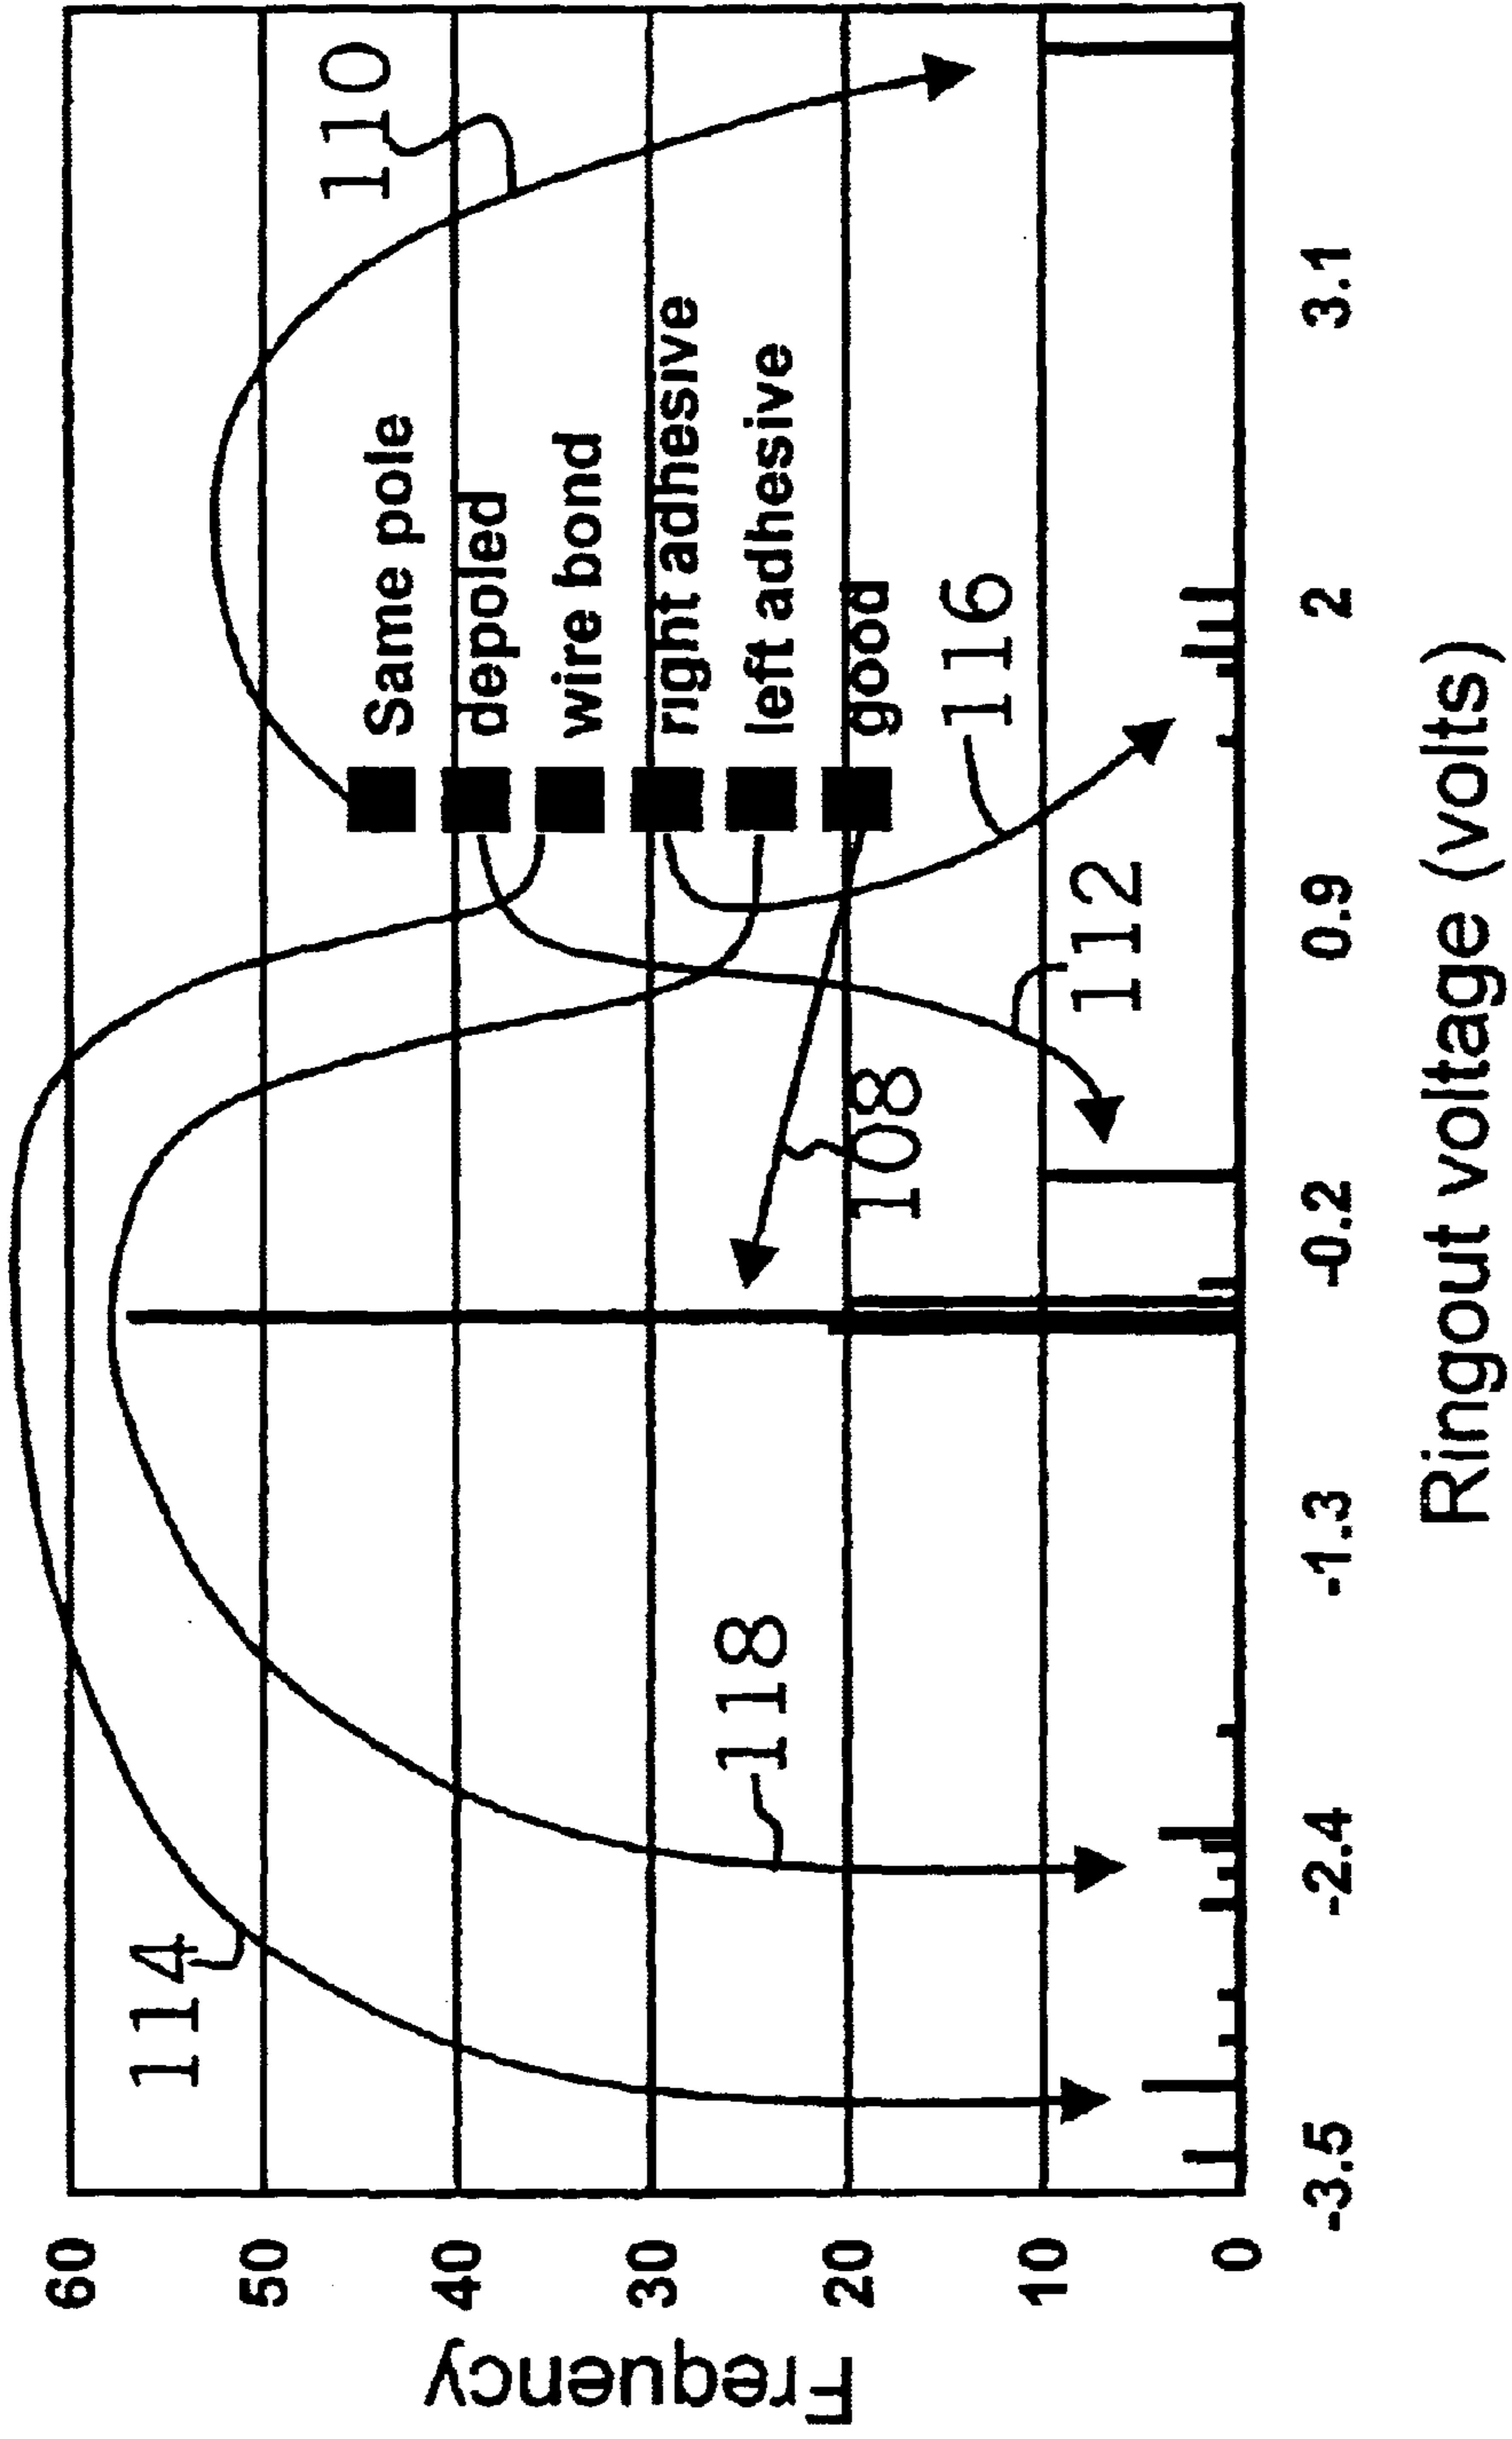
FIGURE 10

FIG. 10 is a histogram of good parts and parts with various other defects.

Referring now to FIG. 10, the separation between known good parts 108 and those with additional defects that the ringout method can detect may be seen. It is to be understood that the data for FIG. 10 has a sign change because the data for FIG. 10 was taken from a suspension intended for operation on the opposite side of a rotating magnetic disk. Furthermore, magnitude of the data for FIG. 10 differs from the data in FIGS. 8a and 9 because the data for FIG. 10 was taken from a different model of suspension than that tested for FIGS. 8a and 9. Nevertheless, it can be seen that discrete, identifiable defects include “same pole” 110, depoled parts 112, broken wire bonds 114, right motor adhesive failure 116 and left motor adhesive failure 118.

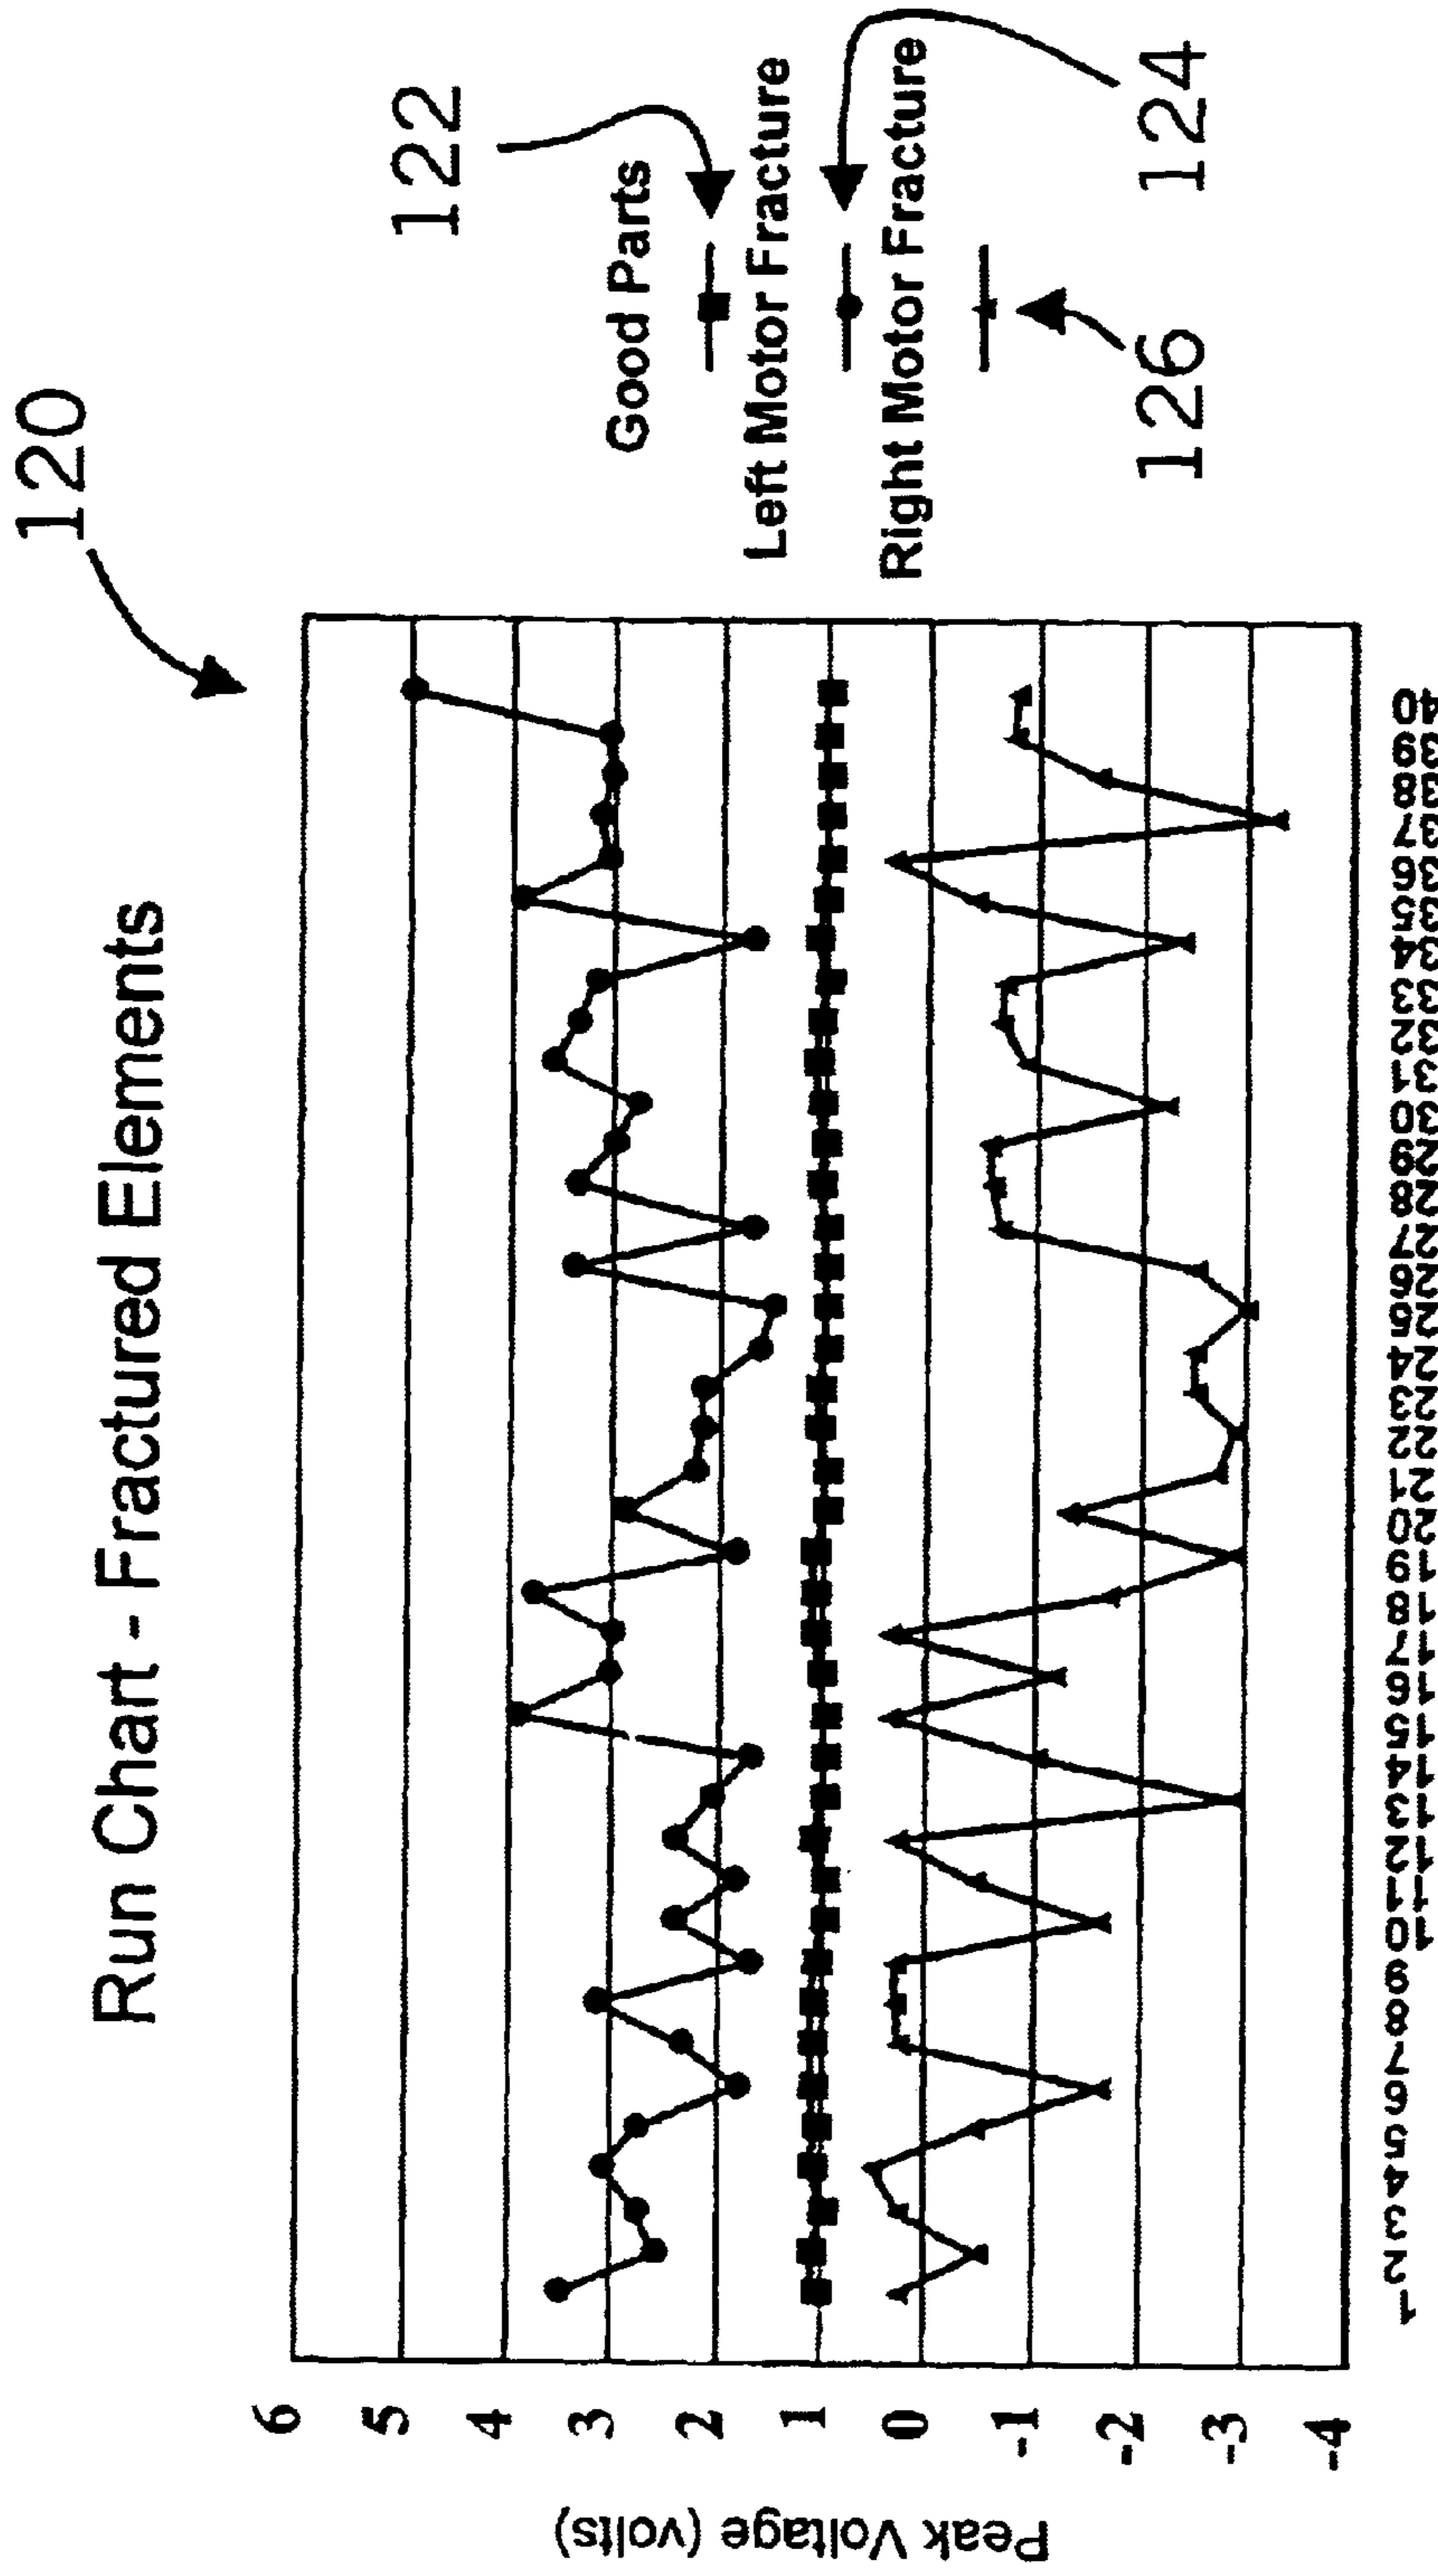
FIGURE 11

FIG. 11 is a graph of signal levels from a series of tested components, some of which are properly functioning, and some of which have fractures in either a left or a right piezoelectric element.

FIG. 11 is a graph 120 illustrating the signal levels from a series of tested components which are properly functioning (“good parts”), or have fractures in either the left or right piezoelectric element of the motor. Good parts are indicated by a square 122, left motor fracture parts by a diamond 124, and right motor fracture parts by a triangle 126.

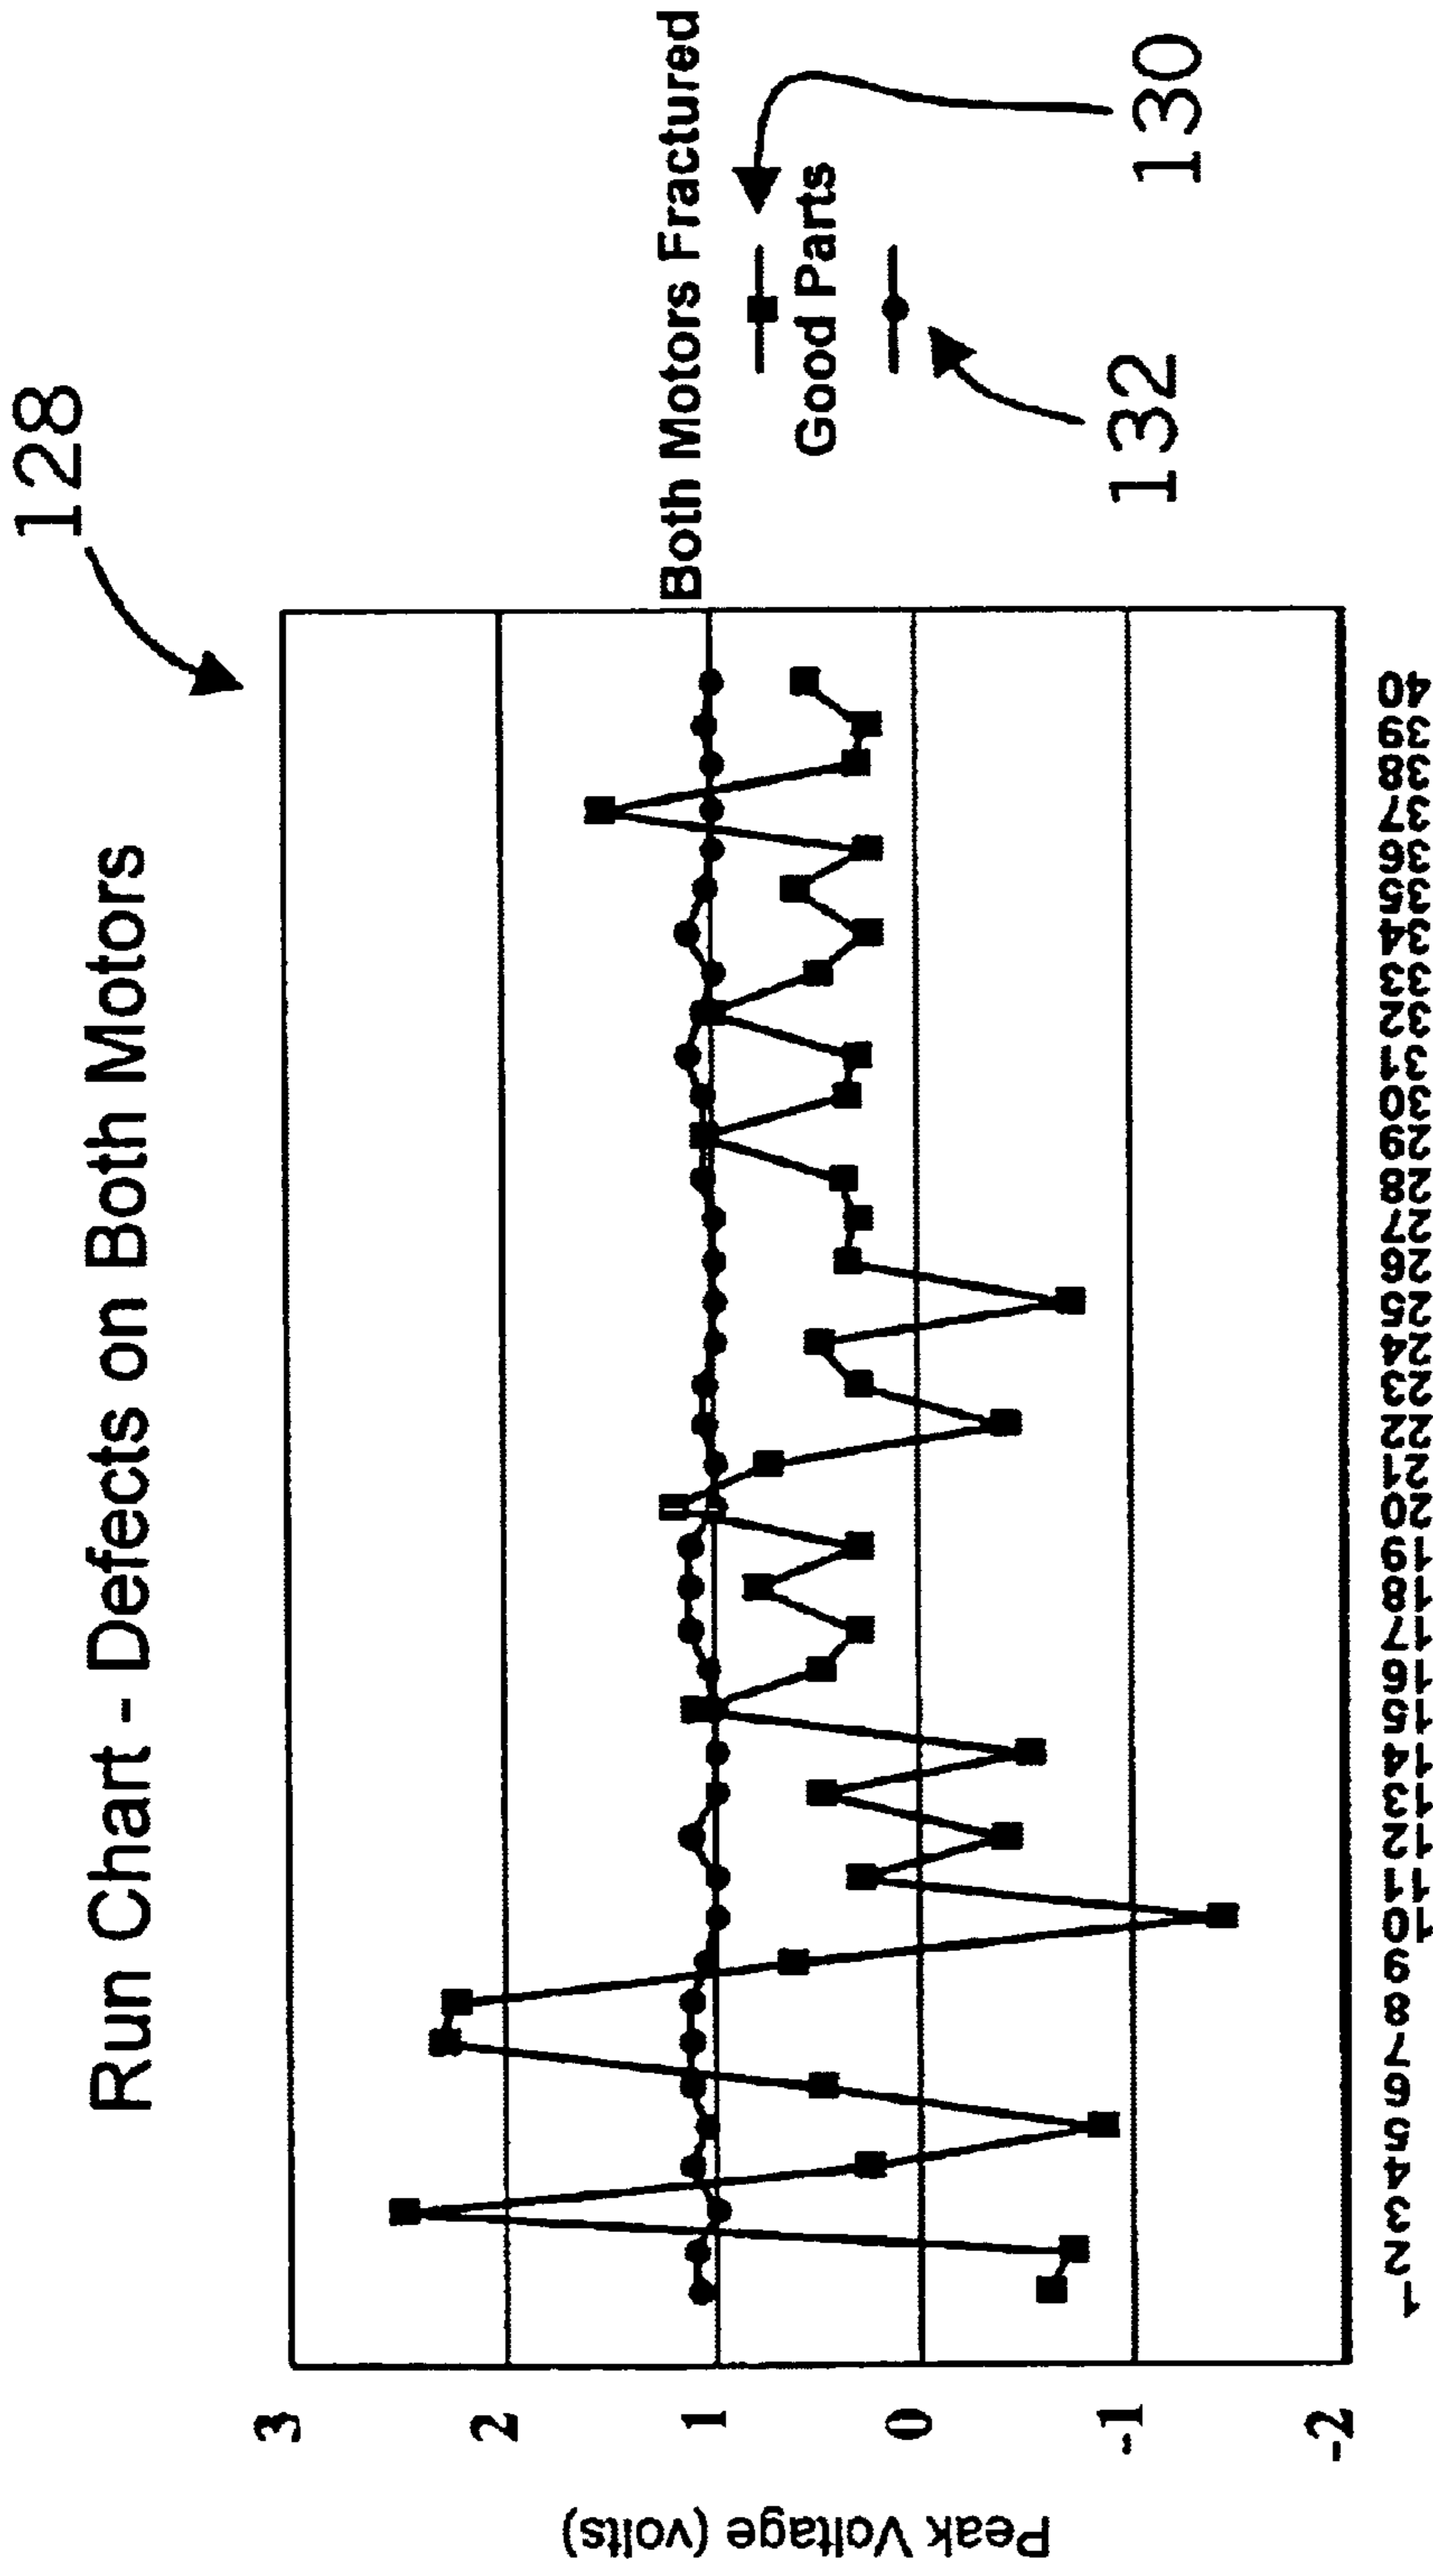
FIGURE 12

FIG. 12 is a graph of signal levels from a series of tested components, some of which are properly functioning, and some of which have fractures in both piezoelectric elements.

FIG. 12 is a graph 128 illustrating the signal levels from a series of tested components which are properly functioning (“good parts” indicated by a square 130), or have fractures in both piezoelectric elements of the motor (indicated by a diamond 132).

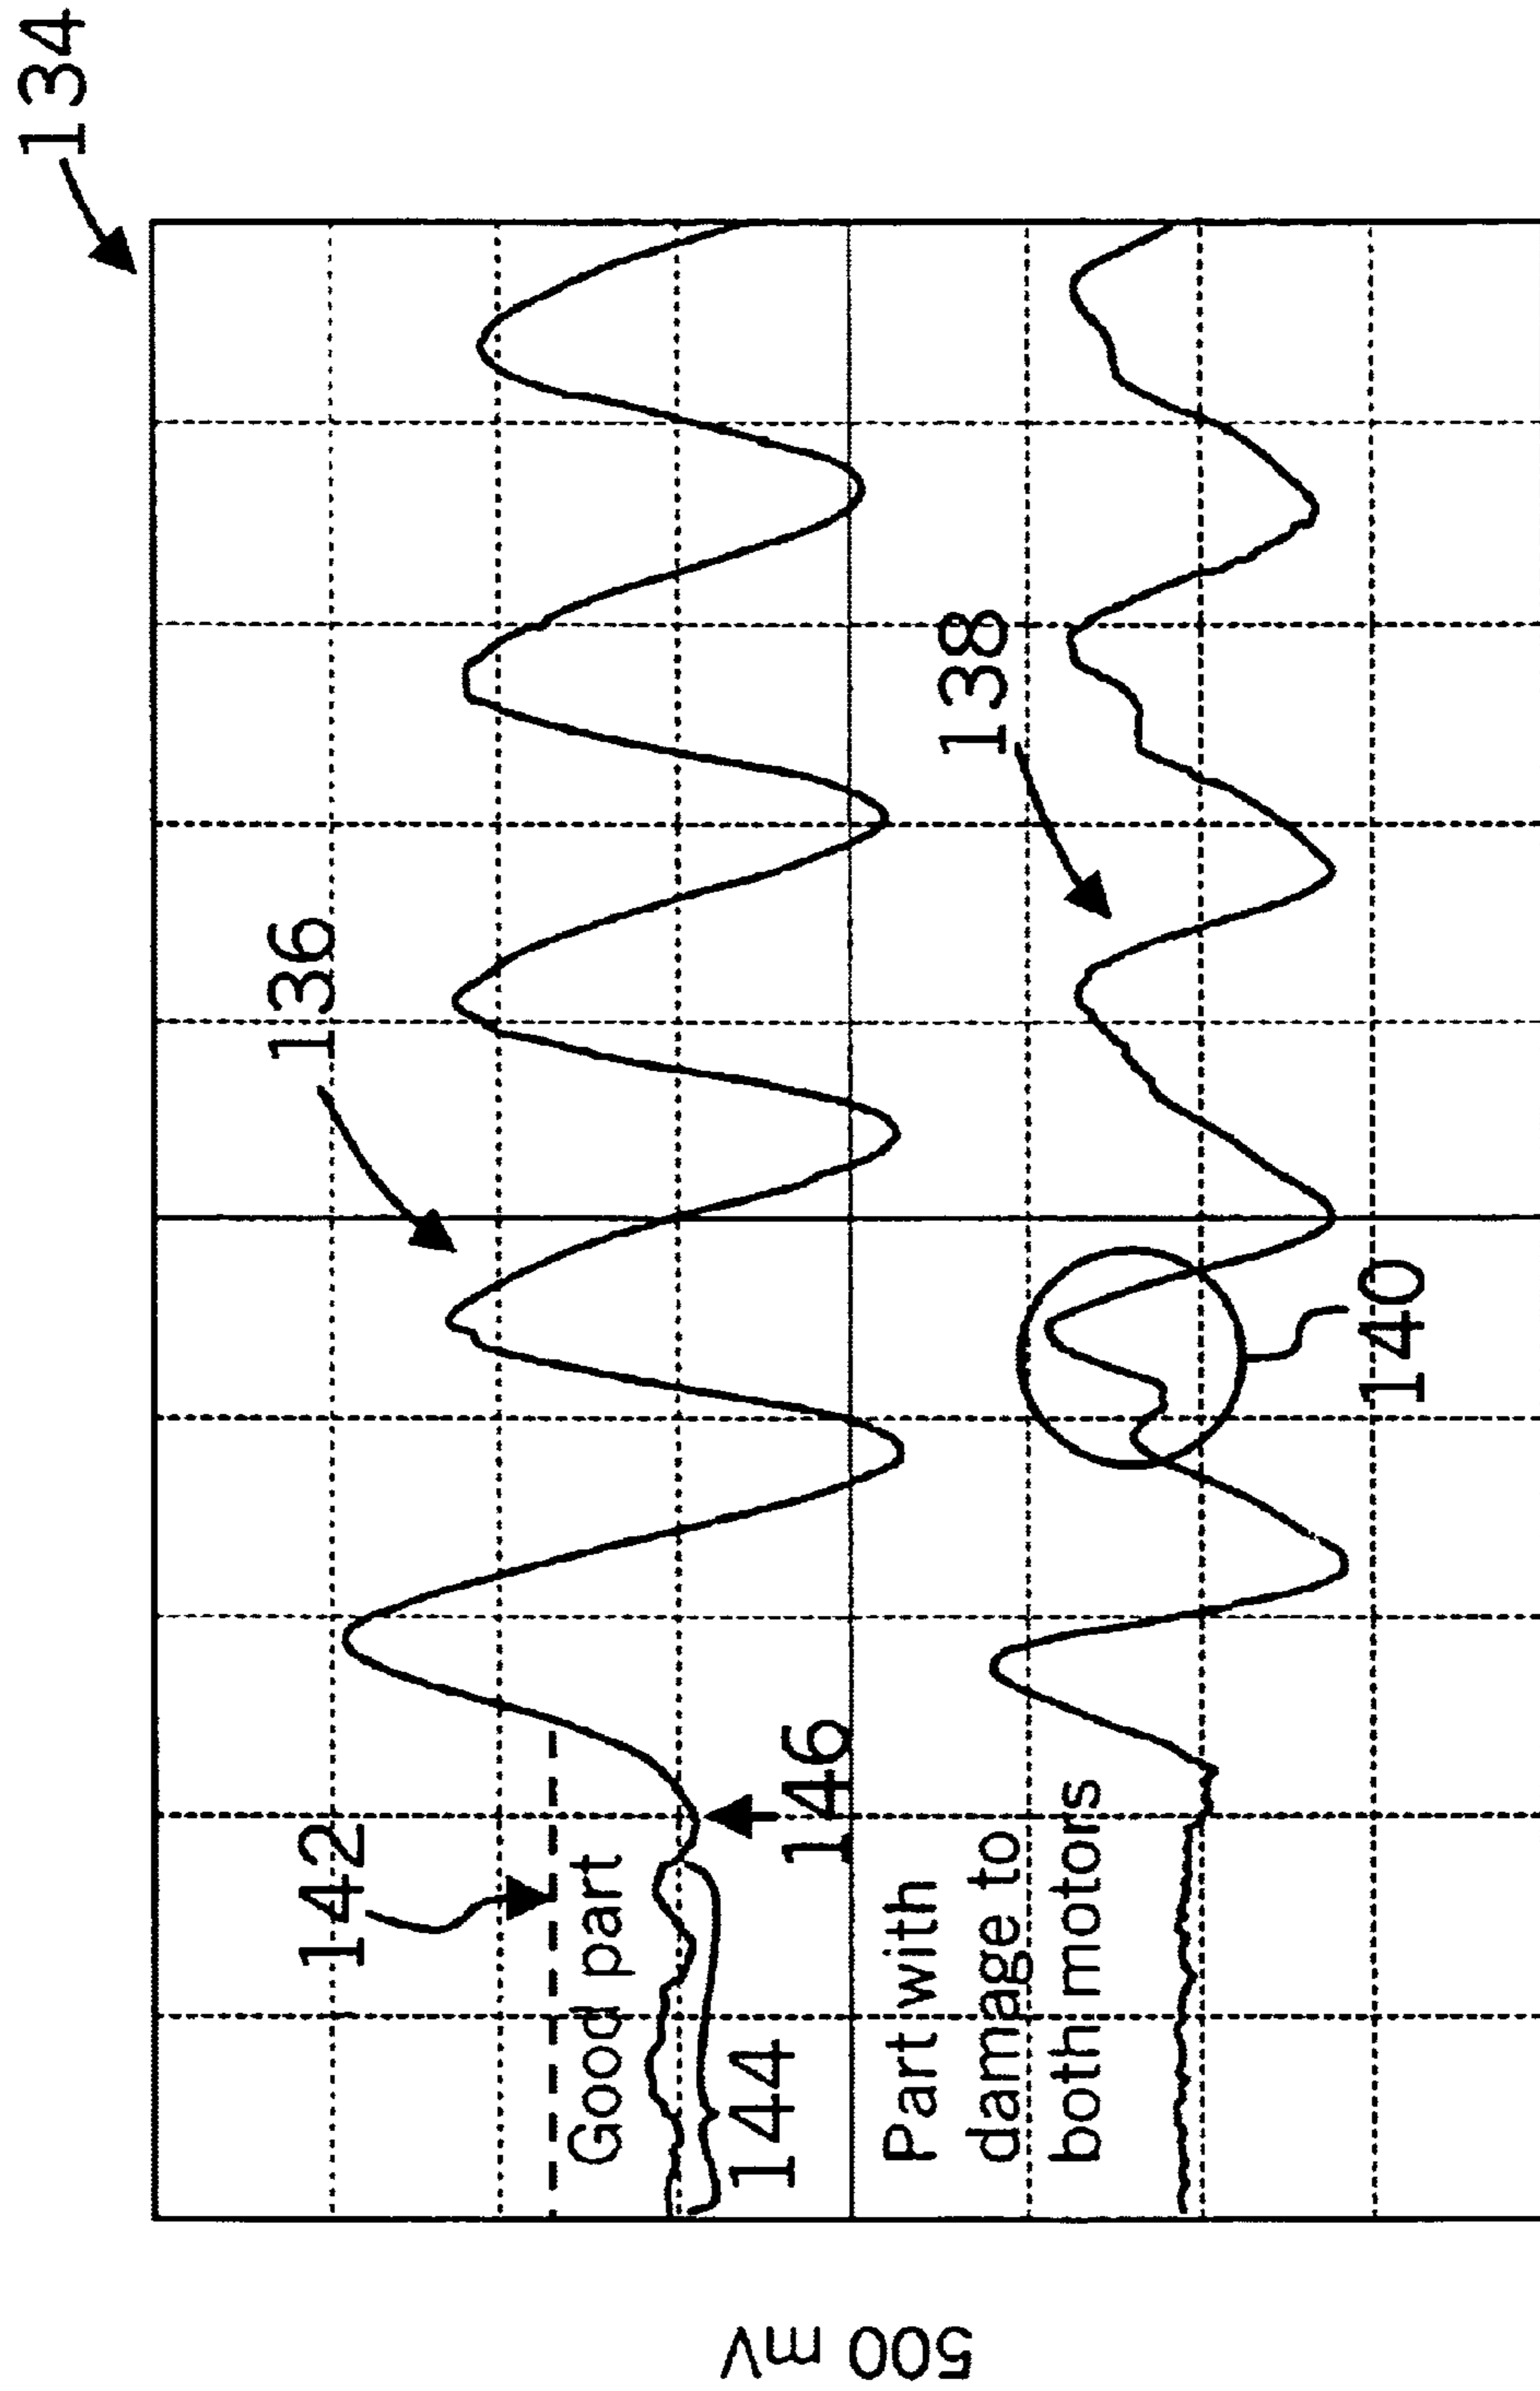
FIG. 13 is a graph of electrical signals produced by a properly functioning and mounted microactuator motor and a suspension motor having failure modes in both piezoelectric elements.

FIG. 13 is a graph 134 illustrating the signal levels from a properly functioning suspension motor (at 136) and a suspension motor having failure modes in both its piezoelectric elements (at 138). As shown, in addition to the signal levels, the shape characteristics of the signal from the damaged motor (i.e., asymmetric, not a sine wave) are also sufficiently different than the shape characteristics of the signal from the properly functioning motor to enable detec-

tion of the failure mode by a comparison of the signals (e.g., electronically or visually). As indicated by circle 140, the waveform 138 can show a bad part even if the peak voltage does not. It is to be noted that with respect to waveform 136 for a good part, the oscilloscope trigger was set at level 142. Waveform 136 displays noise 144 until the part is released at 146.
