(12) **United States Patent**  
**Thomsen**

(10) **Patent No.:** **US 6,639,411 B1**  
(45) **Date of Patent:** **Oct. 28, 2003**

(54) **MICROACTUATED SUSPENSION MOTOR FAILURE DETECTION SYSTEM**

(73) Assignee: **Hutchinson Technology Incorporated**, Hutchinson, MN (US)

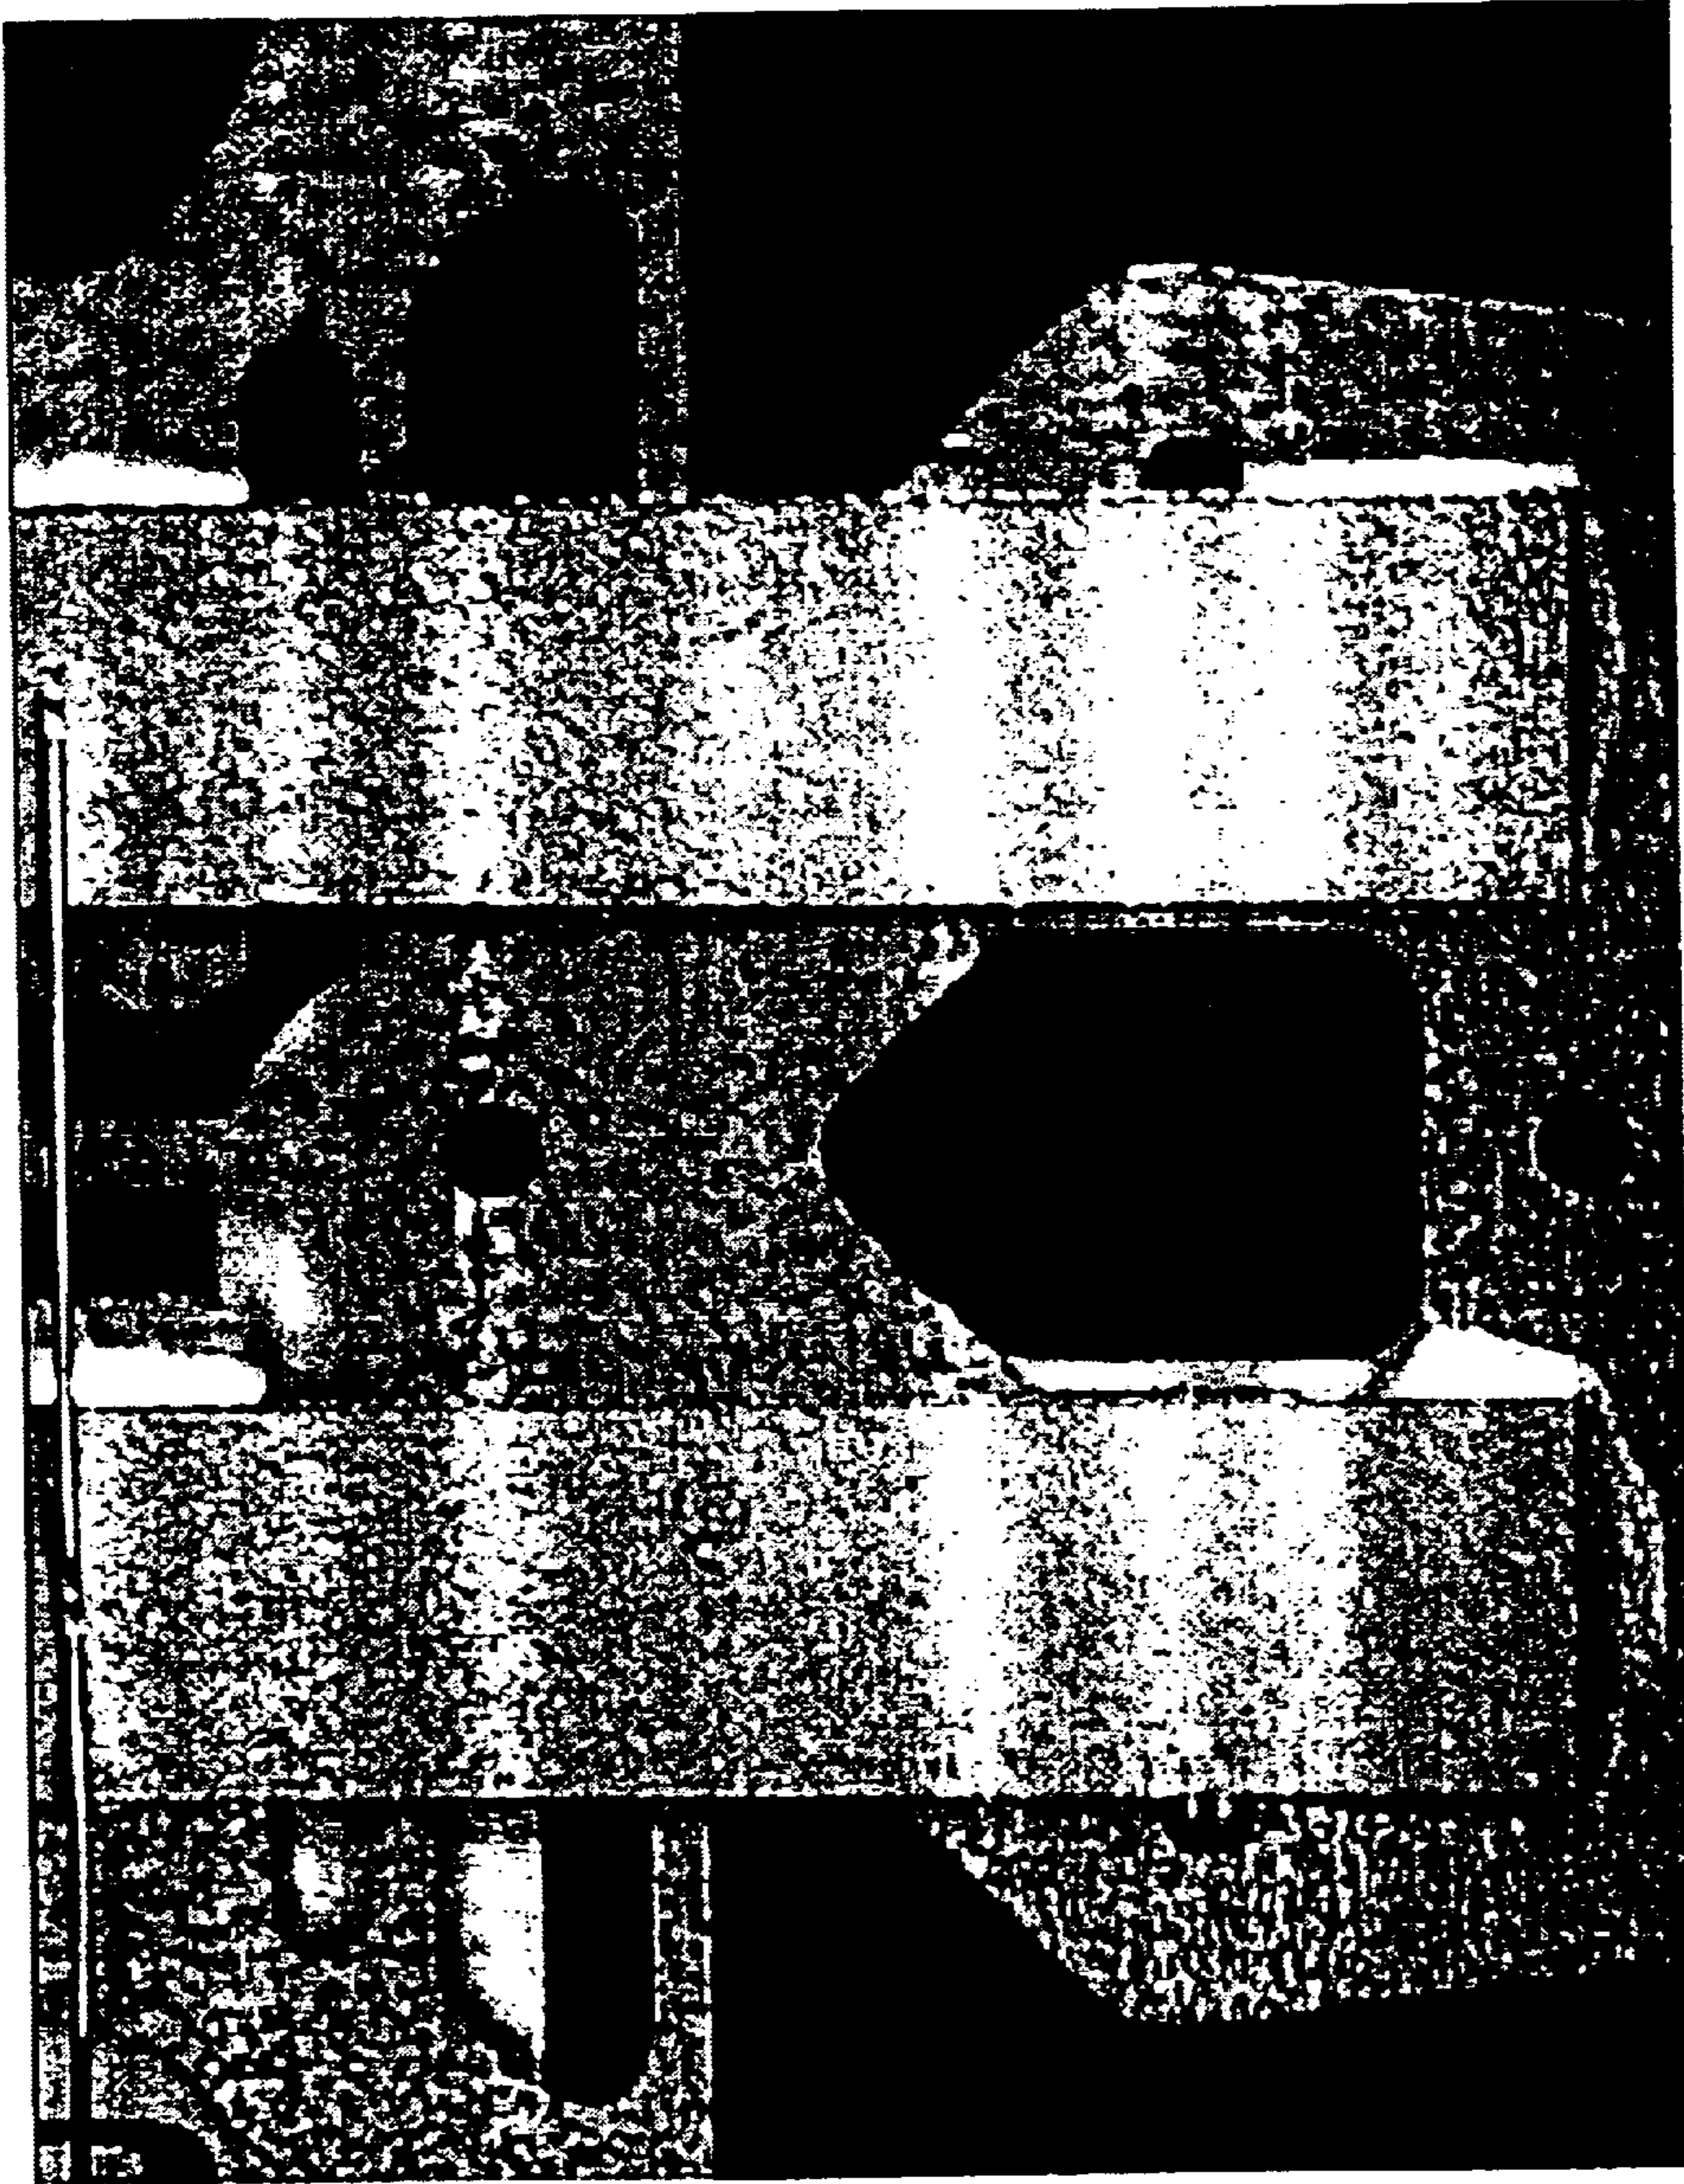
FIGURE 14

FIG. 14 is a photograph of the piezoelectric elements of a suspension microactuator motor having a microcrack (not visible) before application of a sweep frequency signal in accordance with a certain aspect of the present invention.

Following the application of this excitation signal, the suspension motor can be tested using the method described above. FIG. 14 is a photograph of the piezoelectric elements of a suspension microactuator motor having a microcrack (not visible) before application of a sweep frequency signal in accordance with the method described above. FIG. 15 is a photograph of the motor shown in FIG. 14 after application of the crack-expanding sweep frequency signal, with the microcrack now visible through the gold surface of the motor.

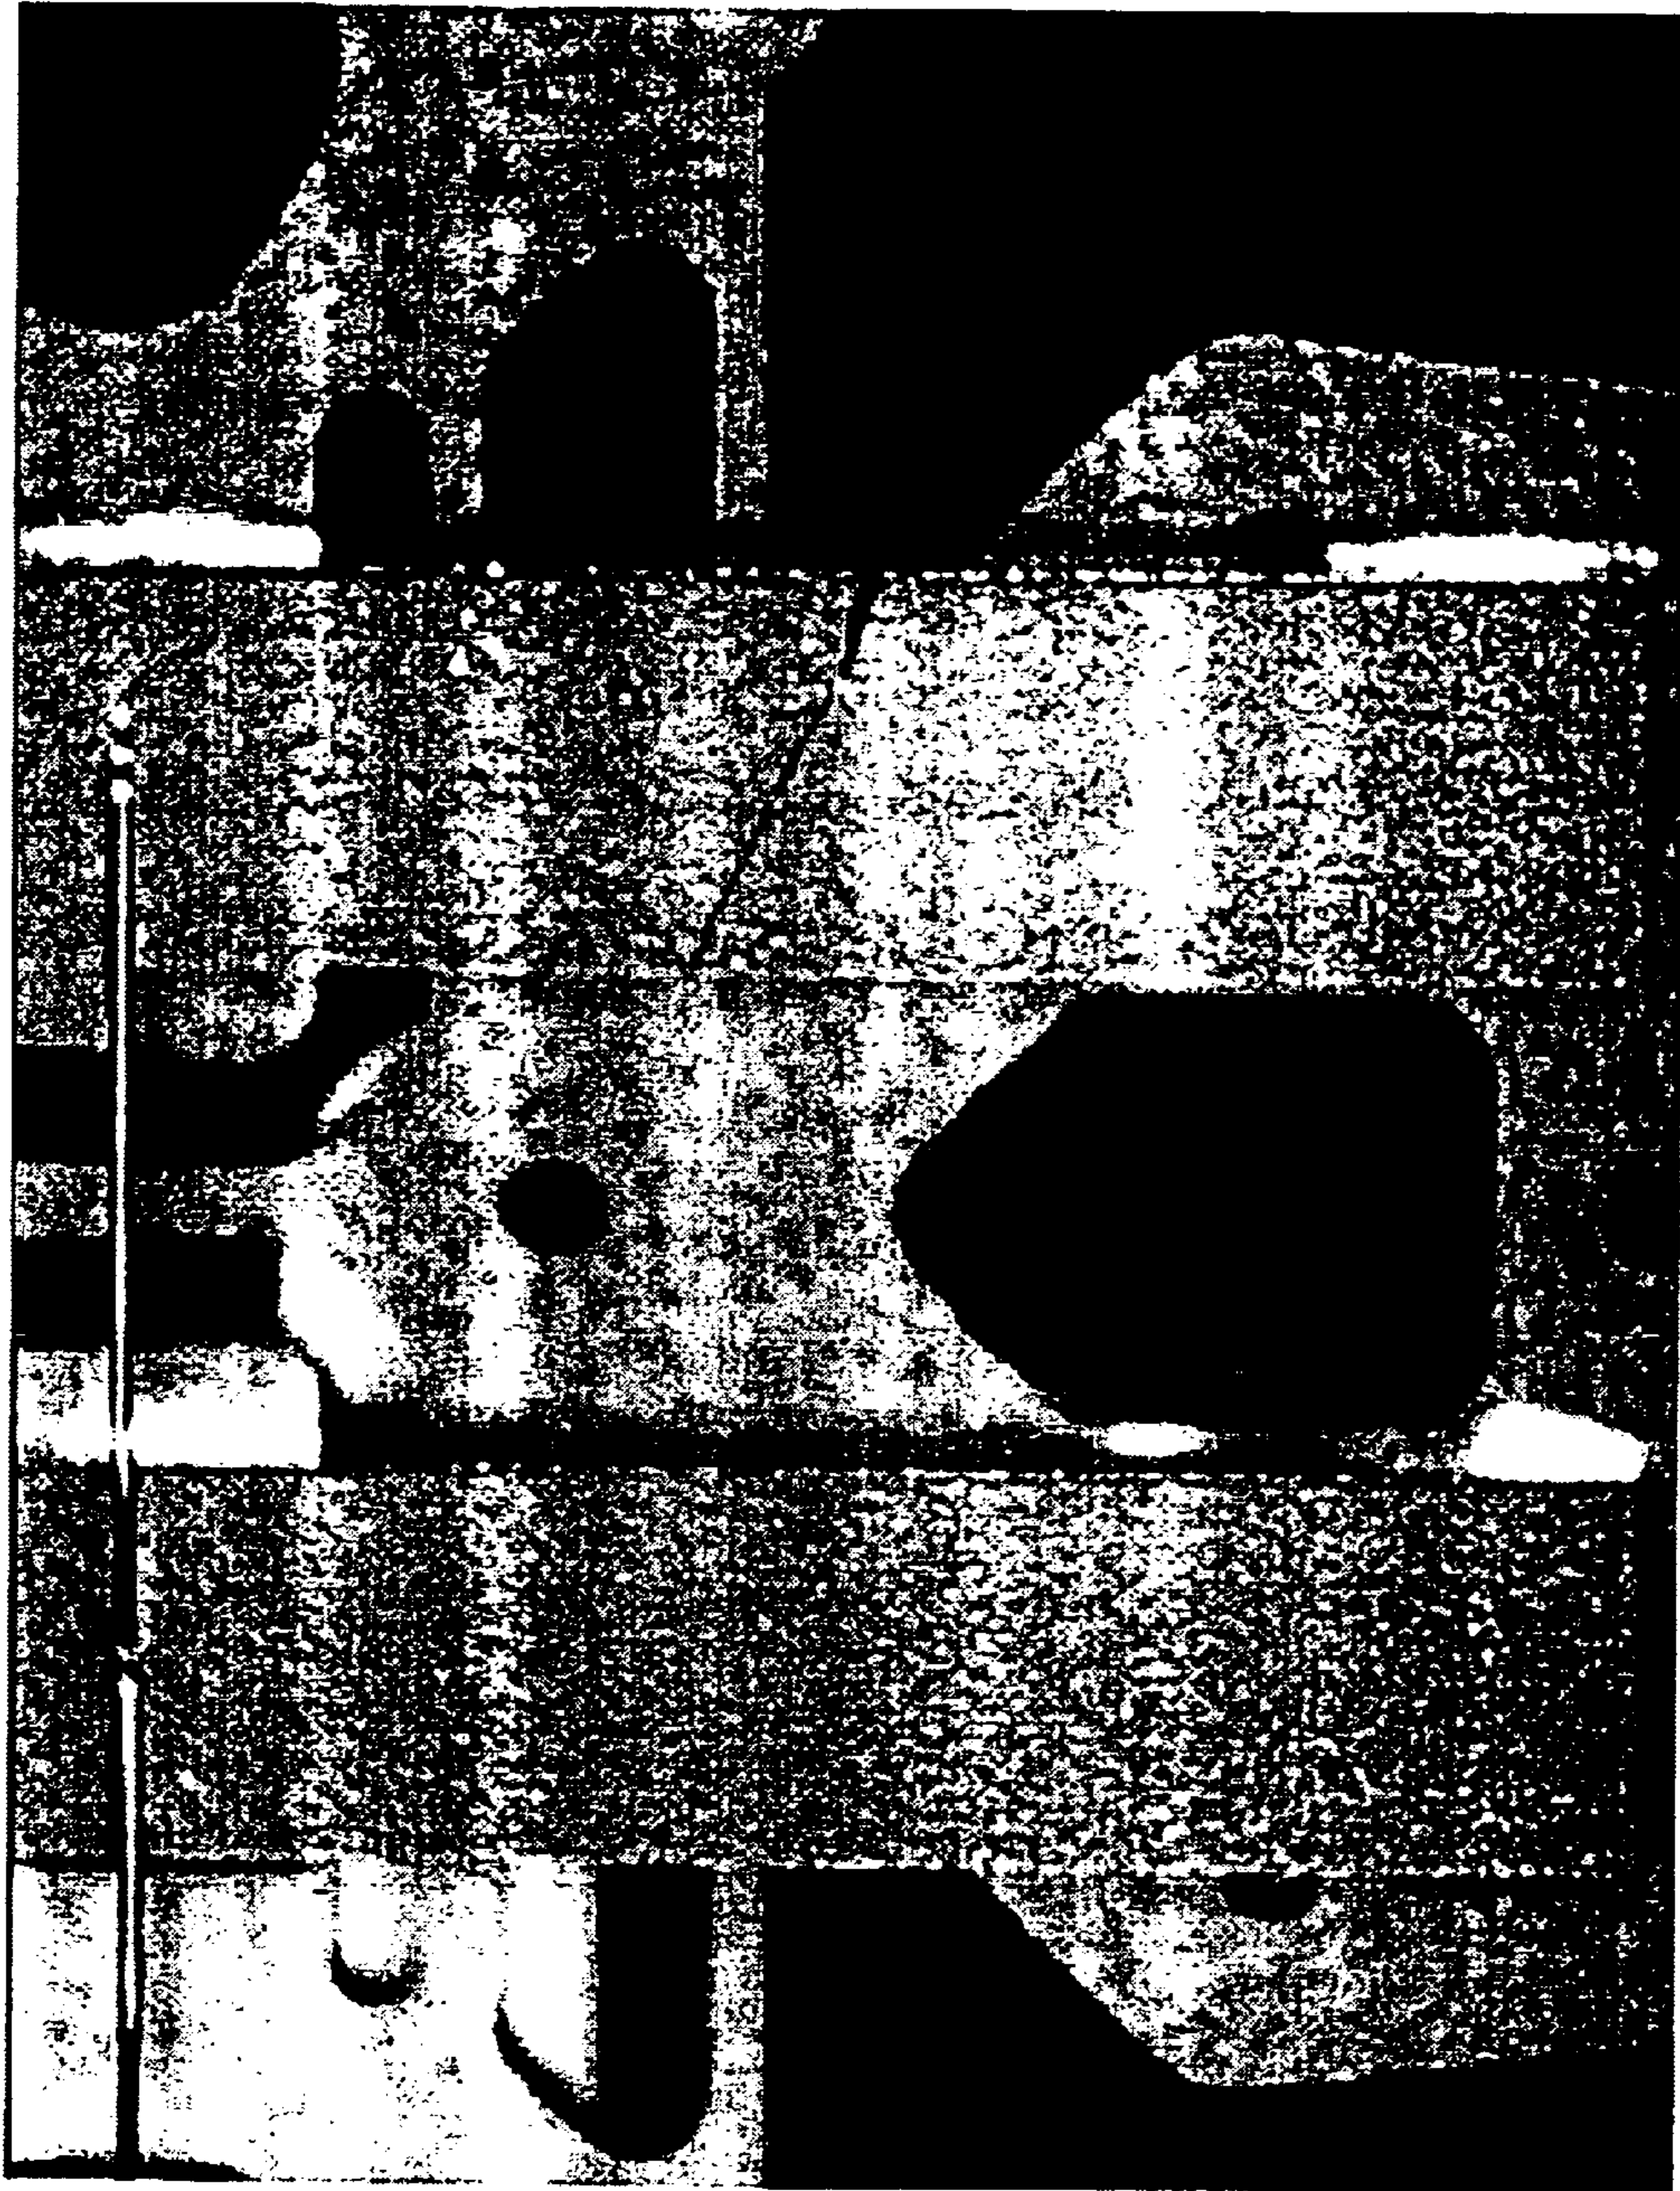
FIGURE 15

FIG. 15 is a photograph of the motor of FIG. 9 after application of a crack-expanding sweep frequency signal.
