(12) **United States Patent**
Dalenberg et al.

(10) **Patent No.:** **US 7,195,578 B2**
(45) **Date of Patent:** **Mar. 27, 2007**

(54) **AUTOMATIC TRANSMISSION AND GEAR TRAIN**

The present invention relates to automatic transmissions. In particular, the instant invention relates to an automatic transmission with improved resistance to deterioration with an increased effective life. The transmission of the instant invention comprises eight pinion gears assembled into one carrier utilizing a forward and a rear sun gear, a ring gear, a band drum and a one way roller clutch.

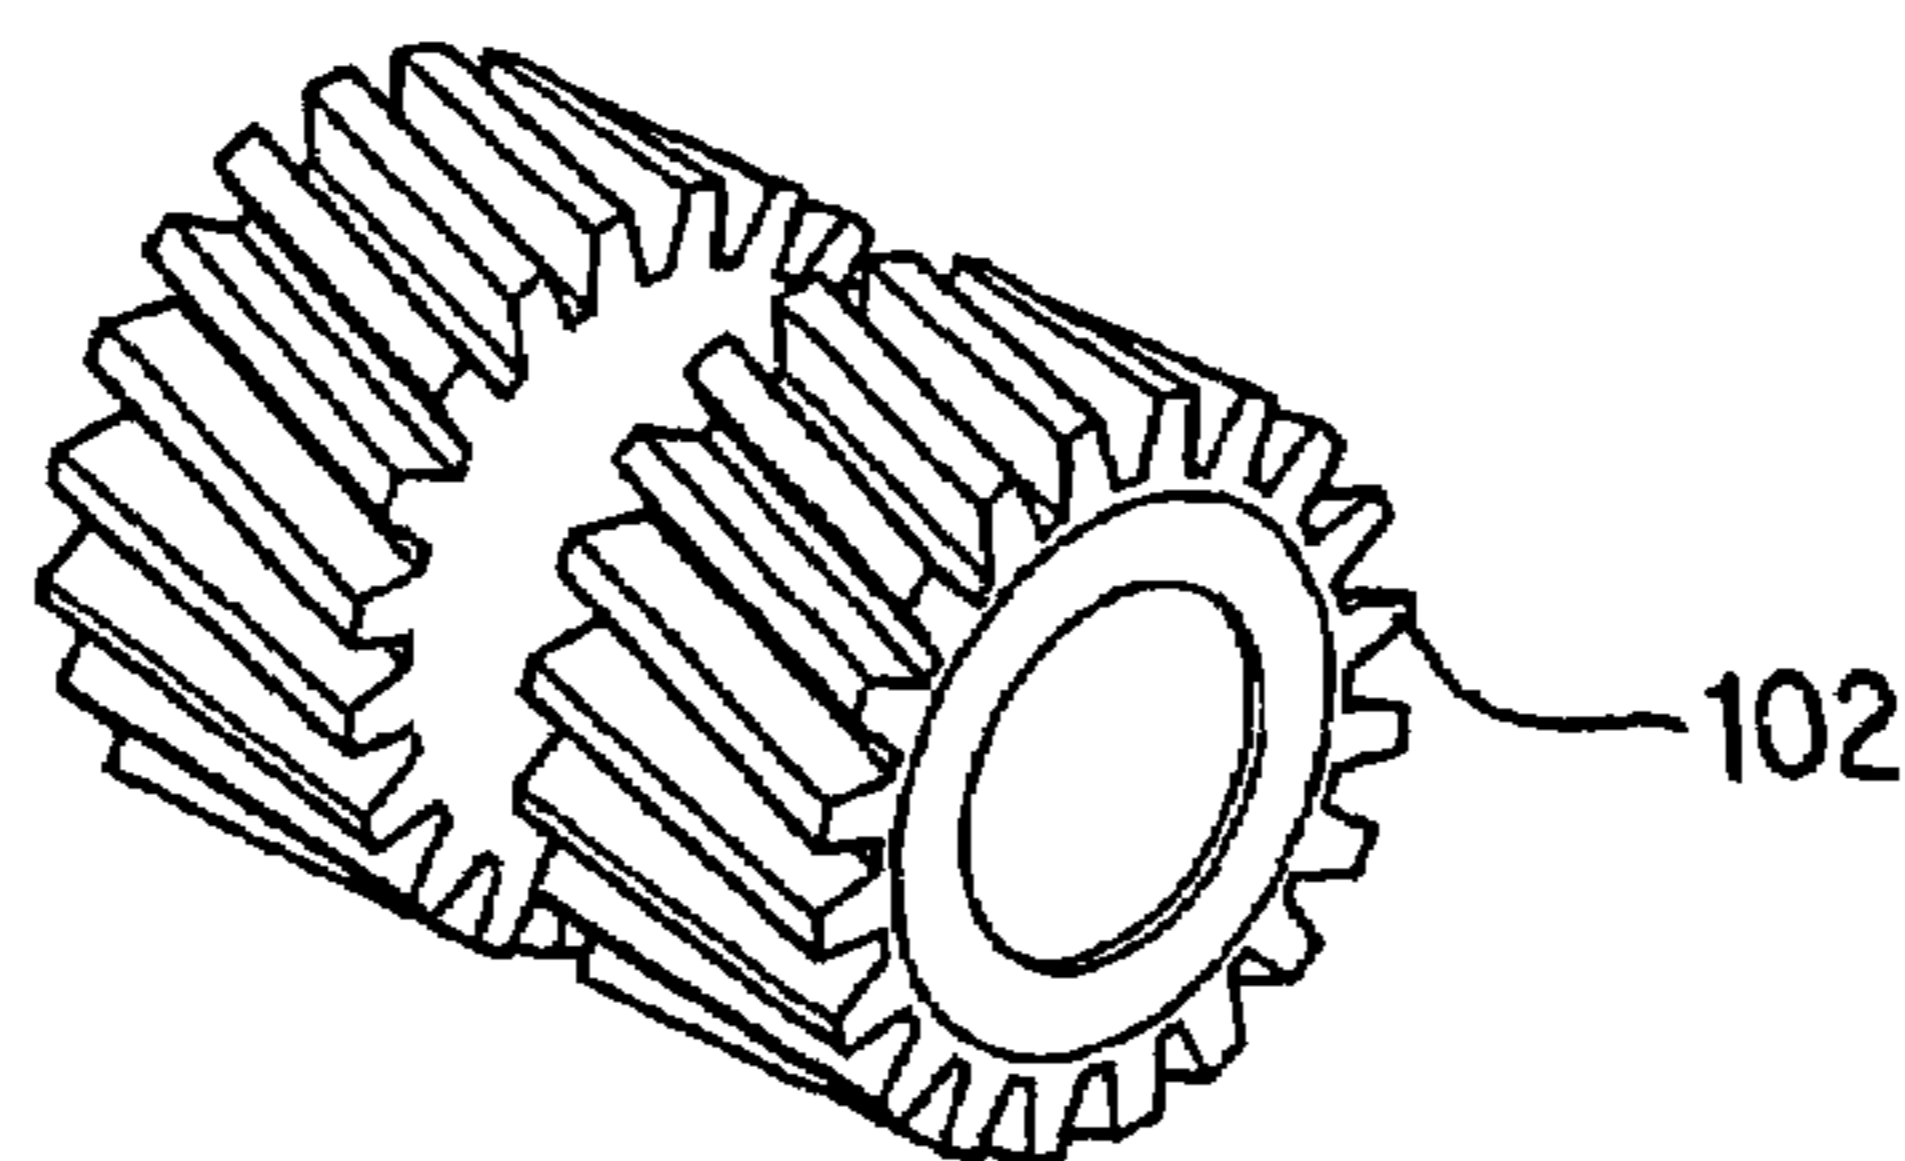
Fig. 1a

FIGS. 1a–1b illustrate a compound pinion gear, with FIG. 1a showing the gear in perspective, FIG. 1b showing the gear in cross section, and FIG. 1c showing parameters.

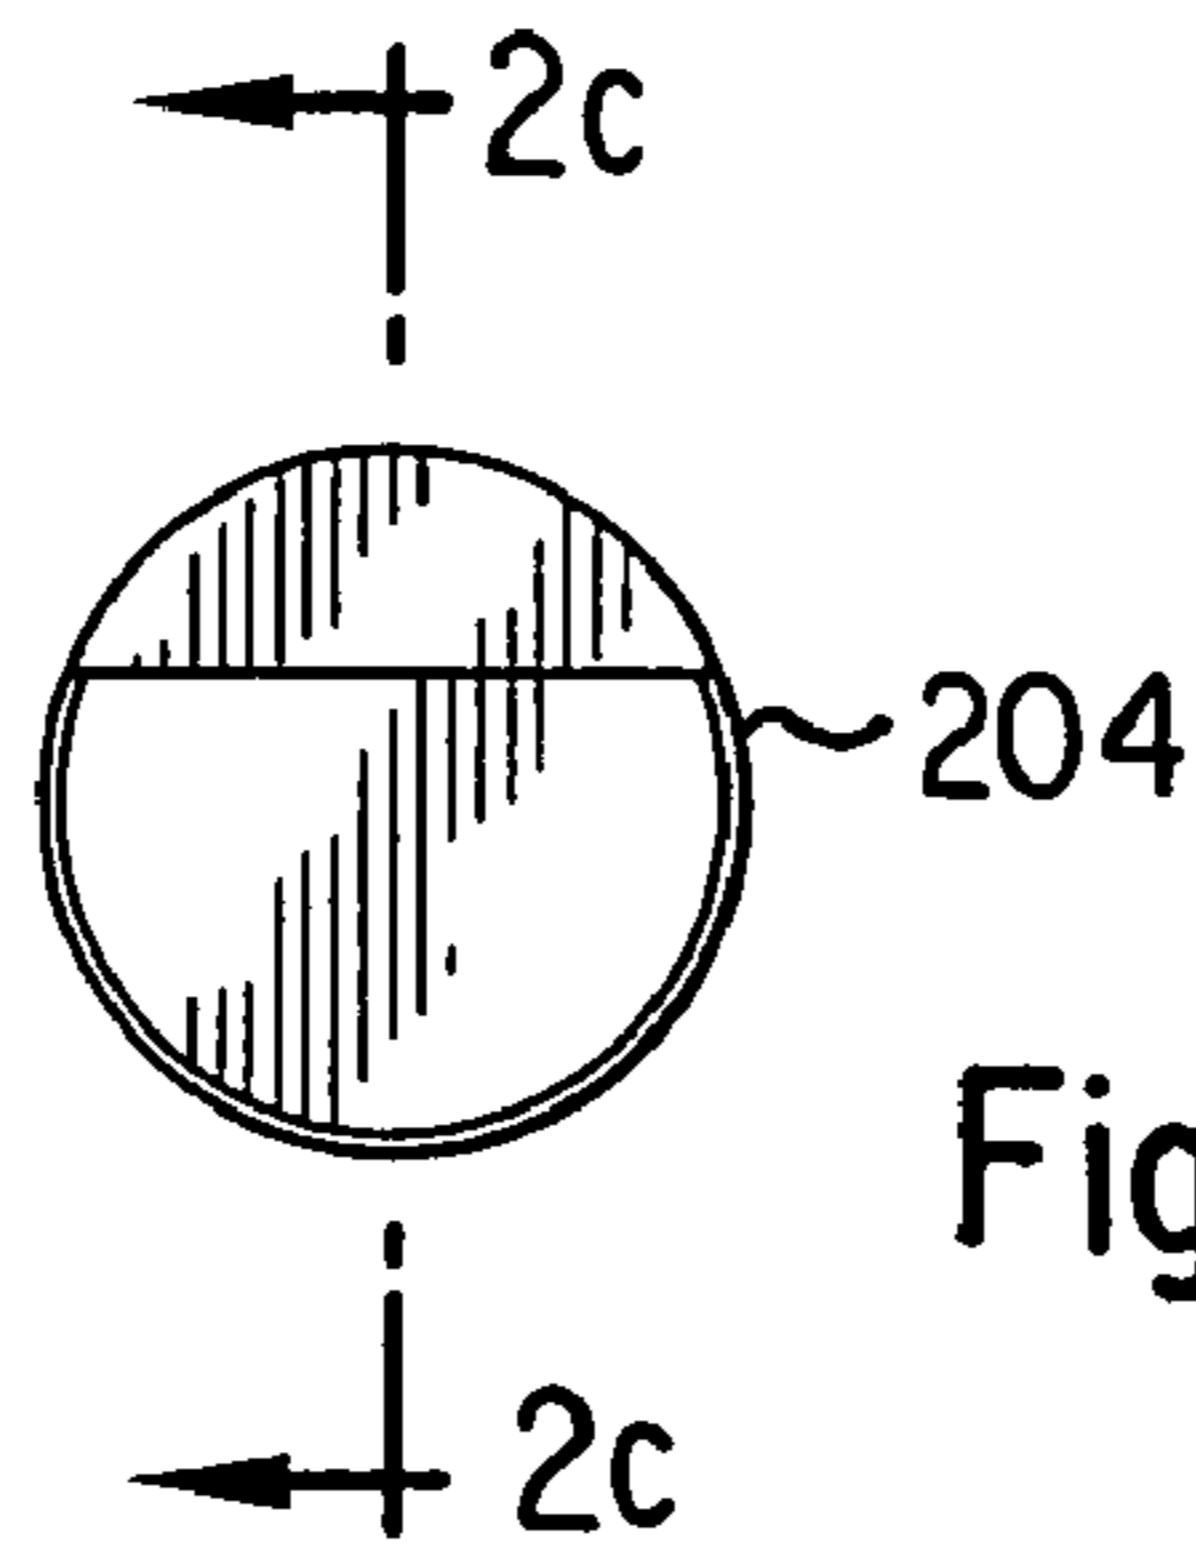
Fig. 2b

FIGS. 2a–2c illustrated a compound pinion pin, with FIG. 2a showing the pin in perspective, FIG. 2b showing the pin from one end, and FIG. 2c showing the pin in cross section.

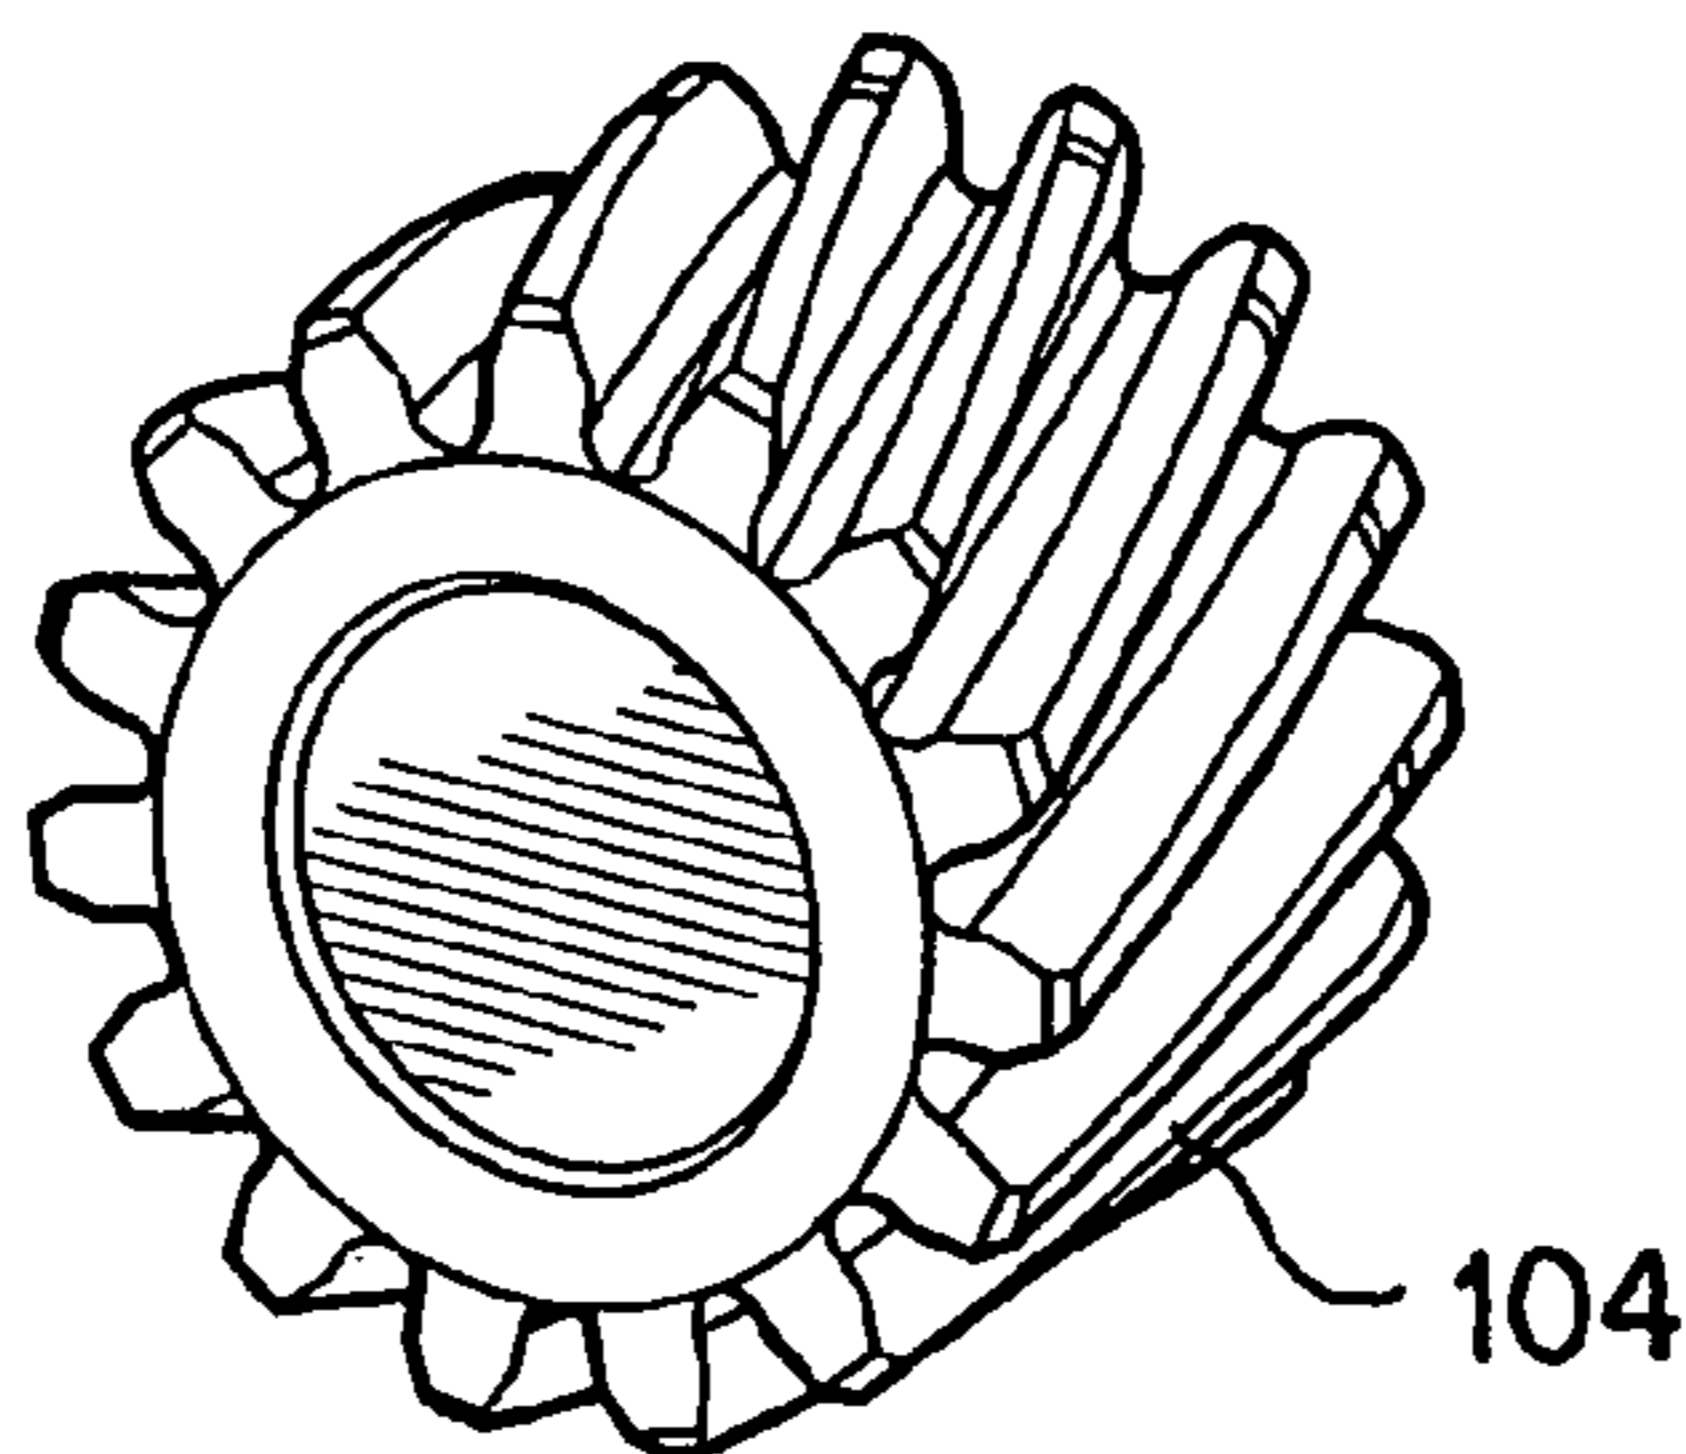
Fig. 3a

FIGS. 3a–3b illustrate a plain pinion gear, with FIG. 3a showing the gear in perspective, FIG. 3b showing the gear in cross section, and FIG. 3c showing parameters.

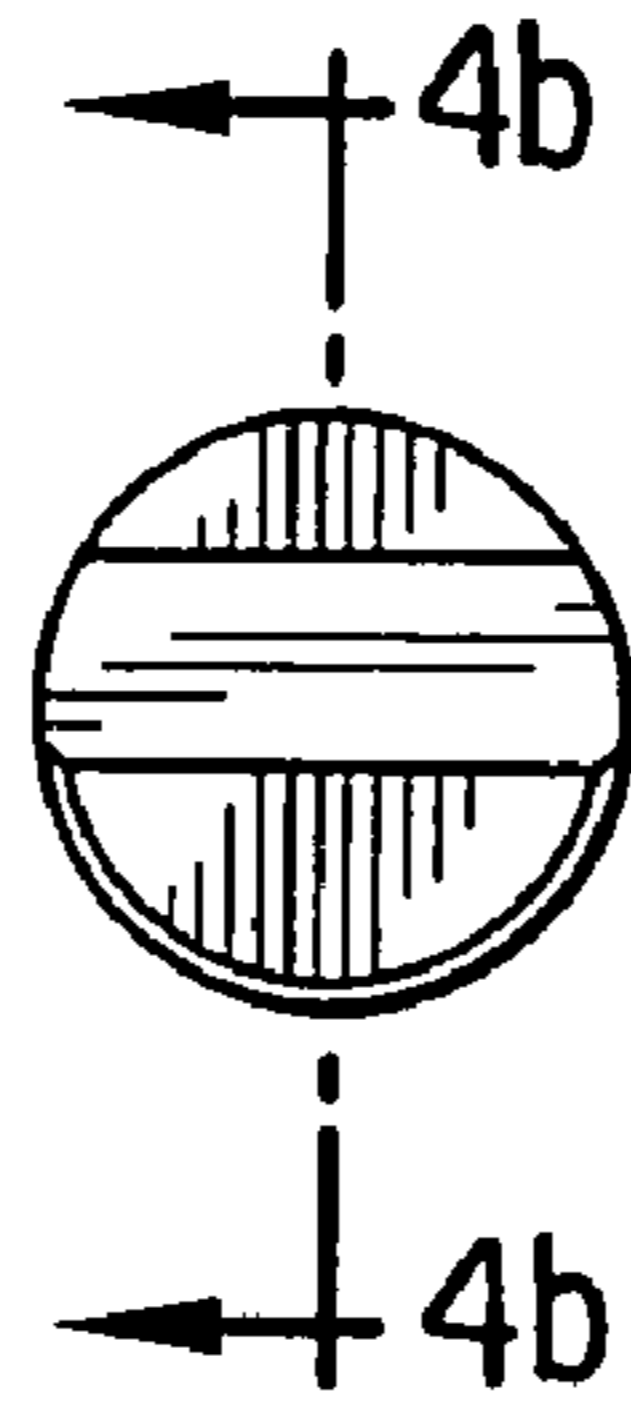
Fig. 4c

FIGS. 4a–4c illustrate a plain pinion pin, with FIG. 4a showing the pin in perspective, FIG. 4b showing the pin in cross section, and FIG. 4c showing the pin from one end.

Also indicated in FIG. 26a-26c are rivets 200, a small phosphor bronze washer 202 (see also FIG. 18a-18c), a compound pinion pin 204 (see also FIG. 2a-2c), a plain pinion pin 206 (see also FIG. 4a-4c), an output shaft 116 (see also FIG. 5a-5c), a lock plate 117 (see also FIG. 17a-17c), a small SK5 washer 218, a large SK5 washer 210 (see also FIG. 19a-19c), a needle sleeve 212 (see also FIG. 20a-20b), a plug 214 (see also FIG. 21a-21b), a large phosphor bronze washer 216, and a needle roller bearing 220 including needle rollers 222 (see also FIG. 22a-22b).

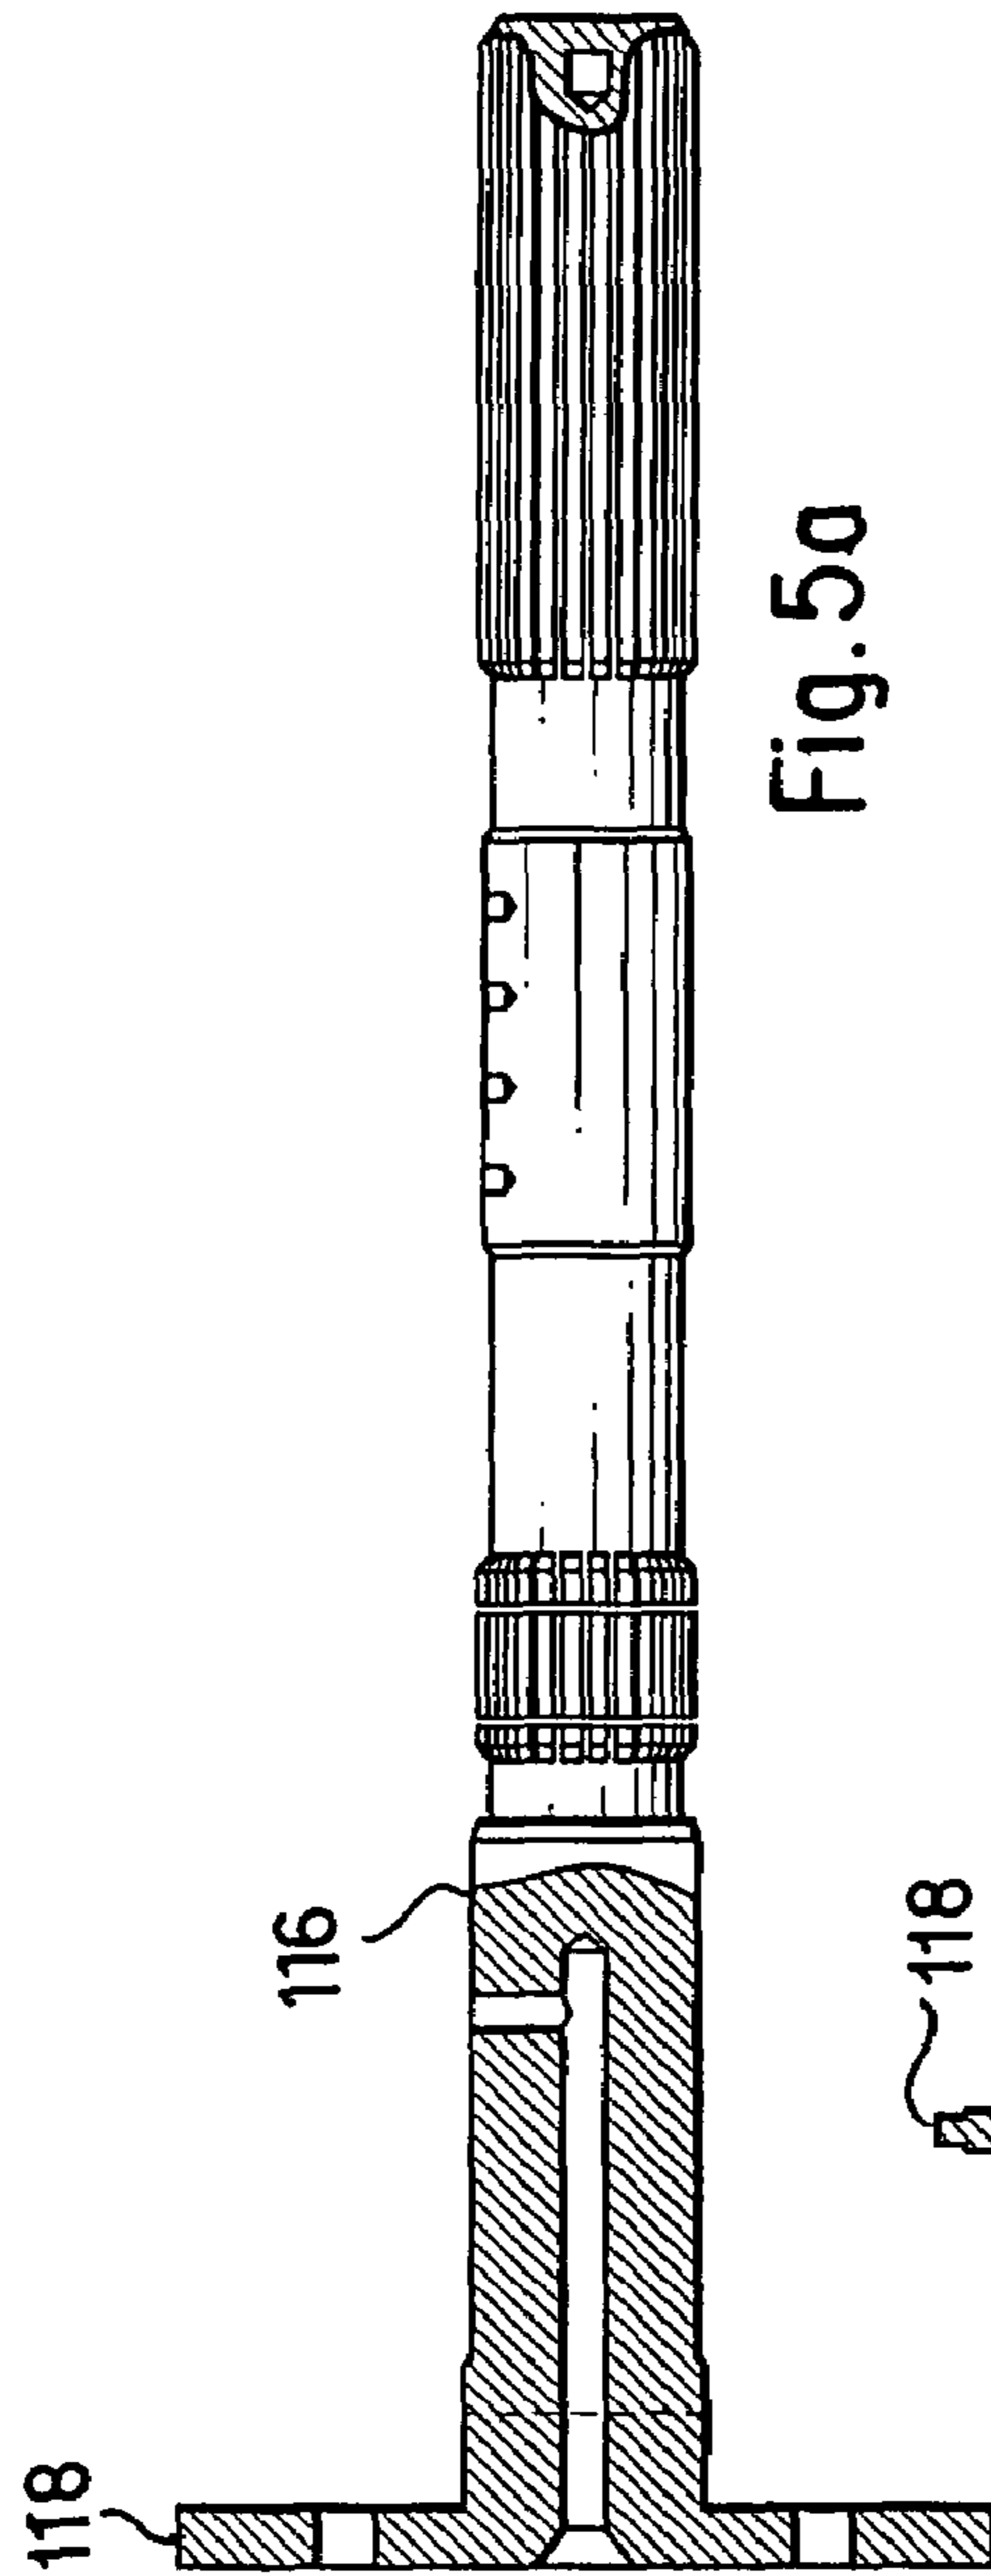
Fig. 5a

FIGS. 5a–5c illustrate an output shaft with flange, with FIG. 5a showing the shaft and flange partly in cross section, FIG. 5b showing the flange from one end, and FIG. 5c showing the shaft and flange in cross section after the flange has been machined.

3. Output Shaft 116 and Flange 118 (FIG. 5a-5c)

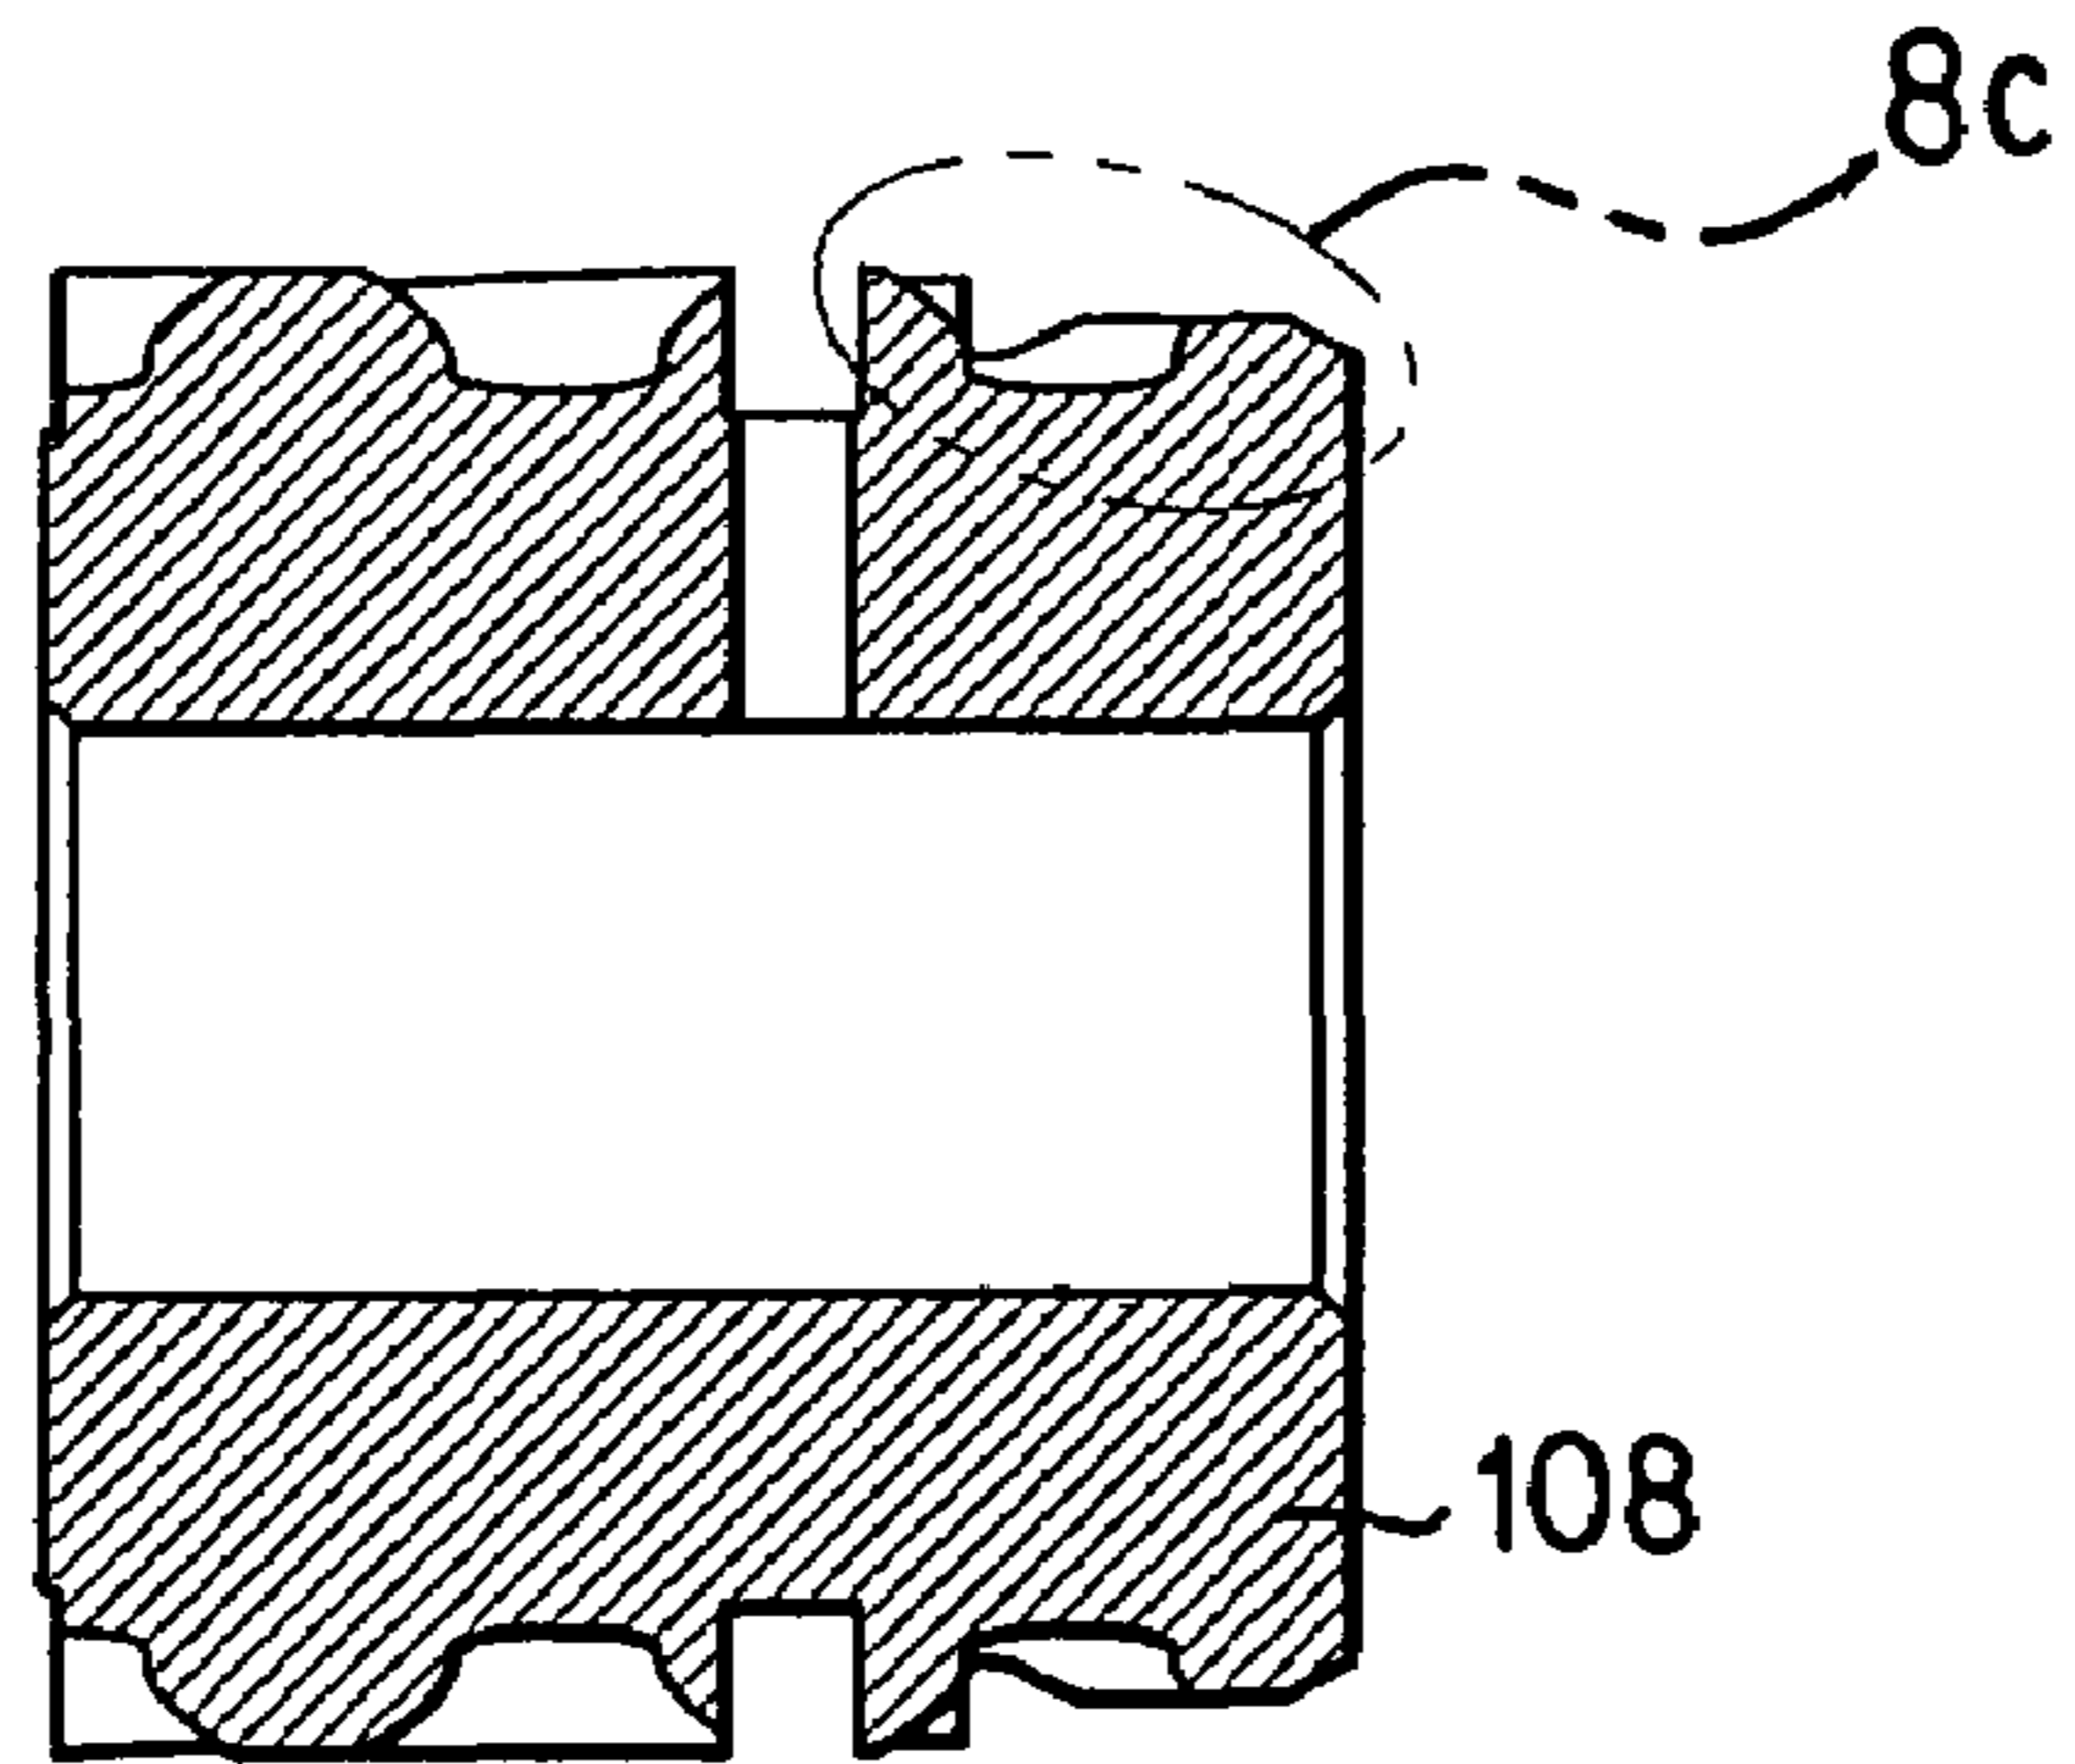
Fig. 8b

FIGS. 8a–8c are various views of a front sun gear; and FIG. 8d is a table of gear data.

7. Front Sun Gear 108 (FIG. 8a-8c)

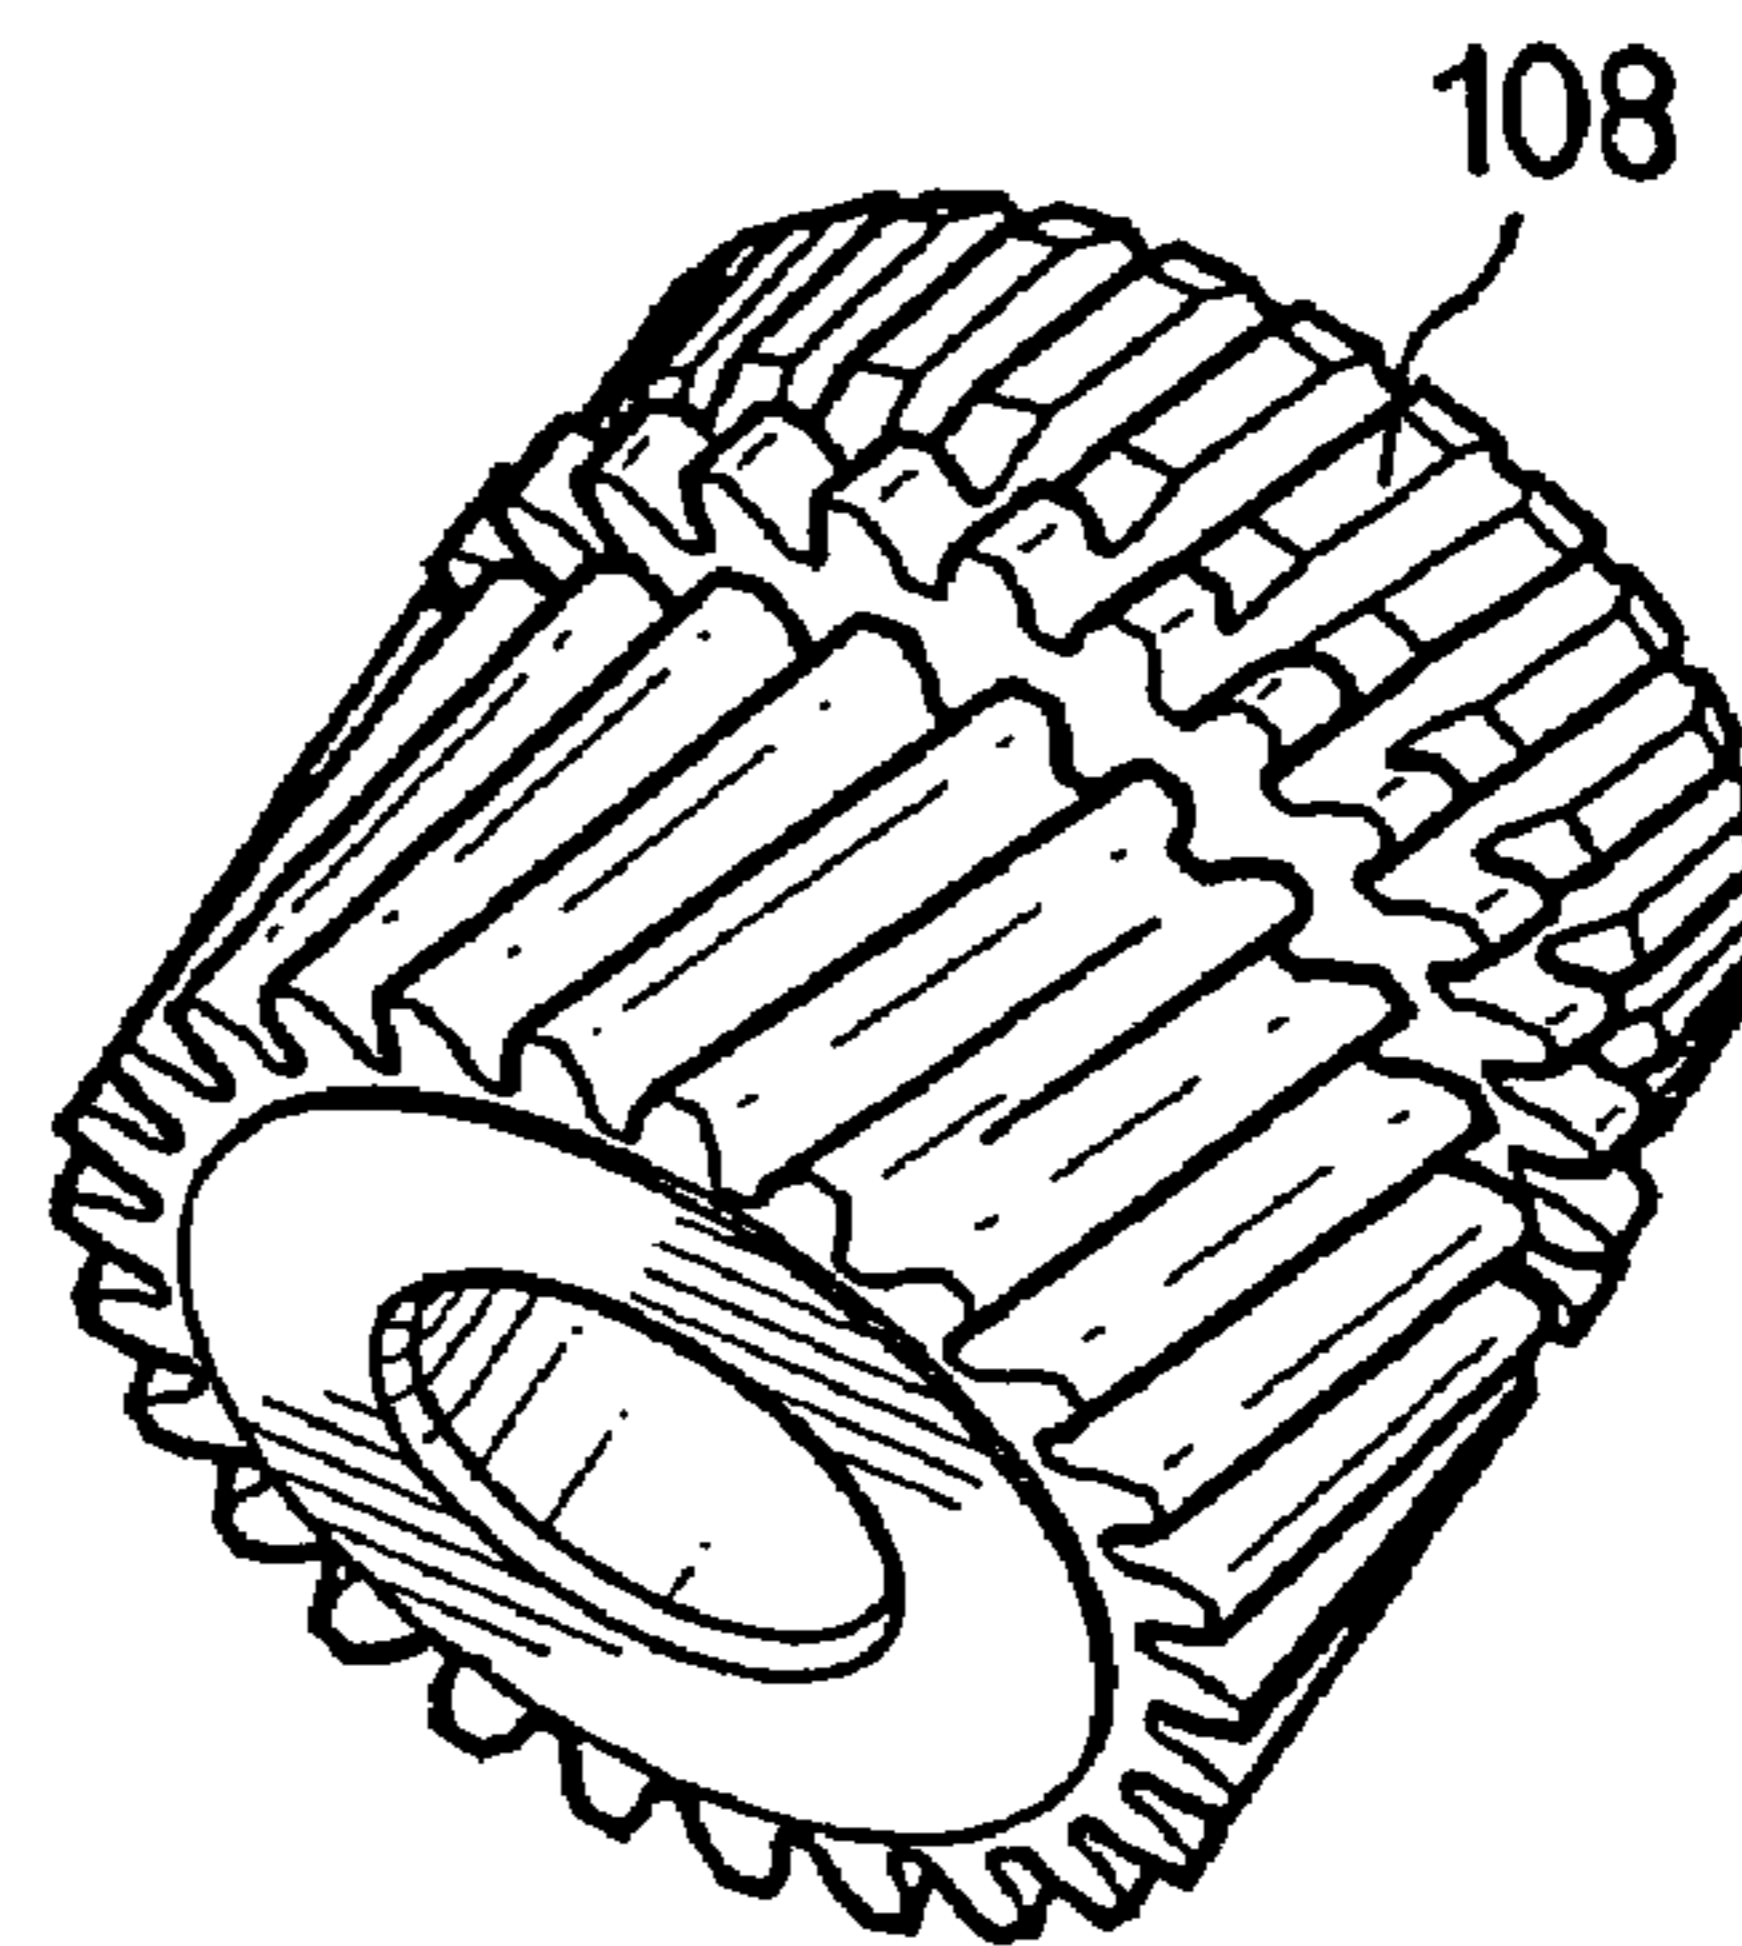
Fig. 8a

EXTERNAL INVOLUTE SPLINE DATA	
NUMBER OF TEETH	26
NORMAL PRESSURE ANGLE	18°
NORMAL DIAMETRAL PITCH	17
HELIX ANGLE	18.08°
HAND	RIGHT
STANDARD PITCH DIAMETER	Ø 40.866
MAJOR DIAMETER	Ø 45.60 ± 0.02
MINOR DIAMETER	Ø 38.40 ± 0.05
DIAMETER OF MEASURING PIN	Ø 3.0
MEASUREMENT OVER 2 PINS	46.844 ± 0.038
NORMAL CIRCULAR TOOTH THICKNESS	2.750 ± 0.018
NORMAL TIP RADIUS	0.25
NORMAL FILLET RADIUS	FULL
TOTAL COMPOSITE TOLERANCE	0.038
TOOTH TO TOOTH TOLERANCE	0.019
MASTER GEAR NUMBER OF TEETH	40
MASTER GEAR NORM. CIRC. TOOTH THICKNESS	2.3470
TEST RADIUS	21.386 ± 0.059
CROWNING	0.03

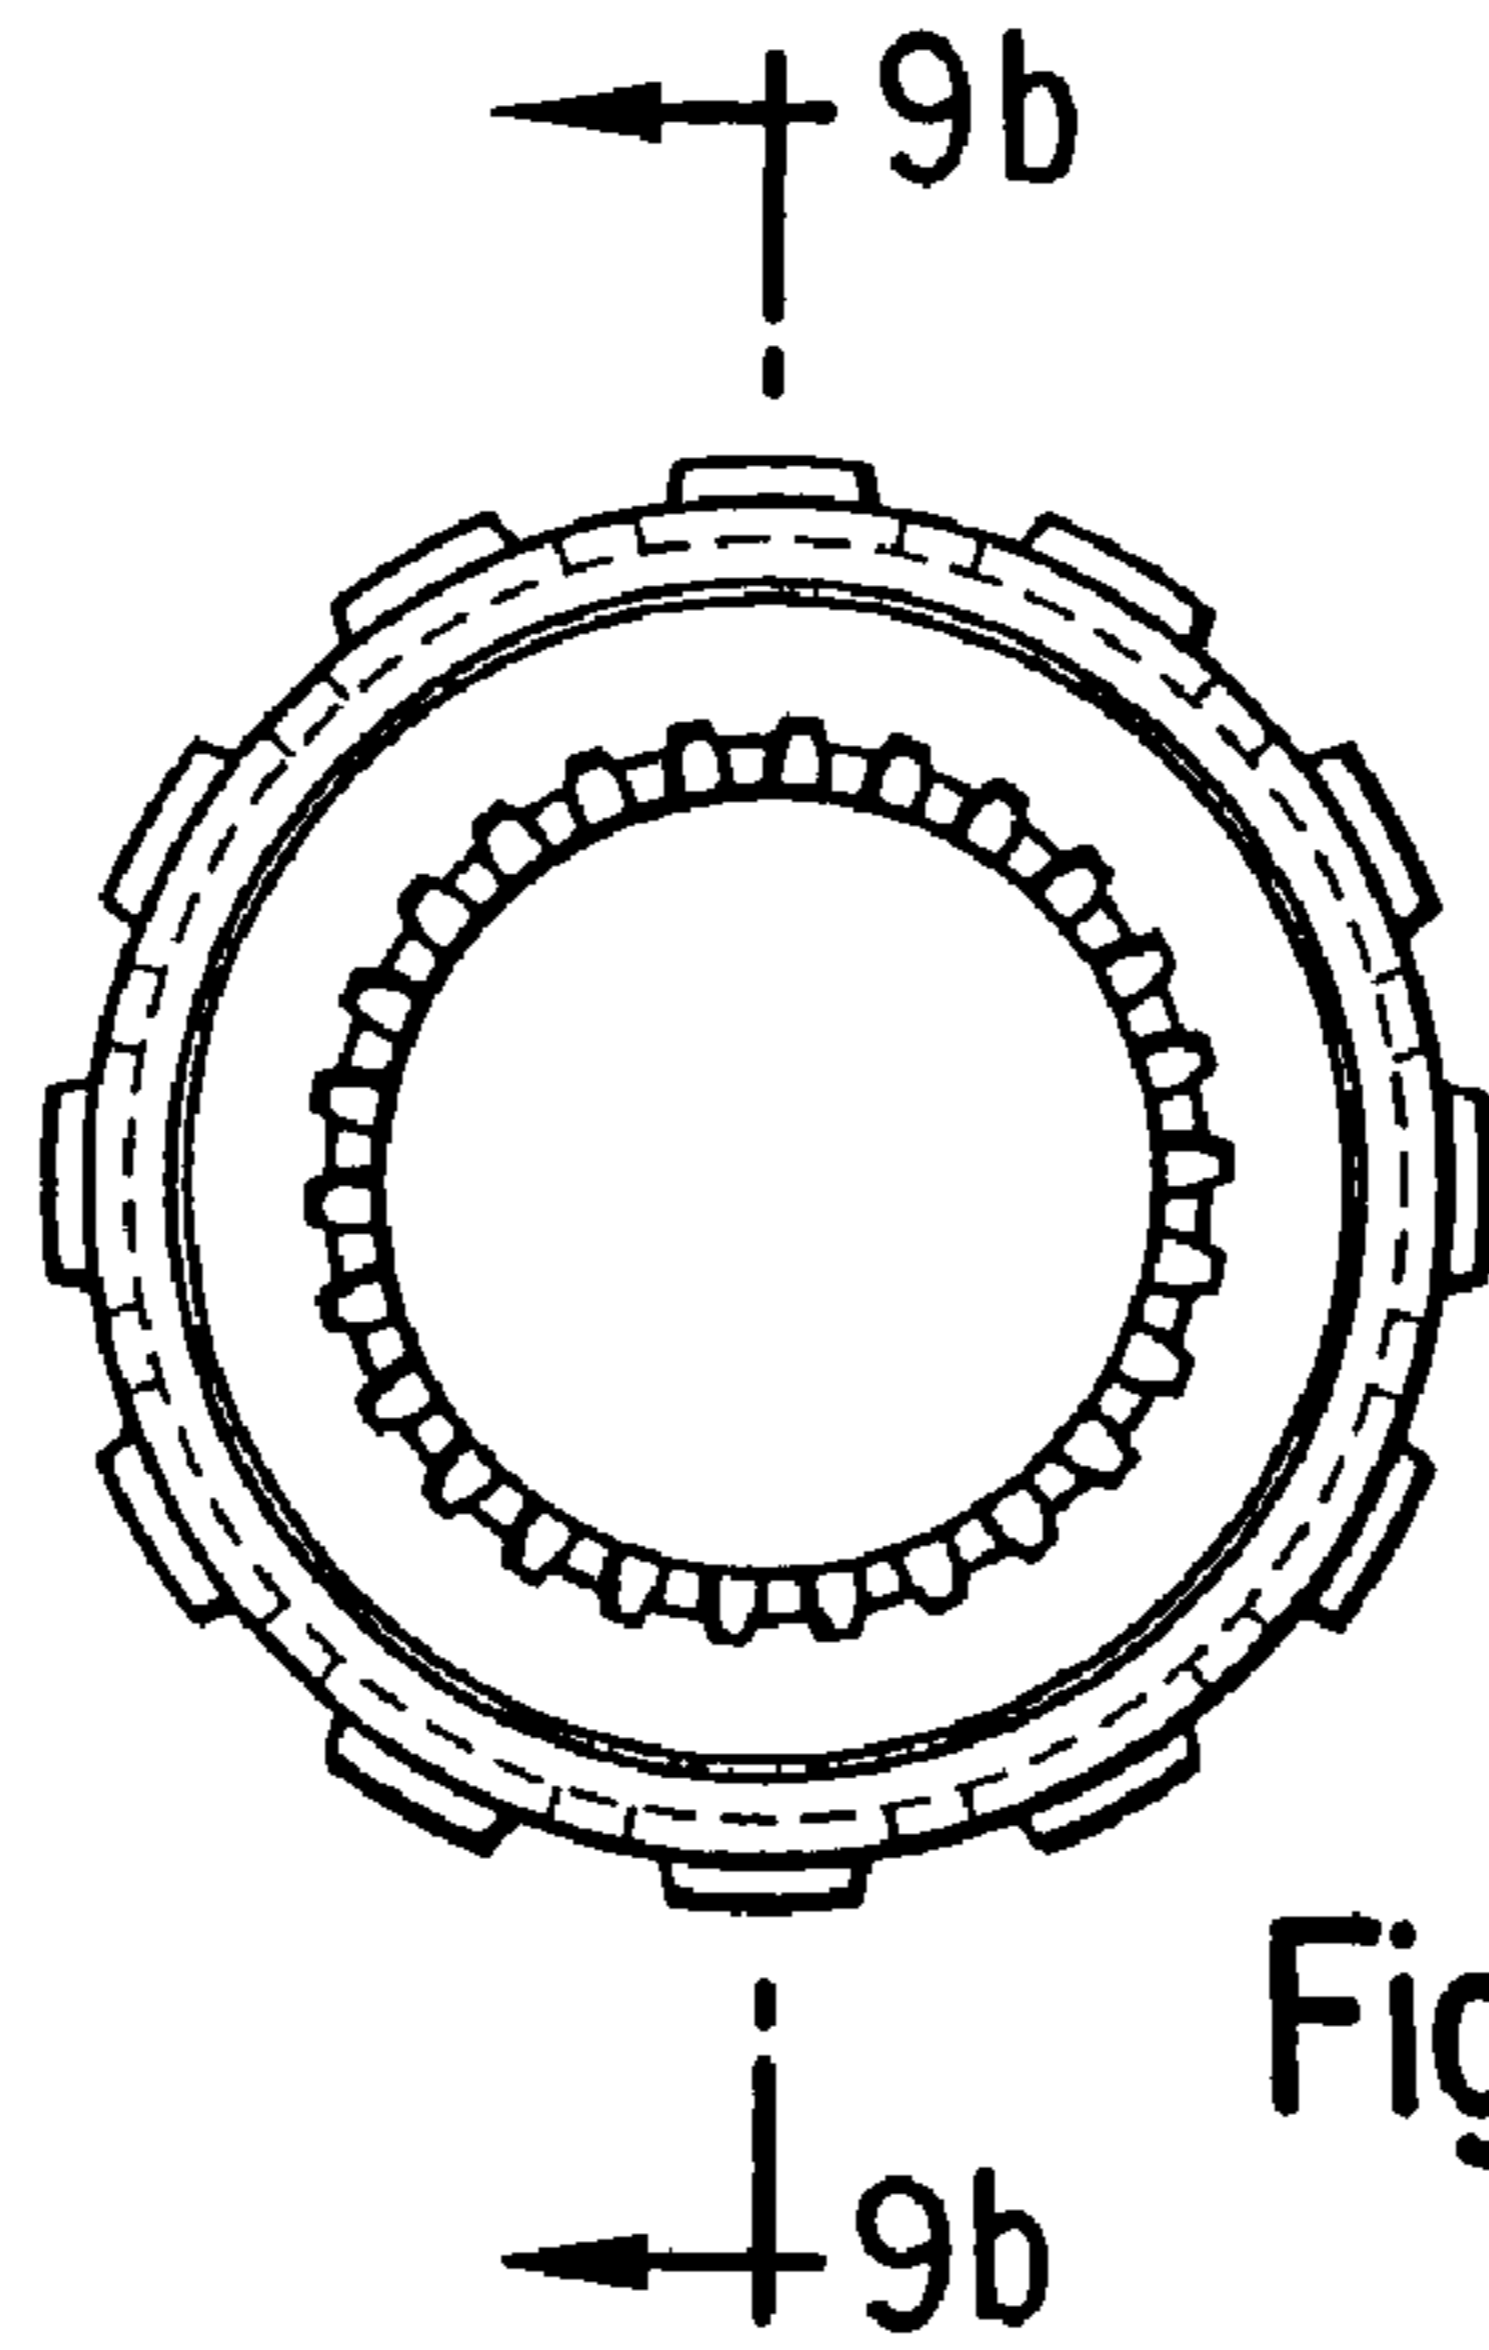
Fig. 9c

FIGS. 9a–9c are various views of a front sun gear hub; and FIG. 9d is a table of gear data.

8. Front Sun Gear Hub 126 (FIG. 9a-9c)
