(12) **United States Patent**
Dalenberg et al.

(10) **Patent No.:** **US 7,195,578 B2**
(45) **Date of Patent:** **Mar. 27, 2007**

(54) **AUTOMATIC TRANSMISSION AND GEAR TRAIN**

The present invention relates to automatic transmissions. In particular, the instant invention relates to an automatic transmission with improved resistance to deterioration with an increased effective life. The transmission of the instant invention comprises eight pinion gears assembled into one carrier utilizing a forward and a rear sun gear, a ring gear, a band drum and a one way roller clutch.

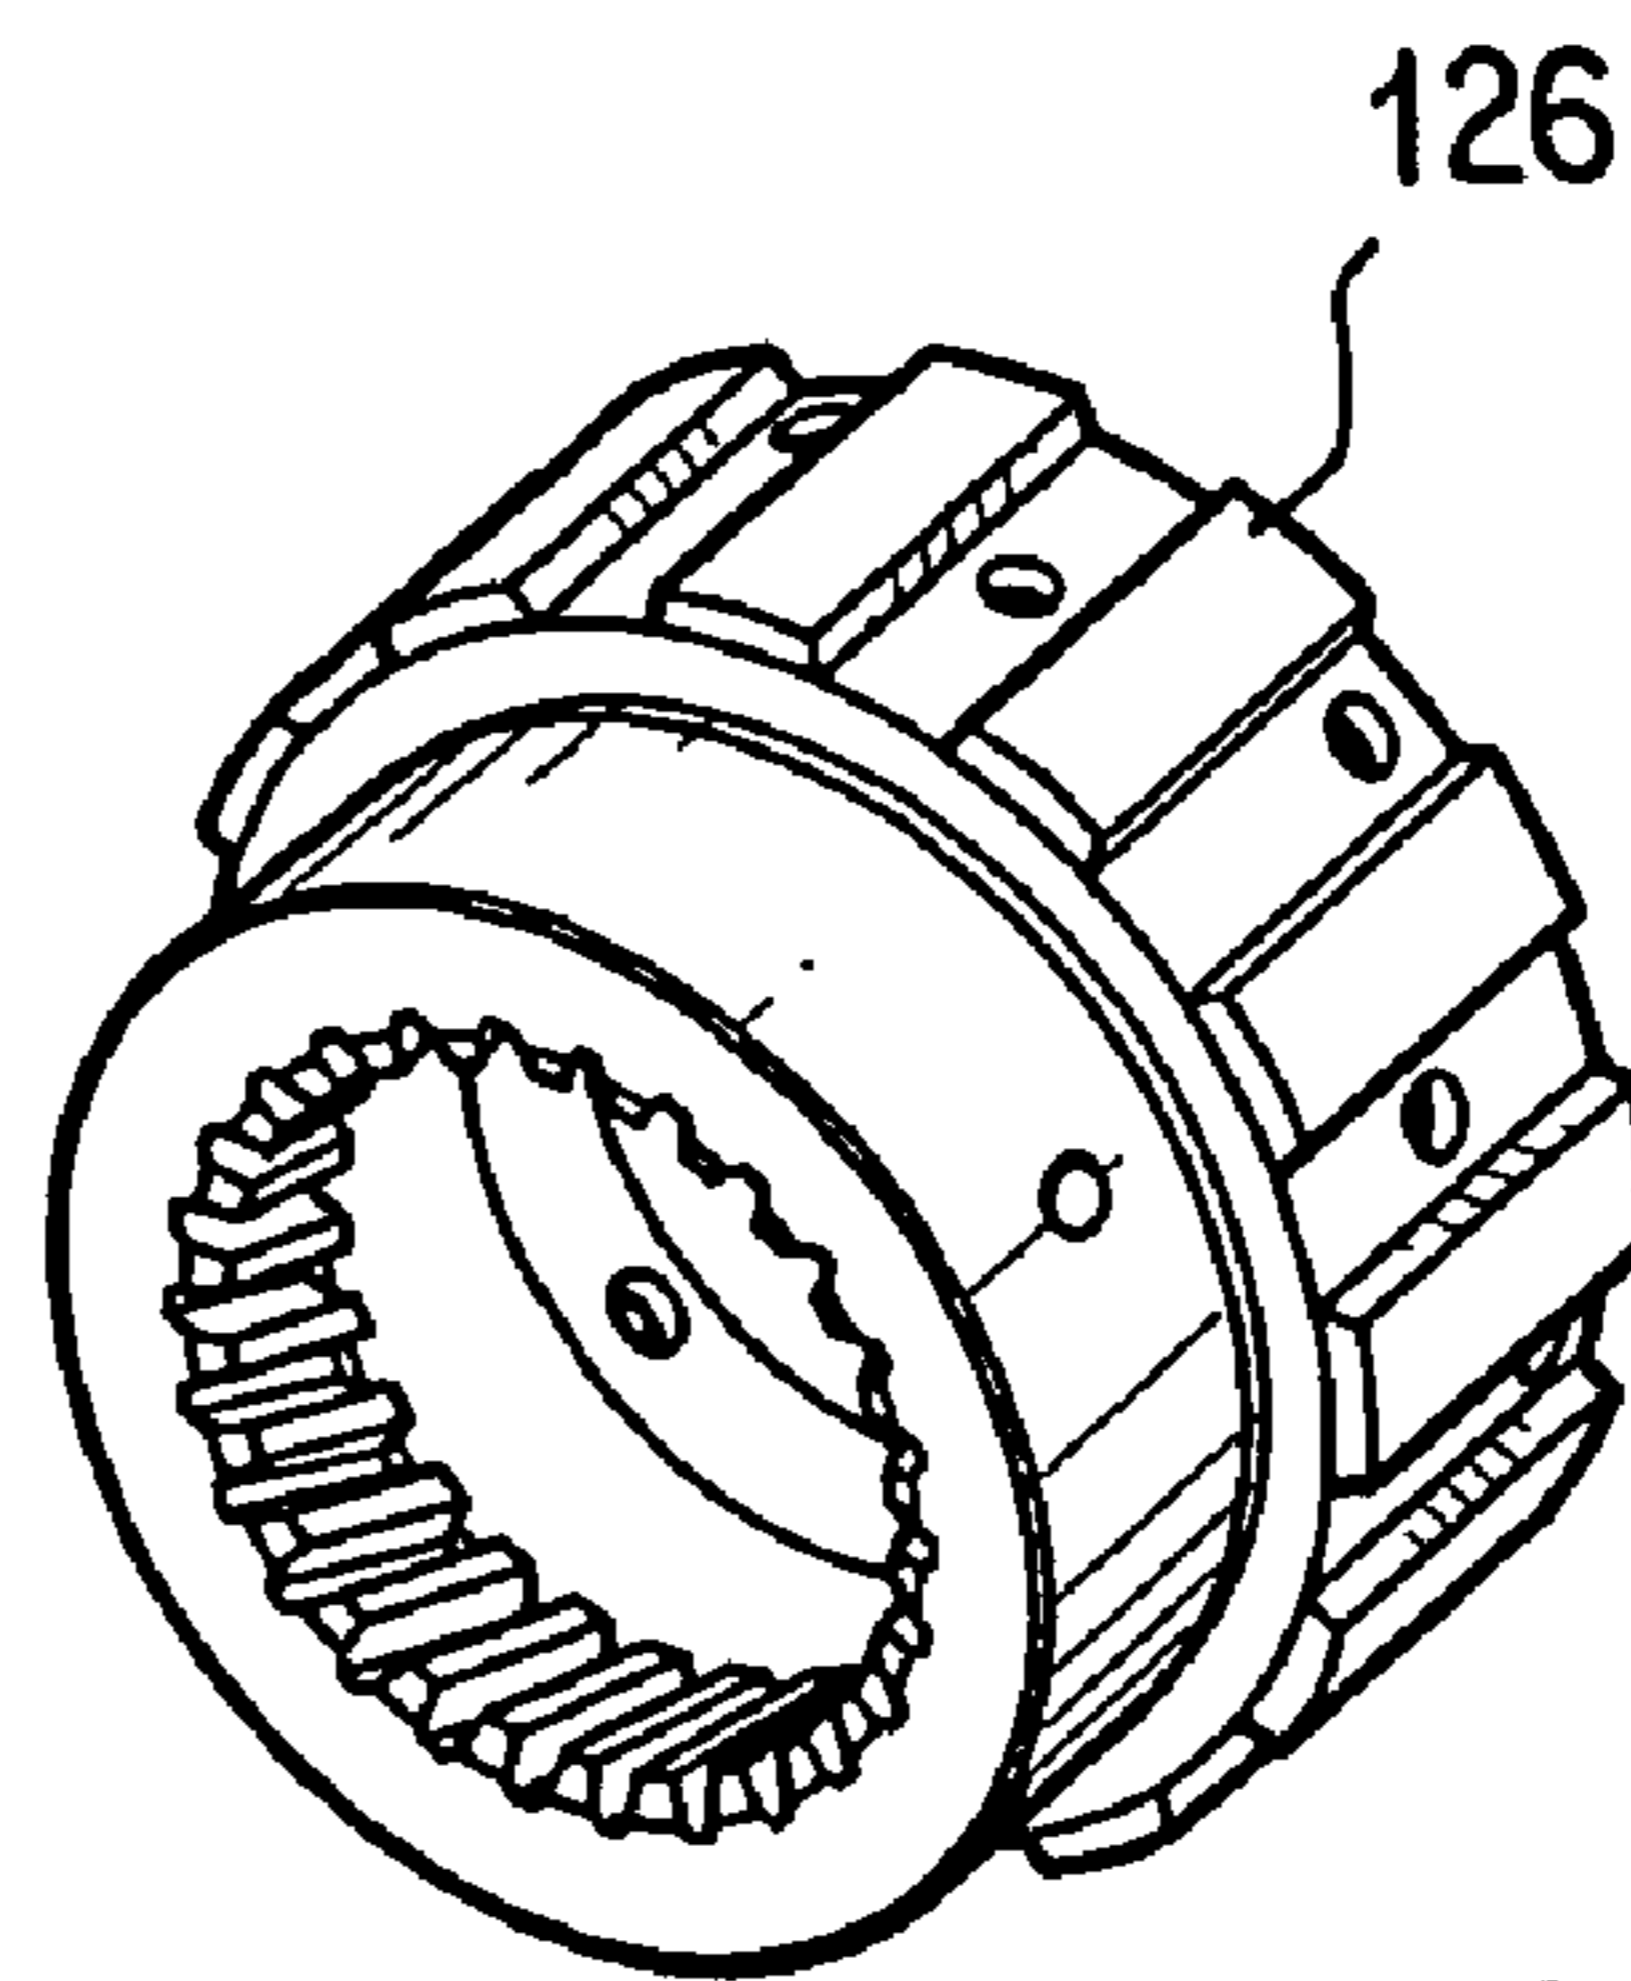
Fig. 9a

GEAR DATA	
NUMBER OF TEETH	12
MODULE	5.25
PRESSURE ANGLE	20°
HELIX ANGLE	SPUR
HAND	SPUR
TOOTH THICKNESS/ NUMBER OF TOOTH	W=41.6 ± 0.04/N=3
MAJOR DIAMETER	Ø 70.45 ± 0.05
MINOR DIAMETER	Ø 66.25 ± 0.05
INTERNAL INVOLUTE SPLINE DATA	
NUMBER OF TEETH	26
DIAMETRAL PITCH	17
PRESSURE ANGLE	18°
HELIX ANGLE	18.08°
HAND	RIGHT
MAJOR DIAMETER	Ø 42.66 ± 0.05
MINOR DIAMETER	Ø 38.65 ± 0.05
PIN DIAMETER	Ø 2.8
MEASUREMENT BETWEEN PINS	37.65 ± 0.04

FIGS. 9a–9c are various views of a front sun gear hub; and FIG. 9d is a table of gear data.

8. Front Sun Gear Hub 126 (FIG. 9a-9c)

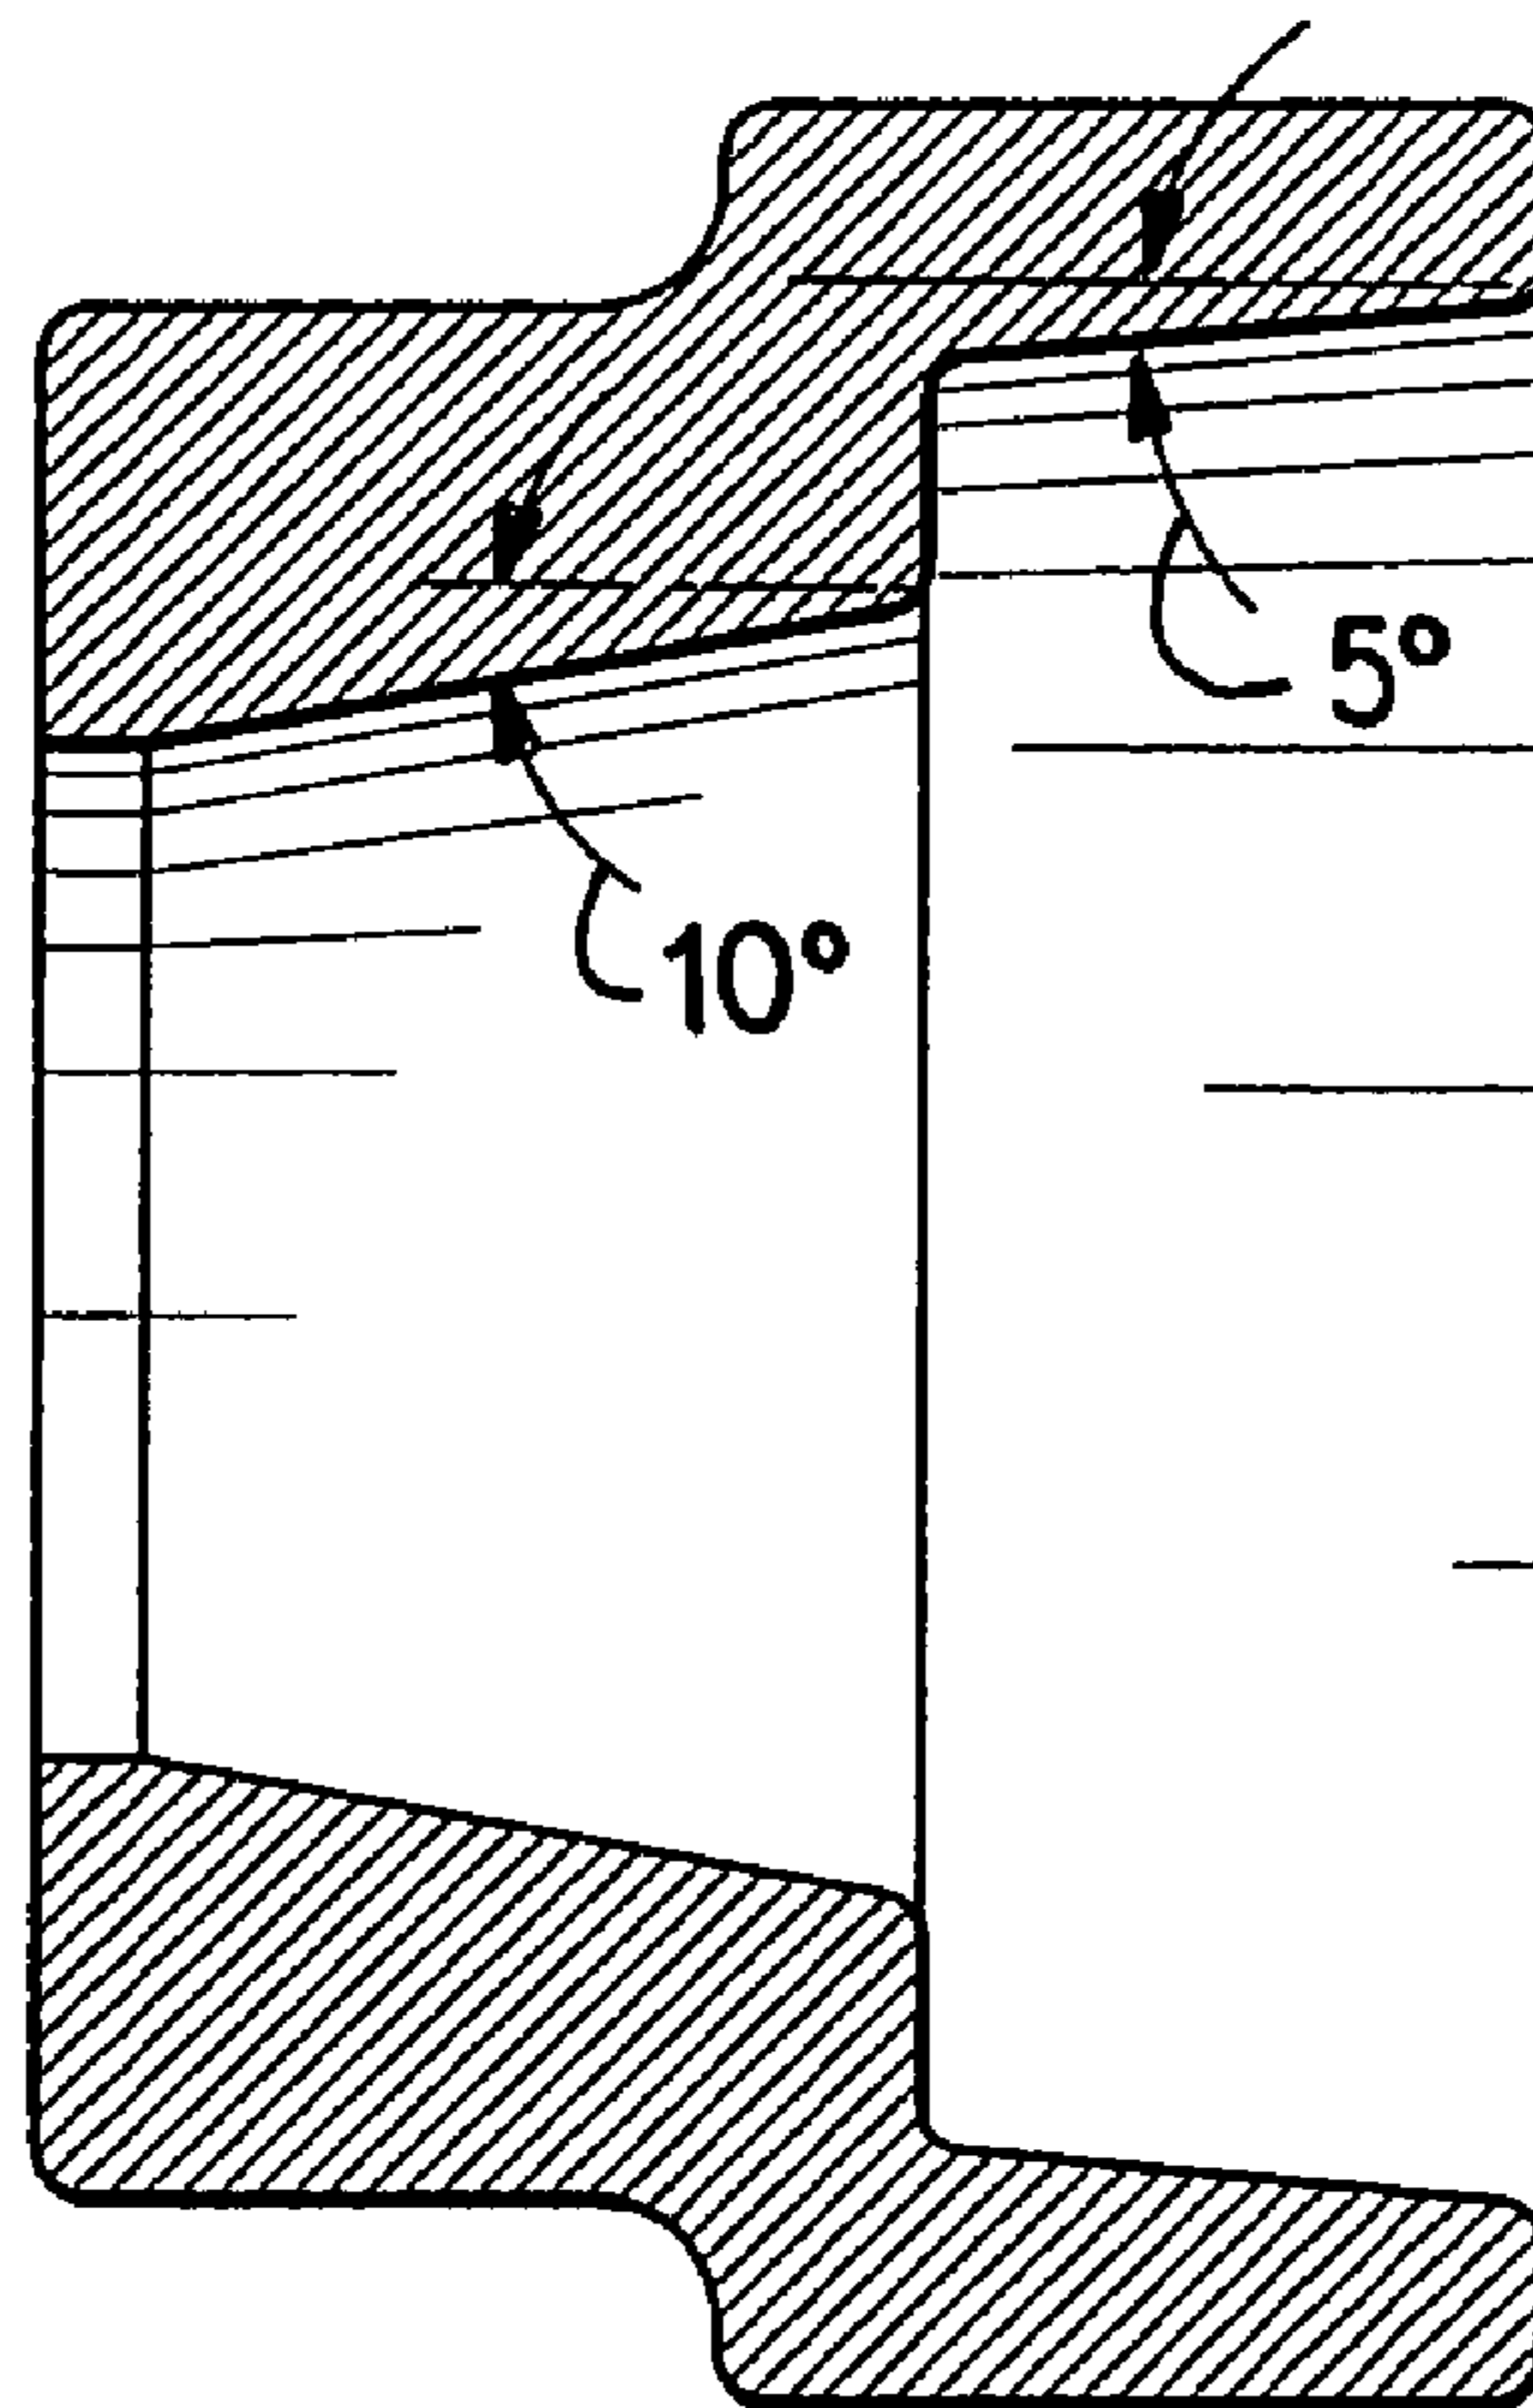
FIG. 10 illustrates front sun gear hub forging.

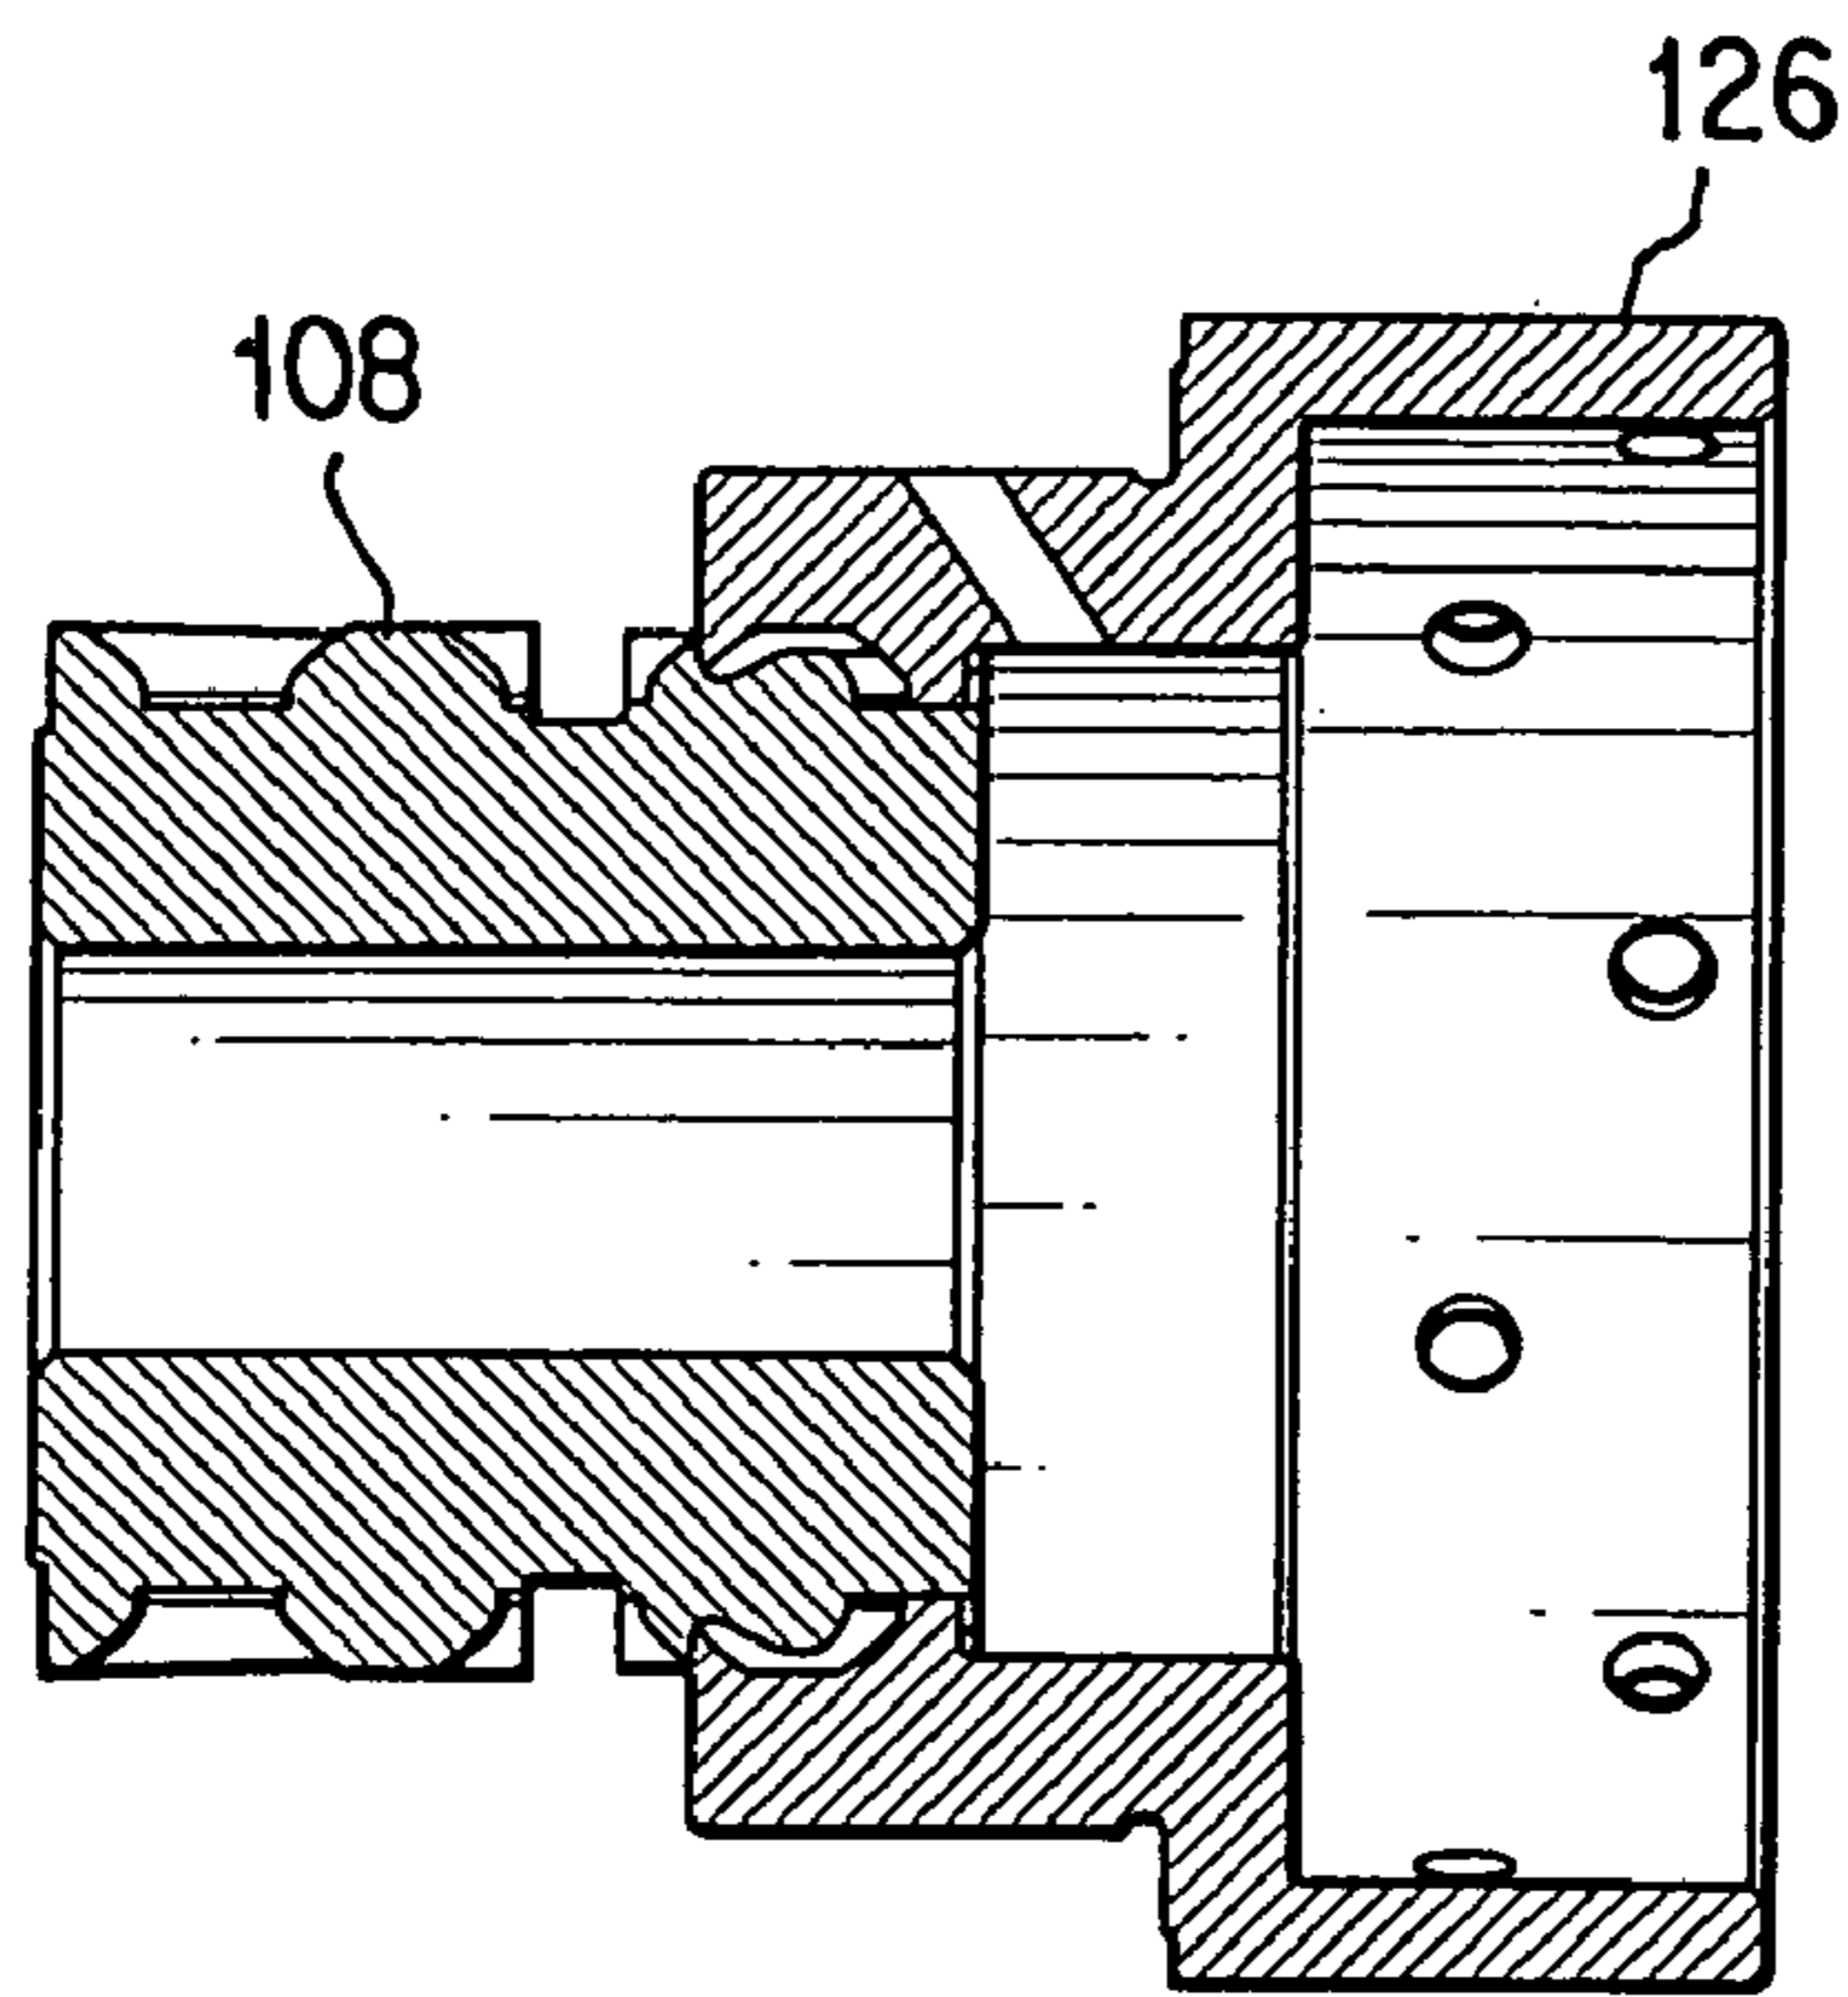
Fig. 11b

FIGS. 11a–11b illustrate a sun gear and hub assembly.

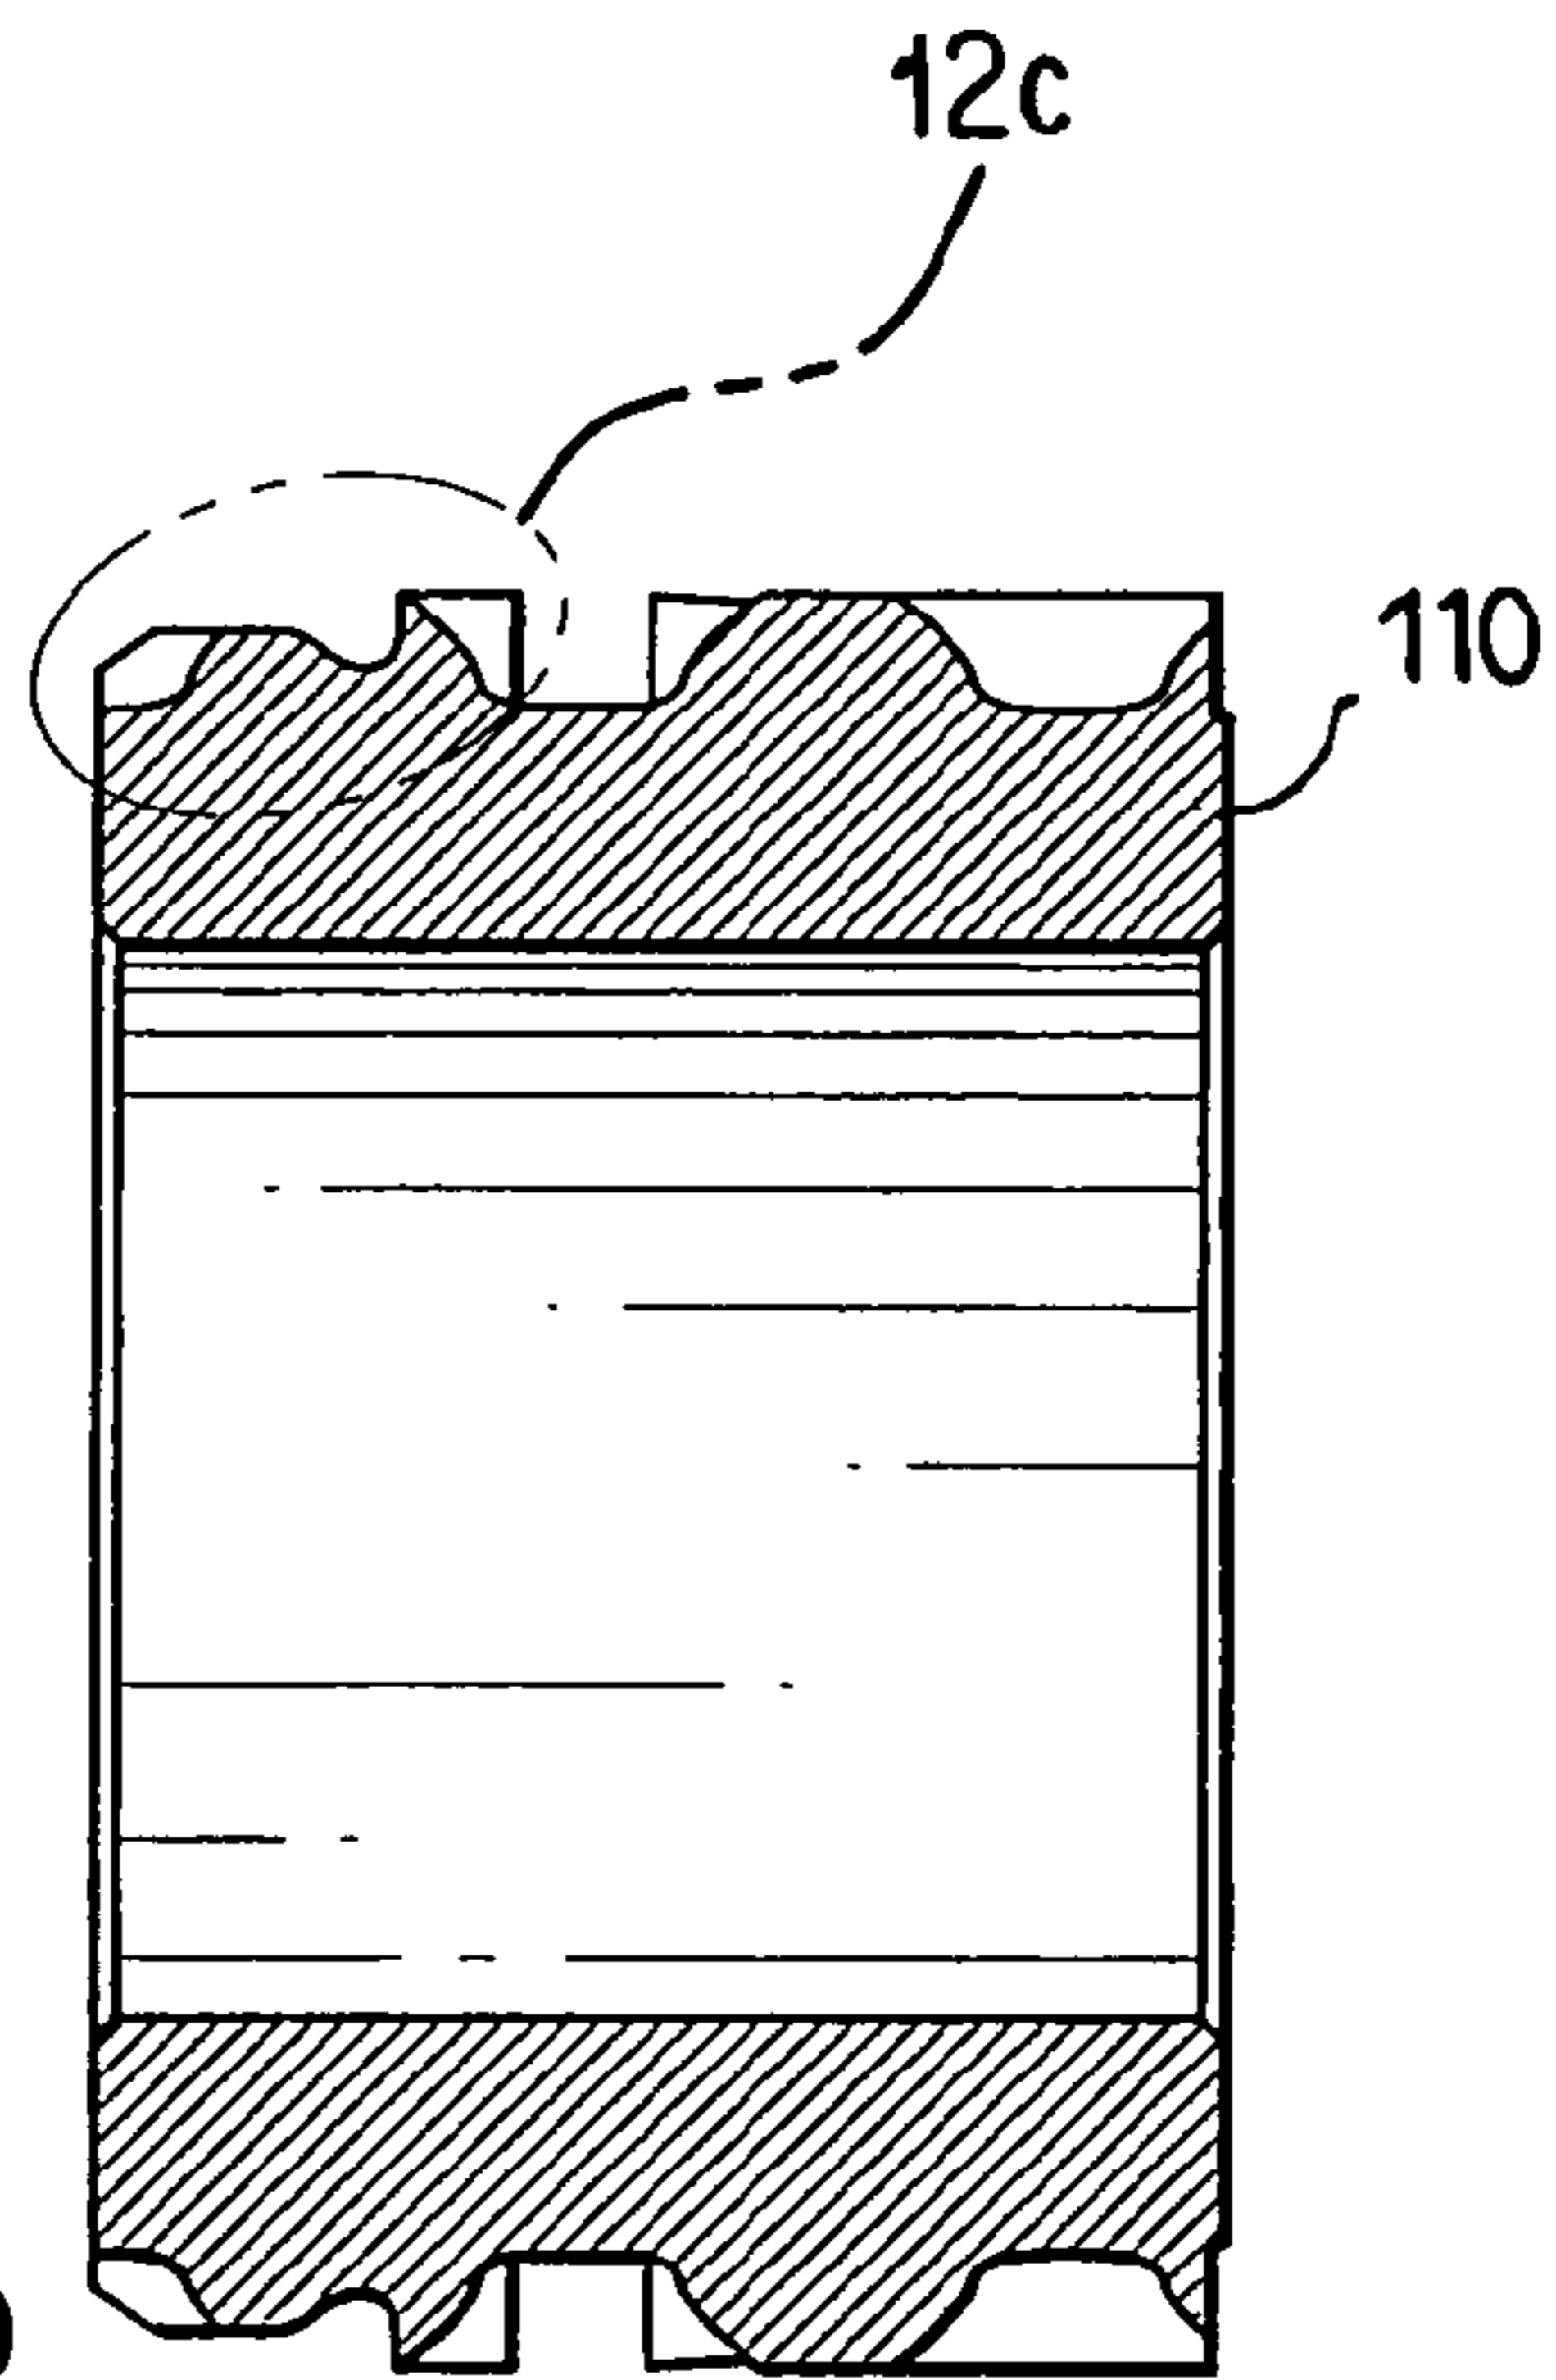
Fig.12b

FIGS. 12–12c illustrate a rear sun gear, with FIG. 12a showing the gear in perspective, FIG. 12b showing the gear in cross section, and FIG. 12c showing a detail 12c of FIG. 12b; and FIG. 12d is a table of external involute spline data.

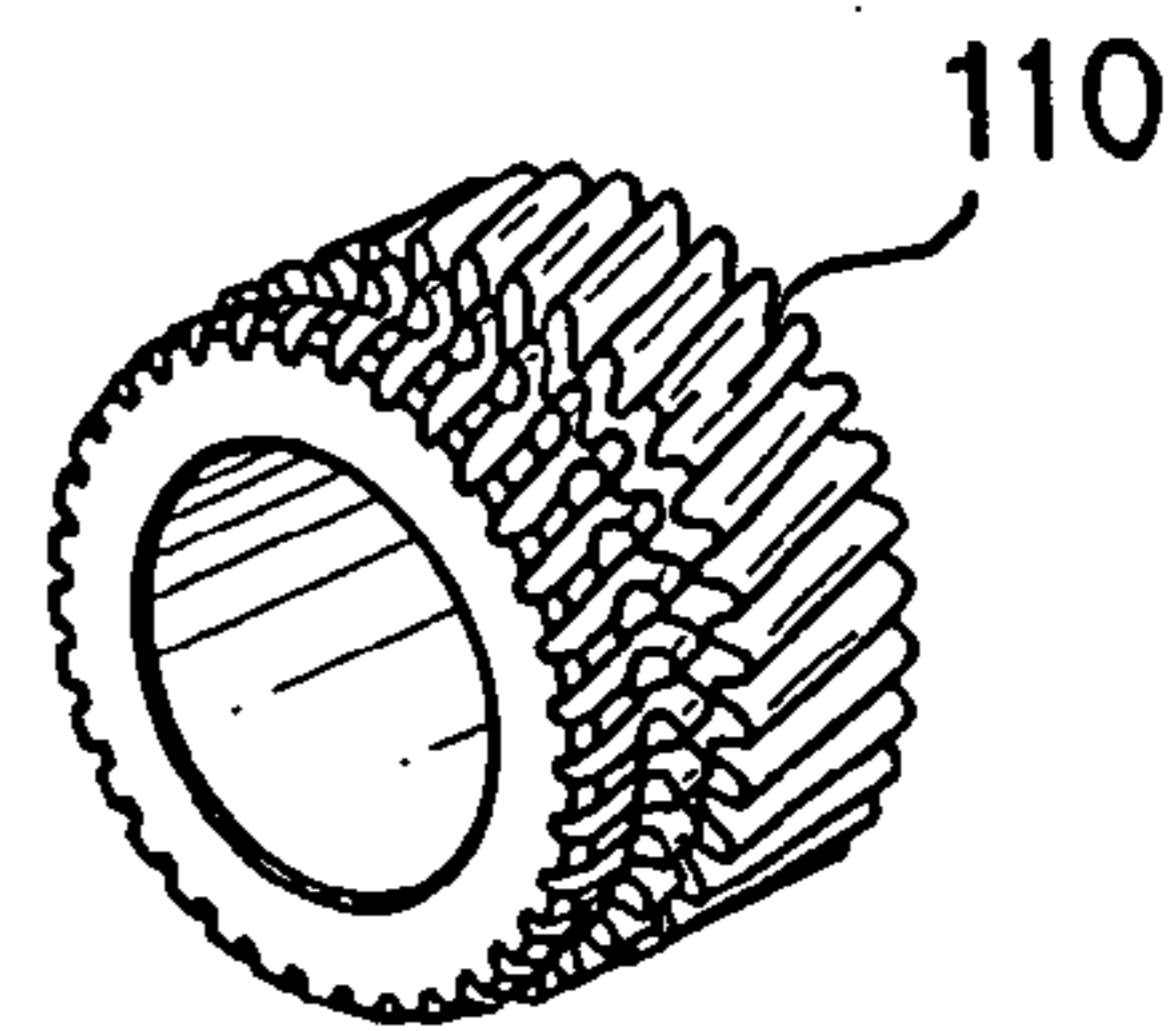
Fig.12a

EXTERNAL INVOLUTE SPLINE DATA	
NUMBER OF TEETH	34
NORMAL PRESSURE ANGLE	18°
NORMAL DIAMETRAL PITCH	17
HELIX ANGLE	18.08°
HAND	LEFT
STANDARD PITCH DIAMETER	Ø 53,44
MAJOR DIAMETER	Ø 57.80 ± 0.02
MINOR DIAMETER	Ø 50.20 ± 0.05
DIAMETER OF MEASURING PIN	Ø 3.0
MEASUREMENT OVER 2 PINS	59.006 ± 0.042
NORMAL CIRCULAR TOOTH THICKNESS	2.520 ± 0.018
NORMAL TIP RADIUS	0.25
NORMAL FILLET RADIUS	FULL
TOTAL COMPOSITE TOLERANCE	0.038
TOOTH TO TOOTH TOLERANCE	0.019
MASTER GEAR NUMBER OF TEETH	40
MASTER GEAR NORM. CIRC. TOOTH THICKNESS	2.3470
TEST RADIUS	27.197 ± 0.067
CROWNING	0.03

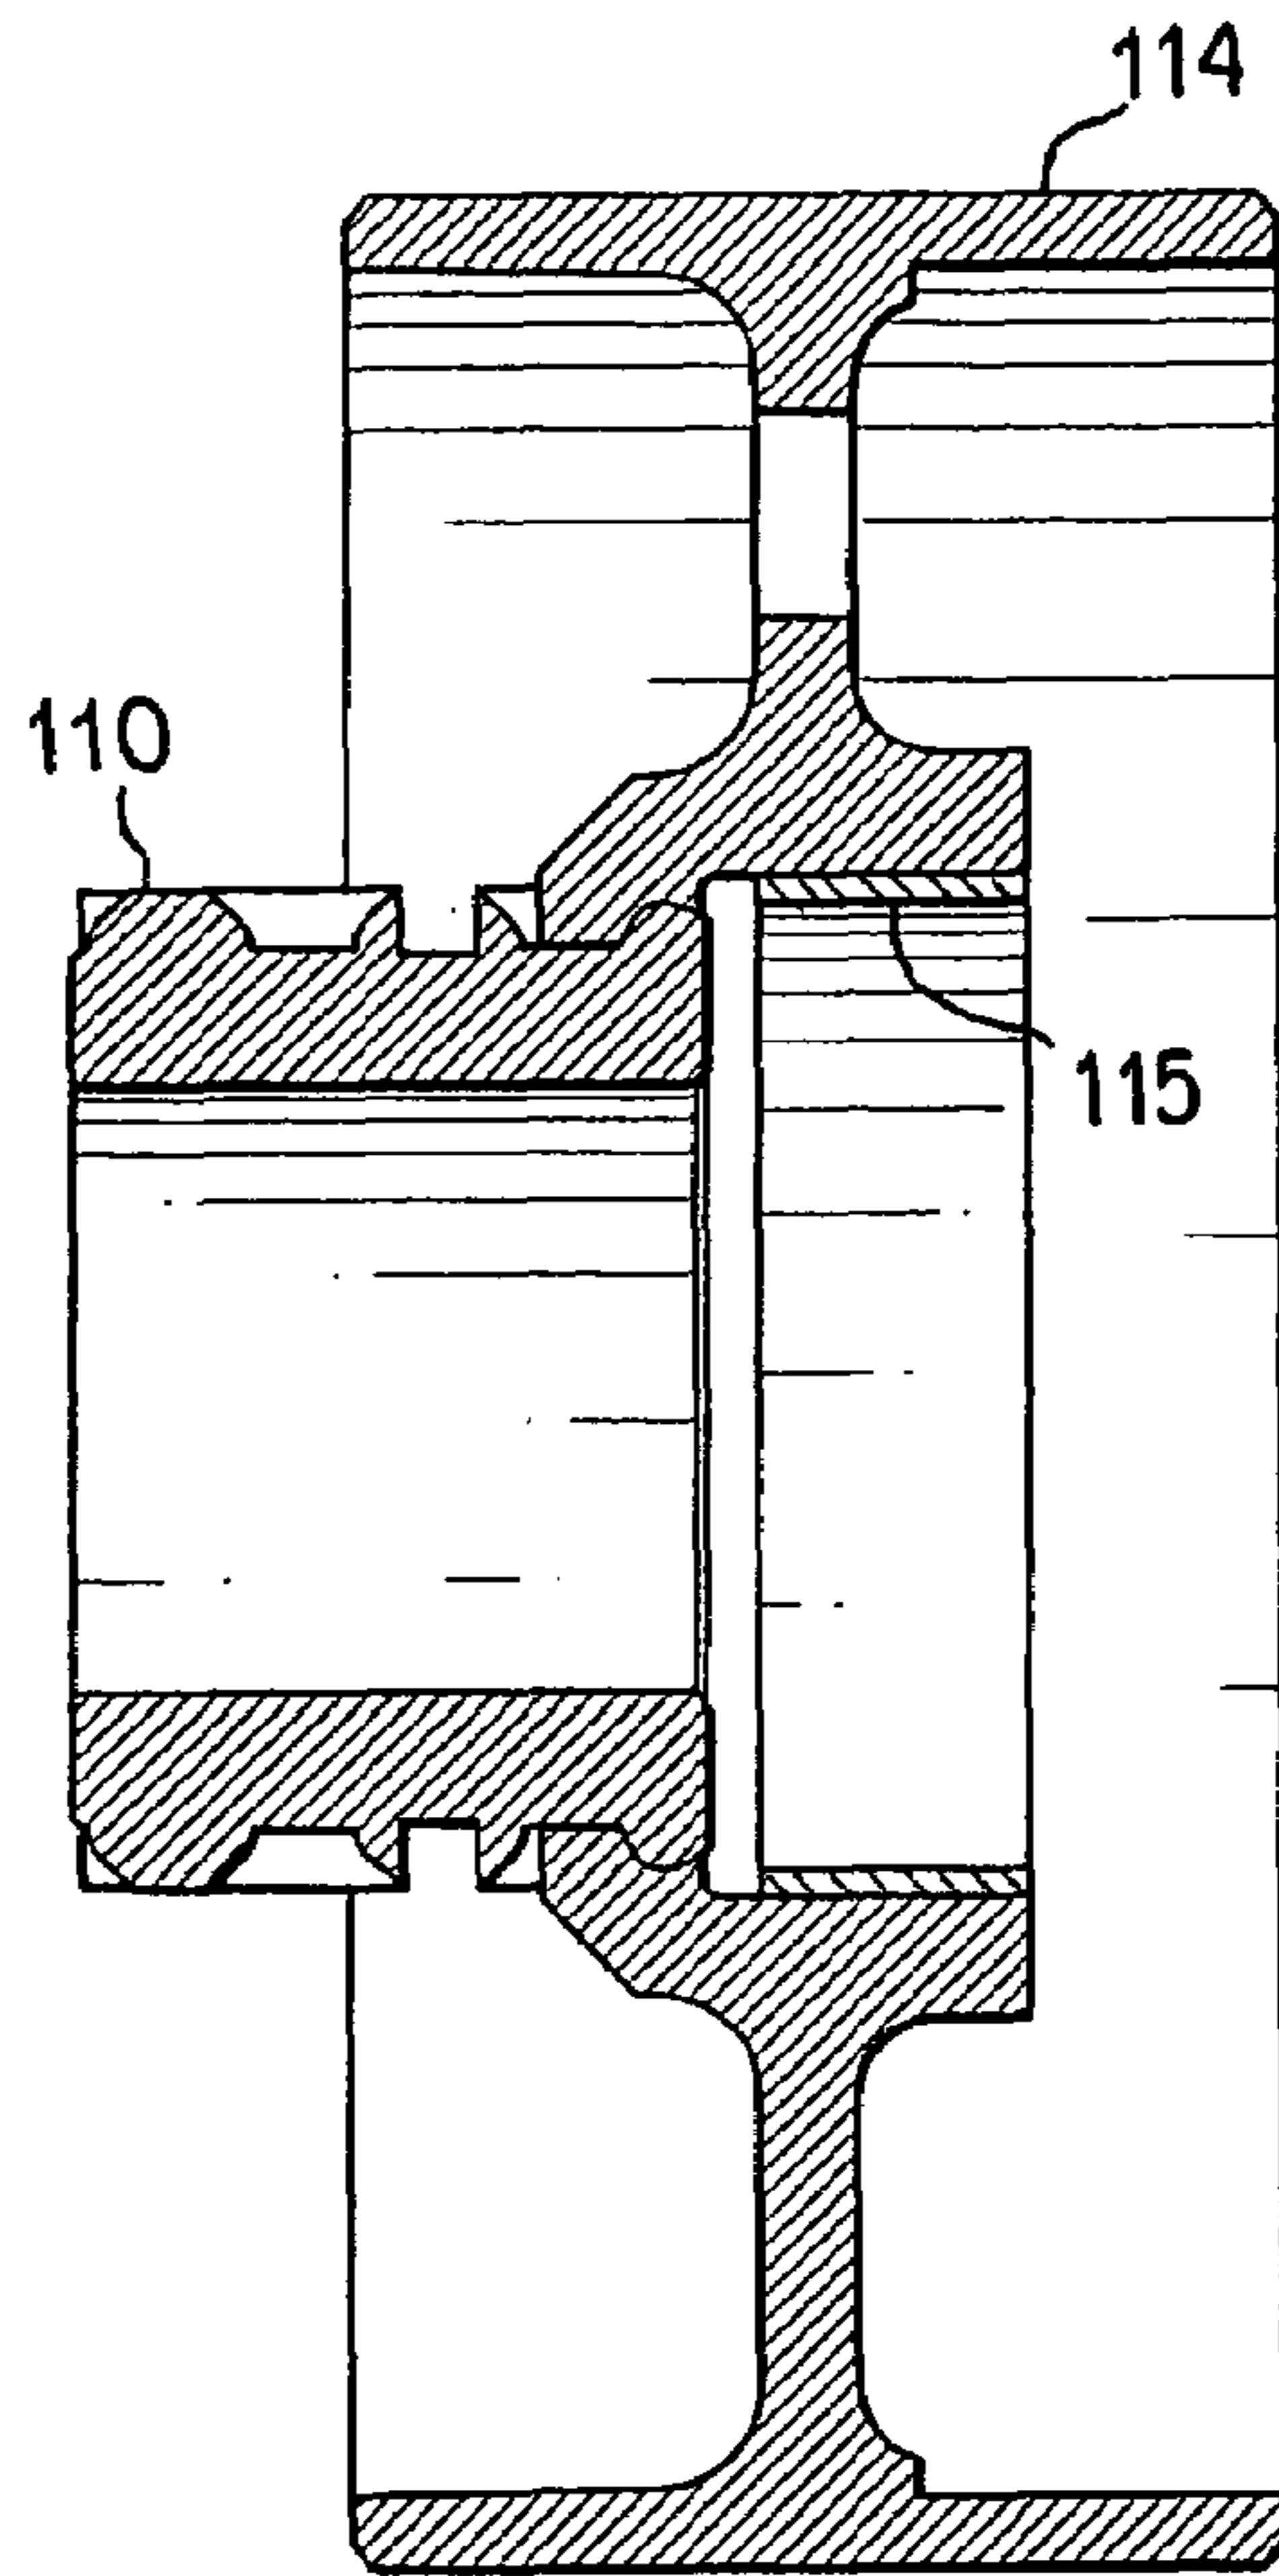
Fig. 13b

FIGS. 13–13b illustrate an assembled rear sun gear.

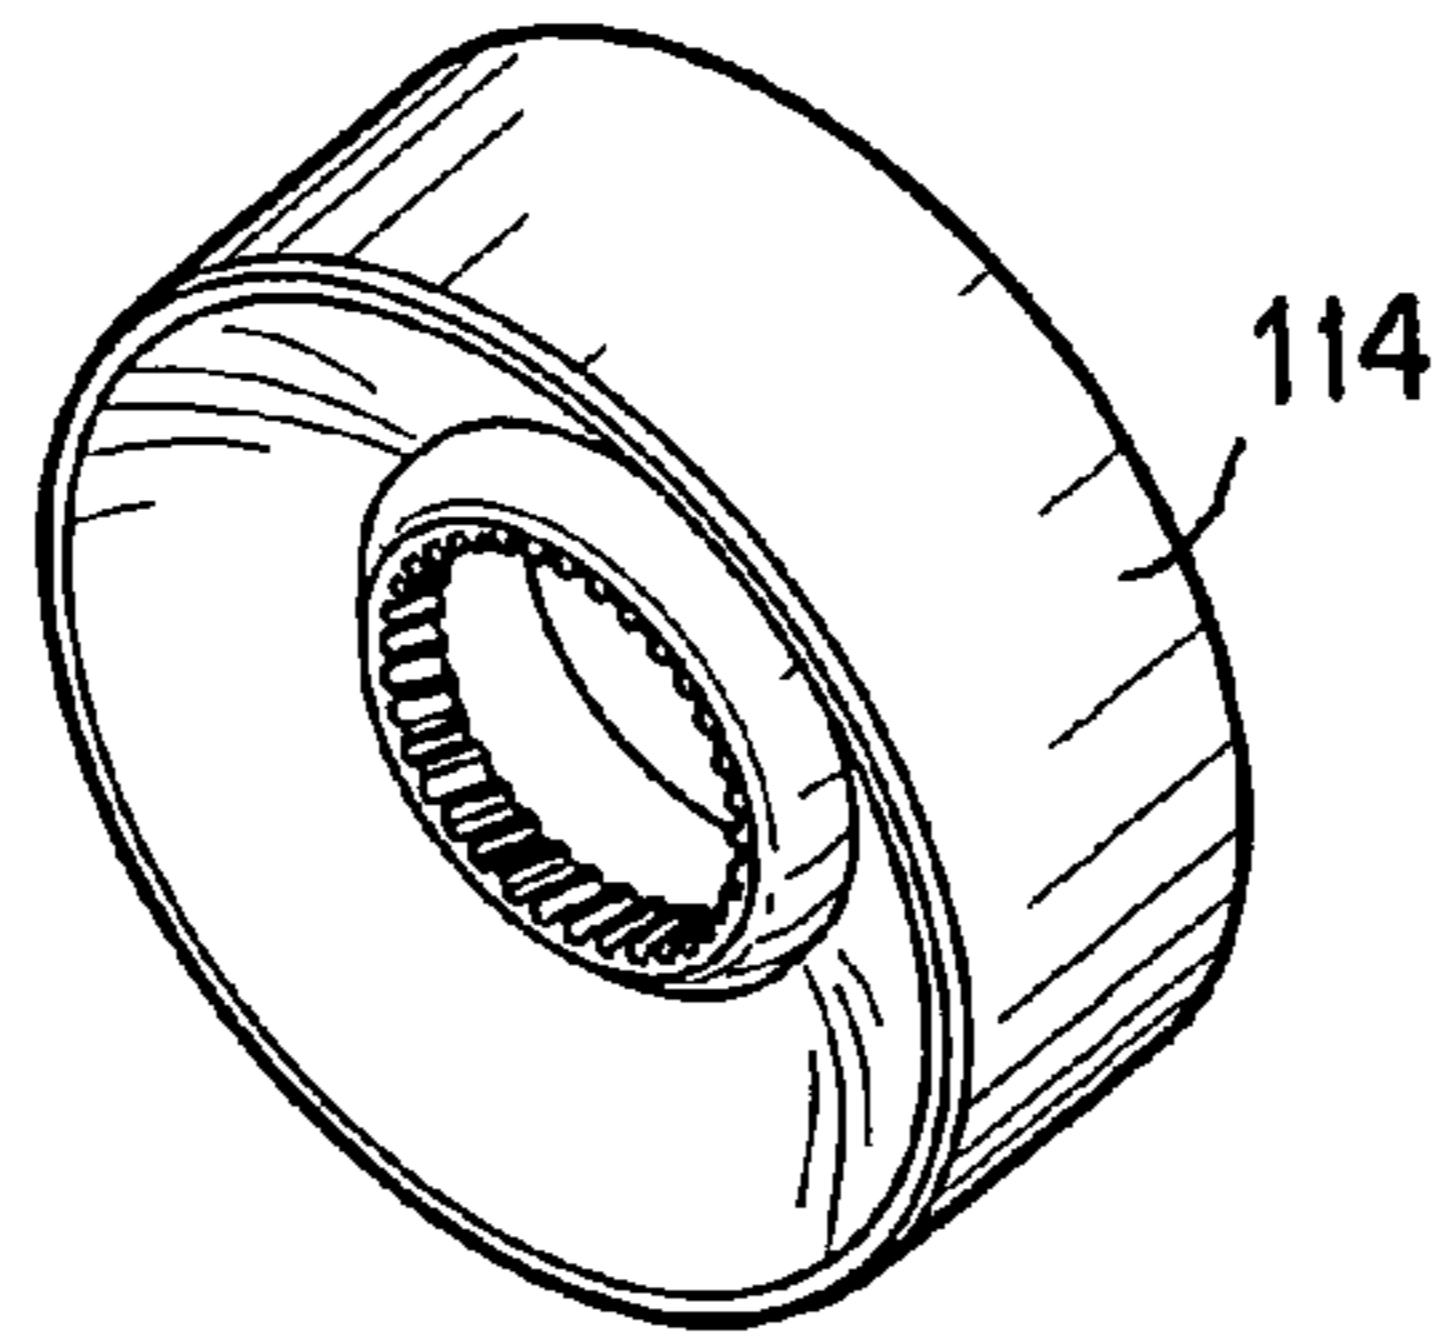
Fig. 14a

FIGS. 14a–14c illustrate a rear band drum; and FIG. 14d is a table of inner gear data.
