(12) **United States Patent**
Dalenberg et al.

(10) **Patent No.:** **US 7,195,578 B2**
(45) **Date of Patent:** **Mar. 27, 2007**

(54) **AUTOMATIC TRANSMISSION AND GEAR TRAIN**

The present invention relates to automatic transmissions. In particular, the instant invention relates to an automatic transmission with improved resistance to deterioration with an increased effective life. The transmission of the instant invention comprises eight pinion gears assembled into one carrier utilizing a forward and a rear sun gear, a ring gear, a band drum and a one way roller clutch.

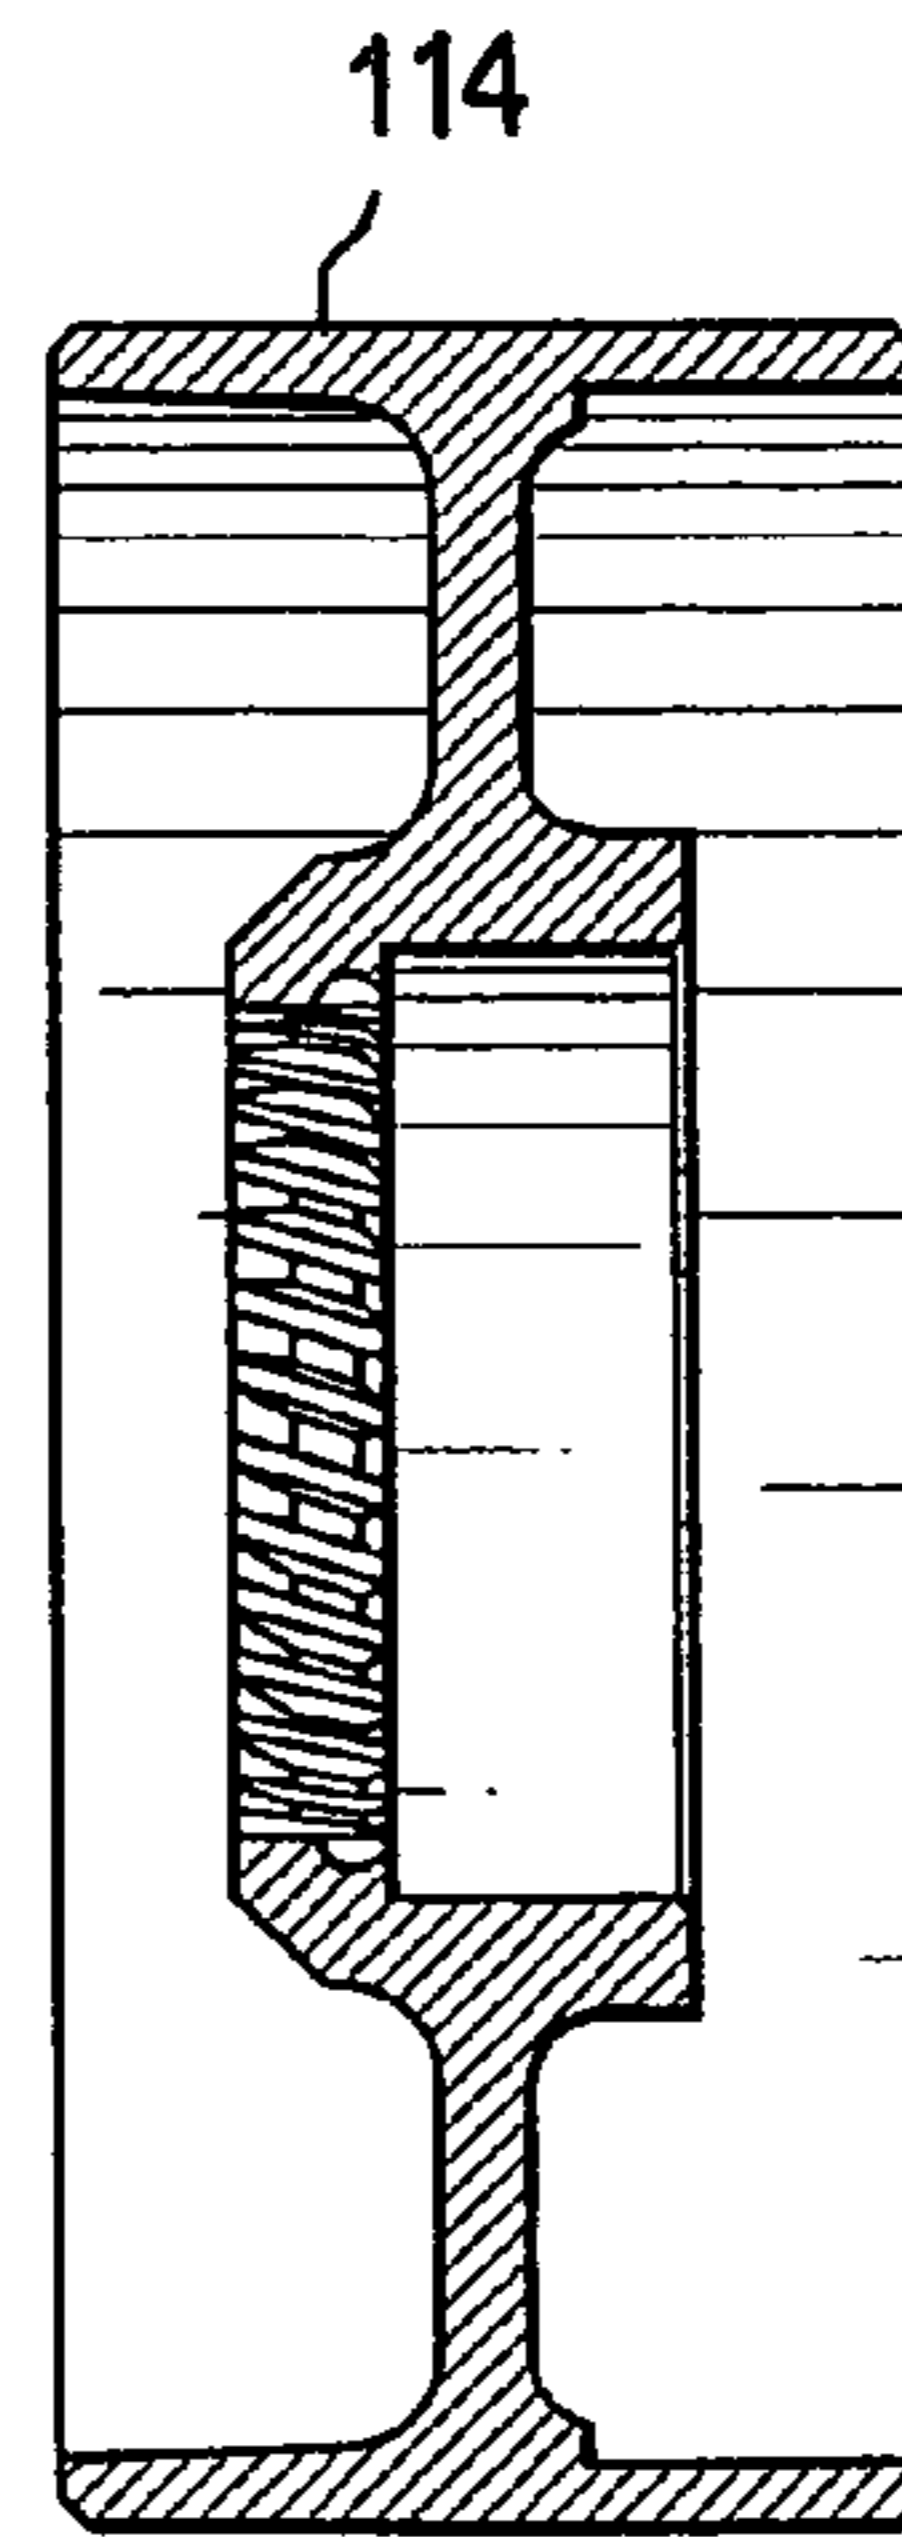
Fig. 14b

INNER GEAR DATA	
NUMBER OF TEETH	34
DIAMETRAL PITCH	17
PRESSURE ANGLE	18°
HELIX ANGLE	18.08°
HAND	LEFT
MAJOR DIAMETER	$\Phi 55.51 \pm 0.05$
MINOR DIAMETER	$\Phi 51.25 \pm 0.05$
PIN DIAMETER	$\Phi 2.8$
MEASUREMENT BETWEEN PINS	49.04 ± 0.04

FIGS. 14a–14c illustrate a rear band drum; and FIG. 14d is a table of inner gear data.

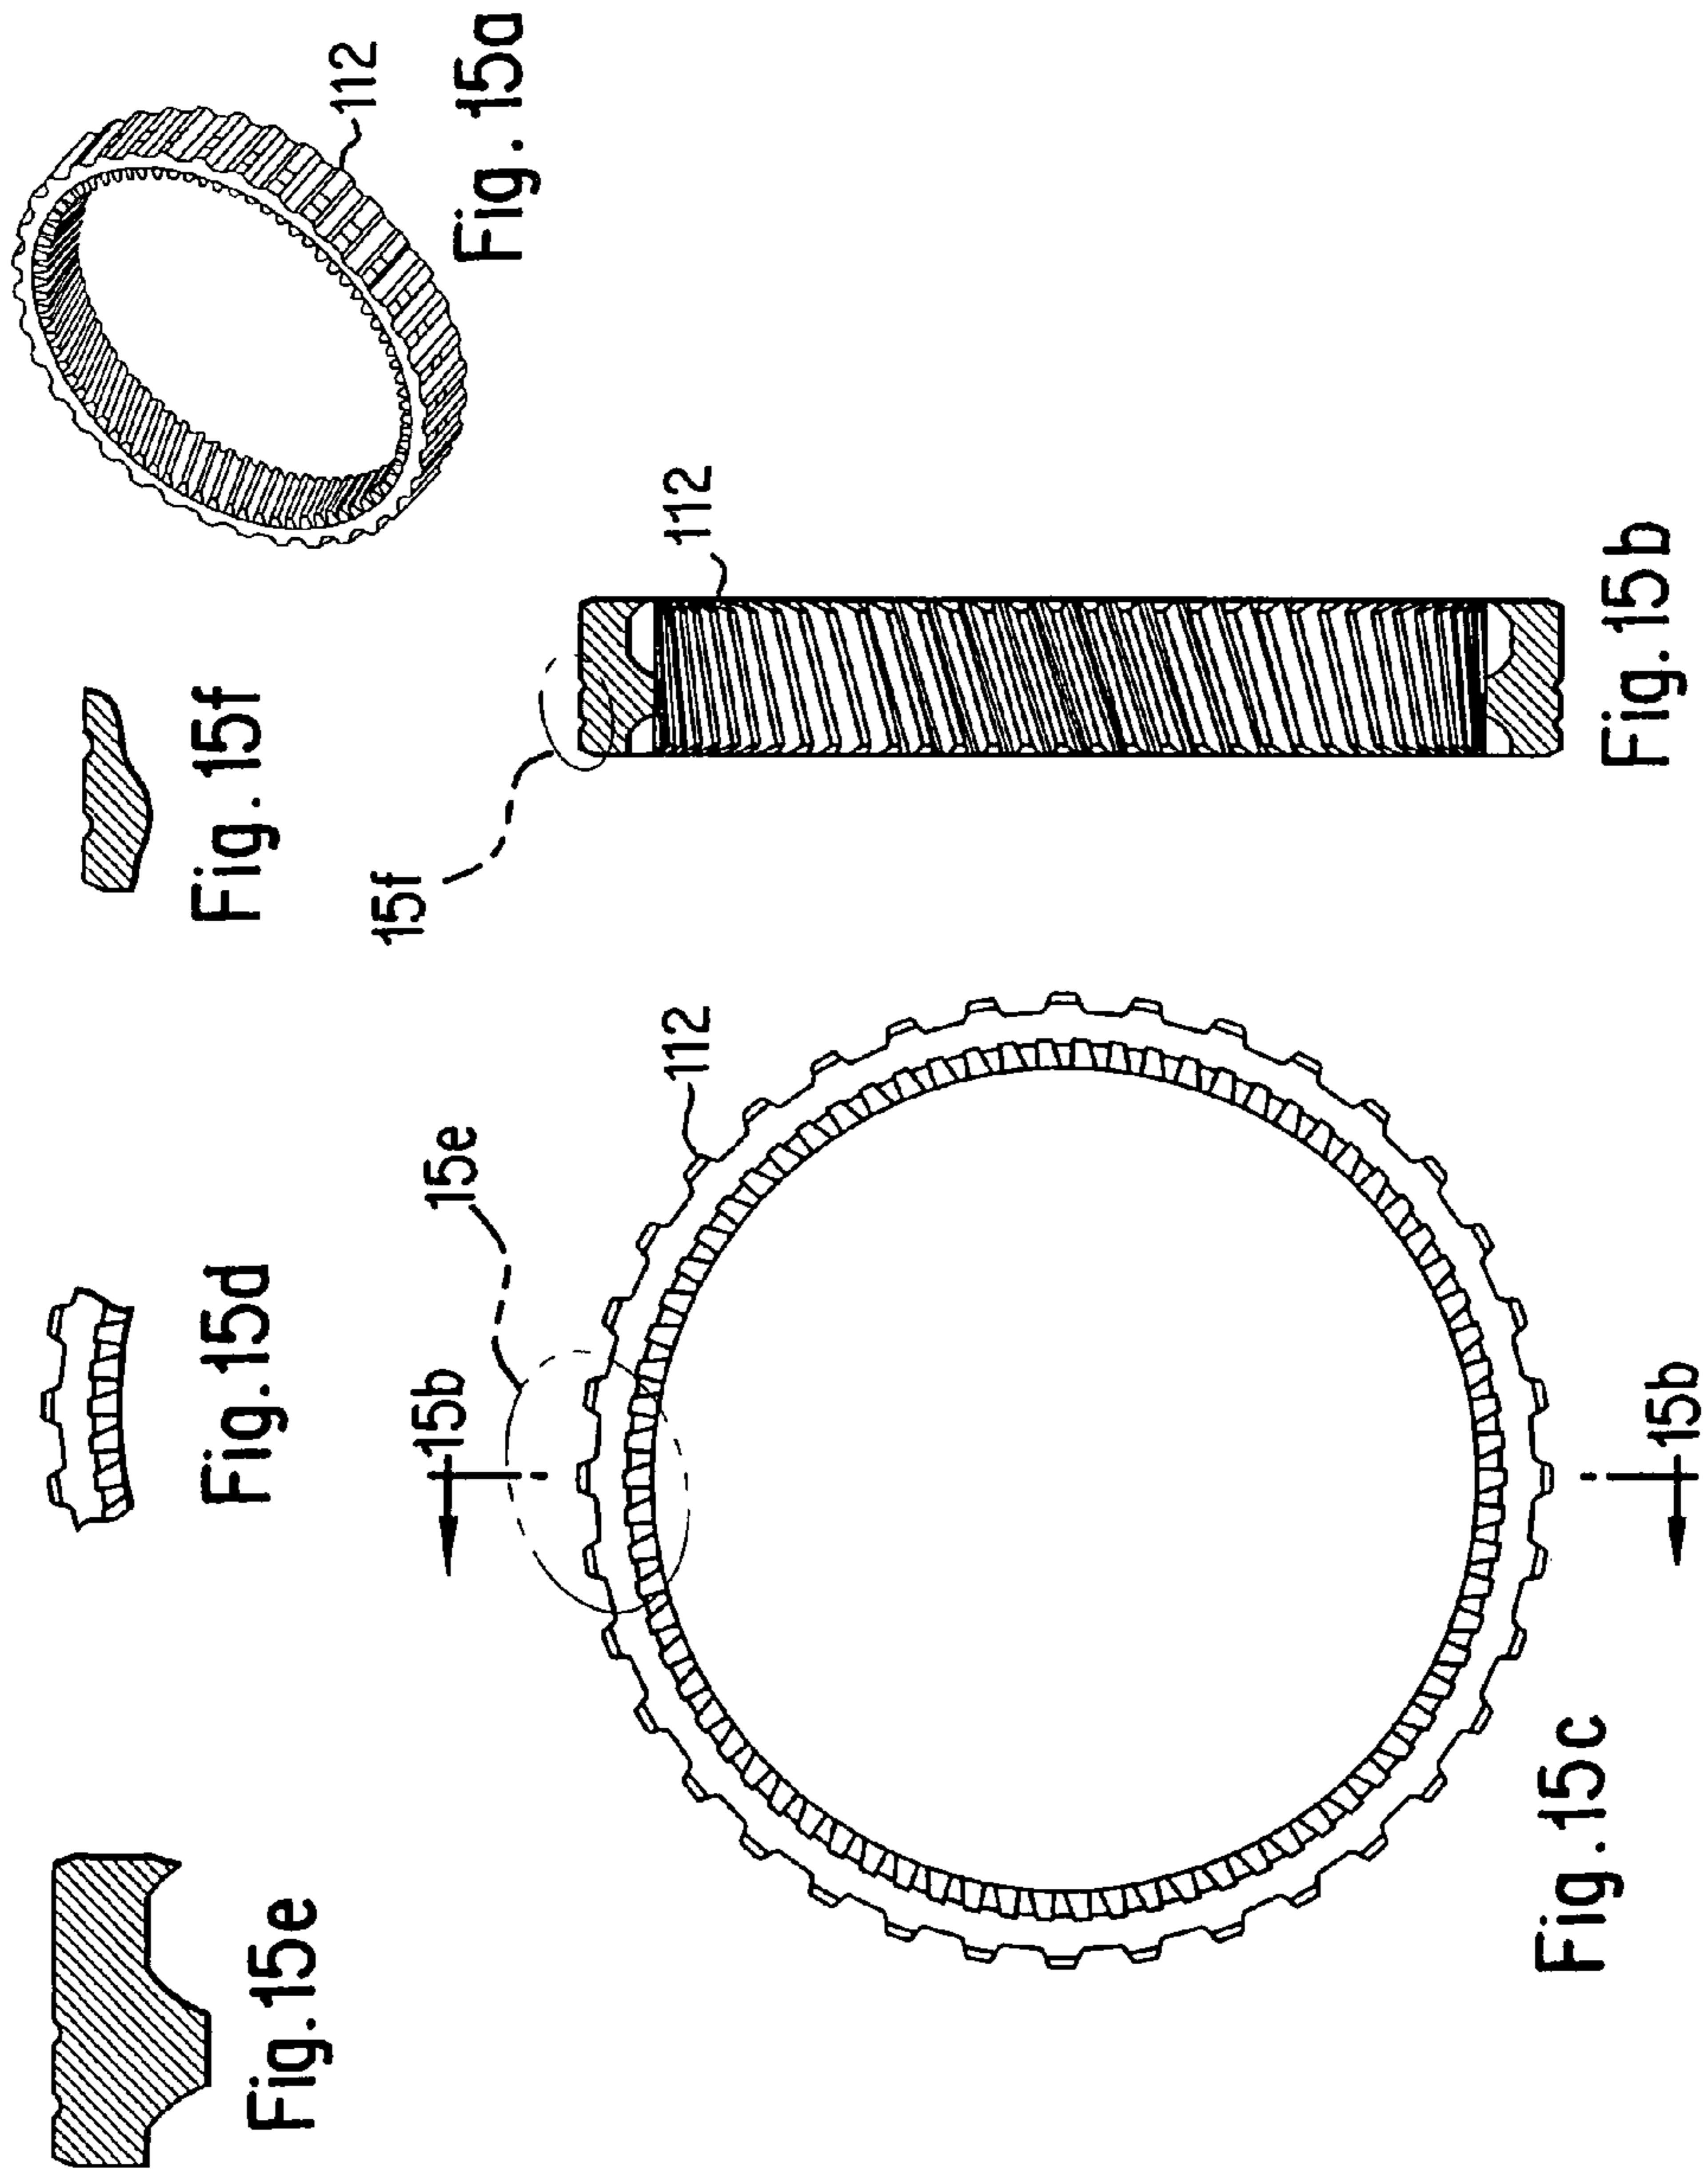
Fig. 15g

EXTERNAL SPLINE DATA	
NUMBER OF TEETH	36
MODULE	3.83245
PRESSURE ANGLE	24° 33' 36"
MAJOR DIAMETER	ϕ 130.070 \pm 0.10
MINOR DIAMETER	ϕ 132.92 \pm 0.10
INTERNAL GEAR DATA	
NUMBER OF TEETH	14
NORMAL DIAMETRAL PITCH	17
NORMAL PRESSURE ANGLE	18
HELIX ANGLE	18.08°
HAND	RIGHT
STANDARD PITCH DIAMETER	ϕ 116.310
MAJOR DIAMETER	ϕ 125.0 \pm 0.25
MINOR DIAMETER	ϕ 116.99 \pm 0.10
DIAMETER OF MEASURING PIN	ϕ 3.0
MEASUREMENT OVER 2 PINS	116.000 \pm 0.038
NORMAL CIRCULAR TOOTH THICKNESS	0.778 \pm 0.015
NORMAL TIP RADIUS AT MAJOR DIAMETER	FULL
NORMAL FILLET RADIUS AT MINOR DIAMETER	0.15 MAX
TOTAL COMPOSITE TOLERANCE	0.177 $\text{\textcircled{T}}$
TOOTH TO TOOTH TOLERANCE	0.063

FIGS. 15a–15f illustrate a ring gear; and FIG. 15g is a table of external spline data.

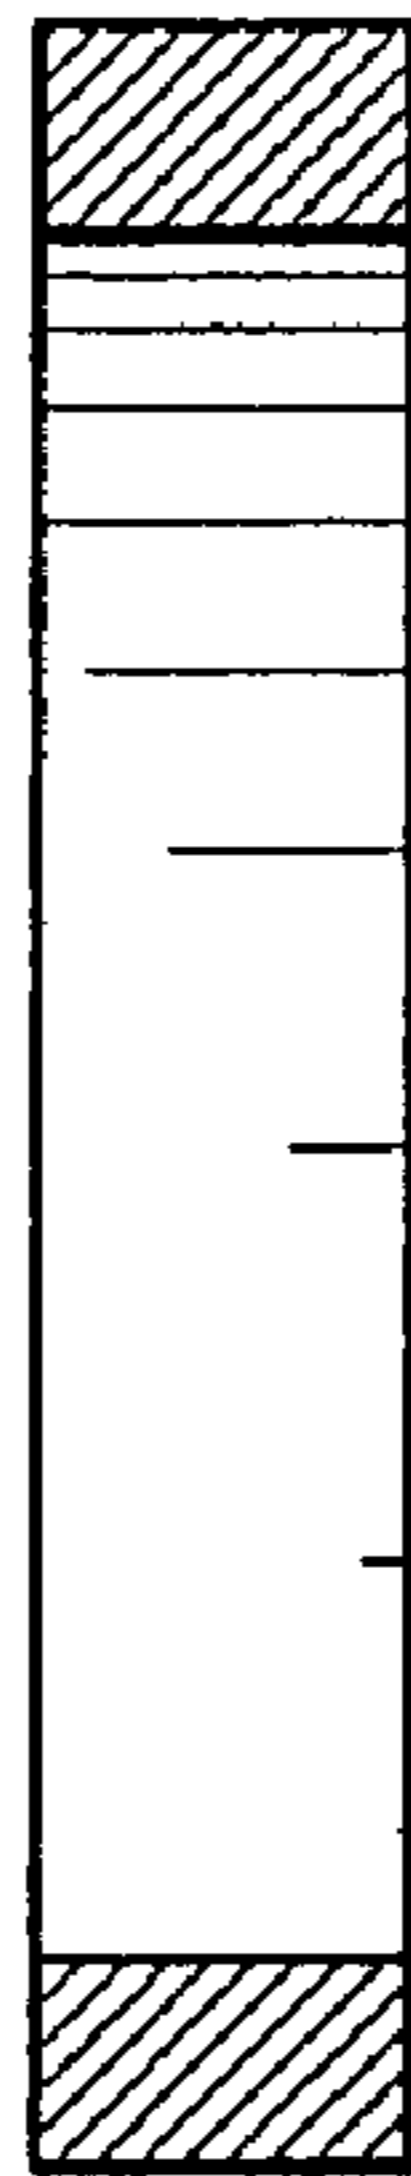
Fig. 16b

FIGS. 16a–16b illustrate a ring gear forging.

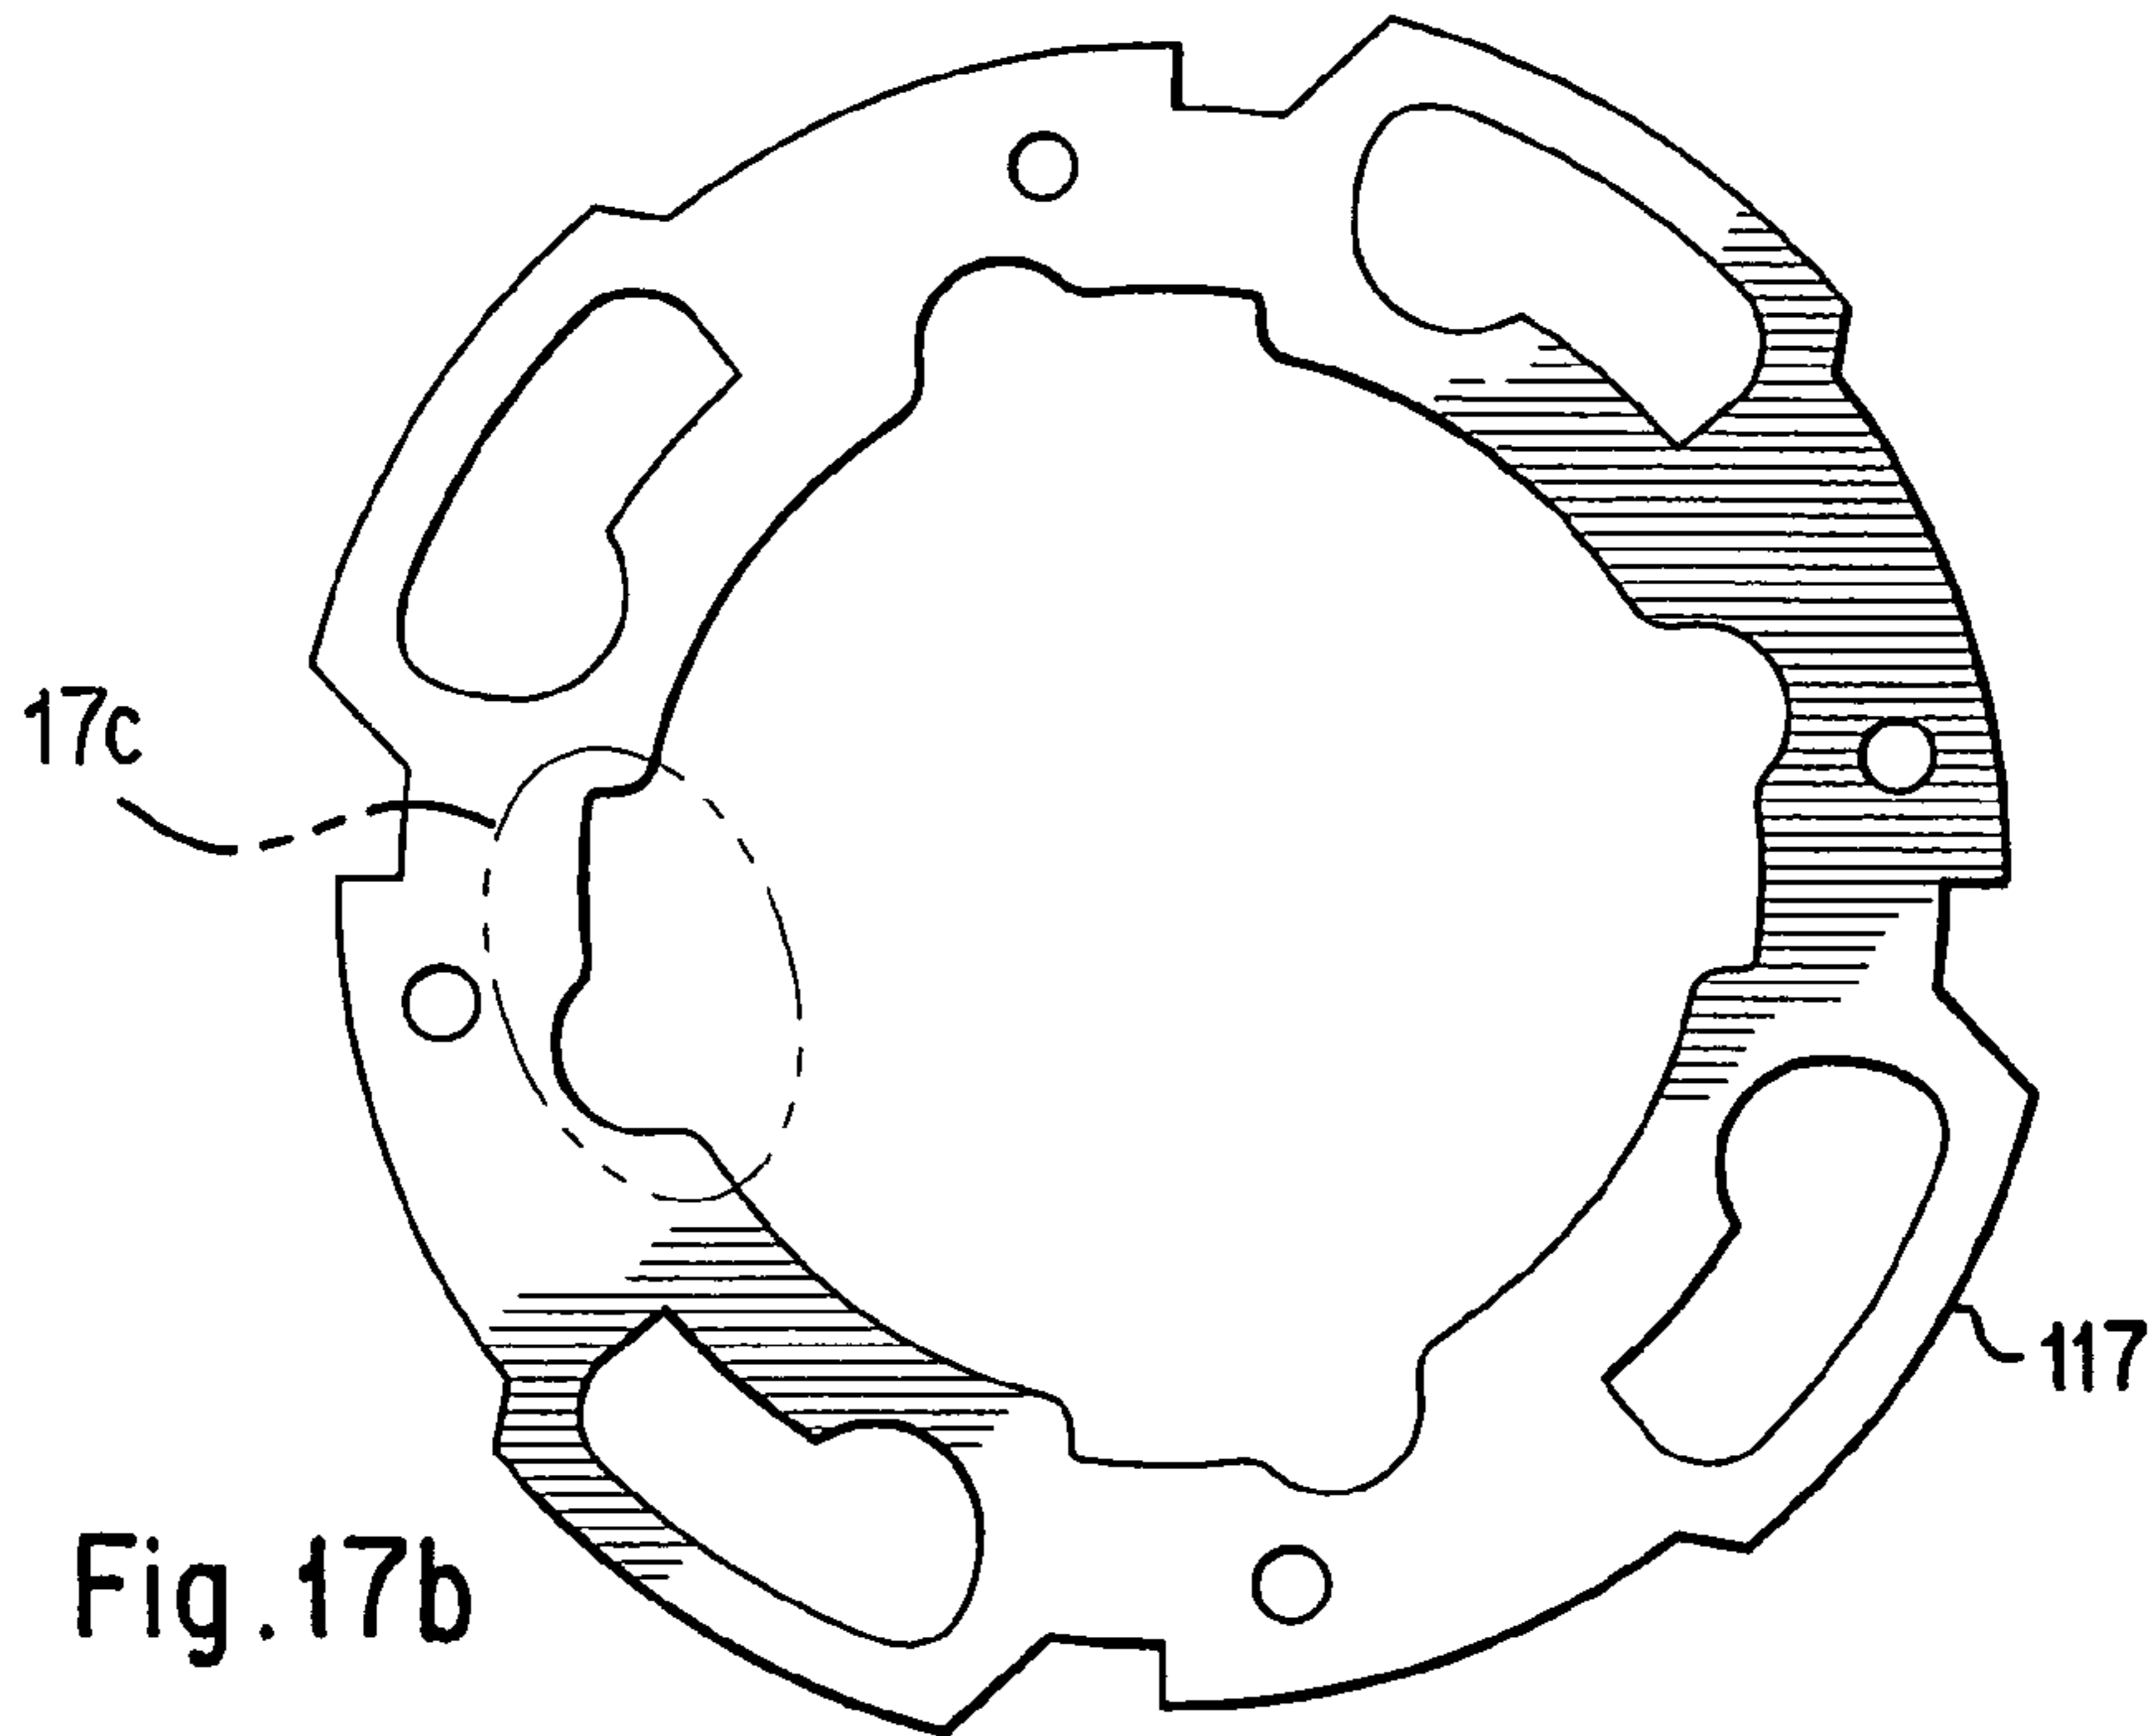
Fig. 17b

FIGS. 17a–17b illustrate a lock plate; and FIG. 17c is an enlarged view of section 17c shown in FIG. 17b.

Also indicated in FIG. 26a-26c are rivets 200, a small phosphor bronze washer 202 (see also FIG. 18a-18c), a compound pinion pin 204 (see also FIG. 2a-2c), a plain pinion pin 206 (see also FIG. 4a-4c), an output shaft 116 (see also FIG. 5a-5c), a lock plate 117 (see also FIG. 17a-17c), a small SK5 washer 218, a large SK5 washer 210 (see also FIG. 19a-19c), a needle sleeve 212 (see also FIG. 20a-20b), a plug 214 (see also FIG. 21a-21b), a large phosphor bronze washer 216, and a needle roller bearing 220 including needle rollers 222 (see also FIG. 22a-22b).

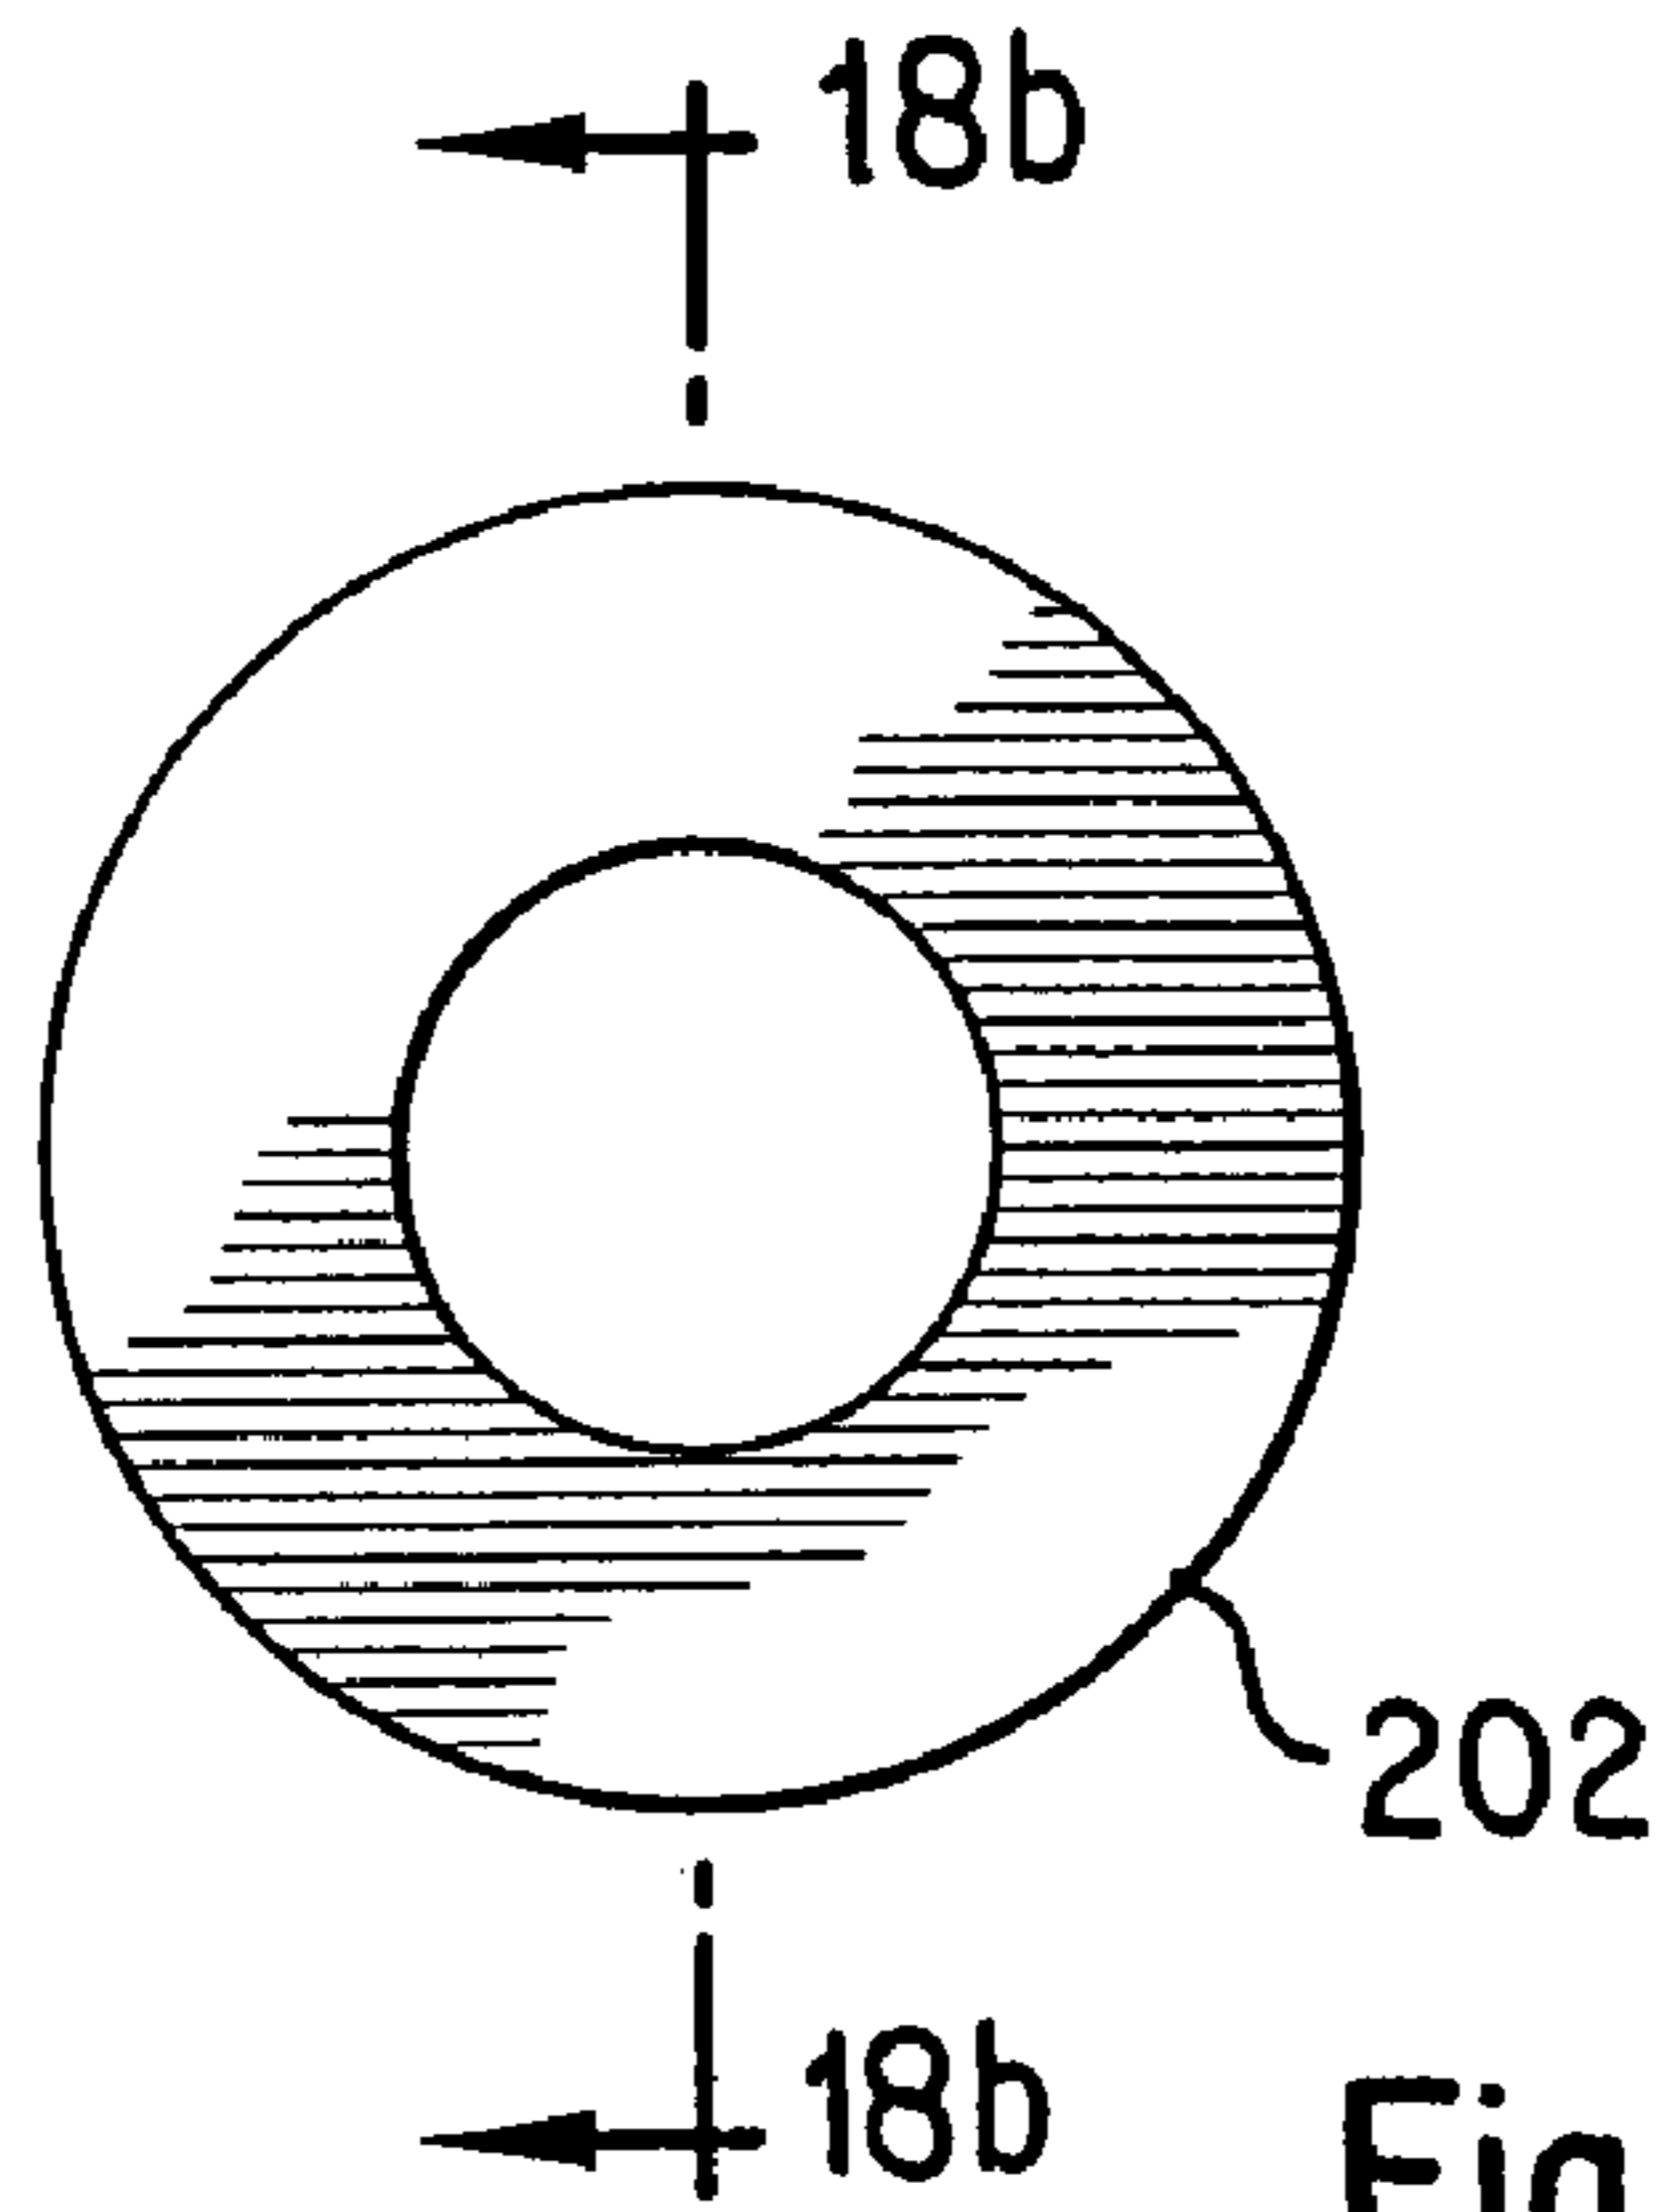
Fig. 18c

FIGS. 18a–18c illustrate a small washer.

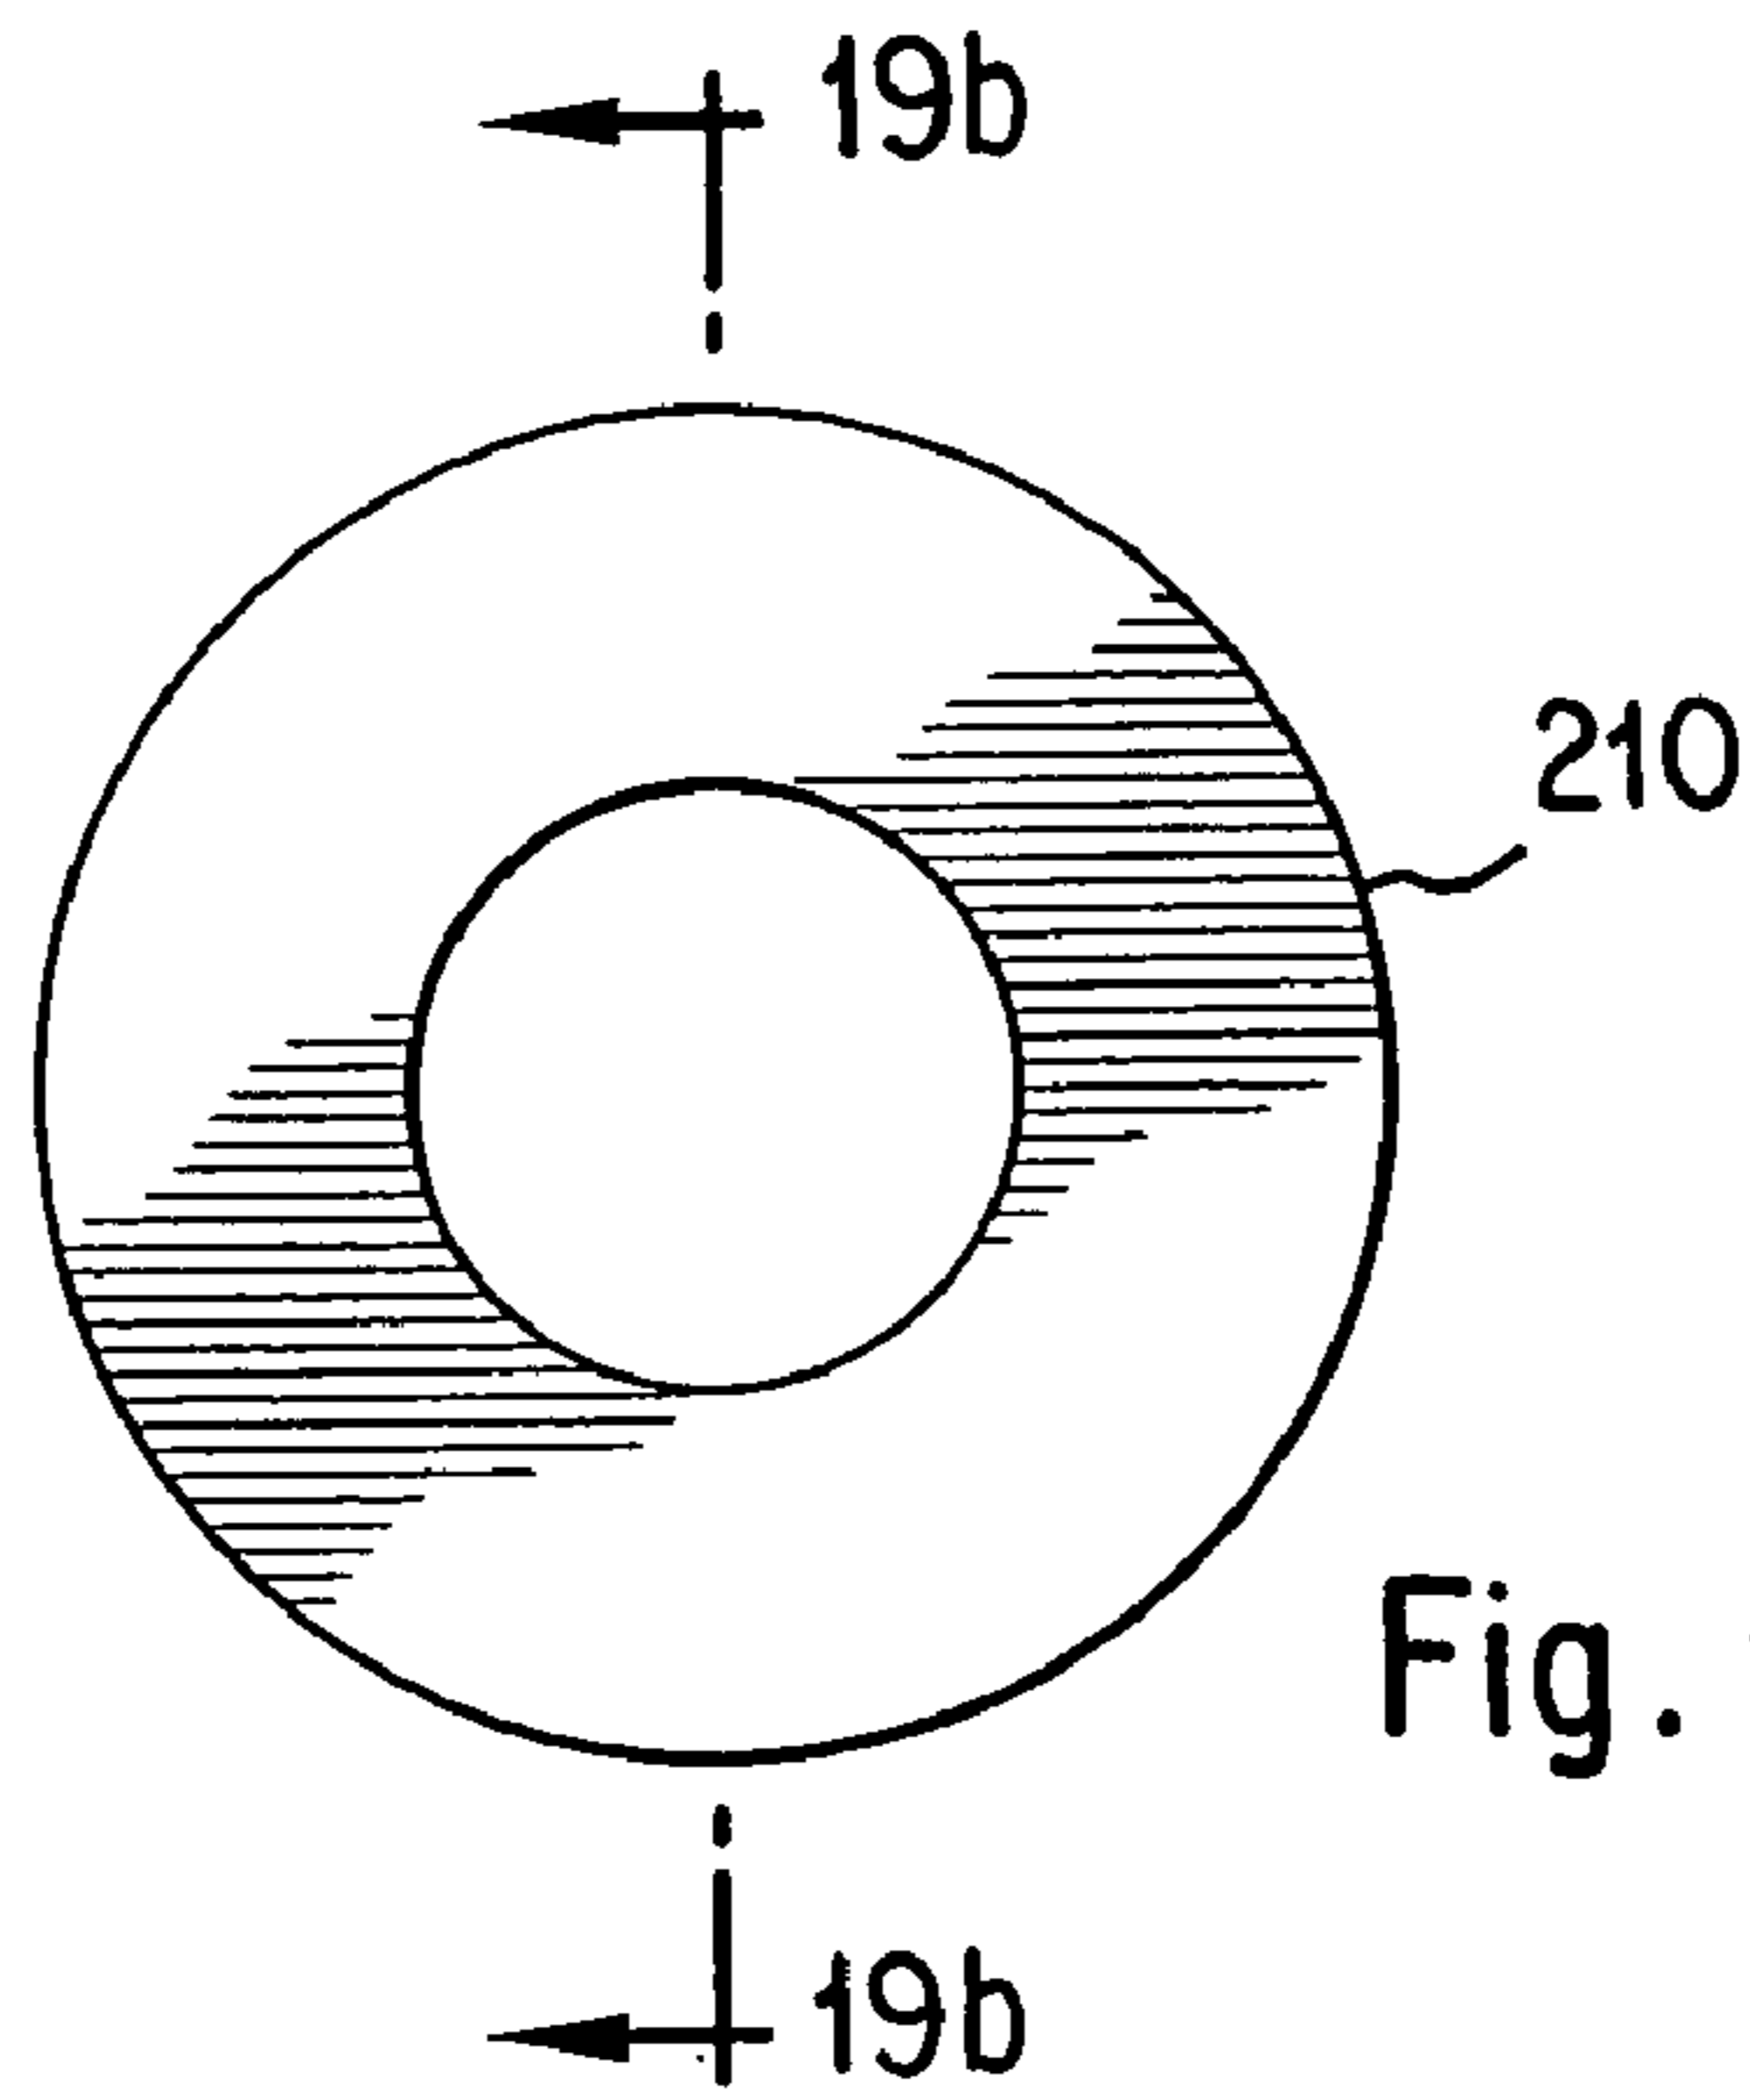
Fig. 19c

FIGS. 19a–19c illustrate a large washer.

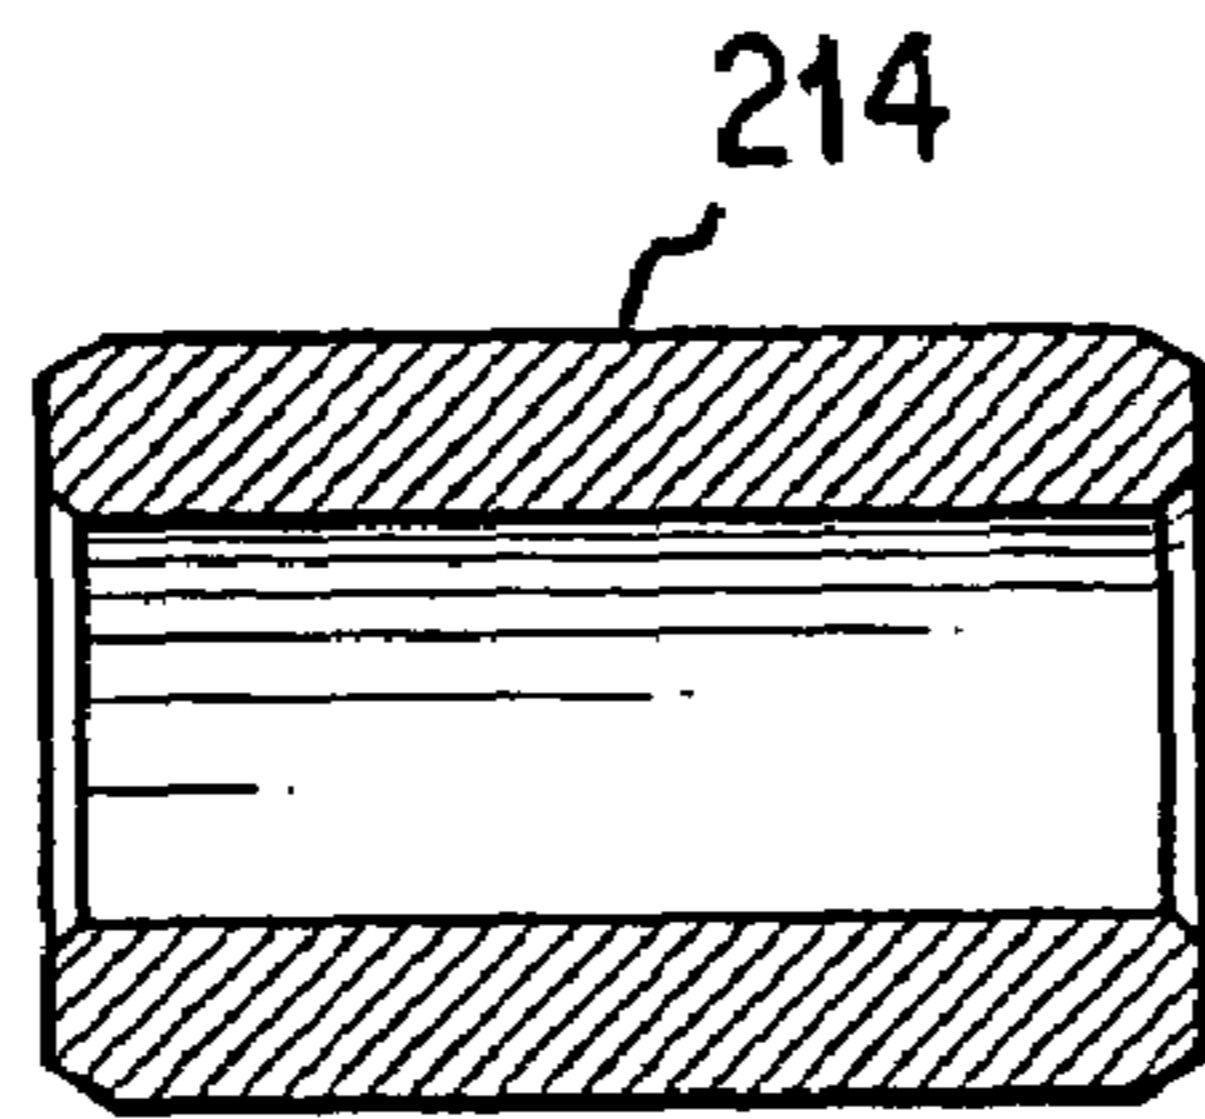
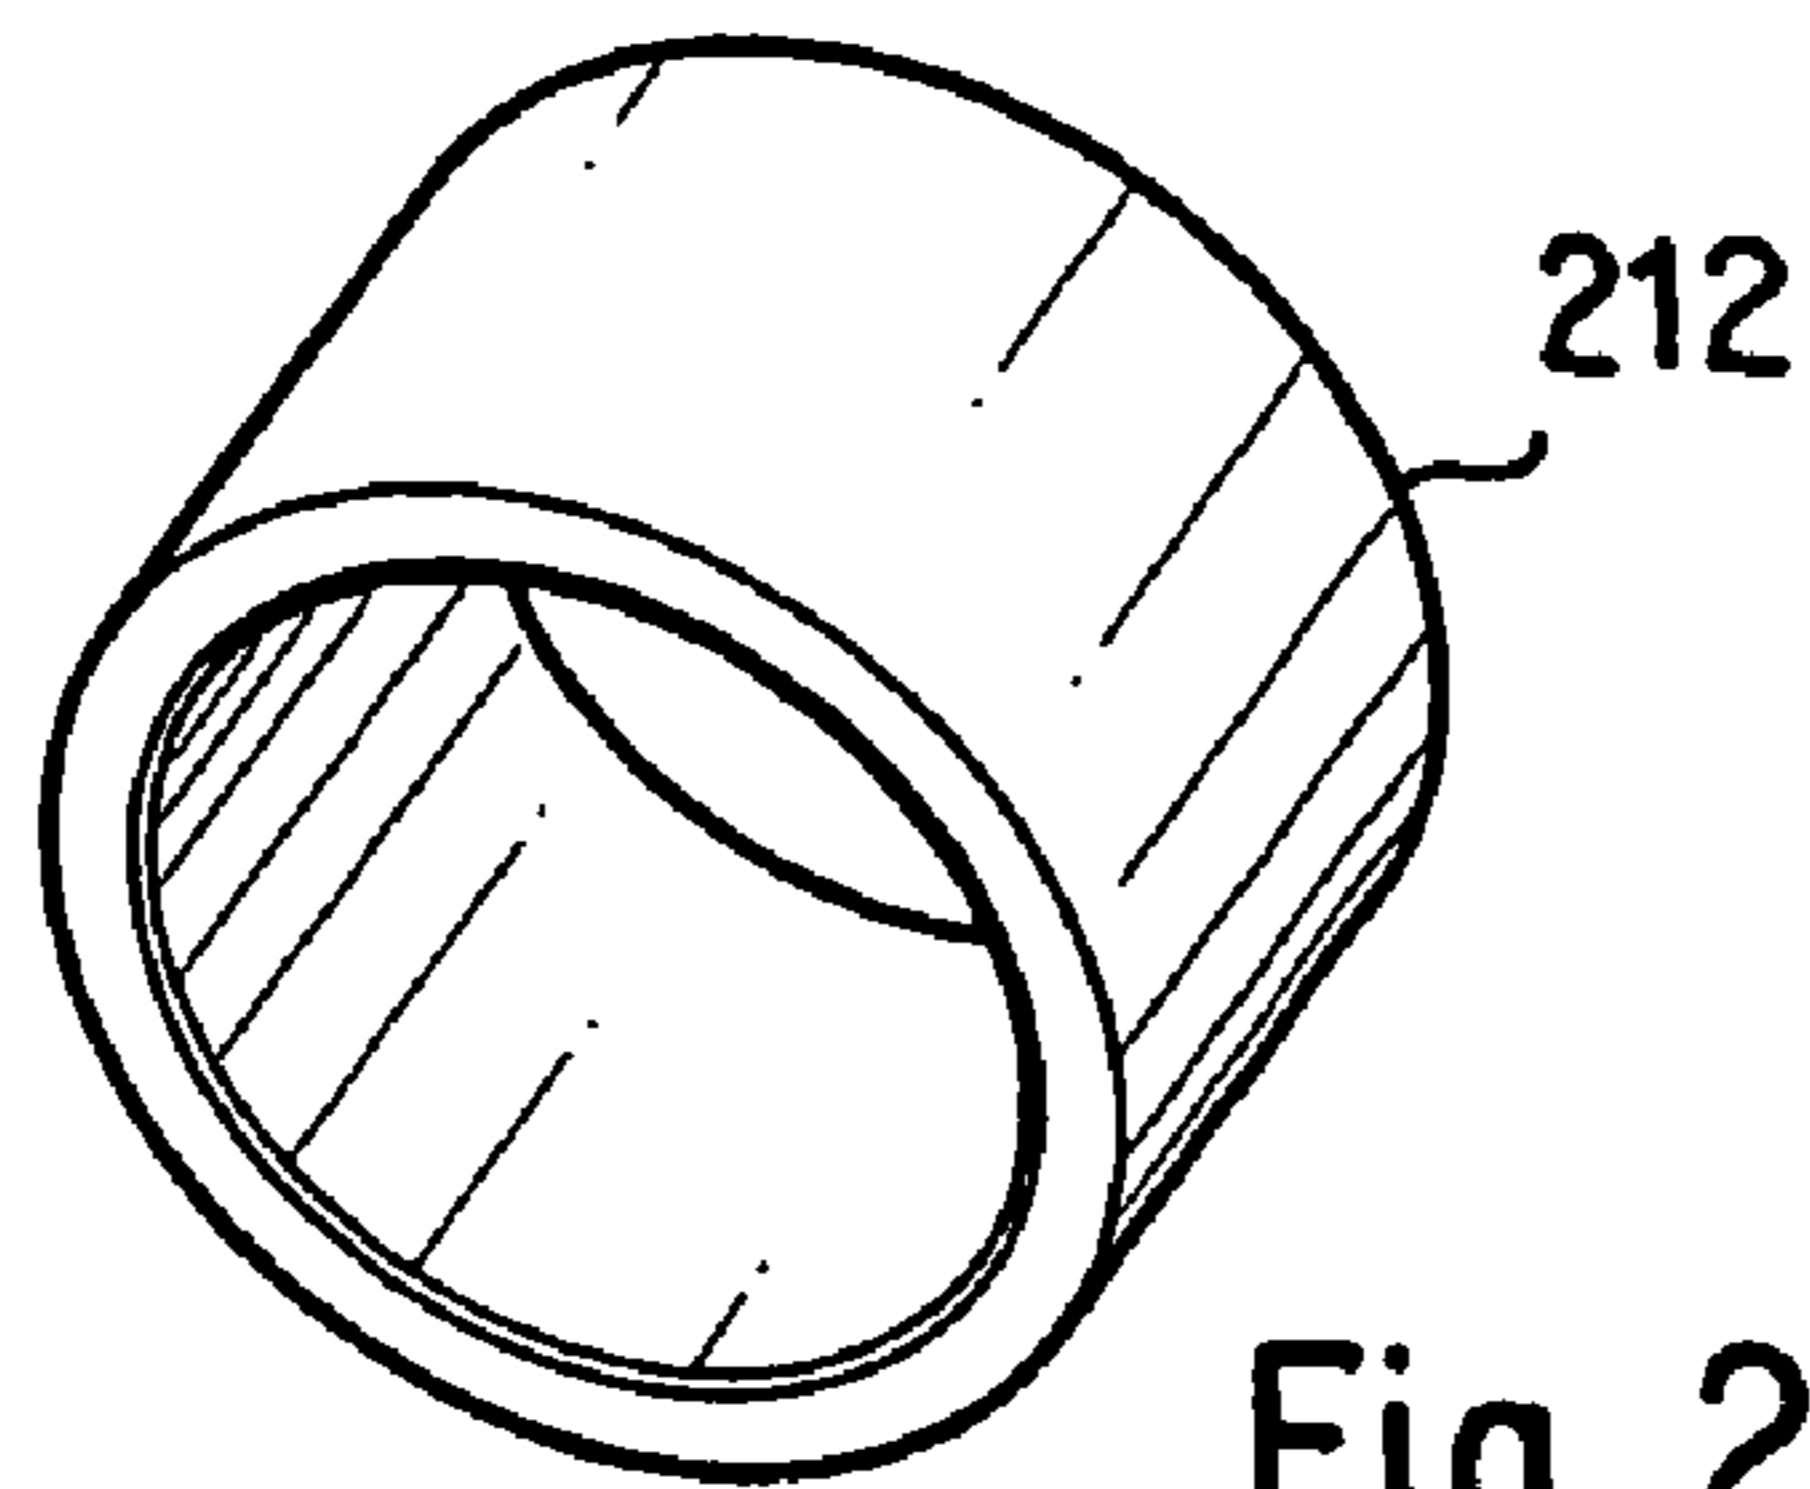
Fig. 20a

FIGS. 20a–20b illustrate a needle sleeve.
