(12) **United States Patent**
Dalenberg et al.

(10) **Patent No.:** **US 7,195,578 B2**
(45) **Date of Patent:** **Mar. 27, 2007**

(54) **AUTOMATIC TRANSMISSION AND GEAR TRAIN**

The present invention relates to automatic transmissions. In particular, the instant invention relates to an automatic transmission with improved resistance to deterioration with an increased effective life. The transmission of the instant invention comprises eight pinion gears assembled into one carrier utilizing a forward and a rear sun gear, a ring gear, a band drum and a one way roller clutch.

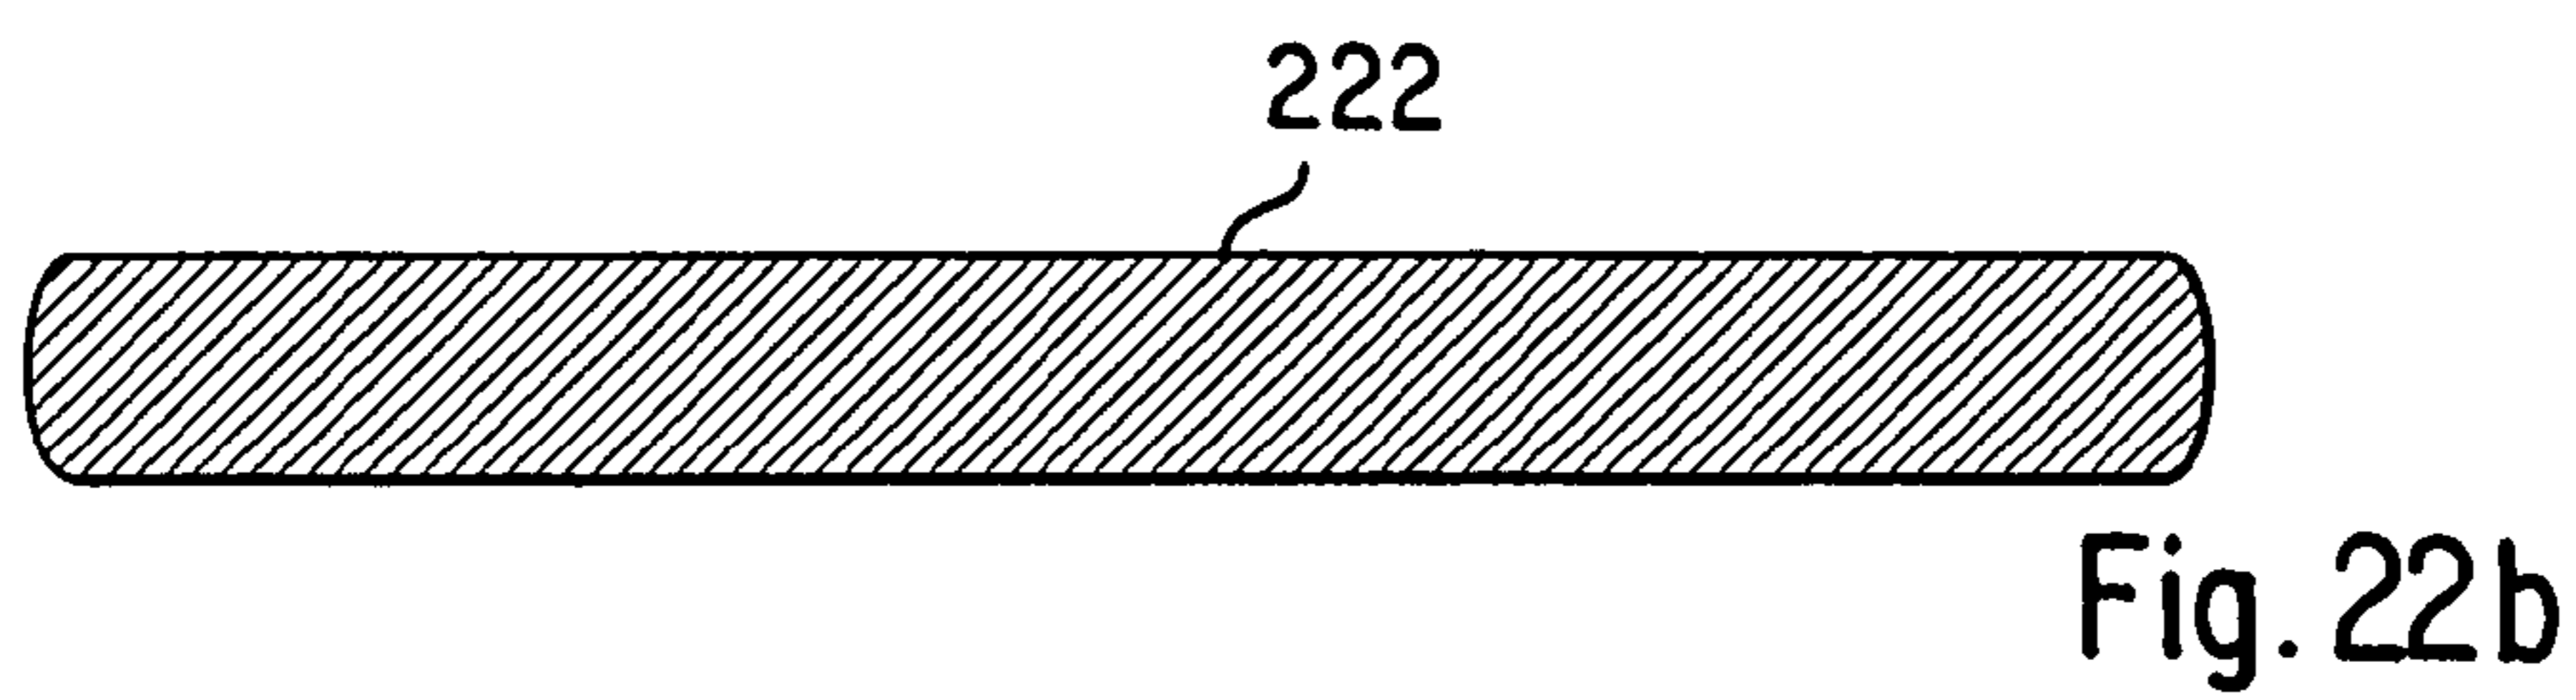
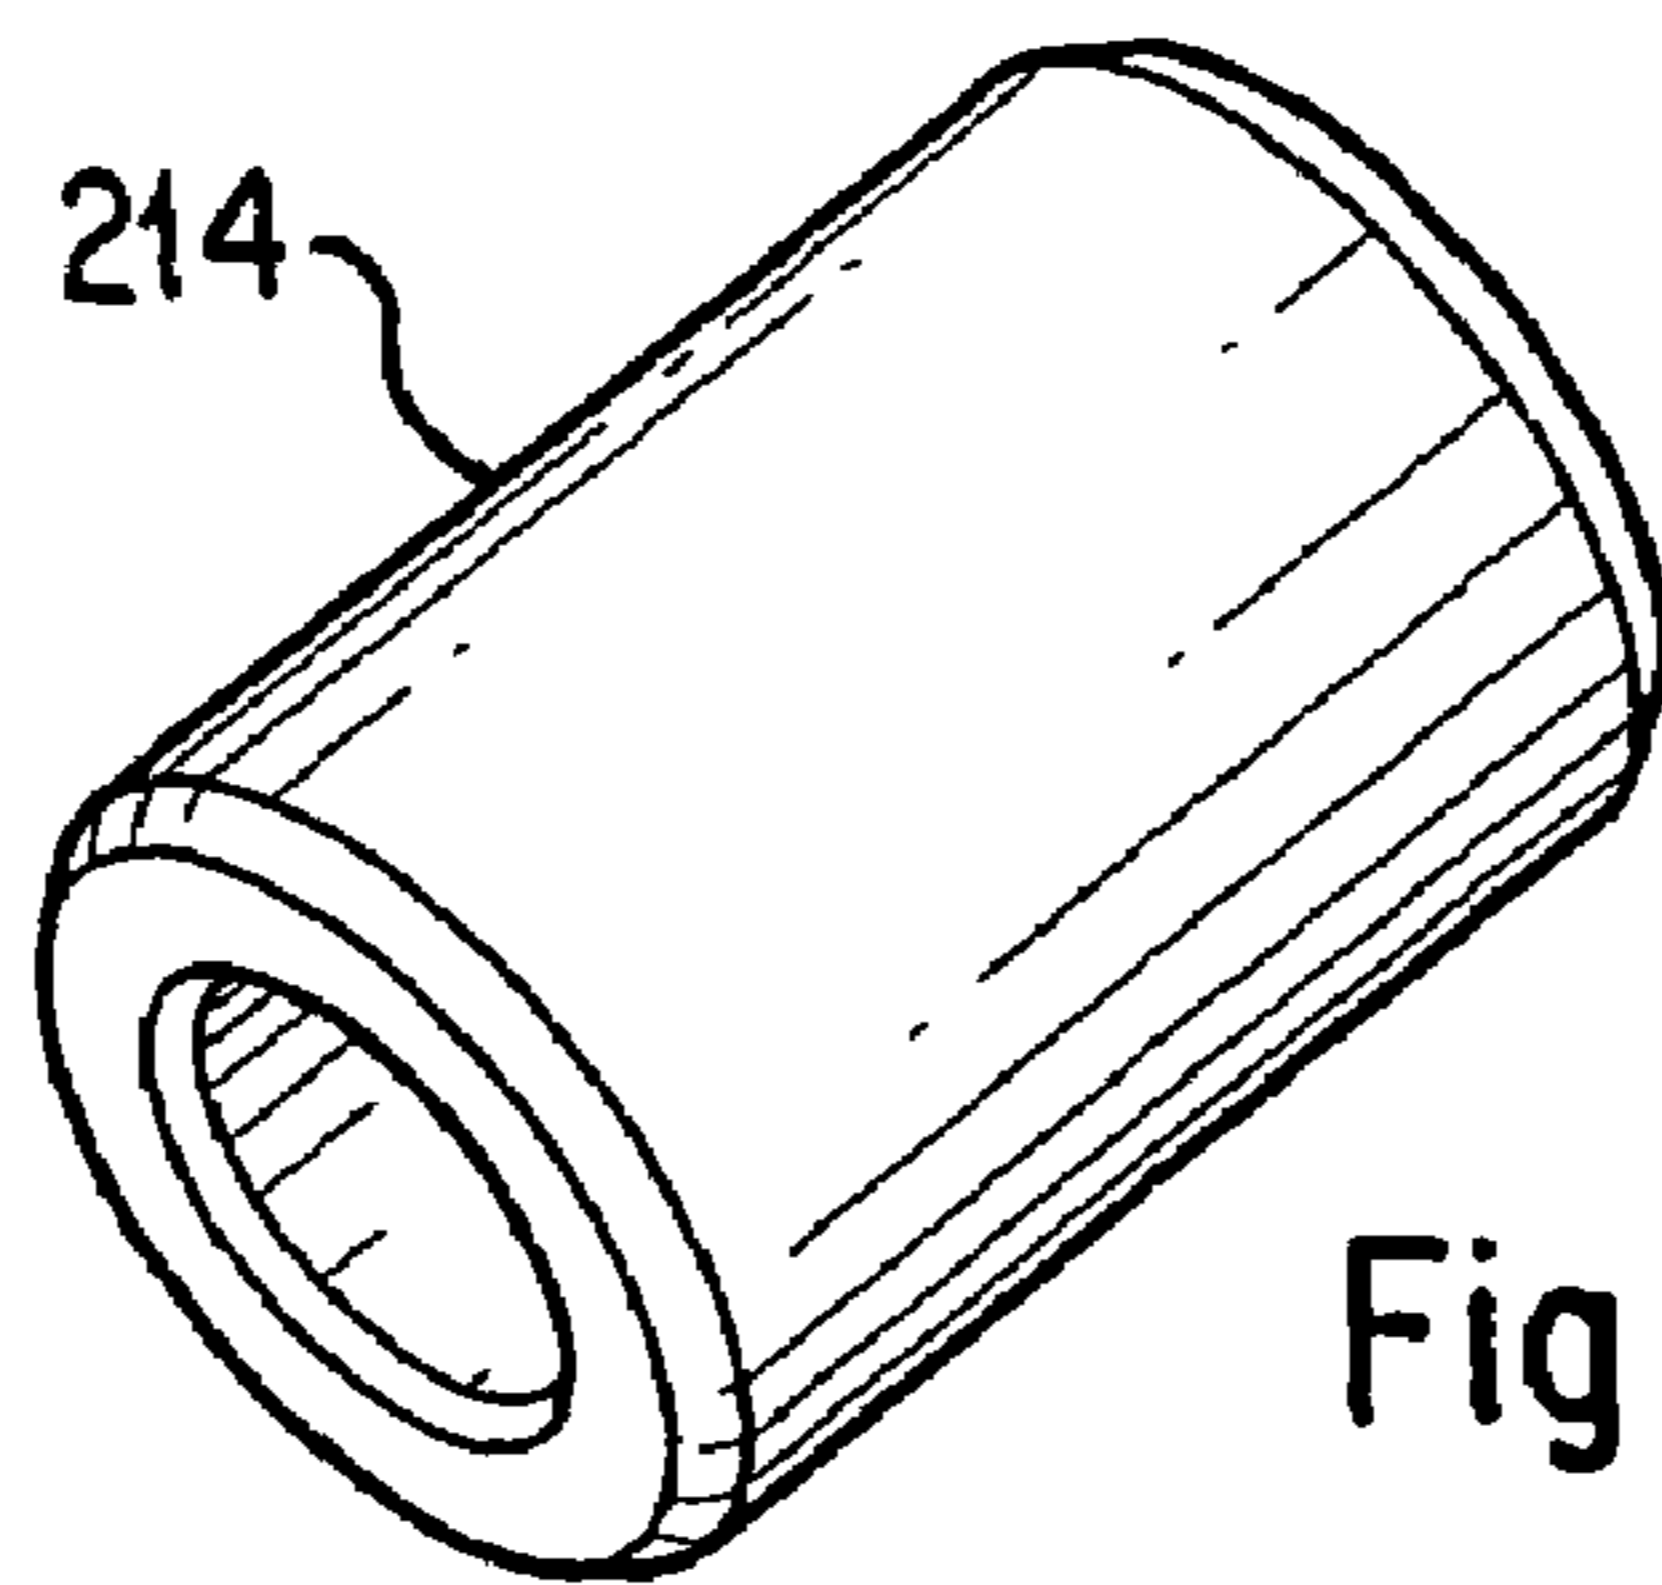
Fig. 21a

FIG. 21 illustrates a plug.

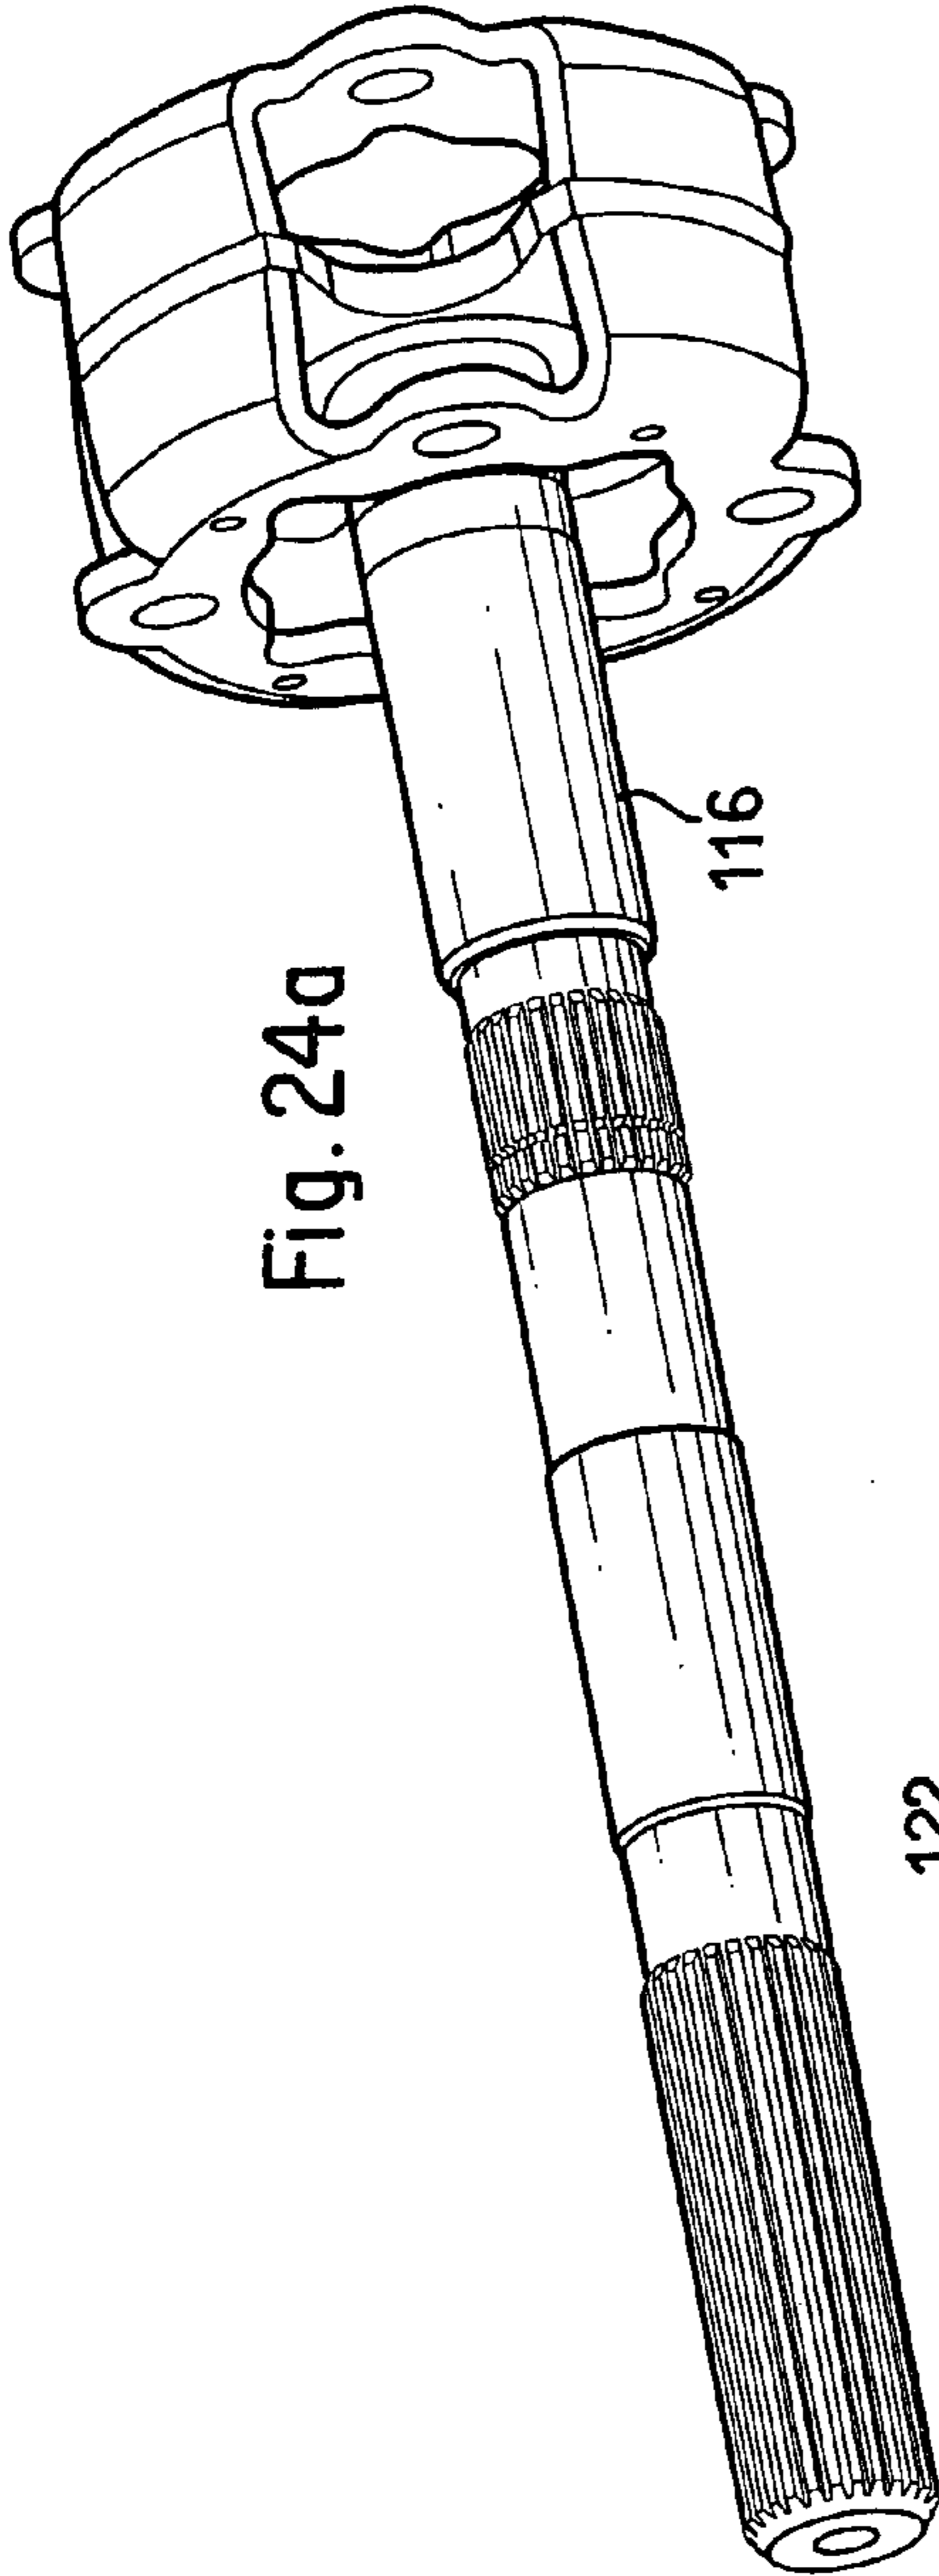
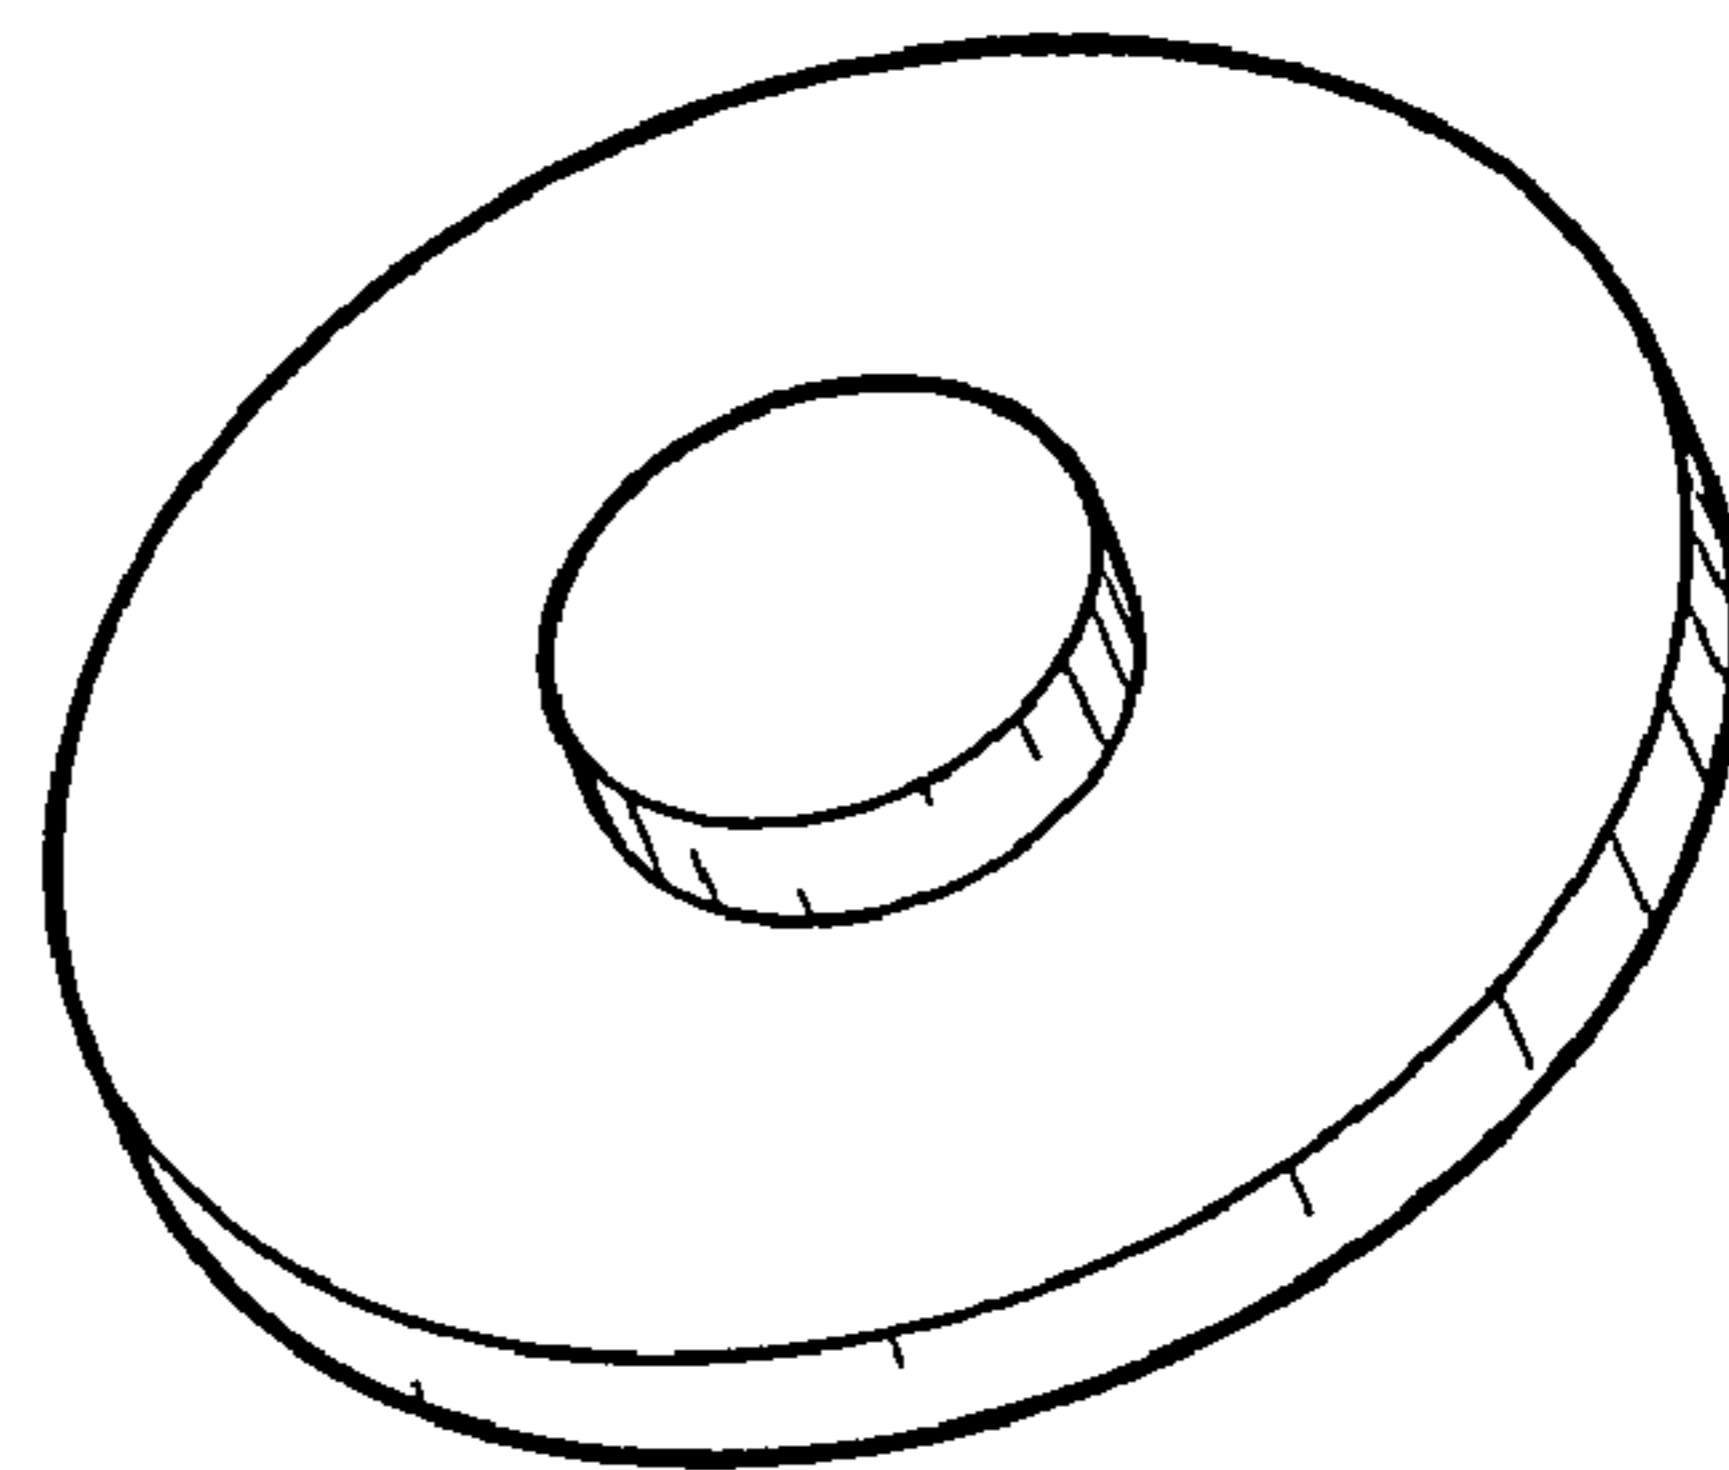
Fig. 23a

FIG. 23 illustrates an output flange casting.

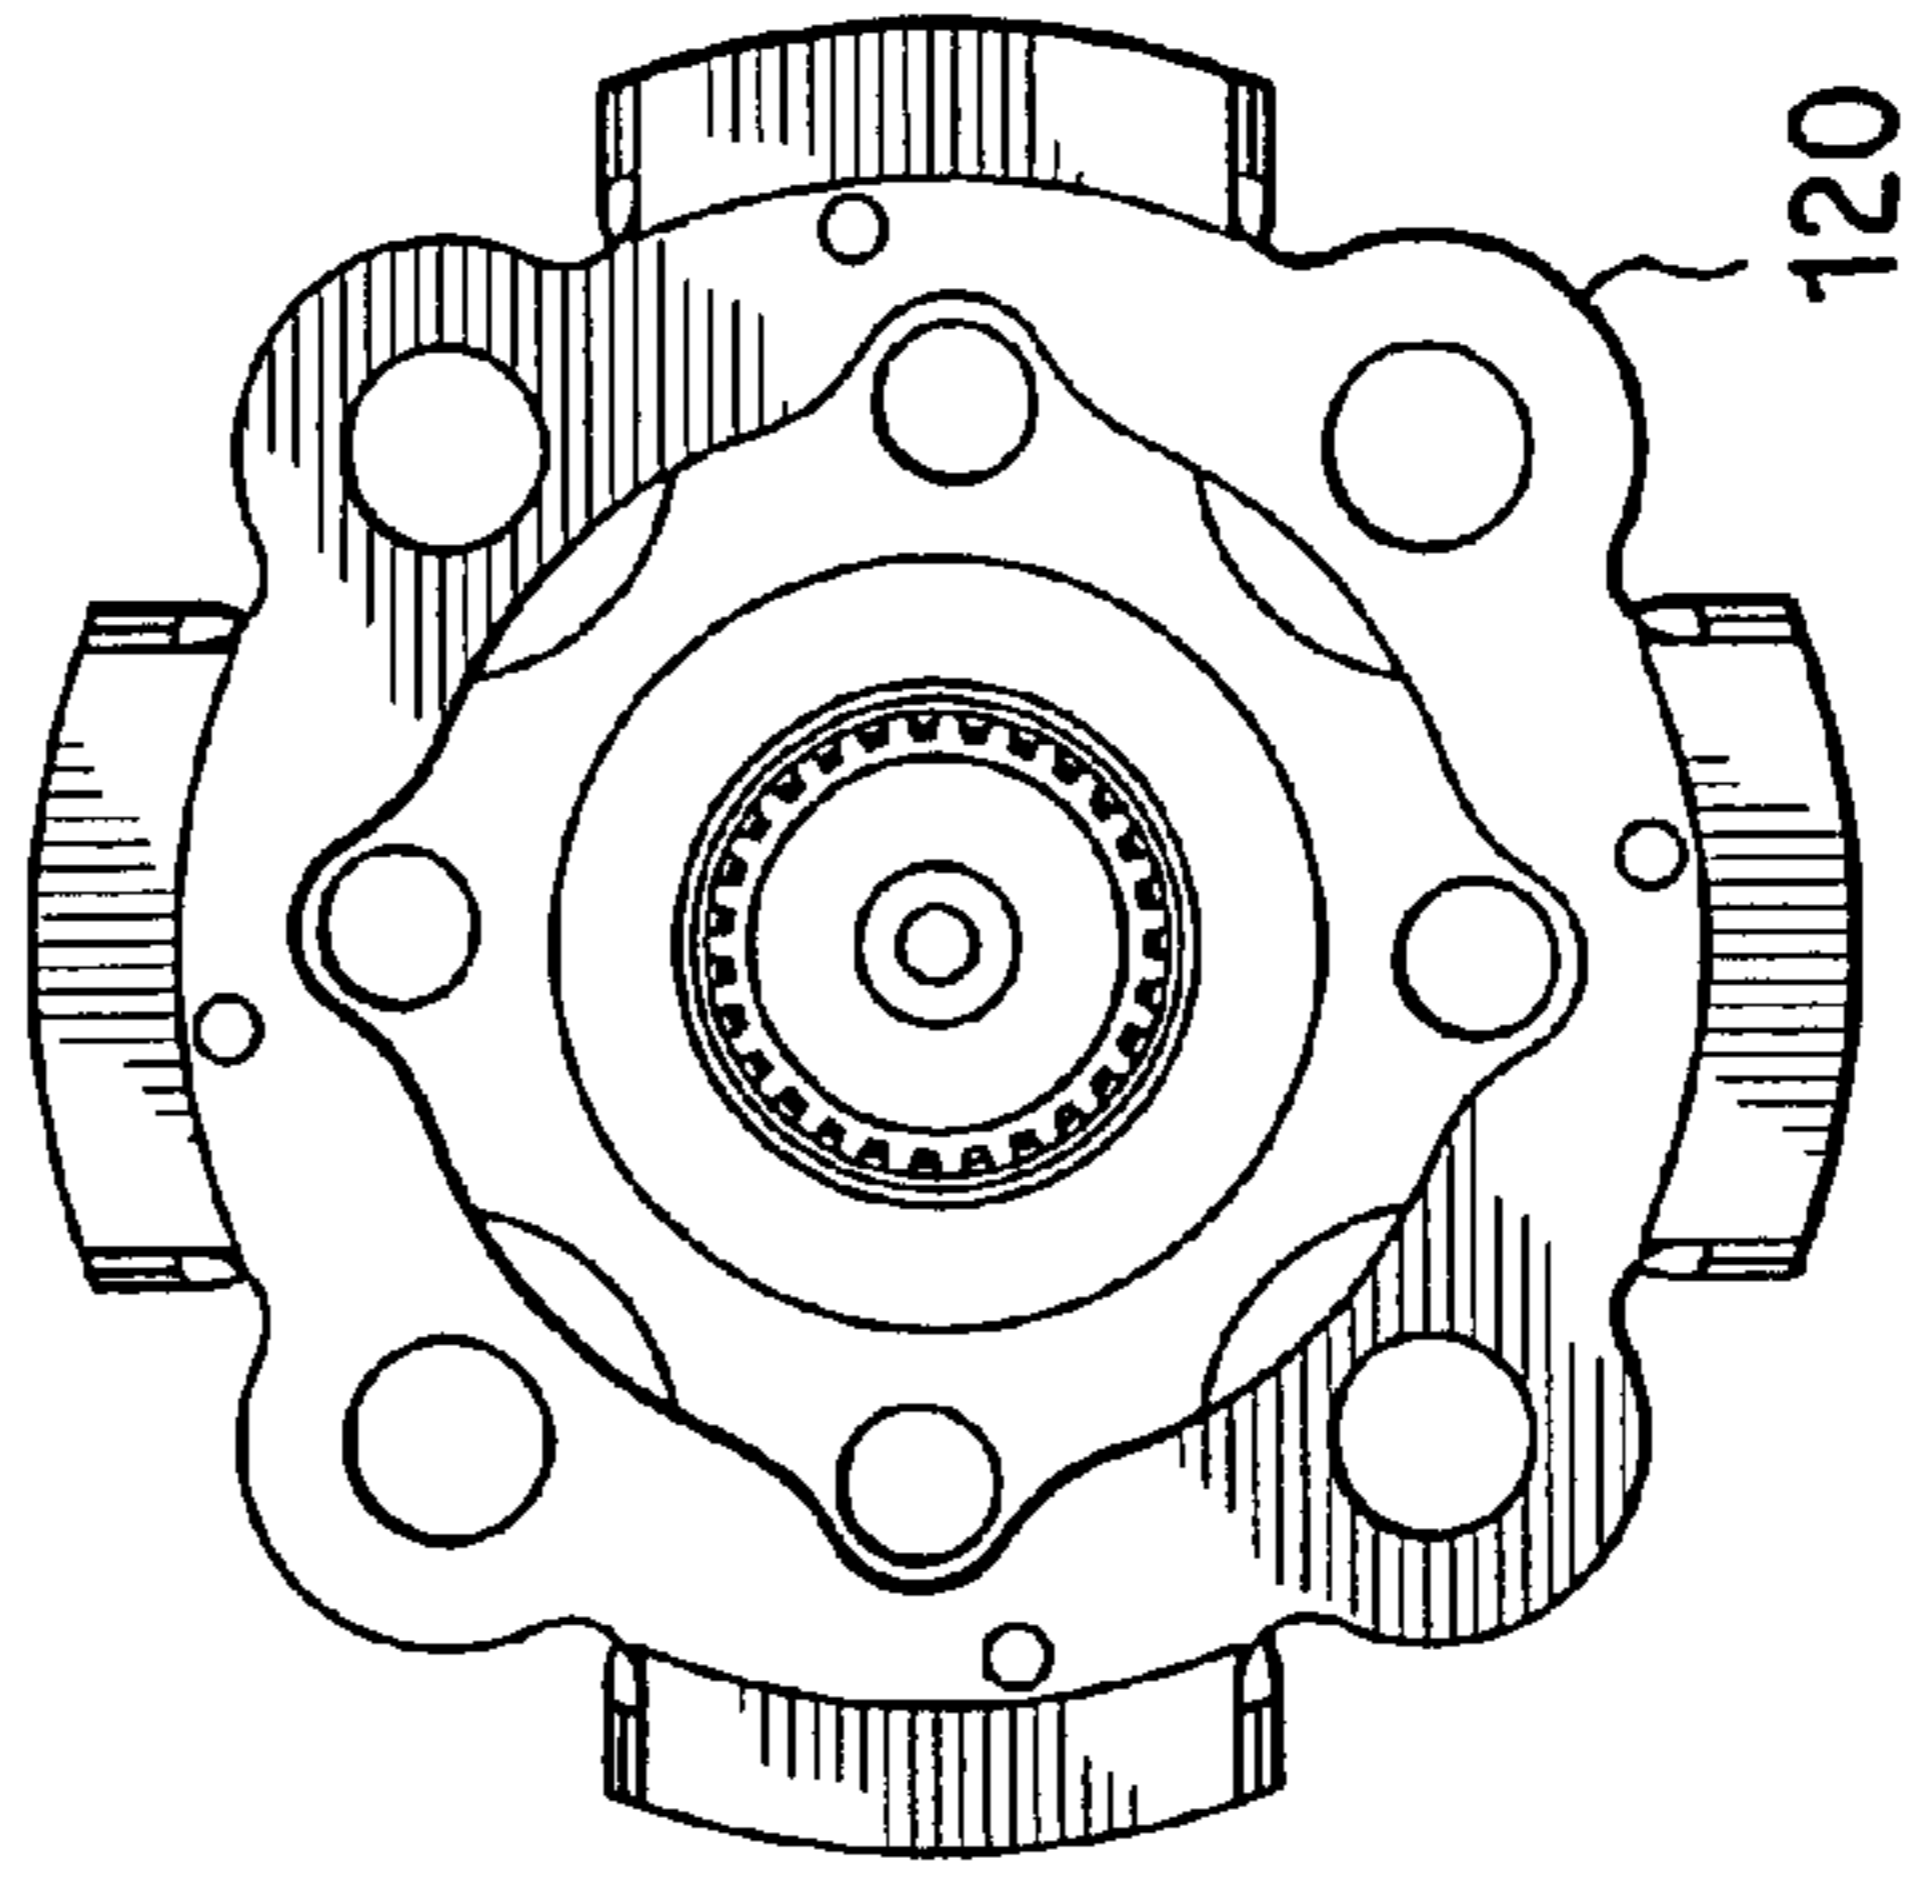
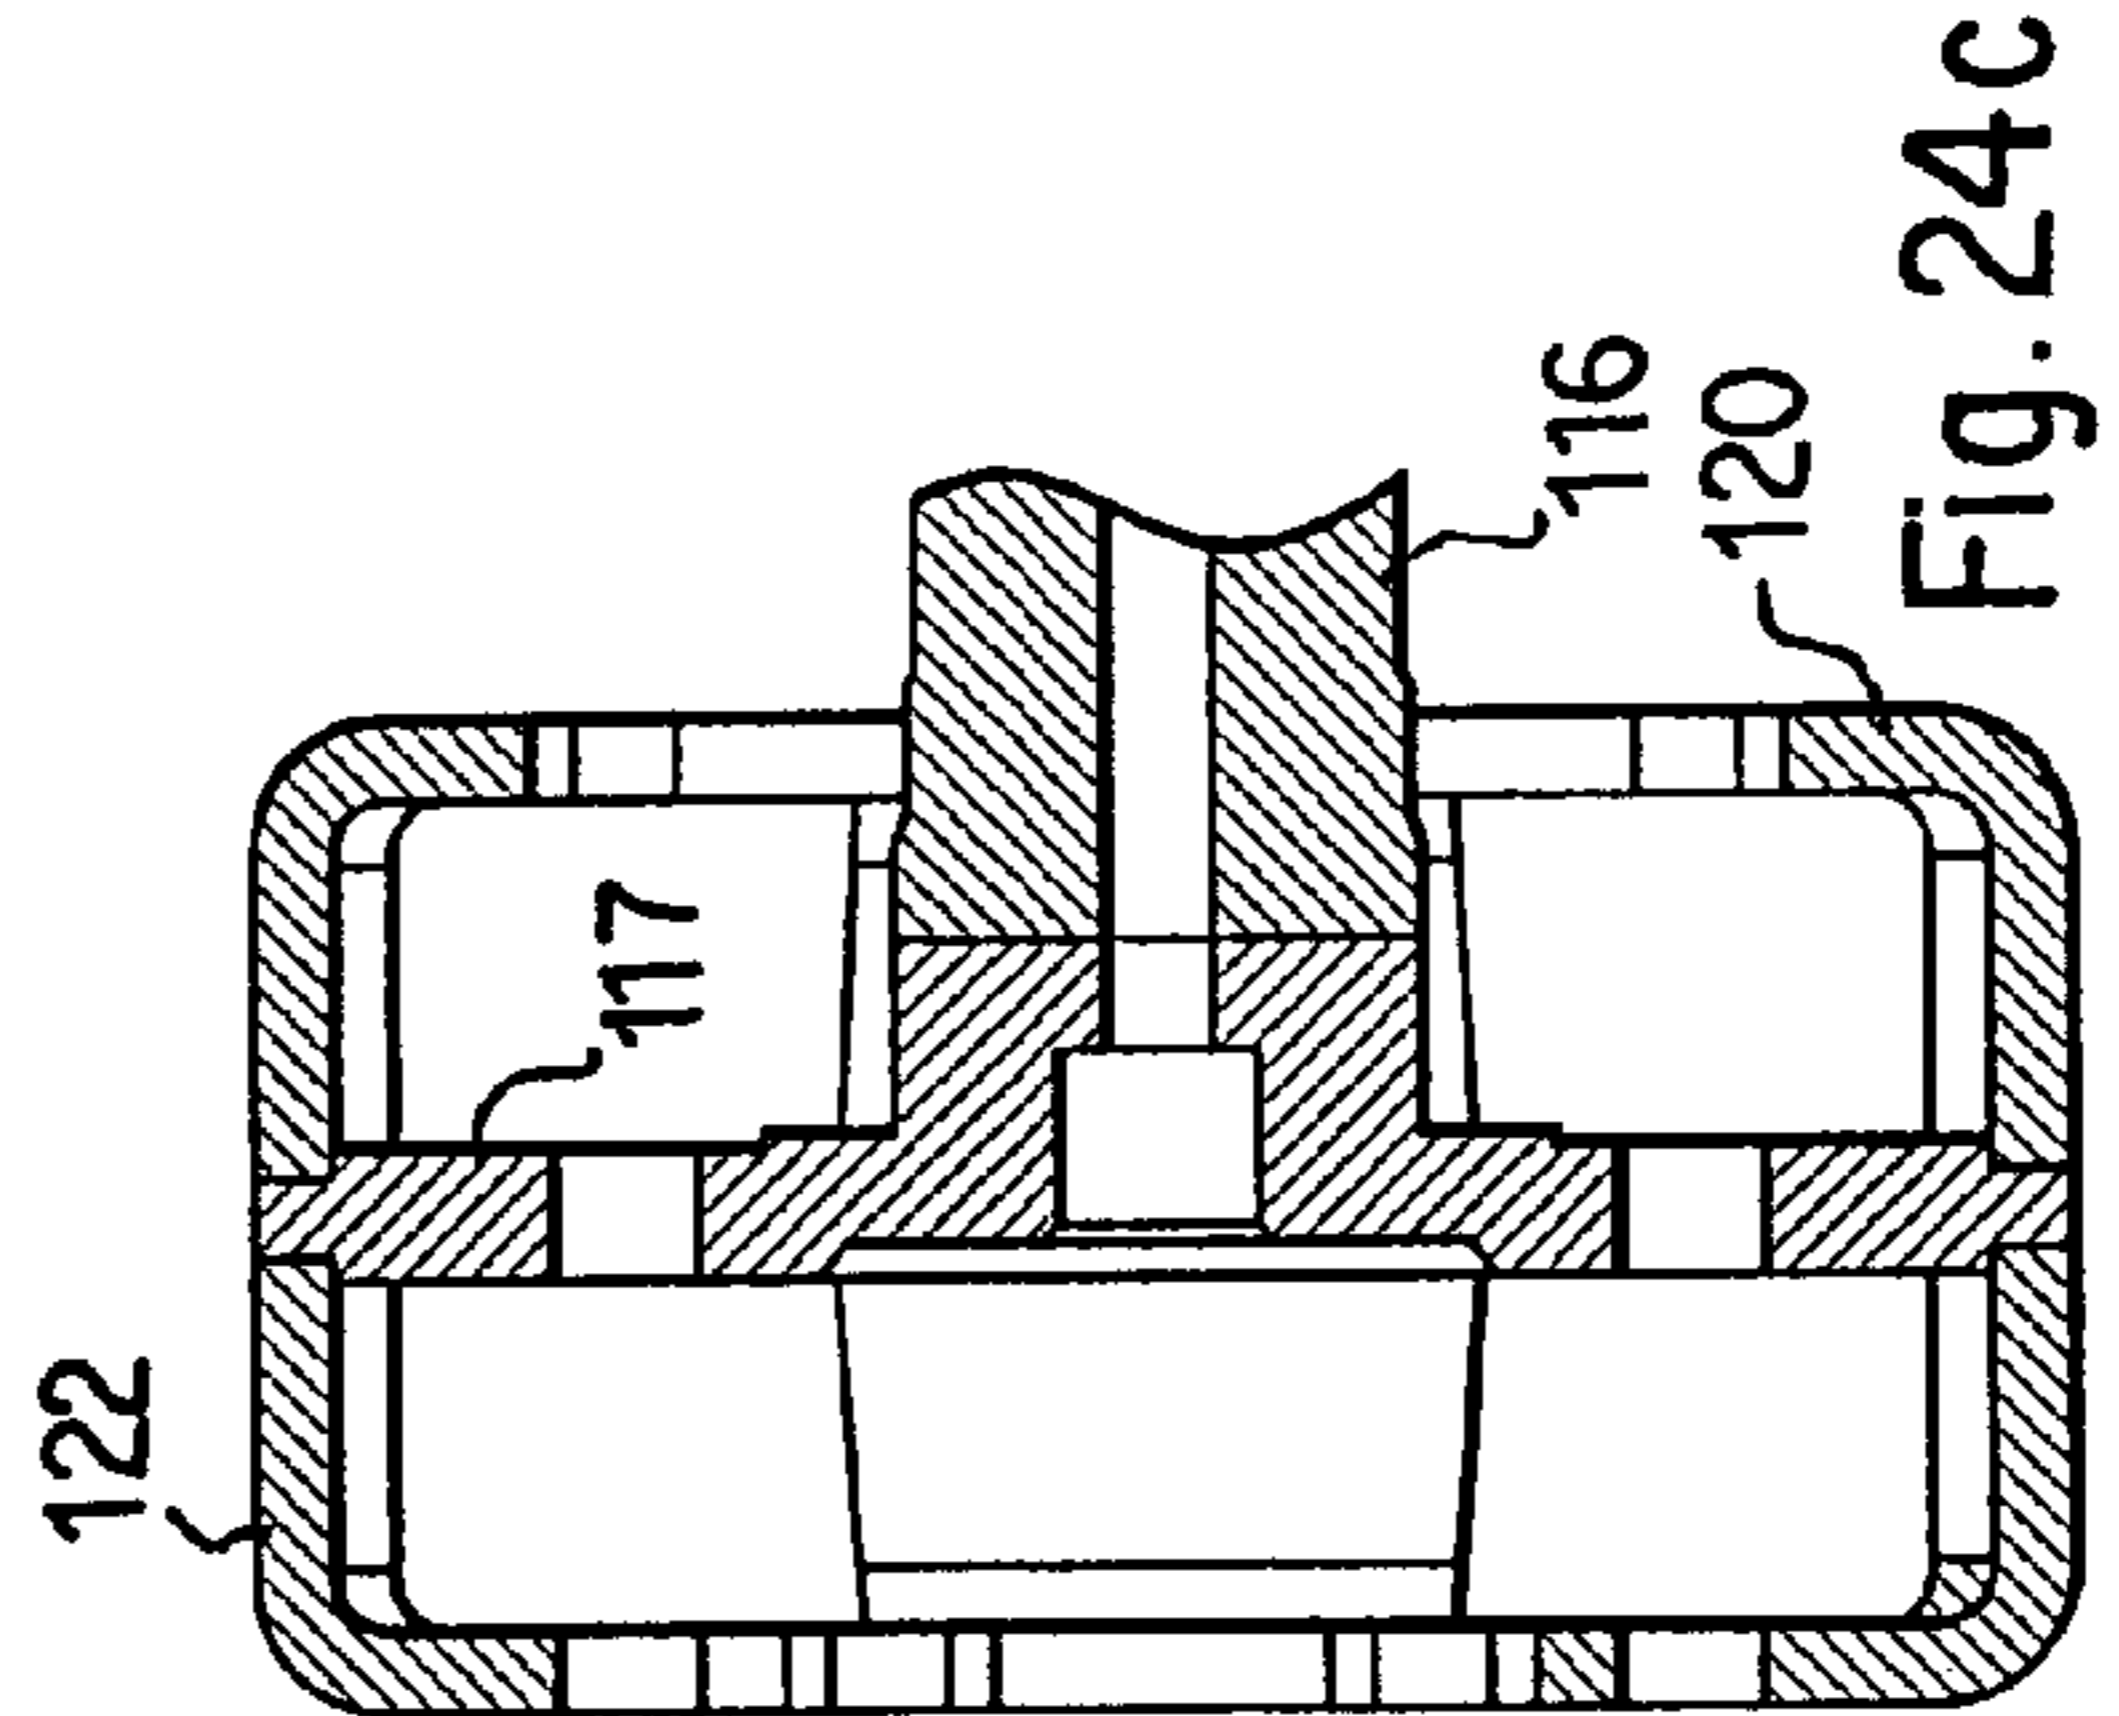
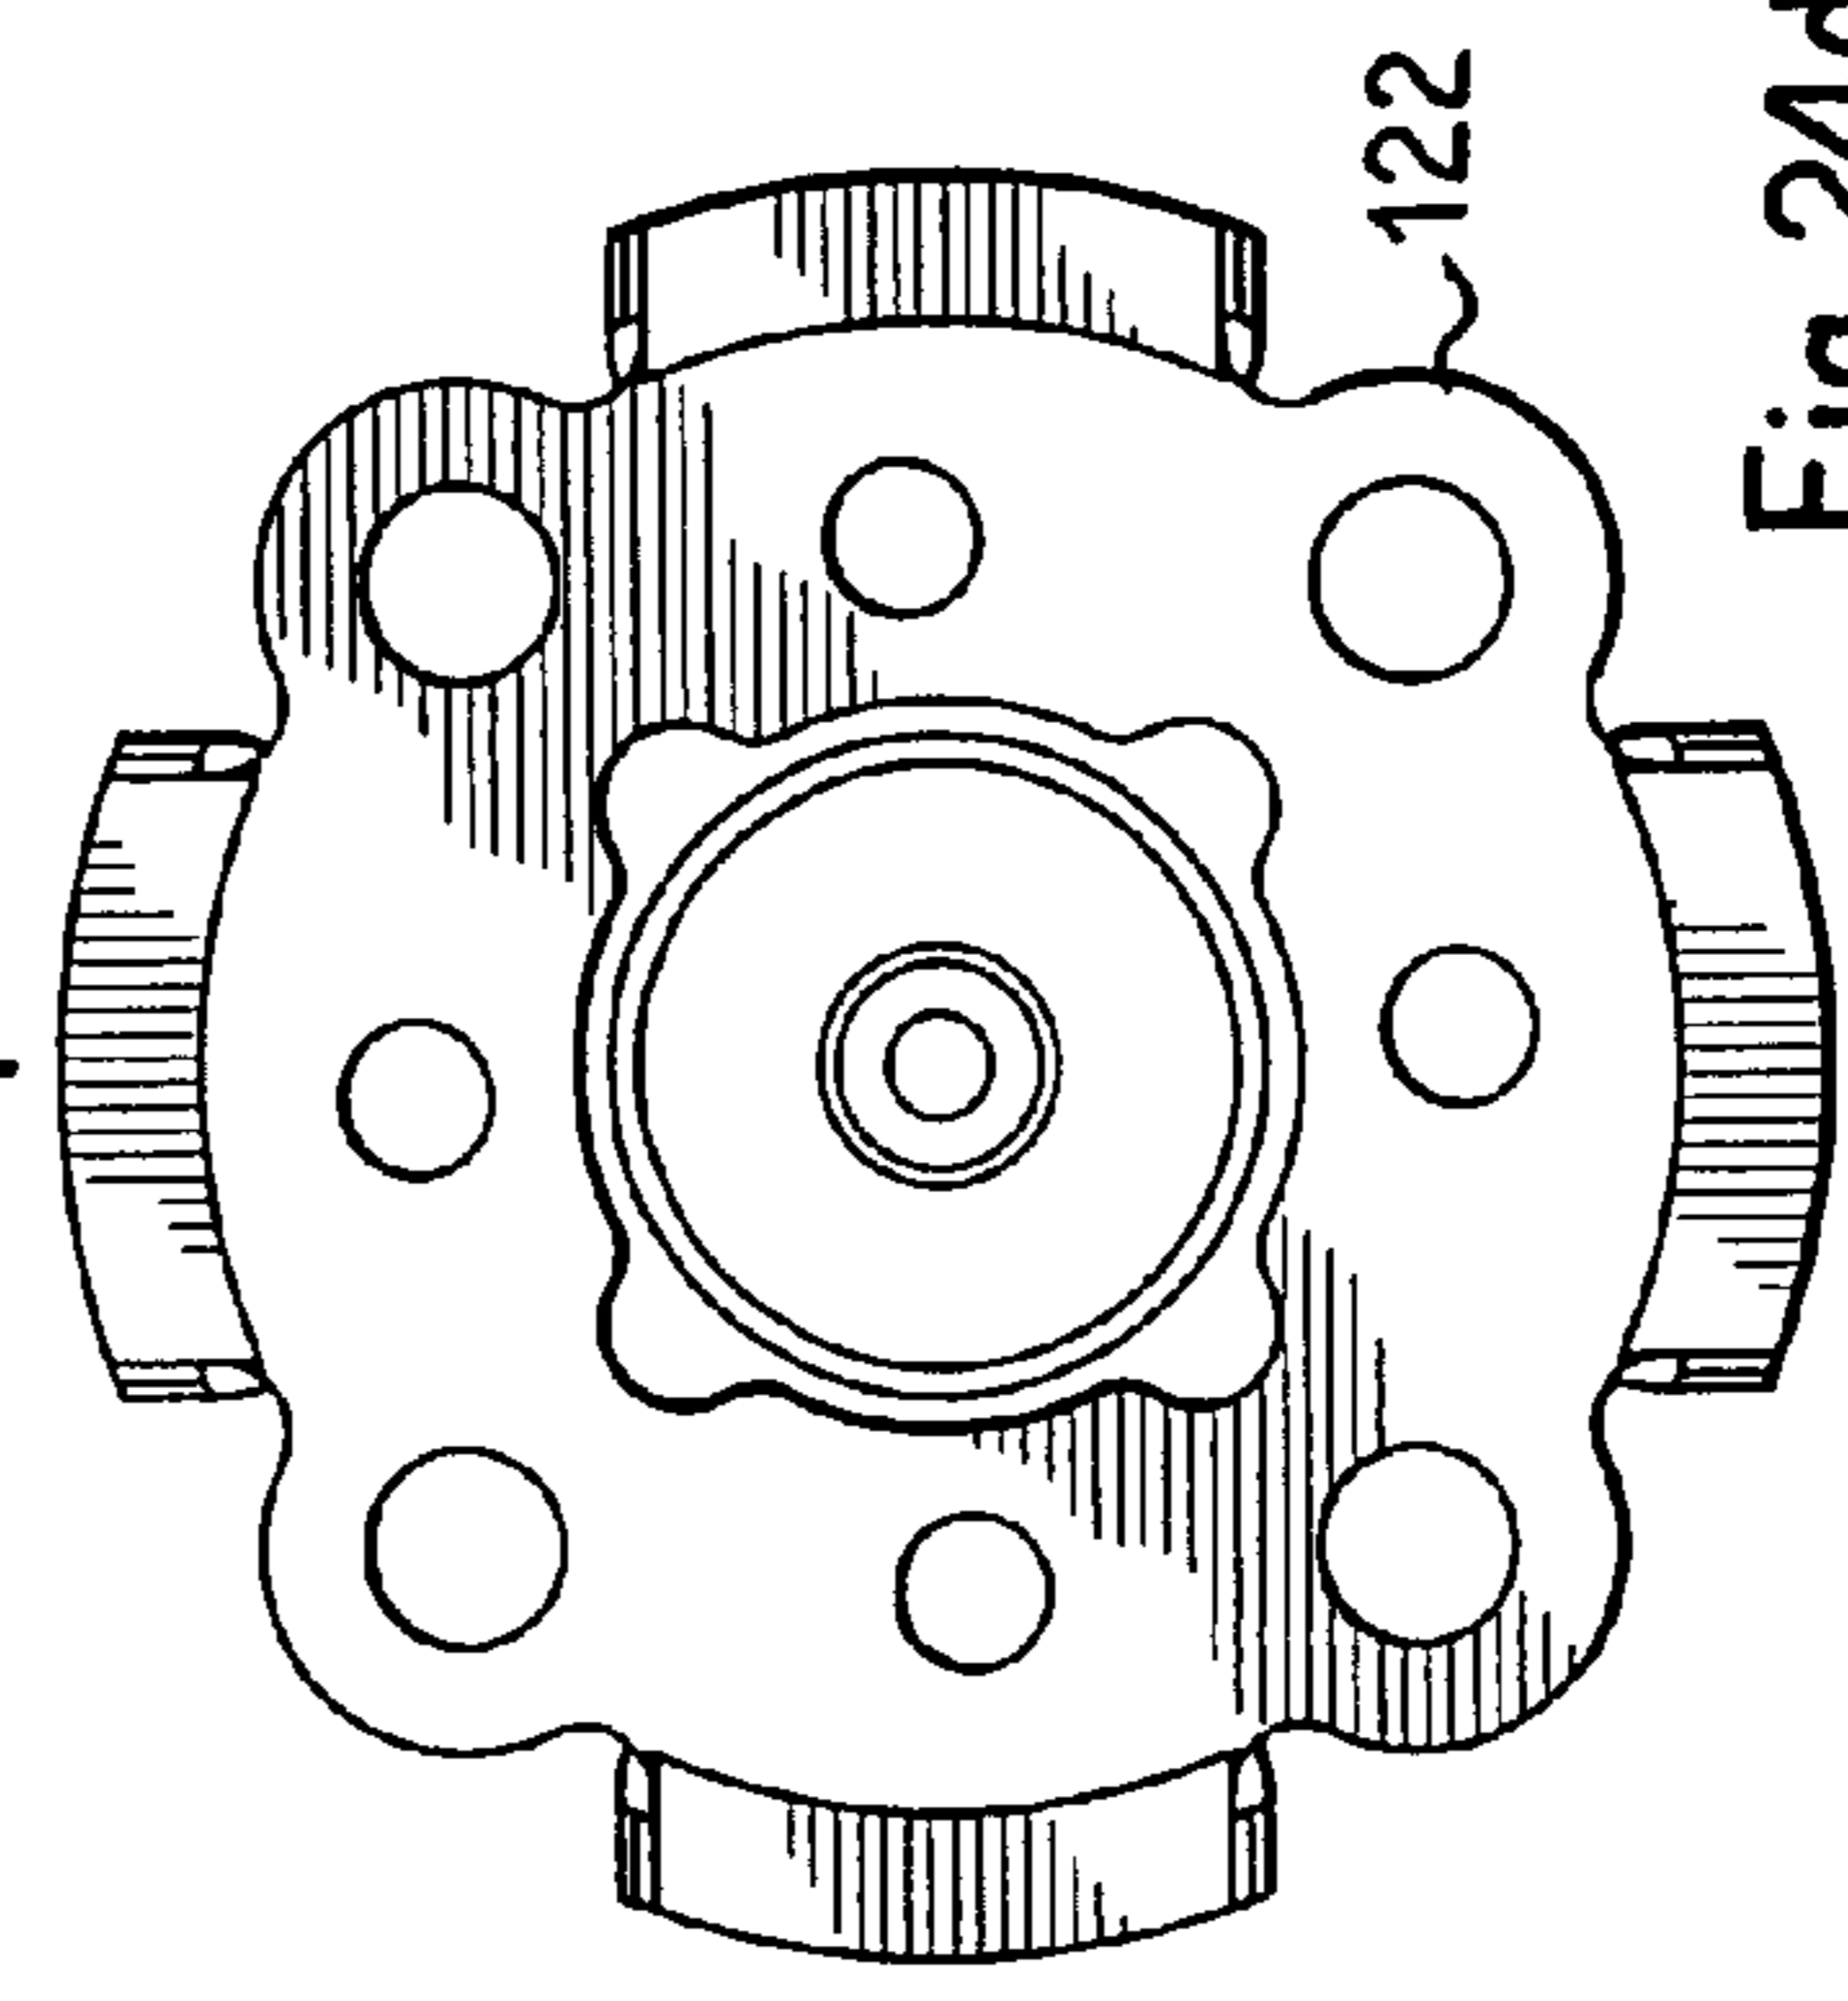
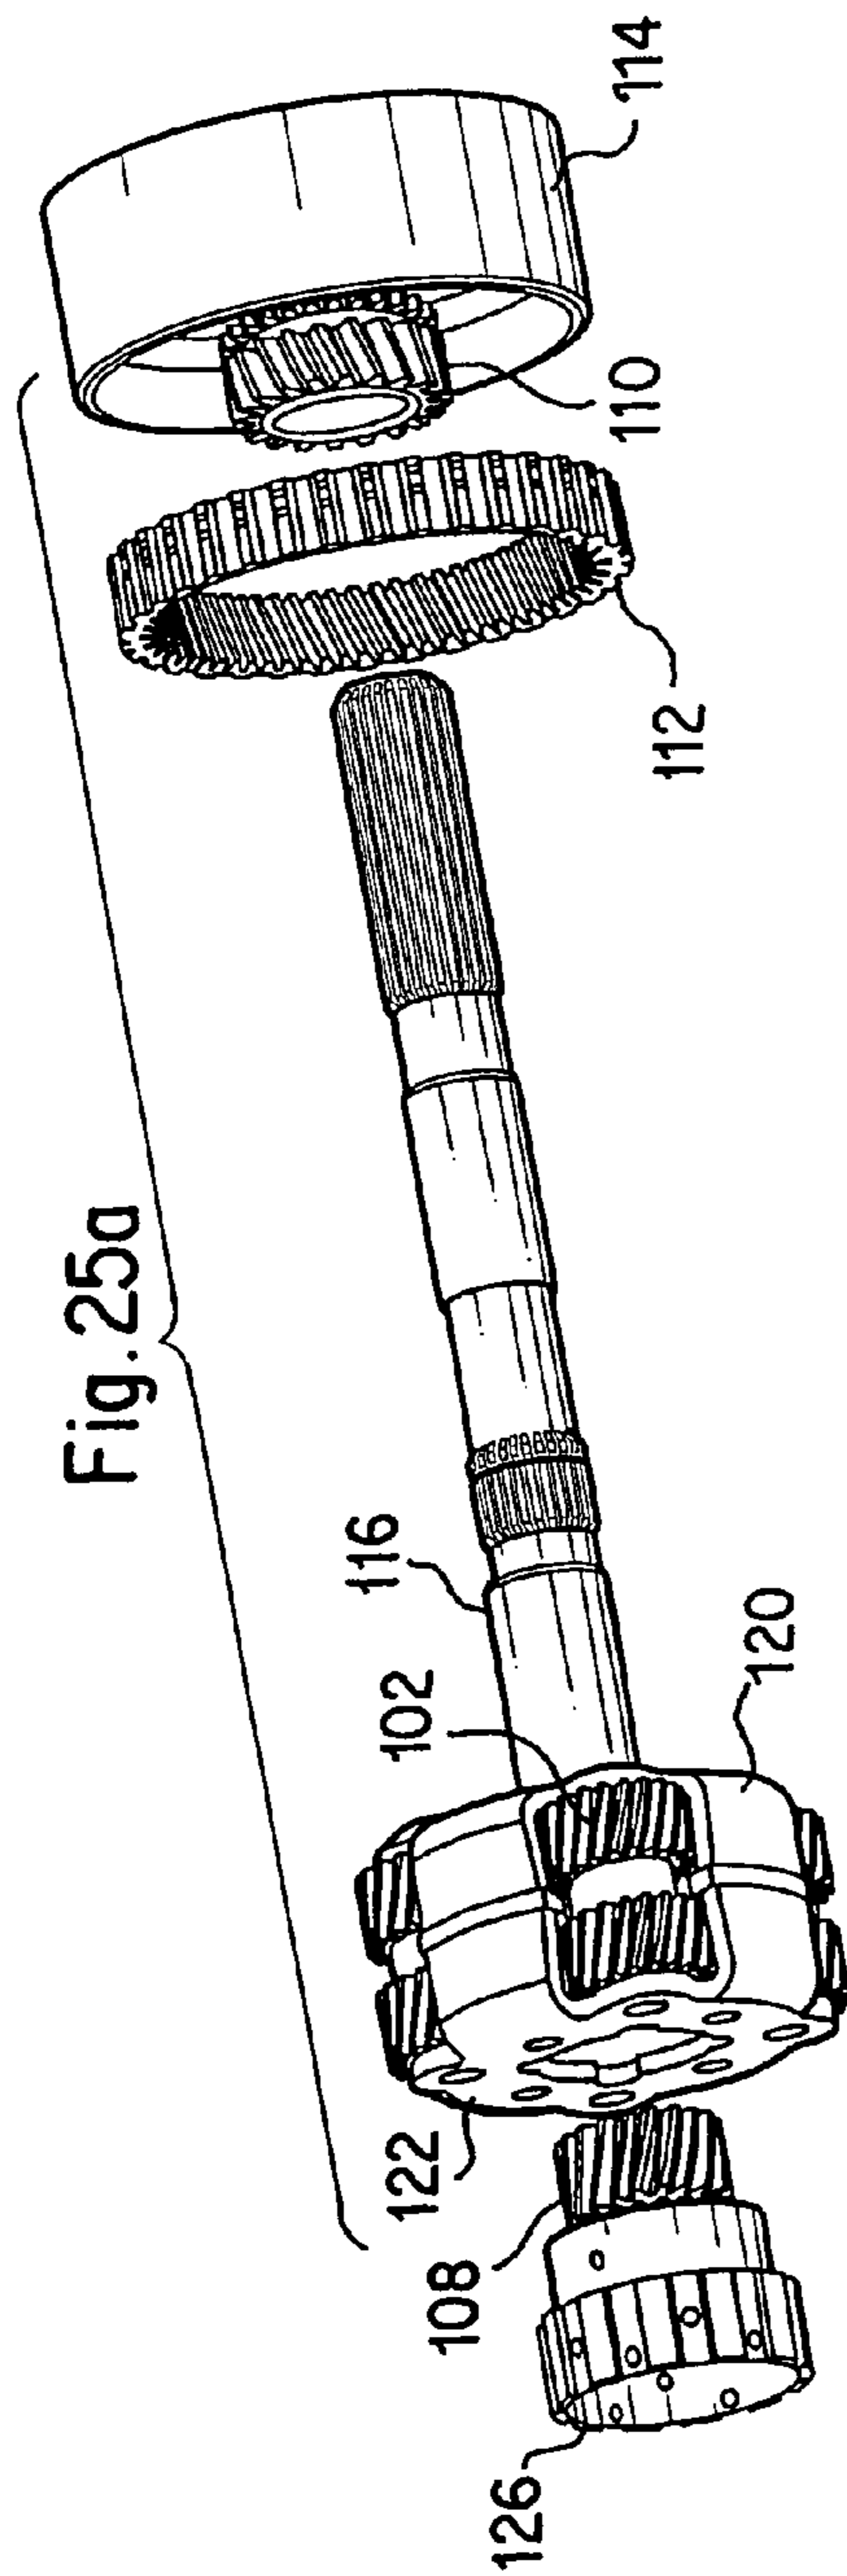
Fig. 24a

FIG. 24 illustrates an assembled body.
