(12) **United States Patent**
Dalenberg et al.

(10) **Patent No.:** **US 7,195,578 B2**
(45) **Date of Patent:** **Mar. 27, 2007**

(54) **AUTOMATIC TRANSMISSION AND GEAR TRAIN**

The present invention relates to automatic transmissions. In particular, the instant invention relates to an automatic transmission with improved resistance to deterioration with an increased effective life. The transmission of the instant invention comprises eight pinion gears assembled into one carrier utilizing a forward and a rear sun gear, a ring gear, a band drum and a one way roller clutch.

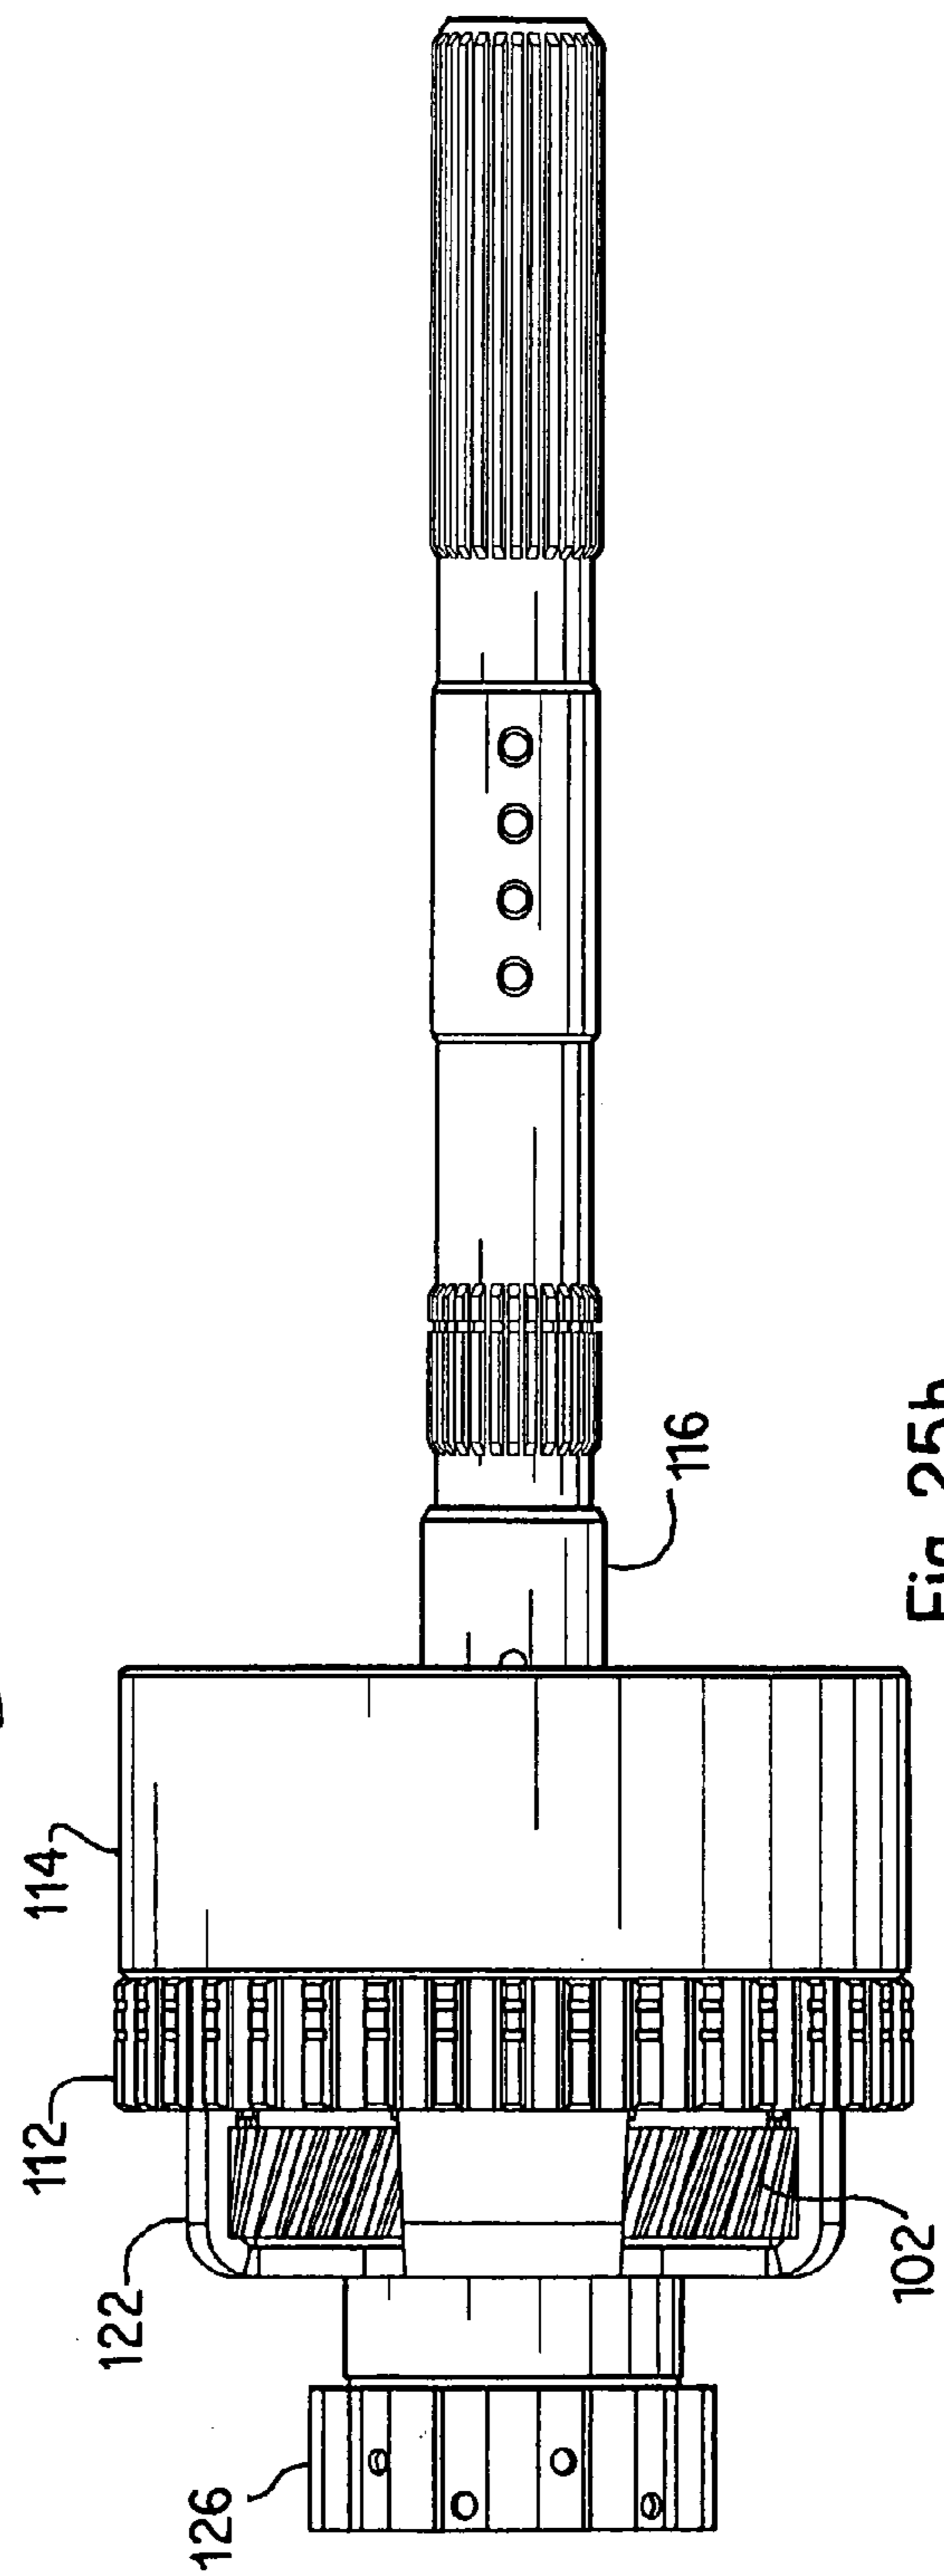
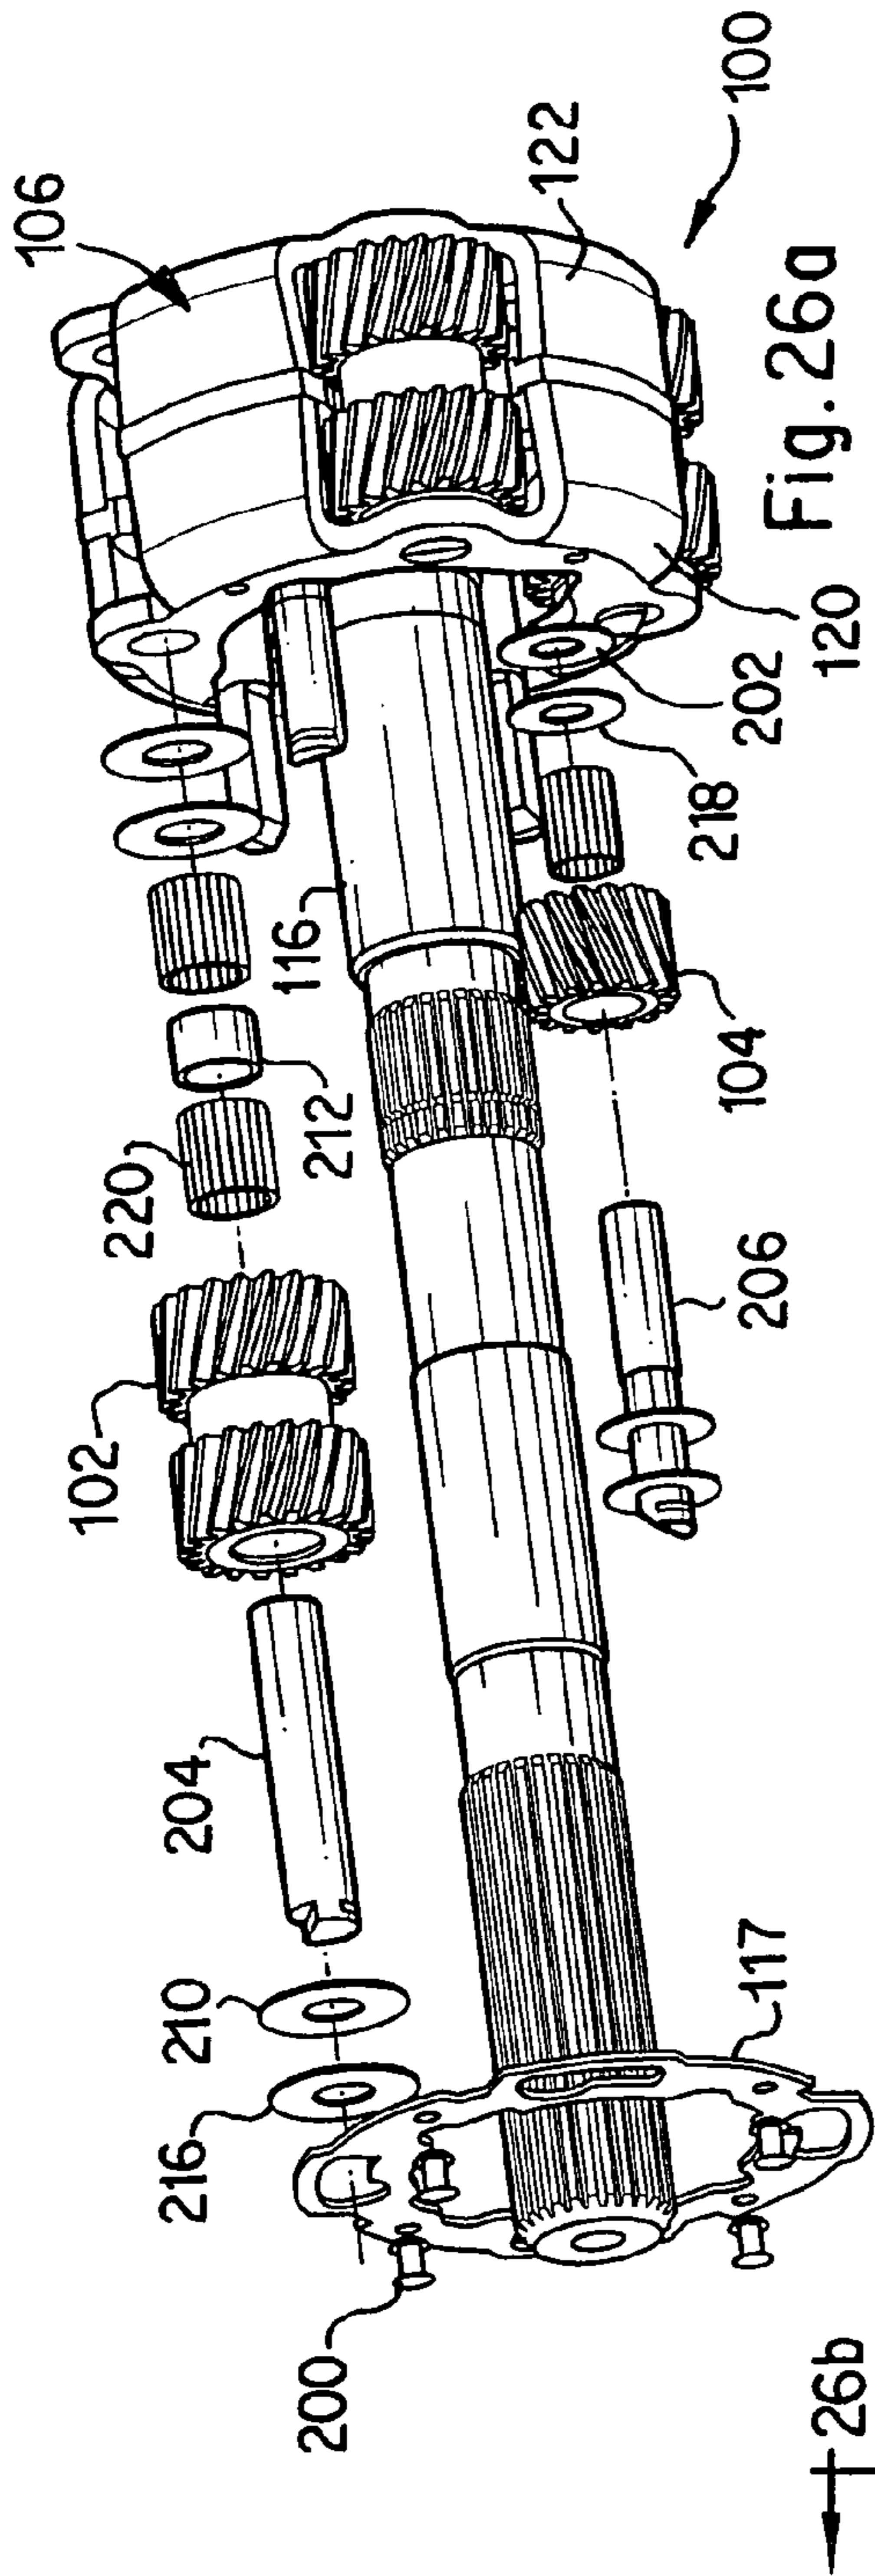
Fig. 25a

FIG. 25 illustrates a complete assembly.

Referring primarily to FIGS. 25a-25b and 26a-26c, but also to various other figures, disclosed planetary gear train 100 is compound in nature. The transmission is composed of eight pinion gears, four of which 102 are compound (see also FIGS. 1a-1b), and four 104 that are plain (see also FIG. 3a-3b), all eight gears being assembled into one carrier 106 utilizing a forward sun gear 108 and a rear sun gear 110, a ring gear 112, a band drum 114 with a busing 115 received therein and a one way roller clutch. The four plain pinion gears 104 mesh with the four compound gears 102 and the forward sun gear 108 and one way roller clutch. The four compound pinion gears 102 also mesh with the four plain pinion gears 104, the front sun gear 108, the ring gear 112 and the rear sun gear 110. A 2.8 reduction is achieved by applying the rear band and driving the planetary assembly 100 by the front sun gear 108 through the one way roller clutch. (First gear) A 1.8 reduction is achieved by applying the intermediate clutch, thus driving the planetary by the ring gear 112 and over running the one way roller clutch. (Second gear) Third gear is achieved (one to one) by applying the direct clutch, and releasing the rear band maintaining the application of the intermediate clutch thus locking the ring gear 112 and front sun gear 108. The unique nature of this transmission lies in the size of the pinion gears 102, 104, the pressure angle to which they are cut and the method of assembly. This unique combination produces a gear train 100 that is thirty-three percent stronger than current design and is four decibels quieter in operation.

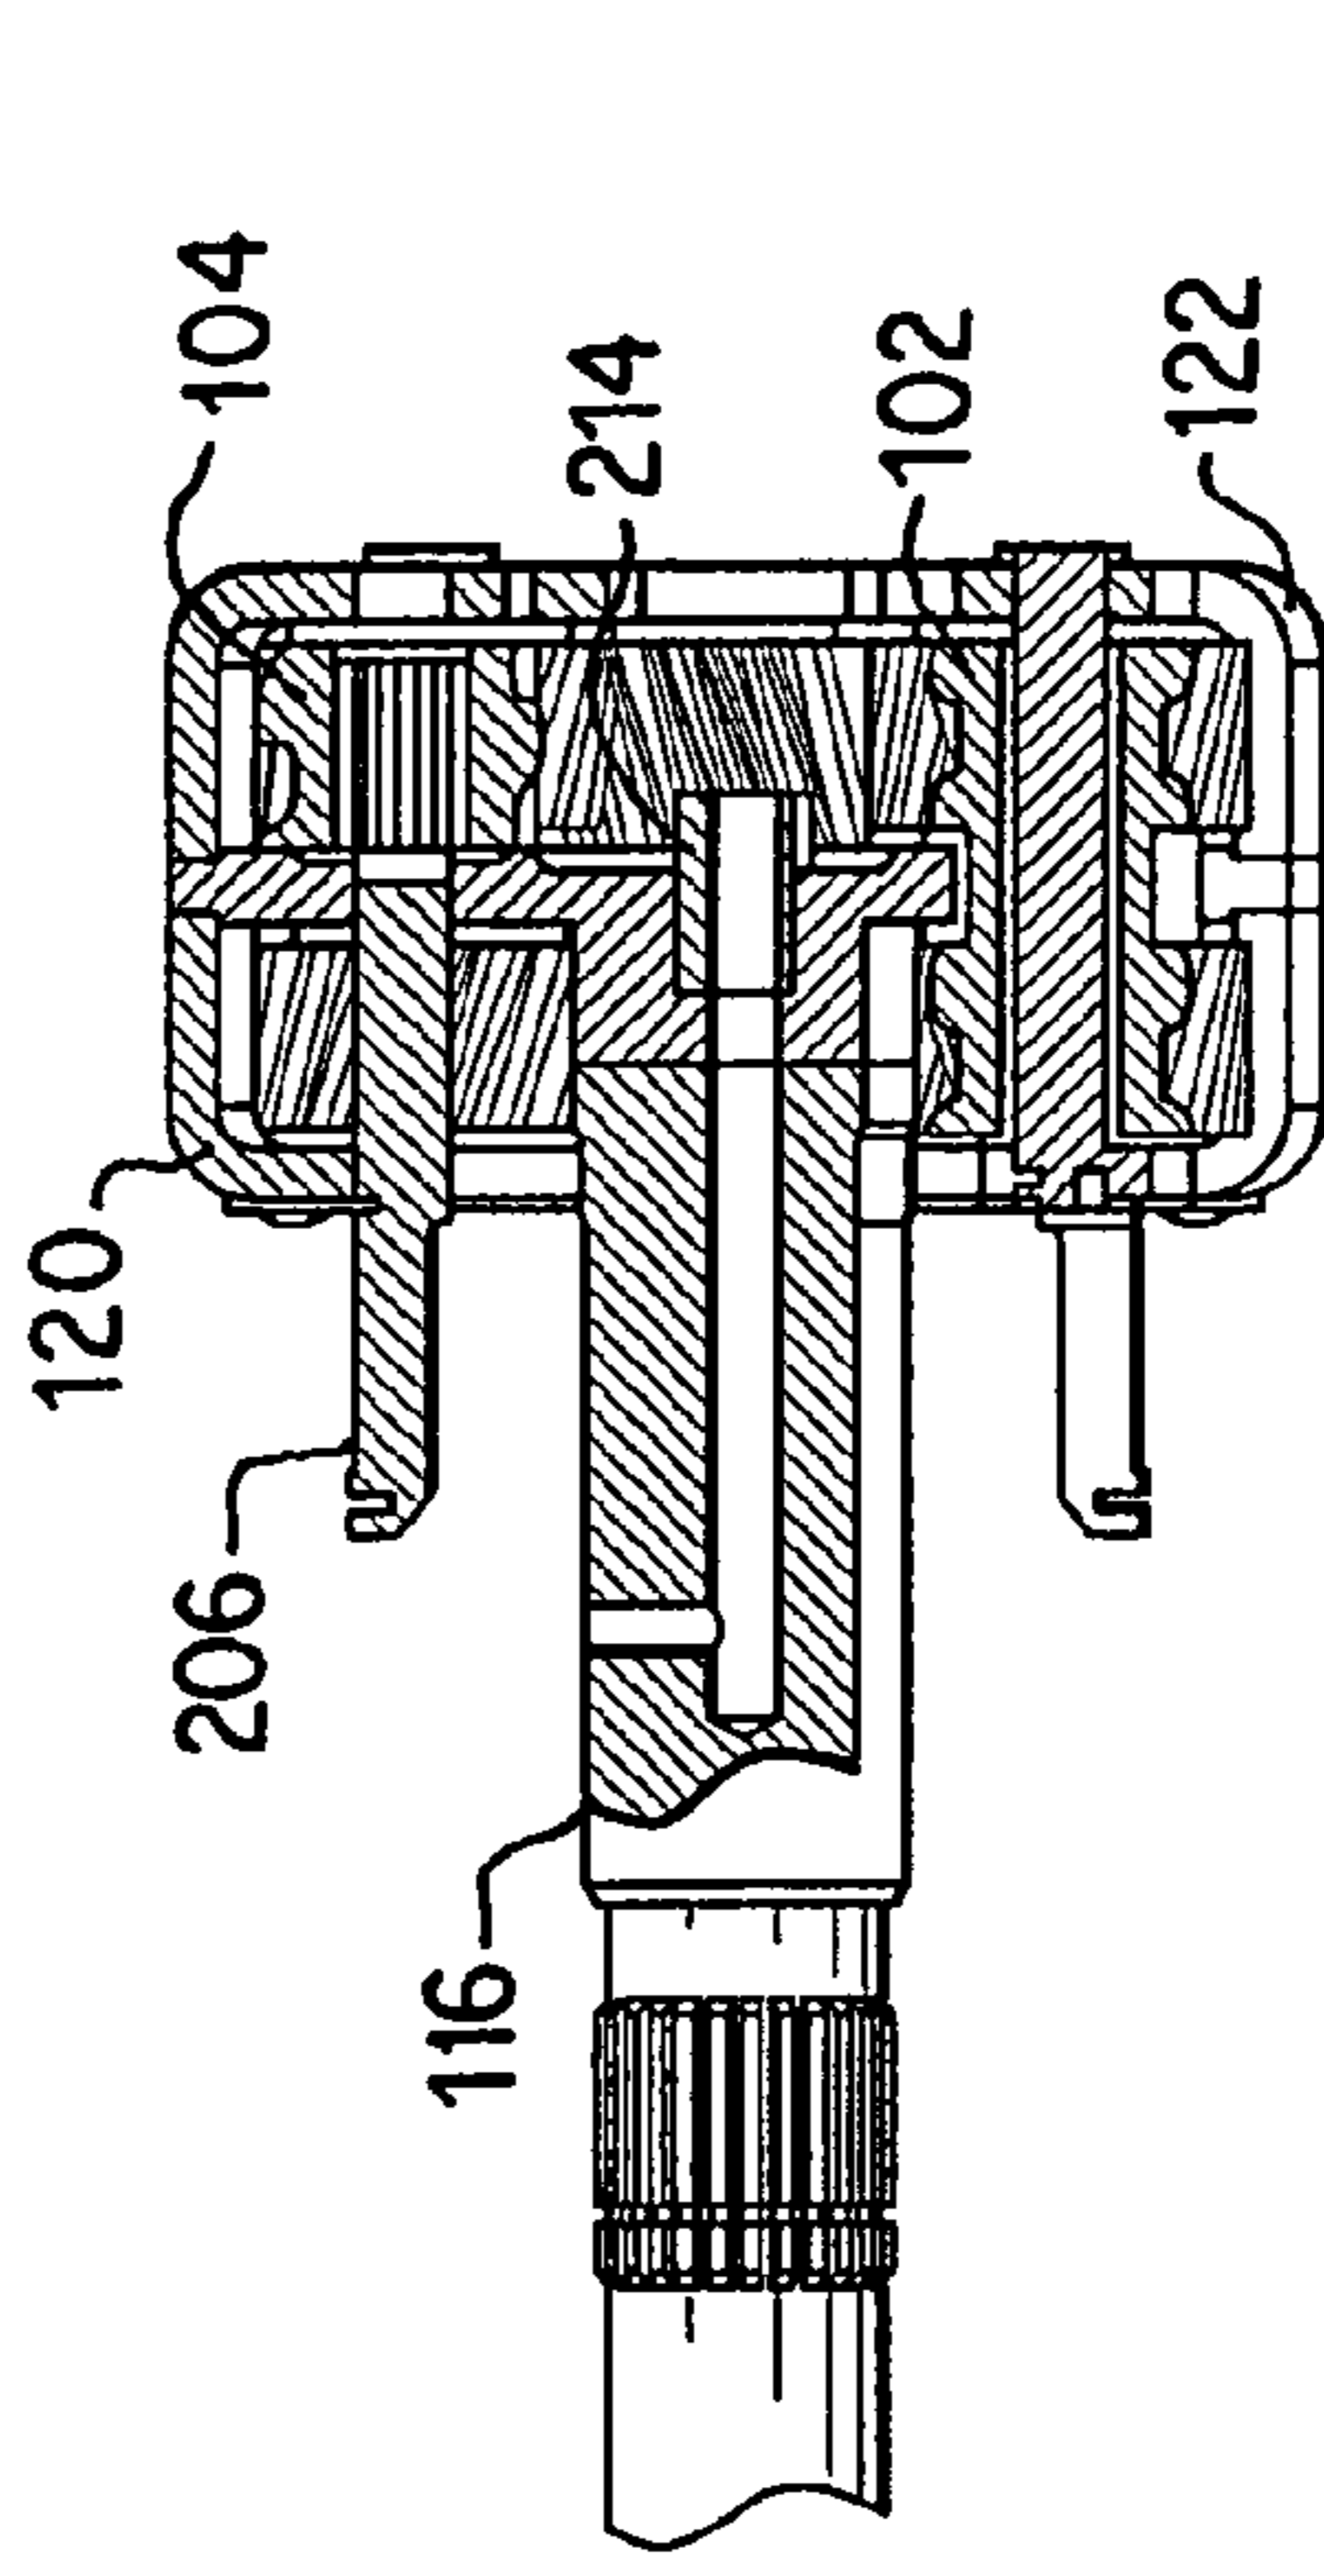
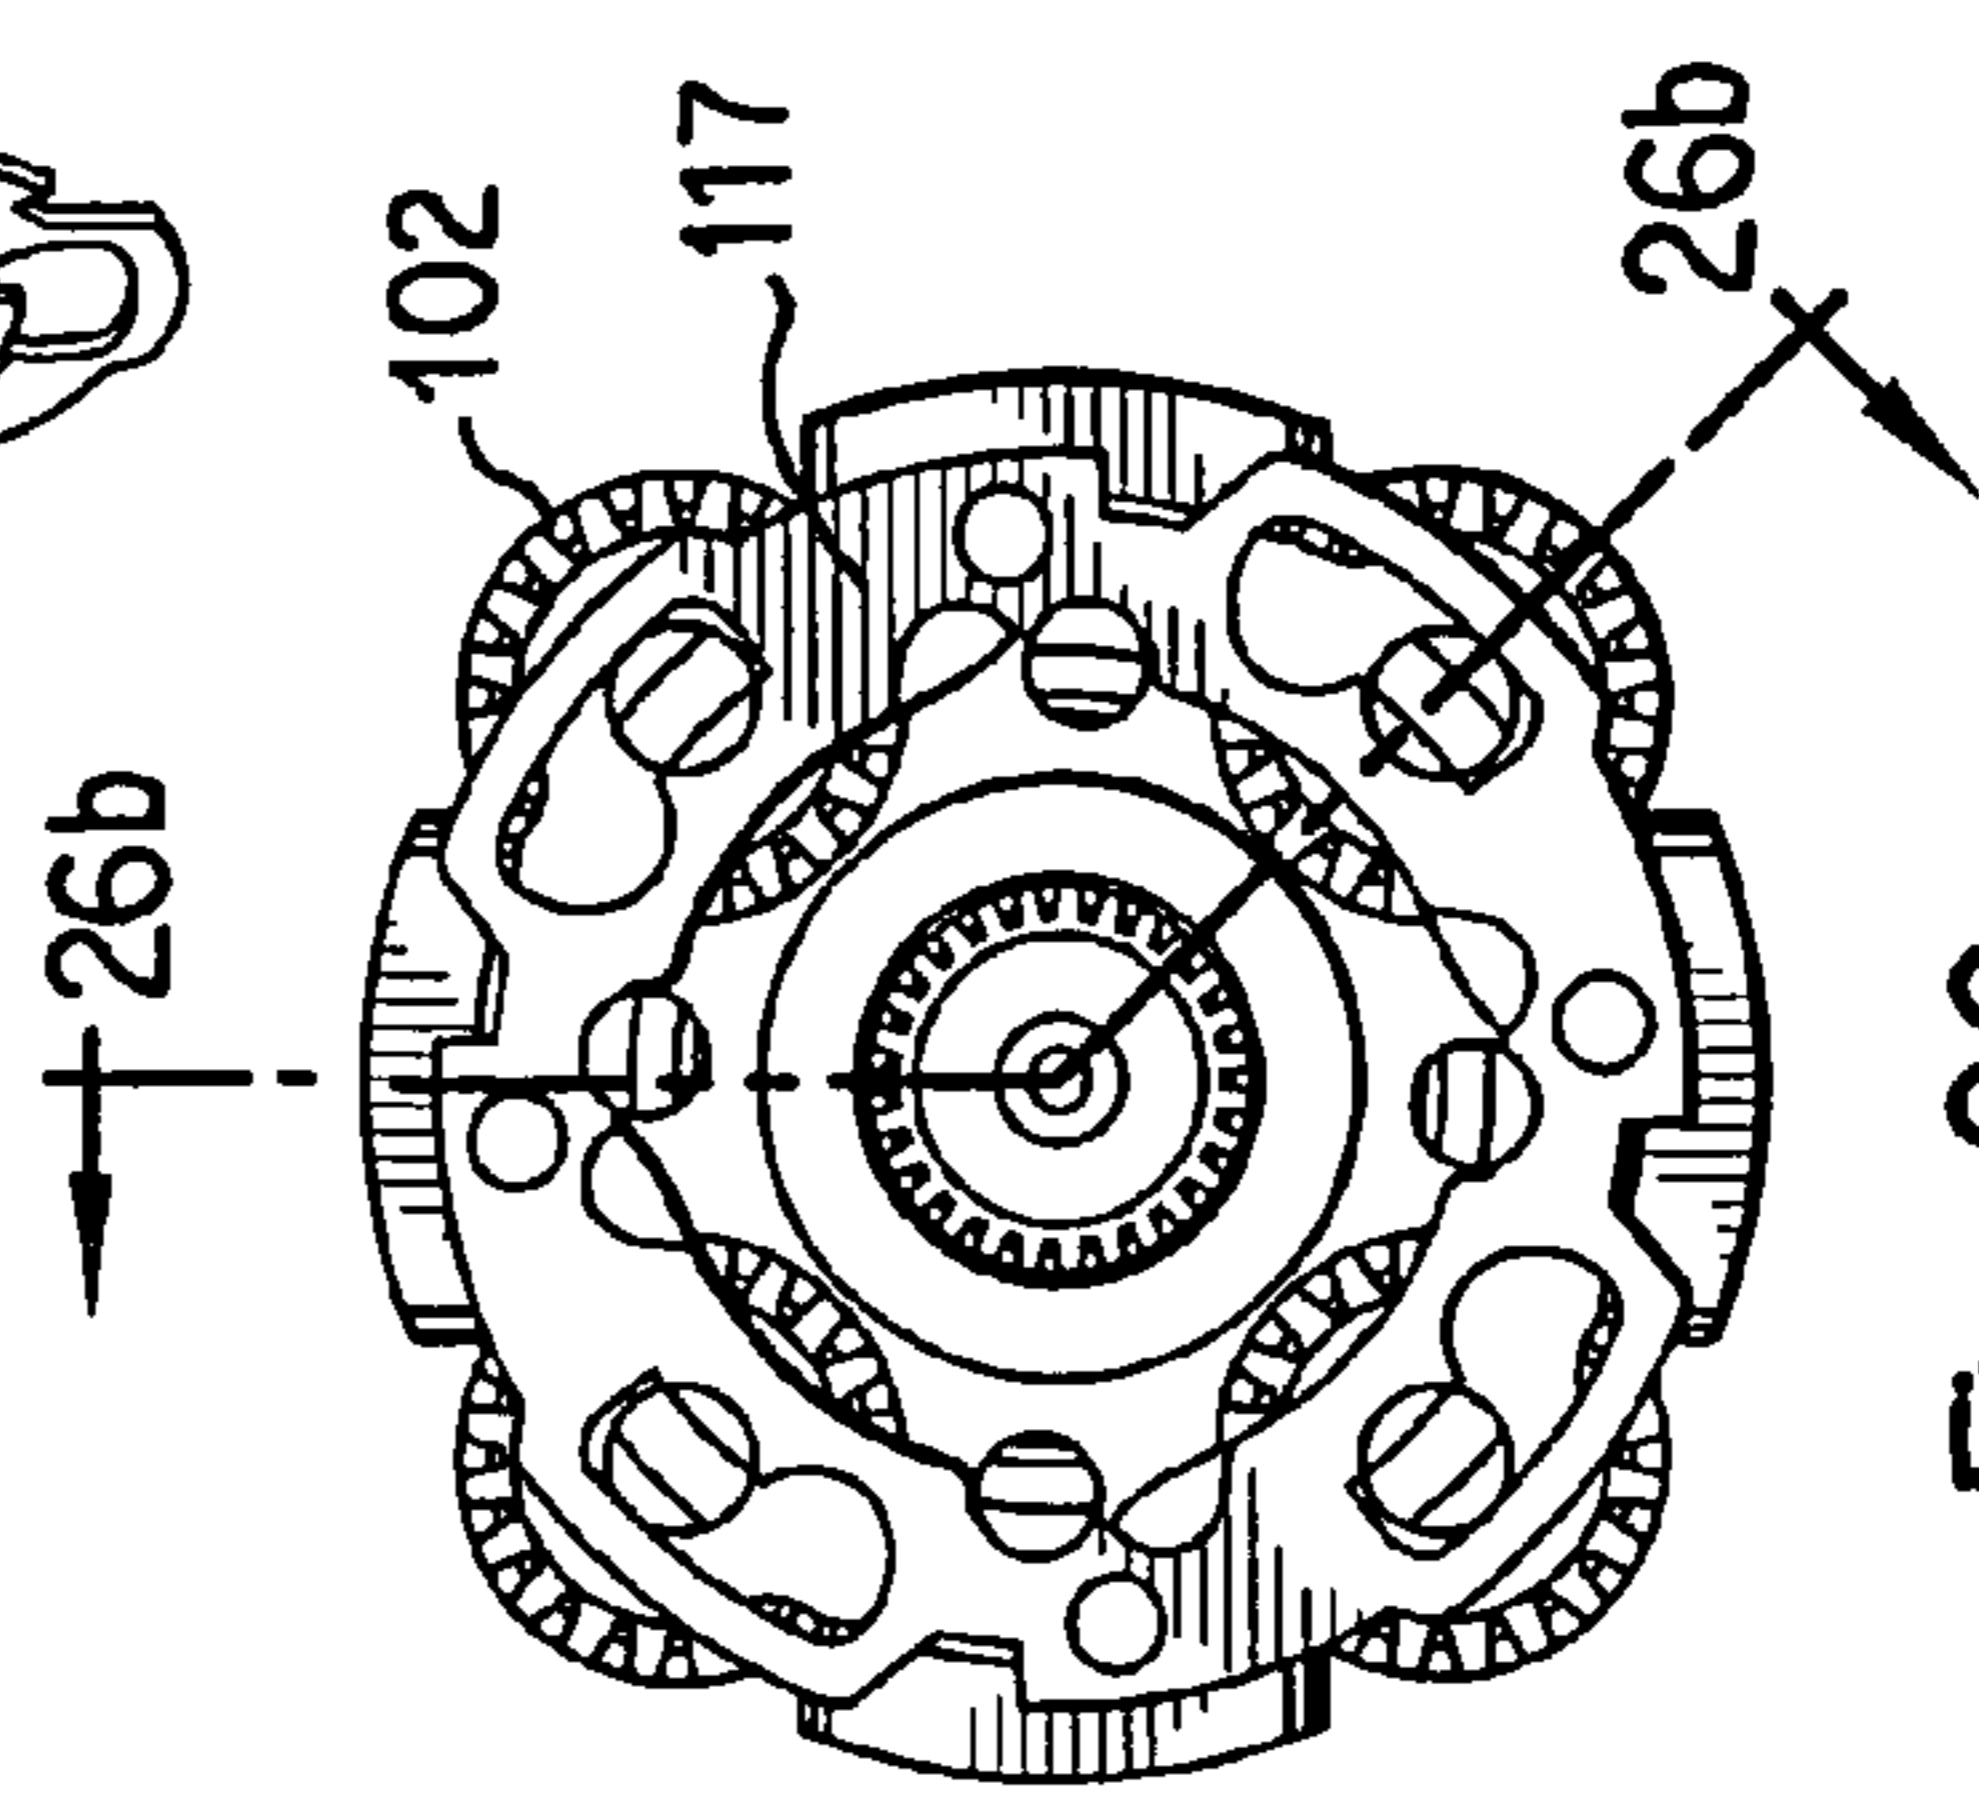
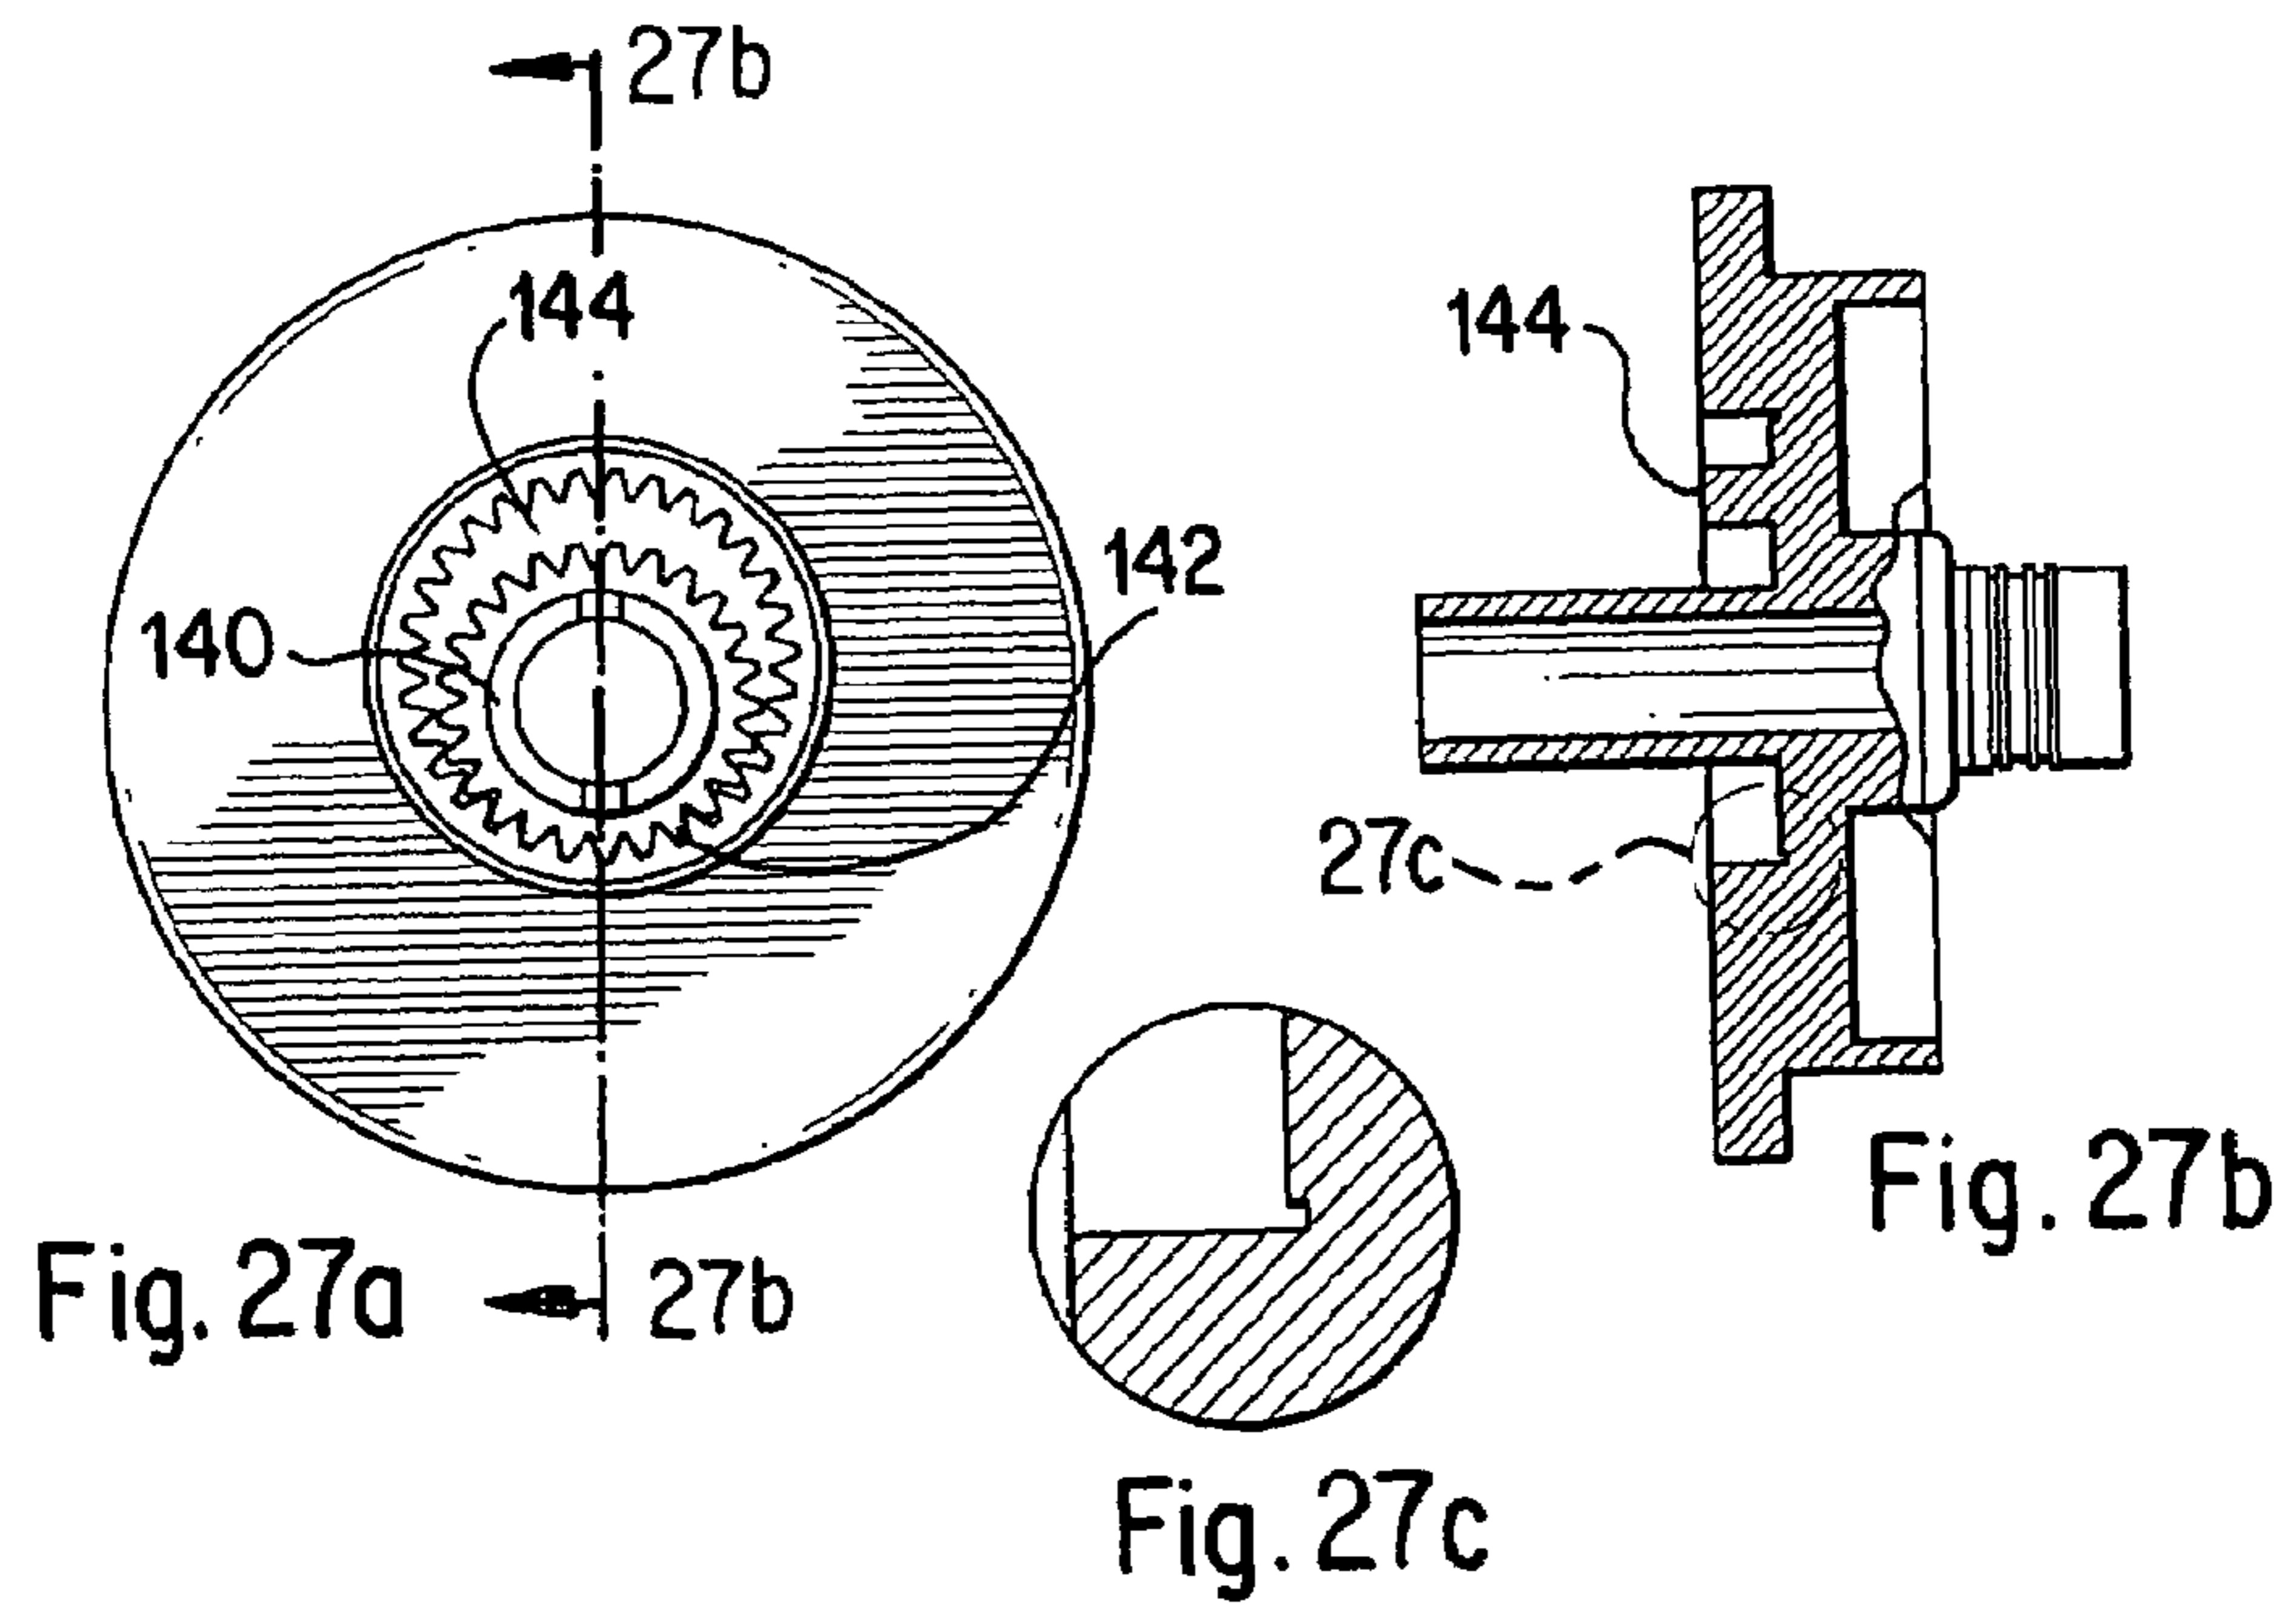
Fig. 26a

FIG. 26 illustrates a complete planetary gear kit.

Also indicated in FIG. 26a-26c are rivets 200, a small phosphor bronze washer 202 (see also FIG. 18a-18c), a compound pinion pin 204 (see also FIG. 2a-2c), a plain pinion pin 206 (see also FIG. 4a-4c), an output shaft 116 (see also FIG. 5a-5c), a lock plate 117 (see also FIG. 17a-17c), a small SK5 washer 218, a large SK5 washer 210 (see also FIG. 19a-19c), a needle sleeve 212 (see also FIG. 20a-20b), a plug 214 (see also FIG. 21a-21b), a large phosphor bronze washer 216, and a needle roller bearing 220 including needle rollers 222 (see also FIG. 22a-22b).

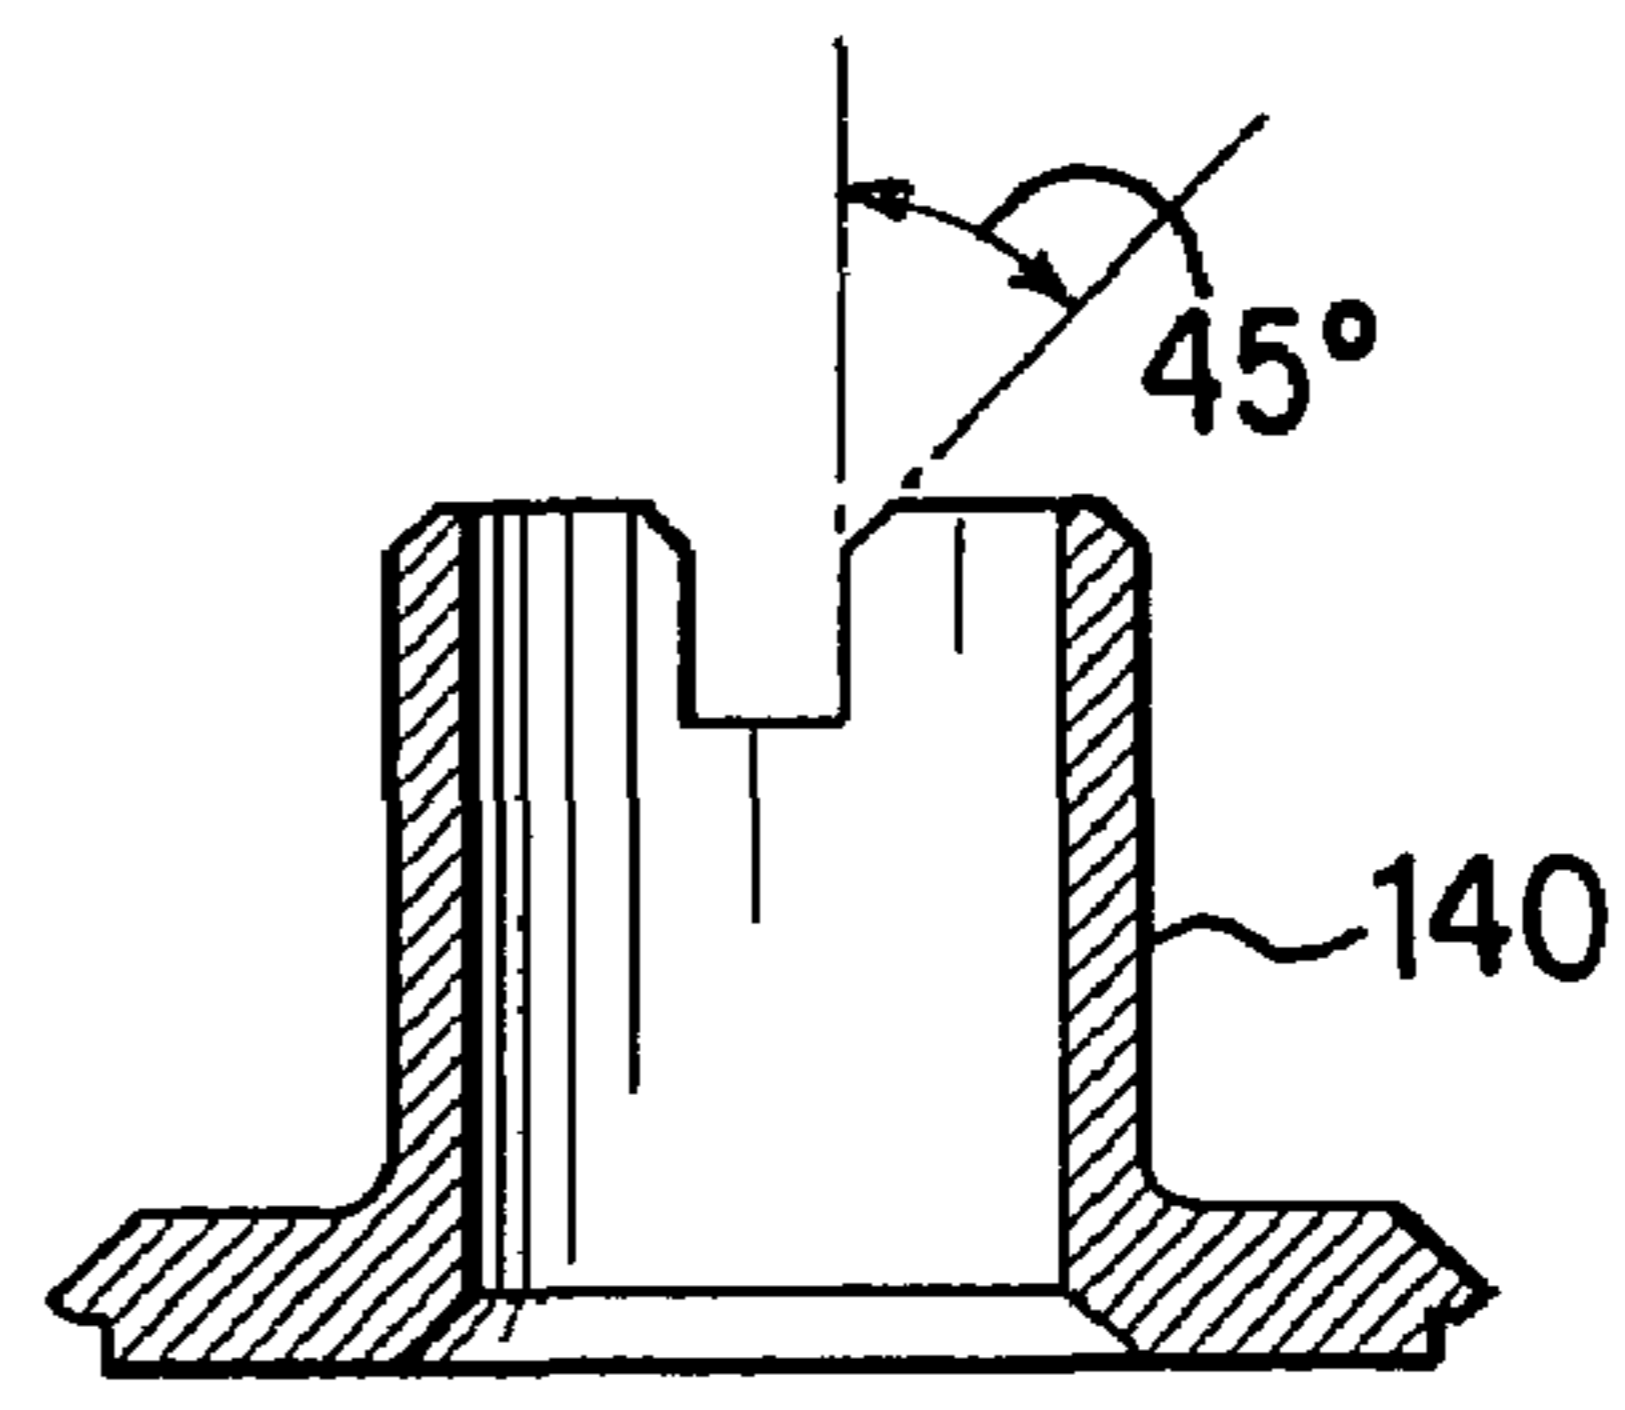
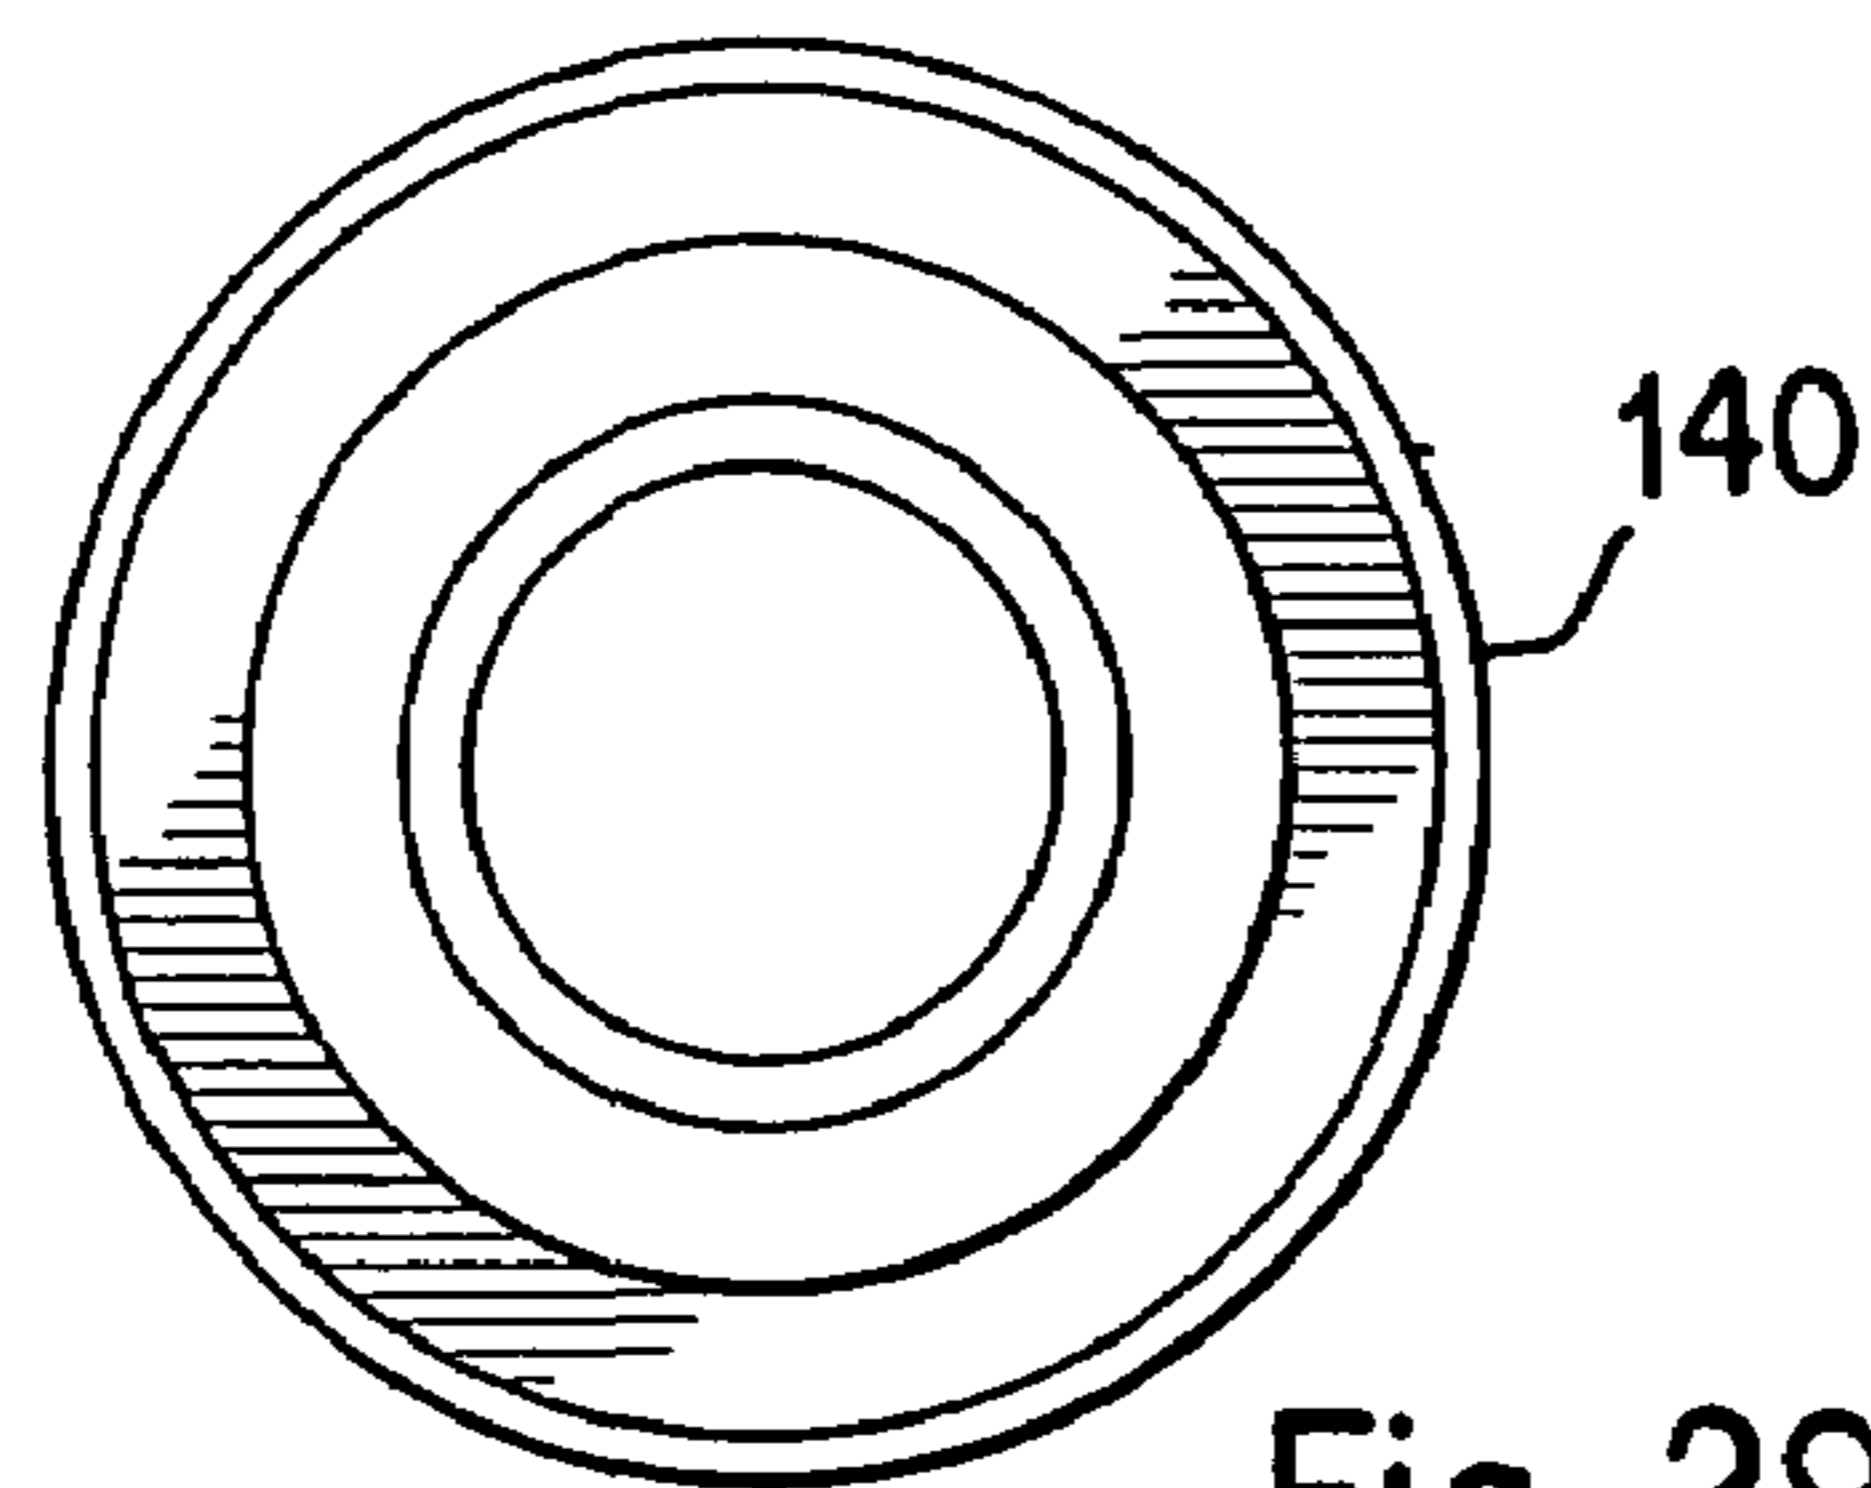
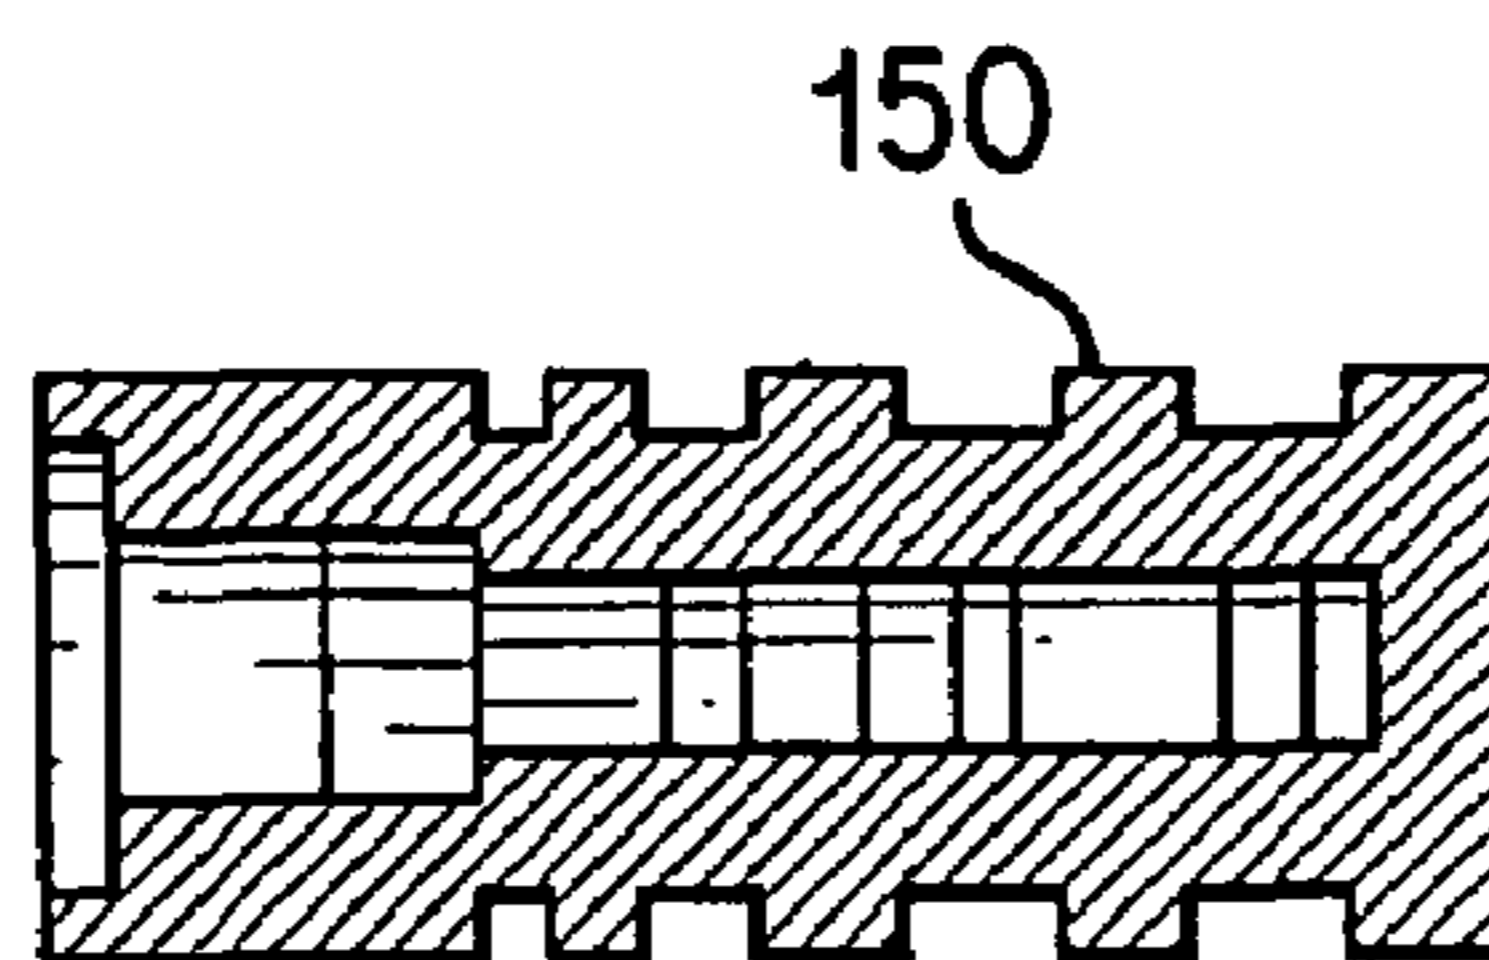
Fig. 29a

FIG. 29 illustrates the 280PS flanged converter hub.
