(12) **United States Patent**
Dalenberg et al.

(10) **Patent No.:** **US 7,195,578 B2**
(45) **Date of Patent:** **Mar. 27, 2007**

(54) **AUTOMATIC TRANSMISSION AND GEAR TRAIN**

The present invention relates to automatic transmissions. In particular, the instant invention relates to an automatic transmission with improved resistance to deterioration with an increased effective life. The transmission of the instant invention comprises eight pinion gears assembled into one carrier utilizing a forward and a rear sun gear, a ring gear, a band drum and a one way roller clutch.

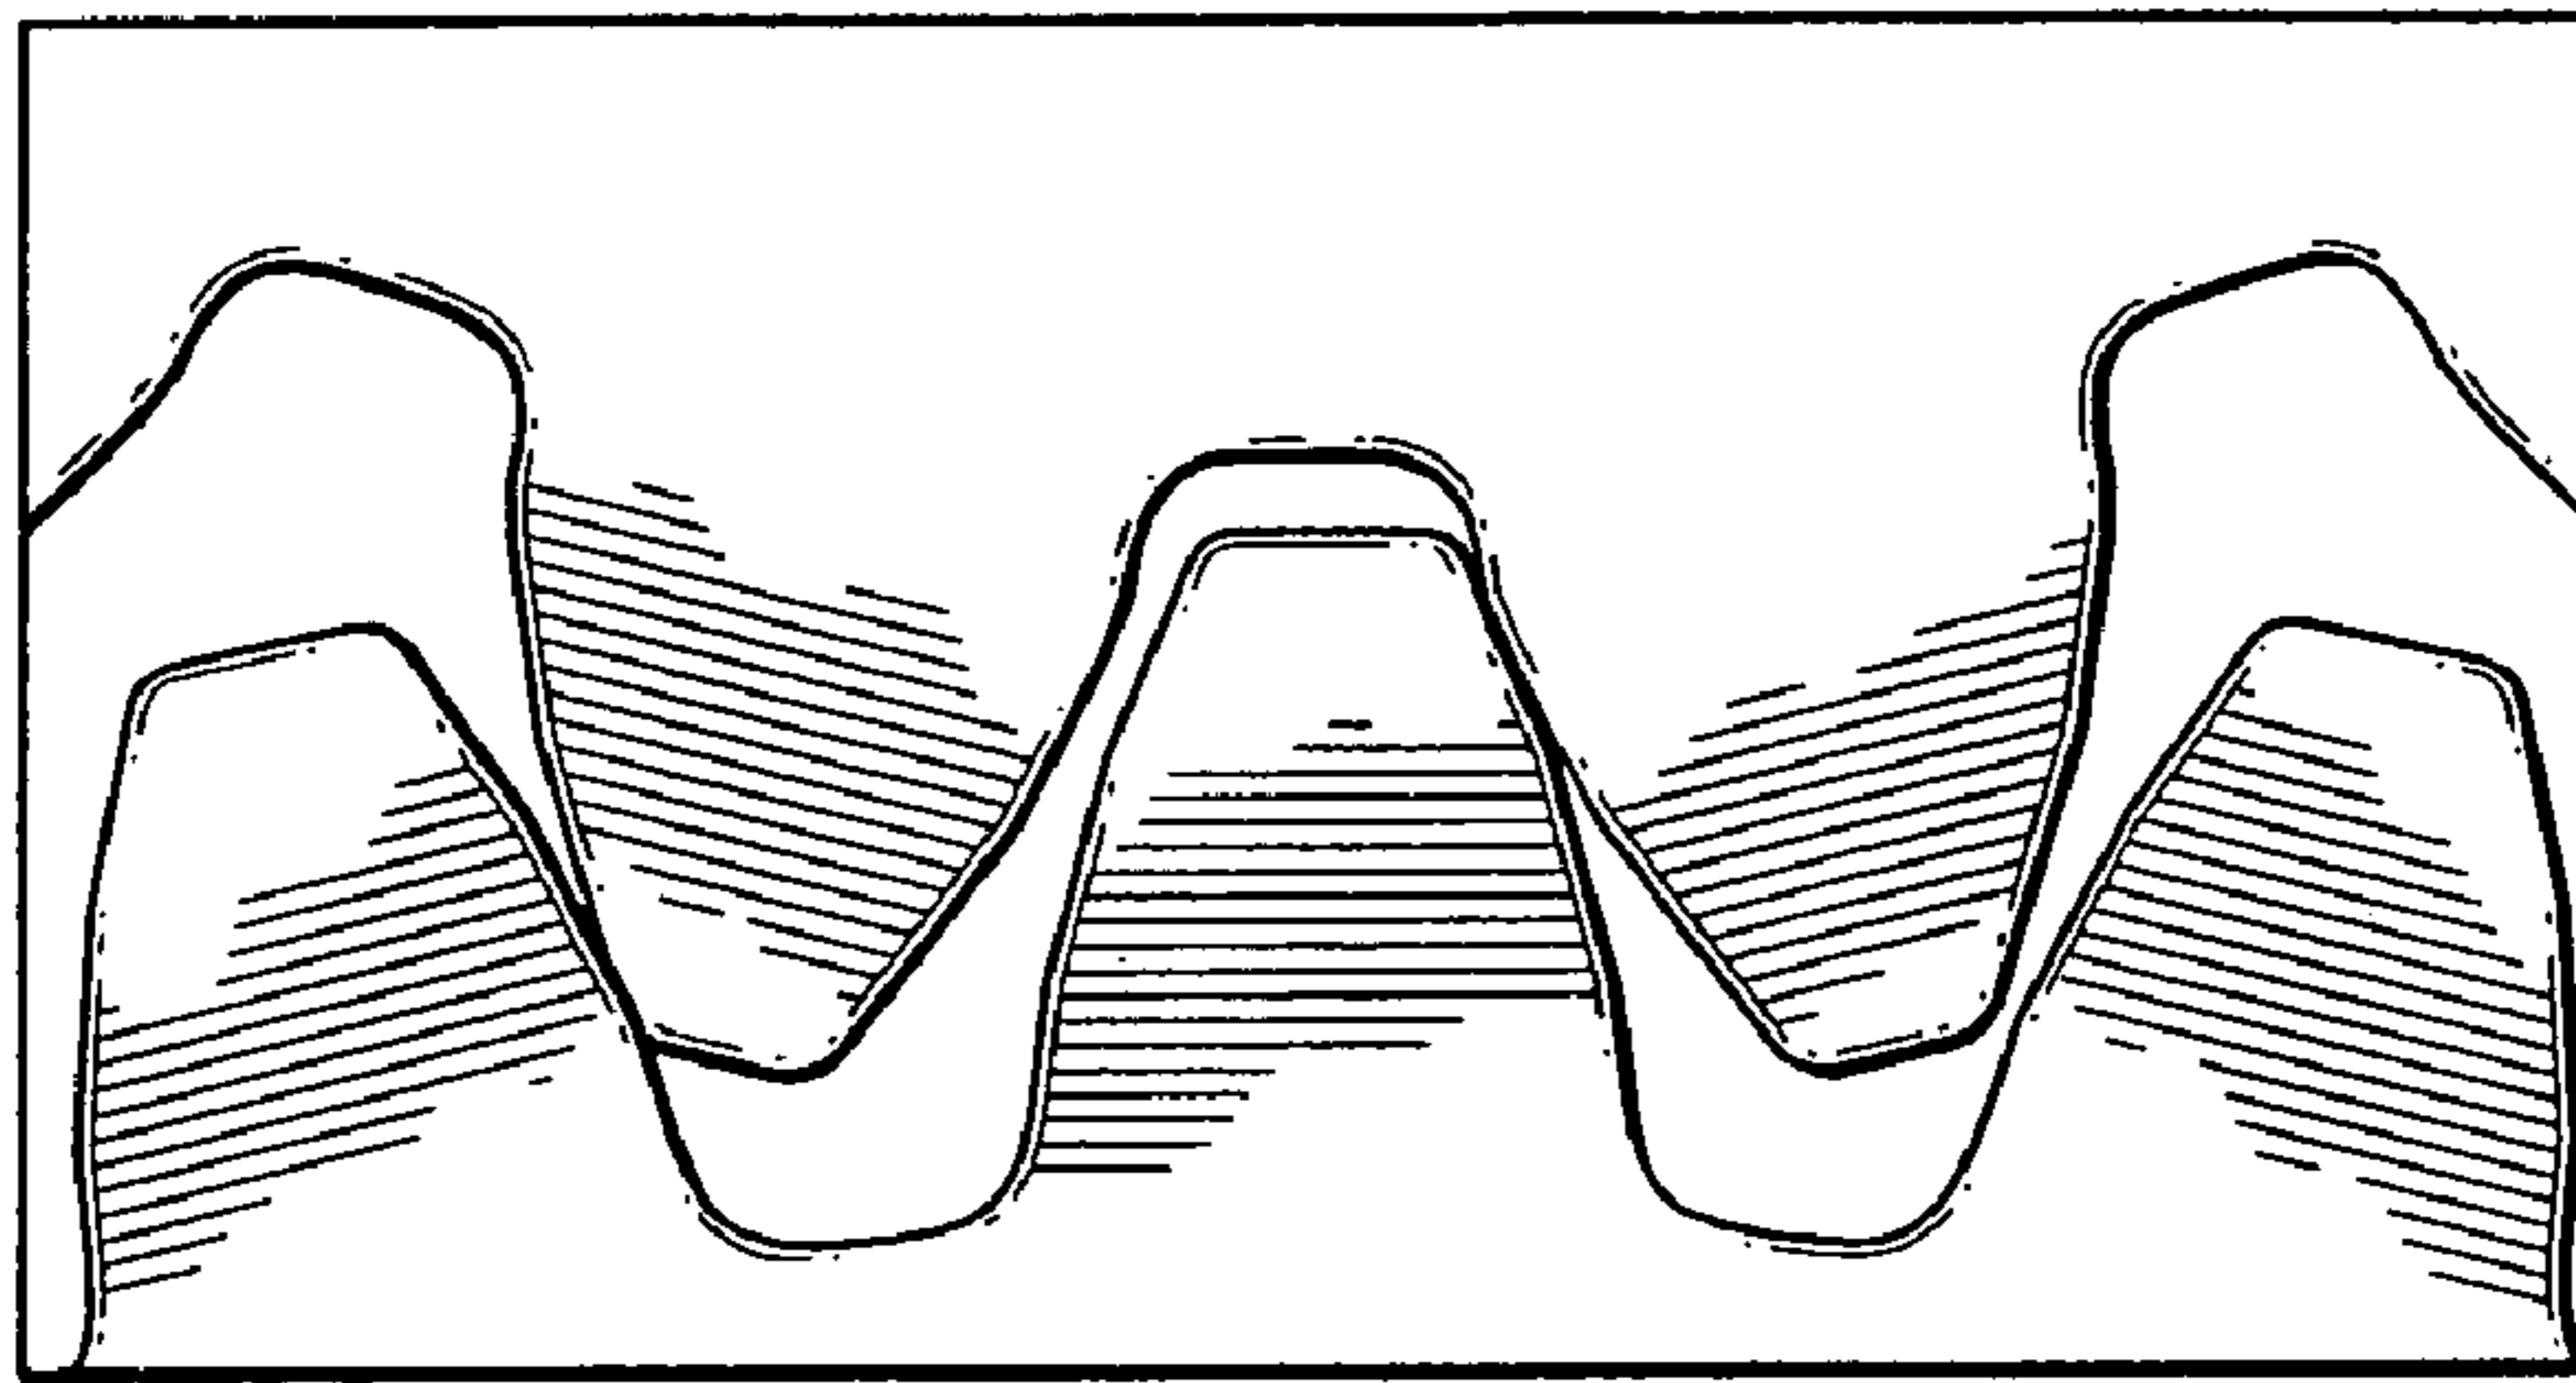
FIG. 33

The new gear geometry is detailed in FIGS. 31–32. FIG. 33–40 illustrate the initial and revised mesh conditions in each stage. Tables 2–4 show the initial and final I and J factors and the % improvement achieved. In each case, improvements to pitting resistance, and bending strength have been achieved by changing the designs to full fillet radii from sharp fillet radii, and by optimizing tooth proportions to provide more load sharing.

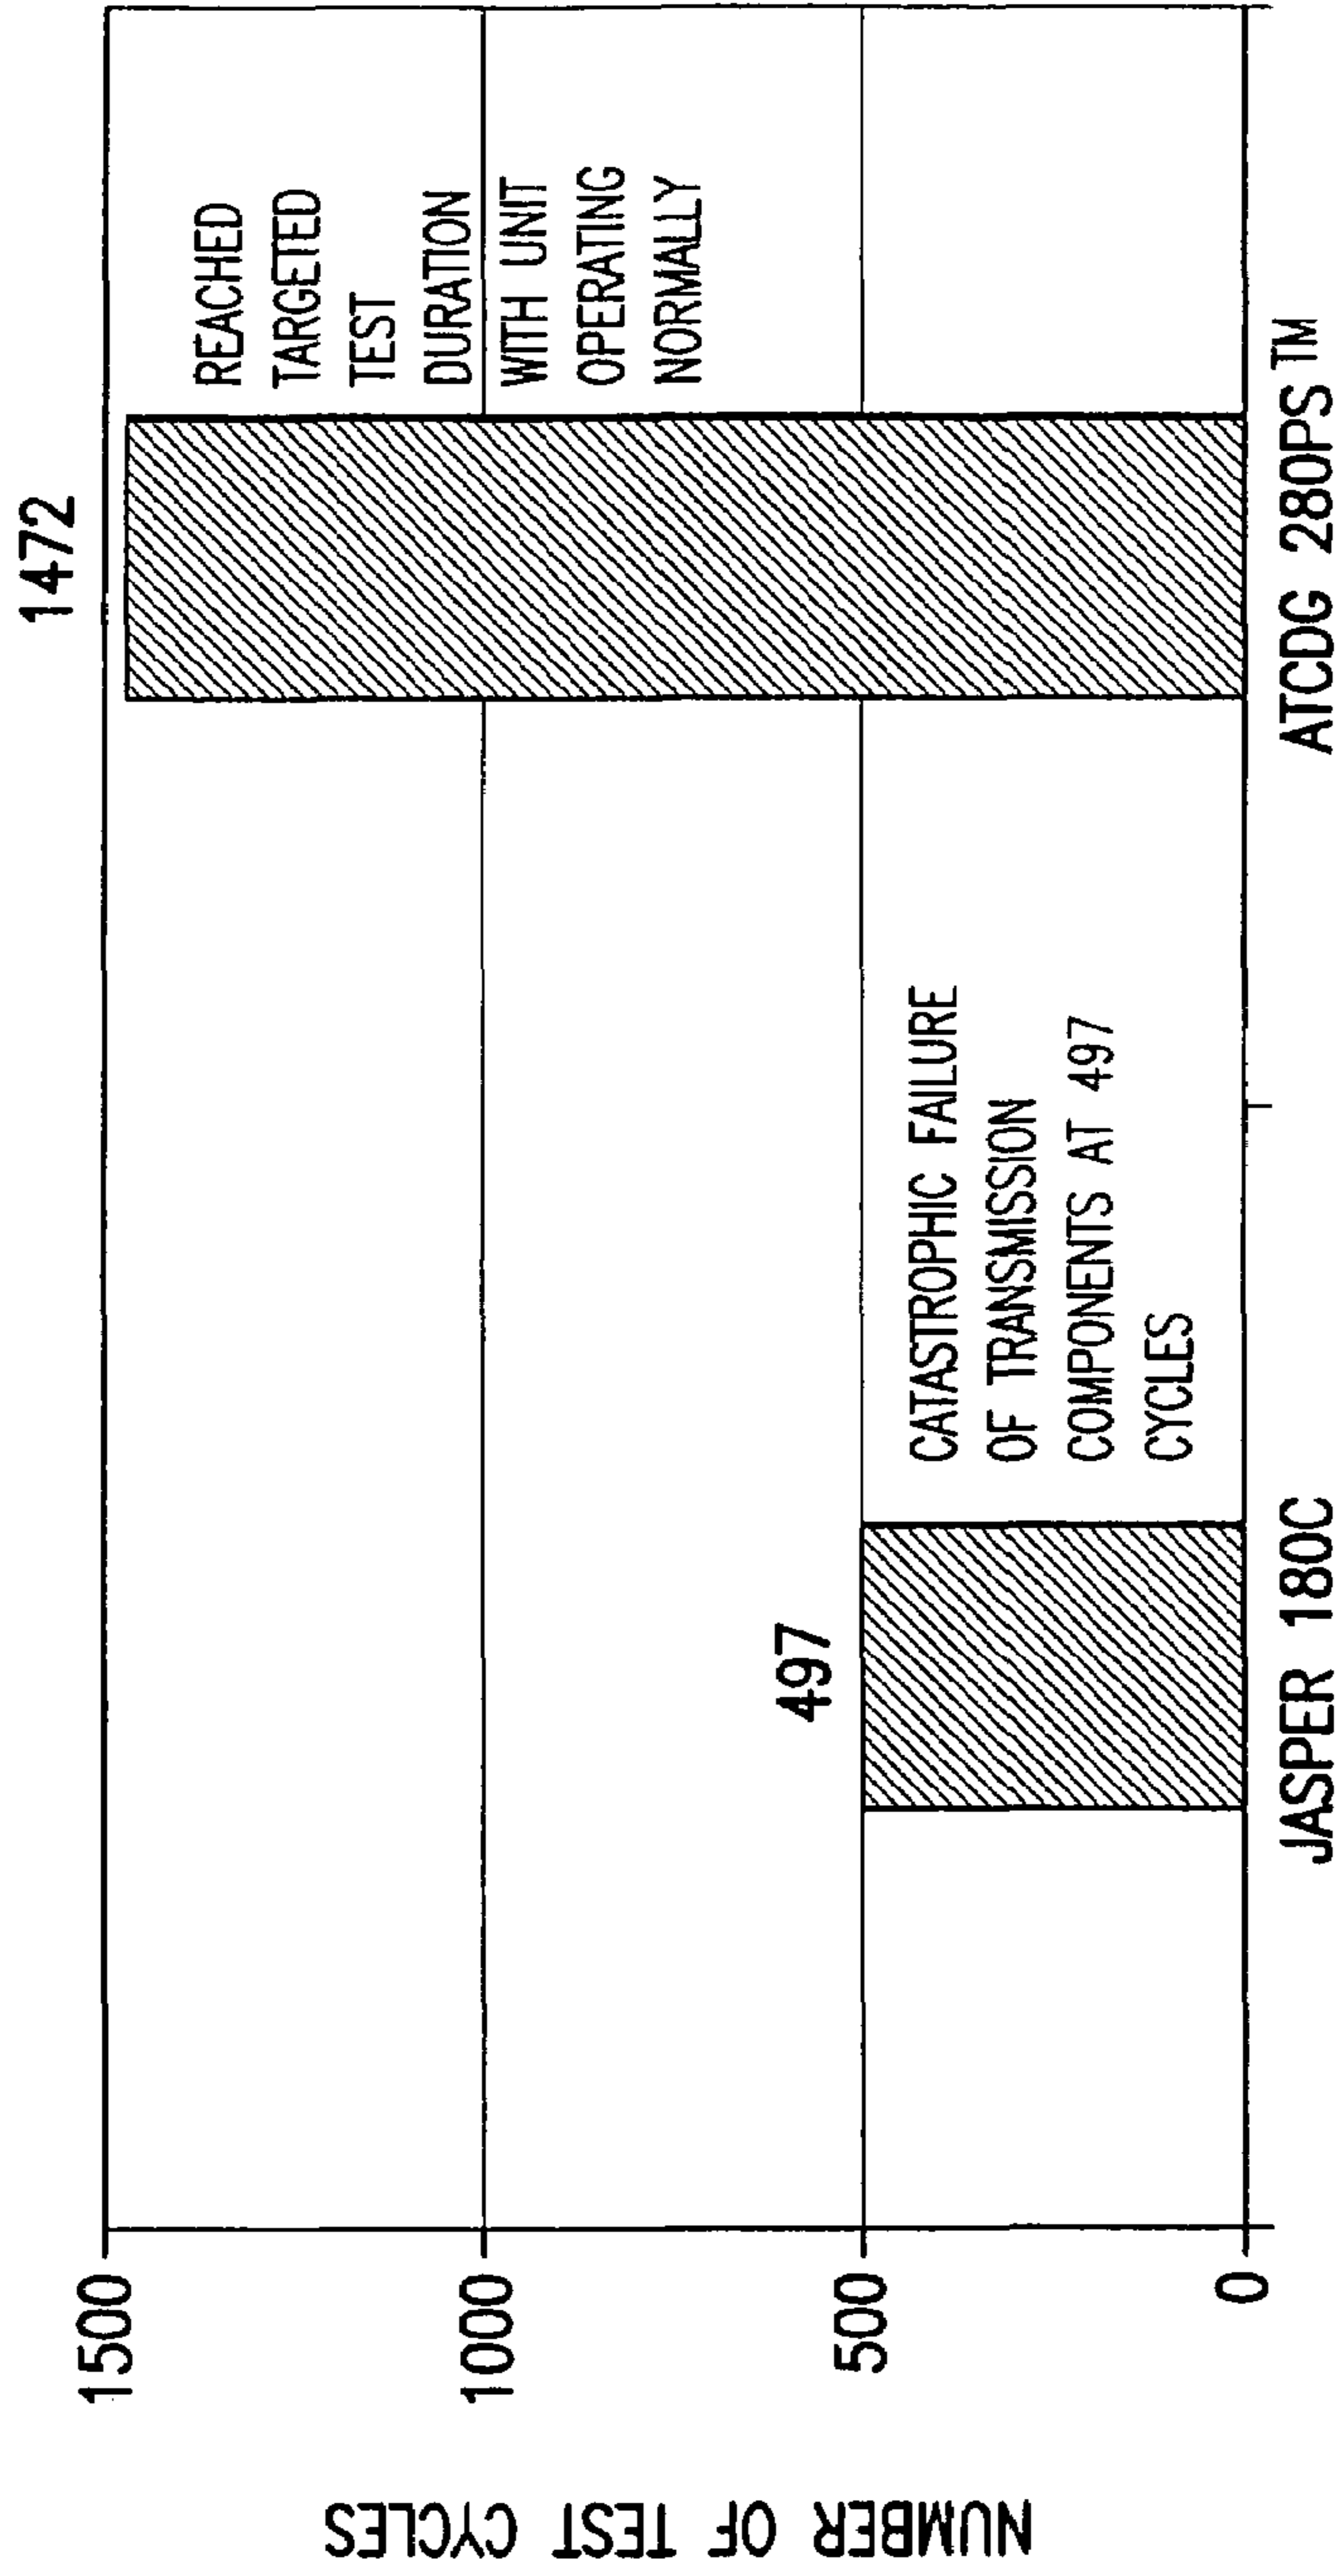
FIG. 42

CONTROLLED COMPARATIVE EVALUATION FINDINGS

DURABILITY - "IN TEST" LIFE

The 280PS™ operated normally through 1472 cycles, or three times the life of the 180C unit, which failed catastrophically at 497 cycles. At the time of its failure, the 180C unit had 75% more iron in the fluid (indicative of gear wear) and 375% more lead in the fluid (indicative of bearing wear) than the 280PS™.

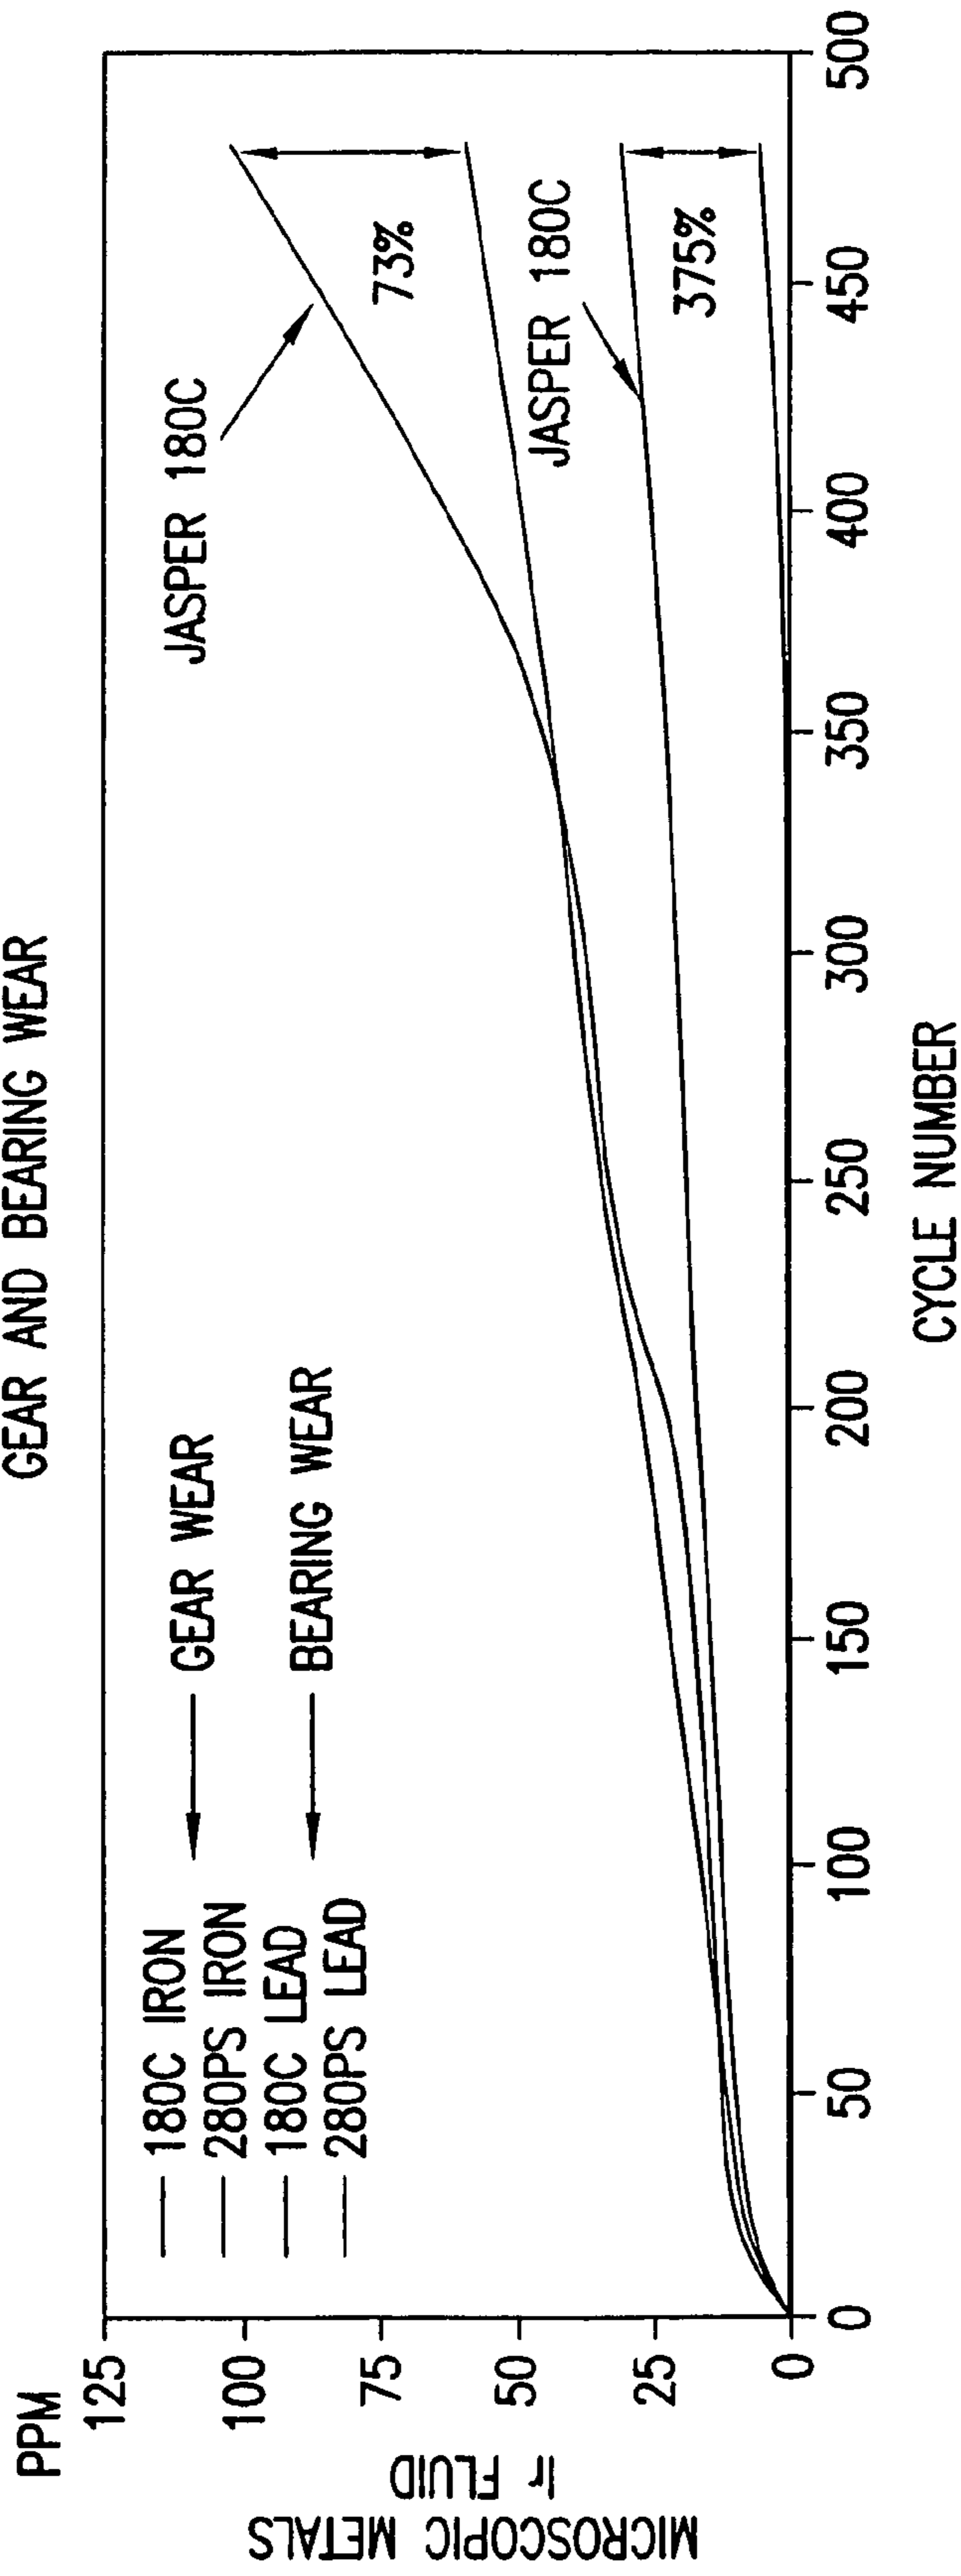
FIG.43

CONTROLLED COMPARATIVE EVALUATION FINDINGS

GEAR AND BEARING WEAR

FIG. 43 illustrates a comparison of the gear wear of the 180c transmission and the 280PS transmission.
