(10) **Patent No.:** **US 7,369,054 B2**  
(45) **Date of Patent:** **May 6, 2008**

(54) **RE-CHECK ALERT SYSTEM**

A warning indicator device installed in the tractor to give a driver an internal warning of a refrigerated trailer malfunction. This includes an internal warning indicator fault speaker and a red laminated light to be mounted on the lower part of the dashboard of the tractor, a 5-plug sensor input, a 5-prong output, a pigtail, a metal bar to secure the pigtail and fittings all made from a variety of materials.

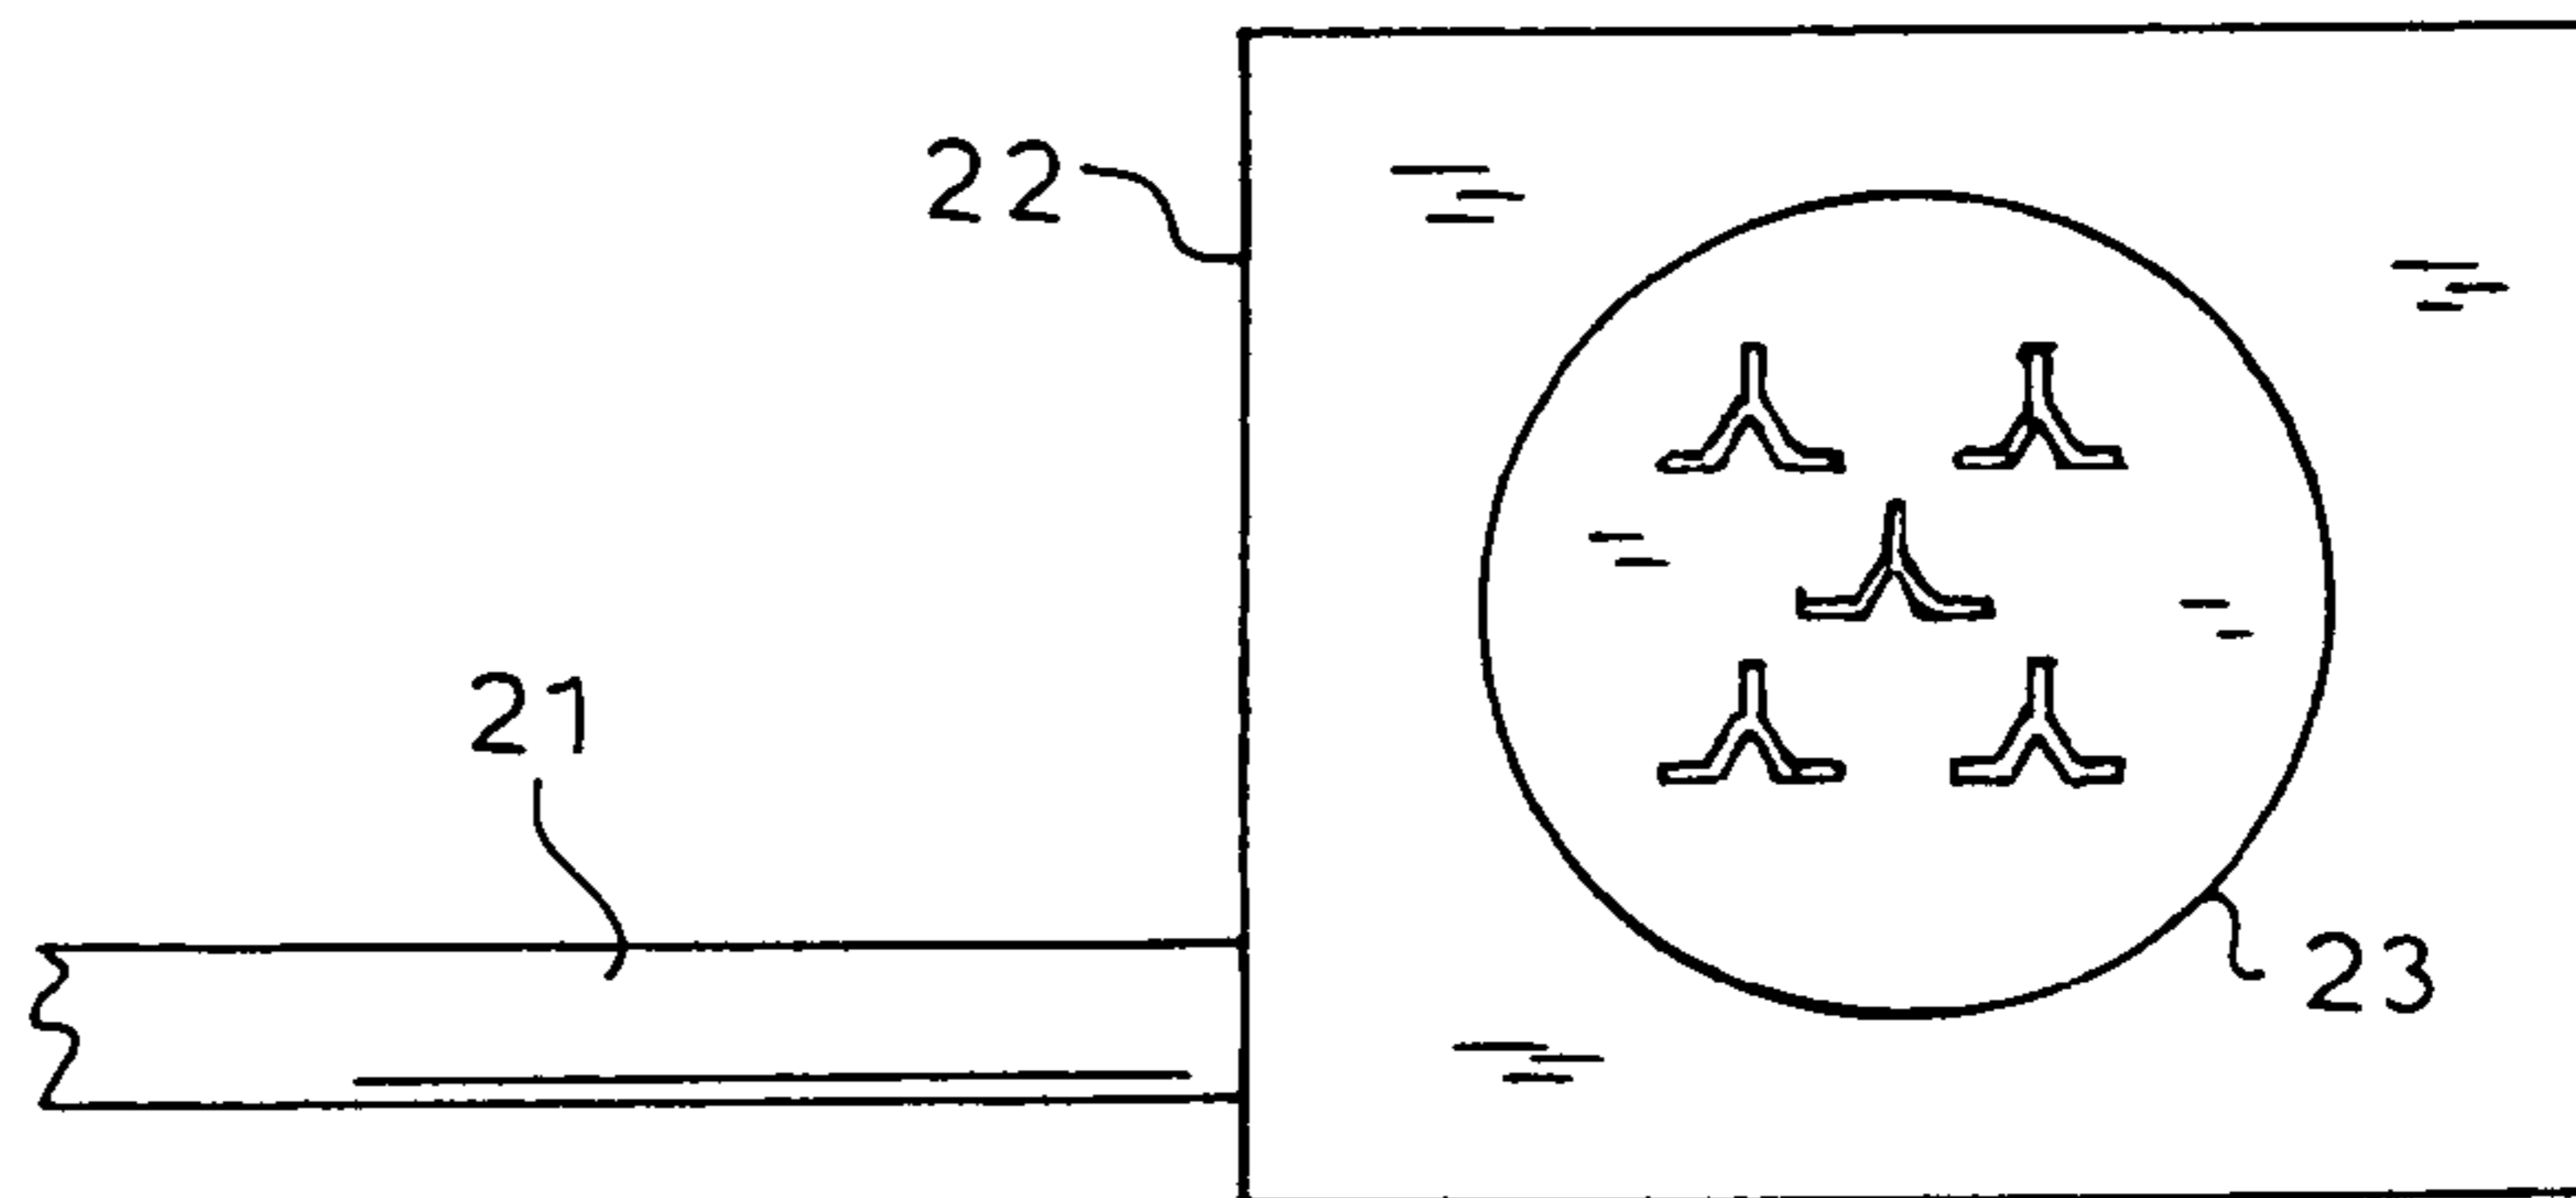
**FIG. 1**

FIG. 1 is a perspective view of the invention, illustrating the extension cord (21) that will connect to the existing indicator as described, illustrating a front view (22) of the protective box, illustrating the 5-plug sensor input (23) as described in the invention.

An extension from an existing light indicator will send a signal to the internal warning indicator. An extension cord made of a variety of materials with a protective cover would connect to the pigtail input. The pigtail input will consist of a square box including a 5-plug sensor. The square box will have a metal protective flap.

FIG. 1 is a perspective view of the invention, illustrating the extension cord that will connect to the existing warning indicator on the existing refrigeration trailer as described, illustrating a front view of the protective box, illustrating the 5-plug sensor input as described in the invention.

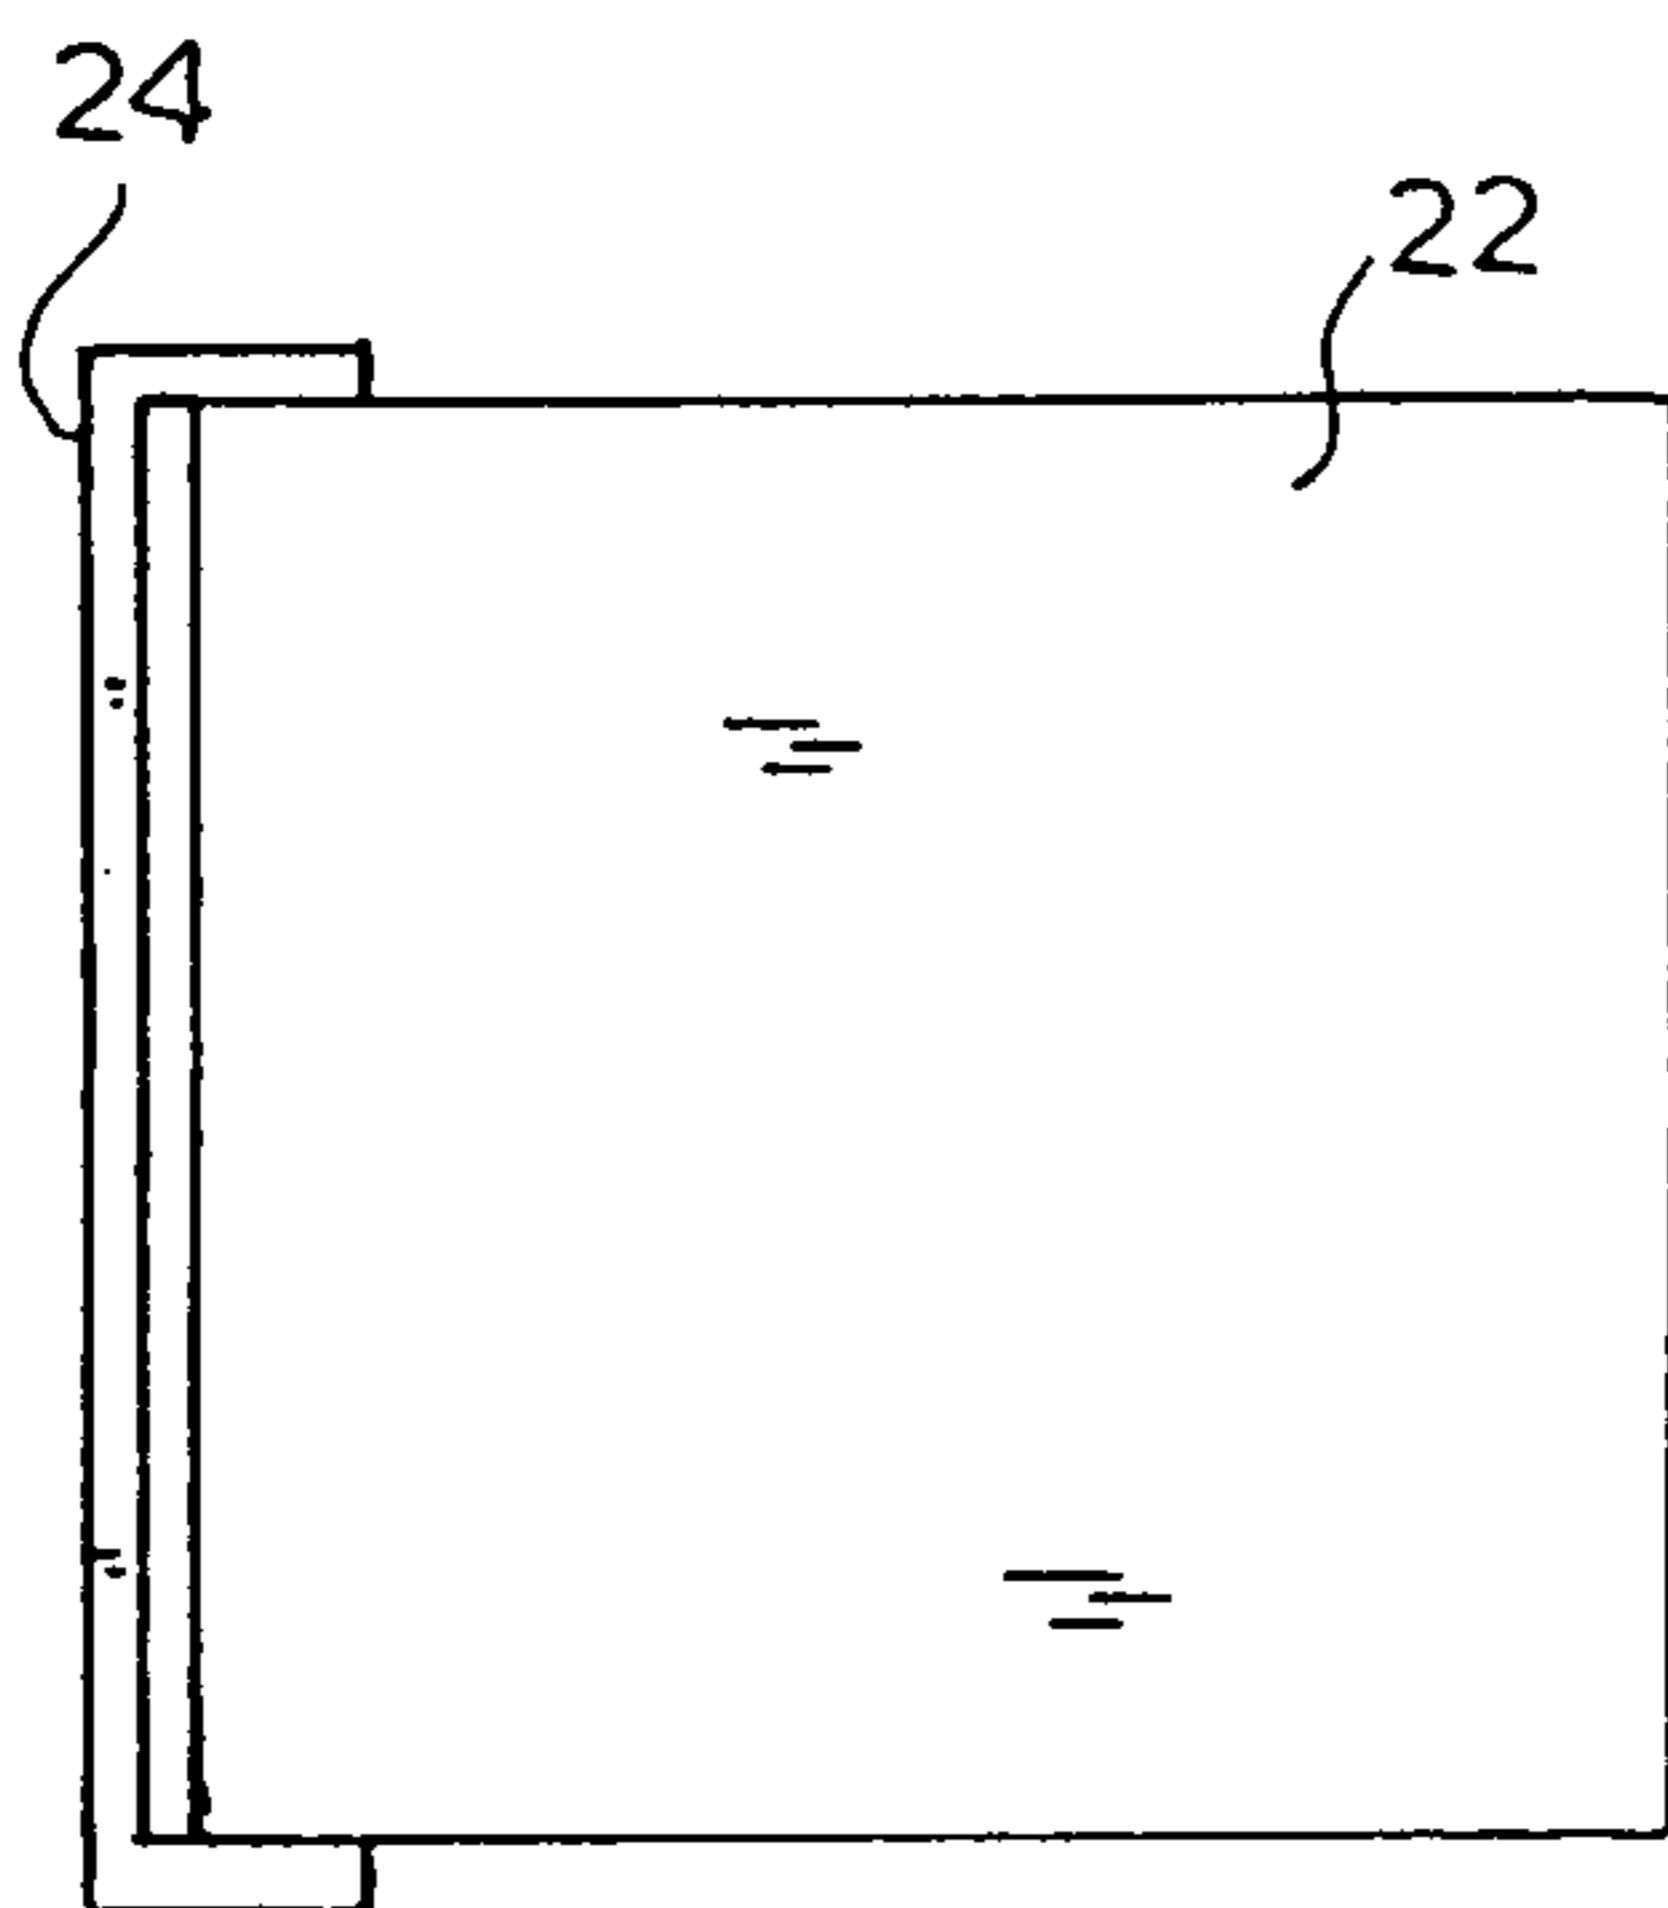
**FIG. 2**

FIG. 2 is a side view of the metal protective flap (24) as described in the invention.

The square box will be made of metal material. The protective flap will be an attachment to the outer surround of the pigtail input box. This as described above will become a fixture to the reefer.

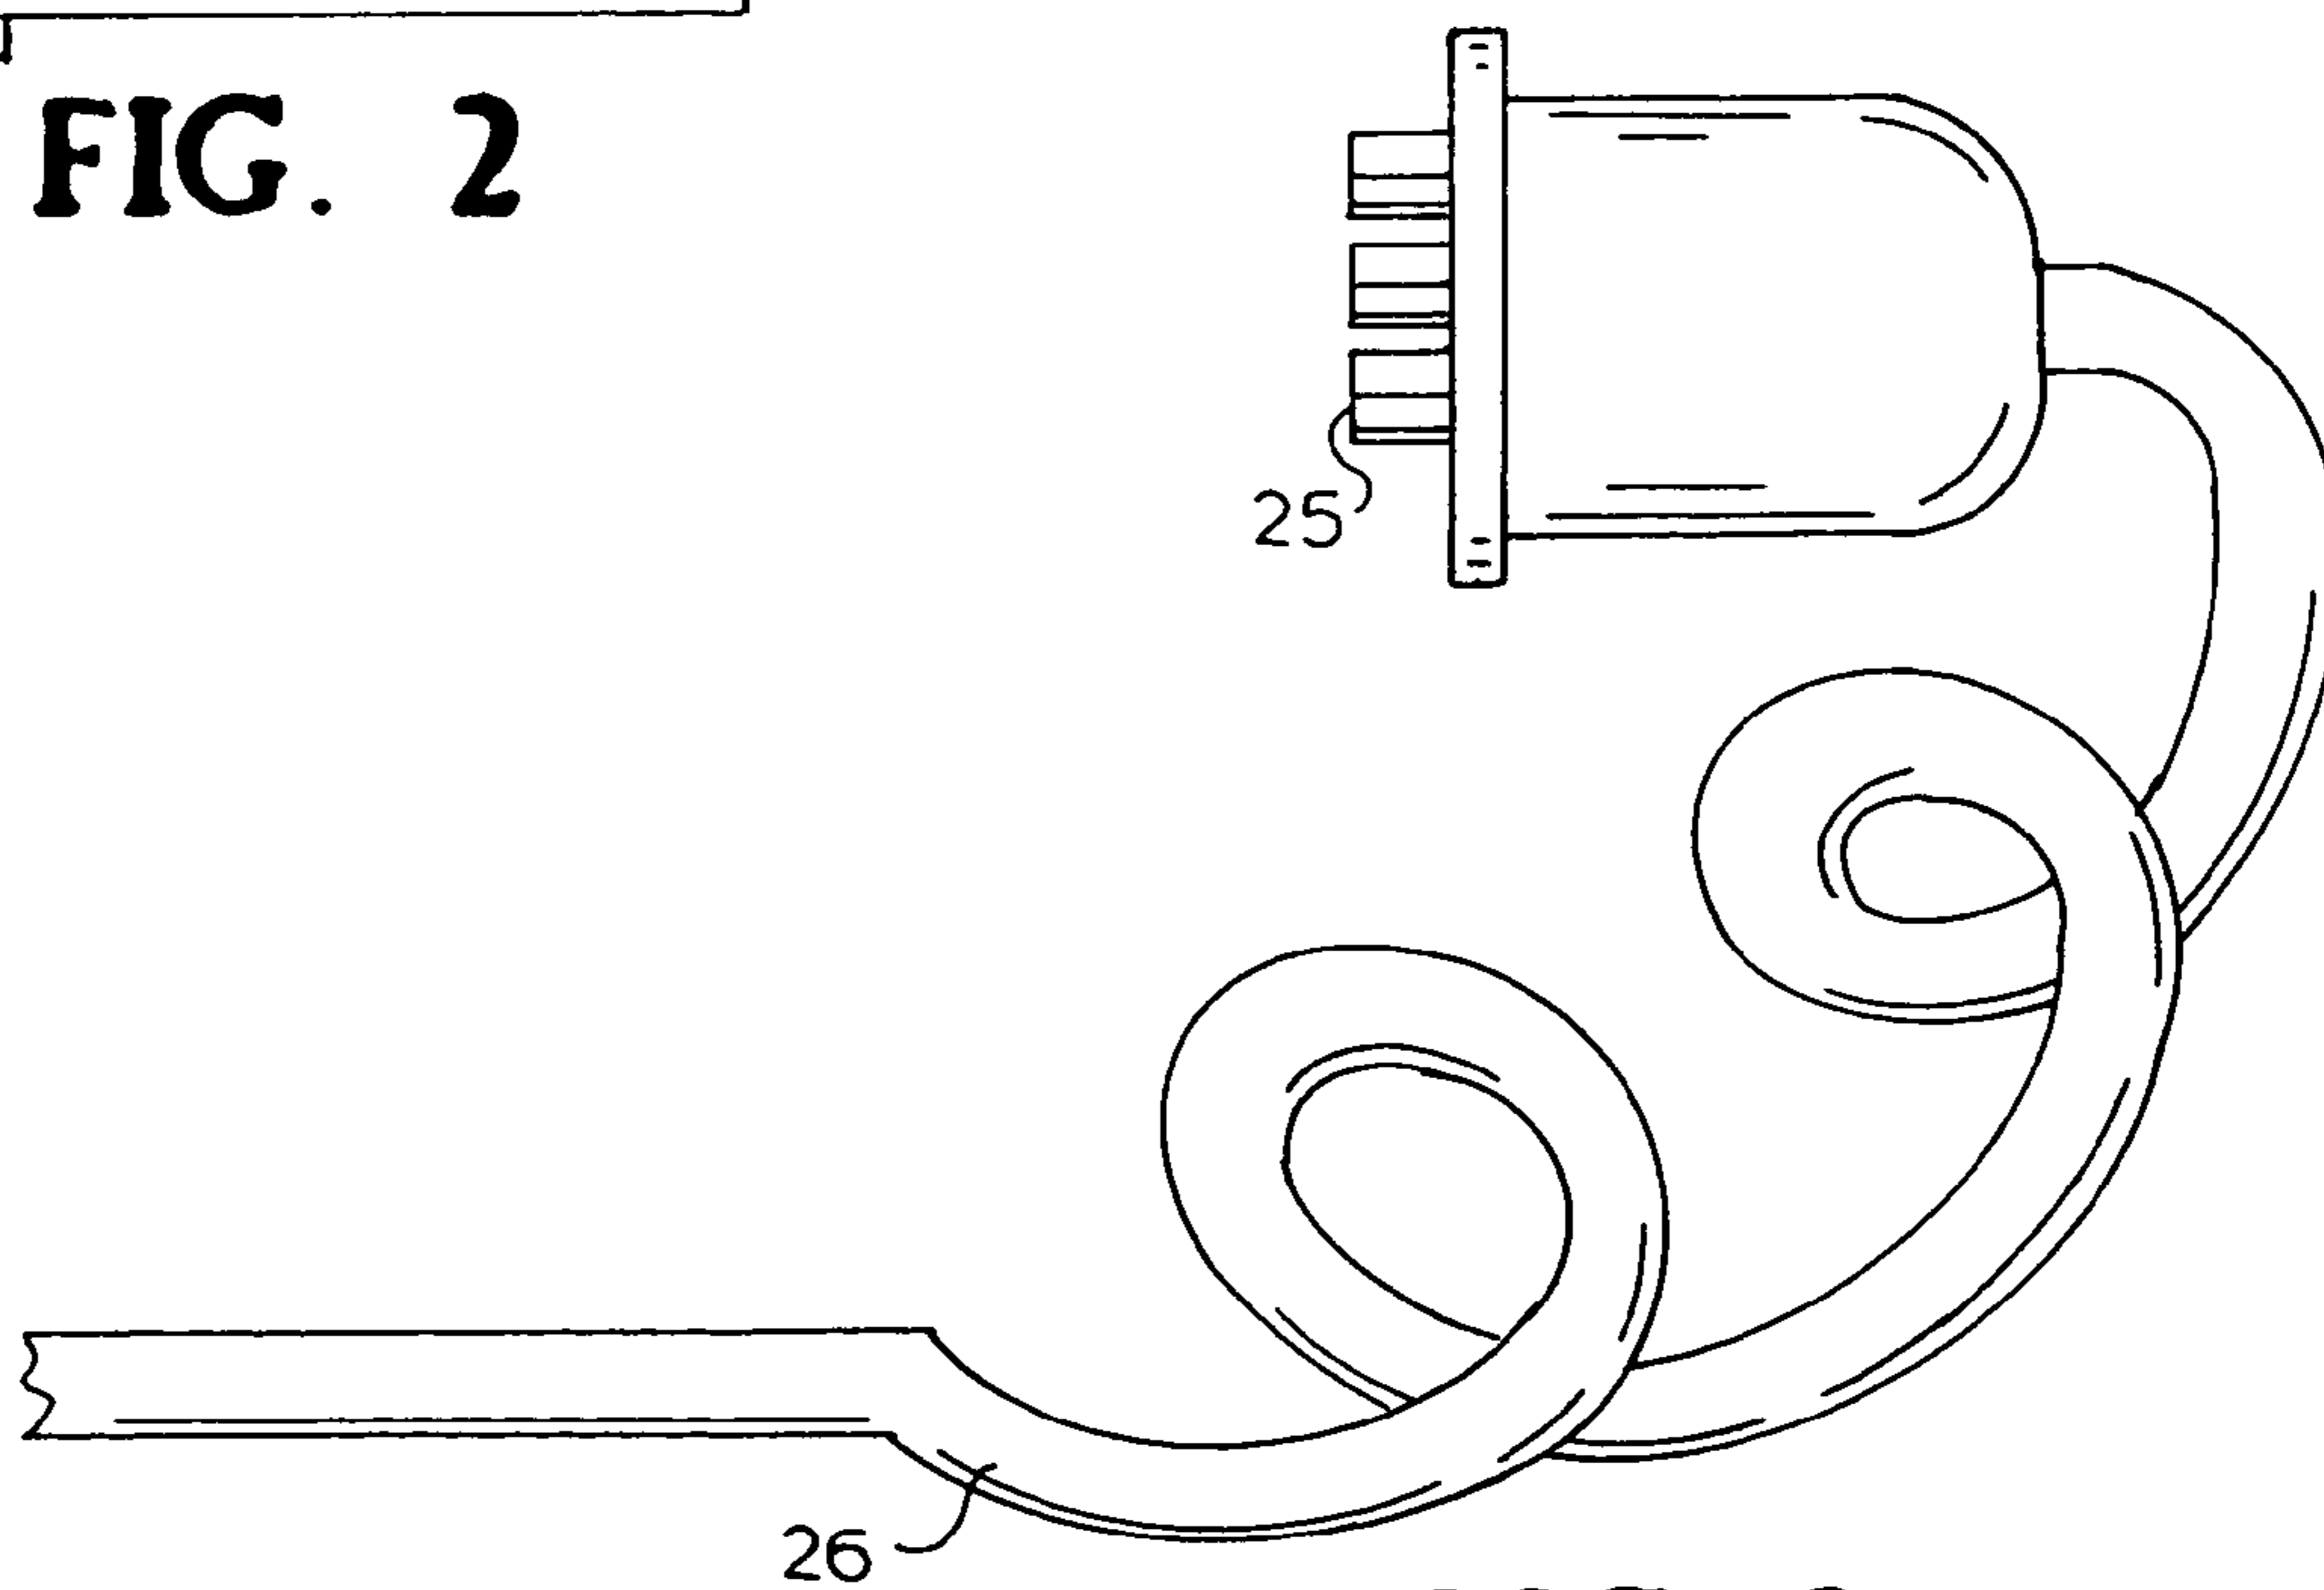
**FIG. 3**

FIG. 3 is a side view of the 5-prong output (25) that will connect to the reefer, and illustrates the pigtail (26) that will consist of a spiral/straight form as shown.

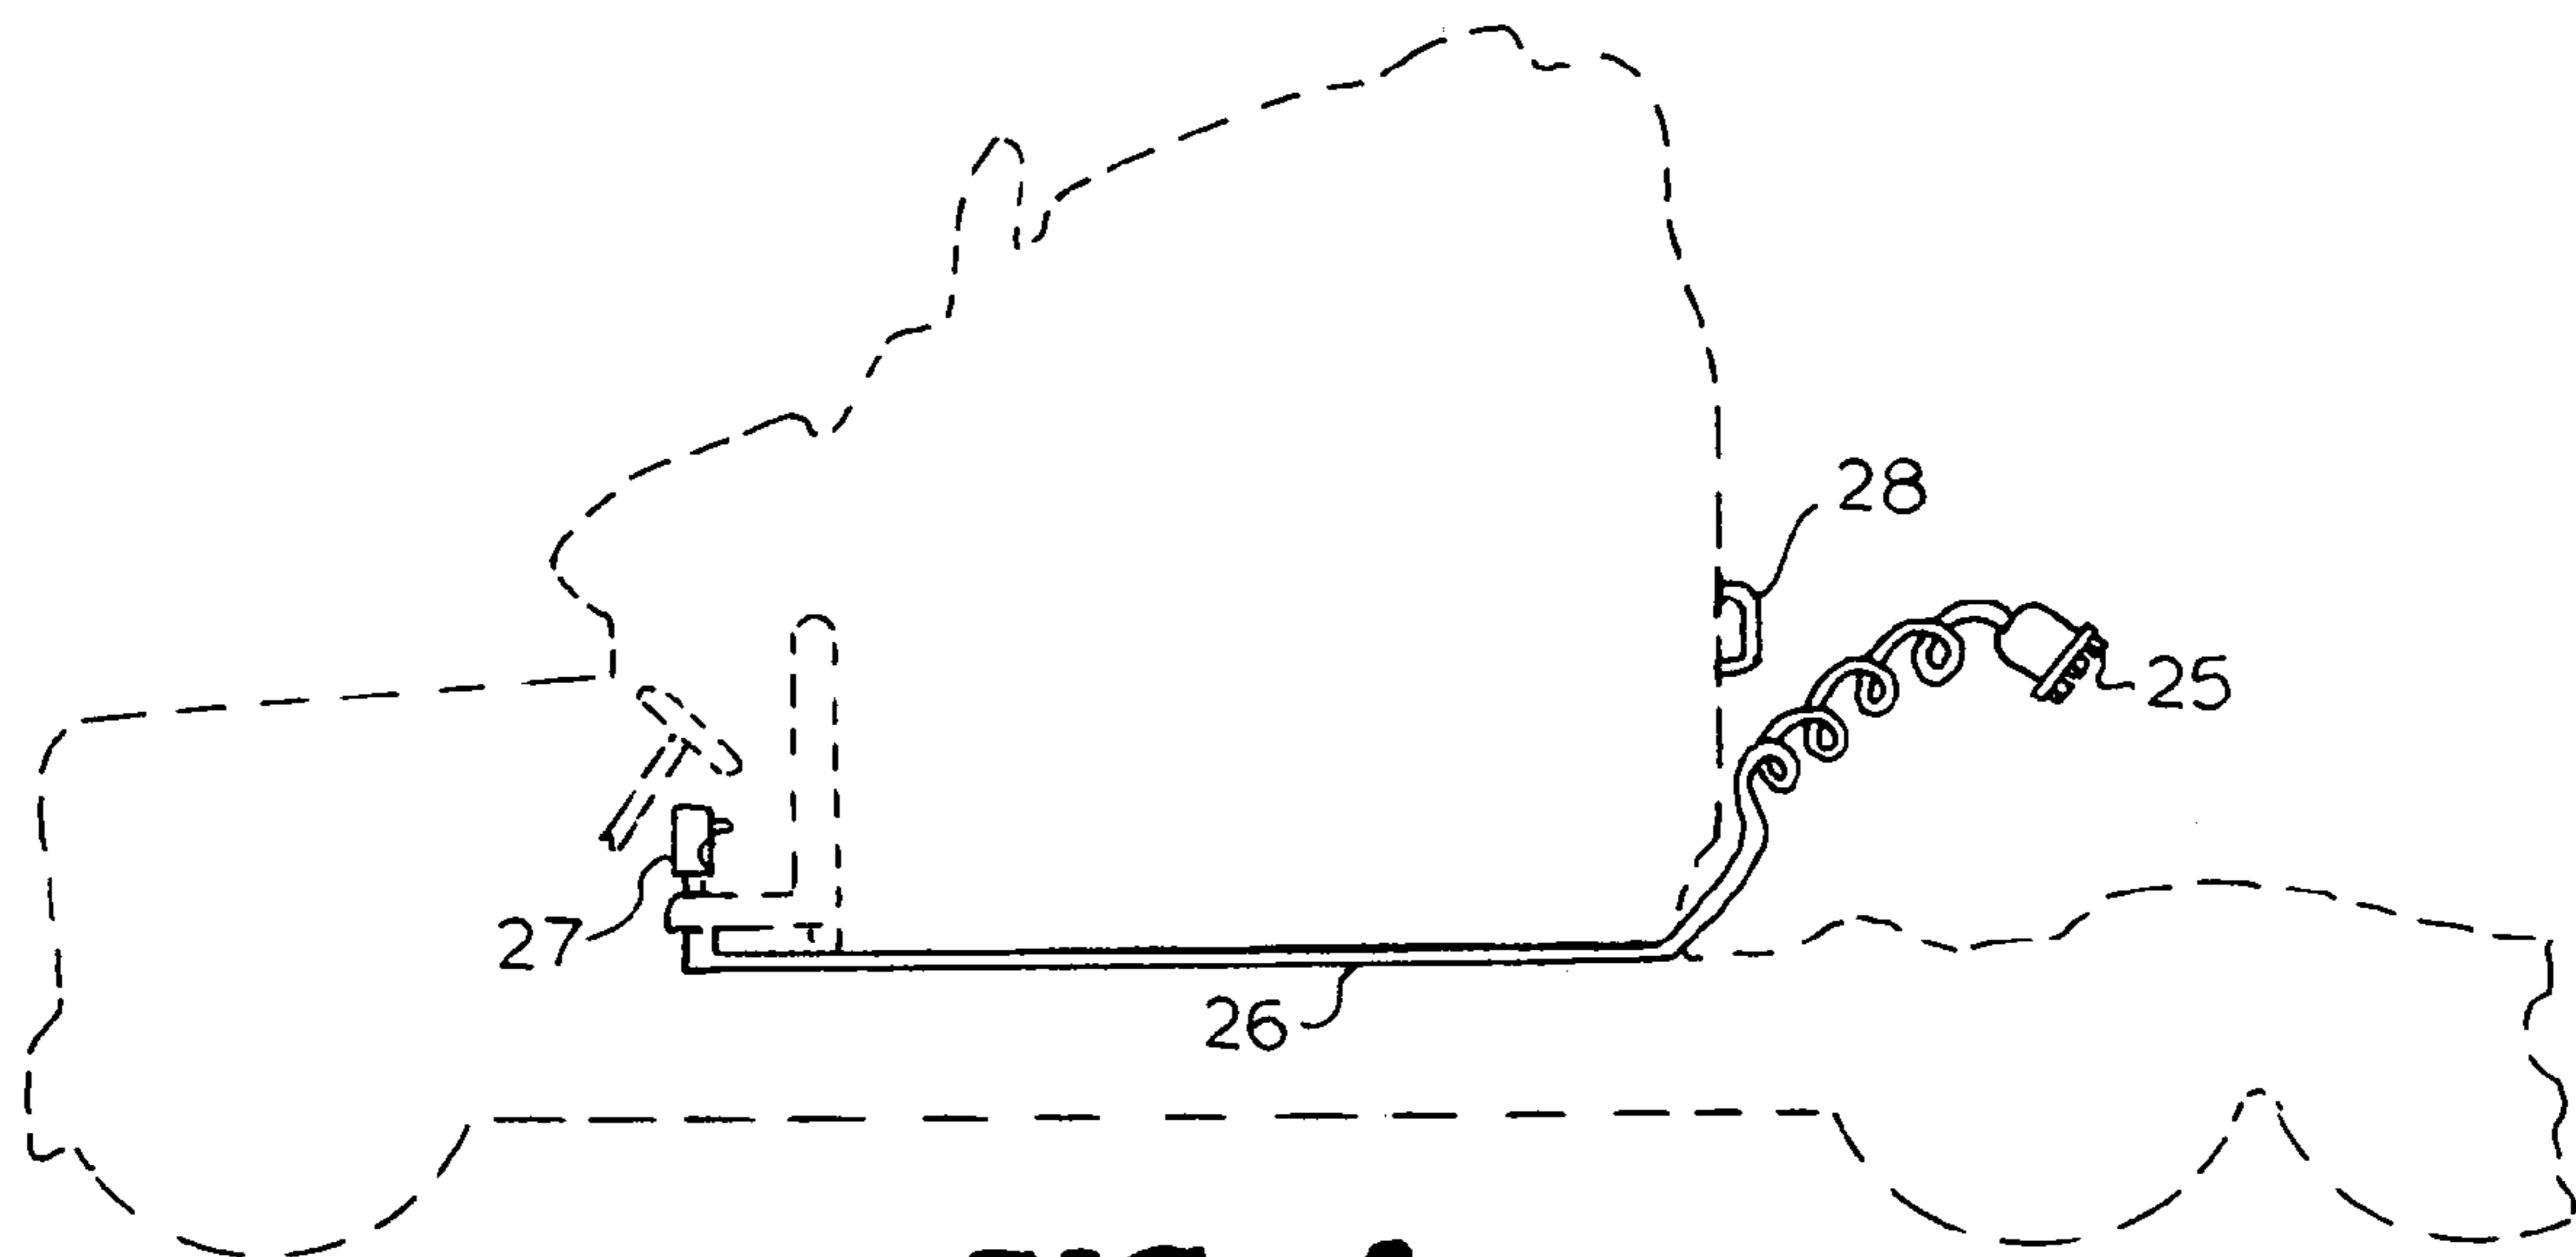
**FIG. 4**

FIG. 4 is a side view of the tractor showing the installations of the invention, illustrating the red laminated warning light and fault speaker (27), a metal bar (28) that will secure the pigtail (26), the 5-prong pigtail output (25) installed on the tractor, so that the pigtail (26) that will route under the tractor into the bottom of the cab.

The tractor will have a 5-prong output pigtail that will send the fault signal to the fault speaker and warning light unit, which will be installed in the cab of the tractor mounted on the lower dashboard.

The 5-prong output cord would route under the tractor, entering the cab of the tractor near the front of the dashboard.

FIG. 4 is a side view of the tractor showing the installations of the invention, illustrating the red laminated warning light and fault speaker, a metal bar that will secure the pigtail, the 5-prong pigtail output installed on the tractor, so that the pigtail that will route under the tractor into the bottom of the cab.

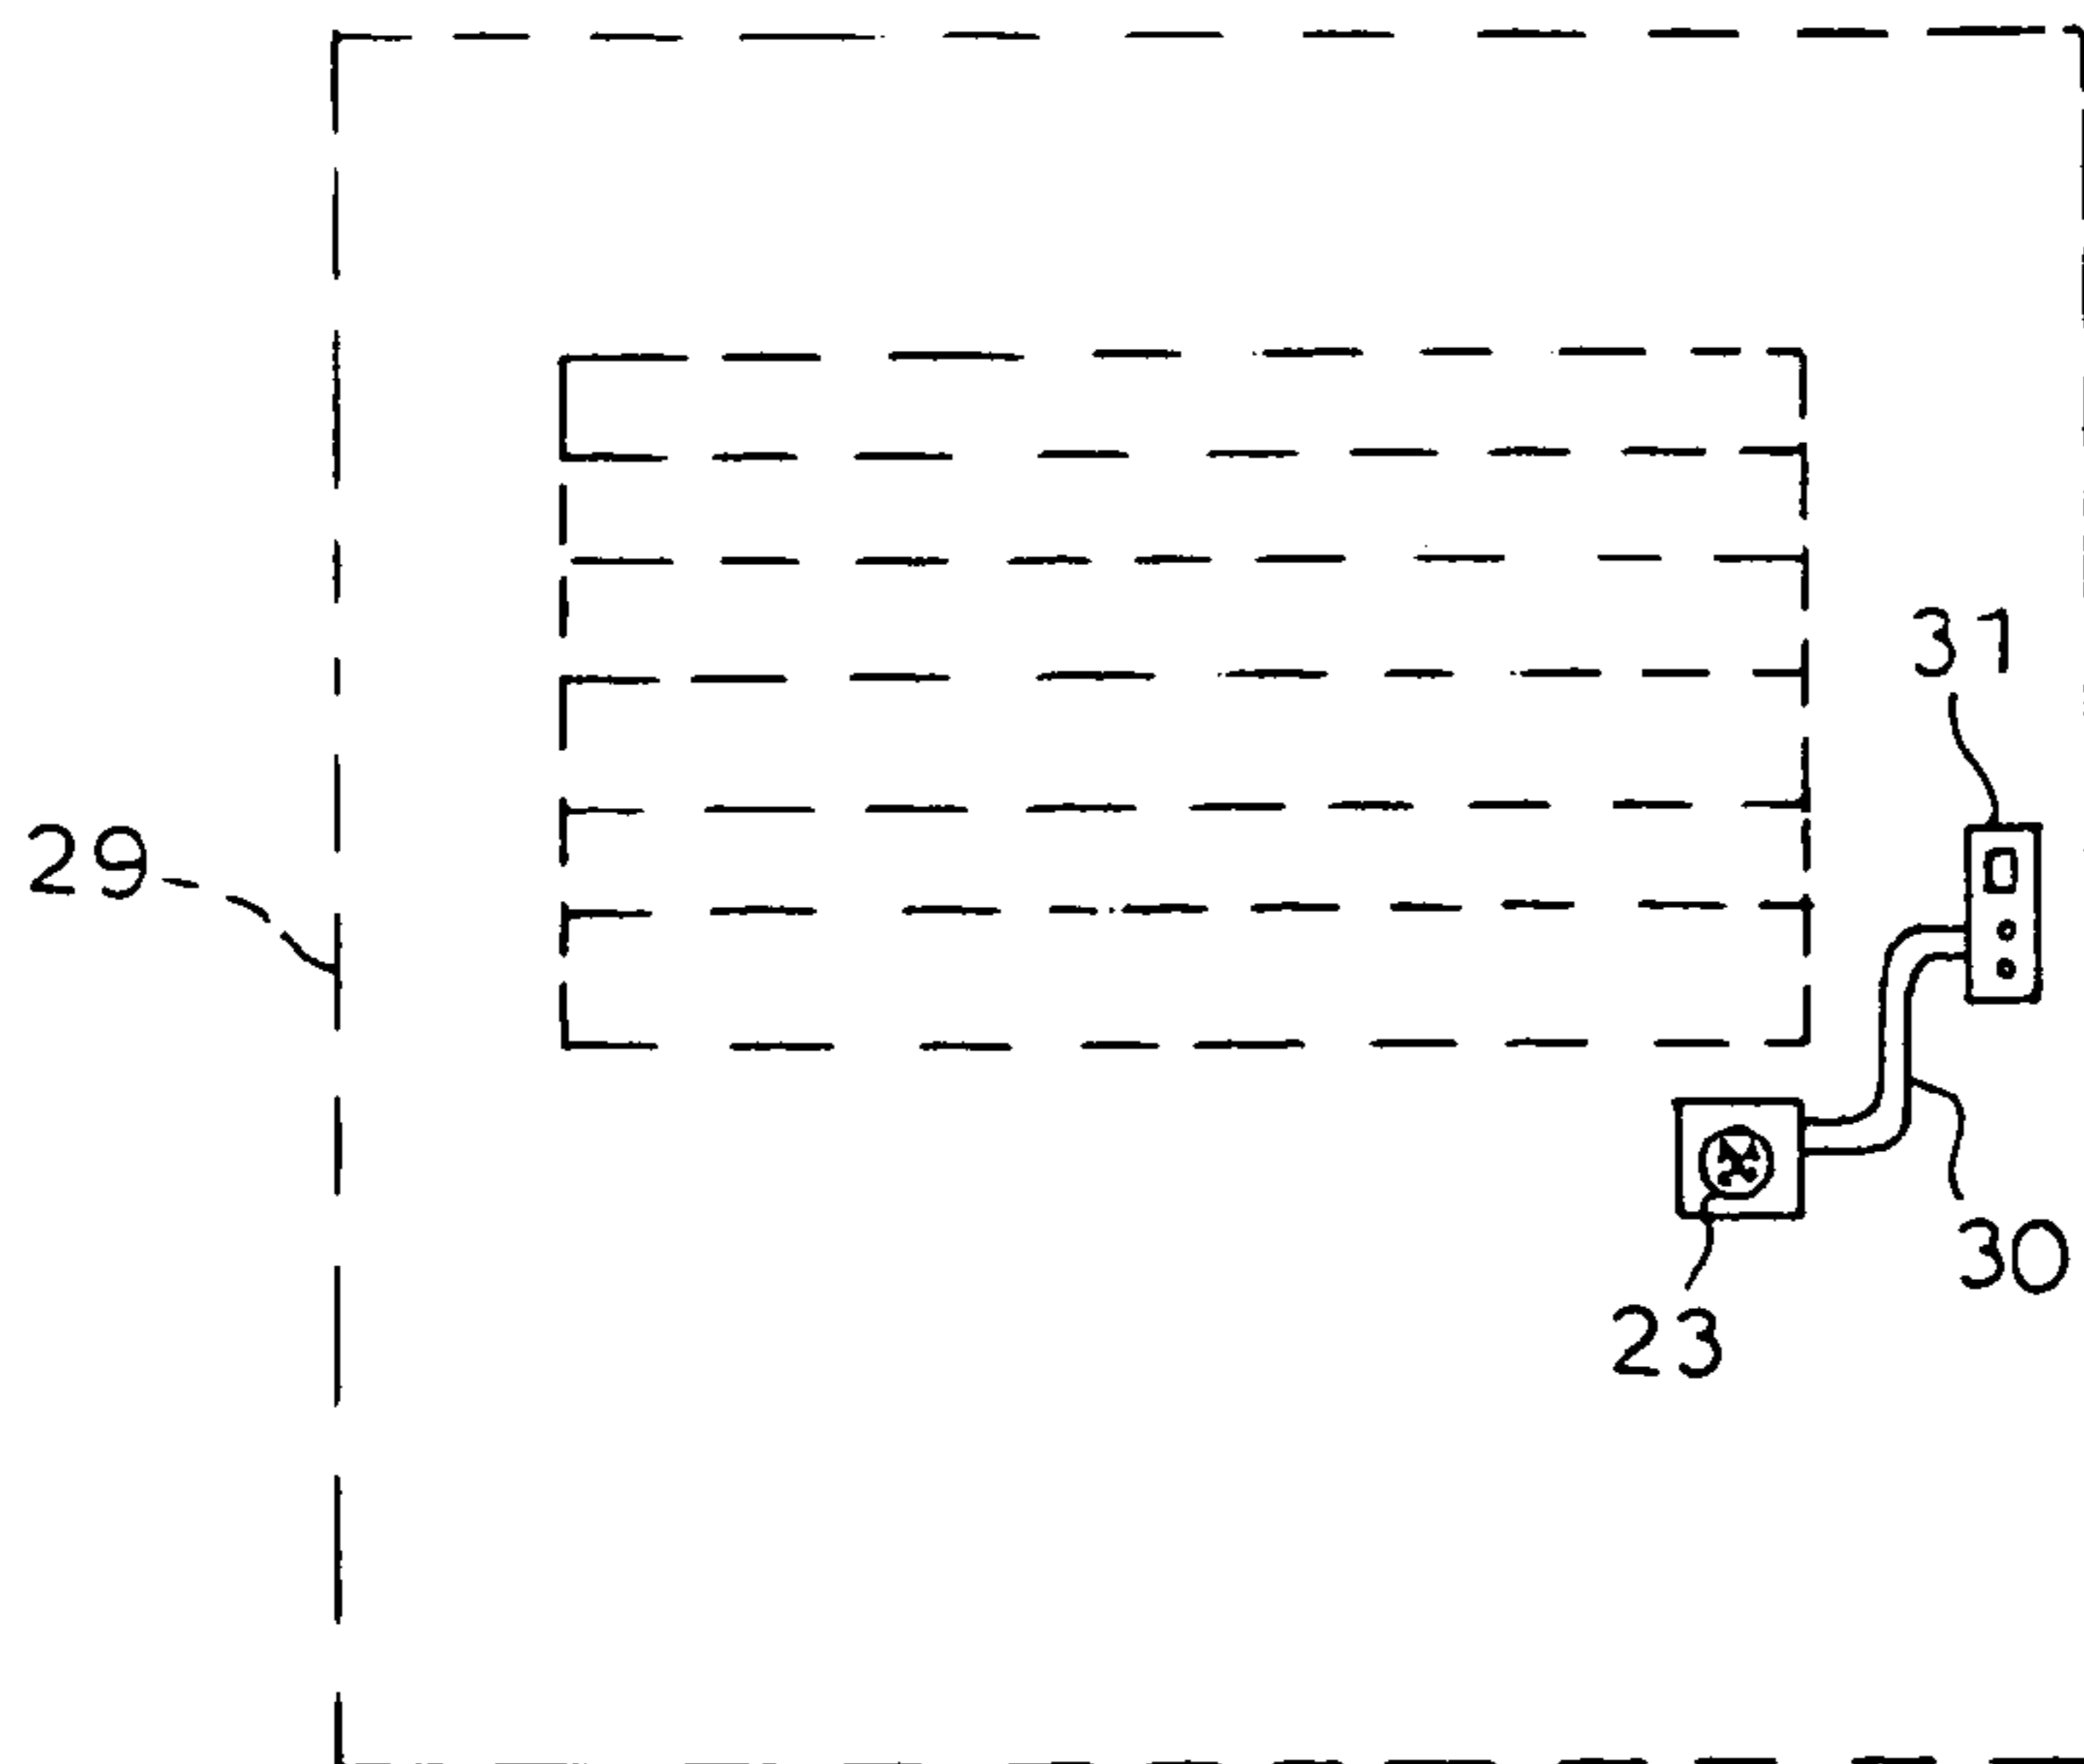
**FIG. 5**

FIG. 5 a front view of a reefer (29), showing the 5-plug sensor input (23) installed on the reefer, the extension cord (30) that will connect the existing indicator to the 5-plug sensor, and the existing indicator (31) and reset button.

FIG. 5 a front view of a reefer, is a front view of the 5-plug input sensor installed on the reefer into the existing warning indicator, is a view of the extension cord that will connect the existing indicator to the 5-plug sensor, is a illustration of the existing indicator and reset button.
